PROCEEDINGS OF THE 24th ANNUAL
HIGHWAY GEOLOGY SYMPOSIUM

SHERIDAN CENTER
SHERIDAN, WYOMING
AUGUST 9-10, 1973

Sponsored By
WYOMING STATE HIGHWAY DEPARTMENT

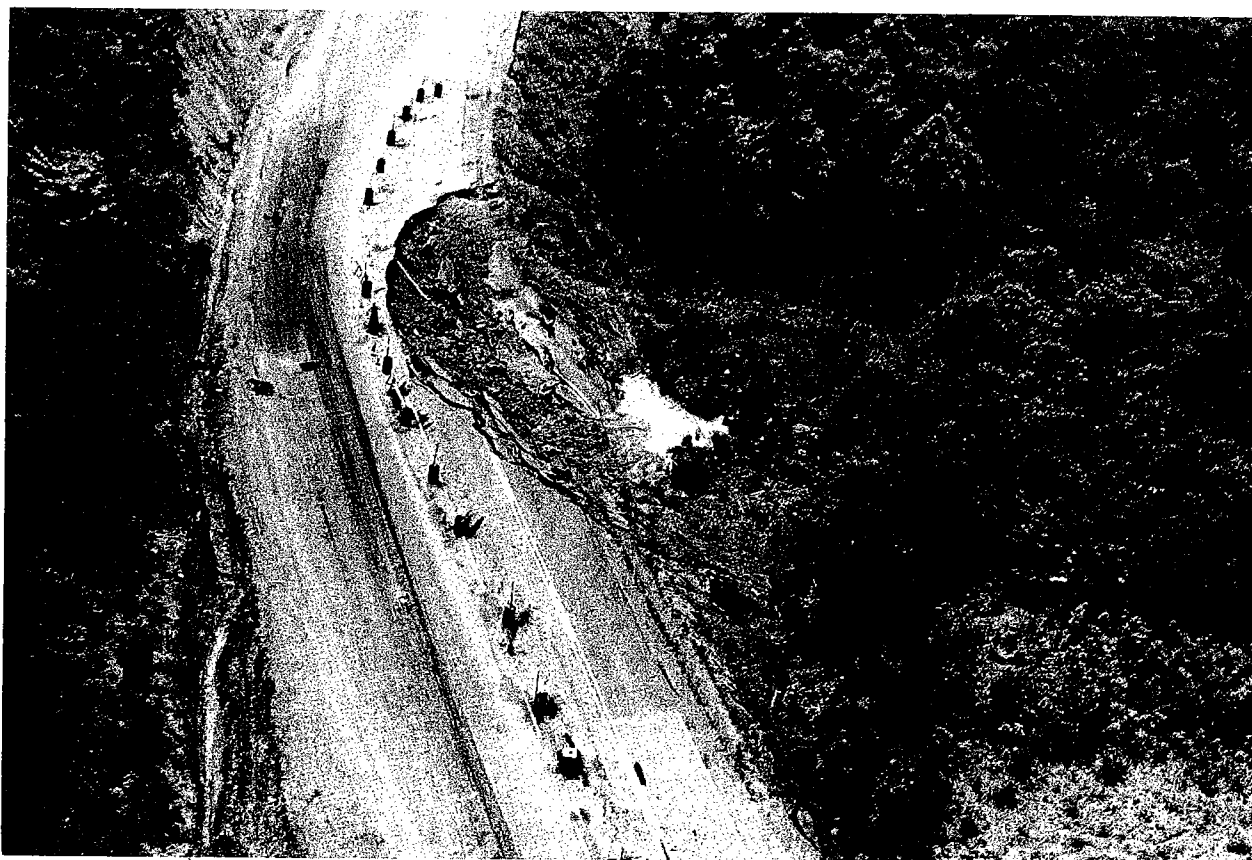
FIGURE 6. EMBANKMENT FAILURE ALONG STATE ROUTE 30 JUST EAST OF DAYTON IN RHEA COUNTY.

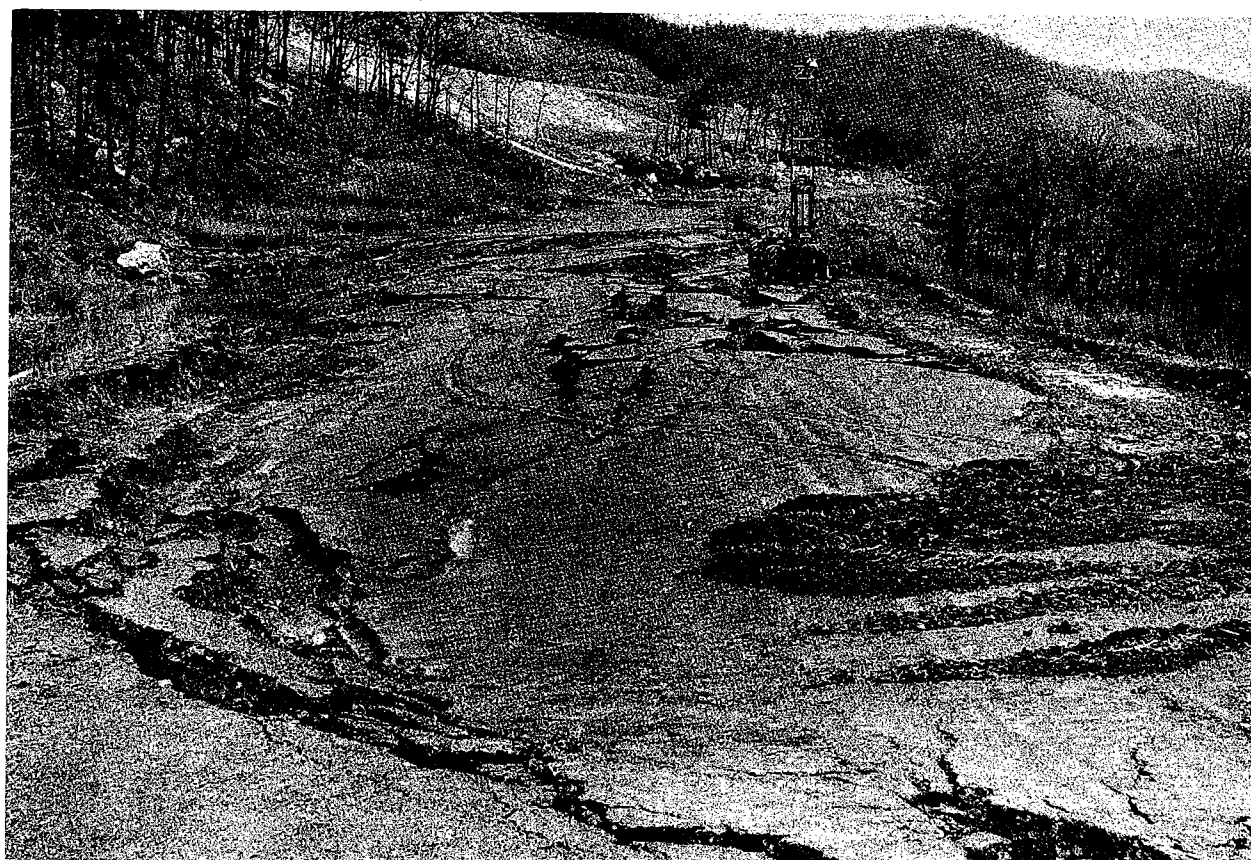
FIGURE 7. THIS FAILURE , ALONG I-40 AT ROCKWOOD, OCCURRED IN JAN., 1973 APPROXIMATELY FOUR YEARS AFTER CONSTRUCTION OF EMBANKMENT.

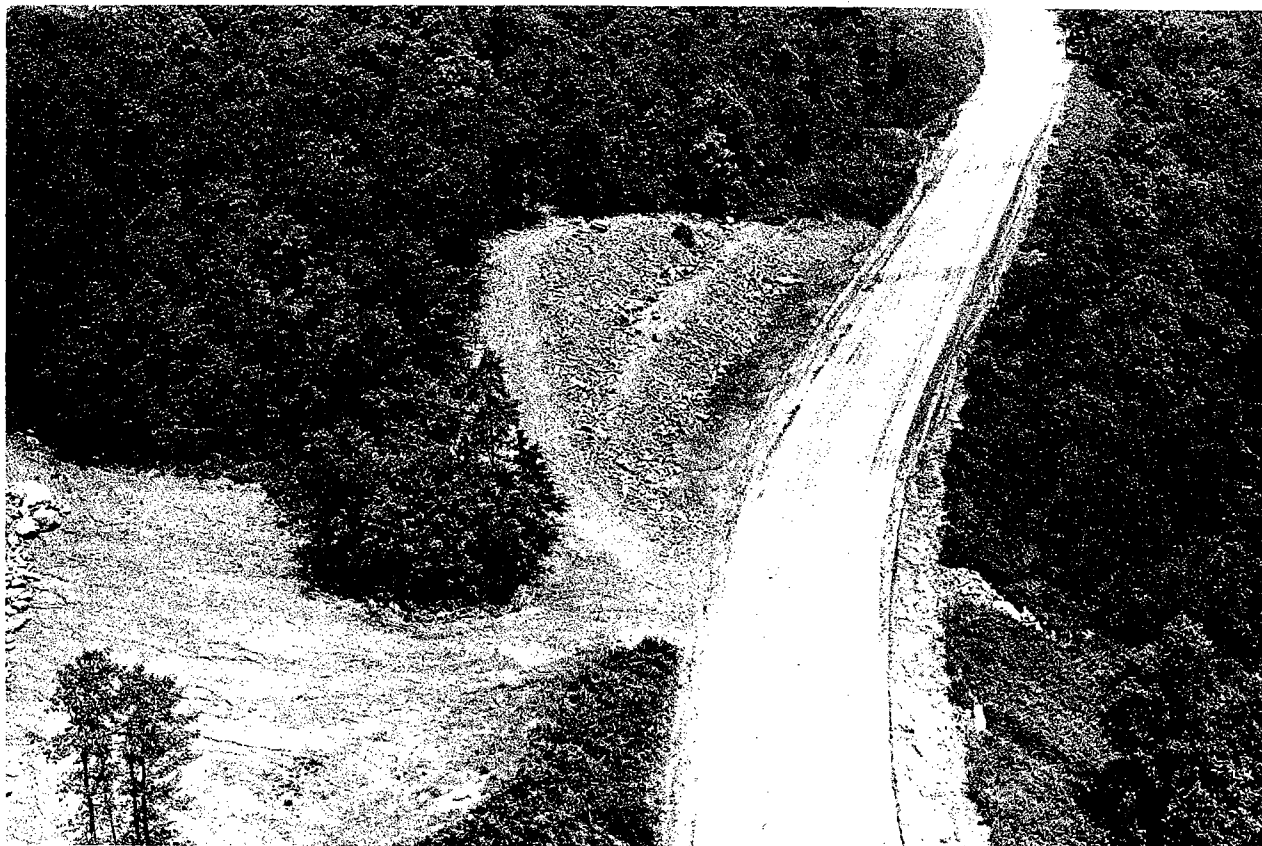
FIGURE 9. BUTTRESS BEING USED TO CONTROL SLIDE ALONG THE EAST-BOUND LANE OF I-40 AT ROCKWOOD.

Rock buttresses (Figures 8 and 9) are free-draining gravity structures consisting of large blocks of non-degradable sandstone or limestone. The gradation being used calls for 50% of the material to be greater than one cubic foot, with no more than 10% passing the #2 sieve. Because of its free-draining characteristics, the rock buttress works well in restraining colluvial slides. Movement is prevented by restraint while at the same time allowing

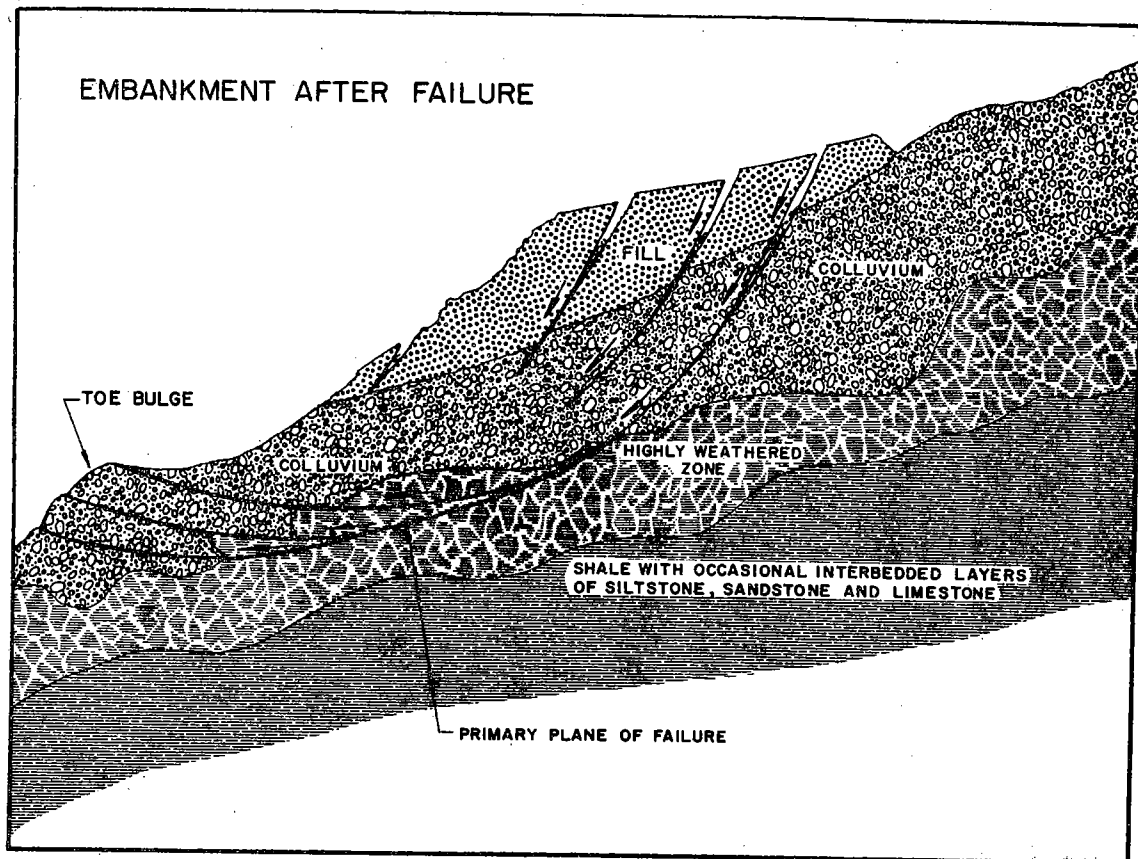
FIGURE 13. SCHEMATIC VIEW OF SLIDE 10 IN THE EAST - BOUND LANE .

and 14) is an example of a fill failure in which the removal and replacement method has been used. In this case the rock pad, which is made up of buttress-type rock, serves as the foundation for the fill while at the same time serving as a drainage outlet and as a buttress against further upslope movement. The reinforced earth structure (Figure 12) was designed with the same principle in mind.

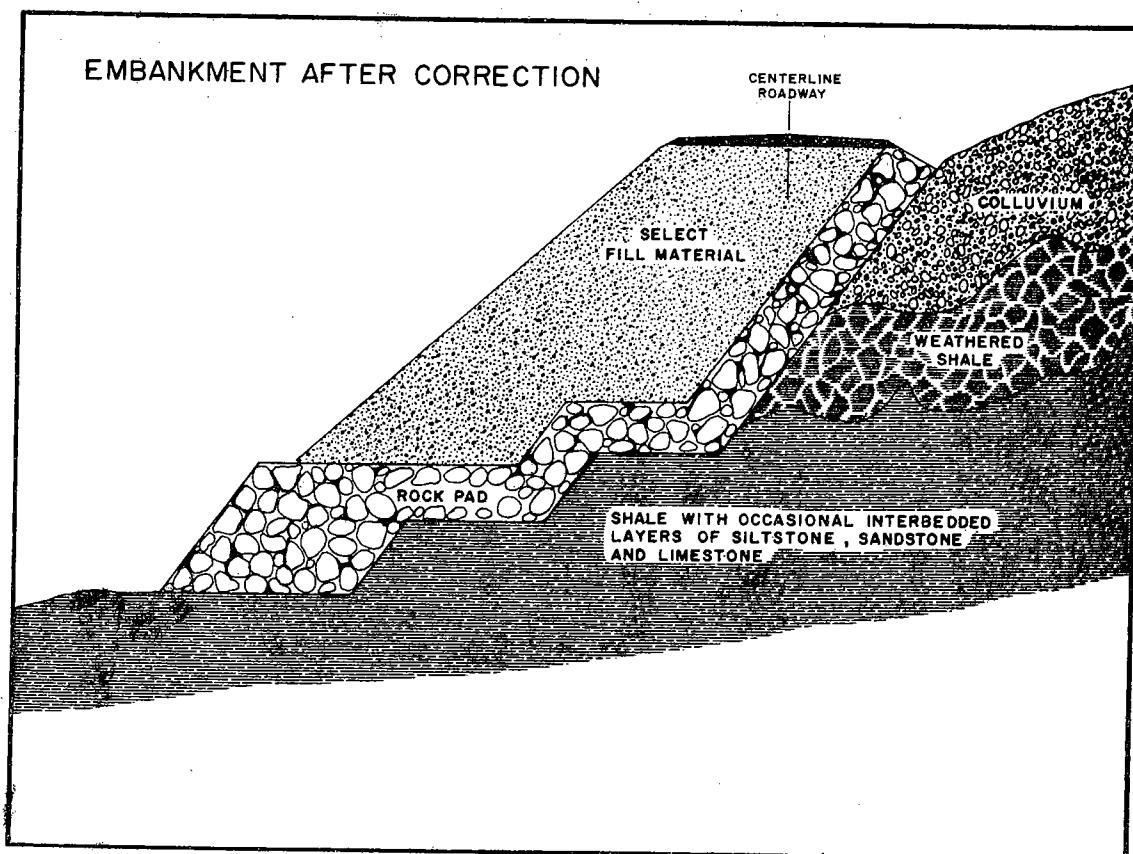
FIGURE 14. DESIGN USED TO REPAIR SLIDE 10 .

Removal and Replacement (Slide #10, East-Bound Lane)

(See Figures 13 and 14)
Length: 600'
Excavation: 125,585 cu/yds. at \$1.97
Excavation cost: \$247,403.00
Rock pad: 29,073 cu/yds. at \$6.00
Rock pad cost: \$174,439.00
Soil replacement: 85,095 cu/yds. at \$1.97
Soil replacement cost: \$167,637.74
Total costs: \$589,480.00

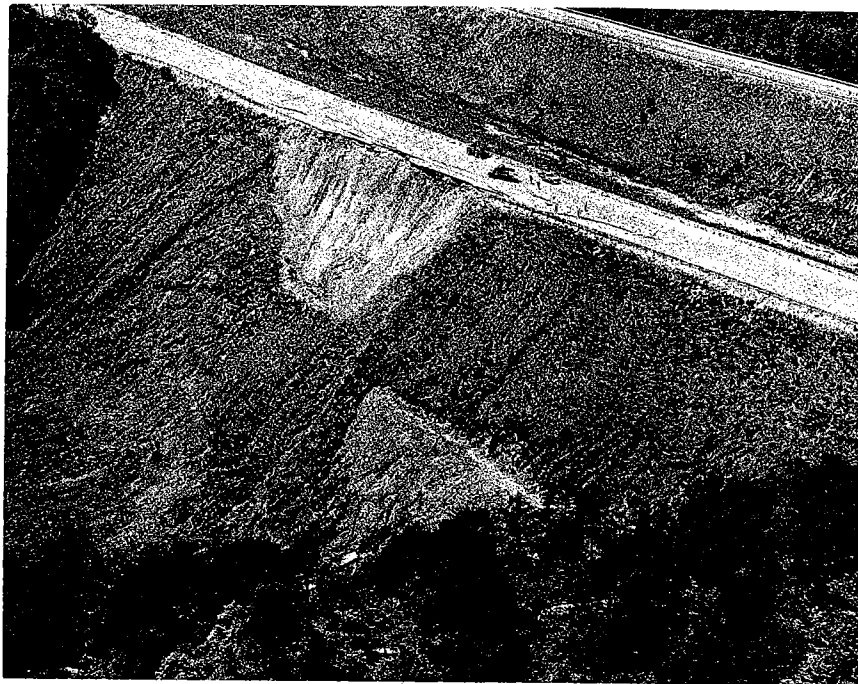
FIGURE 15. AERIAL VIEW OF AN EMBANKMENT FAILURE THAT OCCURRED ALONG THE NORTH-BOUND LANE OF I-75 IN APRIL, 1972 .

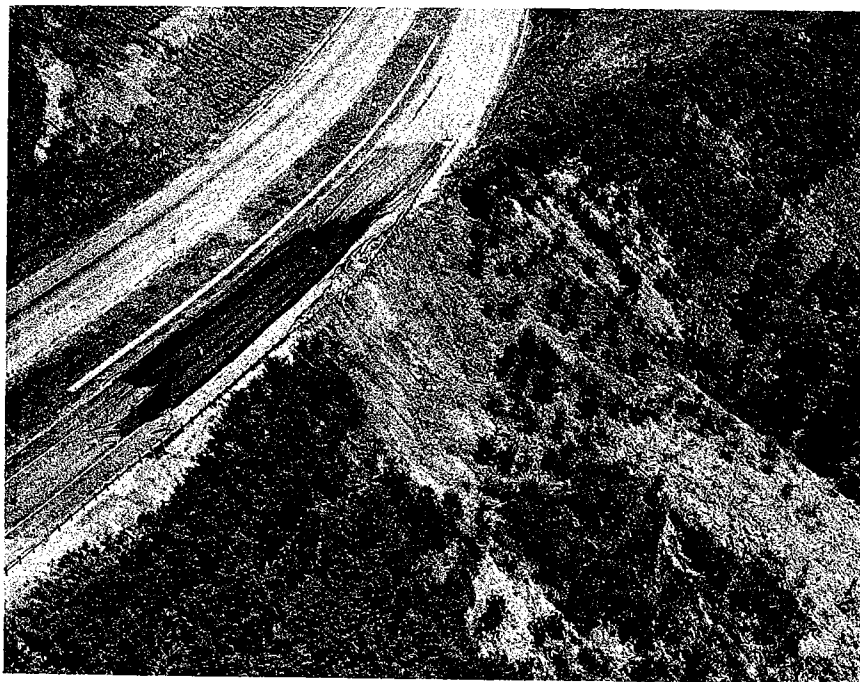
FIGURE 16 . THE 840+00 (S.B.L.) FAILURE ALONG I-75 AS IT APPEARED IN APRIL, 1972 .

To lower the water table at the 840+00 (south-bound lane) slide (Figures 16 and 19), the Department employed a different method. There, twelve 100 foot vertical wells were drilled on 25-foot centers along the median above the slide, and equipped with $\frac{1}{2}$ hp. submersible automatically actuating pumps. Horizontal drains could not be used because of the height, steepness and deteriorated condition of the outside slope. Since the 840+00 slide was to be repaired using the removal and replacement method, and since the removal of this material was expected to jeopardize the stability of the north-bound lane, it was determined that the median area had to be dewatered. This would, hopefully, result in a shear strength increase of the material that was to be exposed in the median. As it was, the 1:1 slope (Figure 20) remained well intact to the full removal depth. Those who were involved in the

construction of the 840+00 repair on a day-to-day basis .
unanimously agreed that the stability of the median slope
had to be attributed to the dewatering operation.

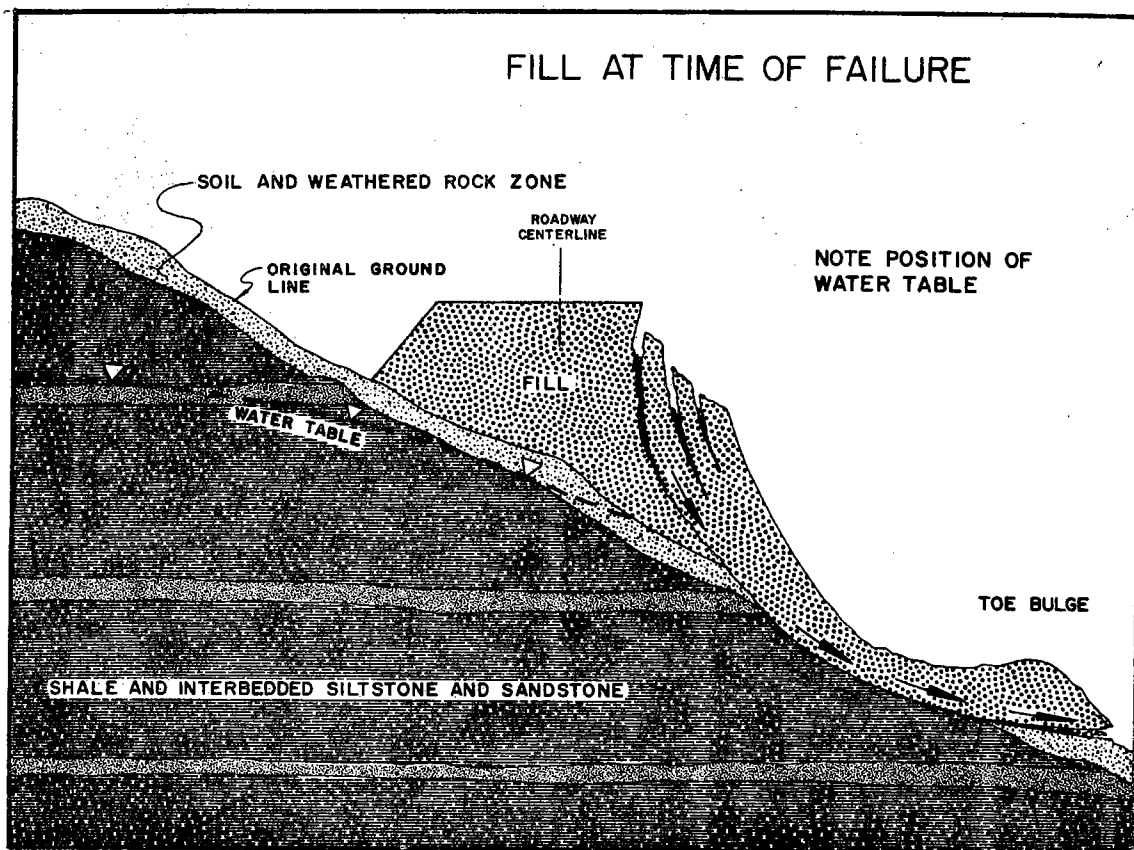
FIGURE 17. SCHEMATIC OF THE 1464+00 (N.B.L.) FILL FAILURE .

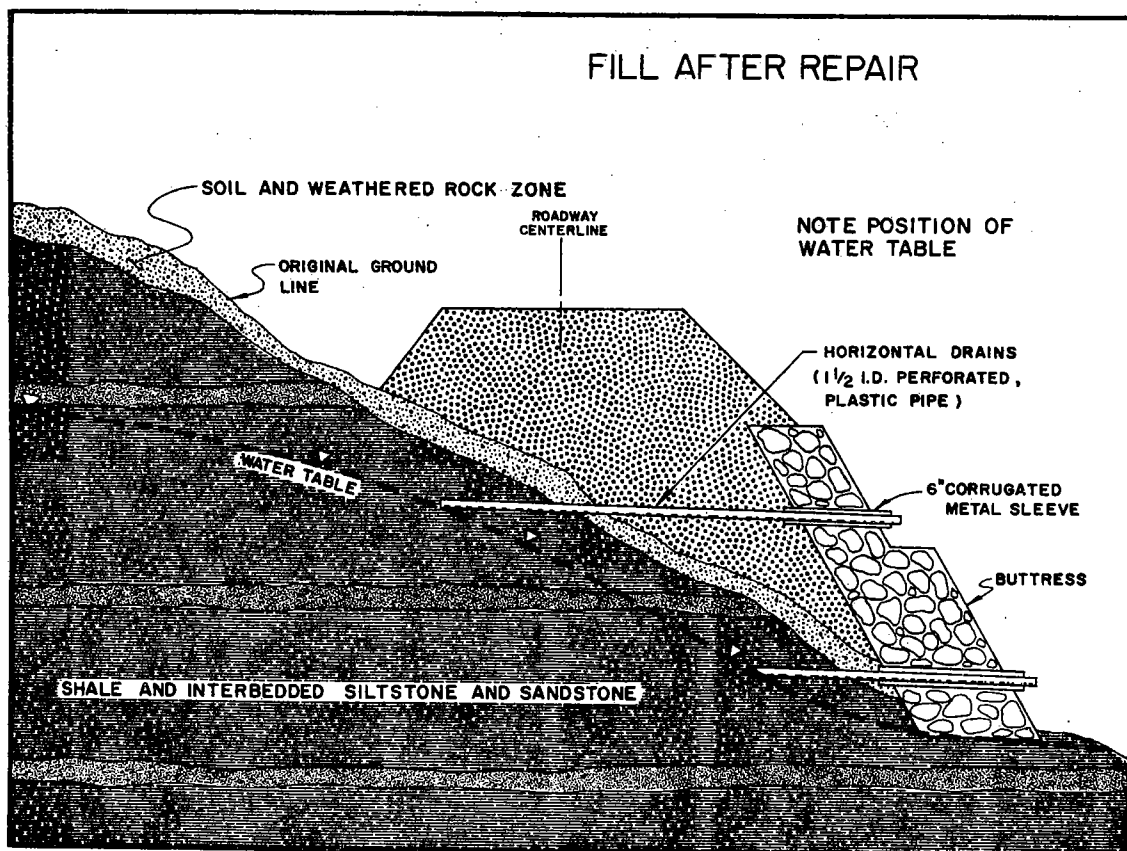
FIGURE 18. SCHEMATIC OF THE REPAIRED 1464 + 00 FILL .

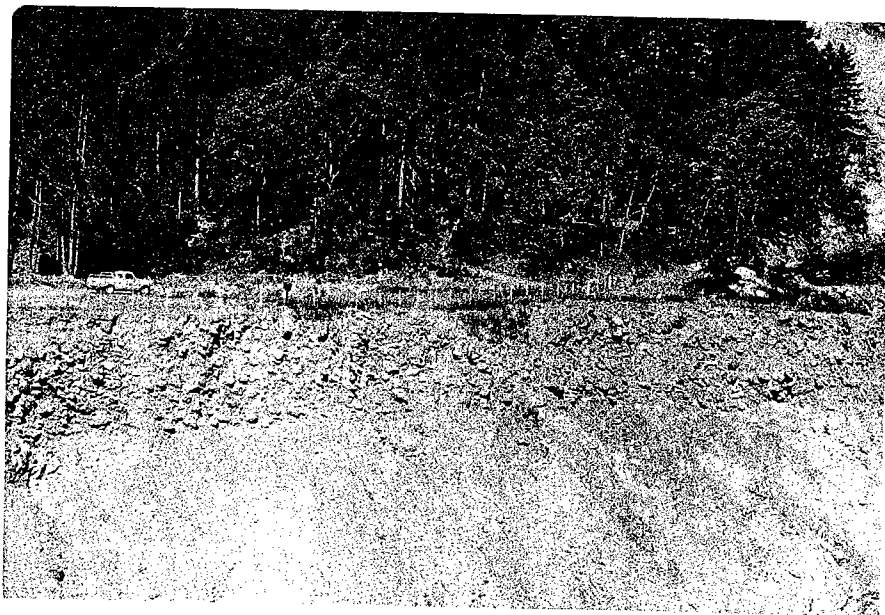
Photo 1

A cross section of Bluff Creek's channel exposed by the capture (see Photo 1) shows that apparently during the 1964 flood an additional 2 m (7 ft) of alluvium was deposited over the existing alluvium in Bluff Creek at the base of the divide. The grey color of this material in comparison with the red alluvium underlying it suggests that it is relatively fresh and probably derived from debris slides initiated upstream by the floodwaters. With the deposition of this material, the difference between the top of the divide and the channel of Bluff Creek was reduced to only about 6 m (20 ft).

Alluvial deposits overlying serpentinite bedrock exposed in gorge cut in abandoned reach of Bluff Creek. Gray layer at the top represents material deposited during the 1964 flood.

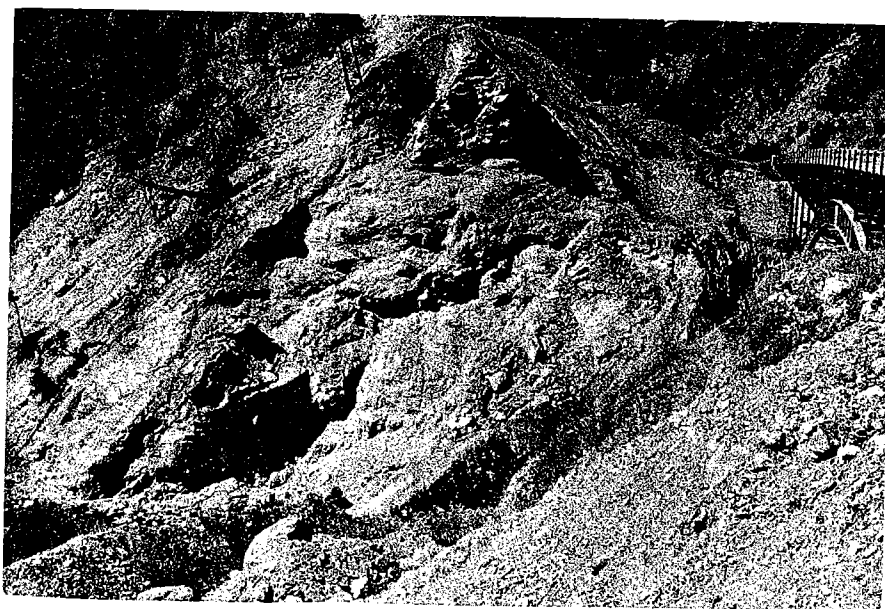
Photo 2

Boundary fault shear zone exposed in eroded divide. Greenschist overlies serpentinite. Note small rotational-translational slide in greenschist failing along shear zone.

The other possible mechanism involves a prominent rock structure defect in the divide. The defect is a shear zone, representing the Boundary Fault, which is several meters (~10 ft) wide in greenschist and serpentinite. From its orientation, as seen in the exposed cross section of the breached divide, it appears to have sliced through the divide, striking approximately parallel to it and dipping about 35° away from Bluff Creek, towards the Klamath River with greenschist overlying serpentinite (see Photo 2). In the divide, it apparently daylighted at the Bluff Creek channel on one side and on the other side at the Klamath River. A landslide along this shear zone could have removed the overlying greenschist, reducing the height of the divide by about 6 m (20 ft) or to the level of the Bluff Creek channel. A small landslide exposed on the south wall of the breached divide (Photo 2) and a larger landslide immediately north of the breach have both failed in a translational sense along this shear zone. They may be the remnants of a slide which removed the divide.

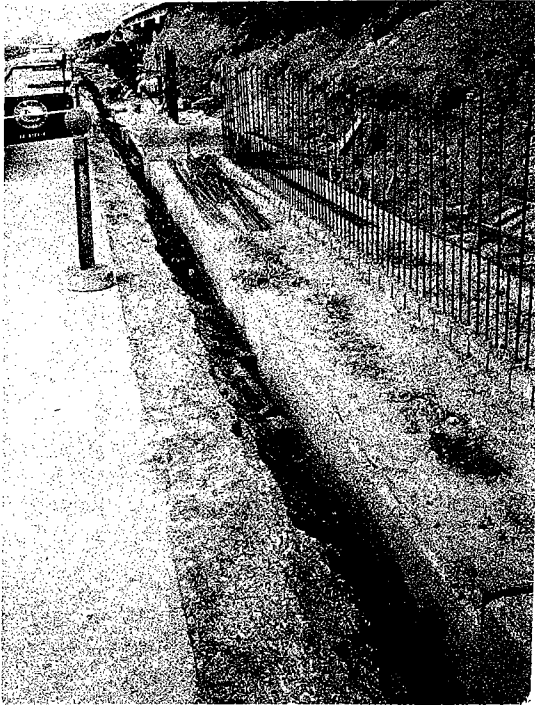
Fig. 11

Photos showing retaining wall foundations also shown in Figures 9 and 10. Distress cracks are indicated. Scale is indicated by pocket knife.
