61st HIGHWAY GEOLOGY SYMPOSIUM

Oklahoma City, Oklahoma

August 23rd - 26th, 2010

PROCEEDINGS

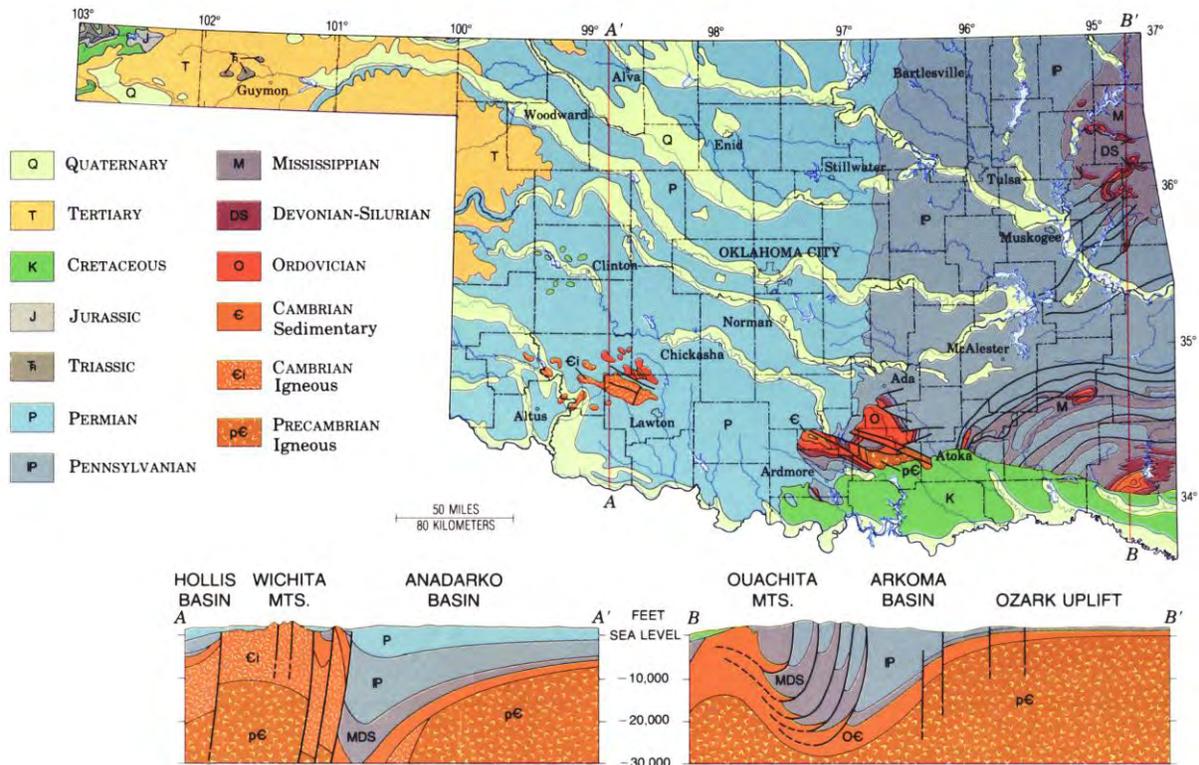
Fig. 2. Generalized geologic map and cross sections that show the subsurface configuration of rock units in Oklahoma.

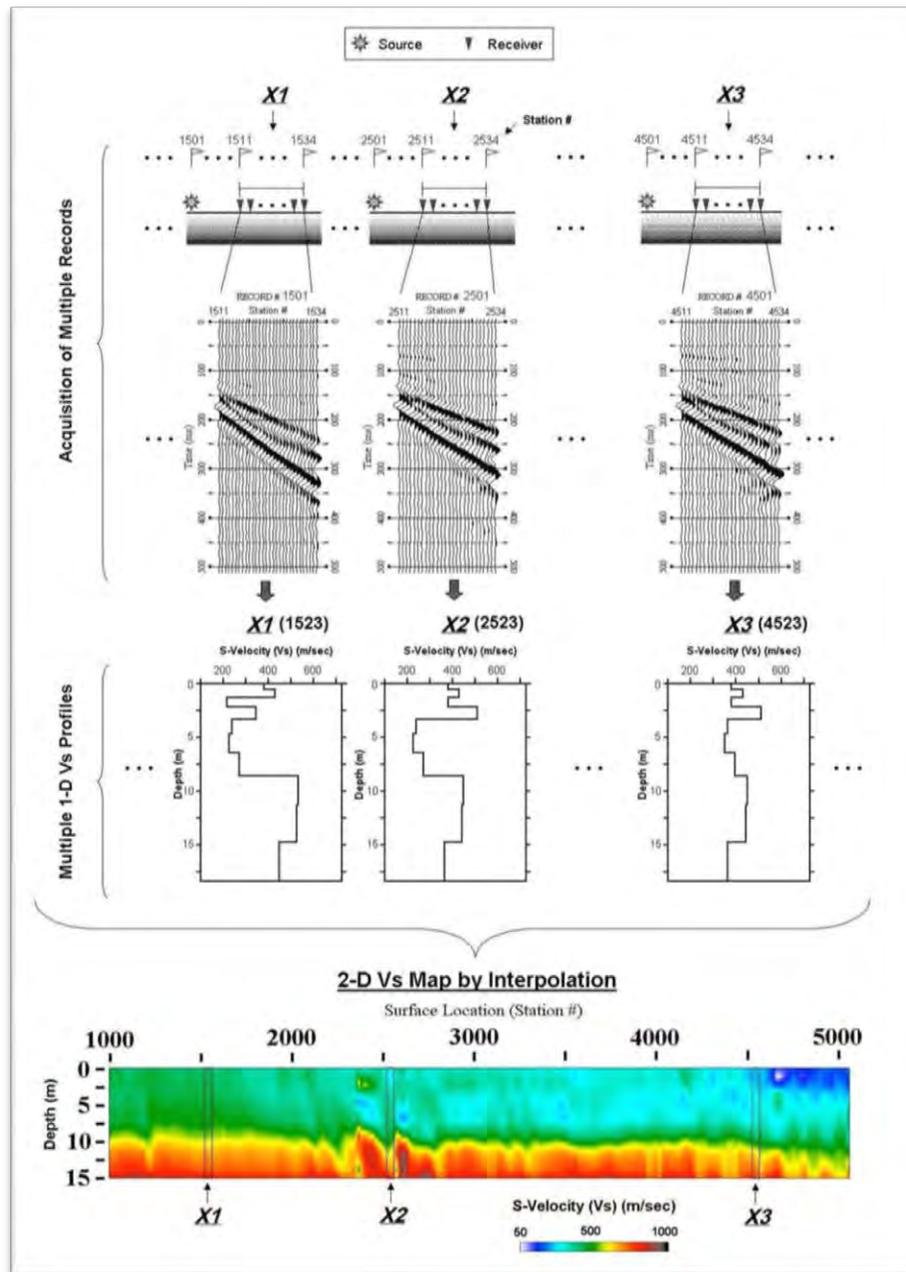
Figure 2 – Illustration of the procedure to generate a 2-D Vs profile from a roll-along mode MASW survey. Reprinted by permission from Kansas Geological Survey Open-file Report 2004-30, MASW to Map Shear Wave Velocity of Soil.

Shot records are made at a pre-determined interval along a survey line in a mode known as “roll-along” - the shot and receiver spread geometry stays fixed while being moved along a line. Each record is then processed and inverted into a 1-D profile of shear wave velocities. The 1-D s-wave profile is analogous to a boring log. A 2-D s-wave profile is created by interpolating between the 1-D profiles from multiple shot records. This process is illustrated in Figure 2.

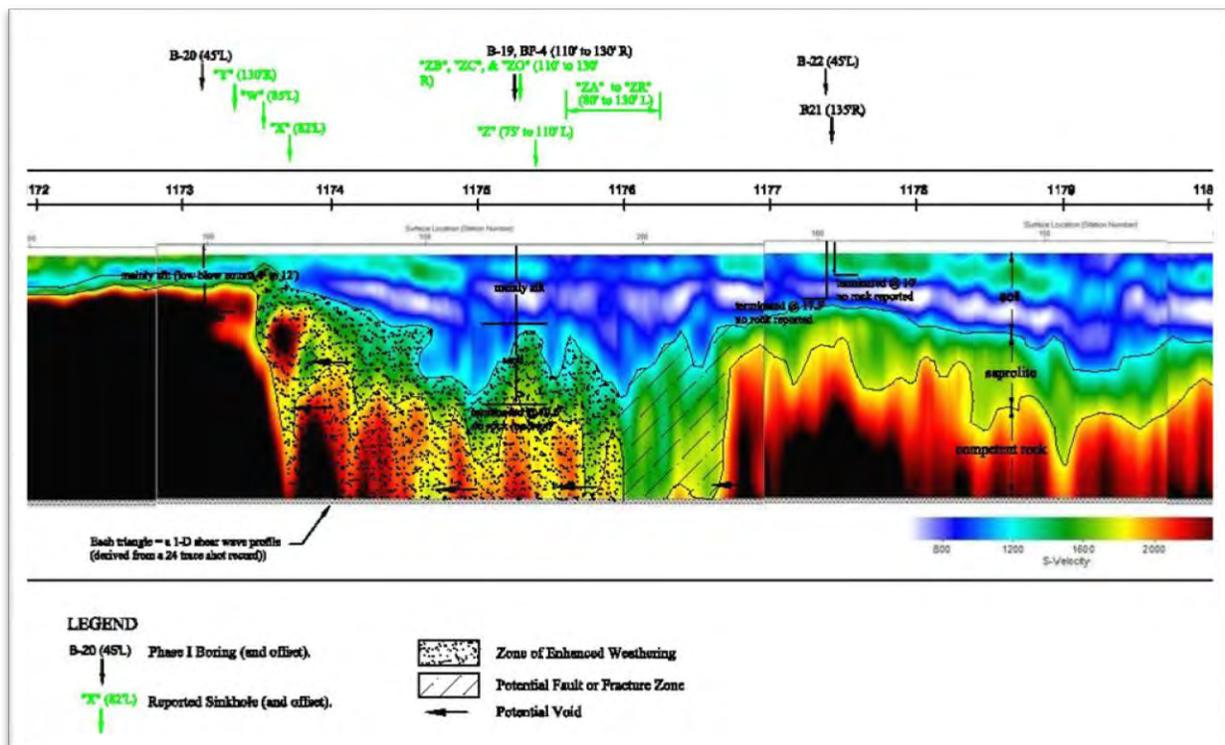
Figure 3 – Vs profile showing reported sinkholes associated with the transition between shallow, competent rock and enhanced weathered rock, and a potential fault or fracture zone. Reported sinkholes are projected into profile. Borings (Phase I) preceded the MASW survey.

The MASW survey linked 44 of 52 reported sinkholes to the following subsurface conditions: 1) the transition from shallow competent rock to enhanced weathered rock, 2) a potential fracture zone or fault, 3) pinnacled rock, and 4) potential voids. These observations were later confirmed by another round of drilling (Phase II). Figure 3 shows a representative MASW-derived Vs profile that was acquired in 1 night of work. The profile is 800 feet long and is constructed from a total of 267 1-D Vs profiles spaced 3 feet apart.

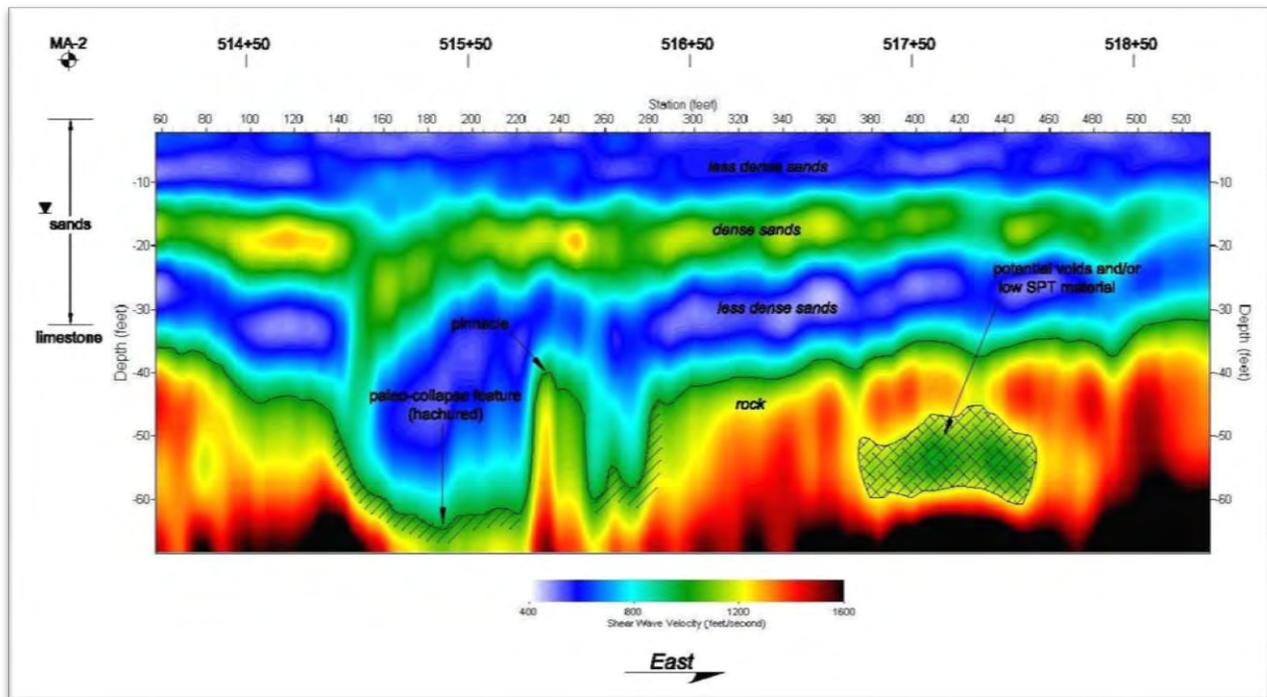
Figure 4 – Vs profile of a paleo-collapse feature (relic sinkhole), a pinnacle, and a low velocity anomaly indicating a potential void or low SPT material. Boring preceded the MASW survey.

Again, where site conditions precluded the use of ERI, MASW was very effective in identifying subsurface conditions associated with sink activity. Figure 4 is a 460-foot long MASW-derived Vs profile that shows a paleo-collapse feature and a low velocity anomaly suggestive of a void. Standard penetration test borings of the paleo-collapse feature confirmed that it is a relic sinkhole.

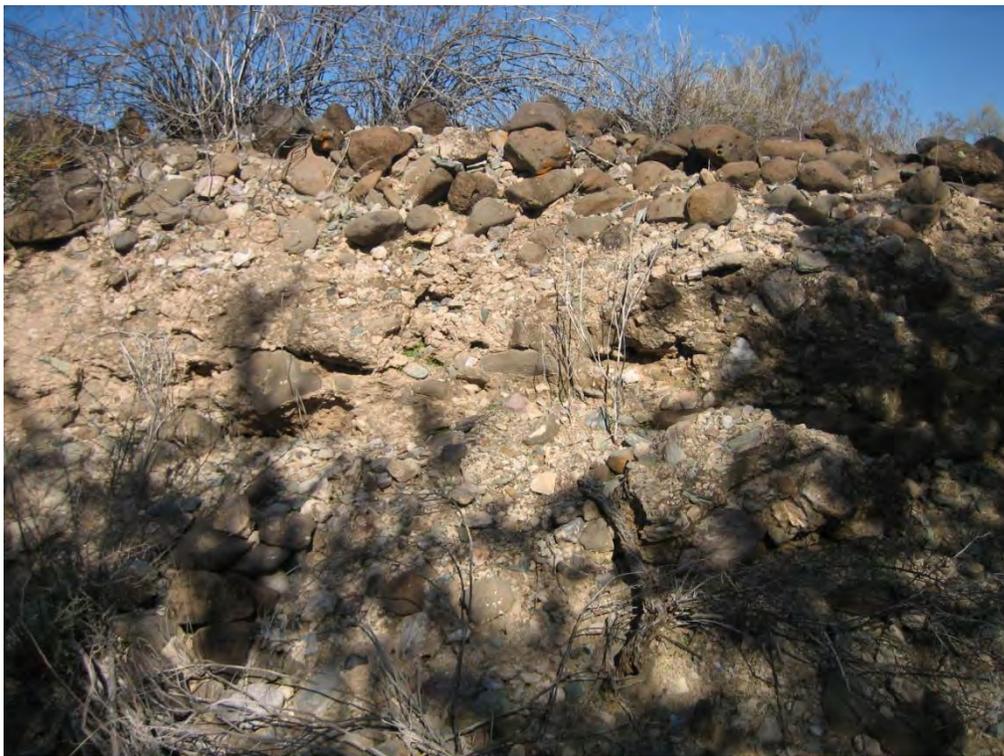
Figure 4 – Near Surface Strongly Cemented Soil in Stratum A

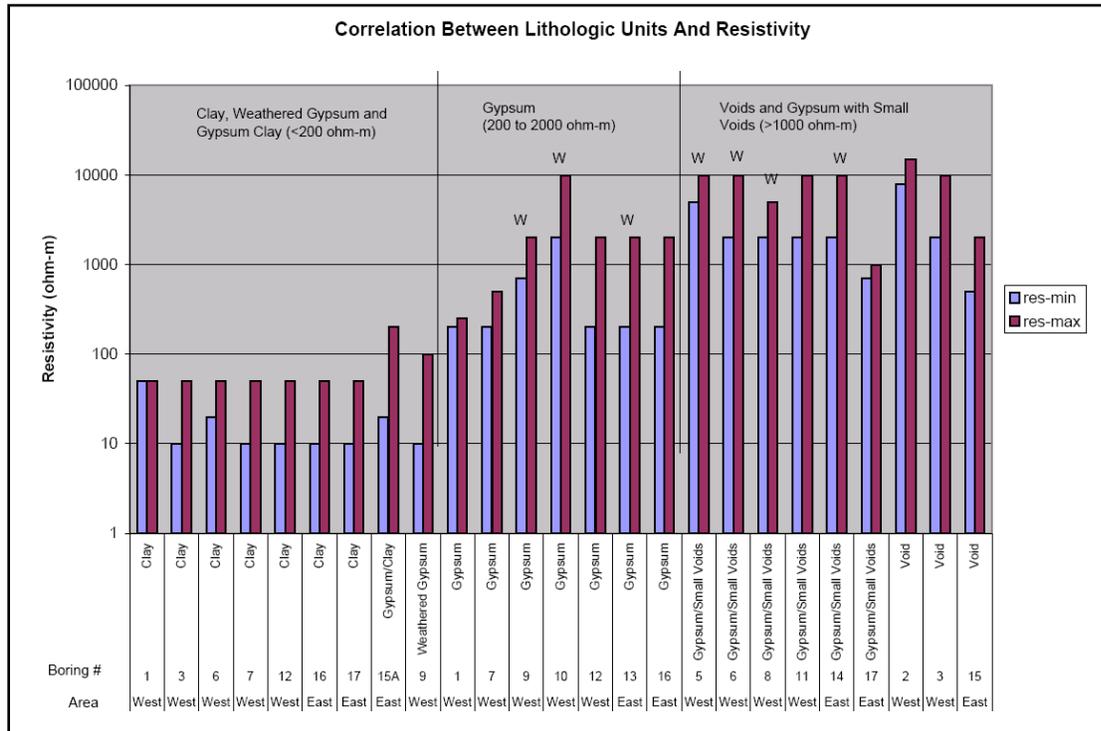
Figure 5, Correlation Between Lithologic Units and Resistivity

Once ground-truthing of the models was complete, the ranges of resistivities within a given material were plotted, and are presented on Figure 5.

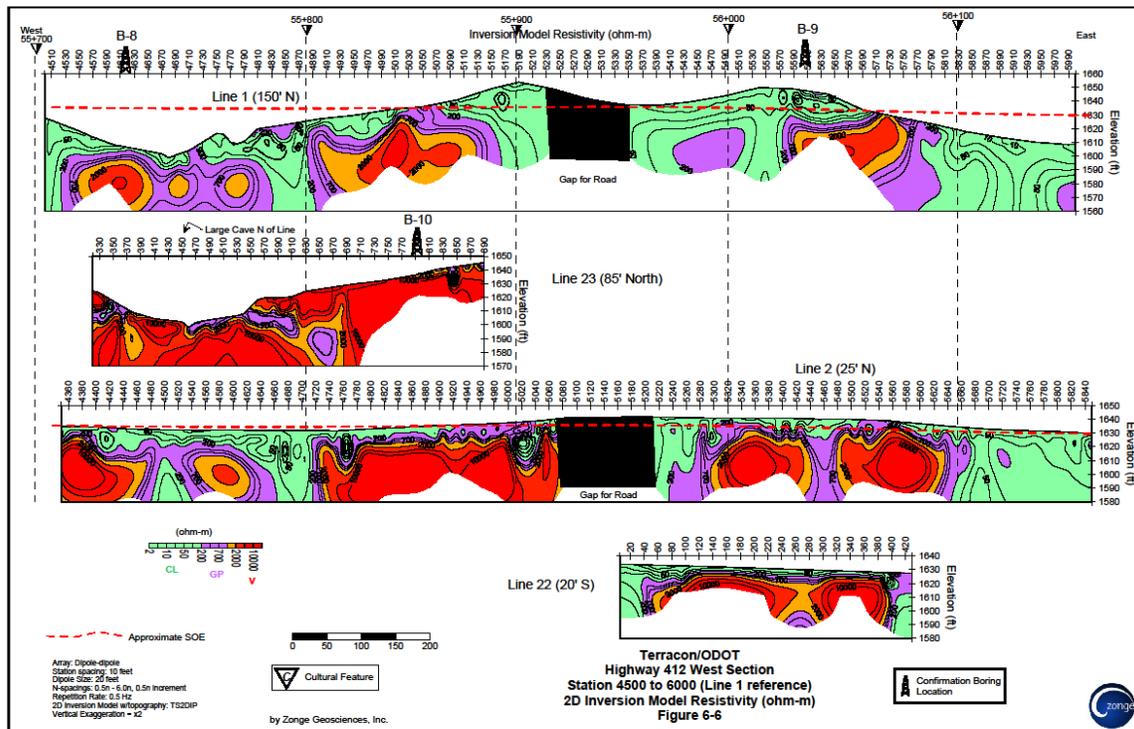
Figure 7, Example 2D Earth Models from ERI surveys

The final interpretation of the geophysical data and geotechnical borings were presented in 2D figures (electrical cross-sections), such as shown on Figure 7. These figures offer a pictorial representation of the boundaries of materials with potential karst features and those of clay and weathered shale.

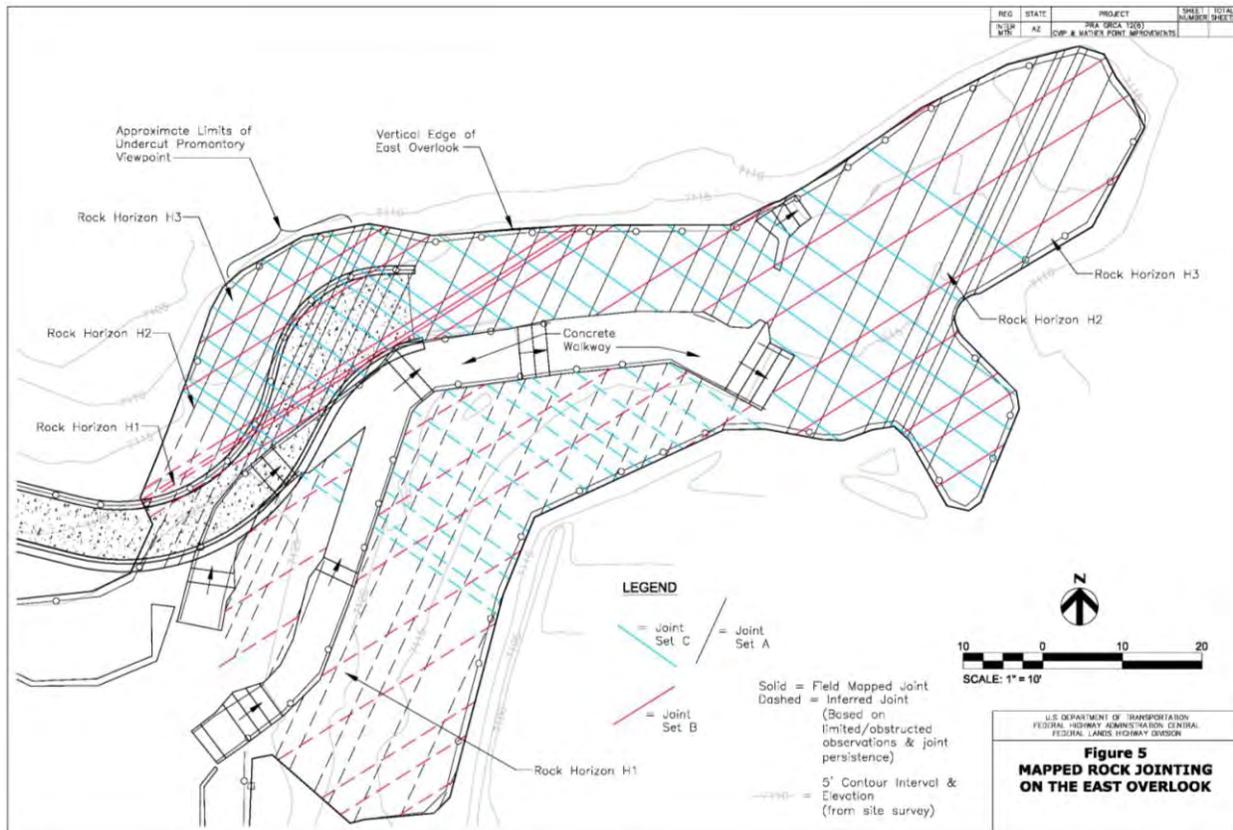
Figure 2: Mapped Rock Jointing

Horizontal rock exposures were generally limited to the East Overlook and consisted of relatively flat-lying, generally-competent rock that dips gently to the southwest with very steep to nearly-vertical joints in three distinct sets. These were identified as Joint Sets A, B, and C. Discontinuities within each identified joint set exhibit consistent orientation (strikes) and dip with strong to very strong persistence. Joint spacing ranges from close to very wide with generally tight to very tight apertures. Joint set apparent dip (in degrees from horizontal) and orientation (in degrees clockwise from north) are summarized as follows: Joint Set A – 60/011 to 65/011, Joint Set B - 85/046, and Joint Set C - 78/311 to 83/311. These joint sets appeared generally continuous through the various rock horizons as observed in horizontal and vertical exposures. Joint Sets A, B, and C, as mapped in the field for the East Overlook, are shown on Figure 2.

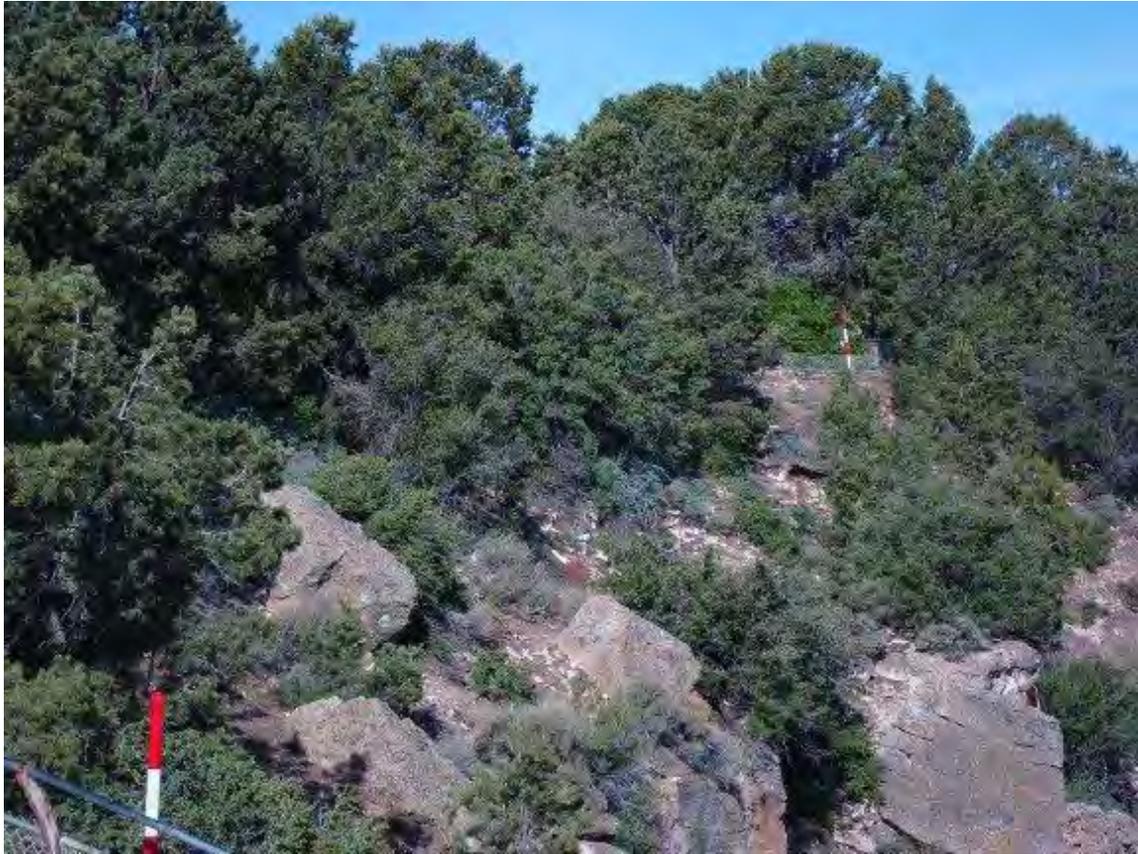
**Photo 2 – ADA Route Alignment
(line rods denote approximate alignment; note dislodged, rotated, or toppled rock blocks on slope)**

ADA Route - The proposed new ADA Route alignment traverses alluvial and colluvial sediments interspersed with slightly- to highly-weathered intact rock and loose, dislodged or rotated, and/or toppled blocks of rock (Photo 2).

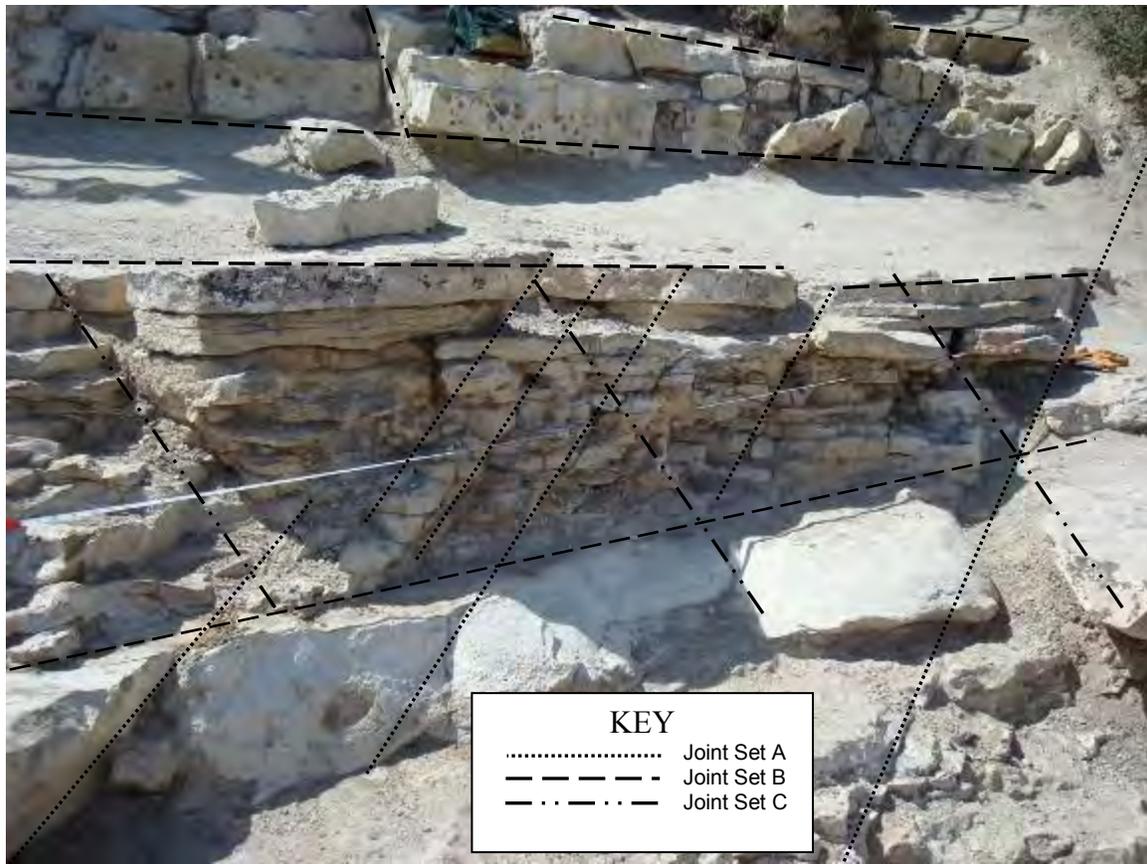
Photo 6 – ADA Route Tie-In Location Showing Horizon H2 and Part of Overlying Horizon H1

Along the west side of the overlook where the eastern end of the ADA Route will tie-in to the overlook, joint spacing within and between the three joint sets decreases. Horizontal discontinuities observed in rock exposures comprising the overlook consist of thinly laminated to medium bedding planes, ranging from clean and open to very tight or intact with faint bedding plane traces. The overlook rock exposed along the proposed ADA accessible areas (areas to be locally ground and leveled to achieve ADA compliance) consists of moderately-soft to moderately-hard, unweathered (except joints) to moderately-weathered rock. The rock exposed at the location of the ADA Route tie-in consists of soft to very soft, slightly- to highly-weathered rock with very-closely to closely-spaced joints (Photo 6).

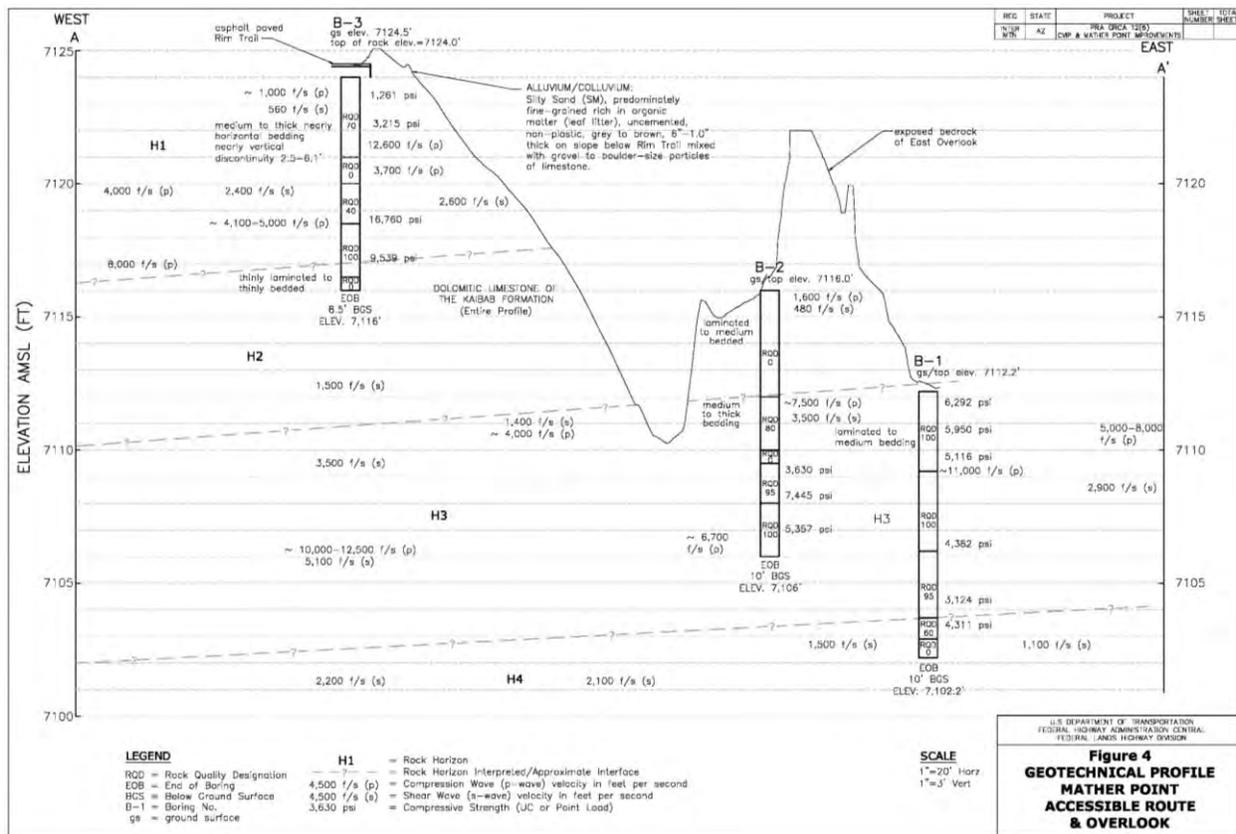
Figure 3: Geotechnical Profile

The unconsolidated alluvial soils consist of silty to clayey sand deposits ranging in thickness from zero to about one foot, which classify as non-plastic silty sand (USCS Classification SM). These sands were predominately fine-grained with fines content ranging from 18 to 41 percent by weight. The colluvium consists of fine gravel- to large boulder-size particles of dolomitic limestone and occurs with the alluvium mainly on steep slopes along and below the existing Rim Trail and proposed ADA Route alignment.

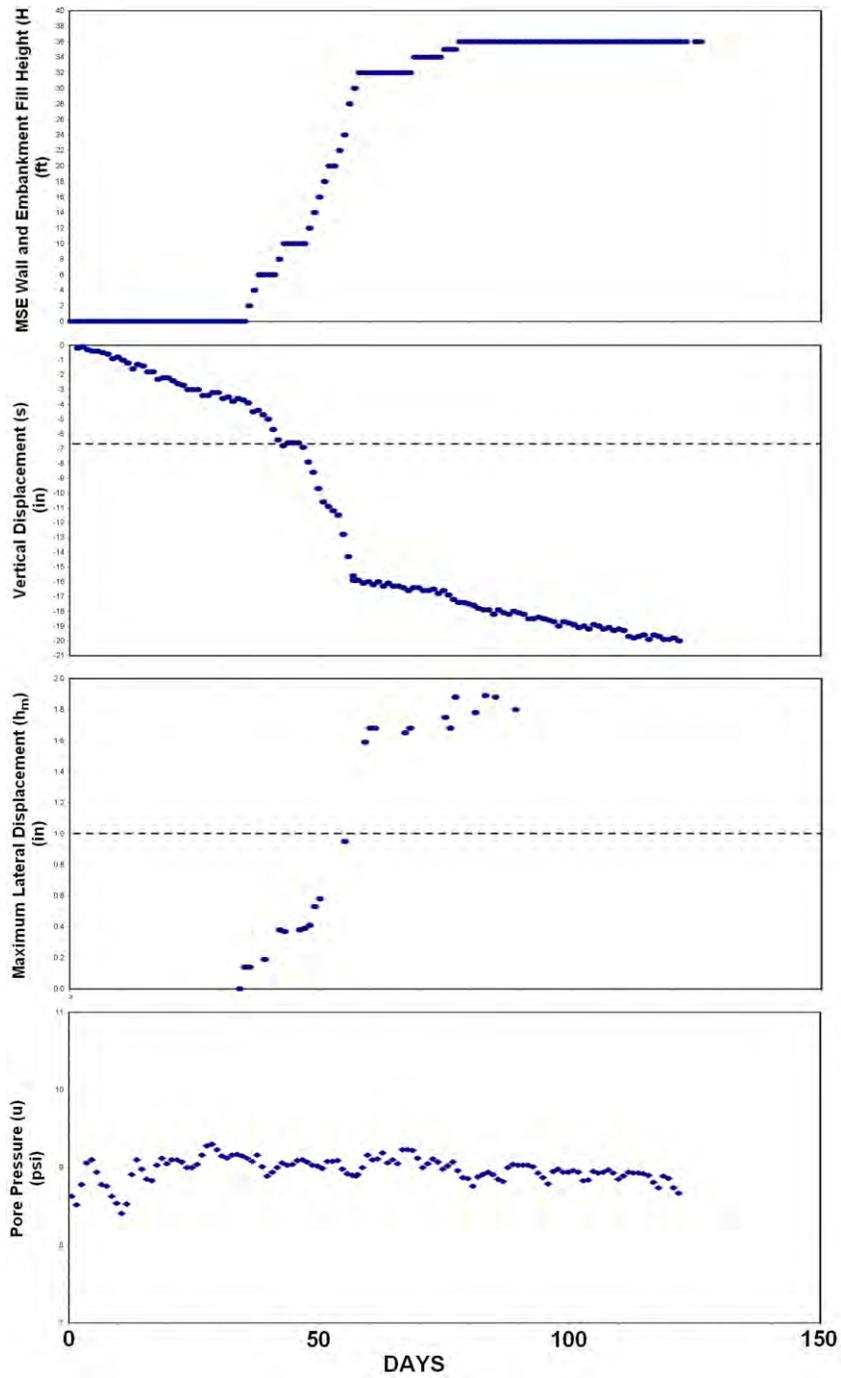
Figure 6 – Foundation Performance Monitoring Parameters: (H) MSE Wall and Embankment Fill Height; (s) Cumulative Settlement; (h_m) Maximum Lateral Displacement; (u) Soil Foundation Pore Pressure

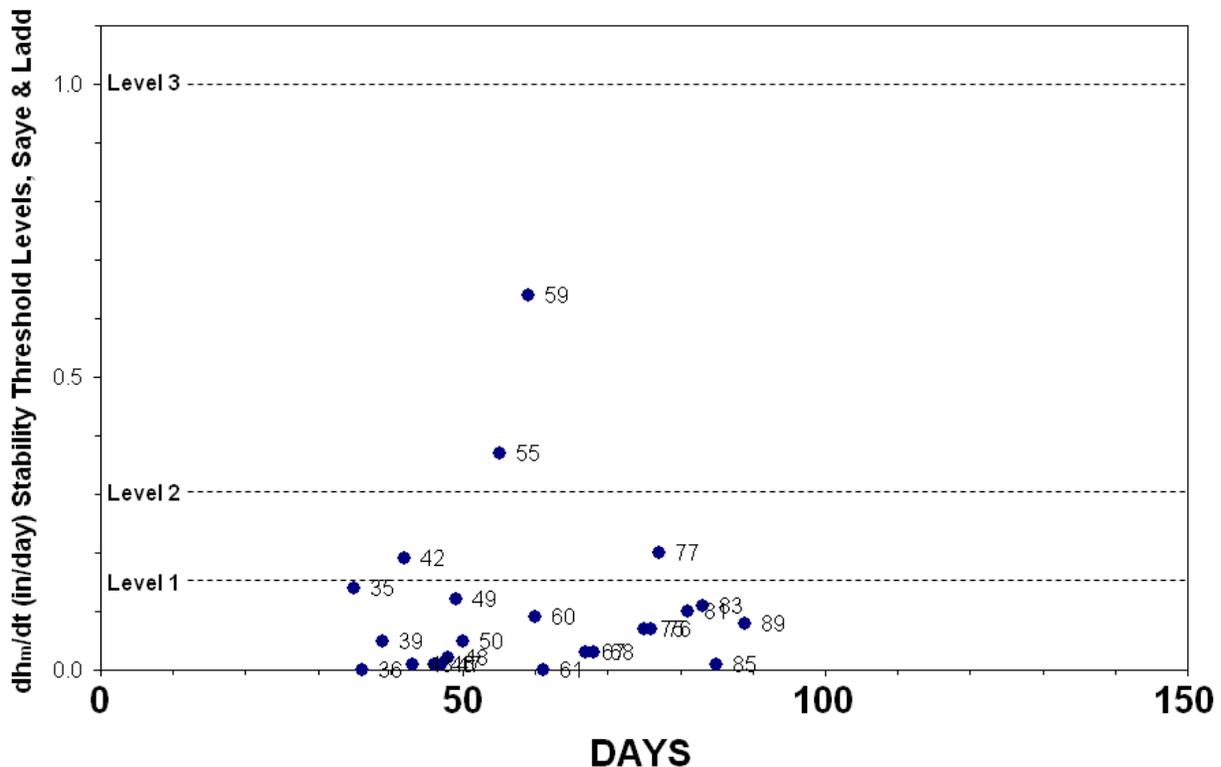
Figure 8 – Horizontal Deformation Rate (in/day) for the Case Study

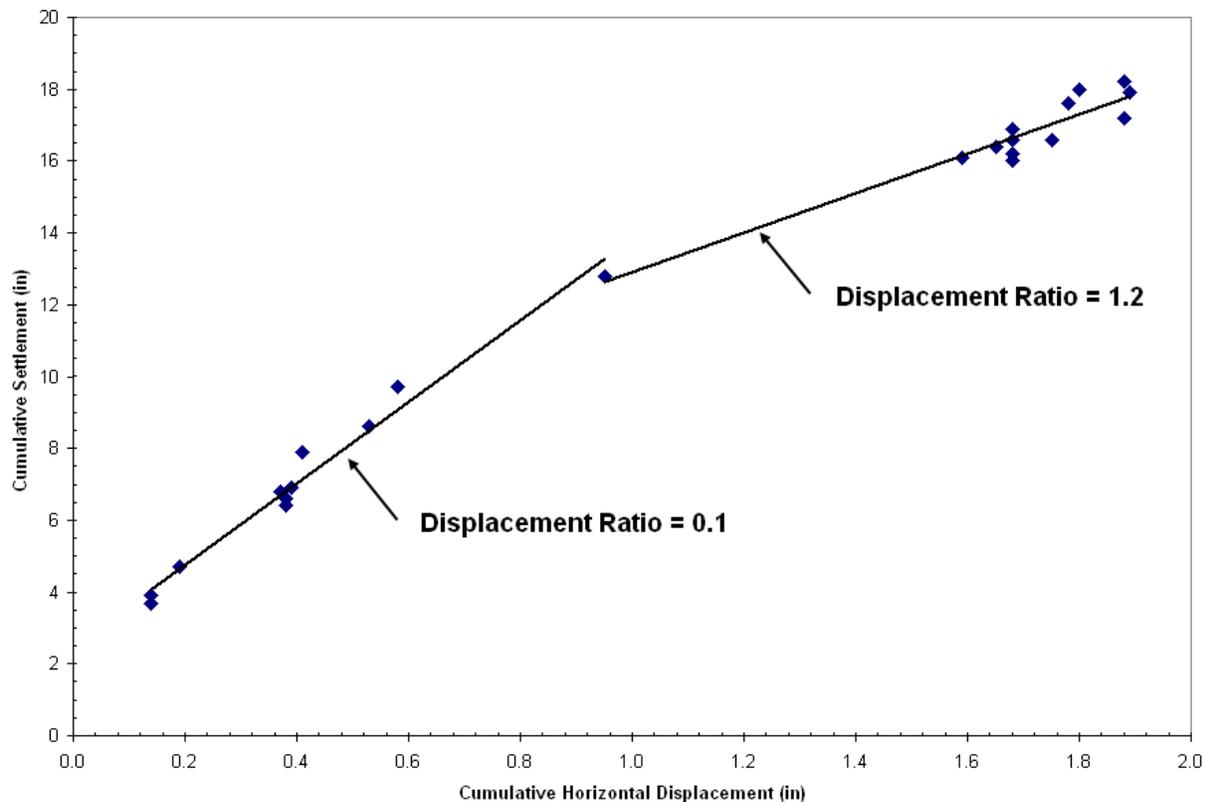
Figure 9 – DR for Case Study Data Showing a Significant Change in DR Trend Occuring Around Day 55.

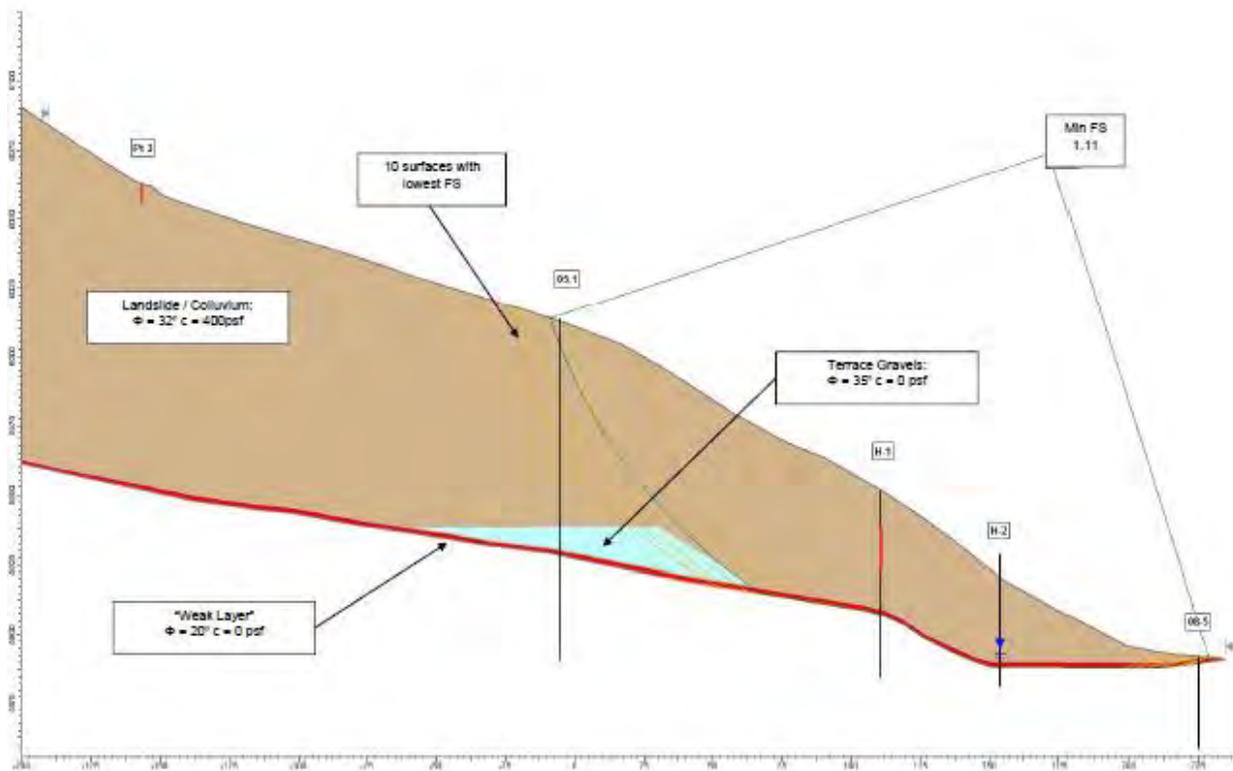
Figure 7 – Weak Layer Back Analyses: Slide Axis

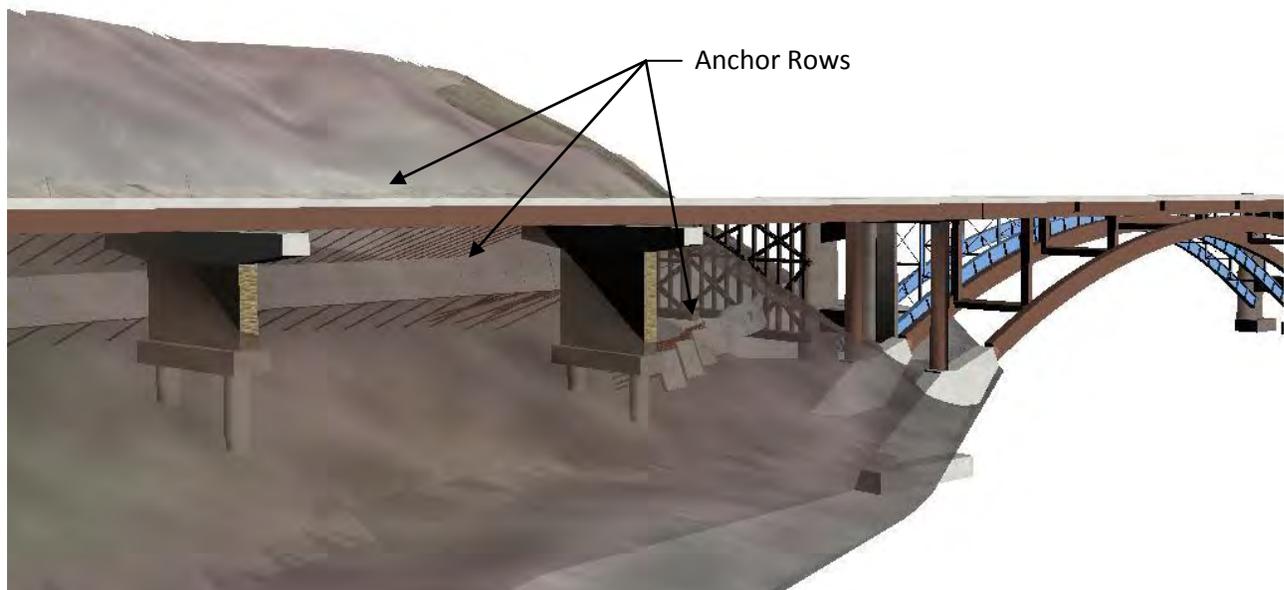
Figure 8 – Ground Anchor 3D Model

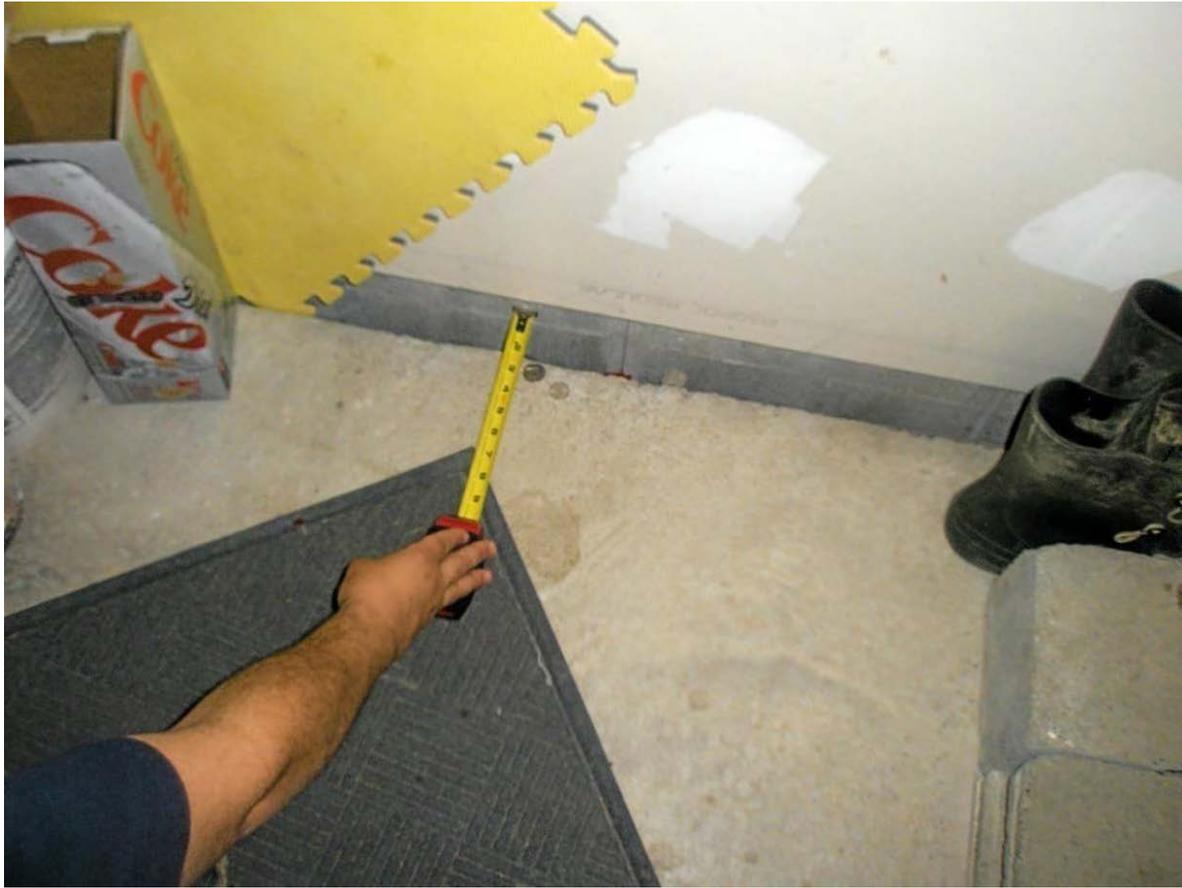
Figure 12. Garage floor pulled away from wall, Meadowlake Hills Road residence.

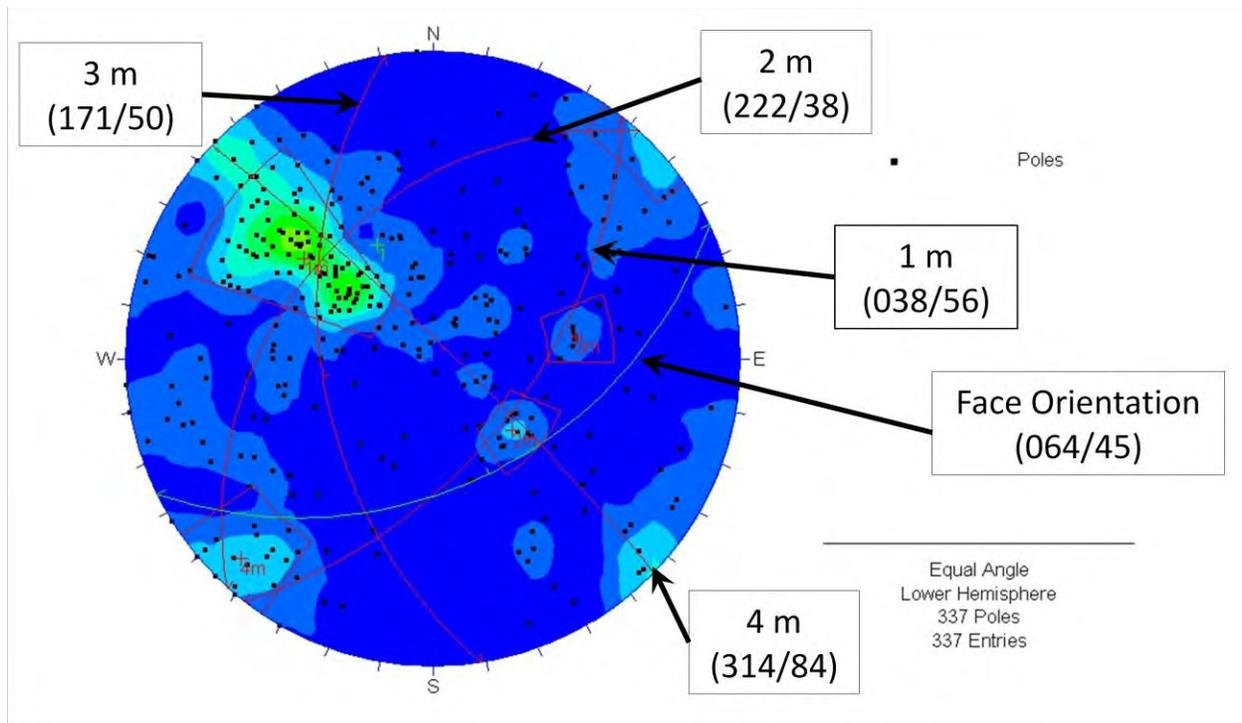
Figure 4 – Discontinuity Stereonet (Major Discontinuity Planes and Face Orientation in Strike/Dip Right Format).

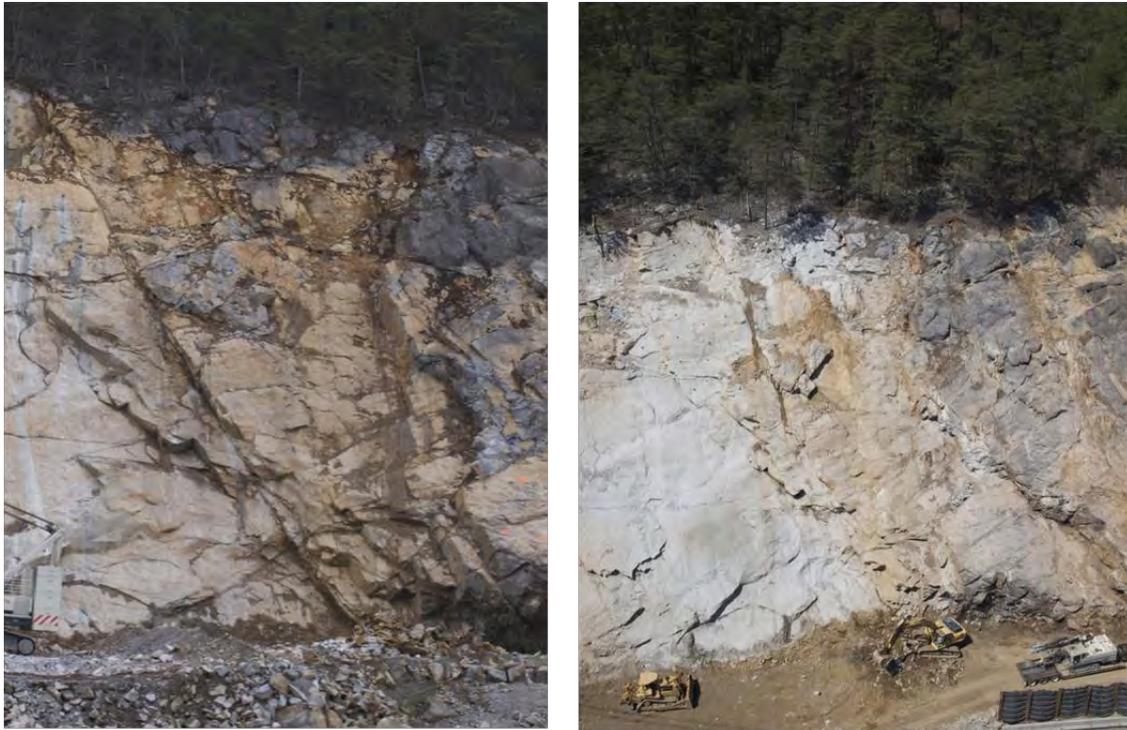
Figure 8 – Evil Twin Area After Removal of Sliding Rock, But Before Scaling and Bolting. Note release surface formed by discontinuity set 4m dipping steeply to the east (right).

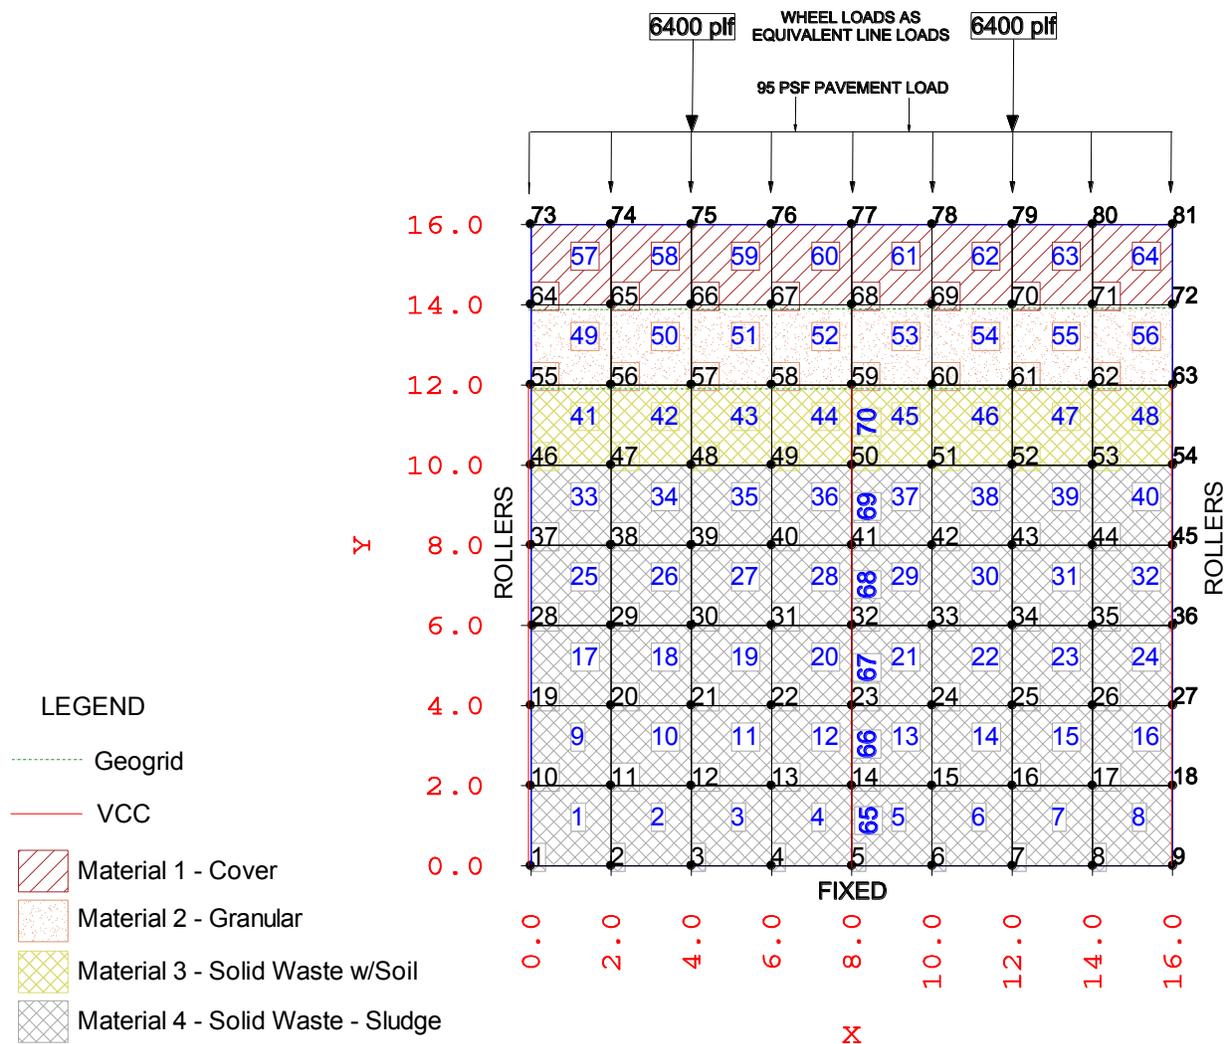
Figure 3 – FEM Solution Mesh for VCC

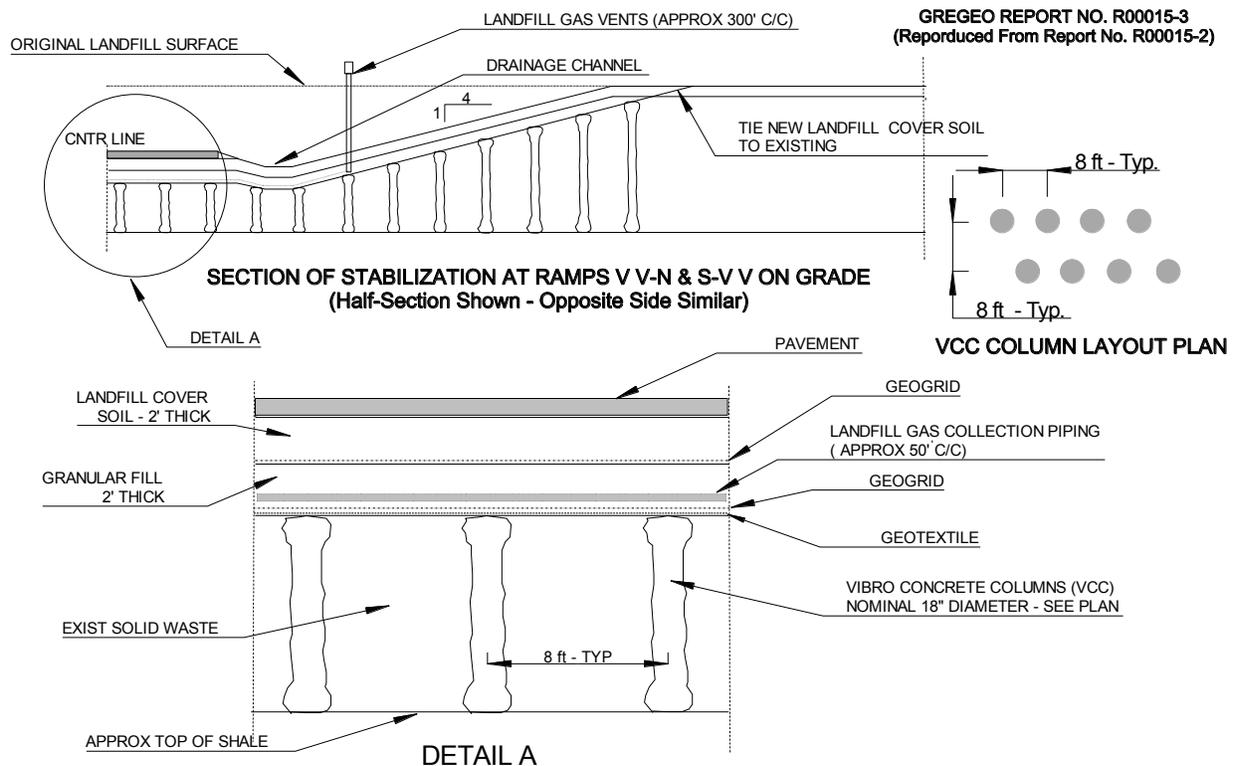
Figure 4 – VCC Details

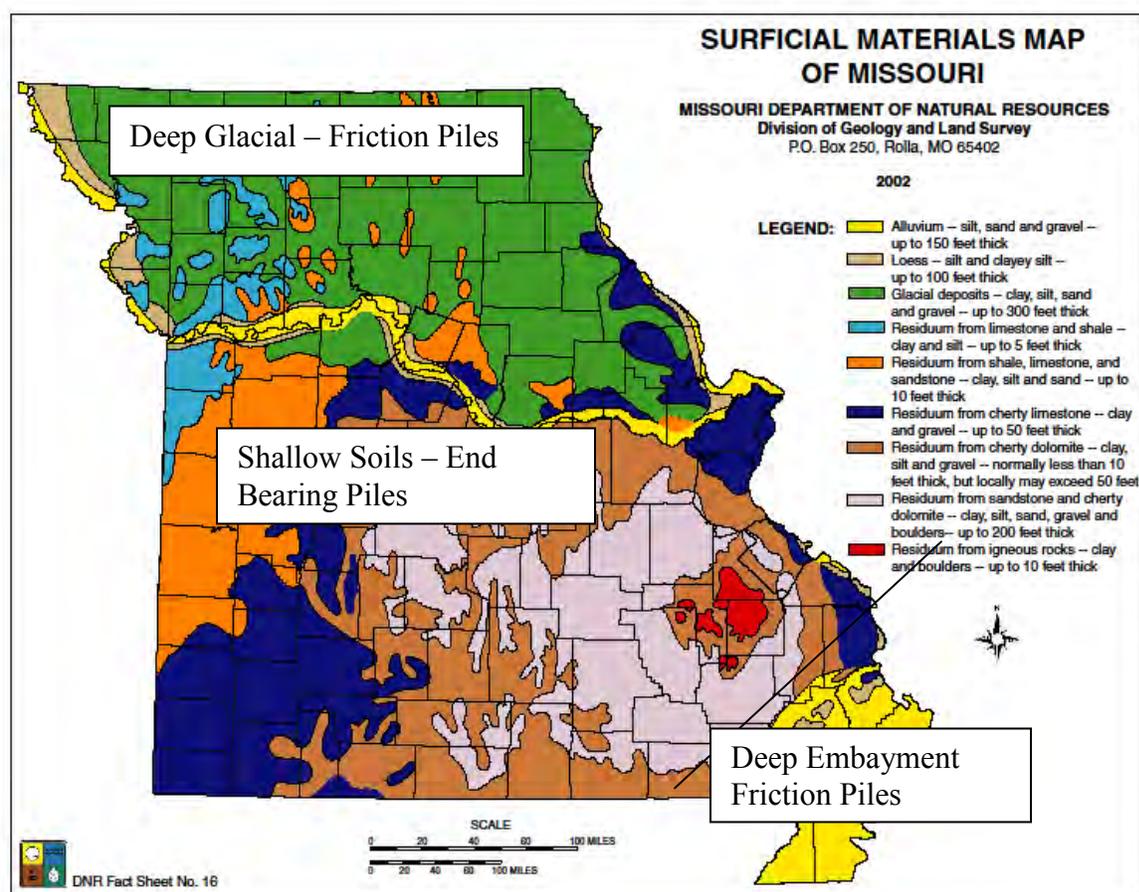
Figure 4 – General Foundation Types
