61st HIGHWAY GEOLOGY SYMPOSIUM

Oklahoma City, Oklahoma

August 23rd - 26th, 2010

PROCEEDINGS

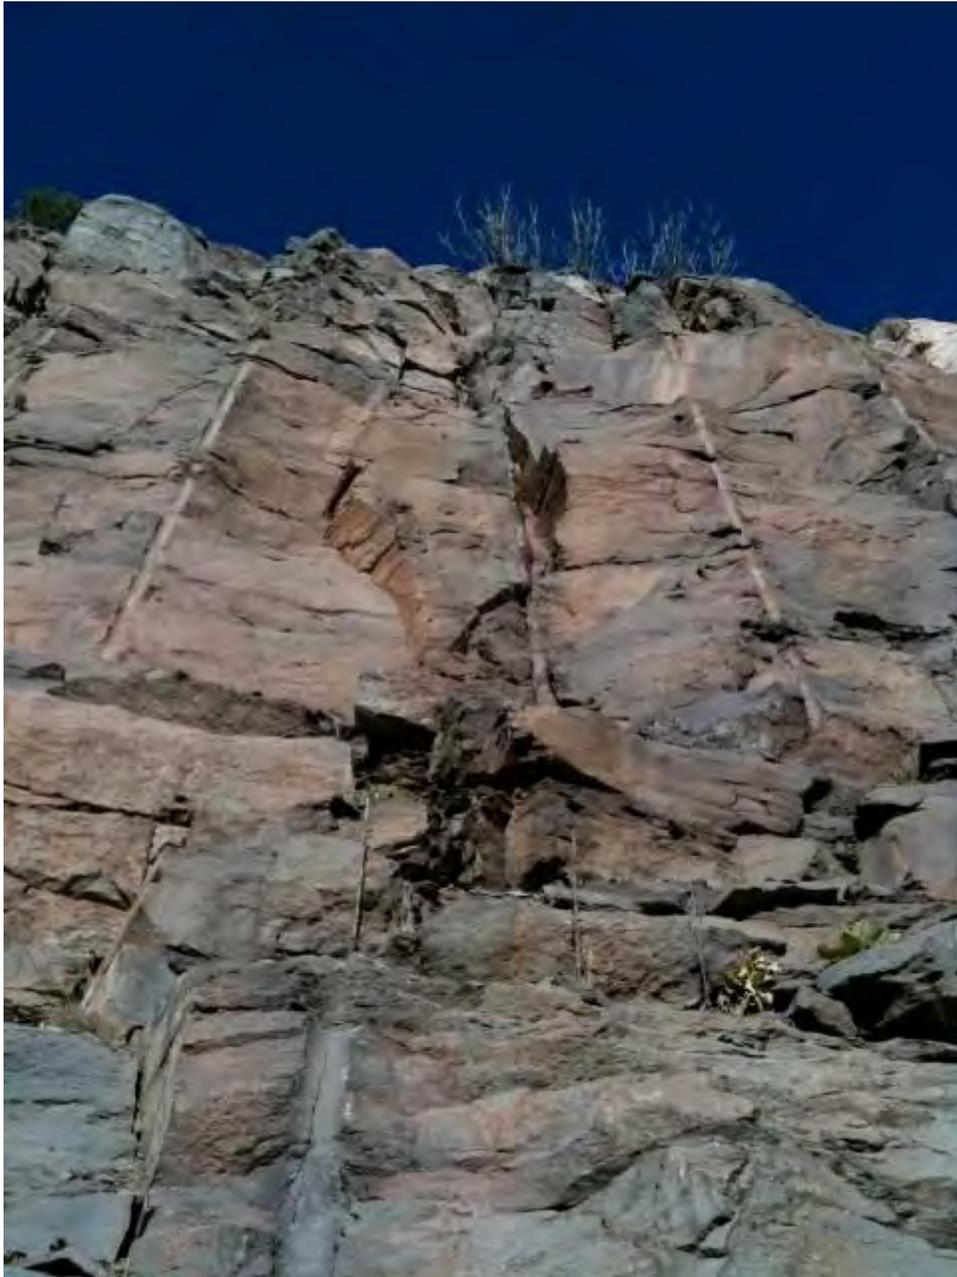
Figure 5. Picture of the part of the Section 2 rock slope showing pre-split half-casts and some natural fractures sub-parallel to the slope.

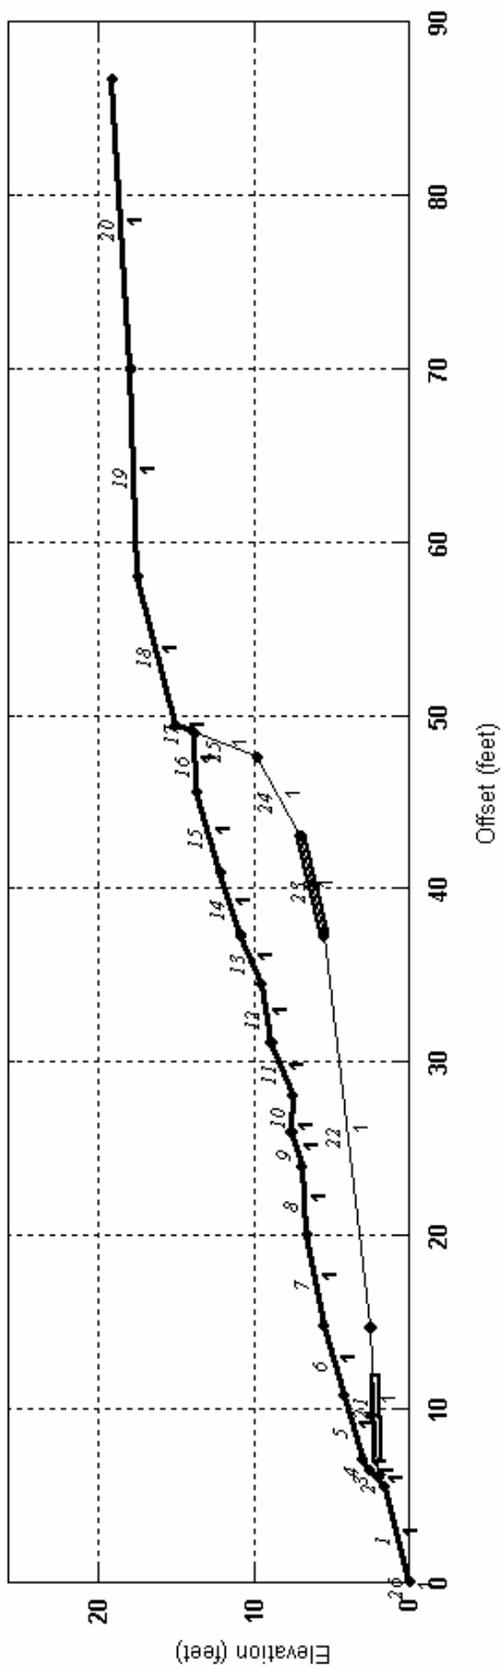
Figure 5 - Estimated slip surface for center cross-section

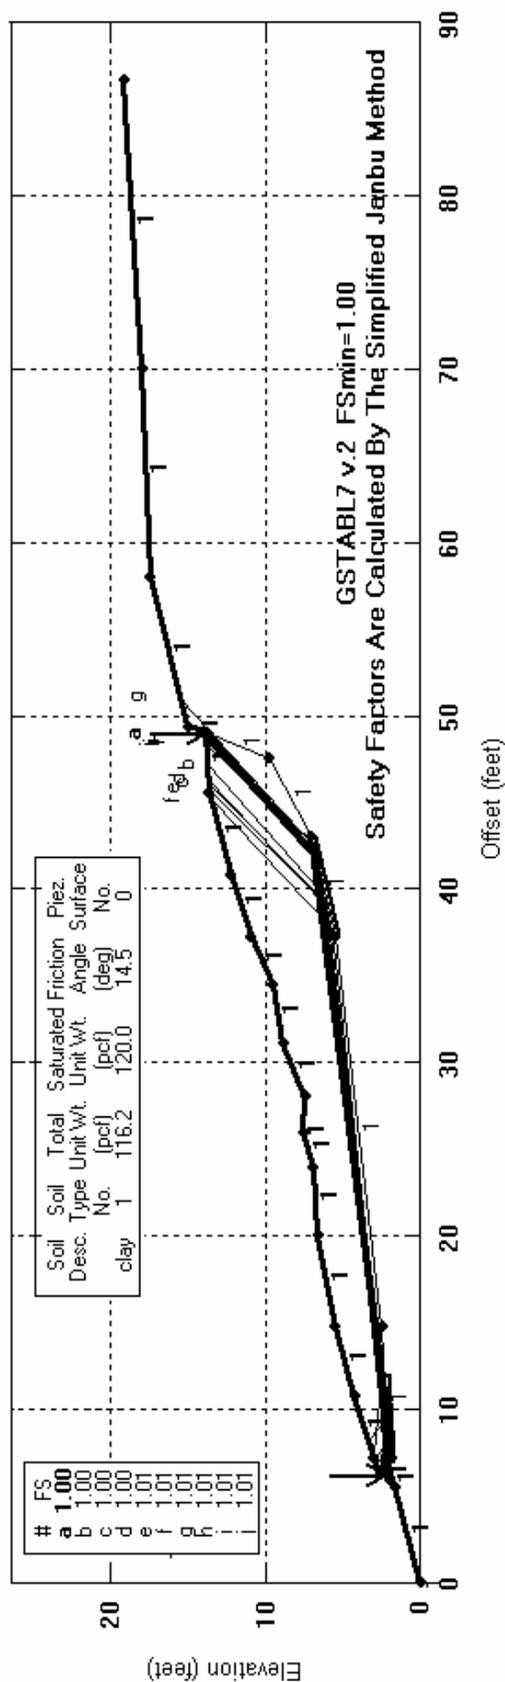
Figure 6 - Trial wedge at failure ($c' = 0, \phi' = 14.5^\circ$)

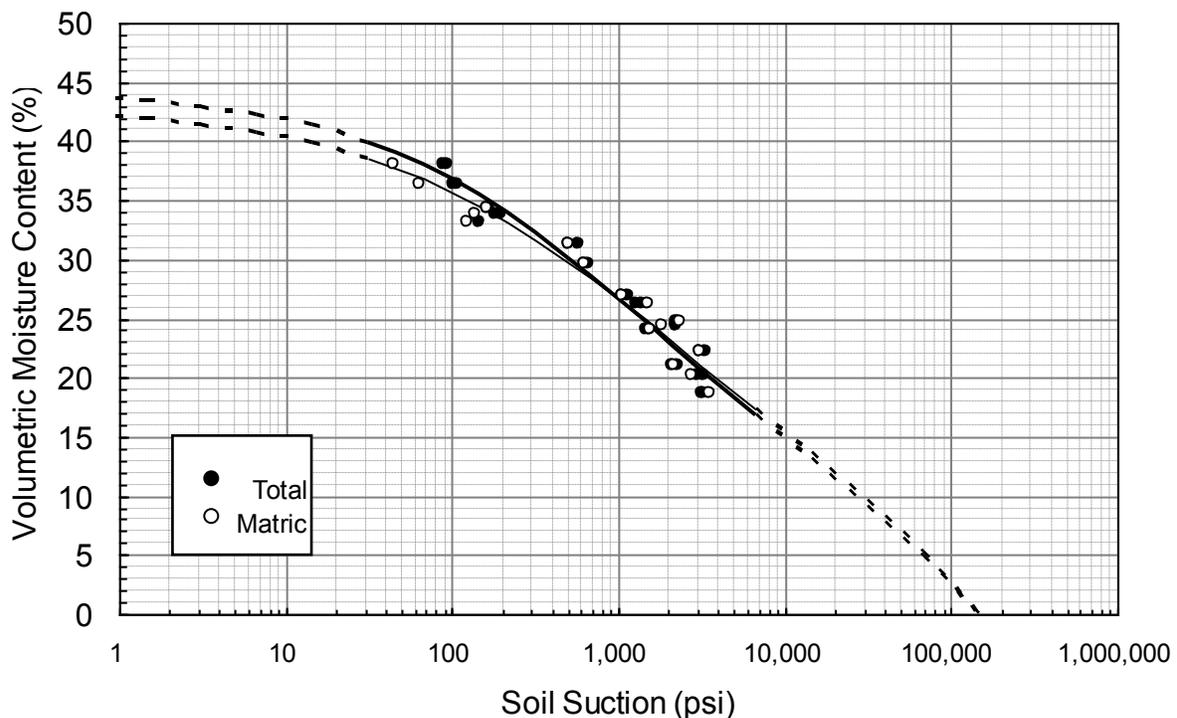
Figure 7 - Soil-Water Characteristic Curve

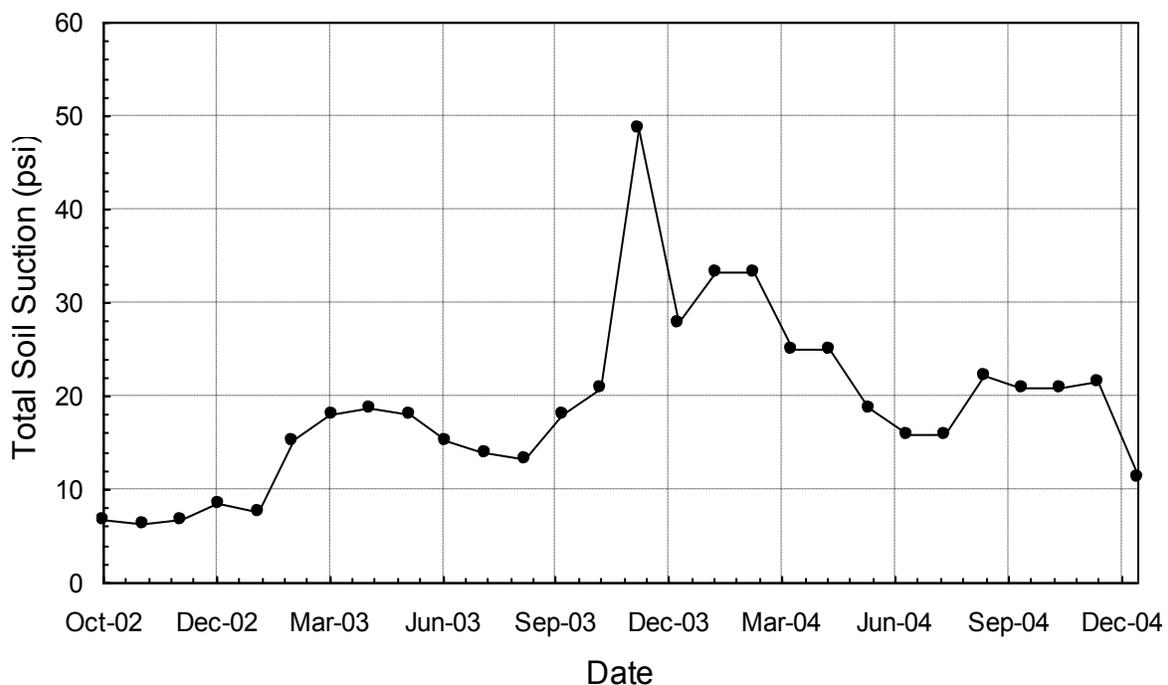
Figure 8 – Time versus Estimated Total Soil Suction

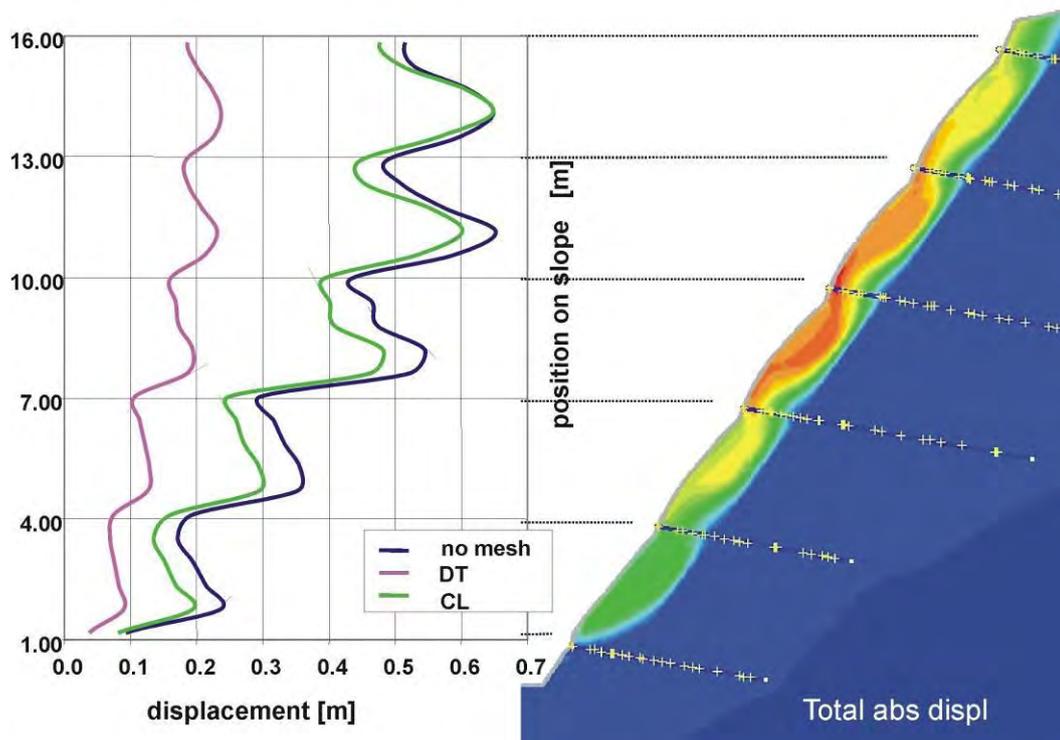
Figure 8: Total displacements on the slope and the relative total displacement graphs recorded with double-twist mesh (purple line), high-performance single-twist mesh (green line) and without the flexible facing (blue line). While the double-twist mesh is effective thanks to its membrane stiffness, the single-twist mesh has practically no effect.

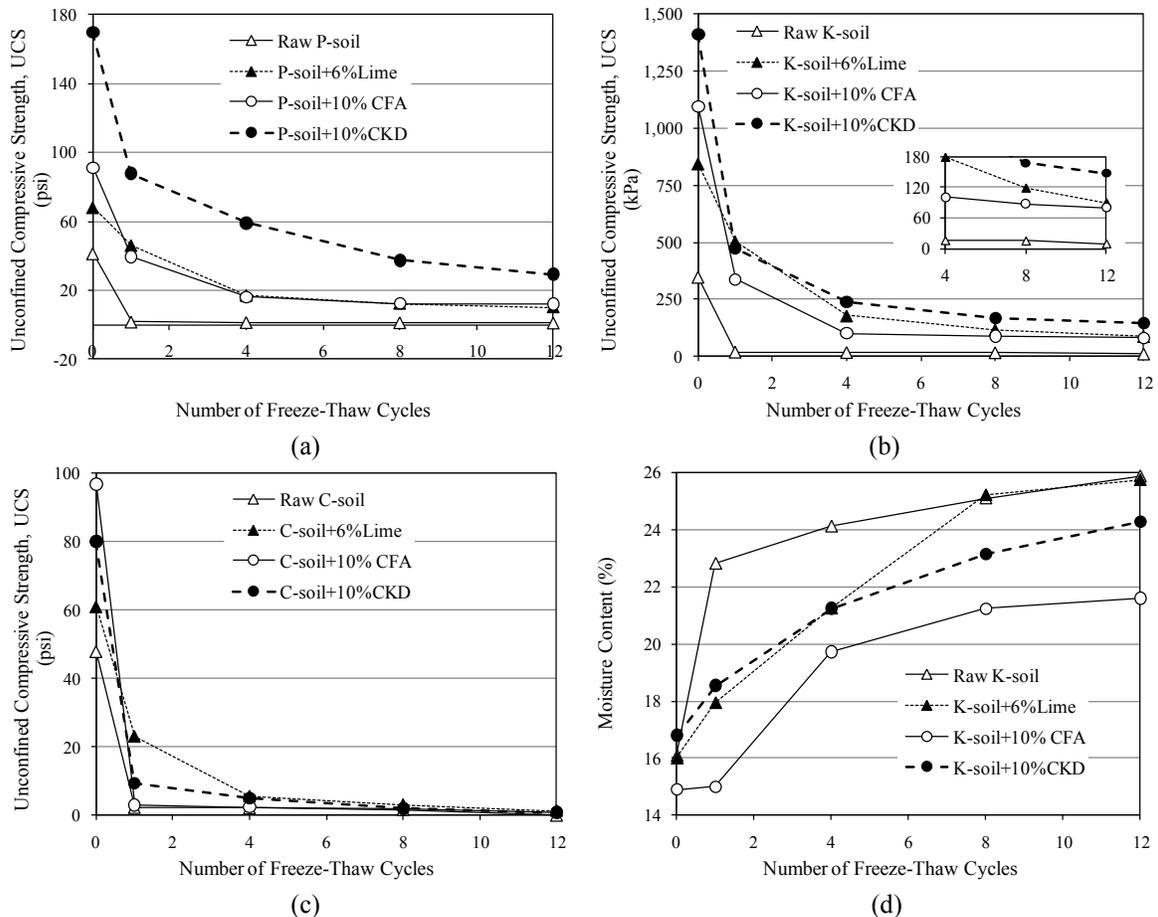
Figure 2 – UCS of Raw and Stabilized (a) P-Soil, (b) K-soil, (c) C-soil specimens at the End of 0, 1, 4, 8 and 12 Freeze-Thaw Cycles; (d) Moisture Content of Raw and Stabilized K-Soil Specimens at the End of 0, 1, 4, 8 and 12 Freeze-Thaw Cycles

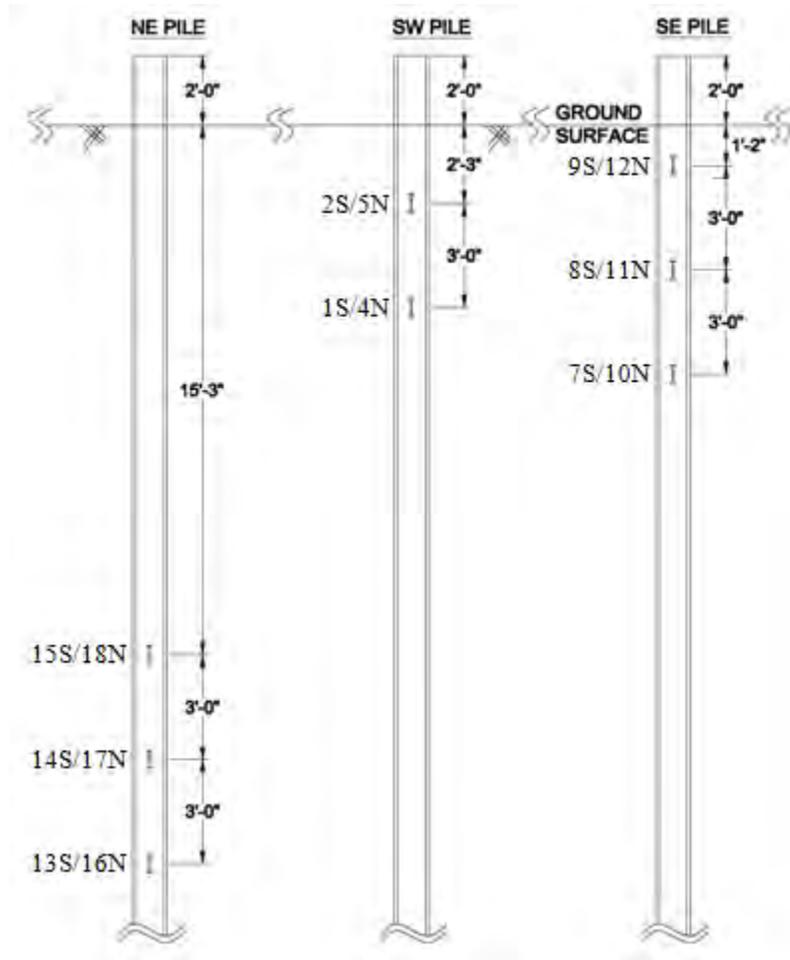
Figure 4. Locations of Strain Gages on Abutment Piles

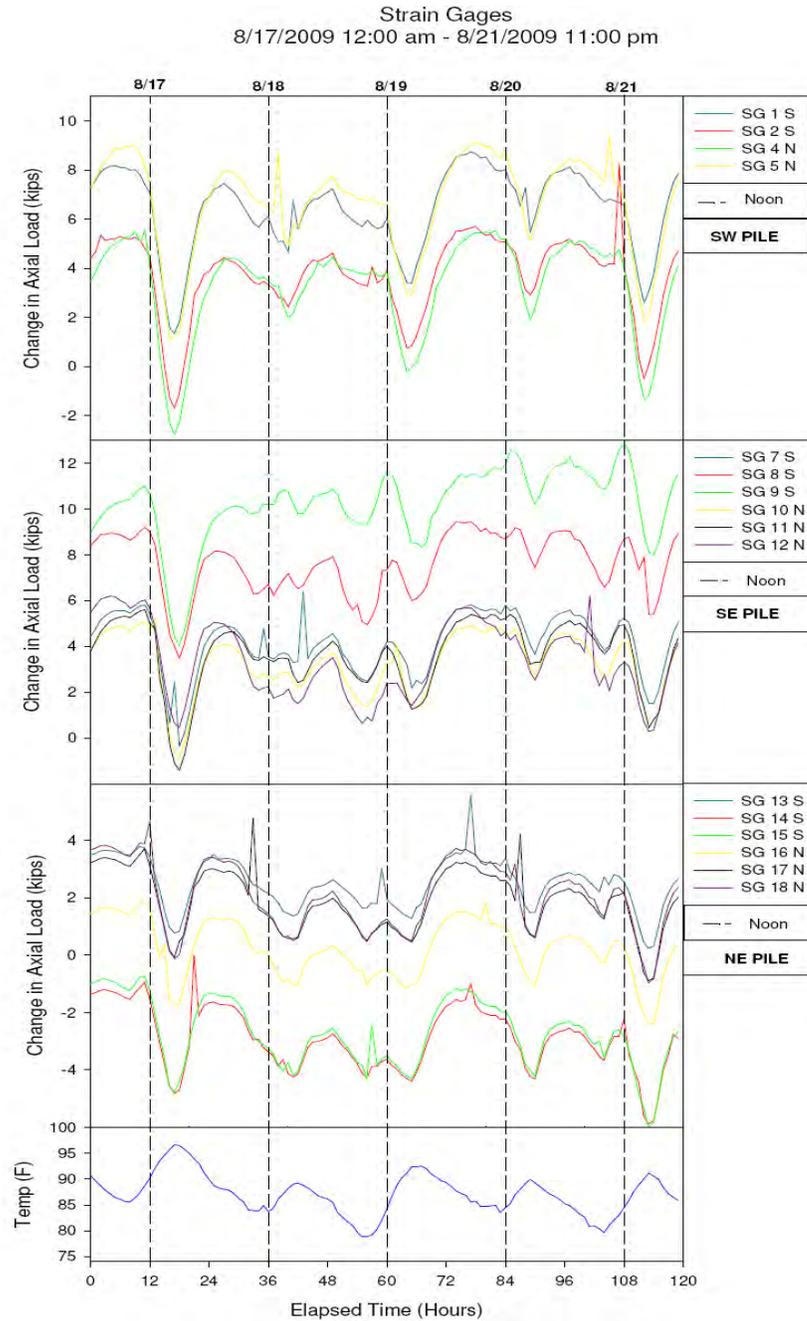
Figure 9. Axial Loads on Abutment Piles

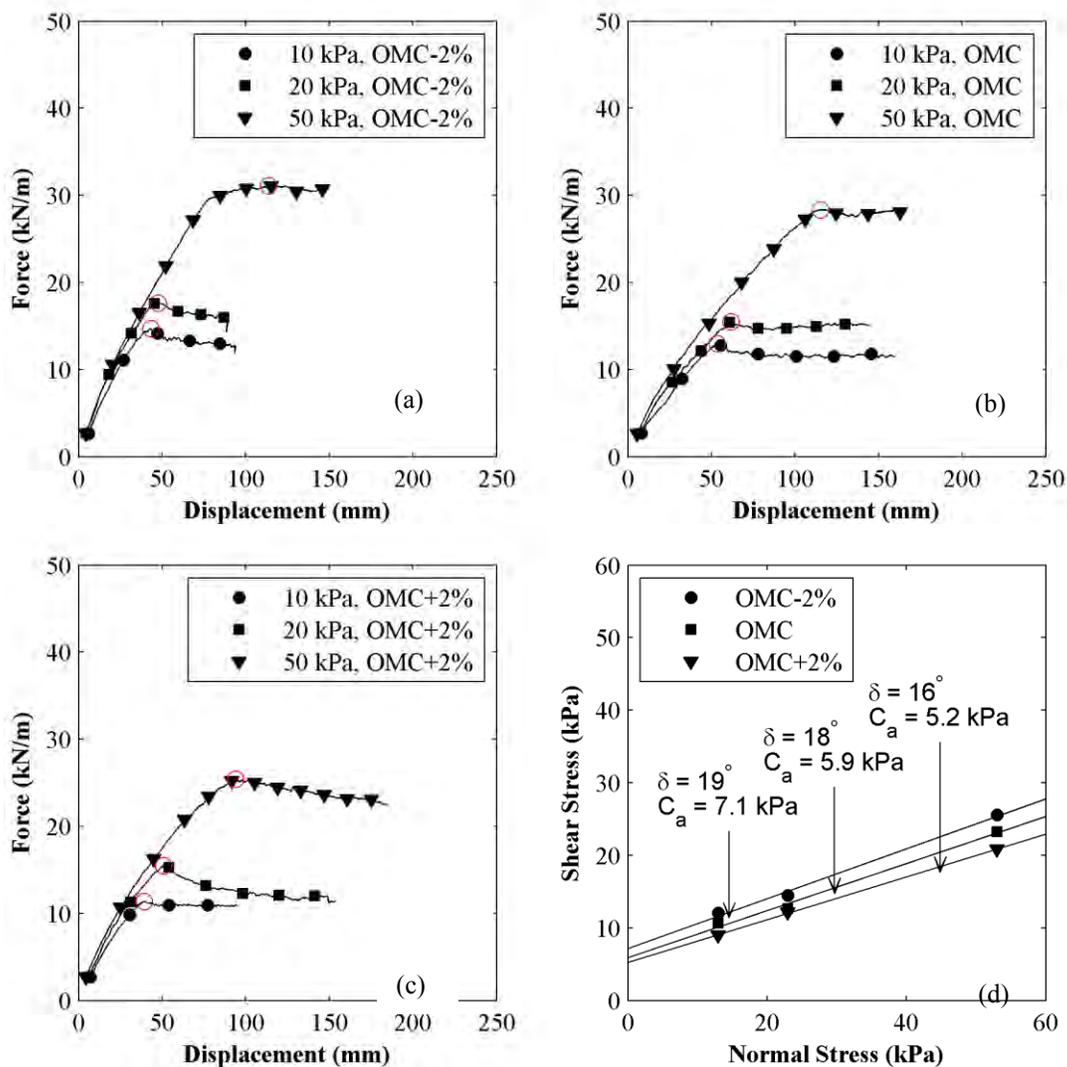
Figure 8 - (a)-(c) Pullout test data in Minco silt at different moisture content values, (d) comparison of failure envelopes for soil-geotextile interface from the test data shown in (a)-(c). C_a and δ refer to the interface friction angle and adhesion intercept, respectively.

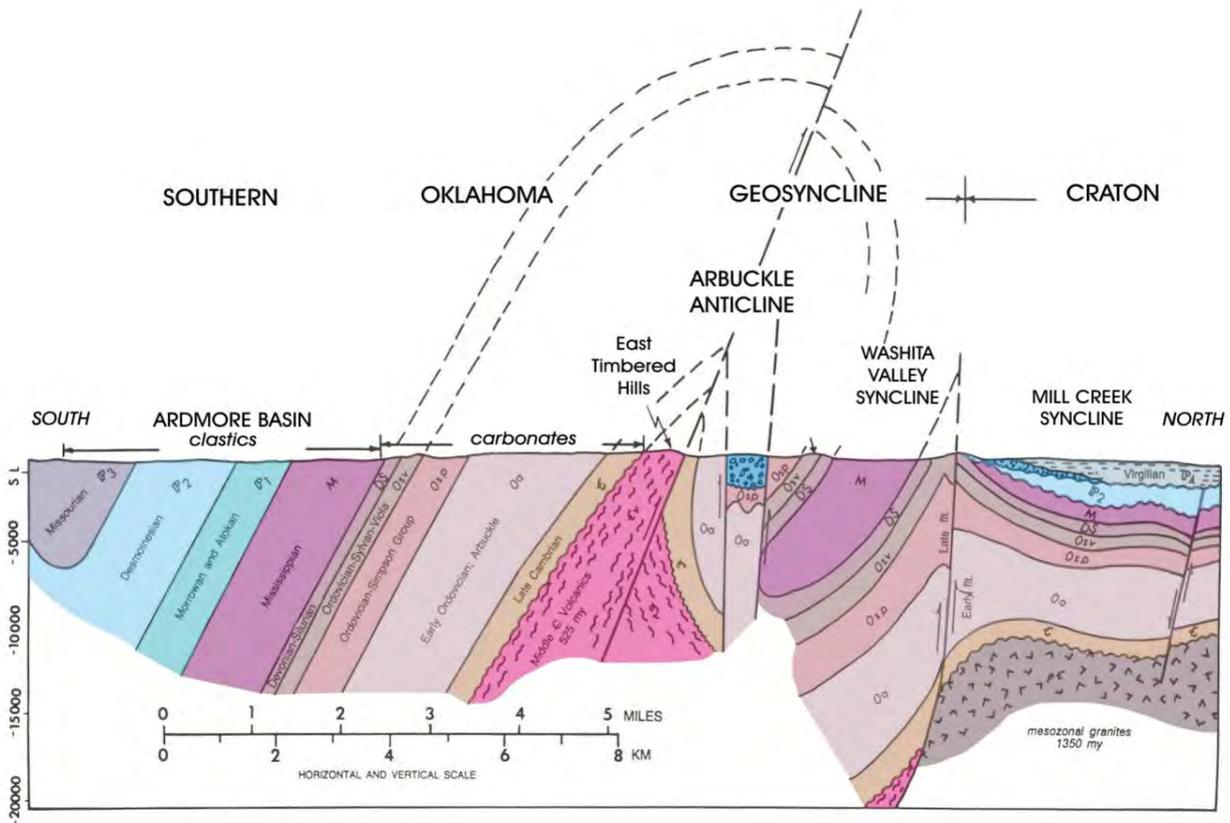
Fig. 3. Structural cross section of the Arbuckle Mountains just west of I-35. The line of the cross section shown on Fig. 6 is in the introductory section (modified from Ham, 1969).

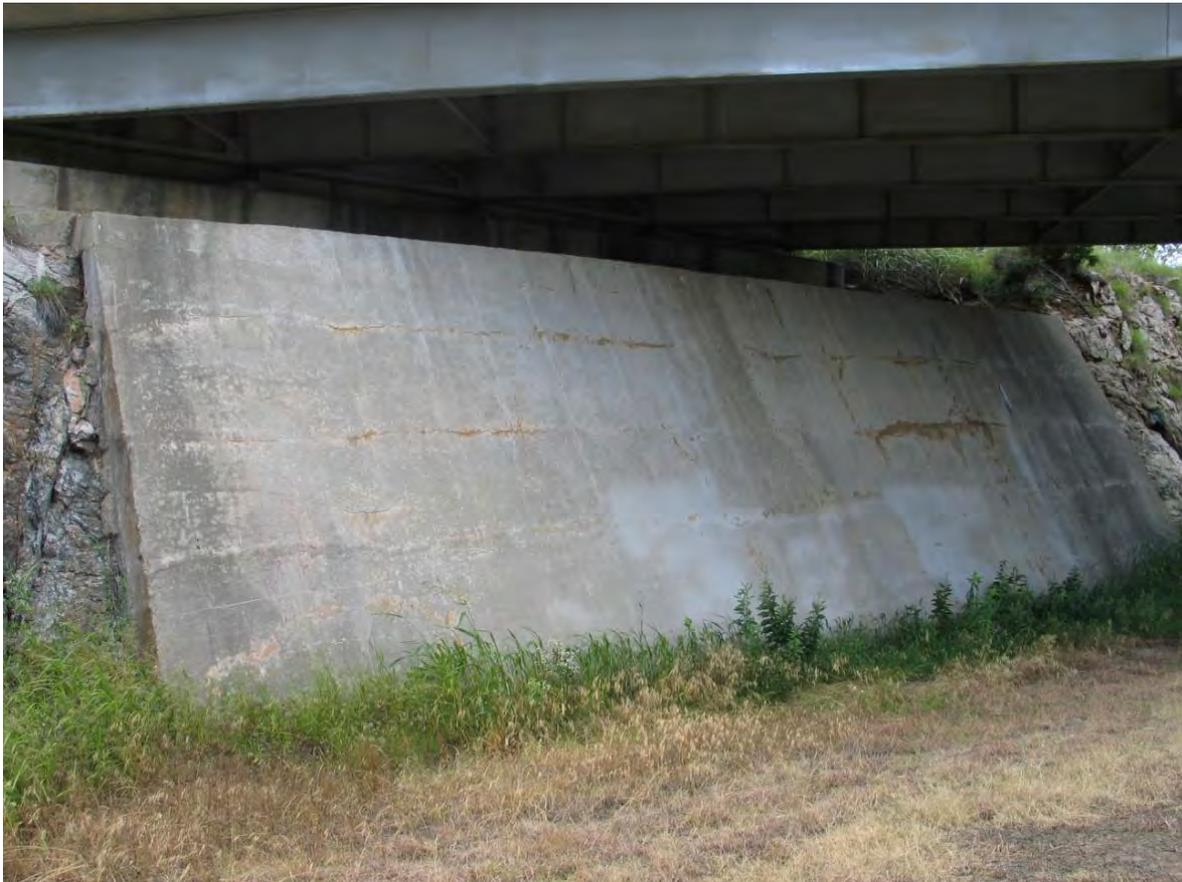
Fig. 4. Slope wall used to retain the clay and loose rock at the northbound bridge abutment.

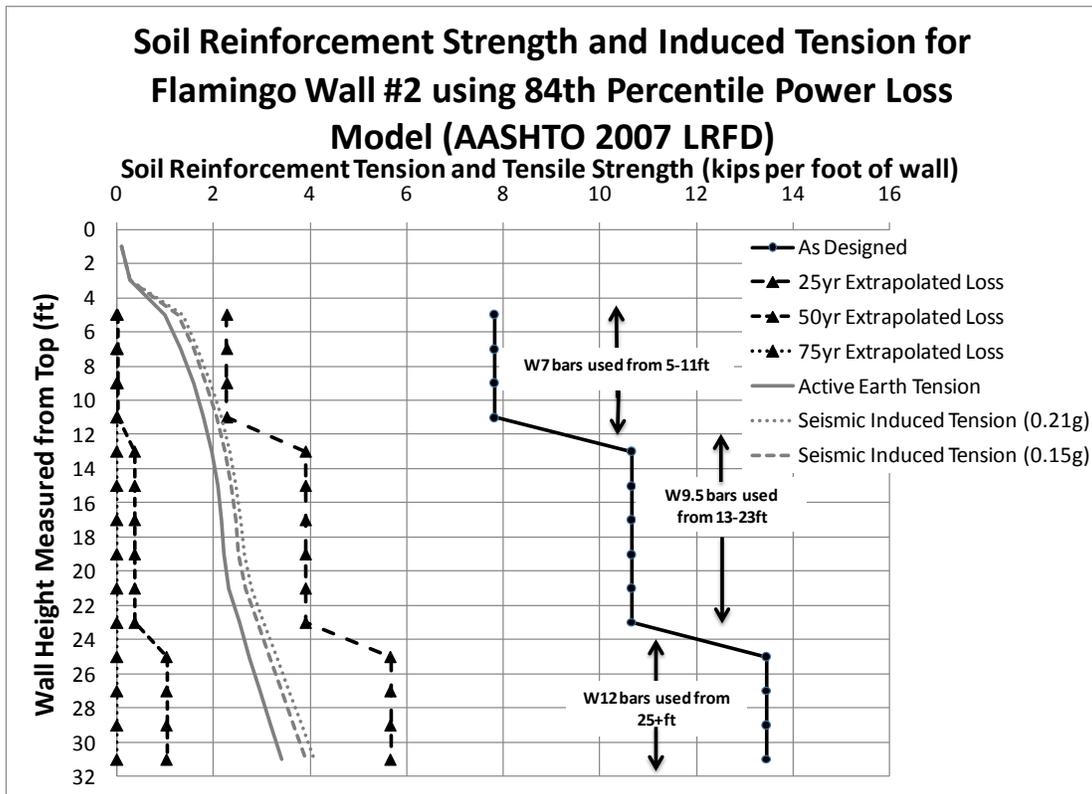
Figure 1. Soil Reinforcement Strength and Induced Tension for I-515/Flamingo Wall #2 – 84th Percentile Power Loss Model.

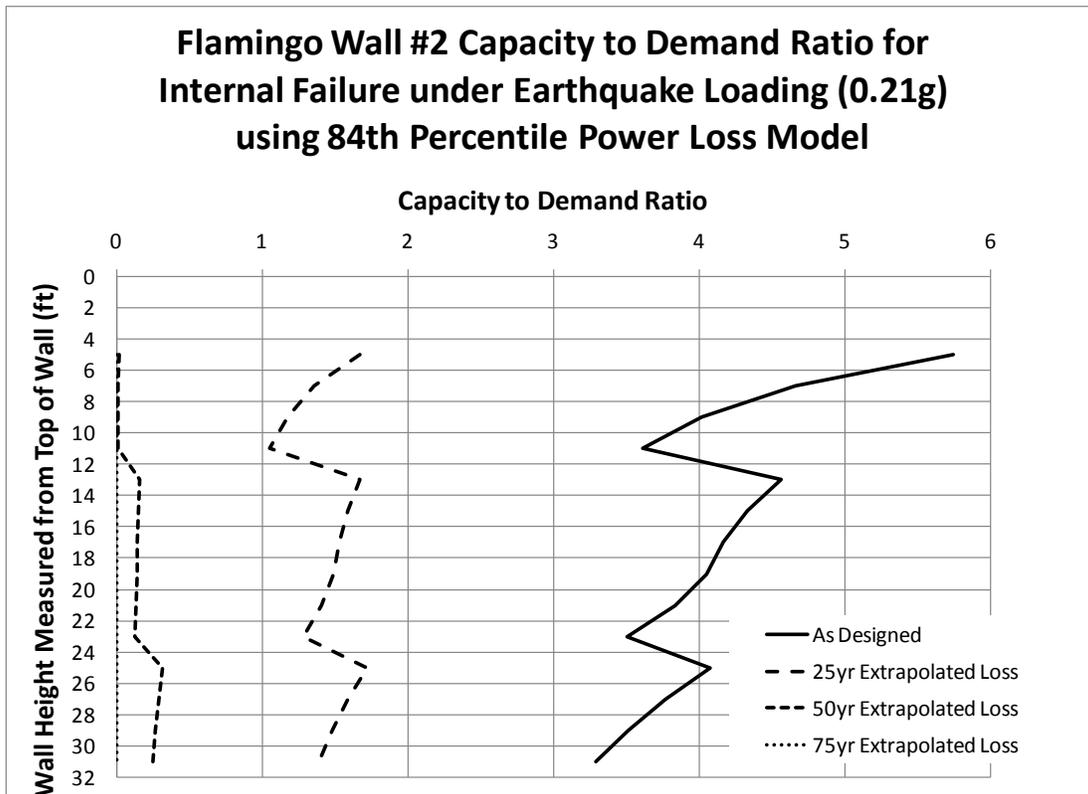
Figure 2. I-515/Flamingo Wall #2 C/D Ratio for Seismic Loading ($a_{max} = 0.21g$) – 84th Percentile Power Loss Model.
