68TH HIGHWAY GEOLOGY SYMPOSIUM MAY 1-4, 2017

2017 Proceedings

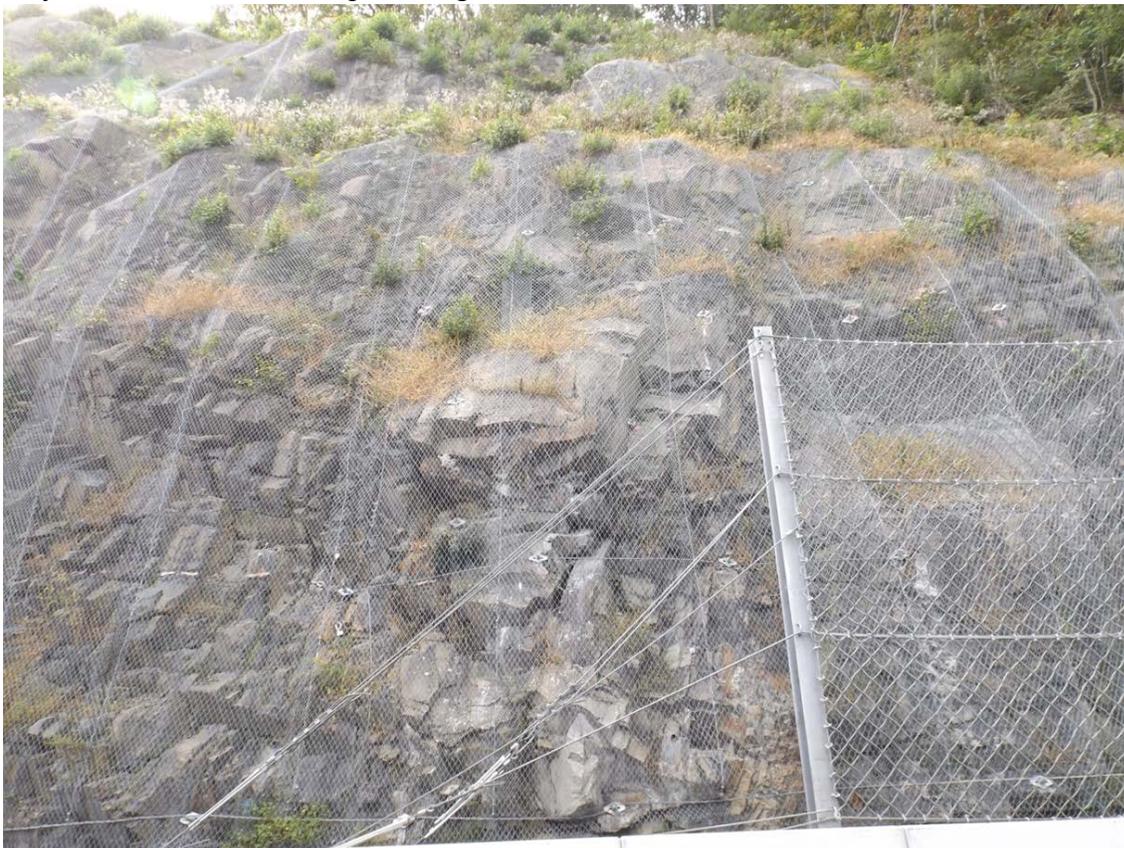
1. Combined drapery mesh and rockfall barrier for rockfall mitigation

Rockfall mitigation in the United States has become essential when constructing and improving roads and highways adjacent to rocky slopes or blasted high-walls. Due to the necessity of rockfall mitigation, the technology and infrastructure for rockfall protection has grown greatly in recent years. Improved options to mitigate different rockfall situations have allowed engineers and geologists to design and implement the most appropriate mitigation for each unique hazard present in a rockfall prone area. A combination of systems often provides the best mitigation for complicated rockfall hazards. By conducting a detailed site investigation and rockfall analyses, rockfall energies can be accurately modeled for specific sections of the site. The findings and results can pinpoint locations of higher rockfall energies for specific mitigation, thereby optimizing the overall mitigation with a combination of systems. In this way, the overall design maybe reduced in size and price, Figure 1.

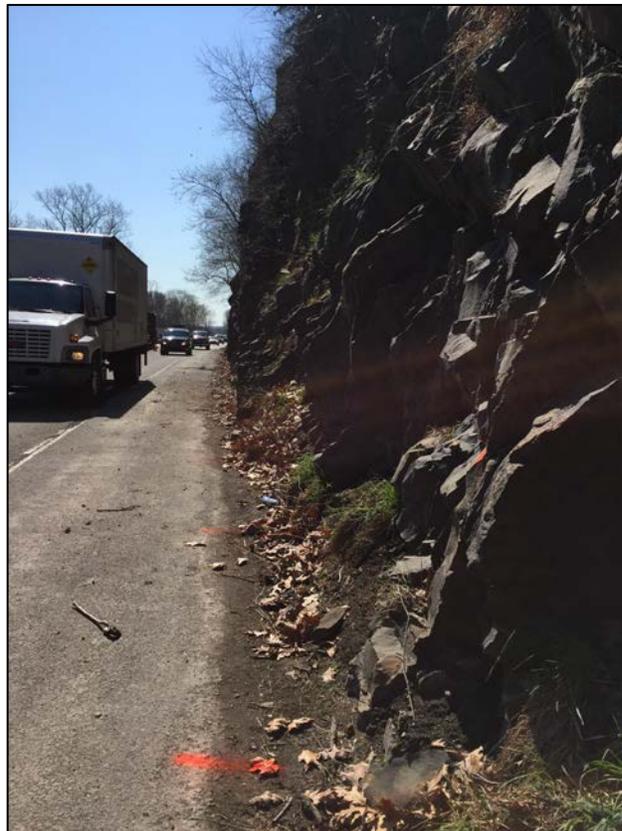
3. Catchment at the toe of the slope

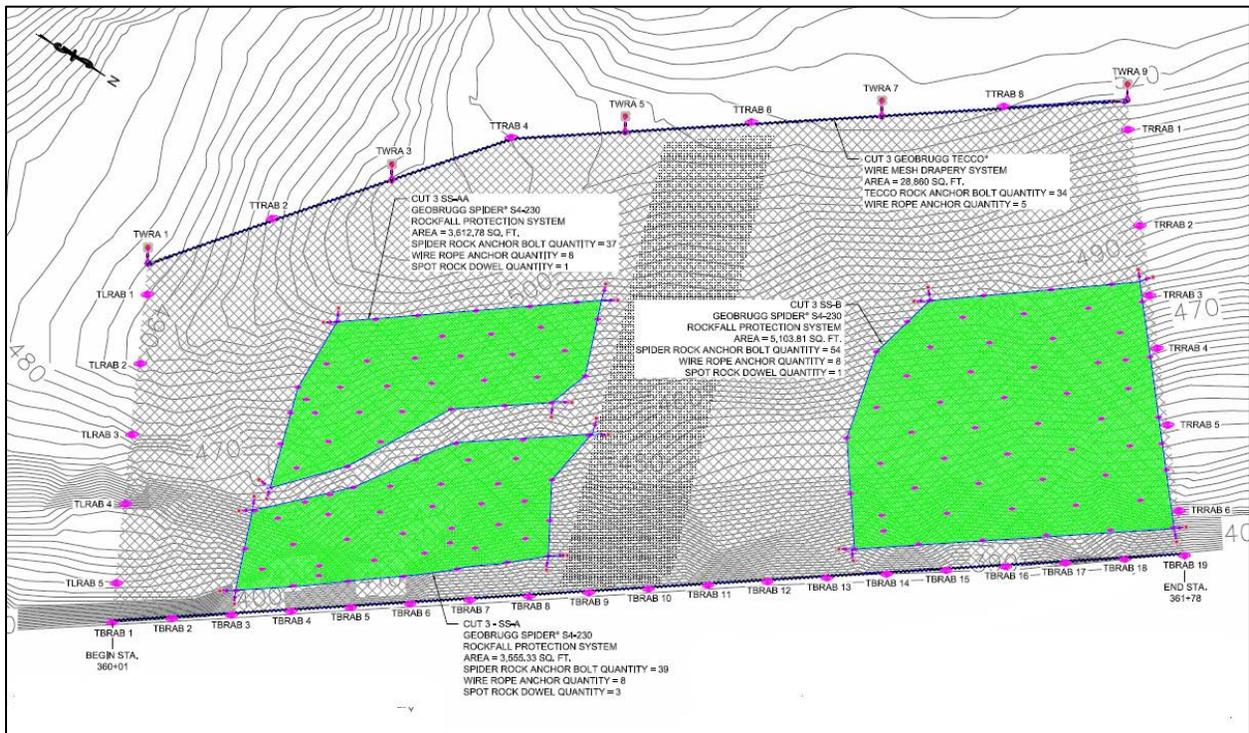
8. Final plan for Northern highwall using tensioned Spider mesh overlaid with TECCO drapery

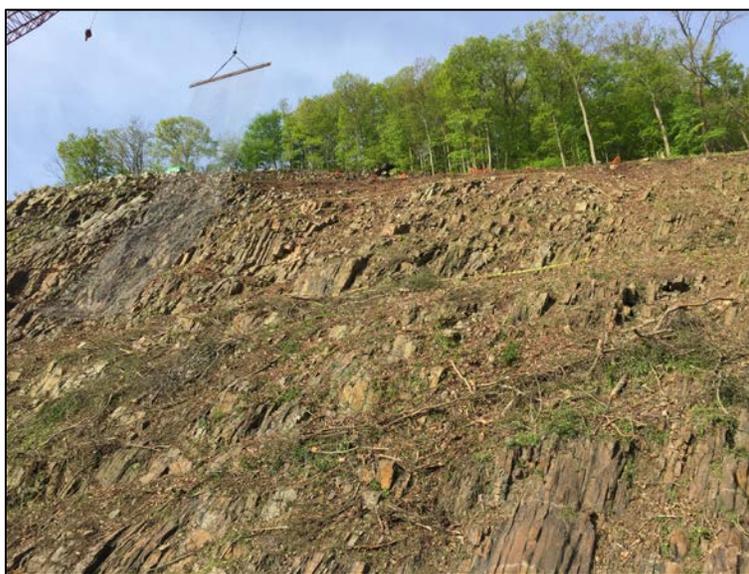
9. Moveable rockfall drapery used during scaling

Following the road closure, the slopes were completely cleared, grubbed, and scaled. As a part of the PENNDOT specifications, a temporary, moveable rockfall drapery was designed and used during scaling to protect the road, workers, and the railroad located below U.S. Route 11, Figure 9.

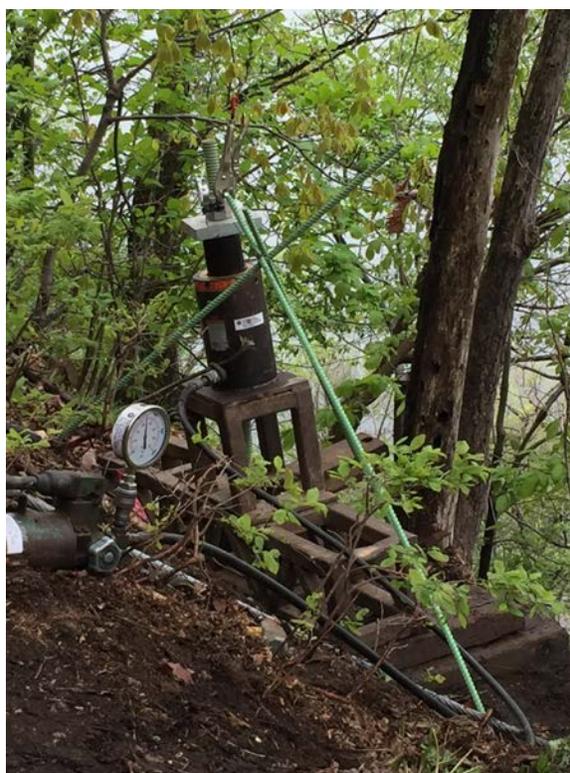
10. Anchor verification test setup

Verification anchors were installed and tested to verify rock strengths in actual, worst-case field conditions, Figure 10. By conducting these tests, an in-field rock/grout bond strength was obtained so anchor depths could be drilled to their most appropriate depth.

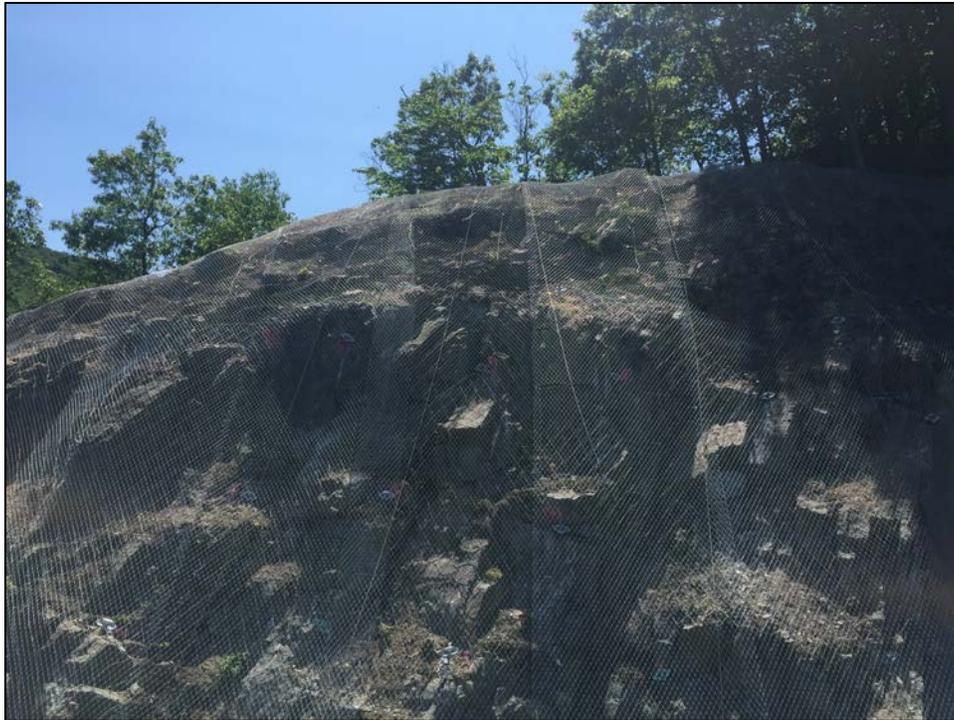
13. Tensioned Spider mesh overlaid by TECCO drapery mesh

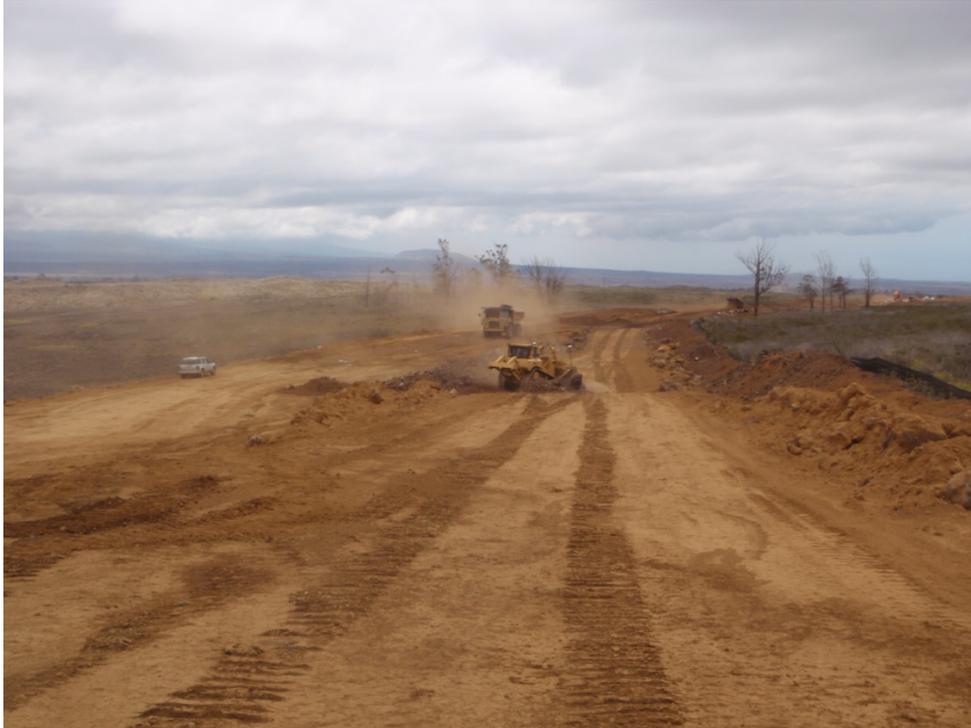
Figure 5 - Dusty conditions during construction work on the Saddle Road, West Side project.

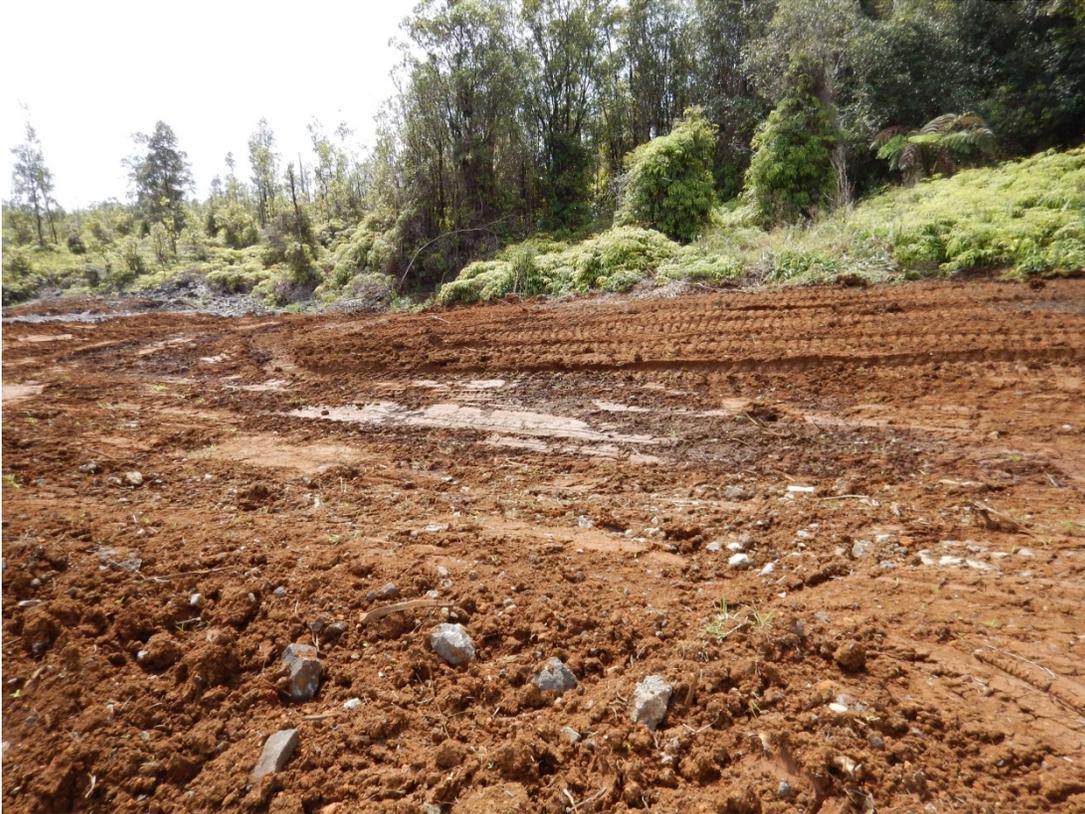
Figure 6 - Weathered ash material exposed during construction of the Saddle Road, East Side project. Note the degree of rutting and sheen visible.

The saturated, weathered volcanic ash is typically very soft (Figure 6). Upon initial disturbance, the ash may be firm enough to support loads imposed by a passenger vehicle. However, subsequent disturbance leads to softening of the ash, making it difficult to traverse with vehicles with rubber tires. Careful excavation practices are required to prepare the subgrade to receive the embankment fill loads.

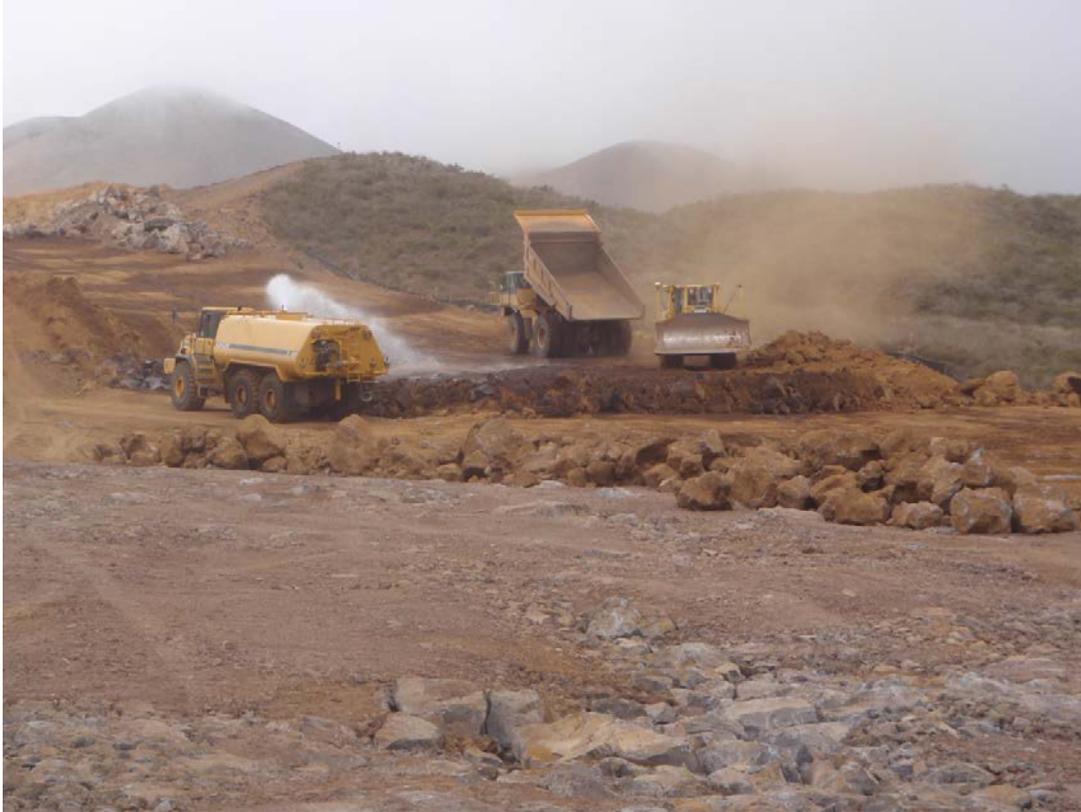
Figure 7 - Mixing ash and rock to achieve compaction and stable embankment subgrade for Saddle Road, West Side project.

To facilitate good subgrade compaction, as part of the special contract requirements for the Saddle Road project west side new alignment, the contractor was required to provide an “Ash Management Plan” that included detailed procedures to handle, stabilize, and compact ash materials prior to beginning construction. The project plans also included ash scarification to a minimum of 2-feet beneath the final roadway grade wetted and mix it with basaltic rock excavated from other areas within the project limits to improve bearing capacity and compaction (Figure 7). Theoretically, water contents between about 30 percent and 60 percent were necessary to achieve required compaction for the ash. With the addition of the rock, the moisture content requirements could be relaxed. Compaction efforts were typically controlled by method specifications due to difficulties in measuring in place density of the mixed rock and ash material.

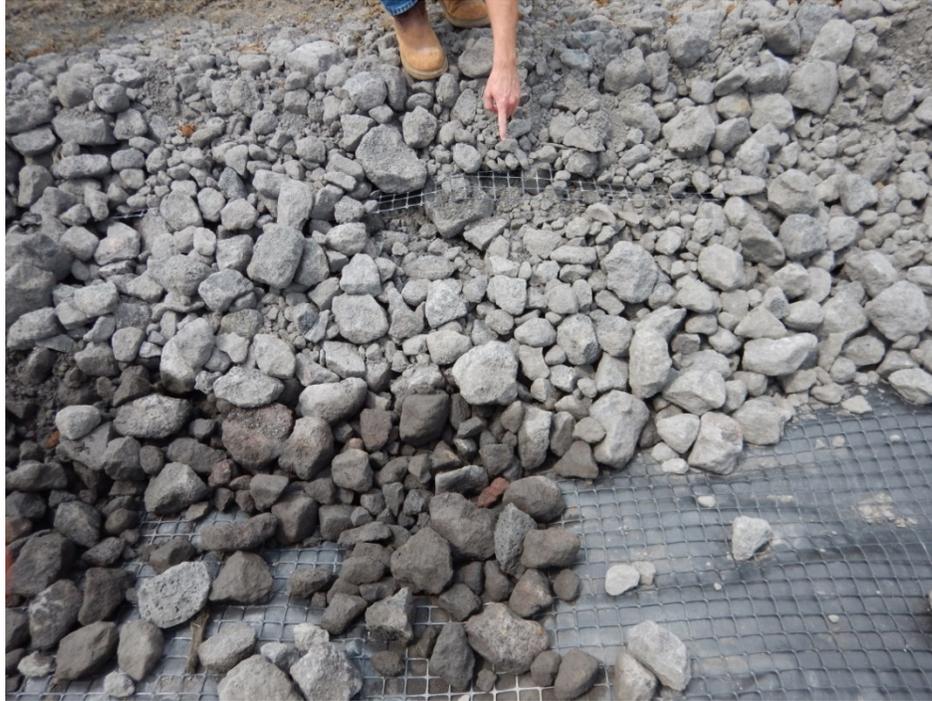
Figure 9 - Installation of reinforced section including geotextile, two layers of geogrid, and crushed rock (select topping) material.

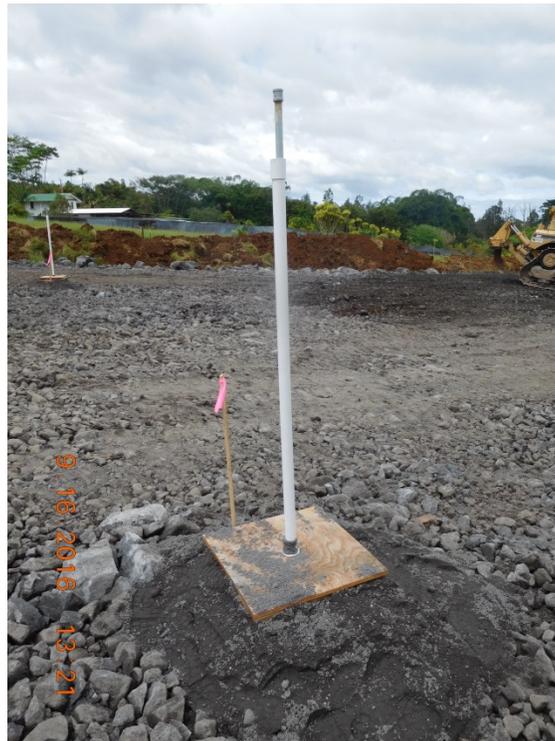
Figure 10 - Typical settlement monitoring point assembly. Assembly was installed near the base of embankment to measure settlement of subgrade ash.

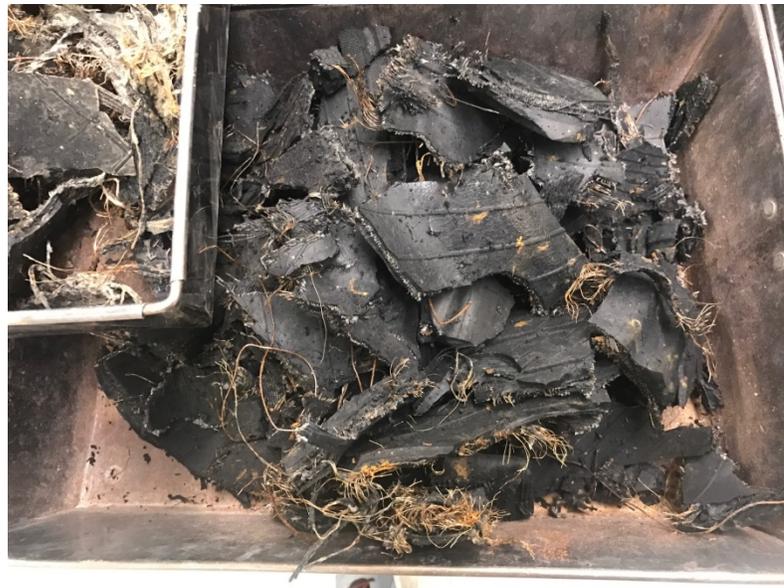
Figure 1 - +30% Free Wire

Tire Derived Aggregate (TDA) used in civil engineering applications is one way to close the gap between generated and used tire shreds. TDA are tire shreds that are compacted and used like aggregate. Tire shreds by definition are waste tires cut in sizes of 2-12 inch pieces. Tire chips are any sizes less than 2 inches. Unless the tires are old, the shreds will contain steel belts. The sharpness of the knives cutting the tires will determine how much wire is embedded in the rubber. Duller knives tend to produce more free wire (un-embedded wire) than sharper ones. For engineering applications, the less free wire there is in TDA the better. Figures 1 and 2 show the difference between +30% free wire and minus 30% free wire.

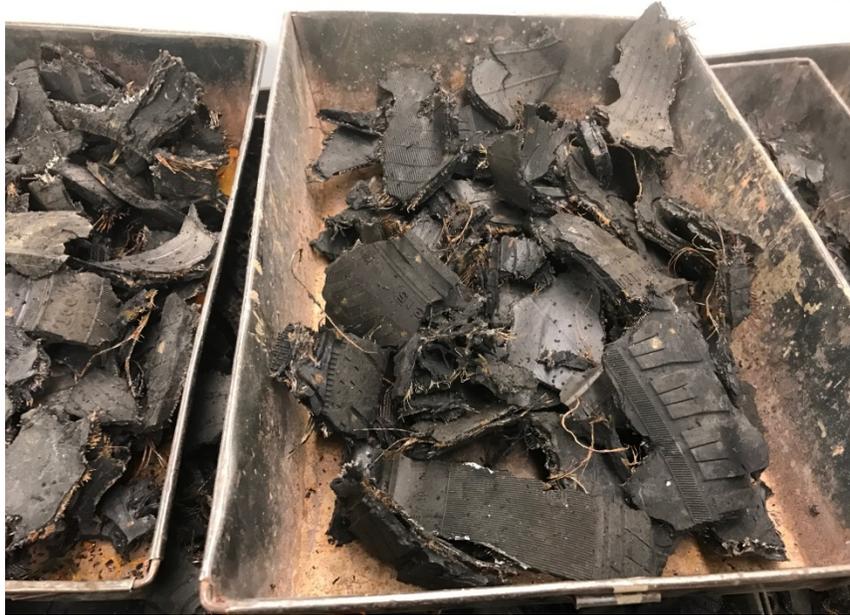
Figure 2 – Minus 30% Free Wire

Rubber fines, dirt, and debris can be seen in Figures 1 and 2 and are a byproduct of the shredding process and should be kept to an extreme minimum for engineering applications (2). The sizes shown in Figures 1 and 2 was proposed for use in MoDOT's project site consist of 3-6 inch shreds and is considered Type A TDA by ASTM D6270-08 (4). Table 1 shows typical engineering values and properties of tire shreds compared to typical rock fill (2)(3)(4)(5).

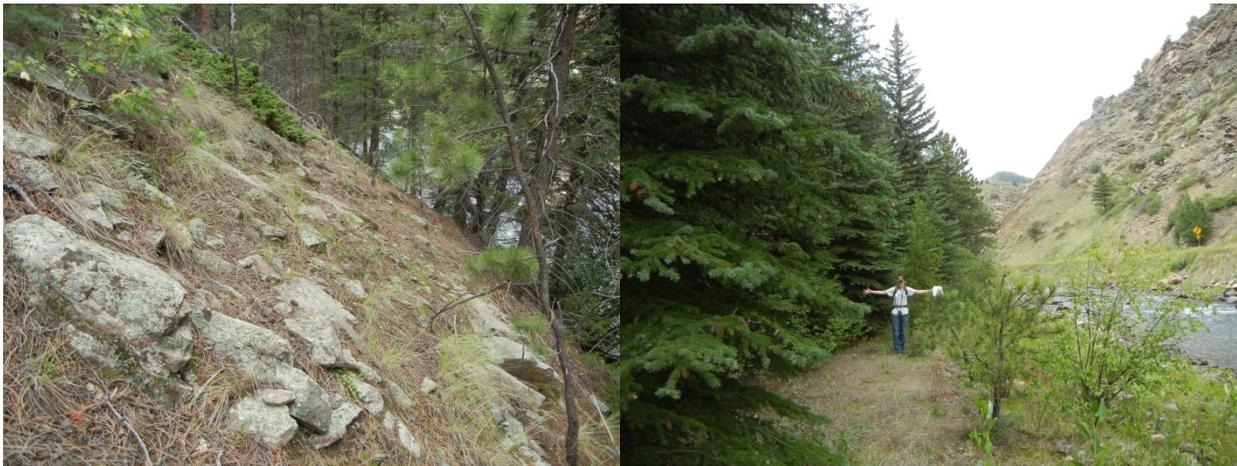
Figure 4 – Example existing conditions before trail construction: (L) steep slopes at proposed trail elevation, and (R) riparian bench next to creek found in some areas.

The existing site conditions for the trail include steep slopes (generally 35 to 45 degrees from horizontal) and a close proximity to Clear Creek and US 6. The project area consists of undeveloped public and private land, with no apparent building structures nearby. The slopes surrounding the trail alignment are vegetated with large conifer trees, shrubs, and grasses. Numerous bedrock outcrops are also visible on the slopes. In some sections there is a small flat bench for most of the year between the water's edge and the toe of the slope; this is a riparian/wetland area in many places. In other sections, higher benches appear to be relic terrace deposits of the creek, and historic railroad grades, walls and a bridge abutment are also present in a few places. Several highway bridges also carry US 6 across the creek within the project limits.

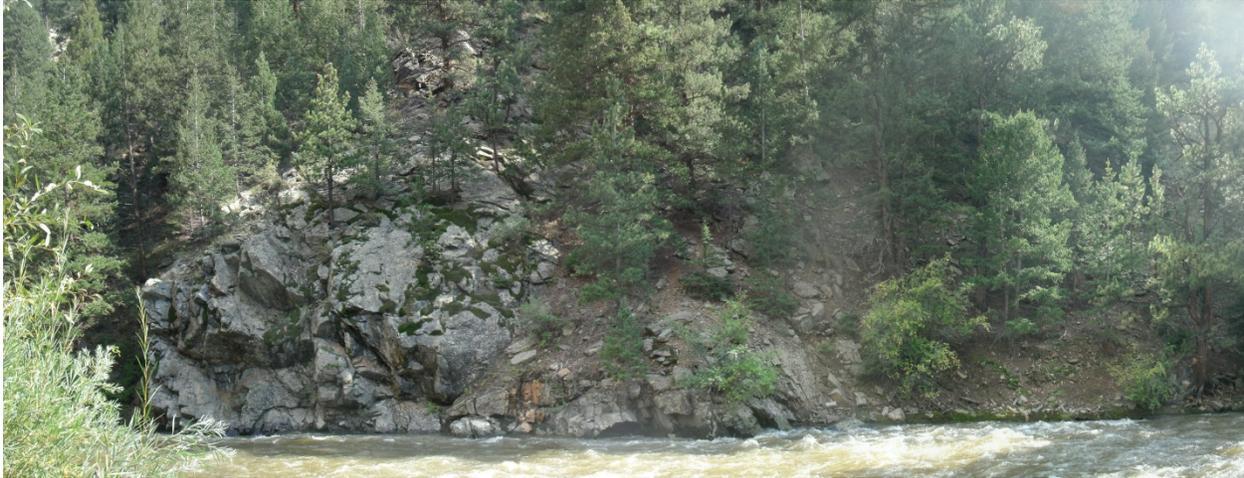
Figure 5 – An area where rock cuts were obviously required. (JC-2 East)

The primary geologic factor affecting the construction budget was the depth to bedrock; if additional retaining walls were needed in certain areas, or additional rock excavation in other areas, it would primarily be because bedrock was shallower or deeper than anticipated. Areas where rock excavation was anticipated were fairly obvious (see Figure 5). To reduce the potential for wall design to be affected by bedrock being too deep, in most places the walls were designed assuming that rock was deep enough to not contribute to bearing resistance or global/overall stability.

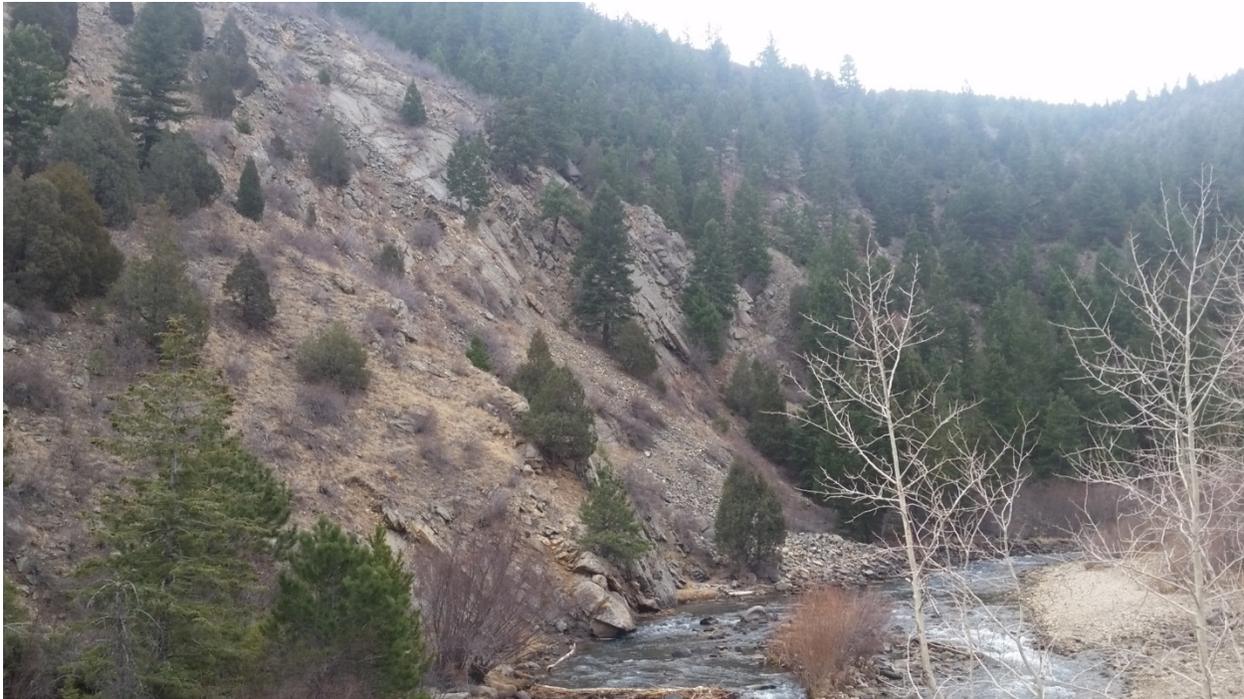
Figure 6 – A steep dip-slope in JC-2 which was avoided by changing the proposed location of a bridge.

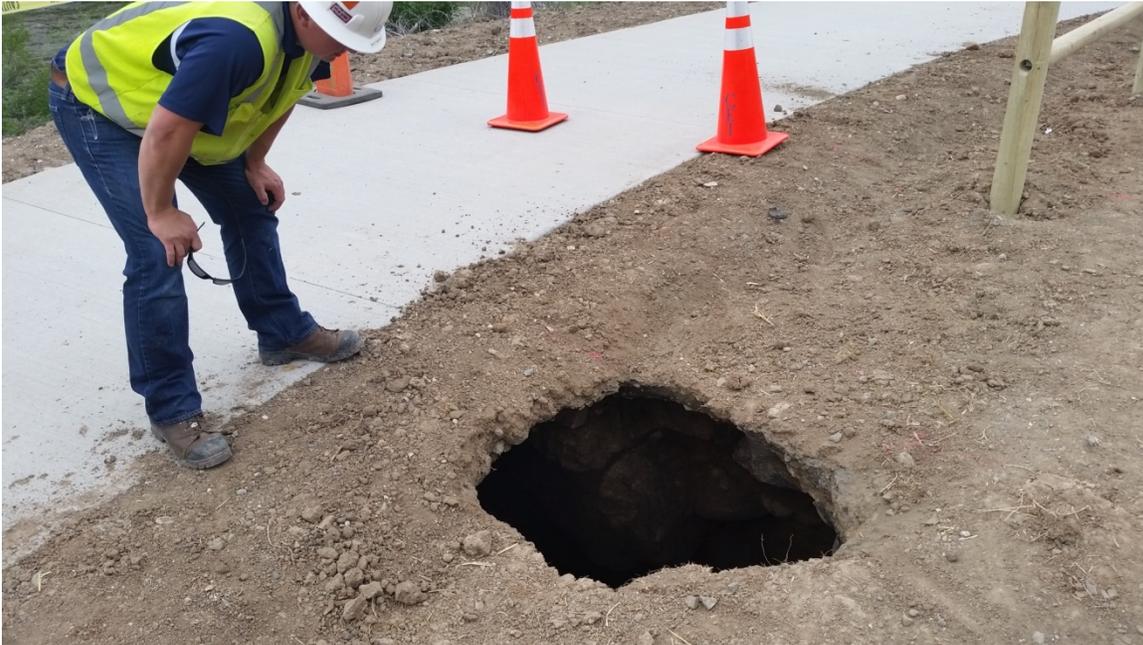
Figure 8 – A collapsed void was encountered during installation of a fence.

- A small “sinkhole” was discovered during installation of a wooden fence in a pullout off the highway; the finished concrete trail was within 3 feet, and was somewhat undermined, yet was not damaged. This void appears to have been either left over from original construction of the embankment, or due to erosion and loss from flood events over the years.

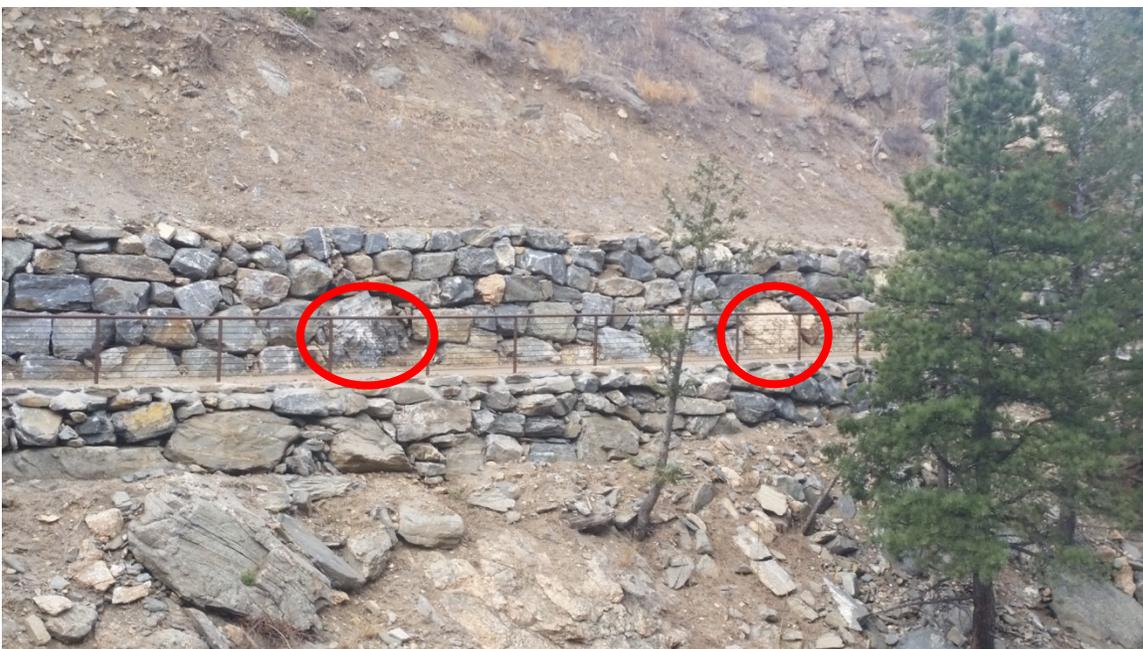
Figure 9 – Bedrock outcrops incorporated into a rockery in JC-2 East.

- Bedrock encountered during excavation of the lower lift of a ground nail wall, where soil was anticipated. Several ground nails were eliminated as a result.
- In one area, it was known that bedrock lay directly under the trail subgrade surface, and the construction plan was to expose this rock, place base course soil, and concrete pavement. However upon excavation, the bedrock surface formed a small cliff which would be under the trail, then sloped down towards the creek. To deal with this, the D/B team designed a hybrid structure with a portion of cantilevered concrete trail deck anchored into the rock at the back, and a portion of cast-in-place concrete wall, also anchored into the rock through the wall footing.

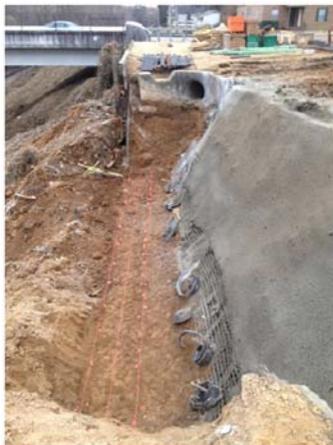
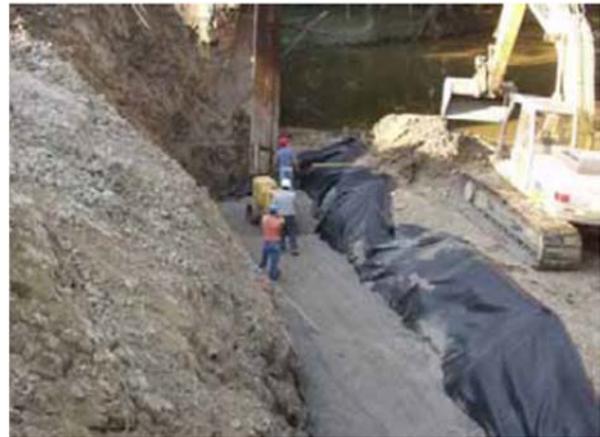
Figure 3 (left): Site excavated and ready for GCS wall foundation
Figure 4 (right): Installation of a reinforced soil foundation

1. Excavate to required elevation and compact existing soil
2. Construct foundation (leveling pad/reinforced soil foundation)
3. Place the first row of blocks
4. Place select fill
5. Compact fill
6. Lay out geosynthetic reinforcement
7. Repeat steps 3-6 until required elevation is reached

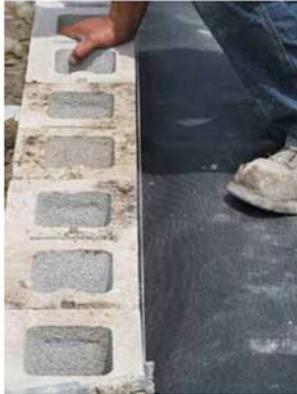
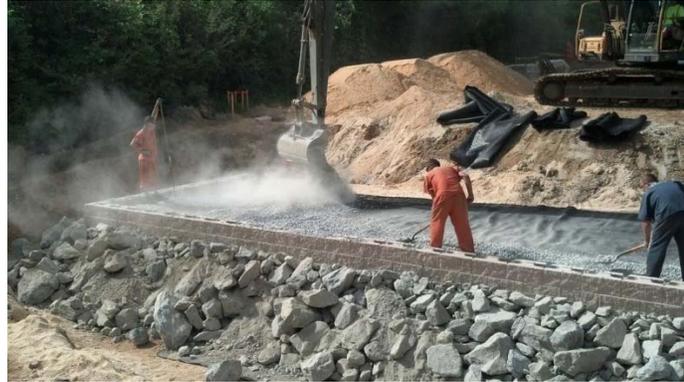
Figure 5 (left): Placing a row of CMUs
Figure 6 (right): Placing select fill

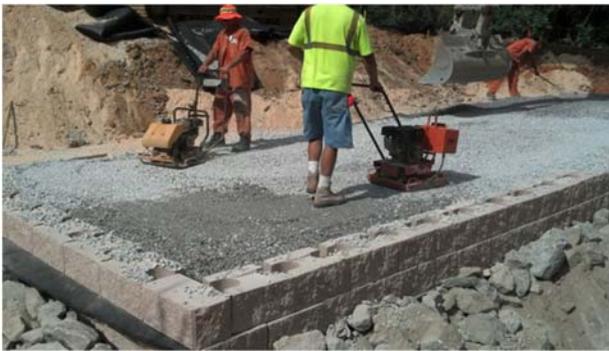
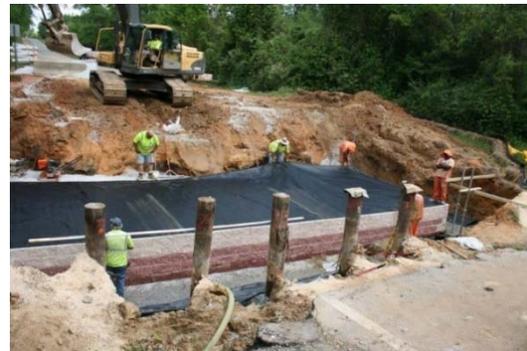
Figure 7 (left): Compacting fill with vibratory plate compactor
Figure 8 (right): Laying out geosynthetic reinforcement

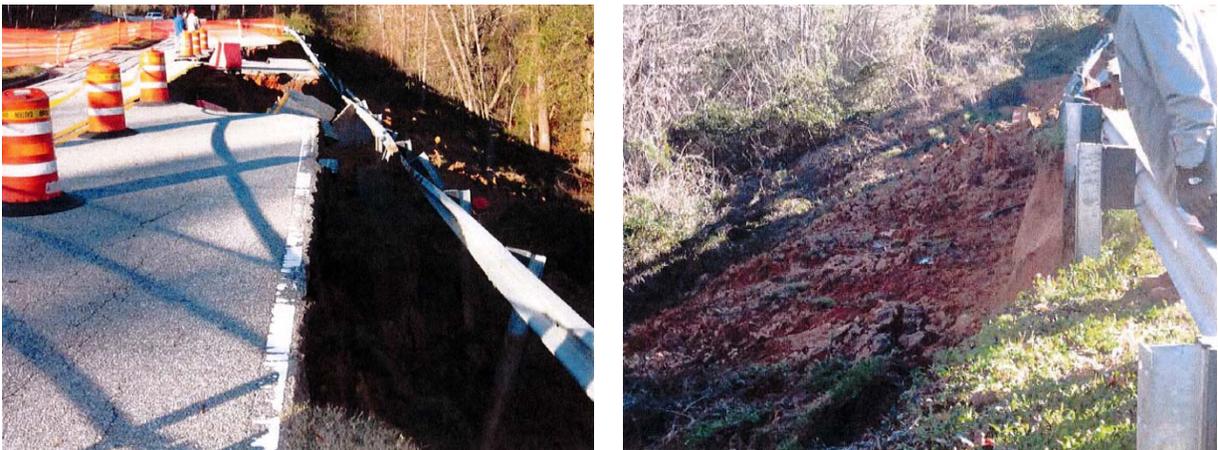
Figure 9 (left): Slope failure undermining roadway platform
Figure 10 (right): Slope failure below roadway platform

Heavy rains experienced in the final days of December 2015 activated a slope failure on 10th Division Rd. just north of Russ Pond. Approximately 400 linear feet of roadway from the centerline and the slope on the northern, downhill side of the road sloughed off towards Upatoi Creek. Engineering from the U.S. Army Core of Engineers (USACE) performed a site visit on January 5, 2016 and observed cracking not only in the roadway but also on the slope face below the road. Figures 9 and 10 are photos of the road and embankment failure during the initial USACE visit.

It is difficult to discern what instigated movement: the undermining of the toe at Upatoi Creek or the rain saturating the soils to the point in which the embankment could no longer support itself. The area of the hill in which the project is located drains from the south to the north where the creek is located just to the north of the roadway. The road embankment was built up such that a large area above the road forms a basin allowing for ponding. A small culvert located on one end of this basin would not have adequate capacity to drain this large area during intense rain events. It is likely a perched water condition developed causing an increase in hydrostatic pressure coupled with the lower effective stress which started the slope movement (ref***).

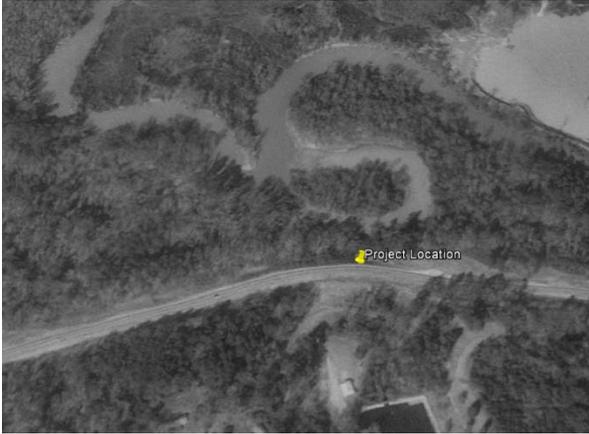
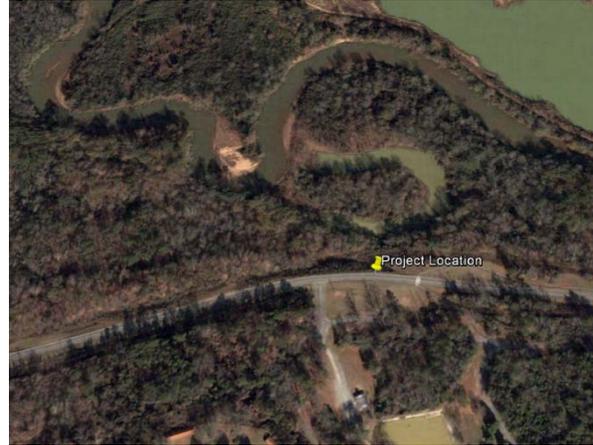
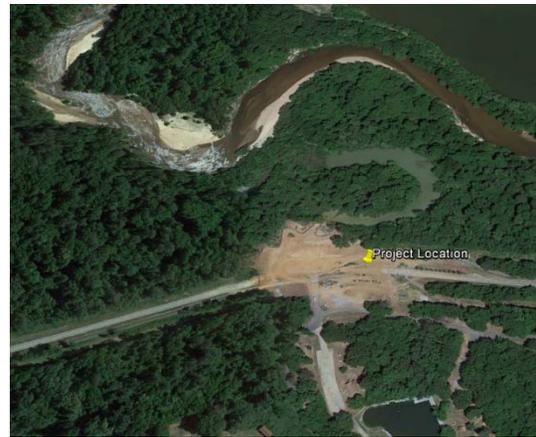
Figure 11: Project location 1993

Figure 12: Project location 2003

Figure 14: Project location May 2016

Figures 11-14 show the meandering of Upatoi Creek from 1993 to the current position of the creek captured in satellite imagery from May 2016 where an oxbow lake has formed. It can be discerned that soils at the toe of the slope are exceedingly soft, loose, and saturated.

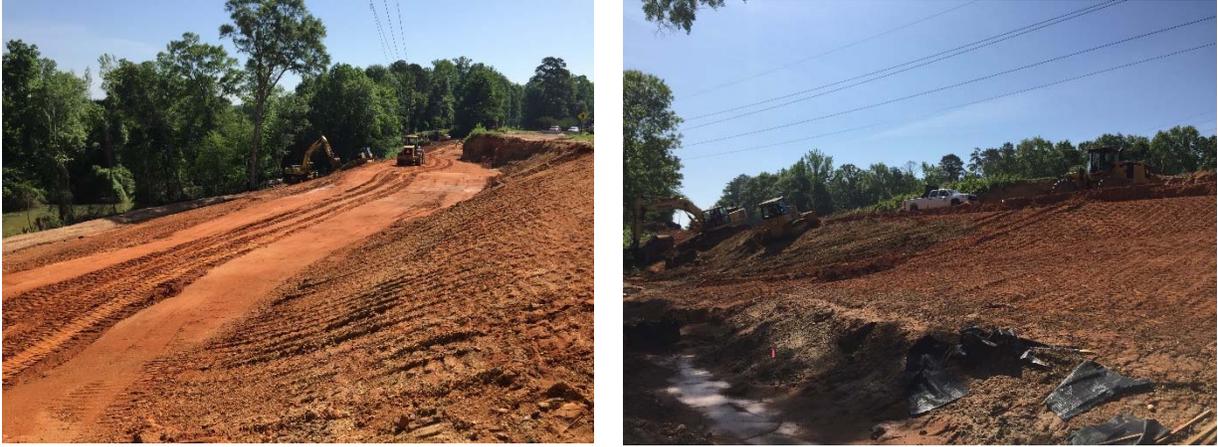
Figure 15 (left): From above – site visit during grading operations
Figure 16 (right): From below – site visit during grading operations

The first attempt by others at reconstructing the slope was solely with grading. Erosion control was set in place, vegetation was removed, and traditional earthwork slope construction commenced. Material was removed and stockpiled then placed back in lifts and mechanically compacted. Slope reconstruction efforts can be seen in Figures 15 and 16 below. During slope reconstruction in April 2016 tension cracks began to form and it became evident that the slope had begun moving again.

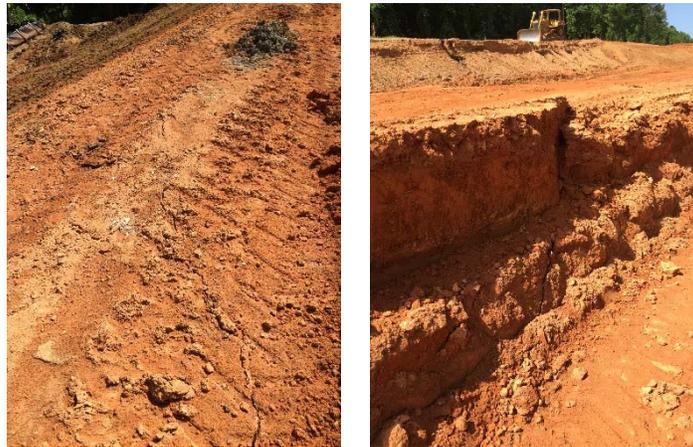
Figure 17 (left): Stress cracking during slope reconstruction
Figure 18 (right): Stress cracking during slope reconstruction

Geostabilization International was contacted in April 2016 to perform a site visit and propose a solution. Despite being more than ten feet below required road elevation, stress cracks were forming during construction of the slope as shown in Figures 17 and 18. It was evident at this point that more robust structure would be required to regain the lost shoulder width given the geometry of the slope.

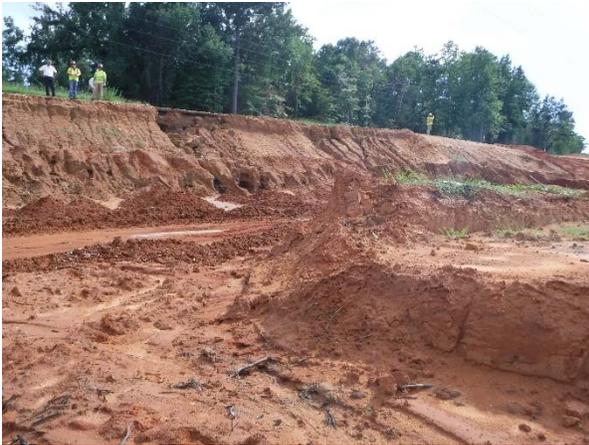
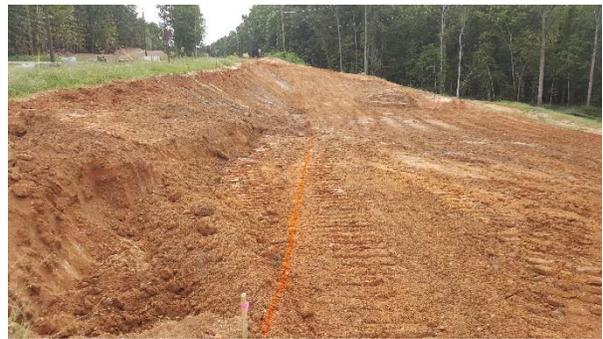
Figure 20 (left): Sight conditions at commencement of work
Figure 21 (right): Surveyed line mark top of wall

Submittals and paperwork were approved in September 2016, permitting GeoStabilization International was able to begin work on the 10th Division Road landslide. When work started, the original road surface was sixteen feet below original grade (Figure 20). This once relatively heavily trafficked road had been closed for eight months, leaving drivers with a time consuming detour.

The first step was to determine the horizontal alignment of the future wall so that the batter of the wall could be planned leaving a safe distance for shoulder width, and a fence to be installed on top of the GCS Structure. The disheveled slope was graded smooth and surveyors marked locations as shown in Figure 21.

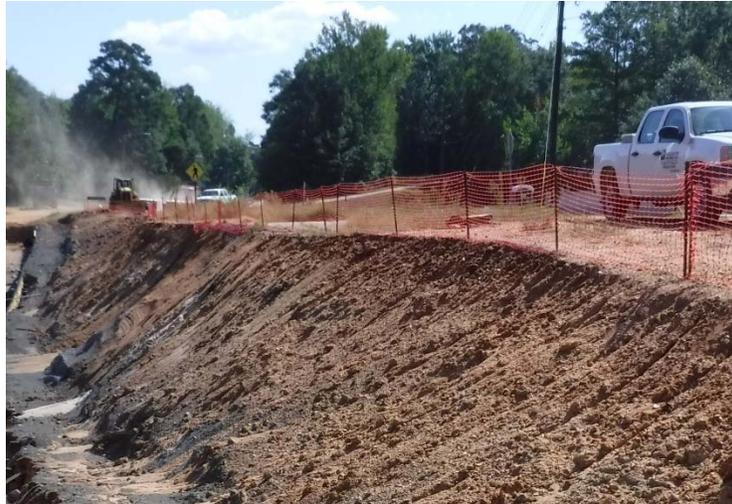
Figure 22: Slope prepared to begin construction of GCS wall

Top-down excavation commenced with one lift being completed at a time. Up to five feet of additional material was excavated at a time, Figures 23 shows the walls being constructed. Note the flat ledge at the top of the wall that will serve as the foundation for the GCS wall. Figure 22 also shows water at the front of the wall that was apparent the entire project and will likely persist indefinitely.

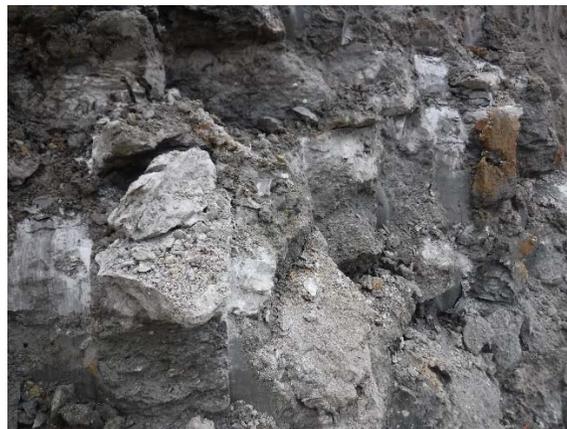
Figure 23: Eutaw Formation observed during construction

While excavating the fourth lift in the center portion of the wall, there was evidence of the Eutaw Formation. Highly weathered sedimentary rocks, clay, and coarse detrital sands all littered with fossilized sea shells were found in the excavation. A photo of the observed stratigraphy is shown below.

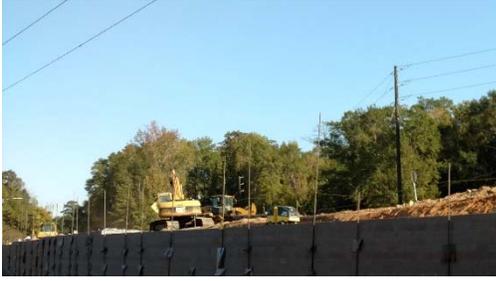
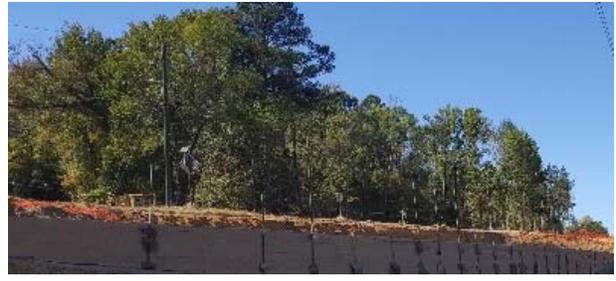
Figure 24 (left): Construction of GCS wall facing east
Figure 25 (right): Construction of GCS wall facing west

Once construction of the GCS wall commenced the wall went up rapidly as workers laid blocks, placed and compacted fill, placed geosynthetic reinforcement, and repeated. Figures 24 and 25 show the project from either ends during GCS wall construction.

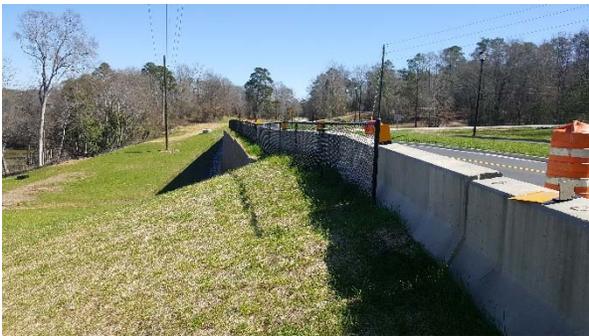
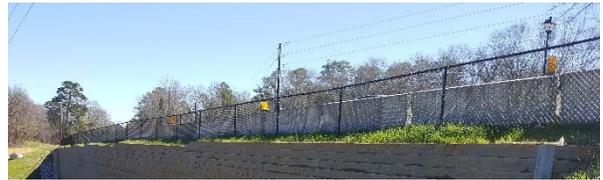
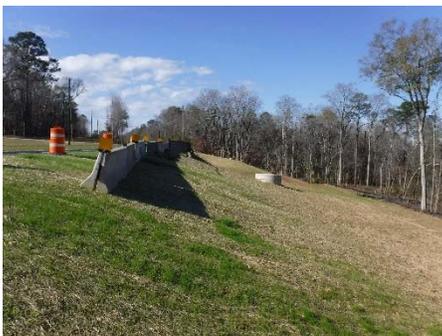
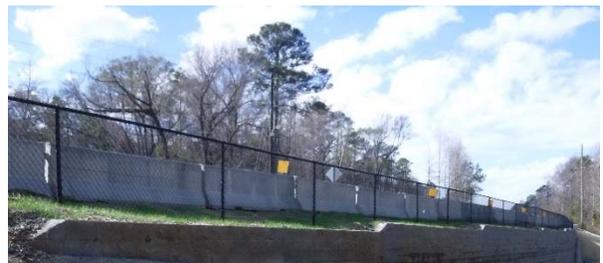
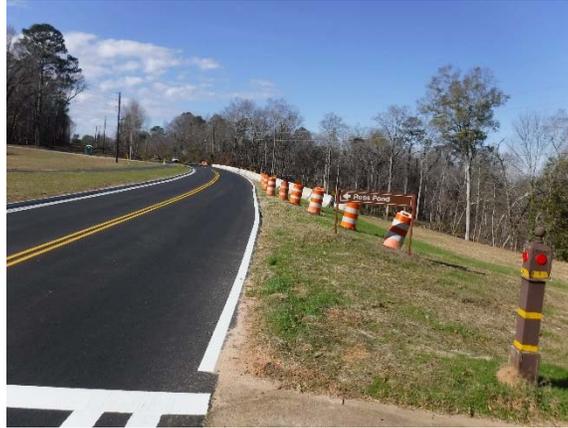
Figure 28: Completed project looking east

Figure 29: Completed project looking east

Figure 30: Completed project looking west

Figure 31: Completed project looking west

Figure 32: Finished roadway platform

The composite wall was completed in November 2016 with final grading and paving following shortly after. The road is currently open to the public who drive across the project without realizing they are right above what was once, recently, a large landslide

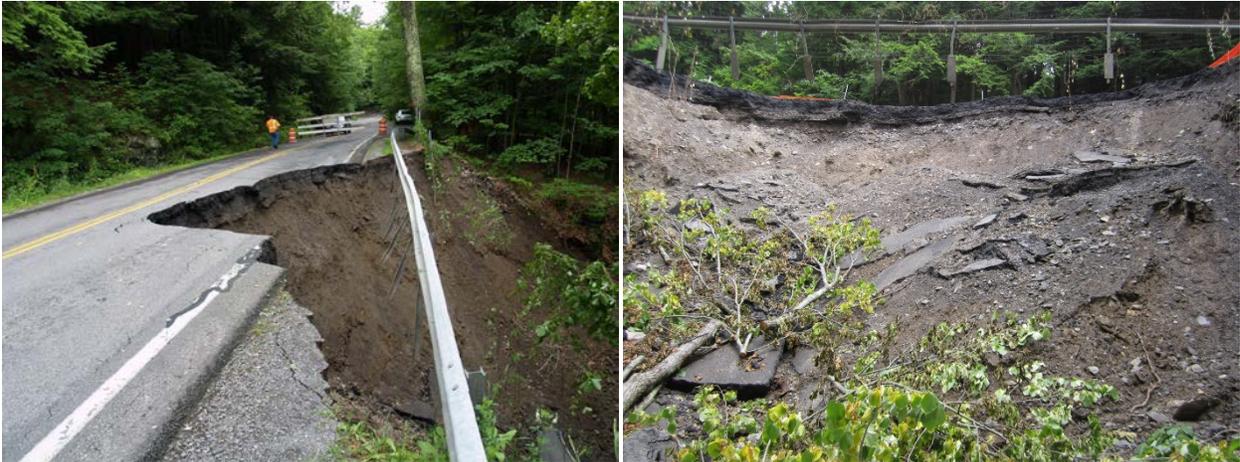
Figure 1 (left): CR 31 Site condition upon initial site visit. The pavement in the foreground would later fall into the gap created by the landslide.

Figure 2 (right): Landslide as seen from below. Note guiderail posts near top of photo.

The slope underlying a segment of County Route 31 in Otsego County, NY, failed catastrophically and dropped over 20 feet after heavy precipitation in the area. The landslide extended back to the center line of the road and the outboard shoulder and lane had fallen away. For seventy five linear feet, the guiderail hung suspended across the gap where the shoulder had once been. Tension cracks formed in the opposite lane, signaling the potential of further progressive failures farther into the road.
