68TH HIGHWAY GEOLOGY SYMPOSIUM MAY 1-4, 2017

2017 Proceedings

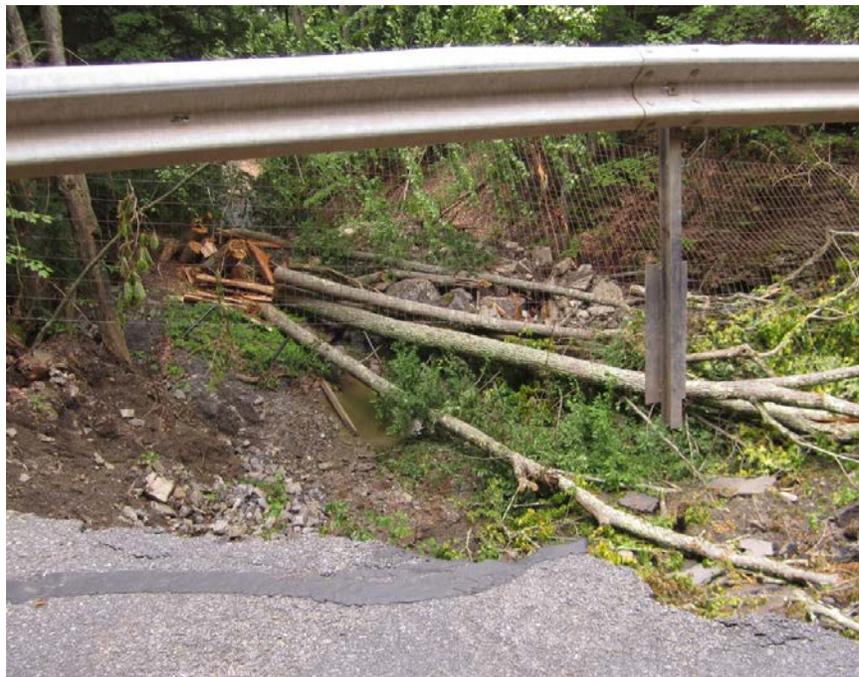
Figure 4: Ponded water was present in the debris at the base of the slide. The existing stream entered the debris from the right of this photograph and continued downslope behind the tree stumps.

Beneath the toe of the slide and debris was a small stream flowing on bedrock. The slide mass had blocked the upper portion of the stream and the debris was saturated, with pools of standing water present among downed trees, fence posts, chunks of pavement, and soil. Water flowed out from below the slide debris into a stream that continued down the slope. On the north side of the scarp, a small metal pipe segment was exposed. A few feet north of the slide, a corrugated plastic culvert extended out from the slope, although no water was leaving the pipe or culvert during the site visit. Much of the water was traveling from the opposite side of the road along the soil/rock boundary.

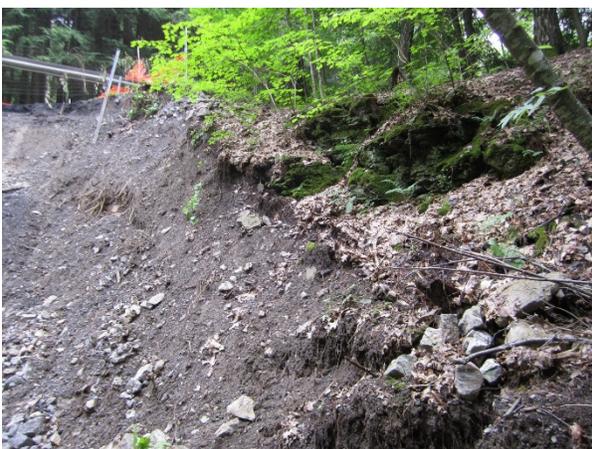
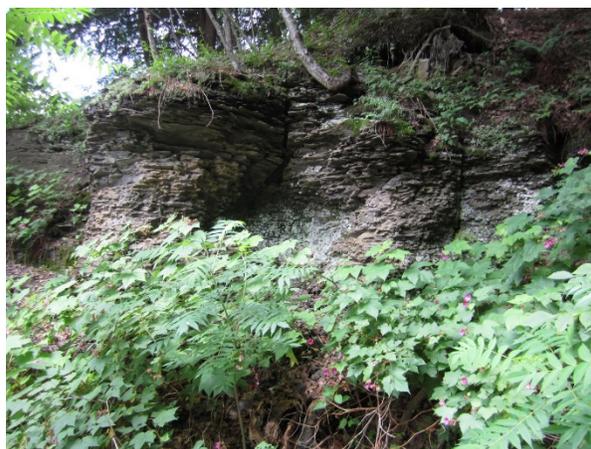
Figure 5 (left): Rock outcrops on the south flank of the landslide

Figure 6 (right): Rock outcrops to the north of the landslide, outside of the slide extents

Properties for the bedrock were determined from average values for similar rock types. Based on its appearance and the regional geology, the rock was determined to be limestone of varying degrees of weathering. Site observations indicated that the failure occurred entirely above the surface of bedrock. The joint sets present in rock outcrops supported this observation in that none of the joint sets dipped at an angle or orientation close to the slide surface. The bedrock was modeled with properties resembling that of a soft sedimentary rock.

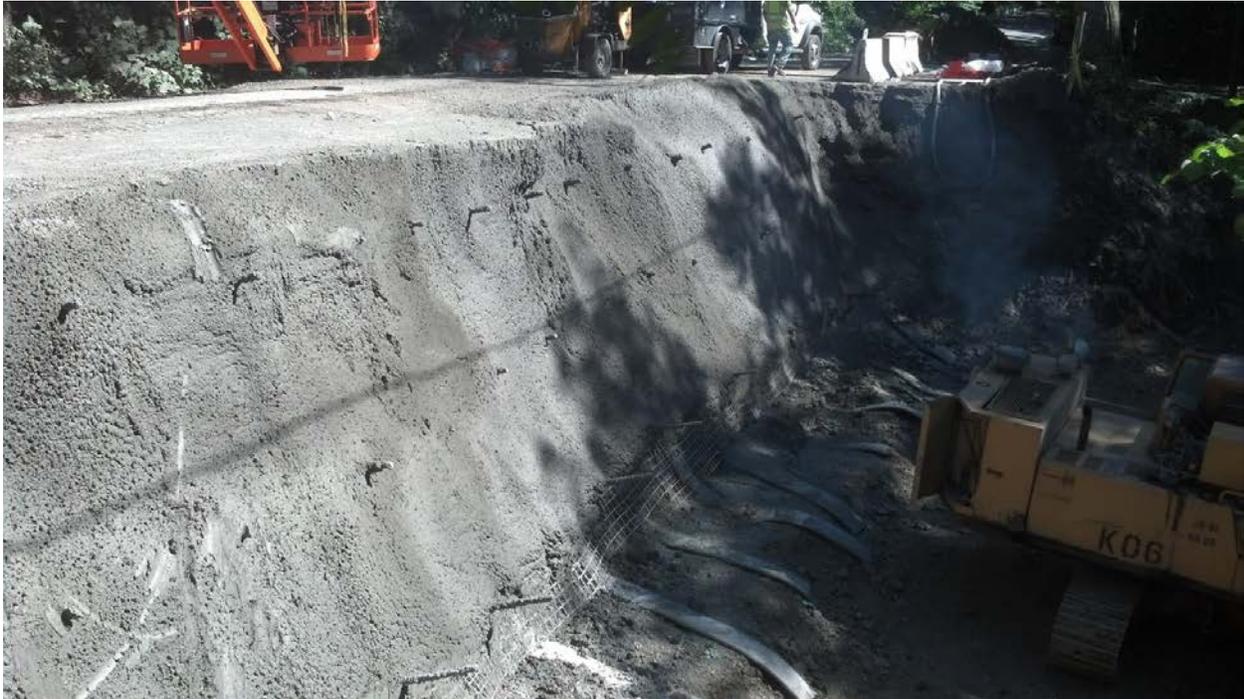
Figure 8: Soil nail wall in progress

Within days of the initial site visit, upon approval, GSI mobilized to the site and began stabilizing the existing scarp. In cooperation with Cobleskill Stone Products, Inc., construction began with the soil nail wall to prevent further movement, sloughing, or collapsing of the soils underneath the road. The soil nails were drilled in rows along the scarp and subsequently each

row was encased in a reinforced shotcrete facing. Because construction progressed in lifts from the top of the slide to the base, the slope behind each lift was stabilized before work began on the next. The first three rows were drilled with equipment on the road, but due to reach limitations, subsequent rows were drilled from below. Cobleskill Stone Products provided an access ramp so that equipment could reach the lower areas of the design.

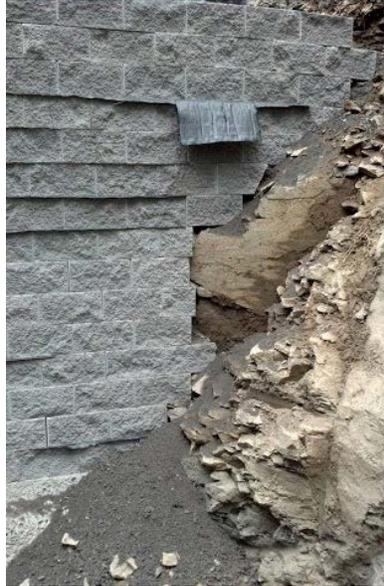
Figure 9: Facing block placement around rock outcrop

The fill wall design also allowed for some flexibility in construction. Along the outer areas of the slide, rock outcrops protruded from the slope. Varying the wall shape to work around rock outcroppings was easily accommodated: the facing blocks were saw cut to shape the face of the wall around the rock outcrops, the reinforcement layers were cut to shape, and the backfill was placed around the rocks as needed. During construction, especially as the wall grew in height, a fall protection system was put in place so that workers could continue to build the wall safely.

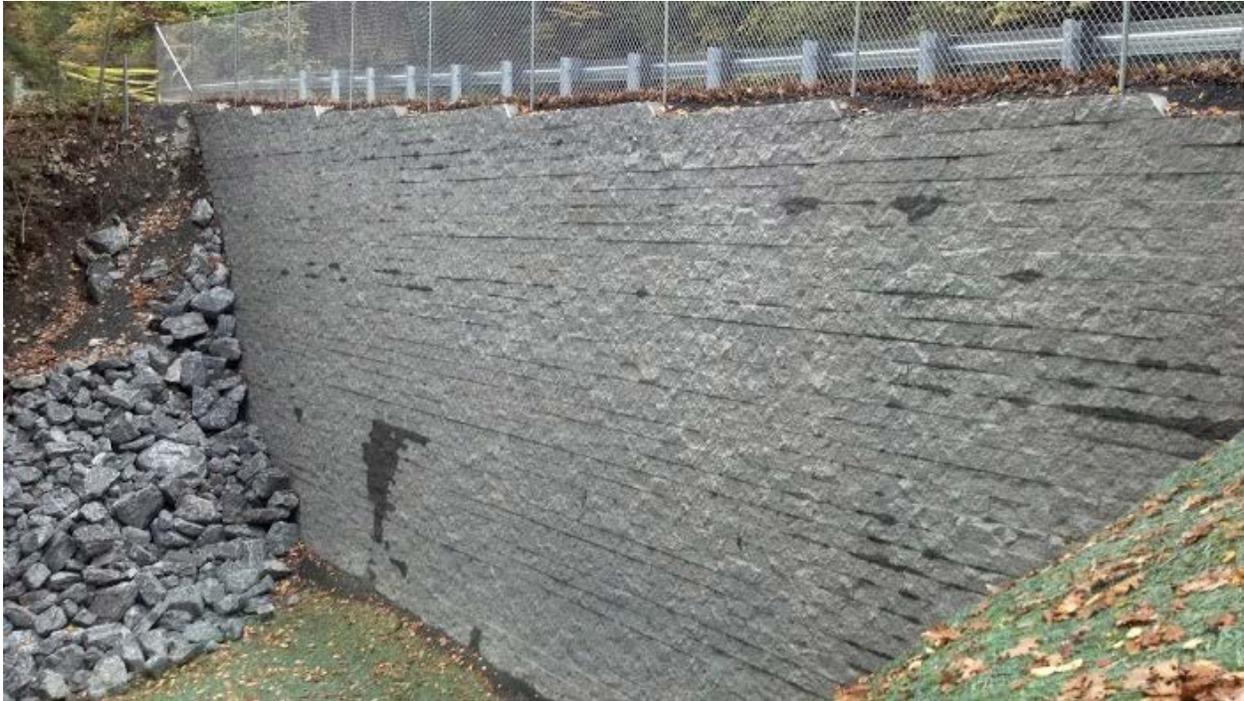
Figure 10: Completed repair

After the landslide occurred along CR 31, taking out one lane of the highway, a rapid reaction from Otsego County Department of Highways, Forestry and Parks allowed for GSI to quickly mitigate the impact of the site. Within days of the slide, GSI had visited the site, engineered a solution, and began construction. The design-build nature of the construction provided constant communication between the engineers and field personnel. Changing conditions at the site were incorporated into the design in real time and the changes relayed back to the operators on site. Since the construction, this site has not experienced any slope stability or construction-related issues and is performing as designed.

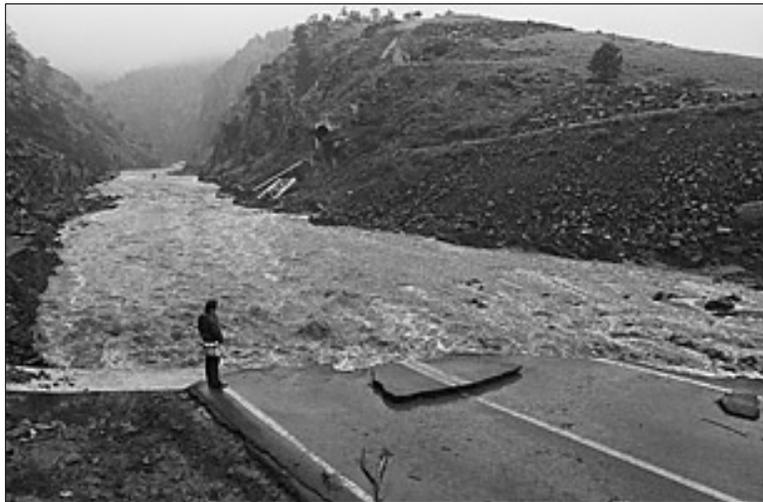
Figure 1. Photograph of the damage after the 1976 flood.

After the 1976 flood US34 was repaired and, for the most part, rebuilt in the same position it was, just with better drainage control and soldier-pile walls to mitigate erosion. A 2-mile section of the highway known as The Narrows was raised above the 100-year flood level through a series of four retaining walls and a bridge. On September 12th, 2013 the Big Thompson Canyon was hit by another significant flood (Figures 2 and 3). The flood has been referred to as the 500-year flood by many. Fortunately the damages were not nearly as substantial, but lives were still tragically lost. Immediately following the 2013 flood 30 million dollars in emergency repairs were made to the road. However, the Colorado Department of Transportation (CDOT) determined some major redesigns to the road were needed to improve the resiliency of the highway and avoid disasters like this in the future.

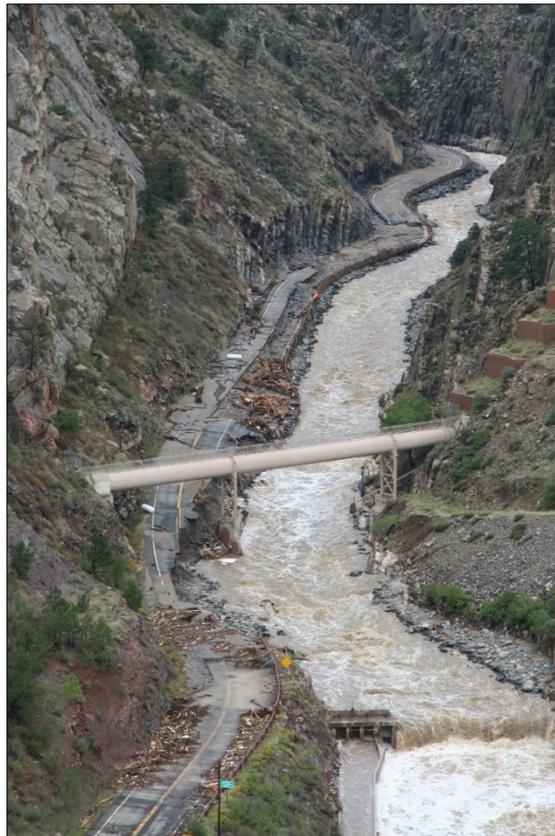
Figure 2. Photograph of "The Narrows" after the September 2013 flood.

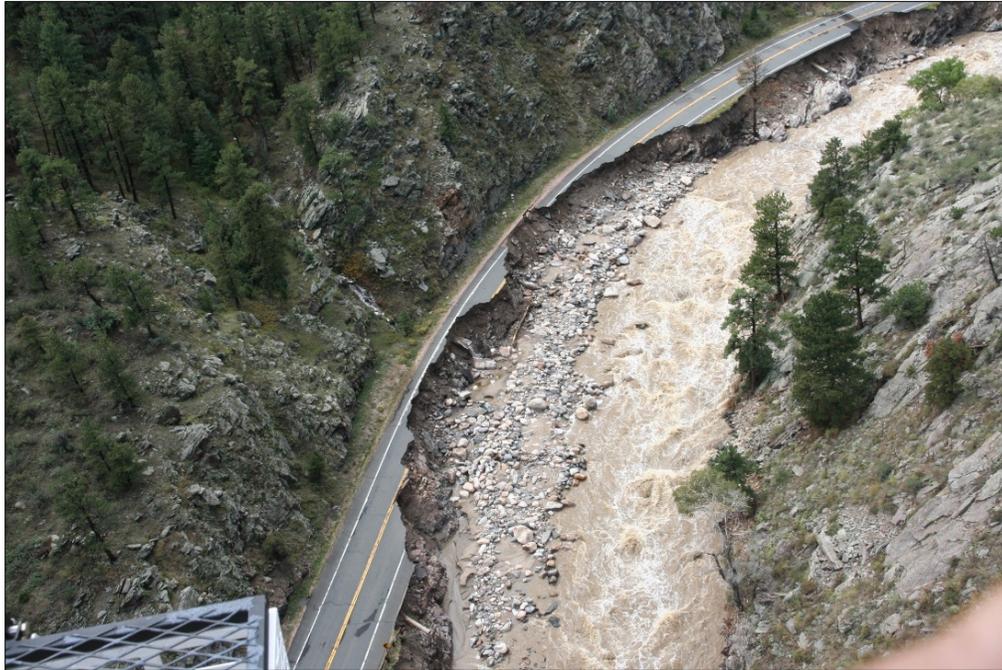
Figure 3. Photograph of highway destruction after 2013 flood.

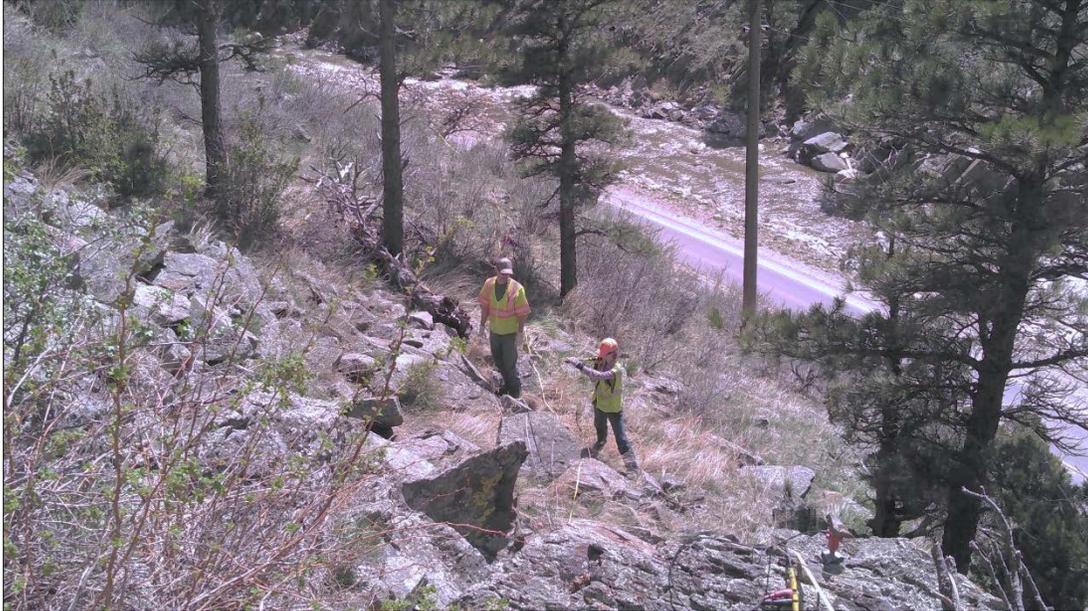
Figure 8. Photograph from Horseshoe Bend, where several seismic lines were collected. Drill rig access to this area was difficult, and expensive, prior to construction efforts.

As mentioned above, the objective of the spring 2016 geophysical investigation was to aid in construction of rerouting the highway. Rerouting was chosen for areas which sustained major damage or destruction in the 2013 flood. Several seismic lines were also collected for the construction of a temporary haul road, to be used for access to dump, process, and crush blasted waste rock and store construction materials. A total of 3,875 line feet of data collect were collected along 16 separate seismic lines. The topography was extreme and 15 of the 16 lines were located in areas not easily accessible by a drill rig prior to construction. Figure 8 is from one of these area, informally known as the Horseshoe Bend.

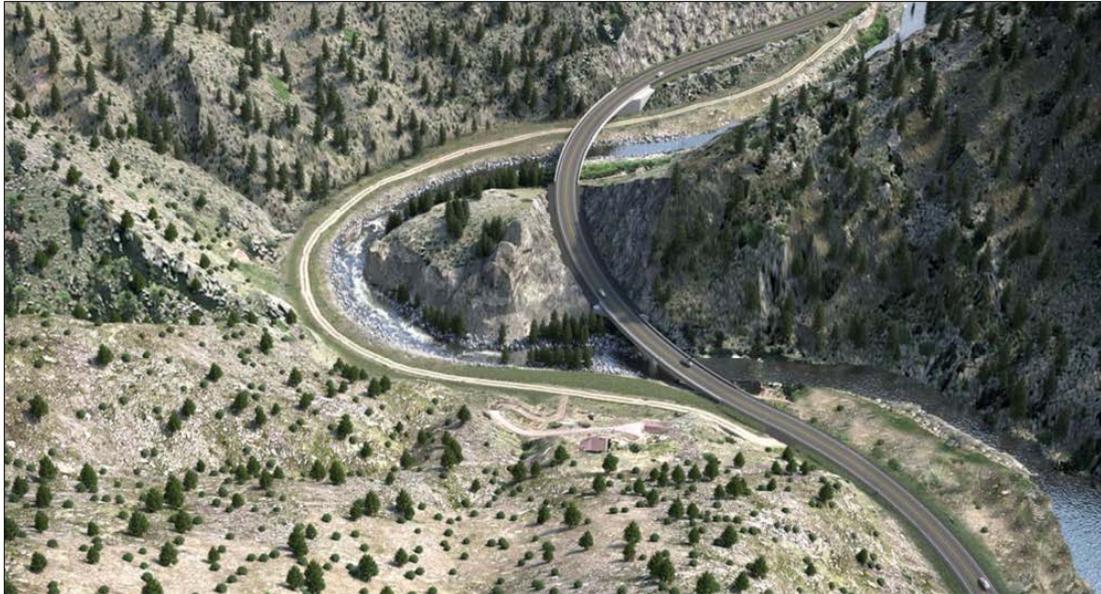
Figure 9. Computer generated image of roadway relocation around Horseshoe Bend.

This 0.4-mile stretch of the highway was completely destroyed in both the 1976 and 2013 flood events. Because of the high river energy through this curve, the preferred design alternative is to bypass the curve with 2 bridge crossings and cutting through the rock on the inside of the curve (Figure 9). Drill rig access to this area, and similar areas for this investigation, required difficult access drilling equipment and helicopters to mobilize the equipment across the river and up the steep terrain. Due to the high costs associated with helicopter access drilling, a geophysical investigation was preferred by CDOT. The SRT equipment easily mobilized across the river and up the steep terrain, making the geophysical investigation a budget-friendly option in the geotechnical design. Additionally, the geophysical investigation required minimal time to acquire and analyze subsurface data across lengths of the roadway.

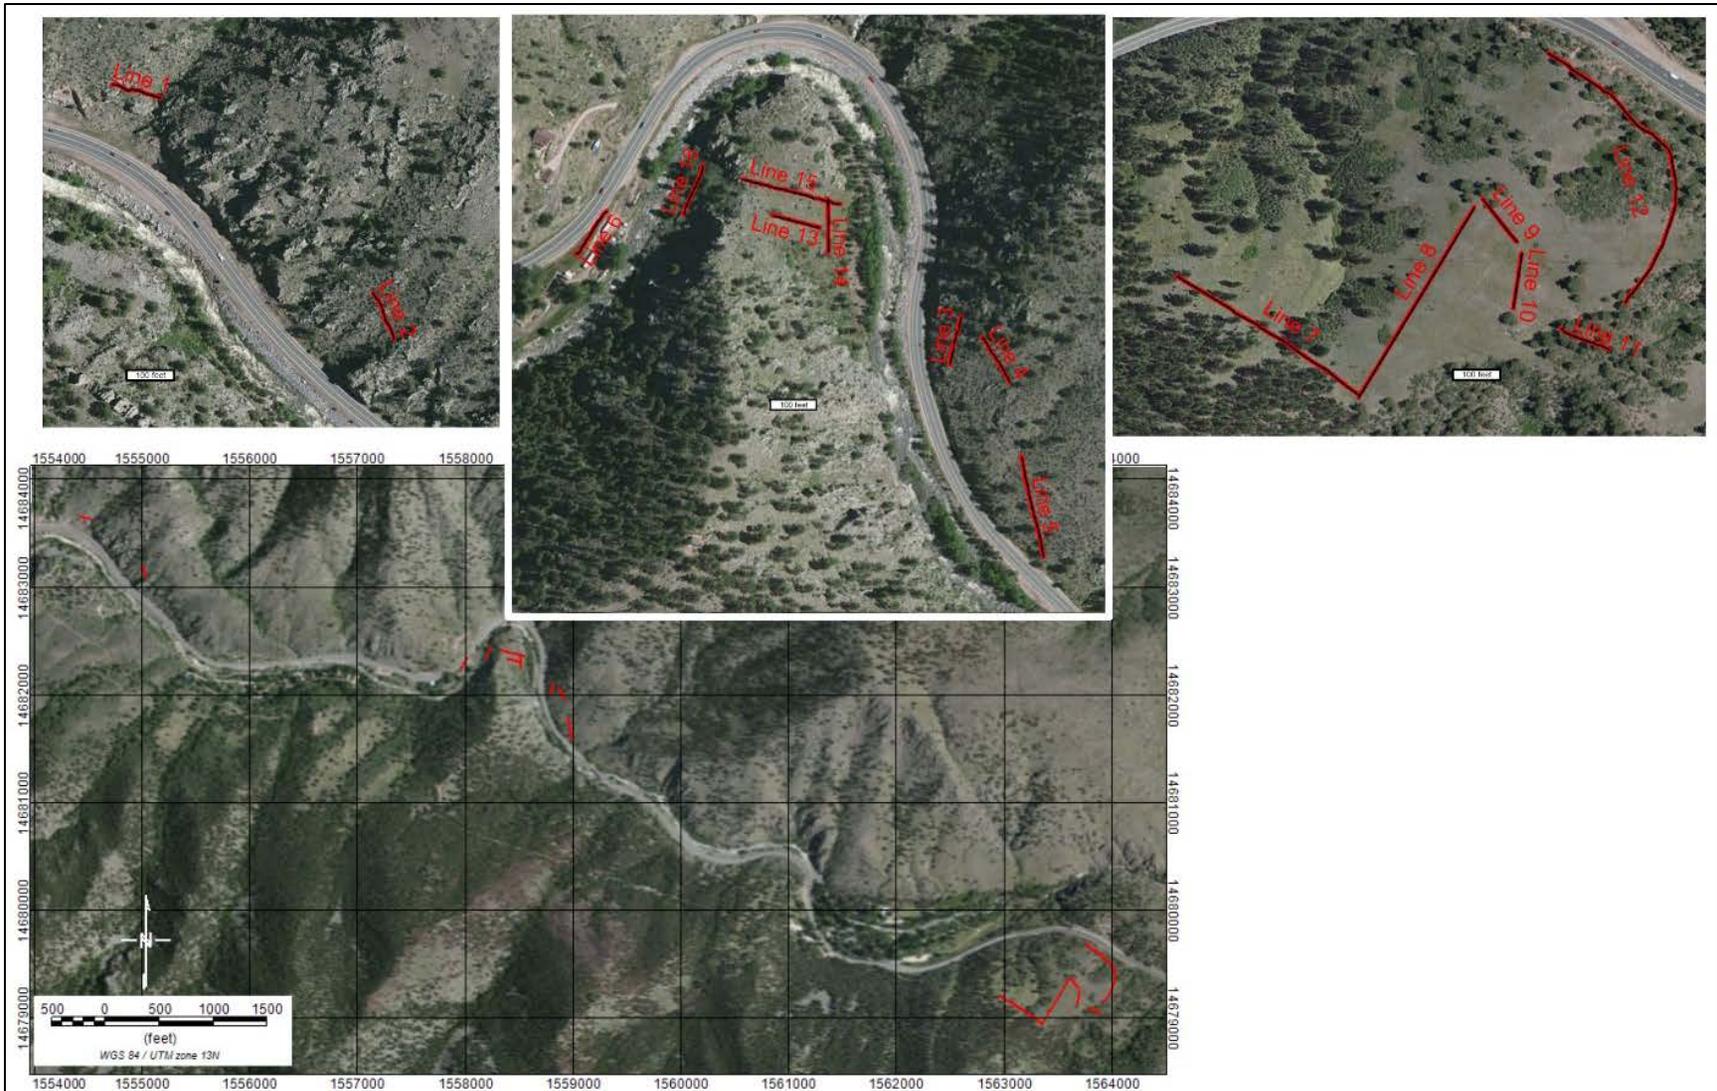
Figure 11. Line location map from first seismic survey, showing 16 separate line positions.

Figures 11 through 16 present P-wave velocity results and line location maps from the two seismic surveys. For each of the results, the horizontal and vertical dimensions are shown in feet. On the color scale, cool colors (e.g., blue) represent lower velocity values and warm colors (e.g., red) represent higher velocity values. Ground surface topography was incorporated when applicable, and a simplified representation of proximal borehole logs were overlain on the profiles. The interpretation of the 2D P-wave profiles were based on a velocity gradient analysis, and correlation to borehole data where available. Where interpretation of the seismic results lack borehole data, it is imperative to understand that the velocity data presented are modeled through an iterative process based on the travel time of refracted waves. Thus, these color velocity plots do not objectively represent intrinsic properties of the geology and structure beneath the seismic lines. The velocity gradient analysis is based on a rapid change in seismic velocity over a short depth range, which are visualized as abrupt color changes. Velocity gradients are typically indicative of a transition from soft to hard layers or materials including the degree of weathering in rock, though not necessarily indicative of the actual geologic interface. Refraction tomography will always produce a gradient at velocity transitions or a layer interface, no matter how sharp the geologic interface or boundary is physically.

Figures 11 through 13 present the velocity results from the first investigation in the canyon. As mentioned before, the objective was to map depth to competent rock and determine rippability. Annotated on the profiles are two contour lines chosen to represent two layer boundaries, between rippable, marginally rippable, and non-rippable according to the Caterpillar Handbook of Rippability for a D10R bulldozer (3). The other two contour lines represent the interpreted top of weathered rock and unweathered/competent rock, at 4,000 feet per second (ft/sec) and 8,000 ft/sec, respectively. These contour lines were chosen based on velocity

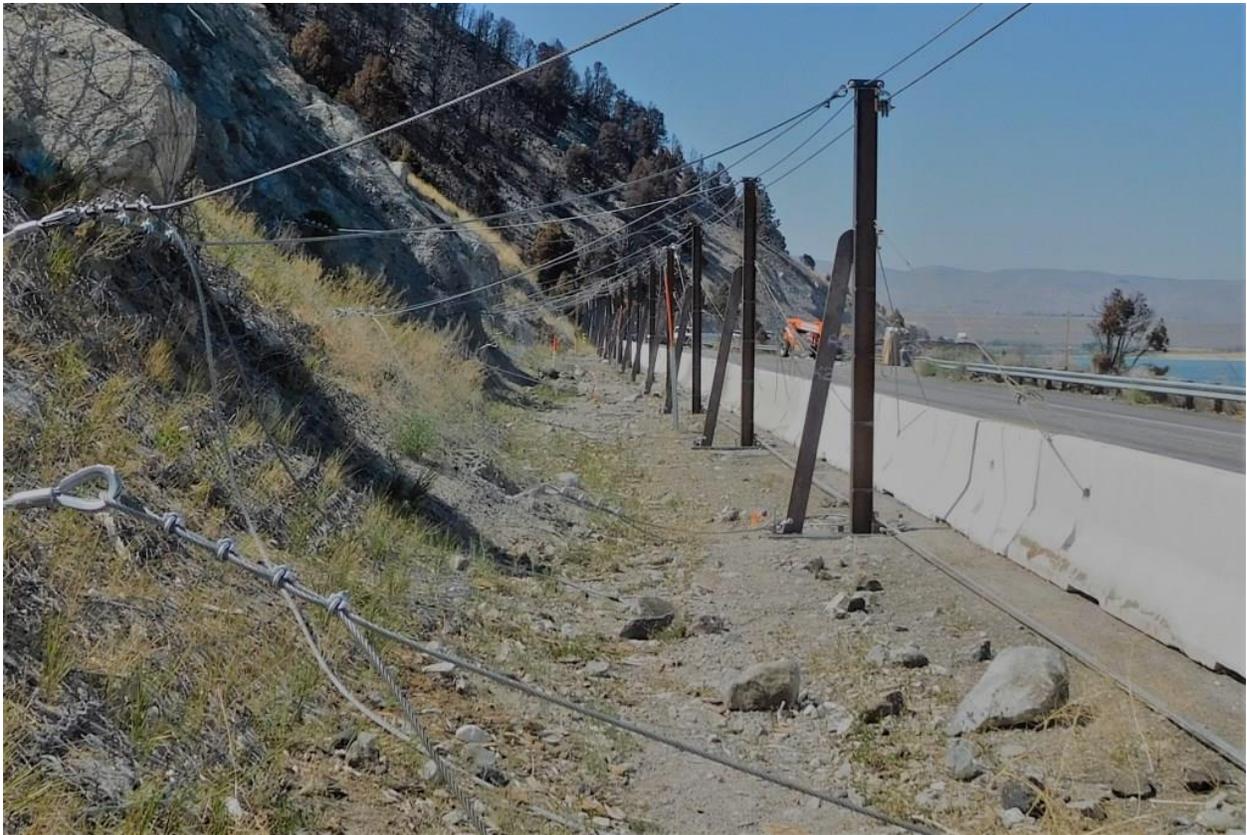
Figure 1. Flexible rockfall fence posts installed on US Highway 395, Mono County, California.

Advantages of flexible rockfall fences include economic feasibility, expedited analysis, and rapid installation. In use in California since the late 1980s (*1*), this type of mitigation is now common throughout the world. Comprised of steel posts, wire mesh, and wire rope components, flexible rockfall fences can be manufactured, delivered and installed under an expedited schedule to provide rockfall protection to a site within a timeframe of a few weeks. Of particular interest to geoprofessionals working in transportation corridors with traffic safety and utility constraints, flexible rockfall fence design can be optimized to accommodate site conditions, Figure 1.

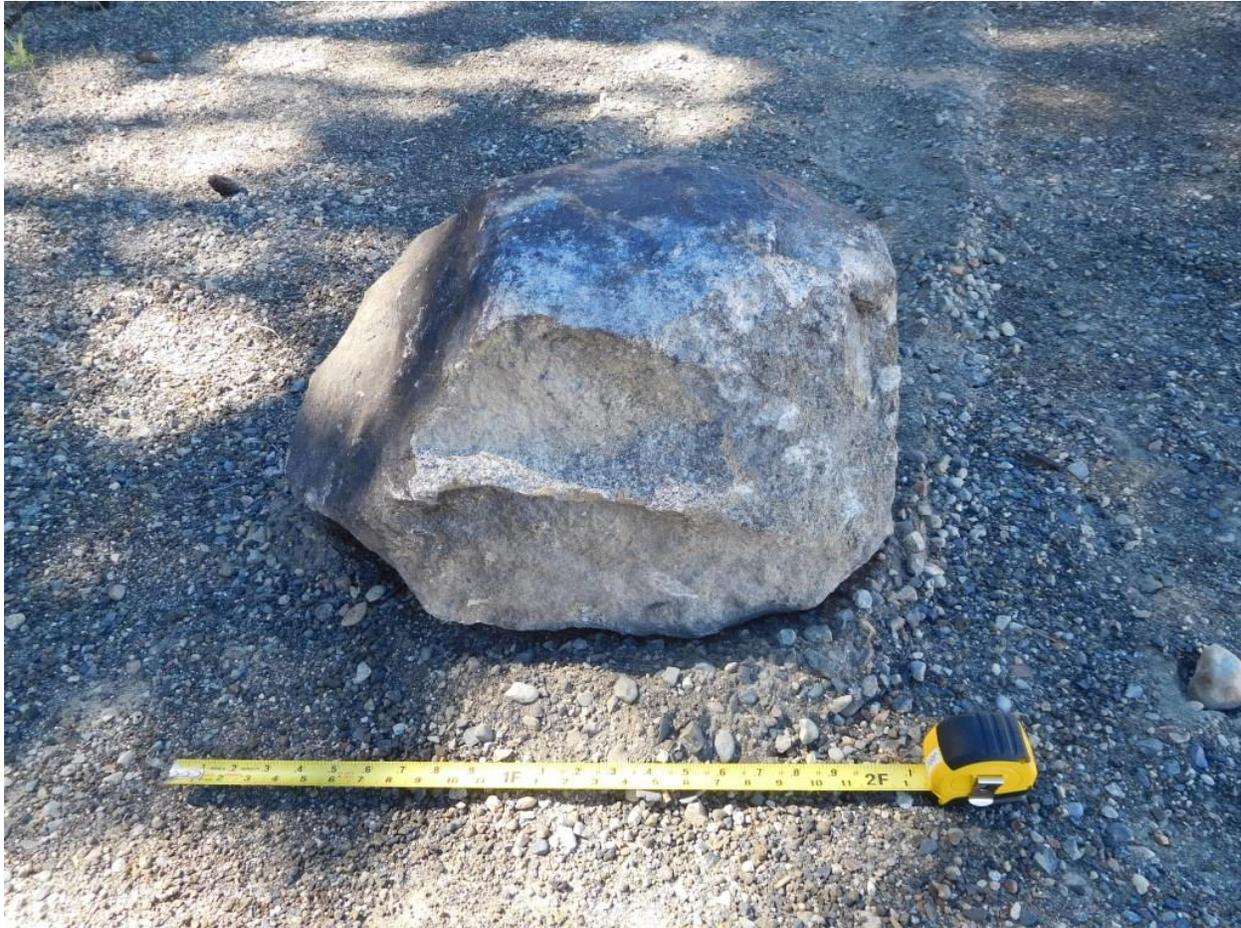
Figure 5. Largest rockfall observed in catchment area during field investigation on July 19, 2016.

Yeh engineering geologists observed rockfall in the catchment area, Figure 5, and evidence of rockfall impacts to the K-rail along the fog line and to the pavement in the traveled way. Caltrans maintenance personnel reported that a rockfall event had occurred that spalled concrete from the top of the K-rail and crossed into the highway.

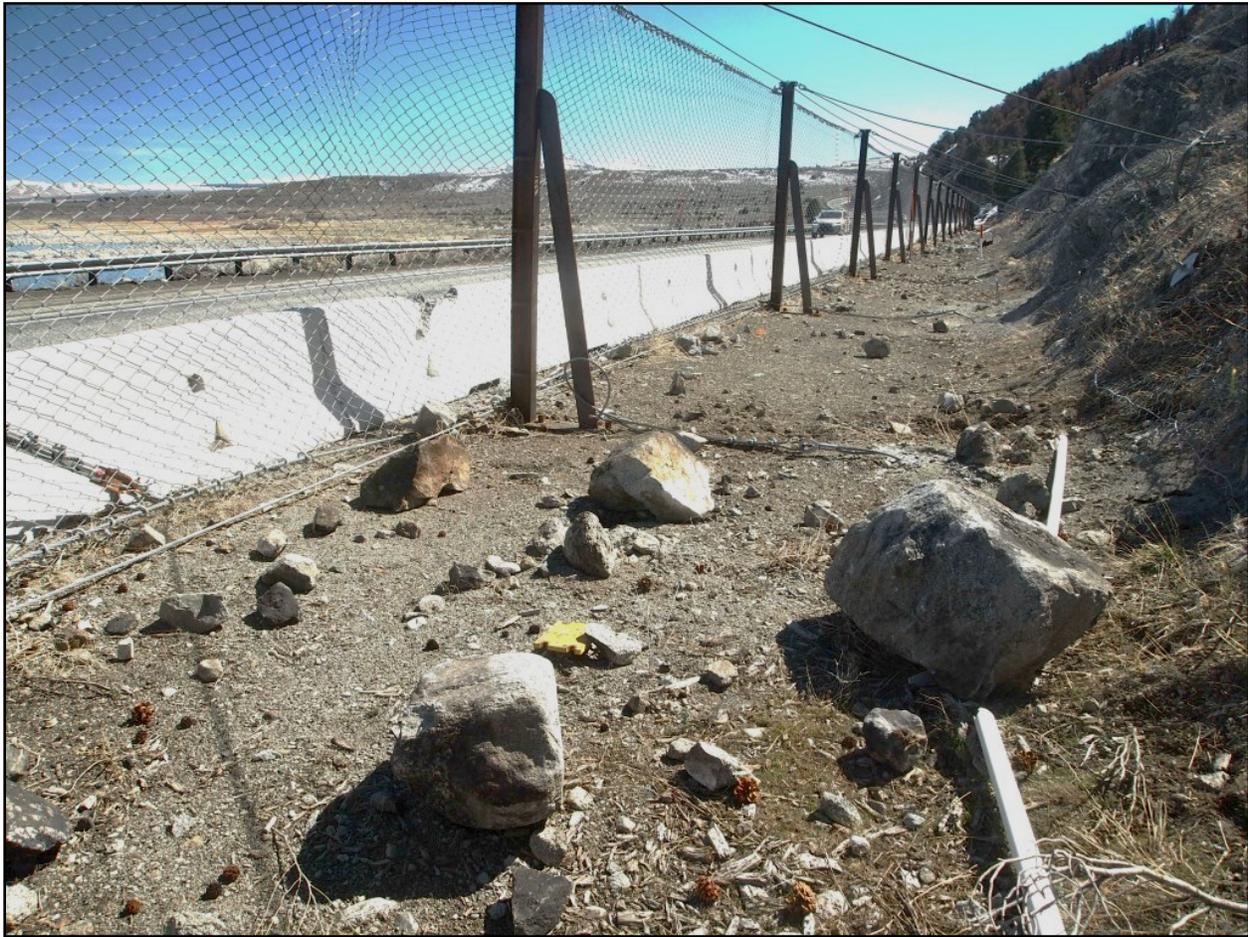
Figure 8. Rockfall event occurring on March 12, 2017 retained behind 3m Geobruigg GBE500AR flexible rockfall fence. (Photo credit: Joe Blommer, Caltrans)

TECCO high tensile steel mesh enough that the force of the impact struck the adjacent concrete K-rail, resulting in a portion of the concrete spalling off into the traveled way, Figure 8.

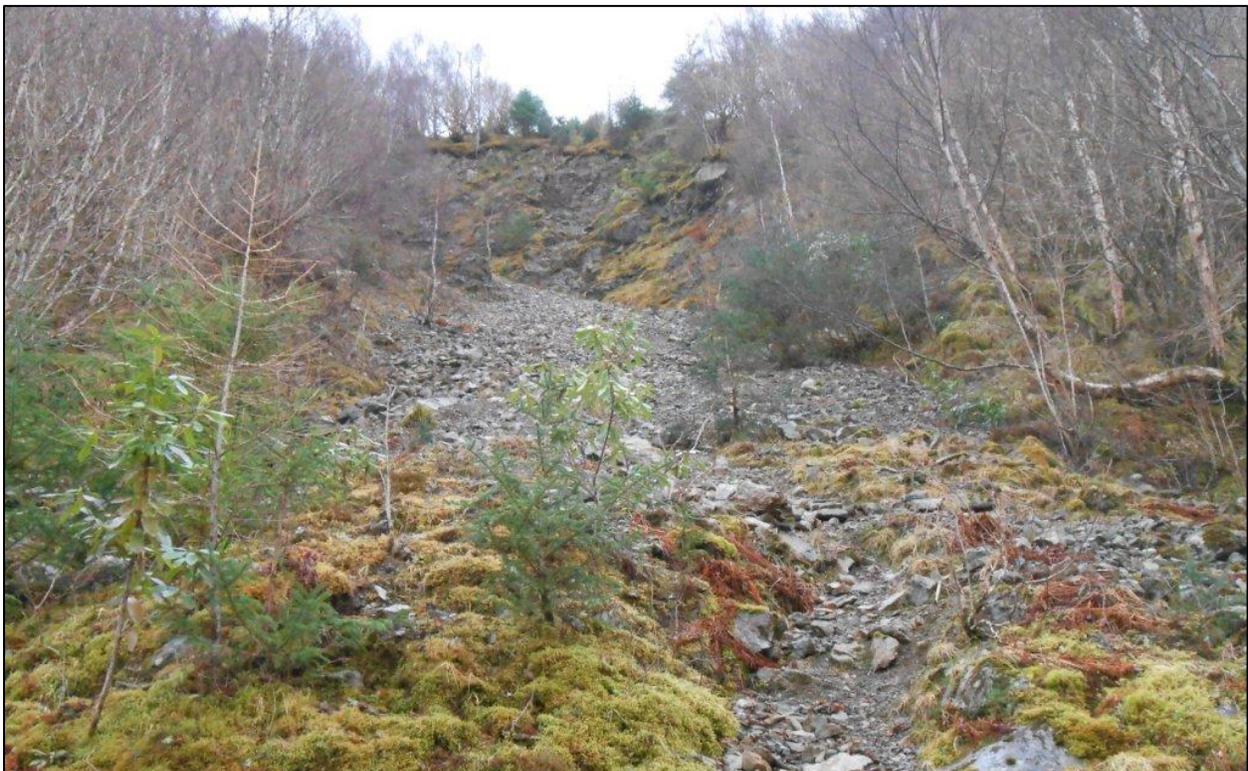
Figure 2 - Photograph looking up talus cone with active rock face at the crest.

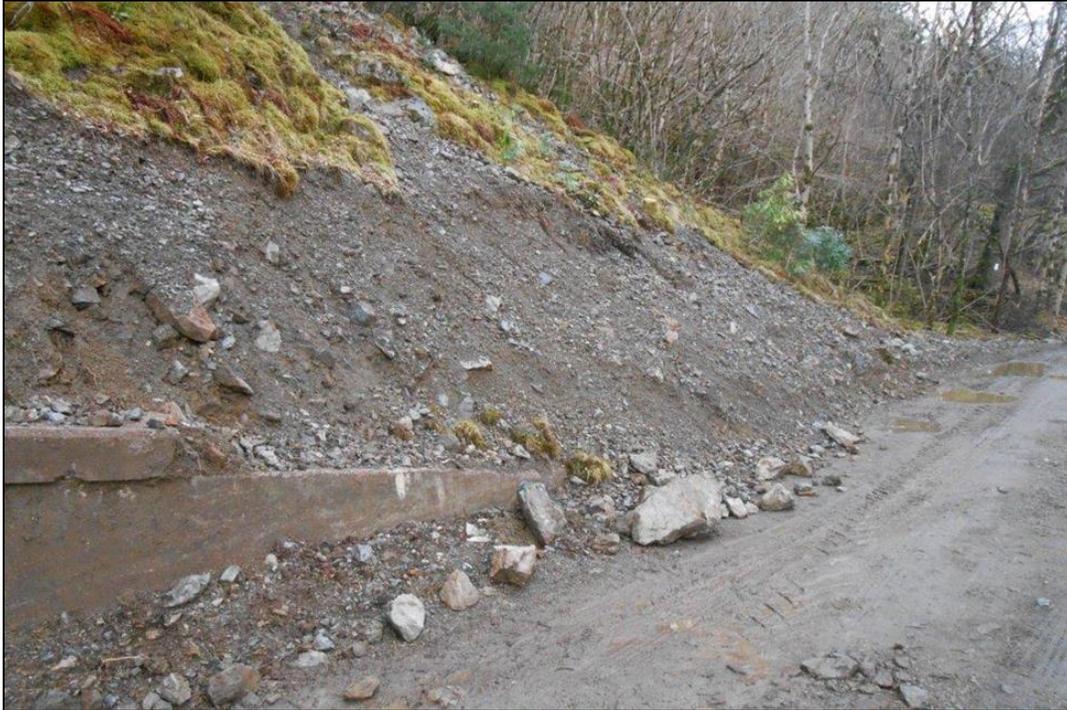
Figure 3 – Photograph of newly fallen rocks on the track.

Rockfall modelling done for the assessment indicated that there was a high probability that falls would reach the track. This was corroborated by the evidence of fresh rockfall with fallen blocks adjacent to the path varying in size up to a maximum of 0.5m³. It was considered that there was a risk of both single-block rock falls occurring as well as a multiple-block rock falls.

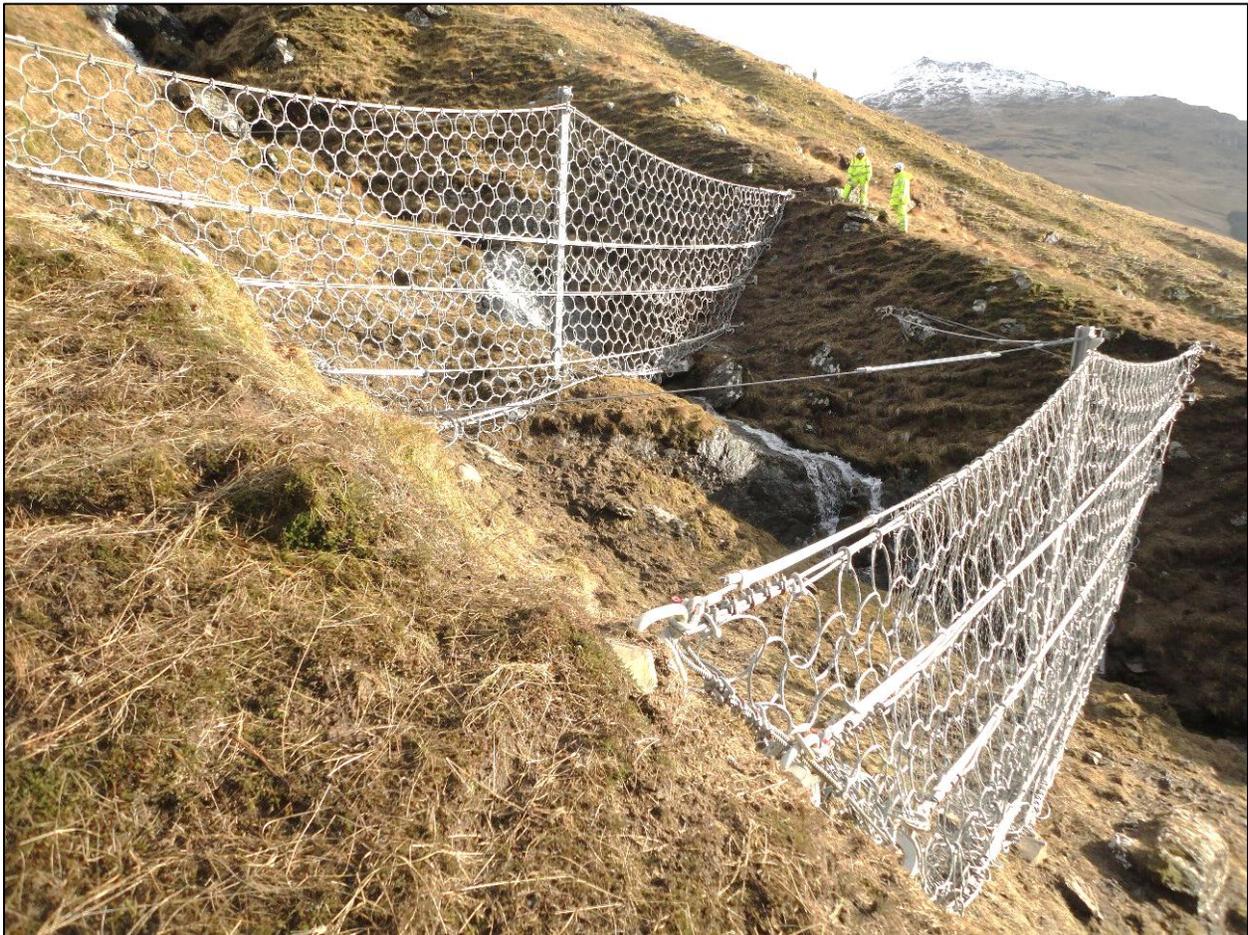
Figure 5: Debris flow protection fences in Argyll, Scotland (courtesy Maccaferri UK).

The use of embankments to protect people and infrastructure from rockfall, debris flow and avalanche impacts, is a well established practice with a very long and successful history. Within the last few decades the commercial sector has driven forward the development of flexible fences designed to offer protection from both rockfalls and debris flows. While these are highly effective protective structures, which are effective across a range of scenarios, they do have limitations. They are costly to buy, can be expensive to install (with installation typically requiring highly skilled specialist contractors) and they often require complex maintenance operations following an impact.

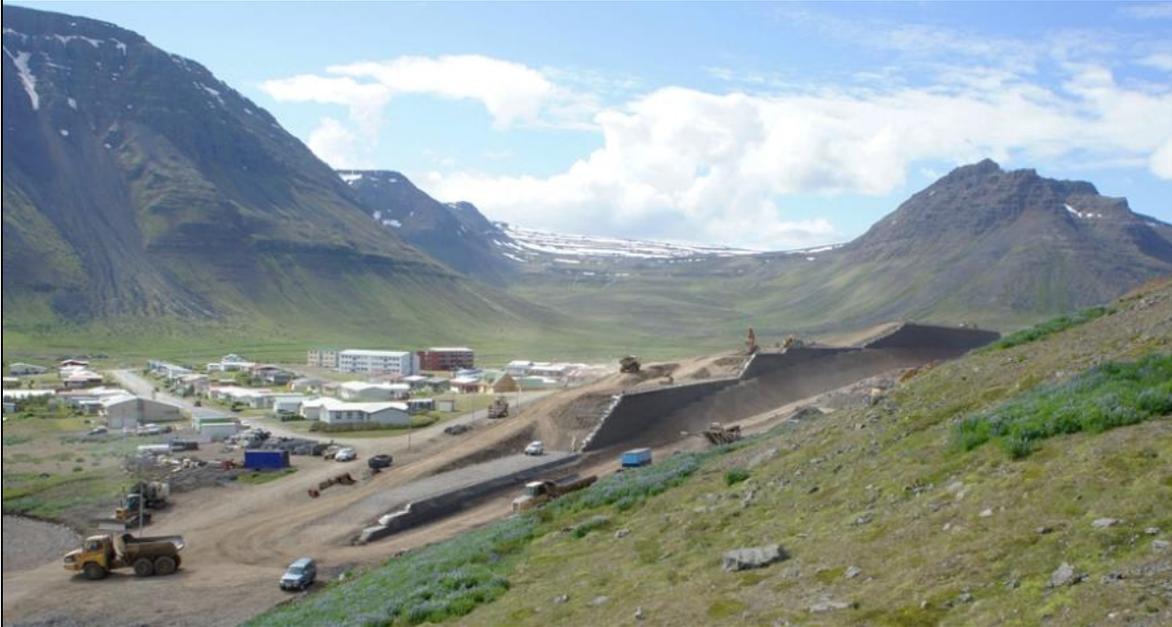
Figure 6: 22m high x 750m long reinforced soil embankment construction, Iceland.

In contrast to fences, protective embankments can be designed to absorb an impact of almost any energy, at any velocity and of any volume. Embankments can offer multiple protective capabilities such as the example shown in Figure 6, where the structure is designed to provide protection from rockfalls, debris flows and avalanches.

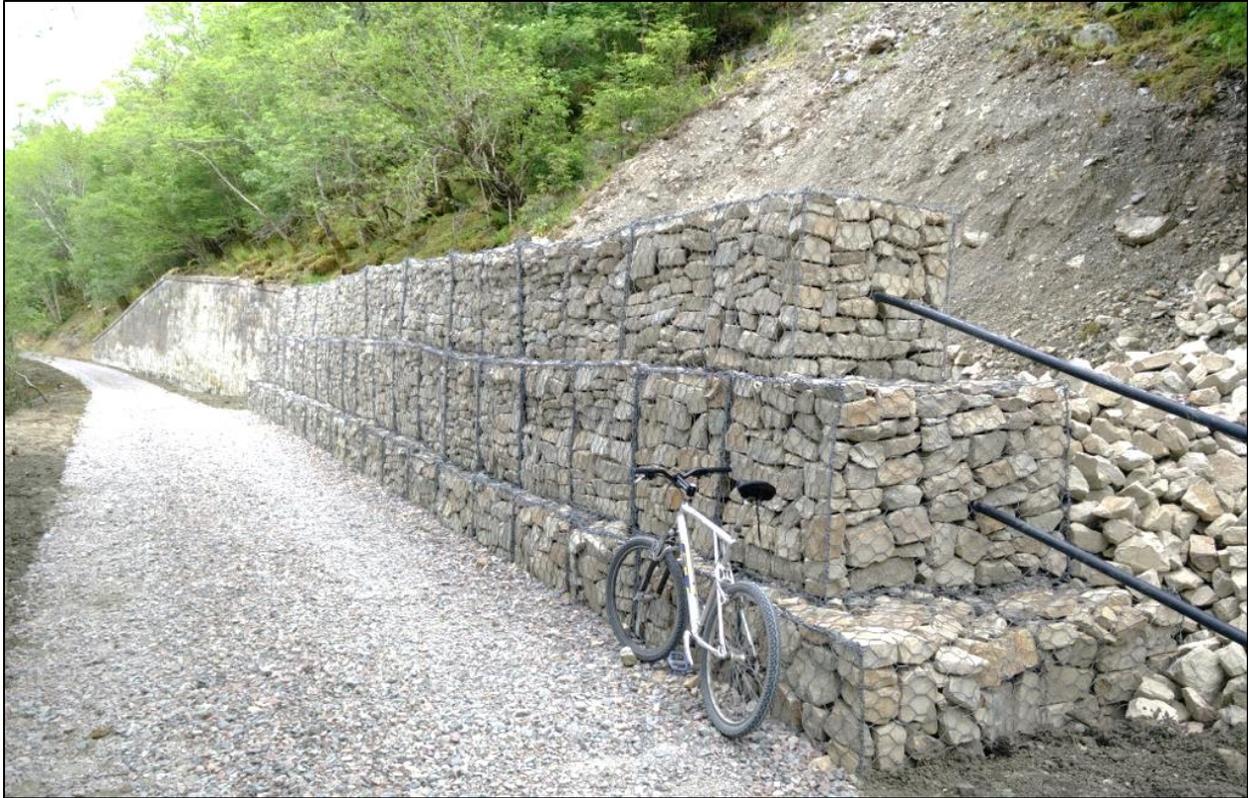
Figure 8: Photograph north showing the completed Parafil® reinforced gabion embankment adjacent to the cycle path. Rope ducts are visible to the right.

Due to the calculated low deflection of the barrier, the forces on the anchors were expected to be high. If the Parafil ropes were to be retained by anchors then a long bonded length would be required because they would need to be installed into the on-site talus. The talus also suggested a range of other problems would be encountered with the use of drilled anchorages (bit breakage, grout loss etc.). Drilled anchorages were therefore discounted in favour of anchorages based on a mass concrete “deadman” system utilizing self-weight of the concrete and passive resistance from the site soils.

These anchors could be constructed easily on site with the plant available and located within the limited area available adjacent to the track. The final deadman anchor design comprised a 500mm x 500mm by 2.0m deep mass of concrete reinforced with A252 mesh. The terminations on the ends of the Parafil tendons were then connected to 32mm diameter steel bars located in the center of each anchor.

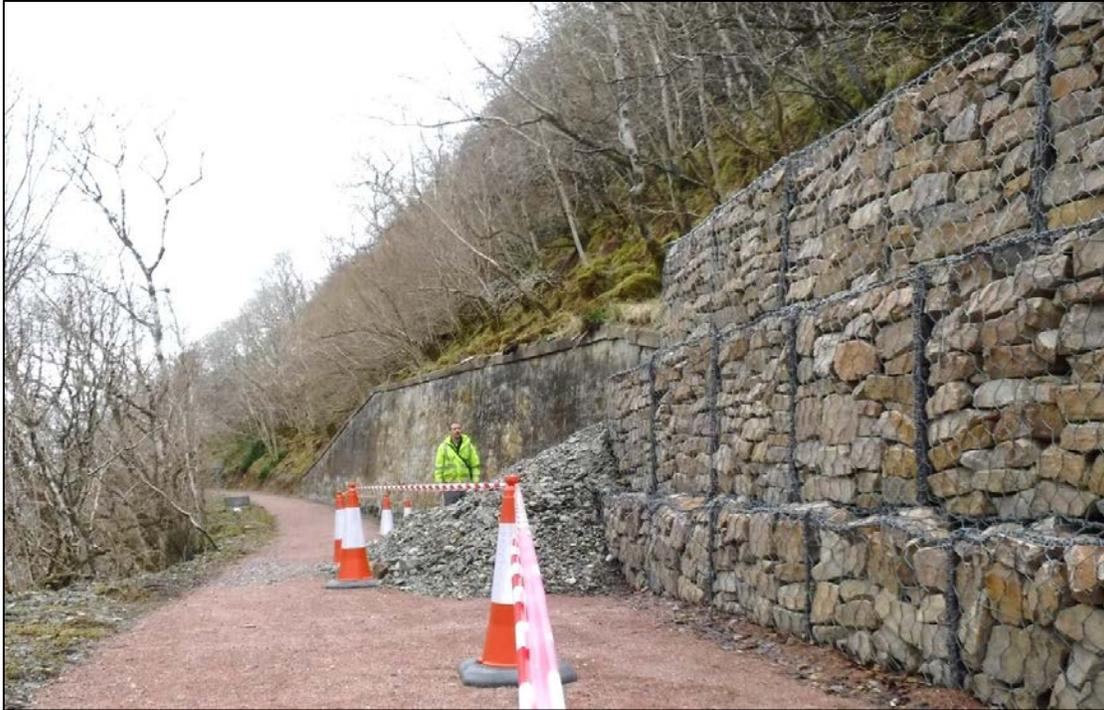
Figure 9: Northern end of the embankment after the impact, showing overspill of debris.

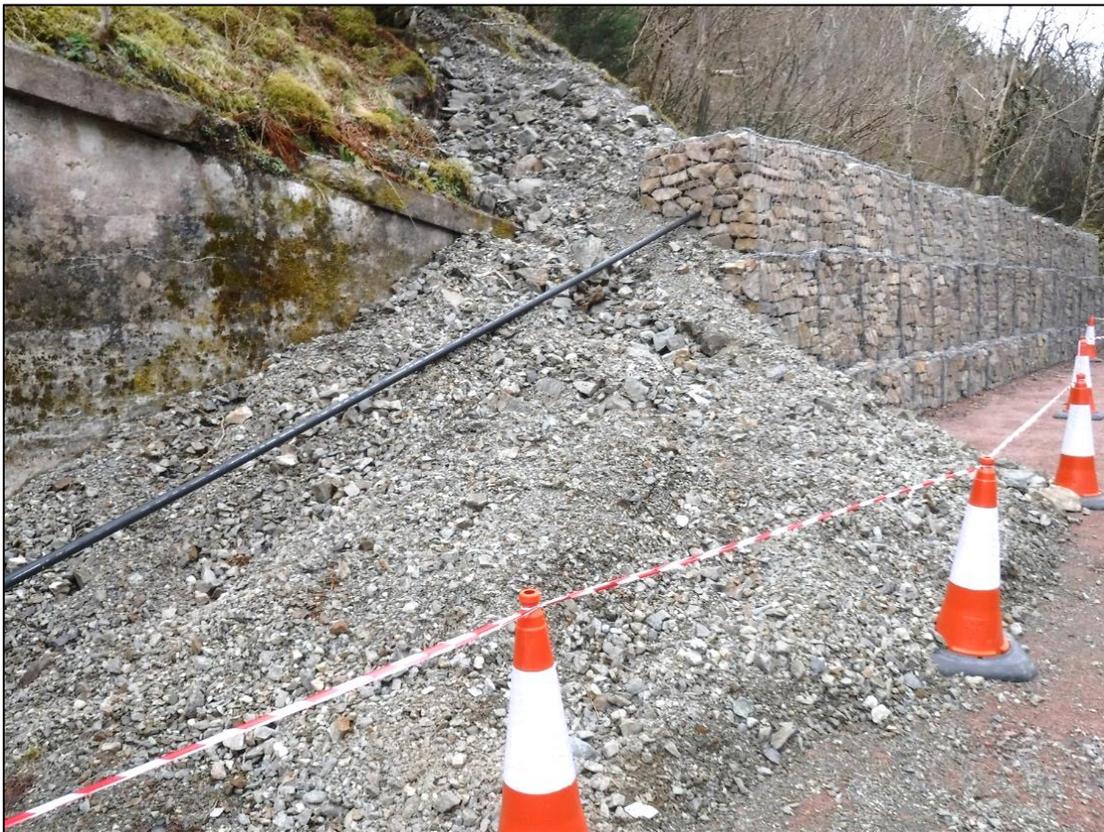
Figure 10: View of the northern end of the embankment showing the overspill of material arising from the second phase of the debris flow impact

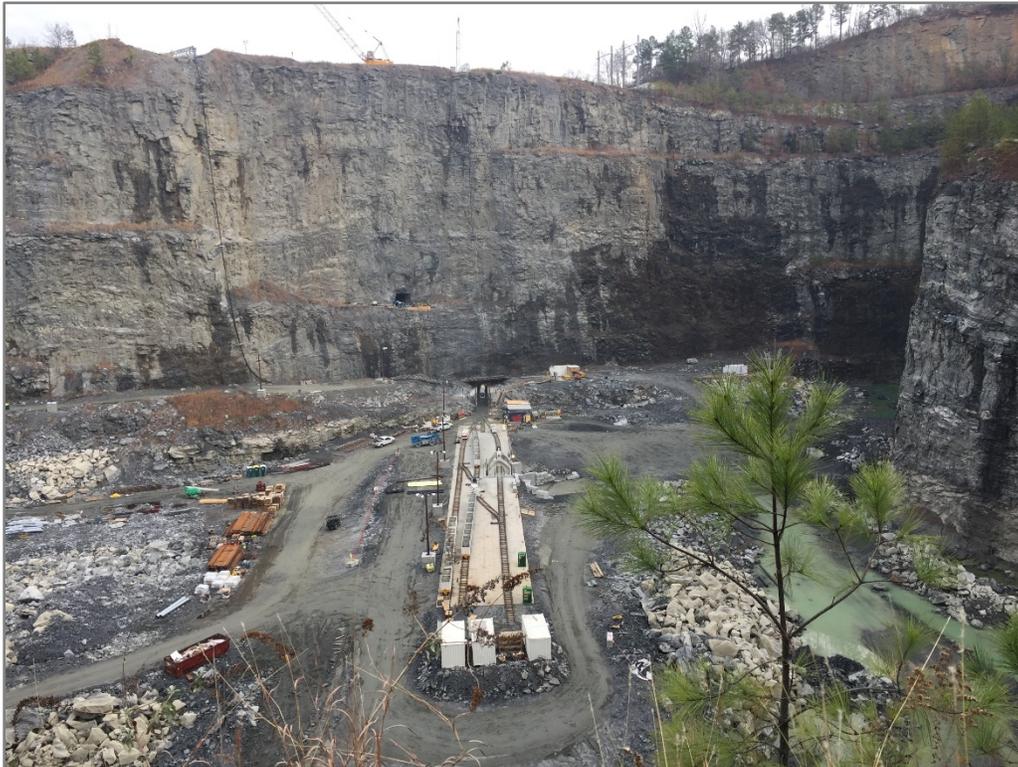
**Figure 1 – Northerly view of quarry highwall, tunnel and adit (on bench)
(Photo by Scarptec, Inc.)**

Initial rock slope scaling took place in the spring and early summer of 2016, prior to mobilization of tunneling equipment, with efforts being highly productive. Previous blasting activities and exposure to the forces of weathering resulted in an abundance of loose rock prior to construction activities. In order to minimize the quantity of potentially unstable rock material, Apex completed scaling efforts using manual methods; (e.g., scaling bars, rope access techniques) and mechanical methods; (e.g., pneumatic air bags) which were employed using specialized rope access techniques.
