68TH HIGHWAY GEOLOGY SYMPOSIUM MAY 1-4, 2017

2017 Proceedings

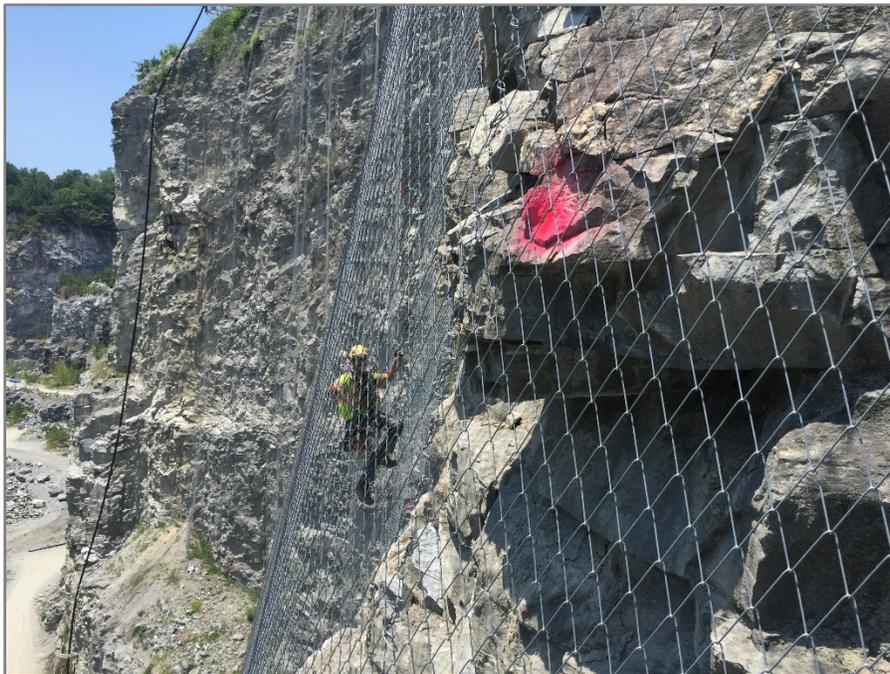
**Figure 3 – Rock dowel layout with paint using rope access
(Photo by Scarptec, Inc.)**

Passive rock dowels were chosen to reinforce potentially unstable rock blocks above both canopy systems due to their relative speed and ease of installation; however, to stiffen up the rock mass and pin down suspect key blocks without the benefit of tensioning requires that additional steel be installed. As such, the initial phase of rock reinforcement called for installation of 74 rock dowels that were marked-out in the field (Figure 3) and submitted to the Owner on plan sheets with calculations.

Rock dowels were comprised of 1- $\frac{1}{4}$ -in. dia. grade 75 epoxy coated bars fabricated by Williams Form Engineering. Minimum embedment depths by location were provided to rock remediation technicians from Apex, who then drilled and installed the dowel bars using wagon drills. In two instances, temporary wire rope cable lashing was required as a precaution to stabilize rock blocks prior to drilling. Rock dowel lengths generally ranged from 10 to 20-ft. in total embedment length.

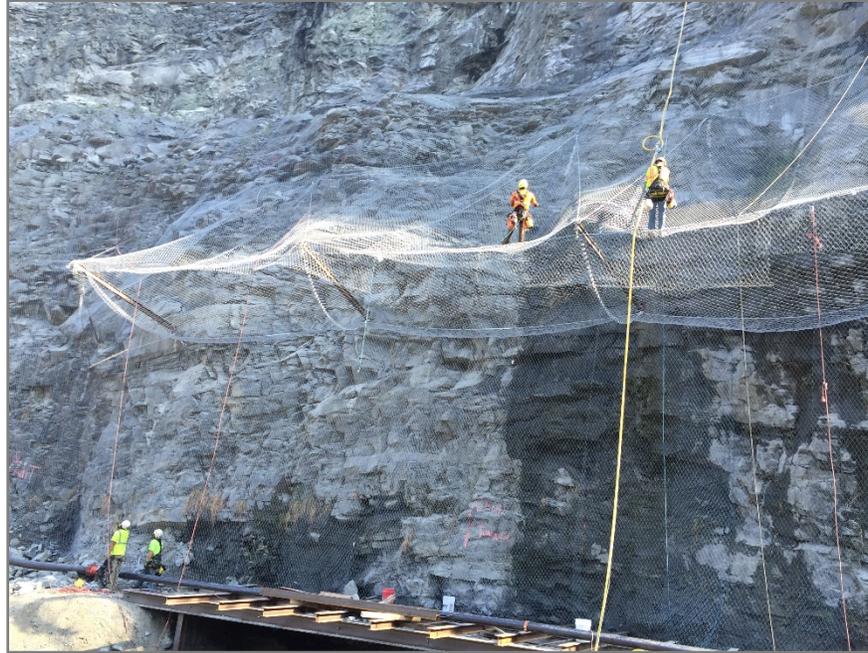
**Figure 5 – Canopy construction and drape tie-in
(Photo by Scarptec, Inc.)**

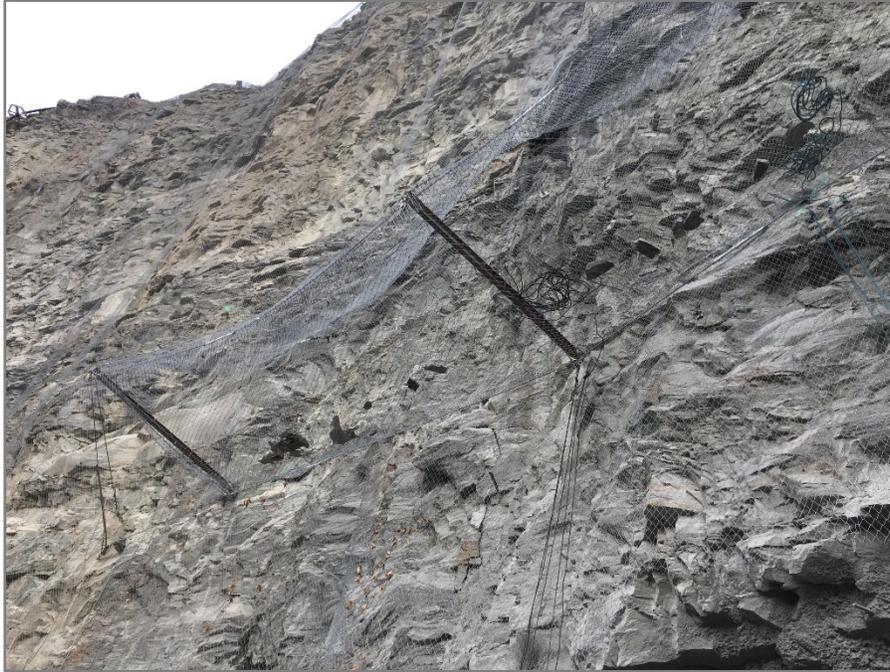
Maintenance of the system over the tunneling construction period was (and continues to be) completed by Apex, based on monitoring visit observations. Small fragments of rock debris were removed from the tunnel canopy system in January of 2017 (Figure 6), and minor adjustments to the canopy system cabling were also completed.

**Figure 6 – Adit canopy rock debris subject to maintenance cleaning
(Photo by Scarptec, Inc.)**

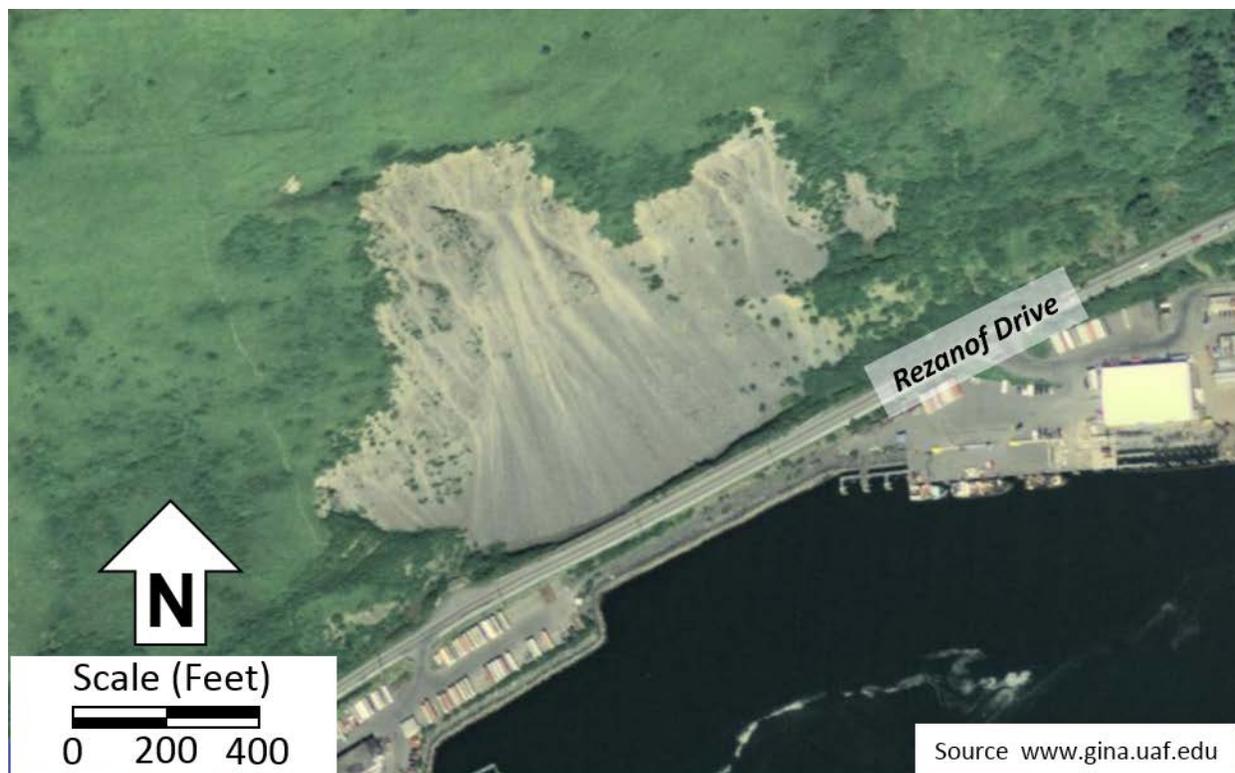
Figure 2 – Pillar Mountain Slide

Rockfall at the Pillar Mountain slide has been a persistent problem for decades. Prior to about 1957 to 1958, Rezanof Drive traversed the flank of Pillar Mountain across the lower portion of the slope at an elevation ranging from 120 to 160 feet elevation (Kachadoorian and Slater, 1978). In part due to rockfall problems, the road was relocated to the toe of the slide. This old road can be seen on aerial imagery by the contrast in vegetation (Figure 2).

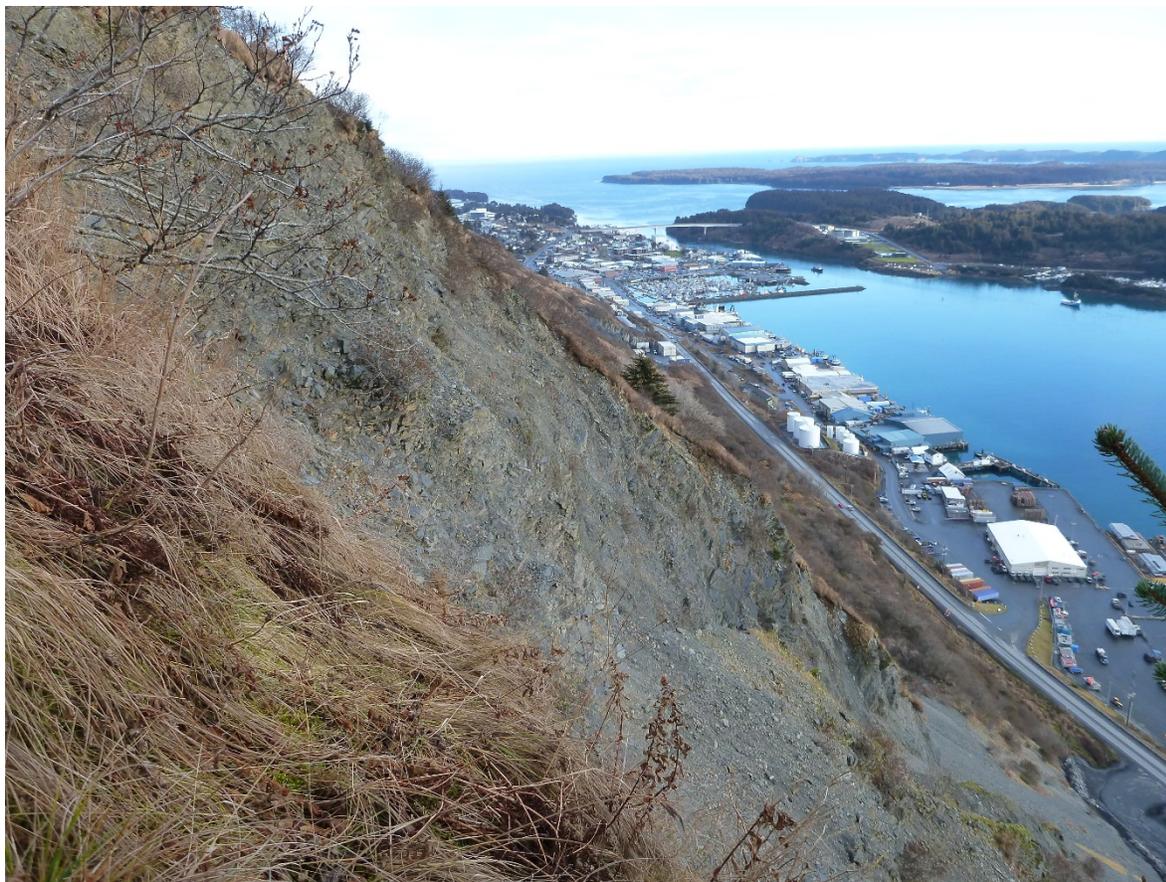
**Figure 3 – View Northeast to Left (East) Flank of Pillar Mountain Slide.
Rezanof Drive at Base of Slide (Right Side of Image).**

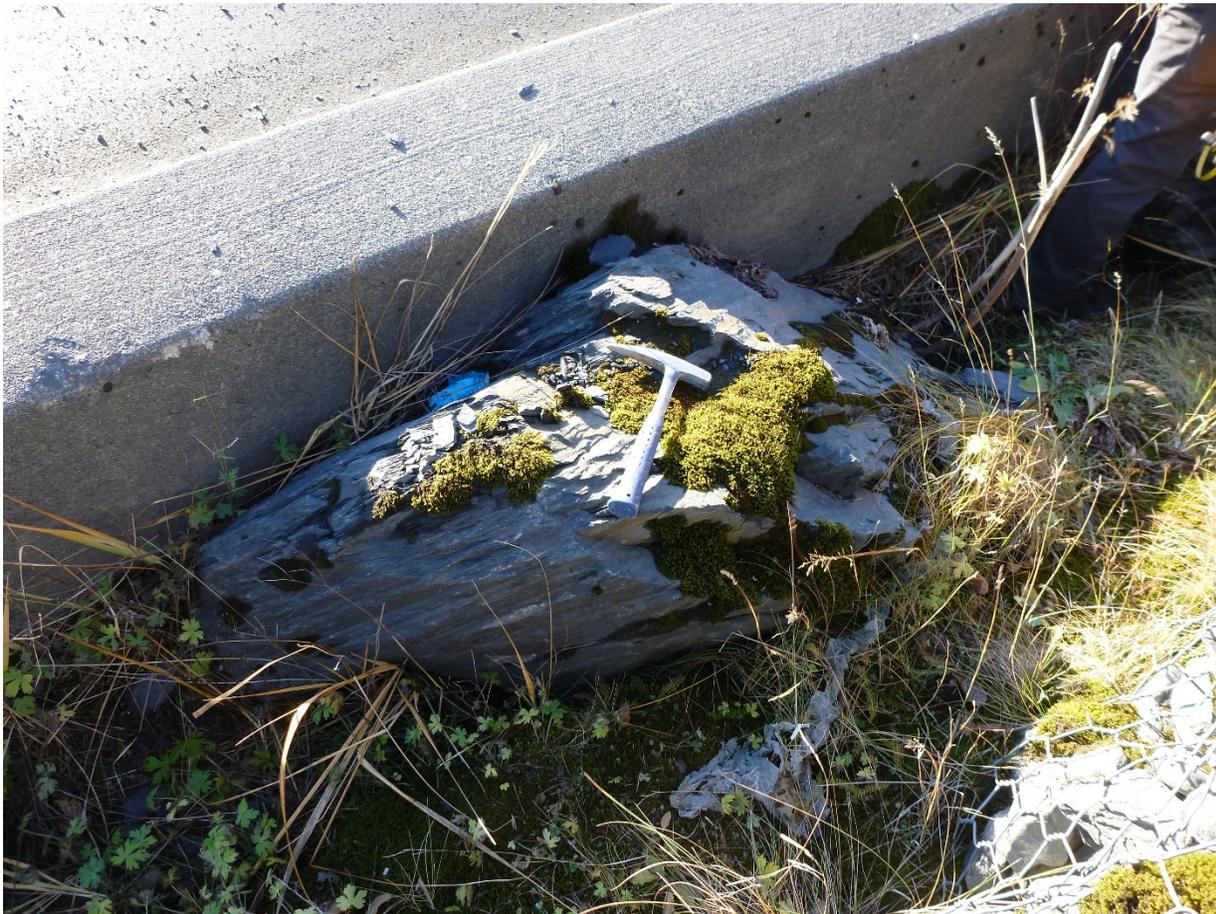
Figure 5 – Example of Rockfall Block Downslope of Gabions at Base of Pillar Mountain Slide (Rock Hammer Approximately 1 Foot Long for Scale)

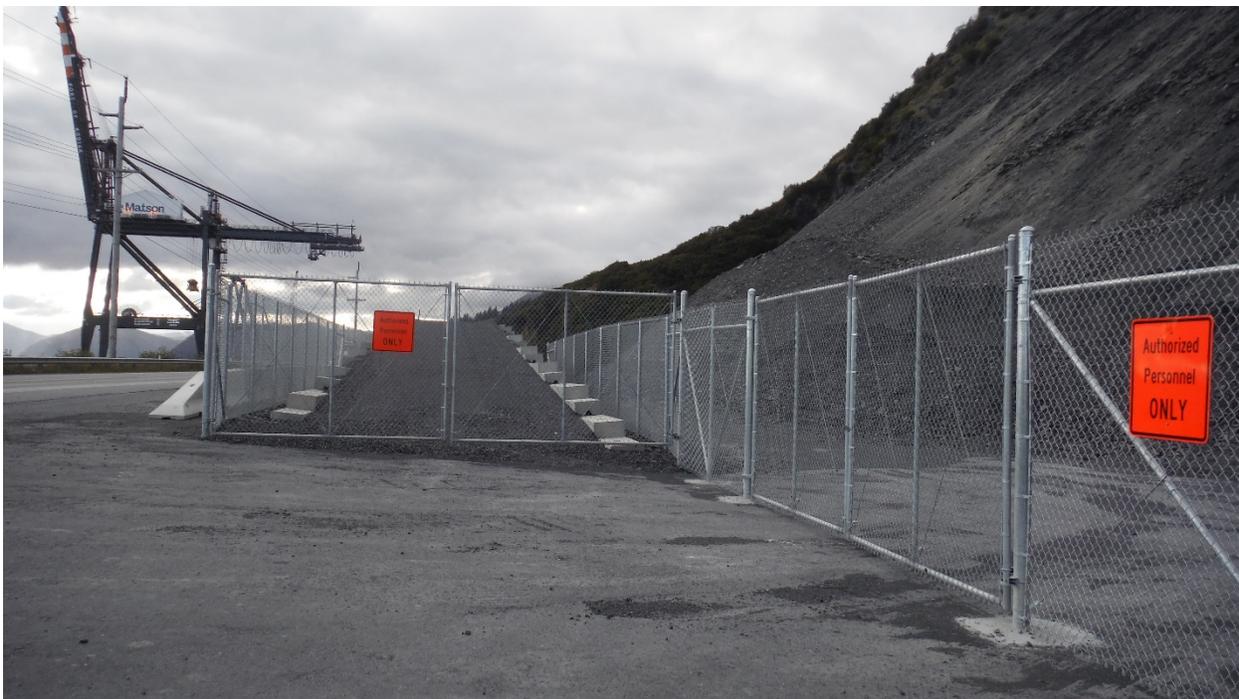
Figure 7 – Completed Rockfall Berm (Photo Courtesy of Howard Weston)

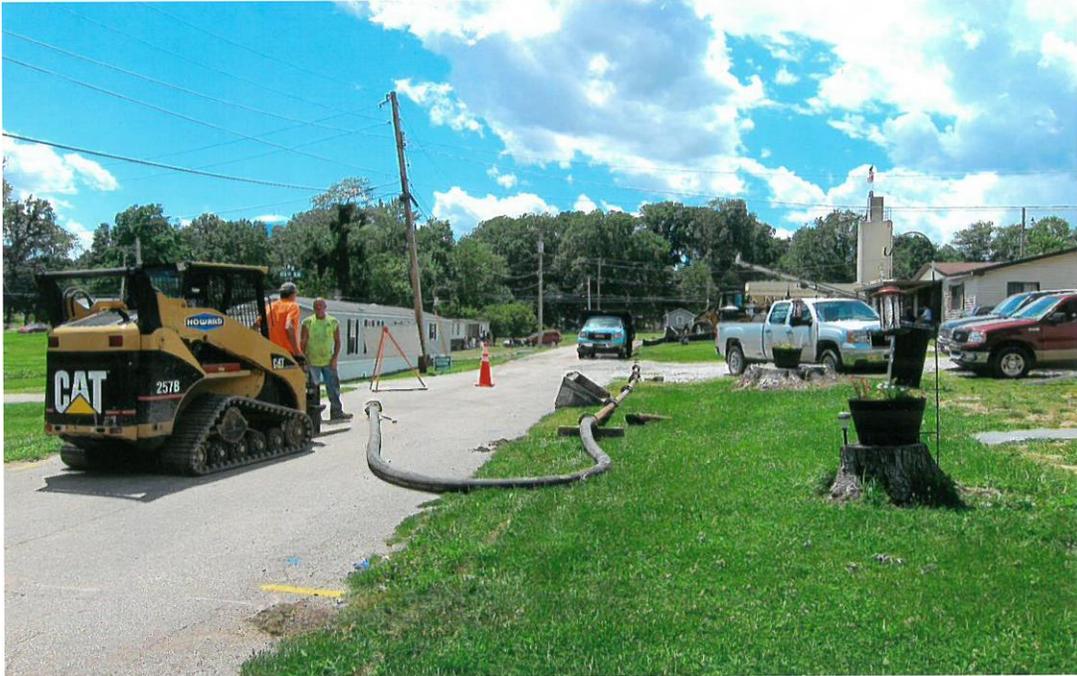
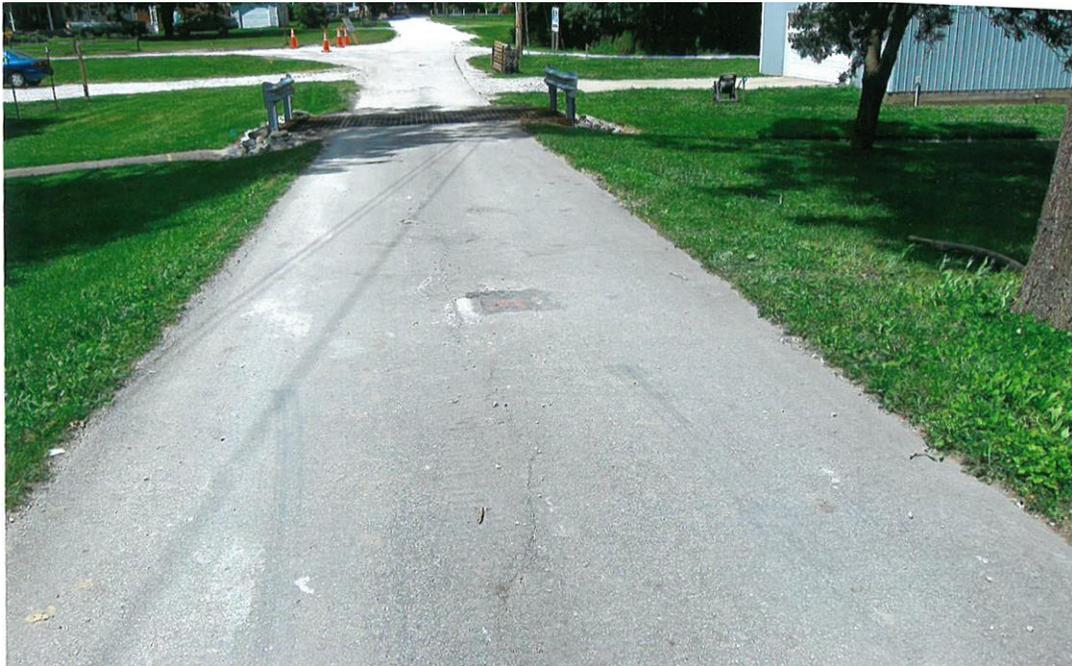
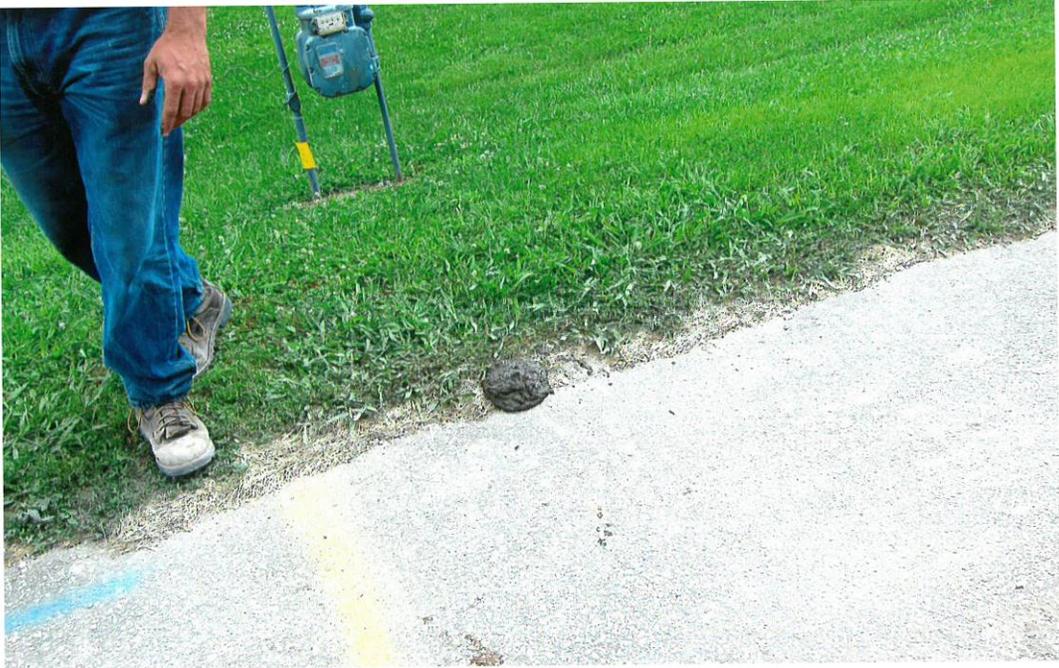
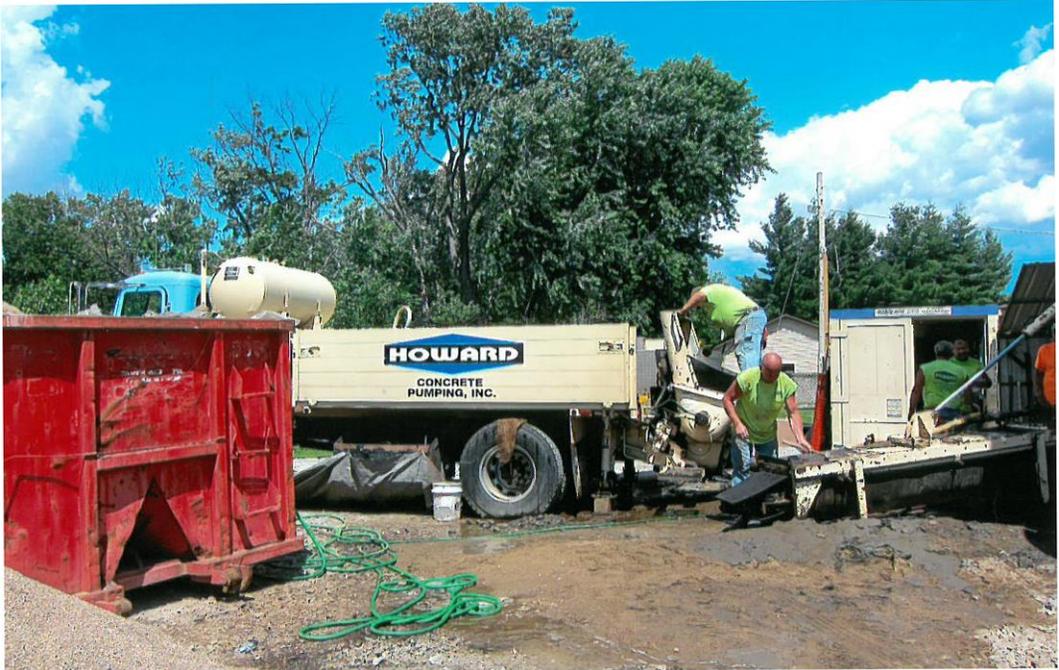
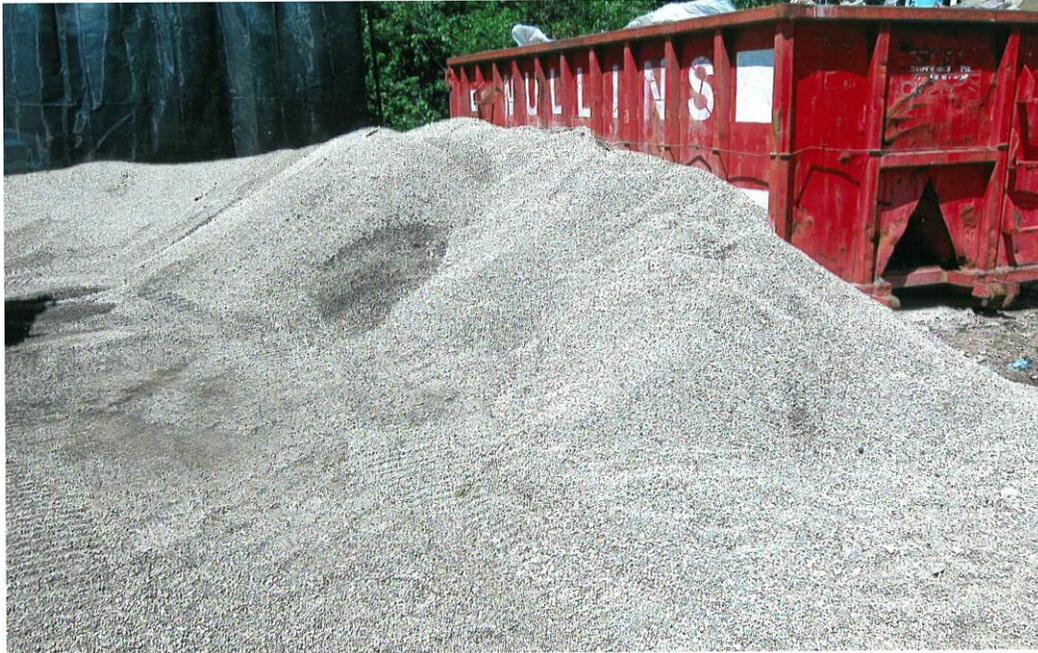
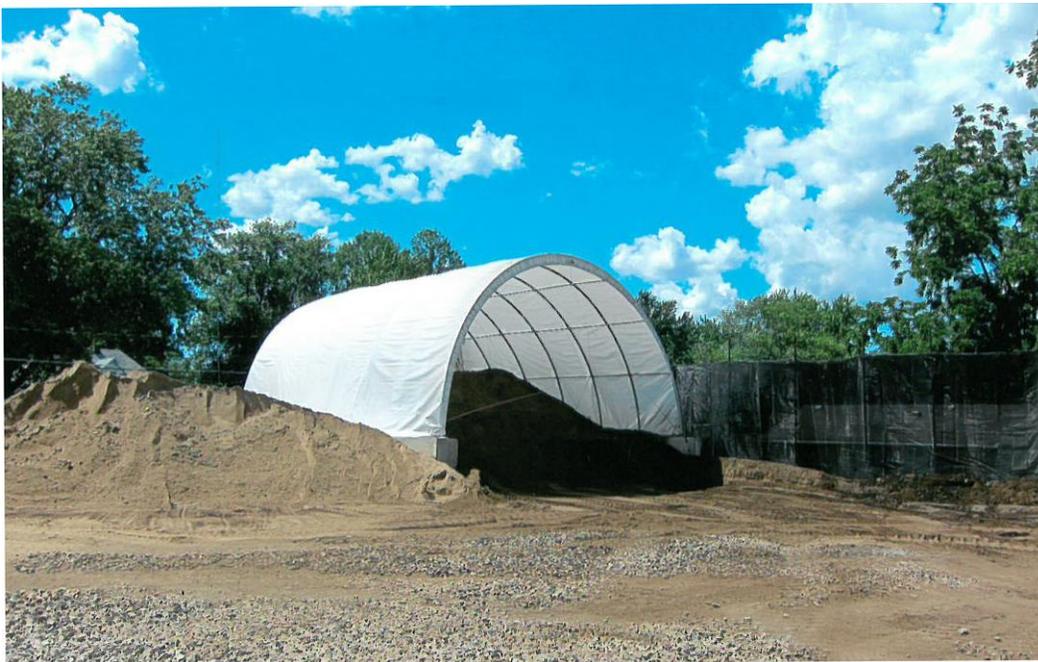
Figure 9. Grouting of Voids Under Roads in Linton, Indiana

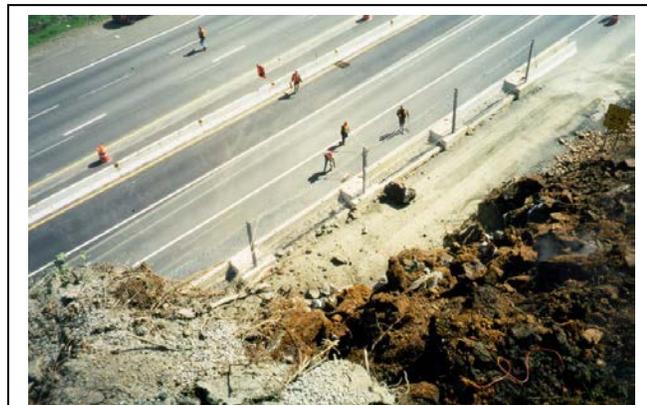
The first example comes from Dick's idea for this paper. In 2003 the Thruway was re-cutting a 110-foot slope in Nyack, New York, in diabase. The ADT was on the order of 90,000 and there was little room for catchment, so an innovative combined concrete barrier and temporary rockfall catch fence (developed by Dick and GeoBrugg through a collaboration developed at HGS) was used to contain rocks being brought down during blasting (Figure 1).

Figure 1 – Temporary Traffic and Rockfall Barrier

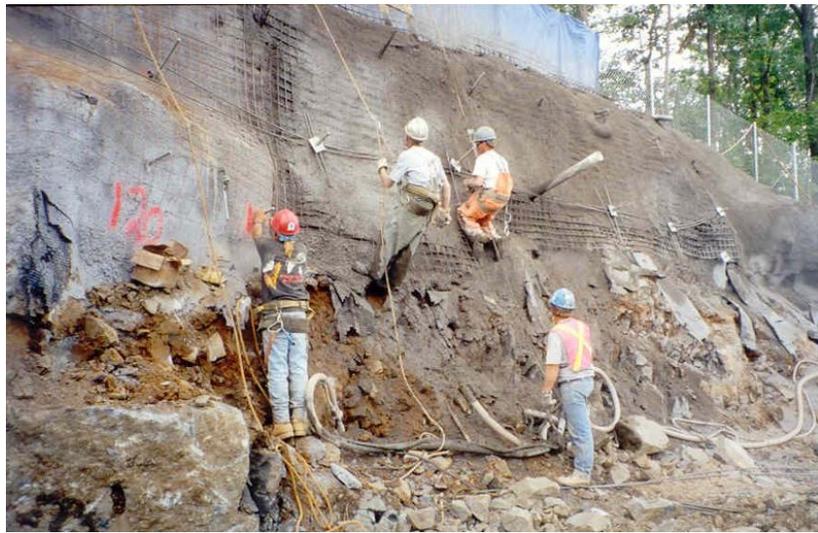
Figure 2 – Soil Nail Wall Being Constructed

The soil nail wall was constructed using rope access methods and the project stayed on schedule (Figures 2 and 3), but the slope had one more problem to be solved. A lower portion of the slope

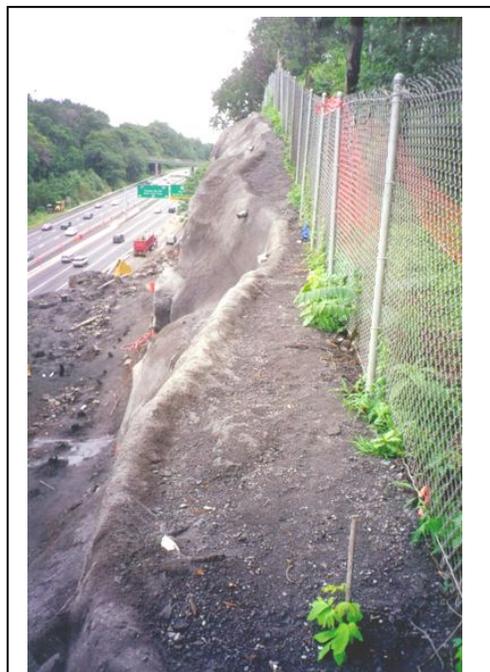
Figure 3 – Completed Wall, note presplit holes at the toe of the wall.

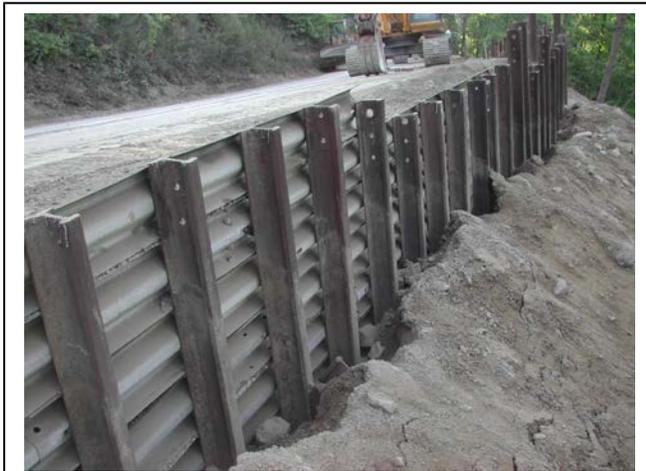
Another example where TDOT benefited from information gathered at HGS meetings is regarding the use of railroad rail walls in repairing small scale embankment failures (Figure 5). The Kentucky Transportation Cabinet geotechnical office presented a technical talk on the repair of small embankment failures on rural and remote roads in eastern Kentucky. Seeing that Tennessee has very similar conditions as Kentucky, the TDOT geotechnical personnel quickly evaluated the Kentucky DOT information as a possible application to TDOT highways.

Figure 5 – Railroad Rail Wall Embankment Stabilization

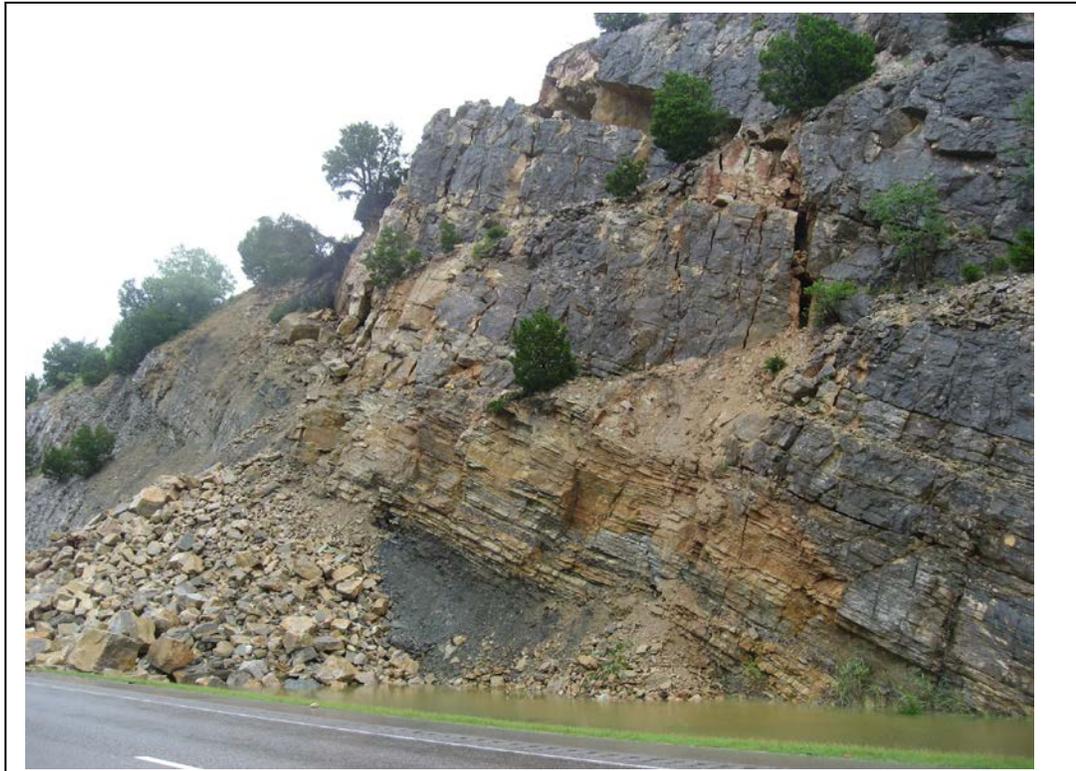
remaining issues included several isolated areas of loose rock still on the slope along with a large section of rock that had become dislodged and was in danger of toppling out onto the highway (Figure 6).

Figure 6 – I-35 Rockslide and destabilized slope, Arbuckle Mountains

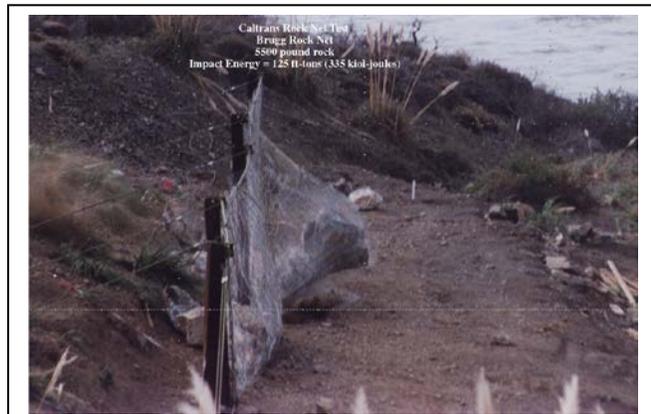
Figure 7 – Early CalTrans Rockfall Barrier Testing

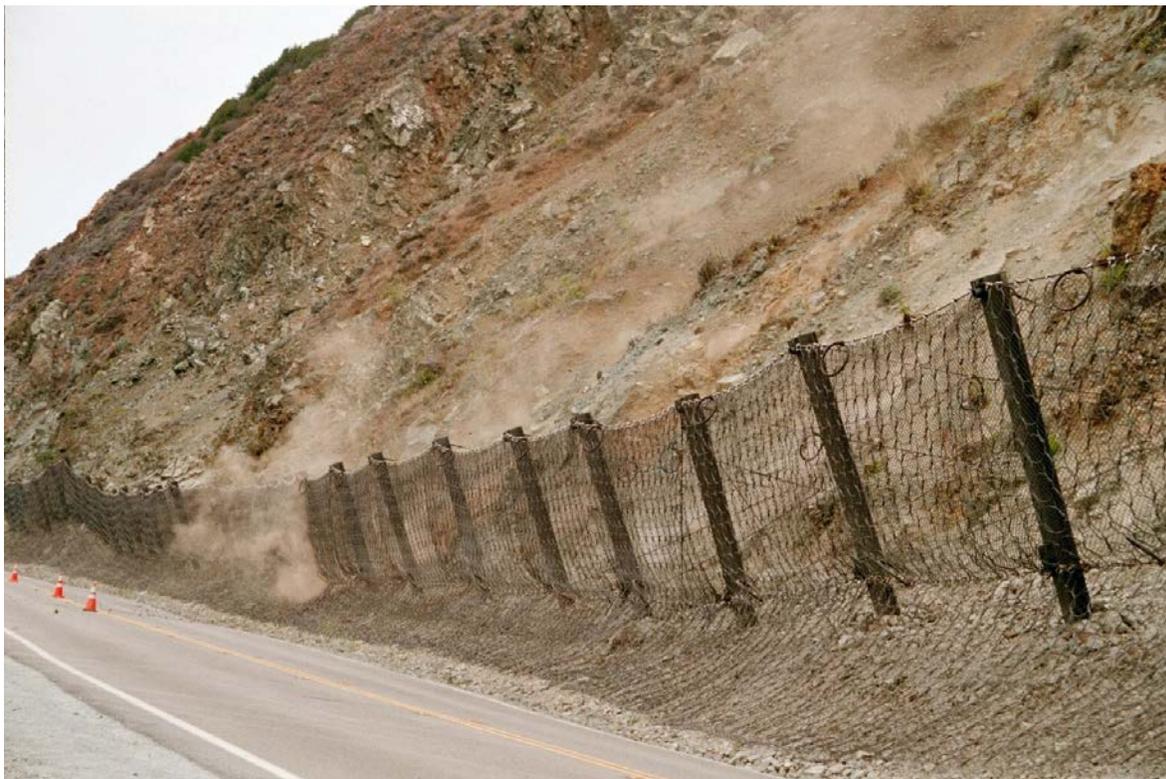
Figure 8 – Rockfall Barrier Live Demonstration Cow Cliffs (US-1, Big Sur) – 53rd HGS Field Trip 2002

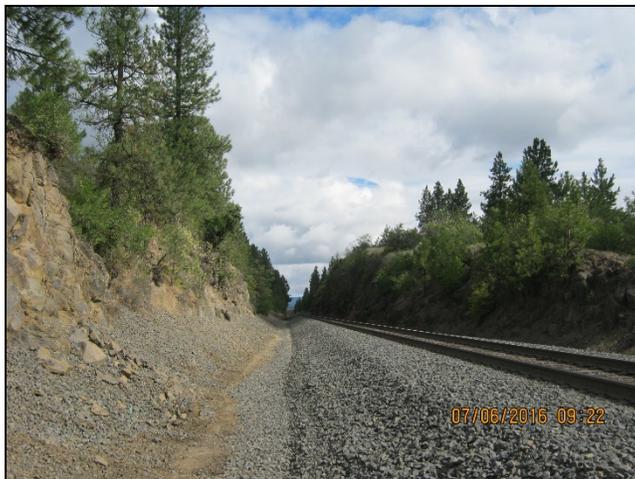
The through-cut is approximately one-half-mile in length, and ranges in height from 20 to 60 feet (Figure 2). Numerous single family homes exist on the west side of the cut, along the entire length. The brow of the slope is moderately vegetated with grasses, shrubs, and ponderosa pines less than 100 feet tall. The through-cut crosses volcanic rocks of the Columbia River Basalt Group, which is locally overlain by the Latah Formation.

Figure 2 – Fossil Cut looking north toward Spokane, WA.

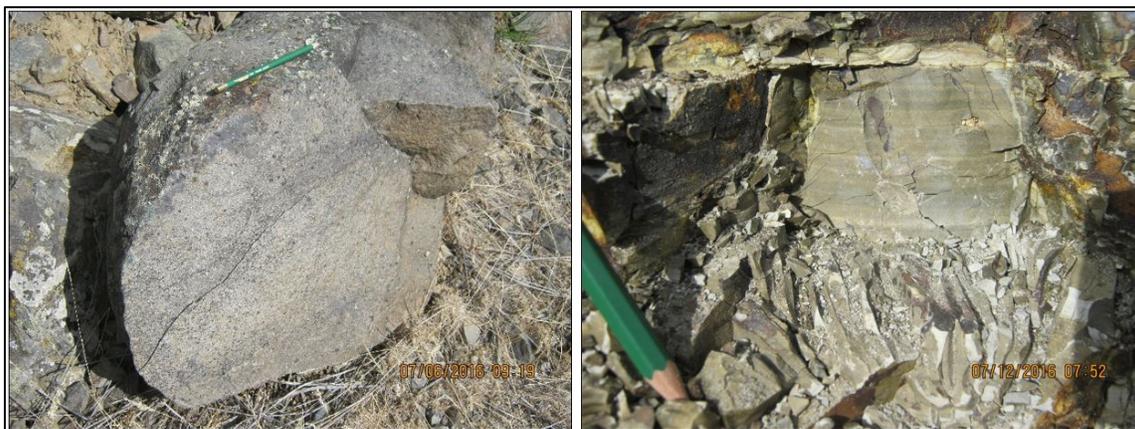
making them susceptible to toppling failure. Priest Rapids basalts (Figure 3) are dark gray to black, fine-grained, and consist of plagioclase (20–30%), pyroxene (10–20%), and olivine (1–2%) in a mostly glass matrix (40–60%) (Derkey et al., 2004).

Figure 3 – Priest Rapids basalt (left); Laminated Latah deposits (right).

The Latah Formation (Figure 3) occurs discontinuously throughout eastern Washington and Idaho. Lacustrine and fluvial deposits of finely laminated siltstone, claystone, and minor sandstone are characteristic of the Latah Formation. Regionally, the Latah Formation overlies pre-Miocene rocks, or is interbedded with the basalt flows of the Columbia River Basalt Group (Derkey et al., 2004). The Latah Formation is notorious for producing unstable slopes and adversely affecting structural foundations (WSDOT, 2013). The unit has presented constant design challenges for construction projects for the Washington State Department of Transportation (WSDOT), Idaho Transportation Department (ITD), and other government and private endeavors.

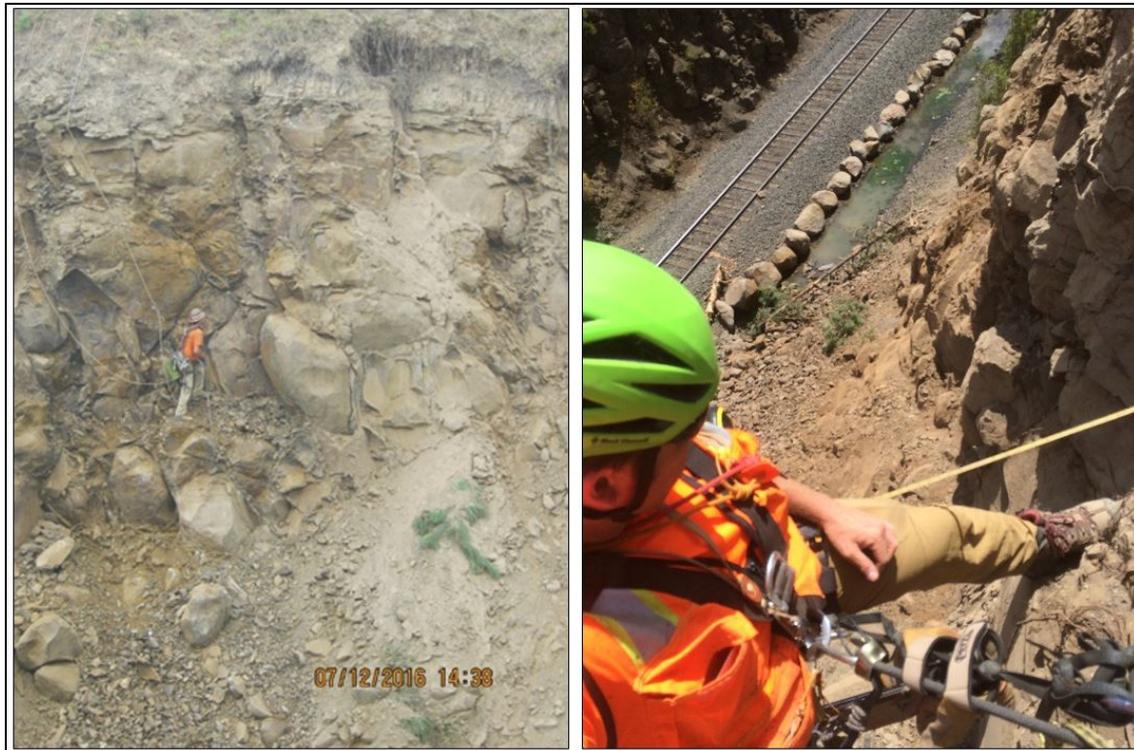
Figure 4 – Spheroidal weathering of Priest Rapids basalt; note the size of basalt boulders (left). Mapping scanline #3 with rope access techniques (right).

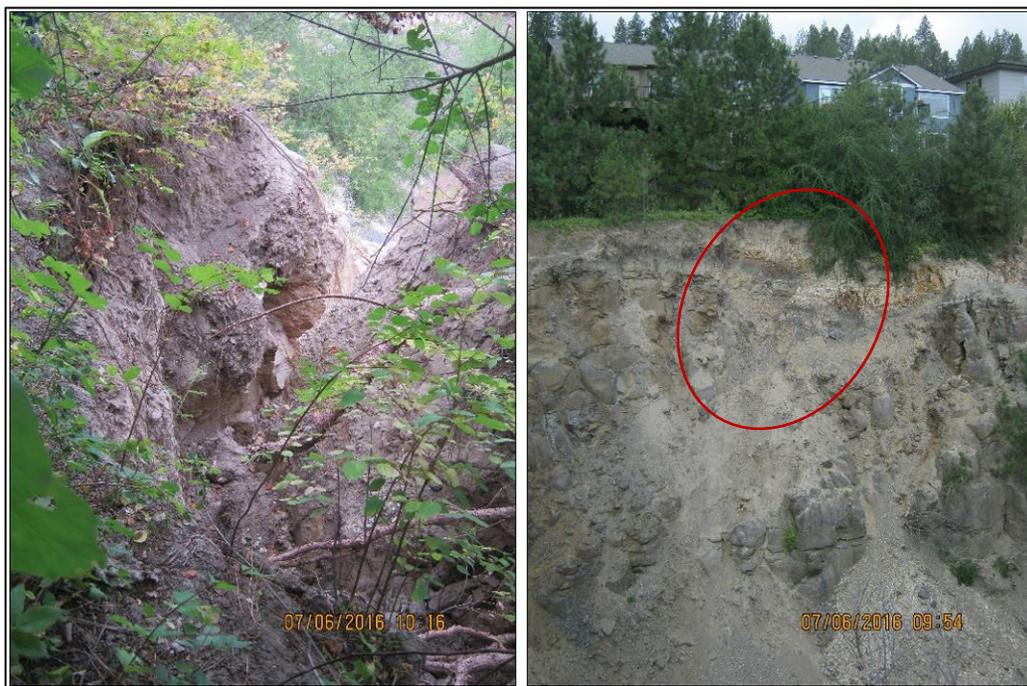
The head scarp on the west side of the Fossil Cut, in the project area, varies in height to a maximum of 14 feet. The head scarp is composed of well-developed soil, bedded claystones, and siltstones of the Latah Formation. When the head scarp was viewed from the east, a clear offset in bedding of the Latah Formation (Figure 5). An extensive root system was also observed penetrating several feet into the brow of the slope (Figure 6).

Figure 5 – Tension fracture, west side of Fossil Cut on the brow of the slope (left). Head scarp on the west side of Fossil Cut and offset of Latah bedding (right).

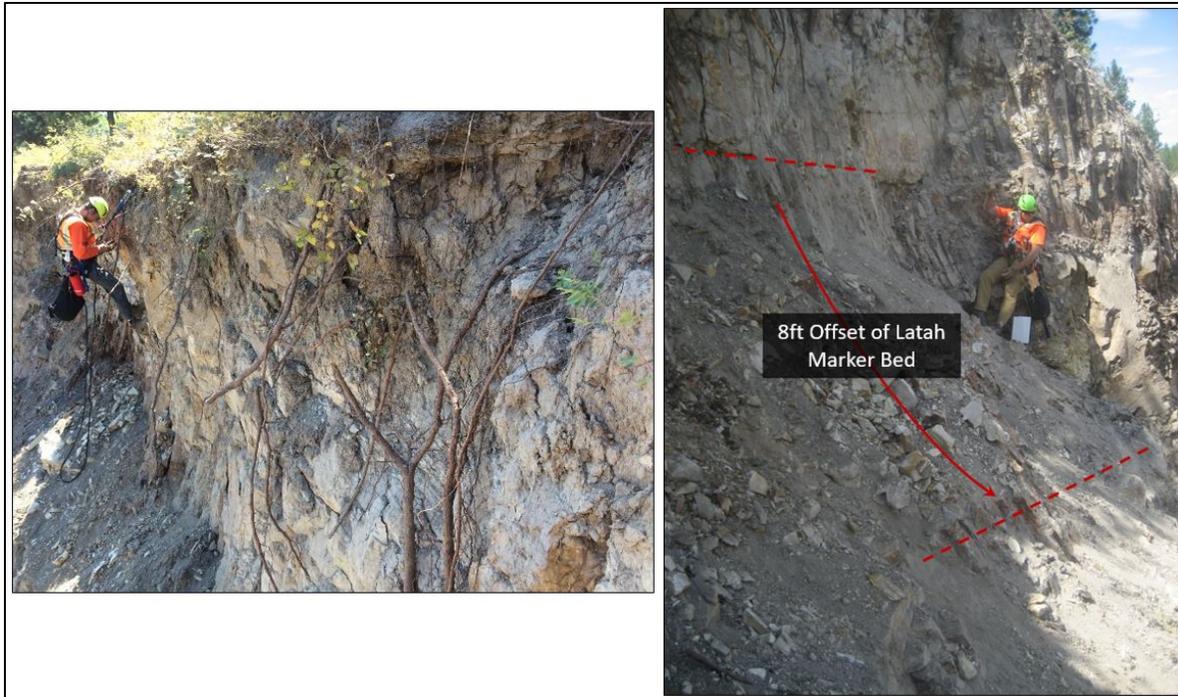
Figure 6 – Exposed root system penetrating the brow of the slope (left). Interpreted offset of Latah Formation along arching failure plane (right).

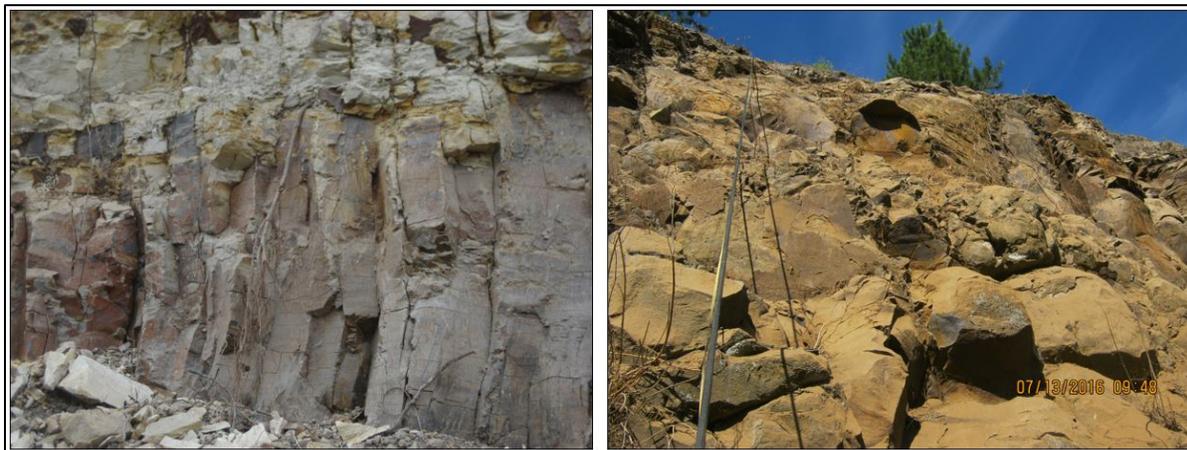
Figure 7 – Jointed Latah Formation (left). Priest Rapids basalt (right); note the spheroidal weathering of the large blocks.

The Latah Formation in the project area varies in color from white on weathered faces, to shades of green and gray (Figure 7). Geologic hammer tests indicate the intact rock strength varies from extremely weak rock (R0) to very weak rock (R1), equating to 36 to 725 pounds per square inch (psi). The rock mass is bedded, forming a blocky to tabular fabric. The RQD calculated with Palmström's volumetric method varies between 26% and 66%. Five distinct discontinuity sets with spacing between 0.8 and 8.0 inches were mapped in the Latah Formation. The discontinuities in the Latah Formation are generally polished with undulating surfaces and aperture widths between 0.02 and 0.1 inch. The rock mass is highly weathered on exposed faces, but the extent of weathering was observed to be less than 1 foot into the rock mass. The peak friction angle, measured with tilt tests in the field, averaged 36°. In summary, the base RMR (discontinuities set to 0 and groundwater set to 15) of the Latah Formation is estimated between 48 and 55, suggesting Class III, fair quality rock. The base GSI of the rock mass is between 43 and 50. Variability in RMR and GSI is largely a result of varying RQD throughout the formation.

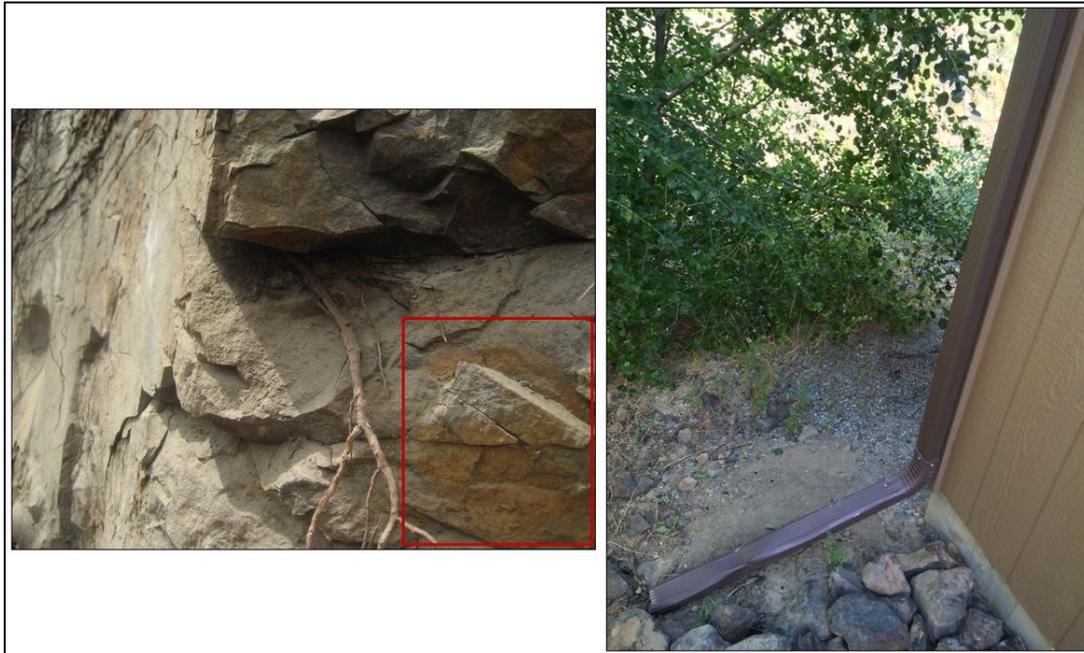
Figure 8 – Oxide staining evidence from surface water infiltration into the rock mass (left). Downspouts from the residents on the brow of the slope (right).

Groundwater seepage and surface runoff were not observed within the slope in the vicinity of Fossil Cut during the site field mapping; however, stained surfaces (Figure 8) of discontinuities suggest there is a history of water seepage through the slope. Infiltrating surface water runoff

from the adjacent properties is likely contributing to the quantity of water flowing through the slope. The homes situated on top of the slope have downspouts from gutter drainage systems discharging into the soil and rock in their backyards (Figure 8). The additional water from these downspouts and other surface water derived from rainfall or irrigation may contribute to the water percolating through the slope.

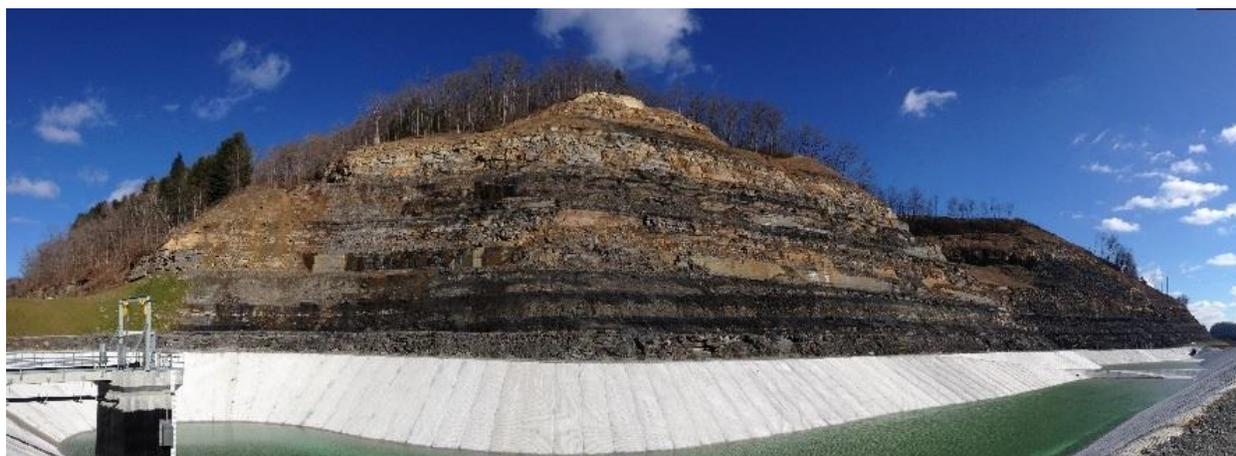
Figure 2 – Pre-construction FLP rock slope condition panorama from west side of FLP. View from northeast (left) to southeast (right).

The slope above the FLP was cut into the old mine highwall in 2013-2014 as part of the site development plan, with an overall design slope angle of 50 degrees and a series of six benches as shown in Figures 2 and 3. The layout of the slope and benches was based on overall slope geometry and was not designed to account for bedrock lithology by building benches in weak units underlying hard units to limit subsequent undercutting and possible rockfall generation. During production blasting, several prominent joint sets were encountered and the slopes between the benches broke along those joints; however, the dip of the joints was steeper than the bench face angle and daylighting joint faces were not created. Some variation in bench width and in some cases complete loss of benches occurred as a consequence of the backbreak along these joint sets (Figure 5).

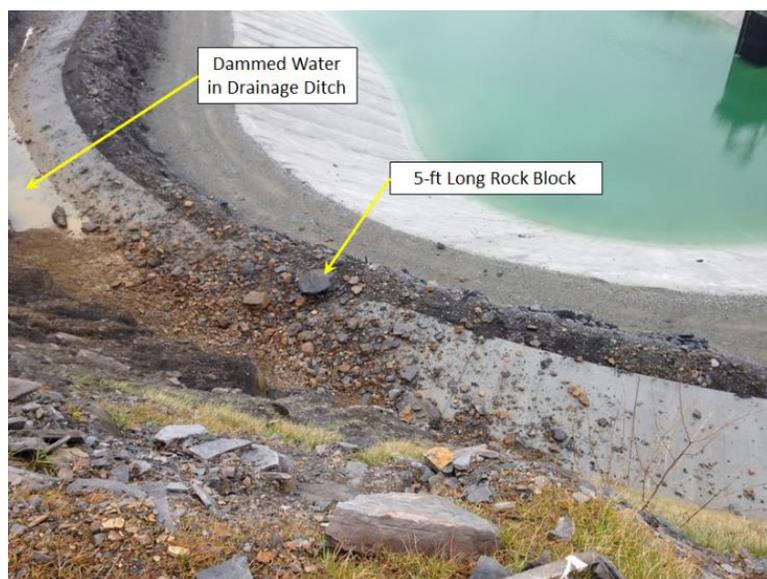
Figure 3 – Rockfall debris accumulating in drainage ditch, perimeter roadway, and concrete liner. Note ponded water in ditch dammed by debris on far left side of photo.

Shortly after construction of the concrete-lined perimeter channel on Bench #1 in late 2014, rockfall debris started to accumulate in the channel, requiring removal (Figure 3). Rockfalls continued to occur, filling the benches and accumulating within the channel, on the gravel roadway, and occasionally reaching the FLP. The rock block sizes ranged up to 3 ft in longest dimension. Based on site observations and review of blasting logs and videos, it appeared that the combination of uncontrolled blasting and other mining disturbance, and the lack of perimeter control blasting techniques led to extensive backbreak within the final rock slope, loss of benches, and to generation of rockfalls. Additionally, the previous bench design elevations were not based on lithology, which led to formation of overhangs of more resistant sandstone overlying less resistant siltstone, shale and coal due to differential erosion.

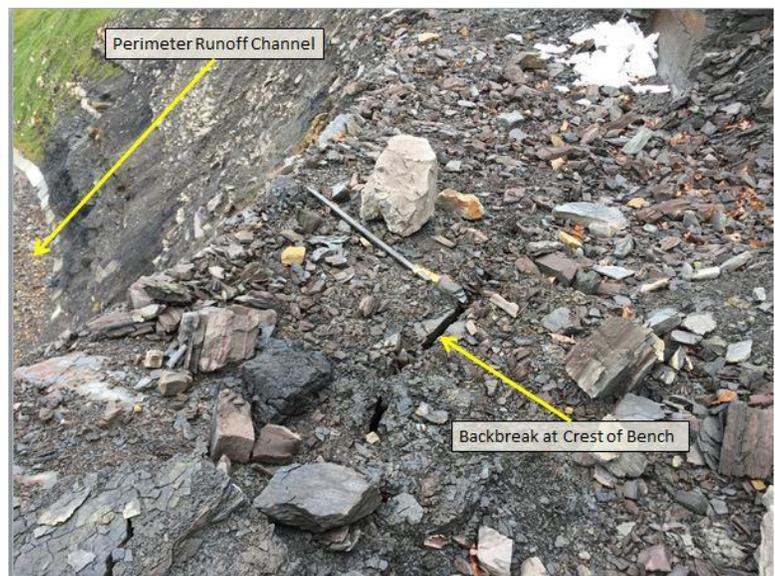
Figure 5 – Backbreak along crest of bench above north end of perimeter runoff channel. Grade stake for scale.

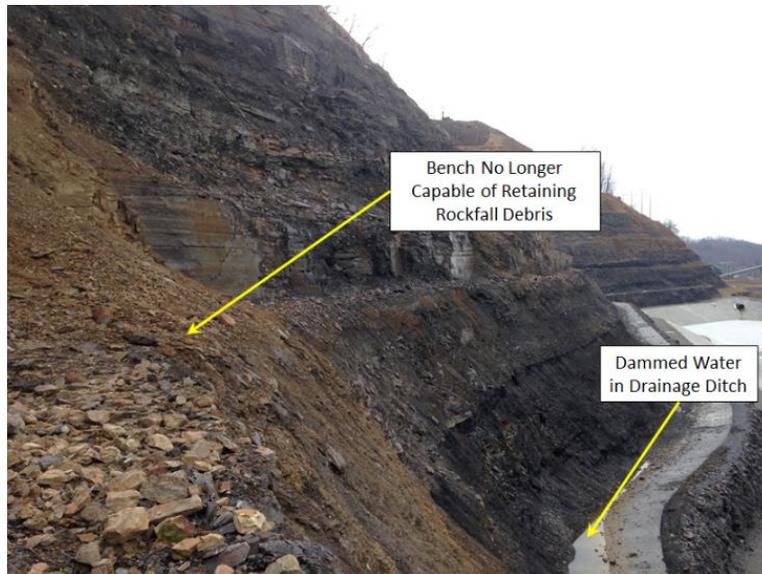
Figure 6 – Heavy bench accumulation of rockfall debris. Bench can no longer retain additional rock blocks and soil, and they are being passed downslope.

accumulated falling rocks from the slopes above, and were filling with debris (Figure 6). Surface water emanating from an adjacent wetland northeast of the highwall drains through strata along the bottom half of the slope at the north end, and is locally perched on the more impermeable cleats at the base of the coal seams. Icefalls and rockfalls are common in these areas throughout the winter season.
