68TH HIGHWAY GEOLOGY SYMPOSIUM MAY 1-4, 2017

2017 Proceedings

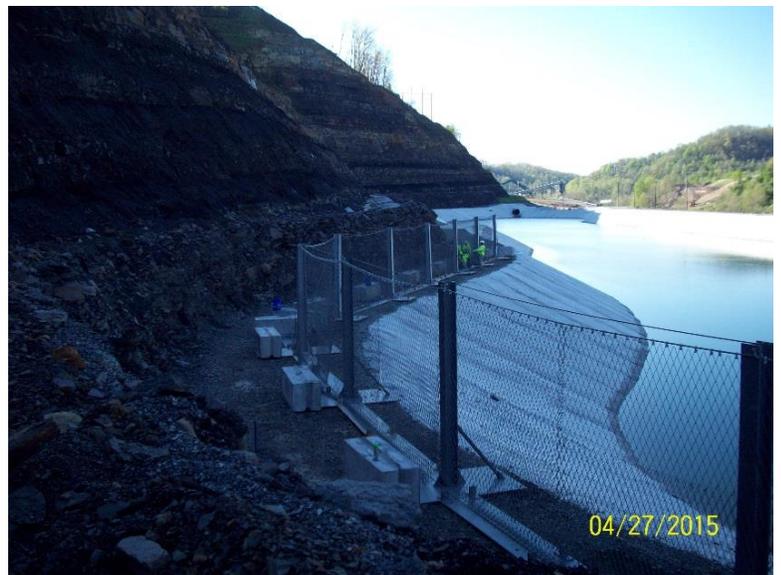
Figure 8 – Temporary rockfall barrier.

Prior to implementing mechanical and hand scaling operations, a 120-ft long, 500 kJ capacity temporary rockfall barrier was installed at the toe of the north end of the slope, just inboard of the FLP (Figure 8). The barrier consisted of 4 mm Tecco™ wire mesh supported by steel I-beams, 10- to 15-ft tall mounted on steel plates, and anchored by concrete blocks. The barrier was designed to be moveable with minimum disassembly, such that the barrier could be dragged along the FLP slope toe by a front-end loader and placed into position below the area to be

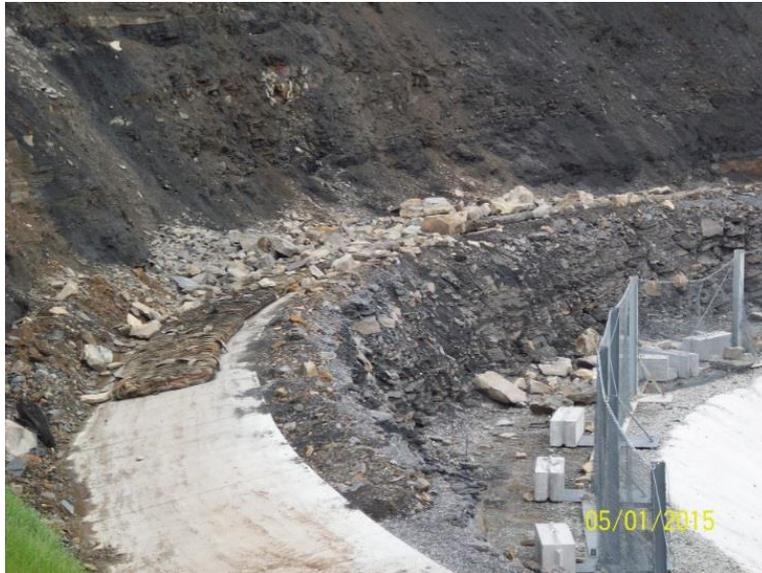
Figure 9 – Scaled debris in concrete ditch resting on blasting mats and contained by temporary barrier.

scaled. The temporary rockfall barrier was used in tandem with rubber tire blasting mats that were laid along the top of the concrete lined drainage ditch on Bench #1 to dampen the kinetic energy of falling rocks (Figure 9). The barrier and mats were moved from a north-to-south direction as the scaling operation moved across the rock slope.

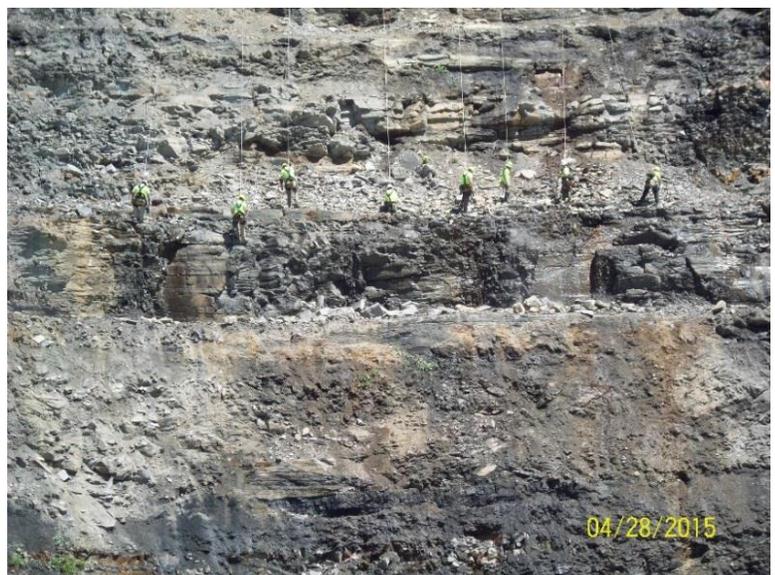
Figure 10 – High scalers scaling rock face.

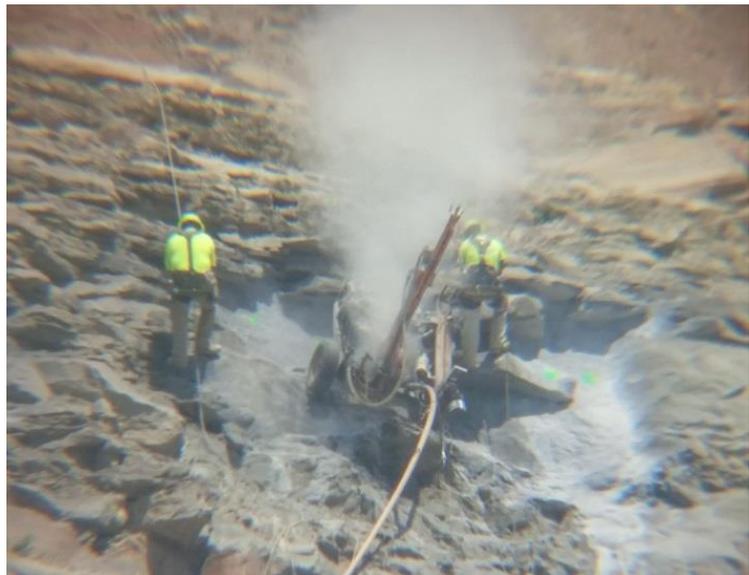
Figure 11 – Drilling shotcrete support dowels.

Rock dowels, shotcrete support dowels, and shotcrete were installed from July 9 to August 27, 2015. The rock dowels were drilled using either a hand held “plugger” drill or a wagon mounted down-hole hammer drill (Figure 11). The dowel spacing and depths were selected to address specific areas of the FLP rock slope where rock blocks were too large to be safely scaled or retained by the Tecco™ rock drape. The rock dowels were separated into two categories: rock dowels used to pin large rock blocks into place, and rock dowels used to provide support to the areas repaired using buttressing shotcrete. The rock dowels used to pin the large rock blocks were designed to be 8 to 15 ft long and fully grouted along their entire length. Rock dowels used to provide support for the shotcrete buttress areas were designed to be 4-ft long and fully grouted.

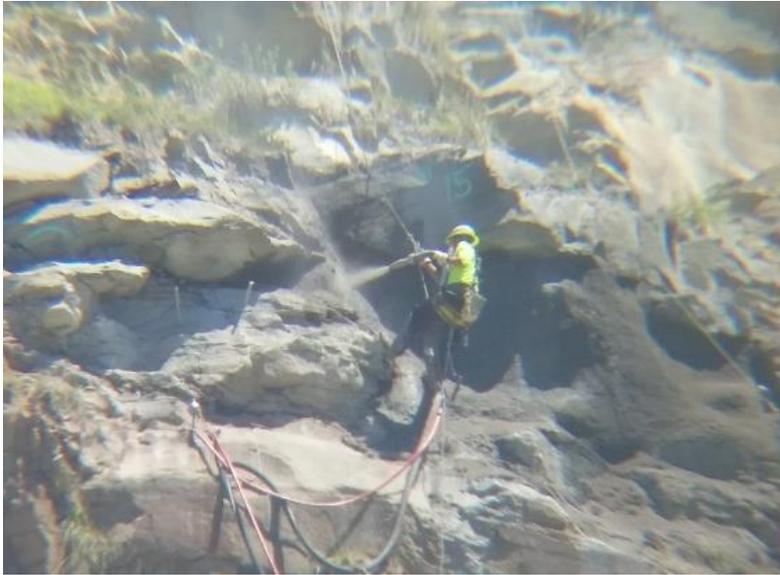
Figure 12 – Dry-mix shotcrete application.

Many of the rock masses had overhangs for which the shotcrete formed a filling buttress for structural support (Figure 12). Dry-mix fiber-reinforced shotcrete was specified due to the large distances between the potential shotcrete plant staging and the application areas, and the difficulty in getting concrete wet-mix trucks close to the slope. Shotcrete was also applied to further stabilize and armor loose portions of the rock slope and limit further crumbling and erosion of the slope. In areas exceeding 5 CY of shotcrete, a

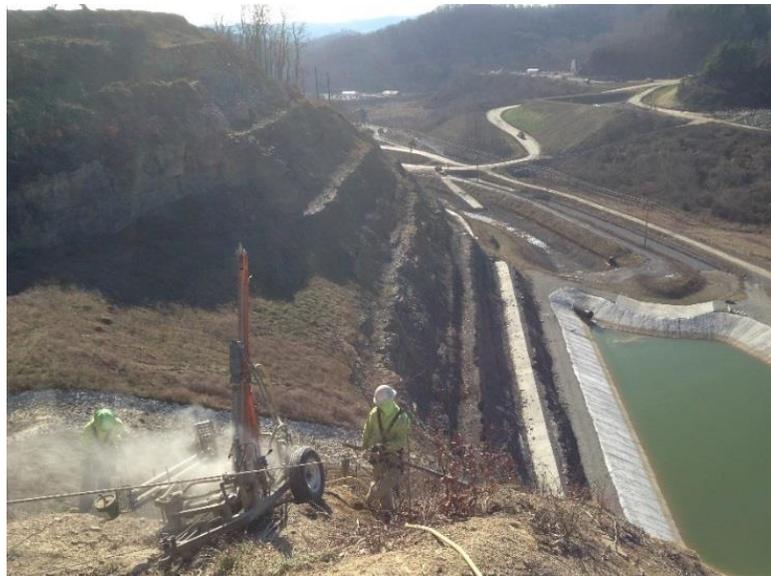
Figure 13 – Drilling cable anchor with wagon drill.

The cable anchors for the top and lateral support ropes for the drape system were installed during winter conditions. The primary cable anchors were installed at roughly 16-ft spacings at the crest, intermediate anchors (three each) at roughly 80-ft spacings at the top, and cable anchors at roughly 50-ft spacings on the sides. The anchors were installed using wagon drills (see Figure 13), and ranged from 15.5 to 25.5 ft in length. Most of the wire rope cable anchors consisted of premanufactured anchors, but for instances where weak rock and/or soil were encountered, longer anchors were fabricated in the field, using an identical design as the premanufactured anchors. Cable anchors for the bottom support rope were placed at roughly 50-ft spacings, using a John Henry-style top hammer drill mounted on a mini-excavator. The excavator accessed the bottom anchor locations from the concrete lined ditch on Bench #1.

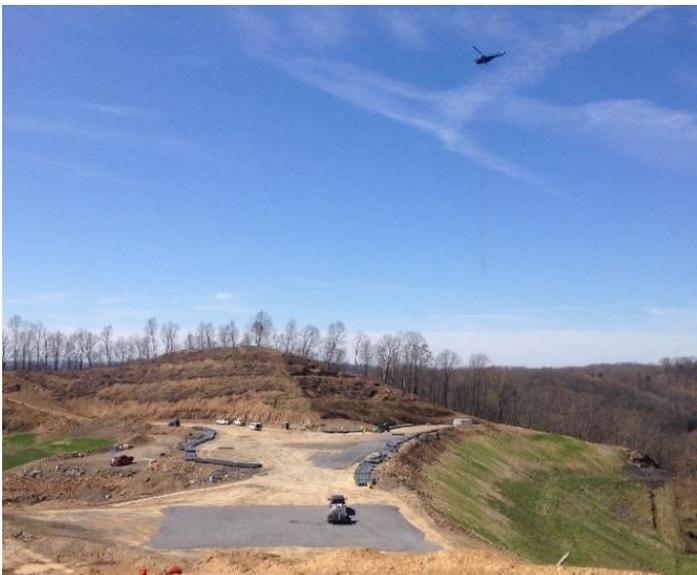
Figure 15 – Drape assembly/staging area and pick.

Between March to mid-April, 2016 the as-delivered Tecco™ rolls (11.5 x 100 ft) were unrolled, and reassembled to panel lengths ranging from about 25 to 225 ft long to stage the rolls for placement on the slope (see Figure 14). The rockfall drape mesh was installed on the FLP rock slope in mid- to late-April 2016 via airlift using a modified Sikorsky S55(T) helicopter (Figures 15 through 17). The helicopter used a proprietary lifting/ spreader bar attached to the cargo hook, which was attached to the bottom of the drape panel. The panel weights ranged from 430 to 1,670 pounds (lbs). The helicopter lifted the unrolled panels from the staging area and flew them to the drape area, where workers on slope would then secure the panels to the top support rope or other deployed panels using temporary pin screw shackles. Additional workers then guided the panel edges as the helicopter flew down the slope so that the mesh could be laid on the slope and properly

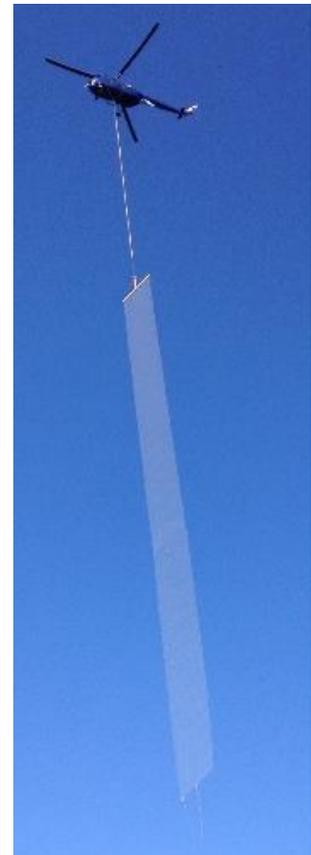
Figure 16 – Helicopter pick

overlapped. Once most of the mesh had been laid on the slope, the pilot released the remotely controlled cargo hook, which opened the lifting/spreader bar from the end of the panel, and the remaining panel length fell onto the slope in a controlled manner.

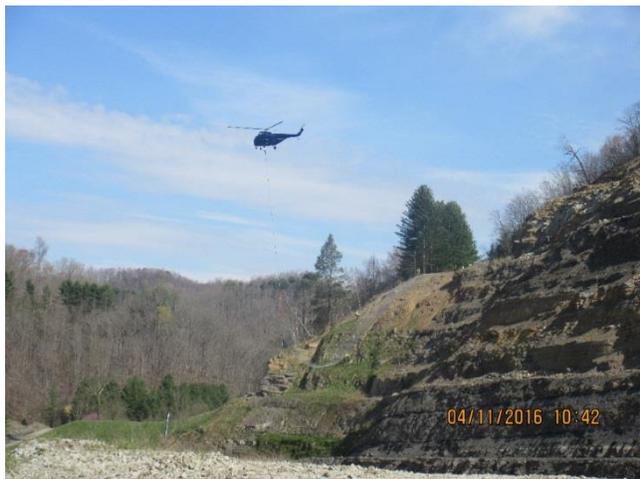
Figure 17 – Deploying drape panel.

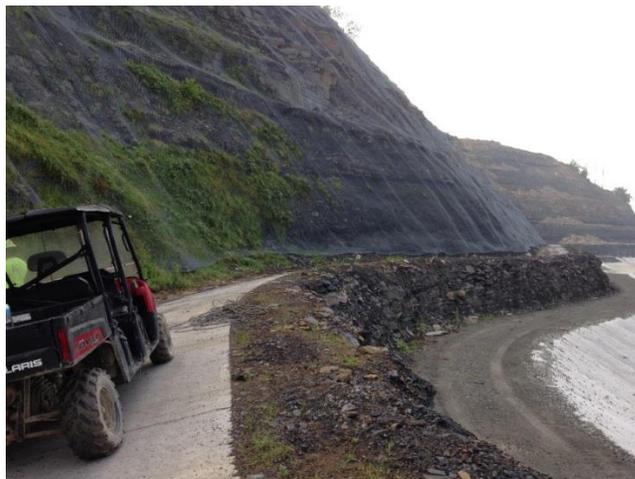
Figure 18 – Completed drape.

Flights per day (“picks”) depended on wind and weather, and ranged from 4 to 27, with daily deployments of 9,200 to 62,940 ft². A total of 187 flights were completed to install 371,846 ft² of drape. After hanging the mesh, workers clipped the panels together with Tecco™ clips with a lateral overlap of 6-in or greater. A seaming rope was then used to attach the drape to the top and side border ropes. The design included a fold of mesh over the bottom support rope to form a hem. Drape construction was completed on in June 2016 (Figures 18 and 19).

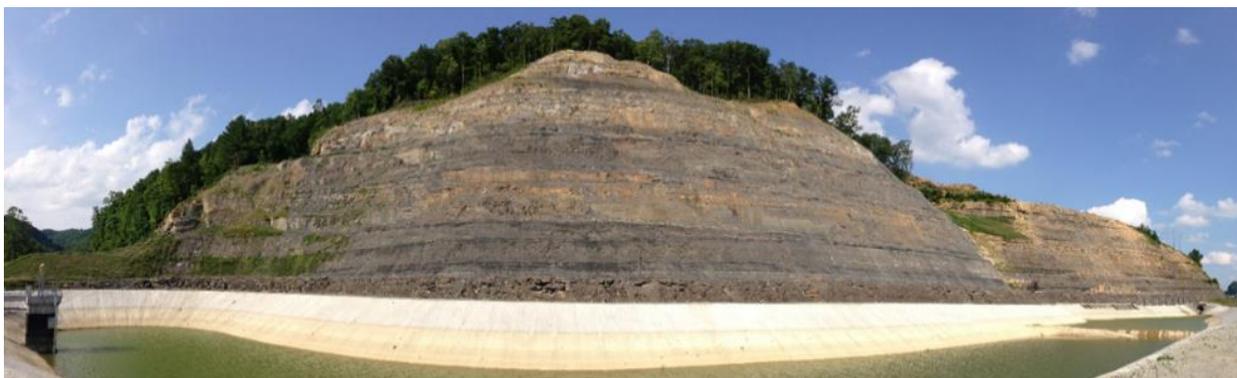
Figure 19 – Completed drape panorama. Compare with Figure 2.

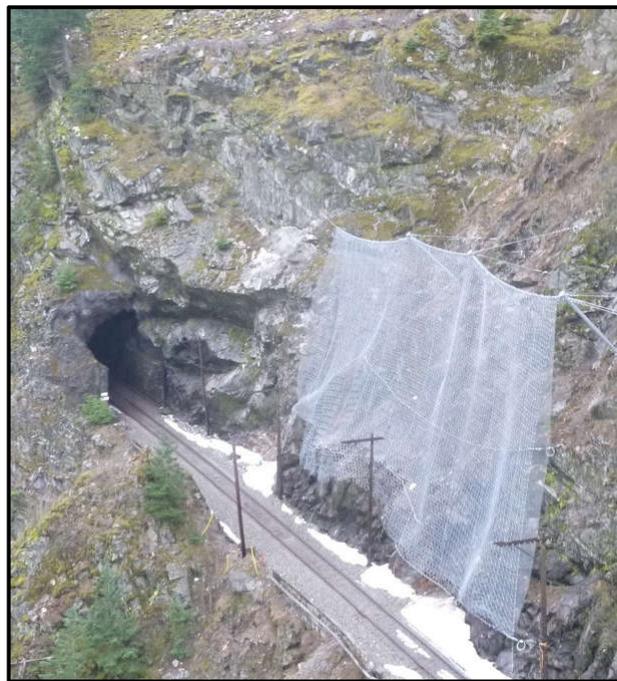
Figure 2. Typical Attenuator installation showing a series of hinged posts with support cables, and a freely hanging net.

Figure 2 shows an Attenuator installed to protect a railway close to a tunnel portal where the source of rockfalls is about 450 m above railway. The design procedure for the Attenuator was to closely study the rockfall trajectories in the lower 50 m of the slope to identify both the path of the rockfalls, and their trajectories, i.e., height above the ground, in order to position the structure correctly on the slope, and that the top of the net would be high enough to contain rocks that could impact the track. The required momentum capacity of the net was calculated by studying the site geology and existing rockfalls to determine the design mass (m), and the trajectories to determine the design velocity (v).

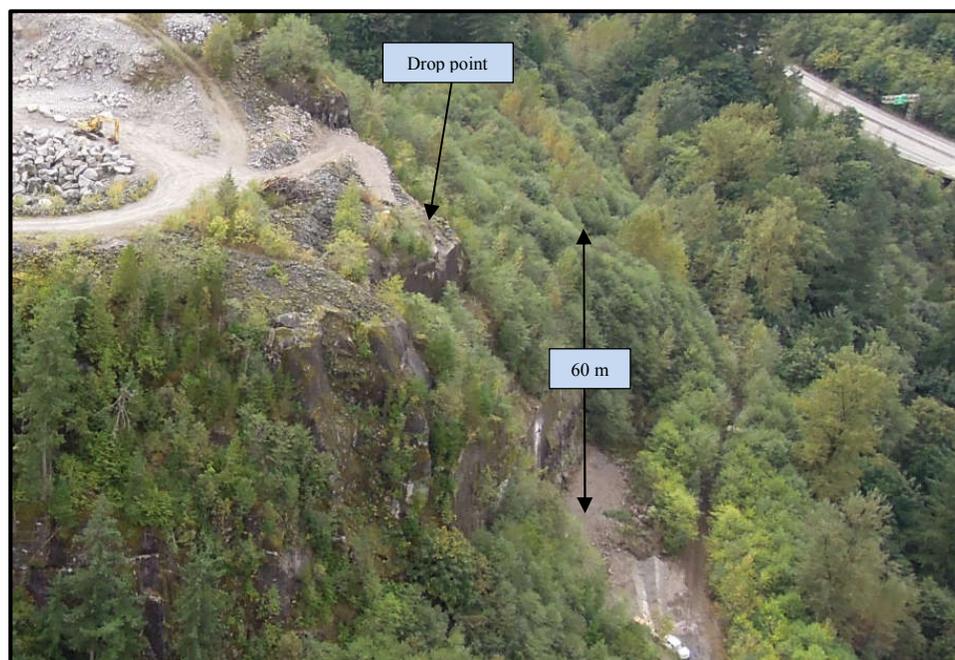
Figure 3. Image of test site

The test facility was constructed in a quarry where the test blocks could be dropped from heights up to 60 m down an irregular rock face at an overall slope angle of 60 degrees (Figures 3 and 4). The Attenuator was constructed with two, 8 m long steel beams attached to hinged bases bolted to the rock face. The posts were 12 m apart, and the 12 m wide by 11 m long (vertically) net was suspended from a 19 mm diameter steel cable strung between the tops of the posts. Each post was supported with two up-slope support cables and two lateral support cables attached to anchors drilled into the rock face. Figure 4 shows a 40 ton crane lifting the posts into place; a man-lift was used to install the support cables and hanging net.

A laser scan was carried out to produce detailed topography of the site, and to accurately locate the anchors for the support cables. The scanner was located at the base of the slope, and because some areas of the face were in occlusion zones, a drone was used to take images of the slope from above the crest. The point clouds from the scans and the images were combined to produce a topographic plan of the site.

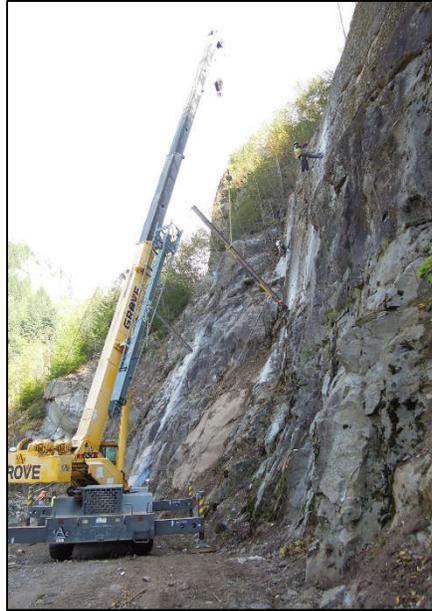
Figure 4. Construction of test Attenuator

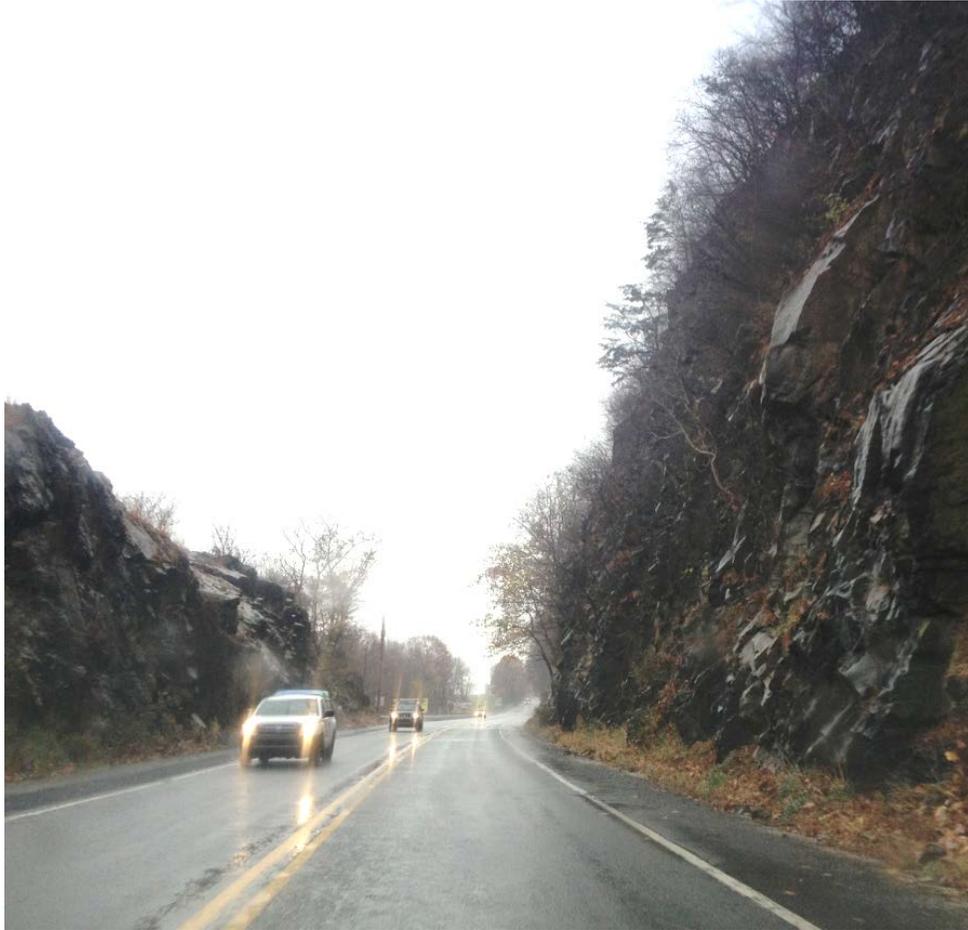
Figure 3 – Photo Looking South (Cut 2 on left and Cut 1A on right)

As shown by Table 2, the slopes throughout the Marysville site are very steep, ranging up to approximately 78 degrees. This factor, combined with the narrow roadway shoulders, creates a very tight roadway configuration with almost no catchment area for falling rocks (see Figure 3). The heavily jointed, blocky nature of the sedimentary rock units along with the steep slopes

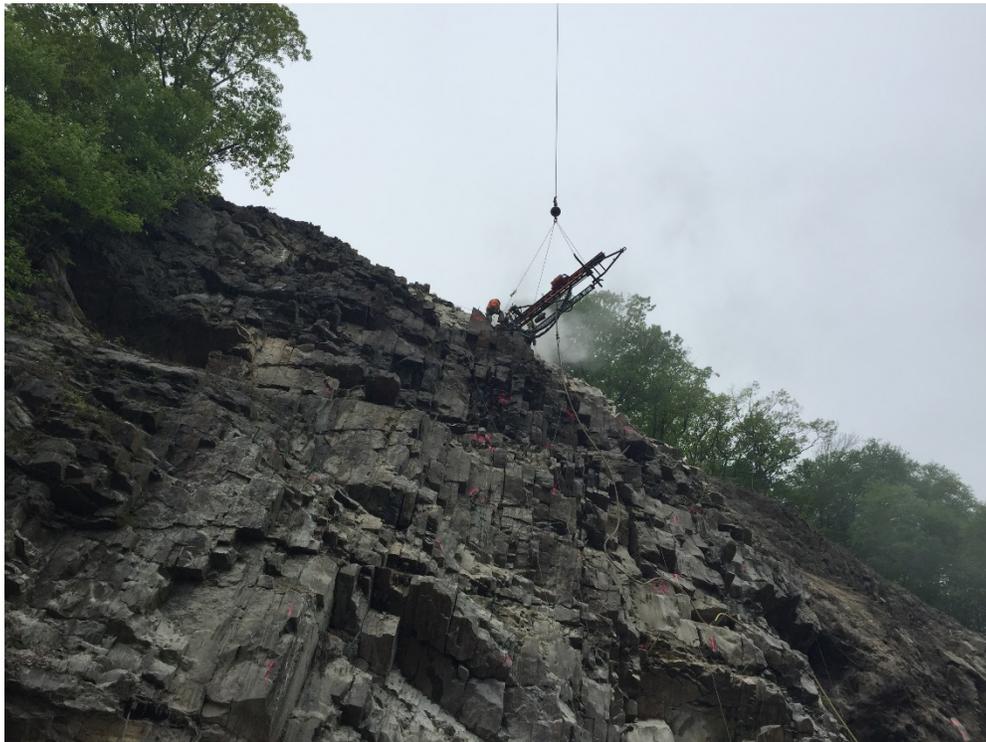
Figure 4 – Rock Bolt Installation on Steeply Dipping, Thinly Bedded Sandstone

about 62 and 89 degrees to the south (see Figure 4). Three unique joint sets had been identified during the preliminary design reconnaissance, and stereonet analyses concluded that wedge failures and toppling were the primary rockfall mechanisms at the slopes. Sandstone beds were observed to exhibit very prevalent well-developed, near-vertical jointing. These relatively hard beds are often undermined by differential weathering of adjacent shale beds, resulting in the accumulation of detached sandstone blocks along the roadway shoulder.

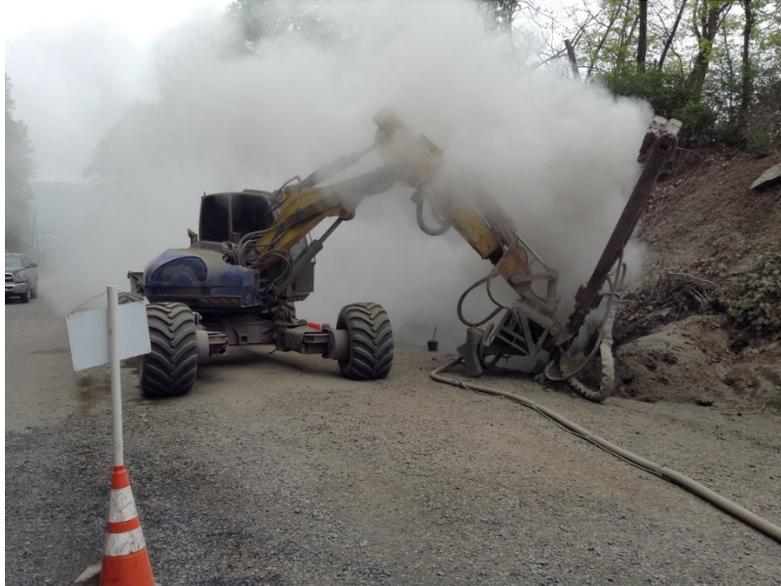
Figure 5 – Drilling Ground Anchors with Articulated “Spider” Drill

Concurrently with the scaling and bolting operations being carried out by Hi-Tech up on the rock face, Eckman forces began drilling (Figure 5) and installing wire rope ground anchors (Figure 6) for the lateral fence supports. The ground anchors consisted of double-leg wire rope grouted into drilled holes oriented between 30 and 45 degrees from horizontal, with rope diameters and minimum bond lengths (in bedrock) as summarized in Table 4. As shown by Figure 6, the anchors were tremie-grouted through sacrificial PVC grout tubes, and the anchor heads were fitted with galvanized thimbles for shackle connection to the longitudinal fence cables and bracing cables.

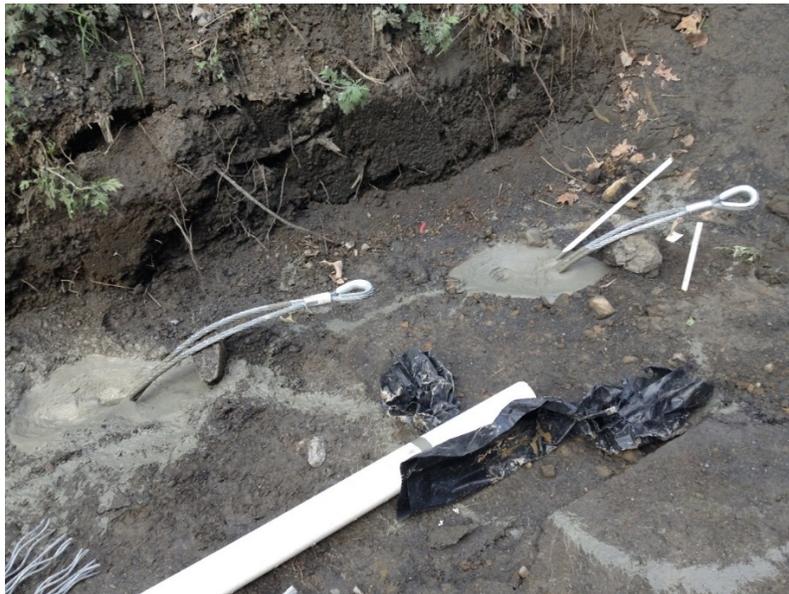
Figure 6 – Anchor Pair After Tremie Grouting

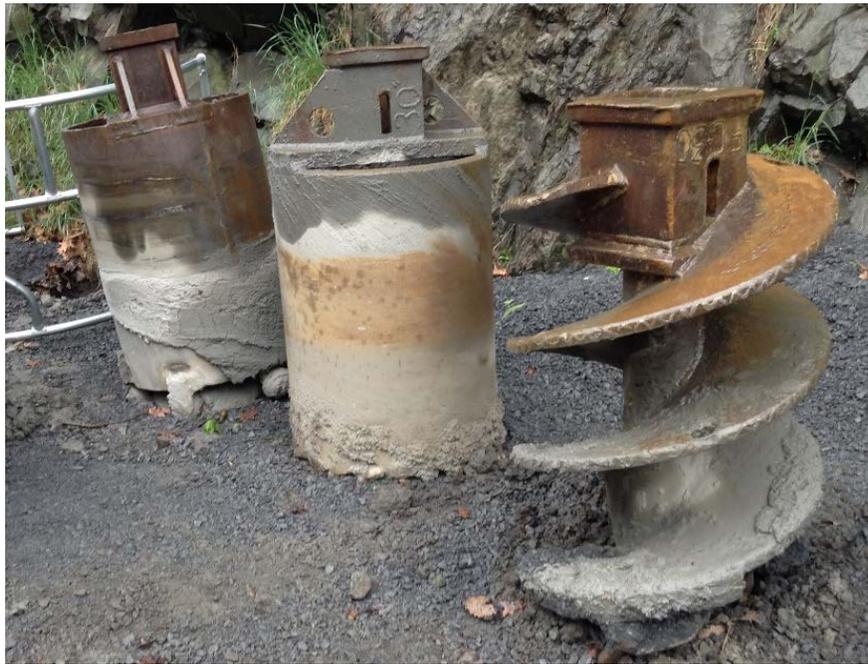
Figure 7 – Caisson Drilling Tools

As a result of the steeply-dipping sedimentary beds striking nearly perpendicular to the roadway, bedrock conditions were noted to change dramatically along the wall alignments. To accommodate the wide range of rock hardness, several different caisson drilling tools were used for the post installations. As shown in Figure 7, the shaft drilling operation utilized core barrels with roller bits (left) and cutting teeth (center), as well as rock augers (right). In the very hard sandstone, a downhole hammer bit was necessary to maintain adequate production.

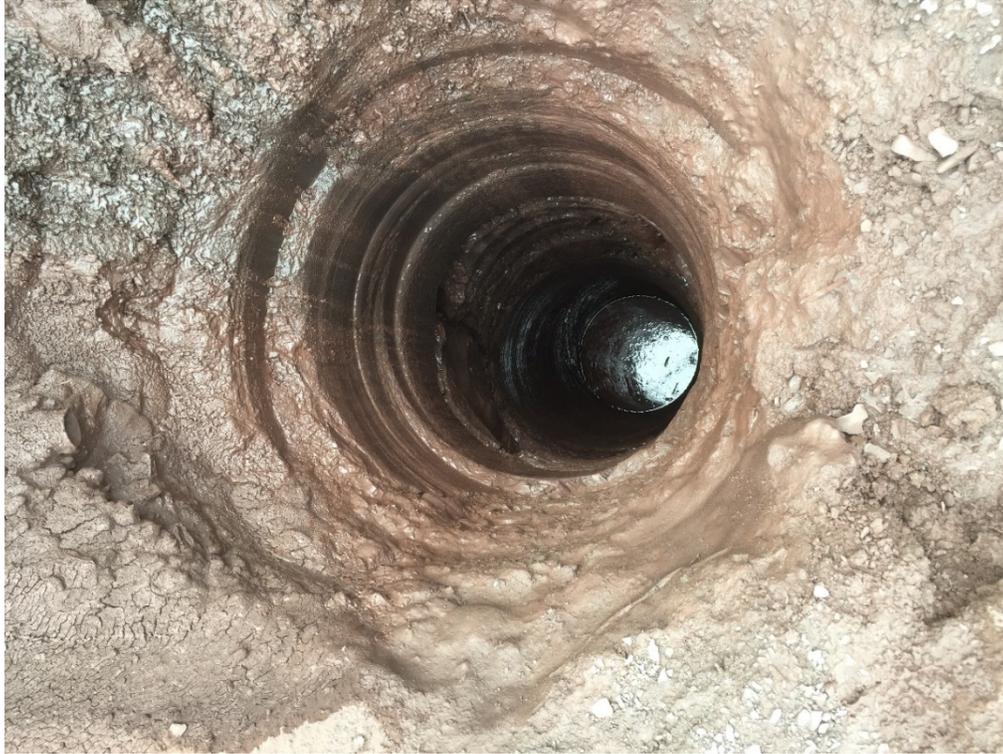
Figure 8 – Typical Caisson With Shallow Bedrock

Some caissons required the use of steel casing to prevent soil caving from above the rock socket interval. However, in most cases competent rock was shallow enough so that the holes could remain uncased prior to post and concrete placement (Figure 8). Following completion of drilling a group of shafts, the posts were set in the holes and temporarily braced during concrete placement and curing. The photo in Figure 9 is oriented looking north at completed posts in Cuts 3 (left) and 4 (right). Note temporary bracing still in place on the Cut 3 fence posts.

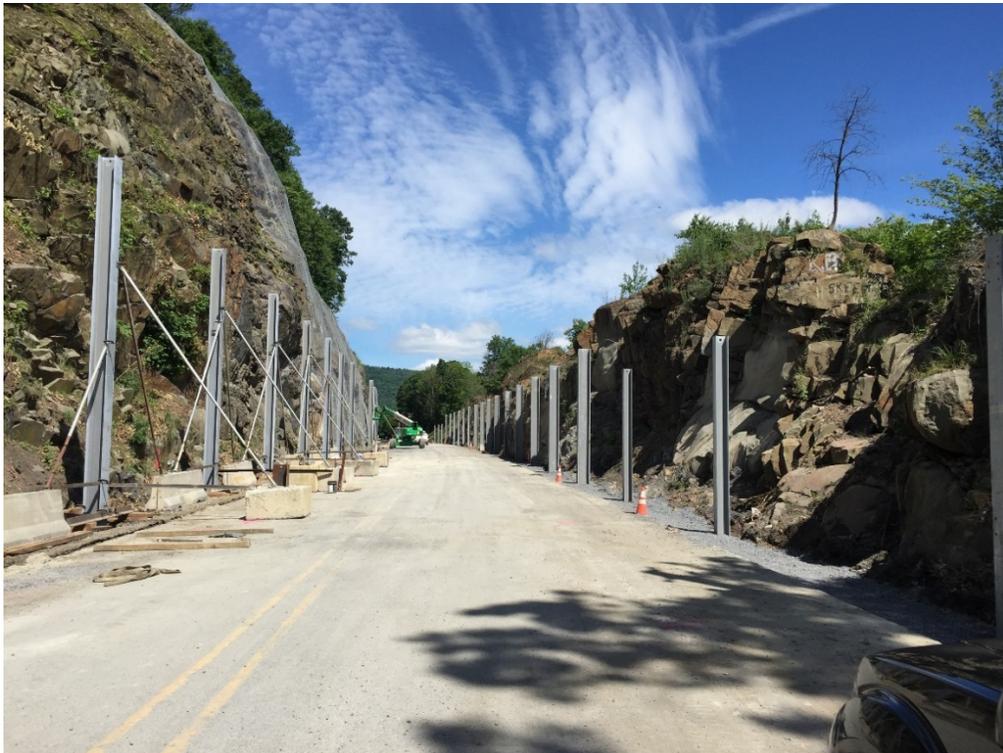
Figure 9 – Completed Posts Prior to Mesh Installation

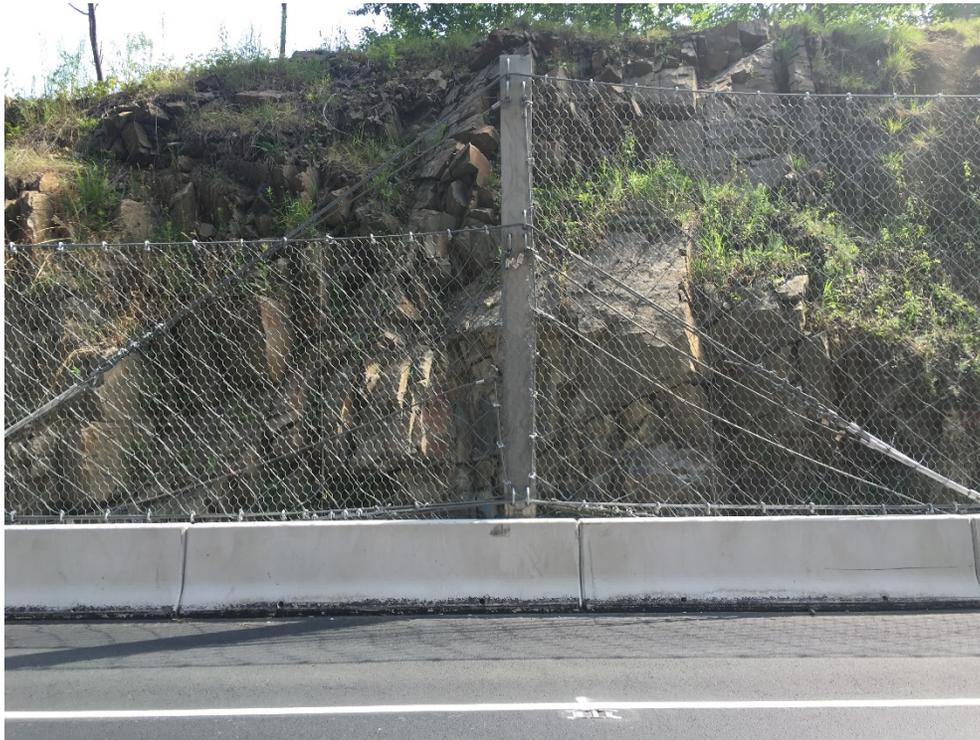
Figure 10 – Completed Fence Section at Height Transition Post

Following the completion of Hi-Tech's work on the slope and the installation of all fence posts and ground anchors with the full detour, the placement of mesh, cables, bracing systems and related hardware could be performed during single lane closures. Figure 10 is a photograph taken at Cut 4 during the final inspection, showing a height transition between different design cases. Note longitudinal cables sloping to ground anchors in both directions about post in center of the photograph.

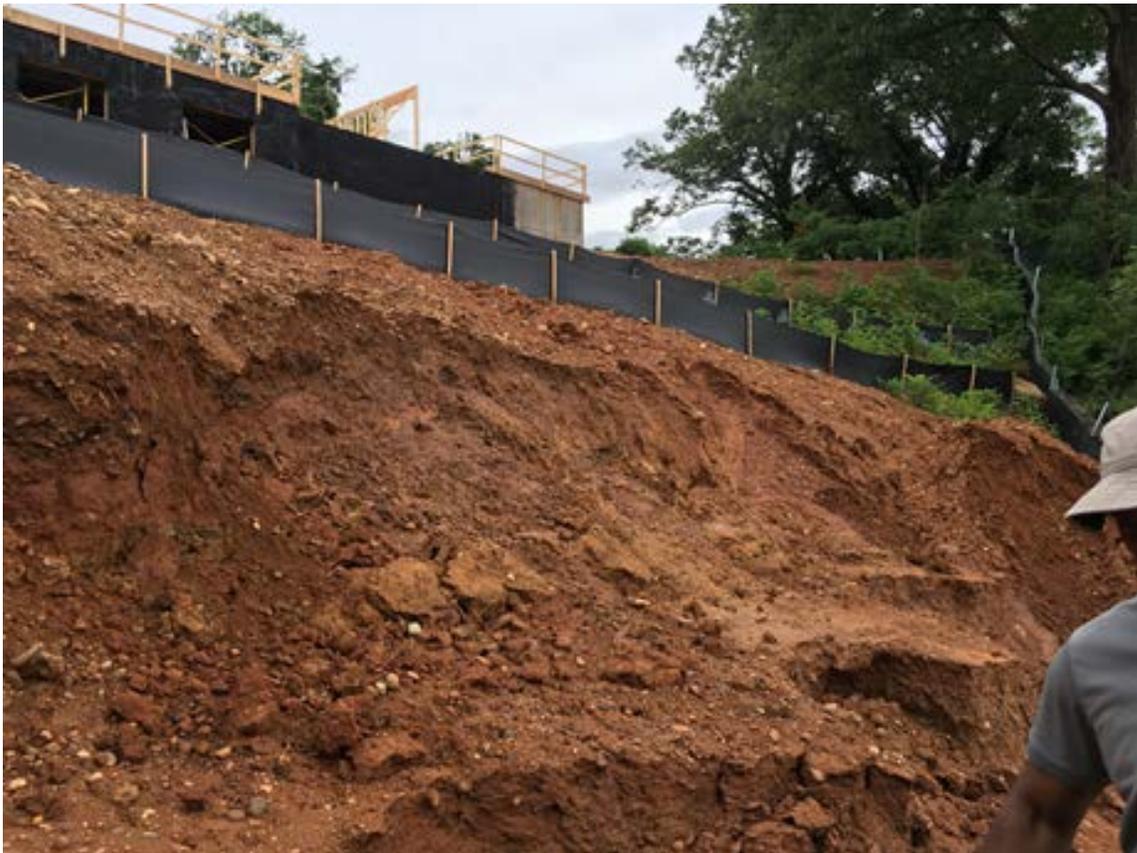
Photo 1: June 23, 2016 - Looking uphill with the house construction in the background and the DSW in for ground.

Based on observations made, it was concluded that the head scarp below the DSW line caused the soil ablation and sloughing observed upslope. Standing water was observed at the mid-slope at head scarp below the DSW in several locations. Seepage was also noted in the head scarp below the top of the caissons. Tension cracks were observed throughout the mid-slope area and into the lower slope area. See Photo 1.

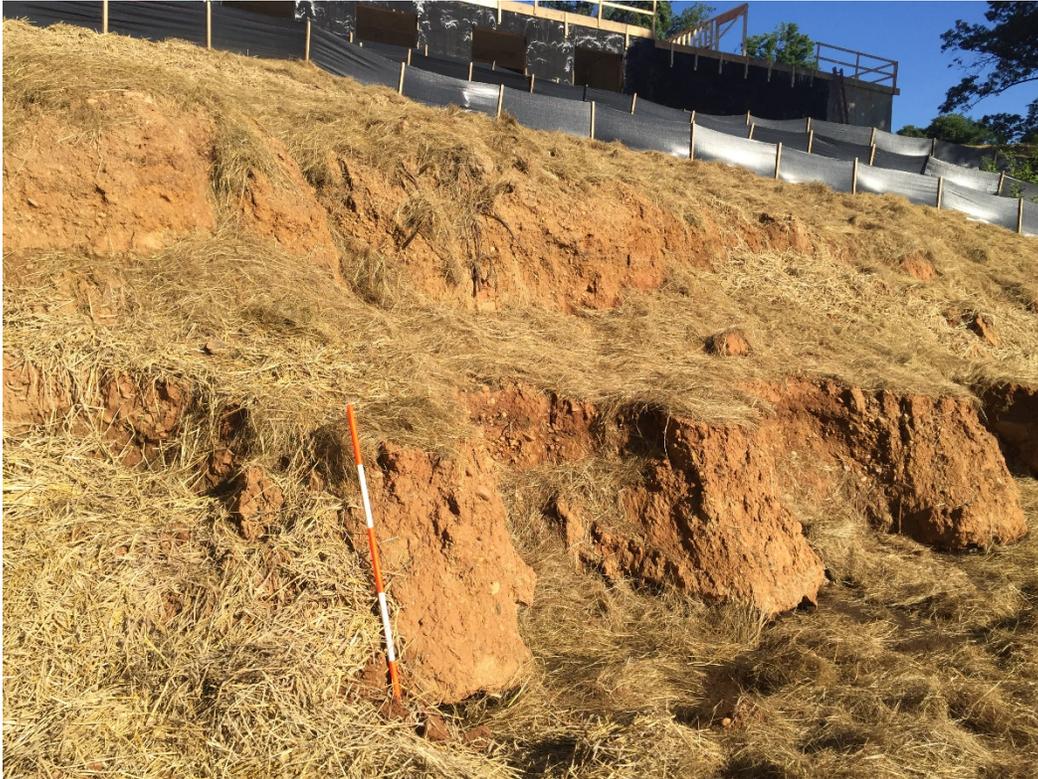
Photo 2: July 11, 2016 - Looking uphill with the house construction in the background and the DSW in for ground. Scale rod with 1-foot increments placed at Caisson 1.

A supplemental reconnaissance was performed on July 11, 2016, immediately prior to the initiation of the subsurface exploration. In general, observations made were similar to those made during the initial reconnaissance. Tension cracking and signs of surface moisture at the DSW line, in the mid-slope, and in the RPA were still present. No further advancement of the sloughing above the DSW line was observed. The head scarp immediately below the DSW line had dropped another approximately 2 to 3 feet vertically. See Photo 2 on the next page.

For reference, the caissons of the DSW line were numbered 1 to 15 south to north. The location of caissons 1 through 12 were visible due to the ablation of soil between the caissons creating an arch-like pattern. This indicates the failure was tied to the spacing of the caissons exceeding the arching effect of the soil between caissons. The concrete and top of shaft were visible in caissons 10 and 11.

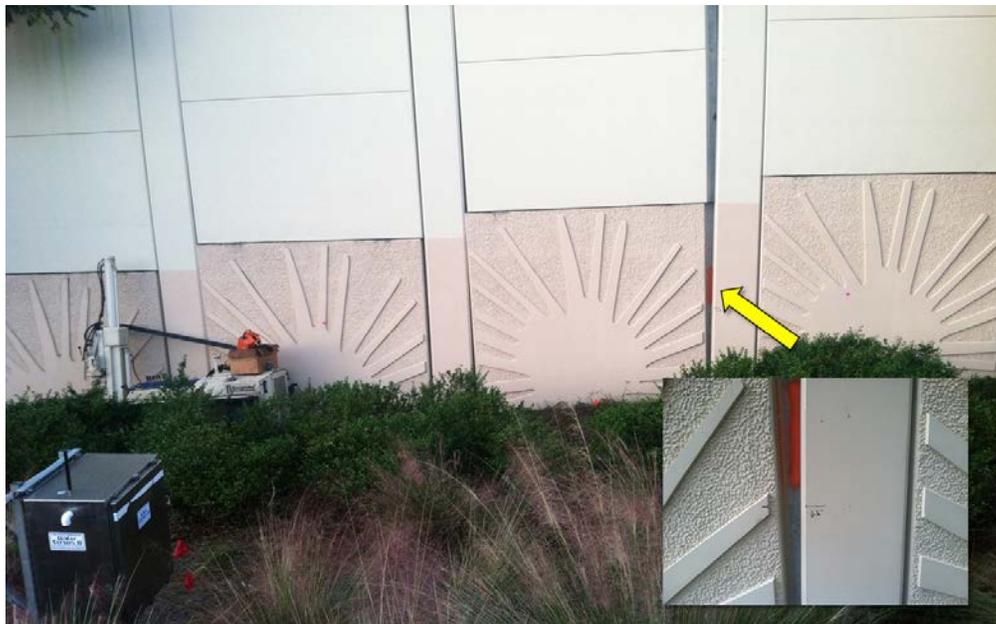
Figure 3: Shows the amount of movement of the sound barrier and DPT installation

Two (2) MERIT geophysical surveys were performed to address the potential sinkhole development in the R-O-W. The first MERIT survey (Line 1) was designed to provide subsurface profile that would intersect the previous three geotechnical standard penetration test borings to depths of 130 feet below land surface (bls). In addition, Line 1 was designed to encompass and extend past the 200 foot long affected area of the R-O-W. After the results of Line 1 were reviewed by Water Conserv II it was decided to perform a second MERIT survey. MERIT Line 2 was conducted paralleling Line 1 but positioned along the sound barrier [See Figure 3].

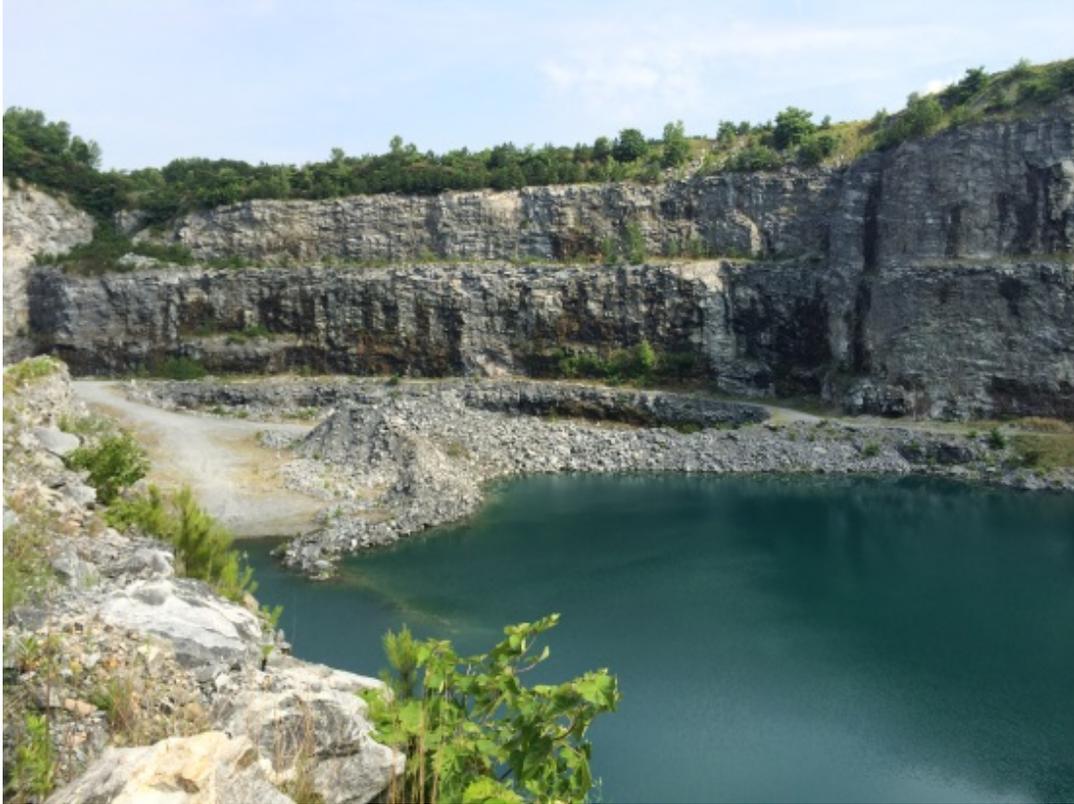
Figure 1. Bellwood Quarry prior to construction.

Using the Quarry (Figure 1) as a water storage facility greatly enhances the reliability and security of the drinking water supply to the greater Atlanta metropolitan area. For many years it was used for mining granitic gneiss and crushed-stone aggregate production. The Quarry has nearly vertical sides and ground elevations around the rim ranging from approximately 850 feet to 970 feet above mean sea level based on the NAVD 88 vertical datum. Quarry floor elevations range from about 520 feet to 540 feet. The proposed full pool level for raw water storage is at an elevation of 840 feet.

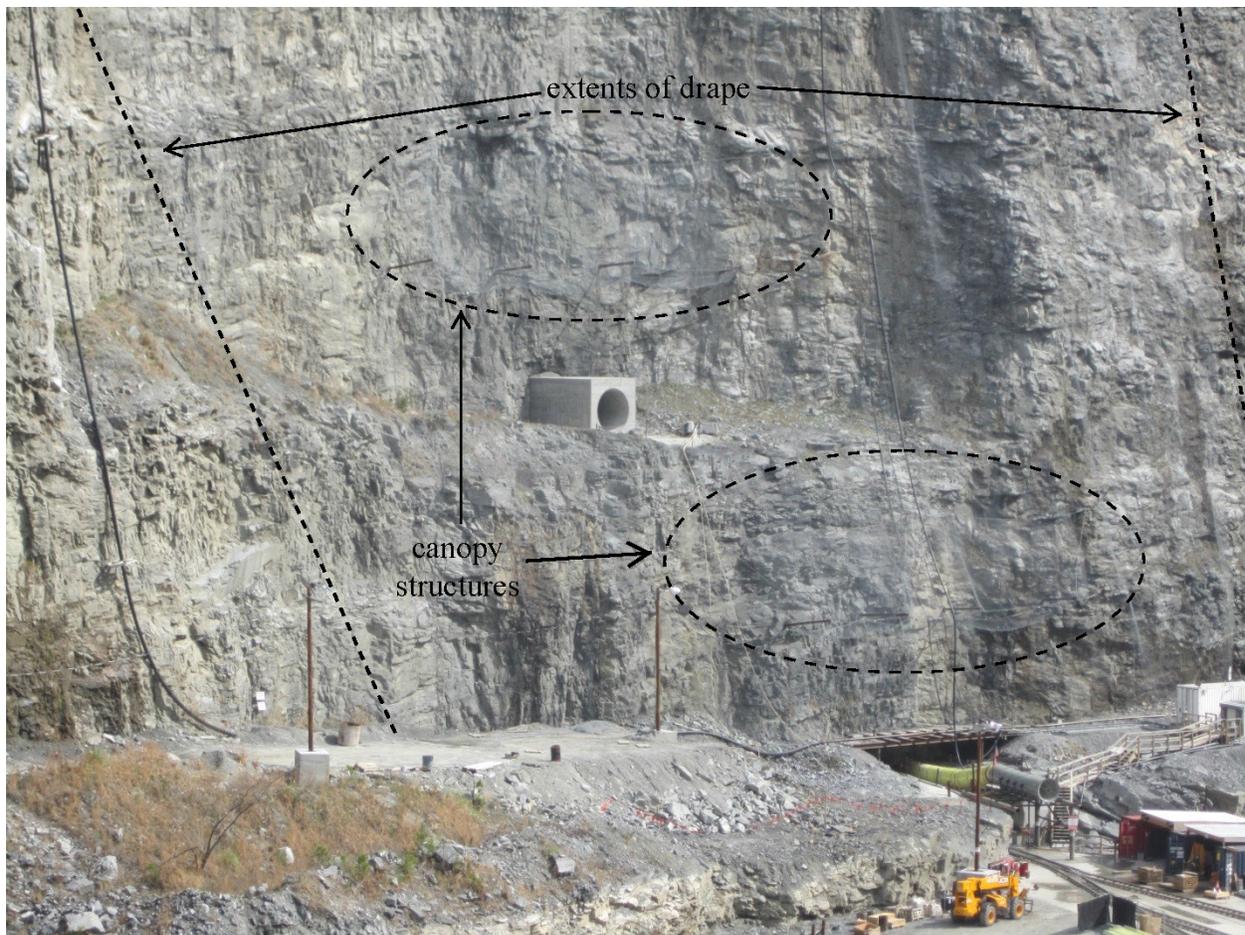
Figure 6. General area of tunnel portal stabilization area and the two canopies.

To secure the approximate 300-foot-tall rock face above the tunnel portal at the base of the quarry, a designed stabilization system was included in the contract documents. The system covers the full depth of the quarry over a width of approximately 400 foot centered over the TBM tunnel portal. The general area of stabilization is shown in Figure 6.

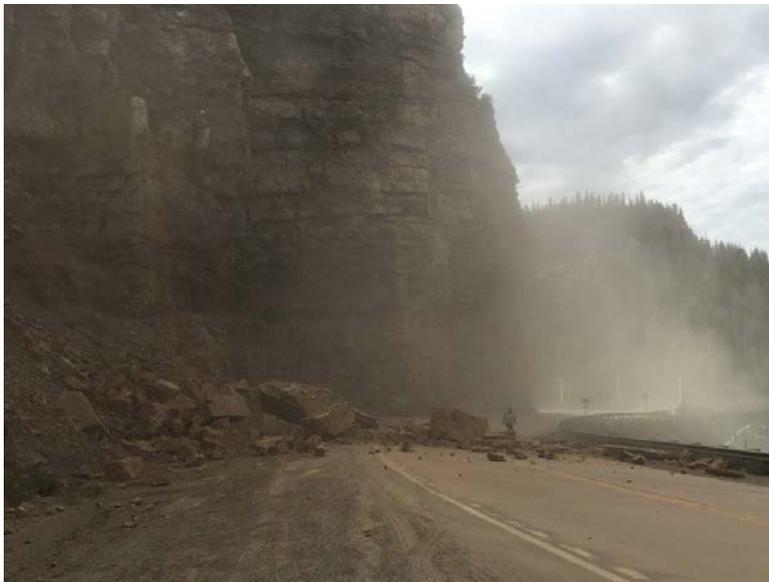
Figure 5. Rock Slope Risk Exposure Reduction on US 24 near Minturn, Colorado.

planned removal project for a relatively direct low cost. A photograph of the site immediately following the slope hazard reduction work is presented in Figure 5 and illustrates the potential threat to safety, mobility, and condition of the system (the “maintenance” goal). By proactively performing this work, CDOT was able to control the safety threat at the site while also minimizing the consequences to mobility and department maintenance expenses. When the cost of the mitigation is compared with the reductions in risk exposure in terms of safety, mobility, and department maintenance expenses, actions like this can demonstrate a favorable benefit:cost ratio. In other words, and using the risk cube for visualization, the action, timed as it was, mitigated risk in the three elements that are the intersection of the geohazards on slopes (Slope (GH)) plane and the physical failure plane, which is the risk source here.

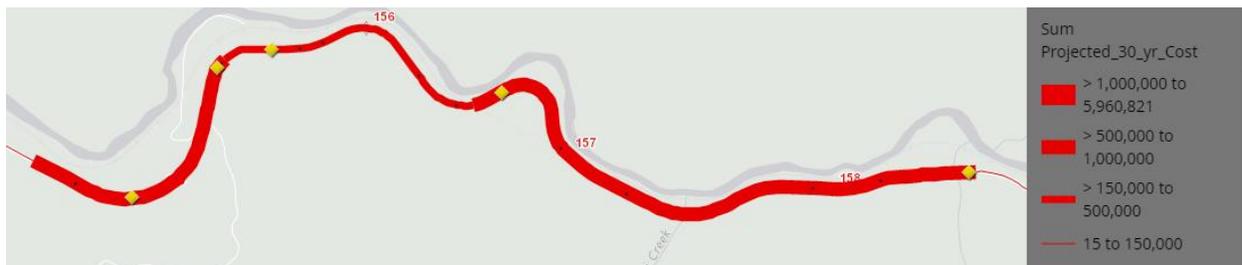
Figure 6: Example Risk Analysis Result on Highway 2 near West Glacier, Montana

Multiplying the annual likelihoods (slope condition likelihood factor x estimated area of face) by the consequence of a road closing event (temporary road closures, accidents, slowdowns, and detours) provides a total annual risk cost in US Dollars. The risks can then be grouped by corridor, road segment, or evaluated on a site-by-site basis. GIS techniques facilitate the analyses, as shown by Figure 6.

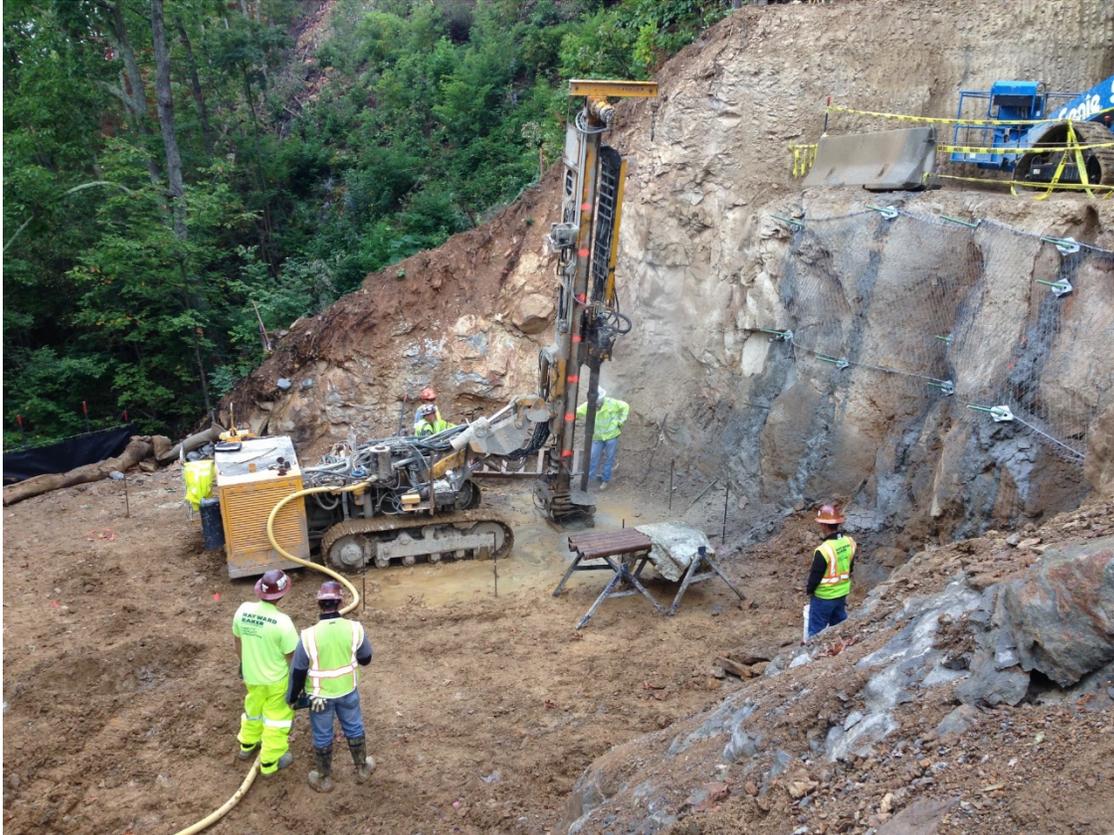
Figure 6 – Bridge Abutment Micropile Installation

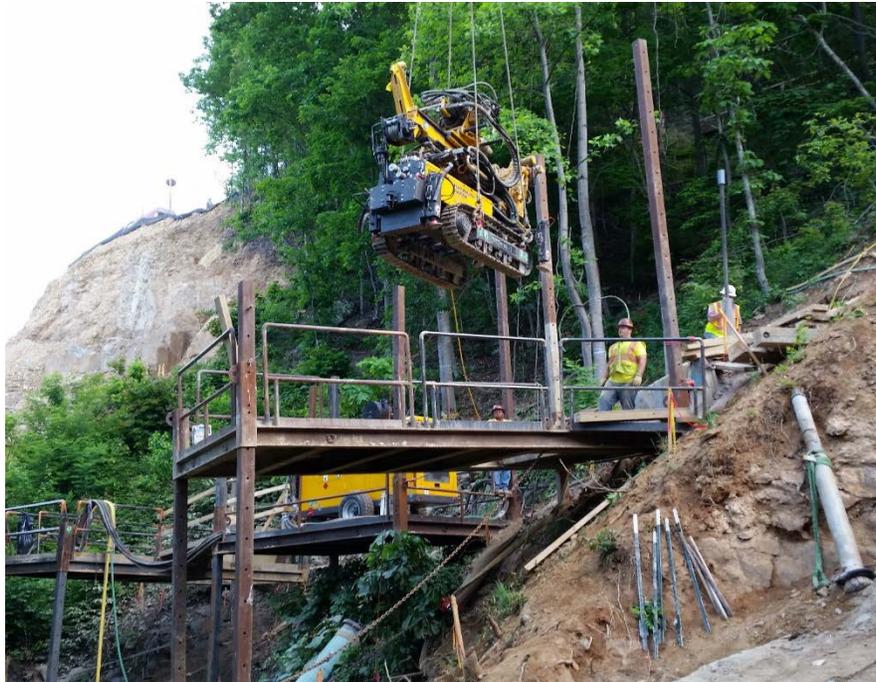
Figure 7 – Setting Drilling Rig on Temporary Platform

To accomplish this, temporary drilling platforms were set at each foundation location. A mini-drill rig was then lifted to each platform, to drill the 4 micropiles per foundation. Figure 7 shows setting a drilling rig on a platform. After completion of the micropiles, cast-in-place concrete pile caps were constructed, followed by the falsework columns and beams. Figure 8 shows completed falsework in place. Once the superstructure was complete, all falsework was removed.
