68TH HIGHWAY GEOLOGY SYMPOSIUM MAY 1-4, 2017

2017 Proceedings

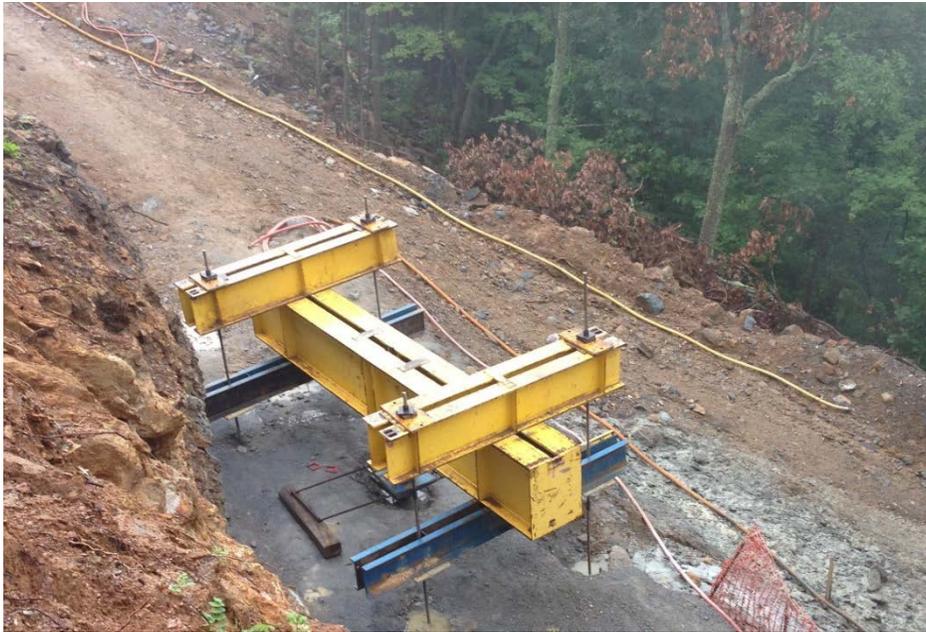
As described above, load testing was conducted to confirm the design bond stress. Load test procedures were the same as those for other deep foundation types. For the Parkway, compression verification testing, in accordance with ASTM D1143, was conducted on pre-production, sacrificial micropiles at each bridge. Figure 9 shows a verification load test setup at a bridge abutment. Four reaction micropiles were used to resist the compression load. The verification test load was typically about 400 kips.

Figure 9 – Compression Load Test Setup

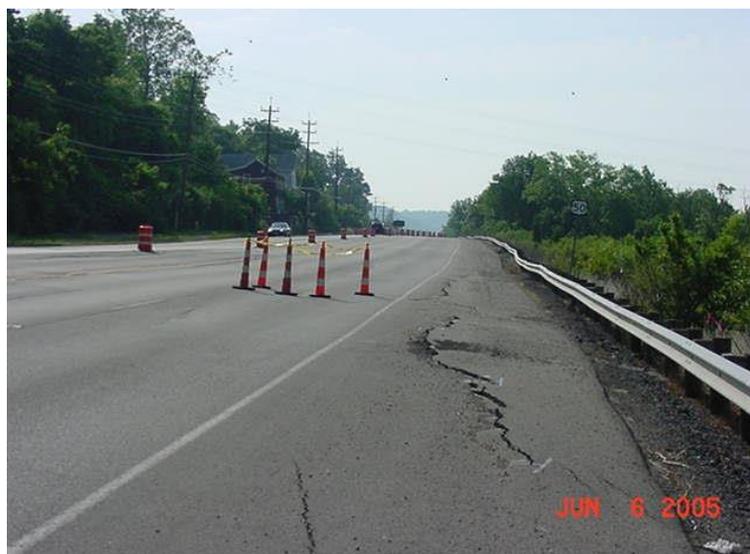
Figure 1 - Roadway failure in 2005.

The landslide displayed deep-seated movement extending down to the top of bedrock that lay about 40 to 50 feet below present grade.

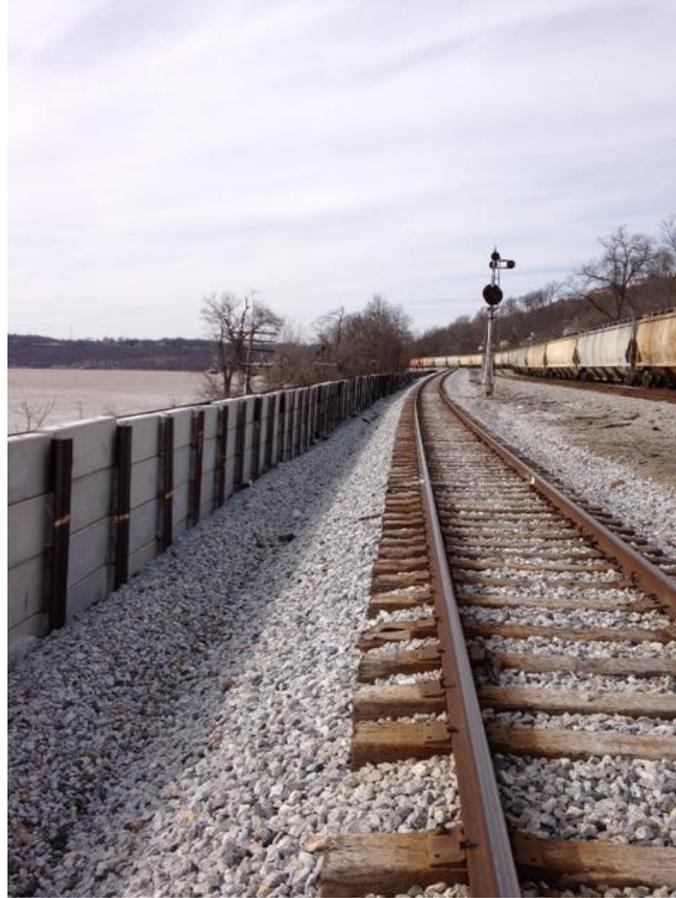
Figure 5 – Soldier pile wall installed downslope of the railroad.

3. Movement continues downslope of the stub piers. Eleven years after construction, inclinometer measurements at two locations just downslope of the stub piers indicated about 1.5 to 2 inches of creep movement has continued downslope and away from the stub piers. Those movements have possibly worsened in recent years, as evidenced by a new soldier pile wall that was installed by the CSX railroad, just downslope of existing railroad lines and about 80 to 100 feet down slope of the stub piers. The writers have not been successful in gathering background information on that soldier pile wall (see Figure 5).

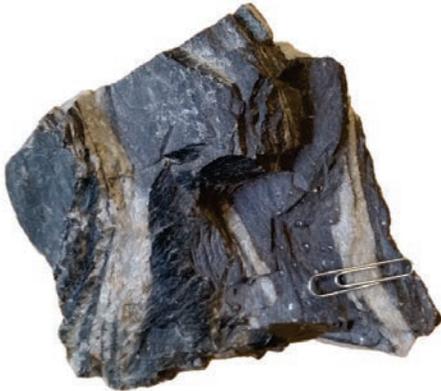
Rock Unit 2A- Brevard Zone Black Mylonite- The BZ black mylonites (Figure 4) is generally composed of biotite, quartz, and feldspar. This unit is typically extremely fine-grained and weakly foliated. Where the foliation is better developed, the rock is shown to be very contorted. In most outcrops, the black mylonite is dark-gray to black and locally contains thin

Figure 4. Brevard Zone black mylonite.

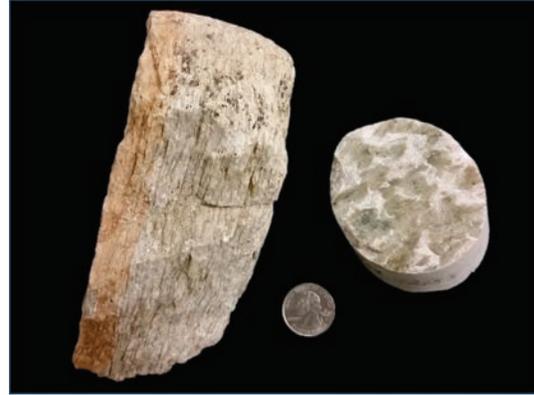
Rock Unit 2B- Brevard Zone White Mylonite- The BZ white mylonite is interpreted to be sheared granite, Figure 5. This mylonitized granite is composed of muscovite, quartz, and

Figure 5. Characteristic Brevard Zone white mylonite.

feldspar; much of the feldspar is pink and coarse-grained. Shearing was pervasive and produced a well-developed shear foliation. Reduction in grain size was not as extreme as in Rock Unit 2A. Weathering of this unit generally yields a white to tan, uniform fine clayey residuum.

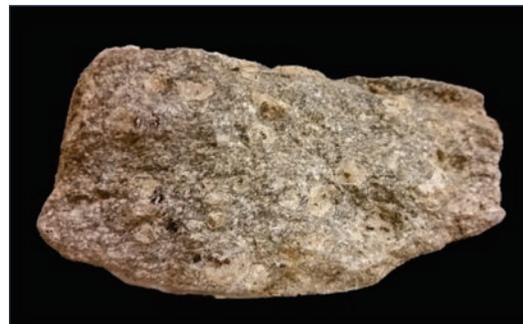
Rock Unit 3- Zoned Feldspar Gneiss- The zoned feldspar gneiss consists of an epidote-muscovite-biotite-quartz-feldspar gneiss, fine- to medium-grained, with disseminated very coarse zoned feldspar crystals, Figure 6. Rock Unit 3 is massive and uniform, generally with moderate to deep weathering. Along shear zones and joints, weathering proceeds to greater depth.

Figure 6. Zoned feldspar gneiss.

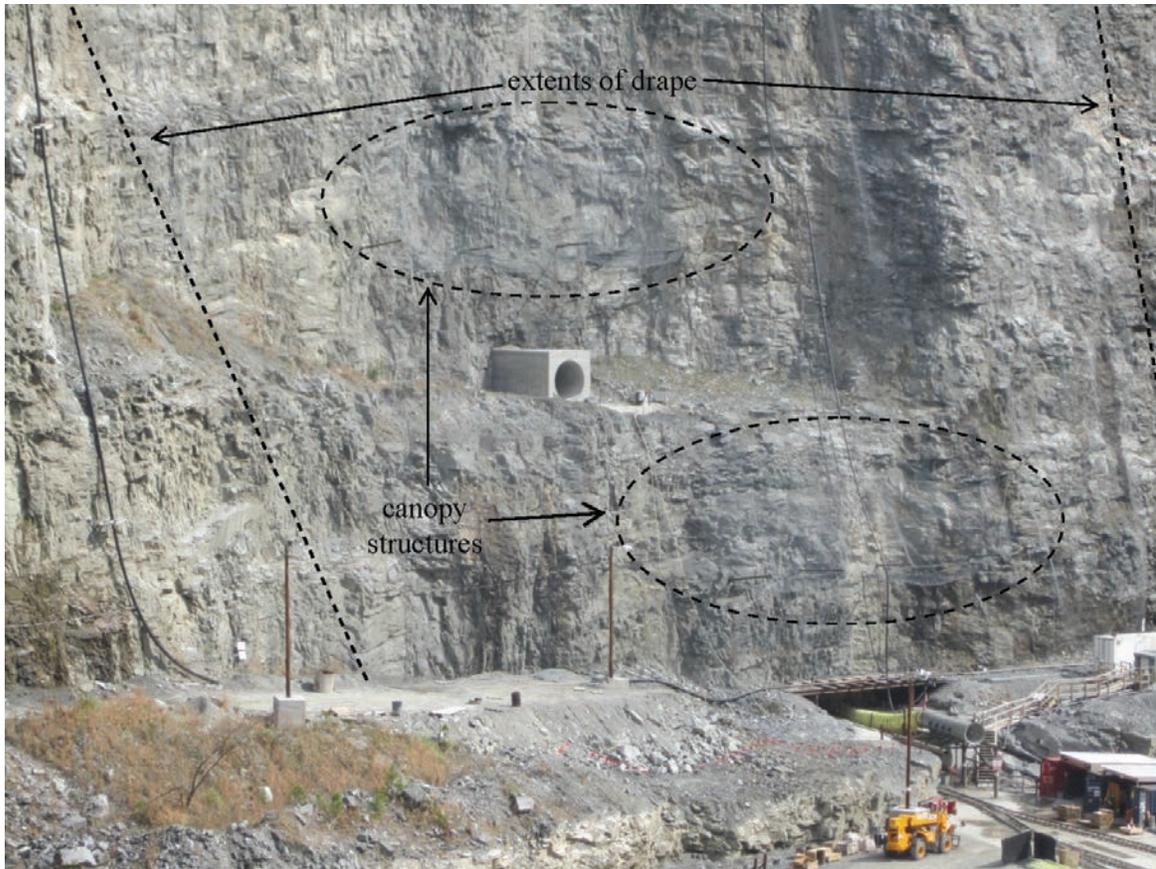
The stabilization system consists of TECCO 3 mm mesh from Geobrugg and rock dowels in the locations that are identified as locations of potential rock wedge failures. Canopies were installed as additional protection to workers at the two portals in the quarry as shown on Figure 5. The canopies are designed to catch any rocks that may come loose and fall behind the drape above the portals. At the portals for both the tunnel and 636’ adit, 20 foot long spiles are installed along the crown to stabilize more fractured ground.

Figure 5. General area of tunnel portal stabilization area and the two canopies.

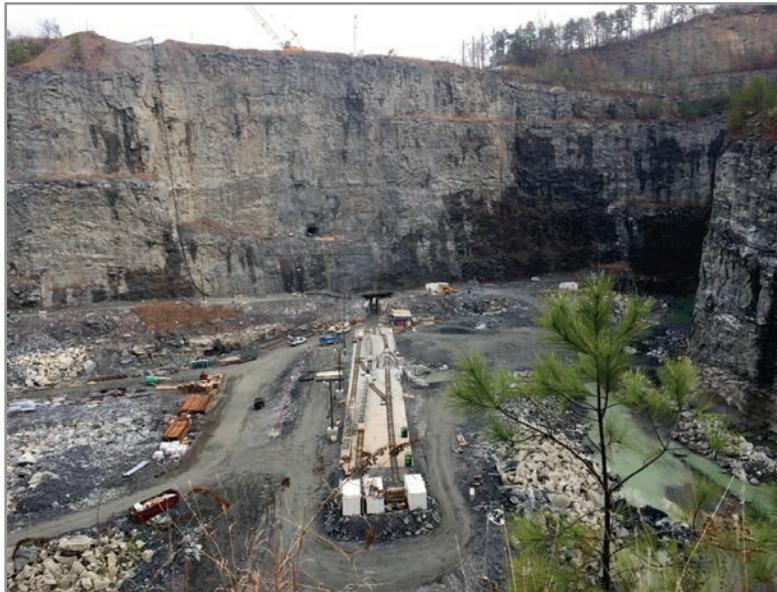
Figure 1. Northerly view of quarry highwall, tunnel and adit (on bench).

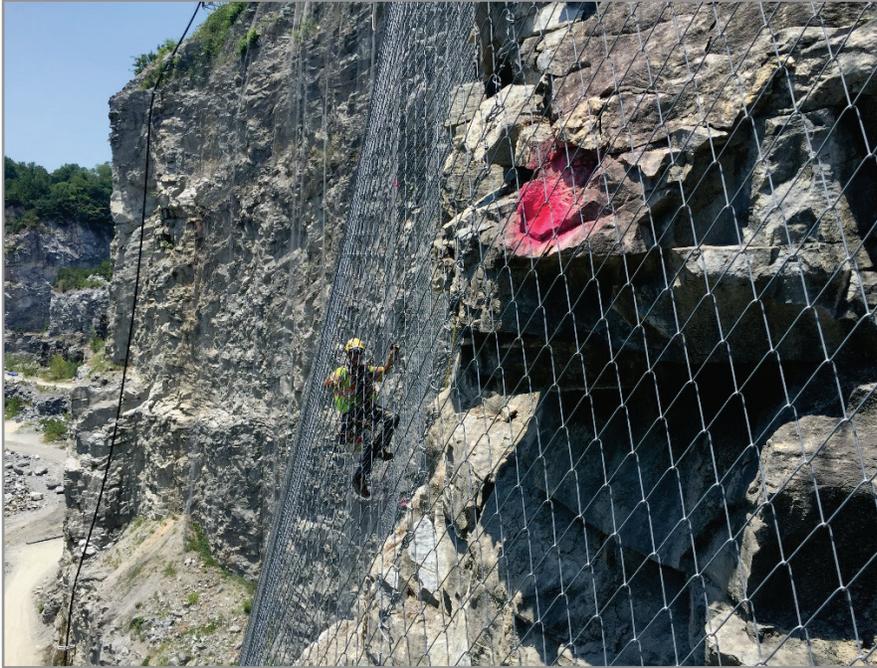
Passive rock dowels were chosen to reinforce potentially unstable rock blocks above both canopy systems due to their relative speed and ease of installation; however, to stiffen up the rock mass and pin down suspect key blocks without the benefit of tensioning requires that additional steel be installed. As such, the initial phase of rock reinforcement called for installation of 74 rock dowels that were marked-out in the field (Figure 3) and submitted to the Owner on plan sheets with calculations.

Figure 3. Rock dowel layout with paint using rope access.

Rock dowels were comprised of 1-1/4-in. dia. grade 75 epoxy coated bars fabricated by Williams Form Engineering. Minimum embedment depths by location were provided to rock remediation technicians from Apex, who then drilled and installed the dowel bars using wagon drills. In two instances, temporary wire rope cable lashing was required as a precaution to stabilize rock blocks prior to drilling. Rock dowel lengths generally ranged from 10 to 20-ft. in total embedment length.

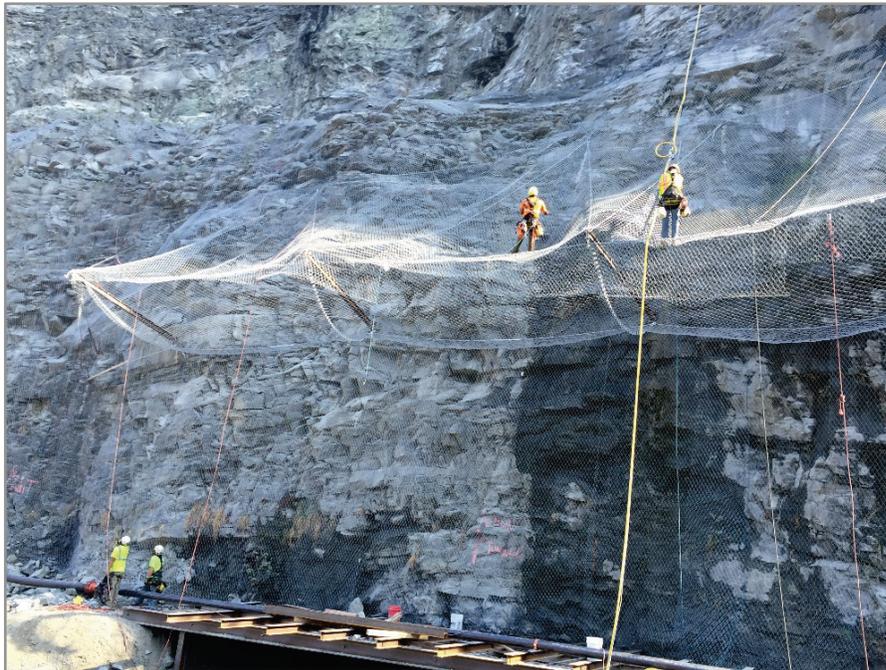
Figure 5. Canopy construction and drape tie-in.

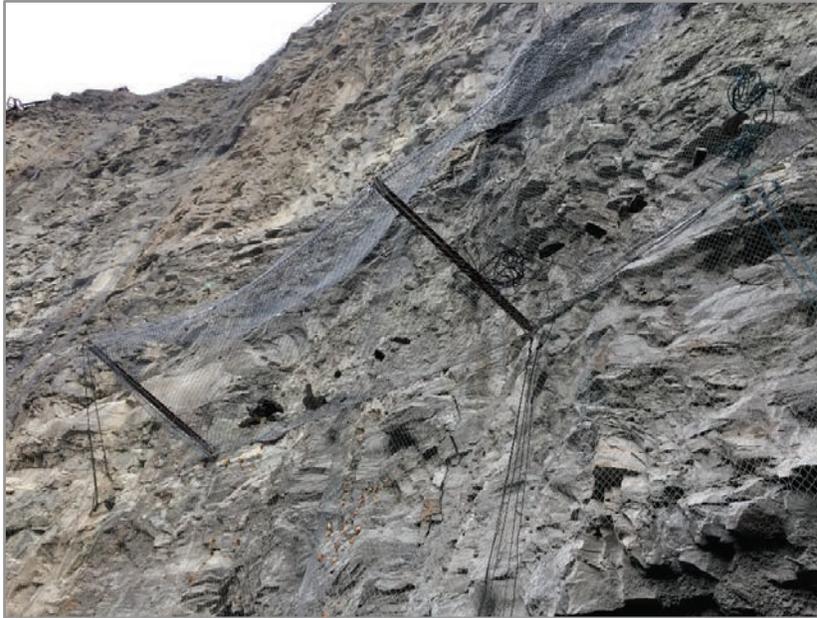
Figure 6. Adit canopy rock debris subject to maintenance cleaning.

Although most surface and underground blasting is now complete, additional destabilizing forces from construction vibrations (e.g., TBM advancement), surface water and fracture-controlled drainage, and bedrock weathering may result in periodic rockfall at the site, all of which underscores the importance of this temporary rockfall mitigation system. To-date, the system has performed as intended and will be maintained as necessary to mitigate both

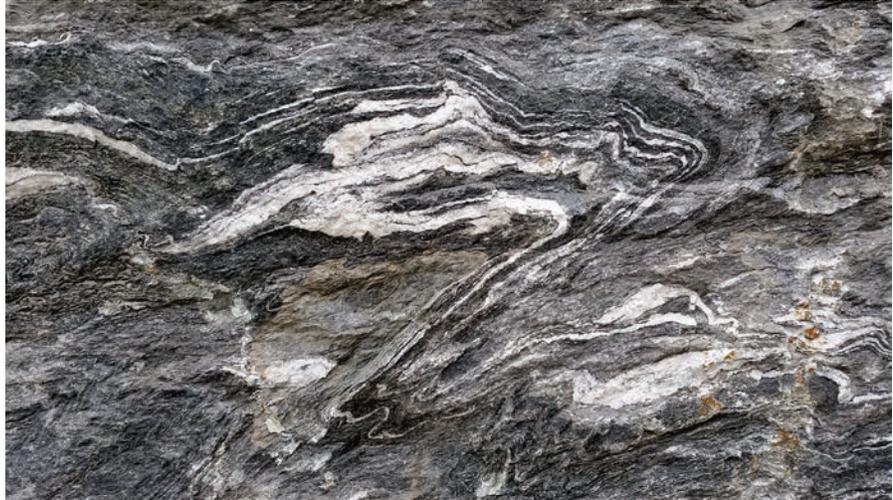
Figure 2. Ptygmatic-style folding in the Clairmont Mélange. Lithologies in the photograph include biotite-schist, migmatitic gneiss, and light-gray, equigranular gneiss.

Based on detailed geologic mapping, the only consistent part of the Clairmont is its inconsistency. This unit is highly contorted into ptygmatic-style folds, Figure 2. In the quarry, there are several lithologies exposed that are characteristic of the Clairmont. The majority of the Clairmont consists of an epidote-muscovite-biotite-quartz-feldspar gneiss, fine- to medium-grained, schistose in part. This gneiss can be either light- or dark-gray depending on the biotite concentration. Overall, the gneiss is equigranular and weakly foliated (granofelsic). Interlayered with the gneiss is an epidote-muscovite-quartz-feldspar-biotite schist, medium- to coarse-grained; garnets may be present, but are small and scarce, and well-banded migmatitic gneiss. Hornblende gneiss/amphibolite lenses and layers (commonly boudinaged) are locally present. In many places, lenses and discontinuous layers of unfoliated granite on a scale of 1ft to 20ft are intruded parallel to the low-angle foliation. Concordant and discordant quartz veins are common. Pegmatitic layers and coarse pegmatites up to 5ft thick are abundant and characteristic; shear foliation in the gneiss/schist wraps around the coarse pegmatites and small bodies of granite, which are generally not sheared.

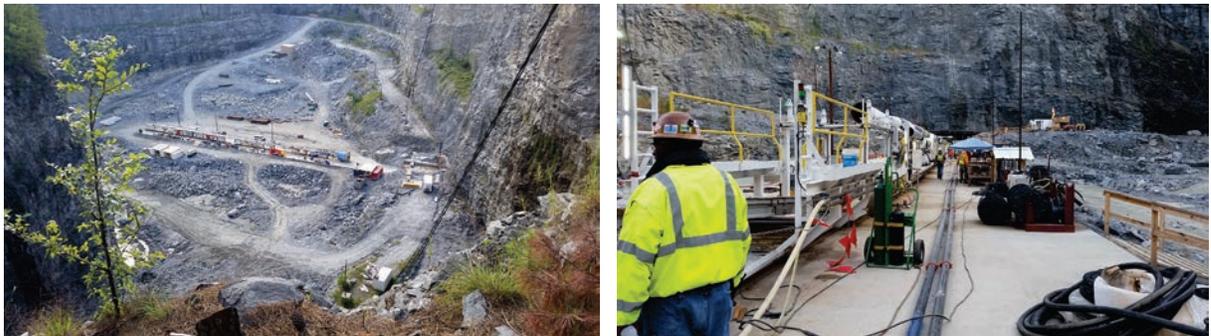
Figure 3. Driller Mike (Tunnel Boring Machine) being assembled at the bottom of Bellwood Quarry.

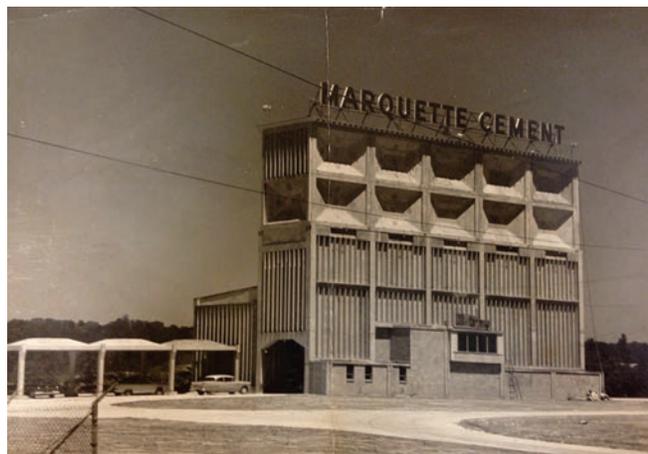
Figure 4. Marquette Cement (aka Buzzi Unicem USA) historic photograph. Note upper panels

A little bit of the history of the cement distribution terminal. It was built for Marquette Cement in 1962-1963 and was originally fed by rail cars from the Marquette Plant near Rockmart, GA. The closed plant in Rockmart is currently used as a cement distribution terminal by Cemex. The terminal at the time was unlike anything in existence and Marquette Cement presented the challenge to Dr. D. A. Polychrome of Atlanta a Professor of Structural Design at Georgia Tech. The walls are constructed of double-tee panels and the upper domed panels (Figure 4) were constructed on site and are designed to high lateral pressure. The facility has the ability to store 1,200

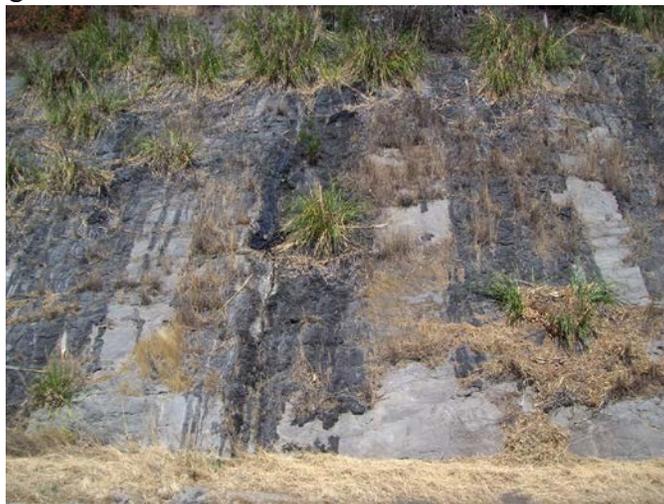
Figure 2. Bituminous Sandstone with Active Tar Seeps

The Edna Member of the Pismo Formation is exposed in road cuts along the Phase 2 alignment. Hall (1973) described the Edna Member in the site vicinity with the following subunits: Tmpe, Tmpe2, Tmpe3 and Tmpec. Tmpe is bituminous sandstone that includes active tar seeps (Figure 2). Tmpe2 and Tmpe3 are non-bituminous sandstone subunits composed mostly of fine and coarse sand, respectively, with varying degrees of cementation, and Tmpec is described by Hall (1973) as a pebbly conglomerate unit.

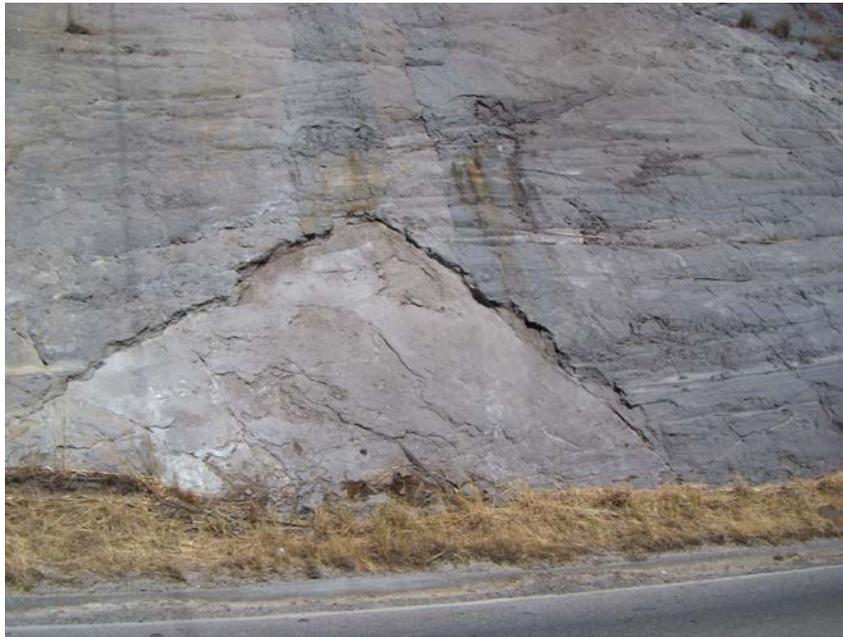
Figure 4. Typical Surficial Failure on Bituminous Sandstone Slopes. Depth of Failure Surface is Approximately 8 Inches Below Slope Face.

Existing slopes in the heavily bituminous unit are prone to surficial instability, particularly during periods of hot weather. This is evident from field observations, where sloughing of the heavily bituminous materials seems to be limited to zones with a thickness of about 6 to 12 inches (Figure 4).

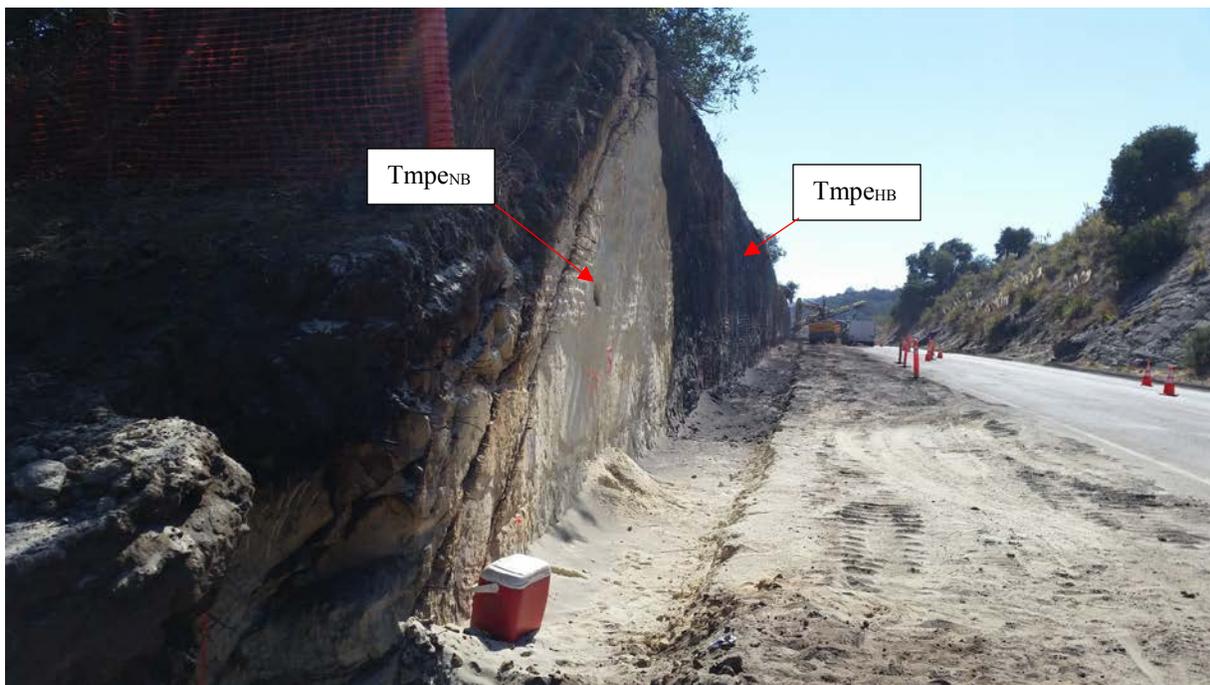
Figure 8. Excavation of The Wall Alignment (Facing South). Note Non-Bituminous Sandstone in Foreground. Heavily-Bituminous Sandstone in Background.

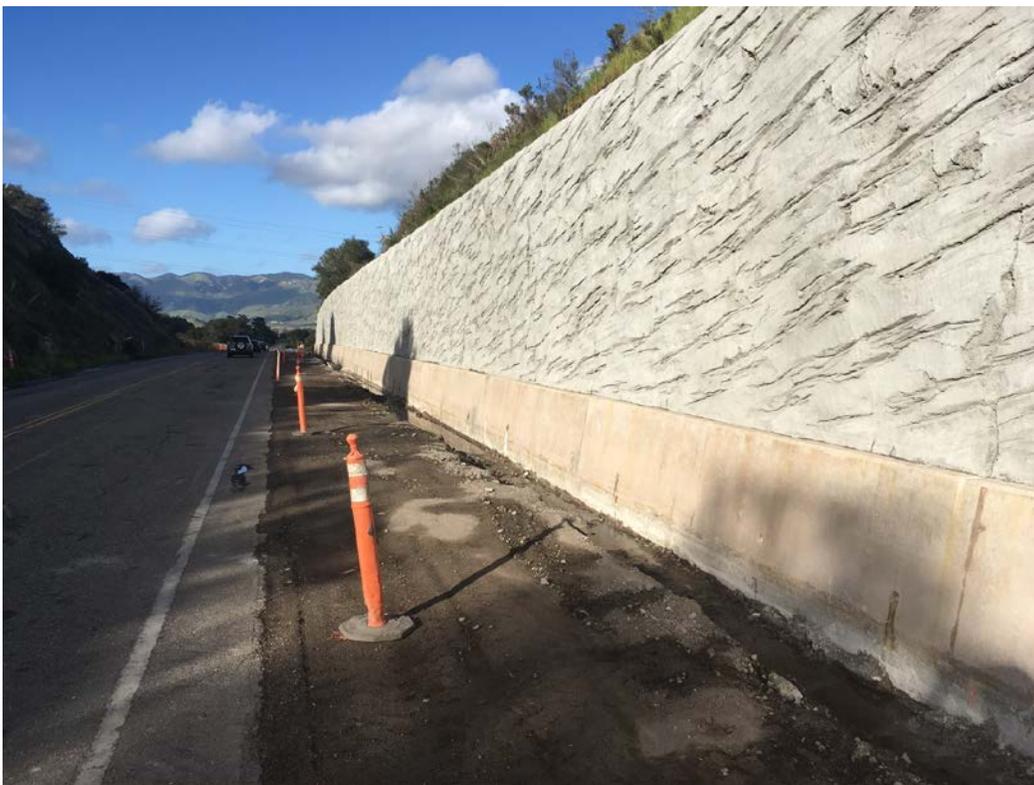
Figure 9. Constructed Rock Dowel Wall with Architectural Treatment (facing north)

In general, construction of the wall within the heavily bituminous material was successful and the bulk of construction was completed in November 2016. Whitaker added architectural treatment/facing in February 2017 and the wall has performed well through the first 6 months of service (Figure 9).
