## 71st Highway Geology Symposium

# HGS Field Trip Guide

## Asheville and the North Carolina Blue Ridge

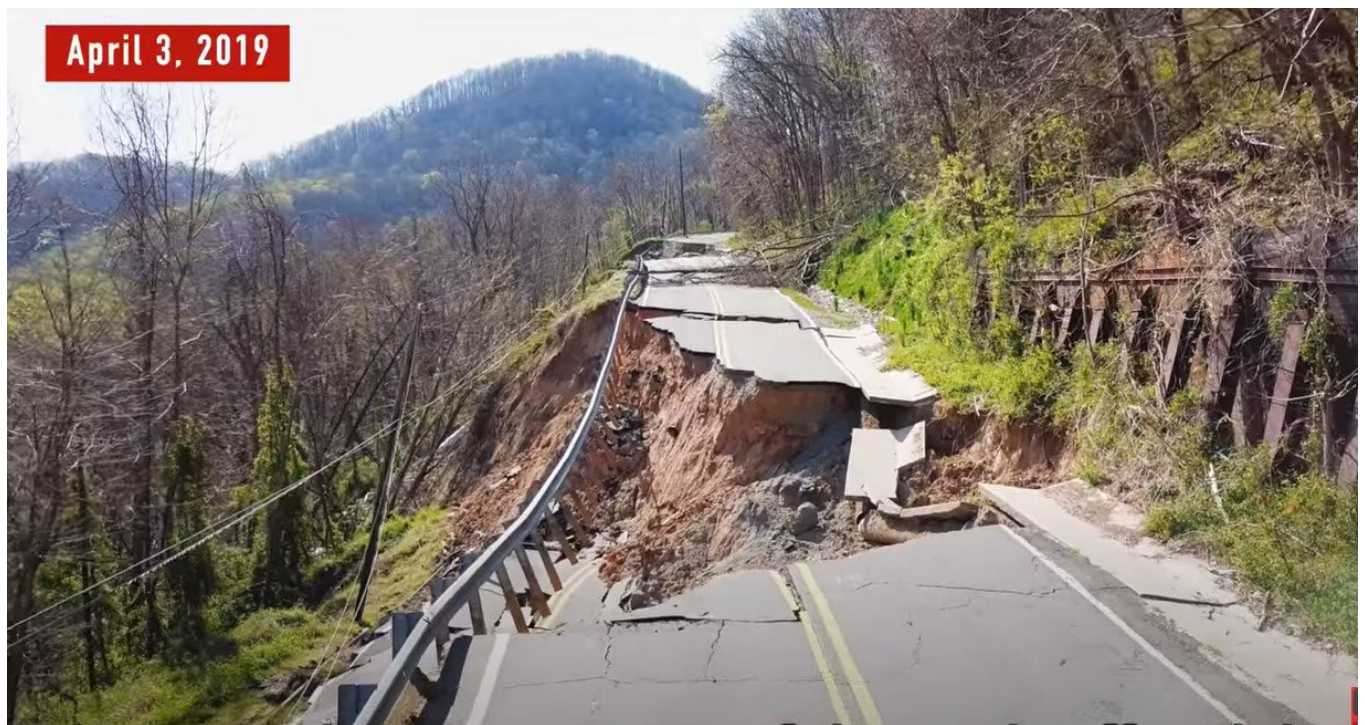
2018 resulted in overwhelming of the I-26 surface drainage system, with a river/wall of water dumped on the secondary road. The Geotechnical Unit was geared up for another round of investigation and recommendations when the largest embankment area morphed into a 15-acre big slow mover.

According to the rating algorithm in the NCDOT Geotechnical Asset Management program, the detour for this is not overly long and is the interstate. This has taken the pressure off to initiate an expensive unexpected repair; good news since this failure area has been expanding beyond what an initial investigation would have discovered!

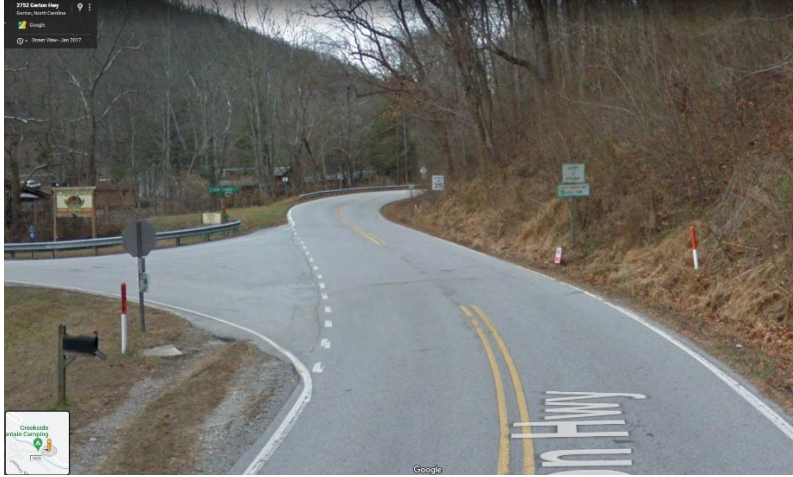
2017 Streetview showing minor ditchline creep. Generally stable for decades. After record rainfall in 2018 this developed into a slow rotational colluvial slide with continuous water and pavement uplift.

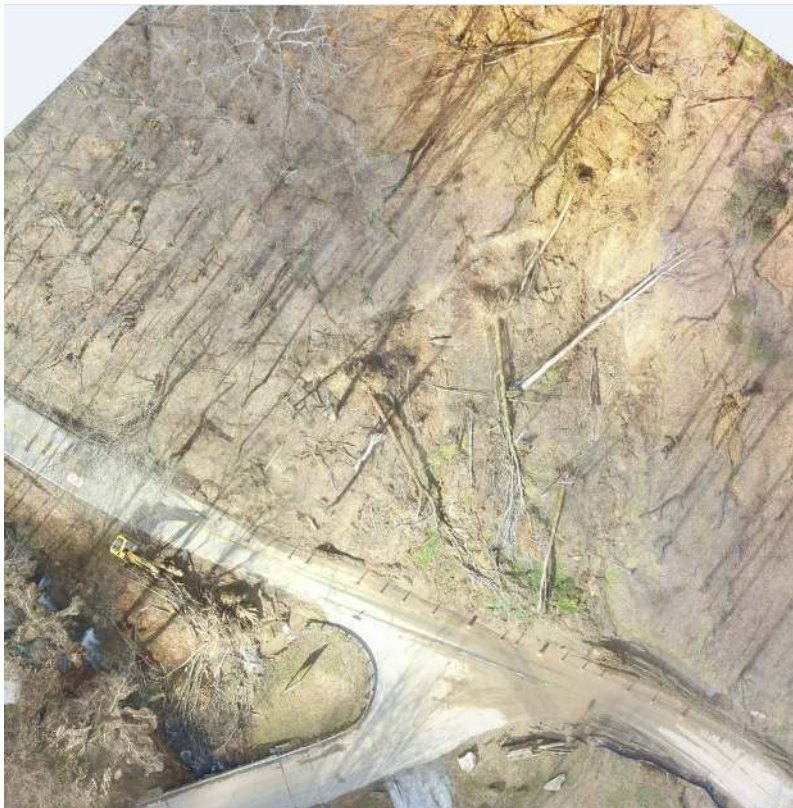
Slide mobilized and now consuming the road...Required multiple maintenance cleanups over a year.

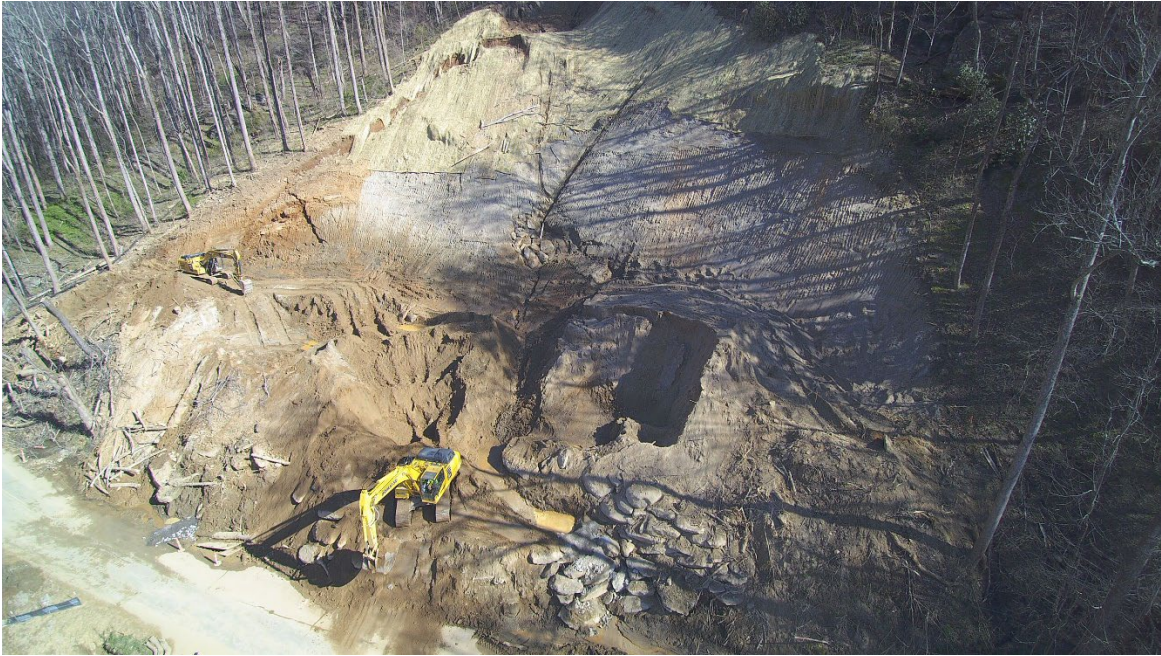
Due to the size of colluvial deposit and steepness; design decisions were rock buttress, shear key, subsurface drainage and generous catchment bench with cleanout access.

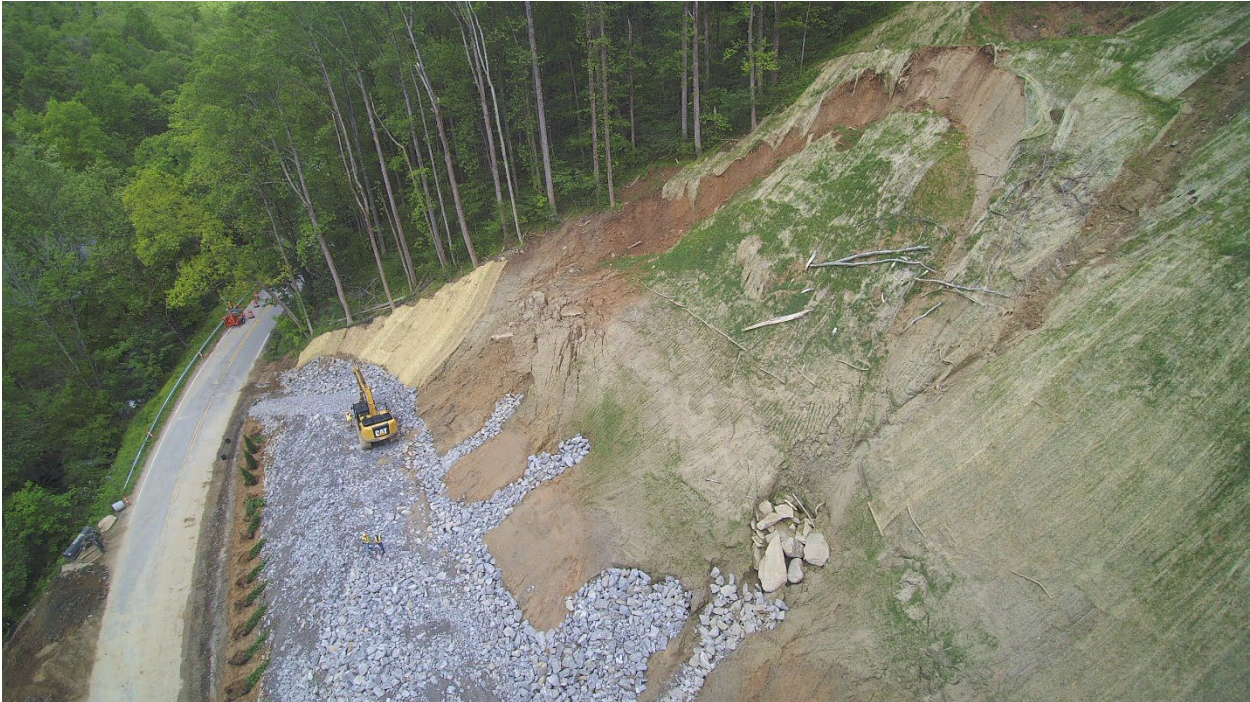
Finished product with scarps developing above.

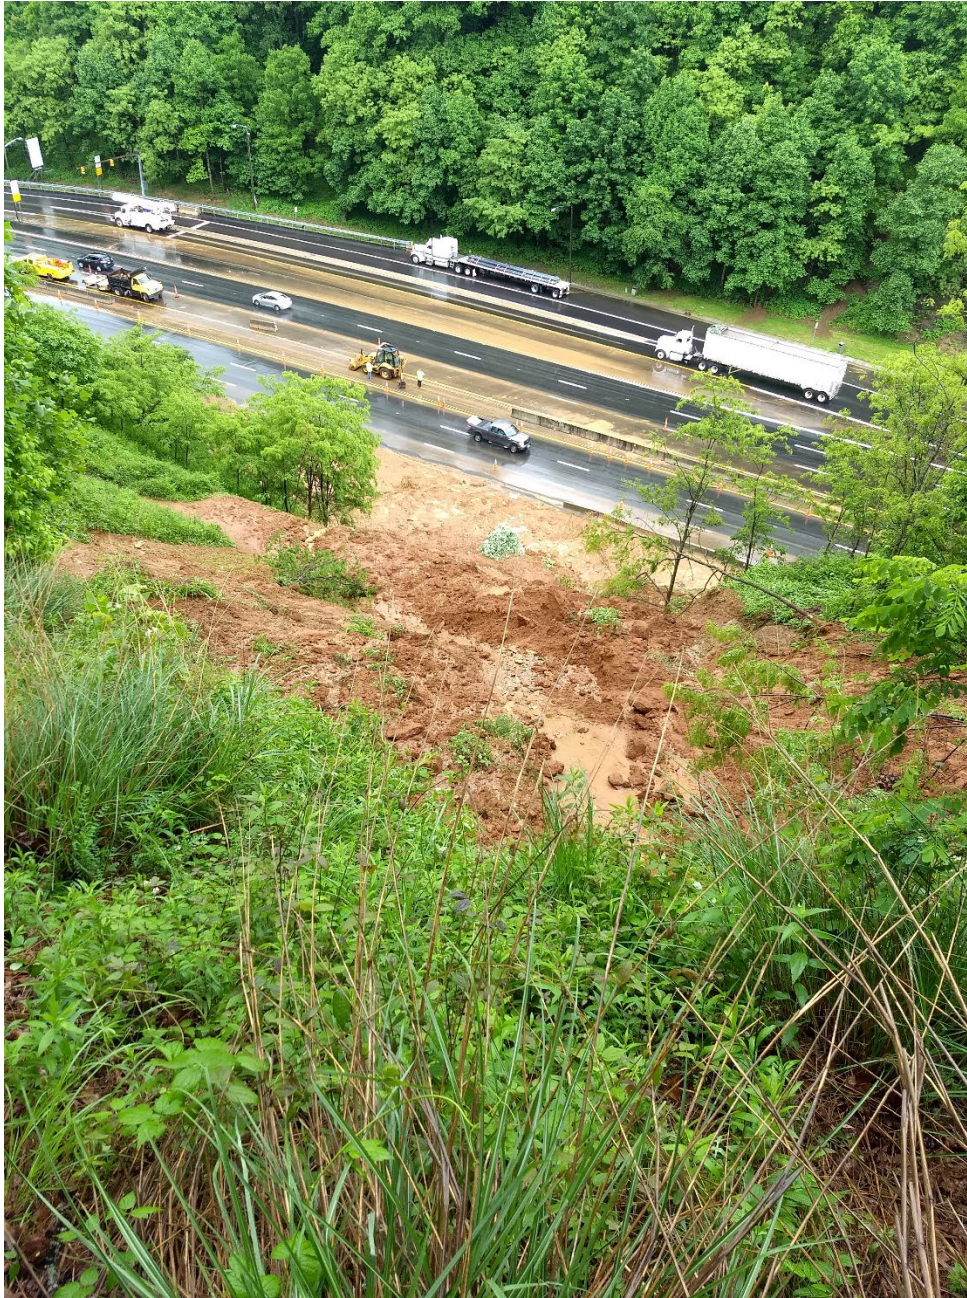
May 30, 2018. Top of current scarp. Slide blocked WB lanes and jumped barrier to EB lanes.

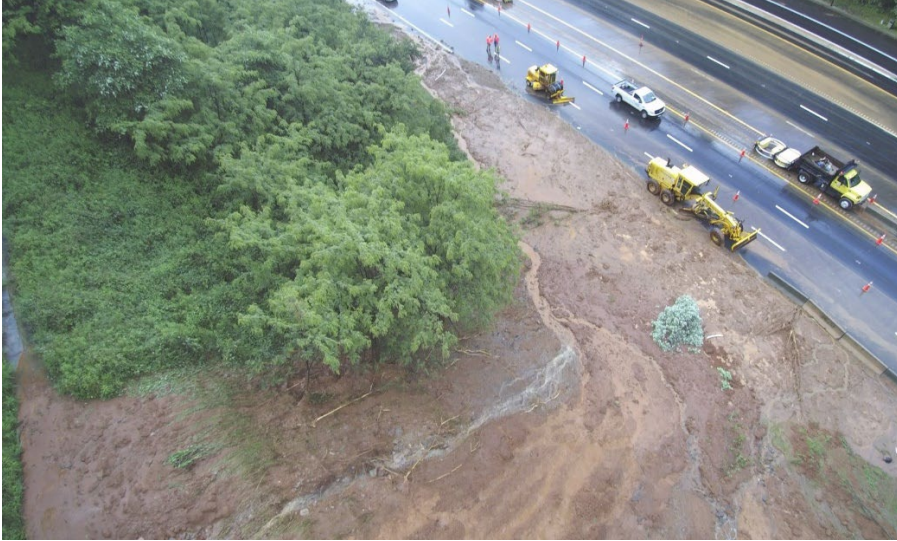
Slide runout with groundwater, mud, and weathered rock.

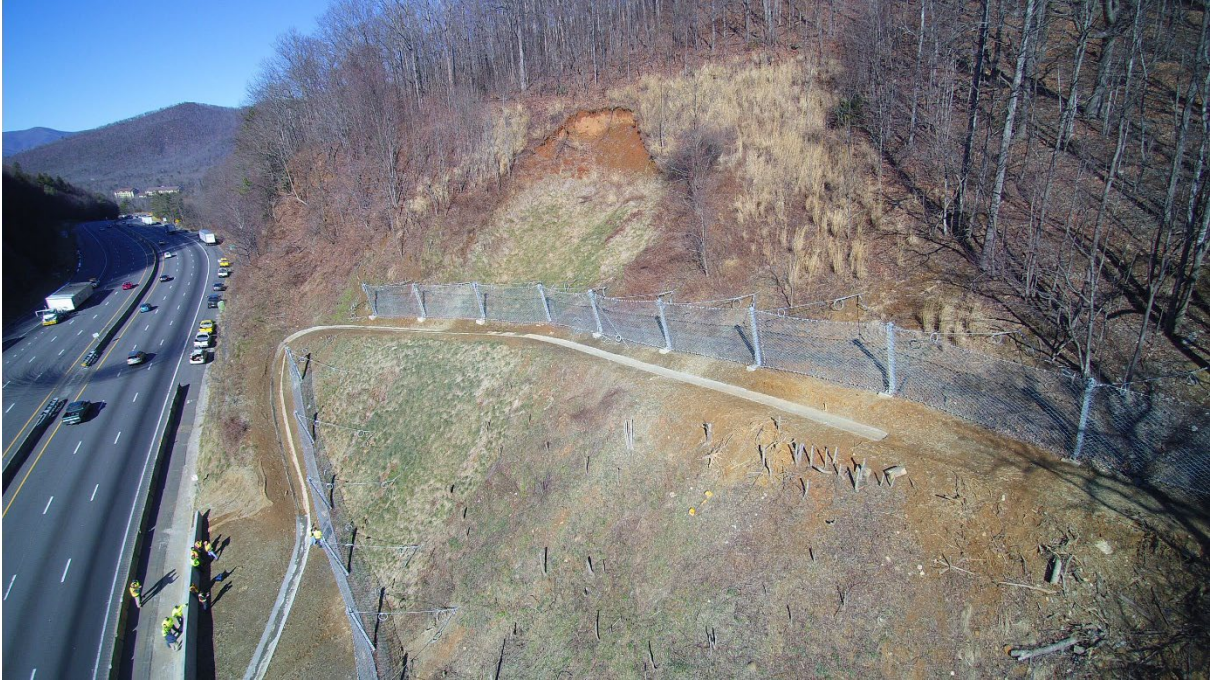
June 22, 2020. Final installation of elements

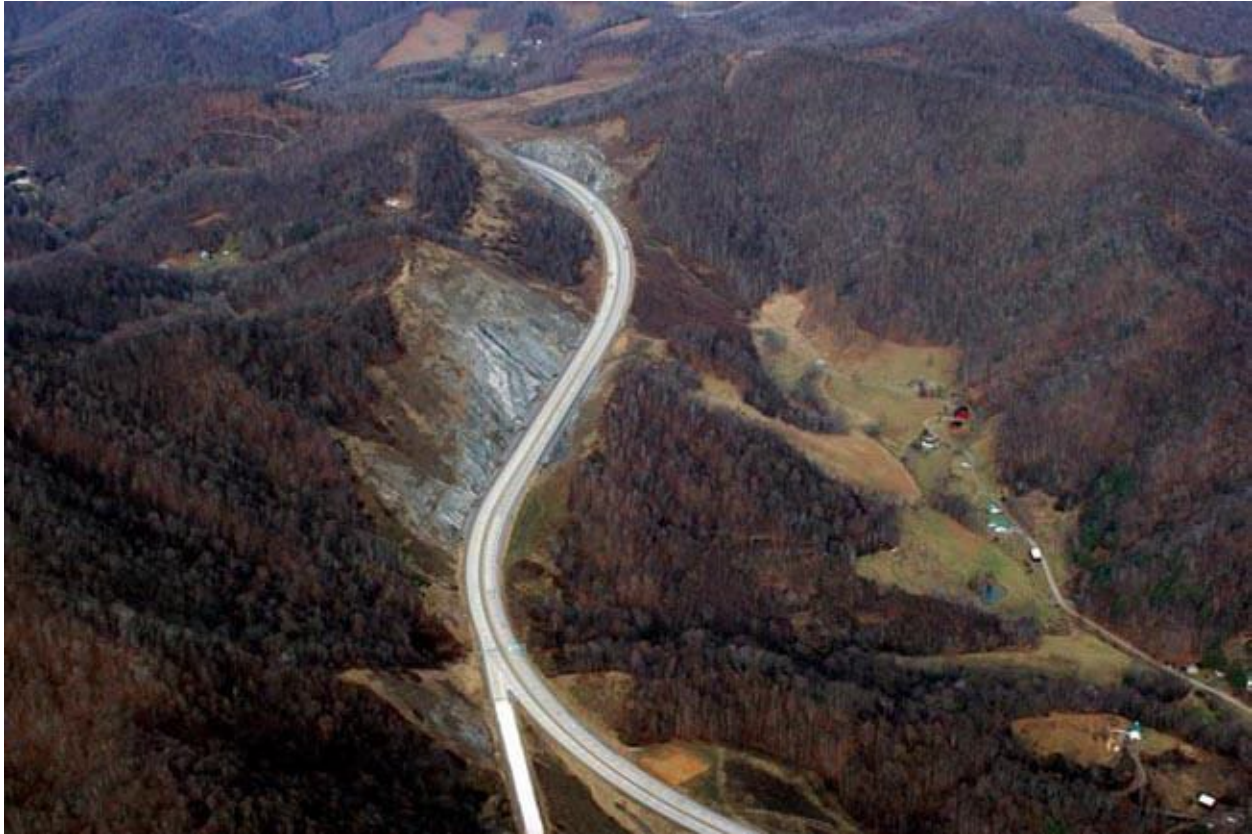
I-26 Looking West at Buckner Gap, Madison County, NC, 2008. By Rob Amberg

North of Mars Hill, NC, NCDOT constructed 10 miles of new alignment Interstate 26 as part of the Appalachian Development Highway System. At the time, 2007, this was the largest single contract and excavation project in the State highway system. The project involved 40 million cubic yards of excavation, 3 million yards of unsuitable colluvial waste, single-slope rock cuts with catchment and rockfall fence, steepened rock fills and buttresses, rock bolting, dowelling, scaling, shotcrete, and a vast horizontal drain system for embankment stability.

Rock slope design was based on oriented core drilling in 10 large cut areas, yielding 17,000 discontinuity measurements. An additional 5,000 measurements were taken from rock outcrops including persistence, water, roughness and other design stability inputs. Investigation included nearly 1,500 borings and 2 miles of refractive seismic.

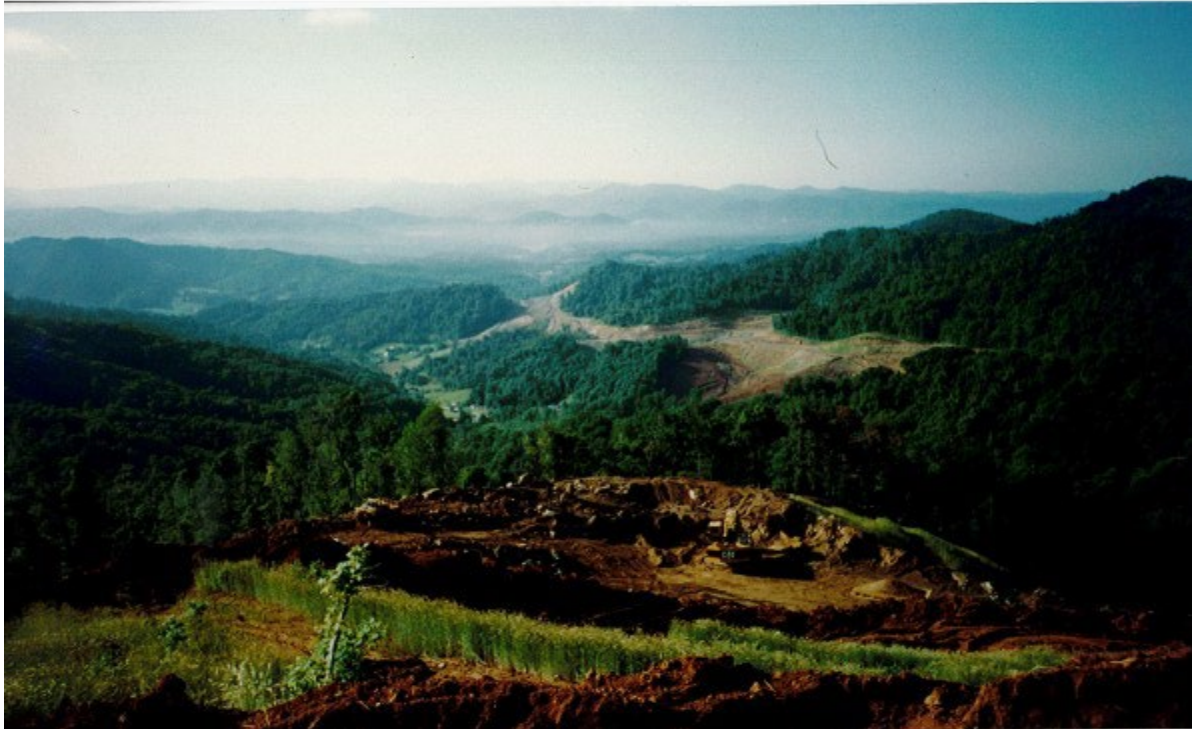
Top lift of Buckner Gap cut construction, looking South toward Asheville.

This cut section is the largest single excavation by NCDOT at nearly 4 million cubic yards. Investigation involved difficult roadbuilding access with surface mapping and multiple oriented core holes. Originally intended as a probabilistic design, ultimately deterministic was used yielding 1:1 on the west and 0.5:1 on the east. 70 tensioned rock anchors and an entire anchored shotcrete bench add stability on the east slope.

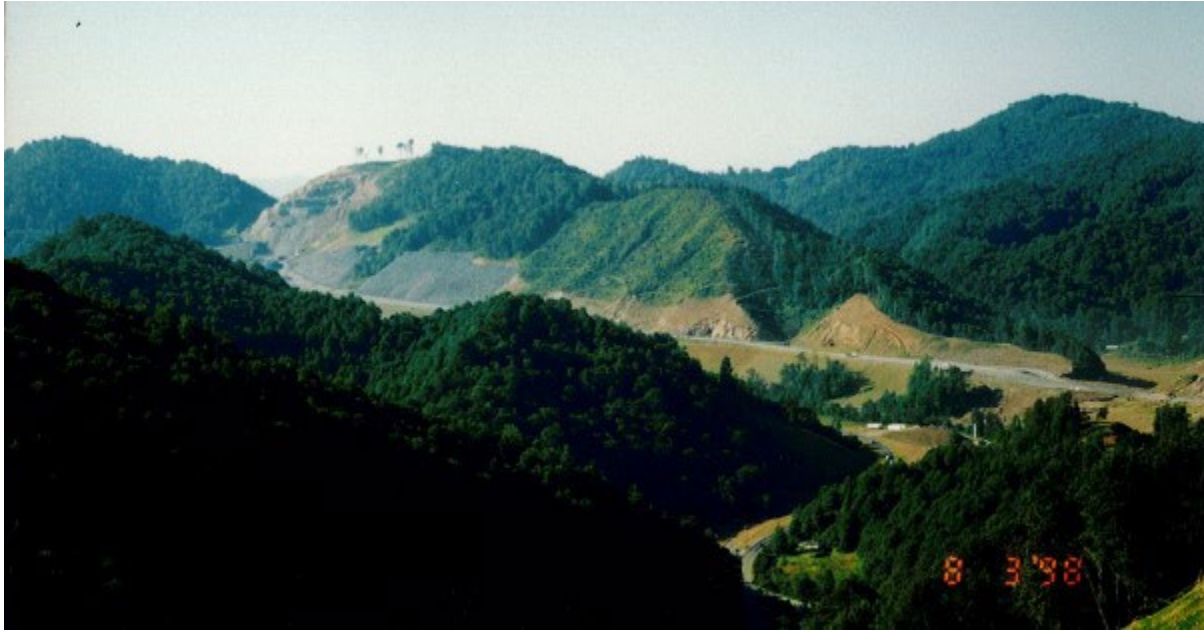
Looking toward Buckner Gap from the north. Cleared gap in distance. Large rock buttresses visible for soil slope support between rock cuts.

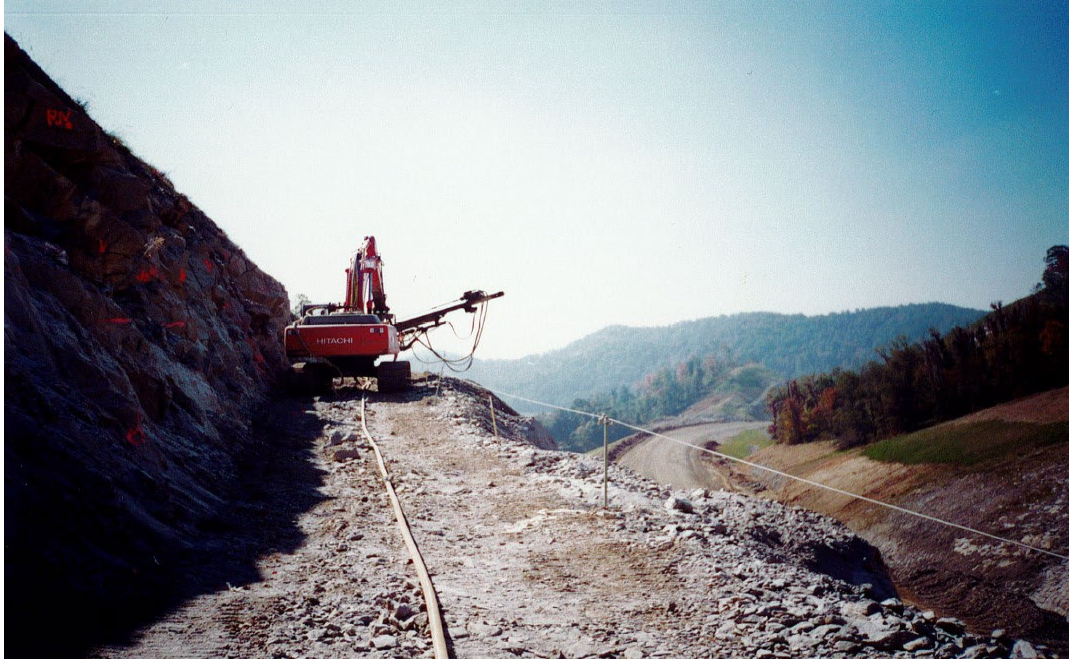
Buckner Gap, east face. Anchor and shotcrete stabilization.

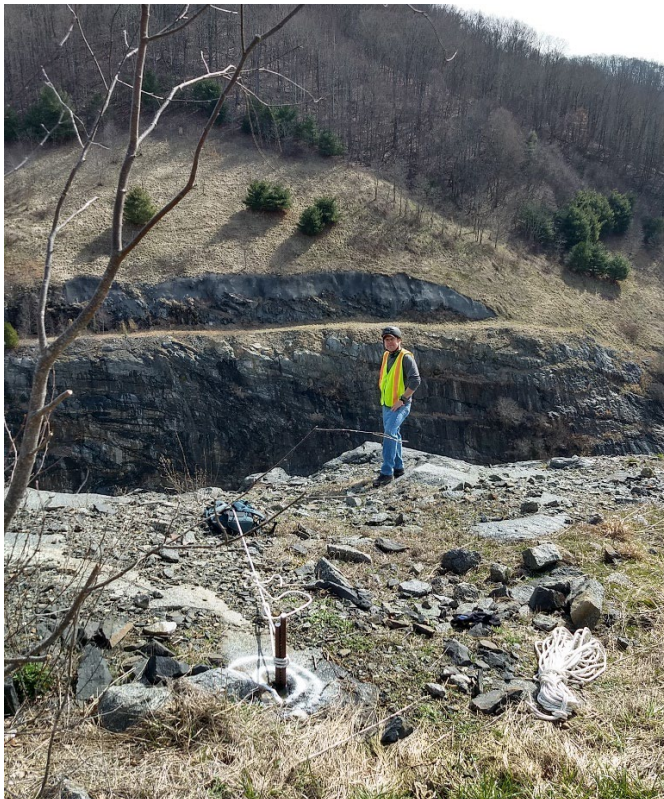
During construction holes were drilled across the benches to provide future rope access points, such as this Lidar study in 2020.

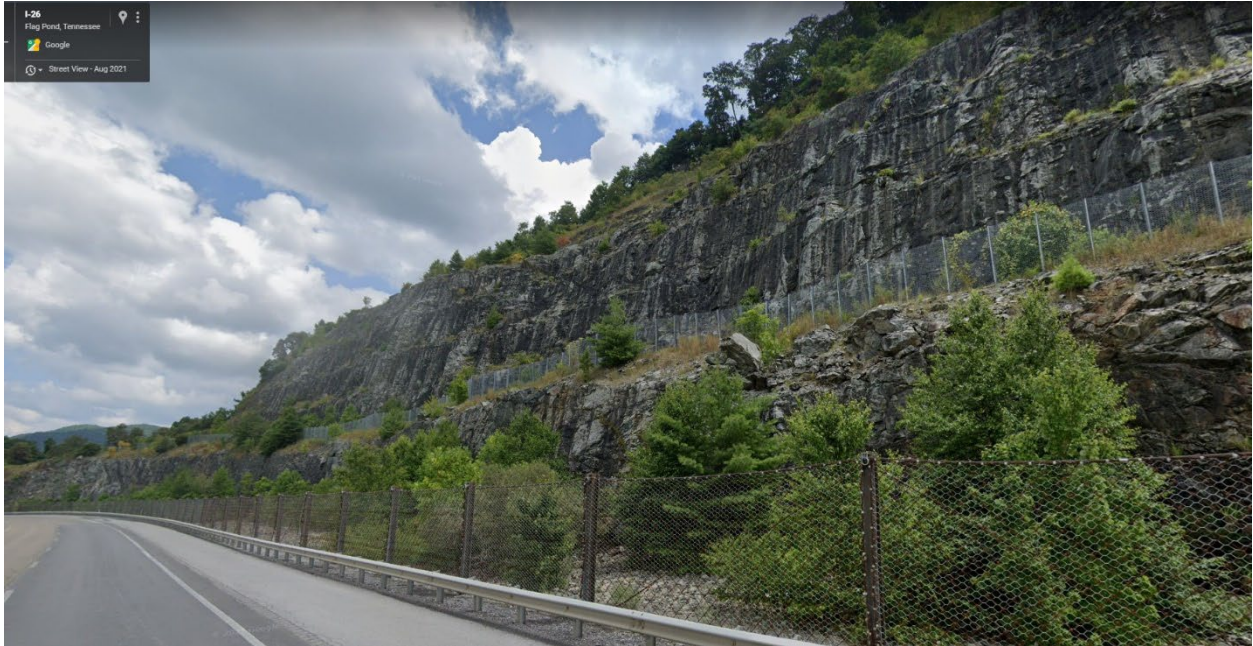
The Tennessee section of I-26 was completed 4 years before NC. Notable difference is the use of benched slopes and stacked rockfall fences.

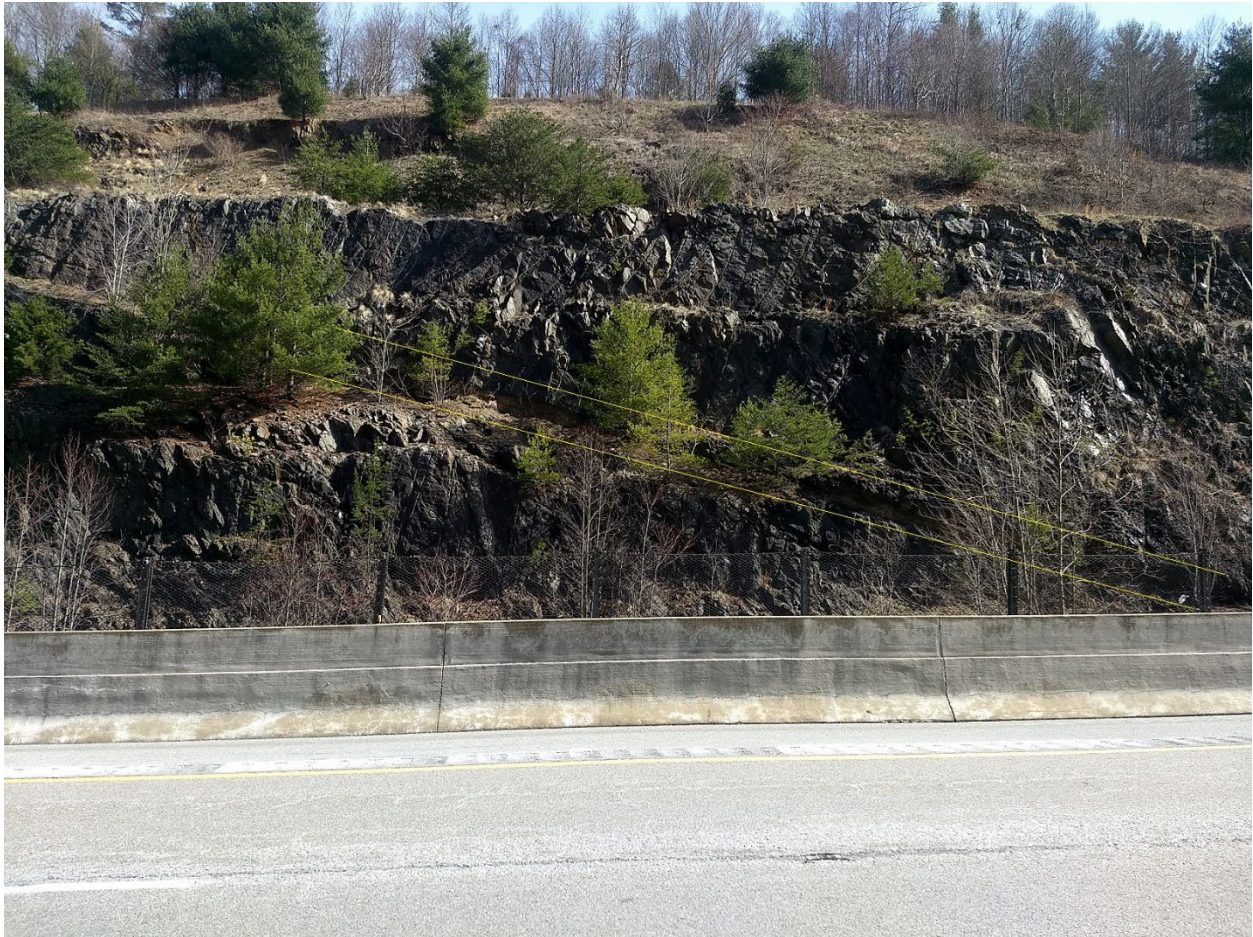
Flag Pond Cut (East face). Well exposed Blue Ridge thrusting within gneissic unit.

1,000' south of the turnaround at Flag Pond (back toward Asheville) is good exposure of a thrust fault on the left side large cut. Iron sulfates at the base of the hanging wall required treatment and encapsulation within the Flag Pond exit embankment (Harry Moore).
