# 75<sup>TH</sup> HIGHWAY GEOLOGY SYMPOSIUM

BETTER HIGHWAYS THROUGH APPLIED GEOLOGY

2026  
HGS  
PROCEEDINGS

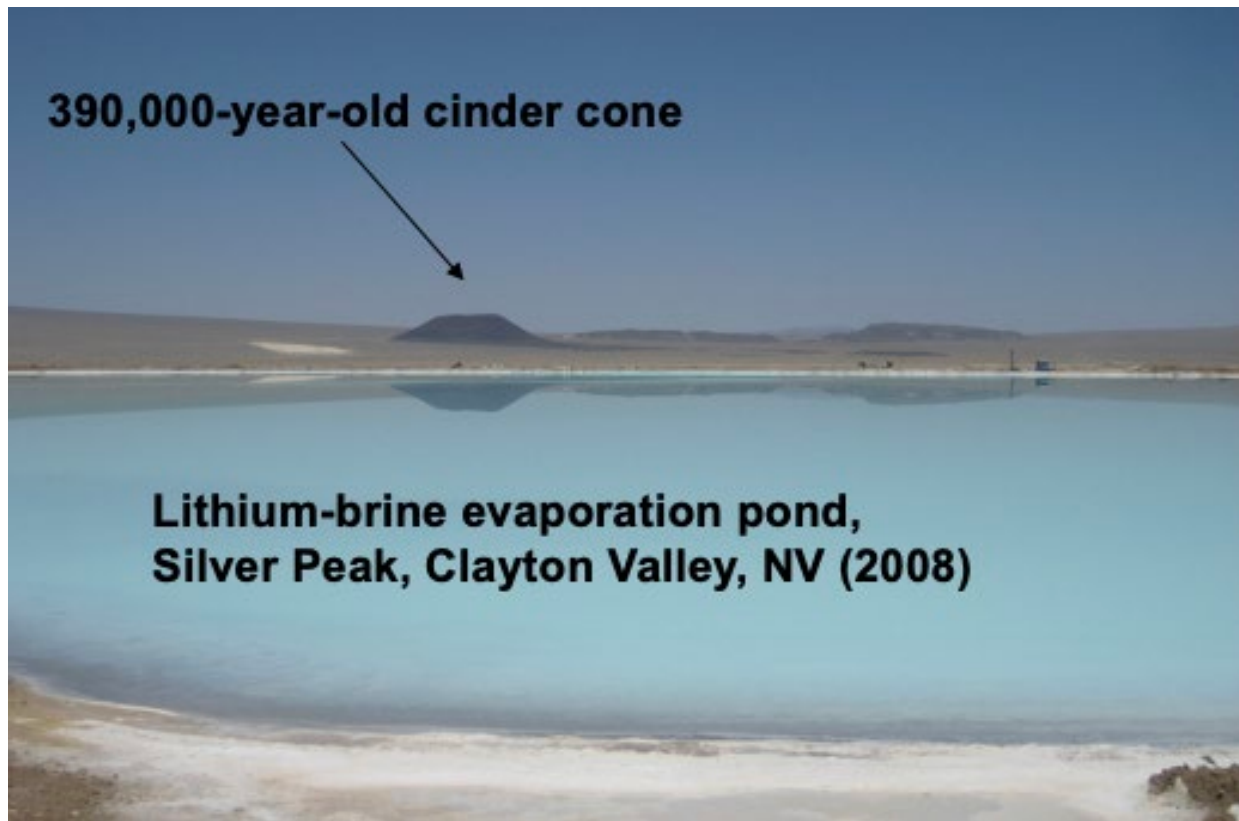
Figure 1. Clayton Valley lithium-brine pond, with Quaternary volcano in the background.

1. The rocks and the resources in them (Fig. 1 & 2).
2. The hazards (Fig. 3).
3. The environmental issues (Fig. 4)
4. The geos, including the geologically interested public (Fig. 5 & 6)

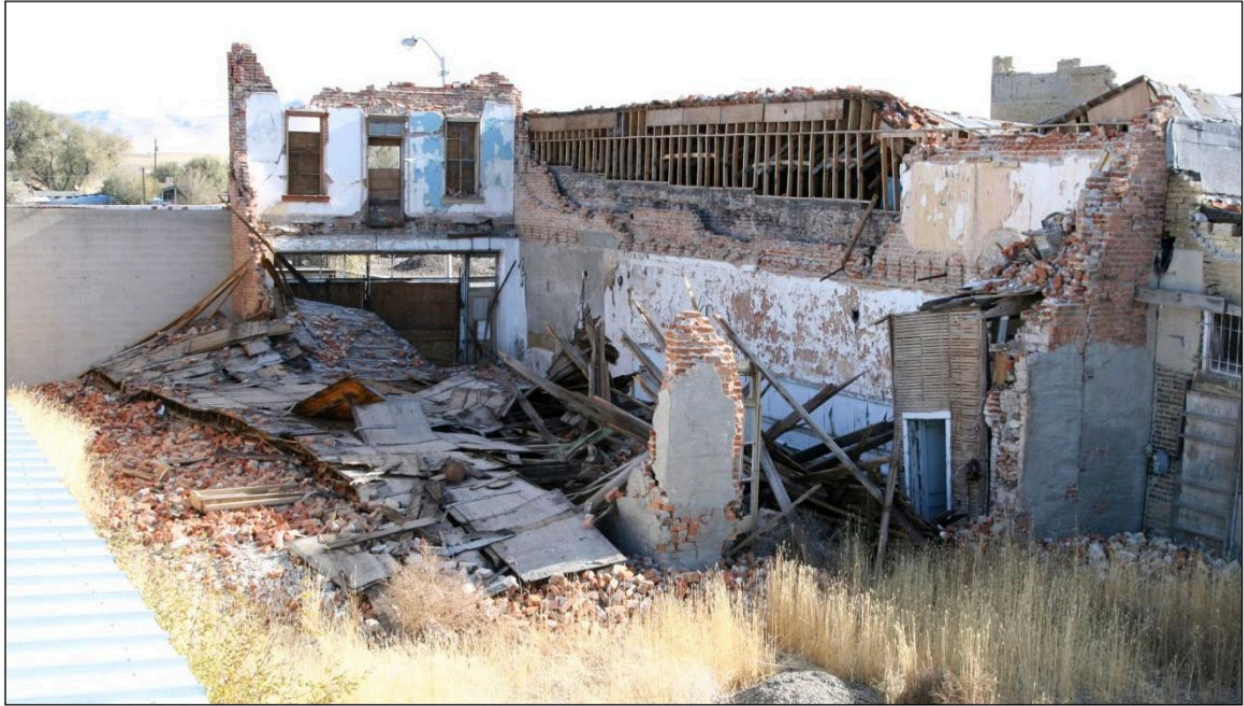
Figure 3. Unreinforced masonry building that collapsed during the magnitude 6.0 earthquake in Wells, Nevada on 21 February 2008, photo by C. dePolo (1).

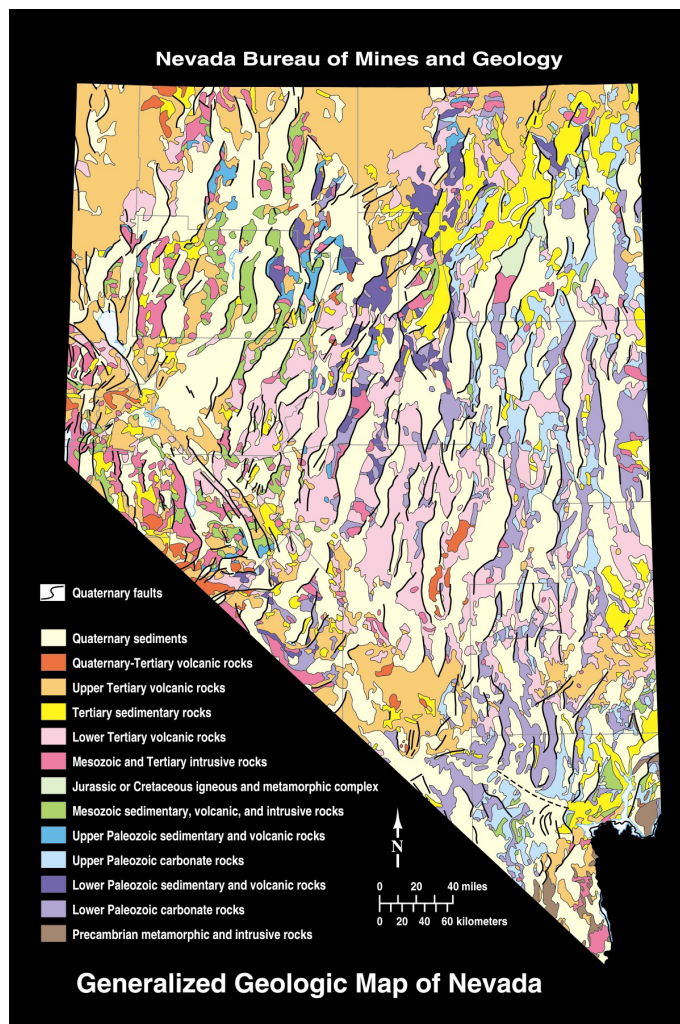
Figure 7. Geologic map of Nevada (3).

Precambrian events included thrusting, folding, metamorphism, intrusion, and sedimentation. Paleozoic thrusting, folding, oceanic crust formation, and sedimentation was followed by Mesozoic thrusting, folding, intrusion and volcanism. Cenozoic compression was followed by volcanism and intrusion, crustal extension with north-trending mountain ranges, and faulting, including right-lateral strike-slip faulting.

The geological history of Nevada (Table 1) is punctuated by magmatic events (Fig. 7), many of which are linked to mineral resources, particularly gold, silver, and copper. Although Nevada is the Silver State (named for the silver-gold mines on the Comstock Lode in Virginia City, which helped the Union during the Civil War), it produces more gold than any other state (Fig. 8). Nevada leads the nation in non-fuel mineral production (2). In terms of value, gold dominates, followed by copper, geothermal energy, aggregate, and silver (Fig. 9). Nevada leads the U.S. in the production of gold, lithium, and barite. Exploration is active across the state (Fig. 10).

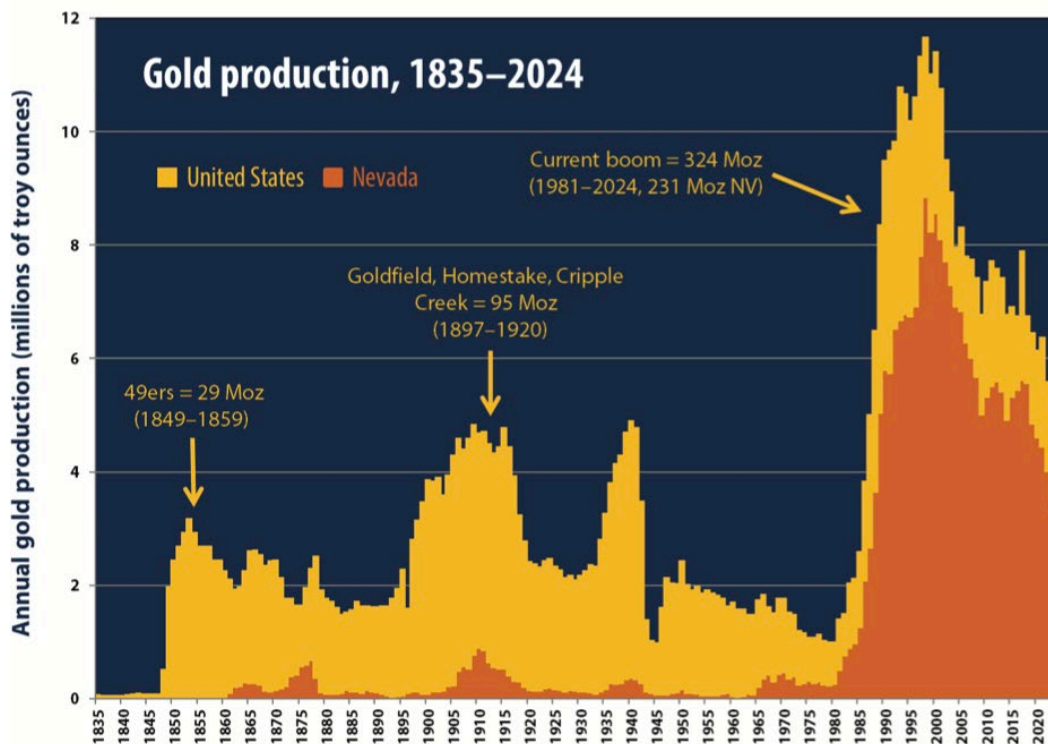
Figure 8. Gold production in the United States and Nevada, 1835 to 2024 (4).

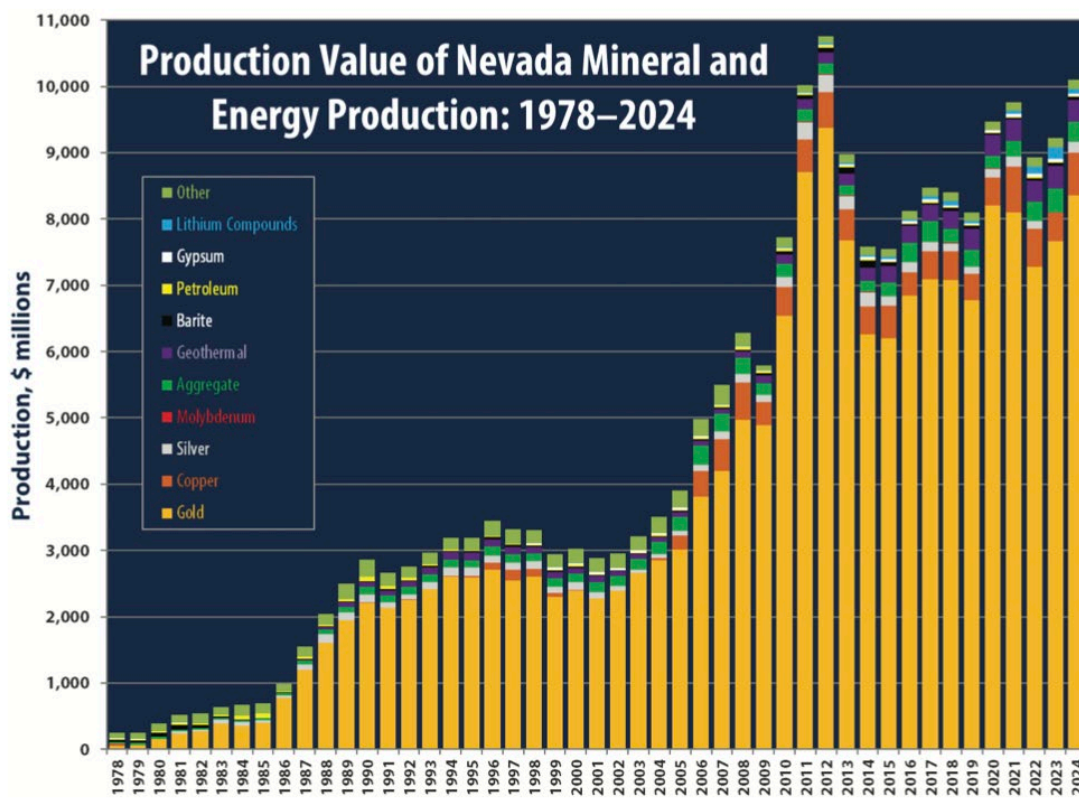
Figure 9. Mineral-resource production in Nevada (4).

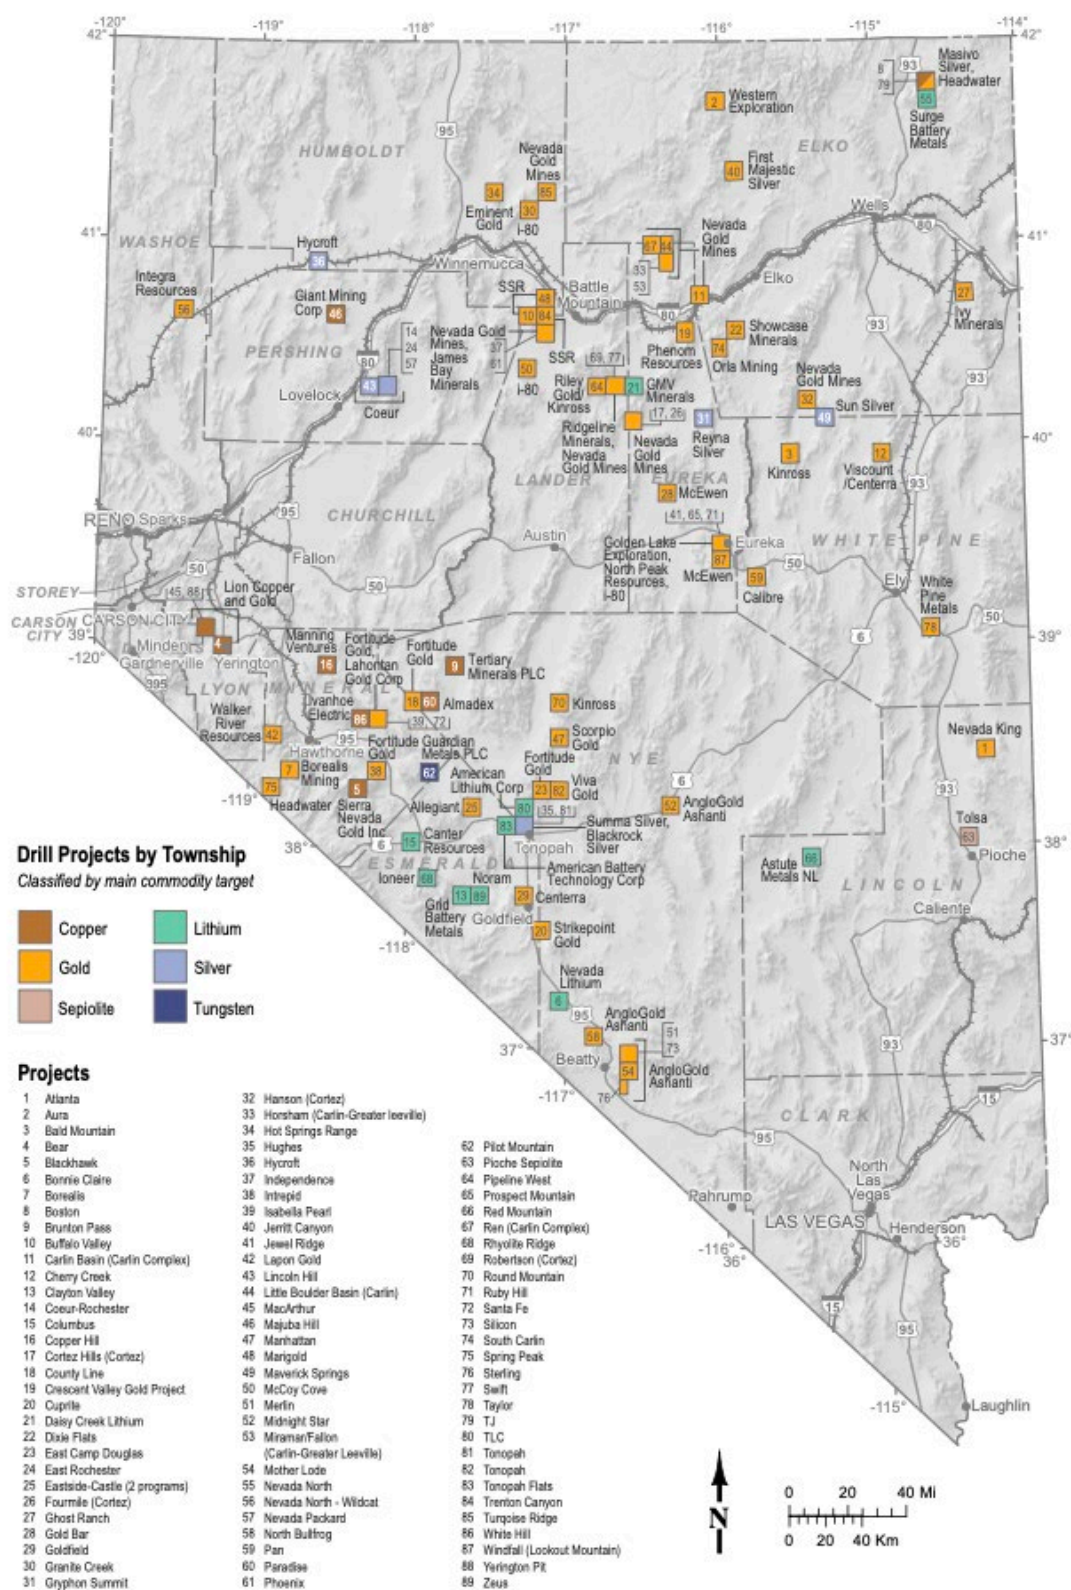
Figure 10. Exploration projects in Nevada (4).

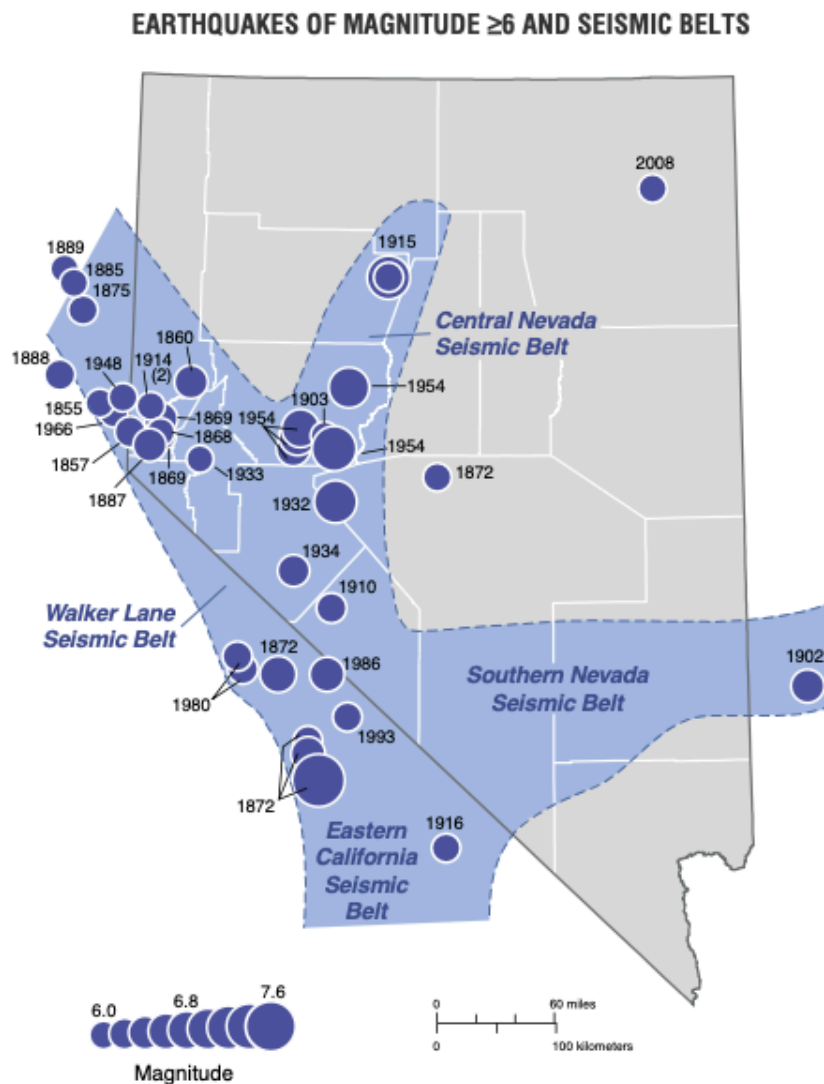
Figure 11. Historical earthquake of magnitude 6 or greater (5)

Major geologic hazards in Nevada include earthquakes and floods. Historical earthquakes have been as high as magnitude 7.3 (Figs. 11 & 12), and Quaternary faults occur throughout the state (Fig. 13). The Walker Lane (Fig. 11) accommodates approximately 20% of the motion between the Pacific and North American plates, most of which occurs along the San Andreas fault. Floods occur throughout the state as well (Fig. 14). Landslides and avalanches are locally significant in mountainous regions. All these hazards have impacts on our highways.

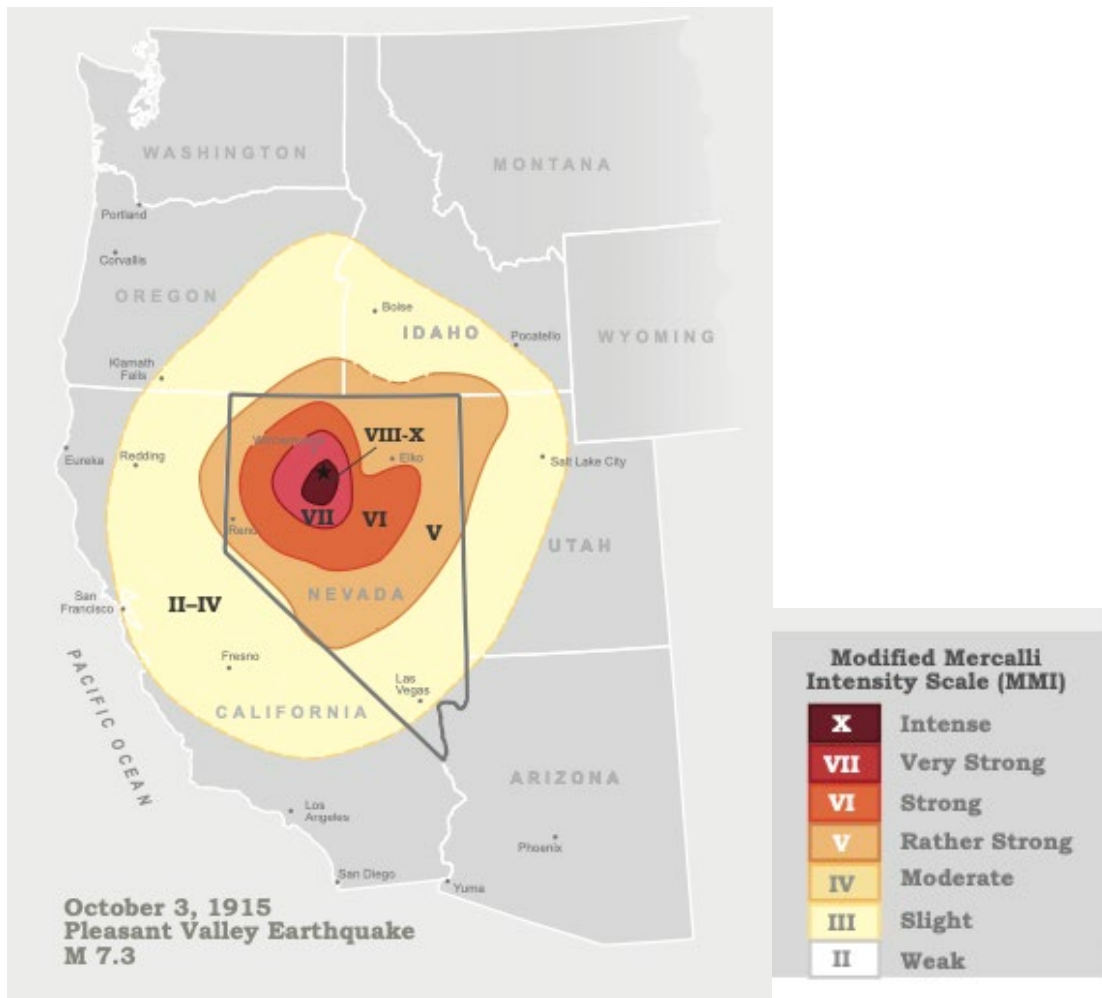
Figure 12. Intensity map of the Pleasant Valley earthquake in 1915 (8).

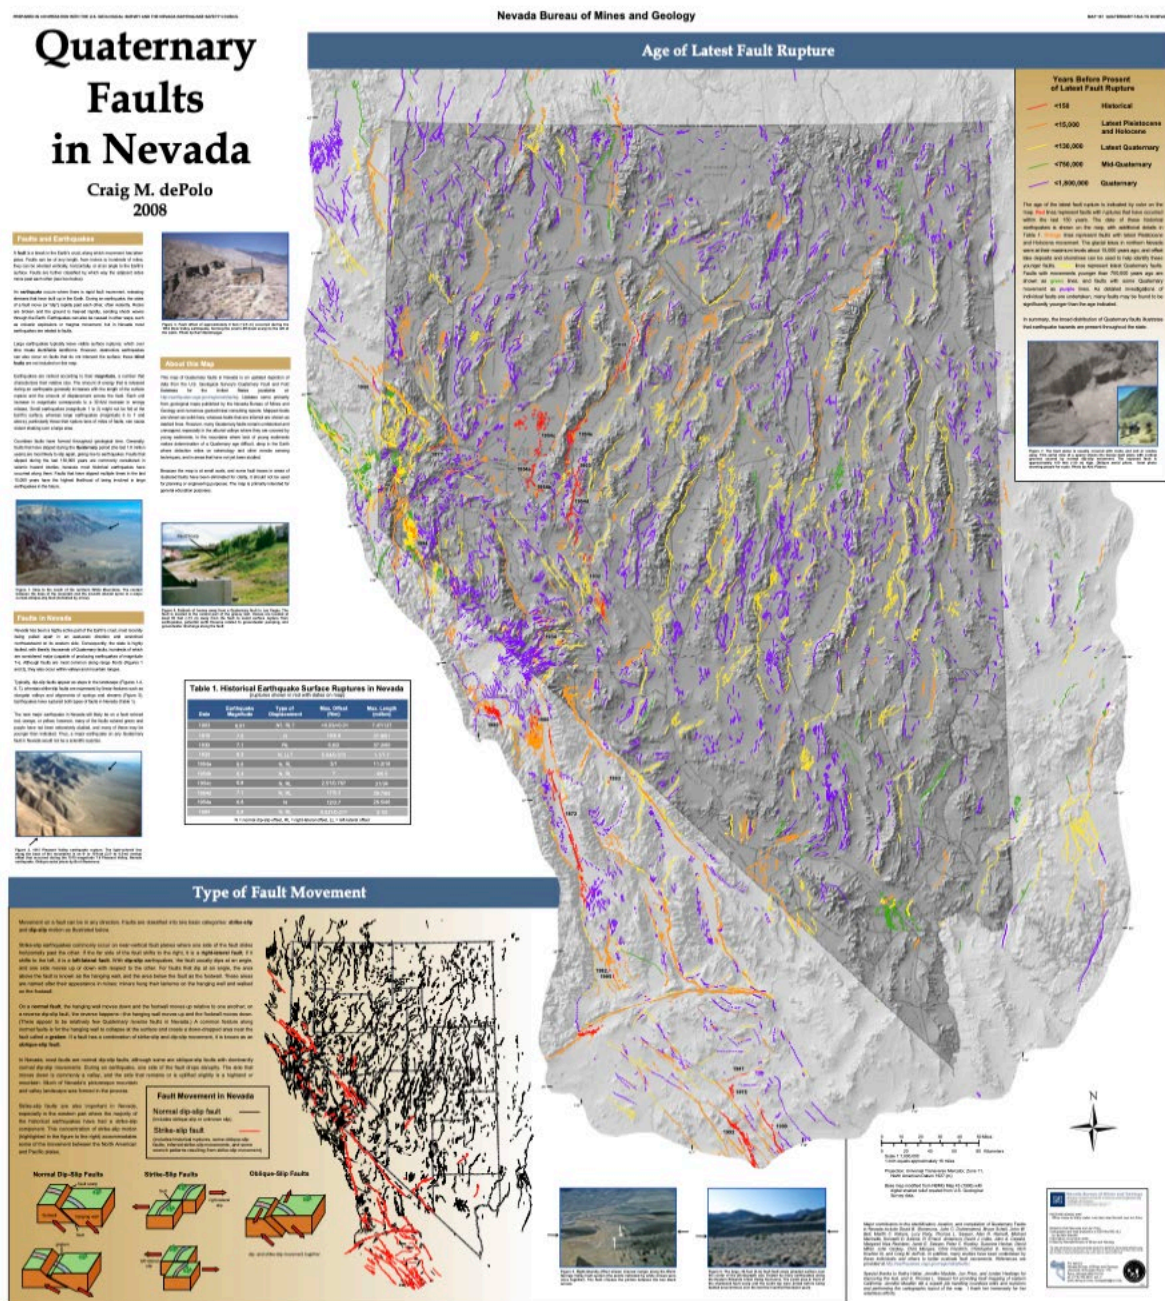
Figure 13. Quaternary faults in Nevada (9).

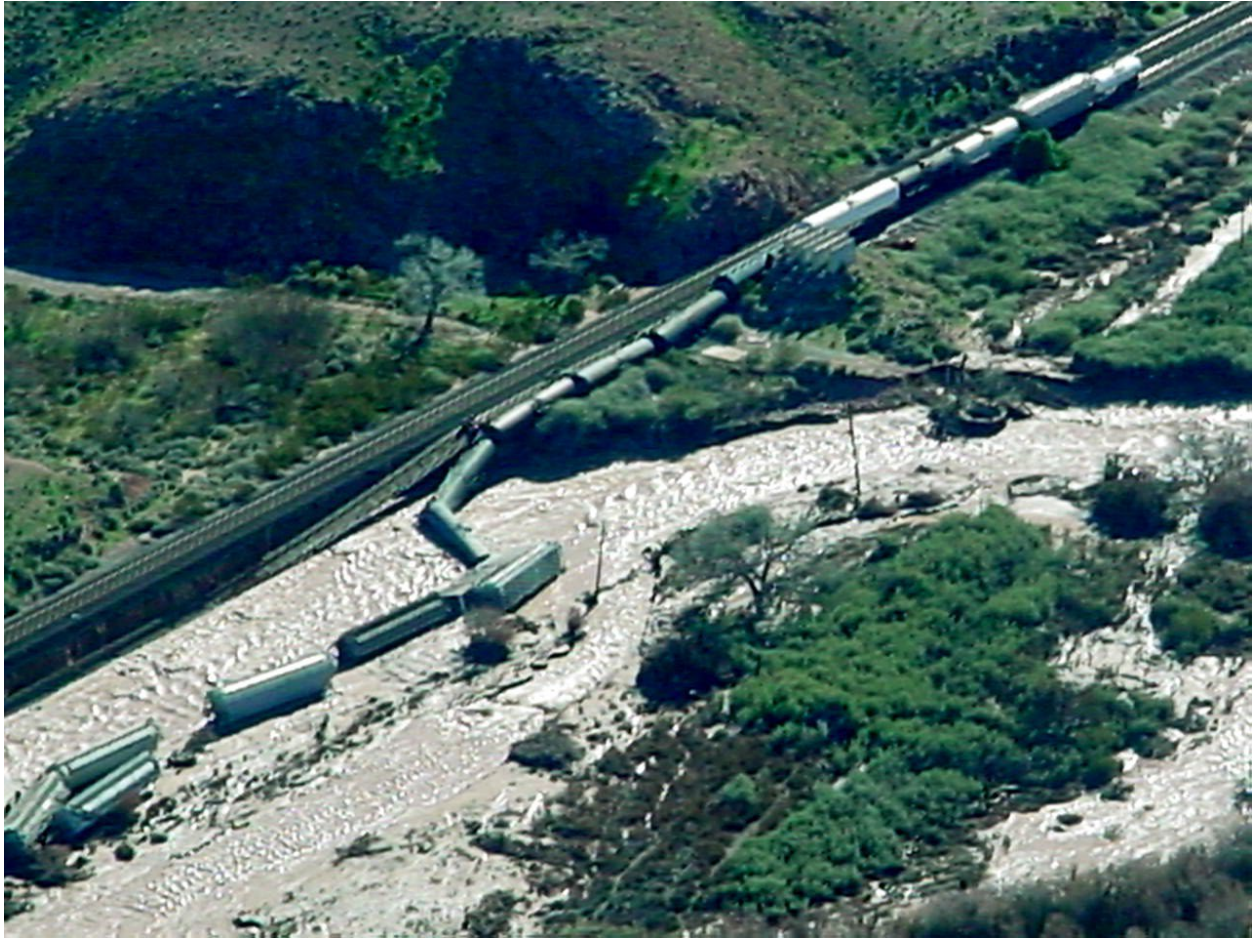
Figure 14. Flood in Meadow Valley Wash, Clark County, January 2005 (photo courtesy of Gale Fraser, Clark County Regional Flood Control District).

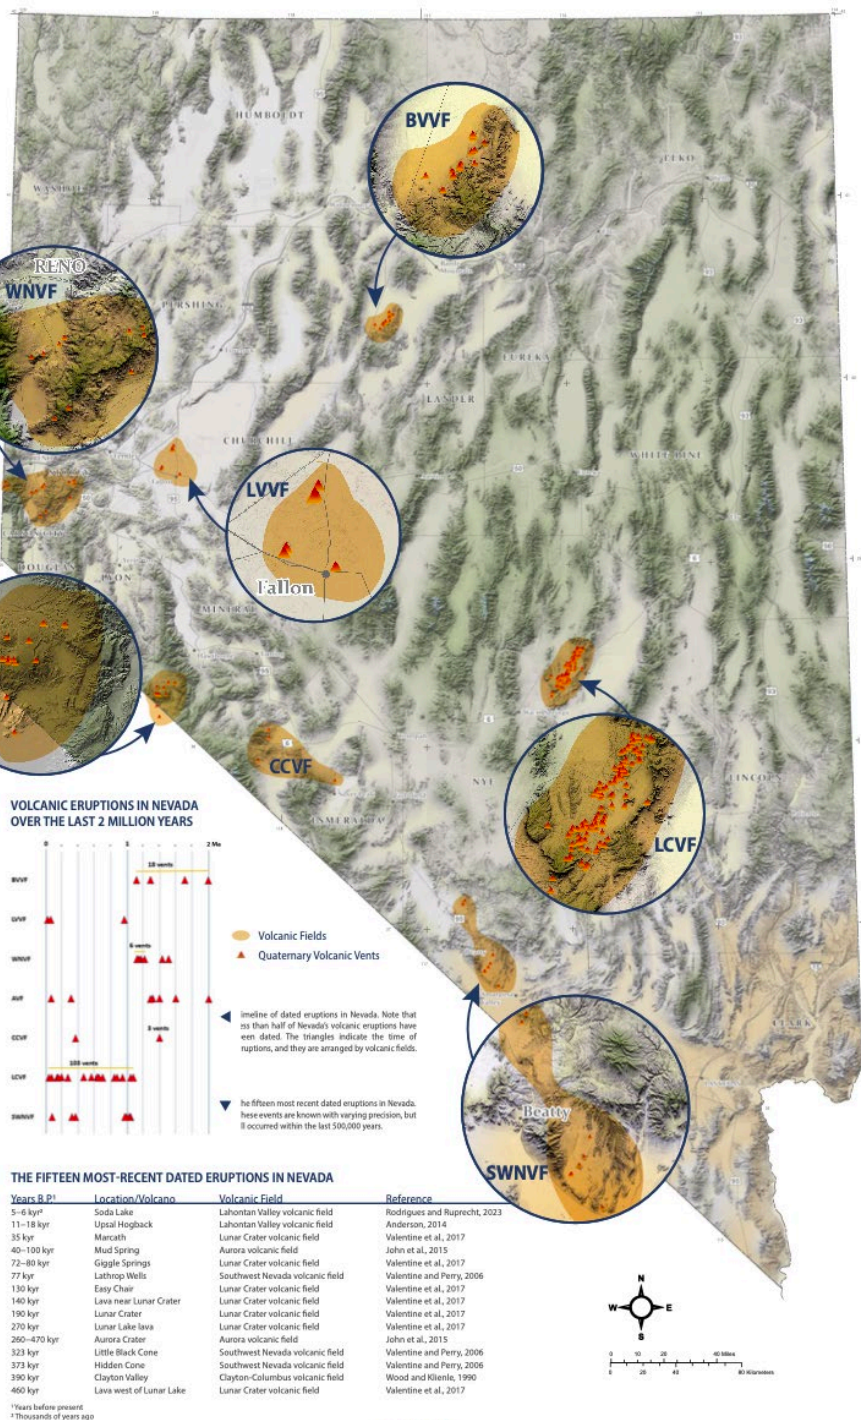
Figure 15. Quaternary volcanoes in Nevada (10).

Although only about a third of the Quaternary eruptions in Nevada have been dated (~54 dates), there is enough information available to make a general timeline of eruptions and gain a sense of the overall volcanic activity across the state. Quaternary volcanic rocks have been dated using potassium-argon (K-Ar), argon-argon (<sup>40</sup>Ar/<sup>39</sup>Ar), optically stimulated luminescence, and beryllium-10 (<sup>10</sup>Be) dating techniques. The dates are used at face value for simplicity, but it is important to recognize that there can be considerable epistemic (knowledge uncertainty) and aleatory (natural variability) uncertainty in an individual eruption age. Future dating and new dating techniques will improve eruption ages.

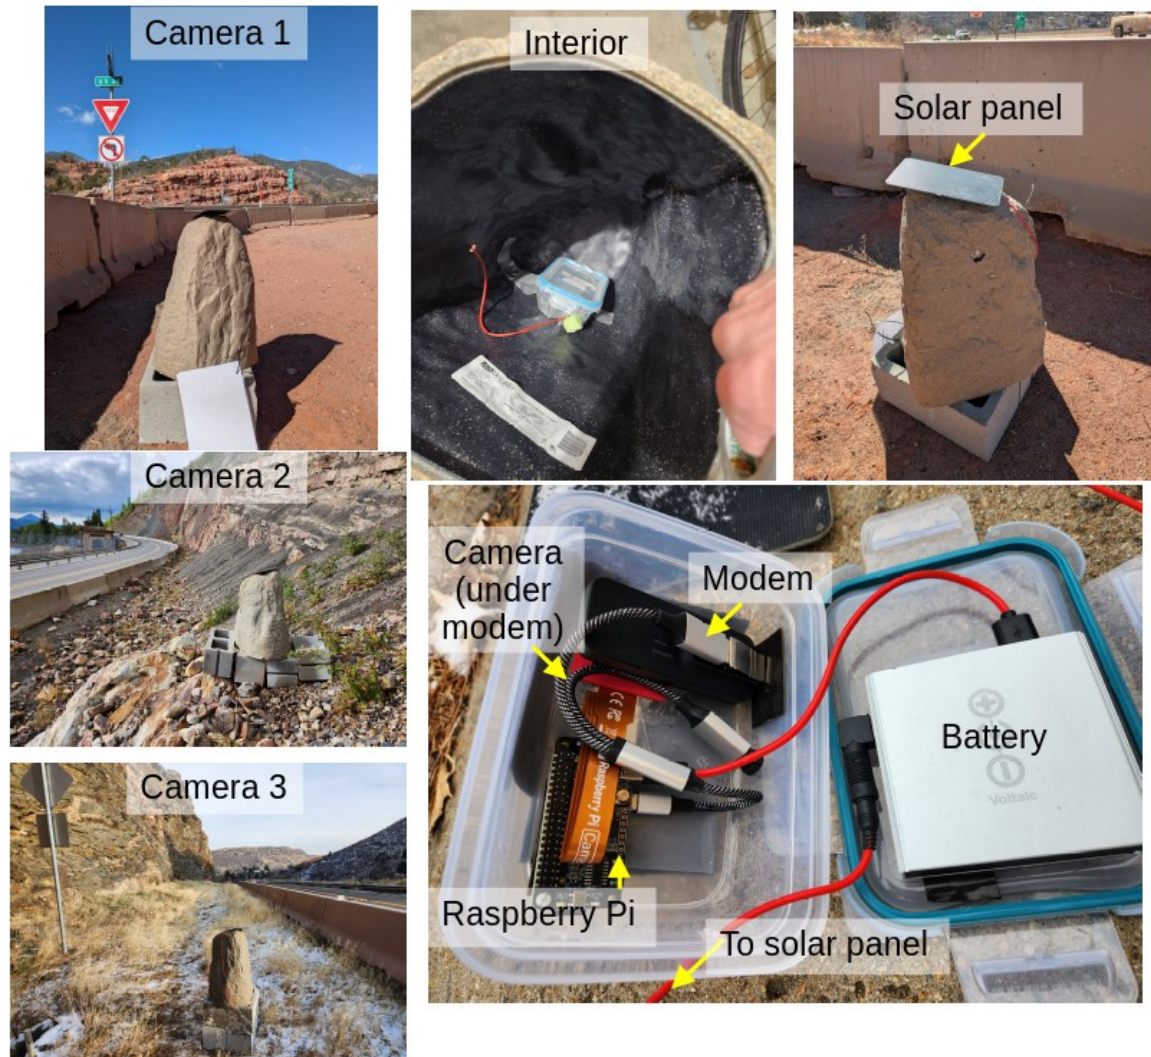
**Figure 1 – (Left) Overview photos of the camera installation locations. (Right) Inside view of the camera system enclosure, showing the main components.**

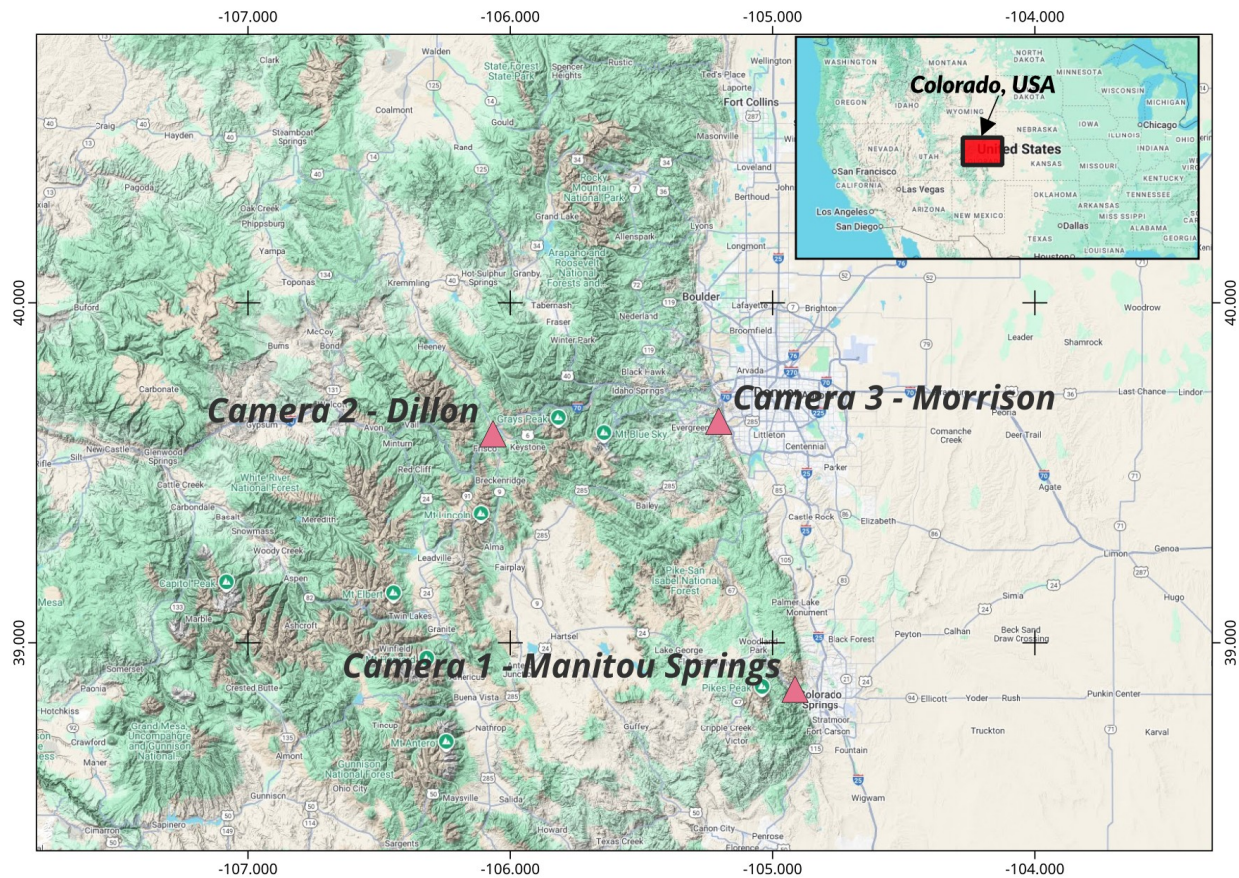
**Figure 2 – Locations of the three camera installations in Colorado, USA.**

- Camera 3 is located at a south-facing gneiss rock cut on Colorado Highway 74 west of Morrison. This slope was the subject of a mitigation program including scaling, bolting, and removing a traffic lane to widen the ditch (3). As a result of the wider ditch, vegetation growth is more prevalent.

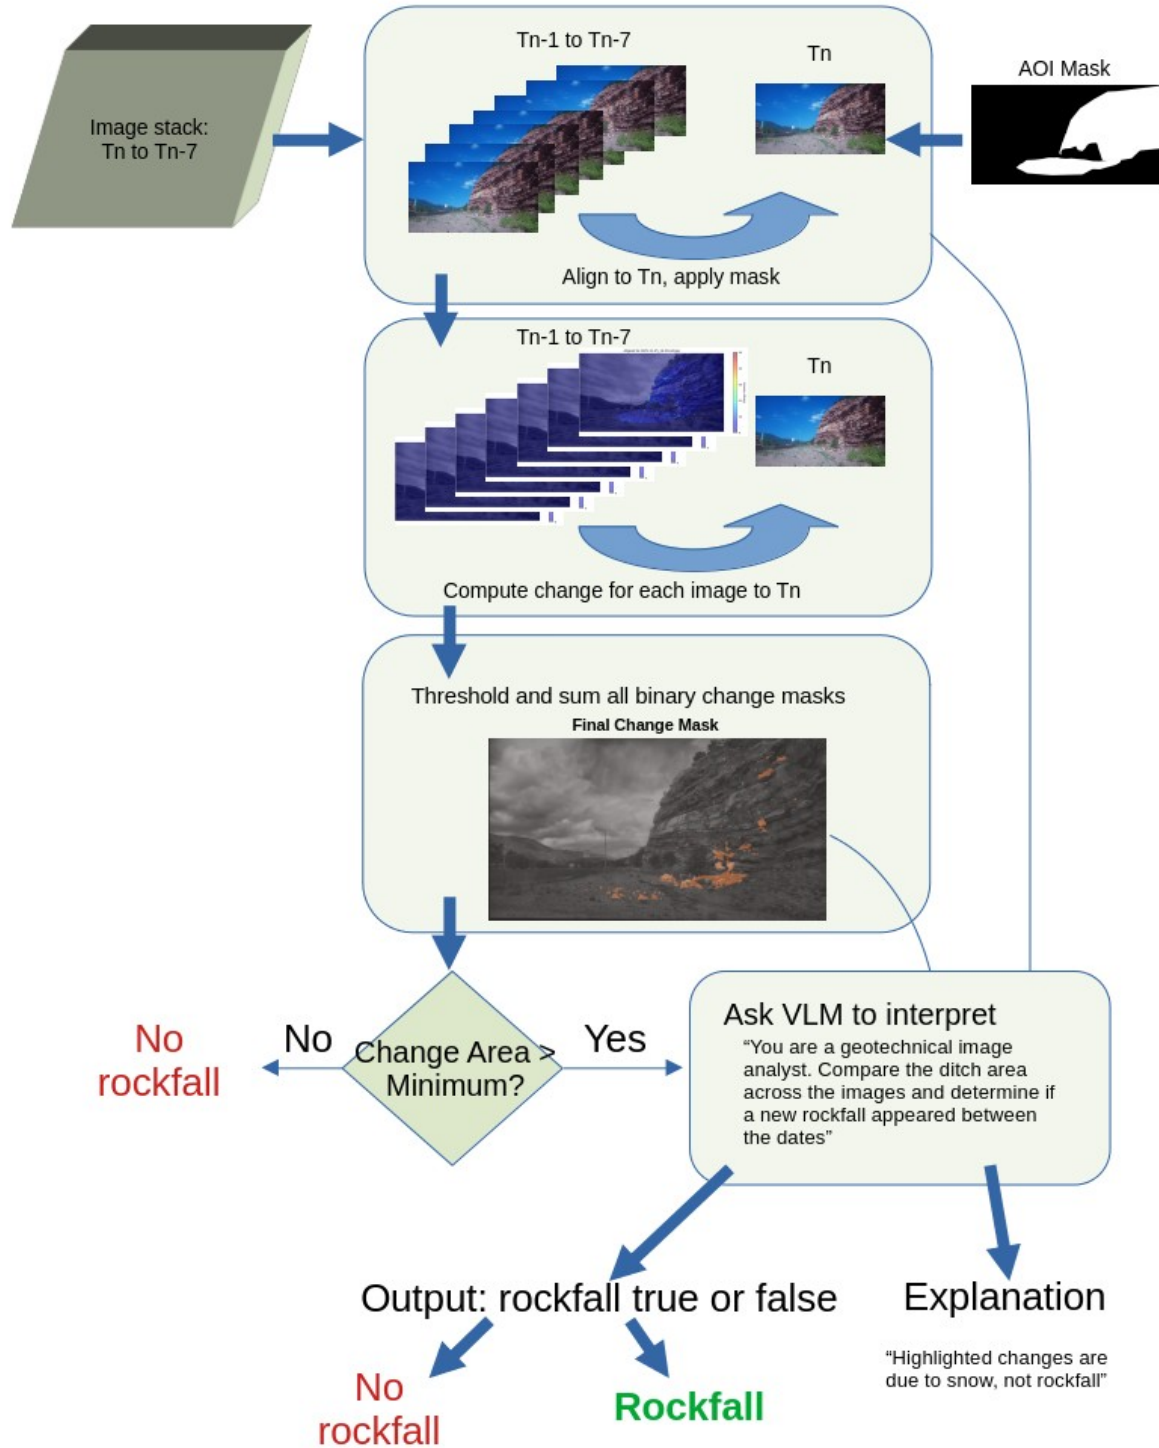
Figure 3 – Overview of the image analysis workflow.

1. If the total area of detected change for a given day using image analysis exceeds a user-defined threshold, the comparison is flagged for VLM analysis. This prevents unnecessary model calls for minor changes that are unlikely to be of interest.
2. All images and the change mask associated with the flagged comparison are passed to the VLM along with a prompt requesting a short description of the changes observed in the images, along with a True/False classification of whether new rockfall is visible in the ditch.
3. Regardless of whether the VLM identifies new rockfall, the output descriptions and classifications are stored for further analysis. For example, the description can be used to indicate the cause of the changes (e.g., weather-related vs. rockfall).

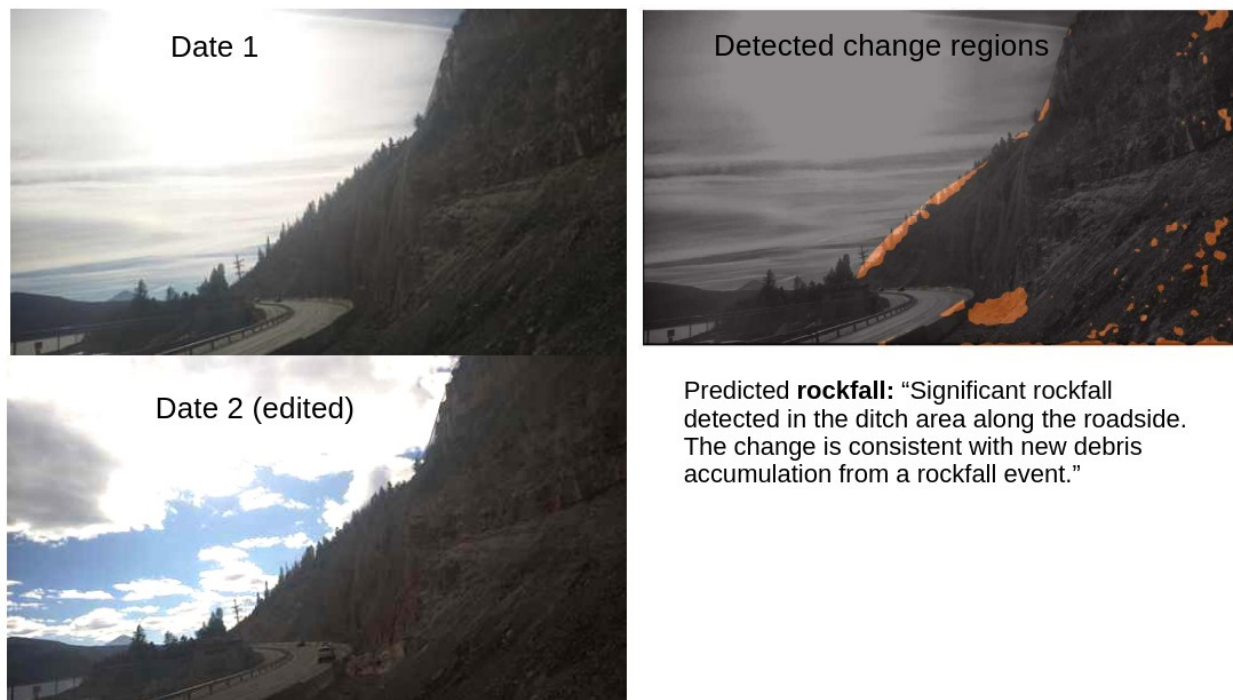
**Figure 4 – Synthetic rockfall experiment for Dillon slope (Camera 2). (Left) Before and after images, where the bottom image is edited to include a synthetic rockfall. (Right) The detected changes region using the image analysis workflow, along with the classification output of the Qwen3 model.**

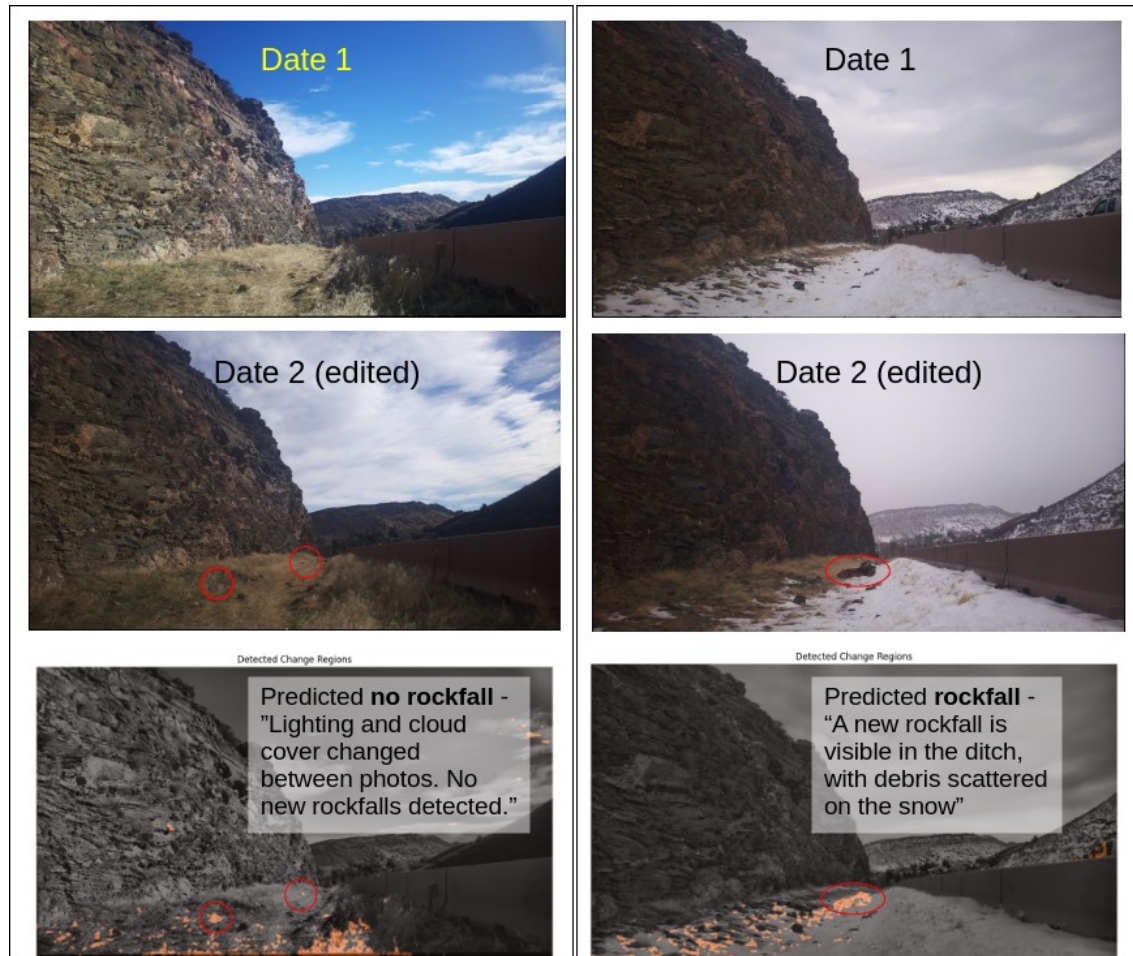
**Figure 5 – Example of synthetic rockfall experiment for Camera 3. (Left) Experiment with two small rockfalls added to the ditch. (Right) One large rockfall added. The bottom panel on both sides shows the detected change regions along with the classification output of the Qwen3 model.**

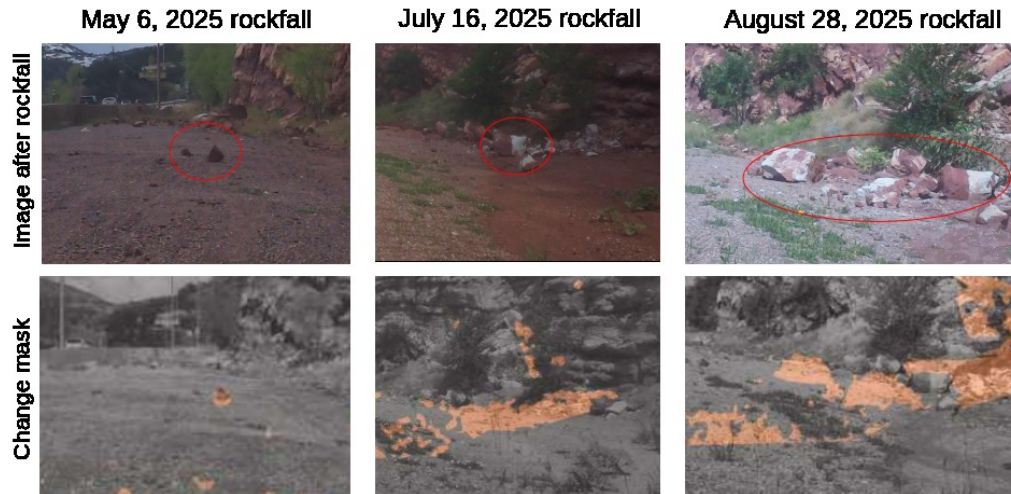
**Figure 6 – Photos of real rockfalls detected at Camera 1 location during the monitoring period. (Bottom right) Change detection results for the August 28 rockfall, with pink areas representing significant changes.**

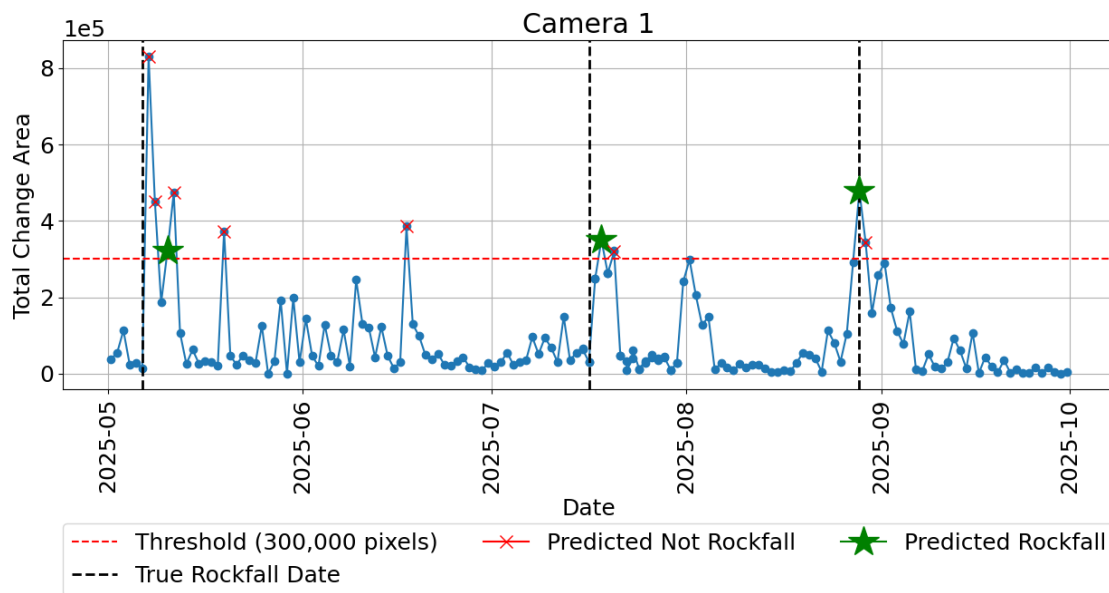
**Figure 7 – Time series of daily detected change area at Camera 1 location over a 5-month period. Dates of real rockfalls are indicated by vertical black lines. Horizontal red line indicates the change area threshold used to trigger VLM analysis.**

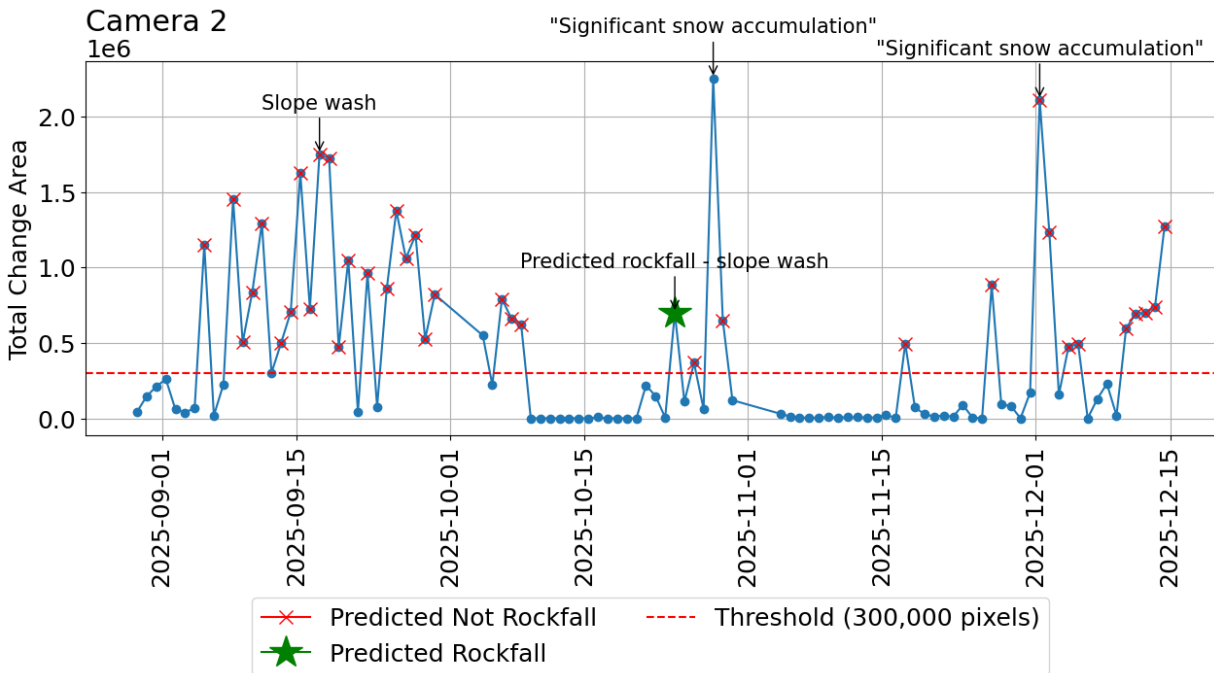
The Camera 2 slope change detection time series is presented in Figure 8. Camera 2 is focused on a ditch where the majority of the right side of the frame is filled with a talus slope which experiences regular slope wash in response to rain. This activity is readily picked up by the image change detection as broad changed areas, but these are not intended to be classified as rockfalls. In all but one instance, the VLM correctly identifies that these types of change are not rockfalls, but the justifications/explanations of the changes are usually incorrect. The model typically cites "lighting/shadow variations" or "vegetation movement" which are not present. In

two cases of snow events which caused large image changes, the VLM correctly identifies the source of the changes as "significant snow accumulation".

**Figure 8 – Time series of daily detected change area at Camera 2 location over a 3-month period.**

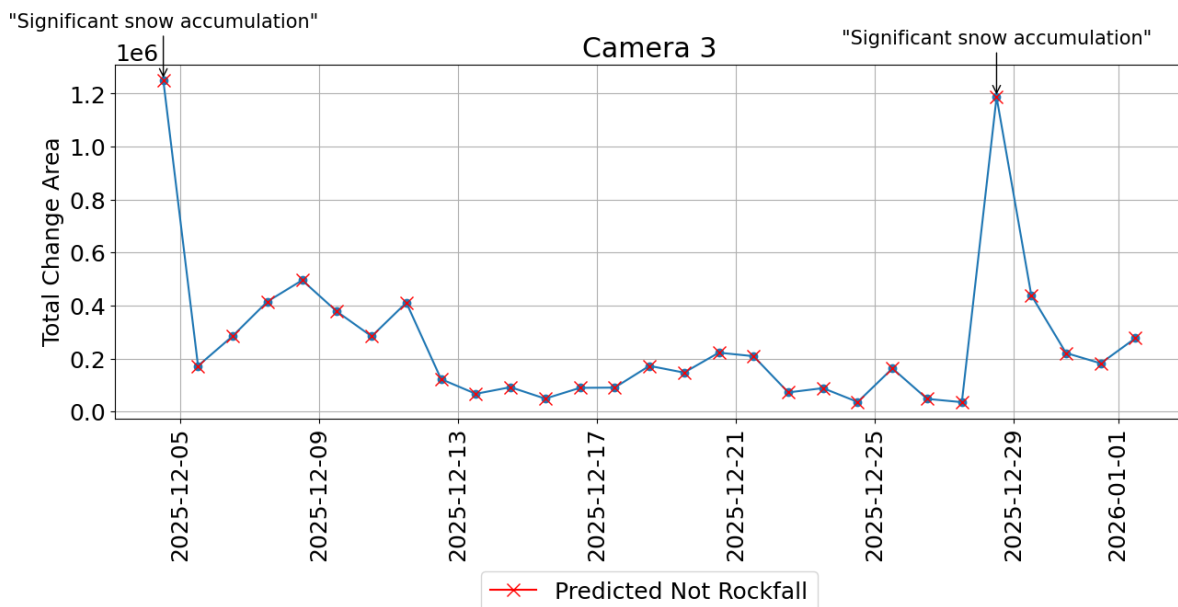
**Figure 9 – Time series of daily detected change area at Camera 3 location over a 2-month period. Note that no threshold was used to limit VLM analysis. The VLM was applied to each image date.**

The Camera 3 slope had the shortest time series of data available at the time of writing (Figure 9). However, it still is useful to illustrate the ability of the VLM to identify major snow events when they result in large change areas.

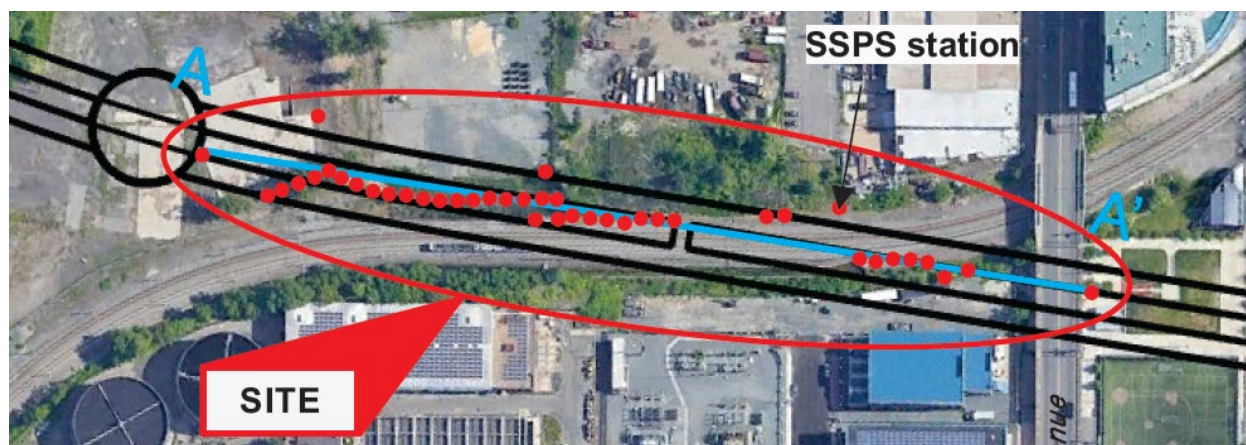
The chosen stations for HVSR recording were planned to be interpreted individually, as scattered points, though they were arranged in a coarse line to follow the area of interest for the investigation (Figure 1).

Figure 1. Site plan showing HVSR stations as red dots (SSPS refers to “single-station passive seismic” – another term for HVSR).
