# 75<sup>TH</sup> HIGHWAY GEOLOGY SYMPOSIUM

BETTER HIGHWAYS THROUGH APPLIED GEOLOGY

2026  
HGS  
PROCEEDINGS

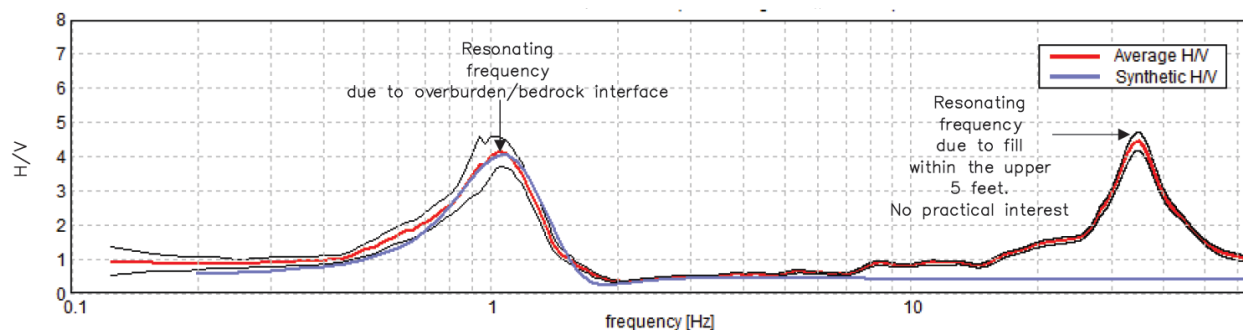
The shear-wave velocity was determined at each of the six borehole locations using the relationships described by Equation 1. This was done by generating a synthetic HVSR curve using the observed, borehole-derived bedrock depth and an assumed shear-wave velocity value as inputs into the model. The synthetic model was then compared to the observed average HVSR curve for the given station (Figure 2). The assumed shear-wave velocity was iteratively adjusted to minimize discrepancy between the synthetic and observed models, until an optimal shear-wave velocity was found. This process was repeated for each of the six borehole locations. Note that the peak frequency is linked to the fundamental resonance frequency of the soil, and the peak amplitude indicates the degree of impedance contrast between the overburden and bedrock, such that higher amplitude indicates higher contrast.

Figure 2. Synthetic and average observed curves of HVSR ( $H/V$ ) vs. microtremor frequency at station #31.

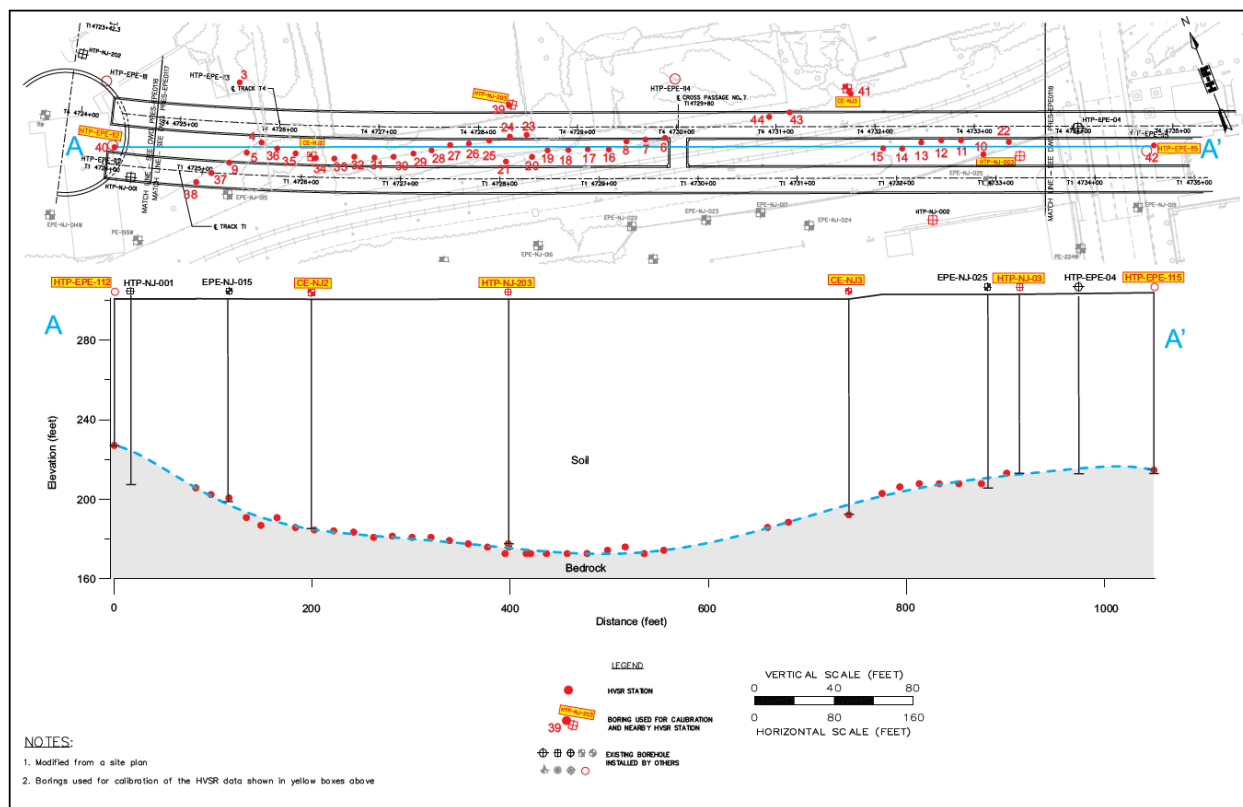
Figure 3. Schematic of HVSR recording stations and bedrock profile.

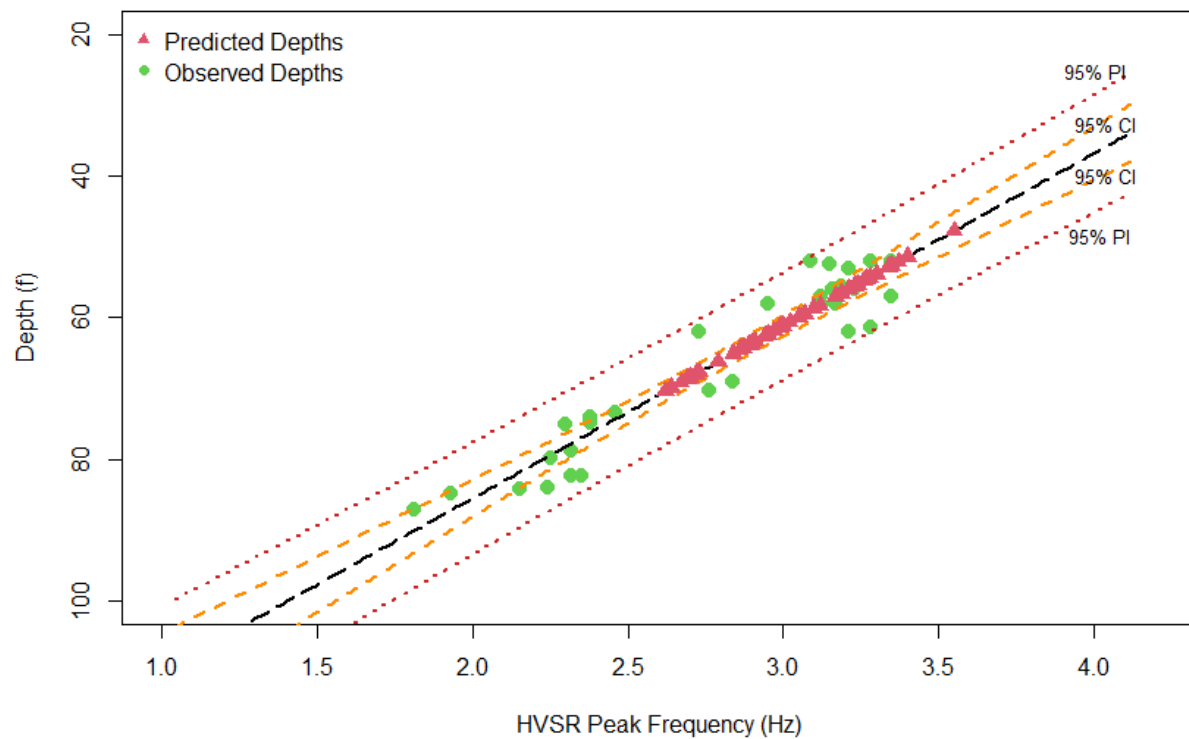
Figure 4. Linear regression model of bedrock depth predicted by HVSR peak frequency, with 95% Confidence Intervals and 95% Prediction Intervals

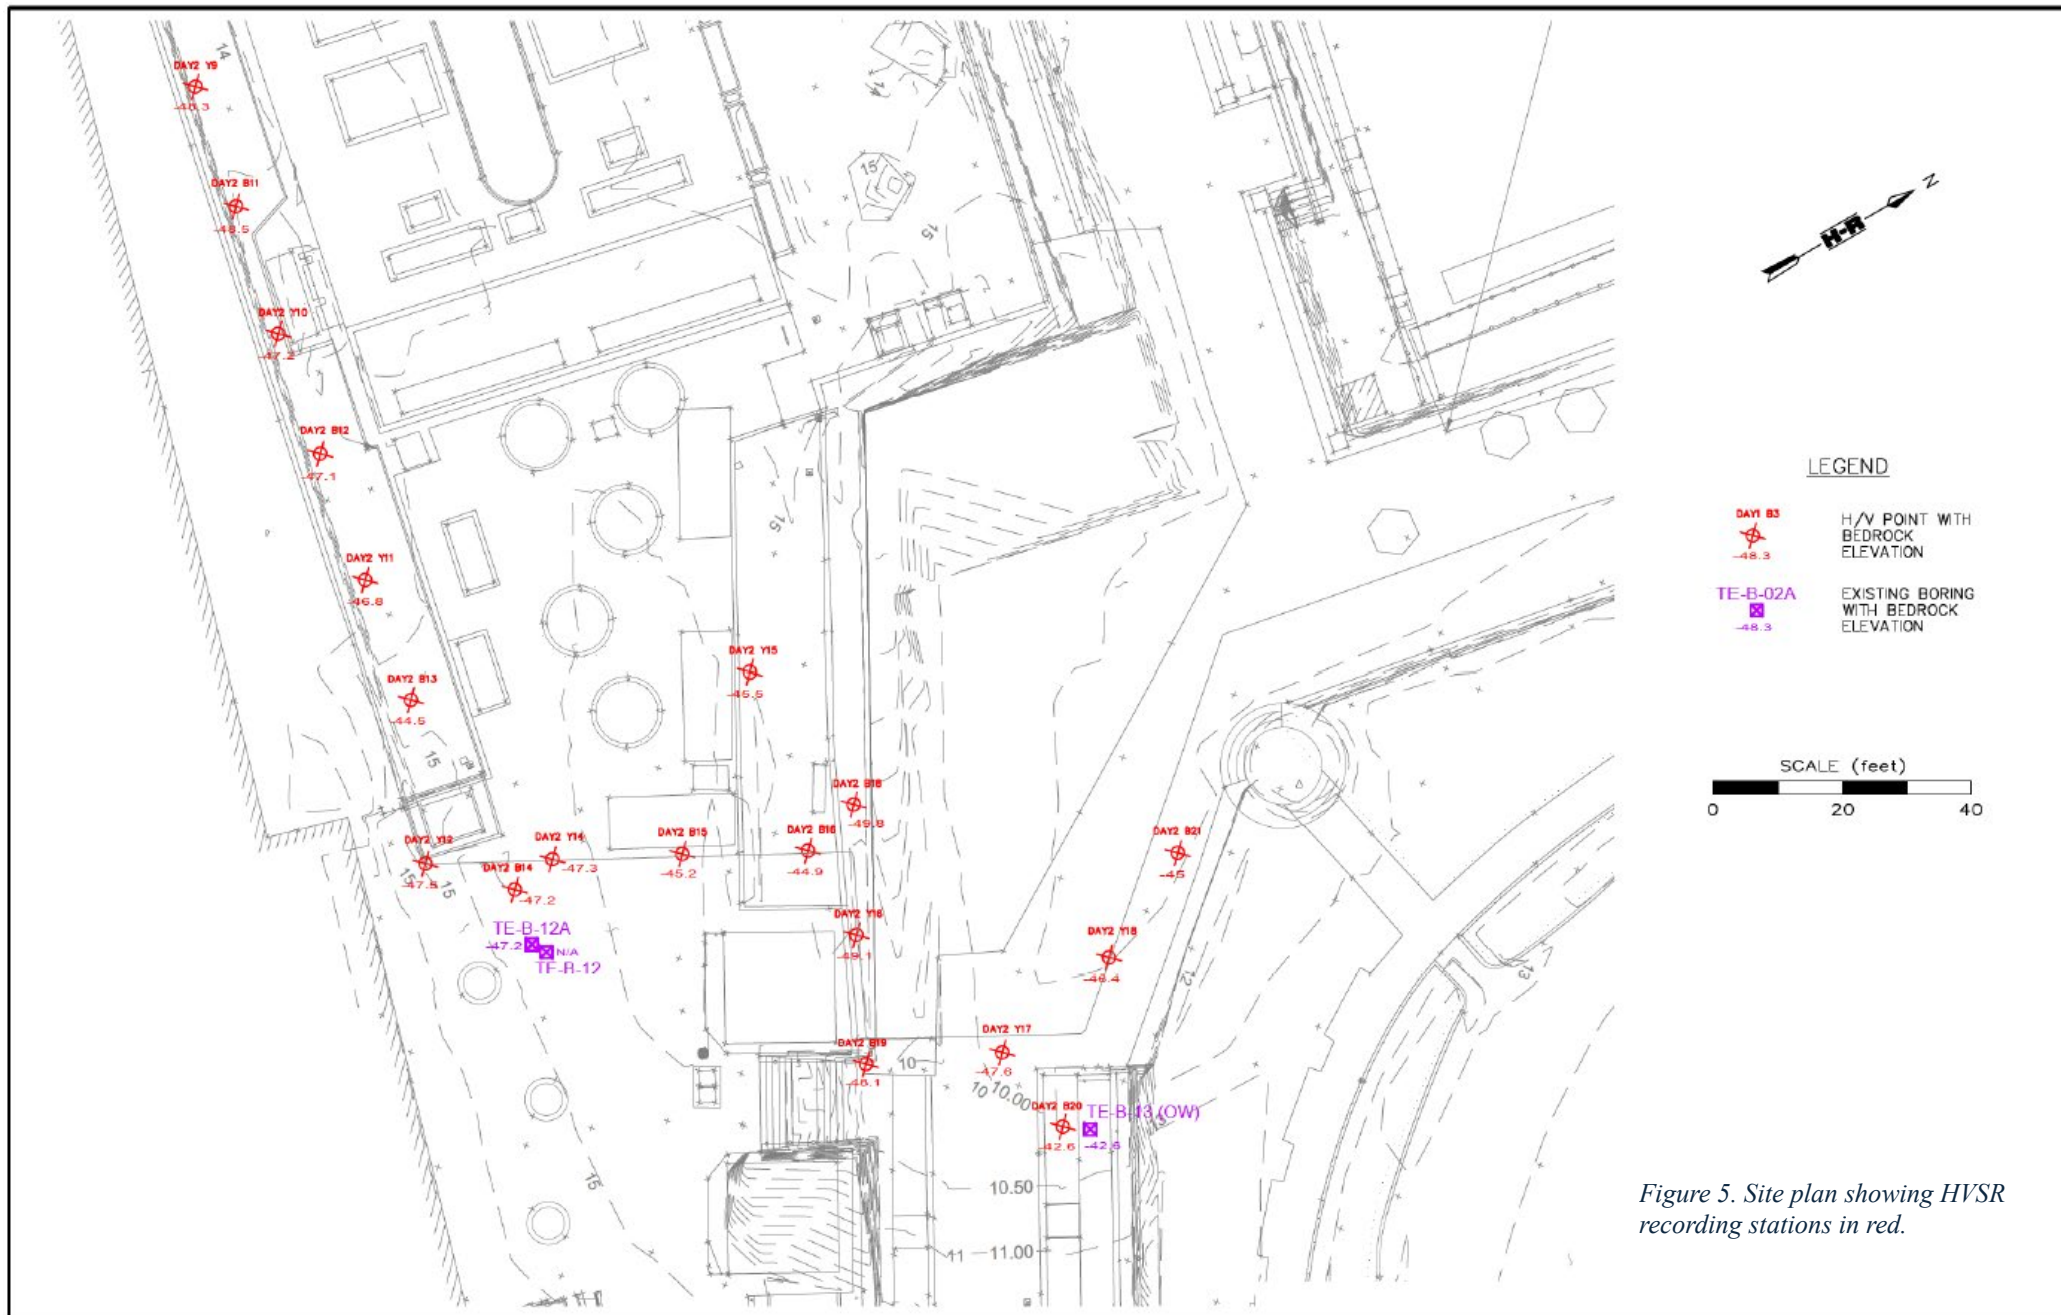
Figure 6 shows an example site plan, one of 20, with HVSR data stations shown in red along with the estimated bedrock elevations. Stations where boreholes were used to train the regression model are shown in purple with their reported bedrock elevation, based on coring. We note that some of the boreholes were completed after the HVSR survey and their final locations were different than the originally proposed locations at the time of the survey.

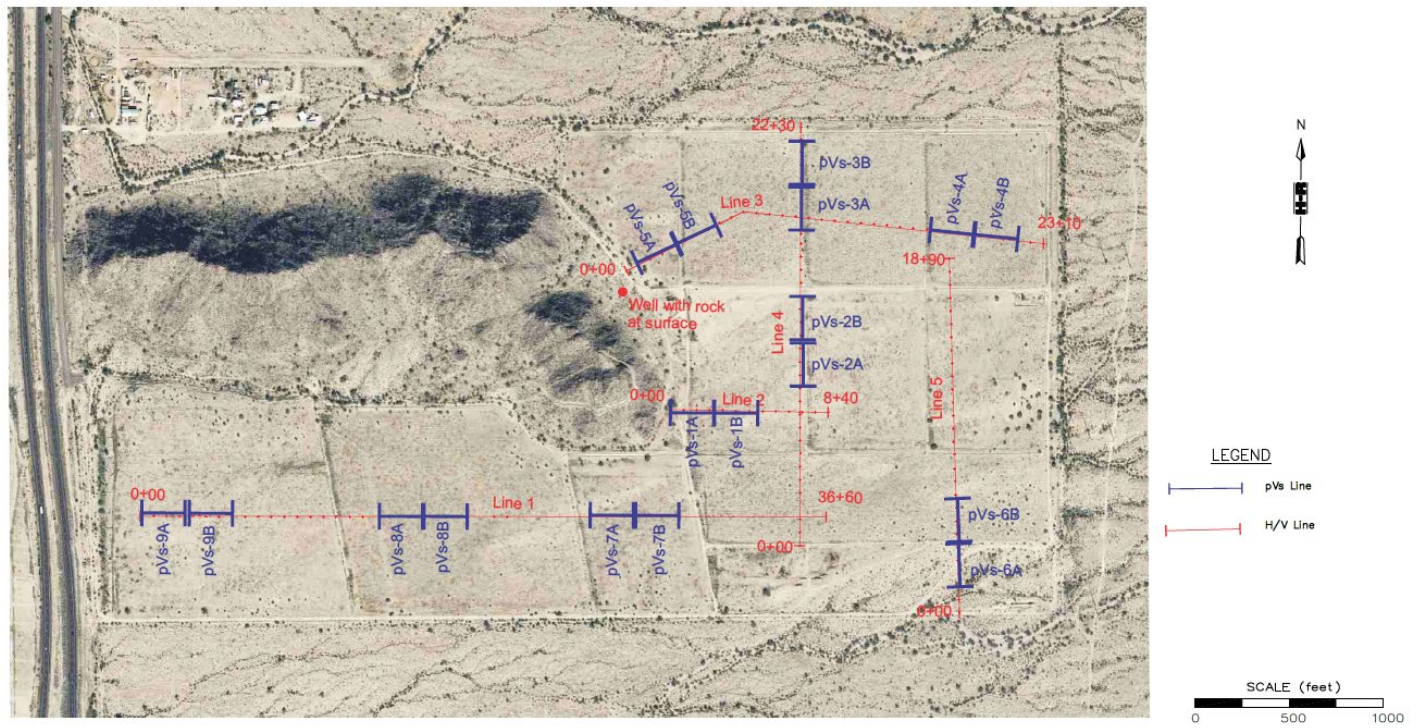
Figure 6. Transect locations for HVSR and pVs surveys at a confidential site in the southwest USA

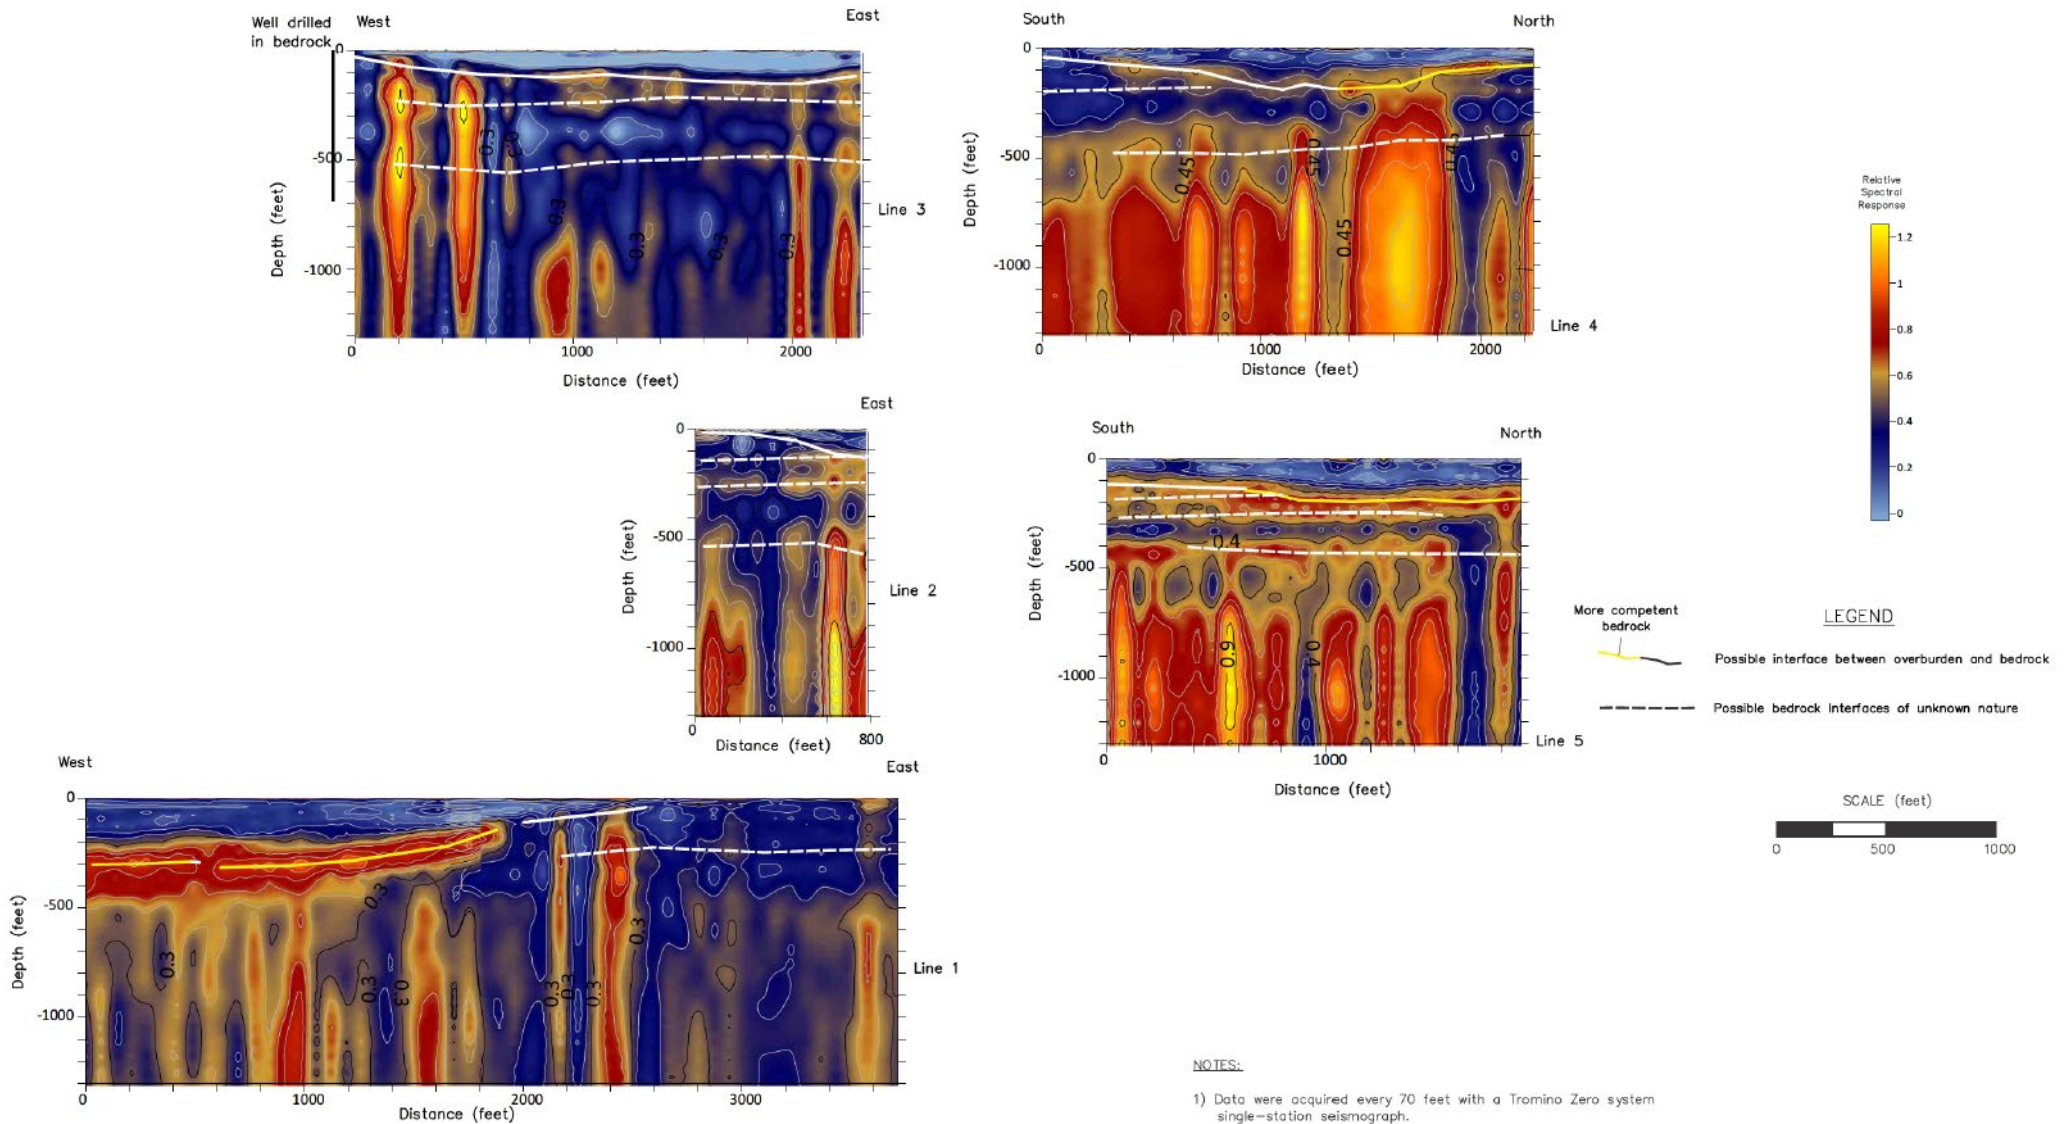
Based on the HVSR survey, the depth of competent bedrock varies between about 20 and 300 feet along Line 1. Rock is deepest at the west end, shallowing significantly to the east. The bedrock surface along Lines 2 and 3 varies from outcropping at the west ends of the lines to about 100 feet deep to the east. Lines 4 and 5 generally exhibit shallow bedrock at their south and north ends and deepen slightly in their centers to about 100 feet or so.

Figure 7. Synthetic contour plots of HVSR for five transects recorded at a confidential site

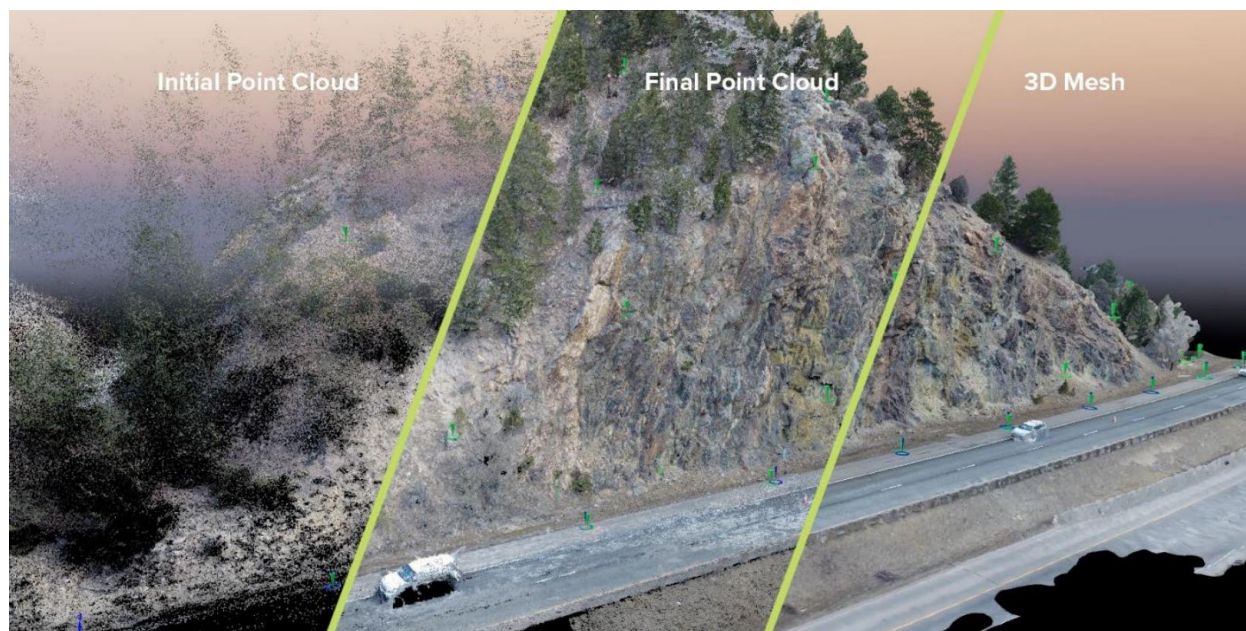
The projects used high-density TLS for tunnel and canyon-wall exposures and UAV-derived data for broader topographic and highwall mapping. The raw point clouds were registered to project coordinate systems and processed to remove vegetation, vehicles, utilities, loose anthropogenic features, and other non-rock returns where practical. Where pointcloud data

is poor or heavily vegetated, cleaning and meshing of the 3D datasets can improve resolution for discontinuity extraction. Deciding upon if discontinuity extraction should be done on the pointcloud or a mesh is a project by project decision. This process is visualized in Figure 1.

**Figure 1. Point-Cloud Processing Workflow Used to Develop a Three-Dimensional Mesh (2)**

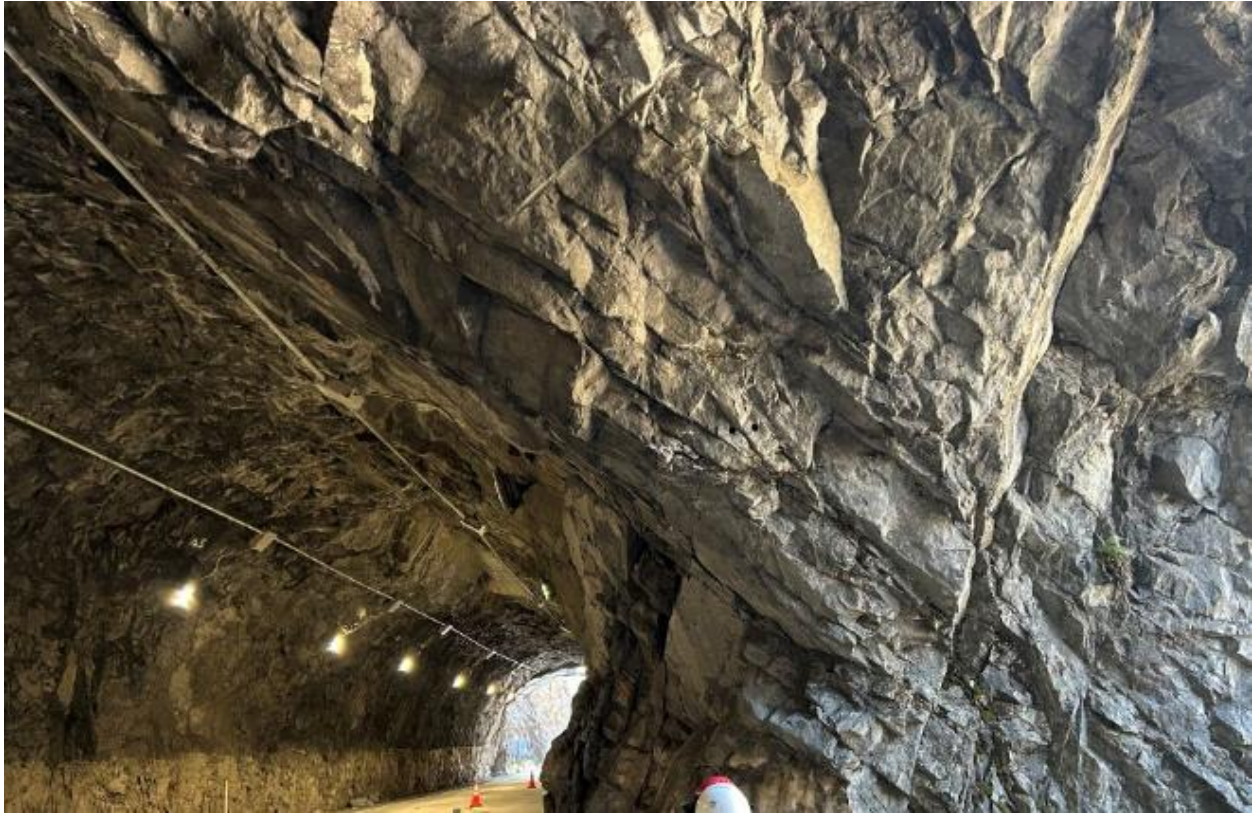
The tunnel is excavated in the Grizzly Creek Pluton, described as a coarse-grained hornblende-biotite-quartz-plagioclase monzotonalite that locally grades into diorite. The rock mass has a strong exfoliation structural trend that produces sheets and slabs roughly parallel to the modern topographic surface. In the tunnel crown, exfoliation surfaces combine with cross-cutting joints to form detachable roof blocks (1, 2). A view of the rock bedding and cross-cutting joint relationship within the tunnel is provided as Figure 2.

**Figure 2. View of exposed rock within the Elephant Butte Tunnel**

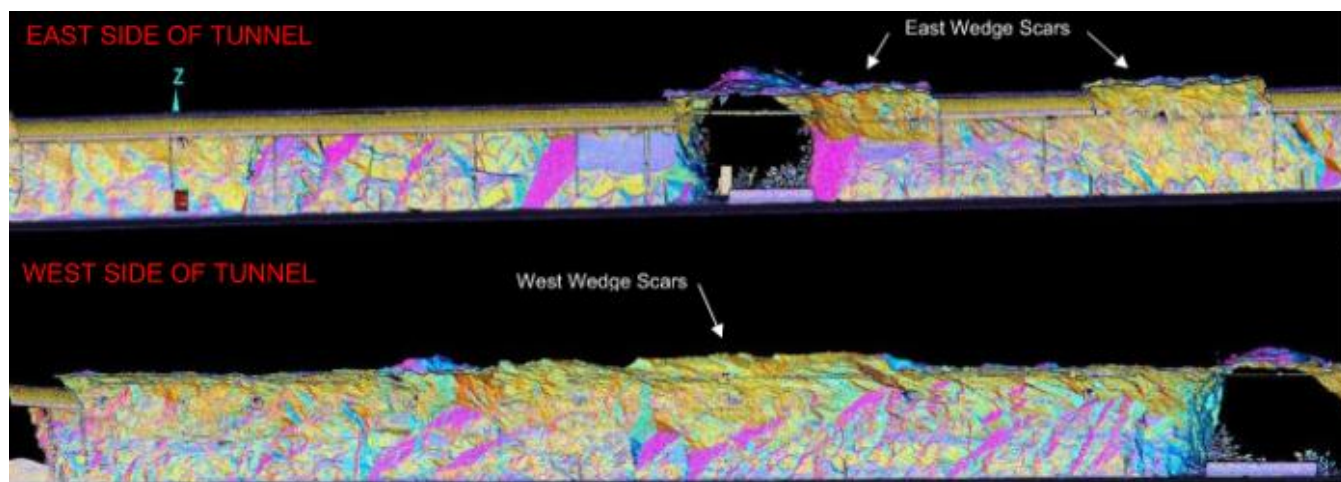
The 3D mesh model of the tunnel can be colorized for dip direction, which can help in visually selecting discontinuities. It also provides a clear image of how discontinuities are presented in the 3D model. A view of this is provided as Figure 3.

**Figure 3. View of Elephant Butte Mesh, Colorized for Dip Direction of Surfaces**

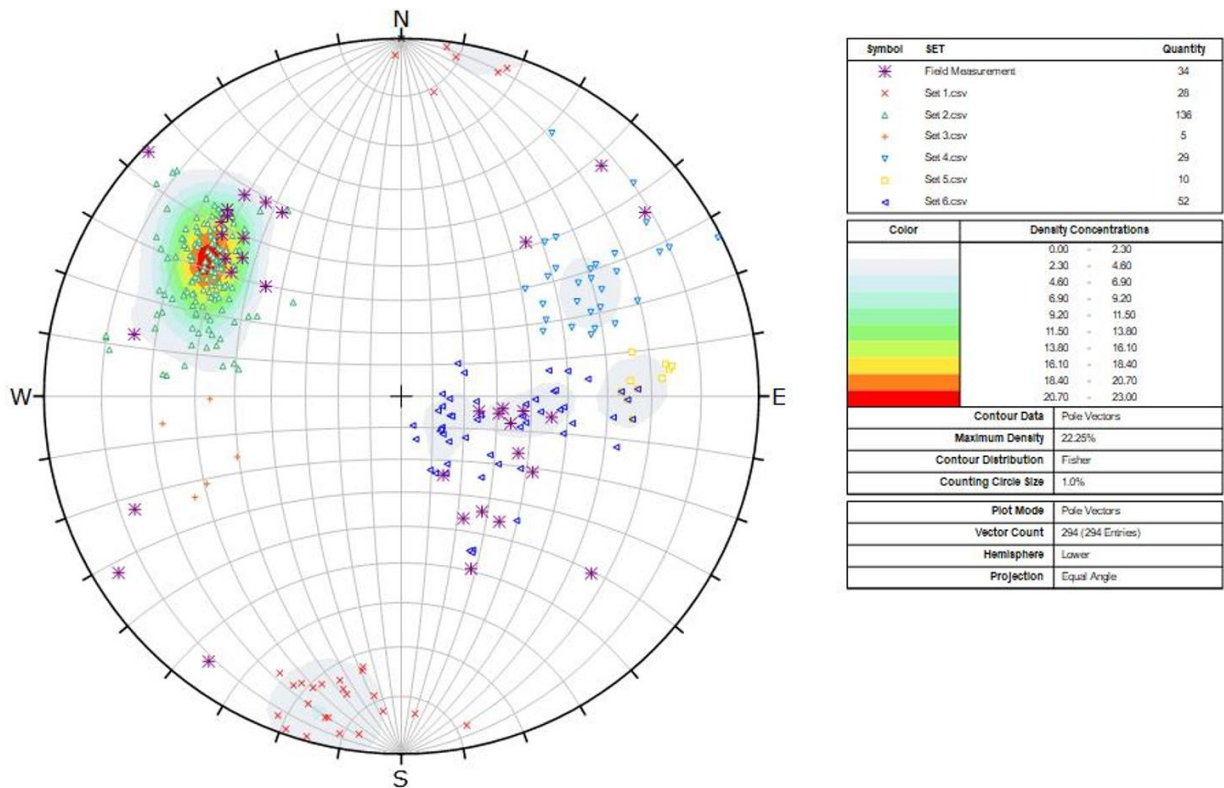
Six structural sets were identified from the tunnel mesh and plotted against measurements taken in the field by experienced geologists using the RocScience DIPS software. The mean orientations from the project report are summarized in Table 2, and the LiDAR-derived stereonet outputs are shown in Figure 2.

**Figure 3. Elephant Butte Tunnel Stereonet Output Used to Compare Joint-Set Orientations of Field and LiDAR-Derived Datasets (2)**

For the tunnel, TLS increased the mapped area by allowing the crown and upper walls to be reviewed from the point cloud. These surfaces are difficult to map directly and consistently from the roadway. The mesh allowed the same exposed surfaces to be reviewed after the field visit and provided a reproducible basis for assigning discontinuity sets. The principal limitation was that LiDAR measured exposed geometry, not internal persistence. In general, it can be gleaned from Figure 3 that field and LiDAR derived measurements match aside from with regard

to Set 1. Set 1 was particularly prominent along the tunnel crown where physical access by HDR geologists was not feasible. In this case, it was necessary to carefully check the discontinuity set on the 3D mesh and validate that the measurements were accurate and not false readings.

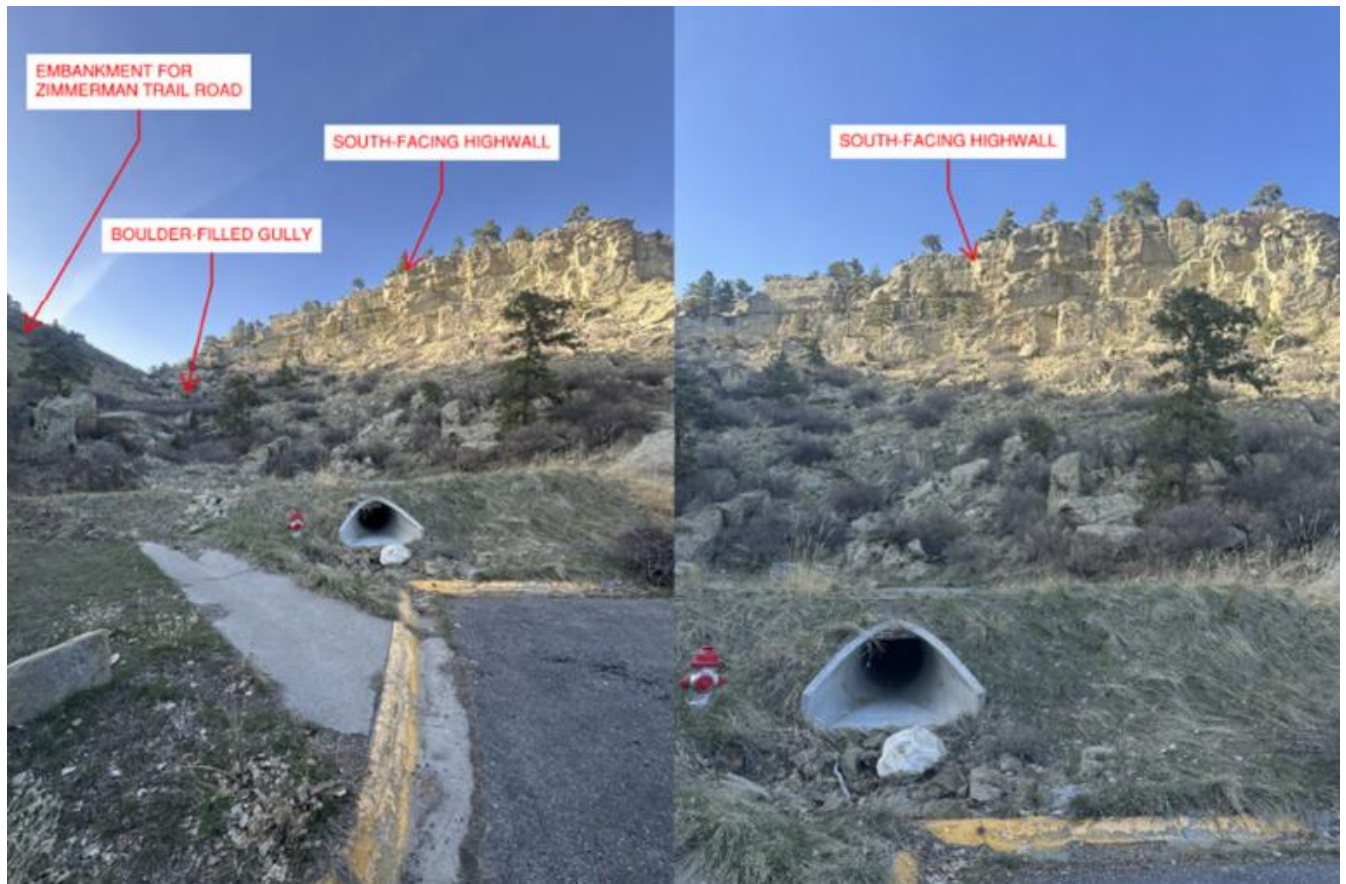
The April 7, 2025 field visit documented changes in rock mass character from east to west, including differences in block size, bedding expression, weathering, calcite-rich sandstone, dissolution features, and local raveling. Measurements of rock bedding and discontinuity orientation were collected by experienced HDR geologists. Separately, a UAV drone mapping program was performed at the project site which focused on the cliffs above and at the project area. A view of the project area with some notable points of interest is provided as Figure 4.

**Figure 4. View of the Stagecoach Project Area with Notable Areas of Interest (3)**

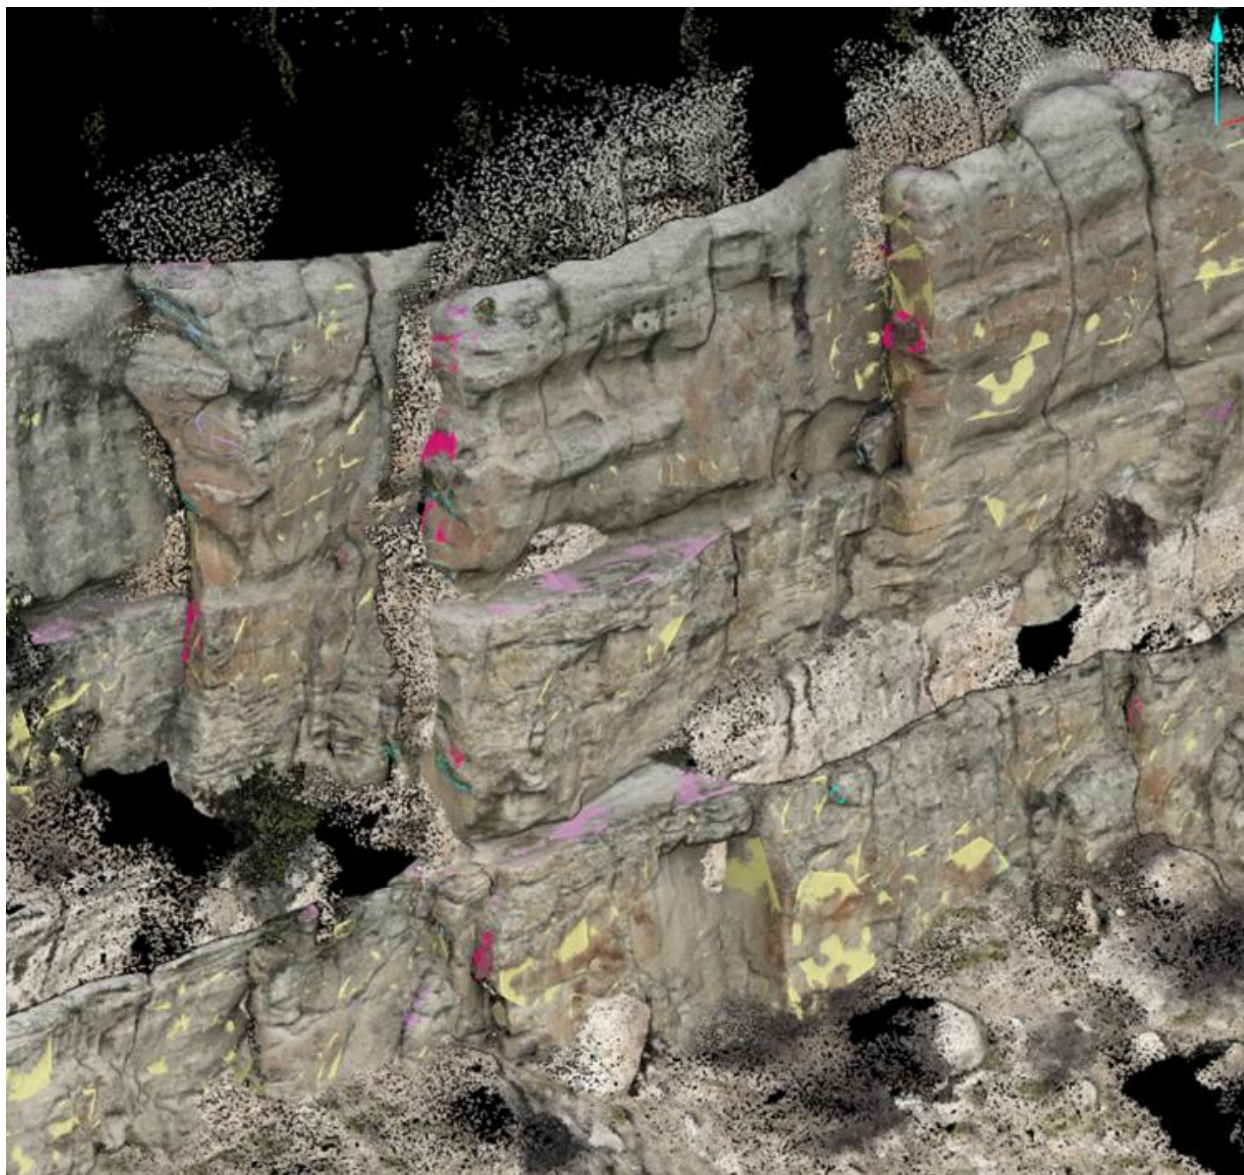
**Figure 5. View of Discontinuity Sets As-Measured on the 3D Pointcloud**

The two datasets provided different types of information. UAV mapping provided broader coverage of steep and elevated surfaces that could not be mapped efficiently from the ground. Field mapping provided direct confirmation of bedding, smaller-scale joints, weathering characteristics, calcite-rich zones, and observed surface conditions. The comparison supports use of a combined workflow in which the point cloud expands mapped coverage and field mapping provides geologic confirmation. A sample view of the extracted discontinuities on the 3D LiDAR dataset is provided as Figure 5 to visually show how the extraction presents on the model.

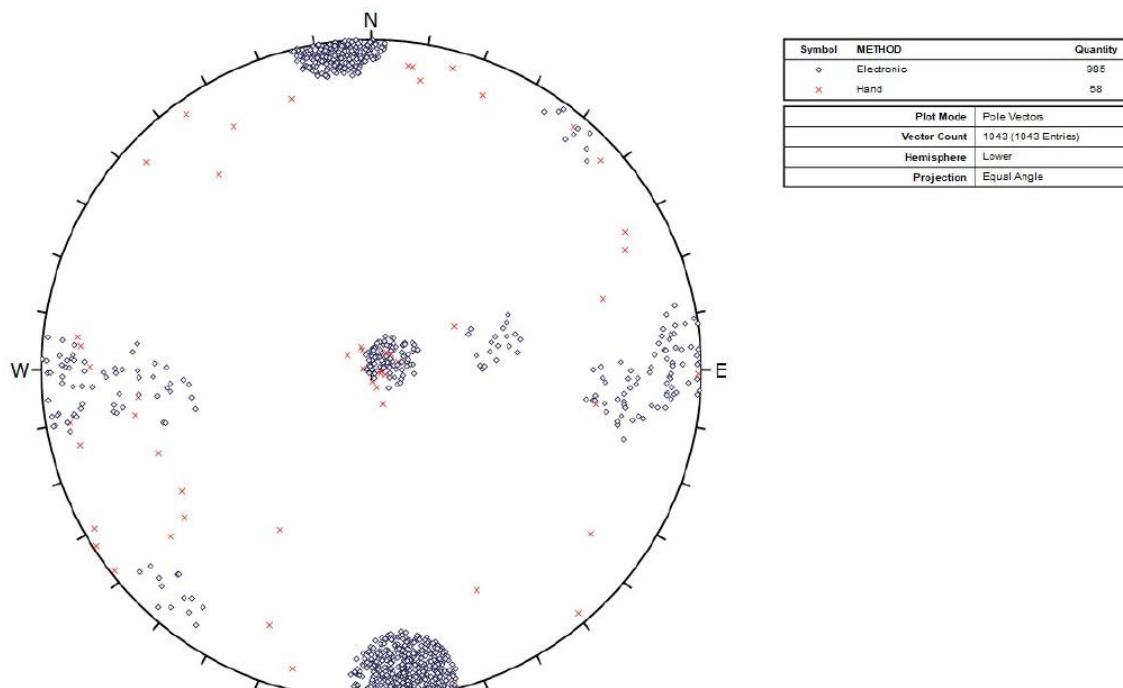
The stereonet comparison in Figure 6 indicates that the LiDAR-derived dataset and the smaller hand-measured dataset captured similar principal discontinuity trends. The LiDAR-derived dataset also provided a larger number of measurements and better coverage of elevated highwall exposures.

**Figure 6. Stagecoach Trail Stereonet Comparing LiDAR-Derived and Hand-Measured Discontinuities (3)**

The Stagecoach Trail data indicate that measurement count alone is not sufficient to evaluate a structural dataset. The UAV-derived dataset provided more measurements and captured elevated discontinuity surfaces that were not practical to reach from the ground. The smaller hand-measured dataset provided a check on surface origin, weathering, joint condition, and smaller discontinuities. Both datasets were needed to evaluate the reliability of the discontinuity mapping. It is also particularly helpful to determine frequency of orthogonal joint sets within sandstone bedrock. Field measurements encountered many near-vertical orthogonal measurements, but electronic measurement confirmed which orthogonal joint sets were most prevalent along the cliff band.

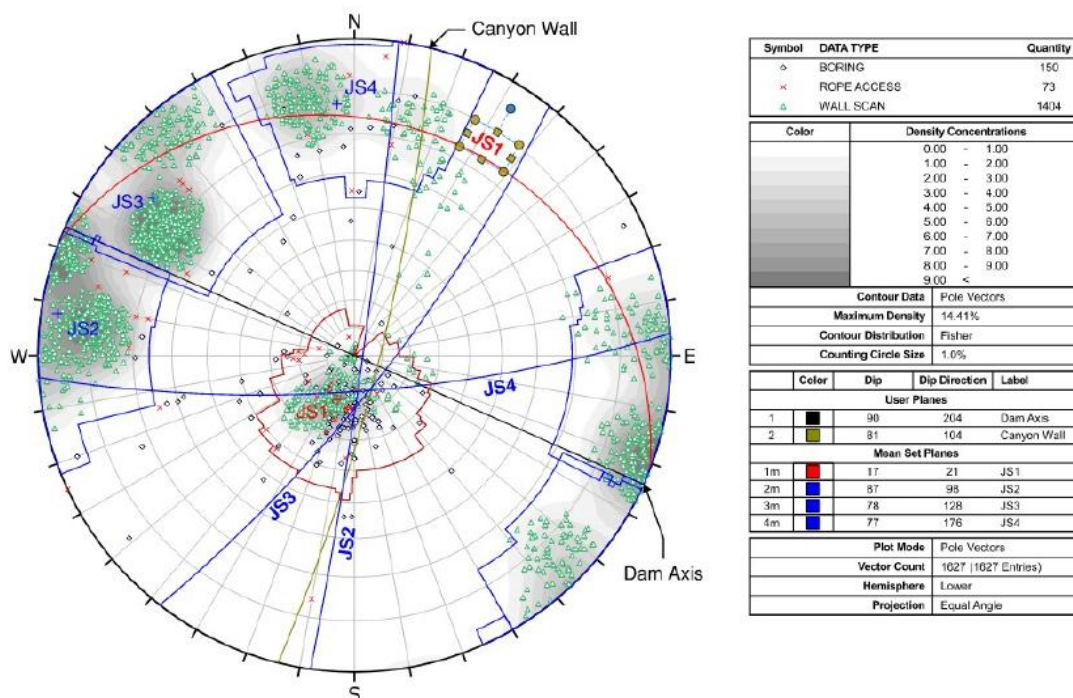
The left-abutment stereonet in Figure 7 shows how LiDAR-derived measurements were compared with conventional structural observations. Figure 8 shows the left-abutment rock-wall scan and rope-access scanline locations used to compare the mapping methods. Televiewer data was performed at various borehole locations across the project site.

In general, good agreement was found between wall scan data measurements and those taken via rope access or downhole televiewer.

**Figure 7. LaPrele Dam Left Abutment Stereonet Showing Boring, Rope-Access, and Wall-Scan Measurements (6)**

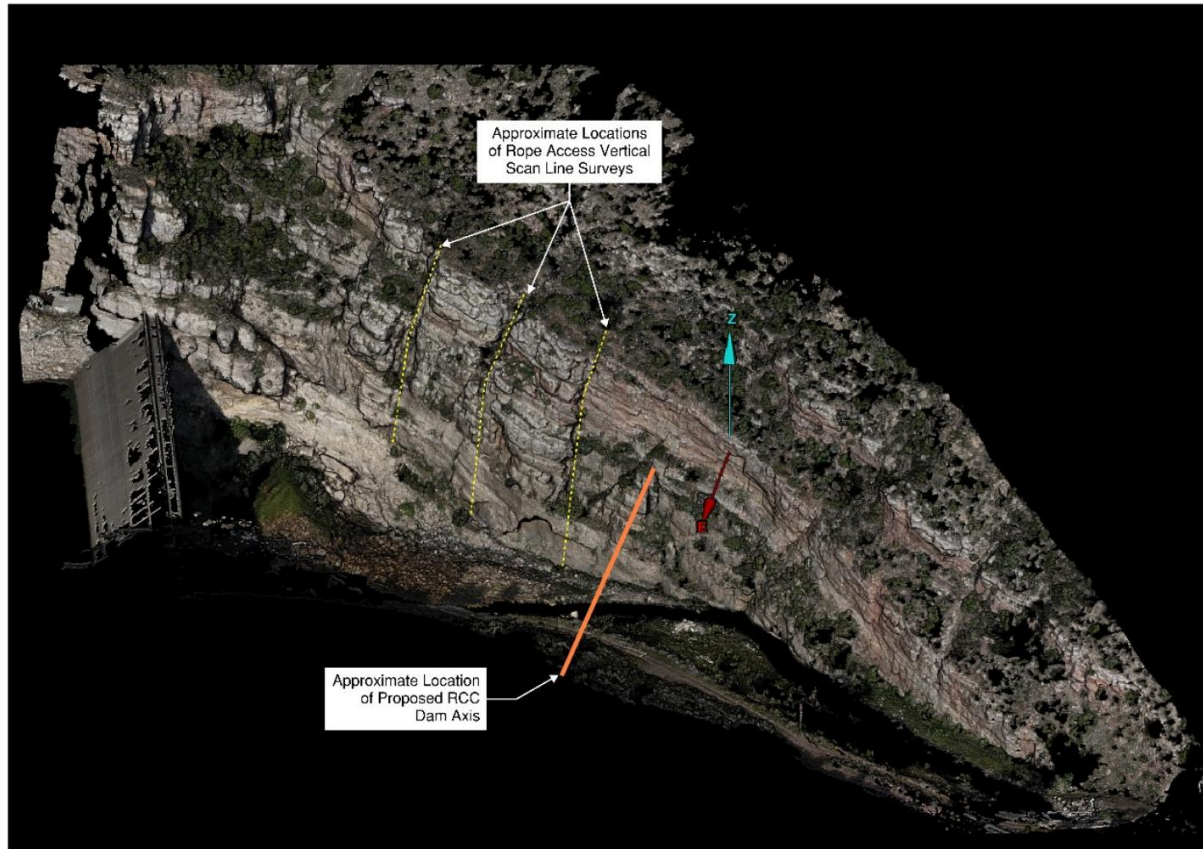
**Figure 8. LaPrele Dam Left Abutment Rock-Wall Scan and Rope-Access Scanline Locations (6)**

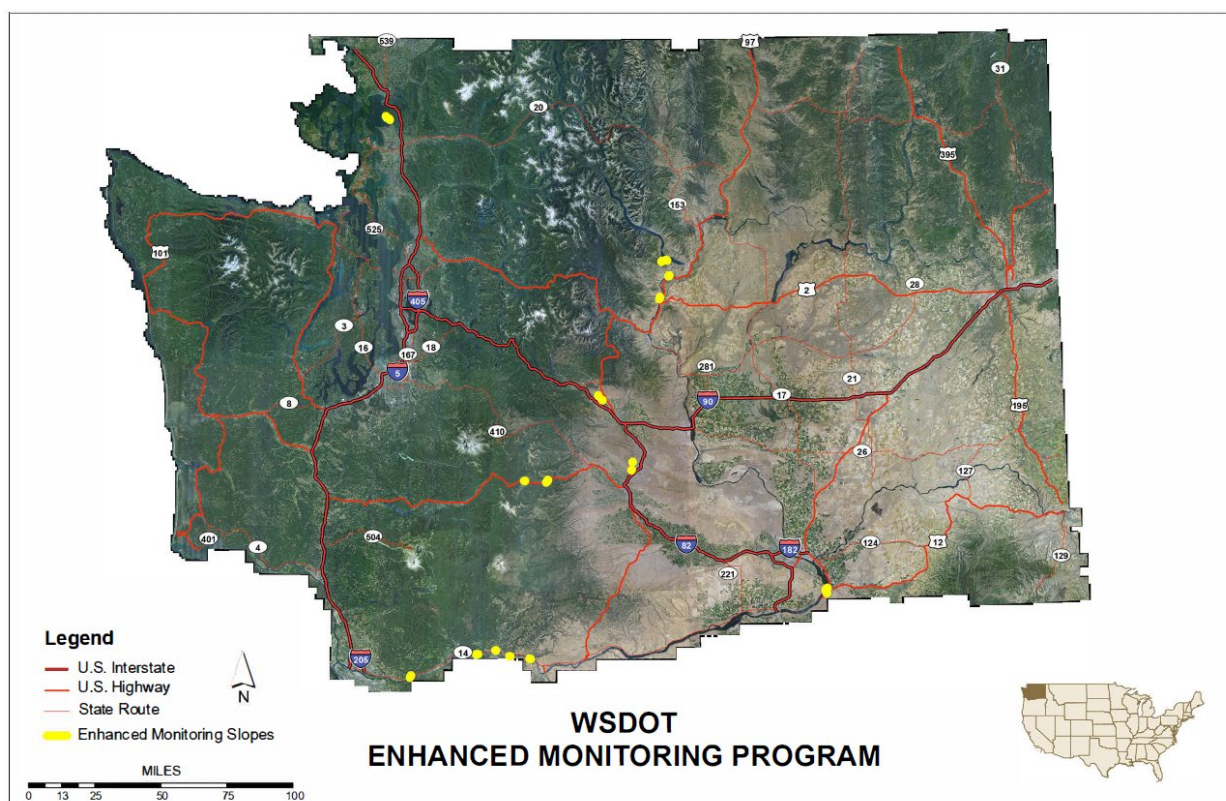
Through this risk-based prioritization process, WSDOT has identified high- and very high-risk unstable slopes throughout the state highway system. The slopes currently considered for enhanced monitoring are distributed across several regions of Washington and include both rock slopes and landslides. Figure 1 shows the statewide distribution of the high-risk unstable slopes included in the proposed enhanced monitoring program.

**Figure 1 – Map of High-Risk Slopes in Washington State for Enhanced Monitoring Program**

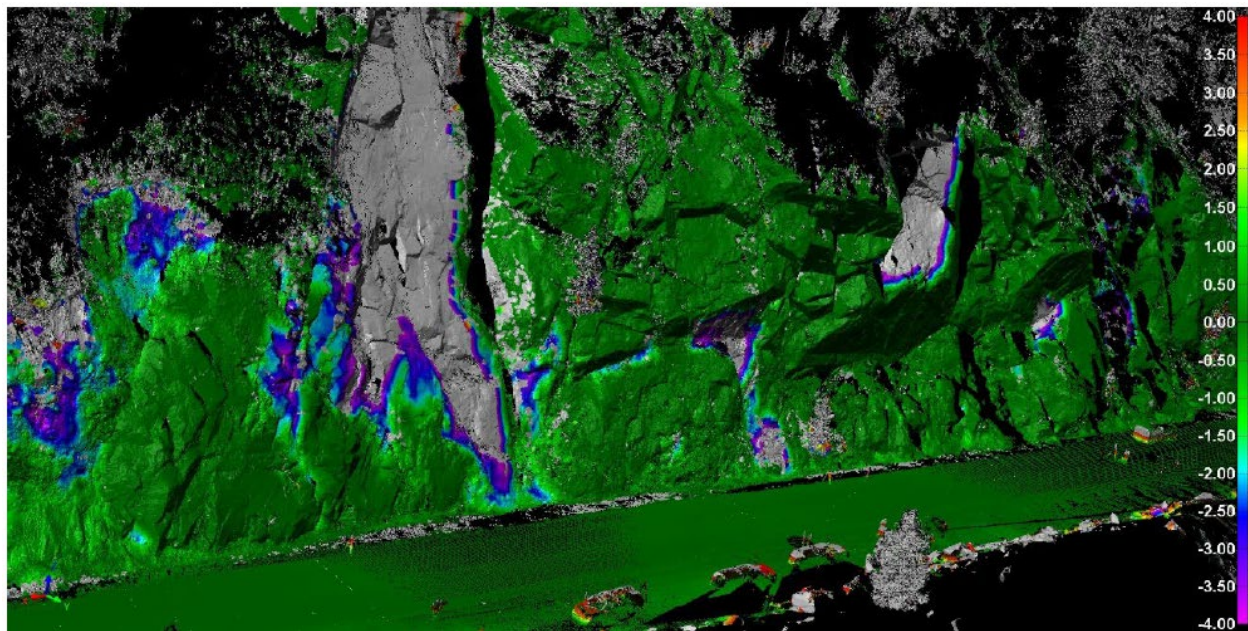
Terrestrial lidar is particularly effective for exposed rock cuts, where high-resolution measurements of the slope face can be obtained from accessible locations along the highway. Repeat datasets can be used to identify the location and extent of rockfall activity. Figure 2 shows an example of lidar change detection along SR 971.

**Figure 2 – Example of lidar change detection analysis along SR 971, gray, blue, and purple areas indicate areas where rockfall has occurred.**

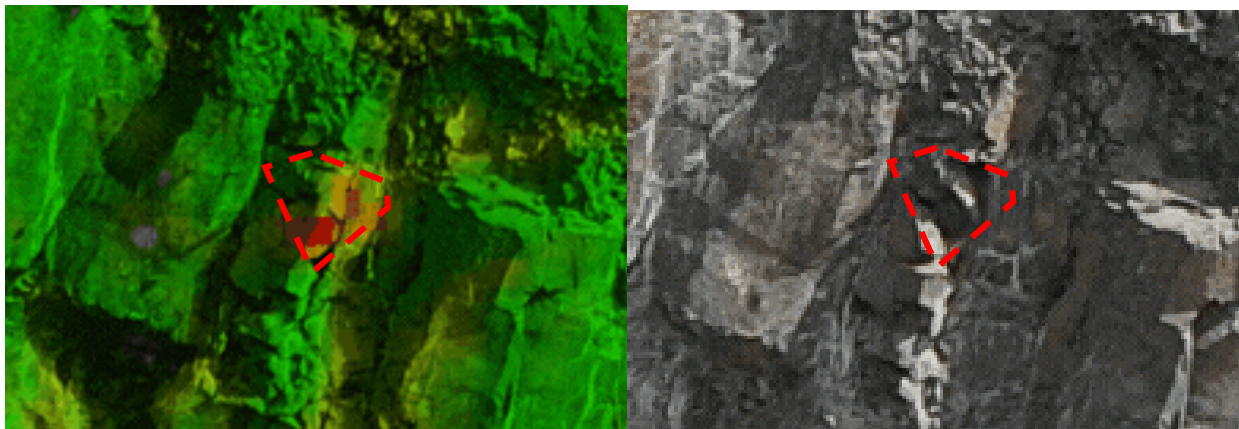
**Figure 3 – UAS Change Detection Analysis Example from SR 14 (Figure Courtesy of Re-Monitor/Nhazca)**

WSDOT previously evaluated UAS-based change detection along SR 14 as an early application of this approach. High-resolution imagery collected during repeat surveys was compared using pixel-based change detection, successfully identifying the source location of a small rockfall that occurred between surveys. This application demonstrated the potential for UAS monitoring to identify localized rockfall activity that may be difficult to document through routine inspections alone. Figure 3 presents an example of the SR 14 change detection results.
