# 75<sup>TH</sup> HIGHWAY GEOLOGY SYMPOSIUM

BETTER HIGHWAYS THROUGH APPLIED GEOLOGY

2026  
HGS  
PROCEEDINGS

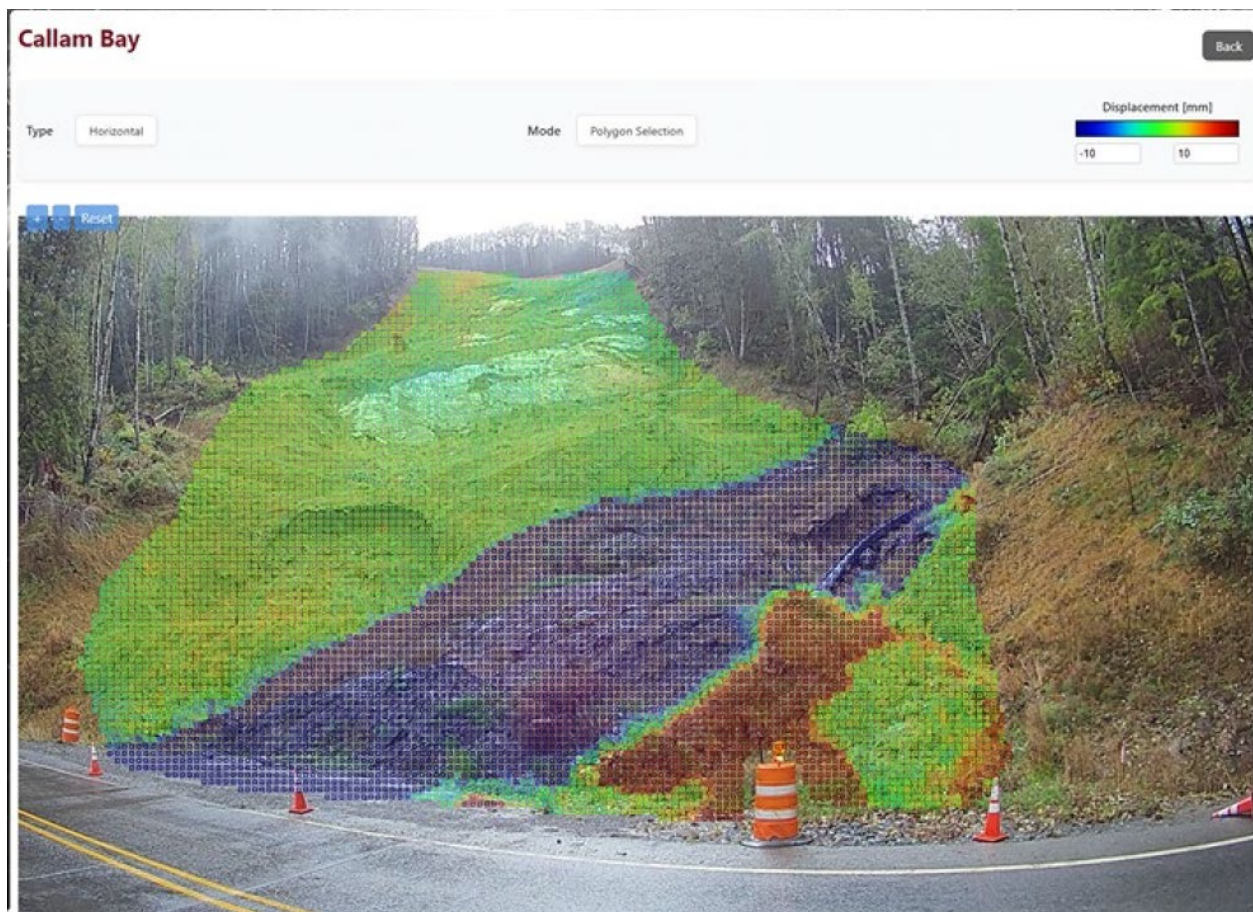
**Figure 4 – Example of change detection analysis using fixed camera imagery for the Clallam Bay Landslide. This was completed using propriety software.**

WSDOT previously evaluated fixed-camera monitoring and image-based change detection at the SR 112 Clallam Bay landslide. Repeat imagery was analyzed using pixel-level change detection to identify movement within the landslide. This early application demonstrated the potential for fixed-camera imagery to monitor an active landslide and helped inform its proposed use within the broader enhanced monitoring program. Figure 4 presents an example of the SR 112 change detection results.

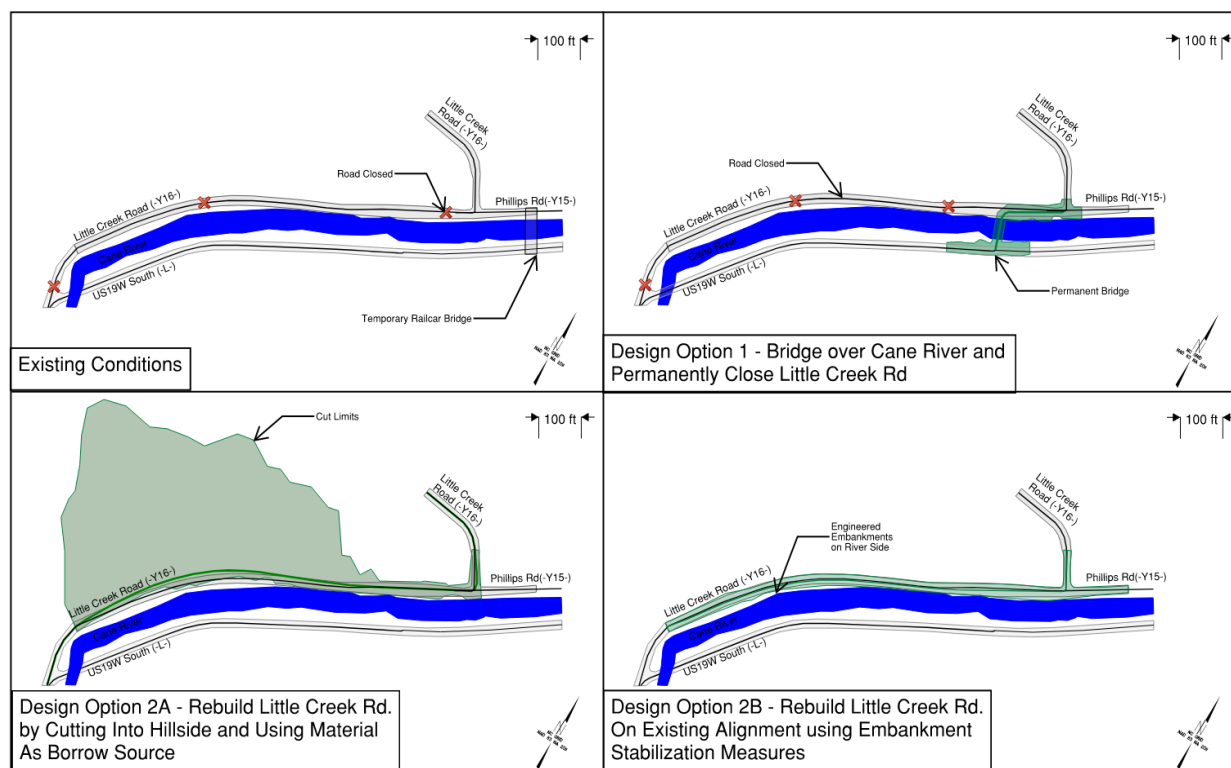
**Figure 1. Design Options for Little Creek Road**

The focus of this paper is to describe the geotechnical investigation, analysis, and recommendations of design Option 2A, cut slope with Little Creek Road rebuild, while working within the constraints, and benefits of, of the PDB project delivery method.

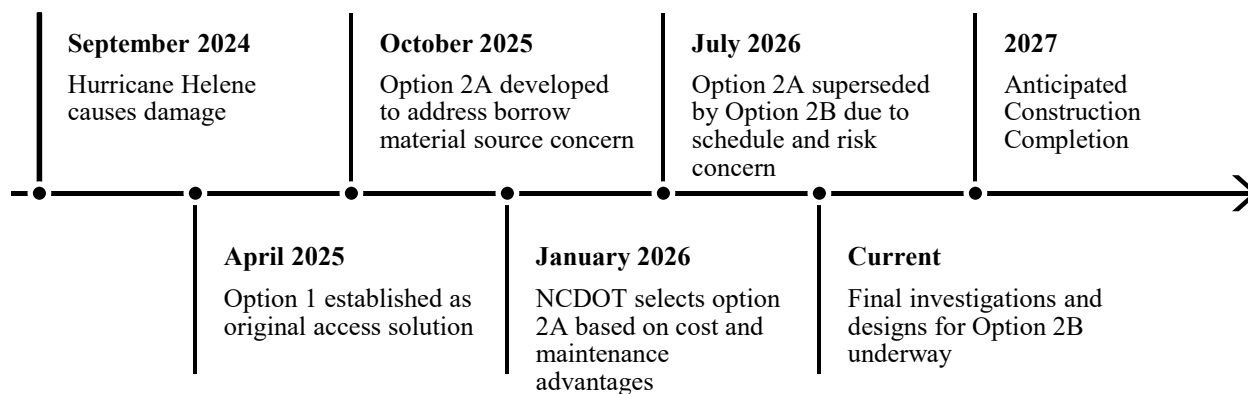
**Figure 2. Little Creek Road Design Evolution Timeline**

By July 2026, concern for constructability and risk began outweighing the pros of Option 2A. However, instead of resorting back to Option 1, an alternative design, Option 2B, was proposed. Design Option 2B, to rebuild Little Creek Road through engineered embankments, was selected over Option 2A in July 2026. Additional investigations are ongoing to support final plan design of Option 2B, with construction scheduled to be completed by Summer 2027.

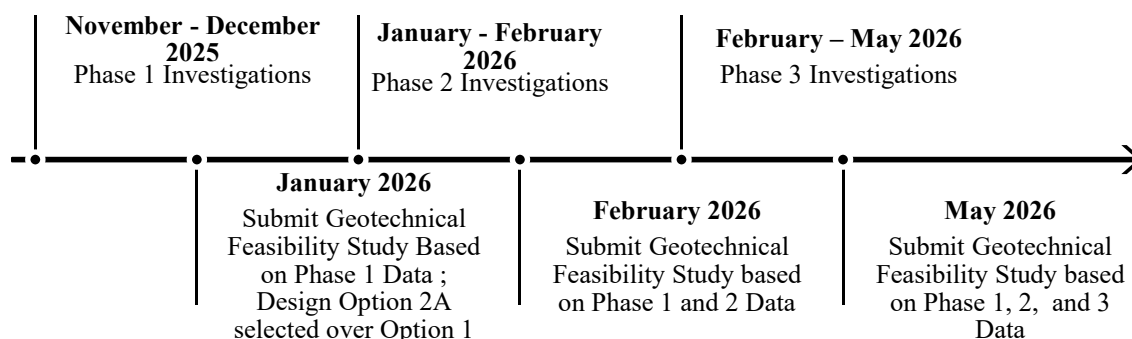
**Figure 4. Evolution of Design Phase 2A Geotechnical Feasibility Report**

Design Option 1 was not geotechnically investigated prior to abandoning the new bridge crossing in favor of Option 2A. Due to the geotechnical sensitivity and schedule of Design Option 2A, investigations were separated into three phases and were performed from November 2025 to May 2026. The design decision between Option 1 and 2A was made after Phase 1 investigations were completed in January 2026. Phase 1 included surficial geologic mapping and seven (7) vertical standard penetration test (SPT) and rock core borings. Six (6) of the Phase 1 borings were located along Little Creek Road, and one (1) at the crest of the mountain. Phase 2 included an additional twelve (12) vertical borings along Little Creek Road. Phase 3 included geophysical survey testing. The geotechnical feasibility report was re-issued at each phase of investigations as more data and testing became available. Additional borehole data on the existing rock and soil slope was not collected due to site access and permitting delays. Investigations to support the design of Option 2B are ongoing and not included in the investigation summaries below.

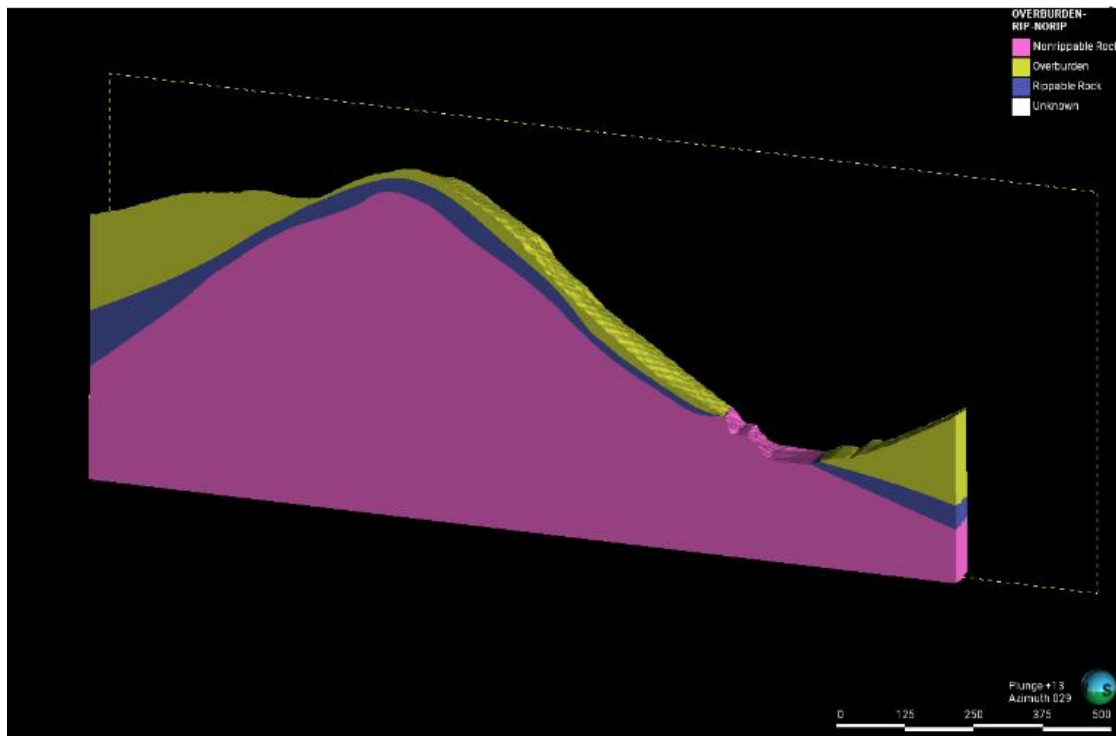
Figure 6. Leapfrog Works Subsurface Model

Geologic cross-sections and profiles are historically drafted in 2-D using Microstation GEOPAK software for NCDOT projects, but the use of 3-D modeling software for this site was crucial for developing geometric extents of layers due to the variability in type of data, phased data collection methods, and due to the mountainous, steep topography. Using Seequent's Leapfrog Works program, a 3-D geologic model was developed using a site-specific DEM as the primary model topography. The SRT seismic velocity profiles for all 16 lines, borehole data, and surface mapping results were incorporated into the model to establish estimated 3-D volumes for the three (3) generalized material layer types. Once the model was completed, the 3-D surfaces for each layer boundary were provided to HDR's Roadway designers and incorporated into Microstation for use in 2-D design. The roadway engineers can use the model and apply it to not only Design Option 2A, but also future (Option 2B) designs, without any additional effort from the geotechnical team. Below are example figures of the 2-D subsurface model produced in Leapfrog and import results in Microstation.

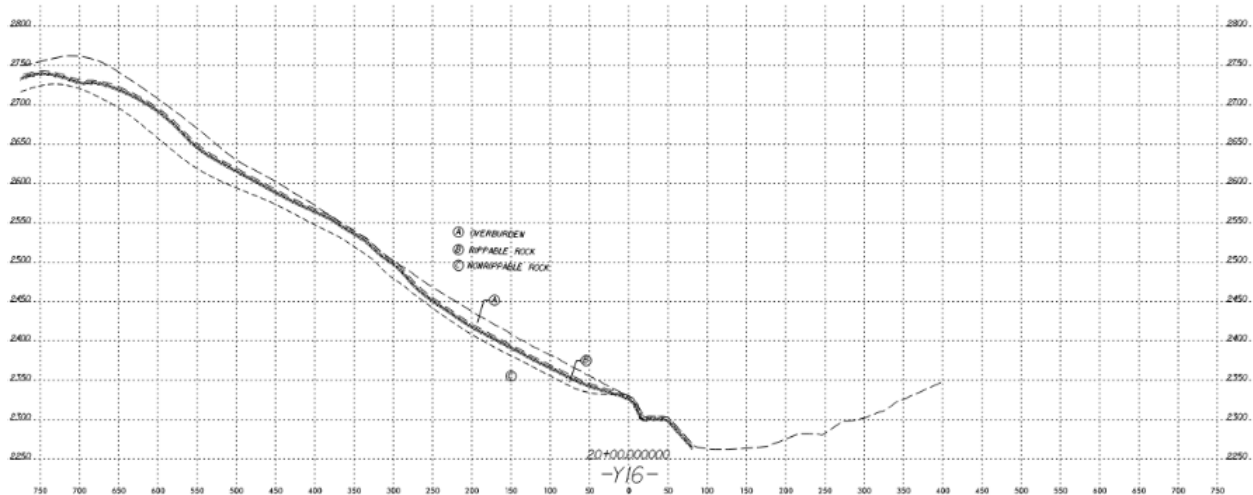
Figure 7. 2D Cross-Section of Subsurface Model from Microstation

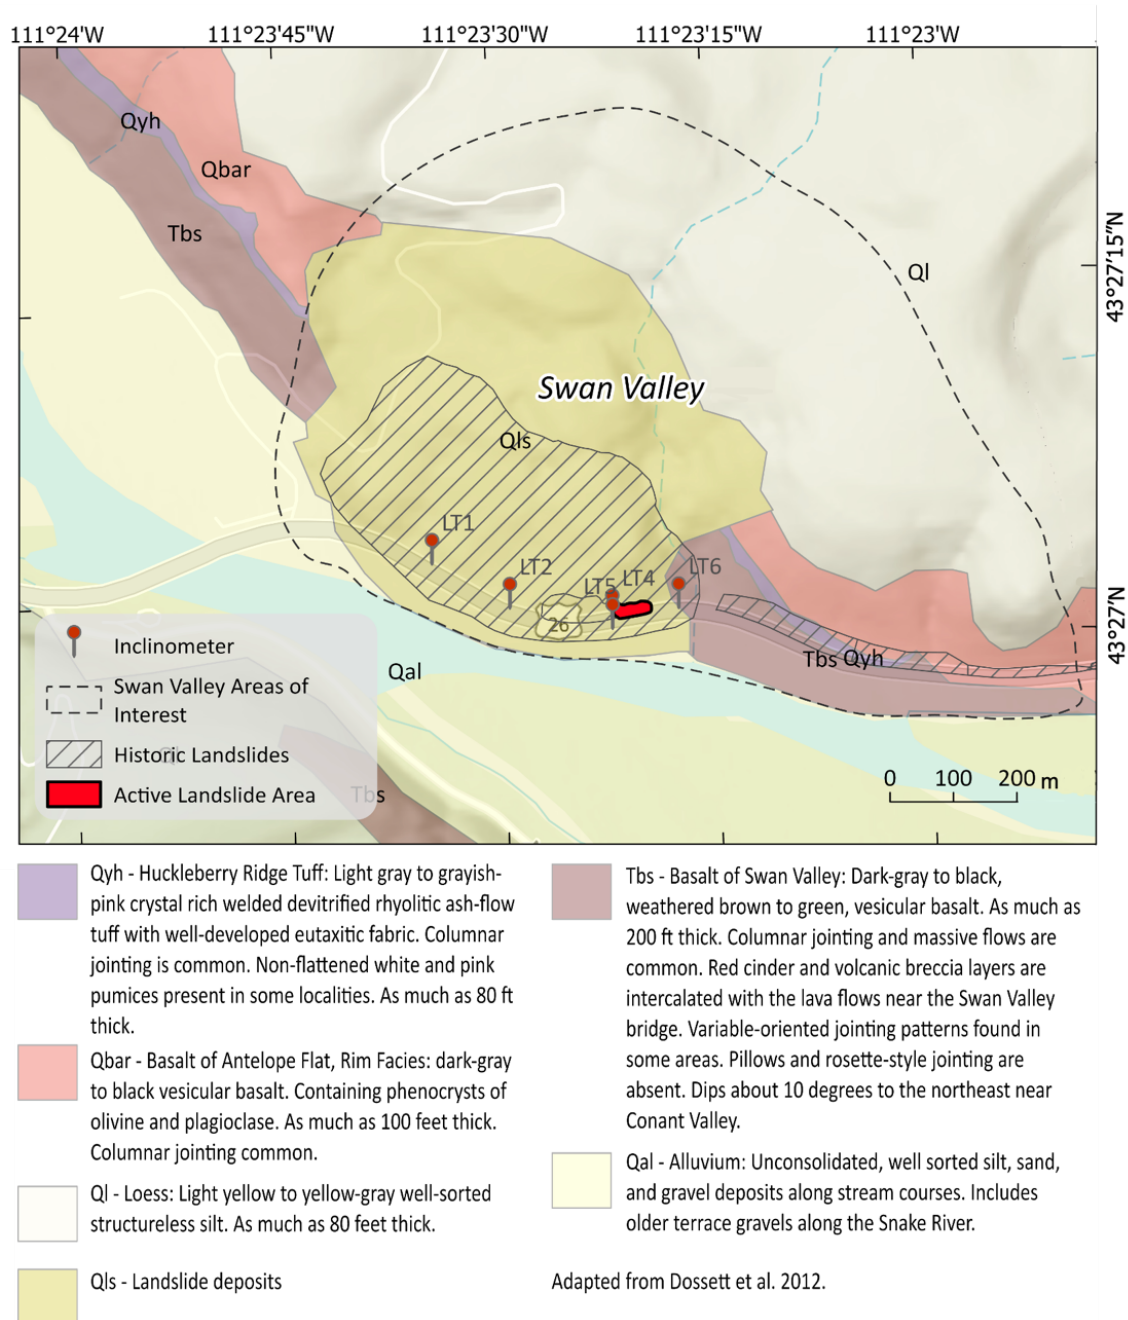
**Figure 2 – Swan Valley Geologic Map**

The Swan Valley site is underlain by a sequence of Tertiary and Quaternary volcanic, eolian, and alluvial deposits that control the site's history of slope instability (Figure 2). Five principal soil and rock units are identified within the complex: loess (Ql), alluvium (Qal), landslide debris (Qls), basalt (Qbar/Tbs), and tuff (Qyh) (2). The uplands overlying the slide-prone slopes are mantled by a structureless, silt-dominated loess (Ql) that reaches thicknesses of up to 80 ft (24 m). This eolian cap unconformably overlies a volcanic sequence comprising the Quaternary-age Antelope Flat Basalt, the regionally extensive Huckleberry Ridge Tuff, and the older Tertiary-age Swan Valley Basalt. Where exposed, these units are expressed as black, columnar, vesicular basalt interbedded with devitrified rhyolitic ash-flow tuff with columnar jointing (2). Available literature suggests the majority of landslides within the highland areas of the study are not presently active, with observed movement generally limited to slow incremental creep. Landslides post-dating the loess deposits are, in most cases, now dormant; however, localized reactivation, as documented during the investigation, demonstrates these features retain the potential for renewed movement (2,3,4,5).

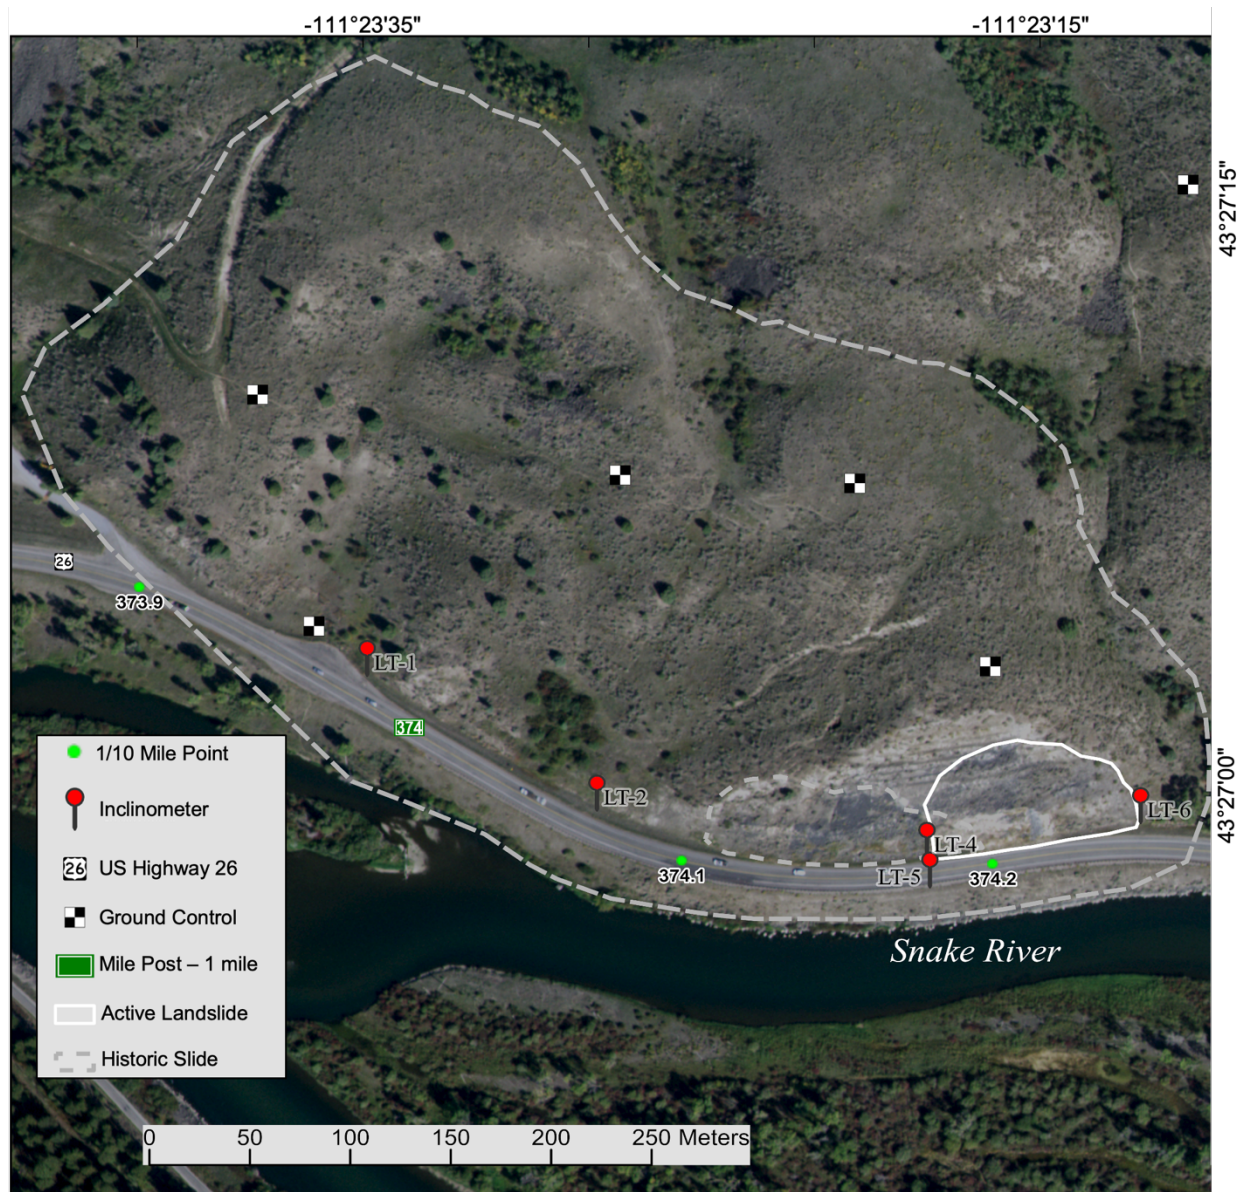
**Figure 3 – Ground Control and Inclinometer Locations**

Ground control points (GCPs) are used to georeference remotely sensed data, ensuring that imagery can be accurately aligned spatially. High-contrast mesh targets with clearly defined centroids were placed throughout the survey site, providing known coordinates distinguishable within the RGB and LiDAR UAS surveys. Mesh target GCPs were positioned outside of potential viewing angle obstructions throughout the topographic highs and lows of the study area (6). GCP coordinates were recorded with paired base-and-rover survey-grade GPS units (Emlid RS2) and processed using PPK (post-processing kinematics) workflows. Poorly situated targets hidden from the flight path, on unstable ground, or visible in fewer than four images have been found to degrade survey accuracy (7). Given this variability, 6 GCPs were placed at the Swan Valley site to ensure adequate visibility (Figure 3).

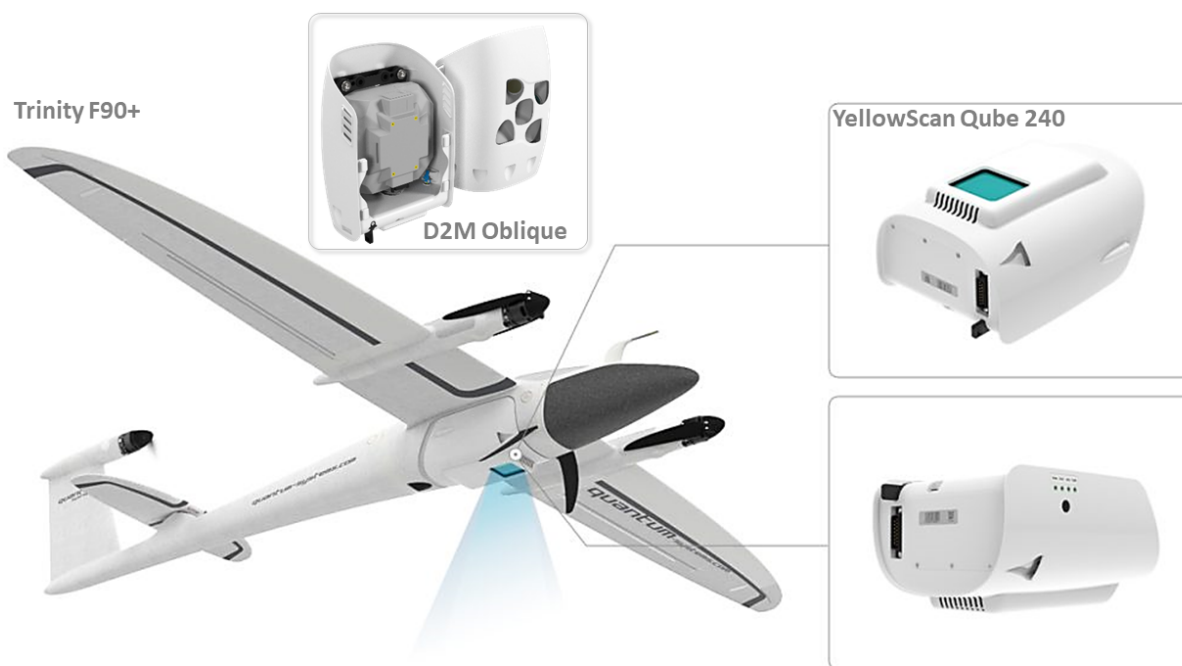
**Figure 4 –Trinity F90+ platform, Yellowscan Qube 240 LiDAR sensor, and D2M Oblique camera**

For this study, the YellowScan Q240 LiDAR system was utilized (Figure 4). The Q240 facilitated data collection at 50-100 points per square meter. The sensor is equipped with a geomatics-grade GPS with an estimated precision of 0.7–1.0 in (1.8–2.5 cm). This sensor

provided LiDAR coverage of the Swan Valley site in 2024. Due to a delay in Q240 delivery, 2023 flights instead used a D2M Oblique sensor payload, equipped with one nadir and four oblique 26-megapixel cameras (Figure 4). While unable to penetrate forest canopy like the Q240, this sensor excels at capturing detailed imagery of sloped and rugged terrain, providing a resolution of 1.8 cm/px at 120 m (394 ft) above ground level (AGL).

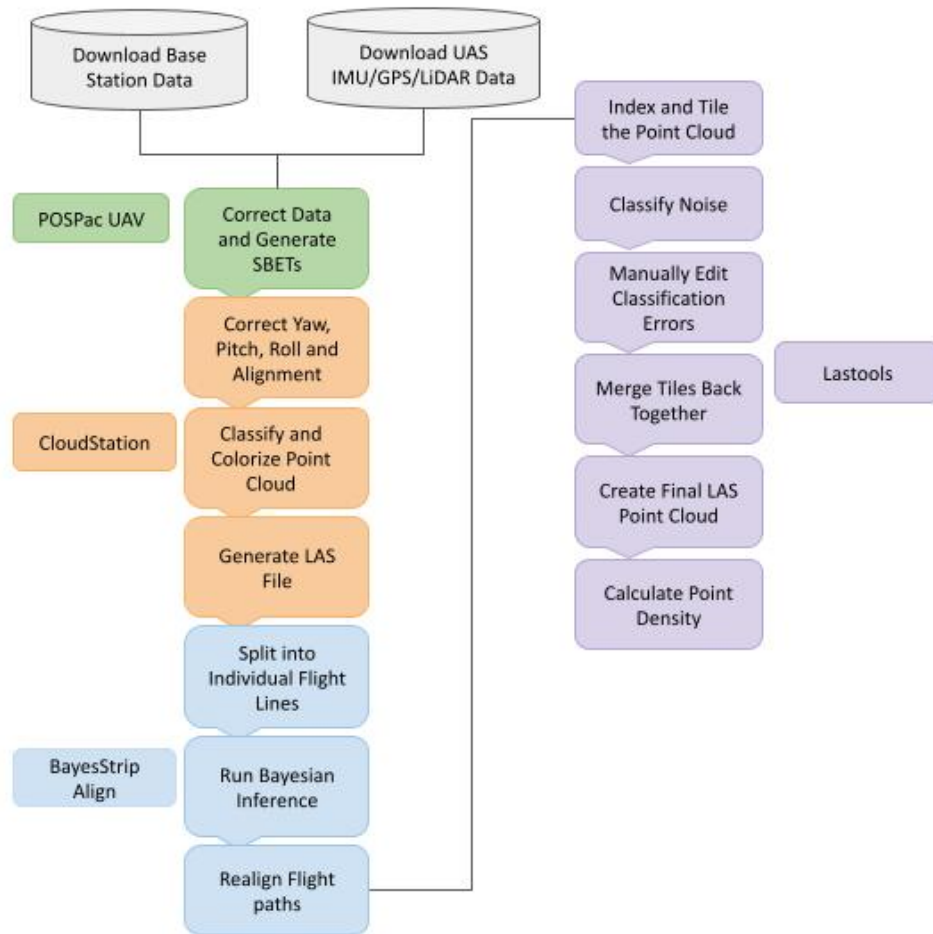
**Figure 5 – LiDAR and RGB Processing Workflow**

Although CloudStation runs a LiDAR strip alignment processing step, BayesStripAlign was used to further refine alignment by applying a Bayesian inference workflow to correct the absolute and relative geometric errors in individual flight lines (Figure 5). The software uses timestamped LAS files and SBET trajectories to register overlapping flight lines and correct errors associated with IMU drift, boresight misalignment, lever-arm errors, and internal geometry miscalibration. The study area was divided into individual flight lines before realignment using the applied corrections to generate new point clouds with improved accuracy. The flight lines were then realigned and exported as a new point cloud, resulting in alignment accuracy values with an XY RMS error of 0.14–0.36 m and a Z RMS error of 0.034 m.

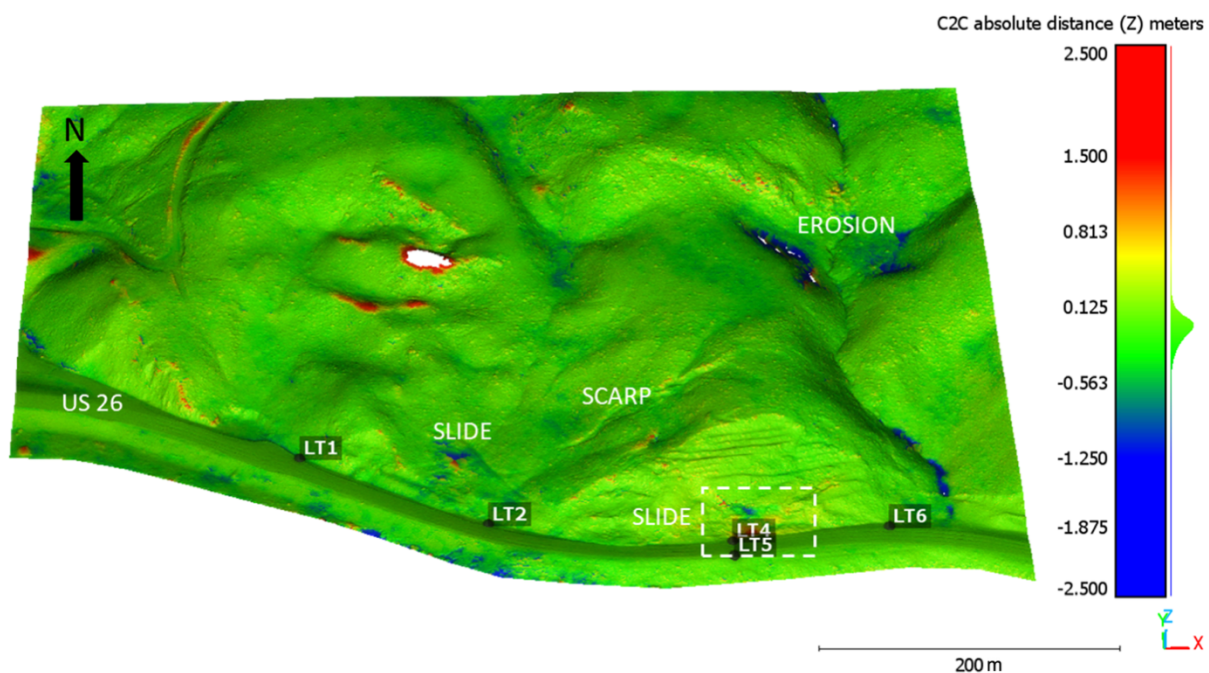
**Figure 6 – Swan Valley Change Detection July 2023 to June 2024**

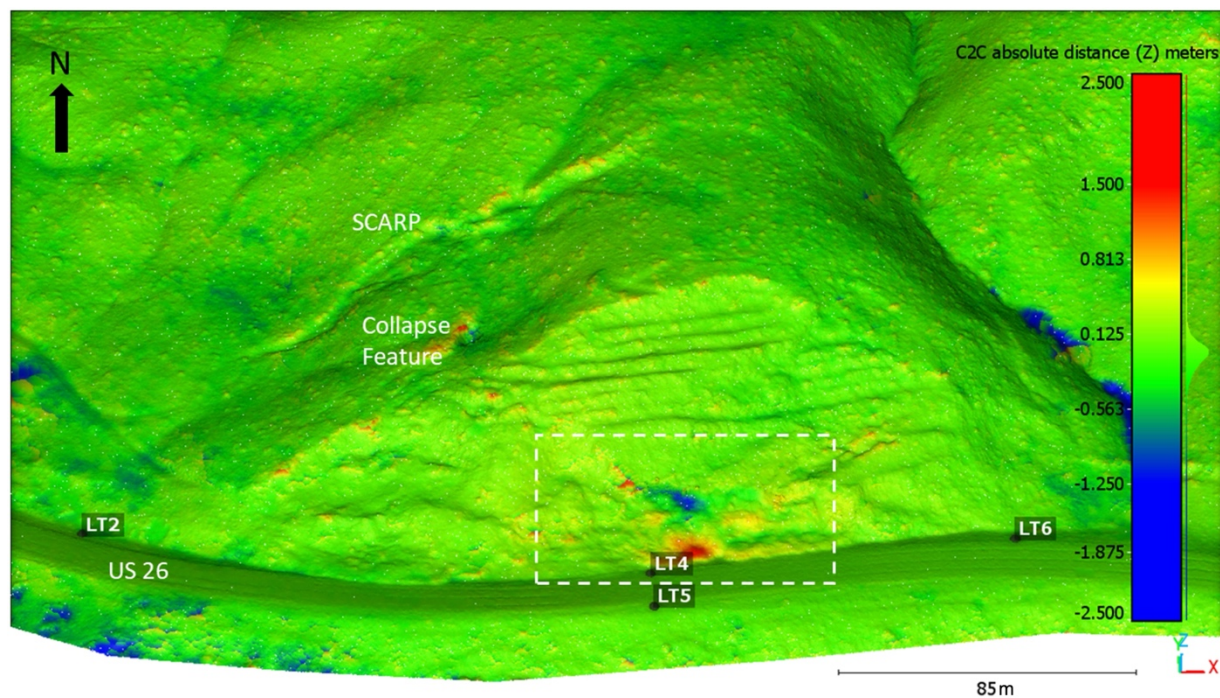
**Figure 7 – Swan Valley Change Detection Landslide Features July 2023 to June 2024**

An active landslide was detected between the July 2023 and June 2024 UAS surveys (Figure 7). Based on the movement pattern, the affected area is approximately 150 ft (46 m) wide and 105 ft (32 m) upslope. A scarp is noticeable at the top of the slide, and hummocky ground is present in and near the toe. The scarp at the top of the slide has a maximum downward

displacement of 8 ft (2.4 m). The corresponding maximum heave near the toe of the slope is approximately 4.5 ft (1.4 m).

A discontinuous linear feature is noted in the change detection approximately 400 ft (121 m) above the active slide area and is a positive indicator of a much larger future slide that could impact the highway (Figure 7). The UAS survey also revealed a major collapse feature along an intermediate scarp 265 ft (81 m) above the road. The depression serves as an active infiltration zone where surface water collects on the slope, flows underground, and saturates the downslope portion of the slide area, potentially leading to slope failure.

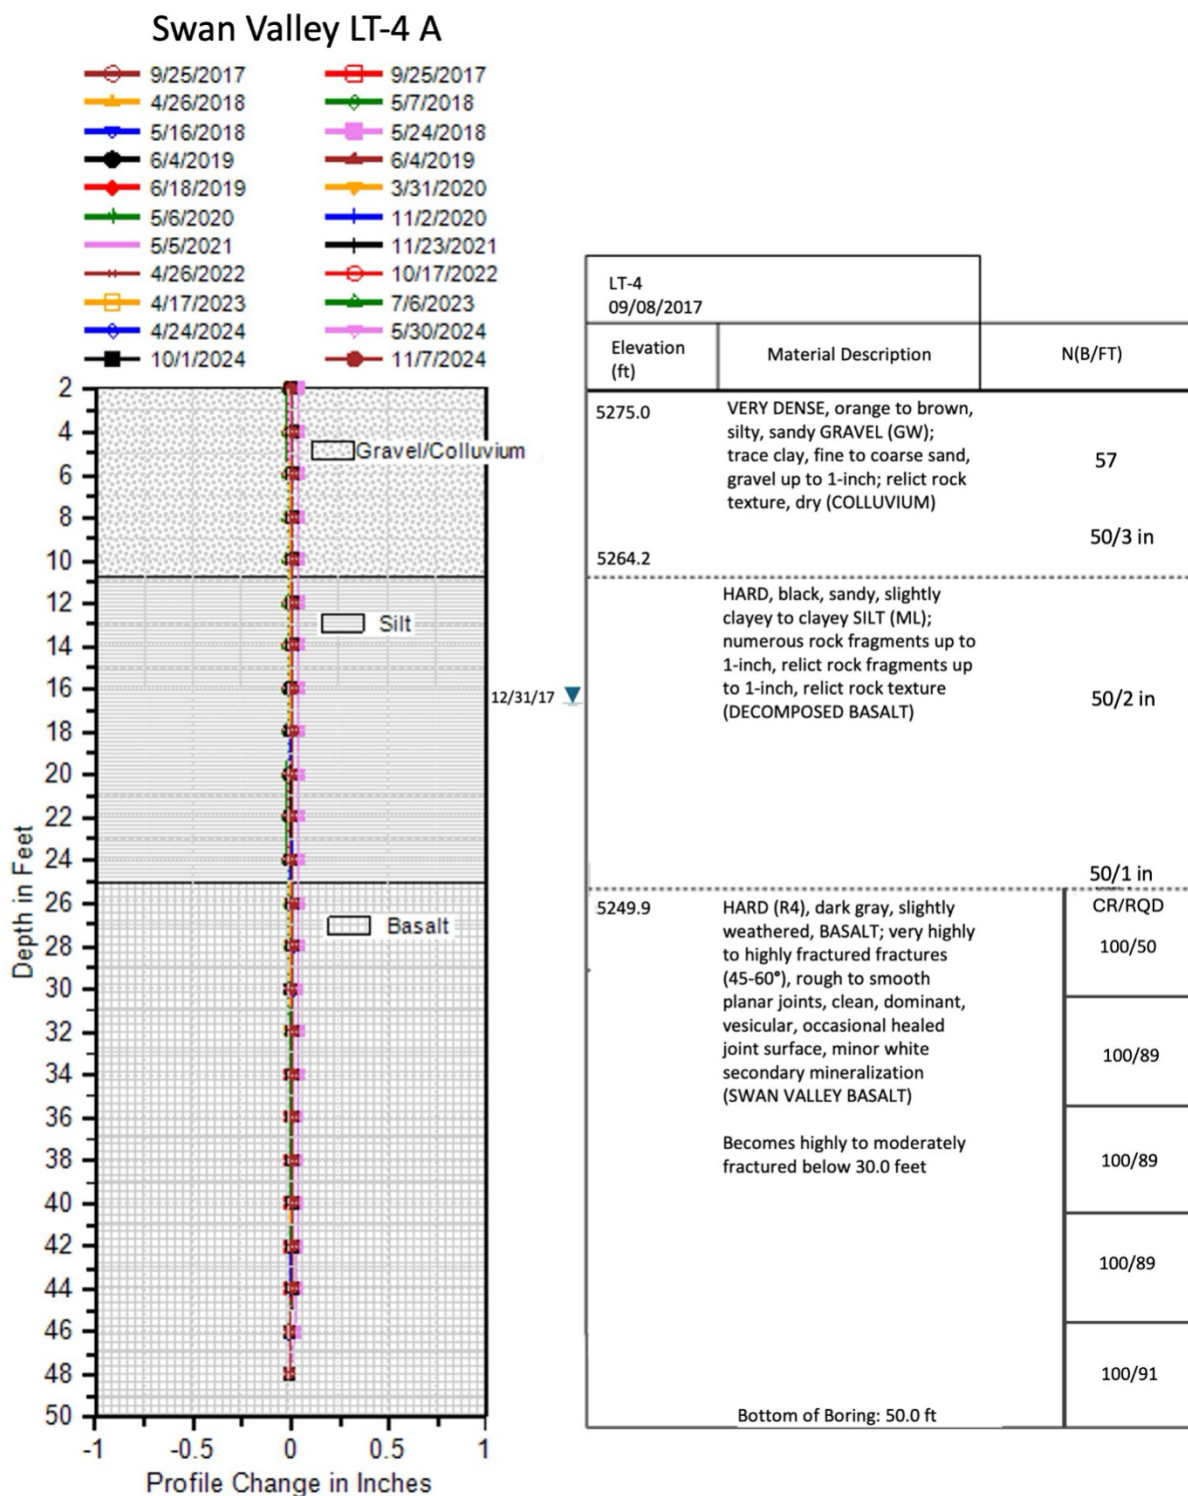
**Figure 8 – Inclinometer Displacements and Corresponding Log of Boring LT-4.**

Lateral displacement at depth was recorded in LT2 adjacent to the active slide area before and during the study period. The displacement-depth plot shows rigid body rotation movement of approximately 0.3 in (0.7 cm) to a depth of 24 ft during the 6 July 2023 to 7 November 2024 measurement period (Figure 9). The displacement continues downward in shear to a depth of 30 ft. The LT2 boring log shows the failure zone in the lower colluvium described as brown silty CLAY(CL) with trace sand. In December 2017, the groundwater table was at and just above the base of the movement zone in the lower colluvial formation. The colluvium, in which the movement is taking place, is resting on a sandy GRAVEL (GW) with trace clay described in the boring log as LANDSLIDE/SLIDE DEBRIS. The LiDAR data indicated no measurable movement during the study period, even though the inclinometer showed a total displacement of 0.3 in (0.7 cm) at and below the ground surface. The incremental slope movement of 0.3 in (0.9 cm) has not reached the 2 cm (0.8 in) horizontal and 3 cm (1.2 in) vertical thresholds for measurable displacement in the LiDAR survey.

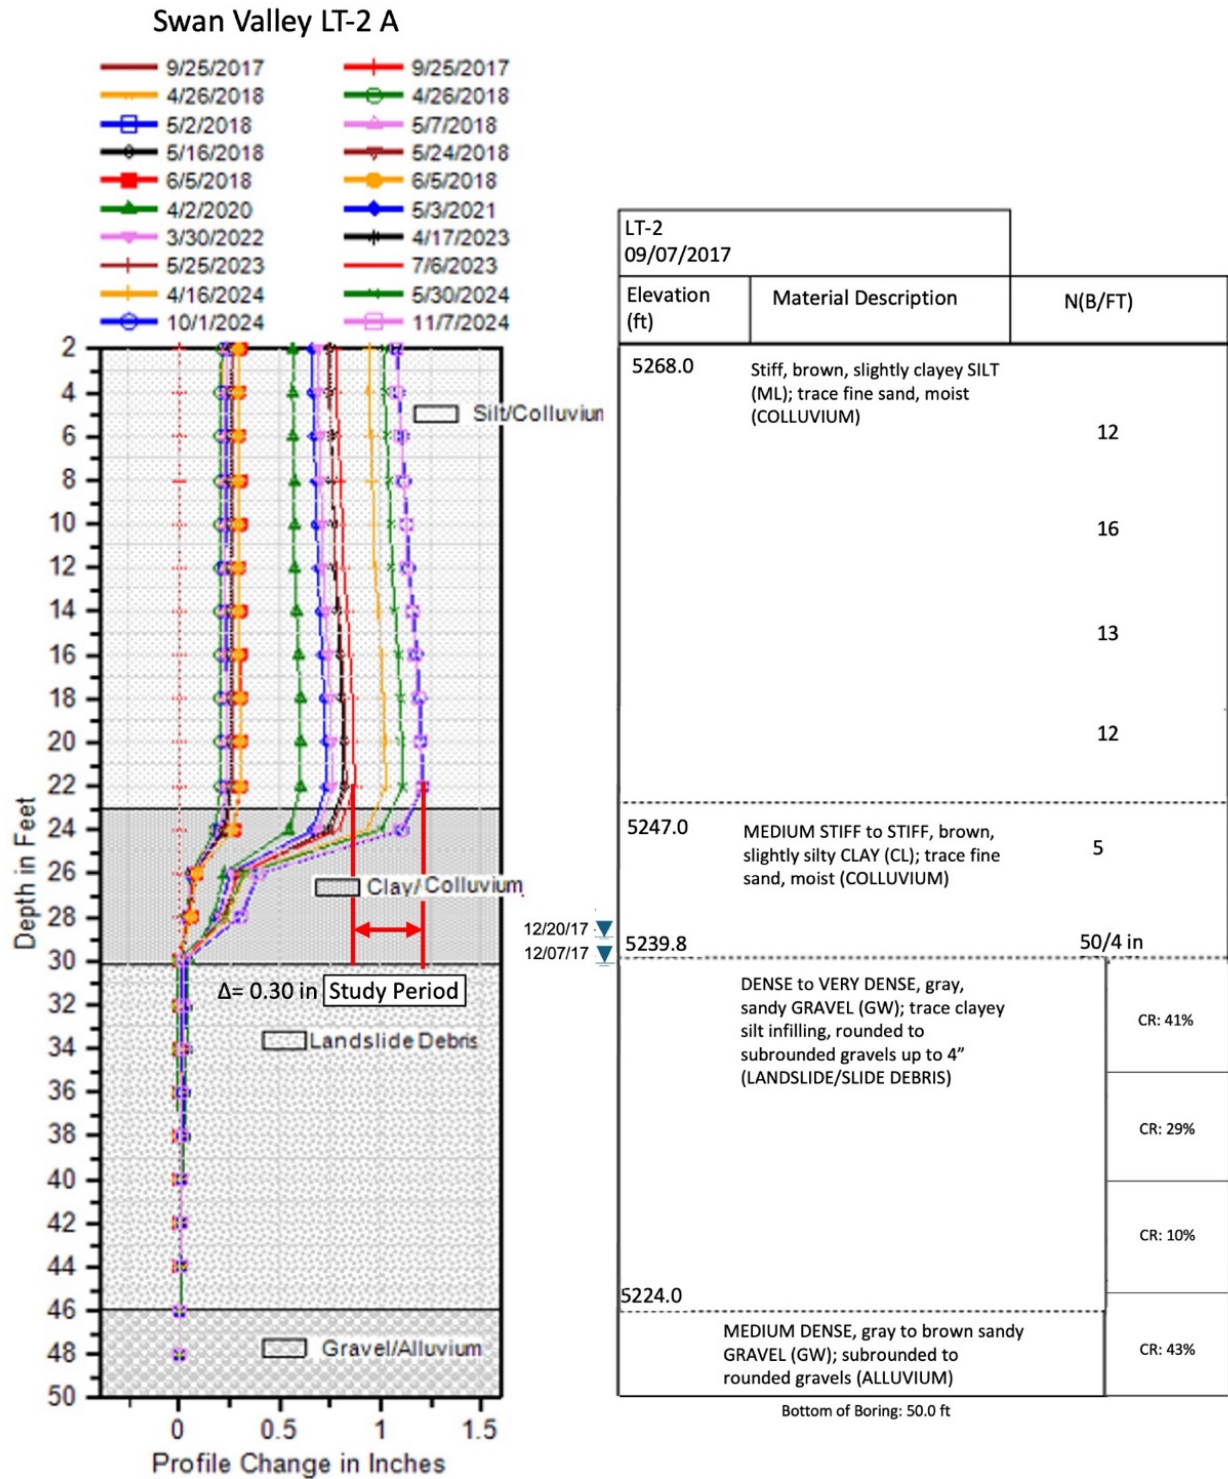
**Figure 9 – Incliner Displacements and Corresponding Log of Boring LT-2.**

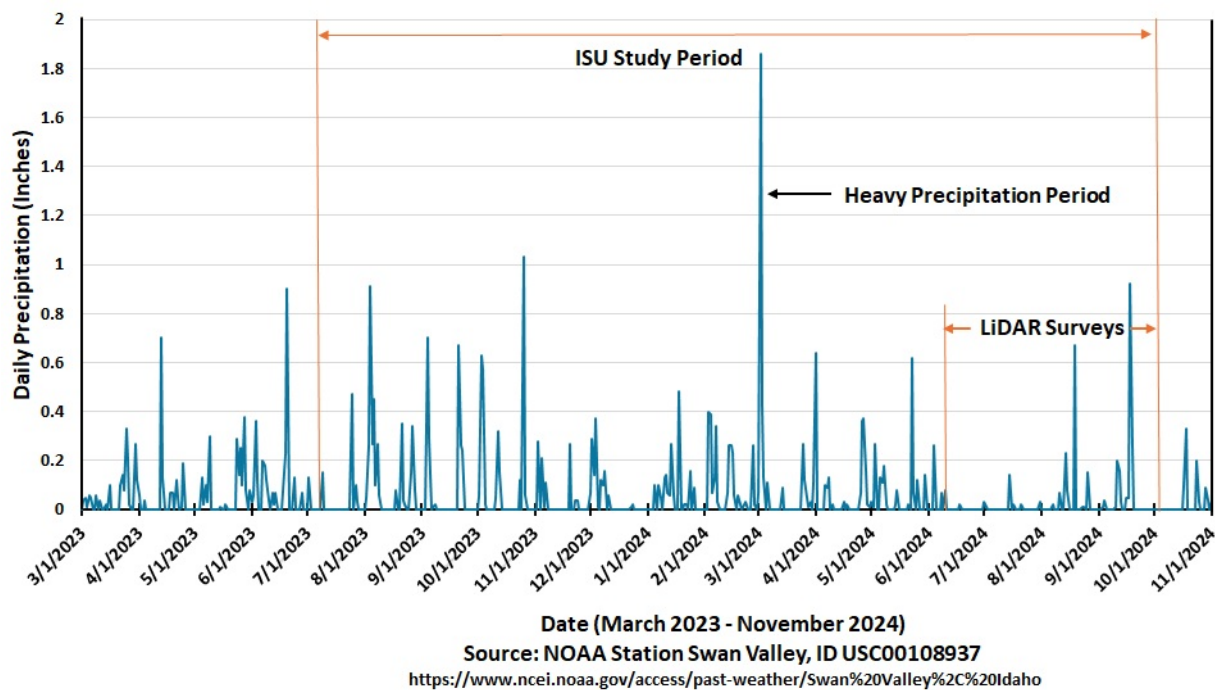
**Figure 10 – Swan Valley Precipitation Record**

Daily precipitation records for the Swan Valley area were obtained from the NOAA Swan Valley, ID weather station, located 5 miles from the study area (Figure 10). Based on the precipitation data, the slope movements east of inclinometers LT4/LT5 most likely occurred during the February to early March 2024 time period. The total precipitation during this period at the gauge location was approximately 3.3 in., with a 1.86 in. rainfall event in the first week of March. The displacement-time plot of the upslope-downslope A-axis in LT2 also shows a significant increase in the magnitude and rate of ground surface movement during the same time period (Figure 9). A combination of weaker lithologies and heavy rainfall during this period was the likely cause of the slope movement event.

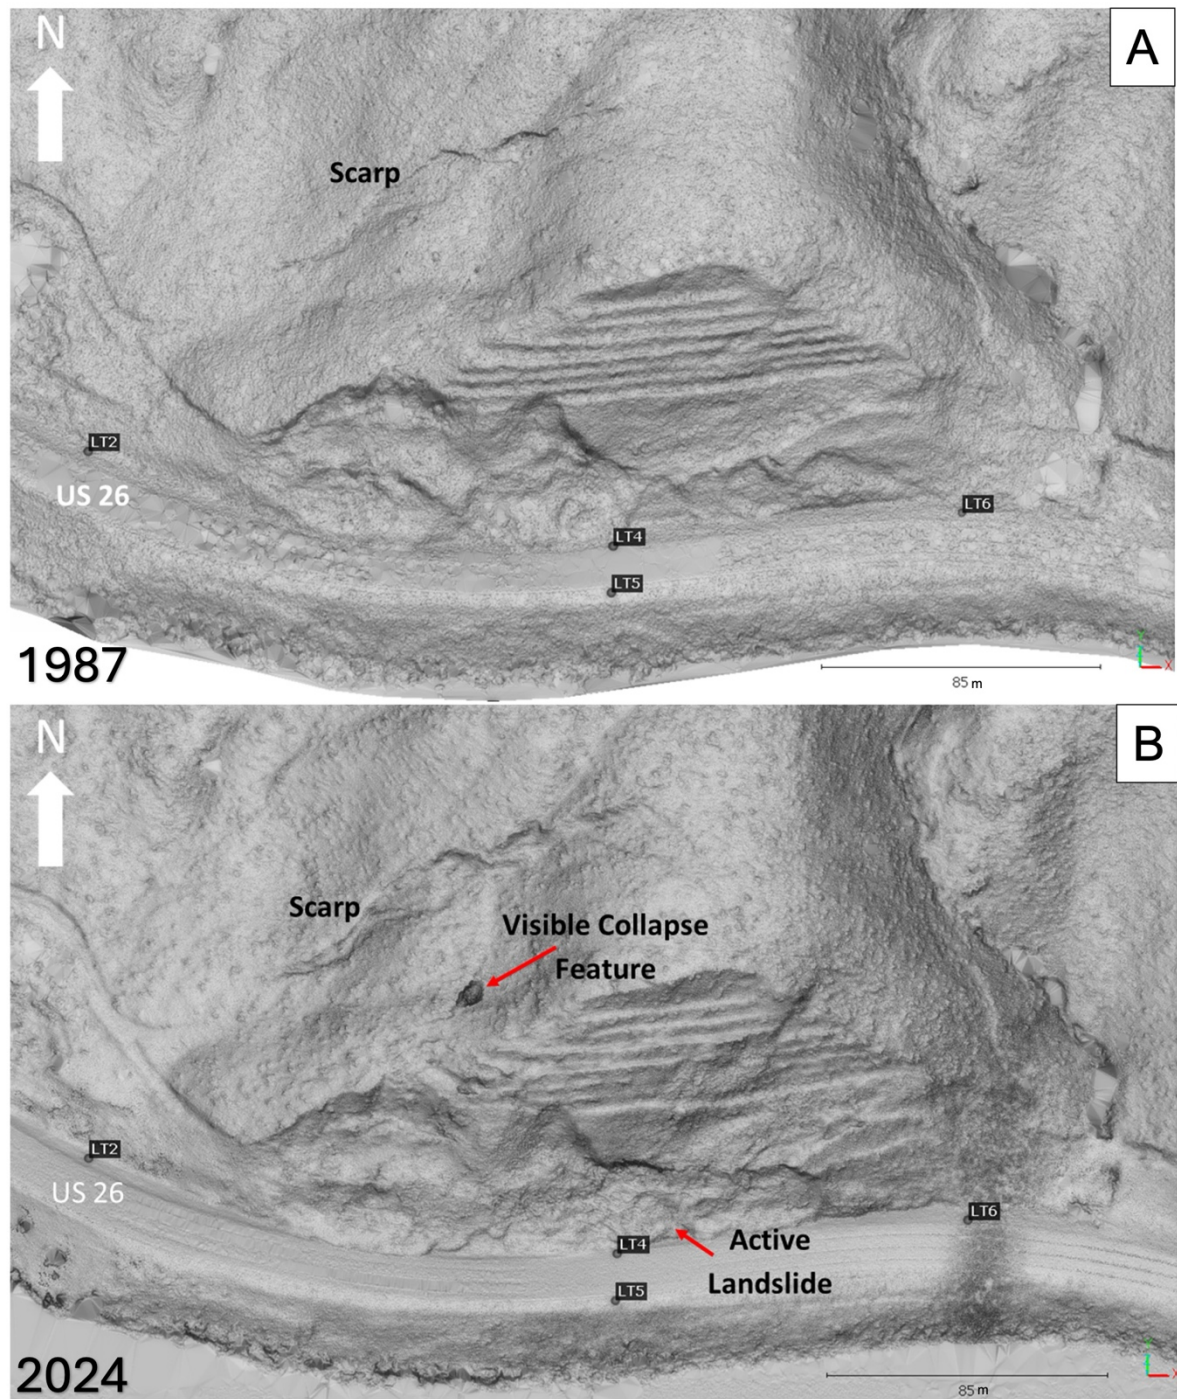
**Figure 11 – A) 1987 Swan Valley Terrain Model and B) 2024 Swan Valley Terrain Model**

ITD provided ISU researchers with aerial imagery captured on 05 November 1987. These large-scale (1:3600) aerial images were scanned, georeferenced, and processed into 3D models using Agisoft Metashape (Figure 11). The 1987 dataset was aligned to the 2024 models for comparative analysis. Review of the models shows a collapse feature present in 2024, but the depression is absent in 1987. A cross-sectional view of the depression shows vertical displacement of up to 2.56 m, indicating that the feature developed in the intervening period (Figure 12).

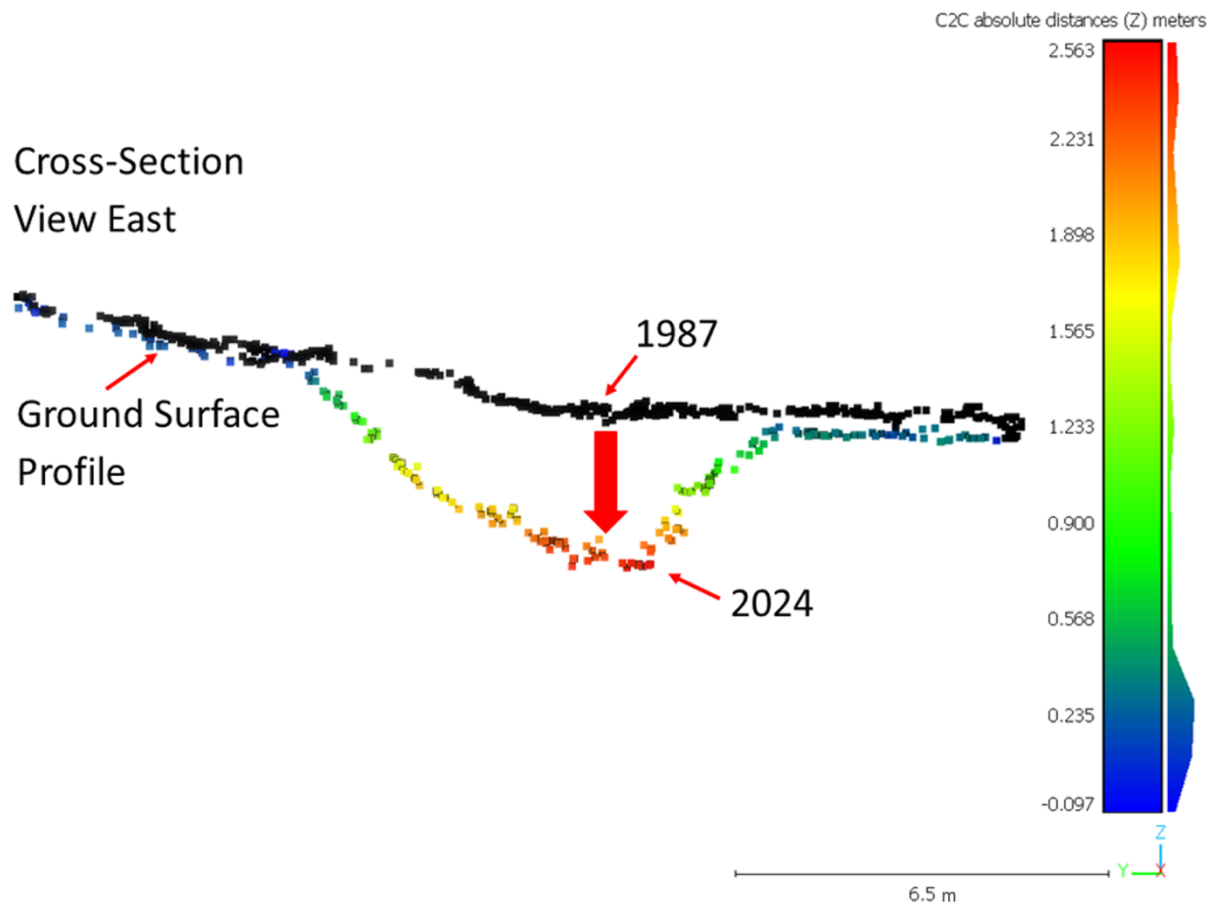
**Figure 12 – Swan Valley Collapse Feature Growth between 1987 and 2024.**

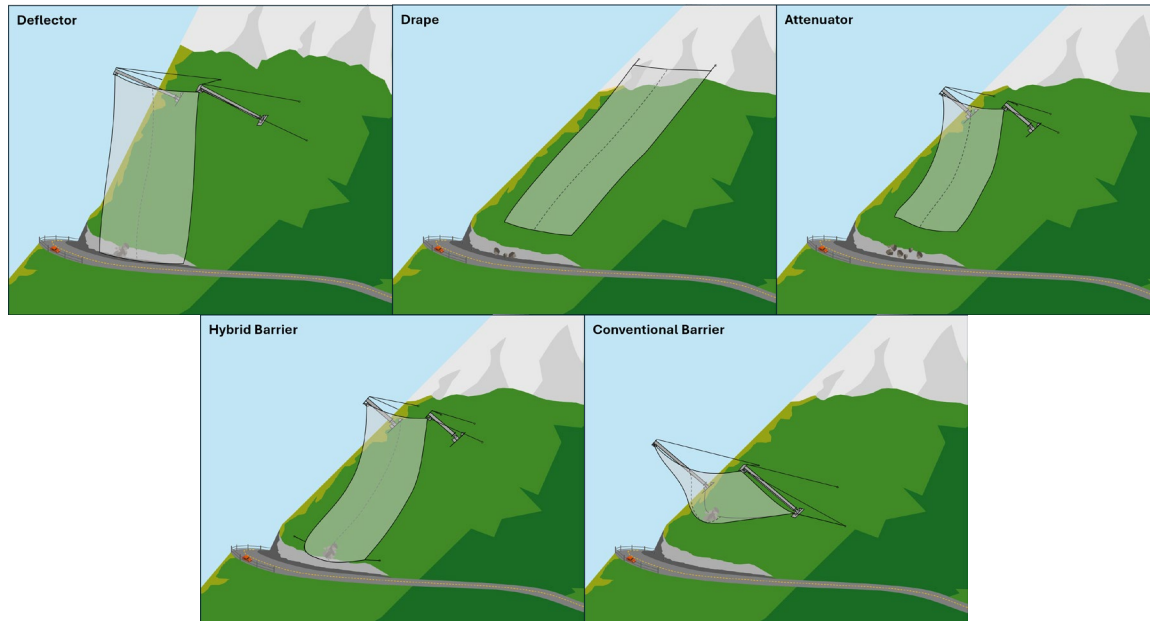
**Figure 1. Energy absorption by structure (modified from Bichler, A. et.al. 2012)**

Deflectors, shown on the far left, absorb the least energy, and conventional rockfall catchment barriers, shown on the far right, absorb the most energy. These hybrid systems – Deflectors, Attenuators, and Hybrid Barriers – will be discussed in more detail in the following sections.

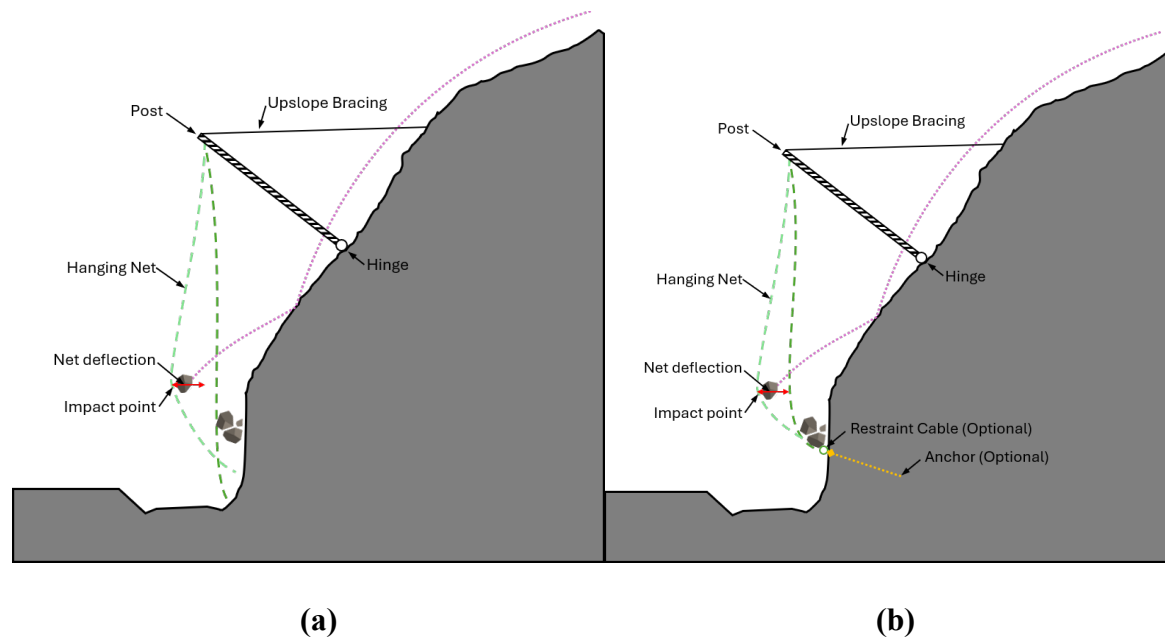
**Figure 2. Schematic of a Deflector, re-directing the energy into the ground  
(a) Open-Toe, and (b) Closed-Toe**

Figure 2 shows a schematic of a Deflector, comprising of a freely hanging steel wire mesh suspended from steel posts bolted to the rock face and may be designed with either an open or closed toe.
