# 75<sup>TH</sup> HIGHWAY GEOLOGY SYMPOSIUM

BETTER HIGHWAYS THROUGH APPLIED GEOLOGY

2026  
HGS  
PROCEEDINGS

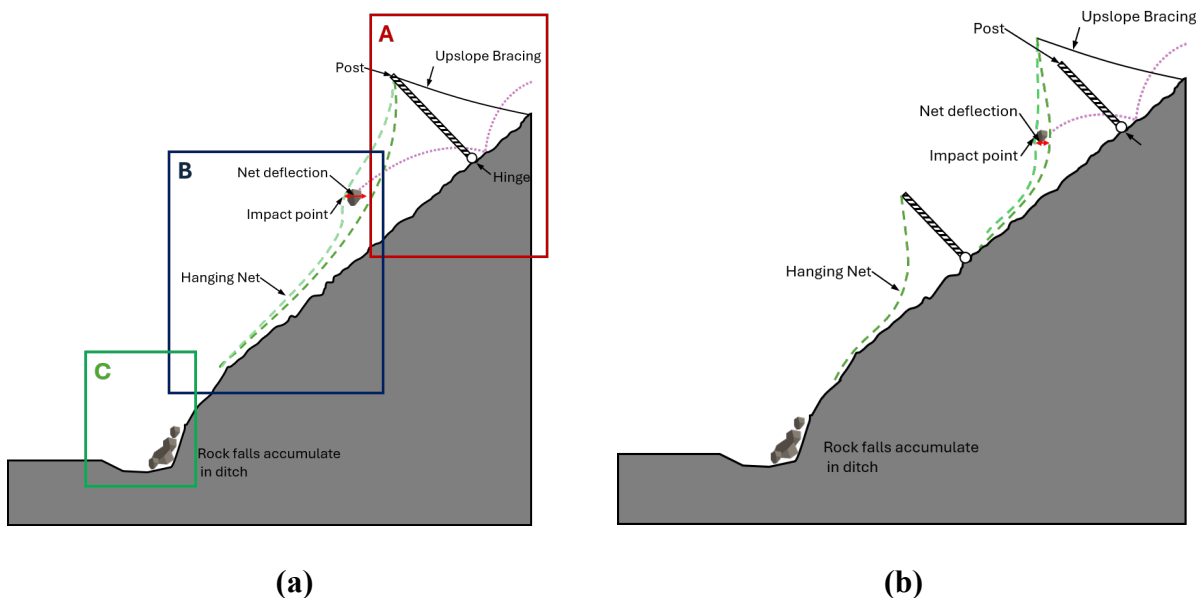
**Figure 3. Schematic of an Attenuator, reducing the rockfall energy into a catchment**  
**(a) Single Attenuator, and (b) Multiple Attenuators**

Figure 3 shows the various zones and components of an attenuator system designed to reduce the rockfall energy into a controlled location. Zone A at the top is where the structure intercepts the rock. The netting is designed to first intercept the falling rock, as a standard flexible rockfall barrier would. In this Interception Zone, the greatest dissipation of energy will occur. Zone B is the Transition Zone where the drape section of the barrier drives rocks and debris toward the toe of the slope, slowing the speed and reducing the energy. Zone C is the Catch Area which may include either a catchment ditch sized to accept the volume of debris leaving the system or a conventional rockfall barrier designed to fully arrest the rockfall energy exiting the system. It is important to note that an attenuator system itself does not fully arrest the rockfall energy as the draped tail is left open at its bottom to allow the rocks and debris to exit the system.

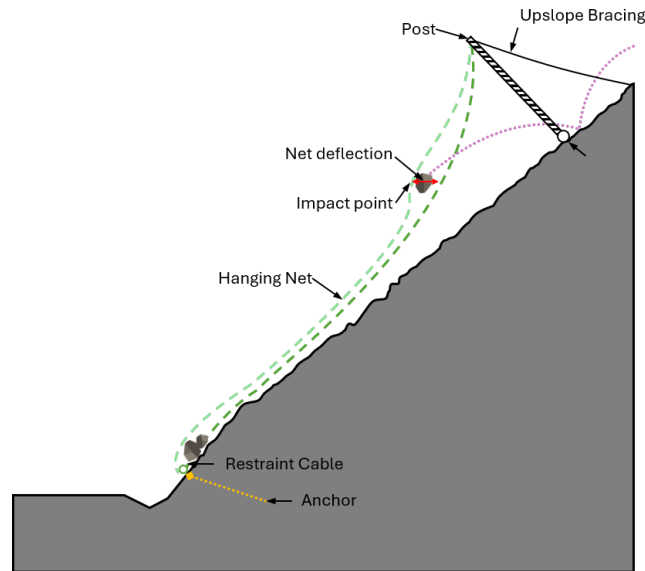
**Figure 4. Schematic of a Hybrid Barrier, fully arresting the rockfall energy**

Therefore, a hybrid barrier has a closer relationship to a traditional rockfall barrier, since the toe of the drapery section is secured, and the rock is brought to a stop, rather than released through the toe of slope. Figure 4 is a schematic of a typical hybrid barrier system with the tail-end of the drapery section anchored to secure the rock and not allow it to exit the system. This application is often used when the slope length and/or catchment area are insufficient to fully arrest the rock’s energy and volume of debris.

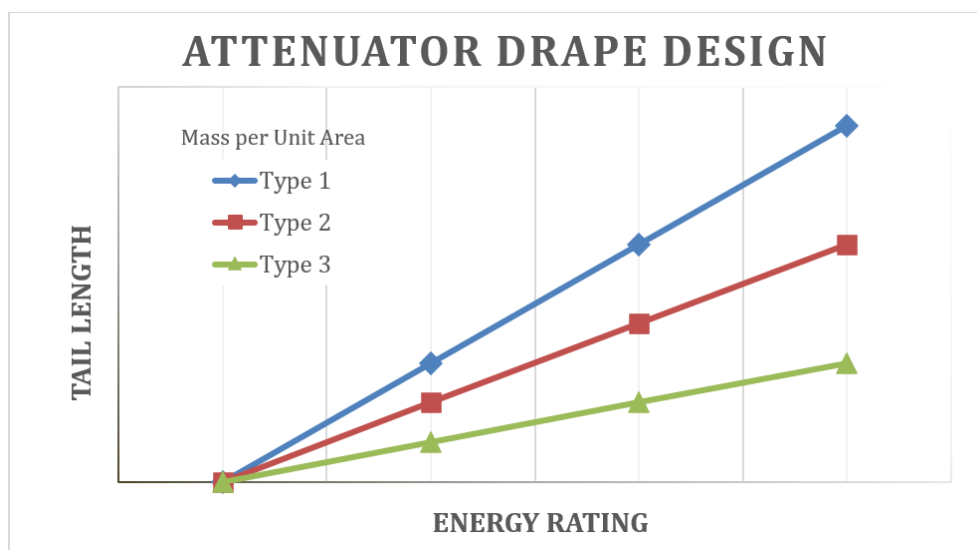
**Figure 5. Relationship between a mesh's mass per unit area and tail length required to dissipate a specific energy level**

The mesh mass per unit area used for an attenuator system will determine the length of tail necessary to reduce the energy of a block from an initial energy to a design exiting energy specification and must be strong and heavy enough to resist the deceleration momentum created by the block. Figure 5 illustrates the relationship between a specific energy level and the mesh mass per unit area and tail length. For a given energy level, a mesh with a lighter mass per unit area will require a longer tail length to dissipate the energy. Whereas a shorter tail length would be required for a heavier mesh to dissipate the same level of energy. For example, Maccaferri SteelGrid (Type 1), with a mass per unit area of 0.50 lbs/sf, requires a longer tail length than RockMesh (Type 2), with a mass per unit area of 0.70 lbs/sf. And the HEA panel (Type 3), with a mass per unit area of 1.0 lbs/sf, requires the least length of tail.

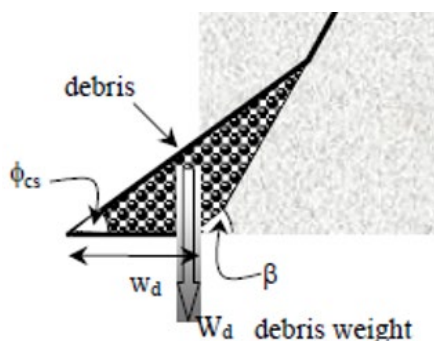
**Figure 6. Loading due to debris accumulation at the toe of a hybrid barrier**

The standard practice to determine the static debris load affecting hybrid systems is to account for a homogeneous expected accumulation pocket defined by a debris accumulation height ( $H_d$ ) and width ( $W_d$ ) as shown in Figure 6. The corresponding debris volume per linear width is multiplied by the debris density of the accumulated material to correctly dimension the debris load.

This debris load should then be combined with the snow load, ice load and mesh weight to determine the total static load affecting the system. This total distributed static load in lbs/ft (kN/m) will also be used to verify the net tensile capacity and to dimension the support cables, anchors and posts to be used for the system.

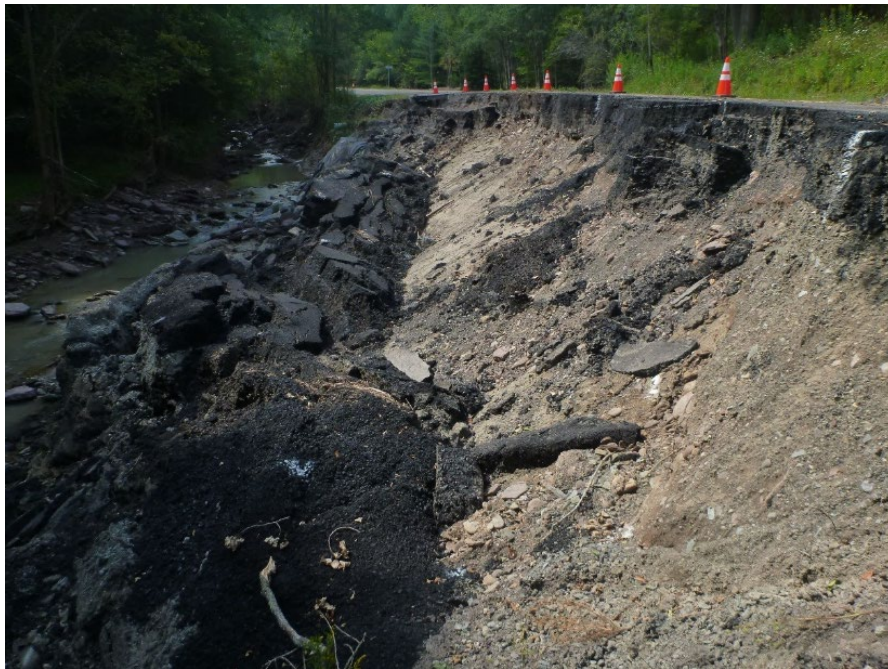
- The slide area is approximately 200 feet in length, approximately 20 feet high and is characterized as a translational failure occurring along exposed medium to highly plastic, varved, glaciolacustrine deposits as shown in Photos 1 & 2.

**Photo 1: Site 1 Landslide**

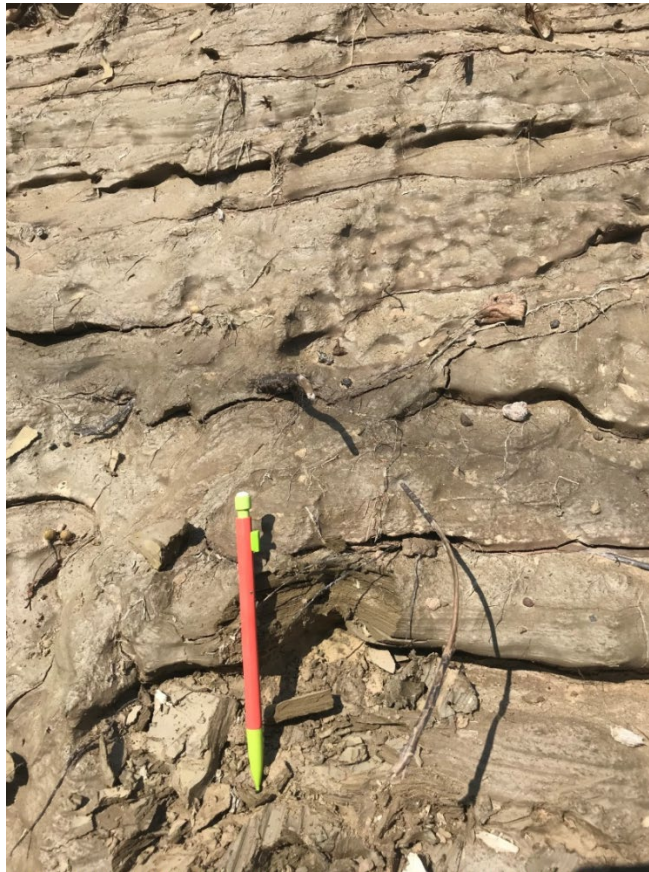
**Photo 2: Site 1 Exposed Varved Glaciolacustrine Deposit**

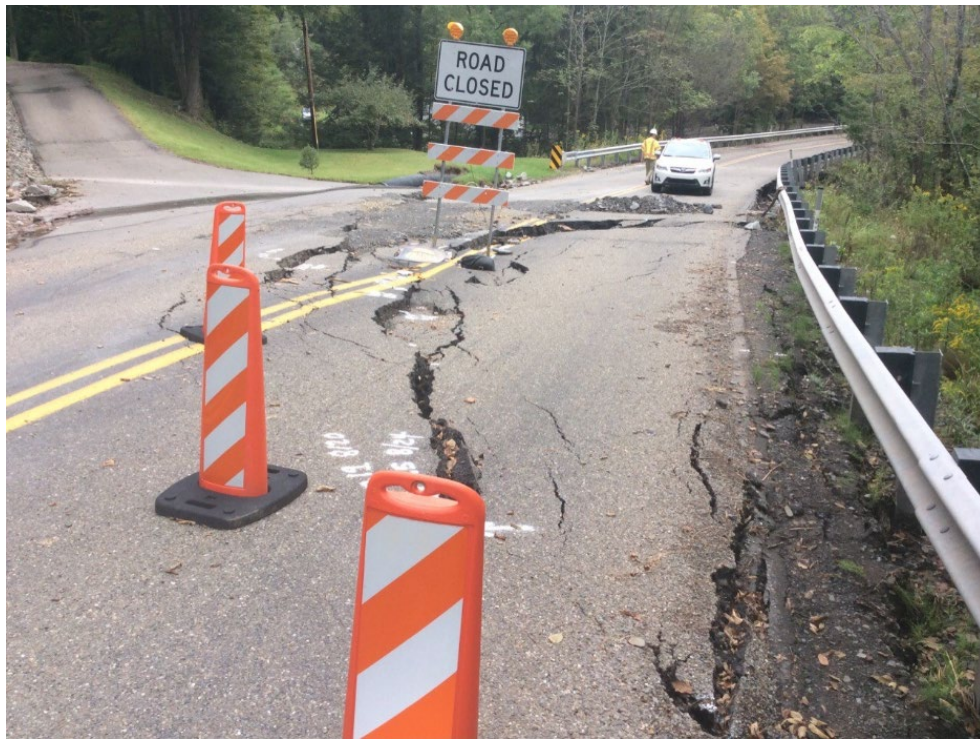
- The slide area is approximately 150 feet in length and is characterized as a circular or rotational failure with the crown of the slide crossing both lanes of SR 3002, which requires the roadway to be closed at this location as shown in Photo 3.

**Photo 3: Site 2 Landslide**

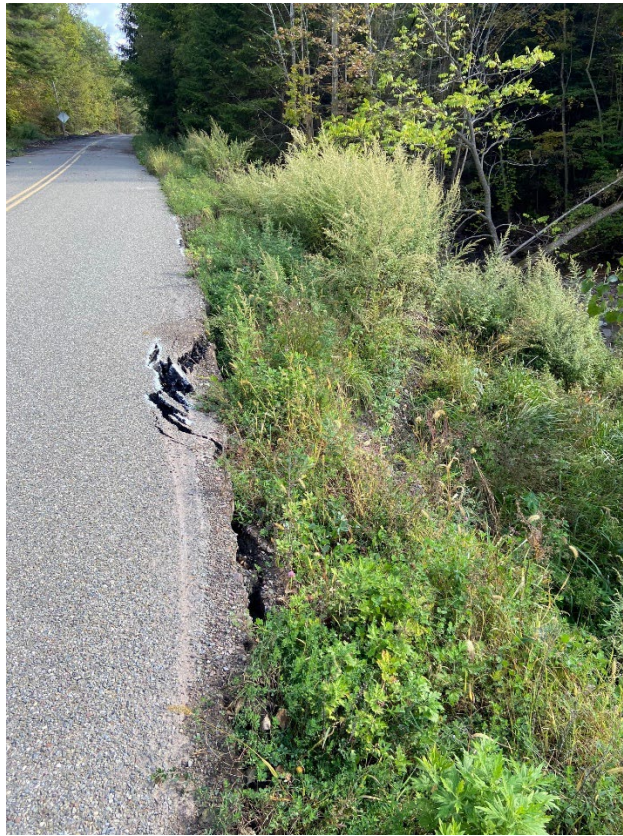
- The slide area is directly adjacent to Ladd's Creek, was approximately 120 feet in length, approximately 15 feet in height, and was characterized as a circular or rotational failure with the headscarp of the landslide located at the shoulder of the SR 3002 eastbound lane as shown in Photo 4.

**Photo 4: Site 3 Landslide**

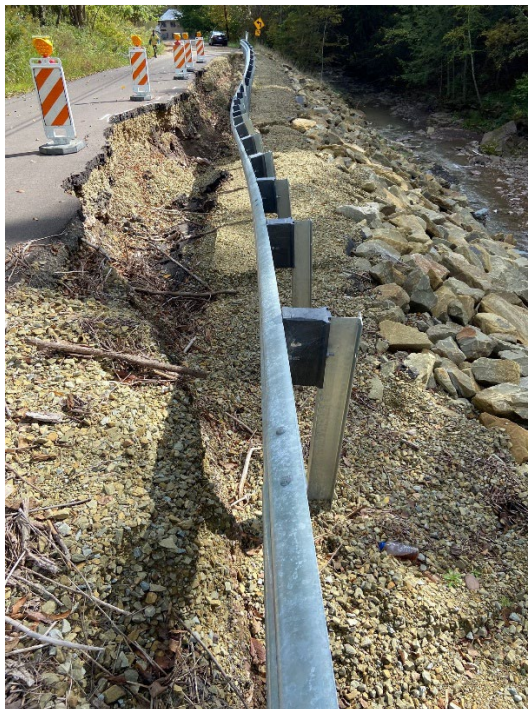
**Photo 5: Failure of Repairs at Site 1**

The condition of the SR 3002 roadway had deteriorated significantly by early 2020 at Sites 1 and 2, and with the discovery of Sites 3 and 4 and final design of the remediation strategy not yet started, it was determined that if the existing SR 3002 roadway in the areas of Sites 1 and 2 was left untreated, access to the 3 residences within the project area could be jeopardized. Therefore, PennDOT awarded an emergency repair project in the Summer of 2020 to restore the SR 3002 roadway at Sites 1 and 2 to ensure local residents could access their property until a permanent solution could be provided. The repairs included a rock buttress and a 14-foot travel lane at Site 1 and restoring the pavement at Site 2 and the repairs were completed by Fall 2020. By May 2021, movement was observed within the rock buttress repair performed at Site 1 and by the end of September 2021, the repair at Site 1 had failed as shown below in Photo 5.

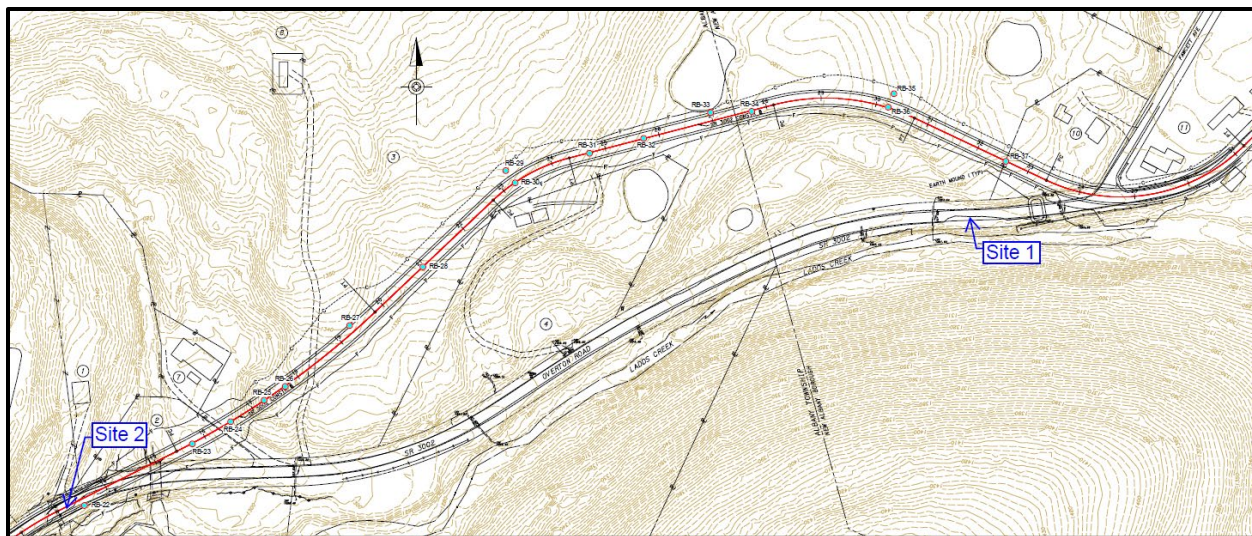
**Figure 4: SR 3002 Realignment Location and Boring Locations**

A subsurface exploration program was conducted for an SR 3002 realignment alternative, which consisted of moving SR 3002 upslope of the existing alignment by approximately 300 feet in an attempt to move the roadway to a more stable location. Seventeen borings, designated as RB-21 to RB-37, were drilled in April and May of 2021 for the proposed realignment. The purpose of the borings was to determine the subsurface conditions underlying the proposed SR 3002 realignment and to collect soil and rock samples for laboratory testing to substantiate the geotechnical design of the roadway. A brief summary of the subsurface exploration program is summarized below. The SR 3002 relocation alternative and boring locations are shown in Figure 4.

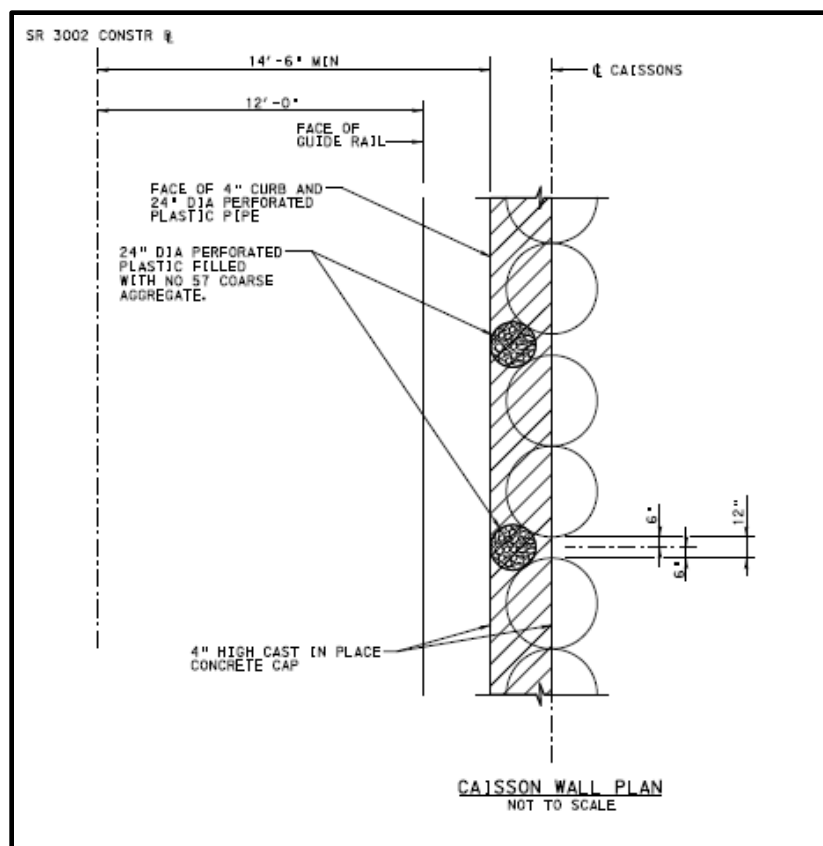
**Figure 5: Typical Caisson Wall**

The tangent caisson walls were designed to promote drainage by including a 24-inch diameter perforated pipe that would extend to top of bedrock and be backfilled with AASHTO No. 57 Coarse Aggregate between every pair of caissons. In addition, a curb was placed on the top of the wall to not allow sheet flow over the caisson walls. A typical wall plan view is provided below as Figure 5.

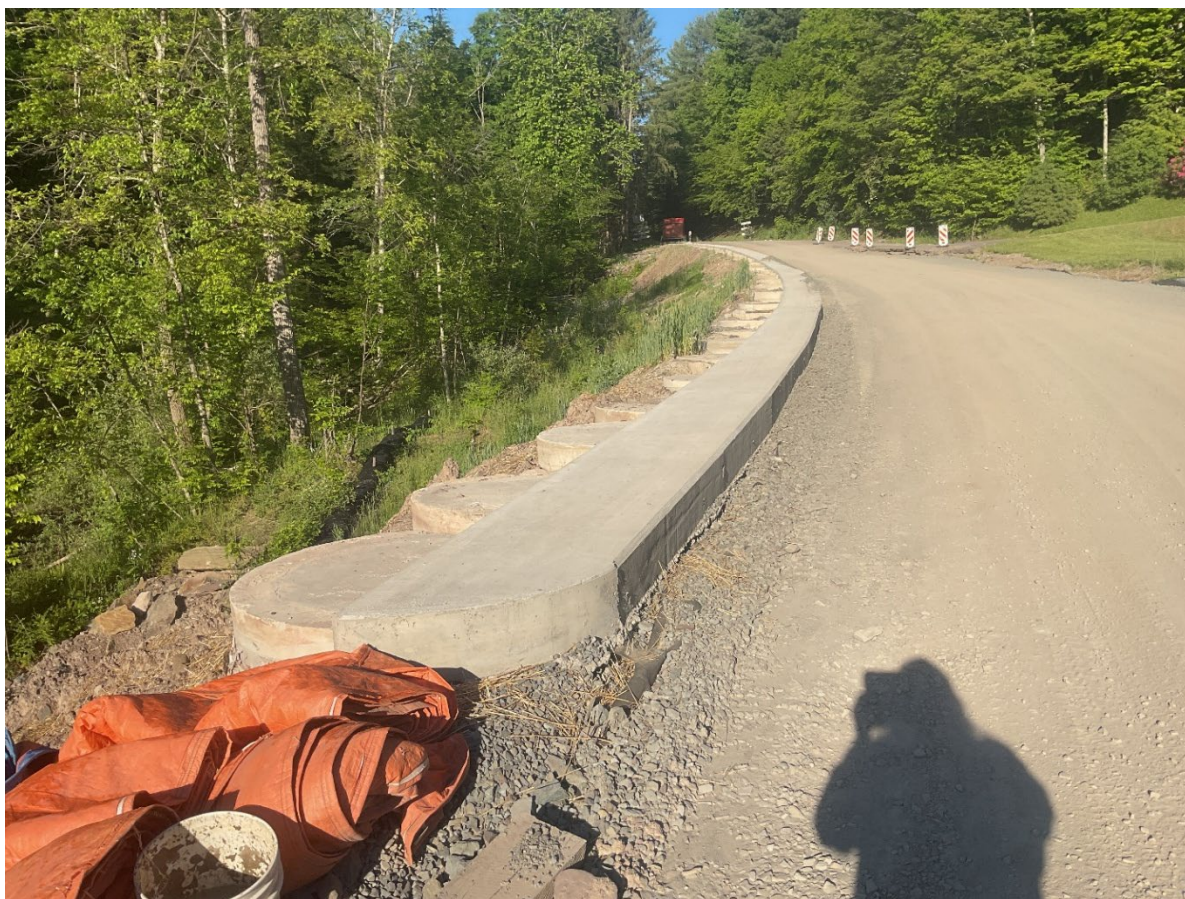
**Photo 6: Completed Tangent Caisson Wall at Site 2**

Based on discussions with District 3-0 Construction staff, construction of the tangent caisson walls has progressed well, and Photo 6 was taken during construction of the landslide remediation at Site 2.

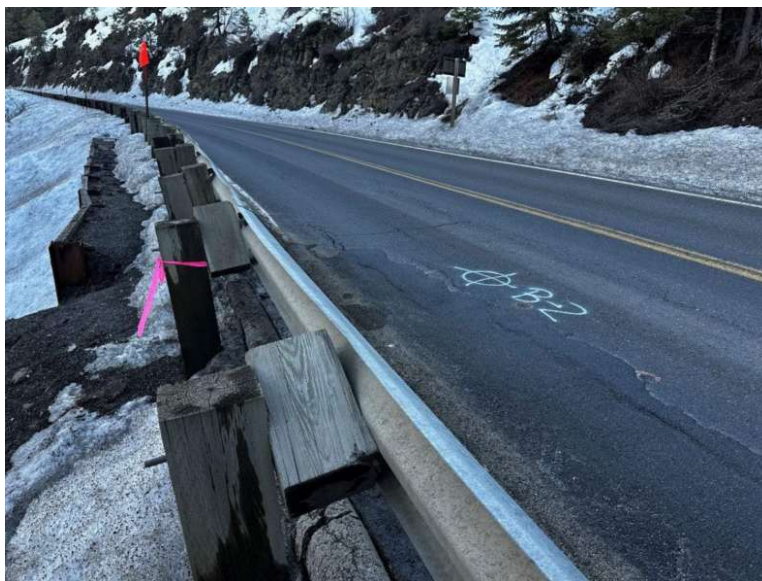
**Figure 2 – NB Lane Showing Cracking Prior to Failure, Photo Taken March 3, 2025**

In October 2024, Delve Underground conducted a preliminary site reconnaissance in the vicinity of MP 146.5 in response to settlement in the area that Idaho Transportation Department (ITD) maintenance crews had observed. Of particular note, the maintenance crews had identified field indicators of developing instability, including localized sagging of the roadway surface and new cracks forming in the northbound (NB) lane. The maintenance personnel had recognized how important these subtle distress features were, signaling an early warning, which allowed ITD to begin planning for a subsurface investigation before any major failure would occur.

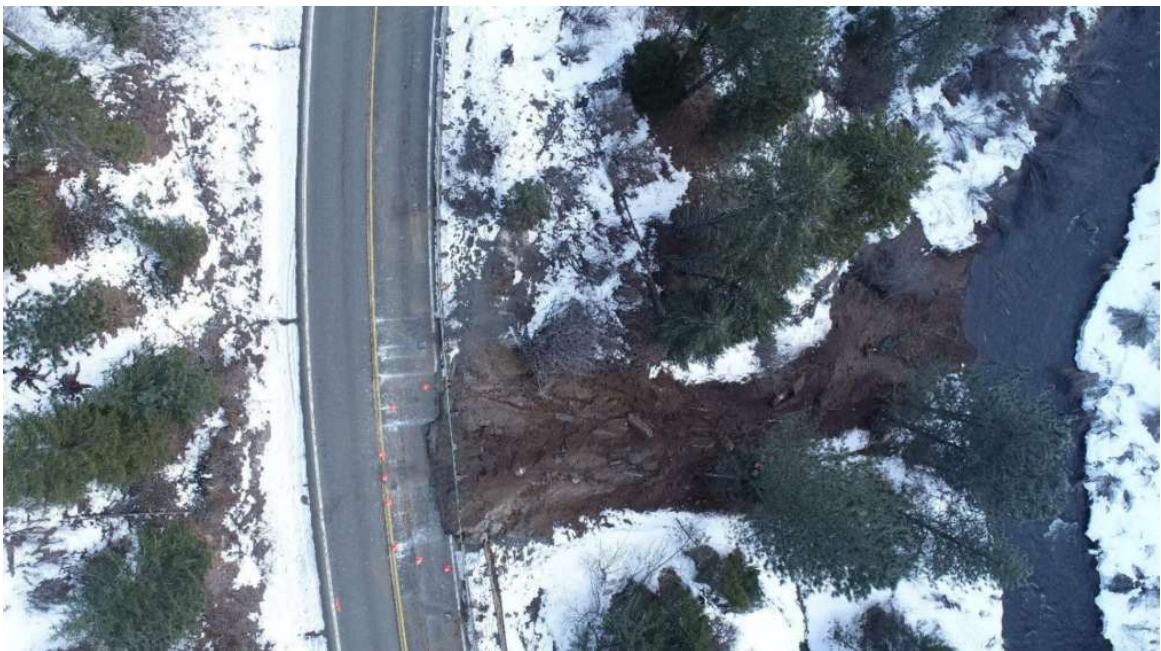
**Figure 3 – Overhead View of Failure, Taken with Drone on March 19, 2025**

On the evening of Sunday, March 16, 2025, a landslide occurred that took out a portion of the NB lane of US-95 at MP 146.5. The failure developed during the spring snowmelt period, consistent with the historical pattern of slope instability in the area. The next morning, Monday, March 17, 2025, Delve Underground was notified of the failure, coincidentally, as the project geologist was preparing to drive to the site for the investigation that had already been scheduled.

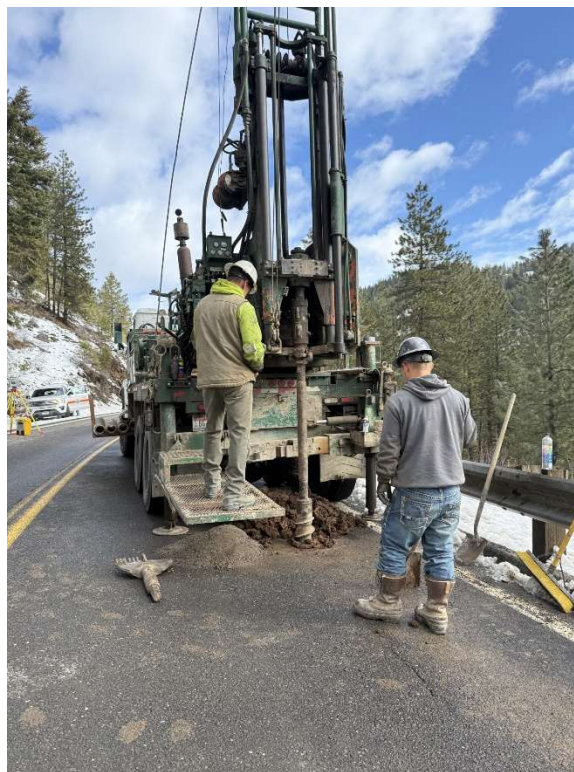
**Figure 4 – Hollow-Stem Auger Drilling During the Field Investigation**

Drilling was performed using hollow-stem auger (HSA) methods. Depth to refusal was variable, and boulder obstructions were considered likely based on the drilling response, as presented in Table 1 below. The accelerated schedule did not allow time for laboratory testing of soil or rock-core samples; characterization therefore relied on field observation and the experience of the field team. HSA methods were selected partly because they allowed direct observation of groundwater conditions during drilling, which was critical given the role of groundwater in the failure. The four borings (BH-01 through BH-04) were advanced around the head scarp of the slide, with each hole terminated at auger refusal. Standard penetration testing was performed at regular intervals, and groundwater was encountered only in the southernmost boring, BH-04, at approximately 39.5 feet (12 m) below ground surface where the drill met refusal.

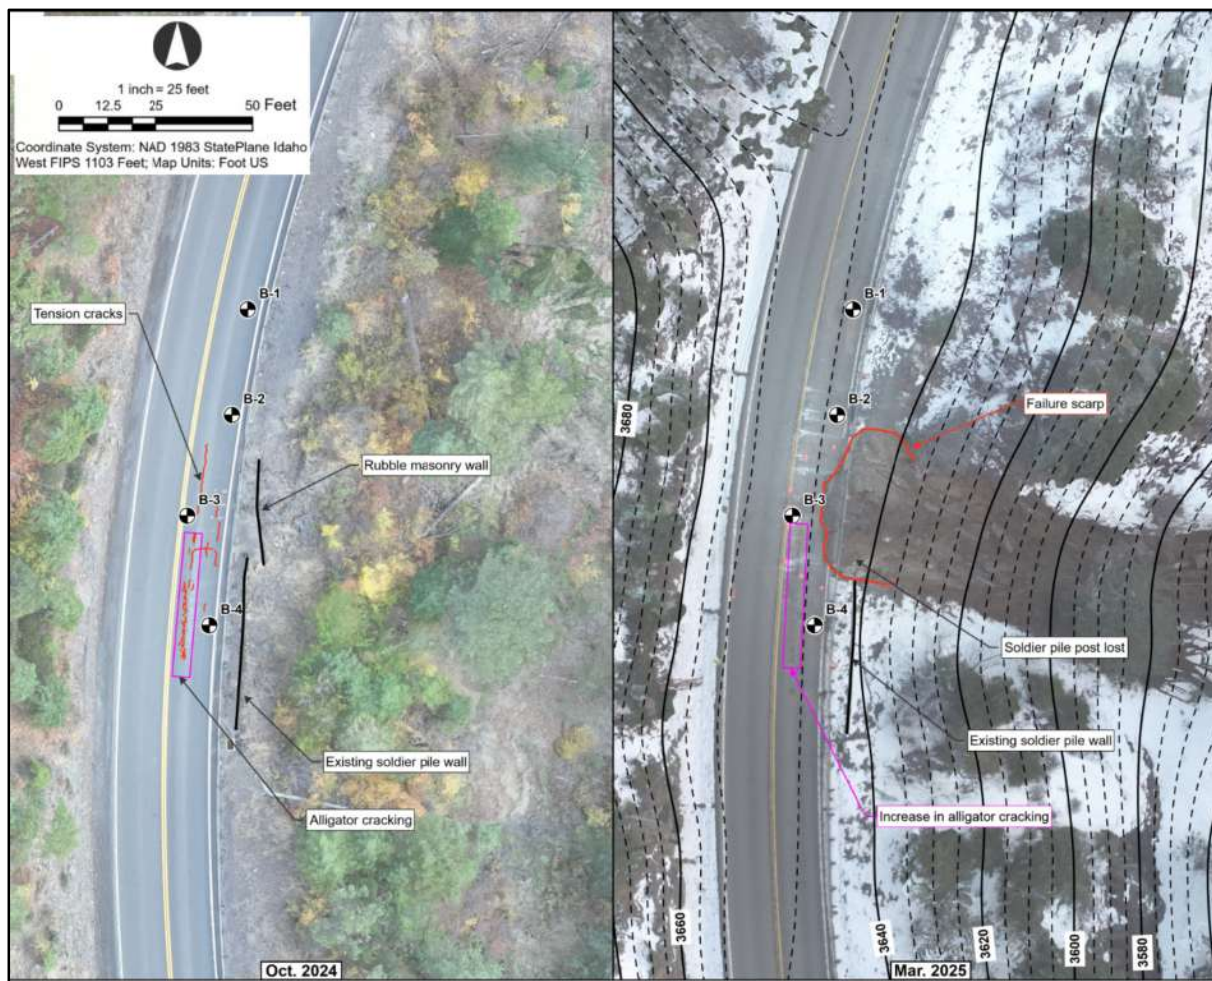
**Figure 5 – Pre- and Post-Failure Aerial Imagery Comparison**

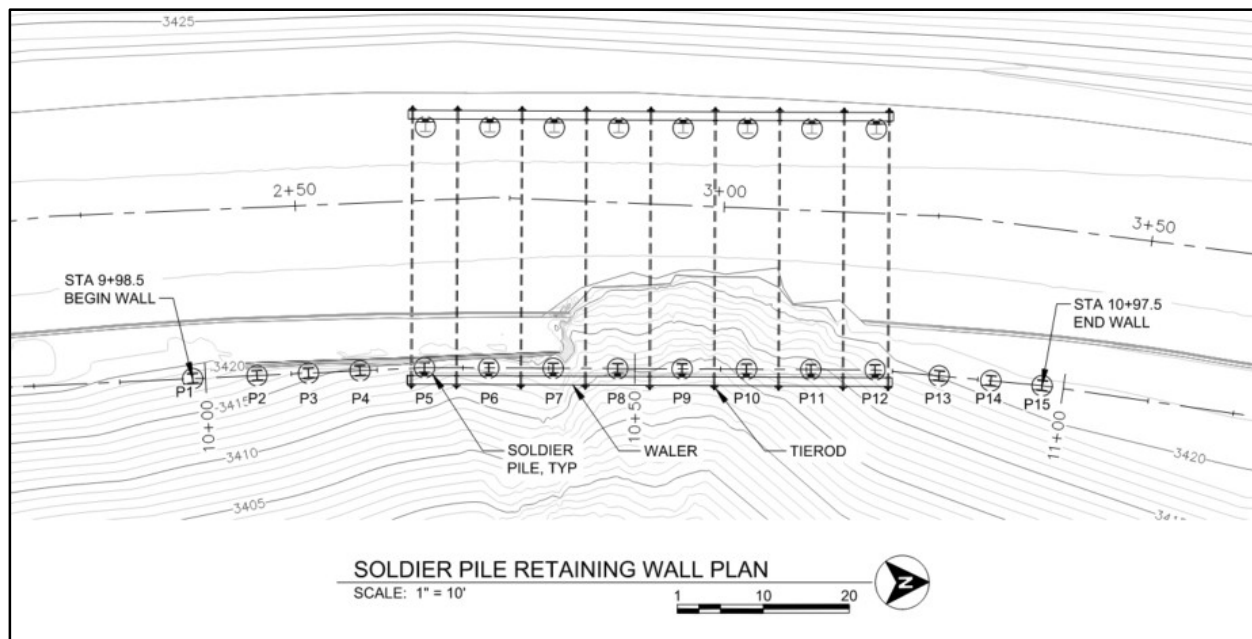
**Figure 6 – Repair Design: Soldier Pile Wall, Deadman Configuration, and Drainage Plan**

The anchored portions of the soldier pile wall required a deadman system to develop the lateral restraint necessary to resist the retained earth loads, as the steep slope in front of the retaining wall did not provide sufficient passive resistance. At this site, the steep slope on the opposite side of the roadway sharply limited the distance available behind the wall face. A conventional deadman could not be set back far enough to clear the active zone without extending beyond the buildable footprint, rendering the typical approach unworkable within the confined roadway geometry.

To resolve this, the design substituted drilled shafts for the conventional buried deadman. Rather than depending on the passive resistance of the surrounding soil, the drilled-shaft deadman developed its capacity through the embedment depth and flexural stiffness of the shaft itself, behaving as a laterally loaded pile. Each front-wall waler was connected to the corresponding deadman shaft by a steel tie rod, transferring the wall load to the shaft, which in turn mobilized lateral resistance along its embedded length. Because this mechanism did not rely on placement outside the active wedge, the deadman shafts could be located much closer to the wall, fitting within the narrow confines of the slope. The approach carried an additional practical advantage: the drilled-shaft rig was already mobilized on site for installation of the soldier piles, so the deadman shafts could be constructed using equipment and crews already in place, without mobilizing a separate operation or specialized deadman-installation methods.

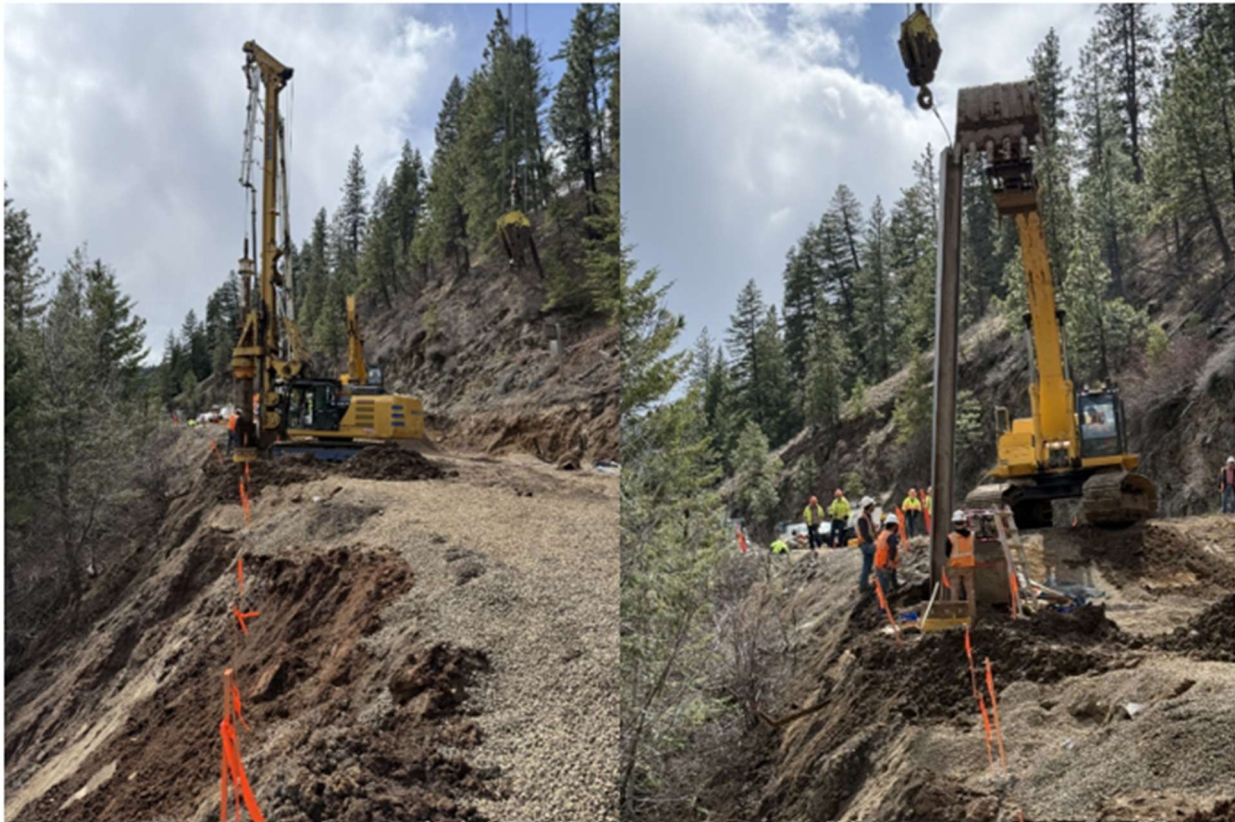
The second approach refined the cold-pour method for the lower portion of the hole. The casing would be backfilled and pulled in lifts for the lower 15 feet (4.6 m) of the borehole, and all standing water would be pumped out or displaced via tremie in every boring before placement. Before fully setting each pile, the crane was first used to confirm that the casing could be extracted easily. If extraction was straightforward, the team continued to backfill and pull the casing in lifts using the crane; if not, the contingency plan would be invoked. Plan 2 proved successful and became the production method for the remaining piles.

**Figure 7 – Pile Installation**

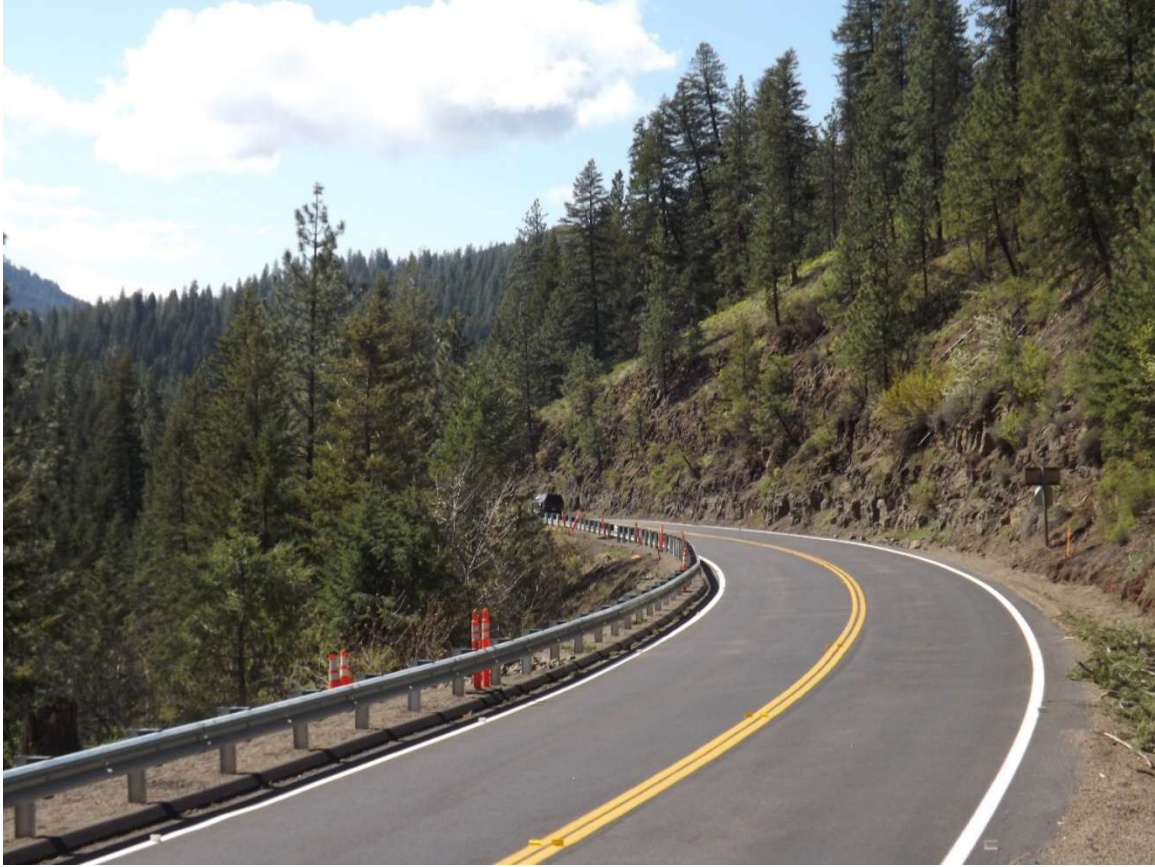
**Figure 8 – Completed Repair and Reopened Roadway, Looking Southward**

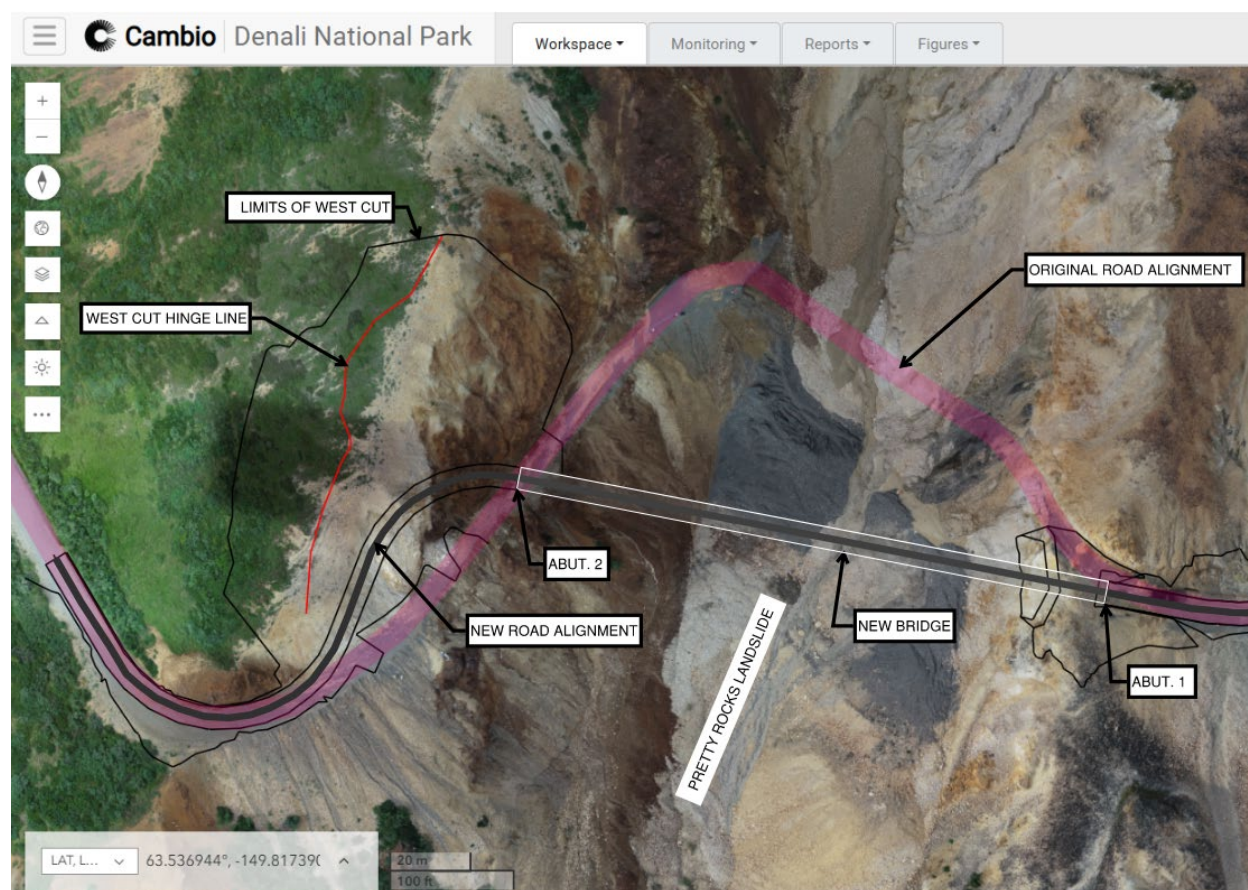
**Figure 1 - Project Site Map with Aerial Imagery (August 2, 2023), Original Road Alignment, New Alignment, and Limits of the West Cut.**

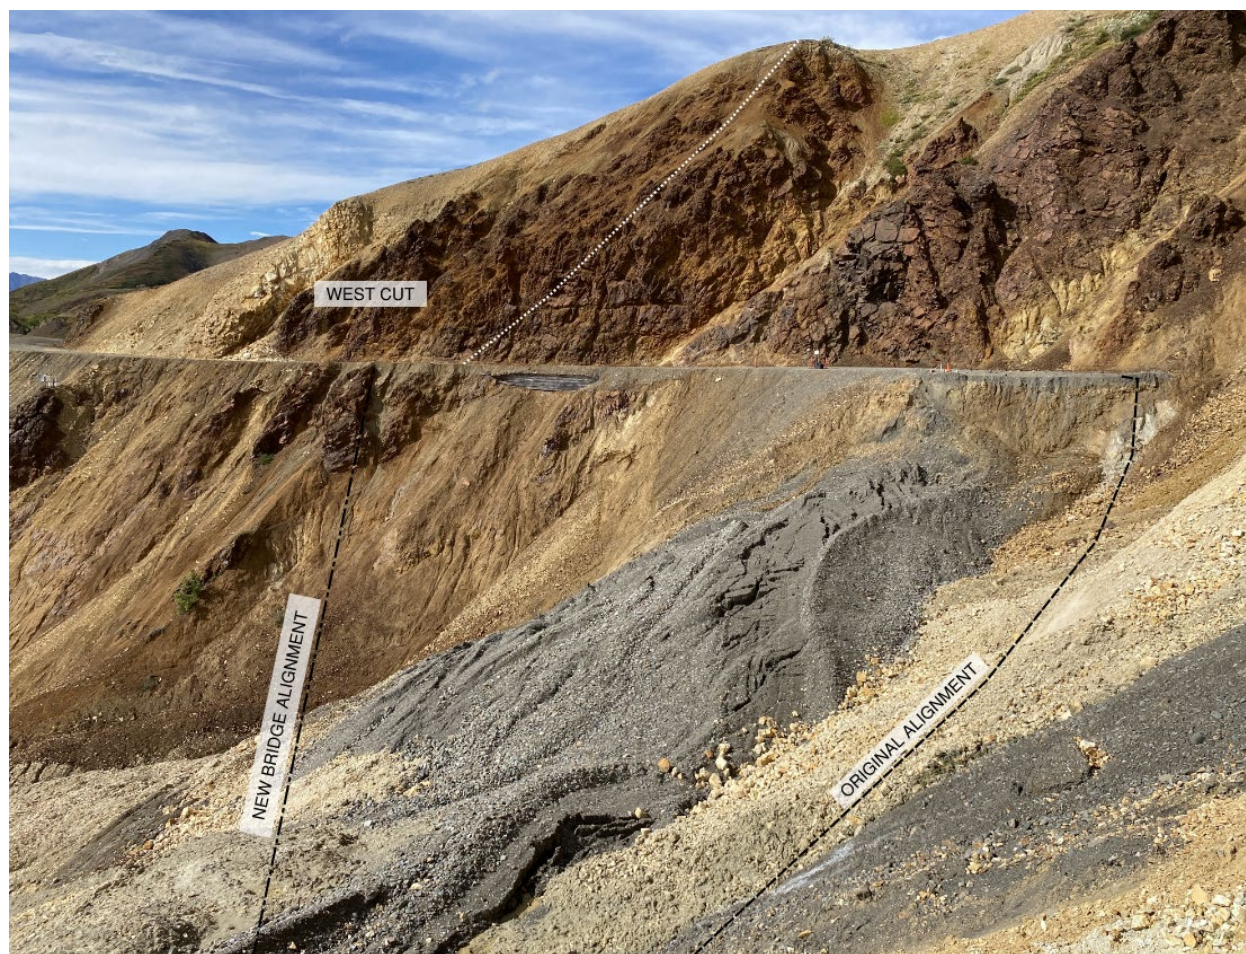
September 2021, the road was closed due to accelerated movement of the Pretty Rocks Landslide located at approximately Mile Post 45 on Polychrome Pass. Following a risk assessment and alternative analysis process, the NPS, in conjunction with the Western Federal Lands Highway Division (WFLHD) of the Federal Highway Administration (FHWA), selected a new bridge to re-establish the roadway at the Pretty Rocks Landslide. The bridge consists of a 475-foot single-span steel truss. To avoid future landslide movement and minimize the bridge length, the west abutment needed to be located on an outcrop of competent material on a new alignment that is on a bearing tangent to the original roadway alignment. This required a large cut for the west bridge approach, which was named the West Cut (Figure 2).

**Figure 2 - Pre-Construction Photograph of West Cut (August 20, 2022) Looking from Approximately Abutment 1 Location towards Abutment 2 and West Cut.**

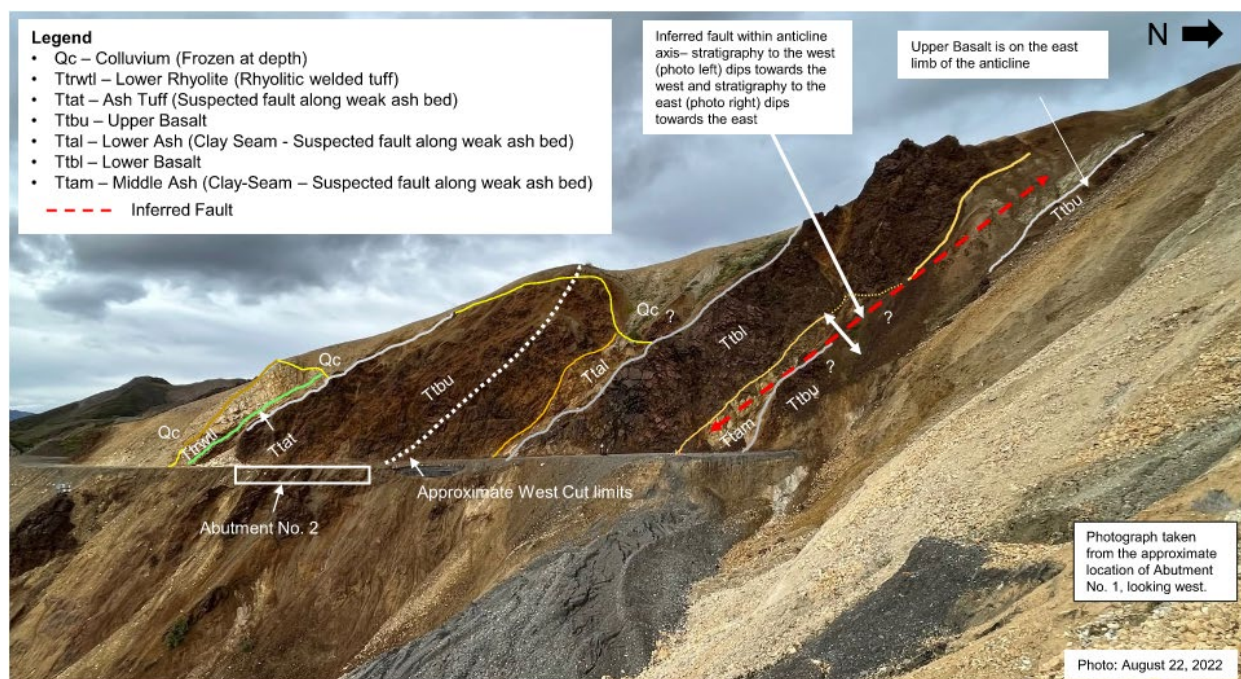
The stratigraphy encountered in the West Cut, from top down, consists of colluvium, Lower Rhyolite, an airfall ash and bentonite clay bed approximately 6 feet thick, and Upper Basalt (Figure 3). These units are dipping south to southwest at approximately 50 degrees. The geophysical surveys indicate seismic P-wave velocities range between approximately 2000 ft/sec and 10,000 ft/sec within the limits of the proposed West Cut (4). An ice-rich frozen colluvium permafrost layer was encountered in boreholes and consists of poorly sorted gravel, sand, and clay with some cobbles and boulders with up to 50% ice by volume.

**Figure 3 - Pre-Construction Interpreted Geology at Proposed West Cut Location. Photograph is Looking West from Abutment No. 1 Down the New Bridge Alignment Towards Abutment No. 2 and the West Cut.**

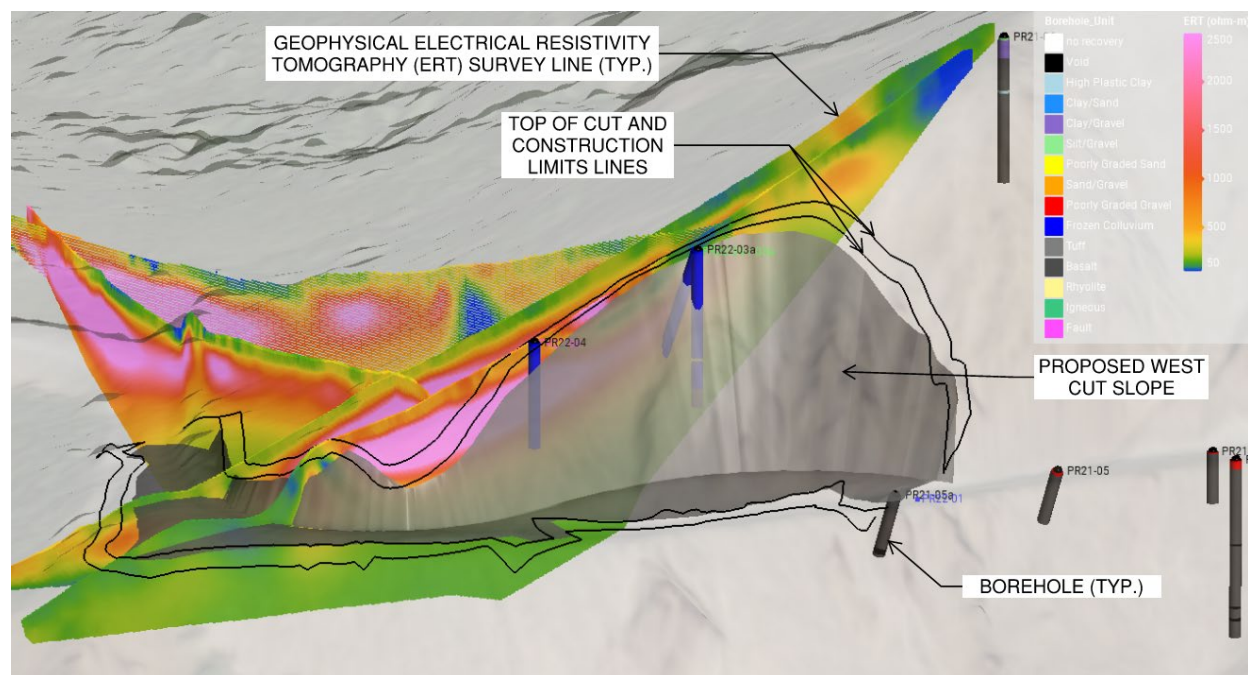
Surfaces were fit through the contact points identified in borehole logs and geologic mapping and given orientations based on the televue and structural mapping data collected from the existing rock cut (Figure 4). In areas where the location or orientation of the contacts was poorly constrained, a regional orientation determined from structural mapping was applied to the surface. The base of the frozen colluvium surface along the west ridge was also defined using borehole logs and electrical resistivity geophysical data (4). The geophysical survey results highlight the approximate extent of the ice-rich deposit spatially, as regions of high electrical resistivity greater than about 2200 ohm-m (Figure 4).

**Figure 4 - Leapfrog Subsurface Model (after 3).**

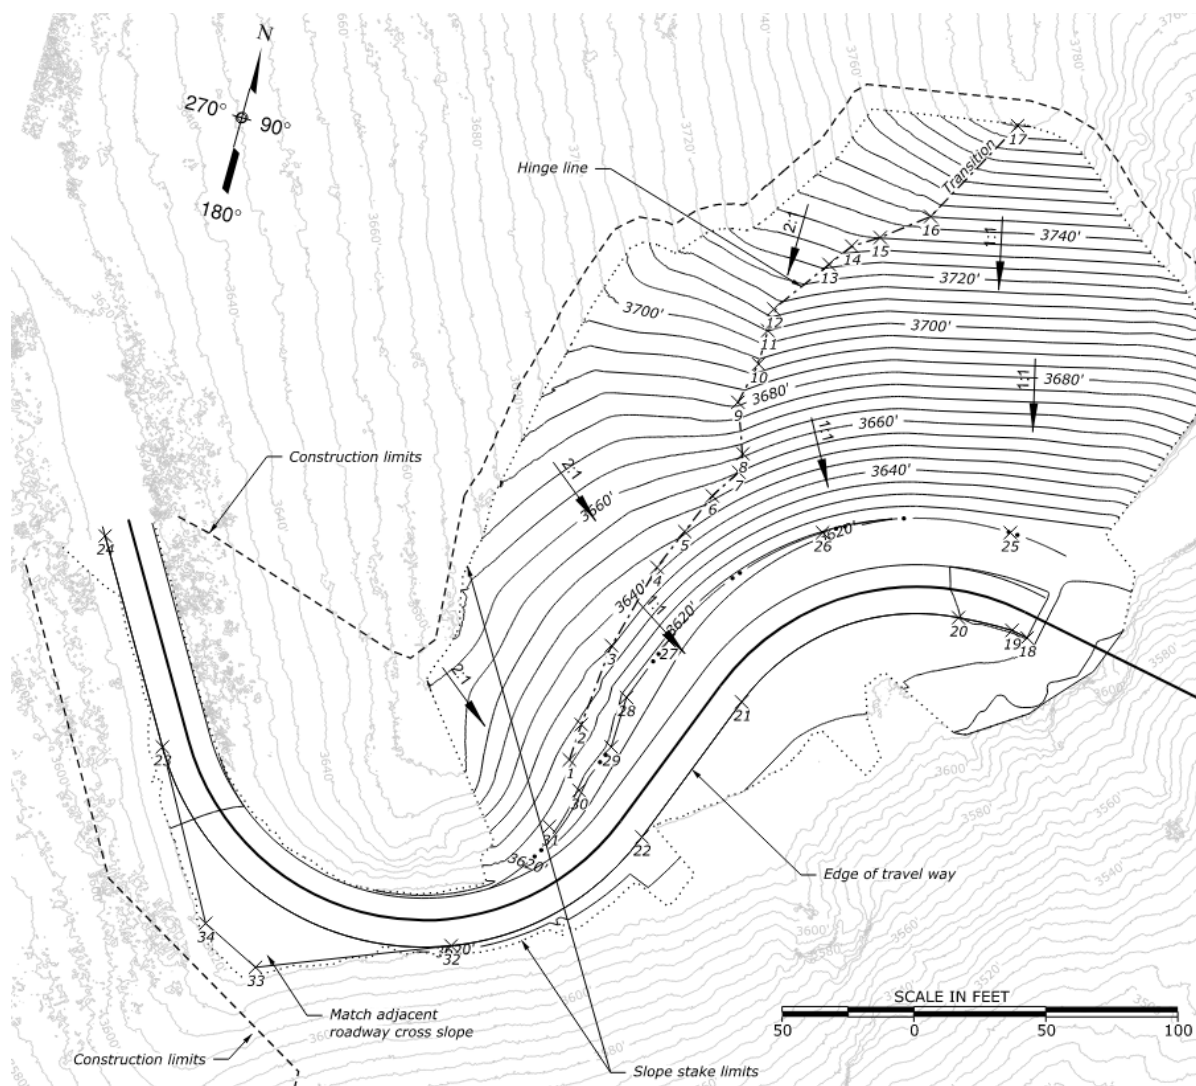
**Figure 5 - West Cut Grading Plan (6).**

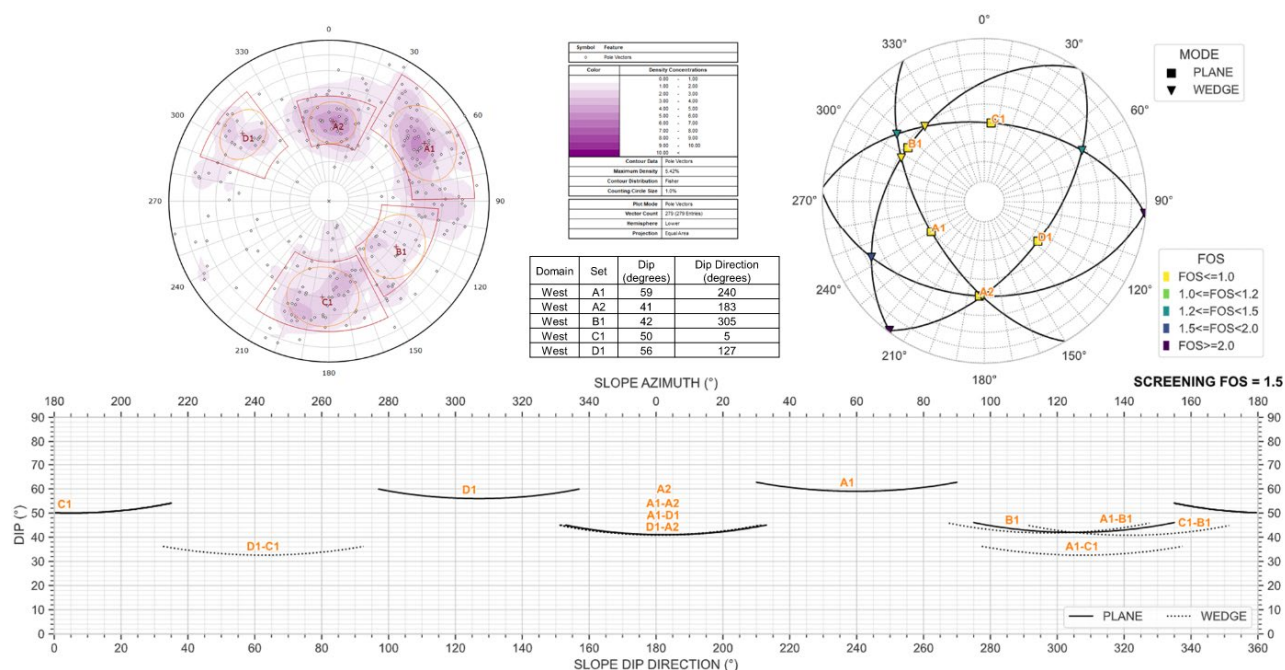
**Figure 6 - Discontinuity Data and Kinematic Analysis for the West Cut.**
