# 75<sup>TH</sup> HIGHWAY GEOLOGY SYMPOSIUM

BETTER HIGHWAYS THROUGH APPLIED GEOLOGY

2026  
HGS  
PROCEEDINGS

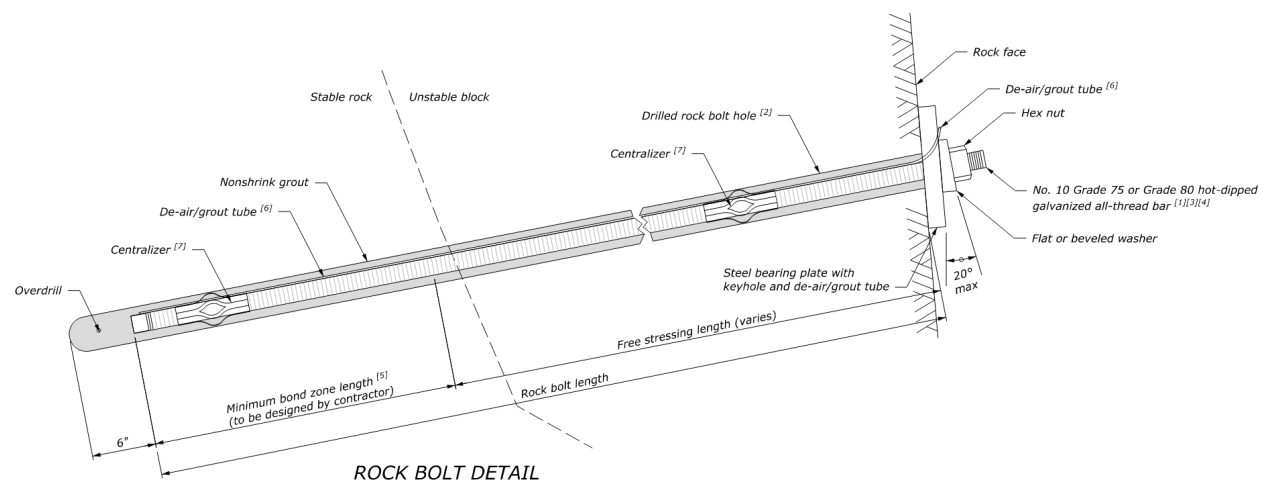
Through the different analyses and design iterations, it was concluded that tensioned rock anchors (rock bolts) were necessary to increase the long-term stability of the cut slope (Figure 7). The rock bolts were designed to manage larger instabilities associated with wedge and planar failures. Due to the desire for the cut slope to resemble a natural slope, the rock bolts were not designed to a set pattern, instead, they were specified to be installed during construction at locations identified by the project engineering geologist/geotechnical engineer. One hundred (100) 30-foot long galvanized #10 Grade 75 or Grade 80 all-thread bars were specified for the rock bolts. The contractor used an 8-foot minimum bond zone length and 3- to 4-inch diameter drill holes. The rock bolt design load is 60 kips. All rock bolts were tested to 125% of the design load during construction.

**Figure 7- Rock Bolt Detail.**

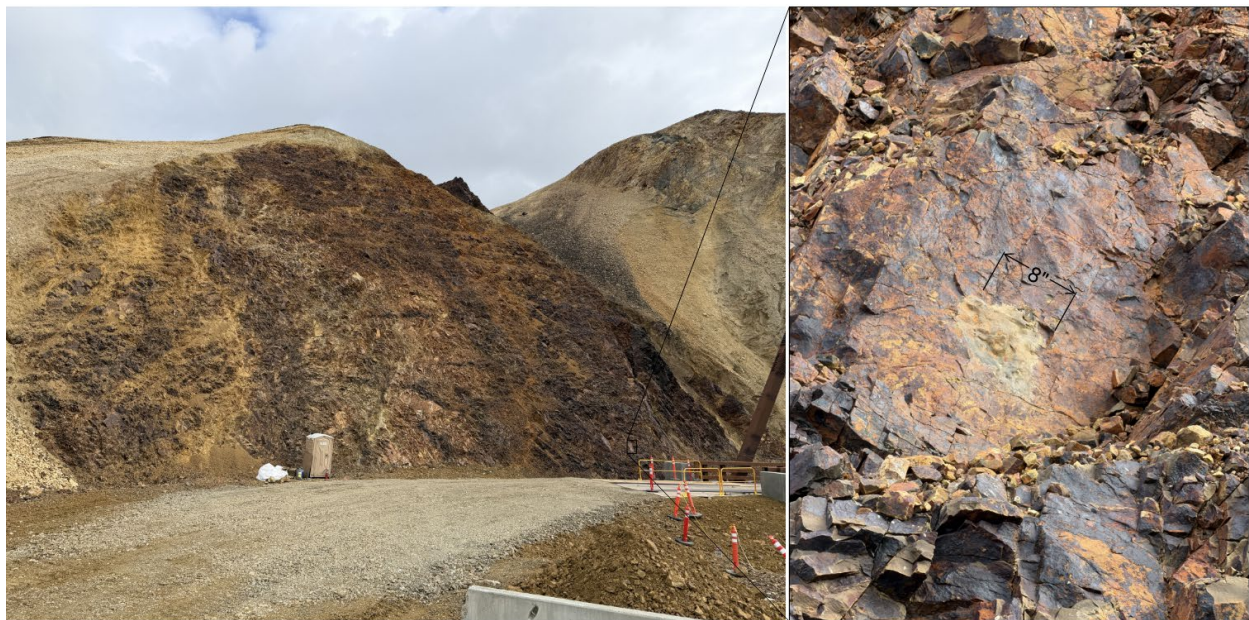
FHWA has context-sensitive practice on NPS projects to remove the plate, washer, and hex nut from rock bolts after grouting is completed. The bar is then cut off at the rock surface, and the annular space is filled with a colored grout matching the surrounding native rock. Any exposed bar ends are galvanized and treated with a weathering agent (Figure 8).

**Figure 8 - Photograph of Completed West Cut and Close-Up of a Completed Rock Bolt Location (June 16, 2026).**

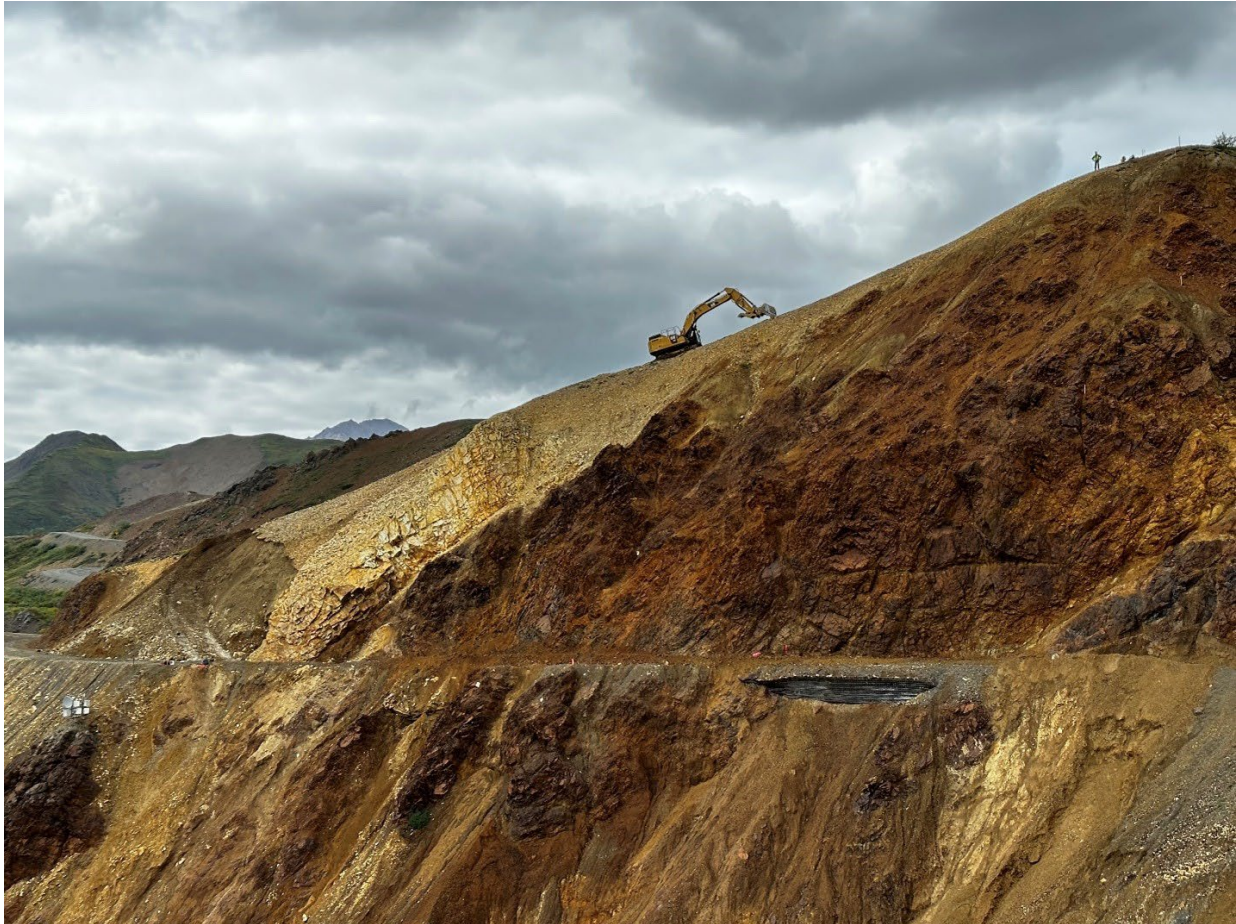
Construction began in August 2023, and excavation of the West Cut began by mid-August 2023 with a pioneer road up the cut to provide access for equipment and materials to the top of the cut (Figure 9). Winter shutdown was from October 2023 to April 2024. The West Cut was completed to design grade in June 2024. The cut was generally constructed using drilling and

**Figure 9 - Photograph of the Pioneer Access to the Top of the West Cut (August 23, 2023).**

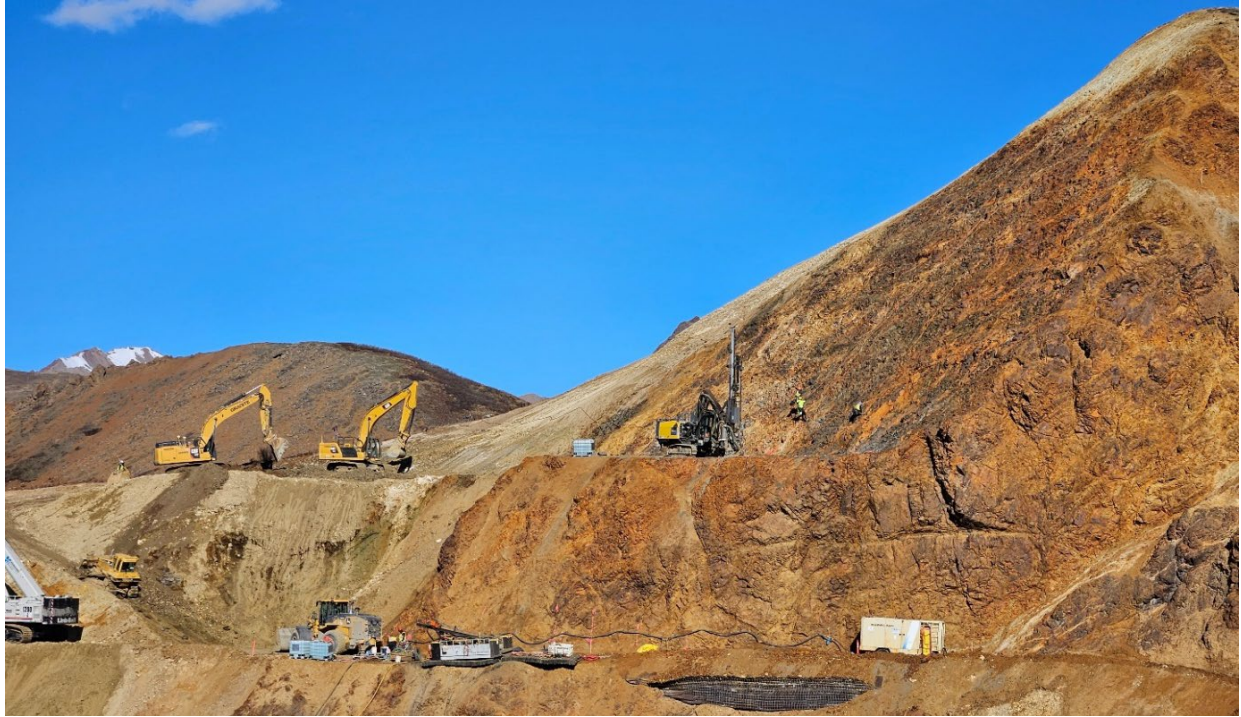
blasting techniques in the basalt (Figure 10) and excavators with ripper shanks and digging buckets in the frozen colluvium (Figure 11). The excavation was brought down in eleven 15-foot-high lifts. After each blast, excavators removed the shot rock from the cut slope. Scaling of the final face was carried out using pry bars and compressed air concurrent with excavation of each lift.

**Figure 10 - Photograph of West Cut Excavation (May 31, 2024).**

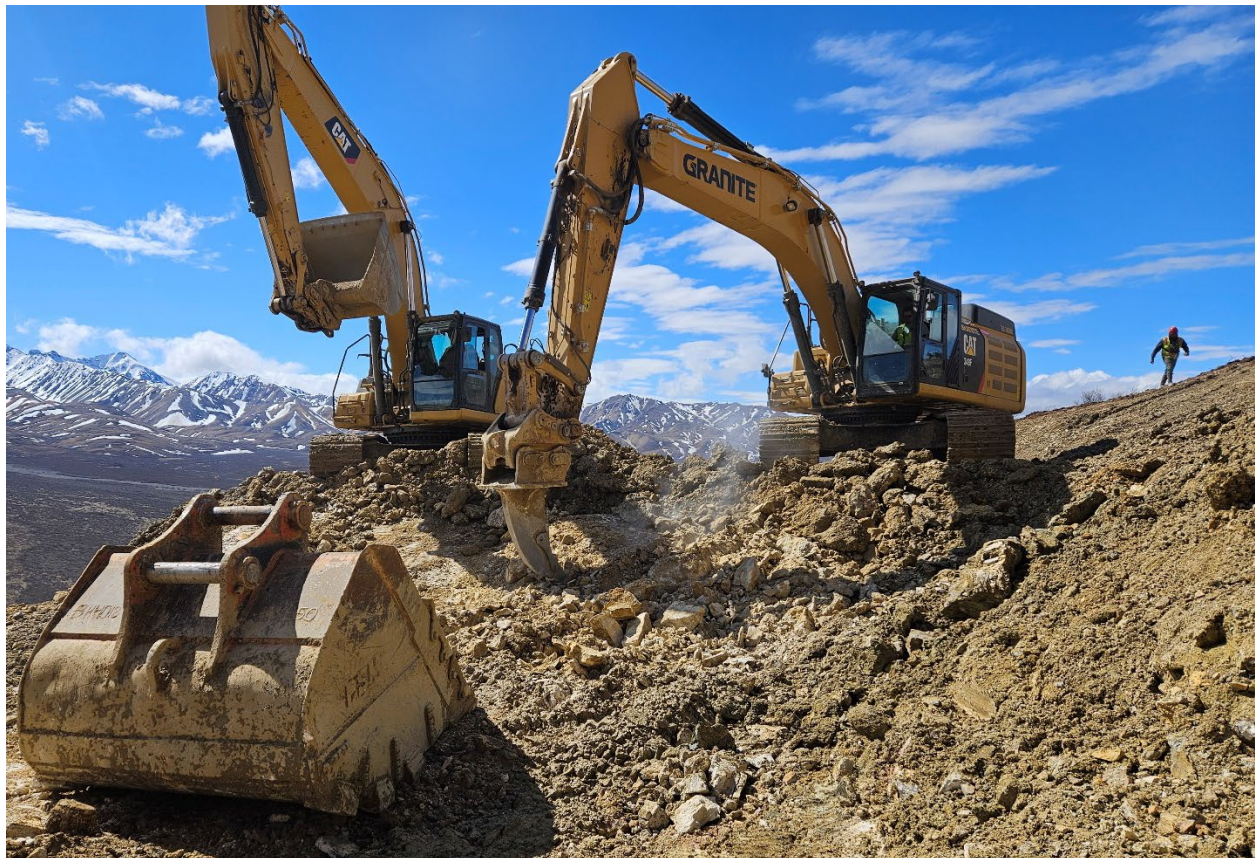
**Figure 11 – Photograph of Frozen Colluvium Excavation (May 30, 2024).**

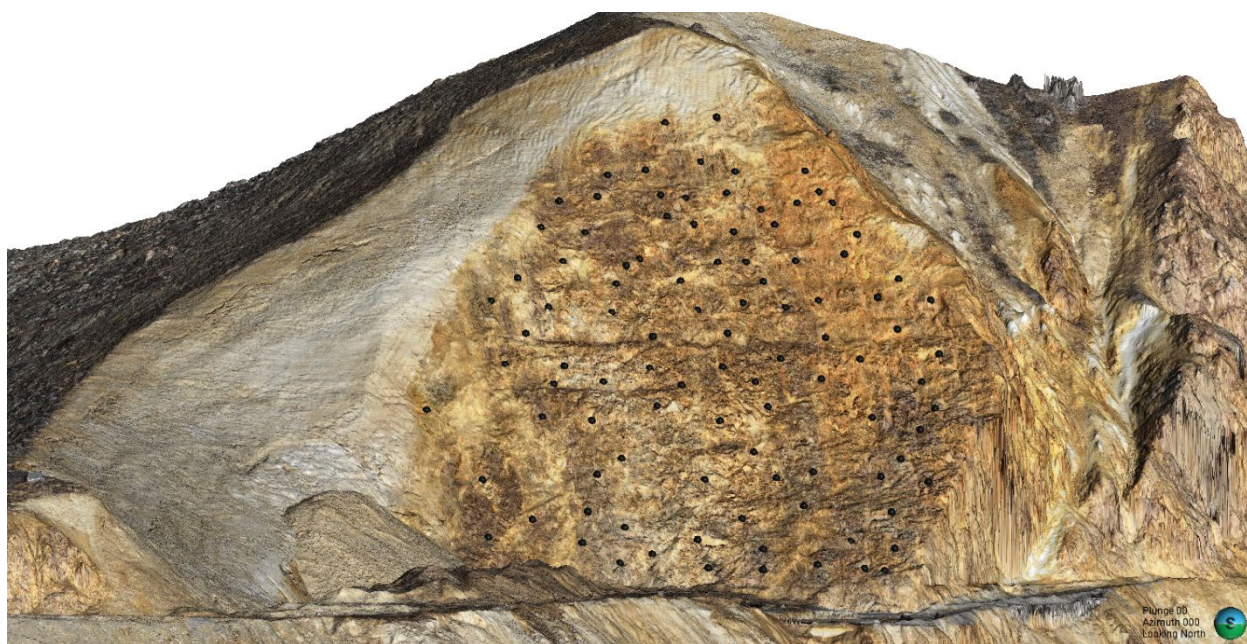
**Figure 12 - Perspective View in Leapfrog Works (5) Looking North at Installed Rock Bolt Locations (Black Dots) as Surveyed in the West Cut (imagery and topography collected October 6, 2024, and provided by Granite Construction Inc.).**

Once scaling was finished, the geotechnical engineer/engineering geologist identified and painted locations for rock bolts, which were then drilled and installed in two stages. Due to the drilling methods used for the rock bolts, it was not feasible to revisit previous lifts for additional bolting after the blast for the next lift. Therefore, onsite structural mapping and identification of potential wedge features were crucial for making informed decisions throughout the construction phases. This process required careful judgment to assess how each lift interacted with one another and to strategically determine where to place bolts based on potential areas of instability that could arise in the subsequent lift. The contractor drilled the blast holes for the next lift during the time that the rock bolts were grouted (two stages), stressed and tested, and locked off at the design load.

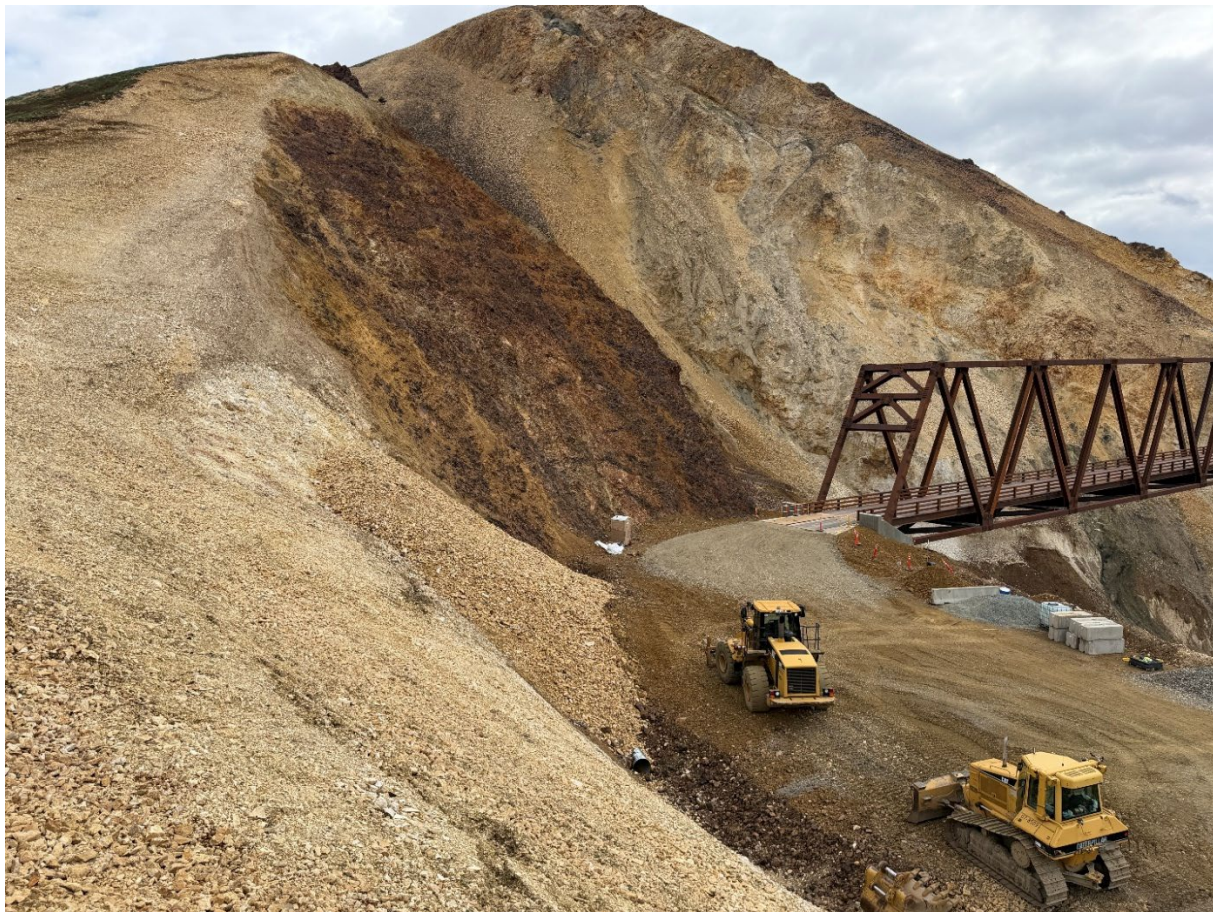
Additionally, the remote location of the project meant that additional quantities of materials could not be acquired within the proposed construction timeline. The team diligently tracked progress during construction, balancing the estimated number of bolts needed against the surface area of each lift to forecast the burn rate for rock bolt installation. The contractor's surveyor collected as-built locations for rock bolts after each lift was completed. BGC tabulated and plotted rock bolt quantities on each lift in Leapfrog Works (5) (Figure 12). This strategic approach allowed real-time adjustments and ensured that stabilization measures were adequately addressed without compromising the overall timeline and safety of the project. The West Cut was completed in June 2024, and the slope is performing well with limited rockfall being observed since the cut was completed (Figure 13).

**Figure 13 - Photograph of Completed West Cut (June 16, 2026).**

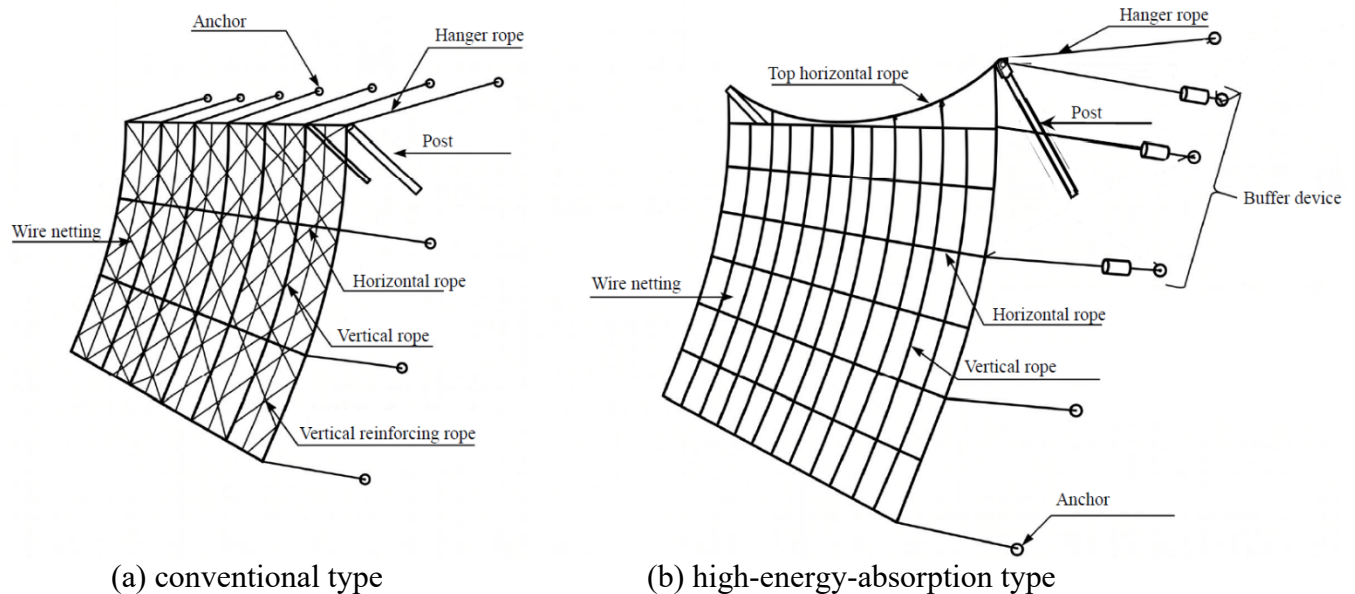
However, its capacity of the conventional pocket-type rockfall protection net to withstand rockfall energy is limited to 150 kJ, so it is generally used in conjunction with preventive measures (active method). On the other hand, as mitigation projects often require considerable time, such as land acquisition, there has been a recent increase in the adoption of high-energy-absorption systems capable of capturing rocks with higher energy levels at the slope toe as described in Figure 1-(b).

**Figure 1: Sketch of a conventional pocket-type rockfall protection net (a) and a high-energy-absorption pocket-type rockfall protection net (b)**

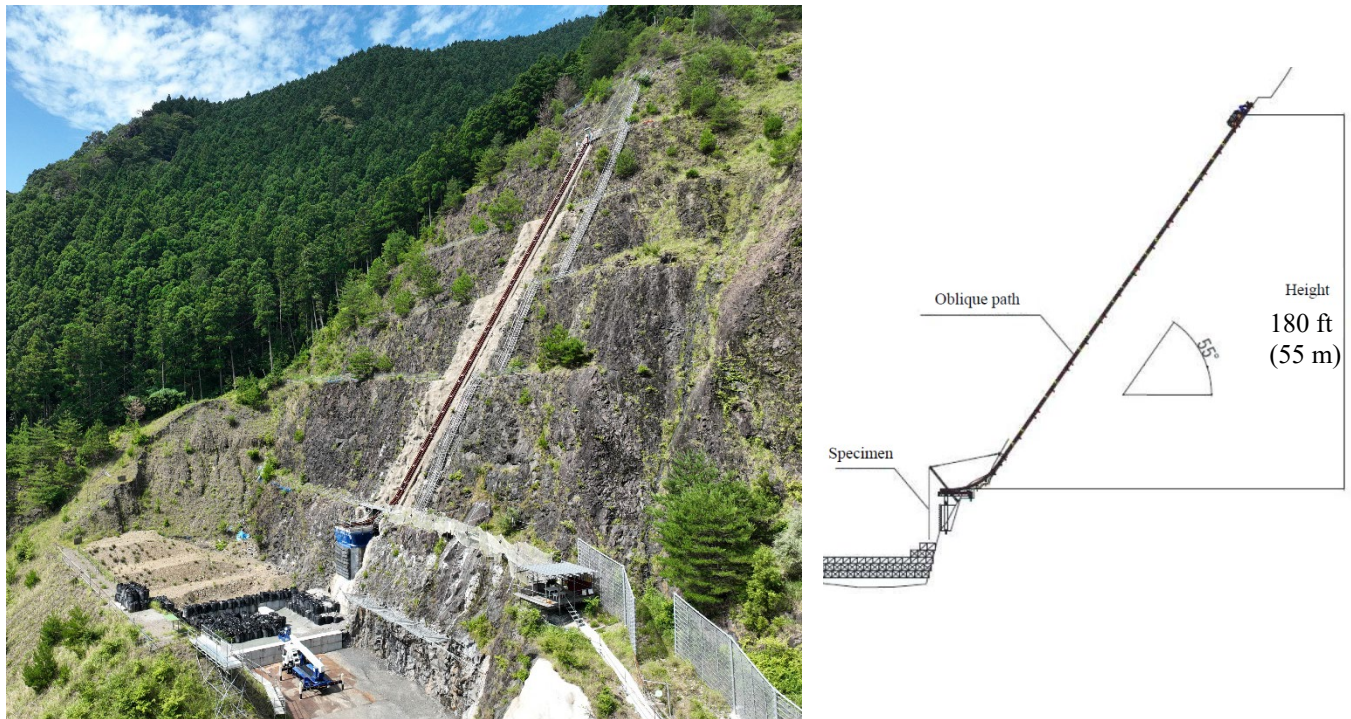
TOKYO ROPE conducted the full-scale test in accordance with *Guide on Rockfall Countermeasures* (5). In the tests, a block is released at a predetermined height on a runway installed in a quarry and collides with a test barrier installed in front of the lower end of the runway as shown in Figure 2. The release height was 180 ft (55 m), and the gradient was 55 degrees. The test barrier has 33 ft (10 m) in spacing between posts and 30 ft (9m) in effective height as shown in Figure 3.

**Figure 2: Test facility**

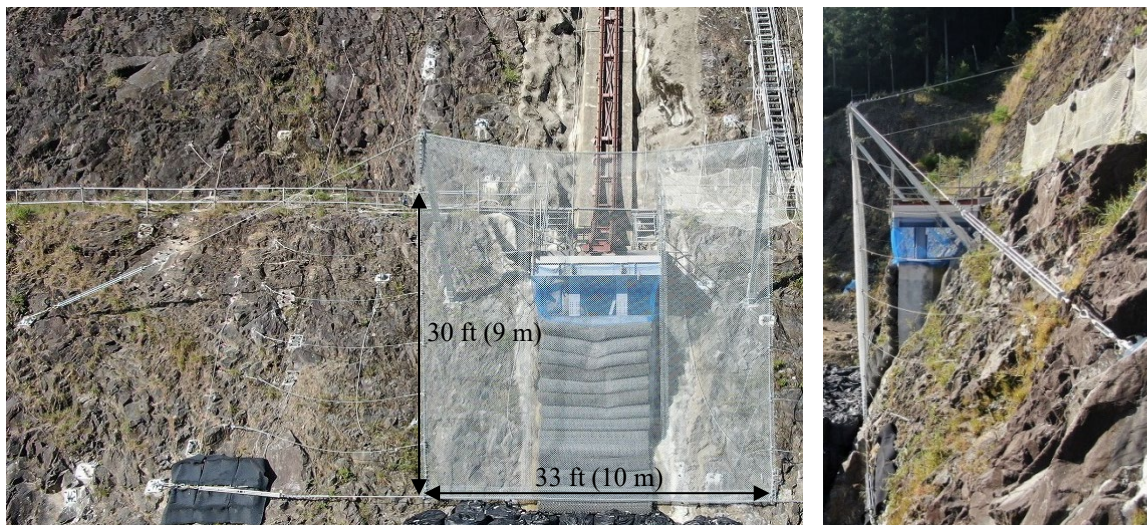
### Figure 3: Test barrier of 1,400 kJ

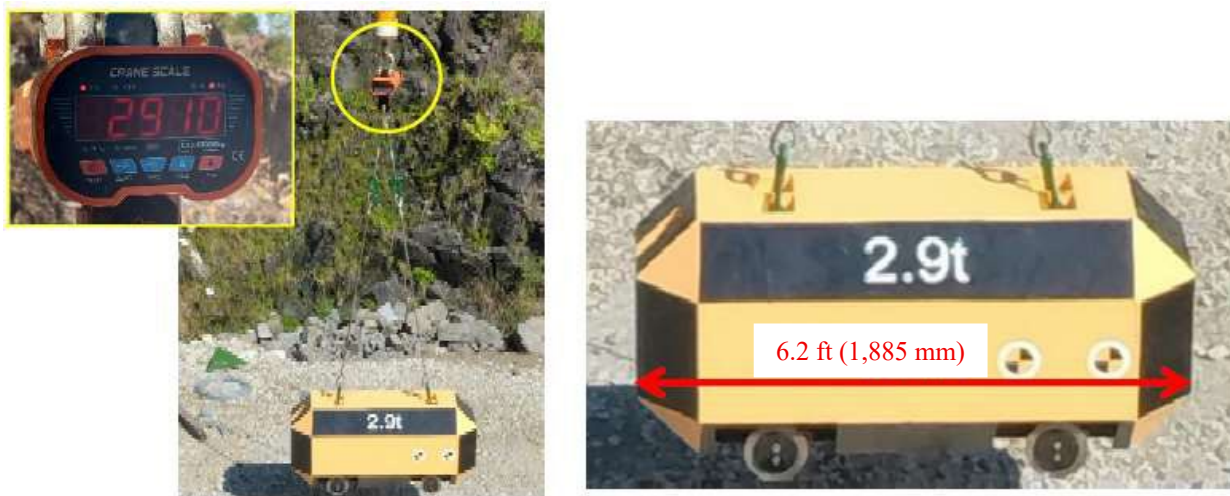
The block used in the full-scale test was a concrete block (mass: 2.9 ton) as shown in Figure 4. Based on *Guide on Rockfall Countermeasures*, the density was  $2,300 \text{ kg/m}^3$ .

Figure 4. Block details

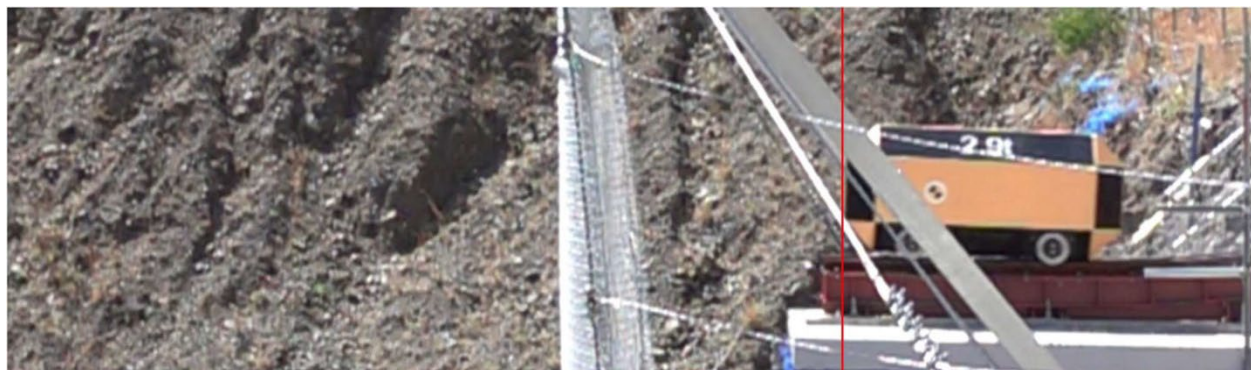
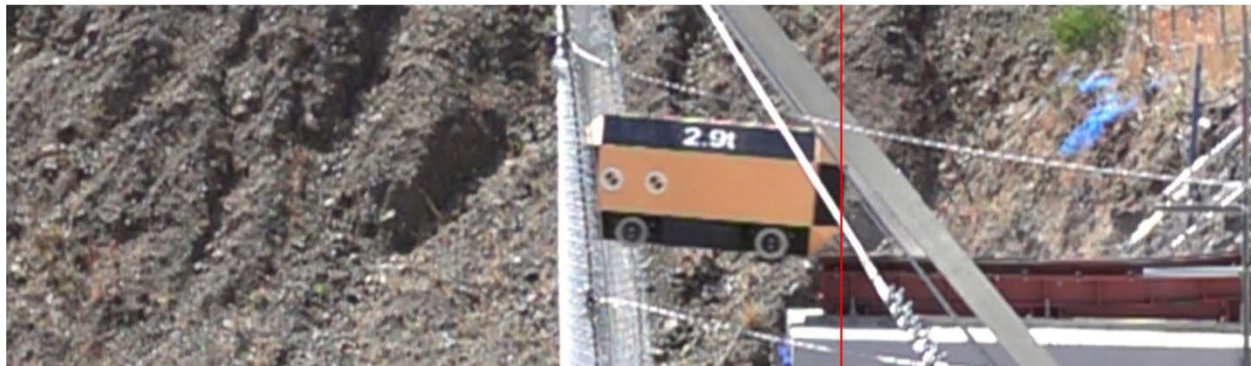
### Figure 5: Velocity measurement

In the full-scale test, the block velocity was measured by a high-speed camera. It can photograph 960 frames per second. The block passed the barrier during 58 frames as shown in Figure 5 (a) and (b).

(a) Velocity measurement start

(b) Velocity measurement end

58 frames correspond to 0.06 seconds (58/960). The length of the block is 6.2 ft (1.885 m), and thus its velocity was  $1.885\text{m} / (58/960)\text{s} = 31.2\text{ m/s}$ . This value satisfies the conditions described in *Guide on Rockfall Countermeasures*, which is that the velocity is no less than 25 m/s. The impact energy was as follows;  
 $E = 1/2 \times m \times V^2 = 1/2 \times 2.9 \times (31.2)^2 = 1,411\text{ kJ}$ .

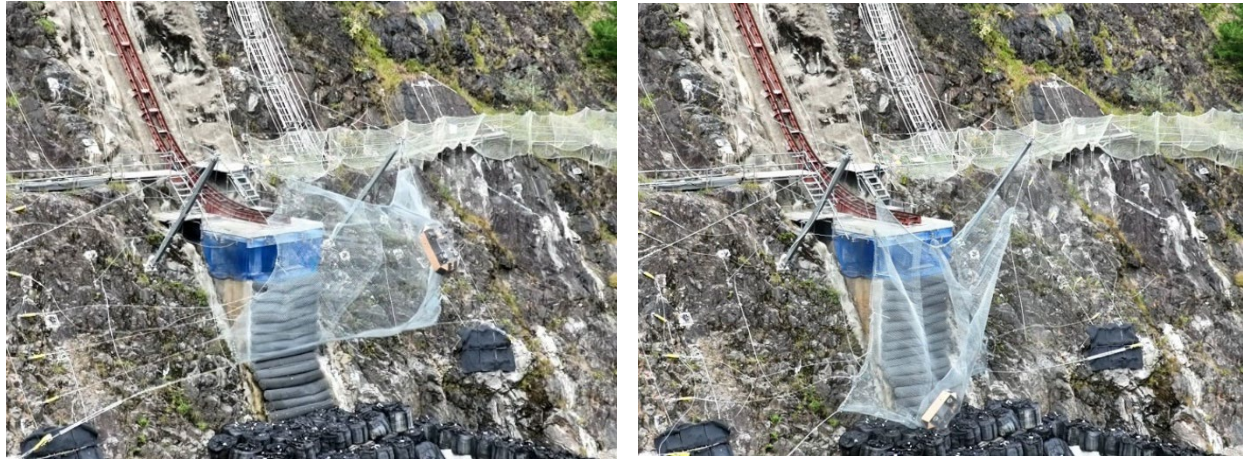
The test barrier after the full-scale test is shown in Figure 6 and 7. The test barrier could capture the block and effectively guide it to the toe of the slope.

Figure 6: Behavior of test barrier (bird's-eye view)

Although the rupture of wire netting near the point of impact was observed, it was caused by rotating wheels of the block and the block was seen to rebound after being caught; therefore, we determined that the structure's overall containment performance was satisfactory.

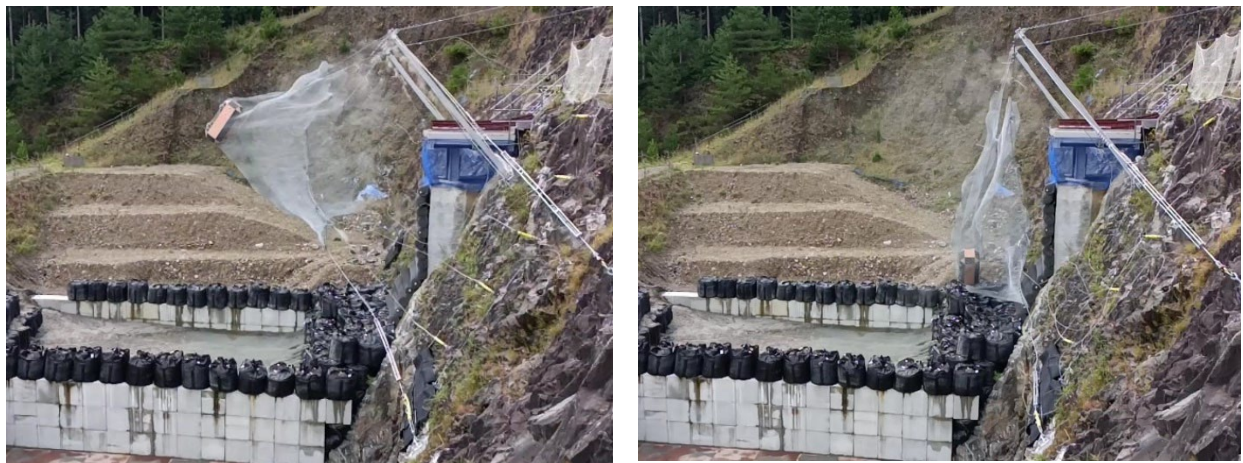
Figure 7: Behavior of test barrier (side view)

Furthermore, no significant tilting of the posts was observed between the moment of maximum deflection and the time following the impact. After the full-scale test, we could easily dismantle the test barrier and remove it. This means that, even after the actual events of rockfalls, administrators can easily maintain this hybrid barrier.

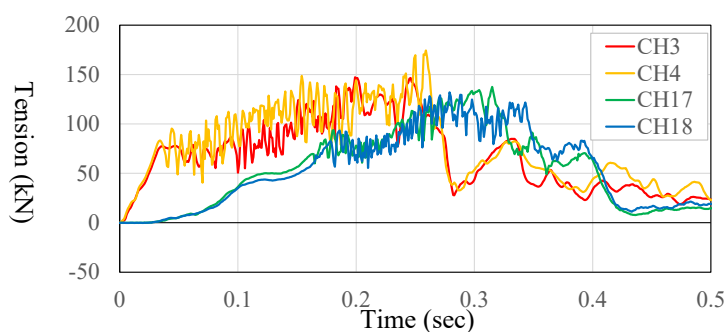
In this full-scale test, we measured the generated tension on wire ropes by a data acquisition system and load cells. Figure 8 shows the time-history response waveforms of the loads on the top horizontal rope (CH3, 4) and the bottom horizontal rope (CH17, 18) equipped with buffer devices. The effect of these devices is evident: once the load exceeds approximately 80–90 kN, the rapid increase in load is suppressed as the waveforms exhibit small-amplitude oscillations.

**Figure 8: Time-history response of tension on horizontal ropes**

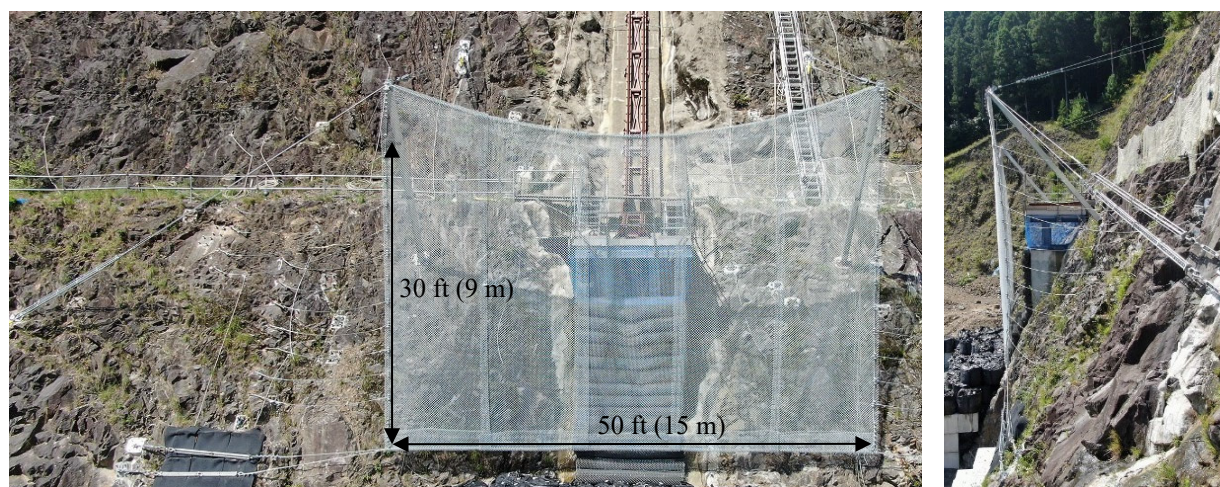
TOKYO ROPE conducted the full-scale test of 2,800 kJ in the same manner as that of 1,400 kJ. The test barrier has a 50-ft (15 m) spacing between posts and 30 ft (9 m) in effective barrier height as shown in Figure 9.

**Figure 9: Test barrier of 2,800 kJ**

We increased the number of wire netting layers (from 1 layer to 2 layers), upslope ropes (from 1 to 2 ropes), top horizontal ropes (from 1 to 2 ropes), and bottom horizontal ropes (from 1 to 2 ropes), respectively.

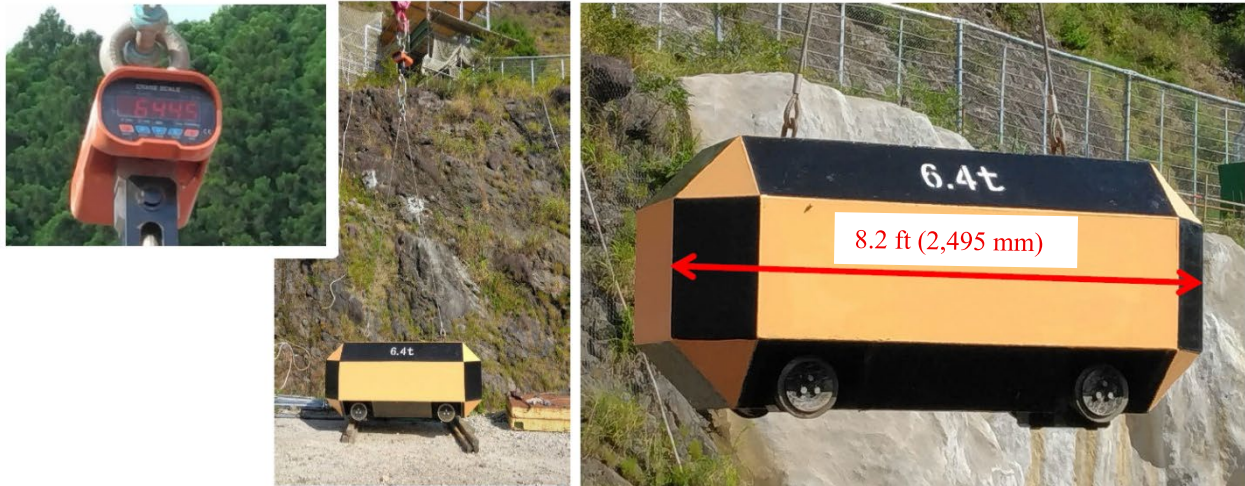
The block used in the full-scale test was again a concrete block (mass: 6.4 ton) as shown in Figure 10. Based on the *Guide on Rockfall Countermeasures*, the density was  $2,300 \text{ kg/m}^3$ .

**Figure 10: Block details**

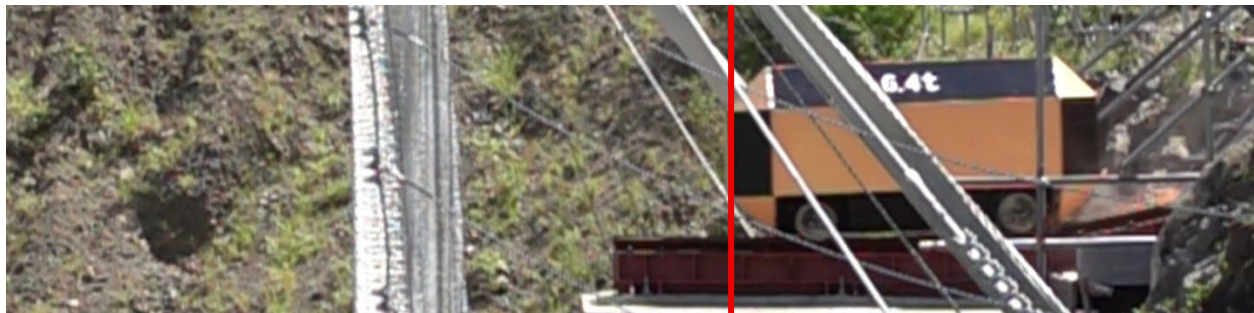
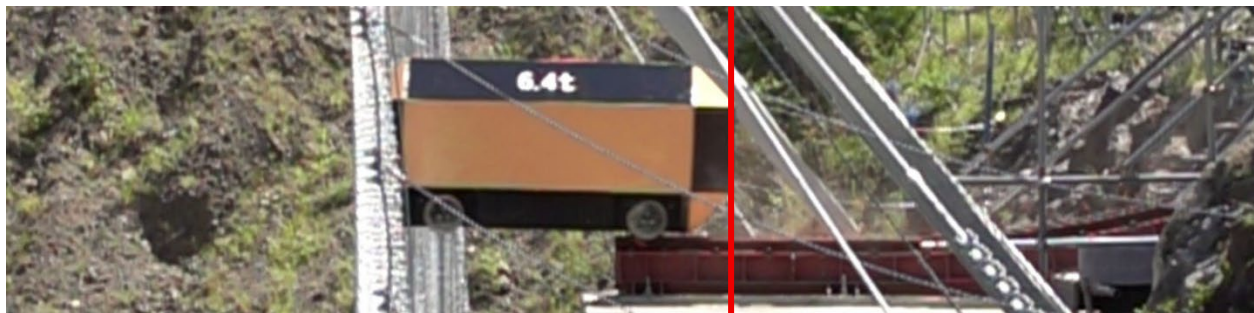
**Figure 11: Velocity measurement**

In the full-scale test, the block velocity was measured by a high-speed camera. It can photograph 960 frames per one second. The block passed by during 80 frames as shown in Figure 11 (a) and (b).

**(a) Velocity measurement start**

**(b) Velocity measurement end**

80 frames correspond to 0.08 second (80/960). The length of the block is 8.2 ft (2.495 m), and thus its velocity was  $2.495\text{m} / (80/960)\text{s} = 29.9\text{ m/s}$ . This value satisfies the conditions described in the *Guide on Rockfall Countermeasures*, which is that the velocity is no less than 25 m/s. The impact energy was as follows;  
 $E = 1/2 \times m \times V^2 = 1/2 \times 6.4 \times (29.9)^2 = 2,868\text{ kJ}$ .

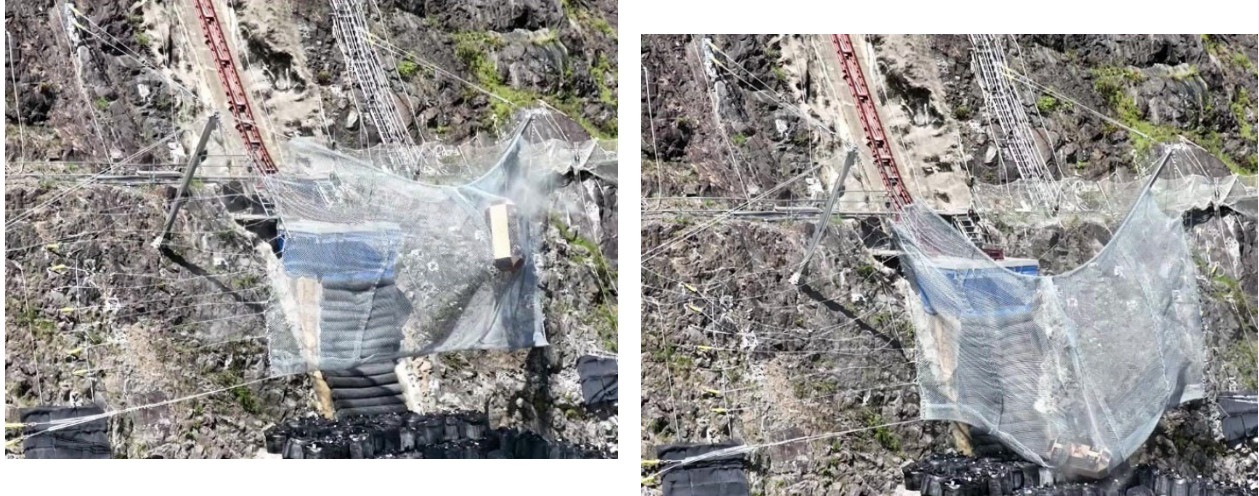
The test barrier after the full-scale test is shown in Figure 12 and 13. The test barrier could capture the block and effectively guide it to the toe of the slope.

**Figure 12: Behavior of test barrier (bird's-eye view)**

Although a deformation of the wire netting near the point of impact was observed, it was caused by rotating wheels of the block and the block was seen to rebound after being caught; therefore, we determined that the structure's overall containment performance was satisfactory.

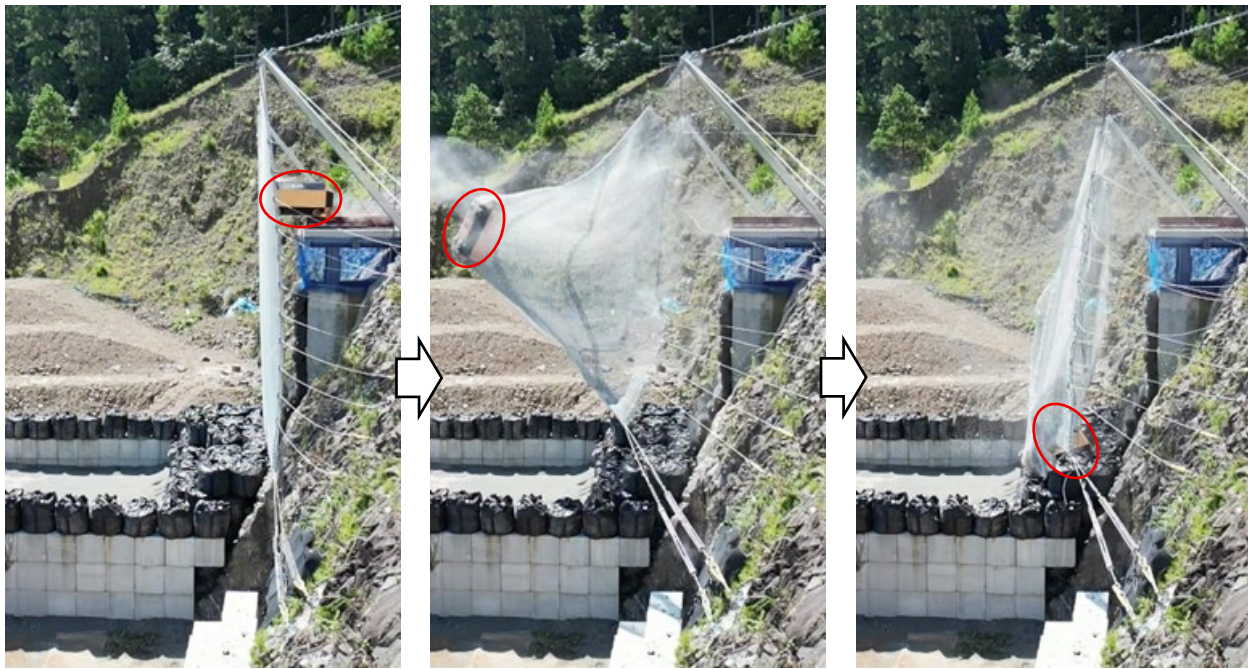
**Figure 13: Behavior of test barrier (side view)**

Furthermore, no significant tilting of the posts was observed between the moment of maximum deflection and the time following the impact. After the full-scale test, we could easily dismantle the test barrier and remove the structure components while leaving posts in place. This means that, even after the actual events of rockfalls, administrators can easily maintain this hybrid barrier.

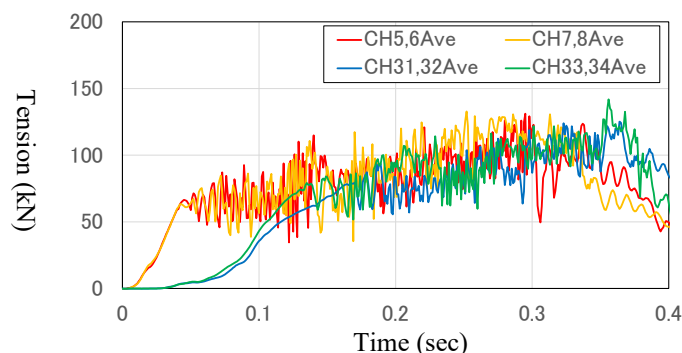
In this full-scale test, we measured the generated tension on wire ropes by a data acquisition system and load cells. Figure 14 shows the time-history response waveforms of the average loads on the top horizontal ropes (CH5, 6 and CH7, 8) and the bottom horizontal ropes (CH31, 32 and CH33, 34) equipped with buffer devices. The effect of these devices is evident: once the load exceeds approximately 70 kN, the rapid increase in load is suppressed as the waveforms exhibit small-amplitude oscillations.

**Figure 14: Time-history response of tension on horizontal ropes**

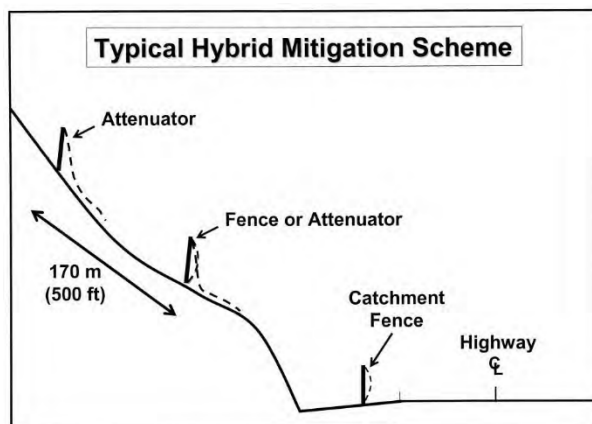
**Figure 15: Conceptual diagram showing installation of attenuator sequence extracted from *Colorado's Full-Scale Field Testing of Rockfall Attenuator Systems***

Let's take a look from the viewpoint of installation. One mitigation scheme was shown in *Colorado's Full-Scale Field Testing of Rockfall Attenuator Systems* (1). Attenuator is installed at a higher place of the slope, Fence or Attenuator at a middle place, and Catchment Fence along

the road as described in Figure 15. In this scheme, 3 systems are installed. From the viewpoint of installation, this is not cost effective.

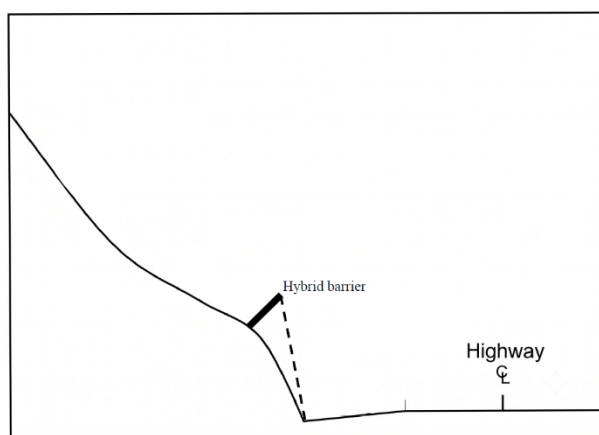
**Figure 16: Conceptual diagram showing installation of hybrid barrier**

On the other hand, if we utilize hybrid barrier, secondary catchment along the road is not required in the best case as shown in Figure 16. We can shorten the installation time and utilize the cost effectively.

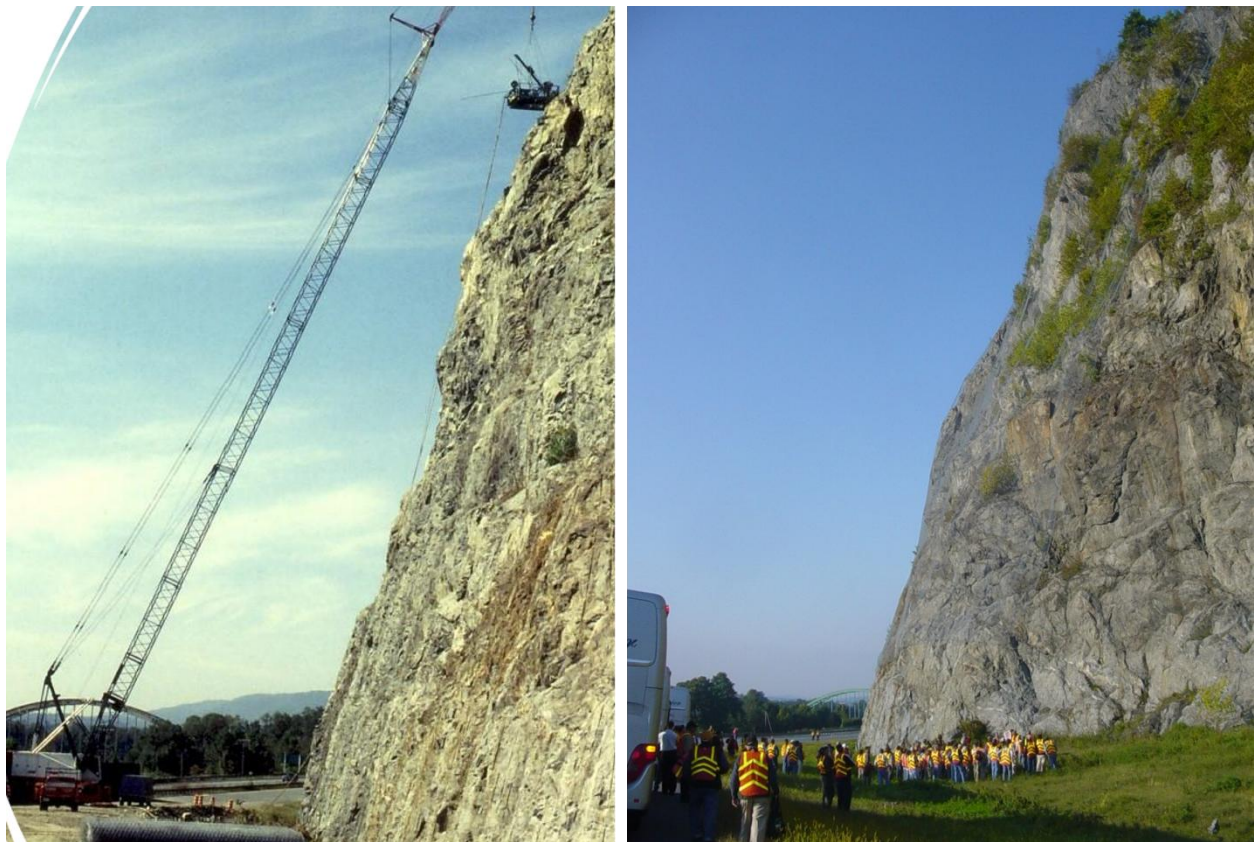
**Figure 3 - 1996 Construction with crawler crane (left; VTrans); 2003 HGS field trip site visit (right, J. Smerekanicz 2003)**

Recurring rockfall events occurred in 1973, 1985, 1987 and 1990 emanating from above the presplit benches that involved vehicle strikes and southbound roadway closures (Baskerville et al., 1993; Westerman et al. 2003). In summer and fall of 1996 VTrans designed and constructed the first rockfall drape system used in the State as part of a regional interstate safety program (Eliassen, 1997). During this work, southbound traffic on I-91 was detoured onto adjacent U.S. Route 5 between Exits 16 and 15 to accommodate construction, including a large crawler crane with about 250 feet of boom length (see Figure 3). Prior to drape placement, the rock slope was cleared of vegetation, hand scaled (over three weeks), and subject to trim blasting. During scaling activities, some rock struck the slope face and ramped over I-91 southbound into I-91 northbound, and then rolled into the adjacent U.S. Route 5 and into the railroad tracks, a distance of over 200 lateral feet. Four large rock blocks that appeared potentially unstable and would exceed the capacity of the drape were secured with ten (10) rock bolts. These consisted of #8 (1-inch diameter) galvanized, 30 foot long, Grade (GR) 150 threadbars, installed in 1-5/8-inch diameter drill holes using a drill on a platform suspended from the large crane, and grouted using fast and slow epoxy setting resin. The threadbars were then tensioned to a proof load of 90,000 pounds (90 kips) and locked off on a bearing plate at 75 kips.

The drape material consisted of Maccaferri No. 11 gauge, galvanized double-twist mesh made of steel wire with a tensile strength of 70,000 pounds per square inch (70 ksi). The mesh was suspended by  $\frac{3}{4}$  (0.75)-inch diameter galvanized wire ropes attached to vertical GR 60 galvanized #8 threadbars above the crest of slope and grouted using resin cartridges (in rock) and cementitious grout (in overburden). The drape was extended to about 30 feet above the slope toe. Two cranes were used to install the drape: the large crawler crane staged on the southbound lanes, and a smaller one located above the crest of the slope on an excavated crane pad. The installed draped mesh quantity was 196,146 square feet (ft<sup>2</sup>).

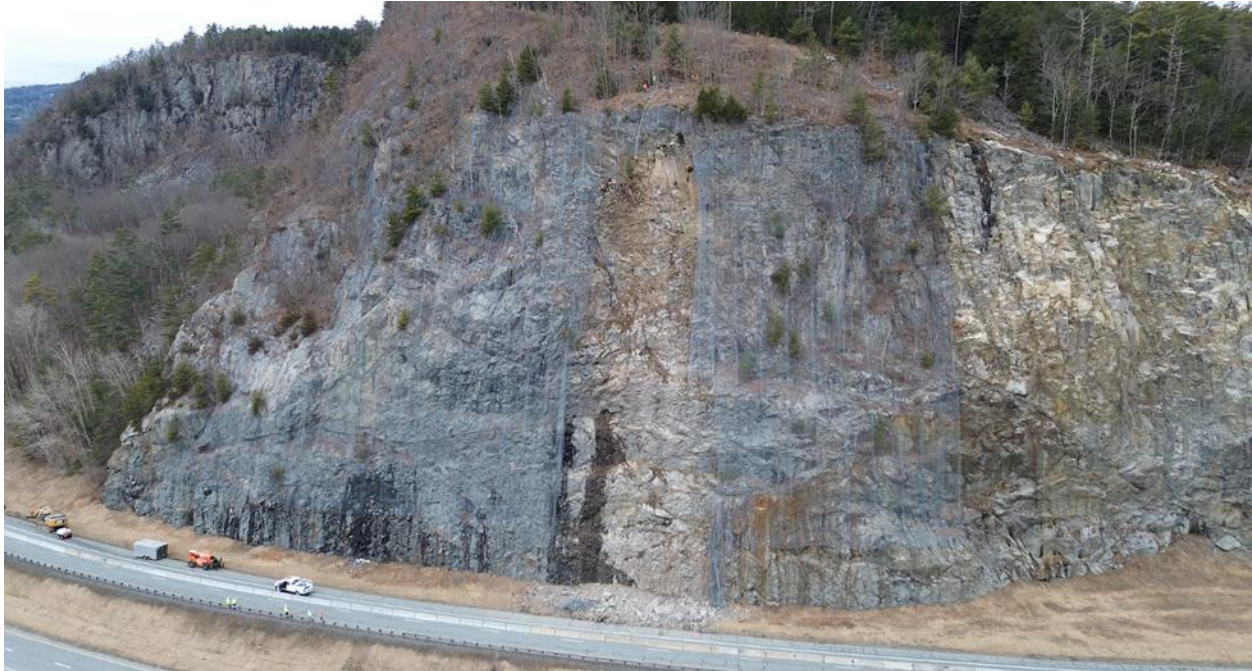
**Figure 4 – Drone image of scalers beginning emergency response on March 5, 2024, following the February 27, 2024 rock fall (VTrans)**

At approximately 11:00 p.m. on February 27, 2024, a rockfall occurred at approximately mile marker 92.55 on I-91, consisting of an estimated 100 to 200 cubic yards (CY) of rock debris, some of which impacted the southbound (SB) lanes with boulders exceeding 4 feet in maximum dimension (see Figure 4). No injuries or significant vehicular damage were reported. The rock fall originated from the upper reaches of the 300-foot-high slope, and ripped through existing rockfall drape netting (Figure 5). The rock fall caused full closure of the north and southbound highway lanes for emergency response and assessment. Northbound traffic was allowed to resume the following day, and one lane of southbound traffic was opened after deployment of temporary concrete barriers and other traffic control.

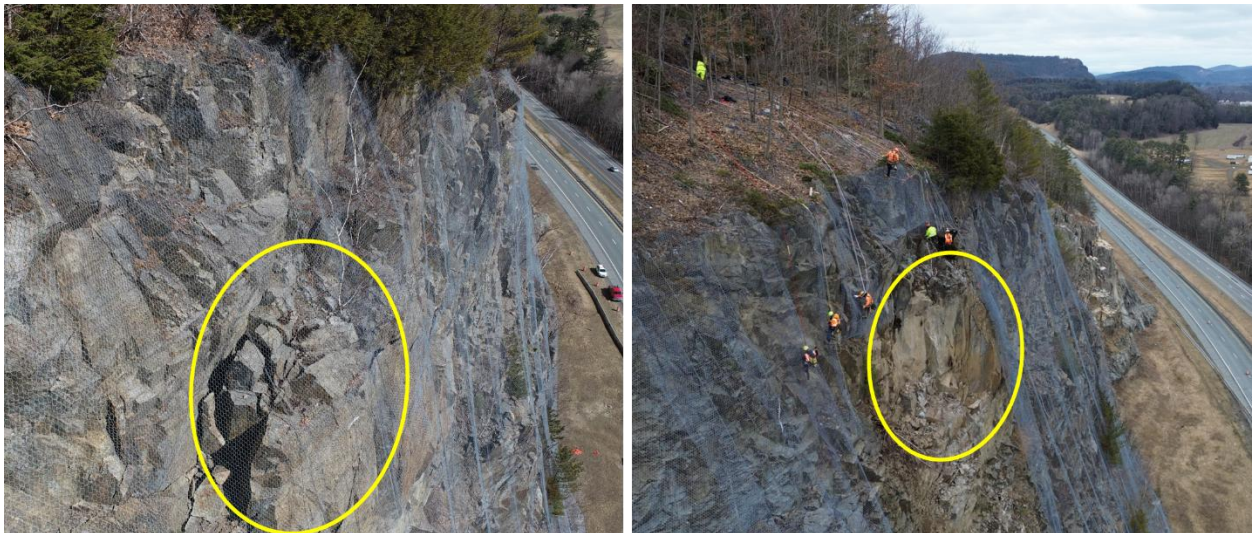
**Figure 5 – Drone images of rock fall source area prior to rock fall (left) on April 5, 2022, and scar following rock fall (right) March 5, 2024 (VTrans)**
