# 75<sup>TH</sup> HIGHWAY GEOLOGY SYMPOSIUM

BETTER HIGHWAYS THROUGH APPLIED GEOLOGY

2026  
HGS  
PROCEEDINGS

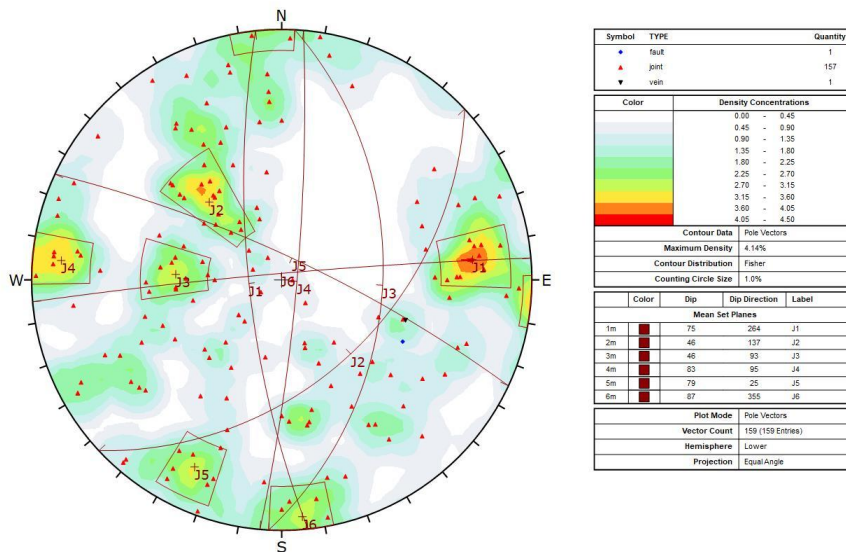
**Figure 6 – Stereonet of discontinuity sets (equal angle projection; 0.45% contour interval)**

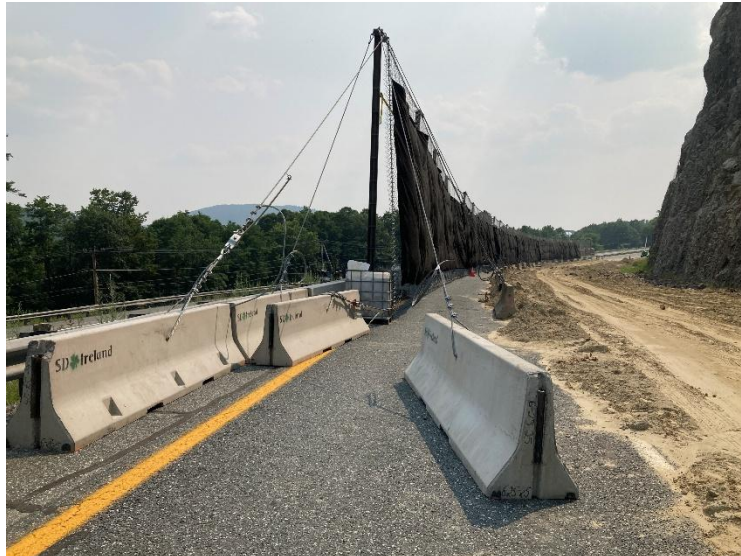
**Figure 7 - Temporary rock fall barrier arrangement and sand cushion (Scarptec, 2025)**

Following temporary closure of the southbound travel lane on July 2, 2025, the contractor setup a temporary rockfall barrier in the travel lane to provide traffic protection during clearing and grubbing activities above the crest of the slope. The temporary barrier, an internal contractor design, was based on GeoBrugg's GBE-500A system with a capacity of 500 kilojoules (kJ), and a height of 20 feet. The barrier used concrete-filled "water buffaloes" weighing approx. 4,000 lbs. as foundation bases for the vertical I-beam posts, and concrete Jersey barriers as anchors for the tie-back cables and braking systems

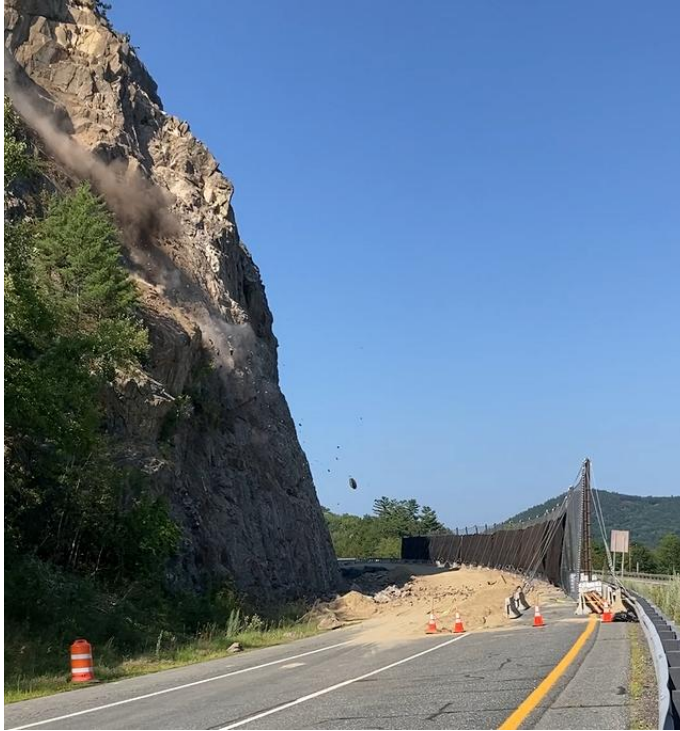
**Figure 8 - Hand scaling operations (Scarptec 2025)**

Between July 30 and August 18, 2025, the contractor conducted hand scaling of the entire rock slope, moving generally from northeast to southwest (see Figure 8). The contractor successfully completed the scaling work within the incentive/disincentive period, which extended by contract from July 26 through August 30, 2025, with the southbound passing lane reopened on August 26, 2025. This included removal of most of the old double-twist mesh remaining from the 2024

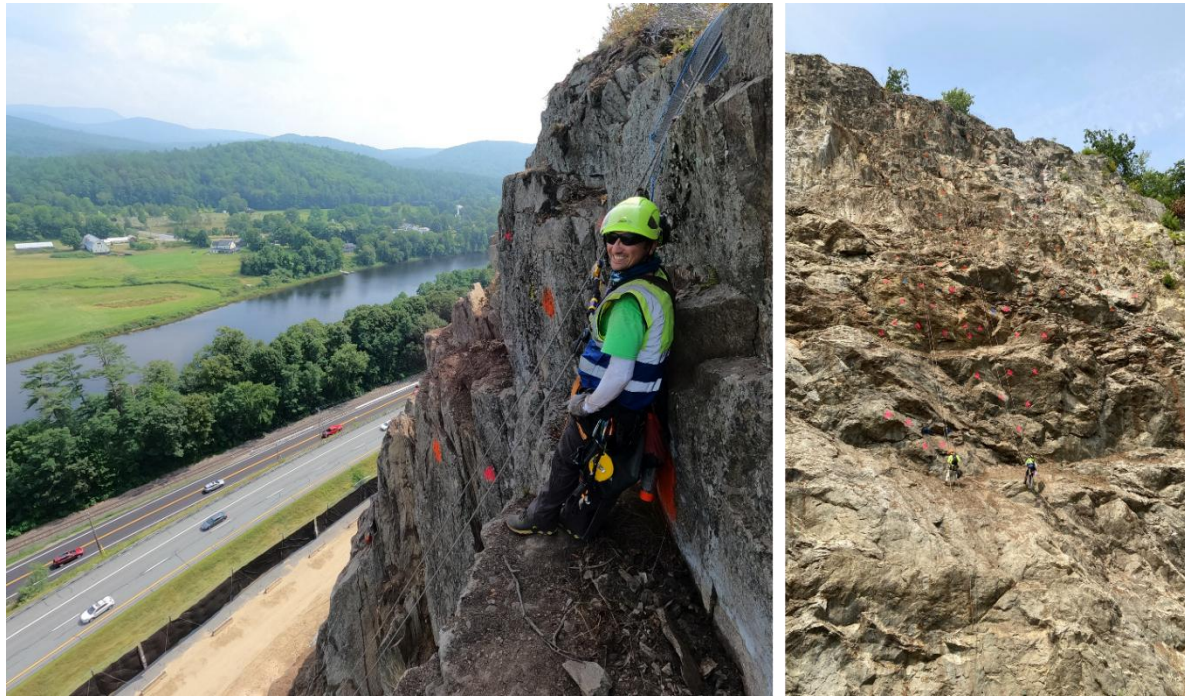
**Figure 9 - Layout of mitigation elements using rope access methods (Scarptec 2025)**

Between August 18 and November 25, 2025, the contractor drilled and installed 2,103 rock slope mitigation elements, consisting of pull testing elements, wire rope anchors, wire mesh dowels, rock slope stabilization dowels, shotcrete rock nails, and drains, with a total drilling length of 33,106.67 linear feet, based on VTrans' field tracking information. Table 4 below provides a summary of the mitigation elements installed.

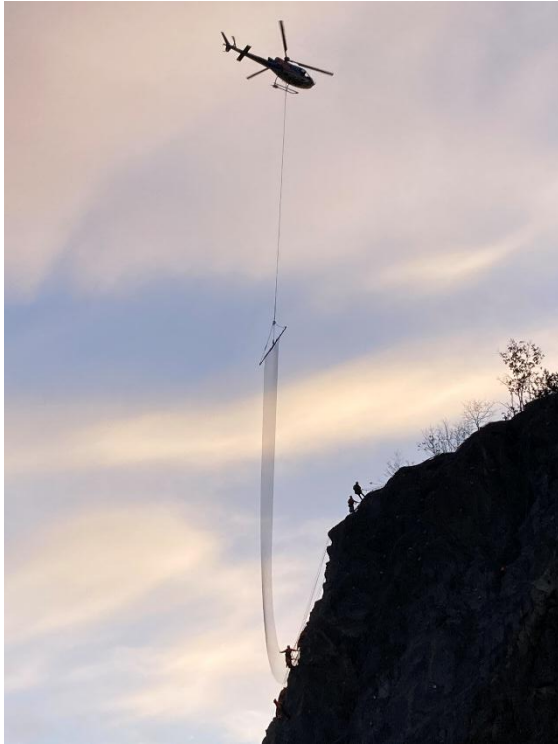
**Figure 10 - Pinned mesh installation using helicopter (Scarptec 2025)**

access methods to first attach the top of the panels with galvanized pin-screw shackles to the top 0.625-inch diameter galvanized perimeter cable (installed prior to the lifts), and then the helicopter slowly lowered the panel, with technicians following to pull the mesh into place and attach it to adjacent panels using the T3 seaming clips. Once most of the panel was placed, the pilot activated a remote release mechanism “flop” the spreader bar down and thus release the panel (see Figure 10).

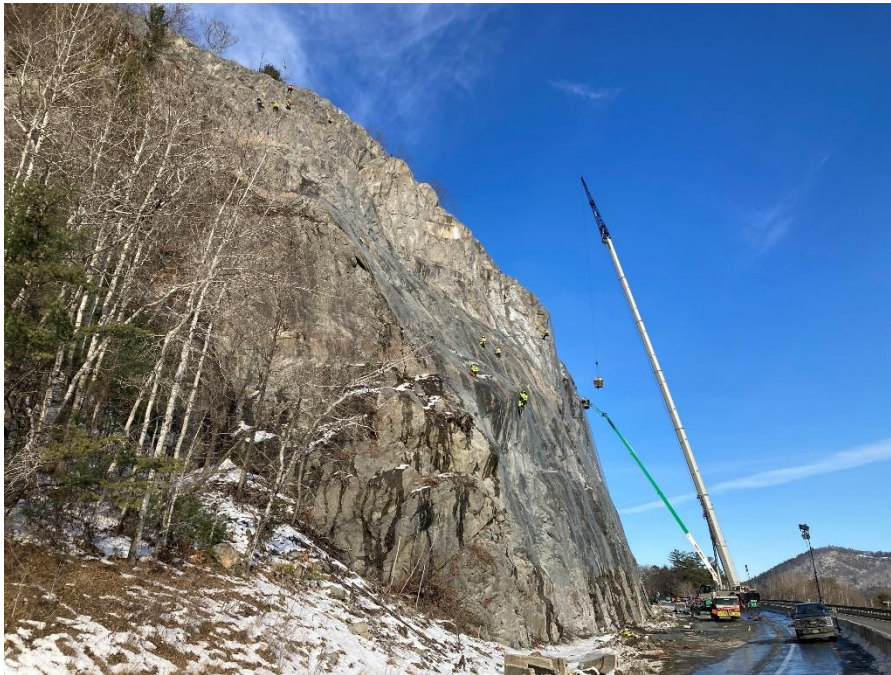
**Figure 11 - Installation of draped mesh using a crane and telehandlers (Scarptec 2025)**

for “pigtails” to allow lifting of the mesh for periodic cleanout. The contractor used a combination of the wheeled crane, Magni telescopic telehandler, and manlifts to hang the mesh (see Figure 11). The contractor attached the mesh on the horizontal cable using galvanized 0.75-inch screw pin shackles, and adjacent panels were seamed using T3 clips. The contractor then extended the  $\frac{5}{8}$ -inch diameter cables below the bottom of the drape and constructed the pigtail loop for future mesh cleanout maintenance from below.

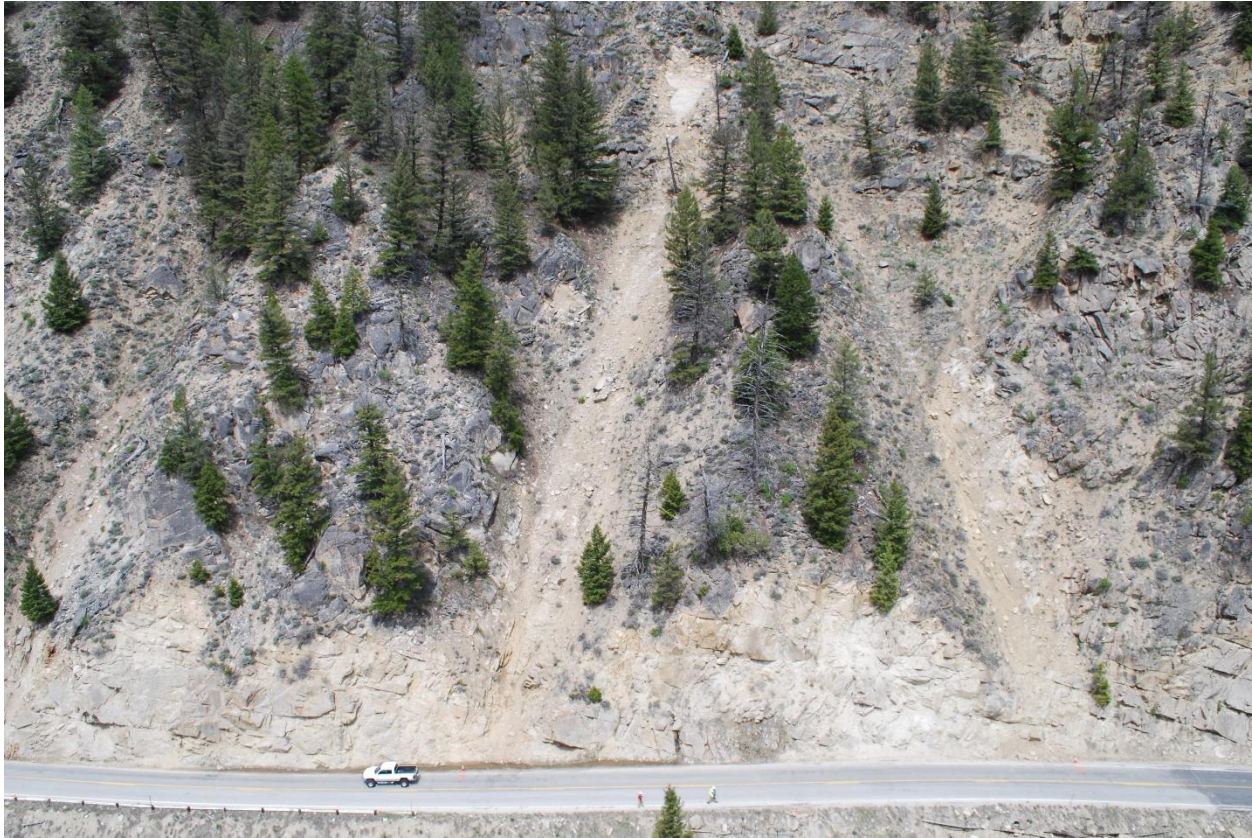
**Figure 3 – 2011 Aerial Oblique of Debris and Avalanche Chutes Pre-Mitigation**

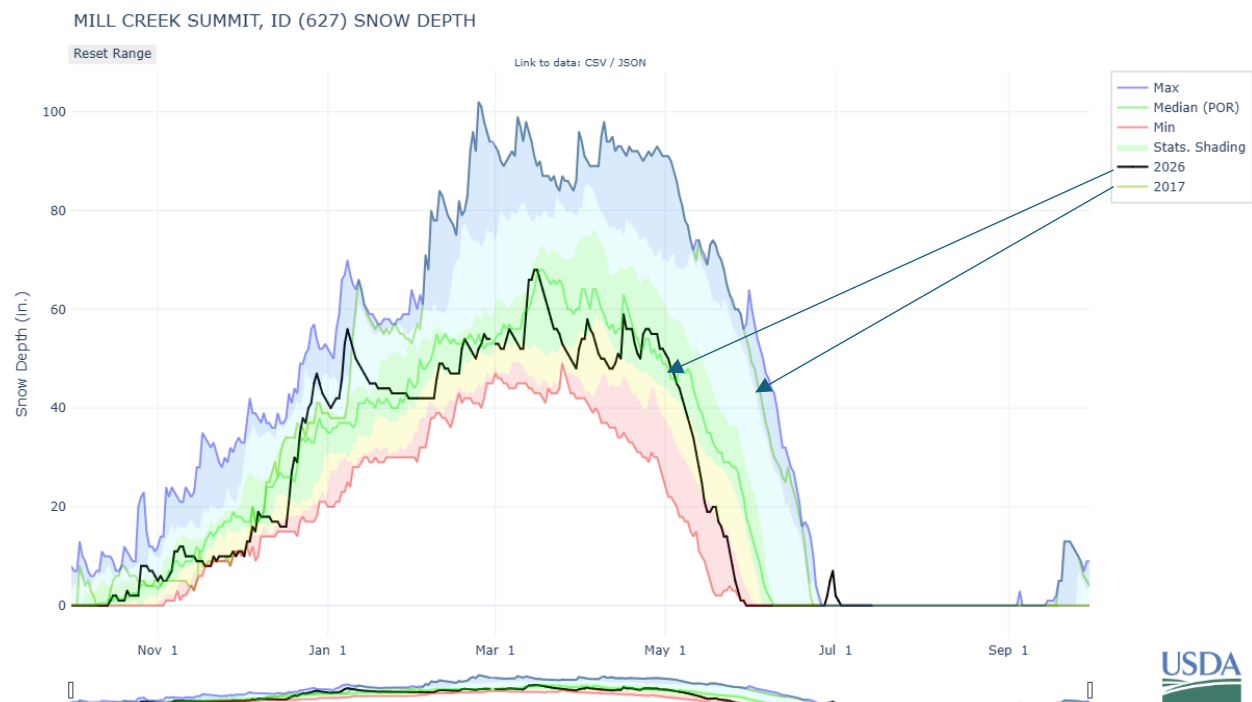
**Figure 4 – Snowpack Depth at the Nearest Snotel Site 17 miles NNE of The Narrows. Note that Snowpack Depth in 2026 at the Attenuator Site was Under One Foot All Winter.**

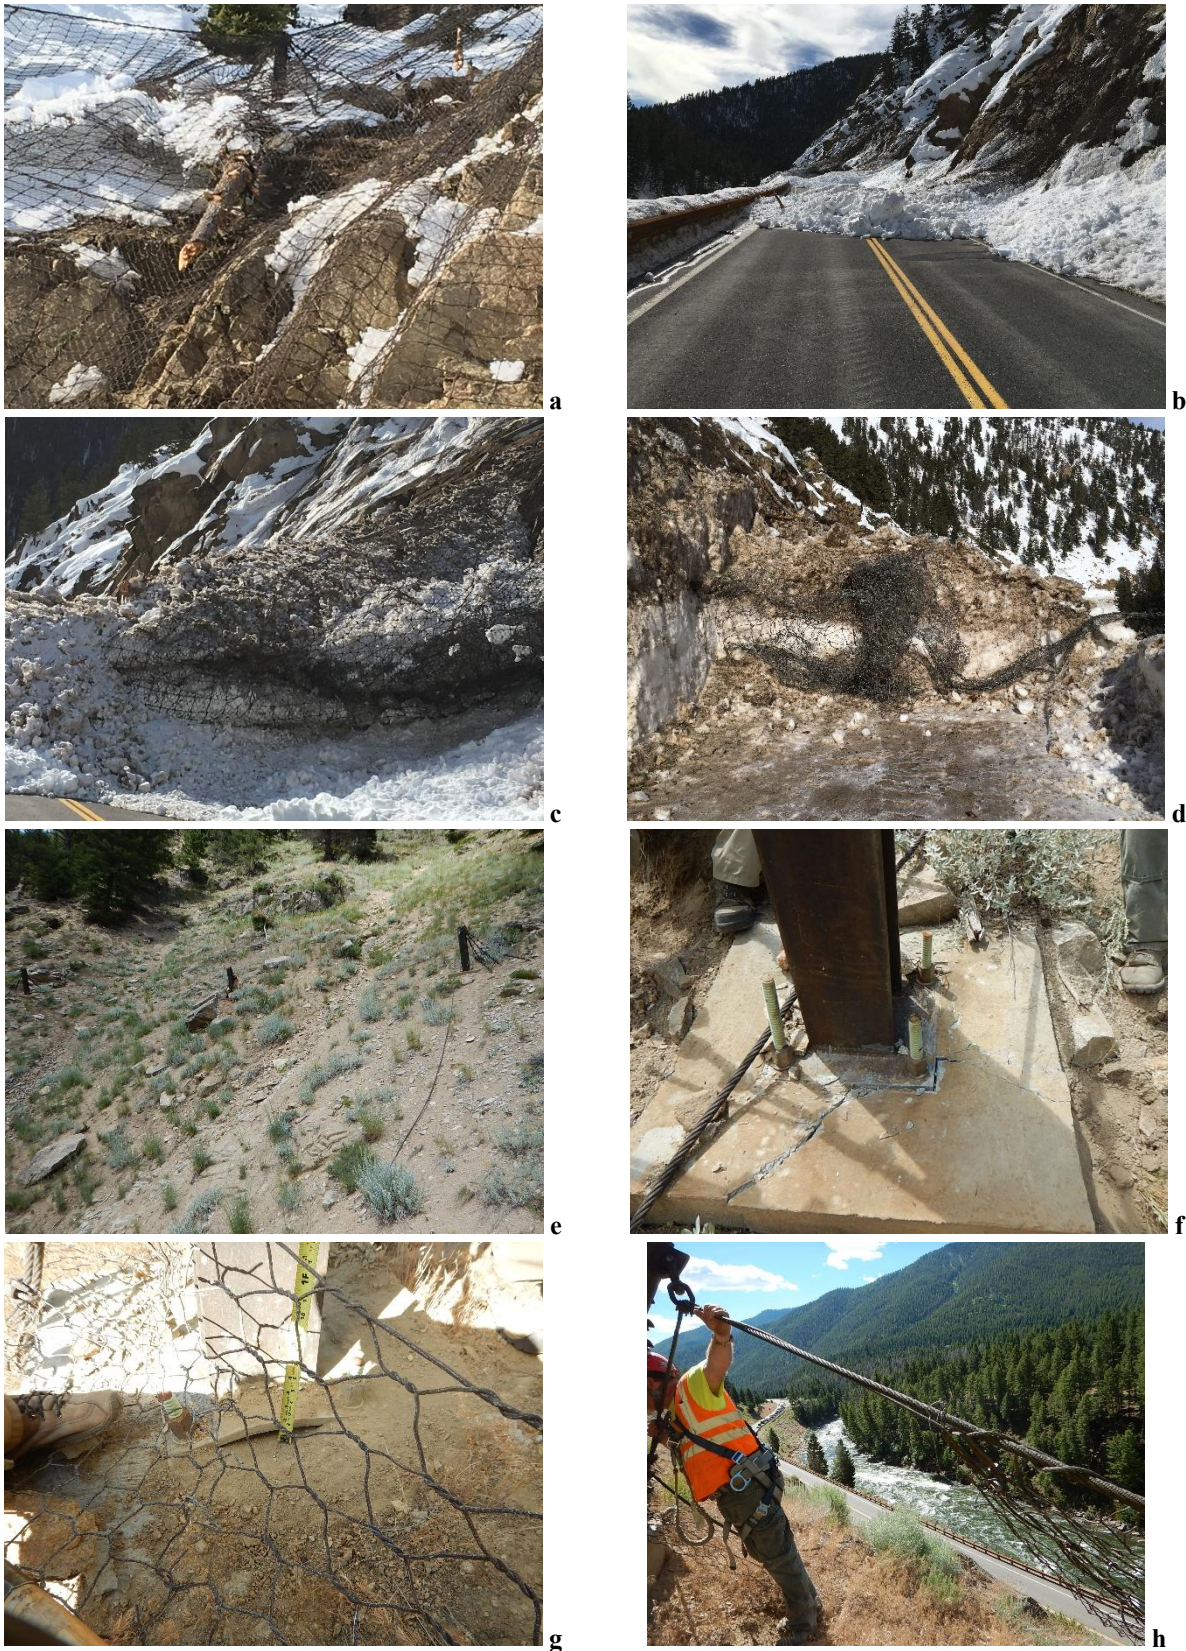
**Figure 5 – Photographs of Typical Avalanche Damage, February 15, 2017 (a, b, c, & d) and from Later Detailed Repair Design Reconnaissance (e, f, g, & h). All Photos from WFL.**

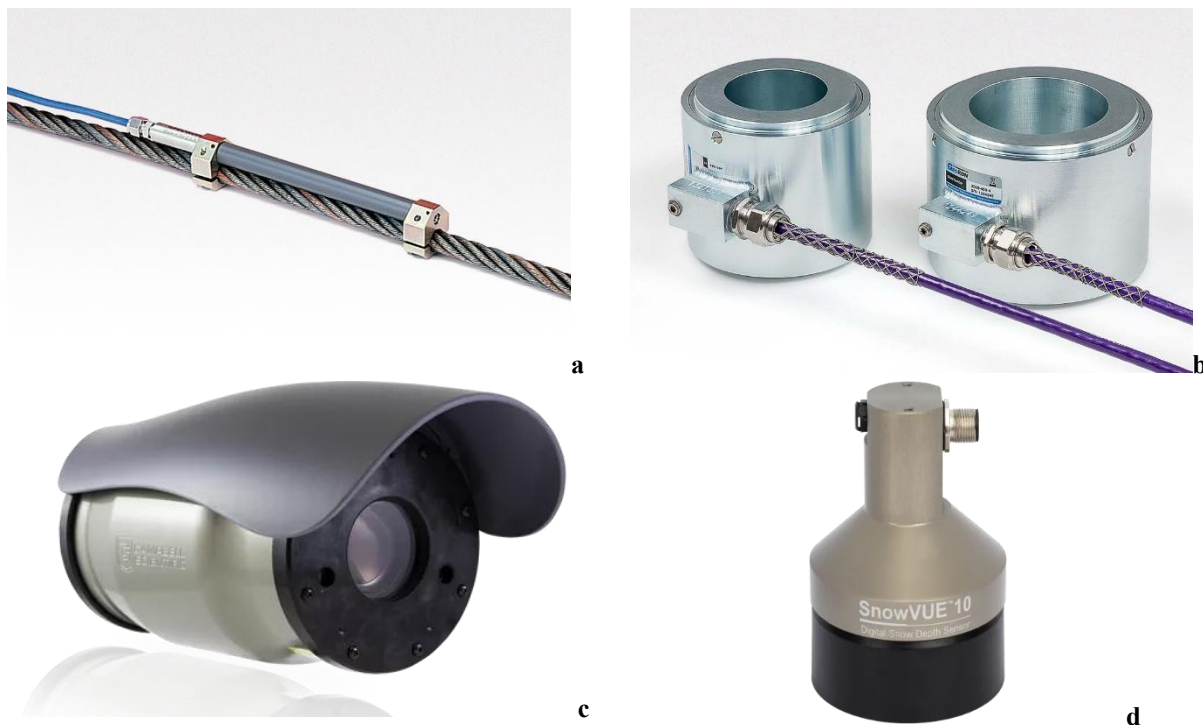
**Figure 6 – Images of Strandmeters (a), Load Cells (b), the Camera (c), and Snow Depth Sensor (d).**

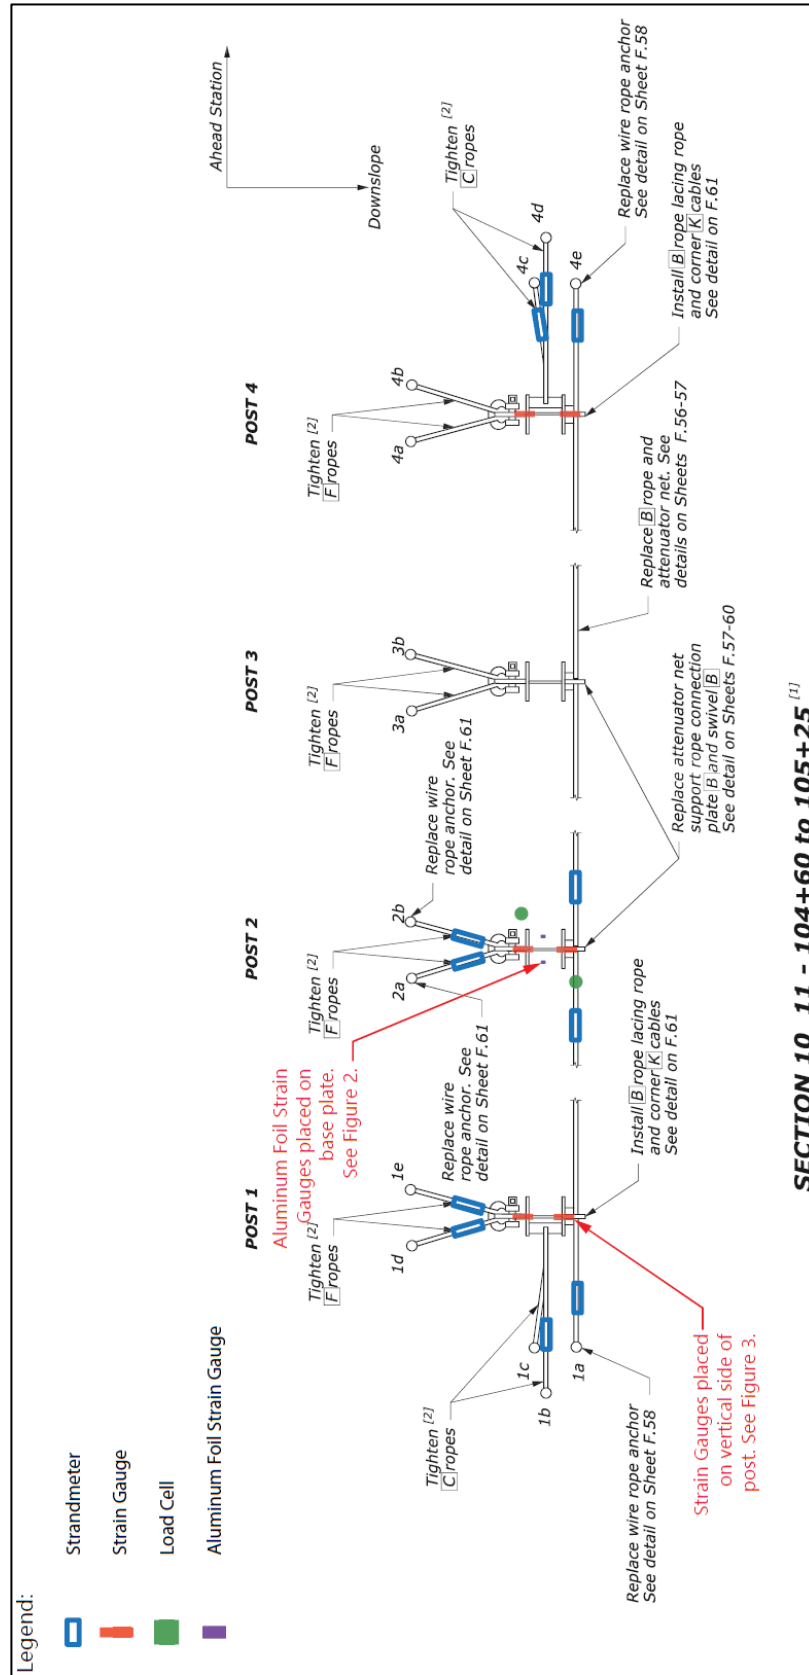
Figure 7 – Sensor Layout on one of the Attenuator Systems.

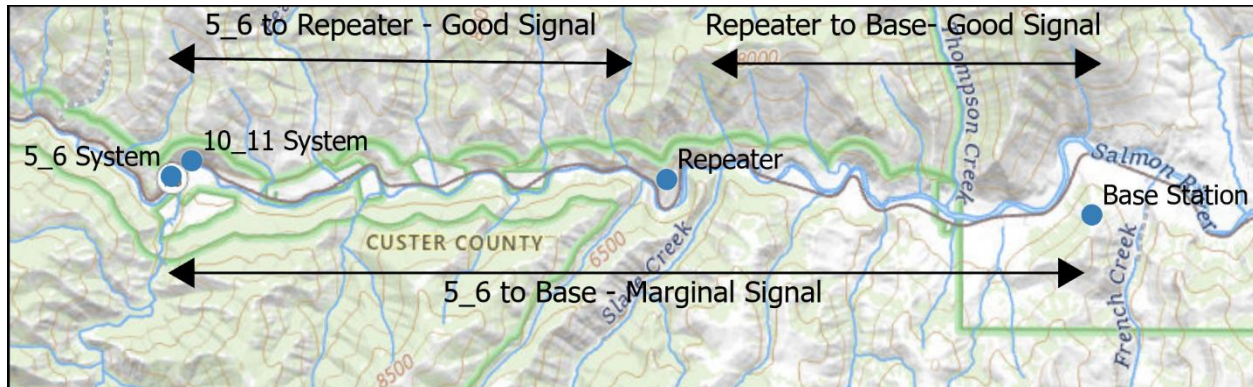
**Figure 8 – Radio Path Testing Results**

Radio testing demonstrated that direct communication between the instrumented attenuators and cellular service locations within the valley was possible, but vulnerable to signal deterioration due to terrain shielding and the narrow geometry of the Salmon River canyon (Figure 8). The testing demonstrated that high-power, 1-watt radios and Yagi directional

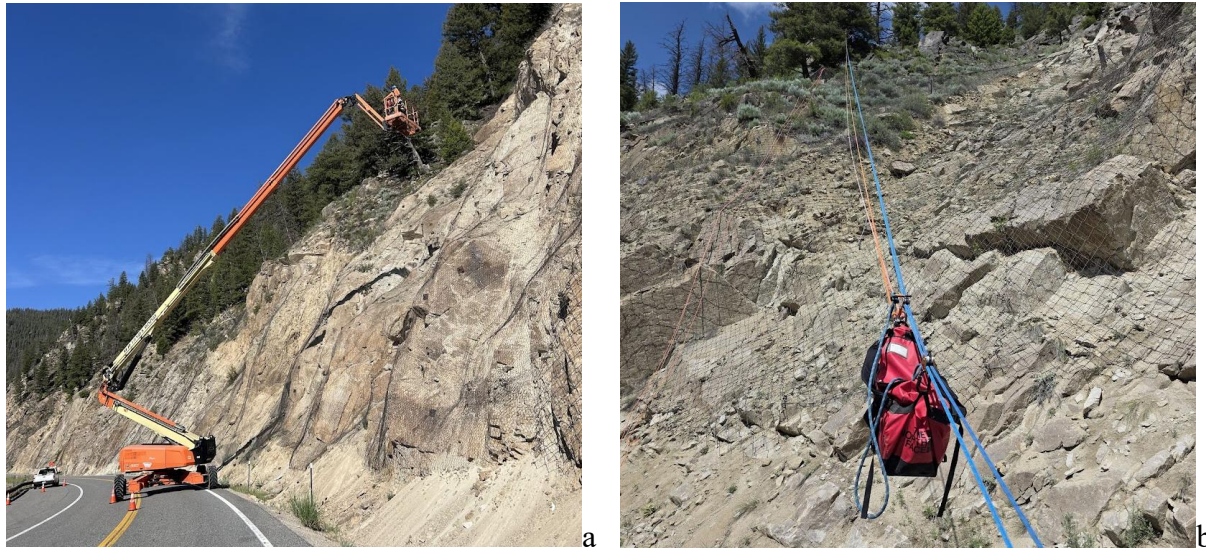
**Figure 9 – Boom Lift Proving Insufficient (a) and Rope Haul System Implementation with a 130 lb. Battery (b)**

The materials required for the instrumentation system were substantial. Each attenuator installation included large-capacity battery banks, weatherproof instrumentation enclosures, solar power systems, dataloggers, radio equipment, and hundreds of feet of instrumentation cable. Individual battery assemblies weighed approximately 130 lb (59 kg), instrumentation enclosures approached 75 lb (34 kg), and numerous 60-lb (27 kg) bags of concrete were required for equipment foundations and support structures. Solar panels, steel mounting hardware, and more than 1,000 ft (300 m) of instrumentation cable also had to be transported to locations situated

well above the roadway on steep, loose slopes. Moving these materials required the use of the mechanical rope-haul systems, multiple hauling stages, and coordinated effort among the installation team. In many cases, equipment was raised incrementally up the slope using anchored hauling systems before being repositioned and hauled again to reach its final installation location. All rope access was supervised by our SPRAT-qualified geotechnical personnel.

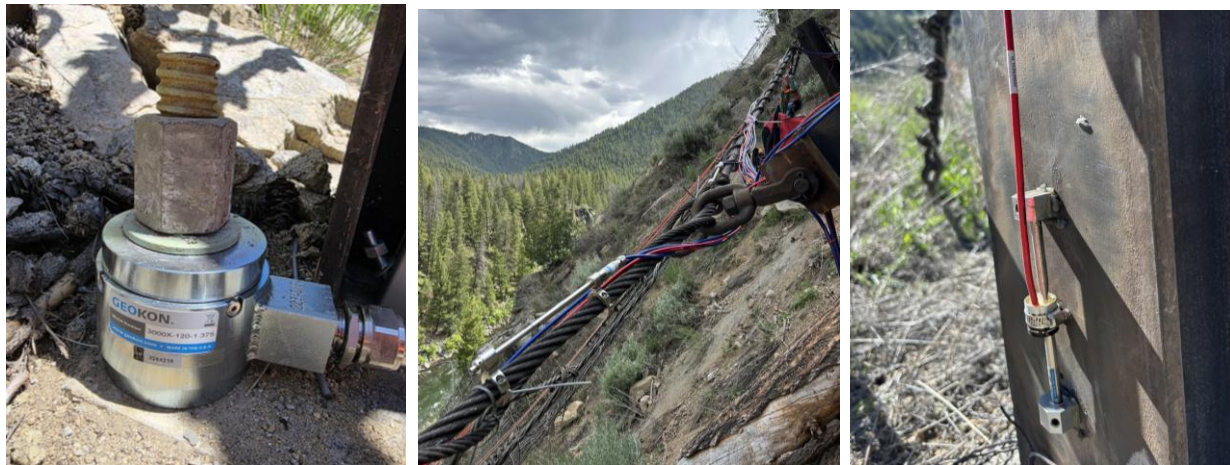
**Figure 10 – Anchor Load Cell (left), Top Rope Strandmeter (middle), VW Strain Gauge (right)**

Following equipment mobilization, sensors were installed and datalogger enclosure posts prepared. Strandmeters were mounted directly to selected support ropes and configured to measure elongation associated with changes in rope strain. Installation required fabrication of custom attachment assemblies and careful positioning to avoid lacing wire conflicts. Vibrating-wire and resistance strain gauges were bonded to post flanges and base plates at locations selected to capture bending strains generated by snow loading and impact events. Surface preparation, gauge alignment, strain gauge shields, and cable routing were critical to minimal potential damage in the rockfall-prone chutes. Sensor cables were installed on the downhill side of the attenuator top ropes to minimize rock strike chances. Sensor cables were secured to the mitigation elements when possible.

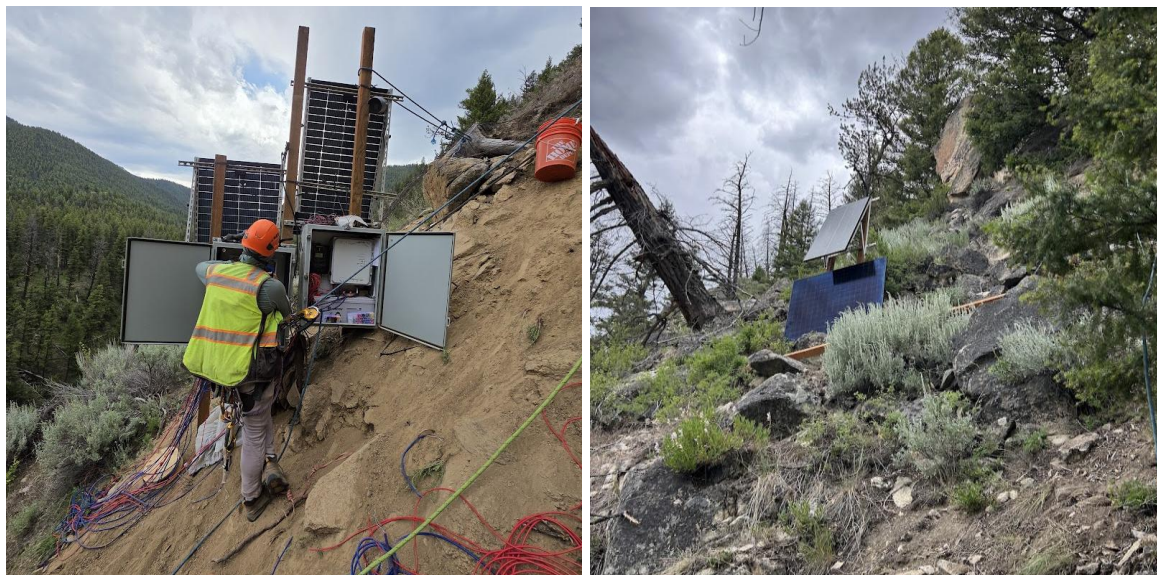
**Figure 11 – Wiring on System 10\_11 (left) and Solar Array on 5\_6 (right)**

Each monitoring station was supported by a dedicated 800-watt solar array and a 12V battery system with 400 ampHr capacity designed to sustain continuous operation throughout the winter months. Each system installation incorporated two weatherproof equipment enclosures housing dataloggers, vibrating-wire analyzers, radios, and power management components. Solar arrays were sized to maintain battery charge during periods of reduced winter sunlight while supporting continuous monitoring, cameras, high-power radios, and continuous high-frequency sensor interrogation (Figure 11). Given the project's location within the Sawtooth National Recreation Area, special attention was paid to the visual appearance of the installations. Equipment locations, mounting configurations, and enclosure finishes were selected to minimize visual impacts and maintain compliance with environmental and aesthetic requirements established for the corridor.

The remote base station was installed on a ridgeline outside of the SNRA to manage communications and data transmission from the remote monitoring sites. Data transmitted from the attenuator sites were routed to a ridgeline base station equipped with a cellular modem, enabling automated upload of monitoring data to cloud-based servers. This architecture allowed near-real-time access to instrumentation data while maintaining reliable operation in an area with limited communications infrastructure. Upon completion of installation, the system provided continuous monitoring of attenuator loads, structural response, environmental conditions, and site imagery, establishing one of the first high-frequency monitoring programs dedicated to understanding the real-world performance of midslope rockfall attenuators.

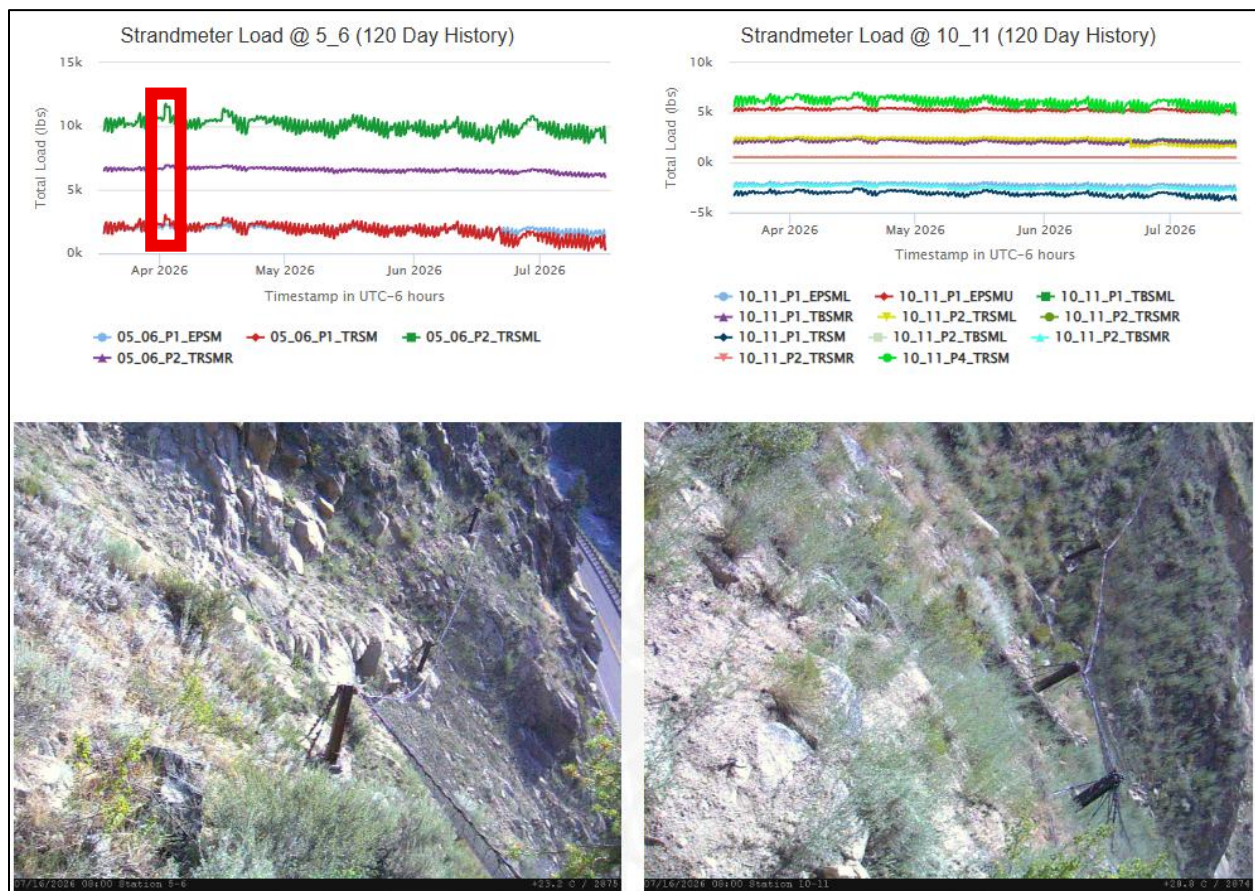
**Figure 12 – Snippet of the Website and Twice-Daily Site Photographs. Red Box on the Left Highlights a System Reaction to a Slight (<2-inches) Snowfall.**

The winter of 2025-2026 showed exceptionally low snow, thus moderate or major static snow loading was not experienced or measured by the monitoring systems. However, when snowfall was experienced with a visual build-up on the draped mesh portions, the system did exhibit clear reactions that quickly dissipated as snow melted (Figure 12).

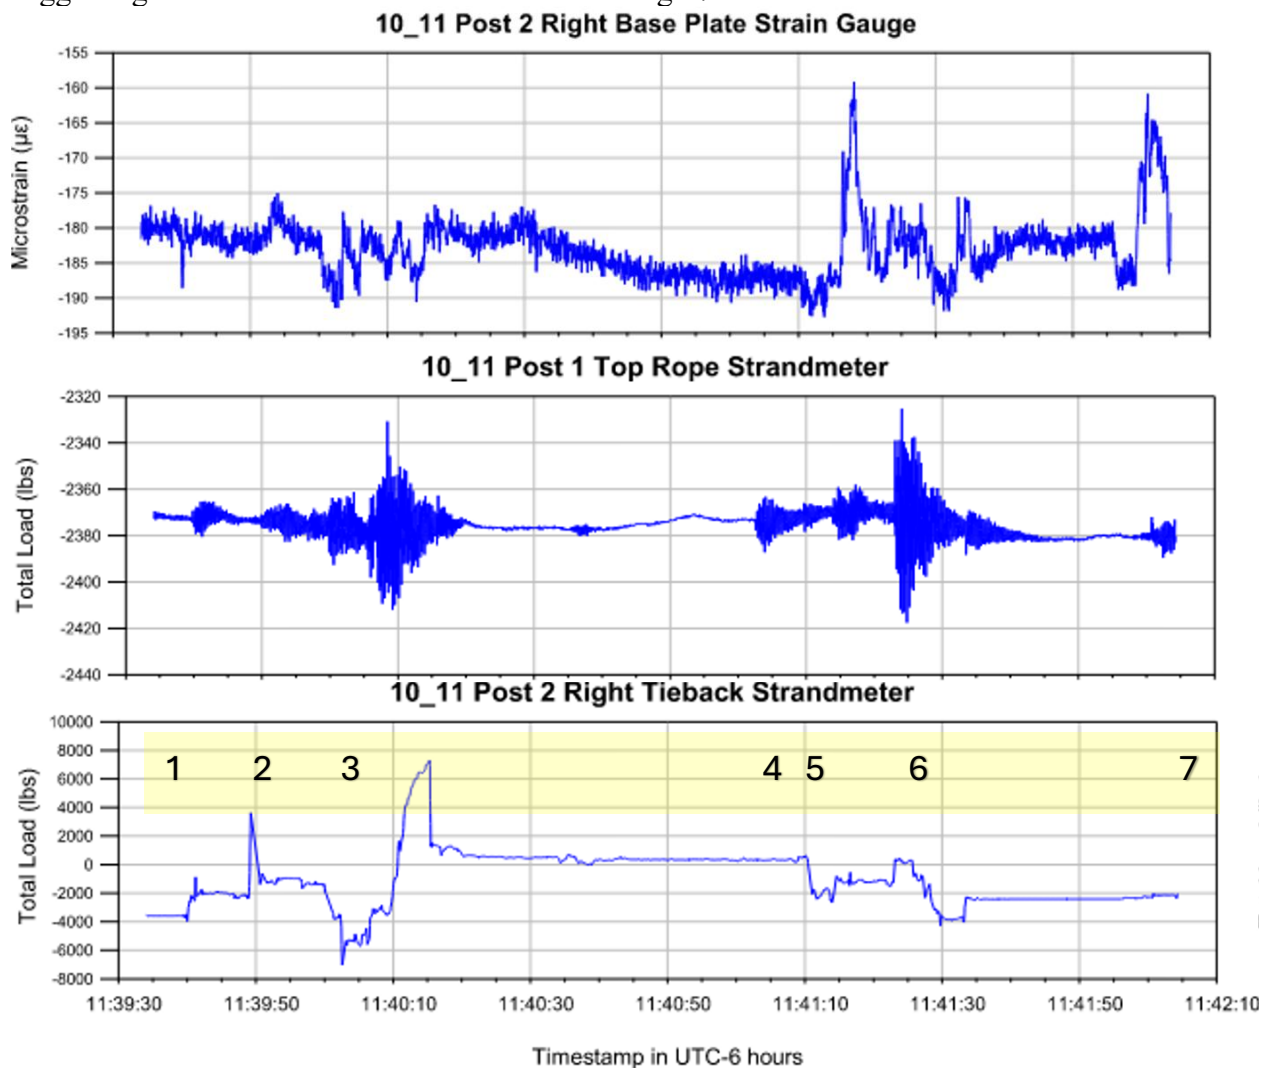
**Figure 13 – Example of a Dynamic Event on a Base Plate (top), a Reverberation Response on the Top Rope (middle), and a Large (~12,000 lbs) Load Increase on a Tie Back (bottom).**

Several dynamic events have been recorded at System 10\_11, primarily at the onset of cold winter weather and repeat freeze-thaw cycles. A noteworthy one occurred October 24, 2025 at 11:39 AM. This event is interpreted to consist of a sequence of six to seven distinguishable sub-events occurring over approximately three minutes. The event was recorded at the 20 Hz sampling rate following threshold exceedance in a strandmeter installed on the right tieback of the system's second post. The triggering response corresponded to an instantaneous load increase of approximately 6,000 lbs at Event 2, with a smaller Event 1 recorded before the trigger event. Load changes in the tieback wire ropes were maintained for brief periods while load changes in the top ropes reverberated through the rope before returning to near its base load. Base plate strain gauge only slightly changed during the first four events. Event 5 reduced loads on the tieback and increased loads on the base plate on the right, uphill side of the base plate while reducing load on its downhill left side. Events 4 through 6 reduced tieback loads with some reverberation on the top rope, with 5 and 7 seeing load increases and drops on the baseplate, suggesting a debris release between events 4 through 7.

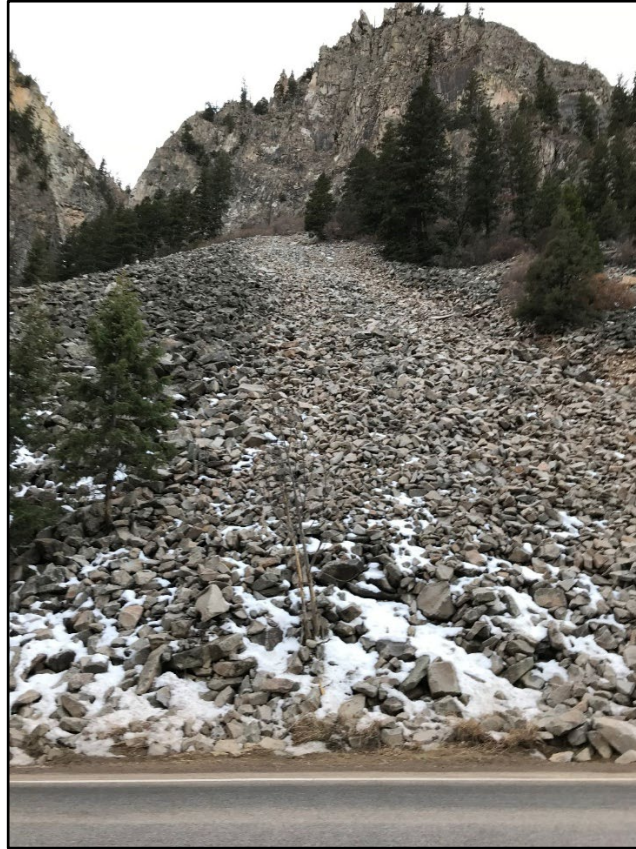
**Figure 1 – Existing Talus Slope in Colorado. Left (darker colored) side is non-displaced talus. Right (lighter colored) side is an example where the toe was disturbed and triggered the entire slope to move downhill to re-establish the existing angle of repose.**

One factor in evaluating cut slopes is to look at natural slopes within these mountainous roadway corridors and, at least in Colorado, many of these corridors have talus slopes that are reasonably stable. This is typically illustrated where lichens are evident of the surfaces of the talus rocks indicating these rocks have not moved for decades or even centuries. Figure 1 is an example where the left side of the talus slope is intact, but the right side of the talus slope has displaced downward. This is evident by the talus slope color differences. The left side has various lichens that are darker, but the right side is lighter colored rock that has moved in recent times. This was an example where the toe of the talus slope was removed and/or disturbed on the right and the entire talus mass began to move downward into the roadway. These slope angles are typically between 33 to 36 degrees and if they are changed even by 1 degree steeper, they begin to move and are no longer stable.

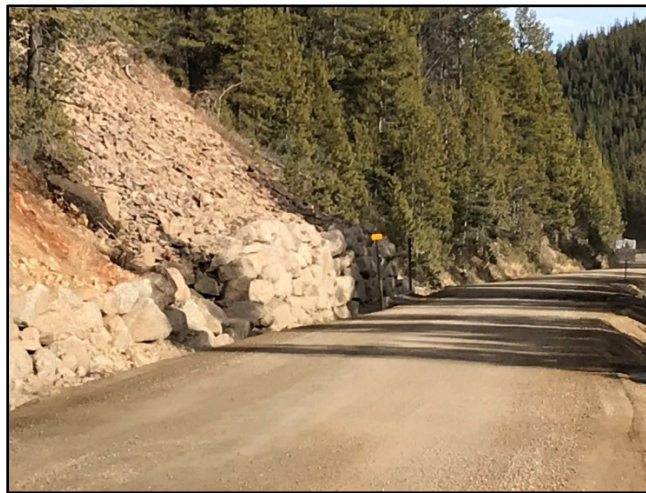
**Figure 2 – Talus Slopes in Colorado where a small rockery wall is stabilizing the natural slope.**

Figure 2 is an example where a small-scale talus slope is supported by a wall feature to stabilize the slope to the angle of repose and match the original slope prior to construction of the roadway. Figure 2 essentially captures the concept of attempting to re-establish the natural slopes to the pre-highway angle of repose and make the rockfall mitigation system more resilient and less of the constant maintenance issue to clean and maintain a system.

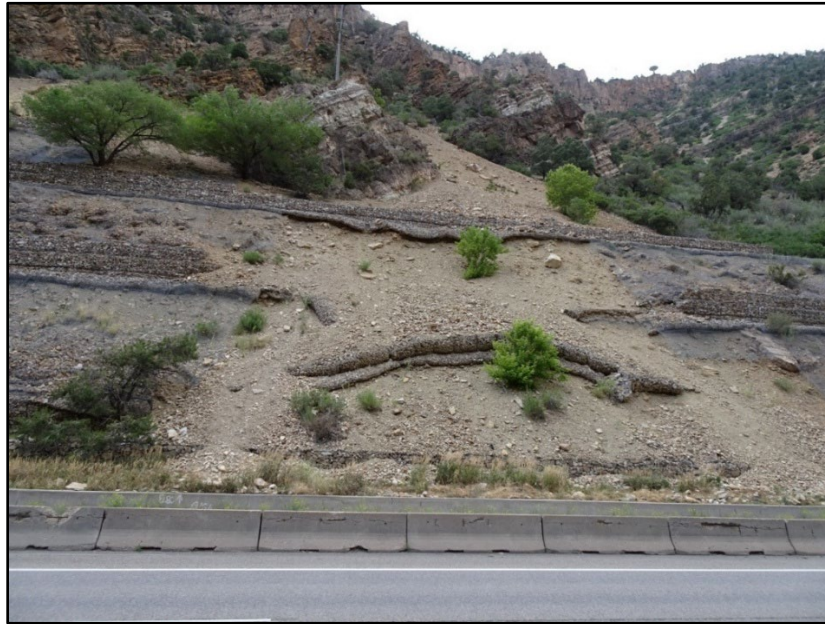
**Figure 3 – I -70 near Glenwood Springs, CO with tiered gabion system to stabilize the cut slope.**

Interstate I-70, which is a major roadway system that bisects Colorado east to west, and has various cut sections that are examples of not considering the geologic effects of cutting a slope to fit a four-lane interstate highway widening during the 1960's and 1970's. This eventually created long-term erosional and stability issues. Figure 3 is an example just west of Glenwood Springs Colorado in which gabion baskets were stacked in an effort to stabilize a natural talus type slope in the late 1960's. The resulting tiered gabion baskets have subsequently failed and become long-term maintenance issues shortly after construction.

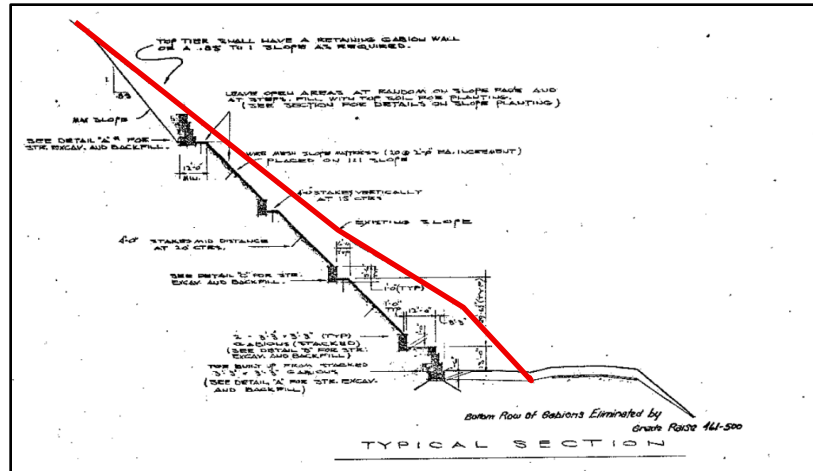
**Figure 4 – I -70 near Glenwood Springs, CO original Project Plans with tiered gabion system in an effort to stabilize the cut slope. The red line was the original slope at the angle of repose, and the tiered gabion system is much steeper.**

Figure 4 depicts the original design plans that illustrate the natural slope that was at the angle of repose and the tiered gabion system that was placed.

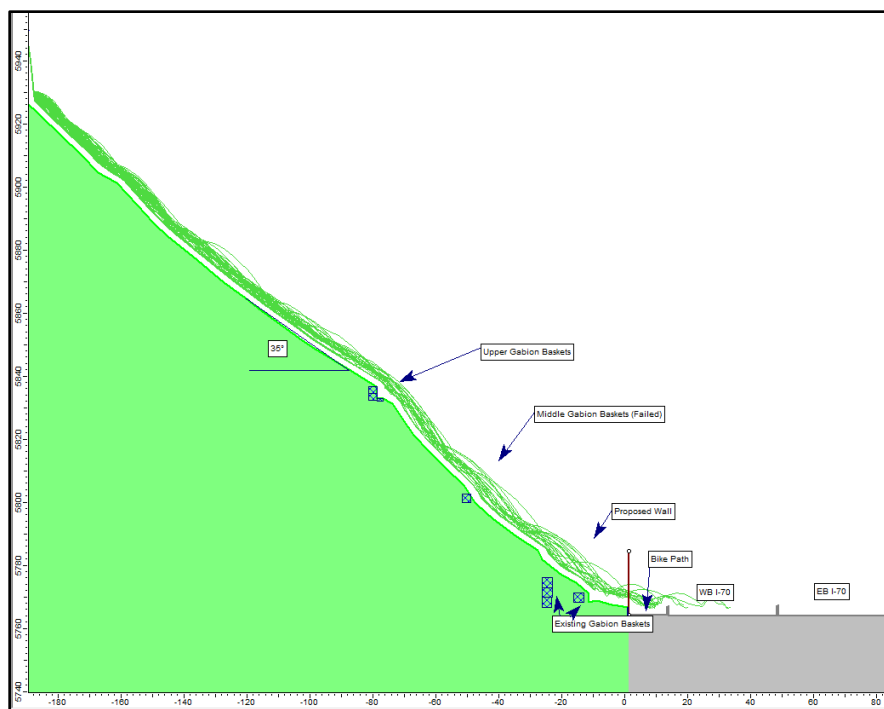
**Figure 5 – I -70 near Glenwood Springs, CO. Rockfall model of the tiered gabion system that was filling in and not effective at slope stabilization or rockfall containment.**

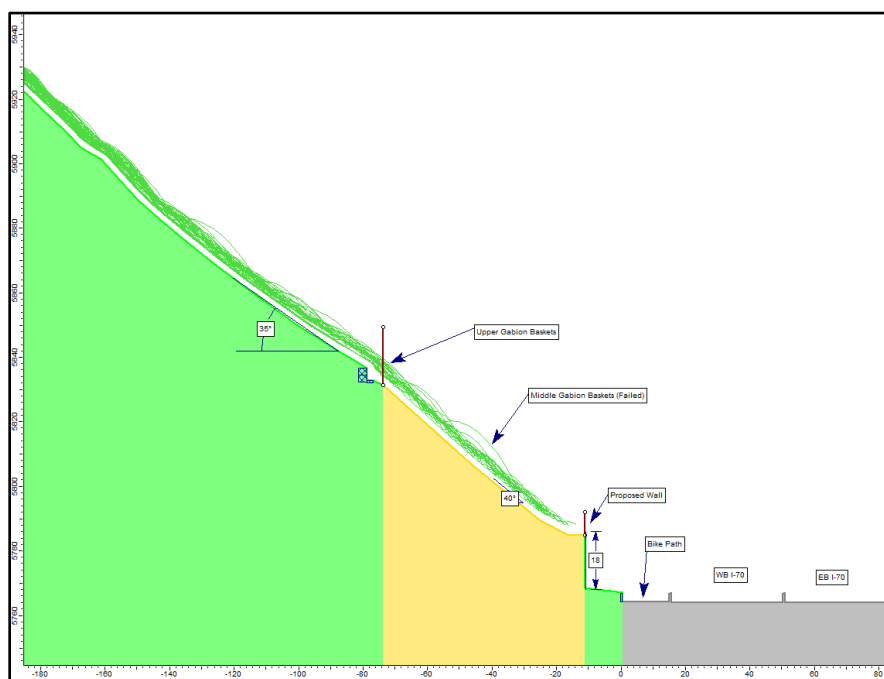
**Figure 6 – I -70 near Glenwood Springs, CO. Rockfall model of vertical wall system at base of slope in the process of filling in to create a slope at the angle of repose.**

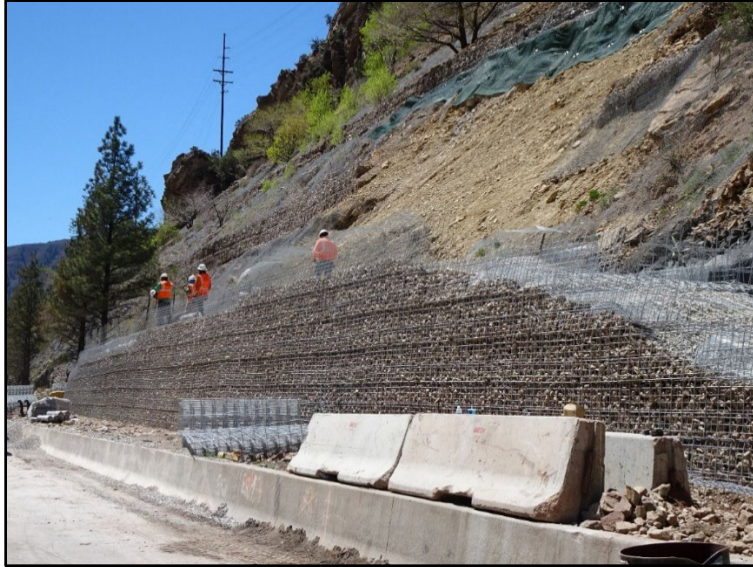
**Figure 7 – I -70 near Glenwood Springs, CO. Construction of the double-sided wire vertical faced rockfall containment wall. Soil nail wall is located behind and out of view.**

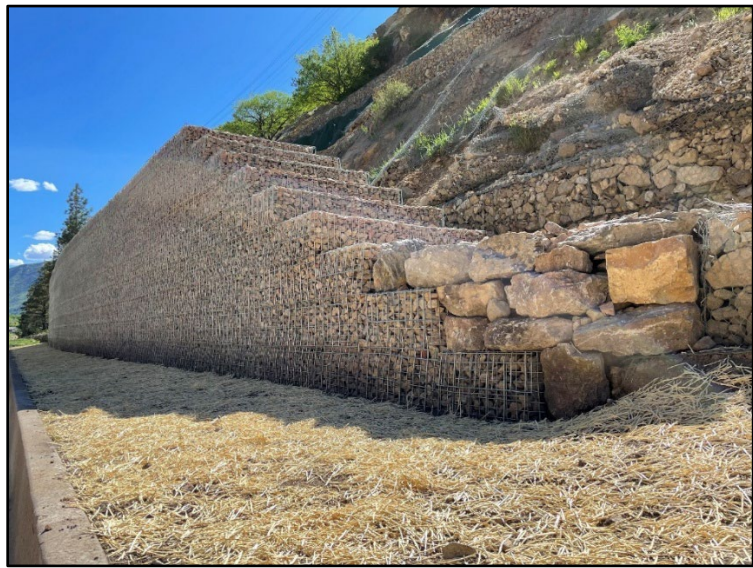
**Figure 8 – I -70 near Glenwood Springs, CO. Final construction of the double-sided wire vertical faced rockfall containment wall.**
