# 75<sup>TH</sup> HIGHWAY GEOLOGY SYMPOSIUM

BETTER HIGHWAYS THROUGH APPLIED GEOLOGY

2026  
HGS  
PROCEEDINGS

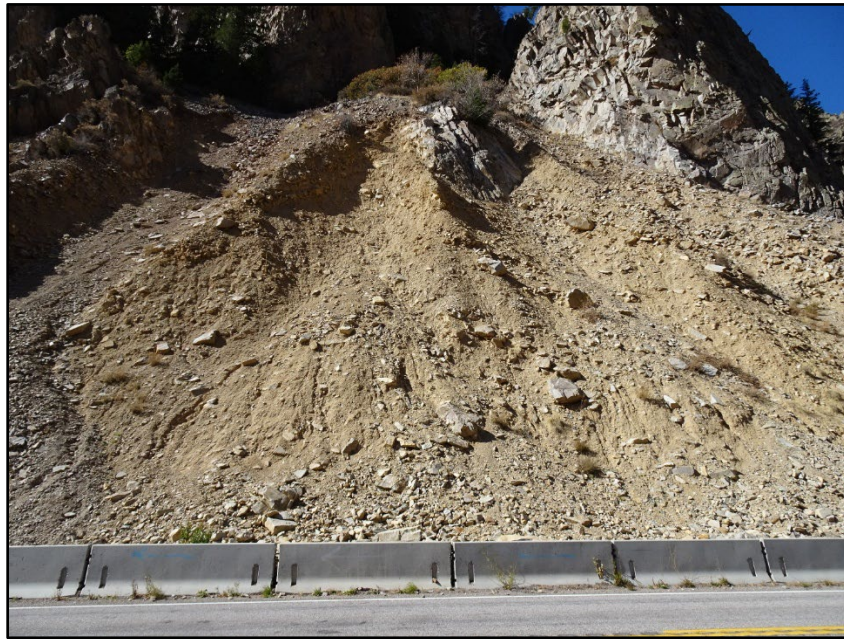
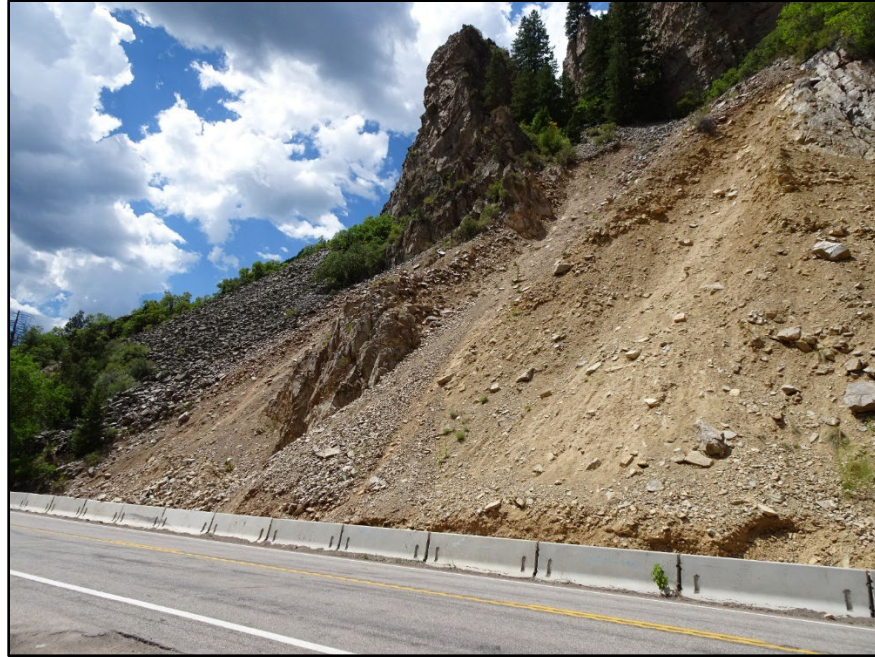
**Figure 9 – CO 133 slope cut into talus slope forming a long term erosional and maintenance issue.**

**Figure 10 – CO 133 slope cut into talus slope forming a long term erosional and maintenance issue.**

CO 133 is another example of the slope being cut steeper than the angle of repose to accommodate a roadway. Figures 9 and 10 are examples of the slope that the toe was cut out of an existing talus slope to accommodate the roadway alignment prior to the 1970's. Since then, the cut slope has been a constant erosional and maintenance problem for CDOT.

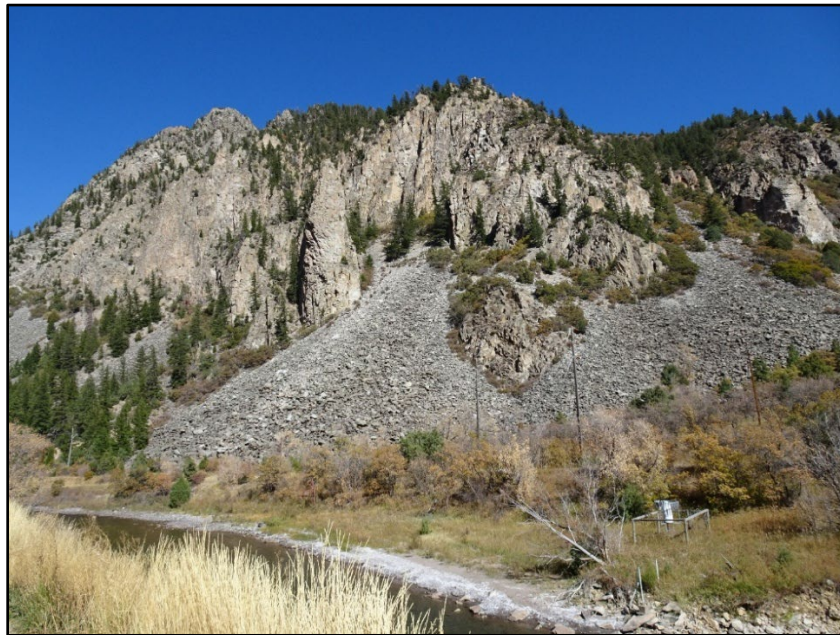
**Figure 11 - CO 133 is an example of a talus slope that was located across the river valley that was in a natural slope condition at the angle of repose.**

Figure 11 is an example of a talus slope that was located across the river valley that was in a natural slope condition at the angle of repose that is relatively stable and has lichen growing on the individual boulders.

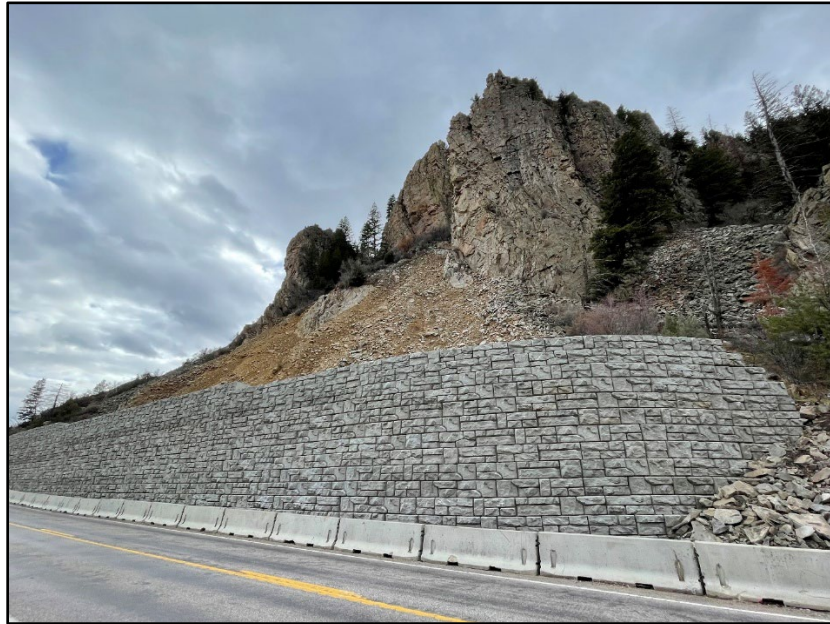
**Figure 12 – CO 133 slope cut with block wall that will eventually fill in to mimic the natural talus slope.**

Figure 12 depicts the vertically faced rockfall concrete block system that was constructed at the site. The characteristics of the rockfall at the site resulted in lower rockfall energy levels and overall smaller rockfall diameters making it possible to use a rigid concrete block in lieu of a flexible deformable facing. The use of the concrete elements also expedited construction and provided for a safer construction timeline in which larger equipment was used to place the blocks

limiting exposure of workers to rockfall. The intent of the concrete block wall is to allow the back (cut) side of the wall to fill in over time, to eventually create a talus slope that will mimic the natural slope that was in place prior to the roadway construction.

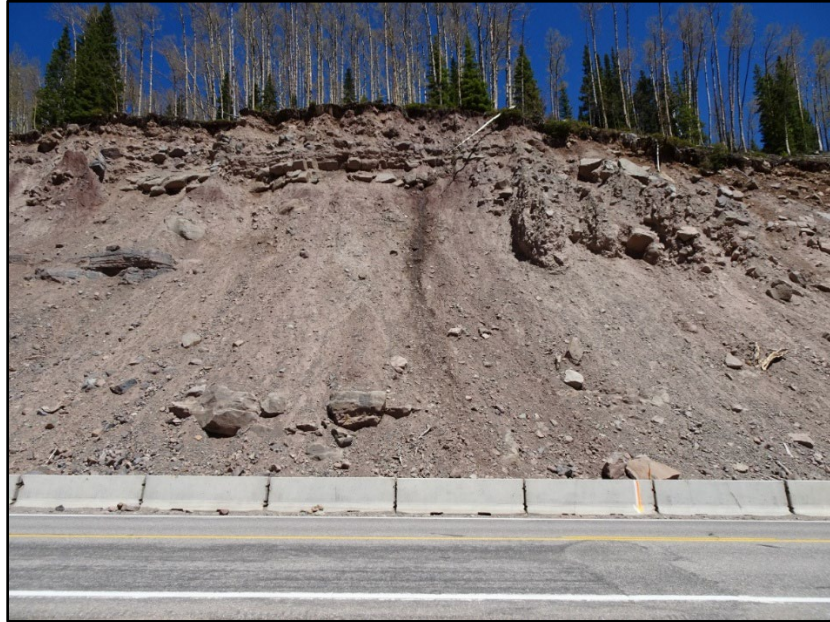
**Figure 13 –US 550 Deer Creek. Slope that was cut to accommodate roadway leaving an over steepened erosional rockfall prone slope.**

US 550 at Deer Creek is yet another example of cutting the slope of a proposed roadway into an existing slope that was at the angle of repose. Figures 13 and 14 are examples of the slope that was completely removed from an existing talus slope which resulted in a constant erosional and maintenance problem for CDOT.

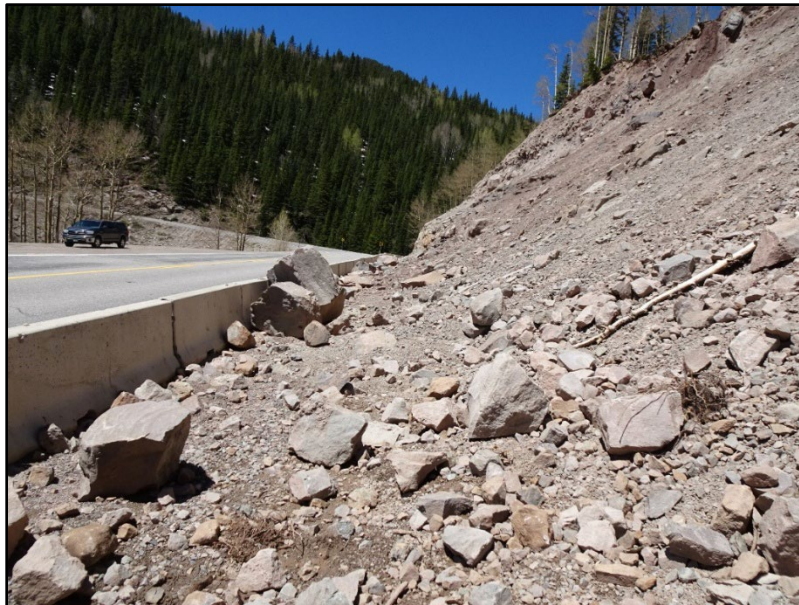
**Figure 14 –US 550 Deer Creek. Side view of slope that was cut to accommodate roadway leaving an over steepened erosional rockfall prone slope.**

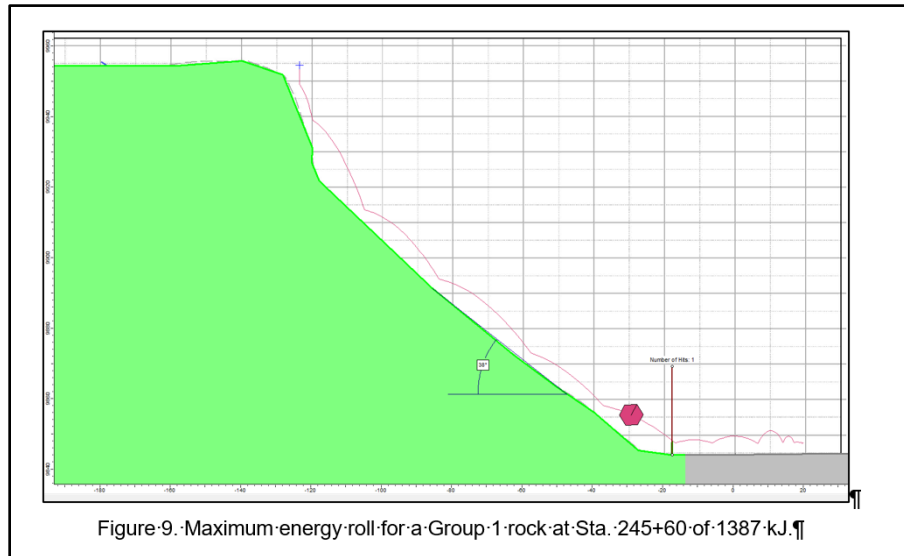
**Figure 15 is a general depiction of the slope with a typical rockfall from the source area.**

Figure 15 is a general depiction of the slope with a typical rockfall from the source area. Figure 16 is the proposed vertical faced wire system which will fill in over time. Figure 17 depicts the generalized rockfall impacts to the wall system using a finite element model to estimate deformation and outward deflection. Figure 18 depicts the completed wall system.

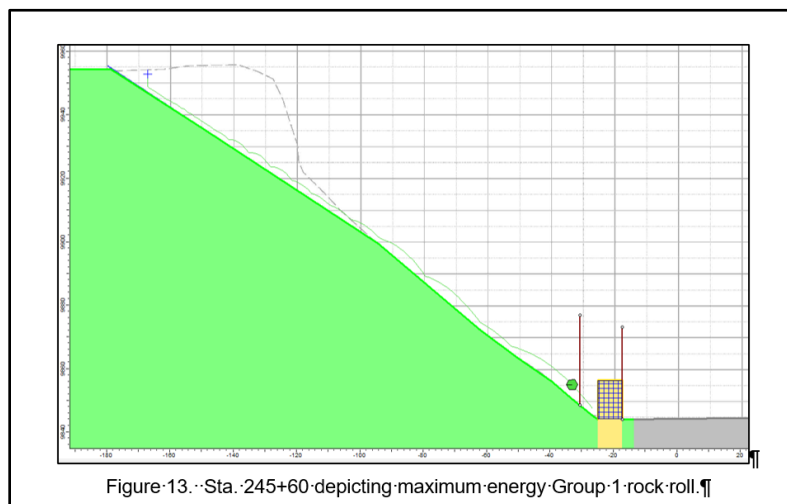
**Figure 16 is the proposed vertically faced wire system which will fill in over time.**

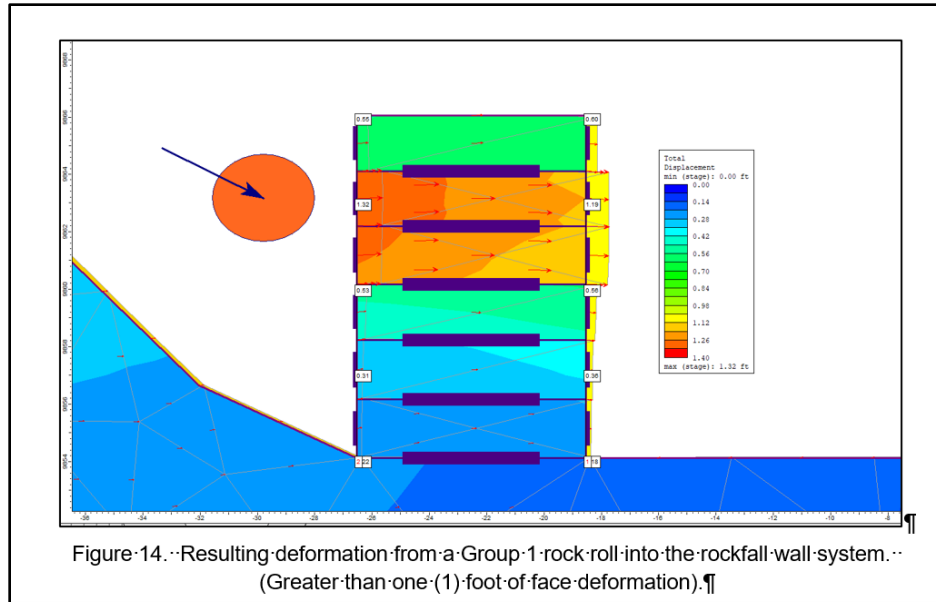
**Figure 17 depicts the generalized rockfall impacts to the wall system using a finite element model to estimate deformation and outward deflection.**

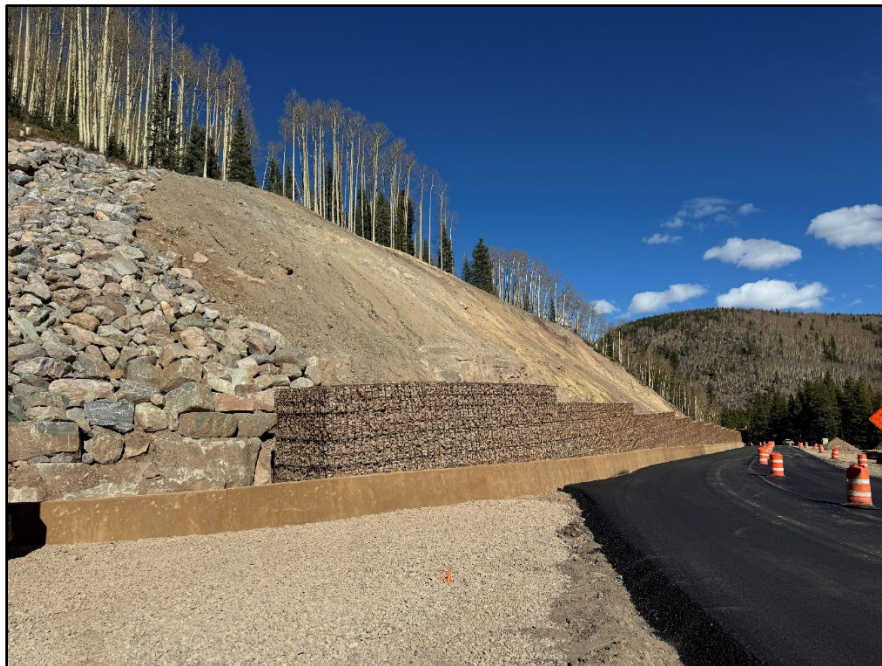
**Figure 18. US 550 completed rockfall containment system.**

US 550 was like other slopes except that it was excavated so far back into the original slope that it required the very top (which formed an almost vertical slope face) to be flattened as part of the mitigation. The mitigation for the slope also consisted of a vertical wire faced deformable wall.

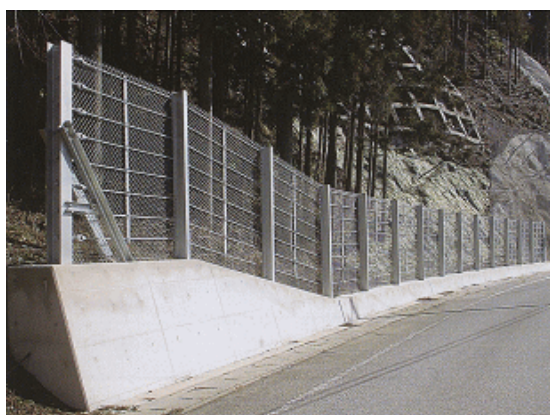
**Figure 1 - Standard-Type Rockfall barrier**

Research on rockfall protection structures in Japan is generally considered to have begun with rockfall barrier experiments conducted at Kobe University in 1967.<sup>2</sup> Studies on rockfall fences, now widely installed along roads in Japan, were subsequently carried out by the Japan Highway Public Corporation beginning around 1973 and formed the basis of modern rockfall fence design.<sup>3</sup> **Figure 1** shows a conventional Japanese rockfall fence, and **Figure 2** shows a conventional pocket-type rockfall net.

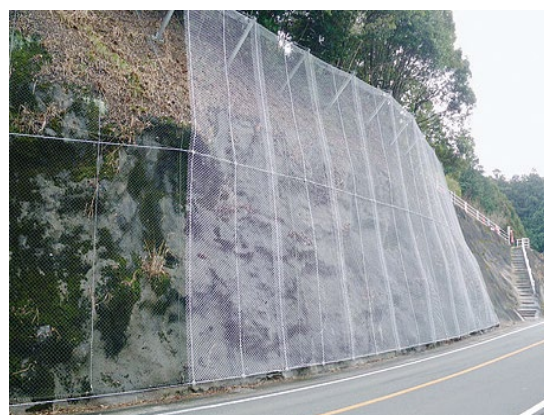
**Figure 2 - Standard-Type Rockfall net**

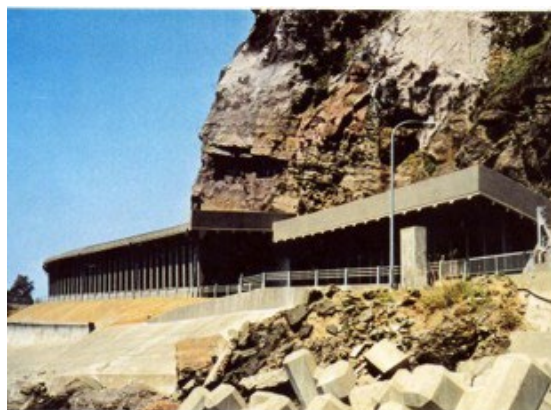
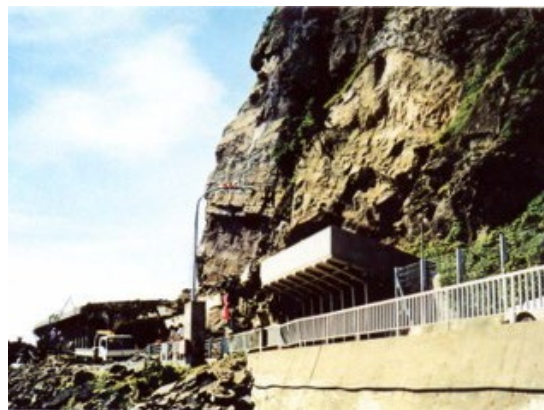
(a) Before the rockfall

(b) After the rockfall

**Figure 3 - Rock slope failure at the Echizen Coast**

Research on rock sheds was active from the 1970s to the 1990s. Following the catastrophic rock slope failure along the Echizen Coast in July 1989, in which a rock shed collapsed and 15 people were killed, the current rock shed design methodology was established. **Figure 3** shows the Echizen Coast rock slope failure, and **Figure 4** shows a prestressed concrete (PC) rock shed.

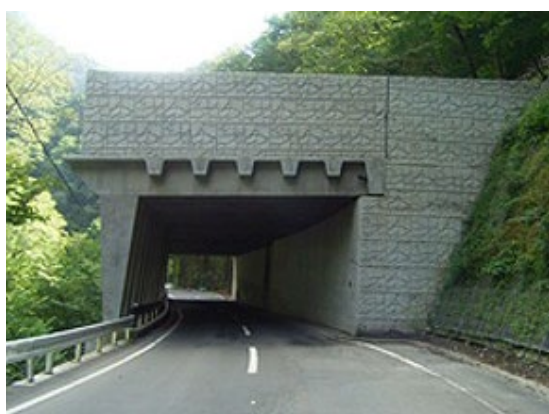
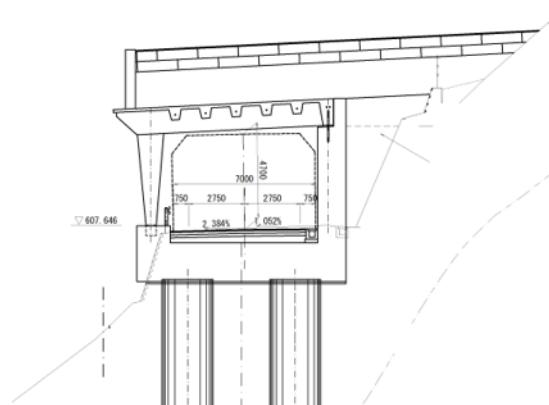
**Figure 4 - Example of a Prestressed Concrete (PC) Rock Shed**

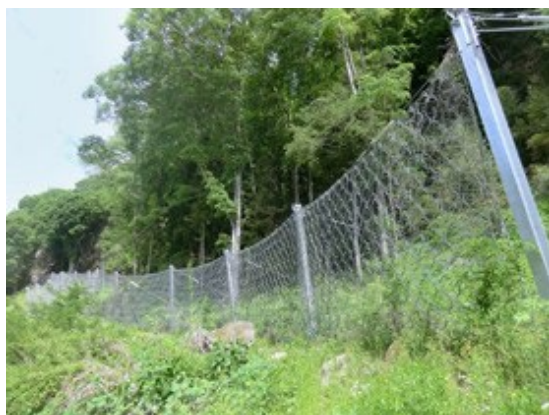
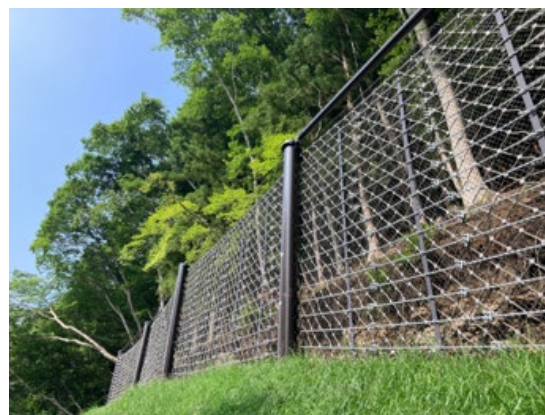
(a) Net-Reinforced Type

(b) Post-Reinforced Type

**Figure 5 - Example of a High-Energy Absorption Rockfall Barrier**

**Figure 5** shows a high-energy absorption rockfall barrier.

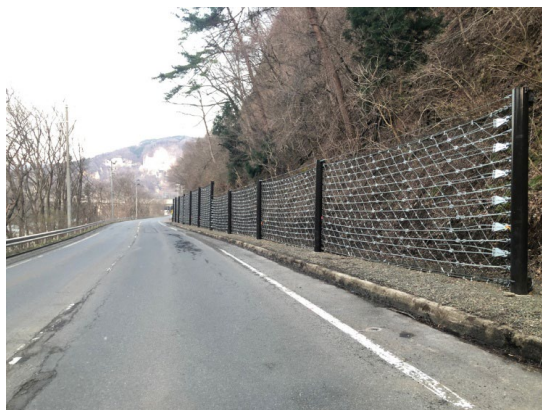
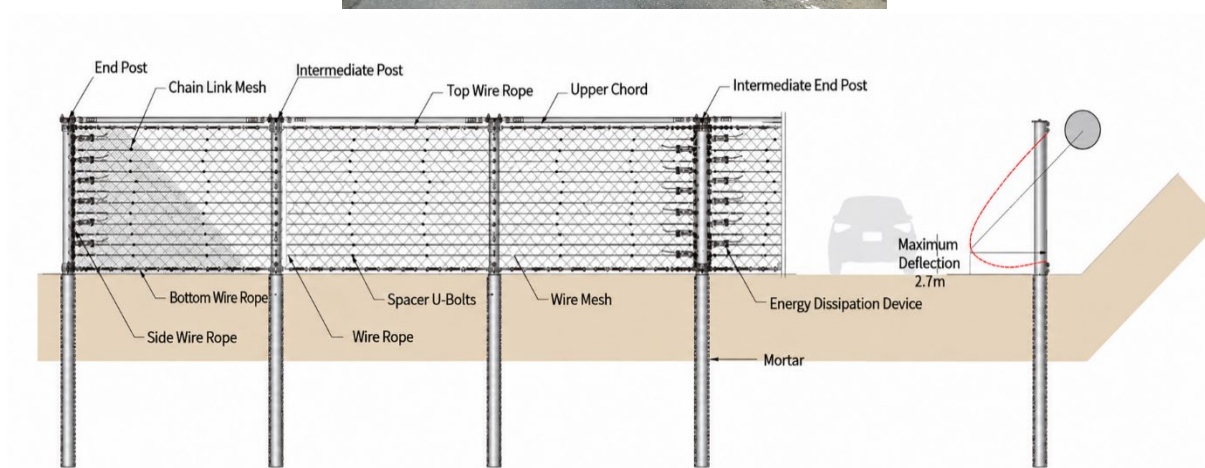
**Figure 6 - Example of a Post-Reinforced Rockfall Barrier (Slope Guard Fence)**

Many post-reinforced rockfall barriers are designed to undergo large deformations while maintaining the bending resistance of their structural members. **Figure 6** shows an example of a post-reinforced rockfall barrier.

In this type of structure, the steel posts and pile foundations are integrated into a single structural system, resulting in relatively small overall deformation. In addition, because no anchor ropes are required, this type of barrier is widely used at sites where available installation space is limited.

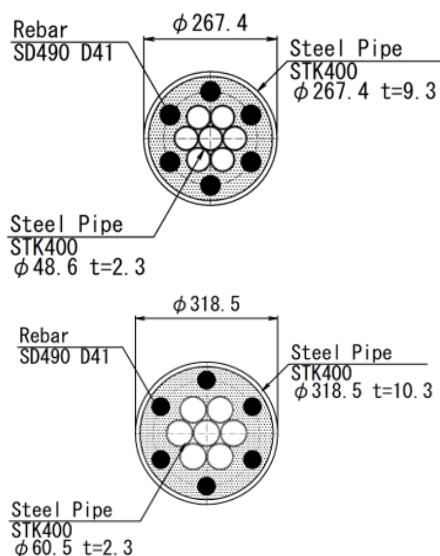
Figure 7 - Cross Section of the Steel Post

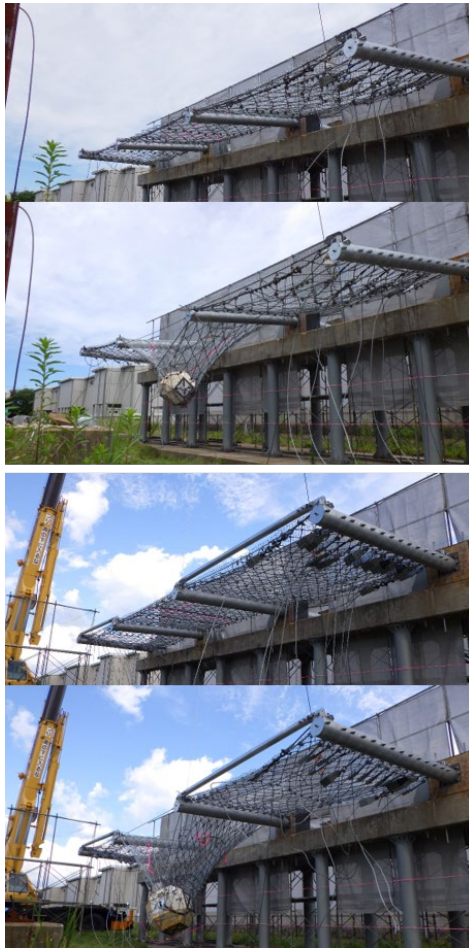
**Figure 10 - Experimental Setup**

The impact weights used in the tests had masses of 1,513 kg (density: 2.6 t/m<sup>3</sup>) and 3,479 kg (density: 2.5 t/m<sup>3</sup>). Each weight consisted of a polyhedral steel shell filled with concrete. The impact location was set at the center of either the middle span or the end span in the horizontal direction and at a height of 2.5 m above the base. After the impact test on the middle span, damaged members were repaired or replaced before conducting the impact test on the end span.

The measured parameters included the drop height, impact velocity, acceleration of the impact weight, residual barrier height, deformation of the interception system, and wire rope tension.

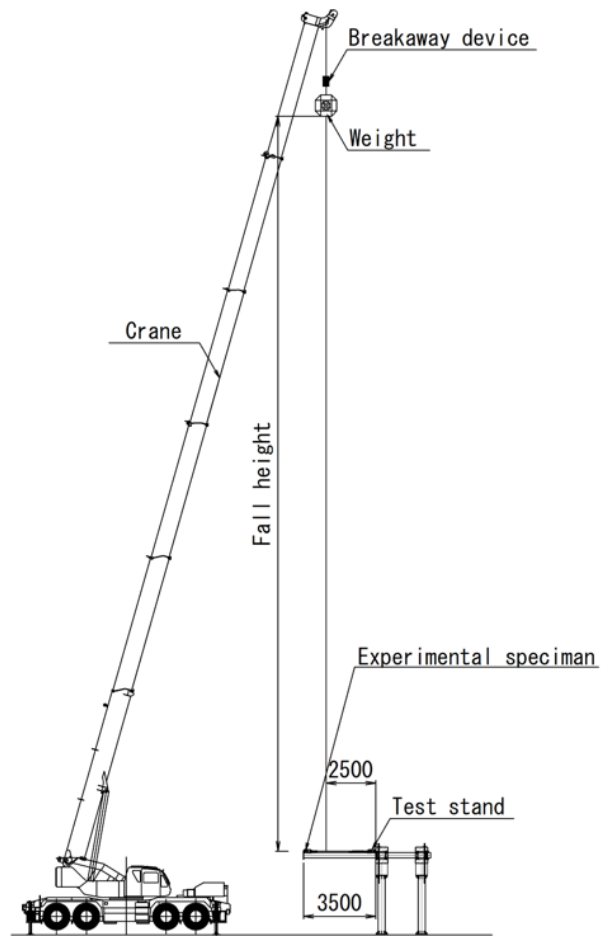
**Figure 11 - Schematic of the Experimental Setup****Table 2. Test Cases**

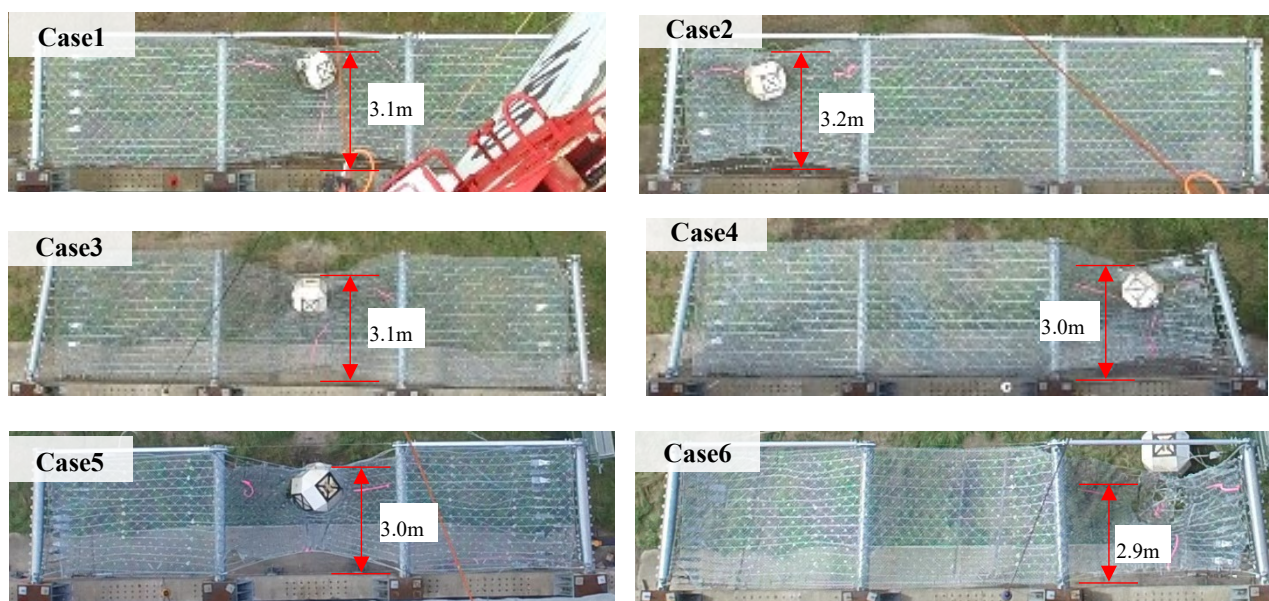
**Figure 12 - Residual Barrier Height**

The residual barrier height after impact ranged from 2.9 to 3.2 m, corresponding to 80–90% of the original barrier height (3.5 m). Cases 1 and 3 showed little influence of the upper chord or wire mesh type on the residual barrier height under middle-span impact. Under end-span impact (Cases 2 and 4), the residual barrier height was slightly lower without the upper chord.

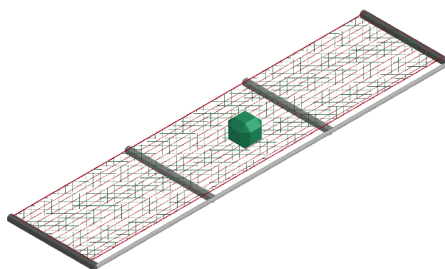
**Figure 14 - Analysis Model**

The LS-DYNA analysis model is shown in **Figure 14**. The model consisted of steel posts, upper chords, wire ropes, wire mesh, and energy dissipation devices. To simplify the analysis, the Chain link mesh was not modeled. The analysis reproduced the middle-span impact tests for each specimen type (Cases 1, 3, and 5).

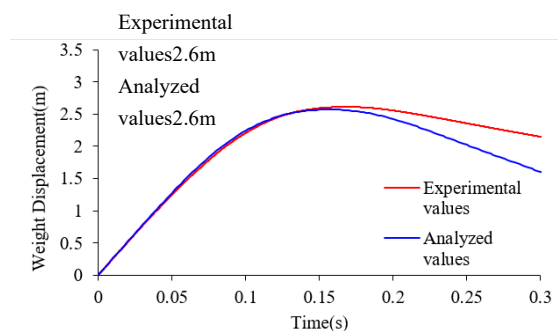
The time histories of the impact weight displacements for Case3 and 5 are shown in **Figures 15(a)** and **15(b)**. The analytical and experimental results showed good agreement in both the maximum displacement and the displacement history up to the peak response. The calculated maximum displacement was 0.9–1.0 times the measured value. These results indicate that the LS-DYNA large-deformation finite element analysis can accurately reproduce the deformation behavior of the barrier and is an effective tool for predicting interception system deformation under conditions different from those examined in the full-scale tests.

**Figure 15(a) -  
Impact Weight Displacement (Case 3)**

6. The impact weight displacement obtained from the LS-DYNA analysis ranged from 0.9 to 1.0 times the experimental values, indicating good agreement with the experimental results. Therefore, the present analytical approach is considered to be an effective tool for evaluating the deformation behavior under conditions that are difficult to investigate experimentally, provided that the analysis is applied within the range of conditions for which its validity has been confirmed through full-scale testing.

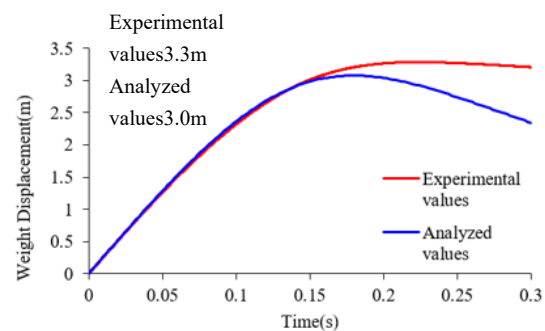
**Figure 15(b) -  
Impact Weight Displacement (Case 5)**

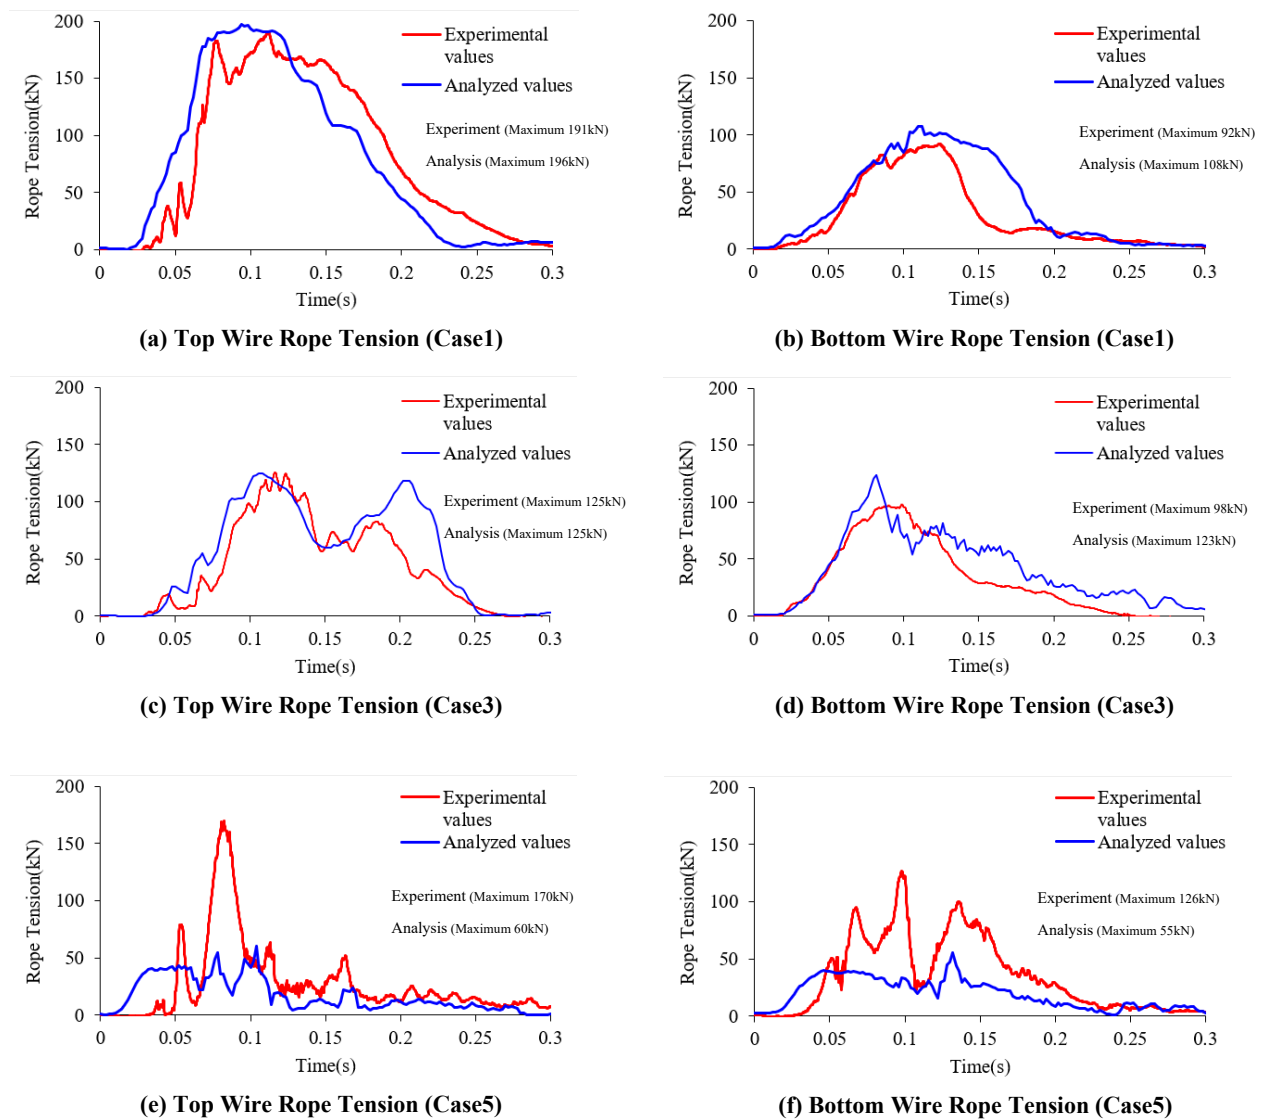
The time histories of the wire rope tension are shown in **Figures 16(a)–(f)**. For Cases 1 and 3, in which no energy dissipation devices were installed on the top or bottom wire ropes, the analytical results agreed well with the experimental results in both the peak rope tension and its duration.

For Case 5, the analytical peak rope tension differed from the experimental value. This difference is attributed to the treatment of the energy dissipation device. In the experiment, the rope tension increased momentarily when rope slippage began, whereas the analysis used the average rope tension during slippage to define the spring force. Nevertheless, the duration of the rope tension agreed well between the analysis and the experiment.

**Figure 16 - Top and Bottom Wire Rope Tension**

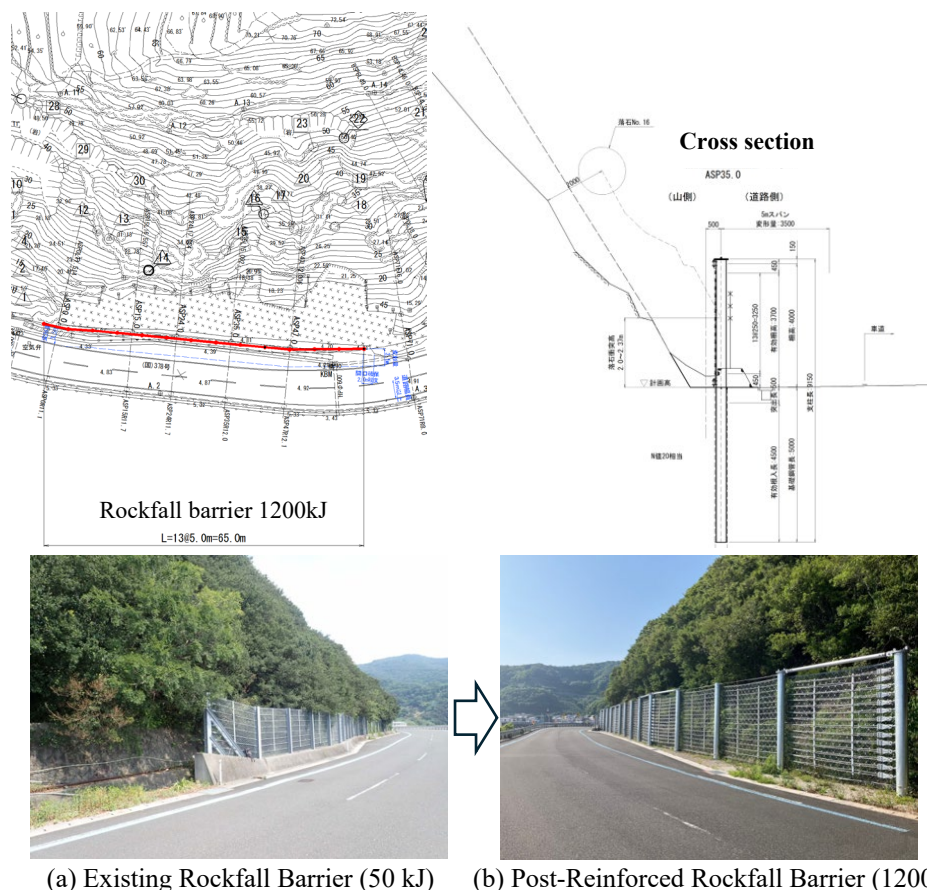
Application examples are shown in **Figure 17**. The site required a rockfall barrier capable of intercepting a 50-kN rock with an impact energy of approximately 1,000 kJ. Although a conventional rockfall barrier and a gravity retaining wall with a spread foundation had already been installed, neither system was capable of resisting the required impact energy, necessitating the investigation of alternative rockfall protection measures.

Because the allowable maximum deflection toward the roadway was limited to 3.5 m, a slope-installed high-energy-absorption barrier with anchor foundations and a pile-supported rockfall barrier were compared. Compared with the pile-supported system, the anchor-supported barrier required installation on the slope, resulting in larger deformation, additional land acquisition, and a temporary working platform for anchor installation. In contrast, the pile-supported barrier could be constructed from the roadside using a down-the-hole hammer without large temporary working platforms or scaffolding, substantially reducing temporary works and shortening the construction period by approximately 50%.

Based on these considerations, the pile-supported rockfall barrier was adopted because it could be installed within the site boundary while providing superior constructability and cost-effectiveness.

(a) Existing Rockfall Barrier (50 kJ) (b) Post-Reinforced Rockfall Barrier (1200 kJ)

**Figure 17 - Application Examples**

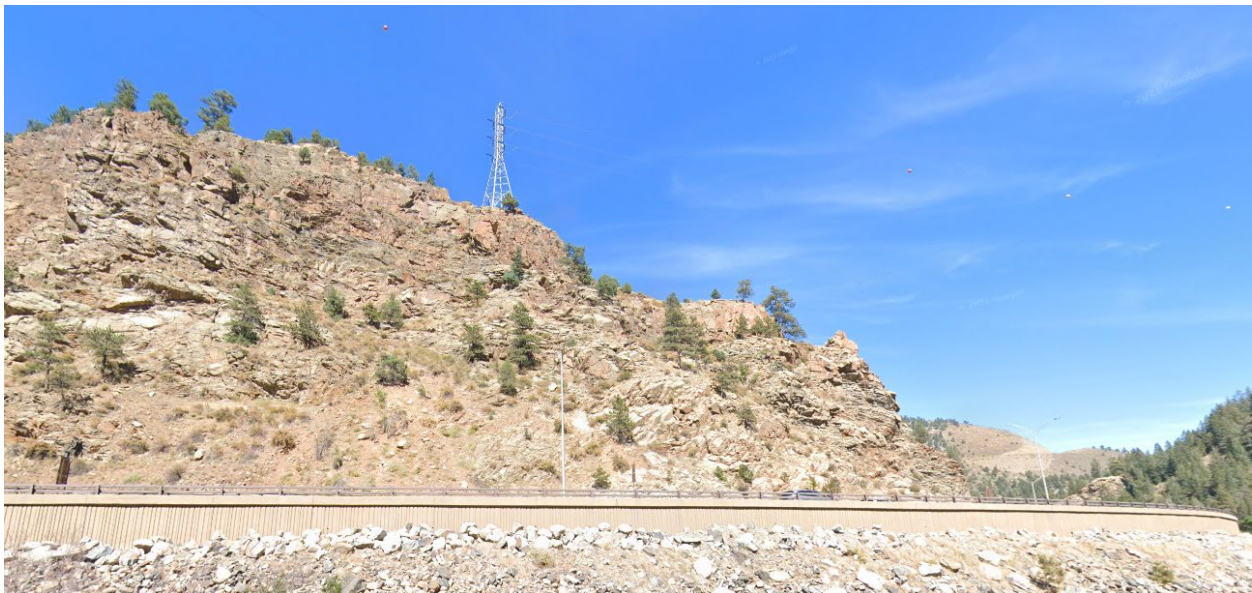
The West Cut reaches a maximum cut height of approximately 210 feet and includes removal of over 350,000 cubic yards of highly metamorphosed gneiss. It was identified as an ideal location for a rock cut due to a relatively flat bench area in the upper portion of the slope that provides a bench for pioneering to the top of the cut, thereby eliminating extensive pioneer blasts. Investigation, design, and construction of the West Cut faced the challenges of working within a steep, narrow mountainous canyon, varying depths and amounts of overburden and weathered rock, variable degrees of metamorphism, strong foliation, designing a rock cut within a curved alignment, and assessing the impacts of the rock cut to a high-voltage electrical transmission tower situated directly above the top of the cut (see Figure 3).

**Figure 3 – Photo of the West Cut Showing the Curved Roadway, Flat Bench, Variable Jointing and Foliation, and Electrical Tower**

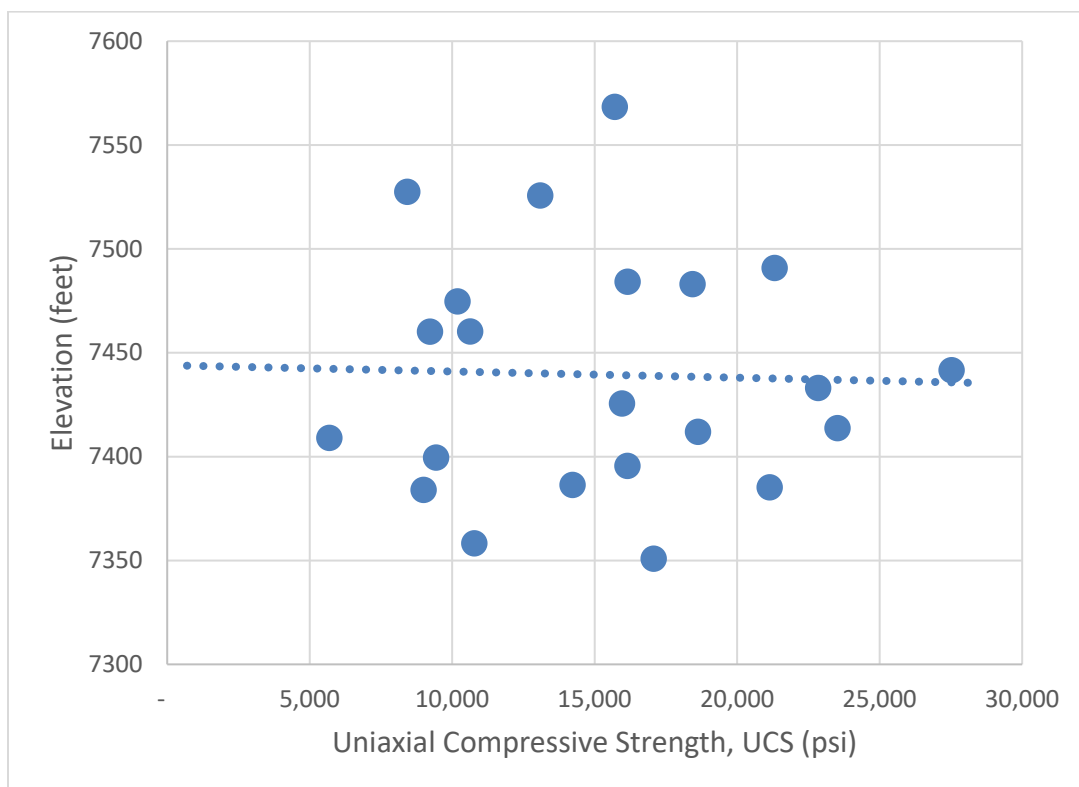
Laboratory testing for the West Cut borings included selecting rock core samples from the borings to evaluate the intact rock strength. The tested samples generally consisted of fresh to slightly weathered metamorphic bedrock. The peak strengths from Unconfined Compressive Strength (UCS) testing are shown in Figure 5. Similar to the RQD results, the UCS testing showed little to no trend of increasing rock strength with depth.

**Figure 5 – West Cut UCS Test Results (Trendline Added)**

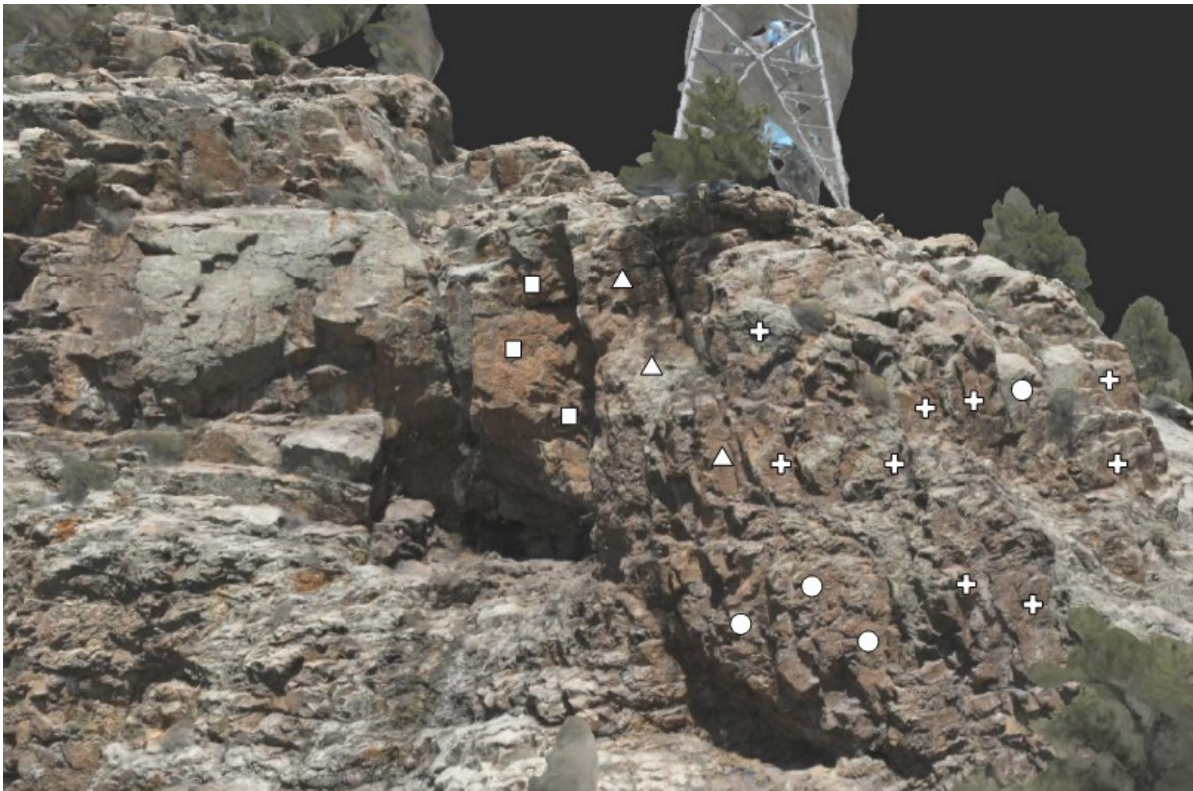
**Figure 6 – Tower Rock Bolting from Plan Set (Symbols Represent Different Lengths and Loading of Bolts)**

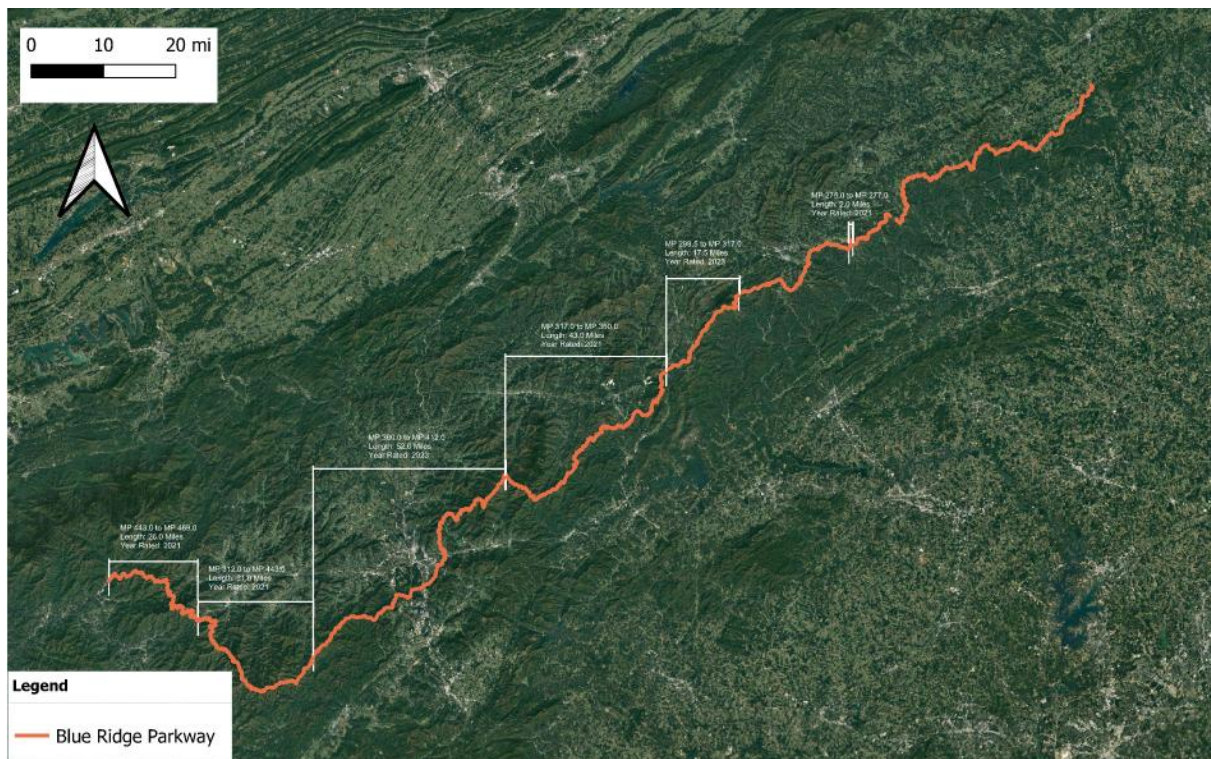
**Figure 1. Blue Ridge Parkway sections mapped during the 2021 USMP inventory. The 2021 program covered Sections A through D: MP 275–277, MP 317–360, MP 443–469, and MP 412–443.**

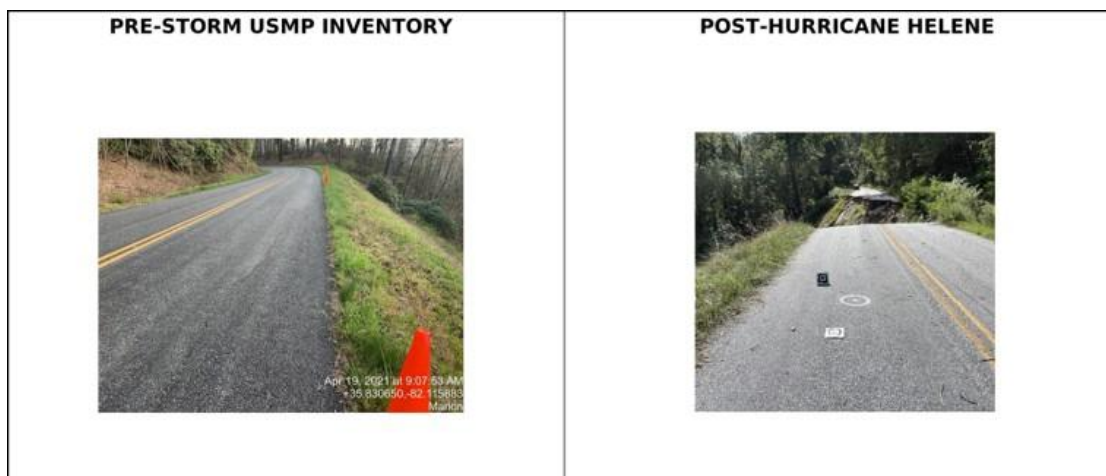
The post-storm failure at MP 336.7 removed the roadway on the southeastern fill slope. The correlated pre-storm USMP site is MP 336.6, classified as a translational slide with a rating of 414. The pre-storm photograph documents a broad vegetated downslope area immediately beyond the roadway shoulder. The correlation demonstrates that the inventory had already identified translational movement susceptibility at essentially the same milepost before the complete roadway washout.

**Figure 2. Pre- and Post-Storm Conditions at MP 336.7. Left: pre-storm USMP photograph at MP 336.6. Right: post-Hurricane Helene roadway washout at MP 336.7.**

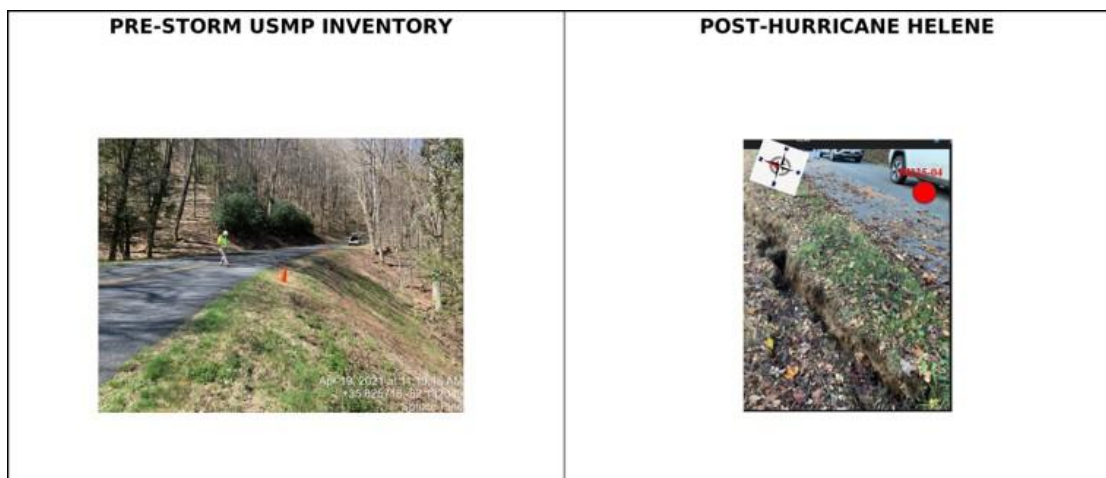
The MP 338.2 post-storm landslide affected the north side of the roadway and produced asphalt stress cracking and slope creep in the outside lane. The USMP record is a direct milepost match and classified the site as a translational slide with a rating of 305. The pre-storm photograph shows a longitudinal pavement crack near the roadway edge. This is the clearest photographic example in the dataset of roadway distress being documented before and after the storm-related movement was investigated.

**Figure 3. Pre- and Post-Storm Conditions at MP 338.2. Left: pre-storm pavement cracking. Right: post-storm outside-shoulder deformation near MP 338.2.**

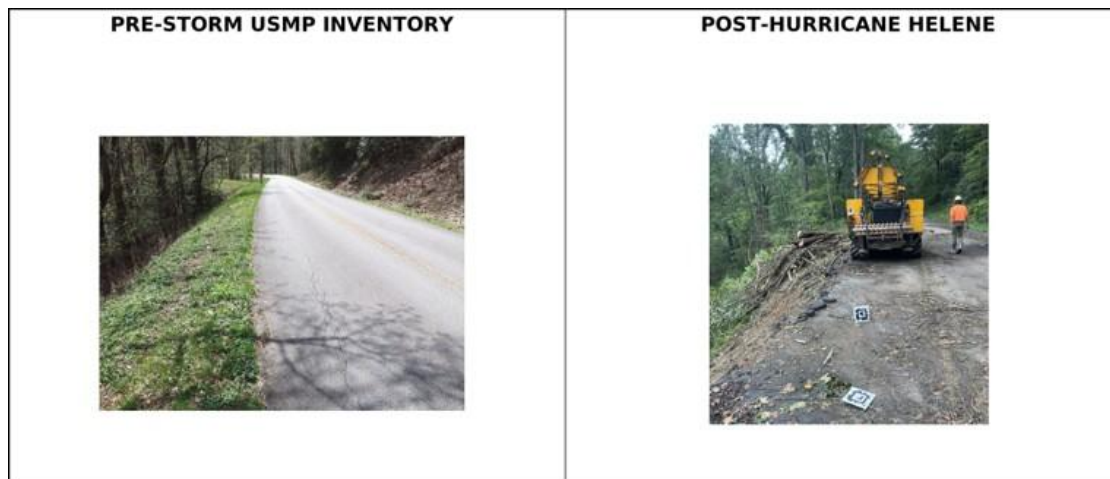
The MP 345.7 post-storm site is a landslide complex with two distinct features. The pre-storm USMP record is a direct milepost match, classified as rotational/translational with a rating of 310. The photograph shows an open roadway curve with a steep wooded downslope side and no obvious large fresh scarp visible from the camera position. The significance of this correlation is not that the photograph alone predicts the later failure; rather, the USMP field assessment and rating preserved a record of instability at the same location before the storm.

**Figure 4. Pre- and Post-Storm Conditions at MP 345.7. Left: pre-storm USMP view. Right: post-storm roadway-edge failure and debris.**

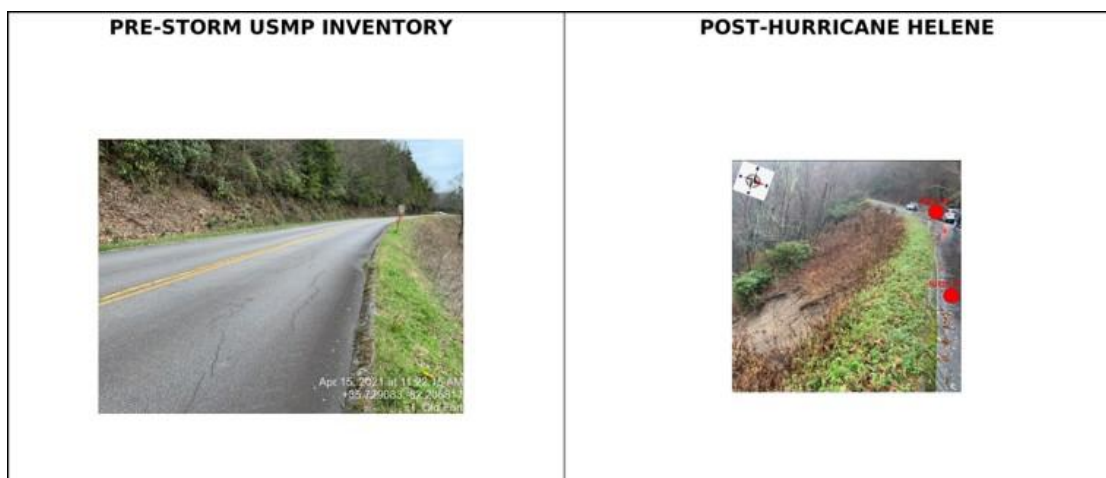
The post-storm MP 348.9 site includes two landslides, pavement cracking, grade separation, slope creep, and exposed bedrock. The correlated pre-storm USMP site is MP 348.8, classified as rotational with a rating of 549. The photograph shows a forested roadway bend with a steep outside slope. The high pre-storm rating and near identical milepost support a meaningful spatial correlation, while the post-storm investigation supplies the additional detail on roadway and slope deformation.

**Figure 6. Pre- and Post-Storm Conditions at MP 348.9. Left: pre-storm USMP view at MP 348.8. Right: post-storm slope failure and boring locations BH25-15 and BH25-16.**
