# 75<sup>TH</sup> HIGHWAY GEOLOGY SYMPOSIUM

BETTER HIGHWAYS THROUGH APPLIED GEOLOGY

2026  
HGS  
PROCEEDINGS

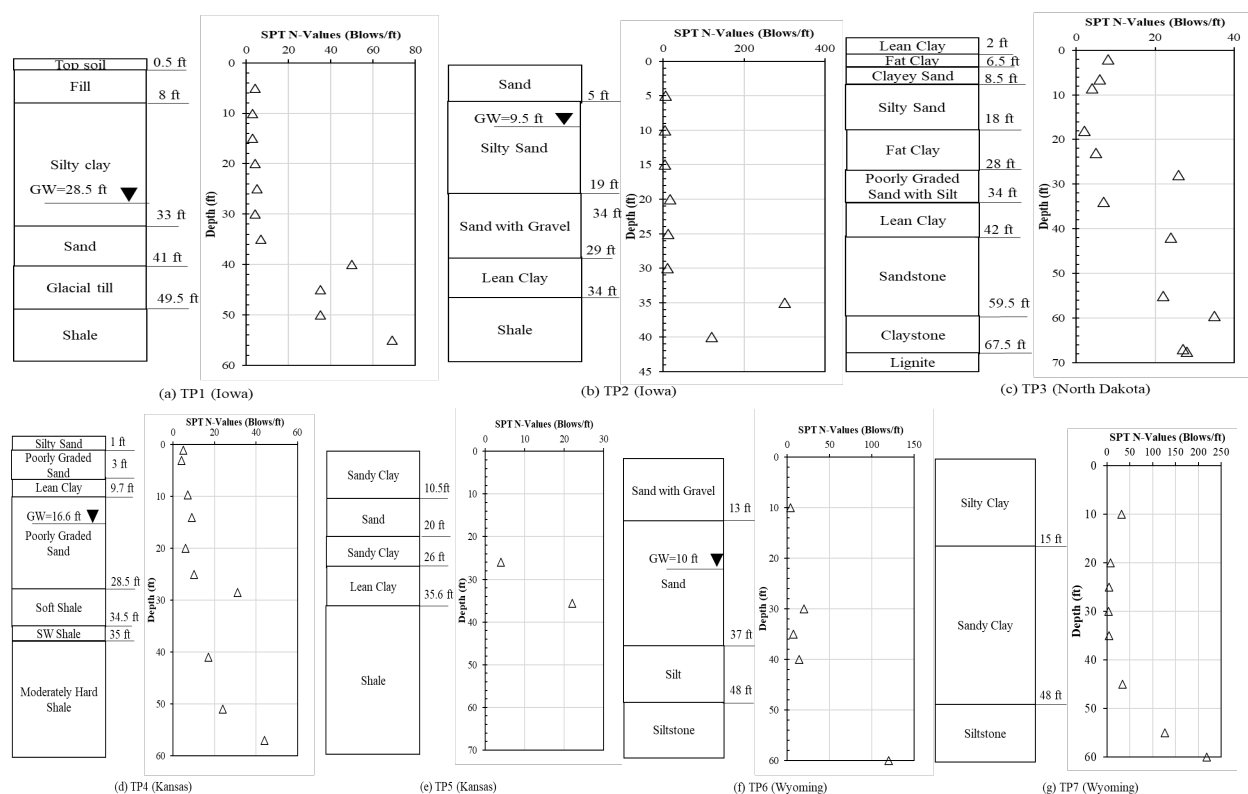
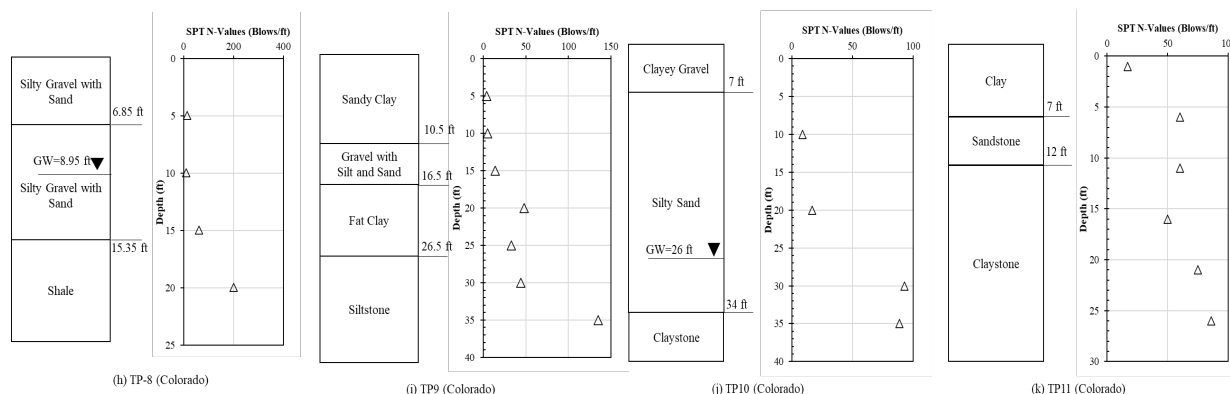
Subsurface investigations consisting of 2 to 6 boreholes were completed at each bridge site to characterize soil and bedrock conditions. The test piles consisted of HP steel sections installed in varying geologic conditions, including clay, silty clay, sand, gravel, glacial till, and sedimentary bedrock formations such as shale, sandstone, claystone, lignite, and siltstone. TP1 and TP2 were located in Iowa, where piles were driven through overburden soils into shale bedrock at depths of approximately 34 to 50 ft. TP3 in North Dakota encountered clay, silty sand, and sand deposits overlying sandstone, claystone, and lignite bedrock at about 42 ft. TP4 and TP5 in Kansas were installed within the Wellington Formation, consisting primarily of soft to moderately hard shale. TP6 and TP7 in Wyoming were driven through sand, gravel, silt, and sandy clay deposits into siltstone bedrock at depths of approximately 48 ft. TP8–TP11 in Colorado were founded in sedimentary bedrock formations including shale, siltstone, sandstone, and claystone with pile penetration lengths ranging from approximately 18 to 41 ft. Groundwater conditions varied across the sites, with groundwater encountered at TP2 and TP6, but not observed during exploration at most other locations. Figures 1a–1k present the groundwater conditions, SPT N-values, and subsurface profiles for all eleven test pile sites. The test pile and bearing layer properties are summarized in Table 1.

**Figure 1. Subsurface profiles and SPT N-values of a) TP1 in Adair County, IA, b) TP2 in Wapello County, IA, c) TP3 in McKenzie County, ND, d) TP4 in Sumner County, KS, e) TP5 in Sedgwick County, KS, f) TP6 in Laramie County, WY, g) TP7 in Sweetwater County, WY, h) TP8 in Delta County, CO, i) TP9 in Arapahoe County CO, j) TP10 in EL Paso County, CO, and k) TP11 in Jefferson and Denver Counties, CO.**

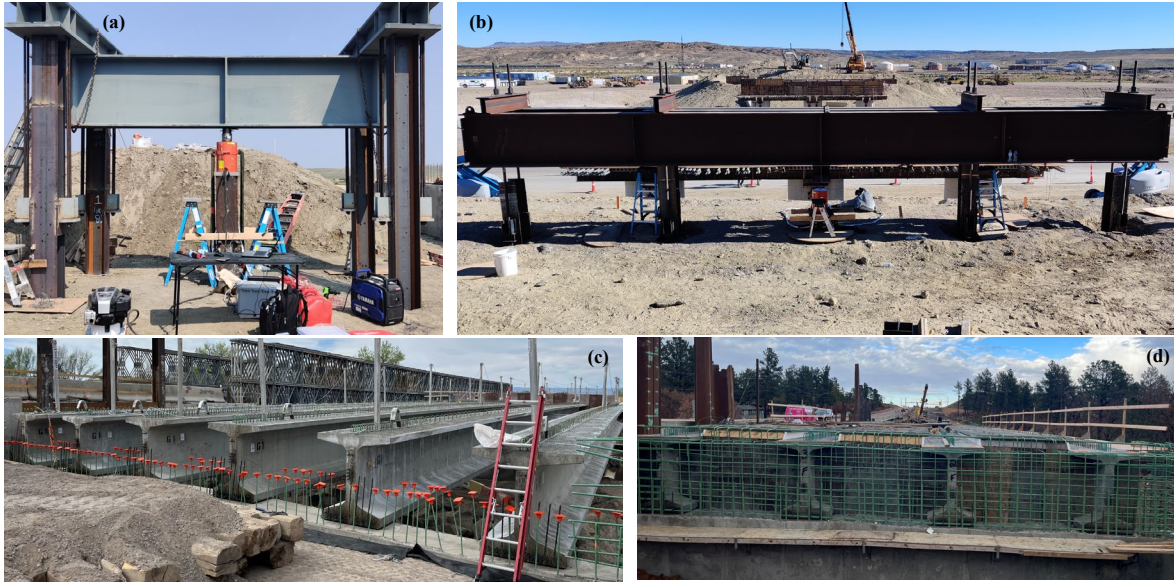
**Figure 2. Photos of three static load test systems: (a) IndeSPLS for TP1 to TP5, (b) InteSPLS for TP6 and TP7, and (c) InnoSPLS for TP8 to TP11.**

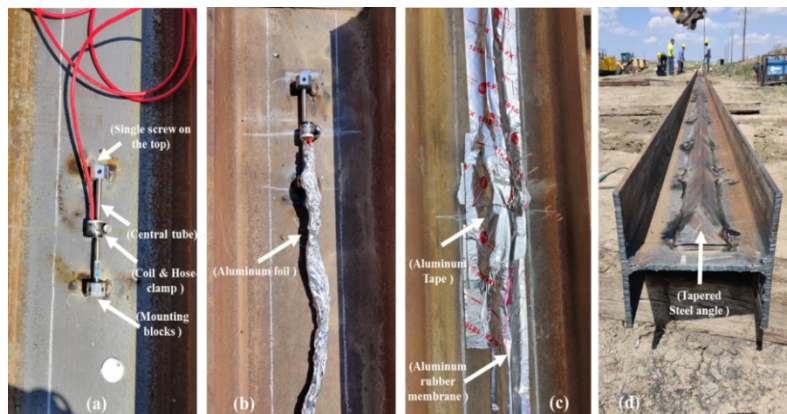
Each TP was instrumented with eight pairs of Geokon® VW 4000A SGs on both web faces along the pile length to determine load distribution and pile bending during the SLT. These SGs were selected for their long-term stability, resistance to water and lightning damage, and reliable signal transmission over long cable lengths. Before installation, the pile surface was cleaned to remove rust and dirt. Mounting blocks were positioned using a spacing jig and welded to the pile web, after which the SGs were secured between the blocks with hose clamps and protective coils (Figure 3). The change in SG readings ( $\Delta R$ ) was converted to microstrain ( $\epsilon$ ) using a gauge factor ( $G = 4.062$ ) and batch factor ( $B = 0.96$ ) by Equation (1).

**Figure 3. Test pile instrumentation: a) SG welded on the web face of the TP, b) protection of cables with aluminum foils, c) protection of SGs and cables with aluminum tapes and membranes, and d) protection using steel angles with tapered steel angles near the pile tip.**

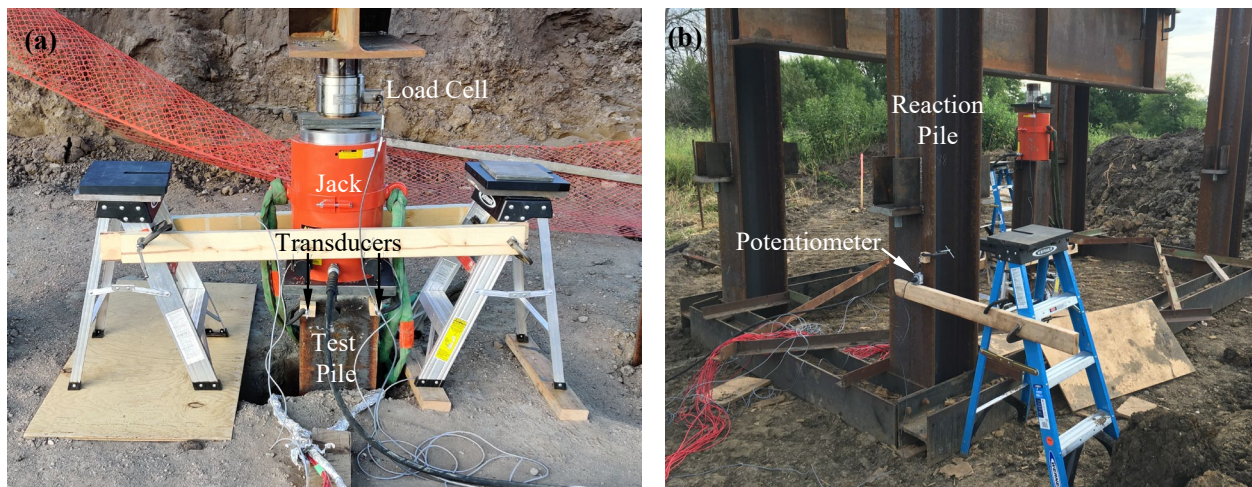
A 355-ton Power Team™ hydraulic jack, with a 10-in stroke, was used to apply axial loads to the TP in the InteSPLS and IndeSPLS systems. The jack was powered by a double-acting gasoline-driven hydraulic pump capable of producing pressures up to 10,000 psi, with a digital pressure gauge used for accurate pressure monitoring. A 500-ton Honeywell load cell measured the applied load, and its readings were calibrated using the hydraulic pump pressure before testing. Pile-top displacements were measured using four UniMeasure JX-P420 linear position transducers mounted on independent wooden reference beams. In addition, two string potentiometers mounted on separate wooden beams were used to monitor the upward movement of the reaction or production piles during the SLT (Figure 4).

**Figure 4. Static load test setup at the a) test pile, and b) reaction or production Pile.**

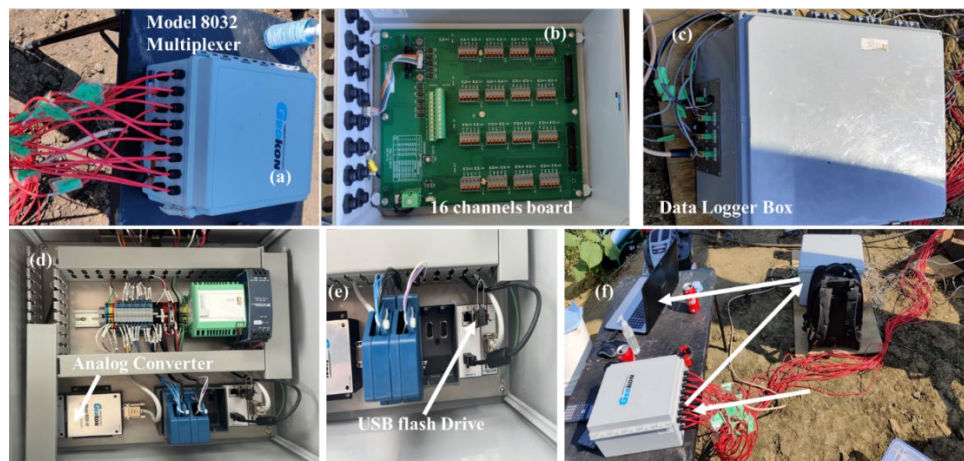
**Figure 5. a) multiplexer, b) 16-channels in the multiplexer, c) data logger box, d) vw analog converter, e) usb flash drive, and f) computer system to collect the readings during SLT.**

A 16-channel Geokon Model 8032 multiplexer was used to collect readings from all vibrating-wire SGs (Figure 5). LabVIEW software synchronized measurement times and organized the data for processing. The multiplexer sequentially reads each sensor through a programmed relay system. A Model 8020-59 VW-analog converter excited the sensors,

measured the frequencies, and converted the readings into voltage outputs proportional to strain and stress values. The data acquisition system (DAS) included a power supply, hard drive, and control switch, and stored all measurements via USB. Load cell data and readings from six displacement sensors were continuously monitored and recorded on a connected PC.

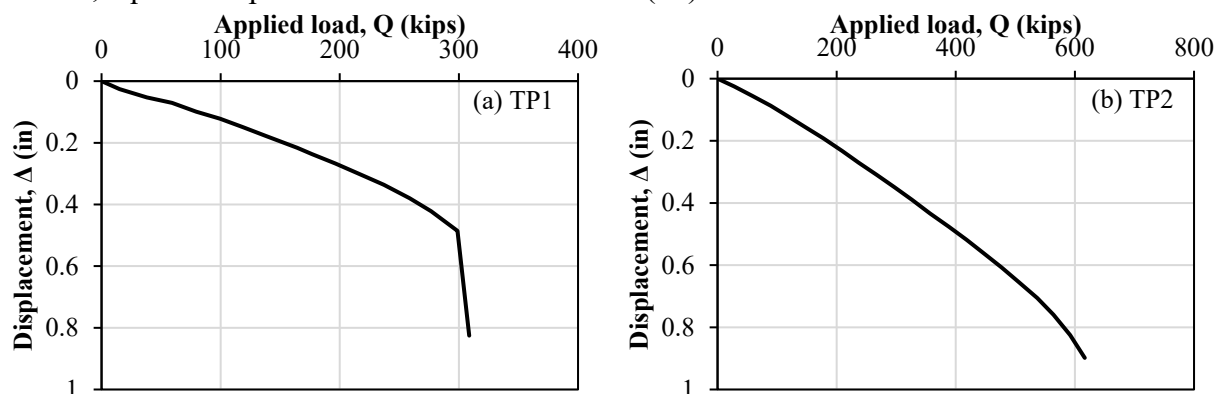
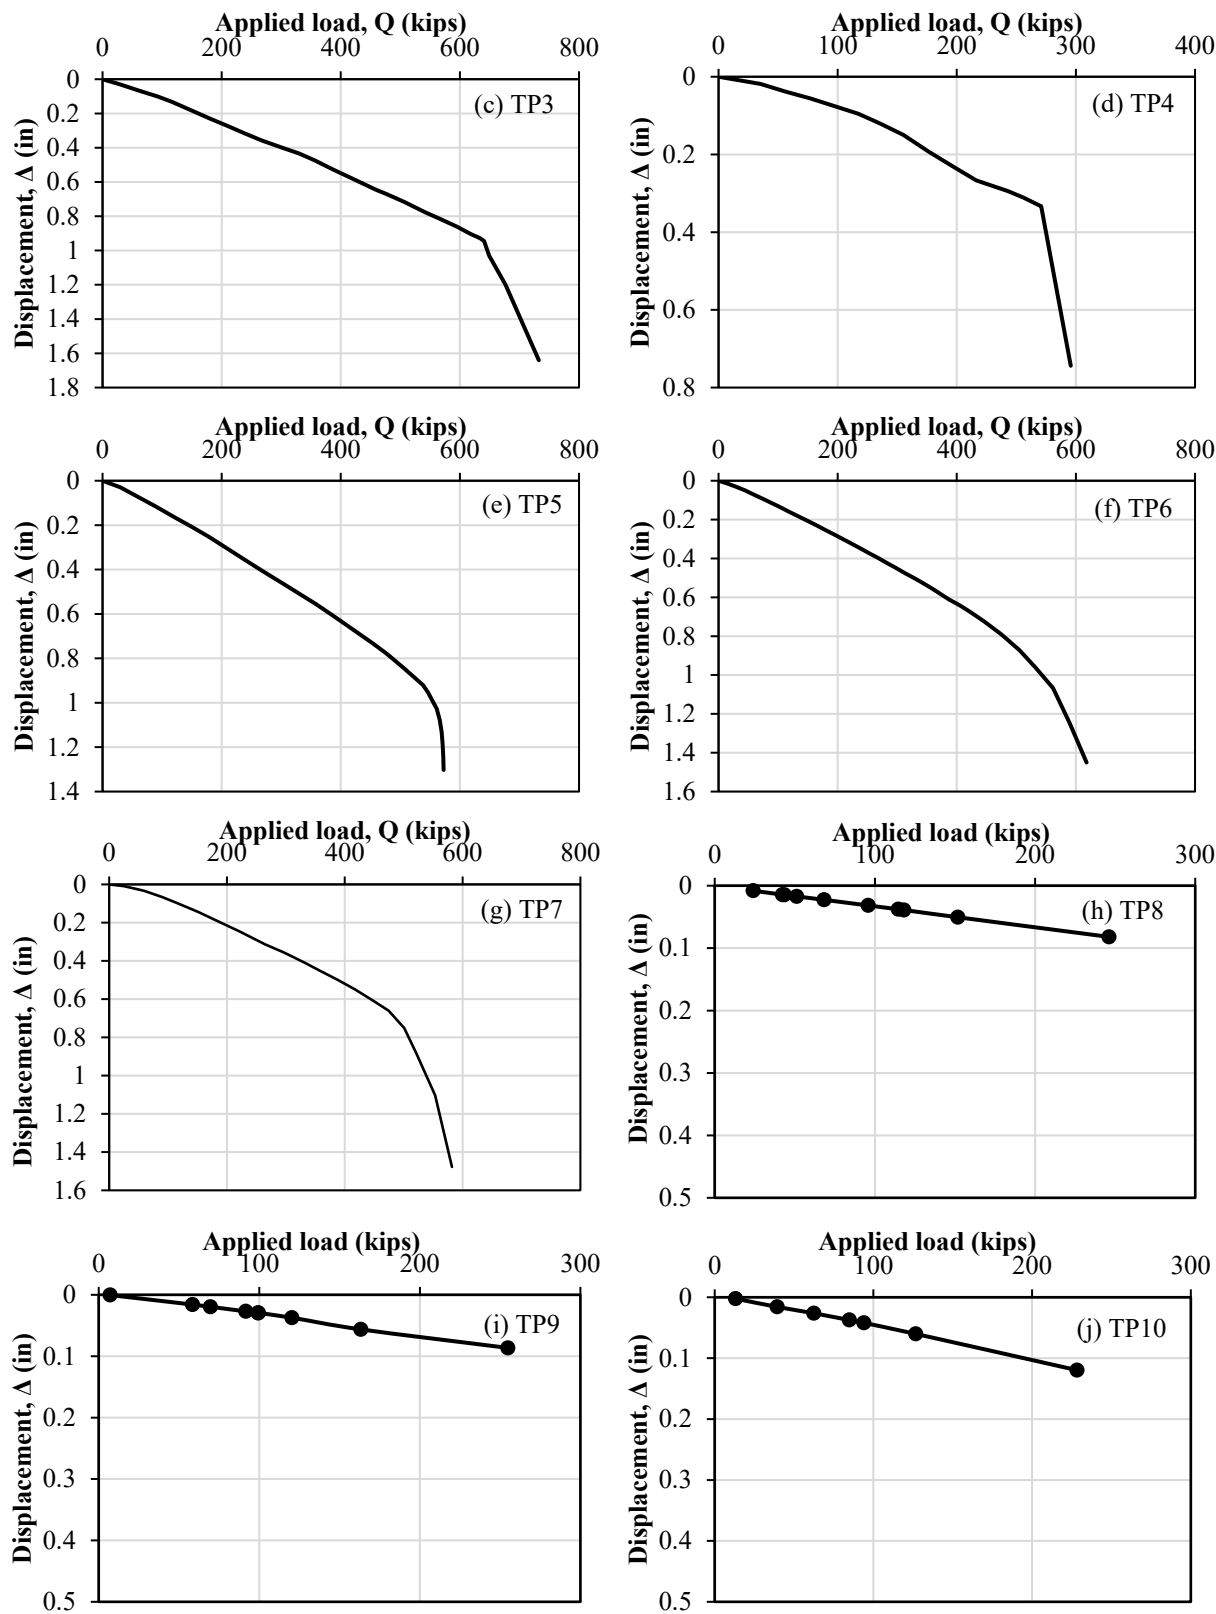
**Figure 6. Load displacement response of a) TP1, b) TP2 , c) TP3, d) TP4, e) TP5, f) TP6, g) TP7, h) TP8, i) TP9, j) TP10, k) TP11, and extrapolated load displacement response of l) TP8, m) TP9, n) TP10, and o) TP11.**

SLTs were performed between 1 and 61 days after EOD, and the pile head load–displacement responses are presented in Figures 6a–6g. For TP1–TP7, the applied load increased approximately linearly with displacement, indicating elastic pile behavior within the monitored load range. TP8–TP11 were monitored using the InnoSPLS system in Colorado. Loads were induced by sequential construction of structural components, including the abutment cap, wing walls, girders, deck panels, haunch, and concrete deck with live load. The load–displacement responses (Figures 6h–6k) remained linear, with pile head displacements ranging from 0.08 to 0.13 in., indicating that the piles remained in the elastic range and ultimate resistance was not mobilized. To estimate the full load–displacement response of TP8–TP11, the extrapolation method was used (17). The measured and extrapolated responses are plotted in Figures 6l–6o. Ultimate resistances were evaluated using the Davisson (18), De Beer (19) Yield Load (YL), Fuller and Hoy (20), 10%B, 5%B, and 1-in. displacement criteria (21). For the 10%B and 5%B criteria, equivalent pile diameters were calculated (22).

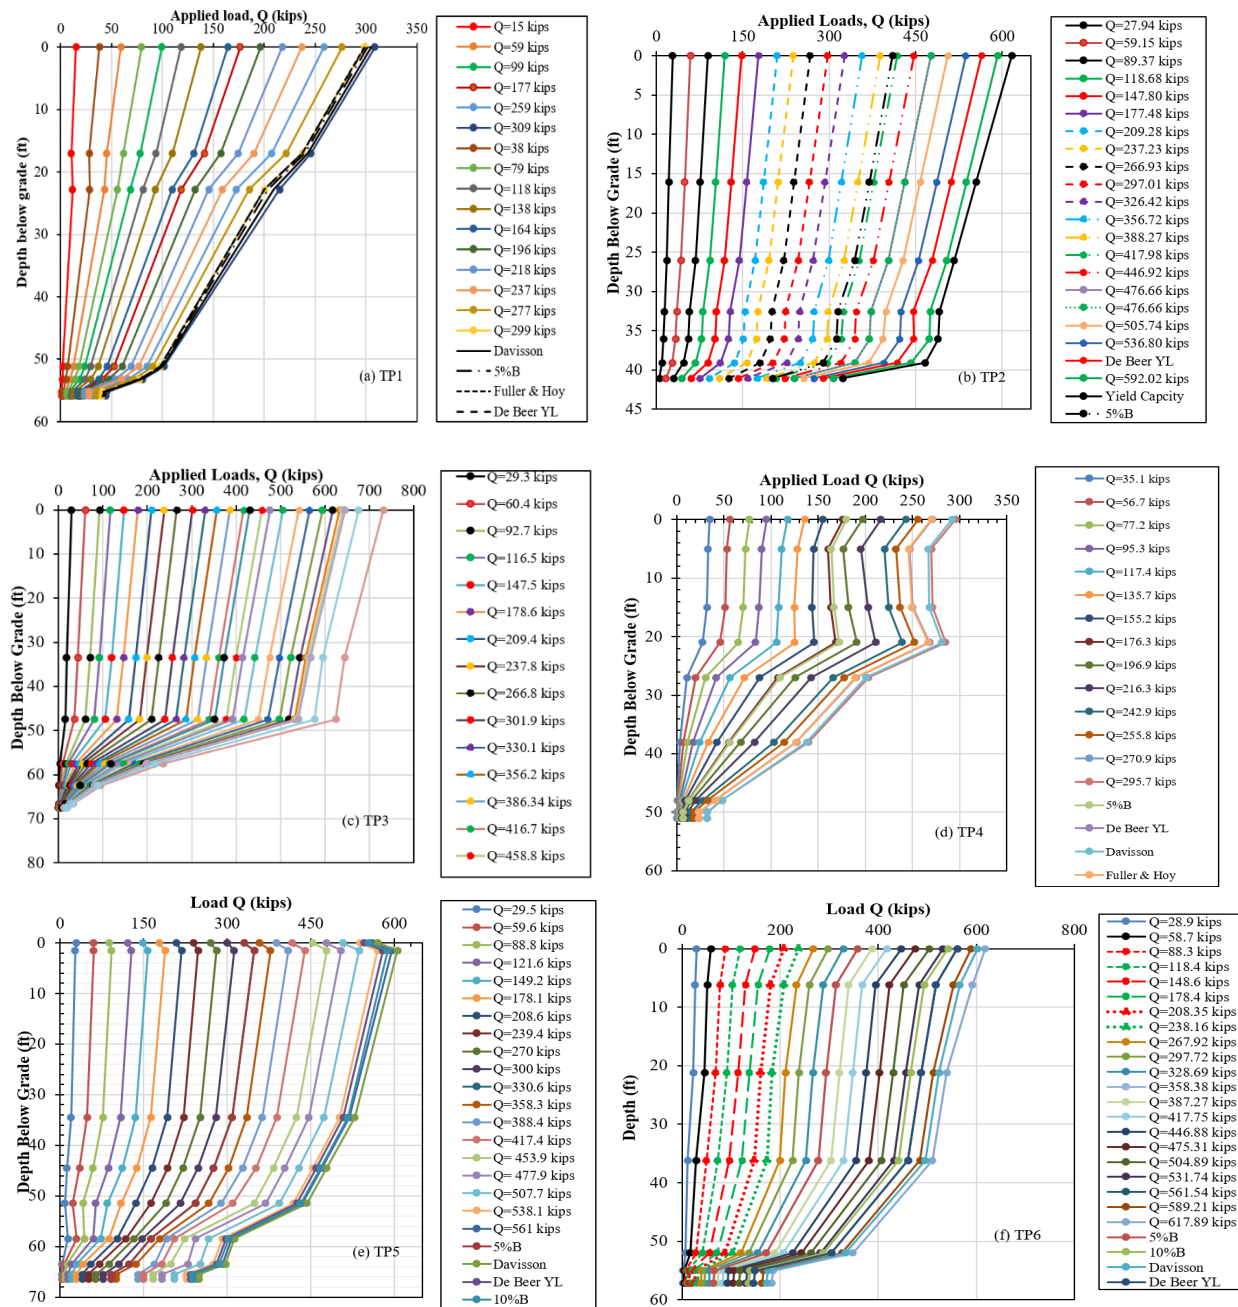
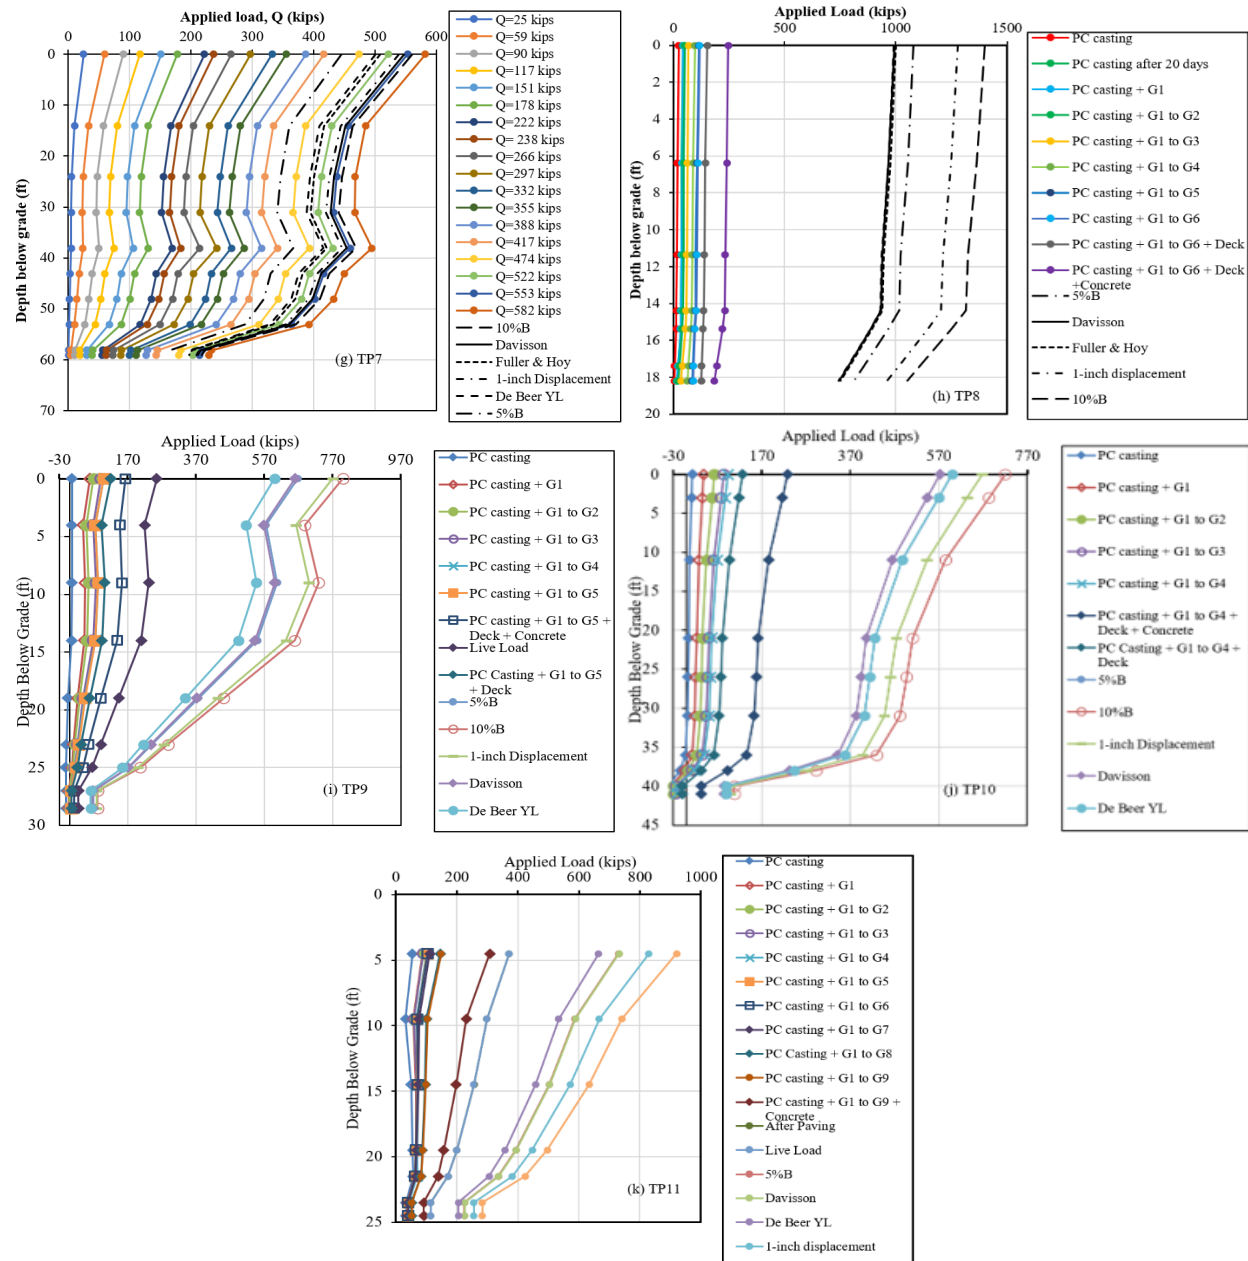
**Figure 7 Axial load distribution along the pile length of a) TP1, b) TP2 c) TP3, d) TP4, e) TP5, f) TP6, g) TP7, h) TP8, i) TP9, j) TP10, and k) TP11.**

Figure 7 presents axial load distributions along the pile length. Shaft resistance was calculated as the difference between pile head and pile toe loads, while end bearing was taken as the load measured at the pile toe. Based on Davisson's criterion, maximum ultimate resistances of 305, 732.5, 292, 571, 602, and 561 kips were obtained for TP1, TP3, TP4, TP5, TP6, and TP7, respectively. The highest ultimate resistances for TP8–TP11 were obtained using the 10%B criterion. For TP2, geotechnical failure was not reached before structural yielding occurred, indicating that pile yield strength governed. Except for TP2 and TP8, end bearing contributed less than 50% of the total ultimate resistance, while shaft resistance contributed more than 50%,

indicating that shaft resistance was the primary load-transfer mechanism for most piles that were tested.

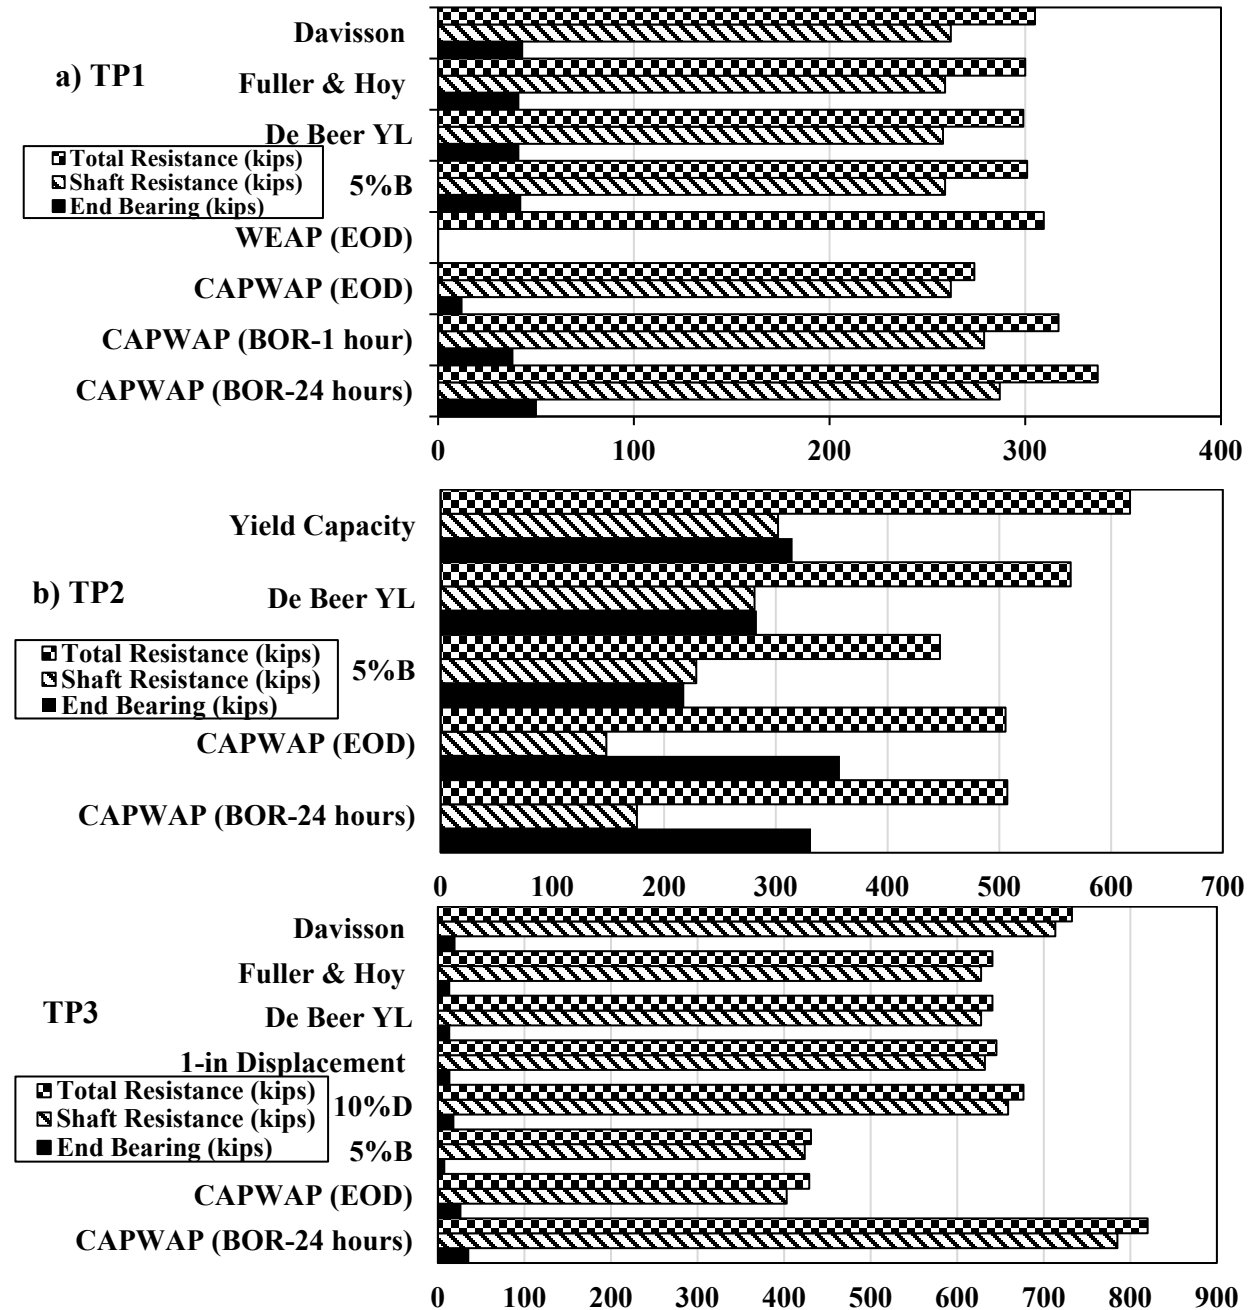
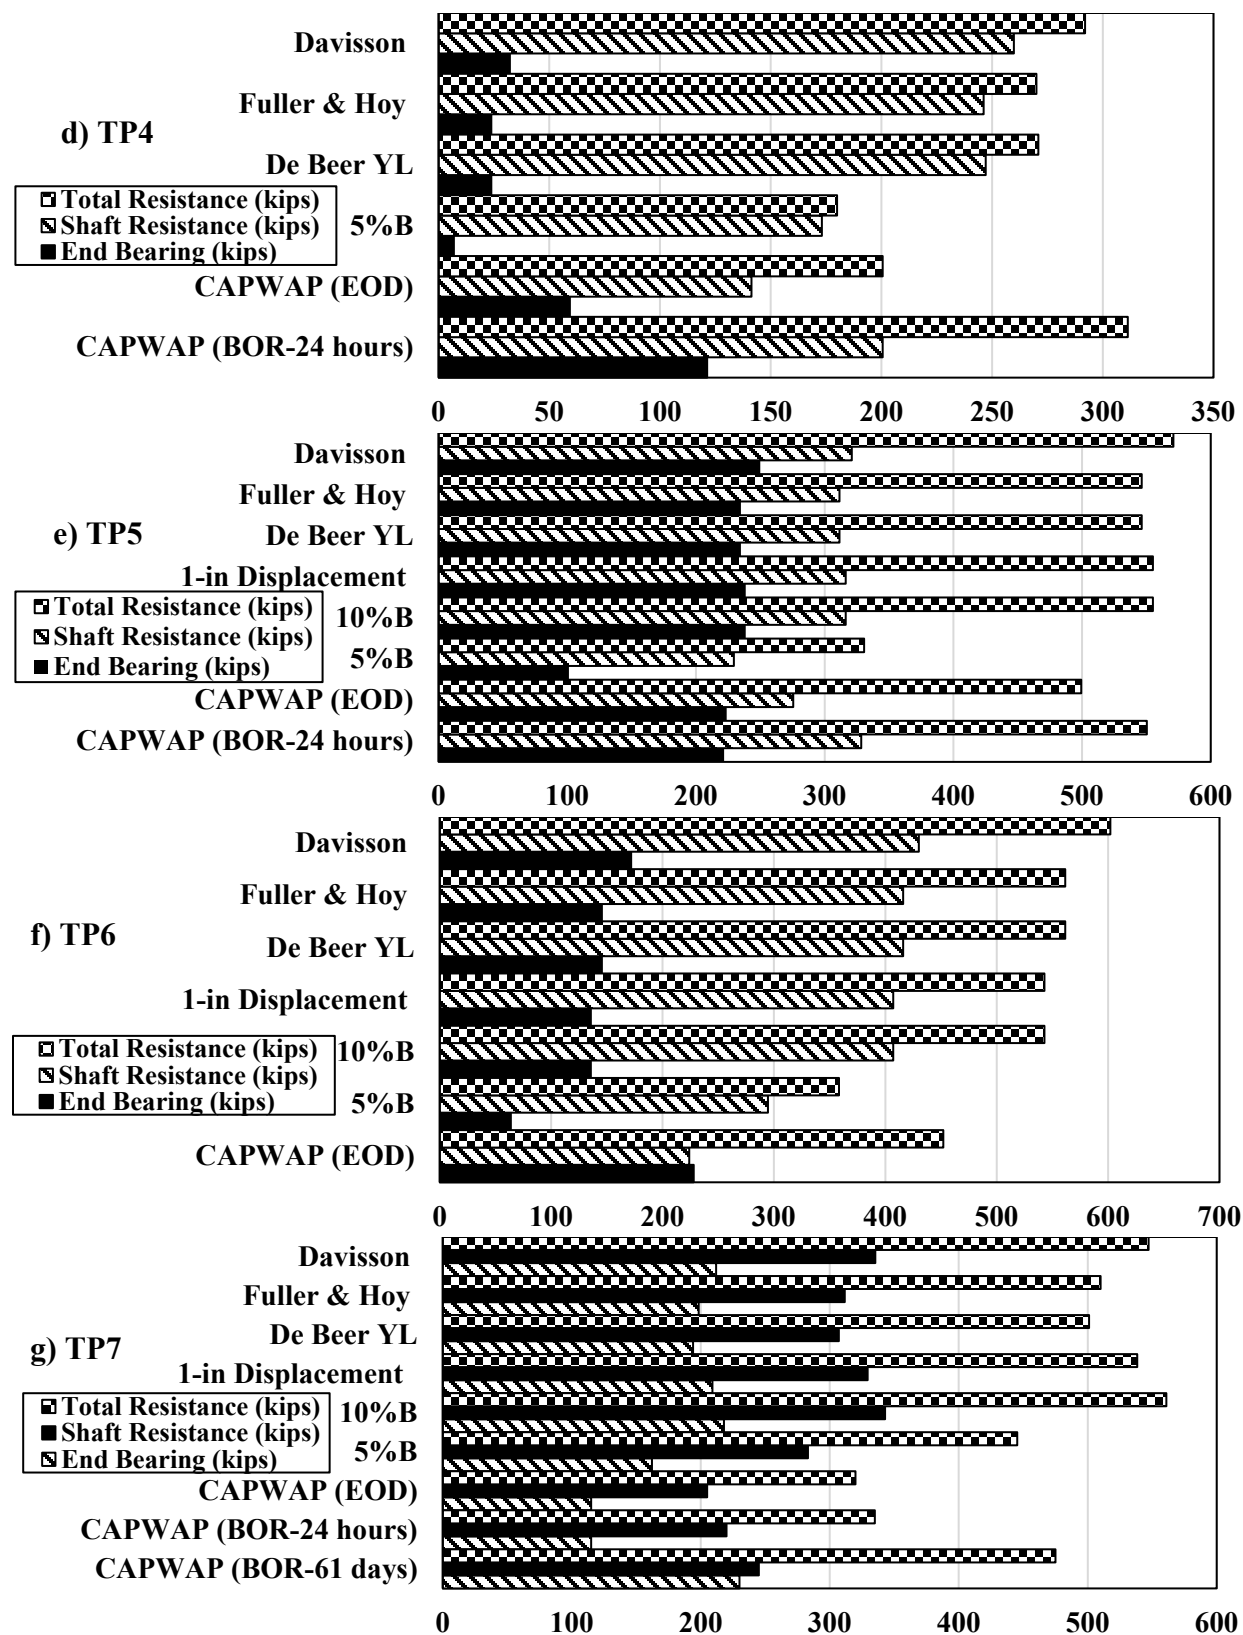
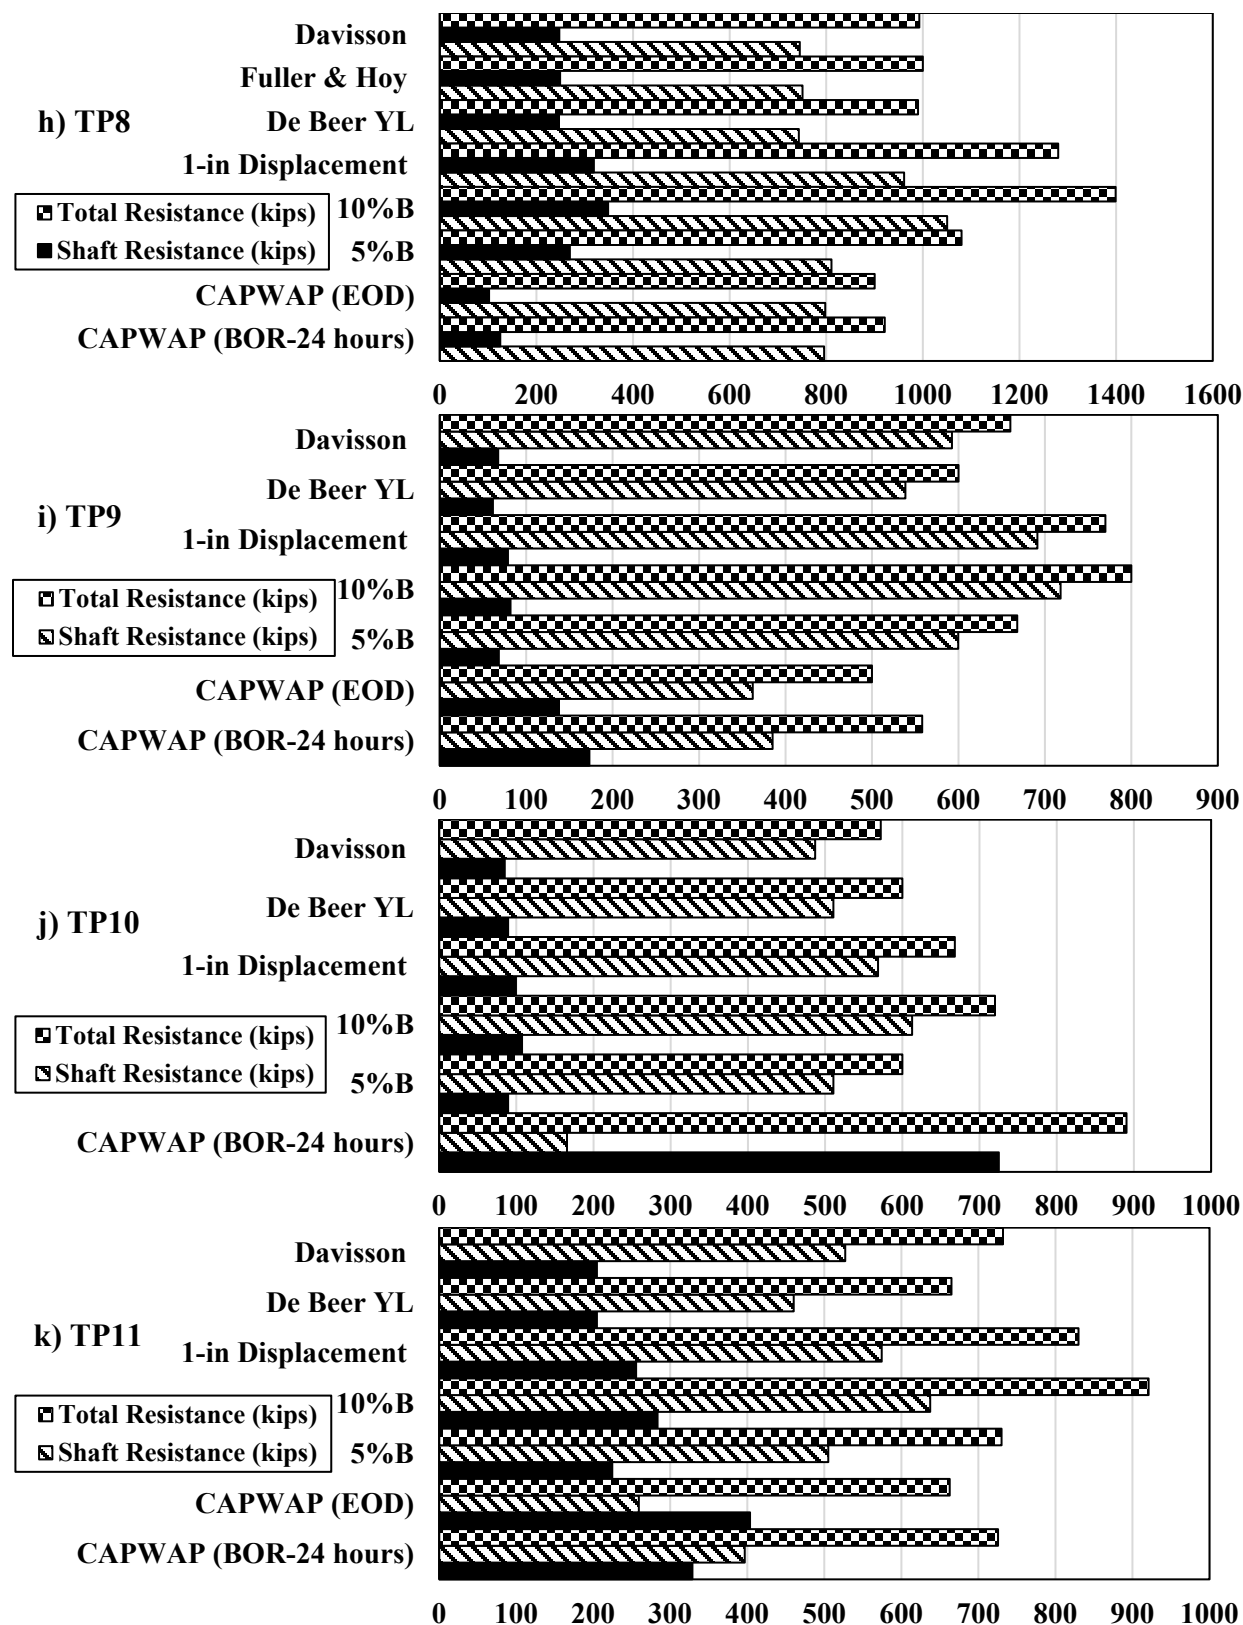
Figure 8. Comparison of total resistance, shaft resistance, and end bearing: a) TP1, b) TP2 c) TP3, d) TP4, e) TP5, f) TP6, g) TP7, h) TP8, i) TP9, j) TP10, and k) TP11.

PDA was used to monitor all test piles during driving and subsequent restrikes. Restrrikes were performed 24 hours after the EOD for all test piles except TP7, which was restruck 61 days after EOD. PDA measurements were analyzed using CAPWAP to estimate shaft resistance and end bearing. The CAPWAP-estimated resistances at EOD and BOR are presented in Figure 8. The total pile resistance of TP1 increased from 274 kips at EOD to 337 kips at BOR or by 23% (Figure 8a). For TP2, only a marginal increase of 0.3% was observed from 506 kips to 507 kips (Figure 8b). TP3 exhibited the largest increase of 93% from 429 kips at EOD to 820 kips at BOR

(Figure 8c). Overall, all test piles showed an increase in total resistance at BOR. Both shaft resistance and end bearing contributed to the increase in total resistance. The highest shaft resistance contribution of 69% was observed in TP3, while TP8 exhibited the highest contribution of 86% from end bearing.

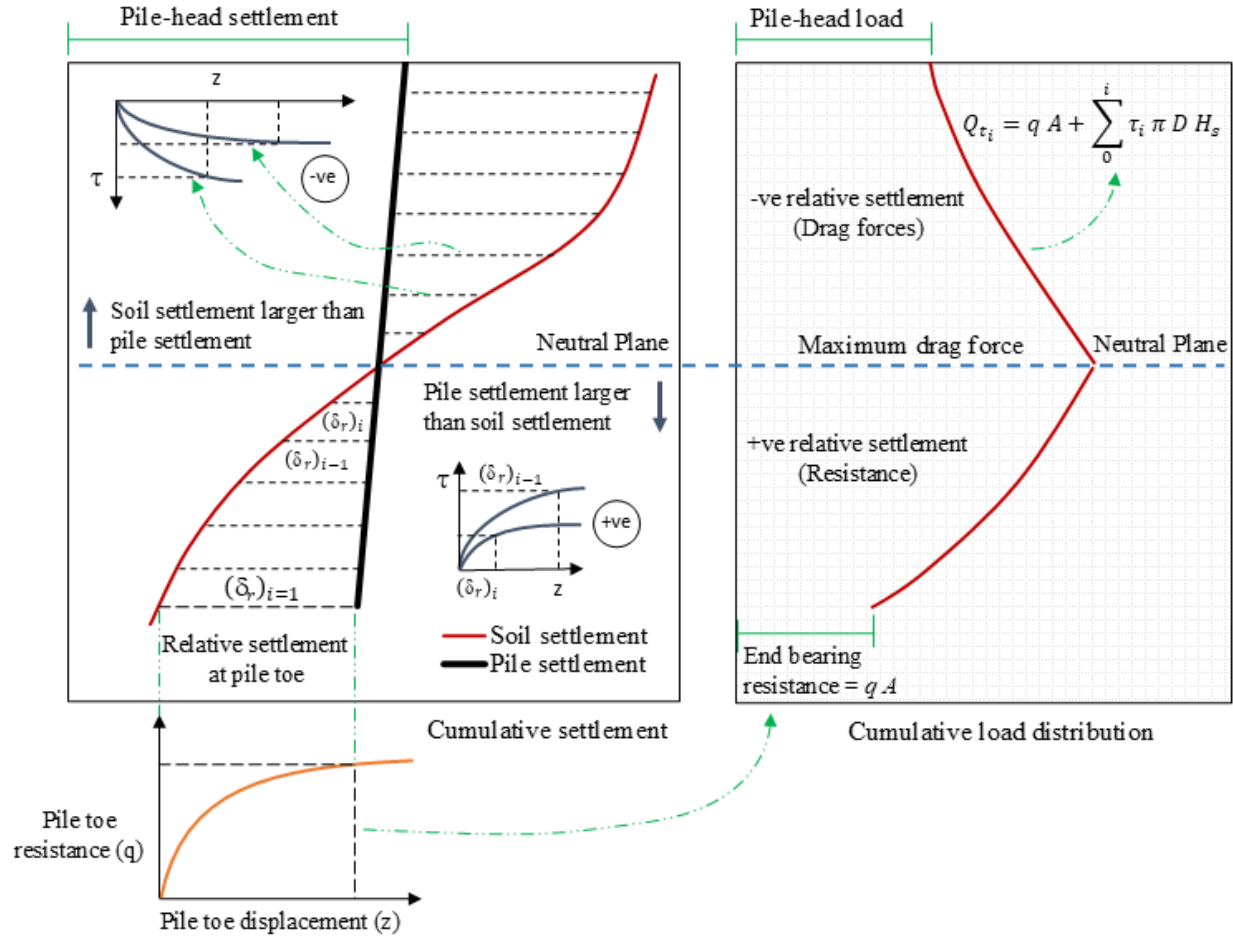
**Figure 1 – Pile and soil settlement profiles coupled with the pile side and tip load-displacement relationships to capture the mobilized response of a pile subjected to negative skin friction. After Ashour and Abbas (21)**

The downdrag analysis couples the soil settlement profile with the pile response through the  $t$ - $z$  and  $q$ - $z$  relationships described above. The soil settlement at each sublayer is prescribed as an input and may be calculated using the method appropriate for the settlement mechanism. Negative skin friction develops where the soil settles more than the pile, whereas positive shaft resistance develops where the pile moves more than the soil. The magnitude of the mobilized shaft shear is obtained from the  $t$ - $z$  relationship for the corresponding sublayer. The calculation begins at the pile tip, where the  $q$ - $z$  relationship provides the tip resistance corresponding to an assumed relative tip movement. The force and displacement at the top of each segment provide the conditions at the bottom of the segment above, allowing the calculation to proceed upward to the pile head. Within each segment, the shaft shear, axial force, elastic compression, and pile displacement are updated iteratively until they are compatible. Figure 1 illustrates the coupling among the soil and pile settlement profiles, the shaft and tip responses, and the resulting axial-load distribution (21).

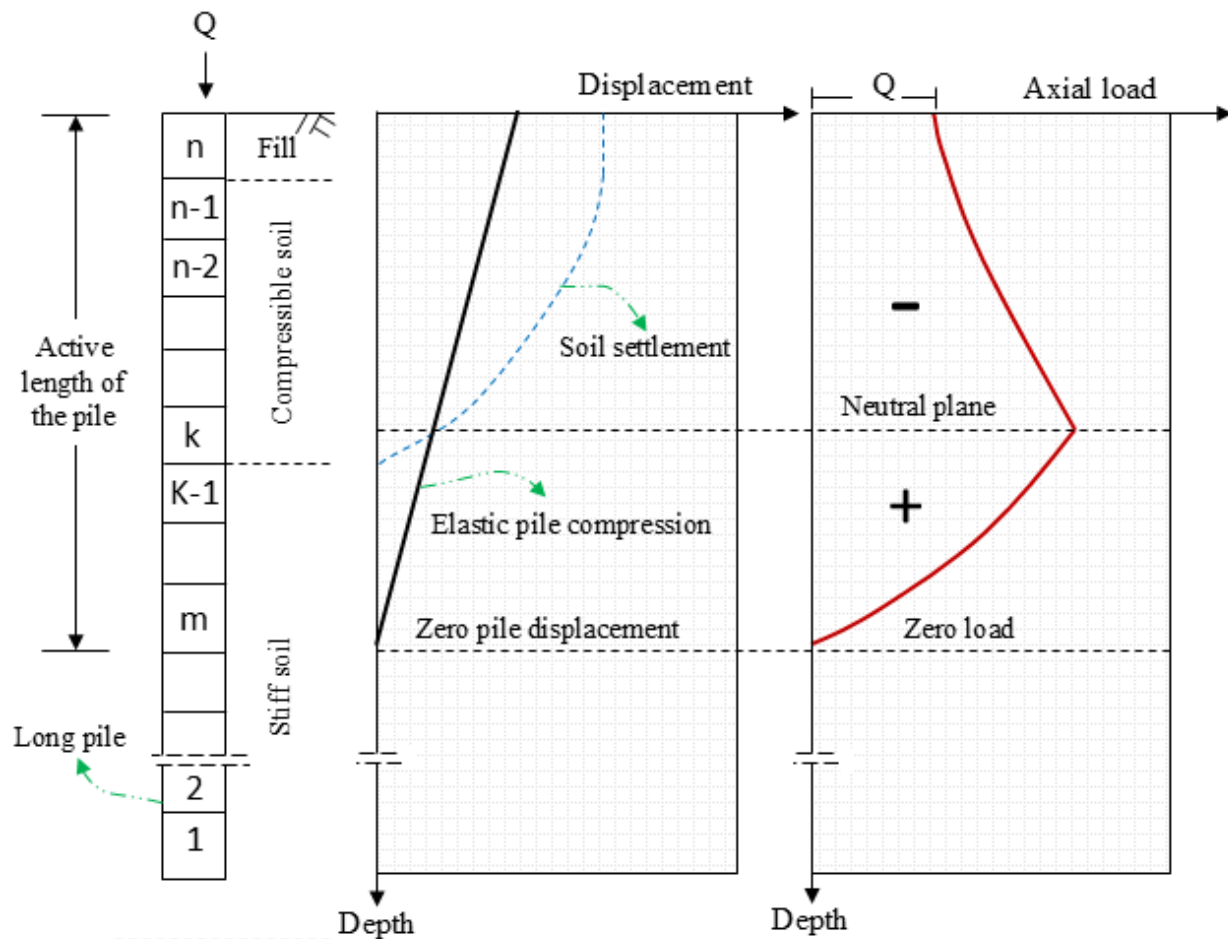
**Figure 2 – Modeling the behavior of long piles subjected to downdrag. After Ashour and Abbas (21)**

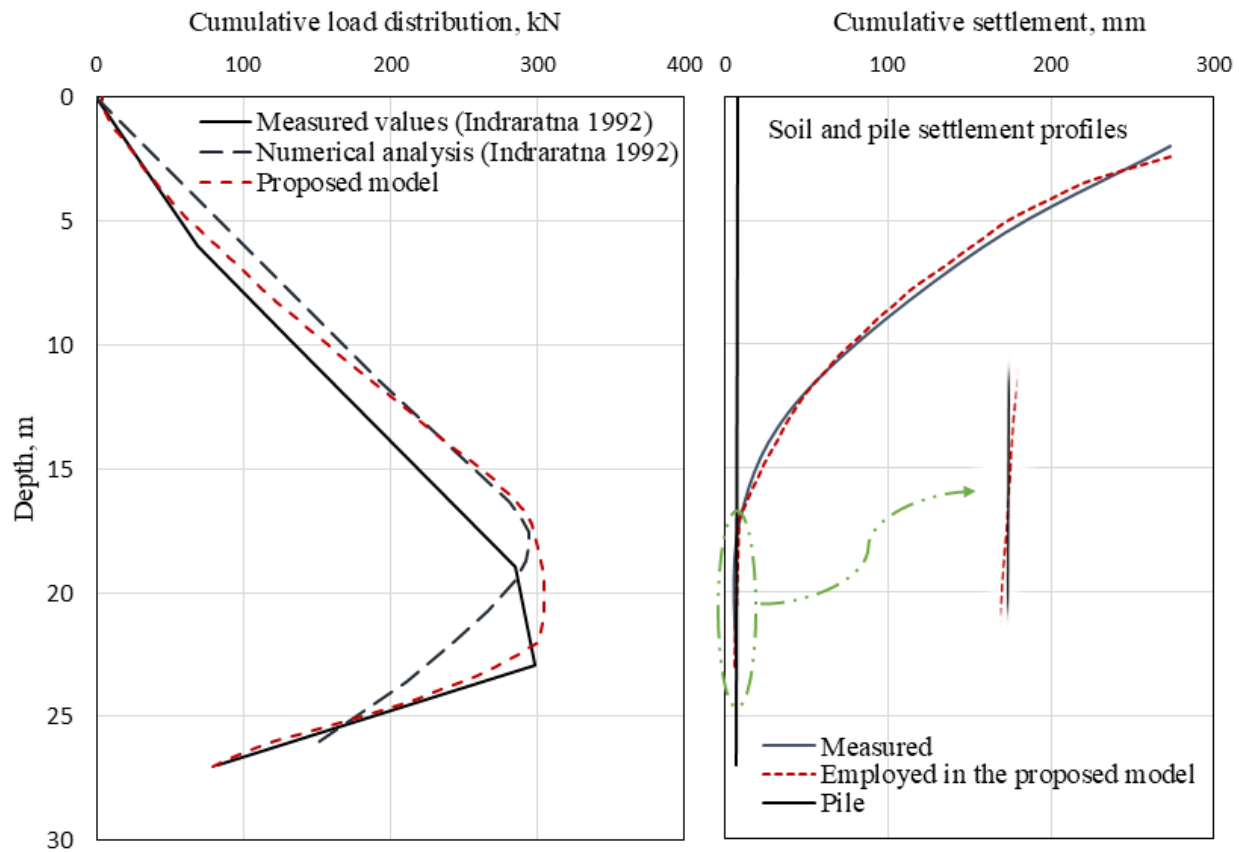
**Figure 3 – Measured and predicted pile response for the Bangkok, Thailand test. Measured and finite-element results from Indraratna et al. (6). After Ashour and Abbas (21)**

Two comparisons with full-scale tests support the procedure. At Bangkok, where settlement was produced by consolidation of soft marine clay under an embankment, the predicted load distribution follows the measured response. At Nikopol, where settlement was produced by collapse of a metastable deposit upon prolonged wetting, the predicted maximum drag load was 10 percent greater than the measured value. The agreement obtained for these distinct settlement mechanisms indicates the potential of the coupled approach for evaluating drag load and downdrag under different settling-ground conditions.

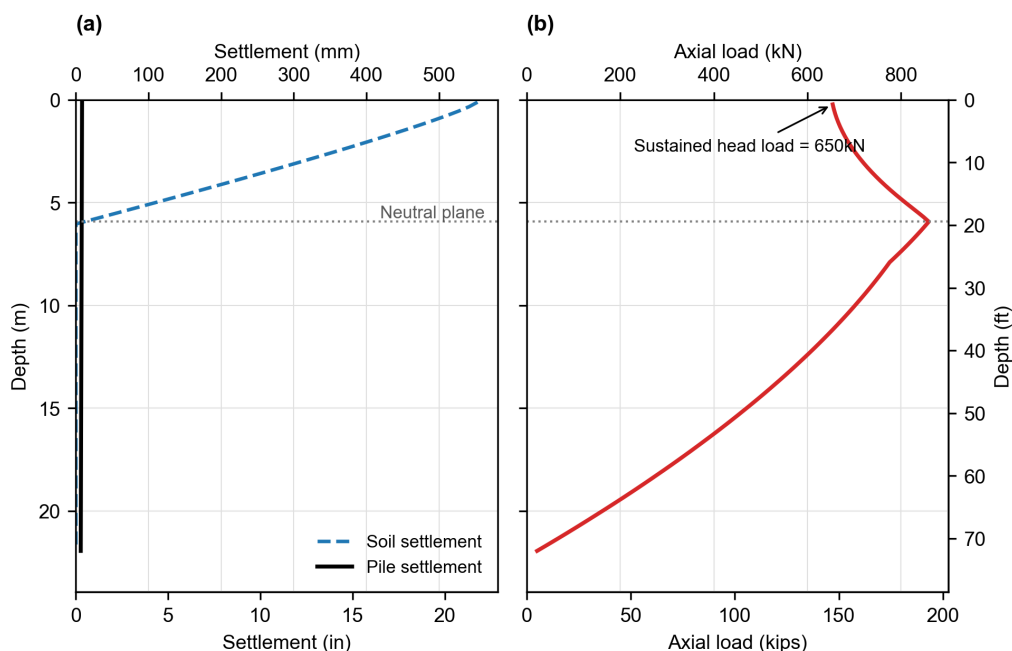
**Figure 4 – Predicted response of the Nikopol test pile: (a) soil and pile settlement profiles; and (b) axial load distribution along the pile**

Grigorian (33) reported a full-scale test on an instrumented bored, cast-in-place pile subjected to prolonged wetting at the Nikopol experimental site. The pile was 72.2 ft (22 m) long and 19.7 in. (0.50 m) in diameter and carried a sustained pile-head load of 146 kips (650 kN). A 65.6 by 65.6 ft (20 by 20 m) test pit surrounding the pile was flooded to a depth of 1.6 ft (0.50 m) for 2.5 months. The conditions adopted in the analysis follow the interpretation of the test records by Noor et al. (11). According to that interpretation, the upper 19.7 ft (6 m) of the collapsible stratum was inundated, the initial degree of saturation was approximately 20 percent, the collapse potential was approximately 7 percent, and the measured drag load was 42 kips (186 kN). The soil properties used in the analysis are summarized in Table 2. The soil settlement profile was calculated using the collapse-potential model of Ashour et al. (34), which uses the pre-inundation void ratio, degree of saturation, applied pressure at wetting, and coefficient of uniformity. The predicted collapse potential increased from approximately 7.5 percent near the ground surface to 10.7 percent at the base of the inundated zone. The near-surface prediction is close to the reported collapse potential of approximately 7 percent. The calculated settlement profile and post-inundation soil properties were then used with the load-transfer and downdrag procedures described above (21, 26).
