# 75<sup>TH</sup> HIGHWAY GEOLOGY SYMPOSIUM

BETTER HIGHWAYS THROUGH APPLIED GEOLOGY

2026  
HGS  
PROCEEDINGS

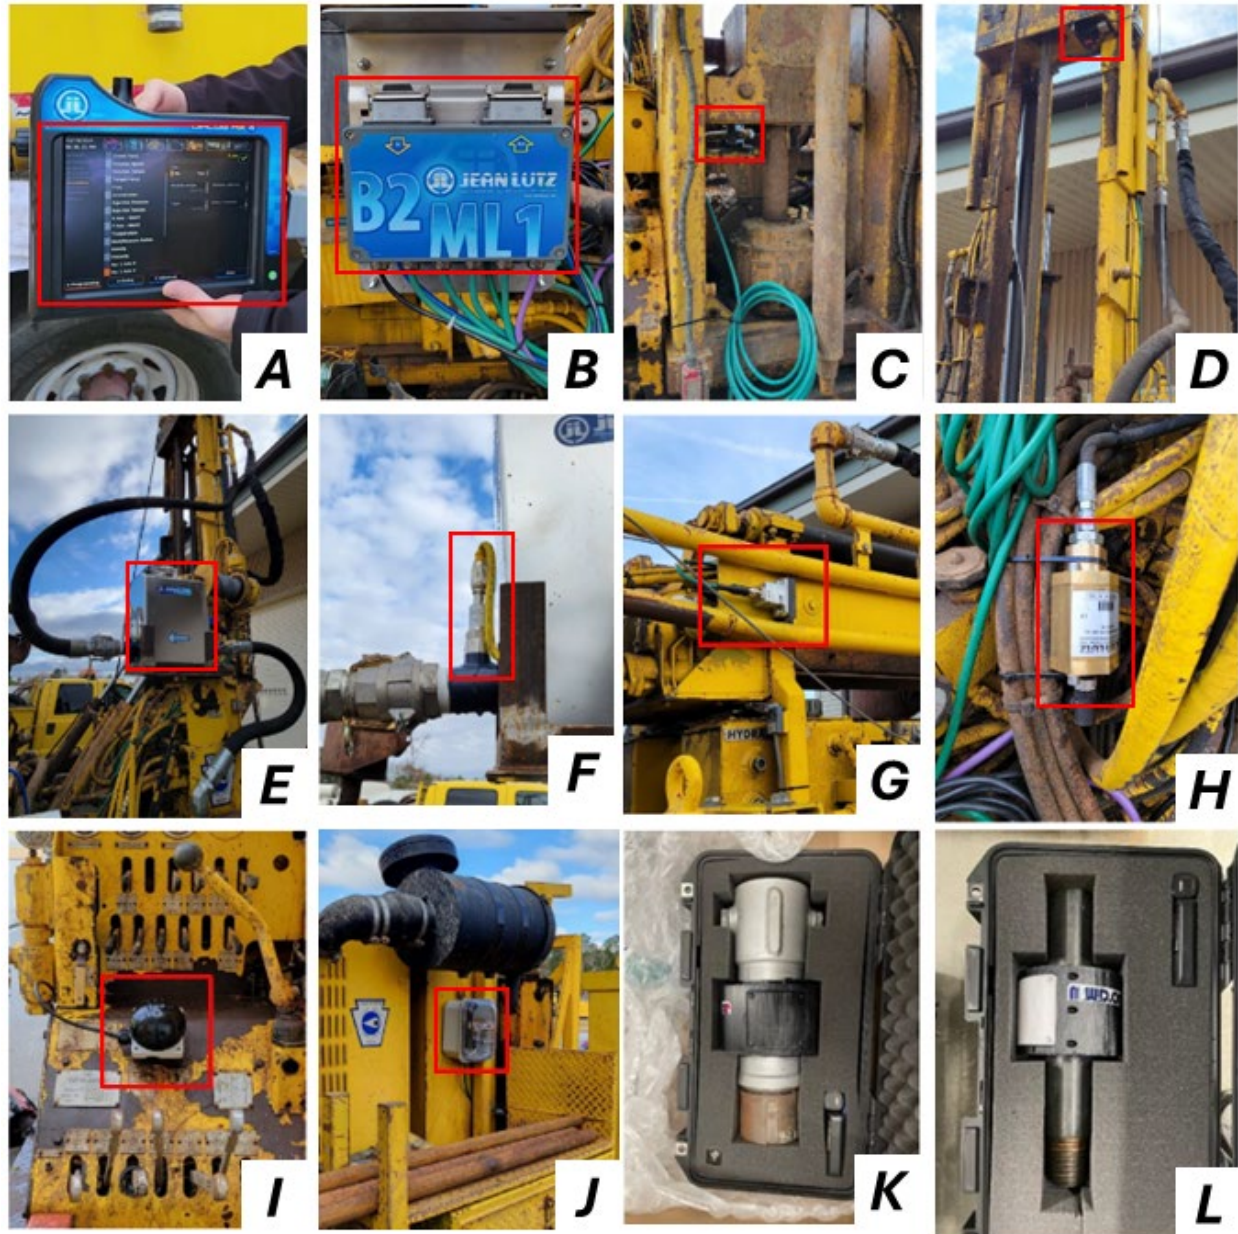
**Fig. 3 – MWD equipment and installed sensors on NCDOT CME-55 Track-rig. A – Jean Lutz Dialog Box; B – Connection Box; C – RPM Sensor; D – Depth Sensor; E – Flow Meter; F – Flow Pressure Sensor; G – Vibration Sensor; H – Crowd Pressure Sensor; I – Driller Button; J – MWD One Wireless Torque Sensor Interface Box; K – Hollow Stem Auger 3 1/4" Torque Transducer; L – NWJ Torque Sensor Transducer.**

The NCDOT Geotechnical Engineering Unit (GEU) selected its 2010 CME-55 track-mounted drill rig to be retrofitted with the MWD monitoring sensors (Fig. 3). The CME-55 track-mounted rig was chosen for its off-road mobility allowing drilling in virtually all land-based environments for maximum MWD data collection. MWD monitoring sensors were purchased from Jean Lutz including a data recording monitor, connection box, RPM sensor, depth-sensor, multi-process variable flowmeter with flow pressure sensor, vibration sensor,

crowd pressure sensor, and data reporting software. Two torque sensors were also purchased from MWD One including a NWJ wireless torque transducer, a hollow stem auger (HSA) 3-1/4" wireless torque transducer, and a wireless interface box for integration with the Jean Lutz Dialog system (FIG. 3J-L).

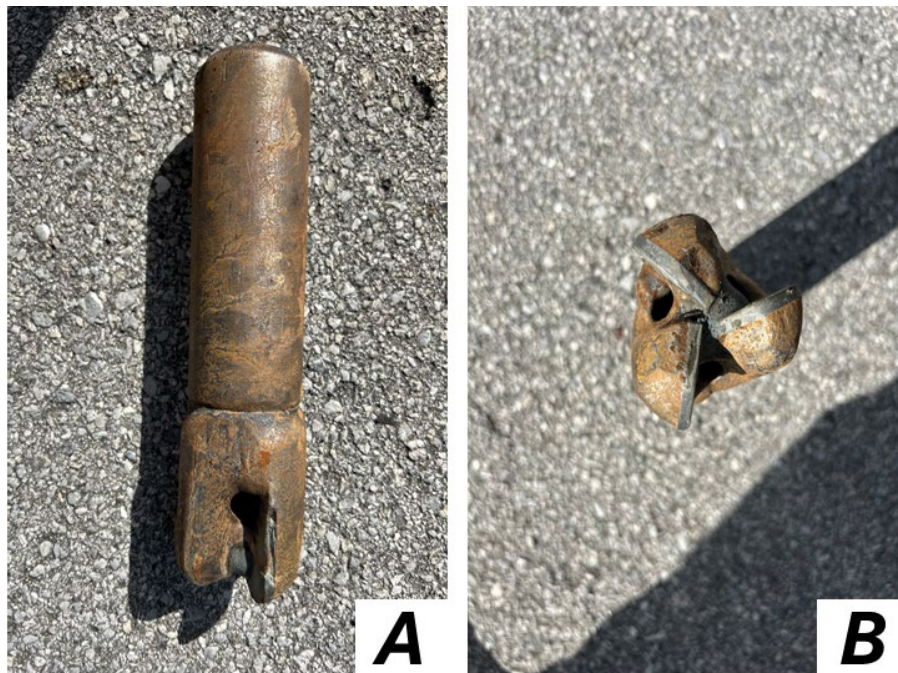
**Fig. 6 – Drag bit used by NCDOT for MWD borings showing minimal wear**

NCDOT chose to mud-rotary drill three MWD borings at three different locations in proximity to the previously drilled CPT and SPT borings in Maple Swamp (Fig. 5). Water was mixed with powdered bentonite to achieve the desired slurry consistency. A three-year old minimally worn drag bit (Fig 6A-B) was used to drill through the alternating sand and clay layers encountered. Access mats were placed for ease of access of the heavy equipment on site for the duration of drilling in Maple Swamp (Fig. 7); however, the access mats were scheduled to be pulled up right after we demobilized from the site. This meant our field crew had just a few days to drill the MWD borings and the accelerated schedule did not allow for further MWD or SPT testing at this site.

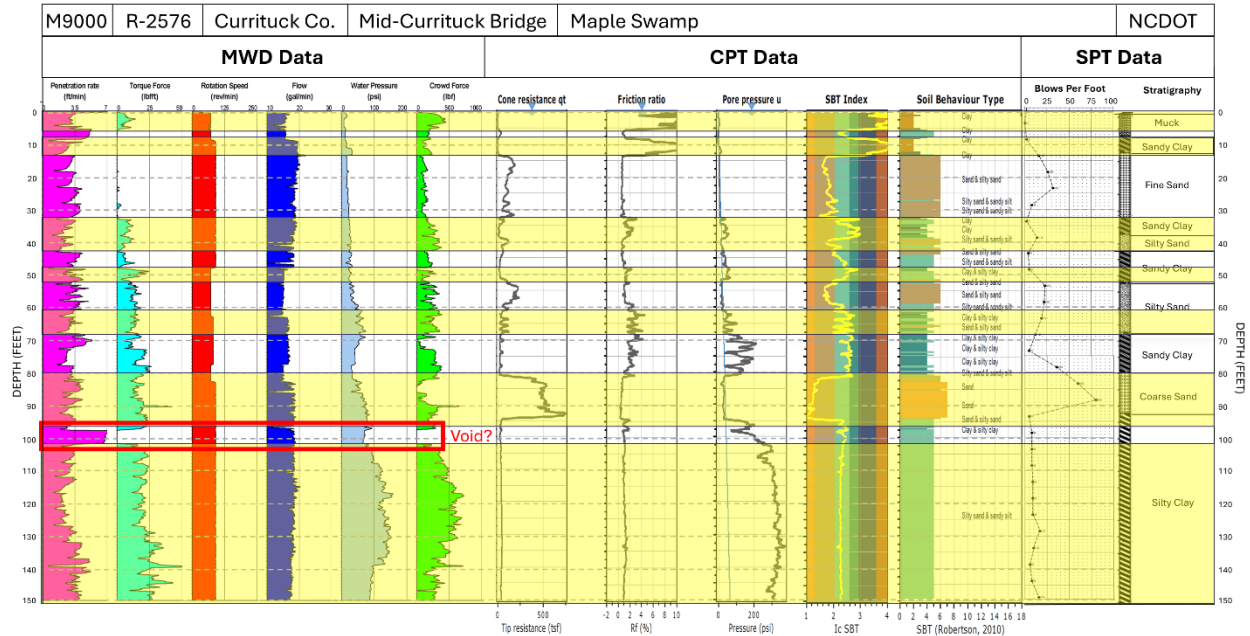
**Fig. 10 – Mid-Currituck MWD, CPT, and SPT Graph for Boring M9000 in Maple Swamp. The Red Box Highlights a Possible Void Shown in the MWD Dataset.**

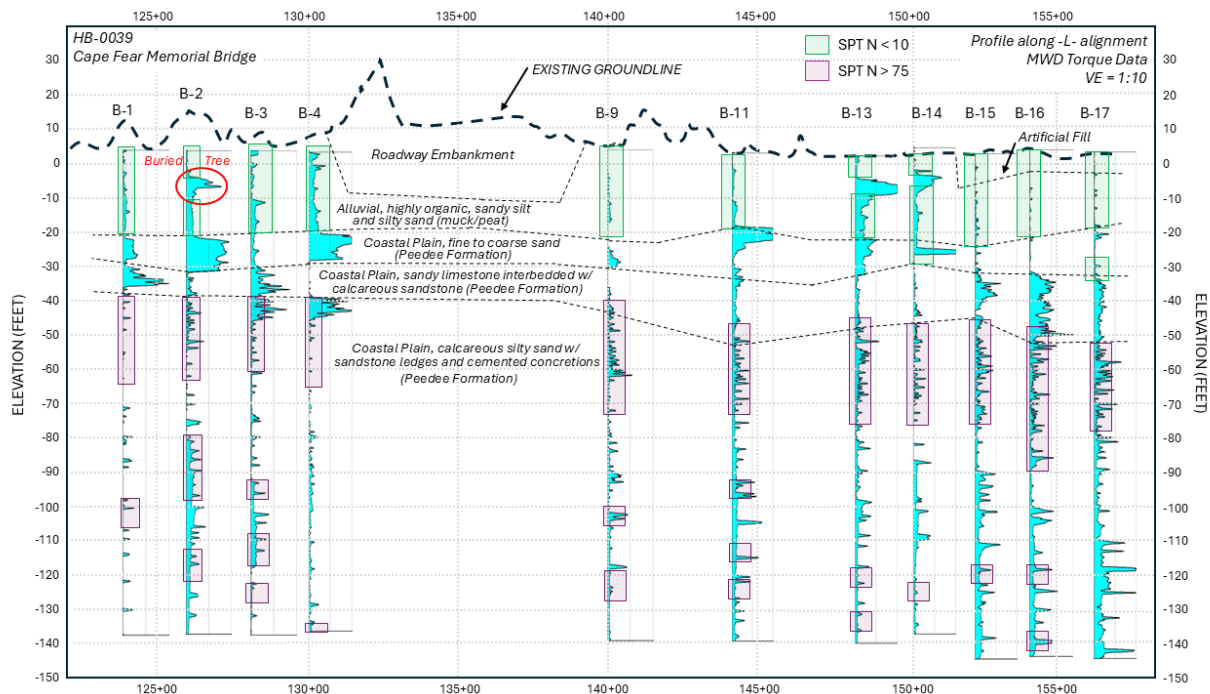
**Fig. 11 – MWD Torque Data (blue graphs) Plotted Along the -L- Profile for the Cape Fear Memorial Bridge Project with General Observed Stratigraphy and SPT Blow Count Data. Green Boxes Have N Values Less Than 10 Blows. Purple Boxes Have N Values Greater Than 75 Blows.**

The general stratigraphy of this field area is 15-20 feet of dark brown and gray, highly organic, alluvial, silty sands and sandy silts (muck/peat). All SPT drives in the alluvial layer produced blow counts of less than 10 blows per foot and are depicted by the light green bars placed over the torque graphs indicating the depth range of these blow counts (Fig. 11). Underlying the alluvial layer is 7-17 feet of Coastal Plain Peedee Formation coarse sand. The torque values are generally high in this layer but there are some borings where the torque value is dramatically lower (B15-B17). Underlying the Coastal Plain Peedee Formation coarse sand layer is 8-20 feet of Coastal Plain Peedee Formation sandy limestone interbedded with calcareous sandstone. Underlying the sandy limestone layer is 100+ feet of Coastal Plain Peedee Formation calcareous silty sand interbedded with very hard, thinly bedded, sandstone ledges and cemented concretions. The torque values are generally low with periodic high spikes. A key observation in this layer is the layers where SPT blow counts are greater than 75 which is depicted by light purple bars placed over the torque graphs (Fig. 11).

The torque values for the fine to coarse sand of the Coastal Plain Peedee Formation are much higher than relative to the overlying alluvial muck layer and can be easily interpreted as a strata change; however, borings B-3, B-15, B-16, and B-17 have similar low torque values as the overlying alluvial muck layer.

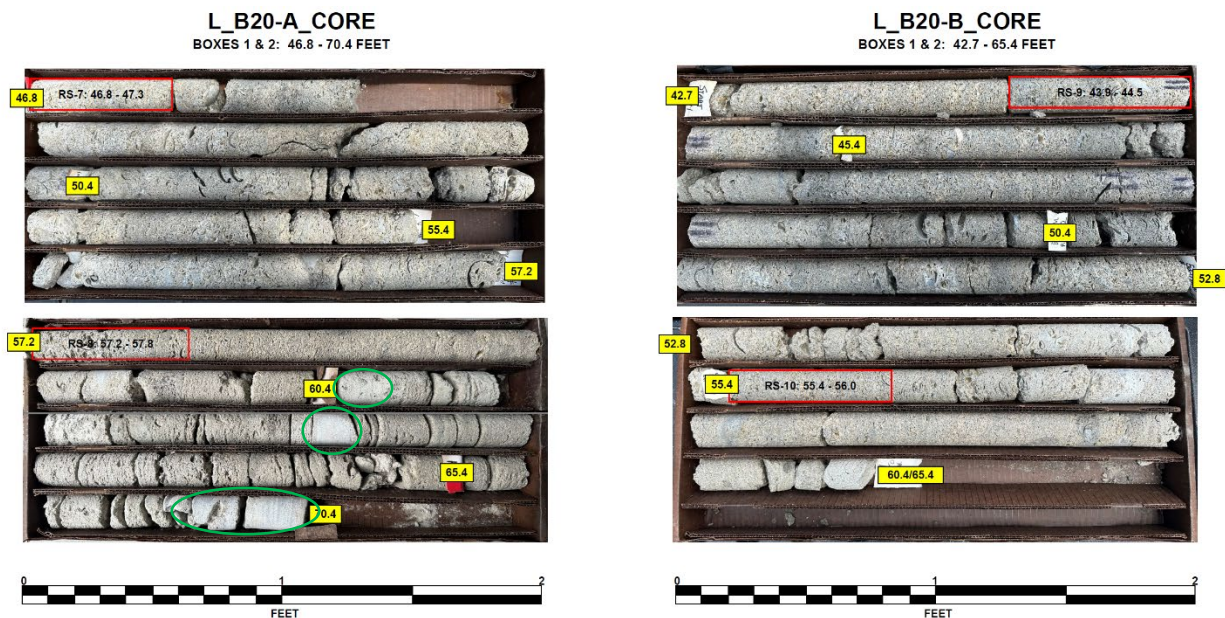
**Fig. 12 – Coastal Plain Peedee Formation Sandy Foraminiferal Biomicrite (Limestone) and Quartz Sandstone with Abundant Marine Fossil Molds. Core Collected From the East Side of the Cape Fear River. Interbedded Calcareous Sandstone Indicated by Green Circles.**

The torque data begins to look different in the sandy limestone layer of the Peedee Formation. First, there are zones of relatively low and high torque in this layer. Second, the torque data shows more erratic values. This is consistent with how variable the limestone is within the Peedee formation (Fig. 12). Figure 12 shows a core photograph of this variable limestone collected from a core just on the east side of the Cape Fear River. There are some sections with higher strength limestone yielding a high rock quality designation value and other sections with lower strength limestone yielding a lower rock quality designation value. Core L\_20-A also contains the interbedded calcareous sandstone layers which are typically harder than the surround limestone. The CPT could not penetrate through the top of this limestone layer which, ultimately, prevents the collection of about 120 more feet of continuous data that we collected with the MWD boring.

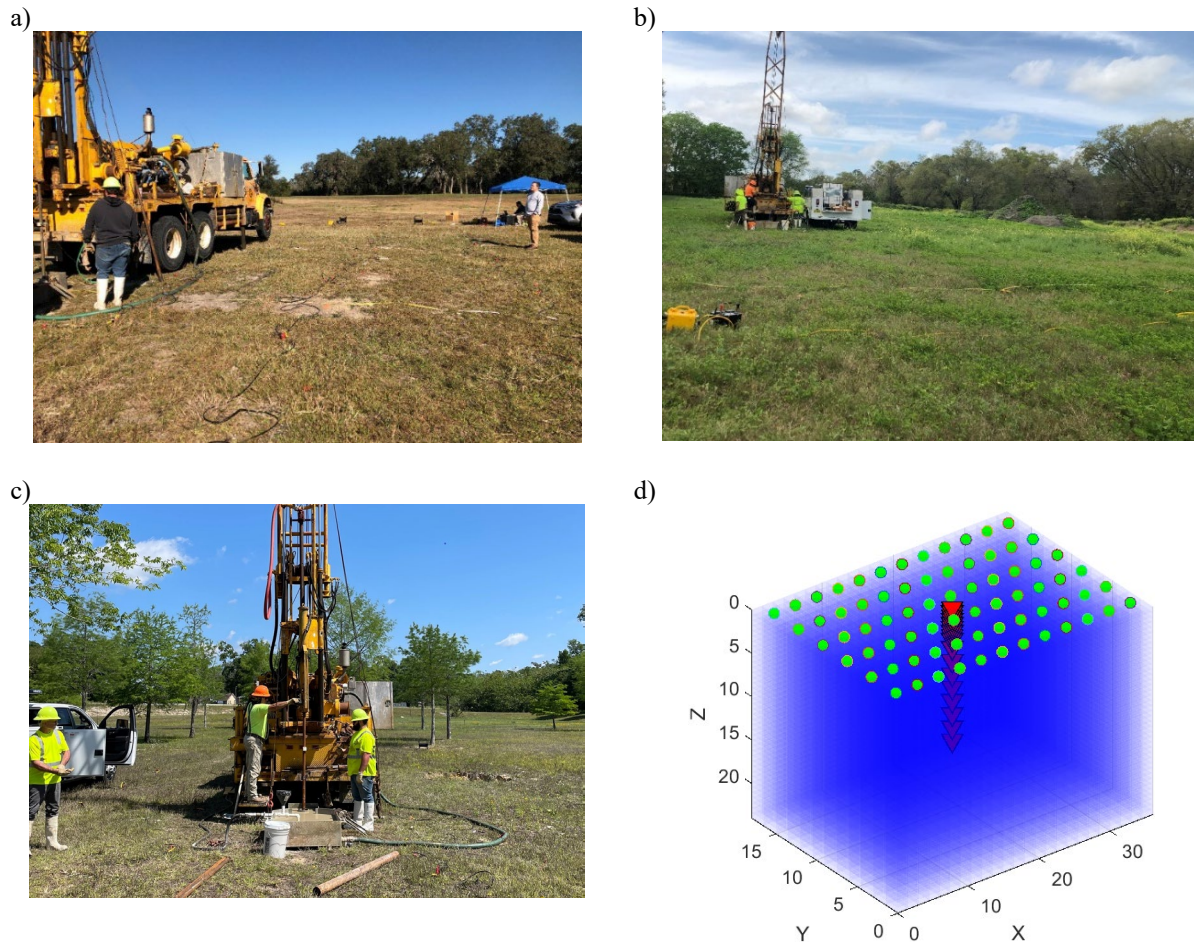
**Figure 1. Field experiments at three test sites: a) Bell site, b) Kanapaha site, c) Newberry site, and (d) test configuration with sources (red triangle) and receivers (cyan circle). The 72 geophones ( $6 \times 12$  grid) were placed over a test area of  $18 \times 36$  m. The SPT location is at the center of the test area.**

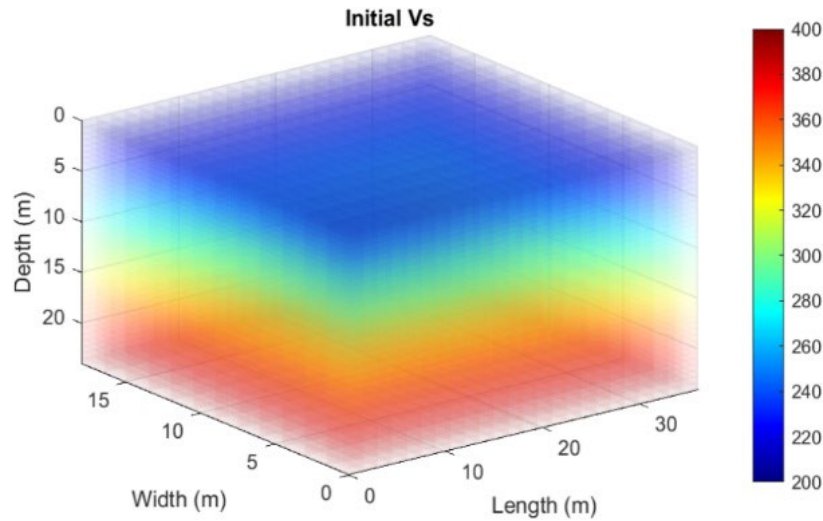
**Figure 2. Initial Vs model used for inversion of all three test sites ( $V_p = 2 \times V_s$ )**

An initial velocity model (Fig. 2) was constructed using a one-dimensional gradient, with  $V_s$  increasing from 200 m/s near the surface to 400 m/s at depth. The initial  $V_p$  was assumed to be twice  $V_s$ . Inversion was performed over a range of 10–40 Hz. Iterations were terminated after either 100 iterations or when misfit reduction became negligible. Comparison between observed and simulated waveforms shows strong agreement (Fig. 3), indicating accurate modeling and successful convergence without cycle skipping.

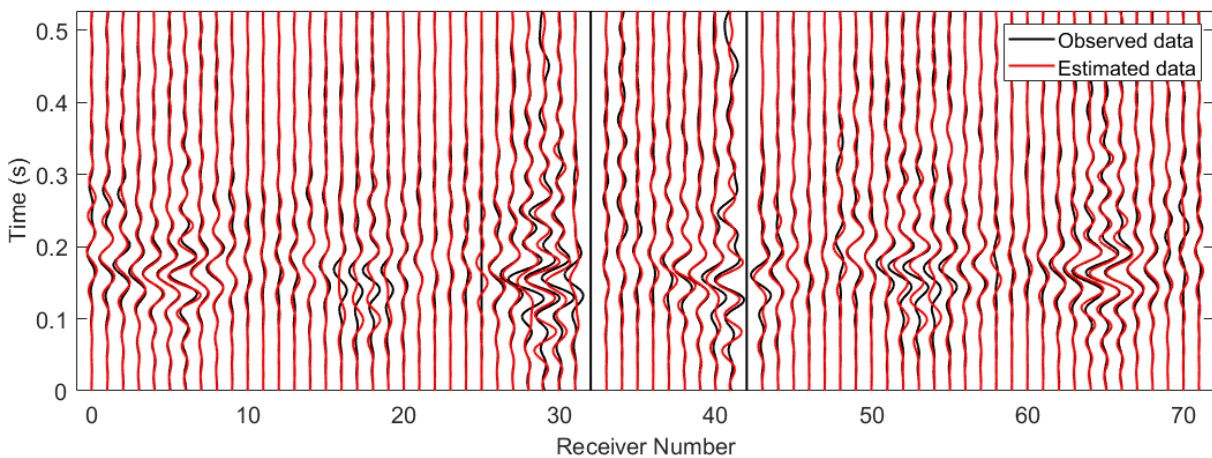
**Figure 3. Comparison of observed (measured) and synthetic waveforms at Bell site for a sample source at 10.2 m depth, two noisy channels excluded from analysis.**

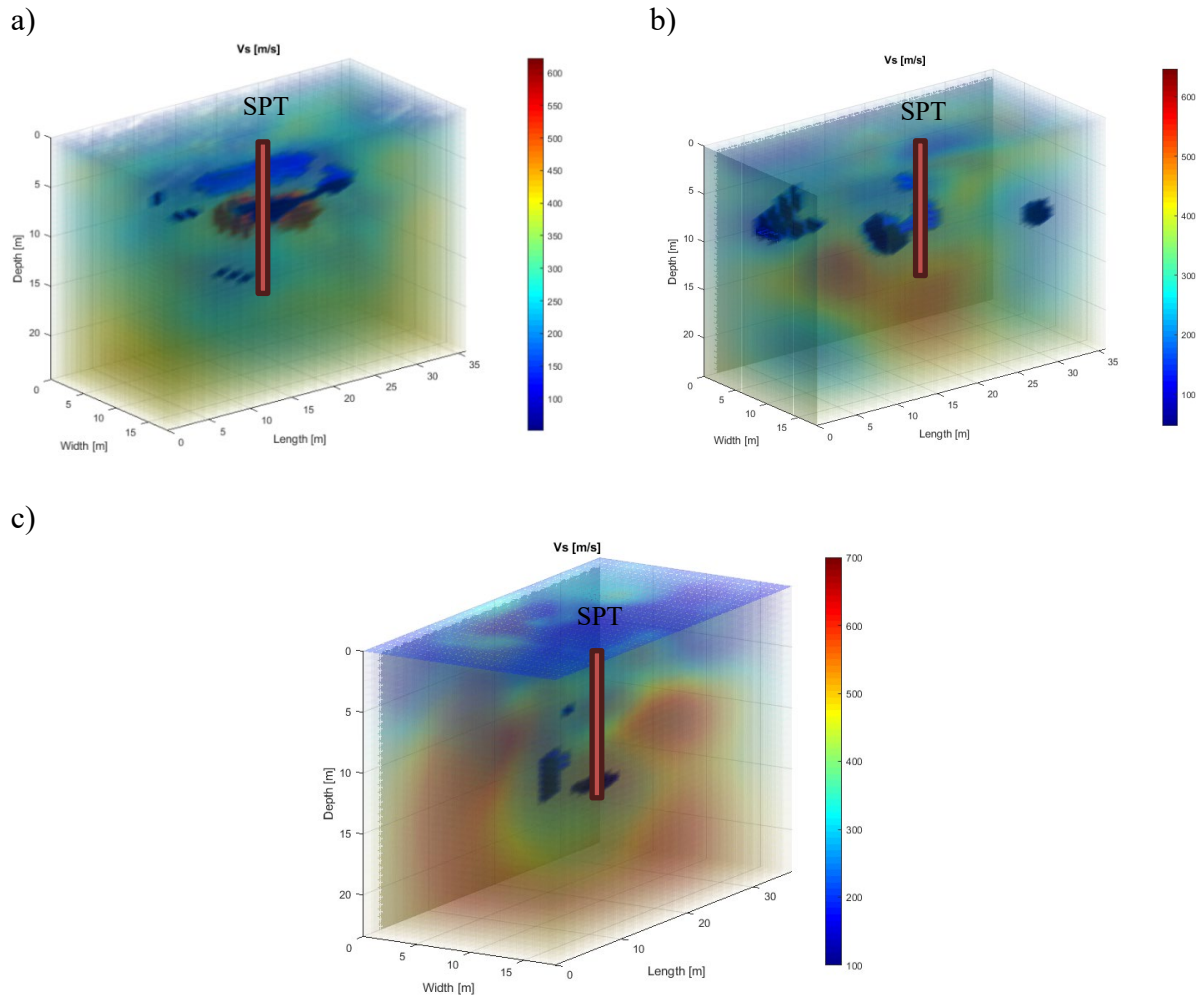
The inverted 3D Vs models reveal detailed subsurface features at all sites as shown in Fig. 4. At the Bell site (Fig. 4a), a soft soil layer overlies limestone, with the bedrock depth varying from 6 to 15 m. A localized low-velocity anomaly at approximately 15 m suggests a void connected to the borehole. At the Kanapaha site (Fig. 4b), the limestone surface varies between 10 and 13 m depth. A distinct low-velocity zone at approximately 11 m corresponds to the void indicated by SPT data. At the Newberry site (Fig. 4c), both soil and limestone layers are clearly imaged. Two separate voids are identified near 15 m depth, one intersecting the borehole and another located nearby, demonstrating the ability of the method to detect off-hole anomalies. Compared to conventional borehole logs, these 3D results provide significantly enhanced spatial information, including the extent and geometry of subsurface features.

**Figure 4. The 3D rendering of inverted shear wave velocities at three test sites: a) Bell site, b) Kanapaha site, c) Newberry site.**

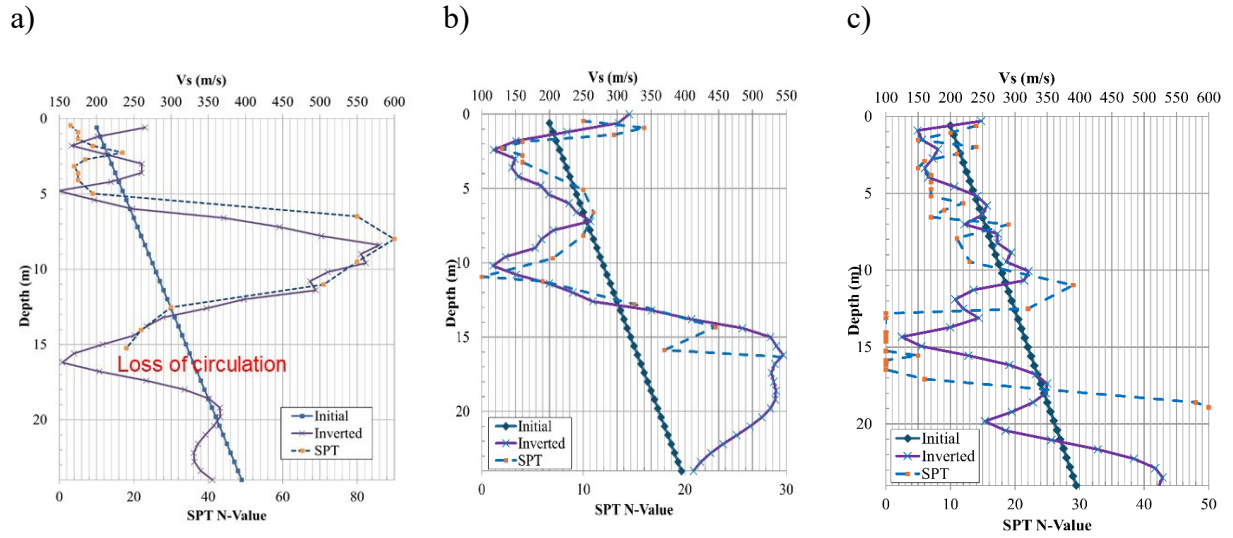
Comparison between inverted  $V_s$  profiles and SPT N-values shows strong agreement across all sites. Low  $V_s$  zones correspond to low blow counts, while high  $V_s$  values align with dense or competent materials. At Bell, the inversion captures both stiff limestone and underlying soft zones. At Kanapaha, the void and stratigraphy are clearly resolved. At Newberry, the general trend matches SPT data, although the  $V_s$  profile is smoother due to spatial averaging and regularization in the inversion process. Overall, the results confirm the reliability of the SPT-seismic approach in characterizing subsurface conditions.

**Figure 5. Comparison of inverted  $V_s$  with SPT N-values for three test sites: a) Bell site, b) Kanapaha site, c) Newberry site**

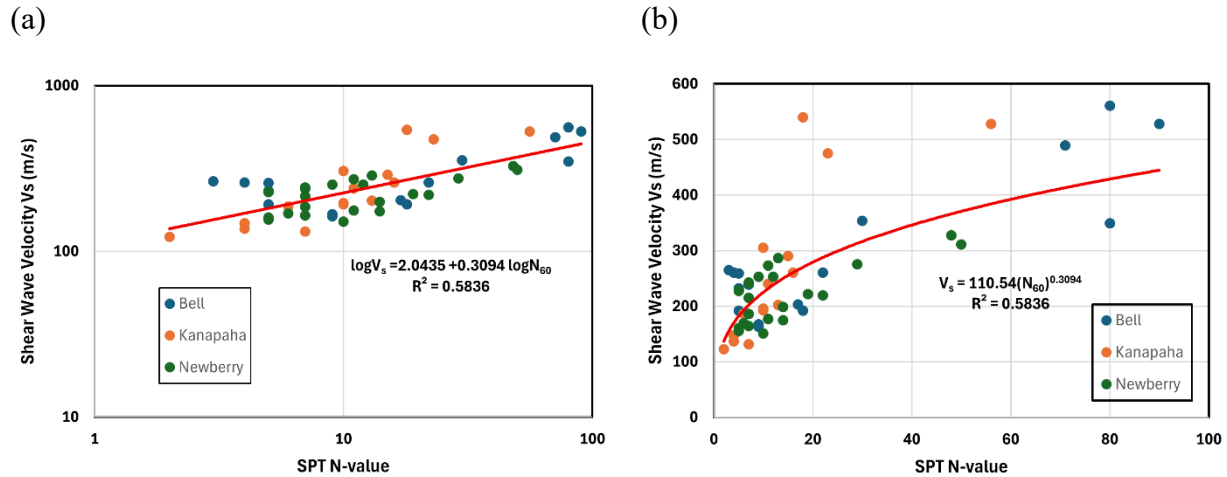
**Figure 6. Correlation between SPT-N values and  $V_s$  for all three sites: (a) Linear regression in logarithmic scale, (b) Power-law fit in regular scale**

The  $V_s$  values obtained from inversion were correlated with SPT  $N_{60}$  values to develop empirical relationships. The combined dataset from all sites spans a wide range of soil and rock conditions. Regression analysis indicates that a power-law relationship provides the best fit, consistent with previous studies (Rahimi et al., 2020).

The resulting model explains approximately 58% of the variability in  $V_s$ , demonstrating a reasonably strong correlation given the heterogeneous conditions.

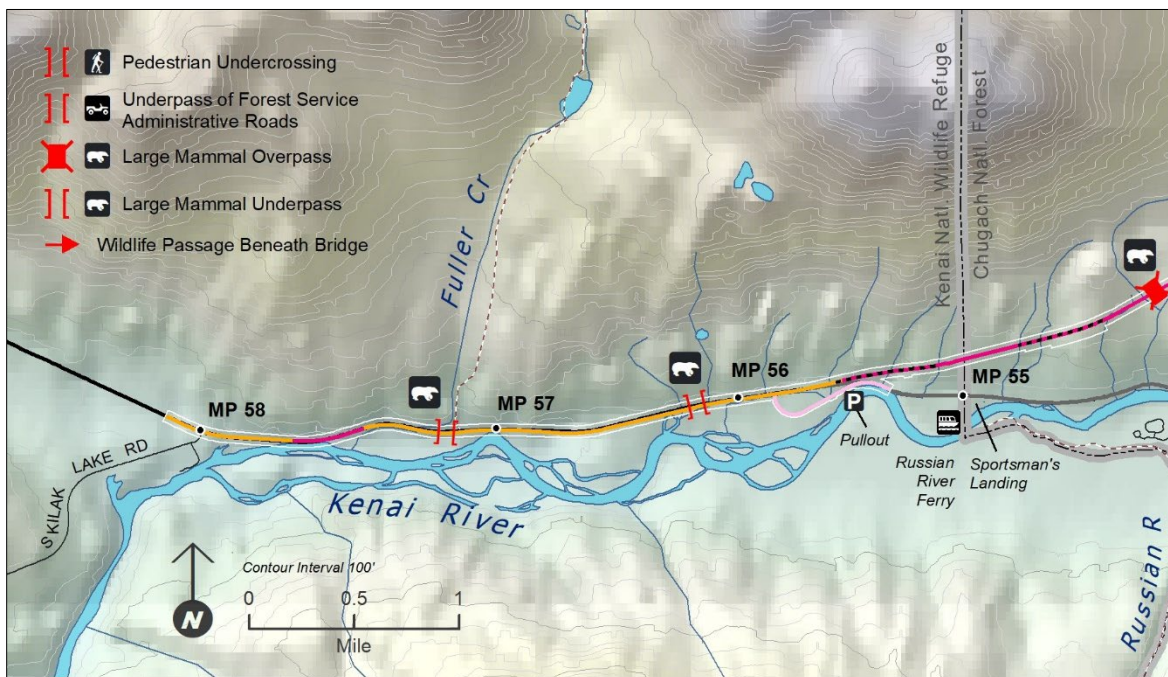
**Figure 2 - Sterling Highway MP 45-60, Stage 5**

The Stage 5 portion of the project area is characterized by near-vertical schist bedrock outcropping along the northern side of the existing Sterling Highway and the Kenai River channel along the south side. The project design for Stage 5 access to the site was provided by Alaska DOT&PF (DOT&PF) and the CM/GC contractor. During the geotechnical and near-surface geophysical investigation, the area was mostly cleared, with some areas protected for archaeological preservation. The near-surface geophysical investigation was performed before the geotechnical investigation to aid in borehole site selection and to develop a two-dimensional understanding of the site subsurface conditions. The intent of the site characterization is to aid in understanding stratigraphic uncertainty and geomaterial engineering properties for the analysis of proposed slope modifications or retaining wall designs. The project consists of a combination of rock and soil cuts. The rock cut is approximately 30 feet tall and above the rock cut, an approximate 10-foot-tall soil cut is proposed. Because of the steepness of the underlying schist bedrock, a retaining wall design has been proposed but the design team is seeking alternative slope stabilization options.

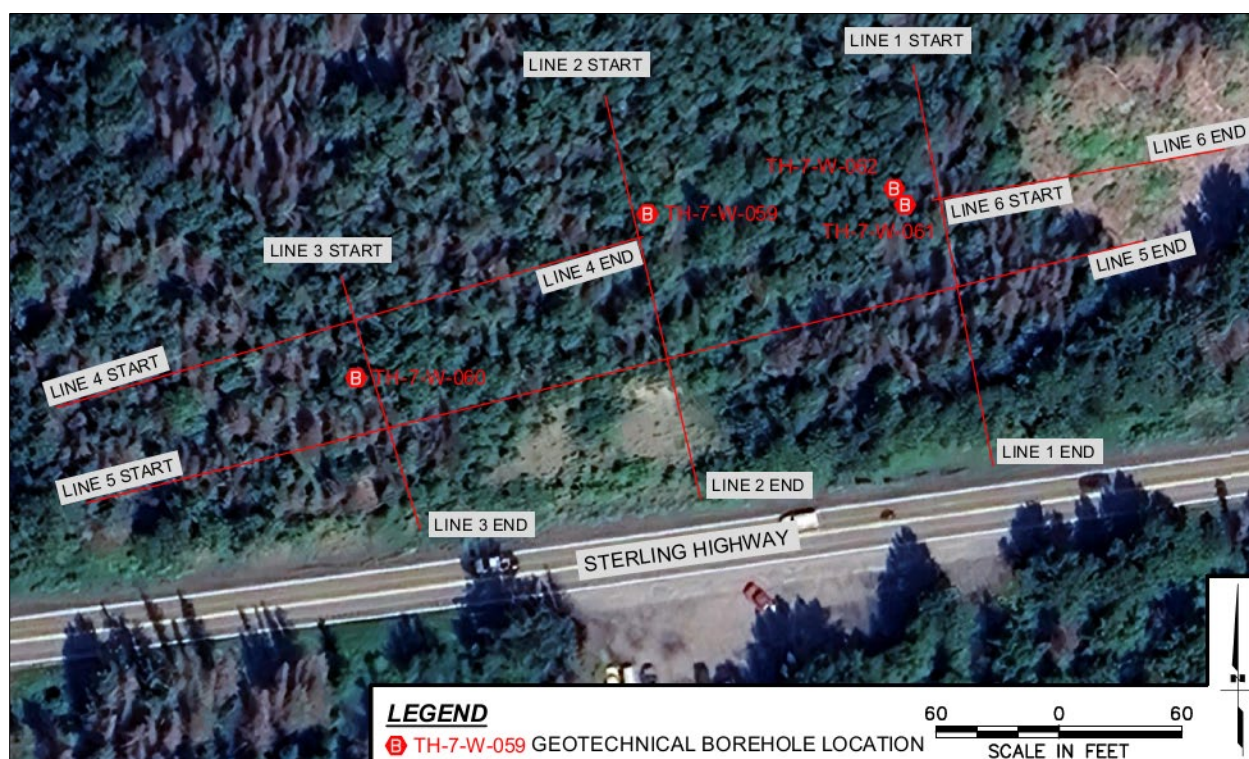
**Figure 3 – Test Boring and Geophysical Transect Location Map – Station 1202+50 to 1208+50**

A geotechnical investigation was performed in the fall of 2025, consisting of the drilling of four geotechnical test borings (TH-7-W-059 to TH-7-W-062) within the limits of interest for this paper. The geotechnical drilling was performed using HWT-size casing advance methods in the lodgement till with sampling performed using a 3-inch outside-diameter split sampler during standard penetration tests (SPT) Upon refusal the drilling method switched to HQ triple-tube rock coring for core recovery and rock quality designation (RQD) data. Figure 3 illustrates the locations of the four geotechnical test borings, as well as the location of six geophysical transects. Test borings TH-7-W-062 and TH-7-W-061 consist of hybrid or directional drilling of a vertical and angled borehole (Landslide Technology, 2026).

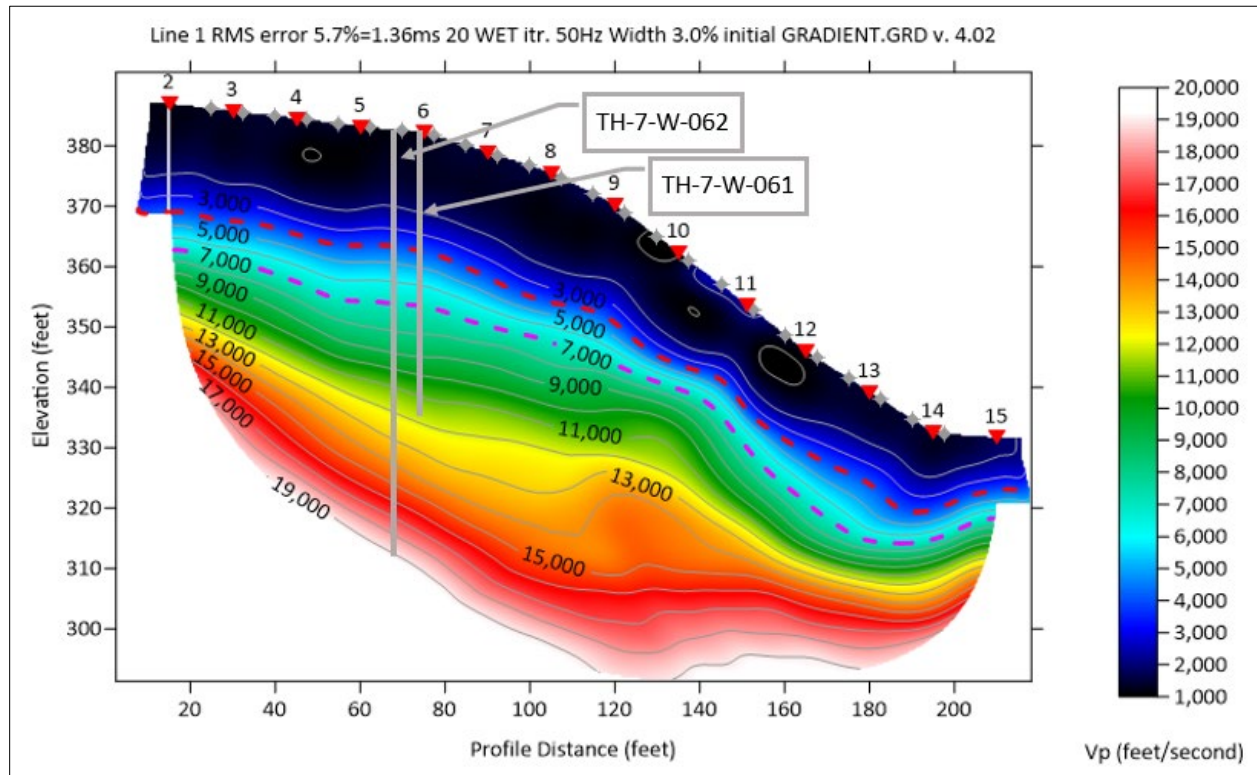
**Figure 4 – Sterling Highway – Compressional Wave Profile – Line 1**

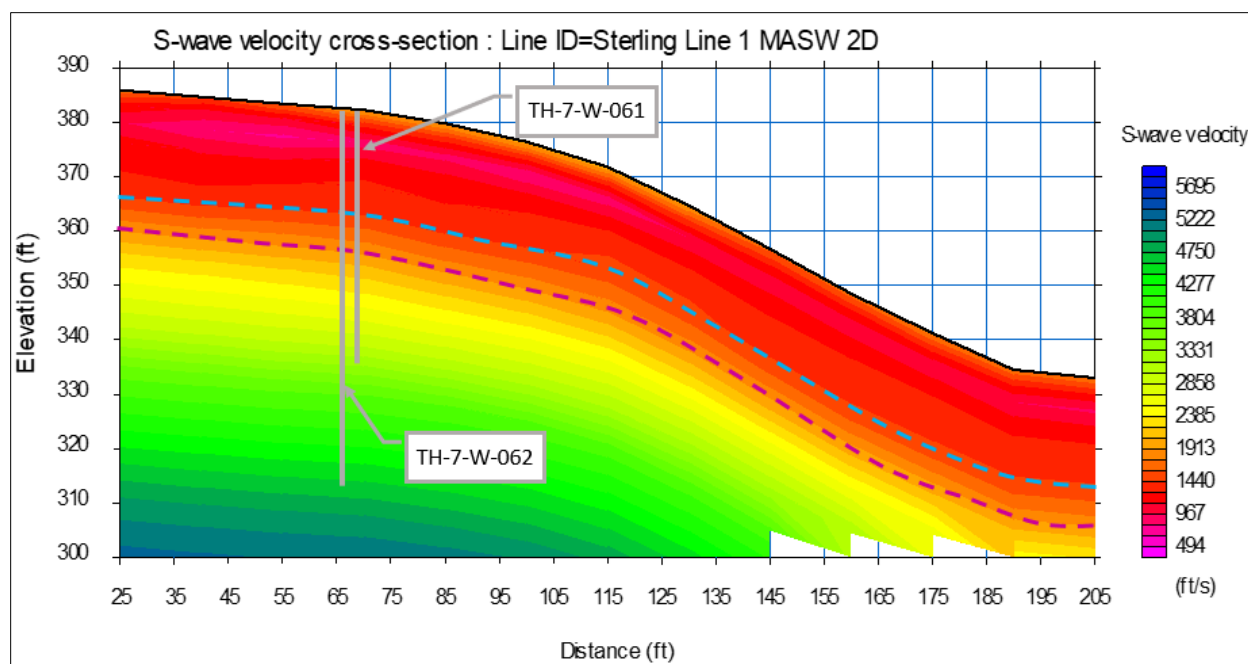
**Figure 5 – Sterling Highway – Shear Wave Profile – Line 1**

From the interpretation of published data and DOWL's experience comparing seismic velocities to known ground truths, DOWL interpreted a shear-wave velocity of 1,500 feet per second for weathered and/or fractured schist bedrock or geomaterials with standard penetration tests greater than 50 blows per foot and a shear-wave velocity of 2,500 feet per second as the threshold for what is interpreted to be sound schist bedrock. A shear wave profile for Line 1 is shown in Figure 5.

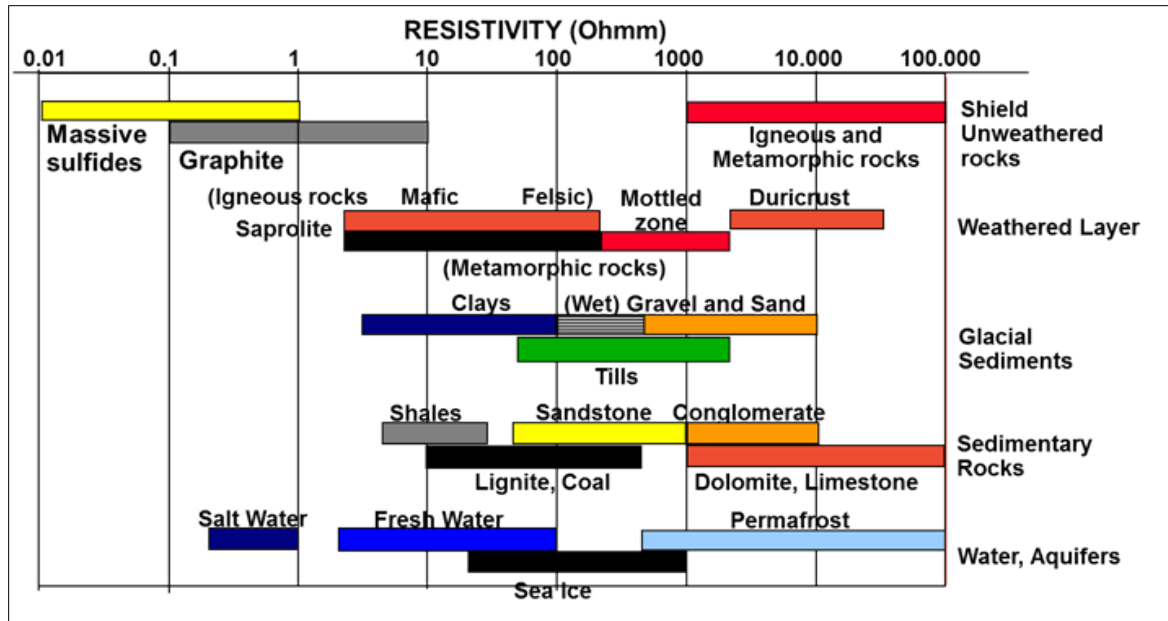
Figure 6 – Resistivity Ranges of Different Geomaterials (Palacky, 1987)

The electrical resistivity tomography (ERT) method utilizes differences and contrasts in electrical resistivity to identify the subsurface materials, depth to water, and subsurface structures. The project team collected the ERT data in general accordance with ASTM D6431-18, Standard Guide for Using the Direct Current Resistivity Method for Subsurface Site Characterization. In this method, the subsurface bulk electrical resistivity is measured, providing information on changes in subsurface lithology and groundwater saturation. The measured apparent resistivity is a function of different parameters, such as porosity, salinity concentration, clay content (especially within unconsolidated sediments), and water saturation. The measured apparent resistivity would be the same as the earth's true resistivity if the earth were isotropic and homogeneous. To compute the true resistivity, a mathematical inversion method is used. The 2D resistivity data were inverted using Res2DInv® (Seequent Software). The inversion code is based on the smoothness-constrained least squares method. The range of resistivity values is logarithmic and varies significantly per type of soil and rock, as illustrated in Figure 6.

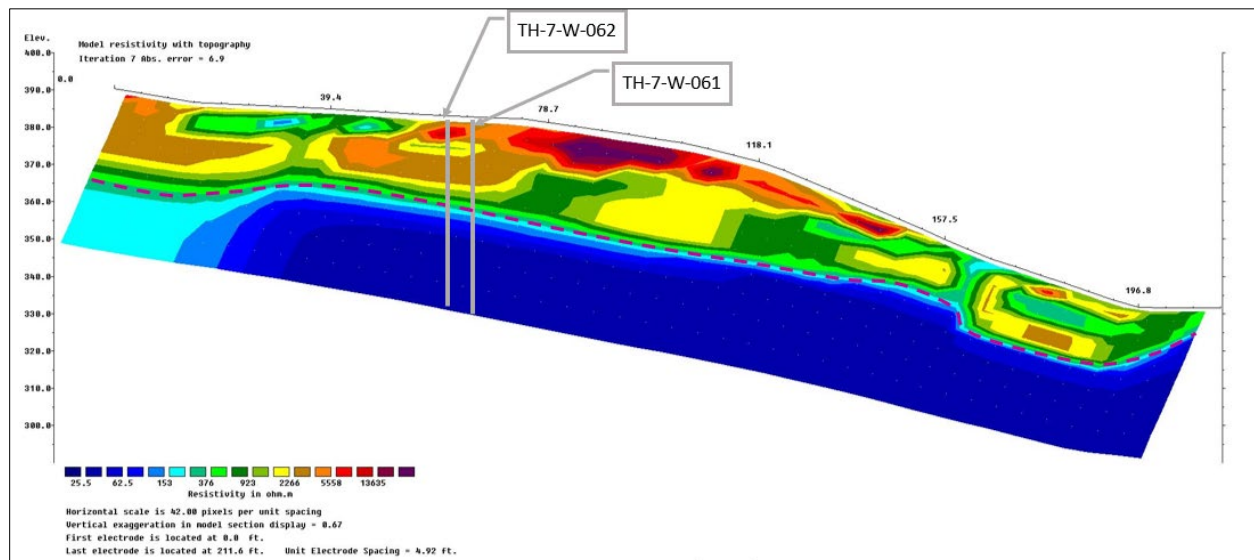
Figure 7 – Sterling Highway – Electrical Resistivity Profile – Line 1

The lithology in the project area consists of lodgement till overlying schist metasedimentary bedrock. As shown in Figure 7, the lodgement till exhibits very high electrical resistivity, typically greater than 500 ohm-meters. The underlying schist bedrock exhibits much lower electrical resistivity values, typically less than 500 ohm-meters. Two concurrent boreholes (TH-7-W-061 and TH-7-W-062) are shown as gray vertical lines in Figure 7 to identify their location along the electrical resistivity profile.

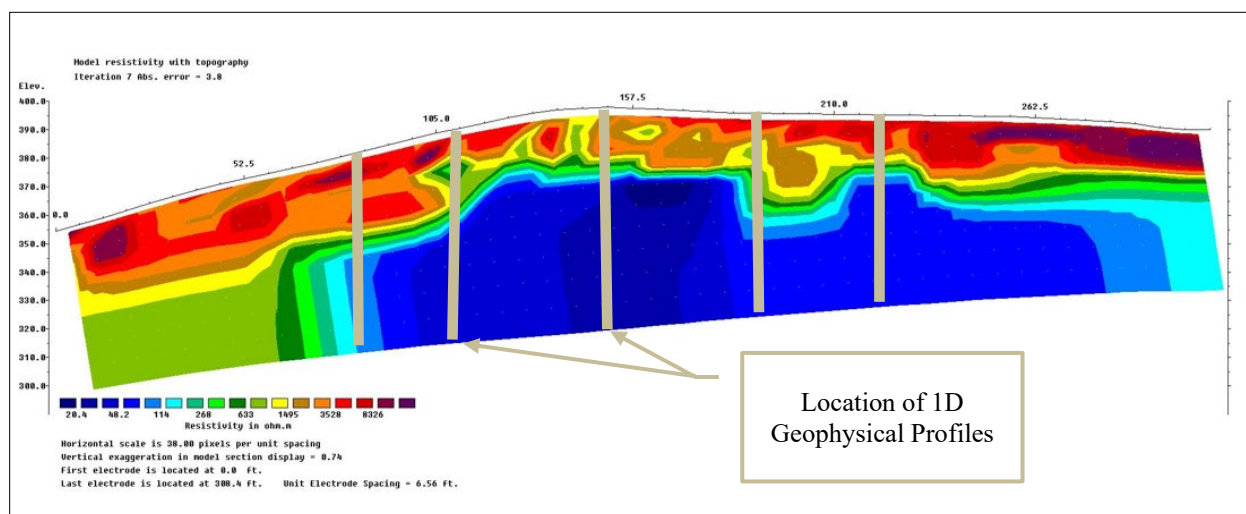
**Figure 8 – Sterling Highway – Electrical Resistivity Profile – Line 4**

To assess geophysical uncertainty at the project site, data were obtained from two 2D profiles, yielding five 1D profiles from each. The five 1D profiles are equally spaced, with the center profile in the middle. Since Line 1 is 225 feet long, the 1D profiles were extracted at Station 62.5, 87.5, 112.5, 137.5, and 162.5 feet. Line 4 is 300 feet long with 1D profiles at 90, 112.5, 150, 187.5, and 225 feet. The authors used Surfer® mapping software (Golden Software) and MATLAB (MathWorks, Inc.) to extract geophysical data. The data from both geophysical lines were combined to evaluate subsurface uncertainty. The extracted geophysical profiles should not be interpreted as statistically independent observations; rather, they provide a measure of spatial continuity along the investigated transects. Figure 8 shows examples of the extracted 1D geophysical profiles along Line 4.

From the five 1D geophysical profiles shown in Figure 8, the geophysical data were extracted for the lodgment till and schist bedrock. The 2D geophysical profiles illustrate stratigraphy, with

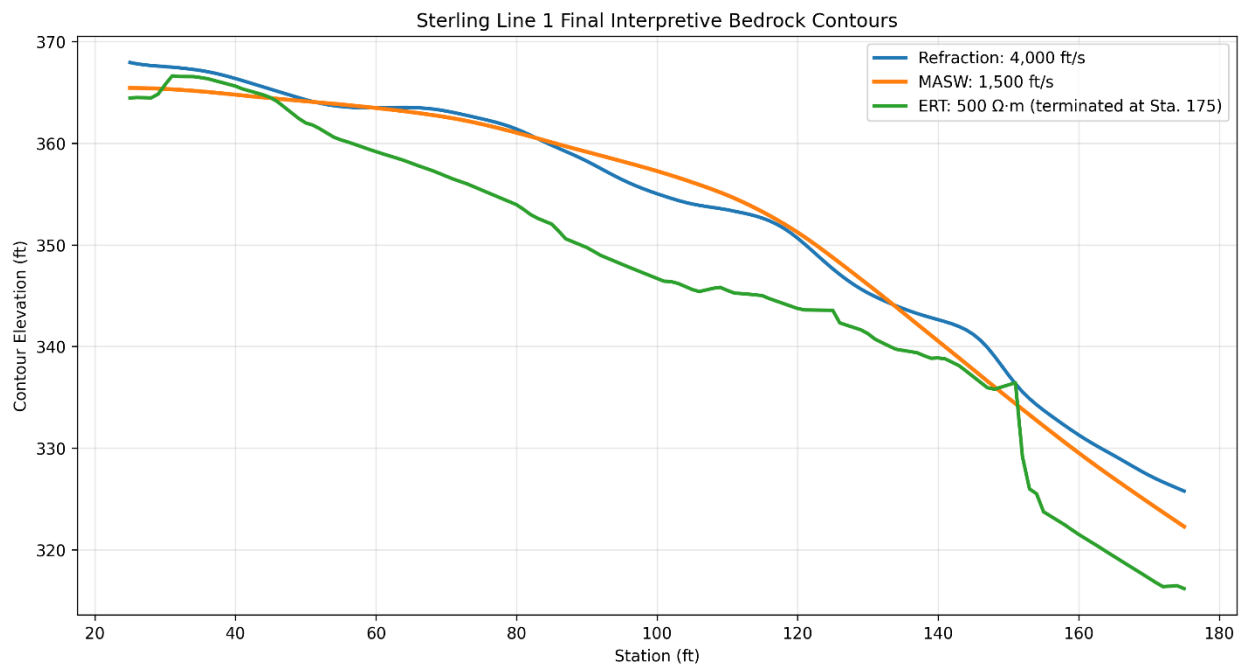
**Figure 9 – Comparison of Interpretive Bedrock Contours of Three Methods for Line 1**

Currently, the authors only import SRT profiles into Leapfrog Geo® for 3D depth-to-bedrock evaluation. To evaluate the quality of the SRT profiles, the authors compared the SRT interpretive depth to the 4,000 feet per second bedrock contour, the 1,500 feet per second MASW contour, and the 500 ohm-meter ERT contour for geophysical Lines 1 and 4. Figures 9

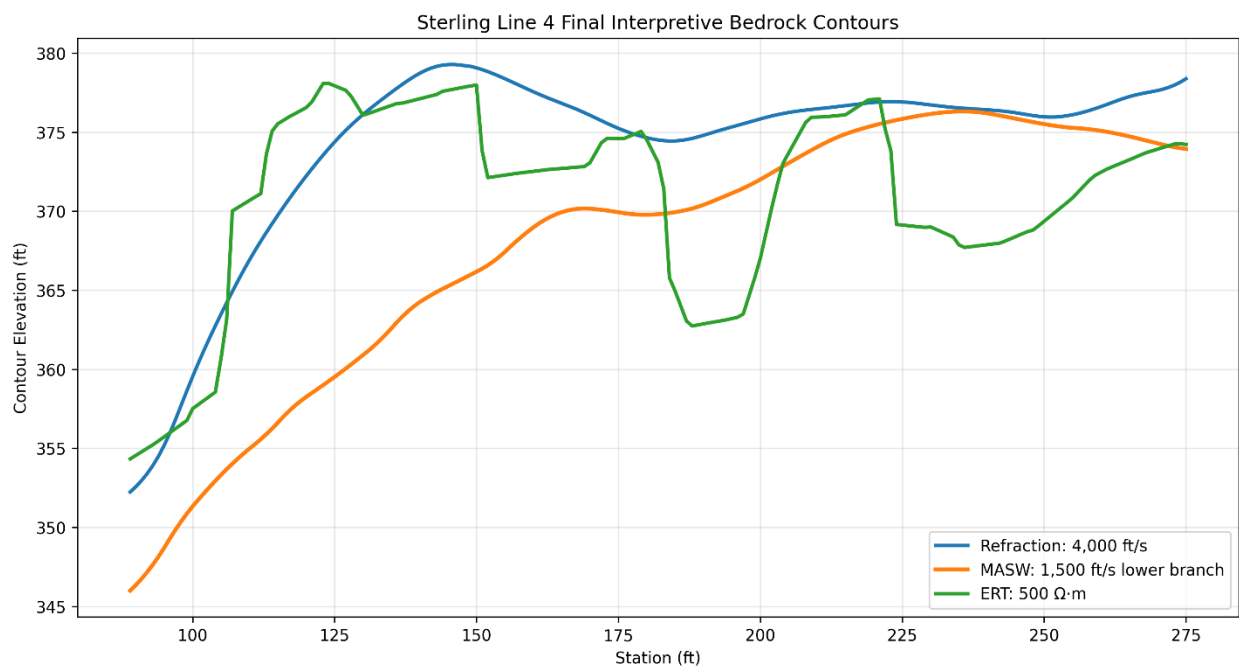
**Figure 10 – Comparison of Interpretive Bedrock Contours of Three Methods for Line 4**

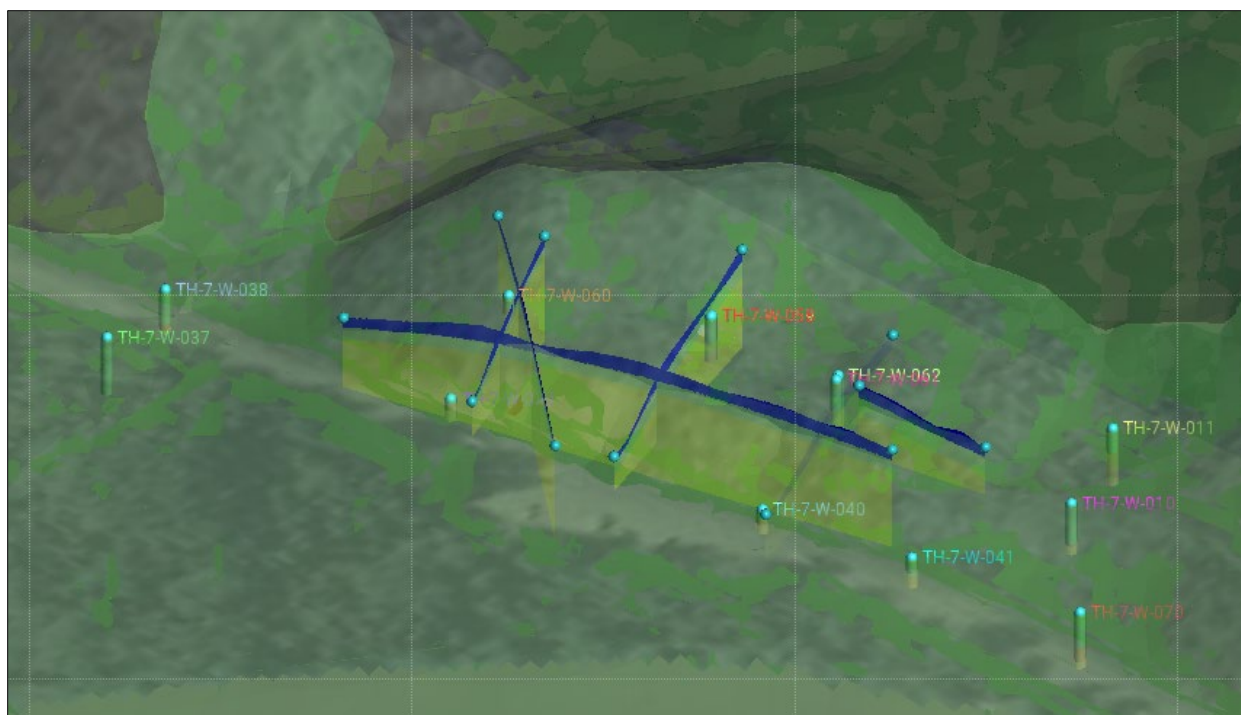
**Figure 11 – Leapfrog Model with Test Boring and Geophysical Transects - Station 1202+50 to 1208+50**

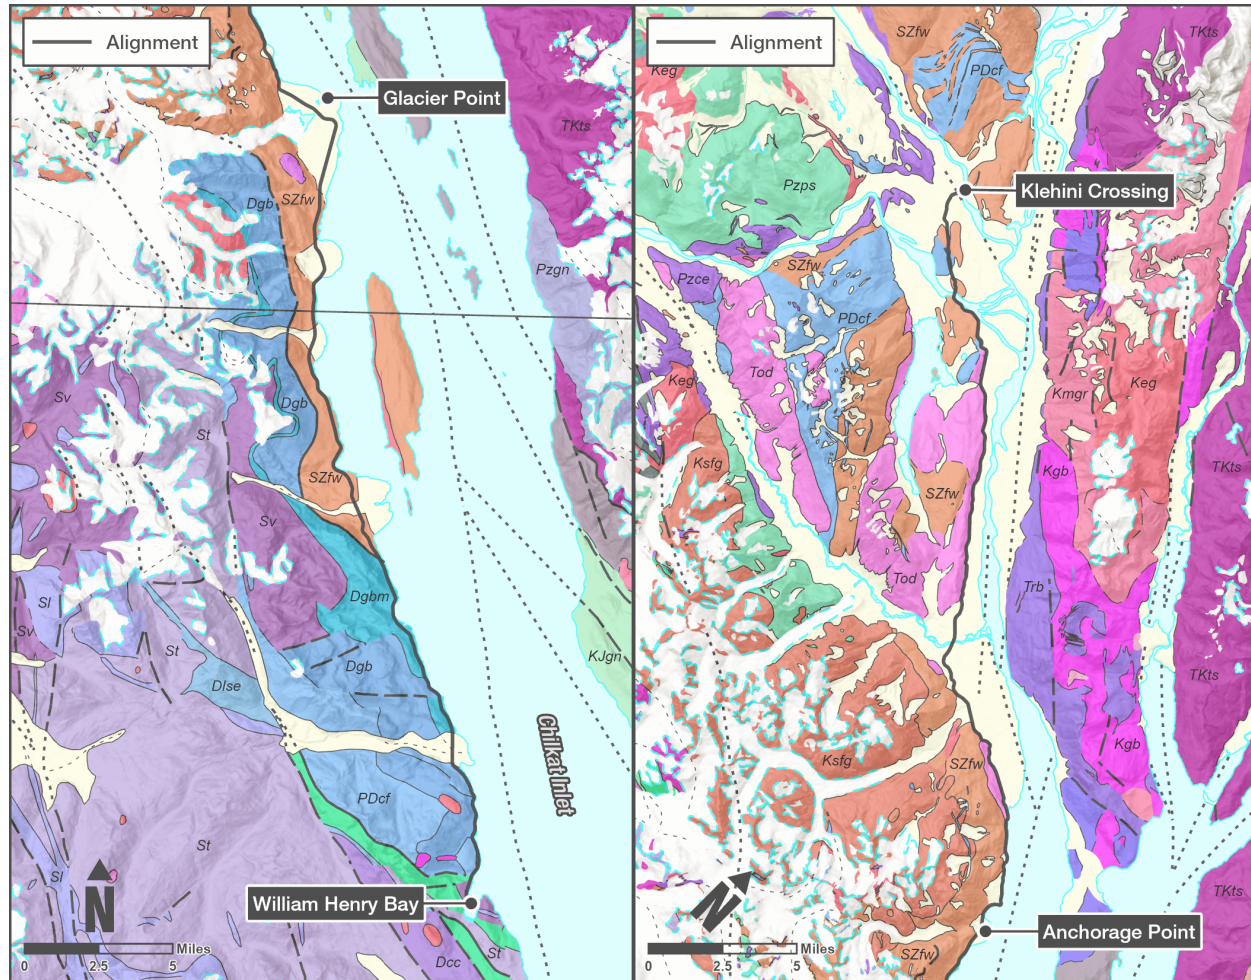
**Figure 2 – Geologic Map of West Lynn Canal**
