# 75<sup>TH</sup> HIGHWAY GEOLOGY SYMPOSIUM

BETTER HIGHWAYS THROUGH APPLIED GEOLOGY

2026  
HGS  
PROCEEDINGS

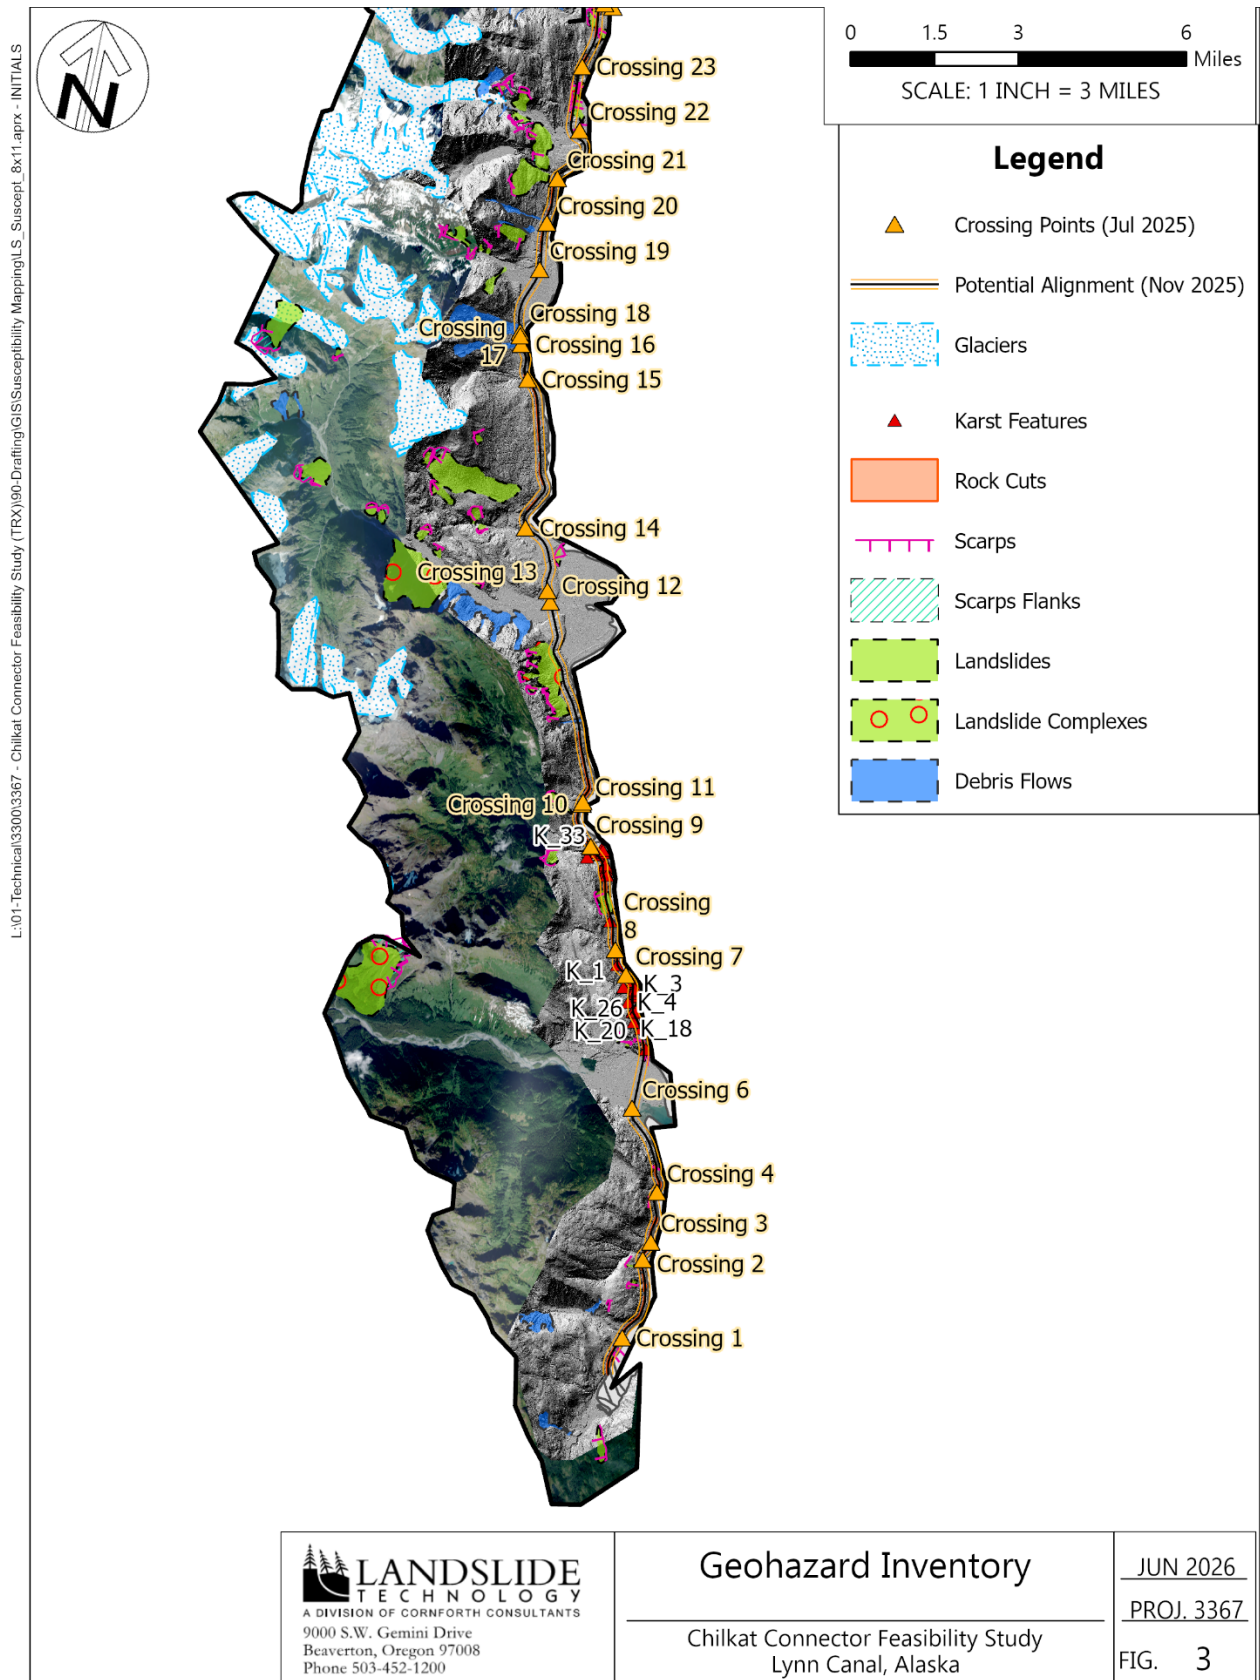
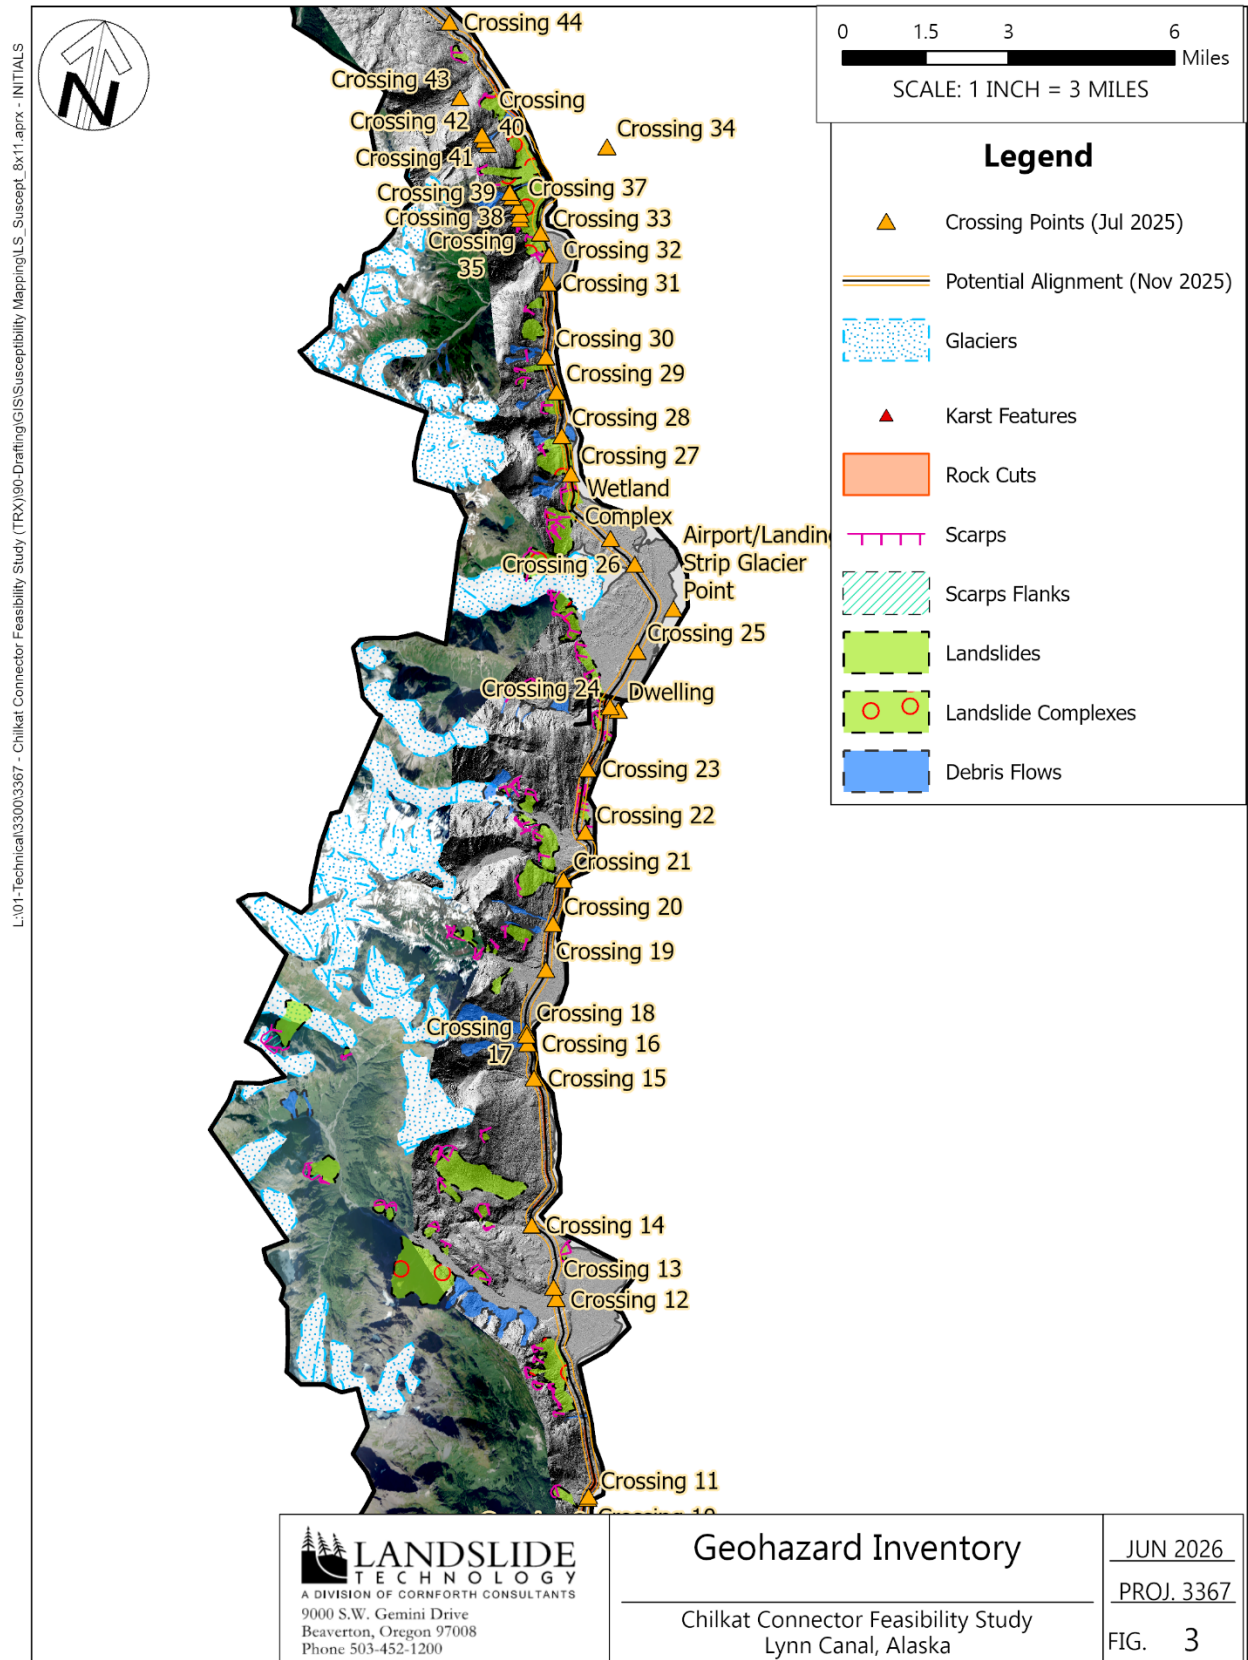
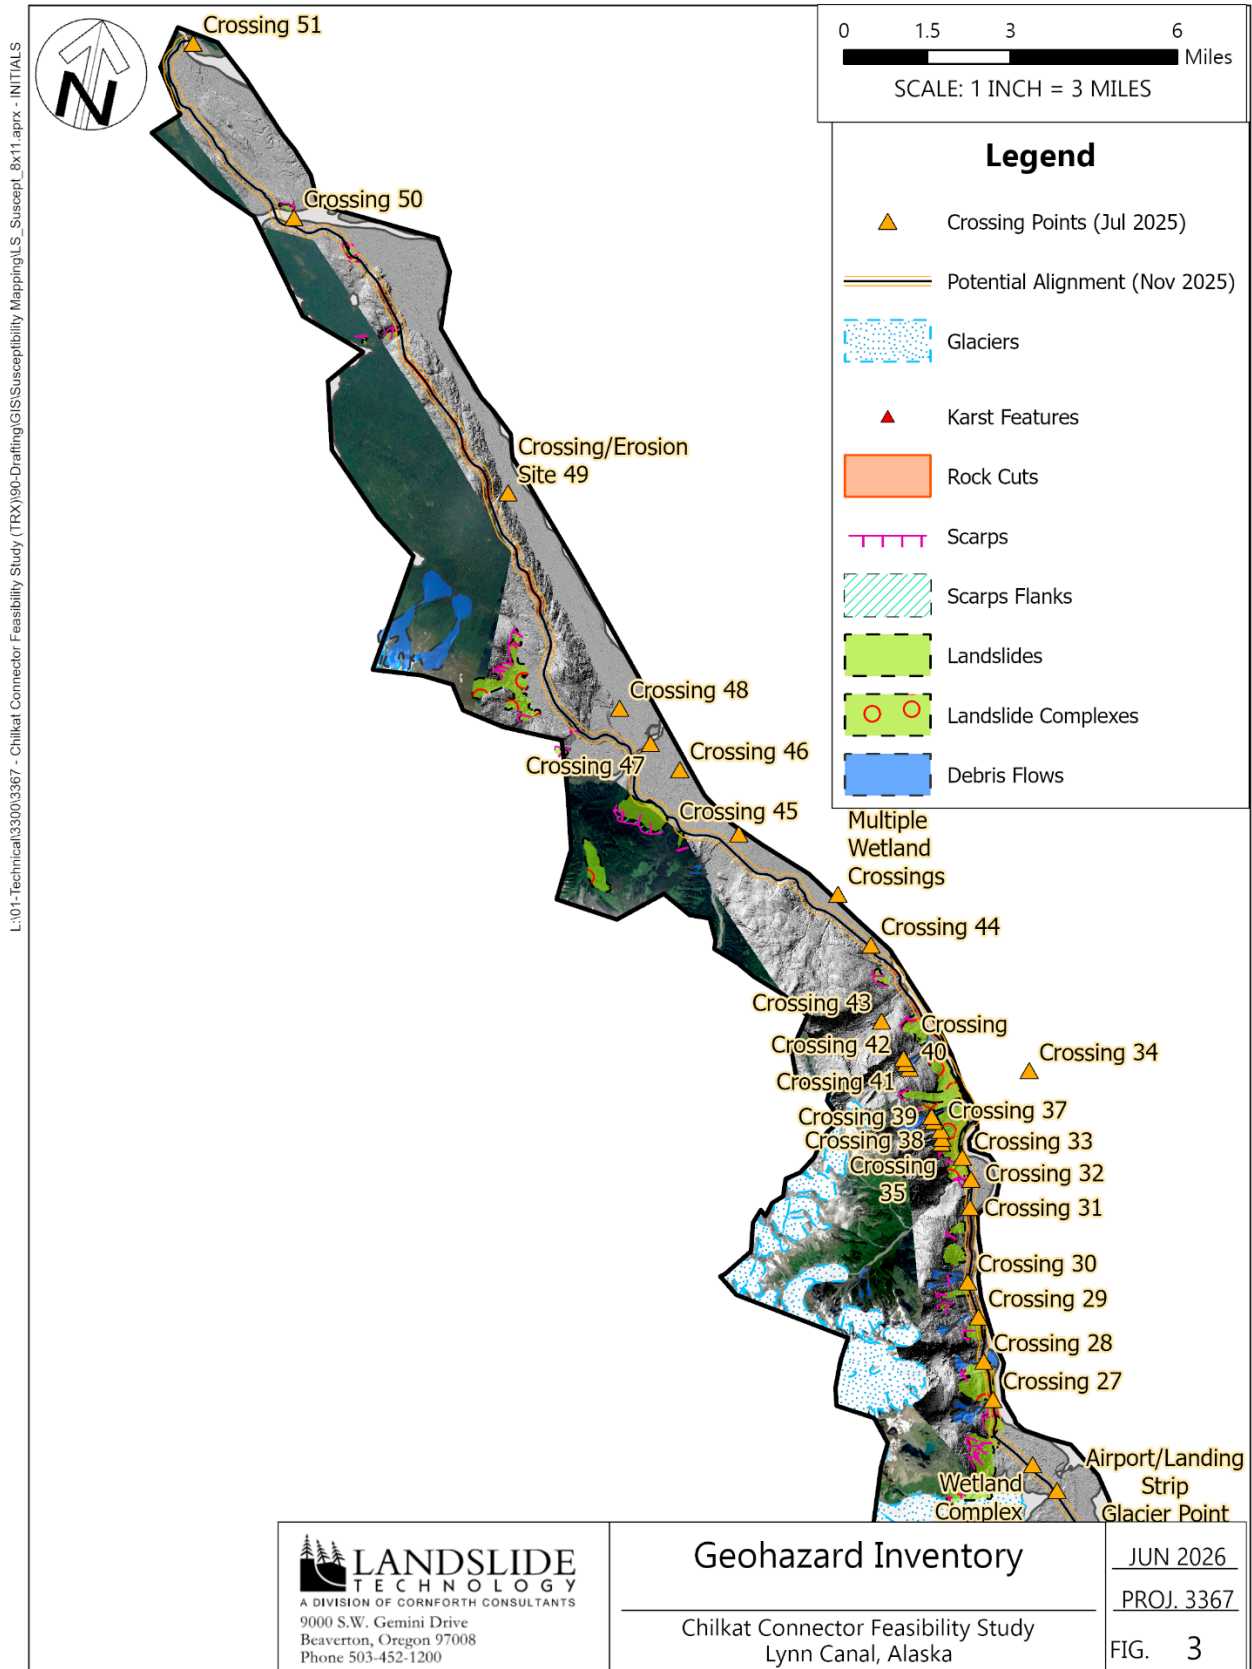
Figure 3 – Geohazard Inventory

debris flows, rockfall at proposed rock cuts, and karst. Hazards associated with snow avalanches, alluvial channels, avulsion processes, erosion, and marine environments were evaluated by others. Imagery used for mapping included publicly available aerial imagery, 2012 USGS Interferometric Synthetic Aperture Radar (IFSAR<sup>1</sup>) data with 5-meter resolution, 2018 Alaska Division of Geological & Geophysical Surveys (DGGs) LiDAR with 1-meter resolution, and August 2025 project-specific LiDAR collected by NV5 with 0.5-meter resolution. The landslide and debris flow inventory database was modeled after Oregon Department of Geology and Mineral Industries' (DOGAMI) Special Paper 42 (Burns and Madin, 2009). Landslides, debris flows, rock slopes, and karst mapping were supplemented by field observations from helicopter reconnaissance and ground confirmation of select geohazard features. Geohazard inventory maps are presented in Figure 3.

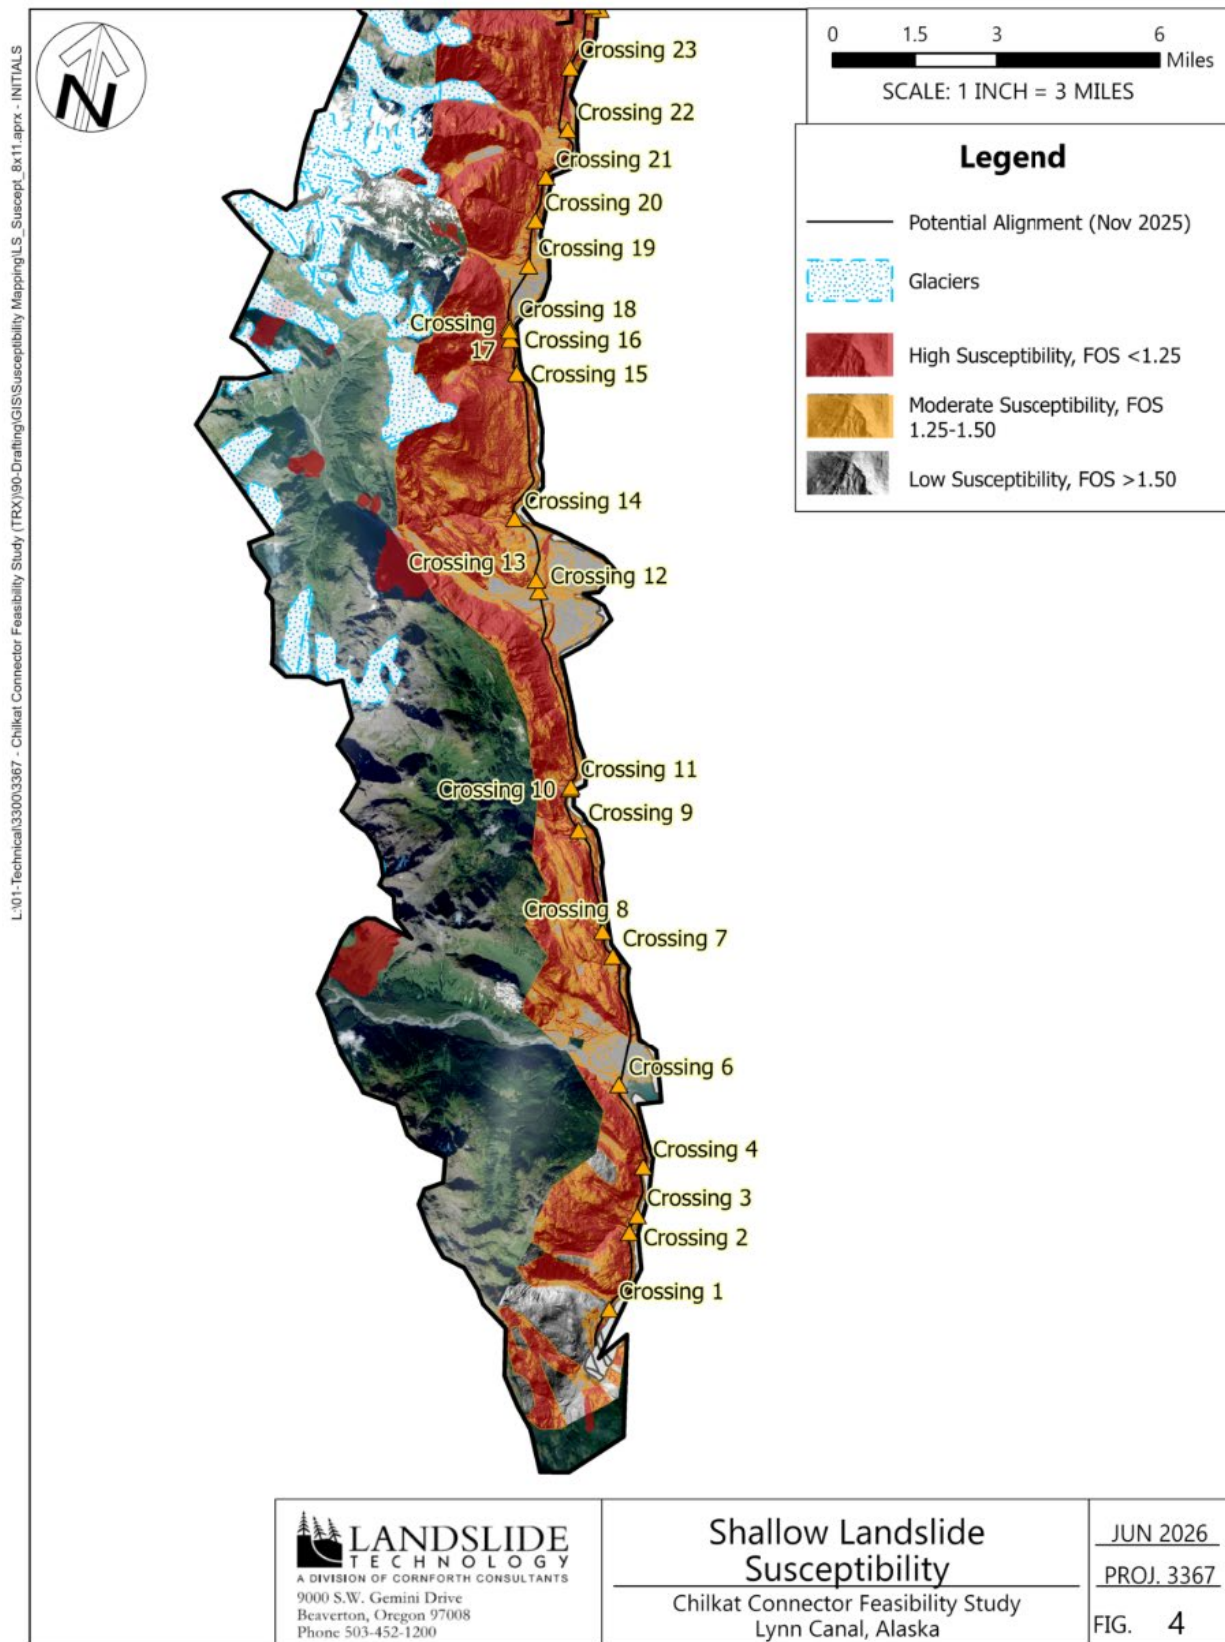
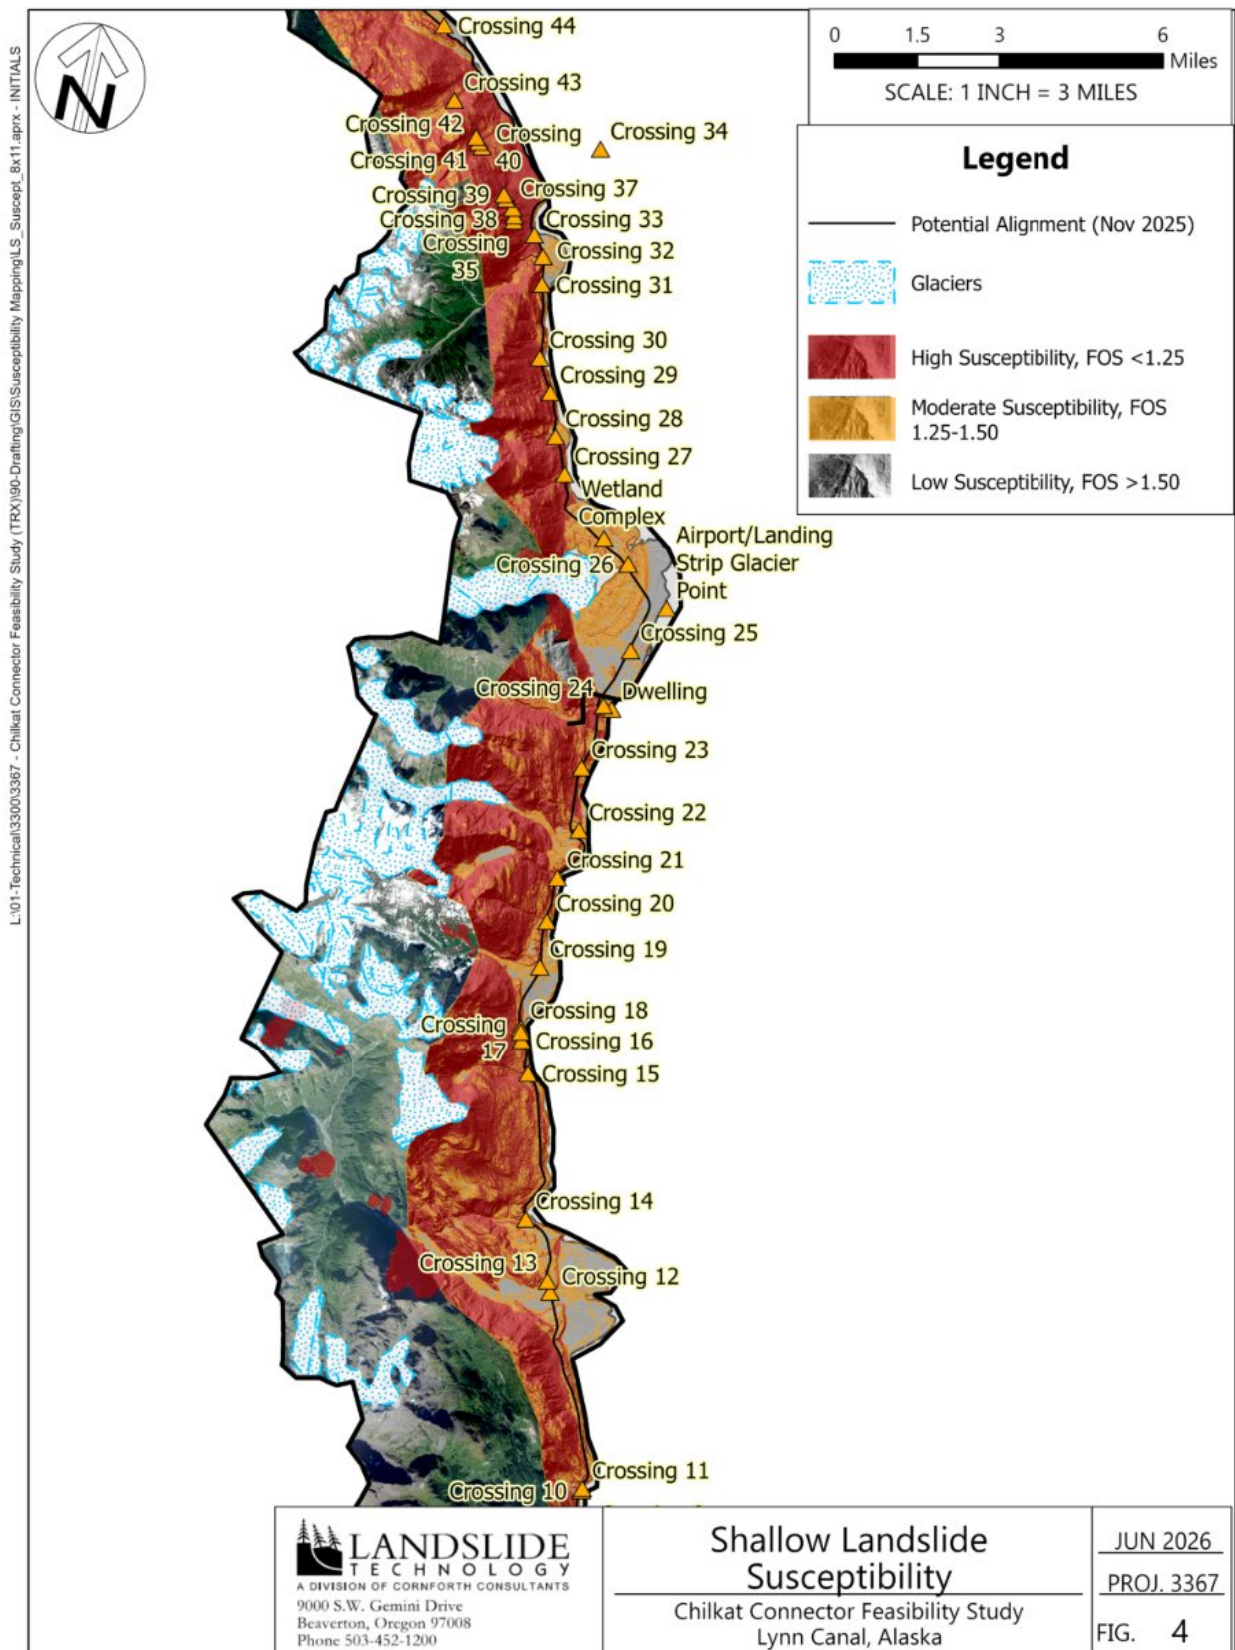
Figure 4— Shallow Landslide Susceptibility

LT conducted shallow landslide susceptibility mapping throughout the project corridor, shown in Figure 4. This was conducted in general accordance with DOGAMI's Special Paper 45 (<sup>4</sup>Burns, 2012). LT used project specific LiDAR data from NV5 with a 0.5 meters resolution for landslide mapping and resampled the data to 1.8-m DEM for susceptibility modeling. The coarser DEM better represents slope gradients at the study scale and avoids overestimating slope inclination. Mapping procedures combined two GIS datasets: 1) landslide inventory mapping, as described above and 2) factor of safety (FS) class maps.

The southern end of the proposed alignment between Crossing 1 and 6 is shown to have slopes with relatively high shallow landslide susceptibility. During limited field reconnaissance conducted in this area and observations from imagery, there was little evidence that slope movements have occurred, and thus the high susceptibility presented in these maps may be misleading. This area warrants further investigation to understand surficial conditions.

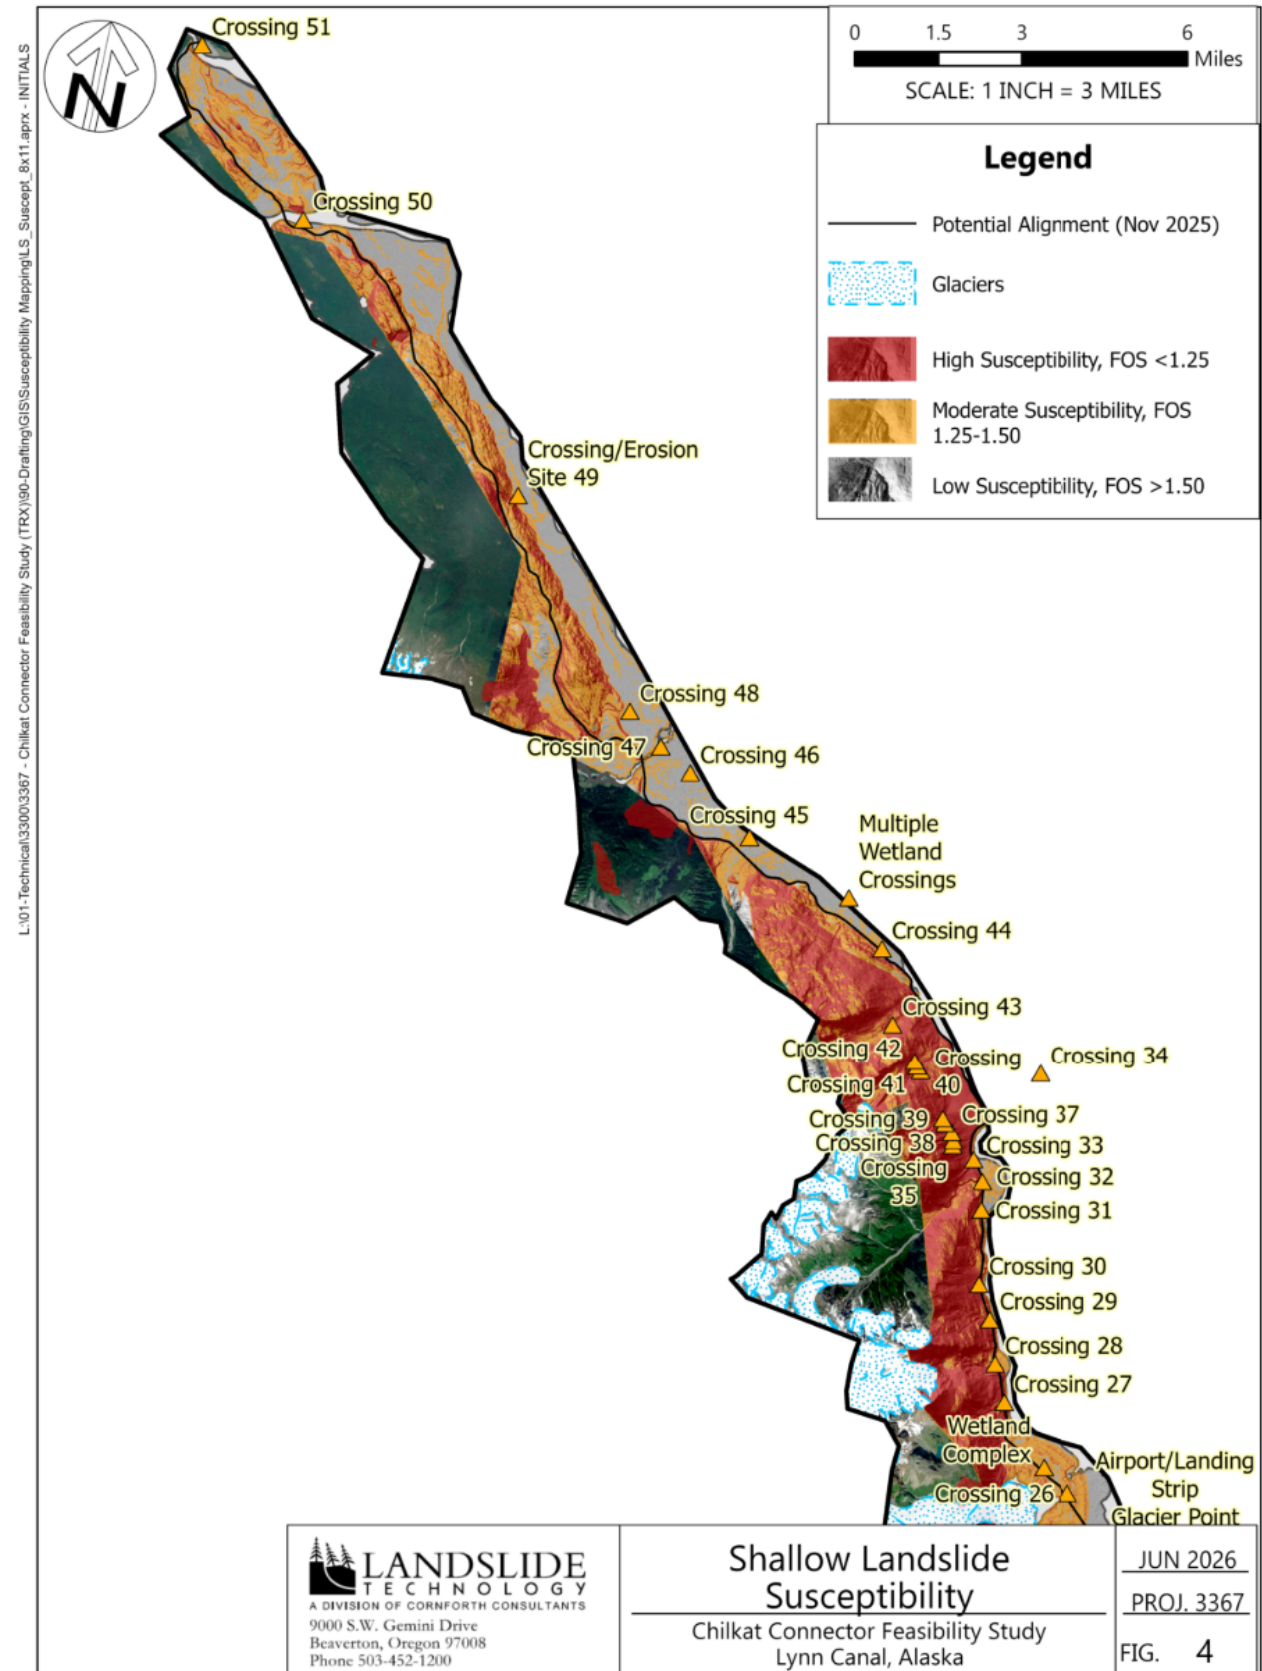
Figure 4 (continued) – Shallow Landslide Susceptibility

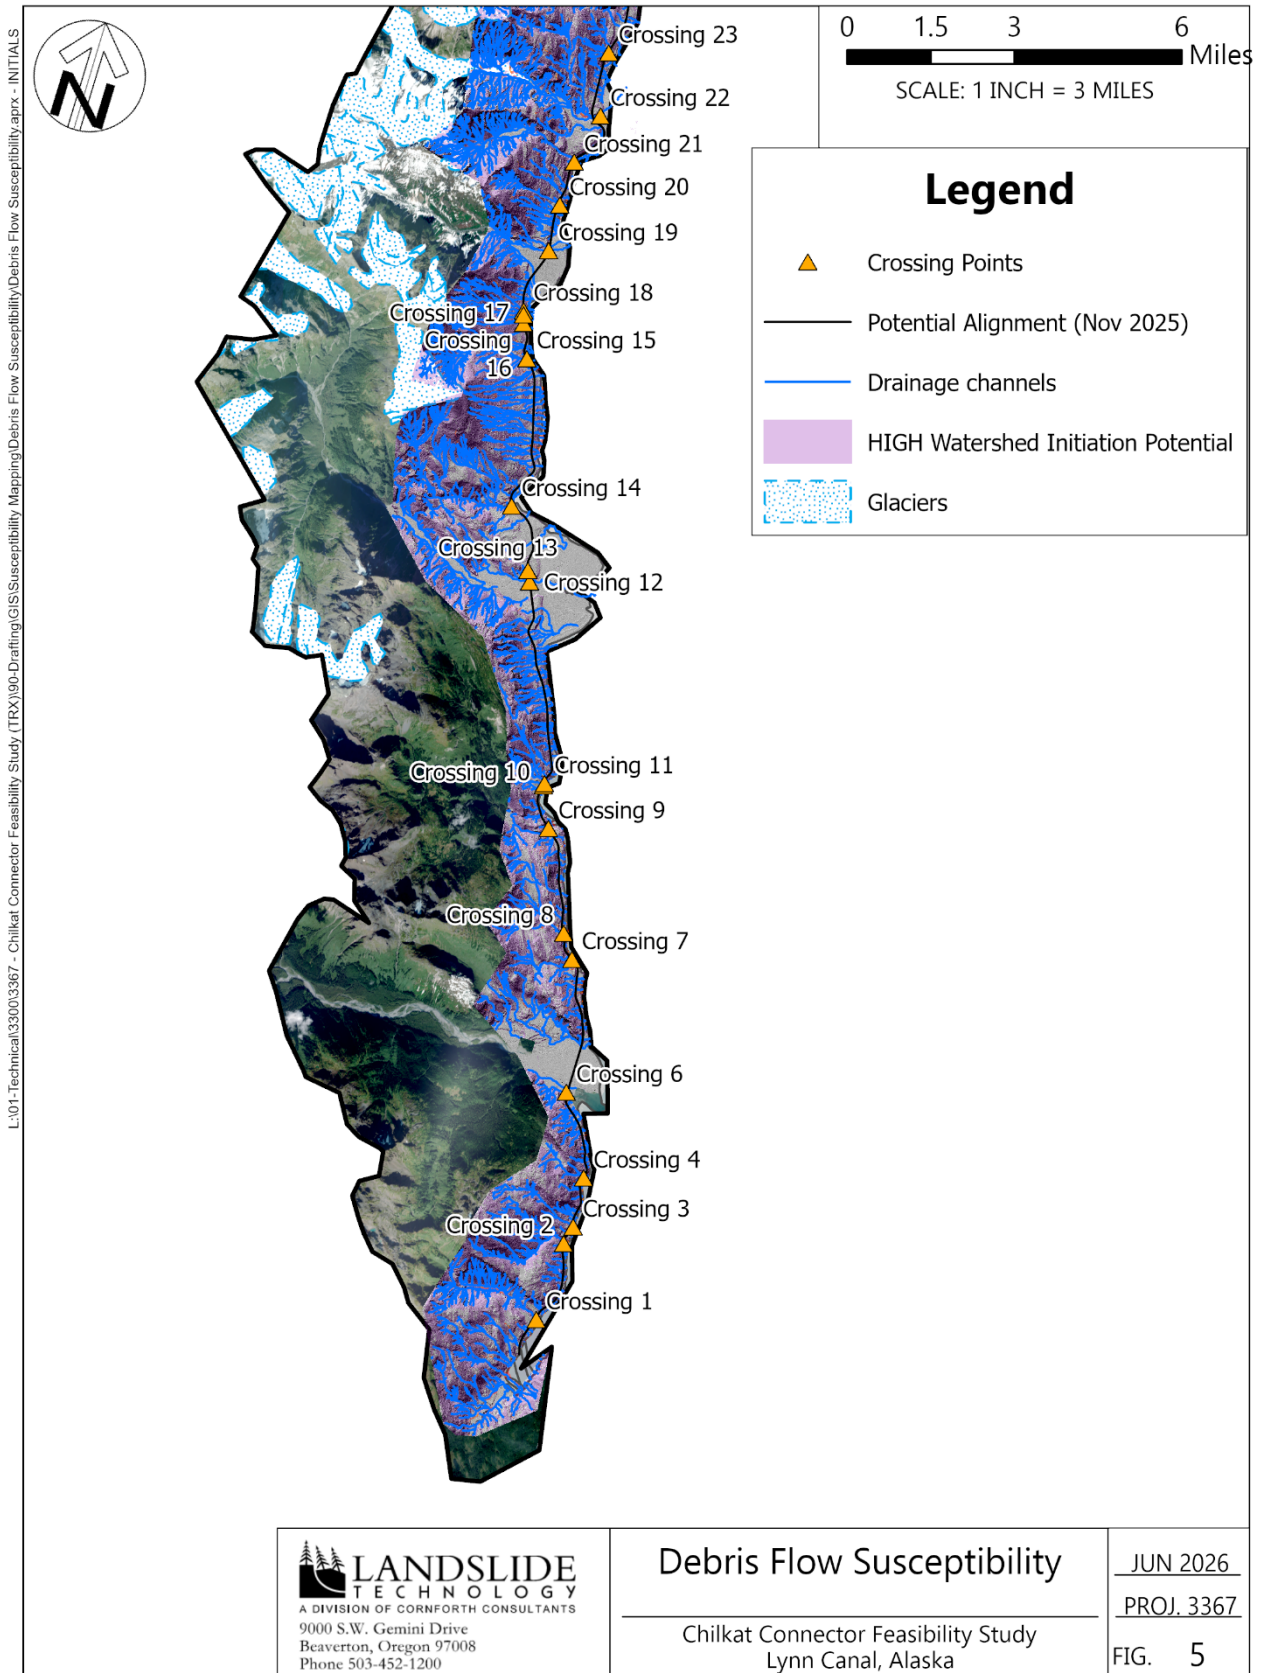
Figure 5 – Debris Flow Susceptibility

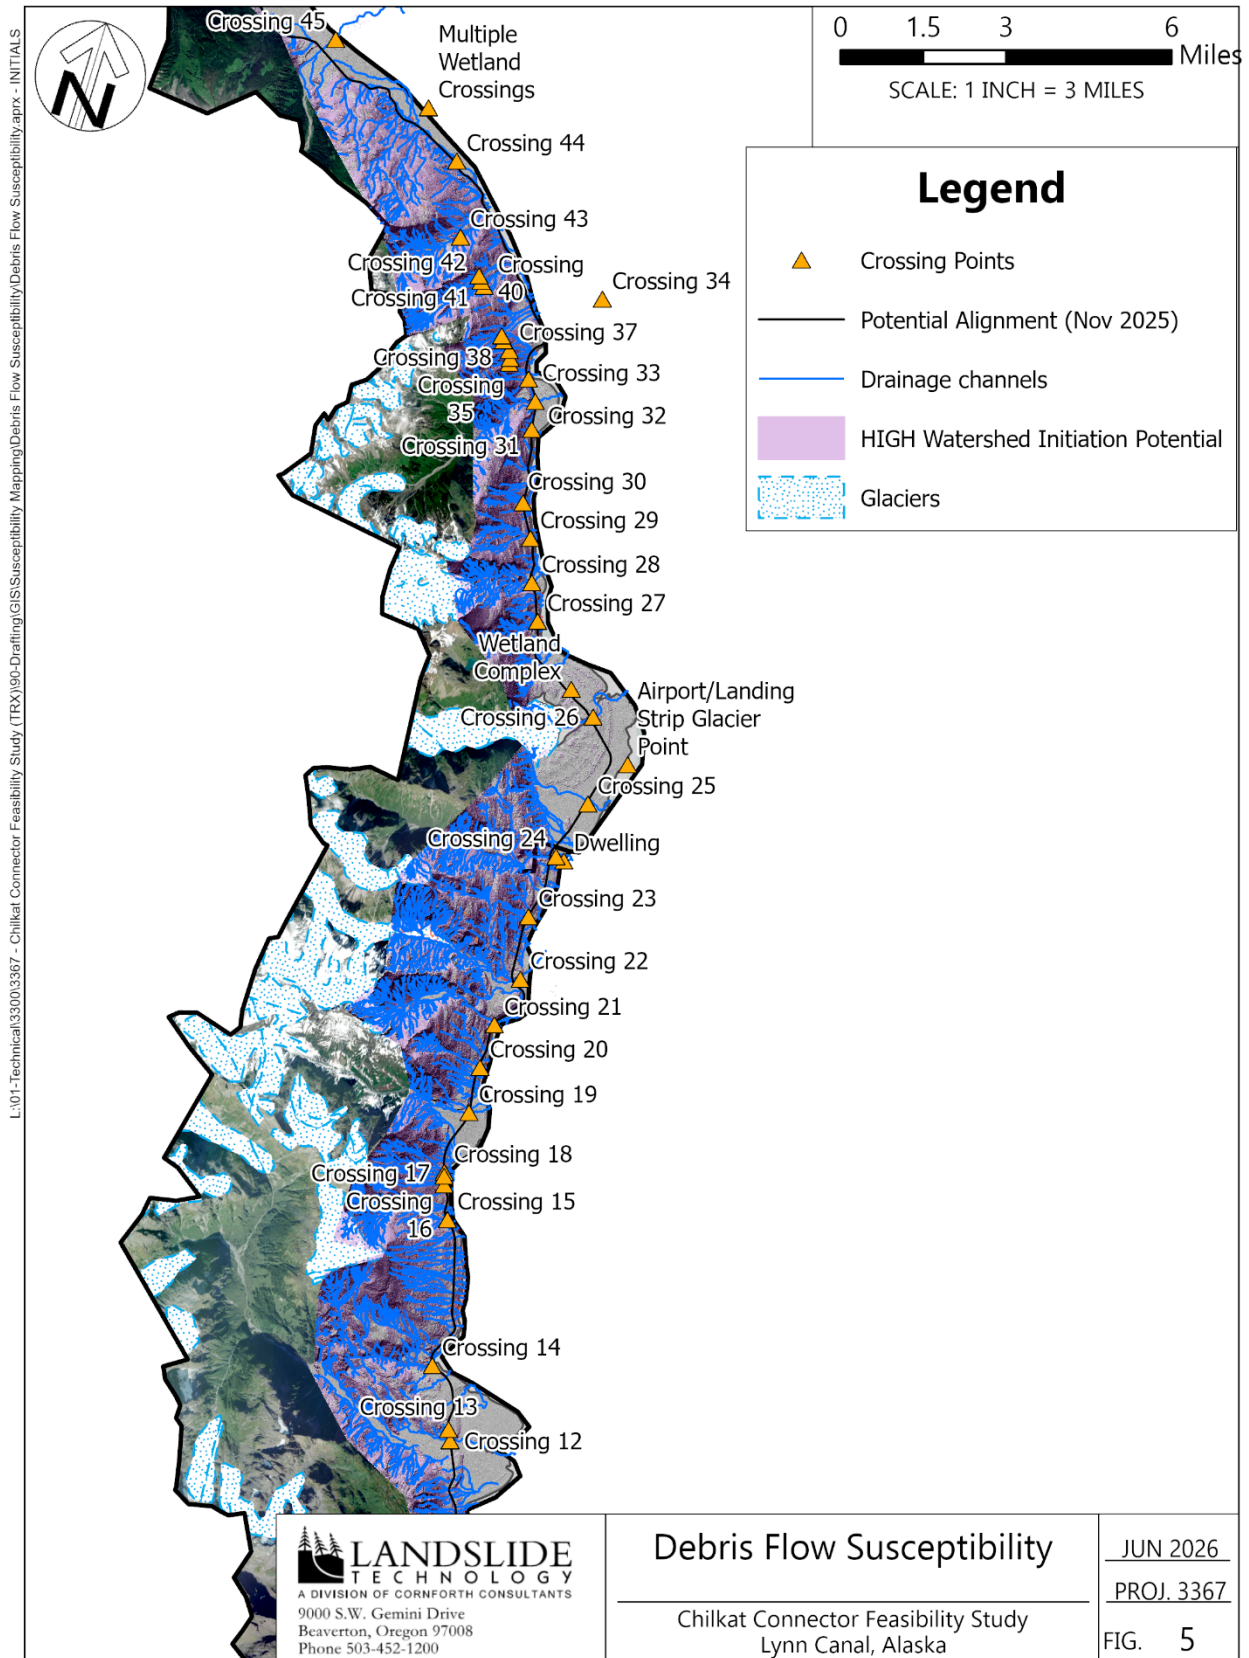
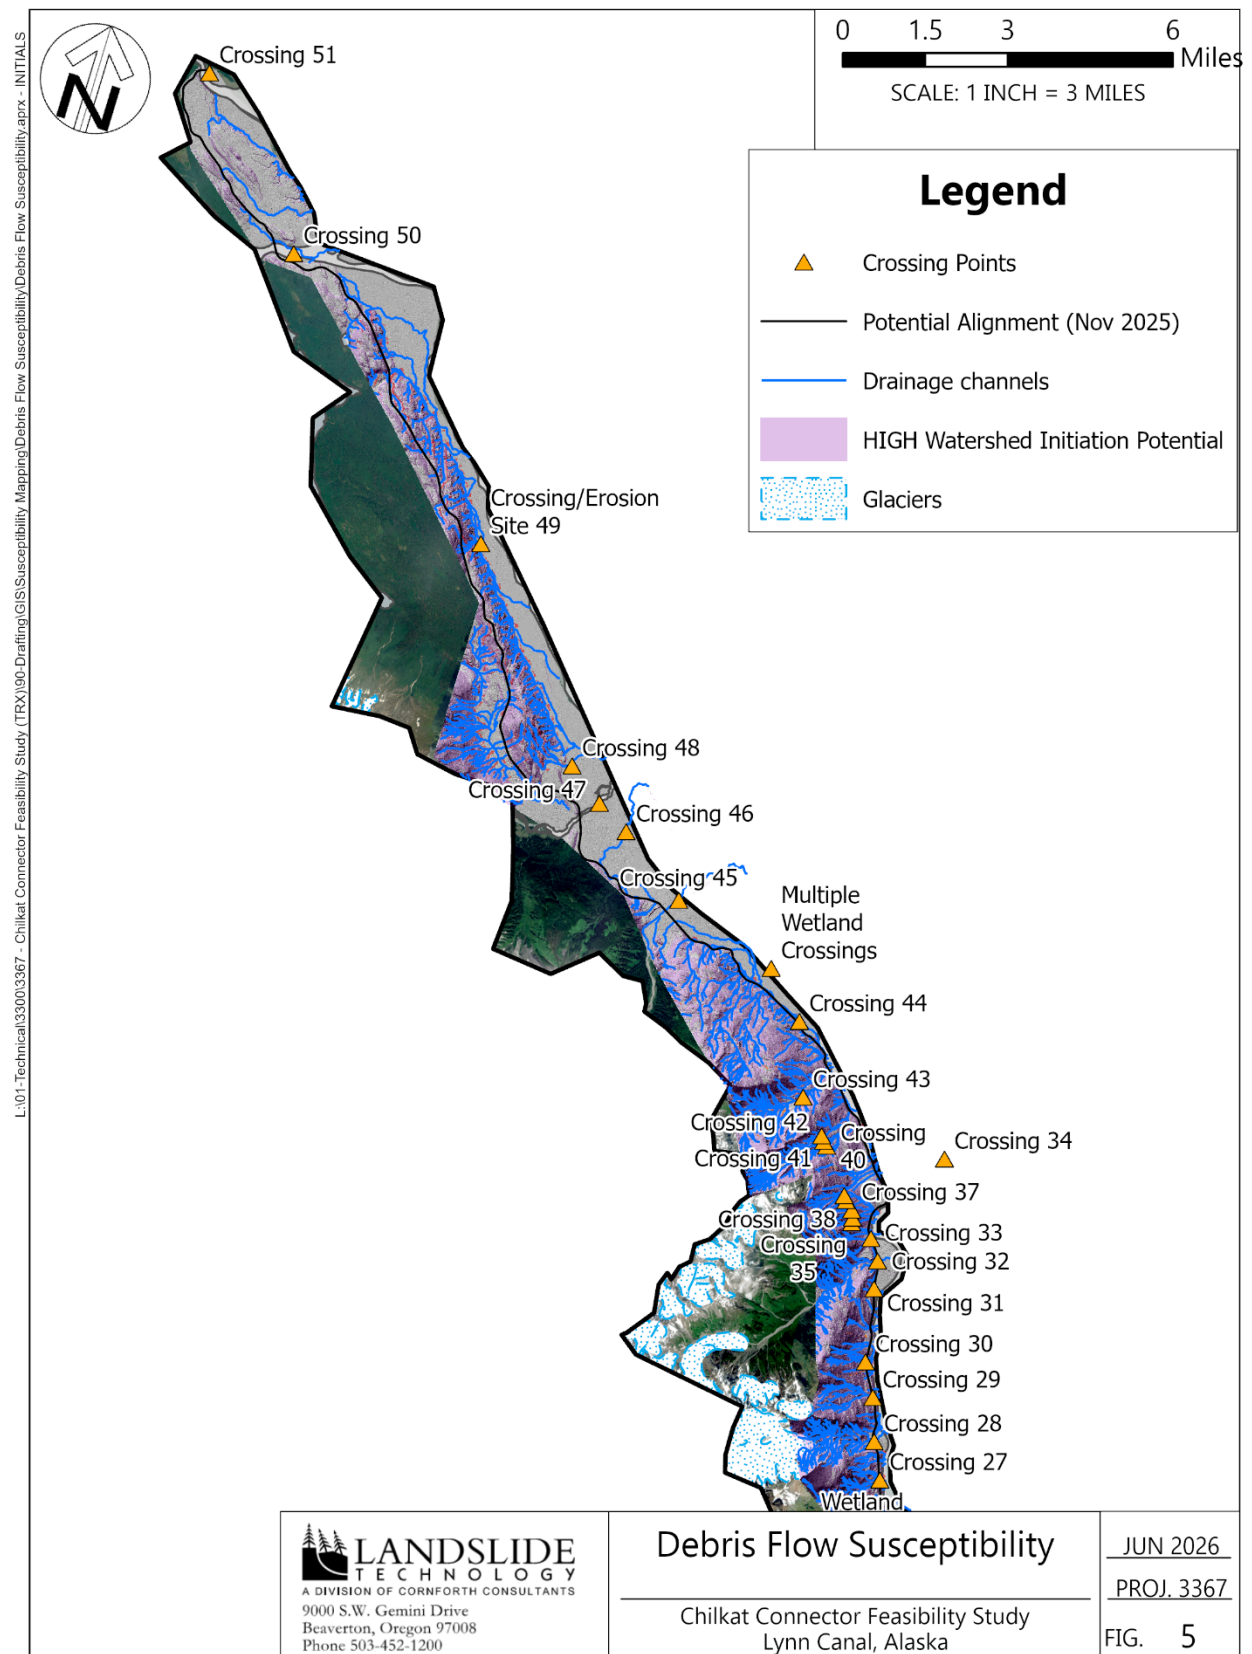
Figure 5 (continued) – Debris Flow Susceptibility

LT conducted Debris Flow Susceptibility mapping throughout the project corridor. Debris flow susceptibility maps are shown in Figure 5. This mapping was conducted using Grfin Tools (<sup>7</sup>Reid et al., 2025; <sup>8</sup>Burns et al., 2022), a DEM based software package that applies empirical mobility relationships to delineate areas potentially affected by landslides, debris flows, or other related mass movements. It analyzes channel topography downslope of a debris flow initiation point to identify possible initiation locations, inundation extents, and estimates an approximate volume of debris entrainment along the channel if triggering conditions are met. Analyses on the project corridor were conducted using a 2025 LiDAR survey-based DEM and a user-defined parameter file. Where possible, parameters were selected based on previous modeling performed by DOGAMI (<sup>8</sup>Burns et al., 2022) and DGGS (<sup>9</sup>Nicolazzo and Larsen, 2024).

In general, the debris flow susceptibility maps show that most drainages within the project corridor are susceptible to debris flows, and that areas with multiple intersecting drainages are generally capable of producing larger runout zones than those with single-channel drainages.

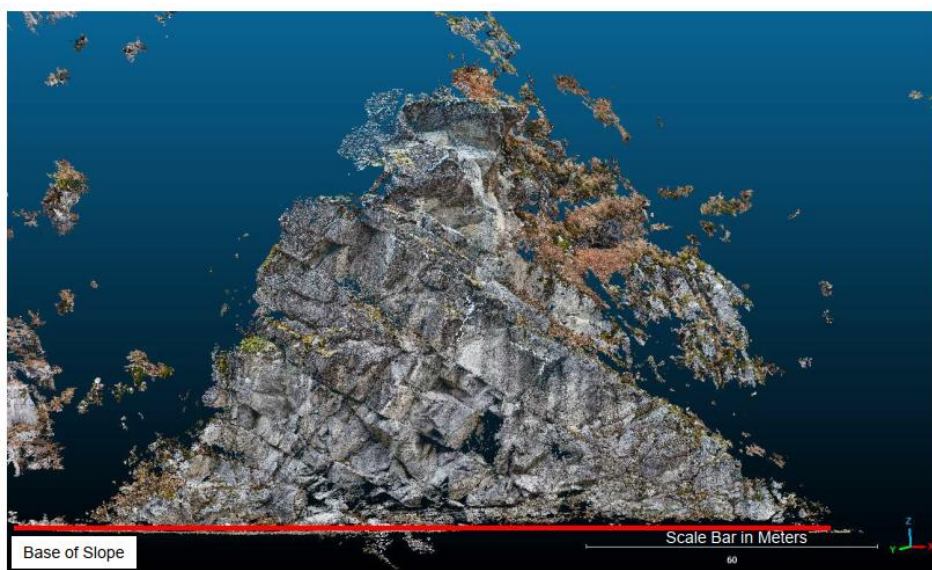
Figure 3. Example of point cloud generated by Pix4D. Red line marks the toe of the slope, the scale bar in the lower right corner is 60 approximately 195 feet (60 meters).

Overlapping oblique photographs of the rock face were collected and stitched together using Pix4D to create a three-dimensional point cloud model for the rock face. Processing the photos through Pix4D required between a day of automatic processing to a week of hand selecting locations for the program to render a mesh. The meshes created by Pix4D were processed into CloudCompare models. In CloudCompare, we were able to view the three dimensional rock face image and identify discontinuities and determine the planar orientations of selected structural features. The result was a collection of structure orientations that could be checked against and incorporated into the hand mapping data. It is important to note that other rock structure information is not obtainable through the photogrammetry analyses and the discontinuity data are intended to complement the hand-collected information.

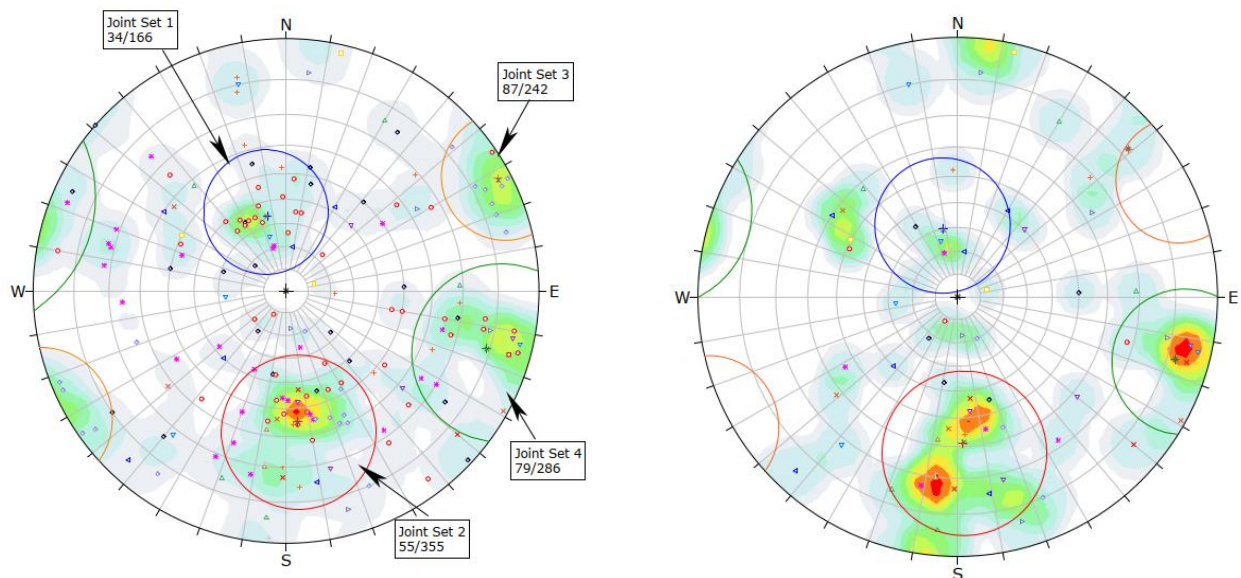
Figure 4. Stereoplot of all collected structure data (left) and only hand-collected data (right)

Measurements taken by hand and measured digitally from photogrammetry were used to create Stereoplots and facilitate kinematic analyses. In general, controlling features within the rockmass were found to be moderate to steeply dipping joint sets. These joints were observed to be largely responsible for apparent planar shear failures across the site. Some of the steeply dipping joints indicated that toppling failures could be possible within certain rock cuts. Other lower angle and randomly oriented joint sets were identified that present the potential for wedge failures. In general, these structures appeared to be independent of lithology, which is generally uniform across the site. The figure below presents two stereoplots, the plot on the left includes the full data set collected during fieldwork inclusive of hand-measured structures and those measured from the 3-D meshes created through photogrammetry. The plot on the right includes only hand-collected structure orientation measurements. The plots are also annotated to show the interpreted joint sets and their orientations based on the full data set.

Comparing the two stereo plots in Figure 4 illustrates that the use of drones to collect supplemental structure data provides a clearer picture of the structure distribution in the exposed rock faces. Inclusion of the drone data suggests the presence of a second steeply dipping

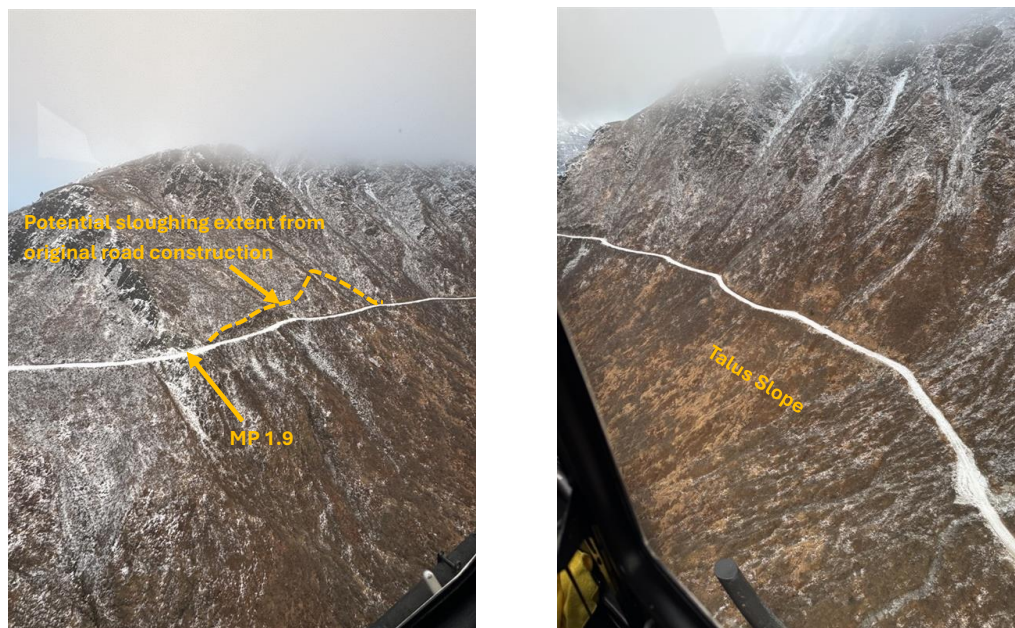
Figure 5. Oblique aerial images of Williamsport Road showing portions of talus slope

Based on our more detailed site work, we identified an unanticipated slope condition that would present challenges during design and construction. Despite the apparent dominance of shallow bedrock between MP 0 and 3, there are numerous areas along the roadway where potential soil instabilities exist. Active areas include debris fans that are accumulation zones for active rockfall areas high above the roadway. Many of these areas have been cut into to create the road and are thus oversteepened. Other isolated areas of till soils are also present and exposed in several cuts above the roadway that could create similar failures, though likely lower in volume and severity compared to the rockfall accumulation zones. In addition, it was discovered that the section of the road between MP 1.9 and 1.1 is constructed on a dormant, overgrown talus slope.

The slope above the roadway likely experienced significant raveling up to several hundred feet upslope above the roadway during and immediately after construction and has since become overgrown and dormant. This feature was discovered during a helicopter flight through the pass where a subtle change in slope vegetation above the road could be observed at the apparent crest of the top of the raveling feature above the road. As such, minor disturbances in terms of loading or reshaping, could trigger progressive failures or instabilities that may be difficult to control.
