# 75<sup>TH</sup> HIGHWAY GEOLOGY SYMPOSIUM

BETTER HIGHWAYS THROUGH APPLIED GEOLOGY

2026  
HGS  
PROCEEDINGS

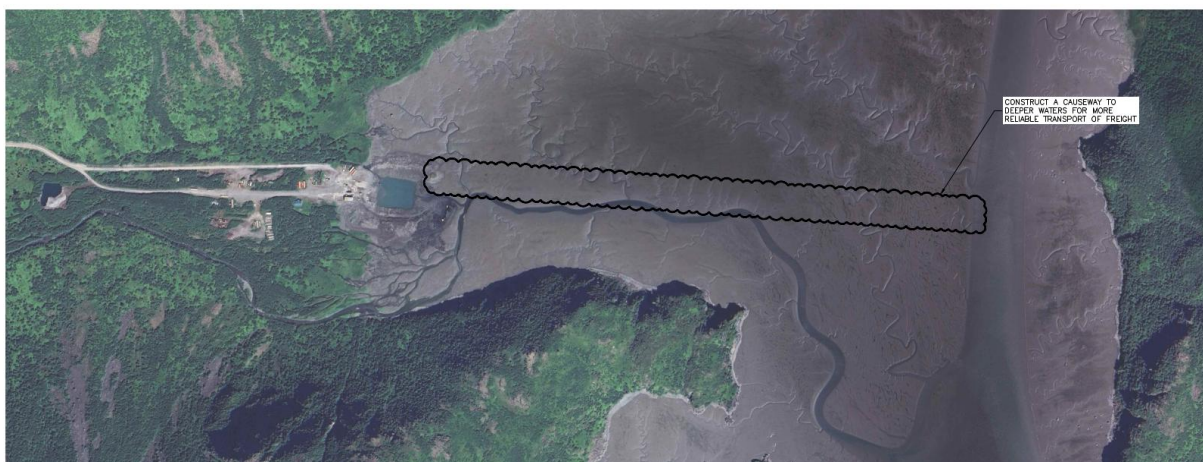
Figure 6. Approximate alignment of proposed causeway into Iliamna Bay (project drawing)

Access challenges to the existing barge landing at the natural beach near the east end of Williamsport Road are associated with expansive and shallow mud flats that are only inundated at extreme high tides. Extending a new causeway out onto the mudflats would allow more reliable access for barges and fishing vessels. The causeway will need to extend nearly 3,600 feet from the existing west end of the road to access a new barge landing, haul-out ramp, and mooring bulkhead.

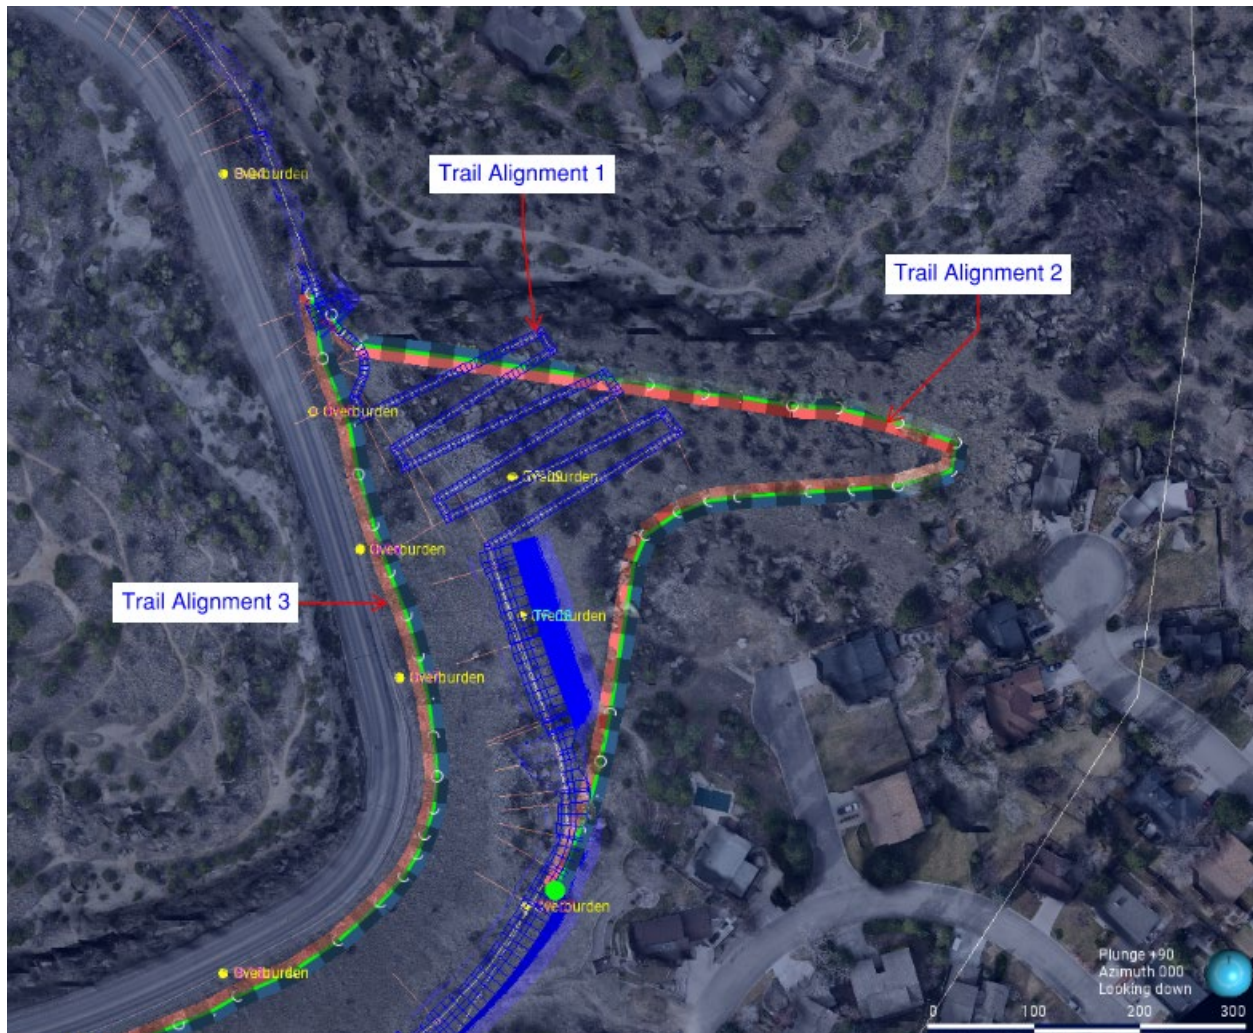
Figure 2 – Site Map

Preliminary screening indicated that Alignment 1 provided significant advantages because it incorporated existing topography and natural drainage features to reduce rockfall exposure while maintaining reasonable constructability. Alignment 2 presented the highest rockfall risk because significant portions of the trail would be located directly beneath active rockfall source areas. Alignment 3 reduced rockfall exposure but introduced additional grading and constructability challenges. Refer to Figure 2 for the Site Map.

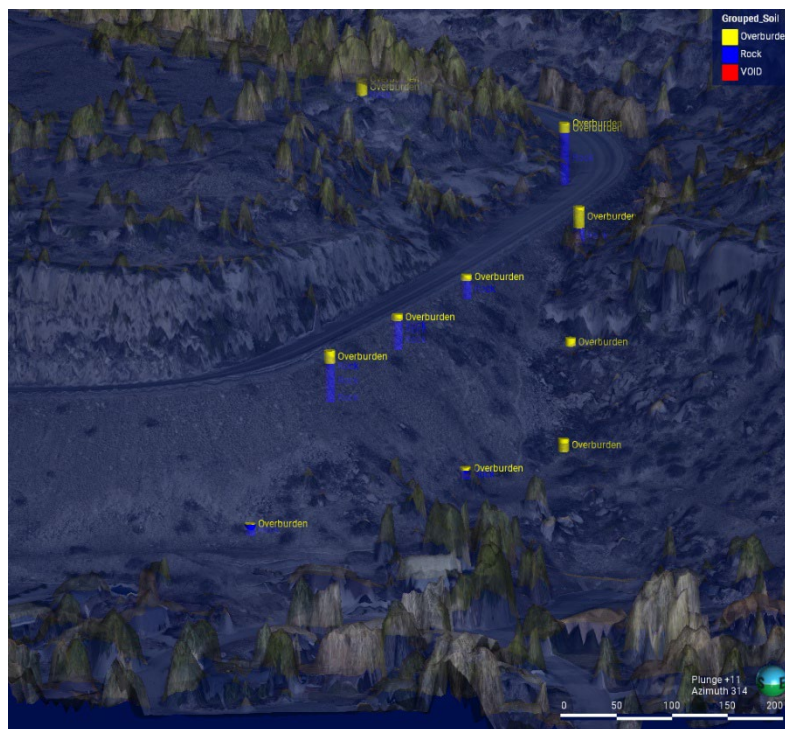
**Figure 3: 3D model of boreholes**

Seventeen (17) boreholes and ten (10) test pits were available from previous Terracon subsurface investigations at the project site. The locations of these were described earlier in Figure 3. Because of the consistency of the subsurface soils and rock encountered in the boring program, these layers were grouped into “Soil” and “Rock” layers within the geologic model. The topography and orthoimagery for this project site was incorporated by using UAV survey data from IMEG. A view of the boreholes with topography is shown in Figure 3 to illustrate how the model data inputs are developed.

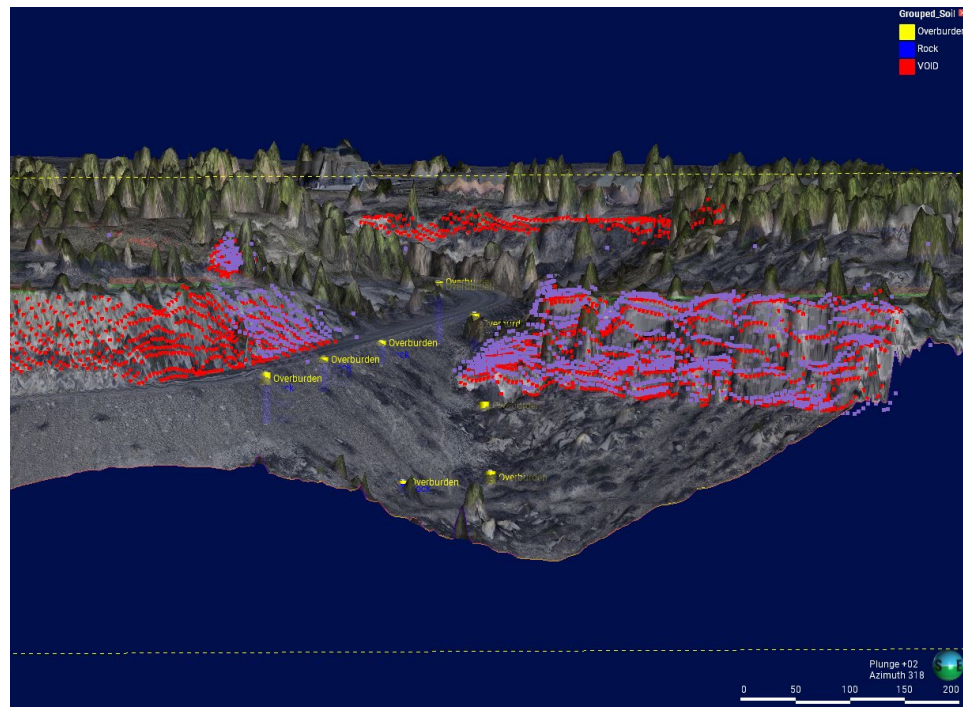
**Figure 4: Top of rock data inputs on topography**

Where outcrops are plainly visible within the 3D topography and orthoimagery, as well as where HDR Geologists encountered top of rock locations within the field, data points for top of rock were incorporated as polylines and 3D points, as shown in Figure 4.

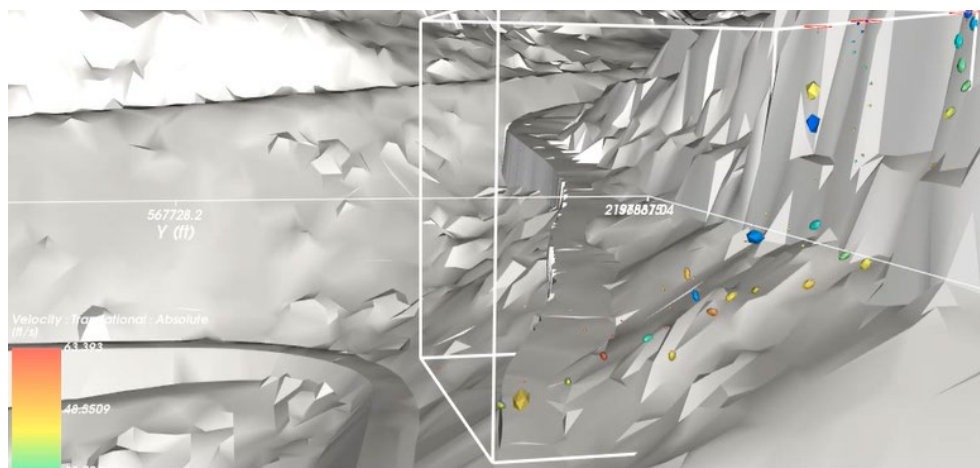
**Figure 5: View of 3D rockfall analysis**

Rockfall hazards were evaluated using ANSYS ROCKY and Rocscience RocFall2. A preliminary 3D risk analysis was performed in ROCKY to evaluate the proposed alignments, then upon determining the alignment with the lowest risk profile, detailed analyses were subsequently performed using two-dimensional RocFall2 models. Four critical sections were selected where trail alignments intersected areas of elevated rockfall potential. These locations represented the highest anticipated interaction between potential rockfall trajectories and proposed trail alignments. Figure 5 below shows a view of the 3D rockfall analysis.

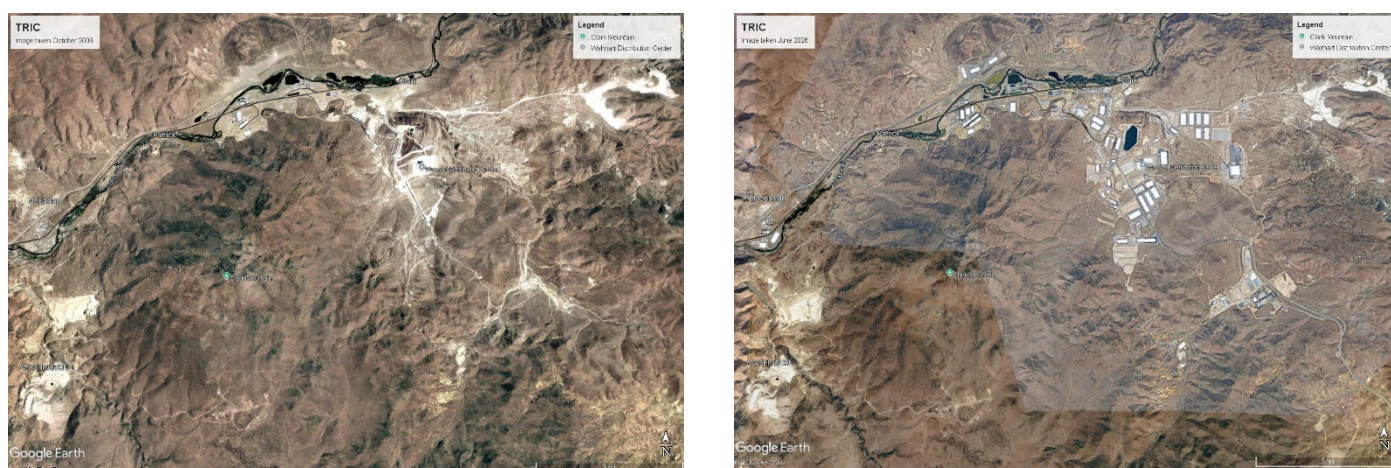
**Figure 1. Aerial imagery showing development within the Tahoe Reno Industrial Center between October 2006 and June 2026. Imagery accessed through Google Earth on July 20, 2026.**

One area experiencing rapid industrial expansion is the Tahoe Reno Industrial Center (TRIC), located east of Reno in Storey County, Nevada. Since the first warehouse tenant was established in 2000, the industrial complex has expanded to more than one hundred tenants occupying approximately 160 square miles (TRIC, 2026). The facility supports a diverse range of industries including warehousing, advanced manufacturing, distribution, and large-scale data centers. Many of these facilities rely on groundwater for industrial processes and cooling operations, resulting in increasing groundwater demand within the region.

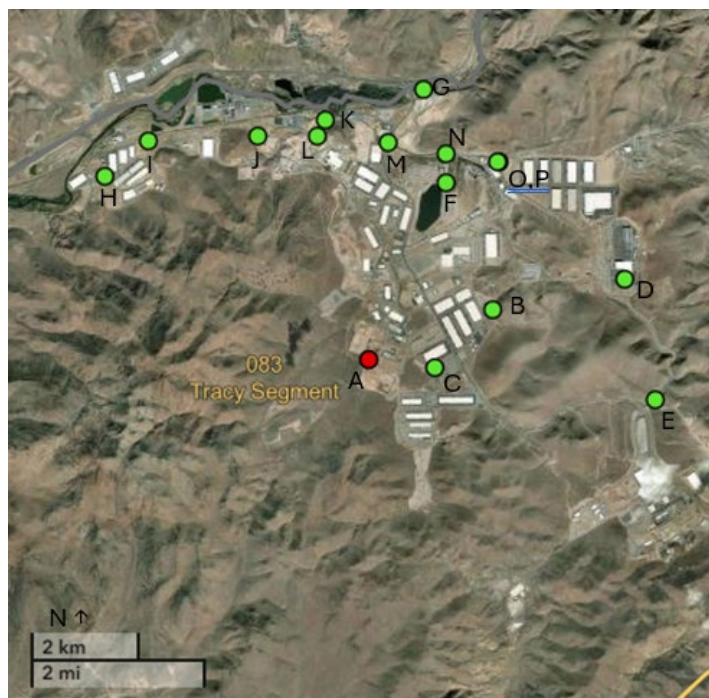
**Figure 2. Groundwater monitoring locations within the Tracy Segment Groundwater Basin (Basin 083) near the Tahoe Reno Industrial Center. Green symbols indicate active monitoring sites and the red symbol indicates an inactive monitoring site. Map obtained from the Nevada Division of Water Resources Water Levels Dashboard, accessed July 2026. Well labels correspond to hydrographs presented in Figure 3 and Appendix A.**

**Figure 2 illustrates the spatial distribution of the groundwater monitoring network within the Tracy Segment Groundwater Basin. Although the monitoring wells are distributed throughout the basin, the network is relatively sparse considering the rapid industrial development occurring within the USA Parkway corridor. Furthermore, the available**

**monitoring wells are not uniformly distributed, resulting in limited spatial coverage for evaluating groundwater-level changes across the basin.**

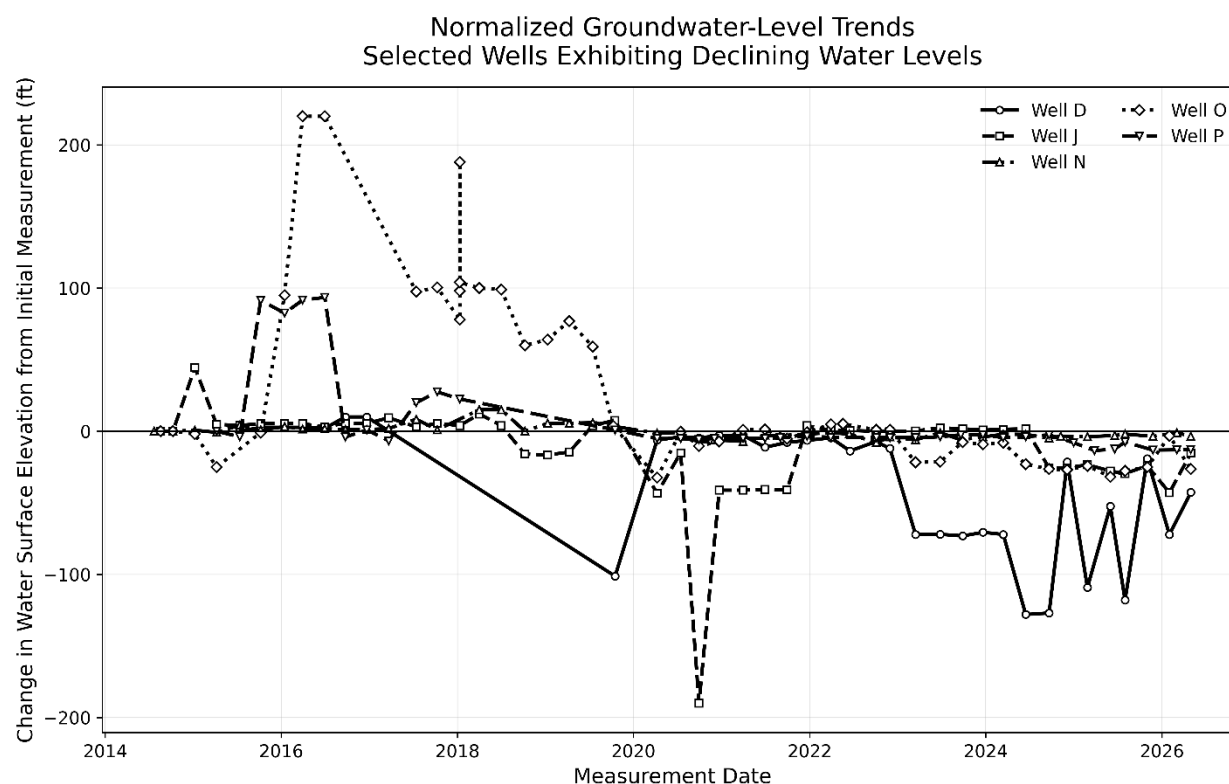
**Figure 3. Normalized groundwater-level trends for selected monitoring wells within the Tracy Segment Groundwater Basin. Water-surface elevations were normalized relative to the first available measurement for each well; negative values indicate groundwater elevations below the initial measurement. Wells were selected to illustrate comparatively coherent declining trends.**

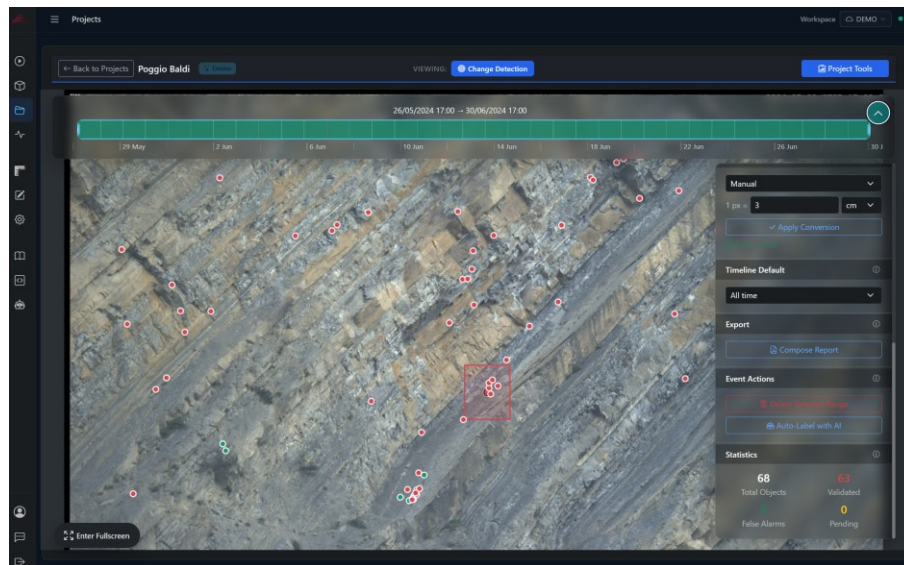
**Figure 1: IRIS pixel-level change detection results for a high-unstable rock slope located in Italy, Poggio Baldi landslide. Each red dot represents a rock fall occurrence that was detected within the monitoring period (May-June 2024)**

Change detection is performed by comparing a coregistered image pair and computing a structural change map. The primary change map is based on a modified implementation of the Structural Similarity Index Measure (SSIM), applied to the luminance channel, with configurable window size and component weights [16]. SSIM is useful because it compares local image structure rather than only pixel-by-pixel intensity differences. The resulting map highlights areas where image structure changed between the baseline and target image. After thresholding, IRIS then applies clusterization through connected component analysis in order to transform the raw change map into distinct clusters representing localized changes (Figure 1). An interpretable object inventory of changes within the monitored scenario is then created and stored for later access. Proper validation logic such as persistence thresholds, short-pair thresholds, merge distances, minimum object areas, and analysis masks are employed to reject outliers and false positives while ensuring the detection of real changes in the scene. Finally, an AI based classification stage is carried out to perform automatic labelling of all the changes detected within the field of view.

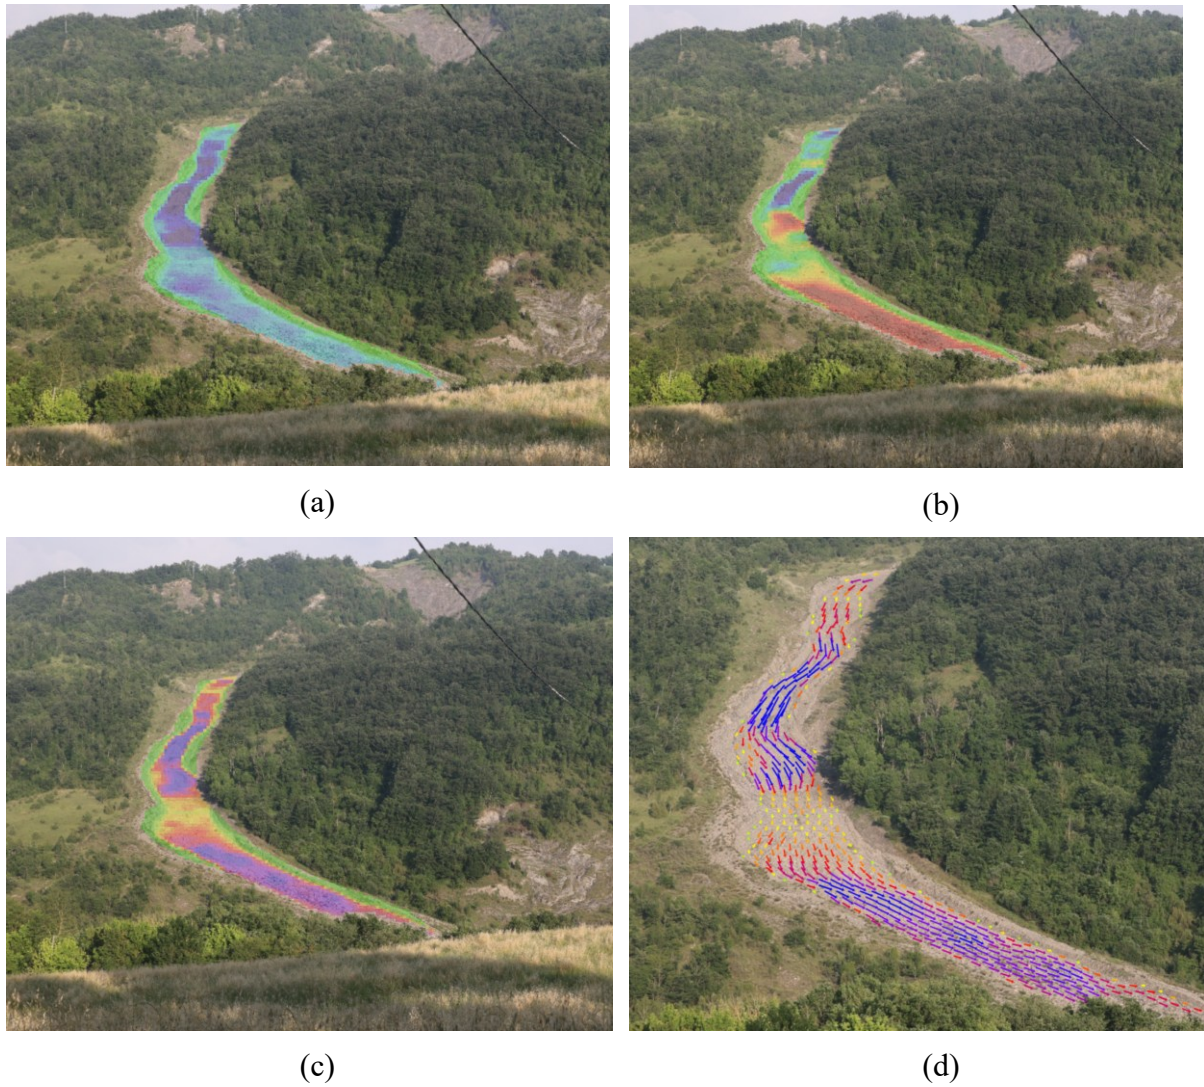
**Figure 2: Displacement analysis results on the Biricuccola landslide (Italy) dataset, over the course of a one-month monitoring period in June 2024; the diagrams show 4 dense maps of displacements: (a) vertical component; (b) horizontal component; (c) magnitude; (d) quiver plot.**

Displacement analysis estimates motion vectors over a regular image grid (Figure 2). Sparse KLT is suitable for fast measurement of small to moderate movements in textured scenes. Phase correlation is suitable for precise sub-pixel shifts within local windows and can use apodization, pyramid levels, and sub-pixel refinement. DIS optical flow is suitable for larger smooth deformation fields. LAMMA-style correlation is suitable for complex motion, large search ranges, or illumination variation. The displacement result contains grid coordinates, horizontal and vertical image displacement, quality indicators, and optional quality metrics such as peak ratio and signal-to-noise ratio. The knowledge of camera parameters such as sensor resolution, focal lens and the distance of the monitored target can be exploited to convert image displacement from pixel units to engineering units through the so-called ground sample distance (GSD). IRIS incorporates a friendly, easy to use tool (Figure 3), that allows users to quickly compute the resulting GSD given a specific camera setup and a distance to the target. A new, AI-based, monocular depth estimation algorithm is under development to determine the depth map of the scenario without the necessity to rely on a 3D model. This will allow agencies to quickly compute per-pixel ground resolution for monitored scenarios which can differ significantly from pixel to pixel in the case of strongly three-dimensional scenes.

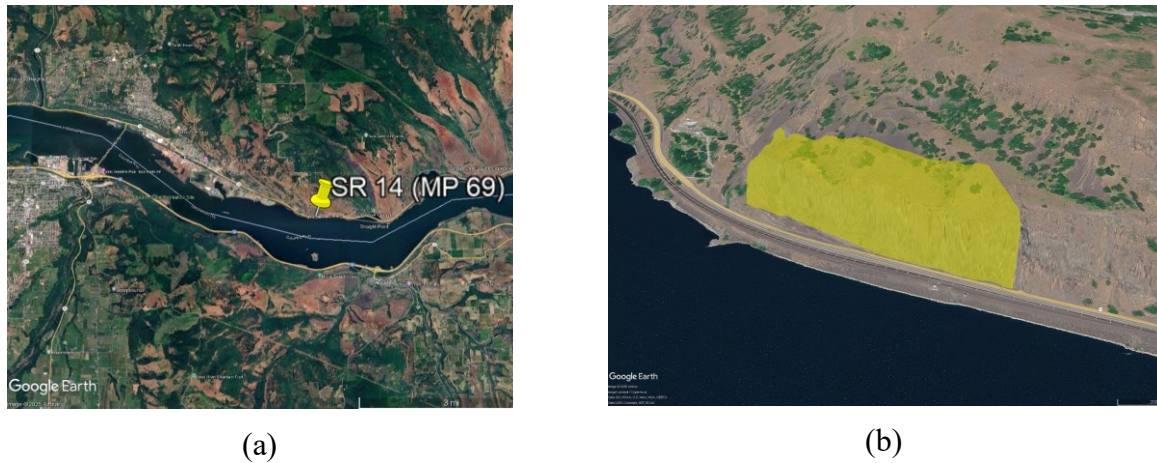
**Figure 4: Location (a) and extent (b) of the monitored site at SR14, MP69 WA (USA)**

In 2025, Re-Monitor and NHAZCA supported an application of image-based change detection for an unstable rock slope along State Route 14 in Washington, between approximately Milepost 68 and Milepost 69.5 with a monitored area of approximately 365,000 ft<sup>2</sup> (Figure 4). The objective was to evaluate repeat-image processing for rockfall-related change detection and to provide rapid, interpretable information for a highway corridor affected by rock-slope hazards.

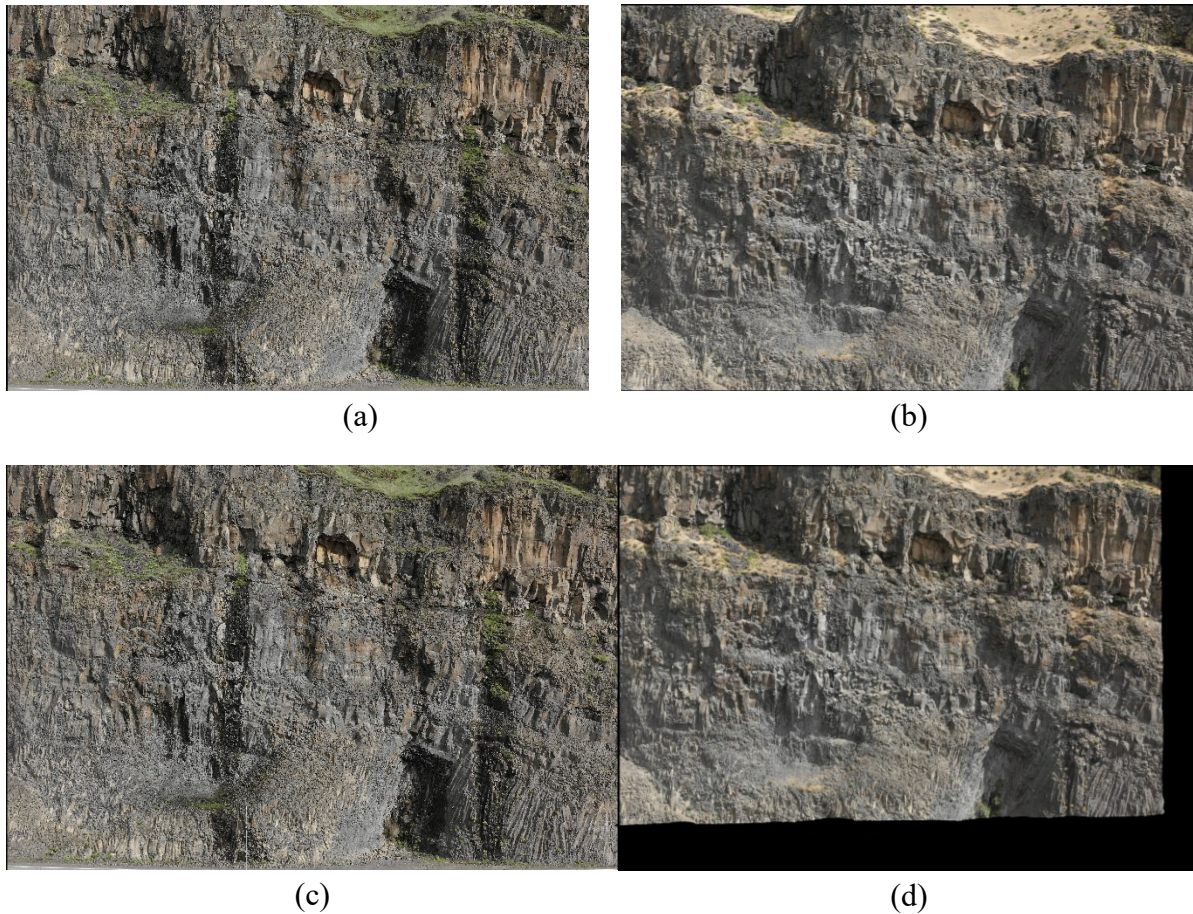
**Figure 5: Effectiveness of IRIS co-registration algorithm tested on a dataset of SR14, MP69, WA. Primary images (a-c); Secondary image raw (b); Secondary image coregistered (d);**

The initial dataset was acquired on March 10, 2025, using a DJI UAV flown on a pre-defined flight plan with RTK-corrected GNSS positioning and vertical sweep imaging of the rock face. This baseline survey was used to verify image quality and confirm suitability for Re-monitor's proprietary rockfall change-detection workflow. Based on the dataset review, Re-monitor provided WSDOT with acquisition guidance to improve repeatability between surveys and to maximize cross-epoch alignment and processing reliability. A second acquisition was carried out on March 25, 2025. Following the collection of the dataset, Re-Monitor immediately began to develop and test a dedicated co-registration algorithm to precisely align the March 10 and March 25 datasets. This was necessary because, due to different camera poses in the two flights, and due to inherent GPS precision limitation, corresponding images taken from two different aerial surveys showed a systematic shift in vertical and (to a lesser extent horizontal) directions as shown in Figure 5 (a)-(b). The results of the co-registration algorithms can be seen by comparing Figure 5 (c) and Figure 5 (d) showing precise alignment.

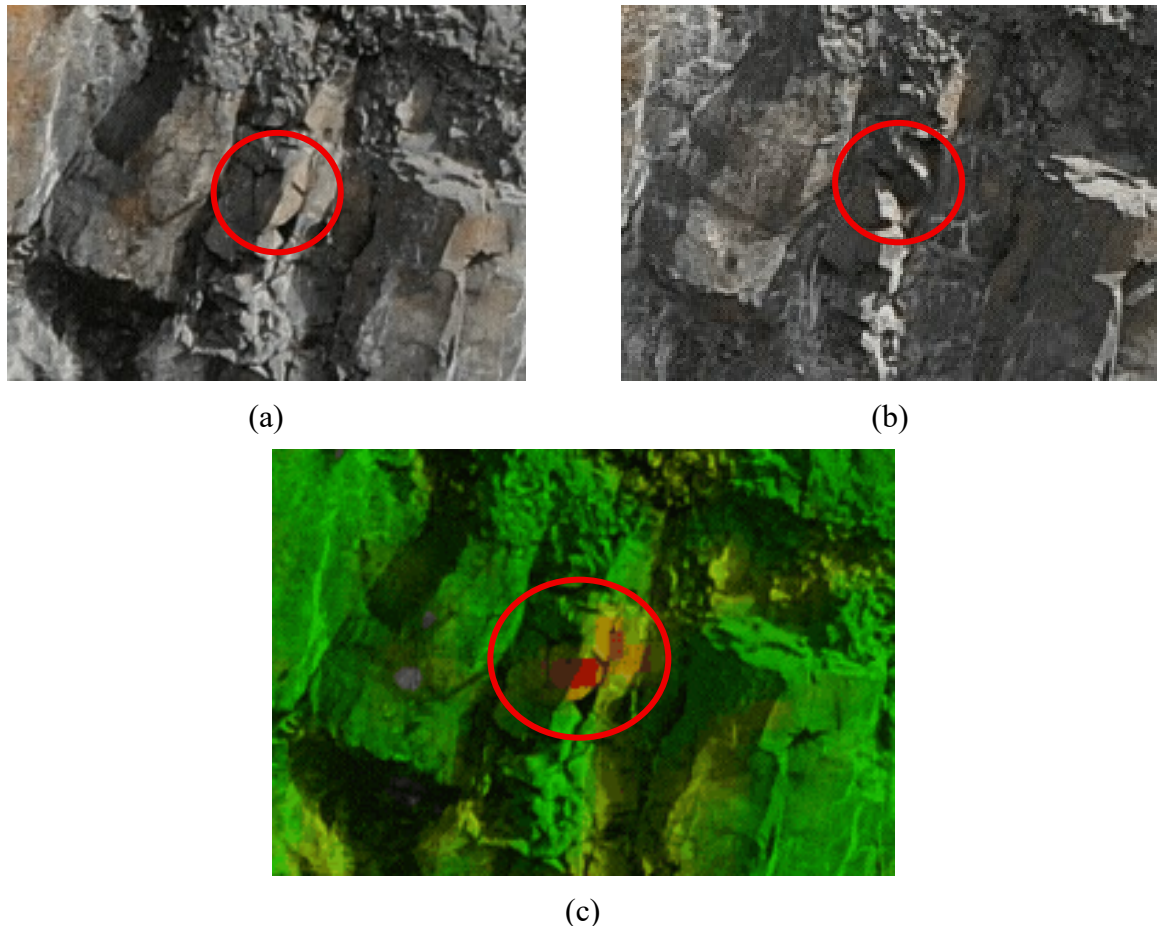
**Figure 6: Example of rock fall detection in the SR14, MP69 dataset: (a) March 25, 2025, dataset, pre-event; (b) May 20, 2025, dataset, post-event; (c) Structural Similarity index result map with red highlights on detected change.**

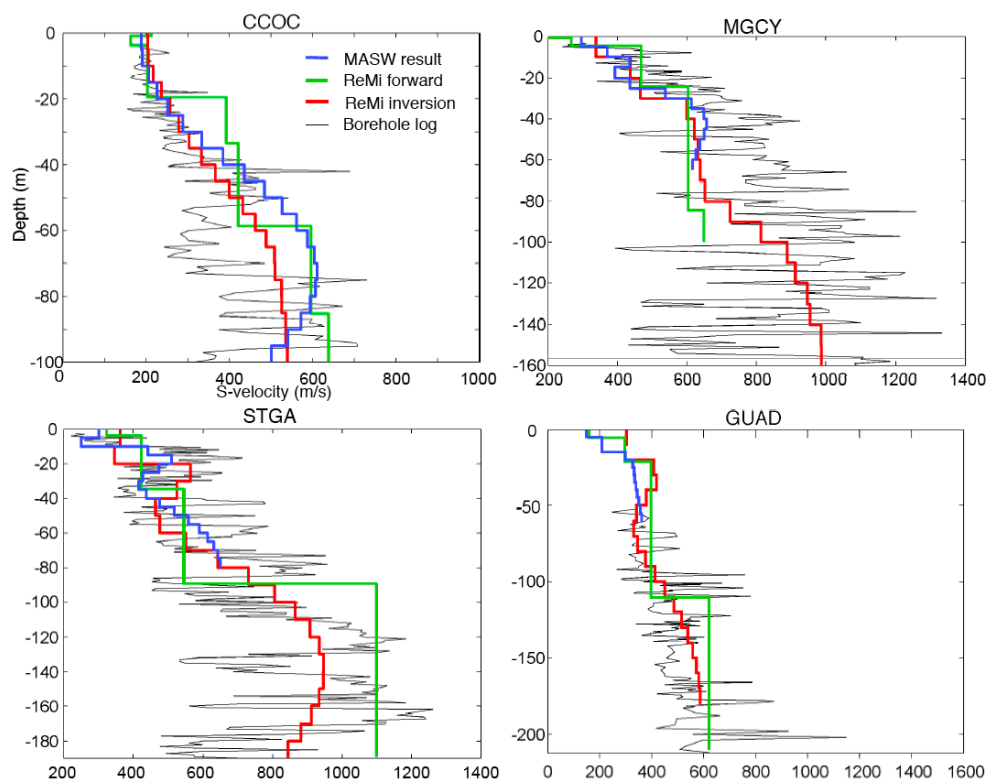
**Figure 1 – Blind comparison of refraction microtremor profiles to MASW and logs (5)**

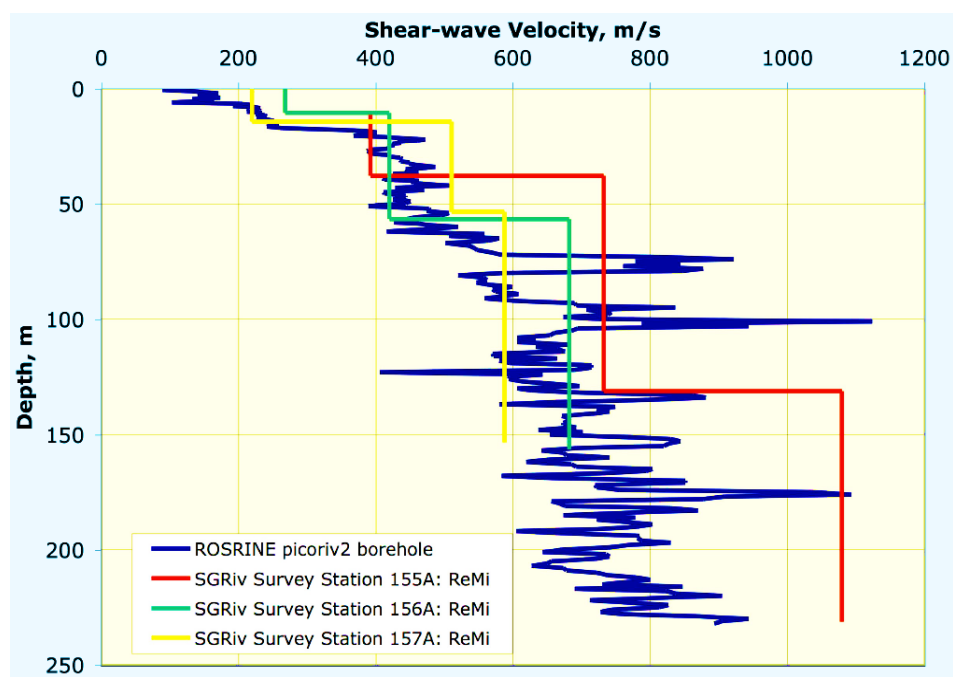
**Figure 2 – Blind comparison of refraction microtremor profiles to a deep Vs log (6)**

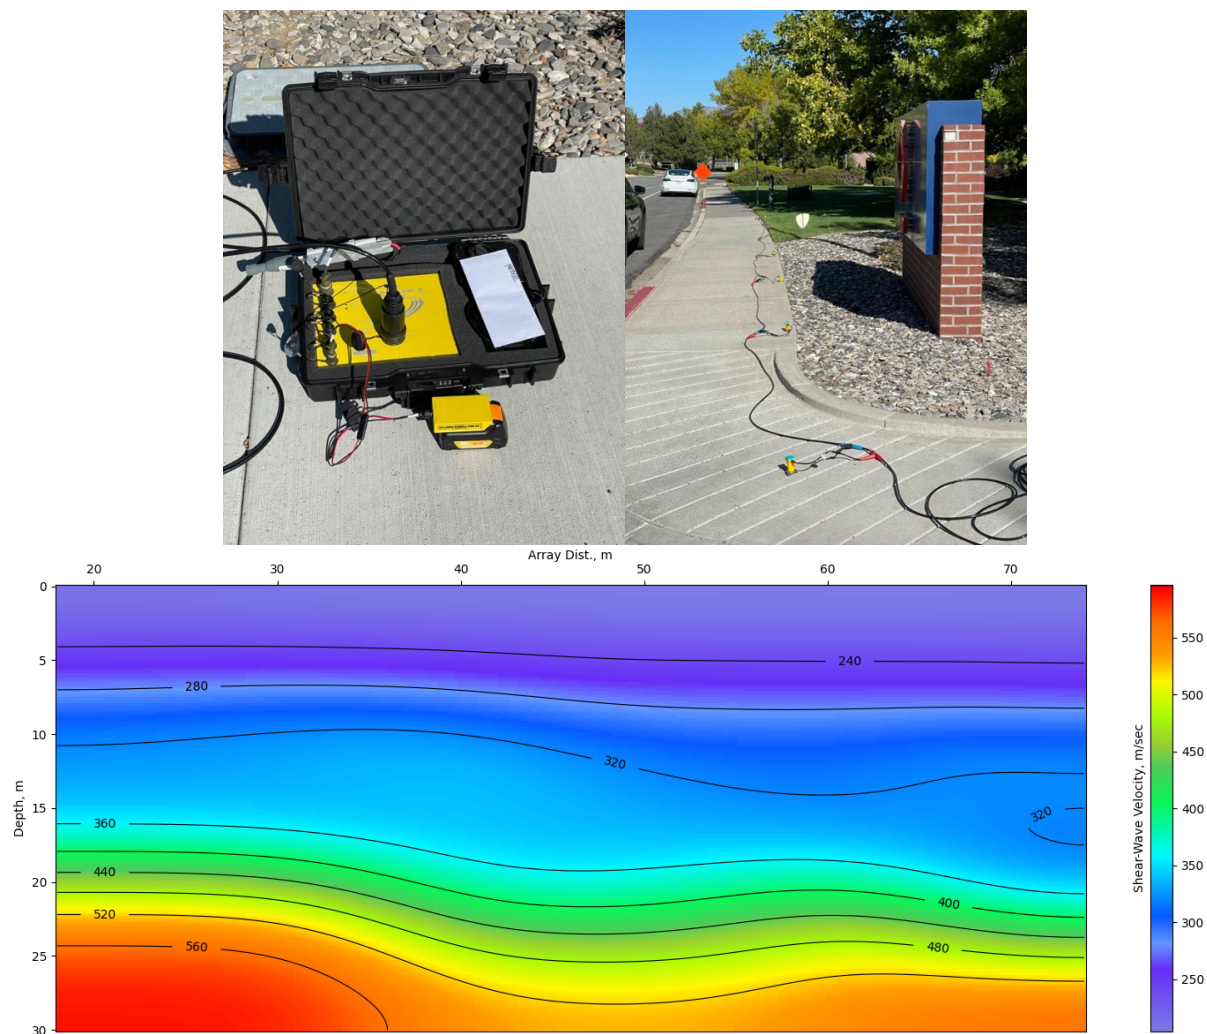
**Figure 3 – (above) Photos of a ReMi®DAQ system deployed at an urban field site. (below) ReMi 2dS™ section measured by Suelo-Estructura near Mexico City (no V.E.).**

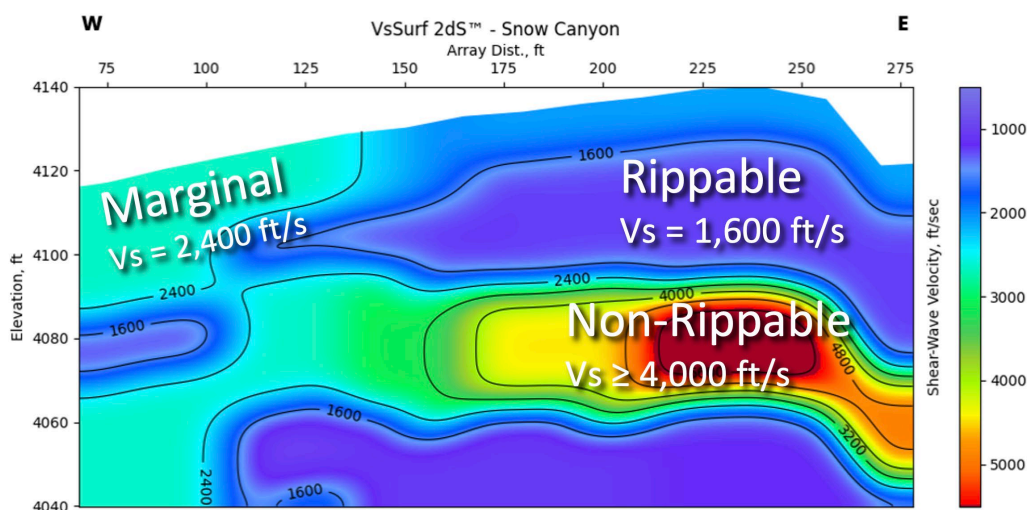
Figure 4 – ReMi 2dS™ section for Utah trail-construction rippability assessment (no V.E.)

For just one of many examples, Landmark Testing conducted a ReMi 2dS™ survey to prepare for the design and construction of an accessible trail at Snow Canyon State Park in southwest Utah. Figure 4 shows the resulting 2dS section. Terēan 2dS™ software and solutions include proprietary technology that allows practitioners to determine rippability of subsurface materials using shear-wave velocities. One concern was that the 20 ft (6 m) topographic ledge would prove to be hard rock resistant to ripping and could have to be blasted to create a level, accessible trail.

The original Caterpillar Handbook of Ripping (7) gives rock and soil rippability as a function of seismic P- or compressional-wave velocity only. Review of ASCE-published literature on the relations between shear-wave and P-wave velocities allowed creation of rippability ranges based on Vs. In this case, the result reveals the subsurface materials to be rippable to marginally rippable in the upper 30 ft (10 m), having shear-wave velocities below 3000 ft/s (900 m/s). The topographic ledge proved to be weathered and fractured to a degree that permitted ripping. This result was verified during the trail construction process.

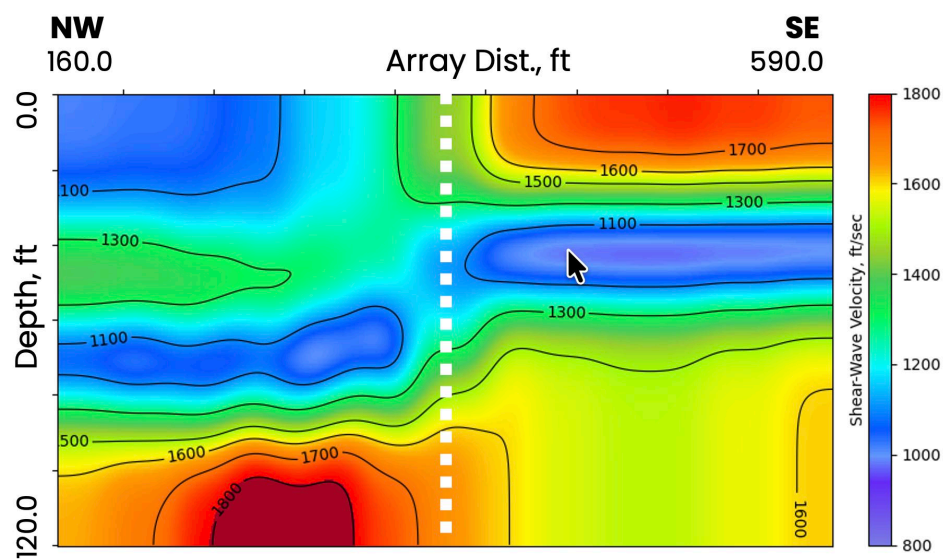
**Figure 5 – ReMi 2dS™ section showing a minor fault in Las Vegas, Nevada (V.E.=2x)**

Figure 5 shows the 2dS section of shear-wave velocity structure resulting from one of the six lines. The longer arrays allowed the section to show structure and stratigraphy to a depth of 120 ft (37 m). Calcified, caliche-cemented soils form the stiff layers colored red, yellow, and green, with shear-wave velocities above 1200 ft/s (360 m/s). The lower-velocity, softer layers are in blue: artificial fill at the surface on the left side, and a clay layer consistently underlying the caliche. Near the center of the section, the stratigraphic package of the caliche layer with its underlying clay is consistently and vertically offset in a normal sense by 30 ft (9 m), down to the northwest. The 2dS section allowed location of the discontinuity, possibly the fault trace at the surface, to an accuracy of 33 ft (10 m). In this case, the likely fault proved to be, within the confines of this accuracy, just where prior mapping (8) had put it.

Some of the six lines suggested definite and consistent discontinuities that are likely the mapped faults but at locations displaced by 100 ft (30 m) from the mapped trace (8). Other lines produced sections that showed anastomosing and inconsistently layered caliche and do not suggest faulting. Southwest Geotechnical followed up with targeted drilling to confirm fault locations more accurately than 33 ft (10 m). The developer is using this information to plan building on the site, with the required setbacks from the possibly active normal faults.

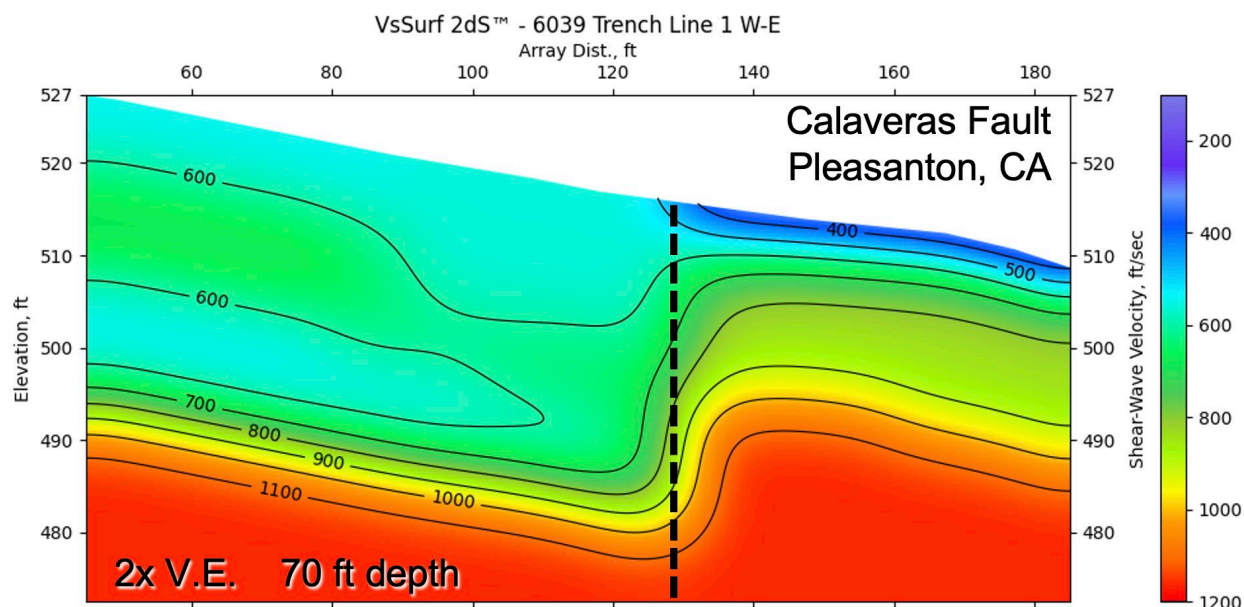
**Figure 6 – ReMi 2dS™ section across the Calaveras fault (V.E.=2x)**

Achievement deployed three ReMi 2dS™ arrays, each 230 ft (70 m) long of industry-standard ReMiDAQ® recording of 24 seismic sensors. The ReMiDAQ® solution has Terēan's ReMi QAQC™ software built in, assuring rapid recording of high-quality array data. Each array took only 30 min to deploy, record for 15 minutes, and pick up. On-line active-source hammer blows were included, for full code compliance. Figure 6 shows one of the sections. The clear lateral discontinuities locate this major strike-slip fault with an accuracy of 10-15 ft (3-5 m). Alameda County was the permitting authority for this development, and they allowed planning and construction to proceed, given the fault location at this level of precision. Further paleoseismic study at this site, if undertaken for research purposes, could be efficiently targeted at this site as a result.

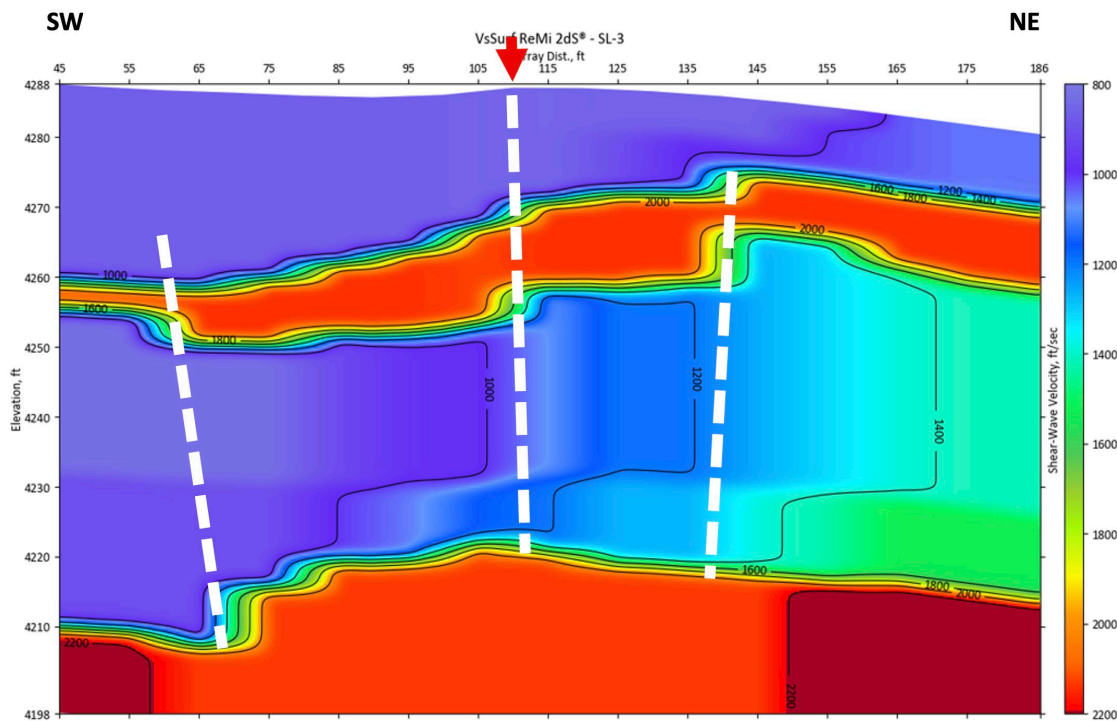
**Figure 7 – ReMi 2dS™ section locating the Honey Lake fault zone (no V.E.)**

Crawford ran three ReMi 2dS™ arrays at the location of the proposed wildlife crossing, two oriented to cross the Honey Lake fault zone and one parallel to it. Figure 7 shows the Vs section resulting from one of the fault-crossing lines. At this location the fault is divided into several near-parallel strands creating a fault zone about 100 ft (30 m) wide. The strands are part of a left-stepping en-echelon structure, which on a right-lateral fault creates a push-up and a classic shutter ridge. Figure 7 finds the push-up to be the result of a positive flower structure on the NE side of the section. On the SW side of the section there may be a sag, the surface expression of a negative flower structure. A few feet of topographic relief express the sag and the push-up, from left to right. More prominent is the expression of perhaps 10 ft (3 m) of sag and push-up in the depths of the fast and slow units below. There are “pinches” in the upper stiff layer in red, that may correlate with three traces of the fault in the section. Since this is mainly a strike-slip fault, the vertical offsets do not have to consistent from depth to the surface. The central strand dividing the two flower structures comes to the surface at the location of a fault scarp Crawford identified from a Lidar survey, marked with a red arrow on Figure 7.

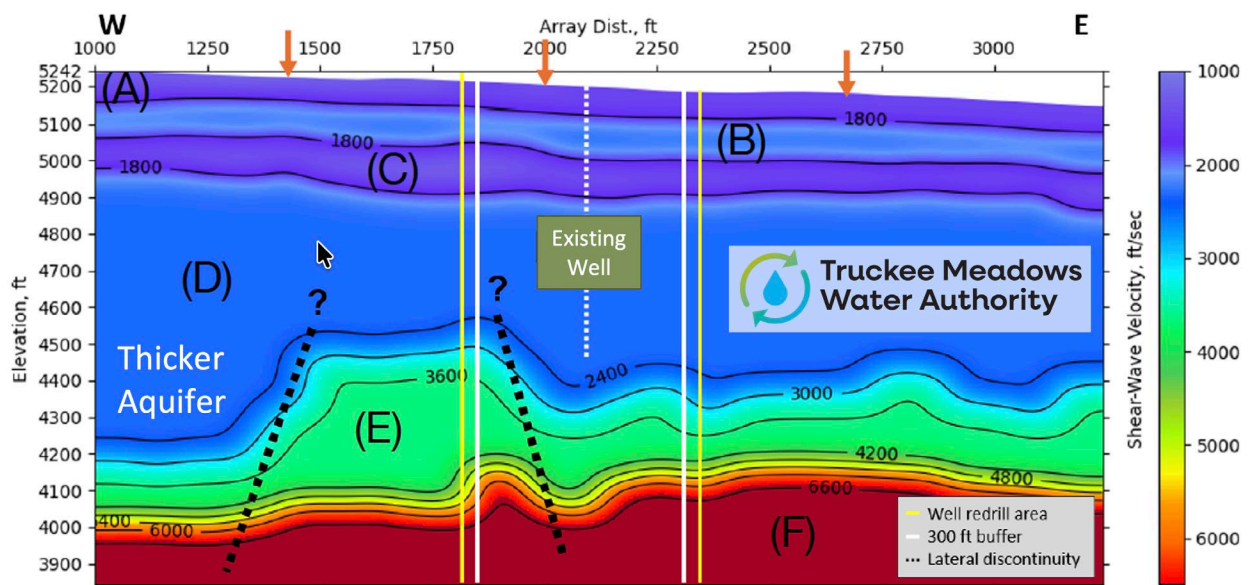
Figure 8 – ReMi 2dS™ locating changes in deep aquifer thickness (no V.E.)

Figure 8 shows the section resulting from a survey in urban south Reno, centered on a 30-year-old well due for refurbishment. The survey layout and recording took less than 6 hours. Correlating the Vs units in the section to the log and production data from the existing well allows the section to extend the identification of hydrostratigraphic units away from the well. The main production aquifer is the lower blue unit (D). The section suggests the aquifer may be thicker and the resource more accessible on the west side of the section. TMWA can input these

A further point of interest on Figure 8 is where the section crosses a few of the very numerous traces of the active Mount Rose fault zone in the USGS database (8), at the orange arrows. This fault zone has both strike slip and normal slip. No significant discontinuities are visible below these locations in the boundaries of the more recent shallow units (A), (B), or (C). Given the 10%-of-depth vertical resolution criterion, it appears that even if these fault strands had been active in the Quaternary, there was not enough motion on any of them to produce as much as 10 ft (3 m) of vertical displacement. Earthquake geologists can consider these limits as they seek to characterize this complex fault system.

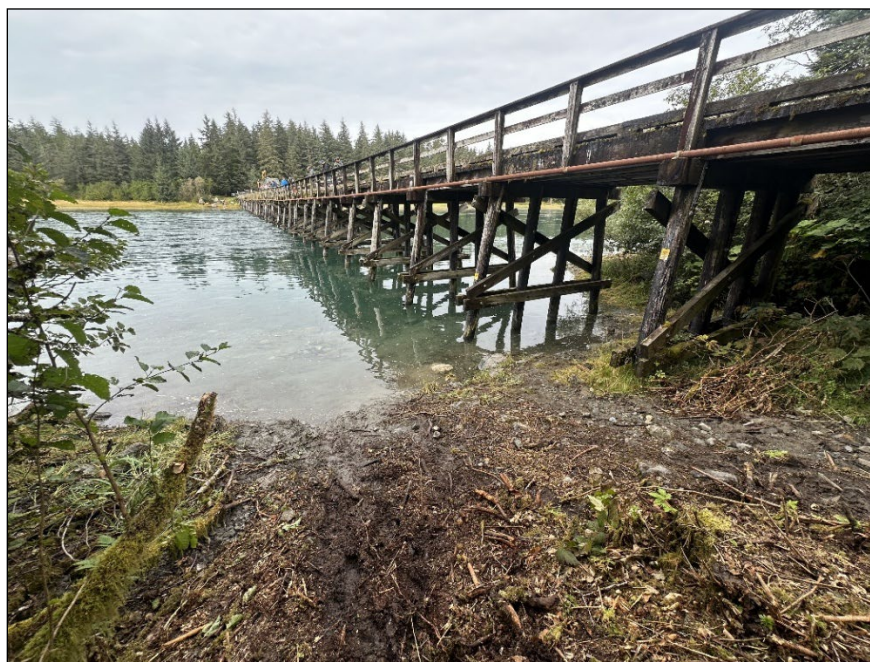
Figure 1: Ankau Bridge in Yakutat, Alaska

The Ankau Bridge spans Ankau Slough in Yakutat, Alaska, and provides access to recreational and culturally significant areas used by the local community. Constructed in 1961, the approximately 500-foot-long timber bridge (Figure 1) has experienced significant deterioration from decades of exposure to the tidal inlet marine environment. During its most recent inspection in 2022, the bridge received a Poor condition rating under the National Bridge Inventory, prompting the development of a replacement. DOWL was retained by DJ&A to perform the geotechnical investigation and develop foundation recommendations and assist with the design of the proposed bridge replacement.

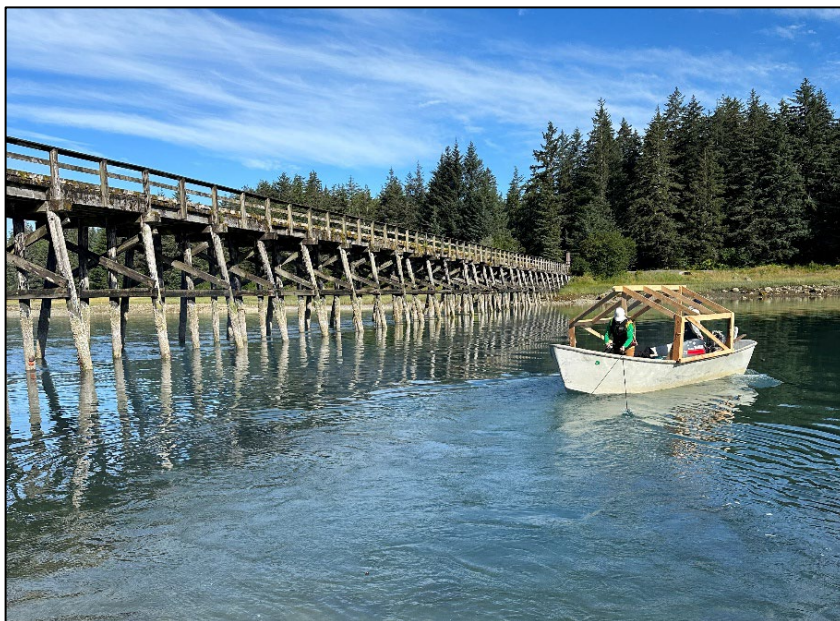
Figure 3: Hydrophones getting strung out across the channel by boat

Because portions of the survey alignment extended into the channel, the investigation used a combination of marine and land-based passive surface-wave methods (linear microtremor analysis). These methods measure naturally occurring ambient vibrations generated by sources such as tidal action, waves, distant earthquakes, and vehicle or marine traffic. Hydrophones were deployed within the channel, and geophones were used on land to collect continuous seismic data along survey lines parallel and perpendicular to the bridge.
