# 75<sup>TH</sup> HIGHWAY GEOLOGY SYMPOSIUM

BETTER HIGHWAYS THROUGH APPLIED GEOLOGY

2026  
HGS  
PROCEEDINGS

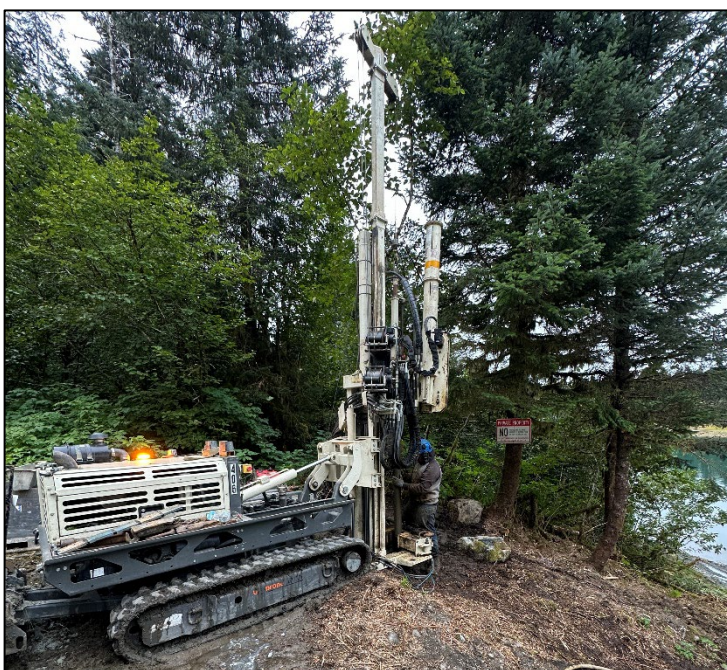
Figure 4: Drill rig advancing a boring at the north abutment

Borings were advanced using track-mounted drill rig fitted with wash rotary tooling, a conventional geotechnical exploration method suitable for overburden soils and weak to moderately cemented rock. The method uses a rotating drill bit and circulating drilling fluid to loosen and remove cuttings, stabilize the borehole, and facilitate advancement through coarse-grained and variable subsurface materials. Soil samples were collected at regular depth intervals using split-spoon samplers, and penetration testing was performed to evaluate the relative density and consistency of subsurface soils. Due to the presence of coarse-grained deposits and challenges with sample recovery, both standard and modified penetration testing methods were utilized.

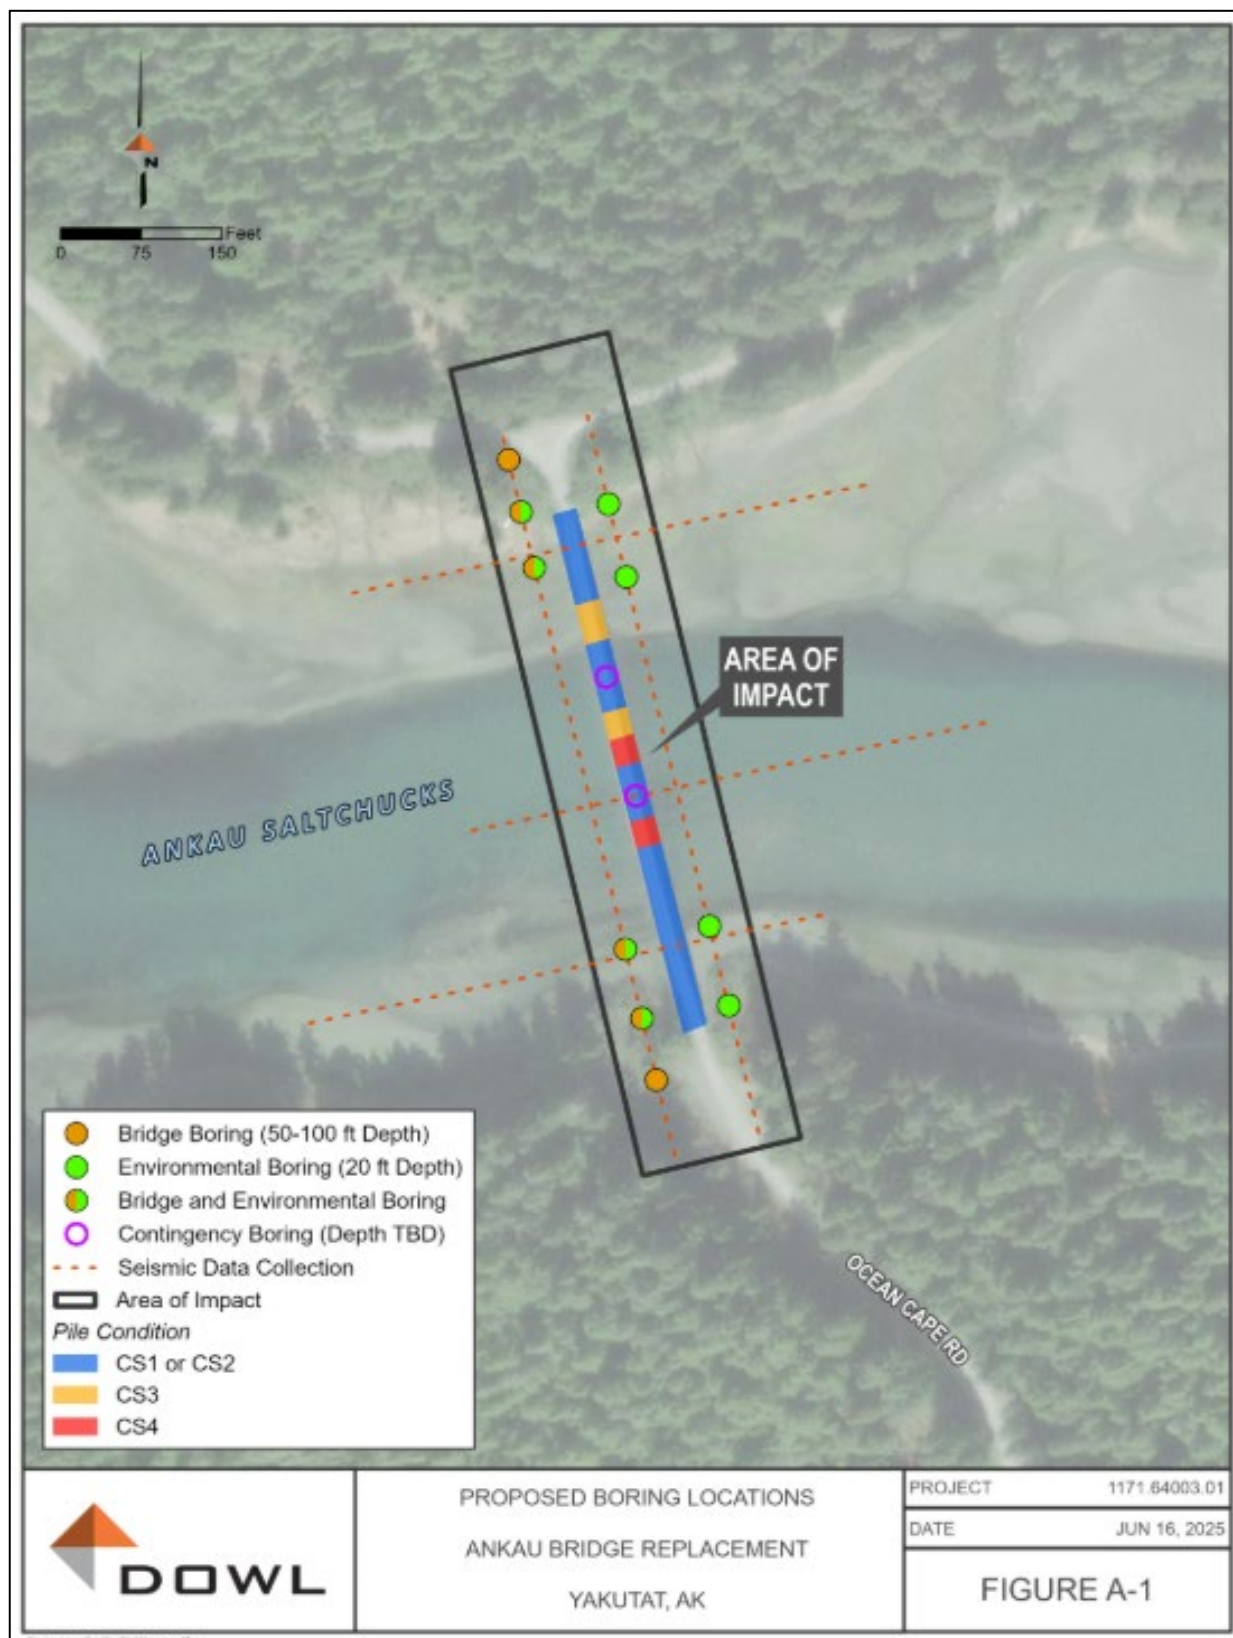
Figure 5: Geotechnical and Geophysical Data Collection Plan

The full geotechnical and geophysical data collection plan relative to the existing bridge is shown in Figure 5.

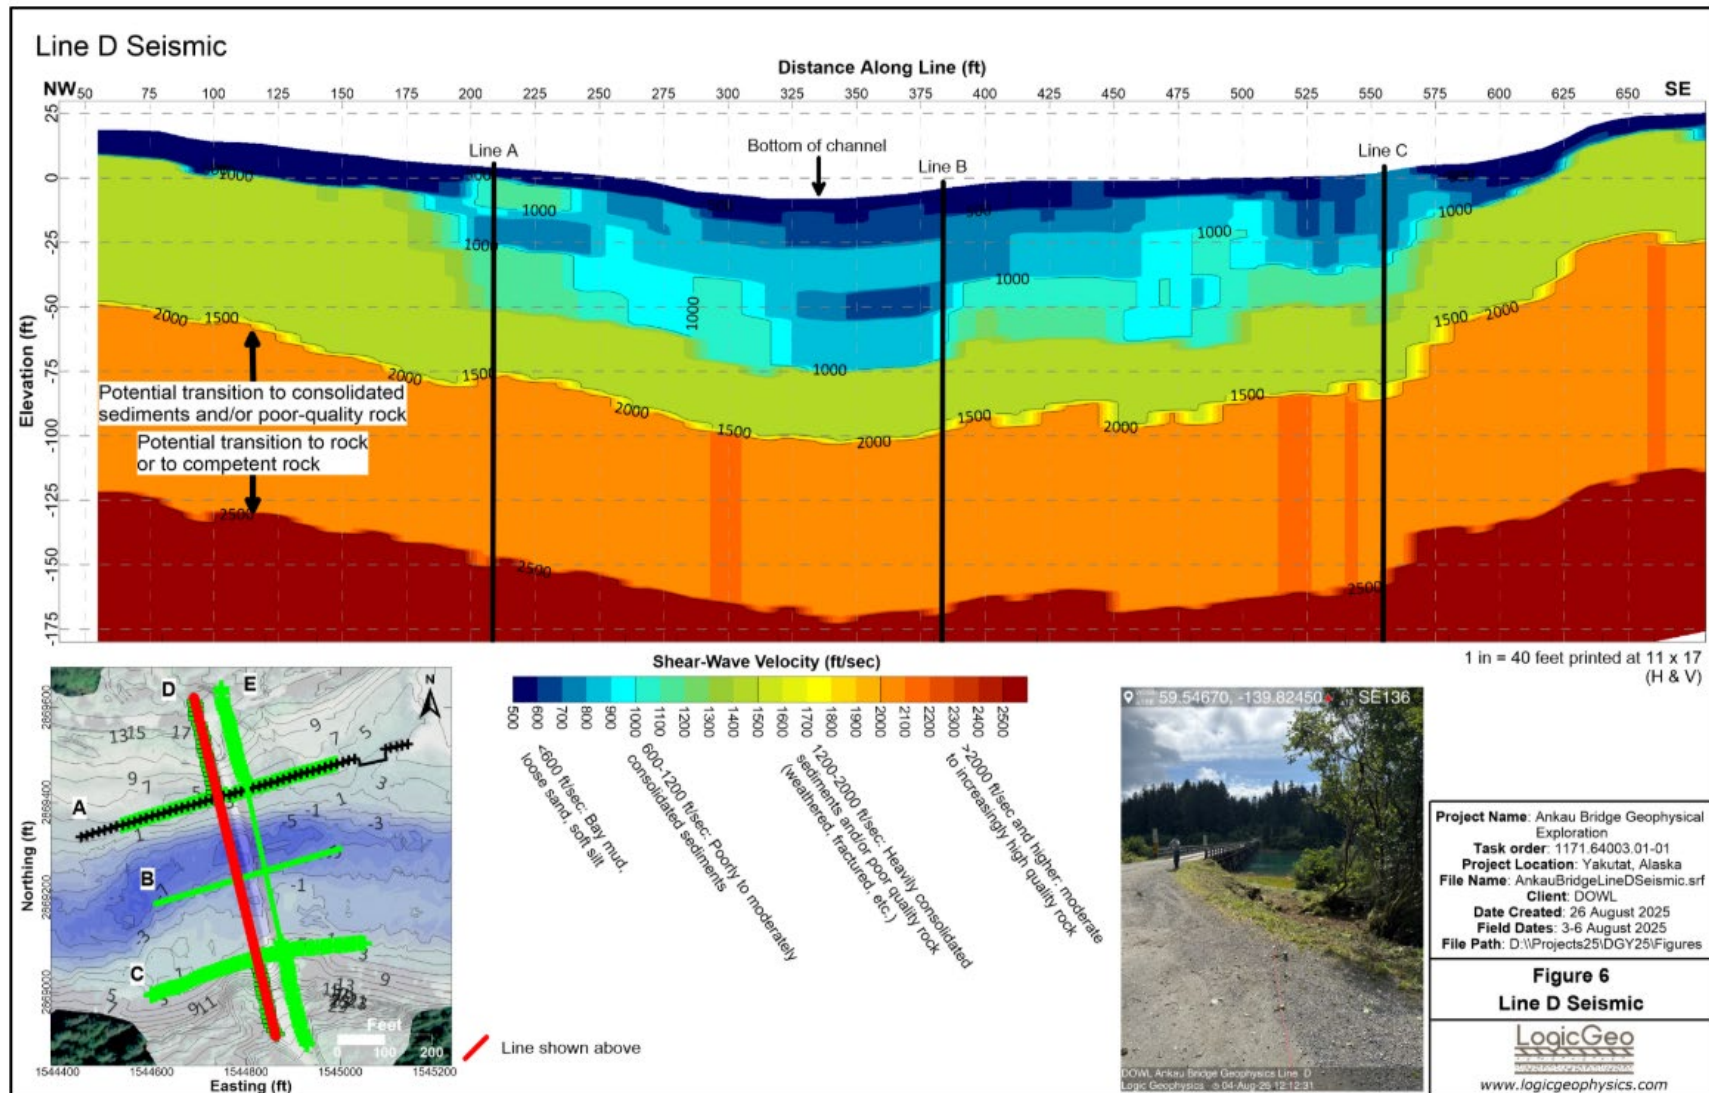
Figure 6: Vs profile parallel to the existing bridge, combination land-based and marine profile

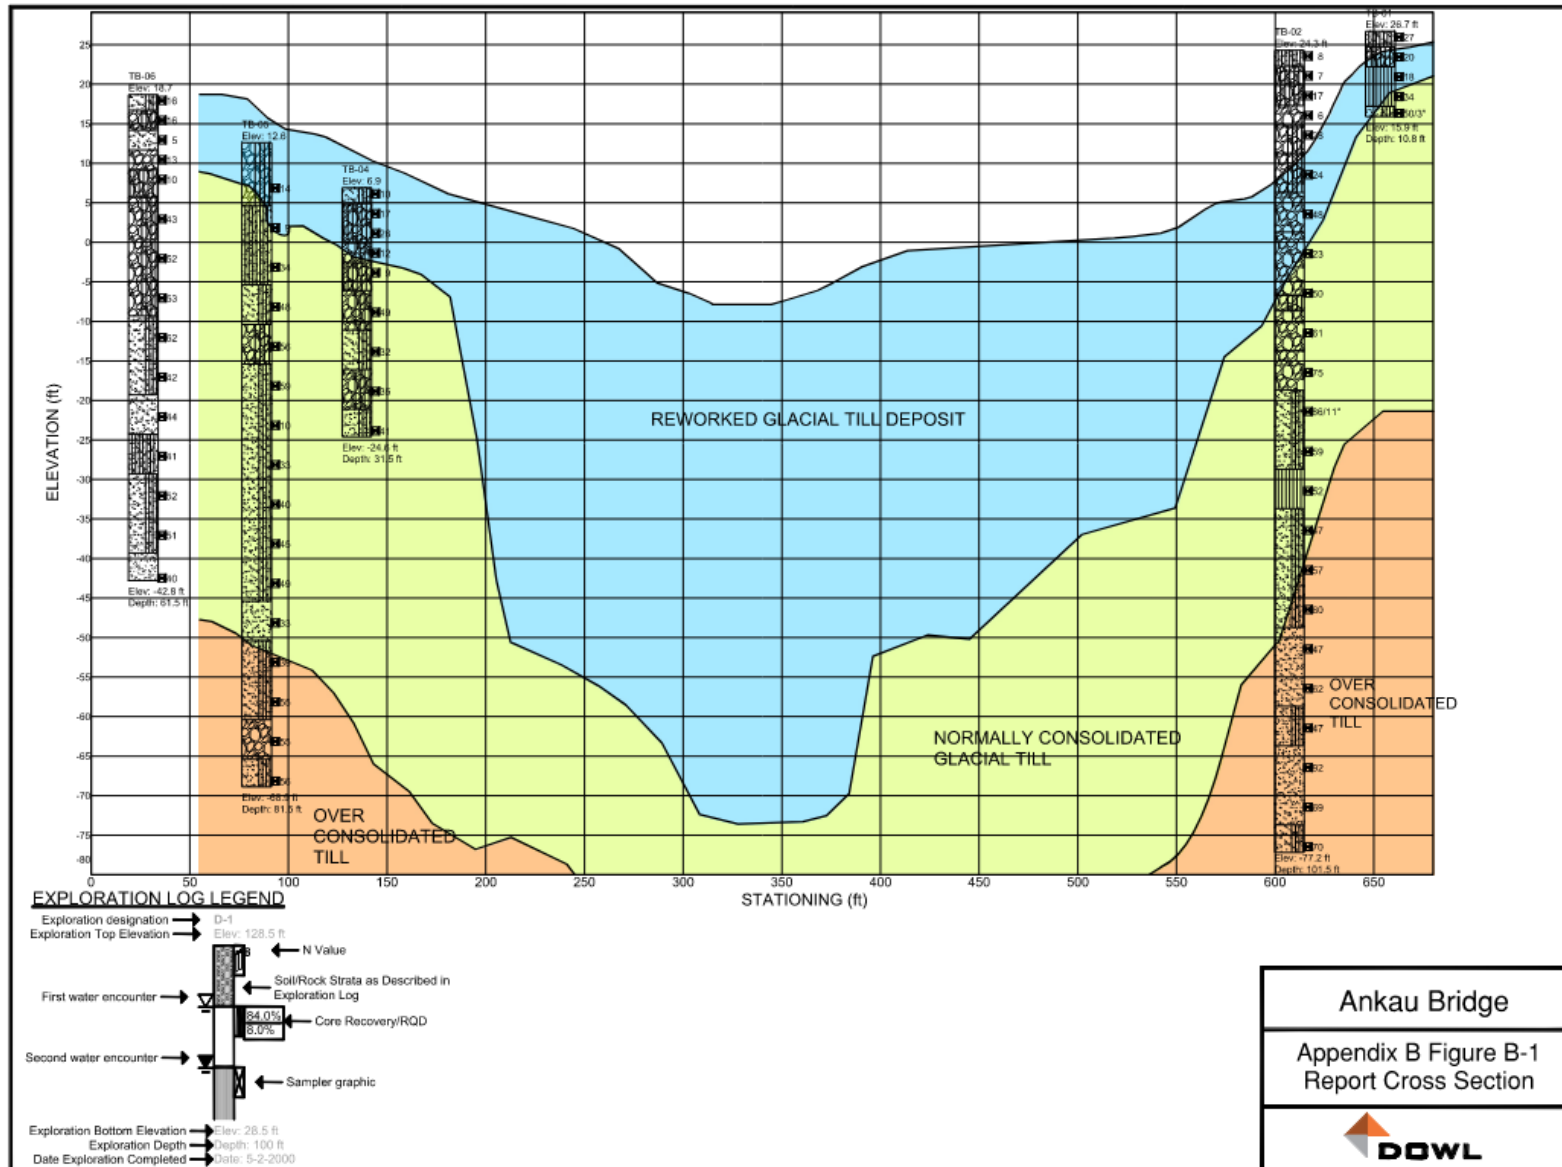
Figure 7: Interpreted generalized cross section using geotechnical boring and geophysical profiles

Underlying the shallow topsoil layer, subsurface conditions interpreted from the Vs profiles (Figure 6) and confirmed by selected geotechnical borings were generally consistent across the alignment and with published geologic mapping for the Yakutat region. For the purposes of this project, the subsurface was divided into three generalized geologic units: (1) reworked glacial till, (2) normally consolidated glacial till, and (3) over-consolidated glacial till. These units are based on field observations, laboratory testing, and interpretation of the geophysical data and represent the generalized subsurface conditions along the proposed bridge alignment (Figure 7).

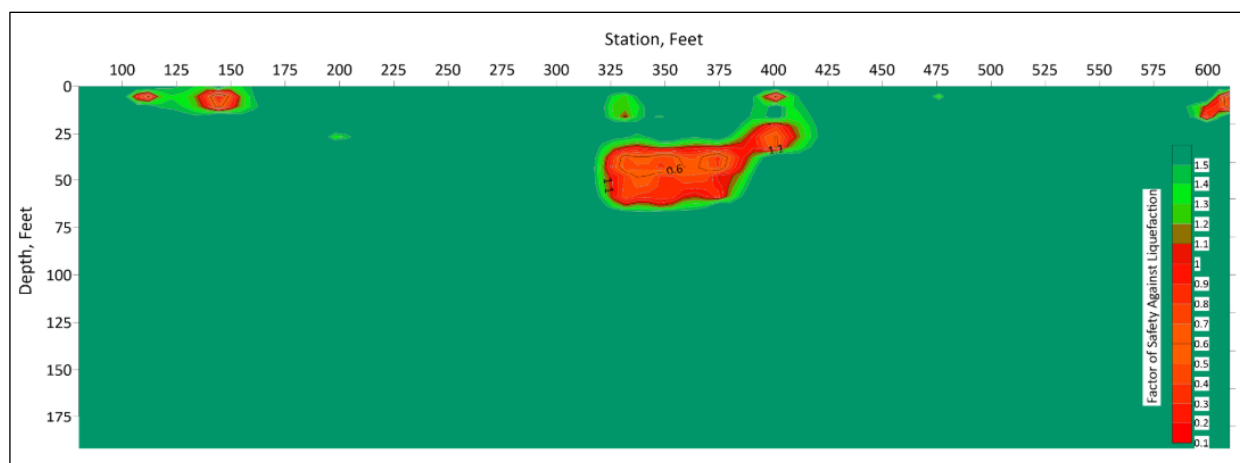
Figure 8: Liquefaction analysis results. The channel is located between stations 225 and 550

The design seismic loading used for liquefaction triggering analyses was based on a moment magnitude ( $M_w$ ) of 7.4 and a peak ground acceleration (PGA) of 0.62g. The PGA corresponds to the mapped seismic acceleration coefficient for Site Class D obtained from the AASHTO hazard maps. Site Class D was selected for defining the input ground motion because the mapped acceleration coefficient is determined prior to the application of site-specific site class adjustments and therefore provides a consistent basis for liquefaction triggering evaluations. Liquefaction susceptibility was assessed using the Vs-based procedure developed by Kayen et al. (2013). Results of the analysis indicate the presence of a laterally continuous liquefiable layer within the channel, extending from approximately 34 to 64 feet bgs between Stations 315 and 390 (Figure 8). This identified liquefiable zone represents the primary area of concern for seismic ground deformation and potential impacts on foundation performance.

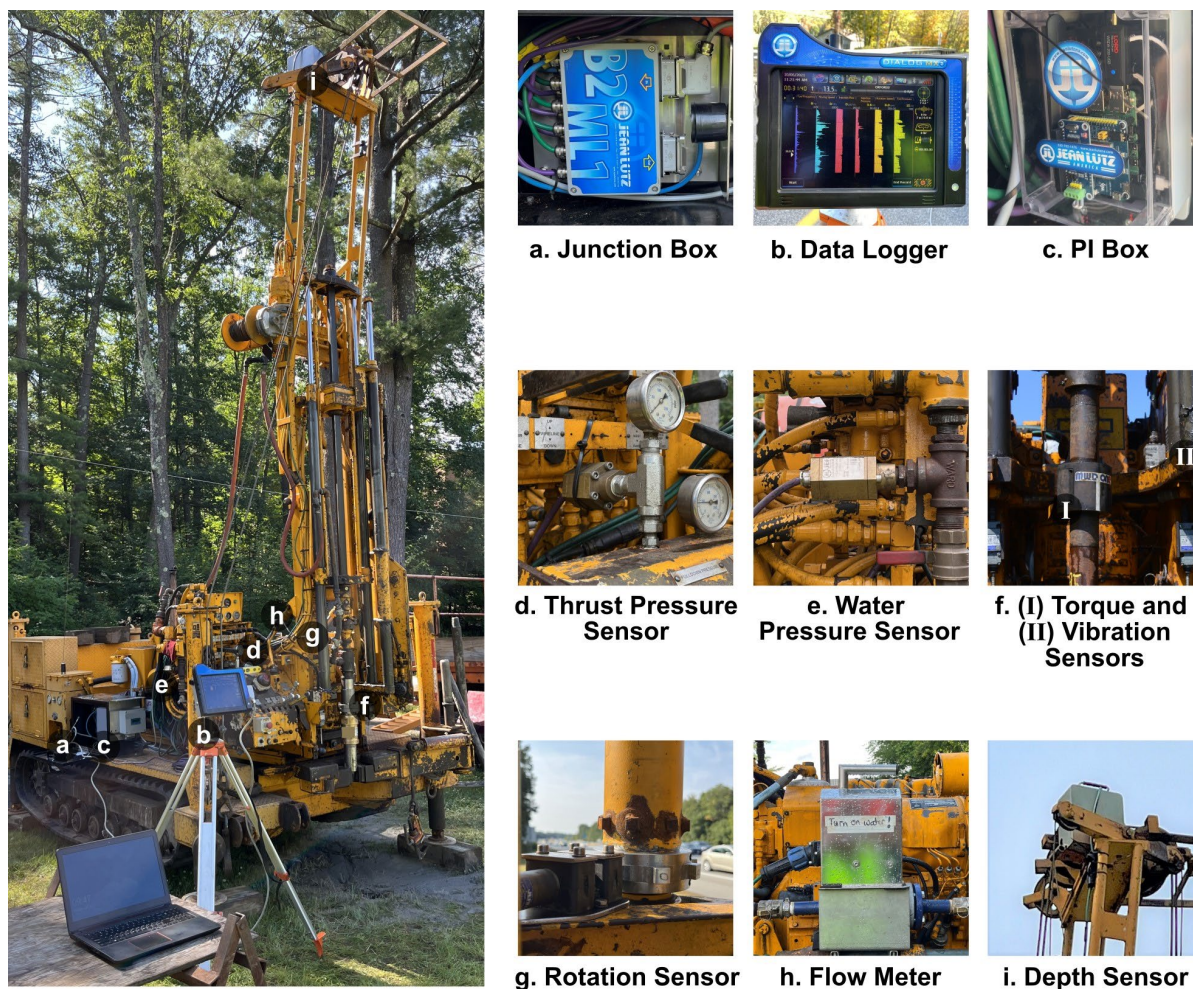
**Figure 1. MWD equipment installed on a track-mounted CME-45C drill rig.**

Drilling fluid to assist drilling operations has traditionally been water for most boreholes drilled by the NHDOT. The inflow is measured with an electromagnetic flowmeter attached downstream of the drill rig pump, as shown in Figure 1h. The flowmeter records flow via electronic pulses and can therefore handle mud or water used as a drill fluid. The driller directly controls the inflow with a valve to ensure efficient removal of cuttings and reduce wear on the drill bit when coring rock. However, without the MWD instrumentation, precise flow-rate information is unavailable. In addition to the inflow, a second flowmeter can be installed at the outflow to measure the fluid lost in the subsurface (fluid lost = inflow – outflow). Measuring the net flow is especially useful in detecting cavities, fractures, or very porous geological material.

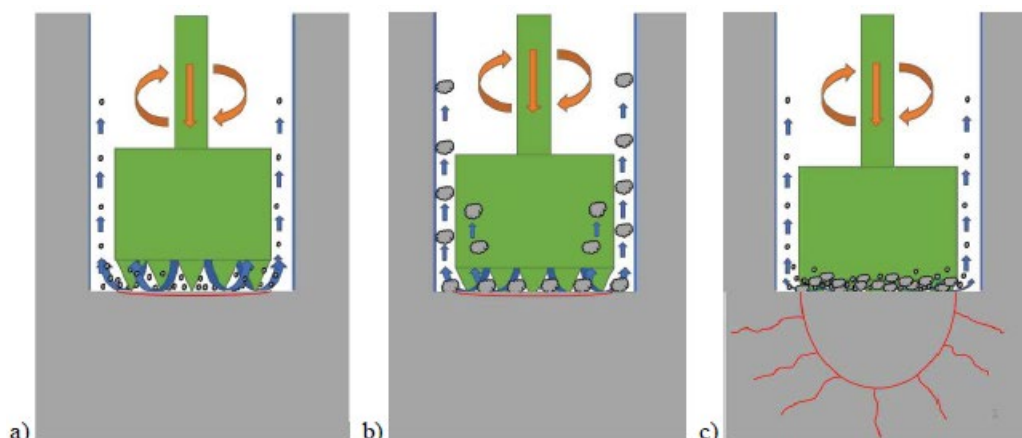
**Figure 3 – The three phases of non-percussive rotary drilling after Rodgers et al. (14).  
a) Inefficient Phase 1, b) optimized Phase 2, and c) destructive Phase 3.**

Drawing on the three drilling phases originally conceptualized by Teale (5) represented in Figure 3, Rodgers et al. (14) describe Phase 1 as an inefficient condition in which insufficient downthrust force prevents adequate bit engagement; the bit tends to slide or grind against the formation, and much of the measured energy is dissipated through friction rather than material removal. Phase 2 represents the optimal drilling condition, characterized by sufficient but not excessive crowd, stable penetration per rotation, effective bit indentation, and efficient cuttings removal. Under these conditions, the drilling response is governed primarily by the resistance of the geological material, producing more representative and repeatable MWD parameters, improved core recovery, and stronger correlations between specific energy and conventional strength measurements. In contrast, Phase 3 occurs when excessive downthrust or inadequate flushing causes cuttings to accumulate beneath the bit, leading to regrinding, elevated torque and energy demand, tool wear, sample disturbance, and unreliable strength estimates. Rodgers et al. (14) therefore argue that MWD should be conducted as close as possible to Phase 2, since efficient drilling minimizes equipment- and procedure-related influences and allows recorded parameters to better reflect actual subsurface conditions. This is critical for obtaining high-quality, design-relevant assessments rather than measurements dominated by drilling inefficiencies.

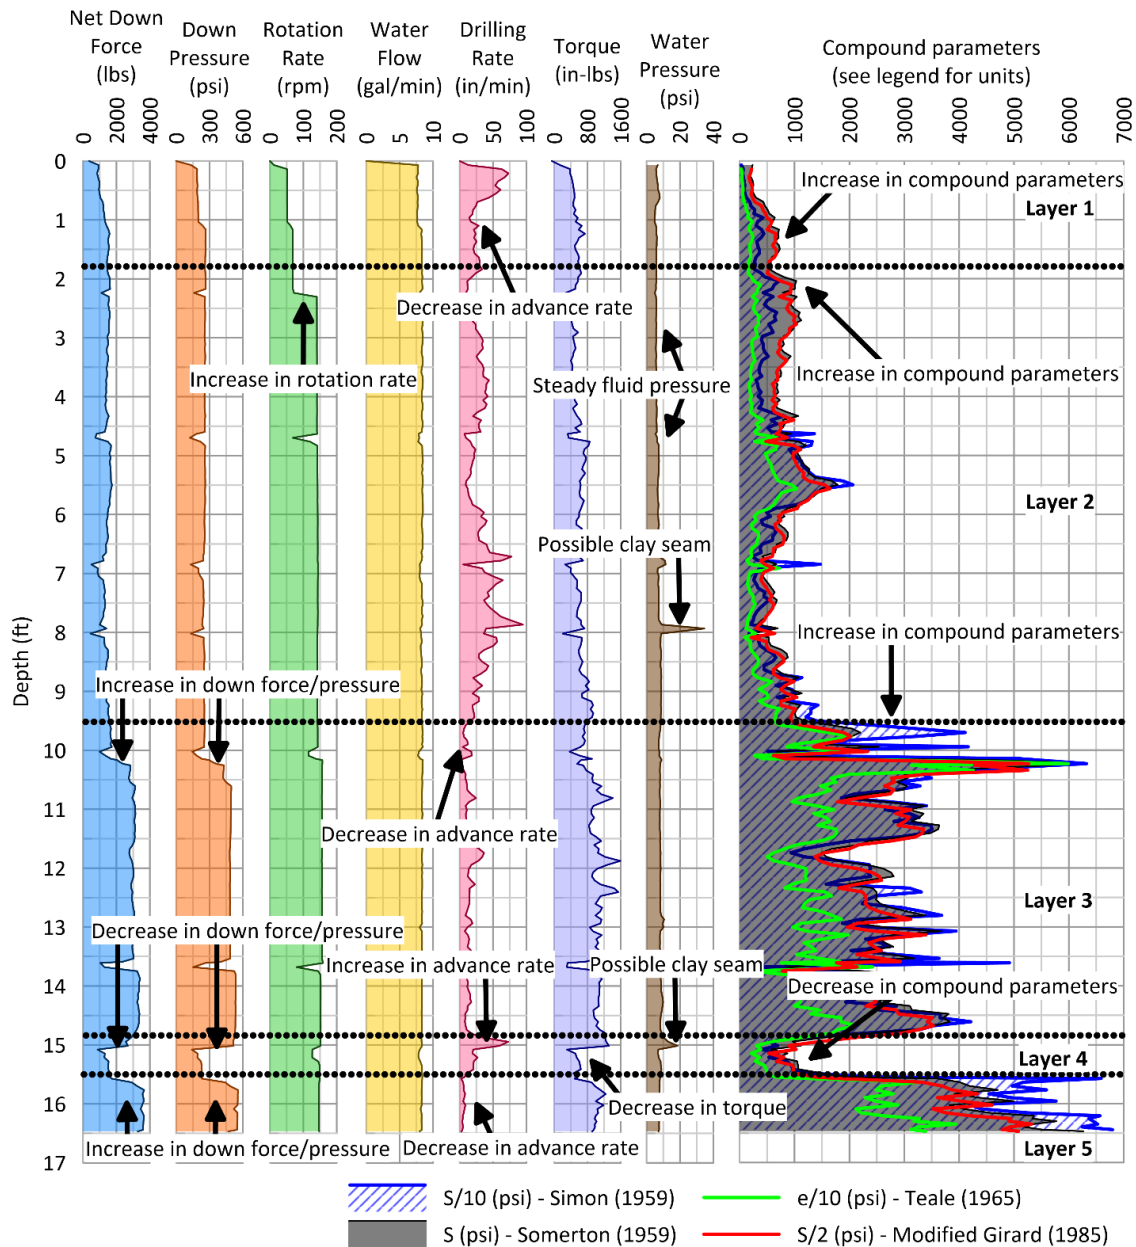
**Figure 3 – Soil overburden drilling MWD profile in Londonderry, NH.**

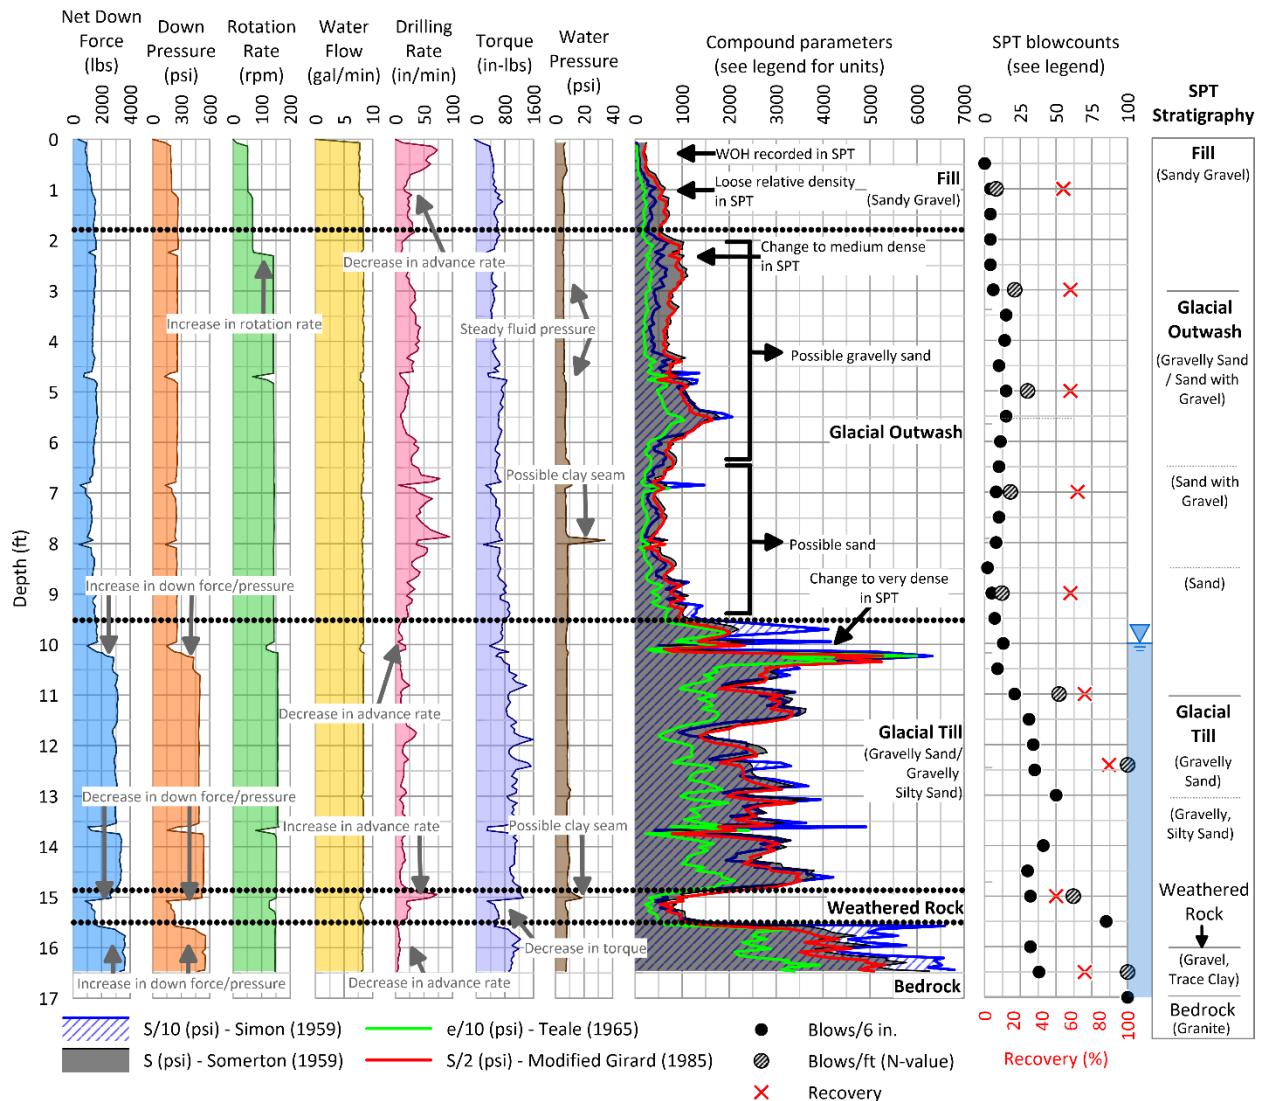
Figure 4 – MWD profile shown in Figure 3 compared to adjacent SPT.

Some differences between the profiles are expected due to the variability of glacial deposits. For example, a boulder logged between 12.8 and 13.9 ft in the SPT borehole was not encountered in the MWD borehole. Weathered rock was also encountered slightly shallower in the MWD

borehole, at approximately 15 ft. In addition, SPT recovery in these deposits was generally below 100% and often near 50%, which limits the precision of the stratigraphic log. The comparison therefore shows that MWD can complement discrete SPT information by providing a continuous profile of changes in drilling response, while interpretation remains stronger when supported by cuttings and nearby borehole data.

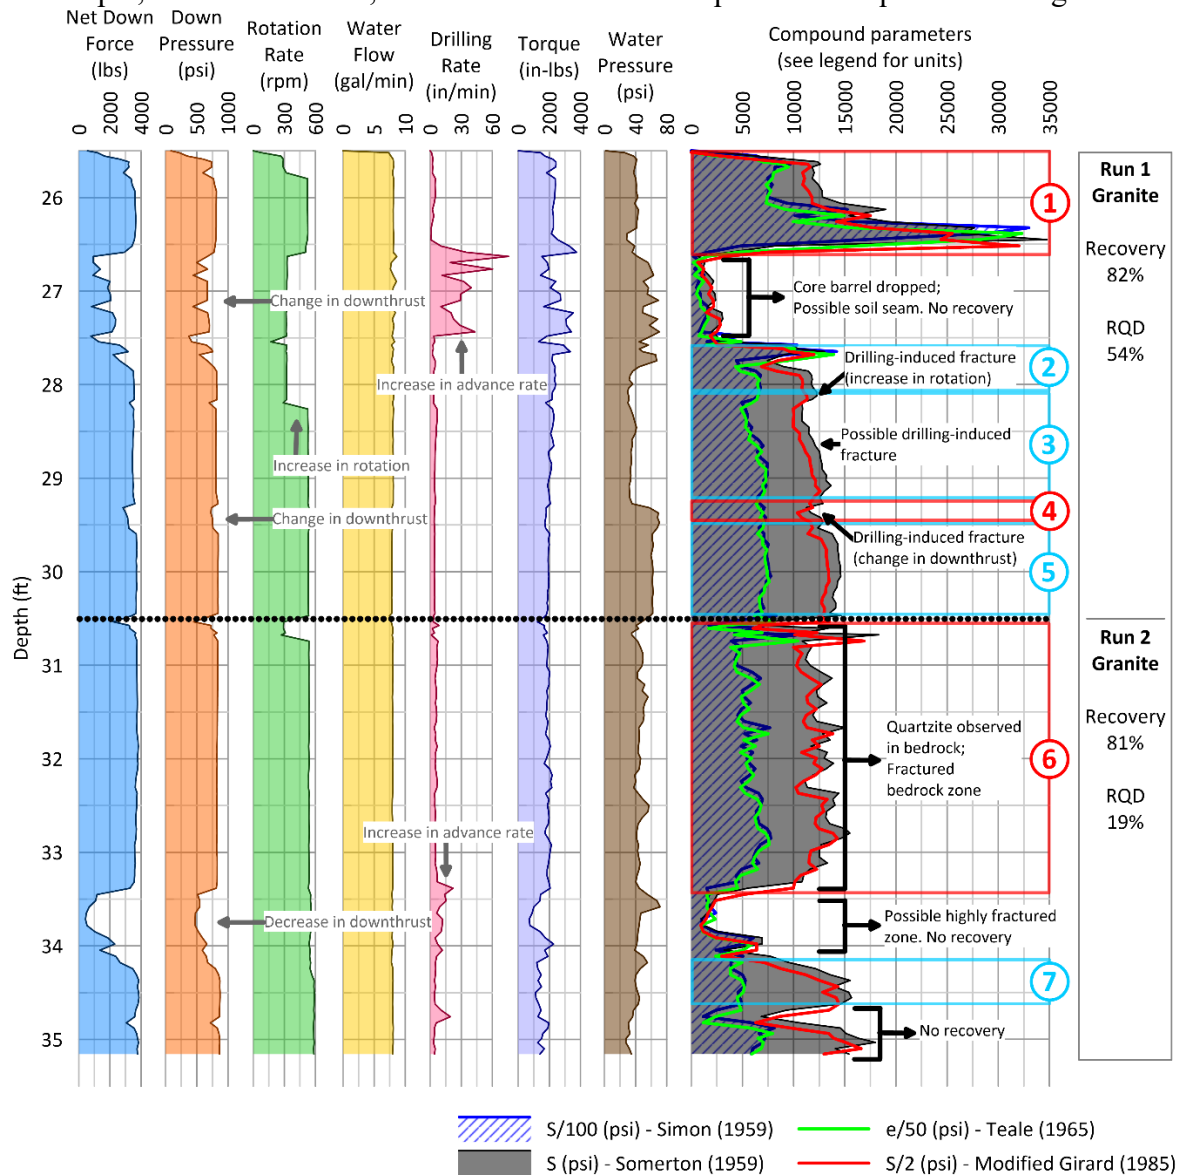
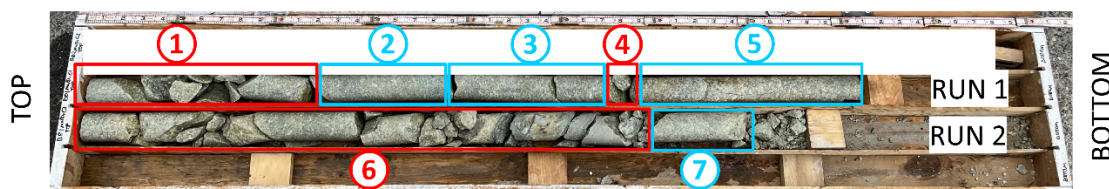
**Run 1 (25.5' - 30.5'):** Hard, slightly weathered, slightly fractured, medium grained, light greenish gray GRANITE.

Low to moderate angle fractures with serpentinite and clay coatings. Dropped from 26.5' to 27.5'.

**Run 2 (30.5' - 35.2'):** Hard, moderately weathered, medium to coarse grained, light greenish gray GRANITE.

Low to moderate angle fractures with clay coatings. 0 to 3' layer of gray quartzite.

**Figure 5 – Rock coring MWD profile in Londonderry, NH.**

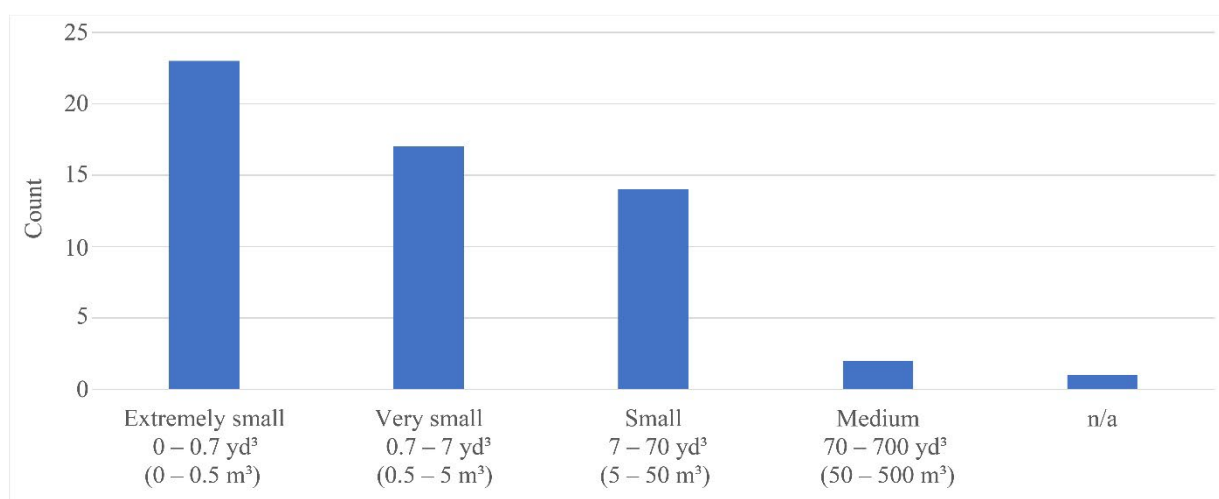
**Figure 2 – Number of rockfall events by impacting volume class (n=57). Range of values for each volume class are shown using the classifications of Wieczorek et al. (11).**

The majority of documented rockfall-vehicle impact events for which source area type information was available ( $n = 54$ ) were initiated from cliffs (63%) compared to roadcuts (37%). This information is critical for assessing overall risk from natural versus engineered components of roadways and may be subject to varying levels of engineering, environmental, and safety standards depending on the location. Impacting rockfall volumes (Figure 2) ranged from extremely small ( $0.001 \text{ yd}^3$ ;  $0.001 \text{ m}^3$ ) to medium ( $130 \text{ yd}^3$ ;  $100 \text{ m}^3$ ) using the classifications of Wieczorek et al. (11). Total volumes involved in the events spanned a larger range (Figure 3) from softball sized rocks ( $0.003 \text{ yd}^3$ ;  $0.002 \text{ m}^3$ ) to considerably larger volumes ( $16,000 \text{ yd}^3$ ;  $12,000 \text{ m}^3$ ). The volume distribution is skewed towards the smaller volume classes for both impacting and total event volume (consistent with published studies; 12) but still show the sizeable range over which impacting rockfalls occur.

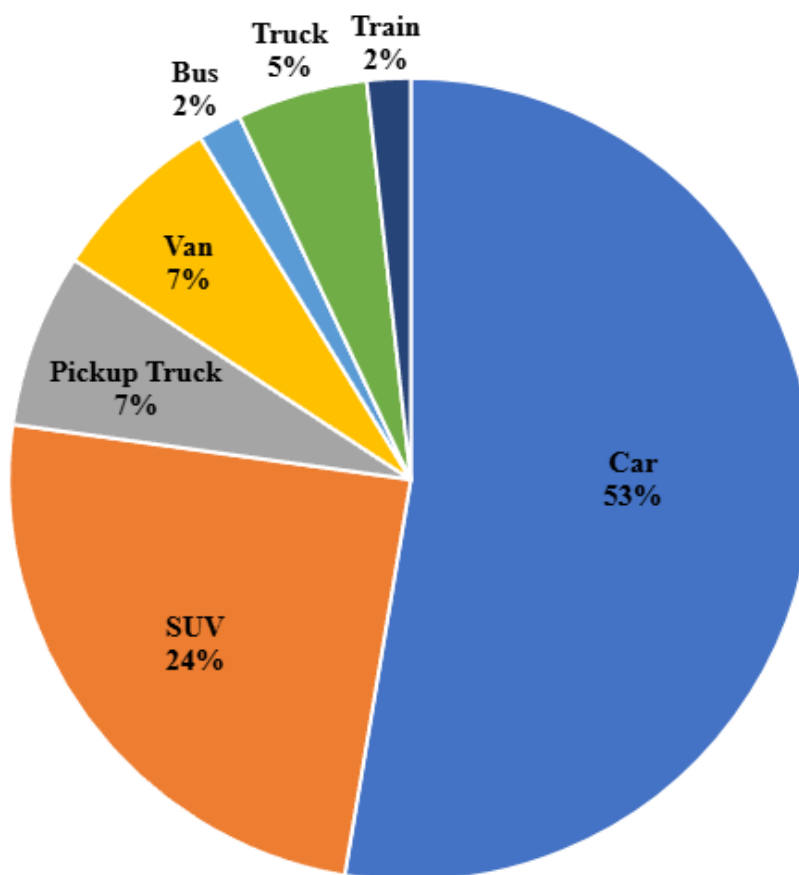
**Figure 4 - Rockfall vehicle impact event by vehicle type (n=57).**

Passenger cars (53%) and SUVs (24%) account for the majority of vehicle types in the database (Figure 4). This is likely consistent with the types of vehicles typically transiting roadways in the countries where rockfalls have been documented. The physical vulnerability of different vehicles and the resulting outcomes for people within those vehicles may be influenced by the type of vehicle struck by a rockfall. For example, a pickup truck or SUV is likely to be higher off the ground and potentially constructed of sturdier structural components if the vehicle has been made to carry heavy loads. On the other hand, the total vulnerability of a particular vehicle is also dependent on the number of seats that a vehicle provides and thus an SUV may have larger total occupancy compared to a car. These details must be considered when drawing conclusions with these data.

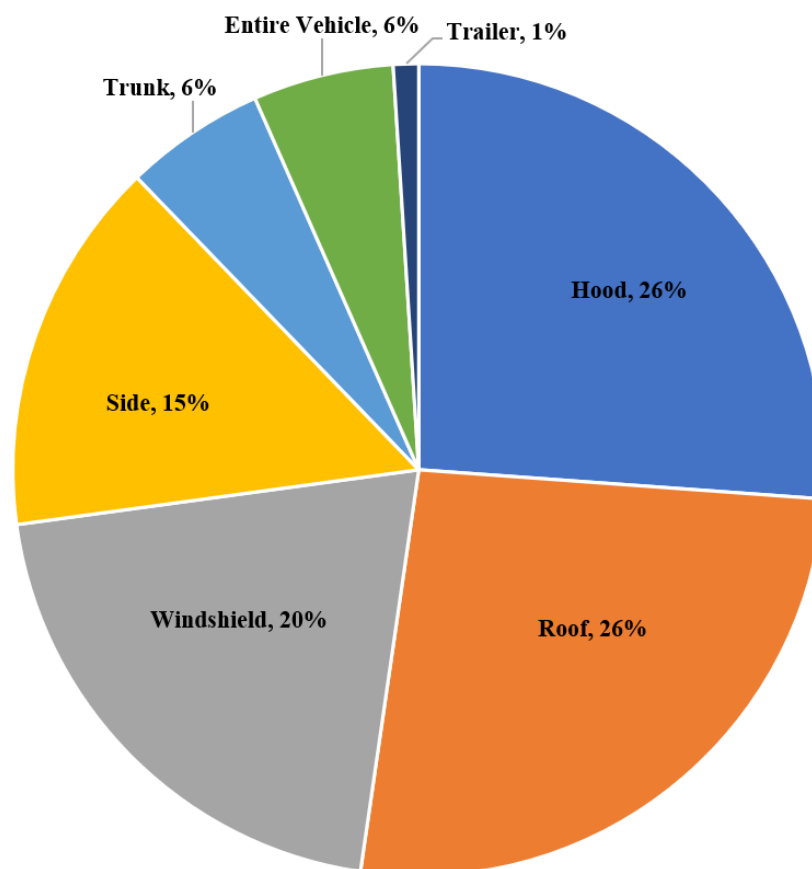
**Figure 5 – Rockfall vehicle impact event by impact location (n=54).**

Rockfalls identified in our database caused disparate sized impacts to vehicles depending on the size of transiting blocks and the total volume of the event. For this analysis, we excluded three events for which the impact area was unknown (thus,  $n = 54$ ). In some cases, extremely small blocks passed through only the windshield of a vehicle creating a distinct hole, whereas in other events a boulder crushed the entirety of a car. The area of a vehicle that a falling block of rock makes impact can broadly be categorized into the following categories: ‘entire’, ‘hood’, ‘windshield’, ‘roof’, ‘trunk’, ‘side’, and ‘trailer’. Whereas many rockfall events impacted more than one of these locations, for simplicity, we assigned the events into the category which formed the most predominant location of impact (Figure 5). Overall, most impacts captured in the data occurred on the hood (26%), roof (26%), or windshield (20%) which matches expectations based on the likely vertical trajectories of many rockfalls. We note that additional analysis is possible with these data but is not conducted here due to their preliminary nature.

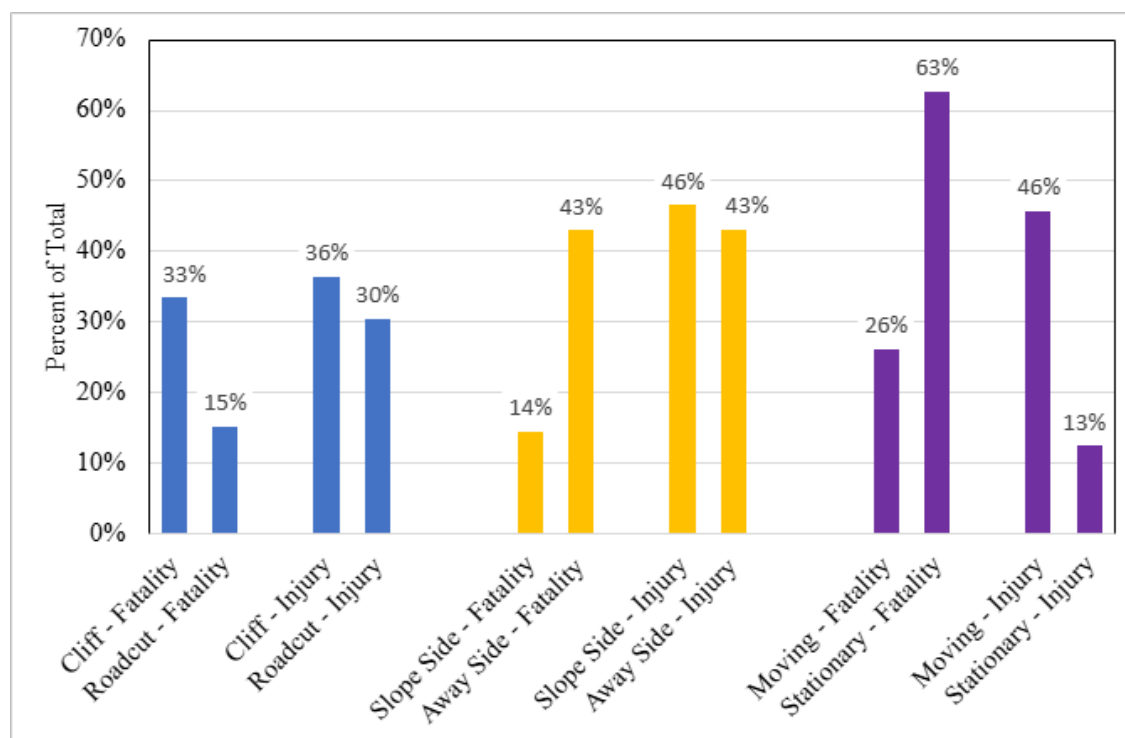
**Figure 6 - Statistical analysis of fatalities and injuries resulting from three parameters related to rockfall and vehicle location characteristics. Values show the percentage of occurrences in which a rockfall caused a fatality or injury from each of the cases (e.g., cliff versus roadcut). For rockfall source location,  $n_{\text{cliff}} = 33$ ,  $n_{\text{roadcut}} = 20$ . For direction of driving,  $n_{\text{slope side}} = 28$ ,  $n_{\text{away side}} = 14$ . For vehicle motion,  $n_{\text{moving}} = 46$ ,  $n_{\text{stationary}} = 8$ .**

The results show that fatalities are more likely to occur from rockfalls sourced from cliffs (33% of the time) compared to roadcuts (15%). Injuries are similarly more likely with cliff-sourced rockfalls compared to roadcuts, but to a lesser degree (36% versus 30%). We hypothesize that this conclusion may be related to the higher potential energy of rockfalls from cliffs given their likely greater height (and thus potentially larger fall height). Exploration of this relationship awaits further study.

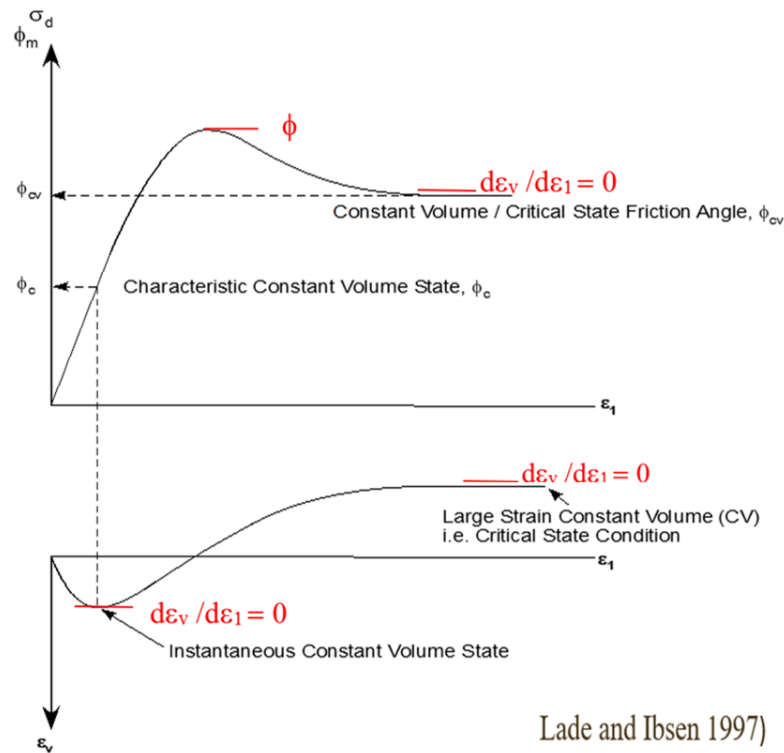
**Figure 1 - Assessment of Characteristic ( $\phi_c$ ) and Constant Volume ( $\phi_{cv}$ ) Friction Angles of Sand (after Lade and Ibsen 1997)**

Of note are the characteristic friction angle ( $\phi_c$ ) and the constant volume or critical state friction angle ( $\phi_{cv}$ ). As shown, the characteristic friction angle occurs when the volumetric strain reaches its maximum compressive value, where the slope,  $d\varepsilon_v/d\varepsilon_1$ , is instantaneously zero. By contrast, the constant volume friction angle corresponds to where the volume change curve flattens out ( $d\varepsilon_v/d\varepsilon_1 = 0$ ) and constant volume is achieved. This constant volume friction angle is also termed the critical state friction angle.

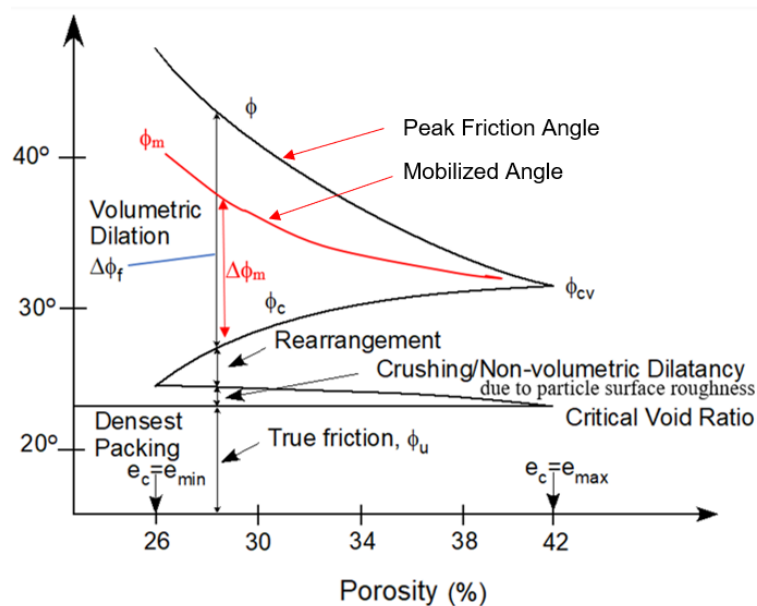
**Figure 2 - Components of Friction Angle (Modified from Mitchell 1993, after Rowe 1962)**

Figure 2 shows how the characteristic friction angle is envisioned and how it changes with density as expressed in terms of porosity (volume of voids / total volume) or void ratio,  $e$  (volume of voids / volume of solids). The peak friction angle ( $\phi$ ) less the volumetric dilatant component of strength at failure ( $\Delta\phi_f$ ) corresponds to the difference in dilation,  $(d\varepsilon_v/d\varepsilon_1)_f$  - ( $d\varepsilon_v/d\varepsilon_1 = 0$ ) that occurs on the volume change curve. But this is the difference in friction angle between  $\phi$  (for which  $(d\varepsilon_v/d\varepsilon_1)_f$  occurs) and  $\phi_c$  (where  $d\varepsilon_v/d\varepsilon_1 = 0$ ). At the loosest state (at the critical void ratio), the peak, the characteristic ( $\phi_c$ ) and constant volume ( $\phi_{cv}$ ) friction angles all become one and the same.

While the peak friction angle,  $\phi$ , corresponds to  $SL = 1$ , another curve,  $\phi_m$ , at a lower  $SL$  is also shown in Fig. 2. The difference between  $\phi_m$  and  $\phi_c$ , is  $\Delta\phi_m$ , the difference due to  $d\varepsilon_v/d\varepsilon_1$  at  $\phi_m$  and  $d\varepsilon_v/d\varepsilon_1 = 0$ , or just  $(d\varepsilon_v/d\varepsilon_1)_m$ .

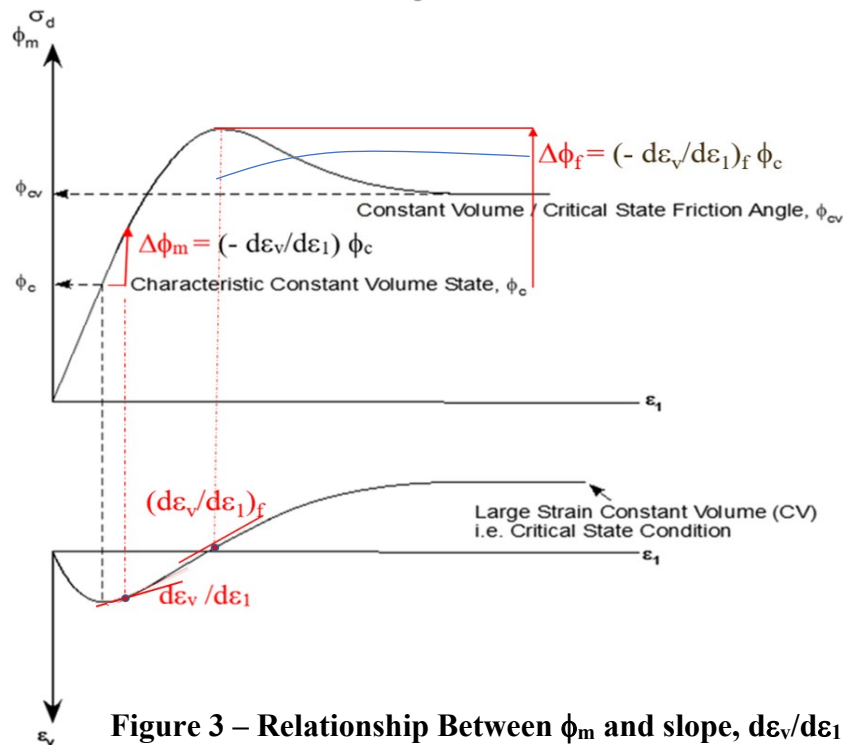
**Figure 3 – Relationship Between  $\phi_m$  and slope,  $d\varepsilon_v/d\varepsilon_1$ .**

The use of this relationship is shown in Fig. 3 where at any axial strain,  $\Delta\phi_m$  is given by Eq. 3f which associates the increase in  $\phi$  above  $\phi_c$  to the corresponding slope on the volume change curve. Be aware that Eq. 3 applies up to  $\phi$  (the peak value). The angle  $\phi_{cv}$  should replace  $\phi_c$  in Eq. 3 for  $\phi_m$  on the post peak side of  $\phi$ , because  $d\varepsilon_v/d\varepsilon_1$  is thereby taken relative to  $\phi_{cv}$  (corresponding to  $d\varepsilon_v/d\varepsilon_1 = 0$ ). This is a subject for another time.

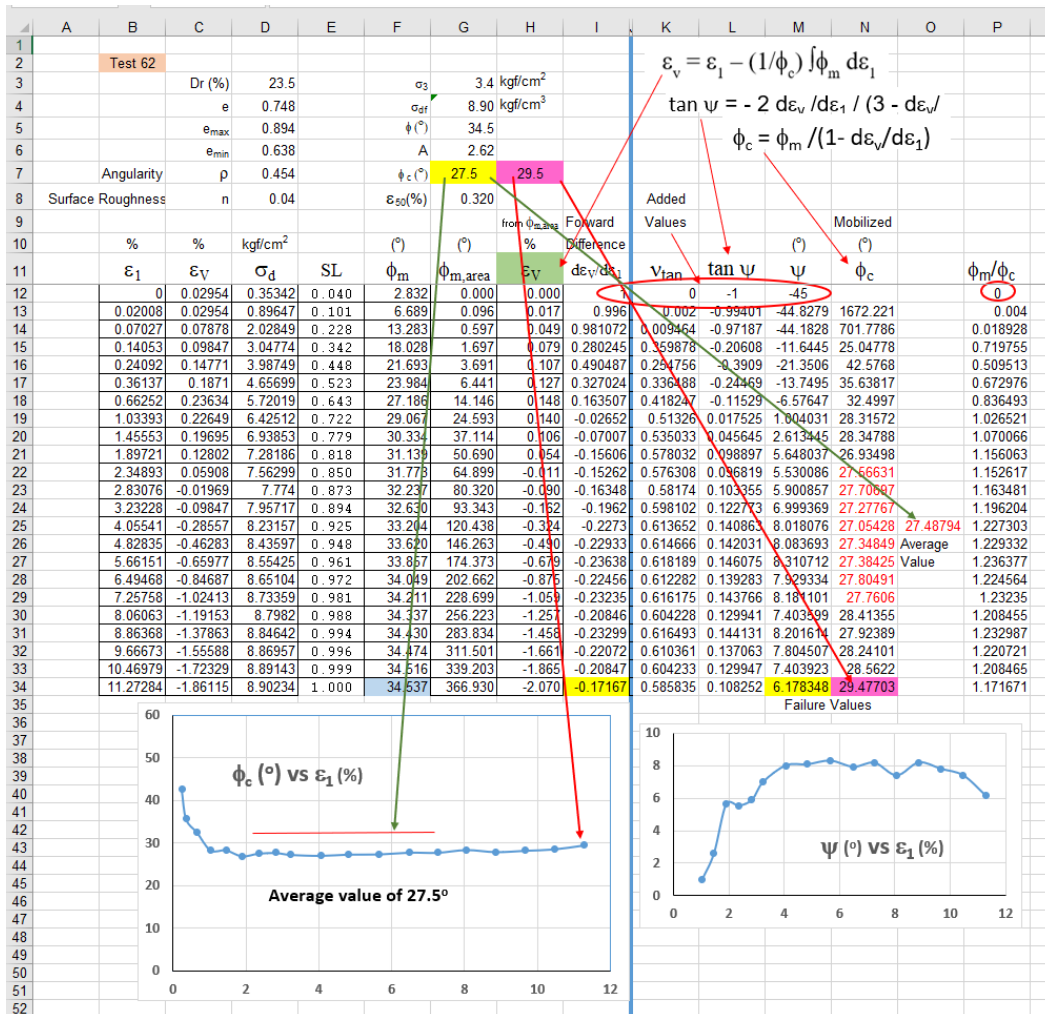
Figure 5 - Spreadsheet of Test 62 Data

There is a plot below columns B through I of Fig. 5 of  $\phi_c$  of column P versus  $\varepsilon_1$  showing a fairly stable (mobilized) value of  $\phi_c$  whose average (27.5°) fairly well matches the visually determined value of cell G7 used to generate the calculated/predicted pink line curve (column H versus B) of Fig. 6. Note that  $\phi_c$  at failure (cell H7) differs from the best fit value which is why the calculated volume change curve deviates from the recorded curve of Fig. 6 near its end.
