# 75<sup>TH</sup> HIGHWAY GEOLOGY SYMPOSIUM

BETTER HIGHWAYS THROUGH APPLIED GEOLOGY

2026  
HGS  
PROCEEDINGS

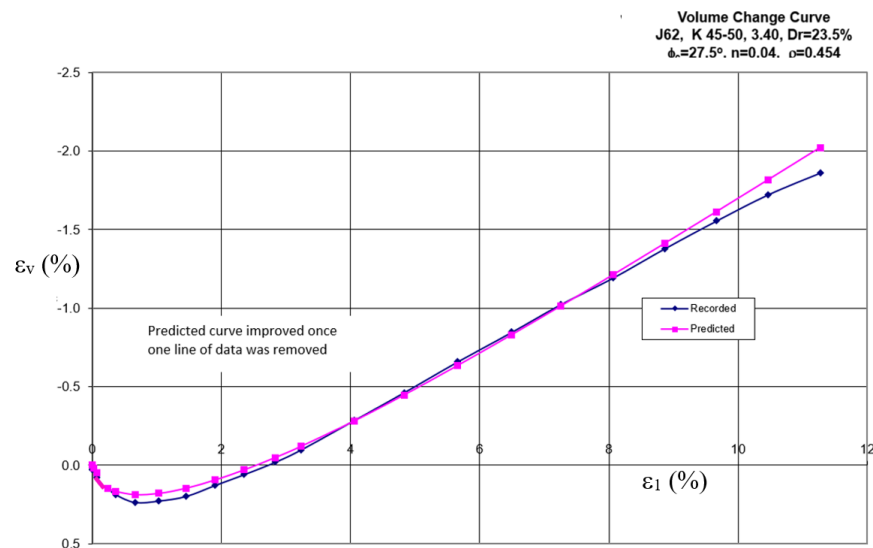
Figure 6 - Best Fit vs Recorded Volume Change Curves of Test 62

There is a plot below columns B through I of Fig. 5 of  $\phi_c$  of column P versus  $\varepsilon_1$  showing a fairly stable (mobilized) value of  $\phi_c$  whose average (27.5°) fairly well matches the visually determined value of cell G7 used to generate the calculated/predicted pink line curve (column H versus B) of Fig. 6. Note that  $\phi_c$  at failure (cell H7) differs from the best fit value which is why the calculated volume change curve deviates from the recorded curve of Fig. 6 near its end.

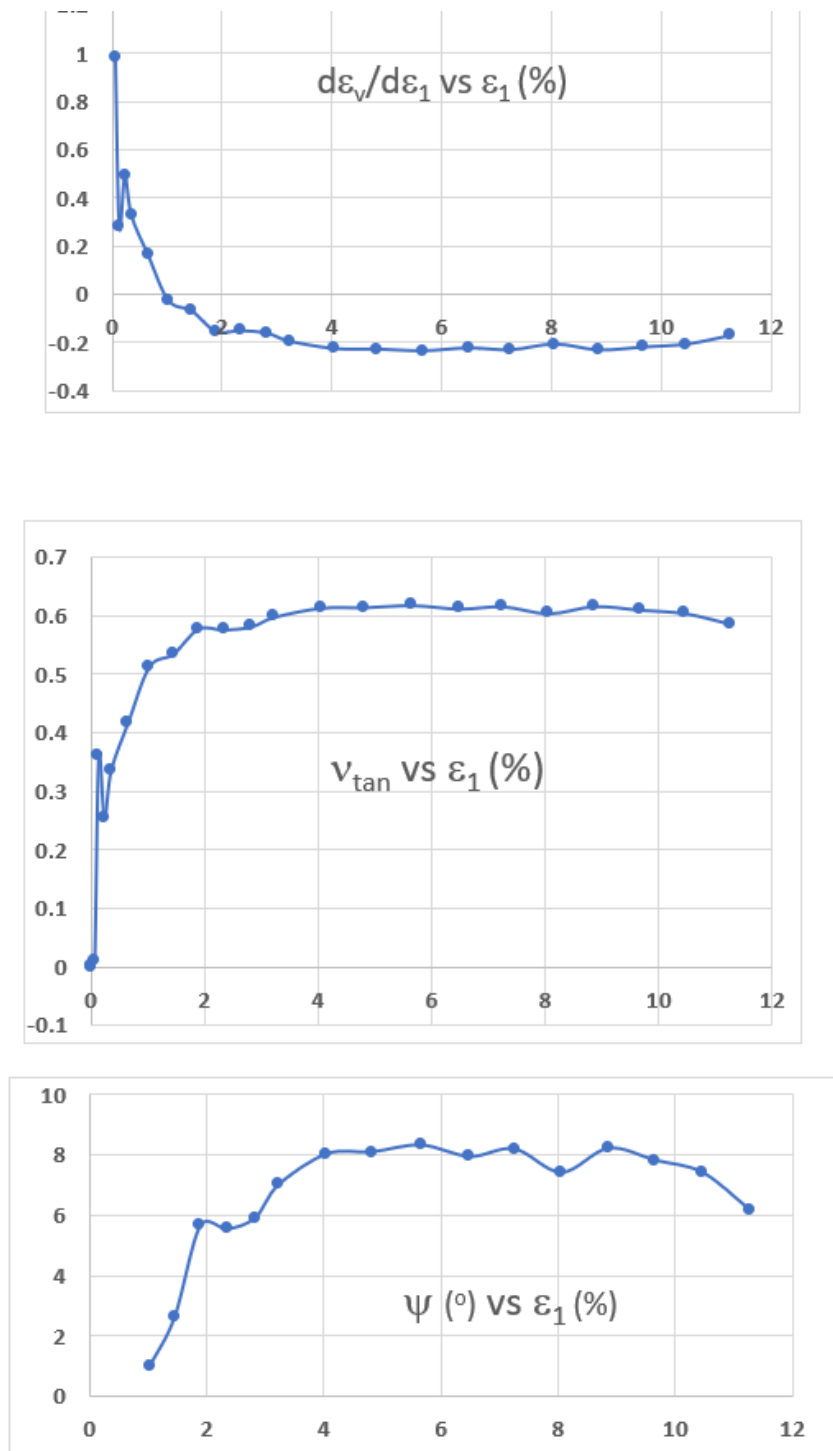
**Figure 7 - The Variations of  $d\varepsilon_v/d\varepsilon_1$ ,  $v_{tan}$  and  $\psi$  (°) versus  $\varepsilon_1$ (%) of Test 62**

Figure 7 shows the variations of  $d\varepsilon_v/d\varepsilon_1$  (column I),  $v_{tan}$  (column K) and  $\psi$  (column M) versus  $\varepsilon_1$  (column B) from the data sheet of Test 62. Figure 8, on the other hand, shows the explicit variations of  $\phi_m/\phi_c$  (column P),  $v_{tan}$  (column K) and  $\psi$  (column M) versus  $d\varepsilon_v/d\varepsilon_1$  (column I).

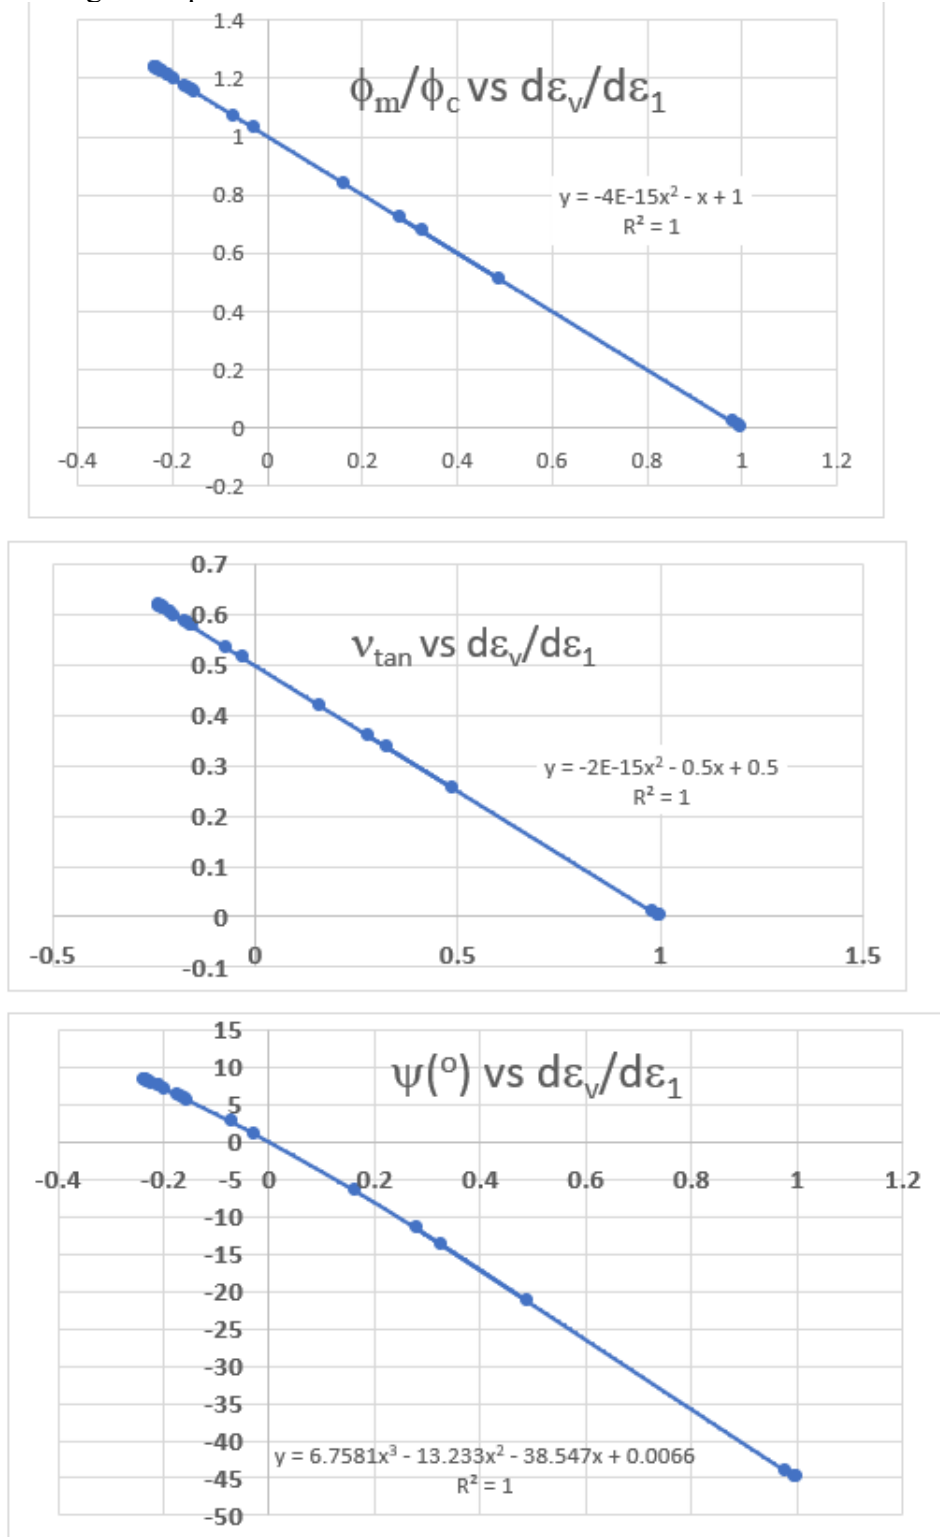
**Figure 8 - The Variations of  $\phi_m/\phi_c$ ,  $v_{tan}$  and  $\psi(^{\circ})$  versus  $d\varepsilon_v/d\varepsilon_1$  of Test 62**

Of particular note, the trendline equation for each of the curves of Fig. 8 yields an  $R^2$  value of one, indicating the explicit nature of the variations.

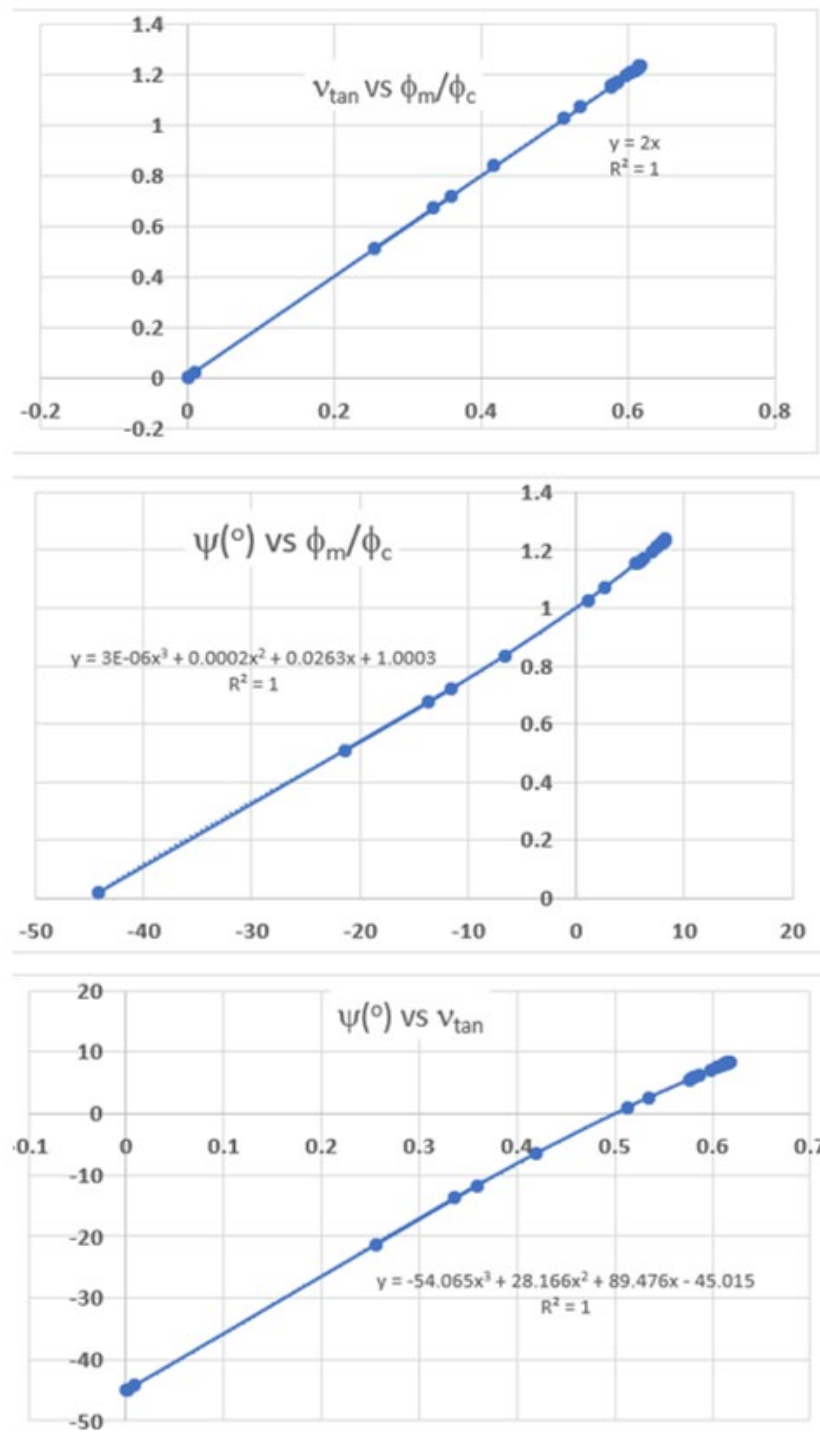
**Figure 9 - The Interrelationships of  $\phi_m/\phi_c$ ,  $v_{\tan}$  and  $\psi(^{\circ})$**

Figure 9 provides the explicit variations of  $\phi_m/\phi_c$ ,  $v_{\tan}$  and  $\psi$ , one to another. As in Fig. 8, the trendline fit of the recorded data points yield equations of  $R^2 = 1$ .

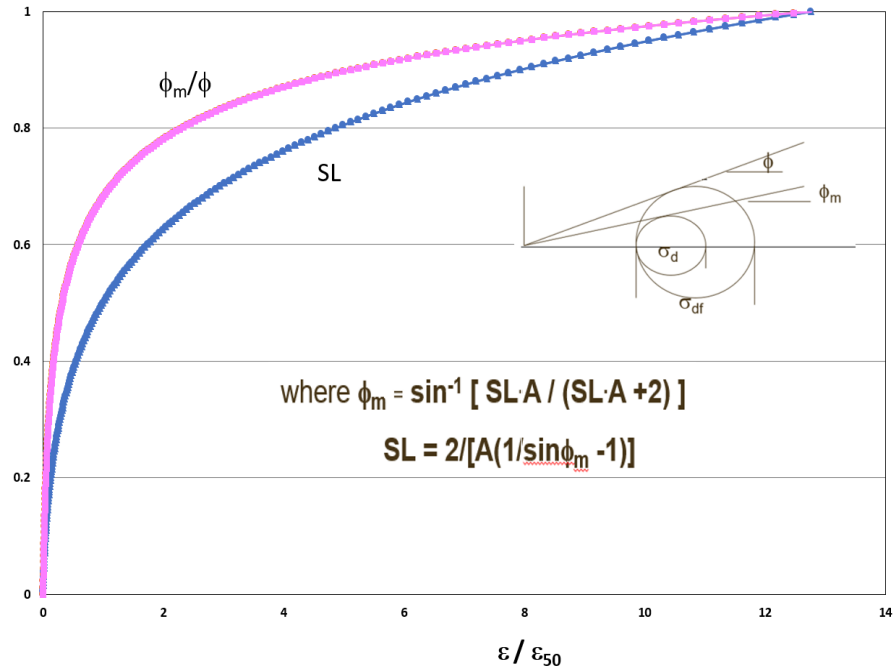
**Fig. 1** SL and  $\phi_m/\phi$  (for  $\phi = 35.9^\circ$ ) vs  $\varepsilon/\varepsilon_{50}$

The mobilized friction angle divided by the peak value ( $\phi_m/\phi$ ) versus normalized strain for a specific  $\phi$  is also shown in Fig. 1.

The deviator stress ( $\sigma_d$ ) versus axial strain ( $\epsilon_1$ ) curve derives from Fig. 1 where SL on the vertical axis is multiplied by the deviator stress at failure,  $\sigma_{df}$ , where

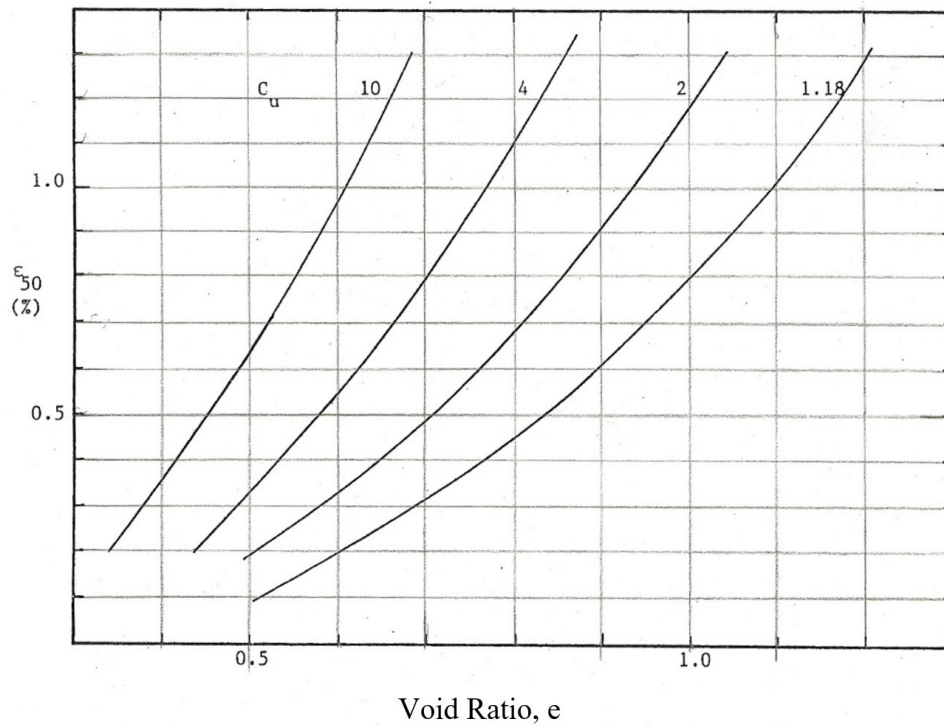
**Fig. 2a**  $\varepsilon_{50}$  (%) versus Void Ratio,  $e$ , at Confining Pressure,  $\sigma_3$ , of 0.425 kgf/cm<sup>2</sup>

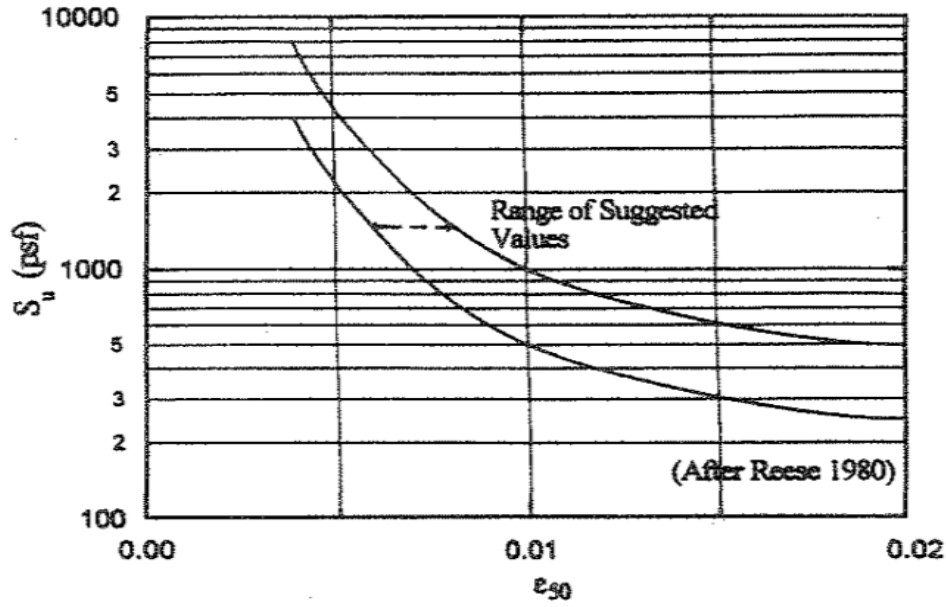
**Fig. 2b Undrained Shear Strength,  $S_u$  (lb/ft<sup>2</sup>), versus  $\epsilon_{50}$**

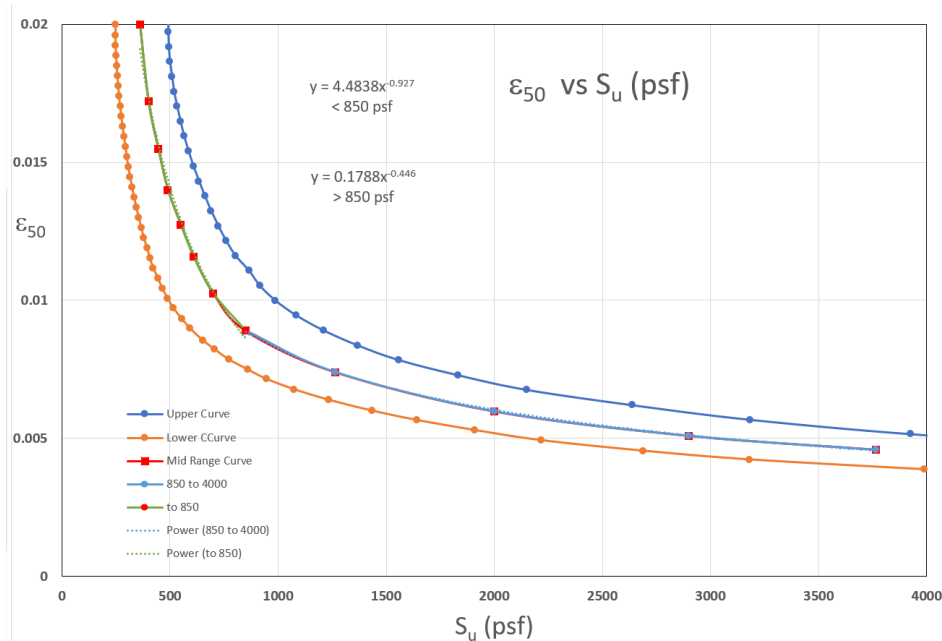
Fig. 3 Reese Curve of Fig. 2b with Reversed Axes

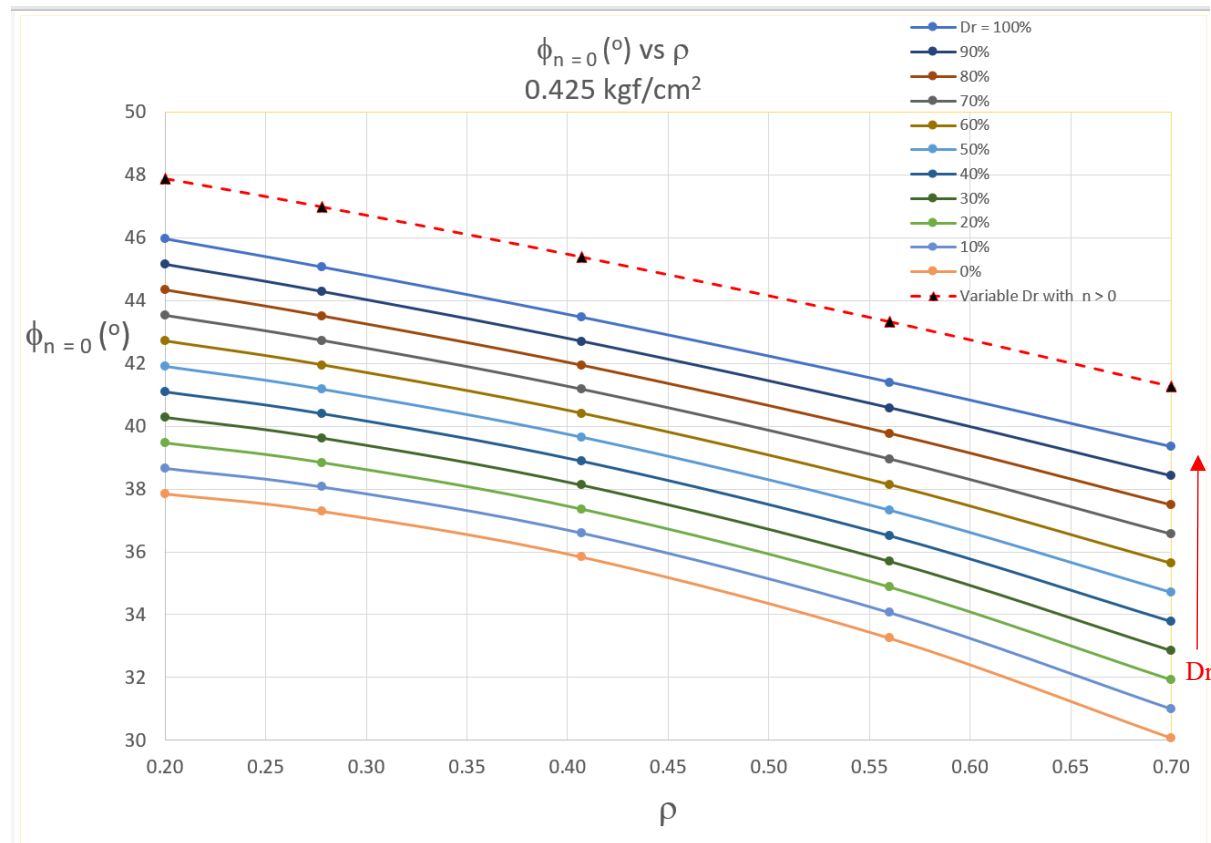
**Fig. 4 Variation in  $\phi_{n=0}$  with  $\rho$  for Different  $Dr$  Based on Eq. 8 for  $0.425 \text{ kgf/cm}^2$  Confining Pressure**

where  $\phi_{n=0}$  is the secant friction angle in degrees, a function of relative density ( $Dr$ ) in %, and particle shape characterized by the sand's roundness value ( $\rho$ ). See Fig. 4.

The reader should note that while  $\phi$  increases with  $Dr$  in Fig. 4,  $\phi_c$  decreases with  $Dr$  in Fig. 7. For a given roundness value,  $\rho$ , at some value of  $Dr$ ,  $\phi$  and  $\phi_c$  will become equal and that common friction angle will also be the constant volume/critical state friction angle for confining pressure 0.425 kgf/cm<sup>2</sup>. While Fig. 4 will change for confining pressures 1.20 and 3.40 kgf/cm<sup>2</sup>, Fig. 7 will not. Their meeting can be established from Eqs. 8a and 8b and Eq. 12 with Eq. 8a modified for the confining pressure of interest.

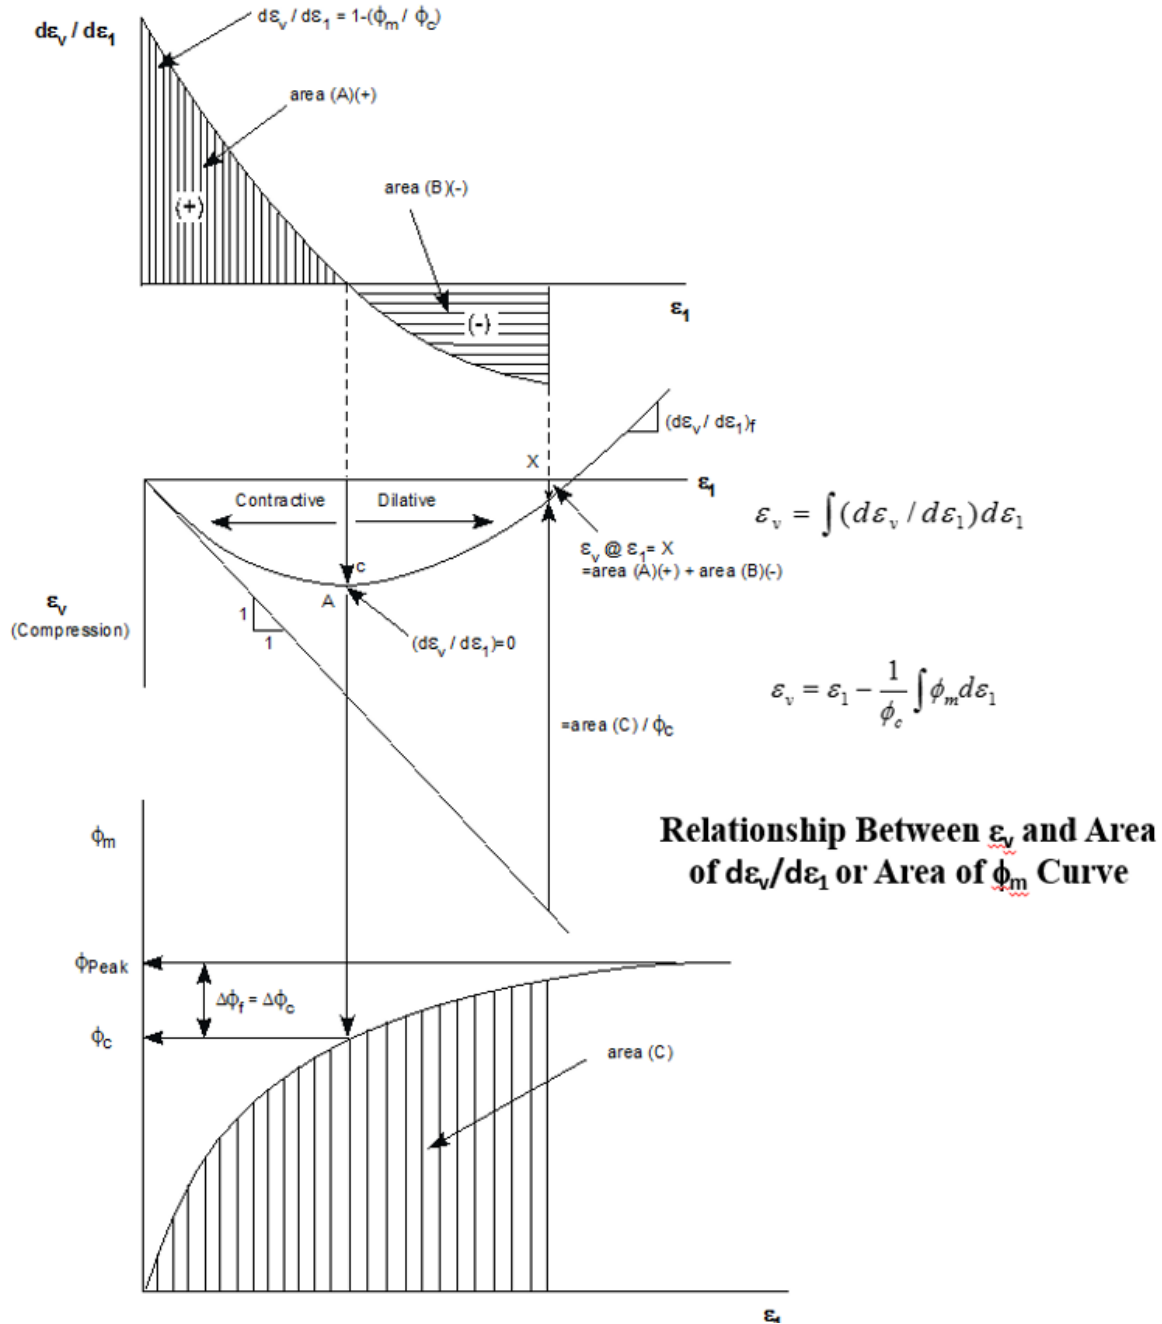
**Fig. 5 Relationship Linking Mobilized Friction  $\phi_m$  vs  $\varepsilon_1$  and Volumetric Strain,  $\varepsilon_v$ :**

$$d\varepsilon_v/d\varepsilon_1 = 1 - \phi_m/\phi_c$$

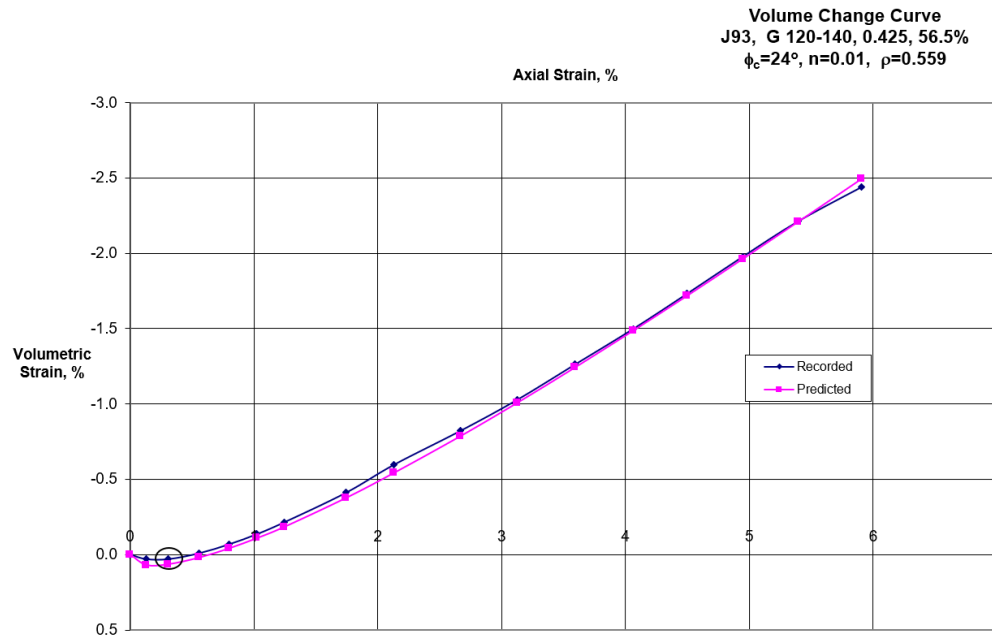
**Fig. 6 Volume Change Curve of Test 93**

It is noted here that the mobilized value of  $\phi_c$  in Eq. 11 at the characteristic point of Fig. 6 may differ slightly from the best fit value used in Eq. 10b that is needed to achieve the best match of the assessed to the recorded volume change curve.

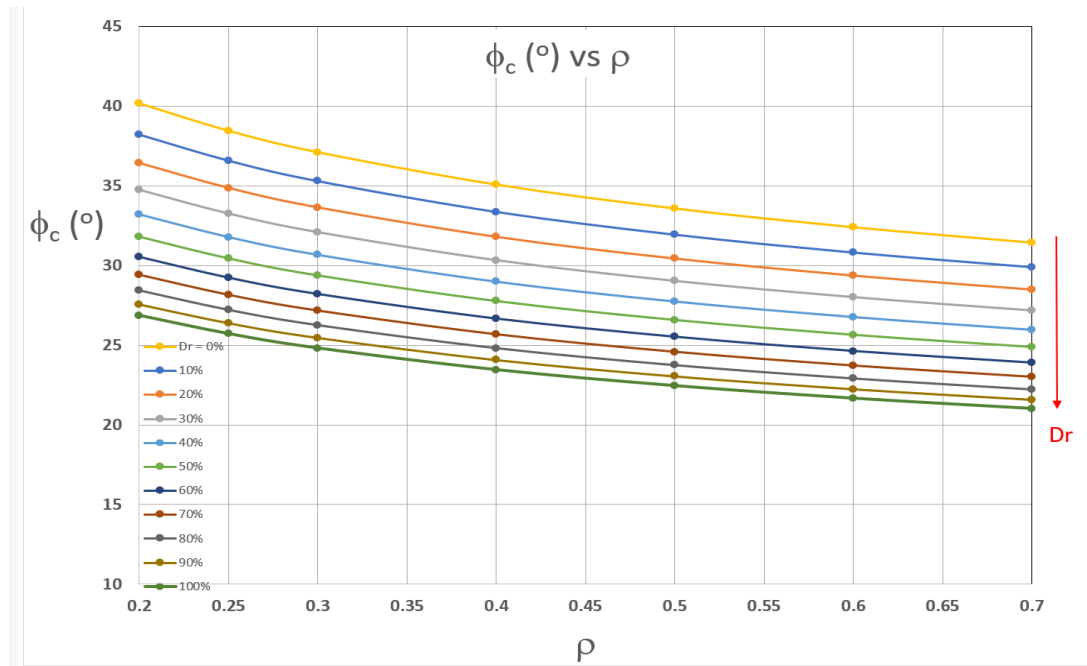
**Fig. 7 Variation of the Characteristic Friction Angle,  $\phi_c$ , with Shape (Roundness,  $\rho$ ) and Relative Density,  $Dr$**

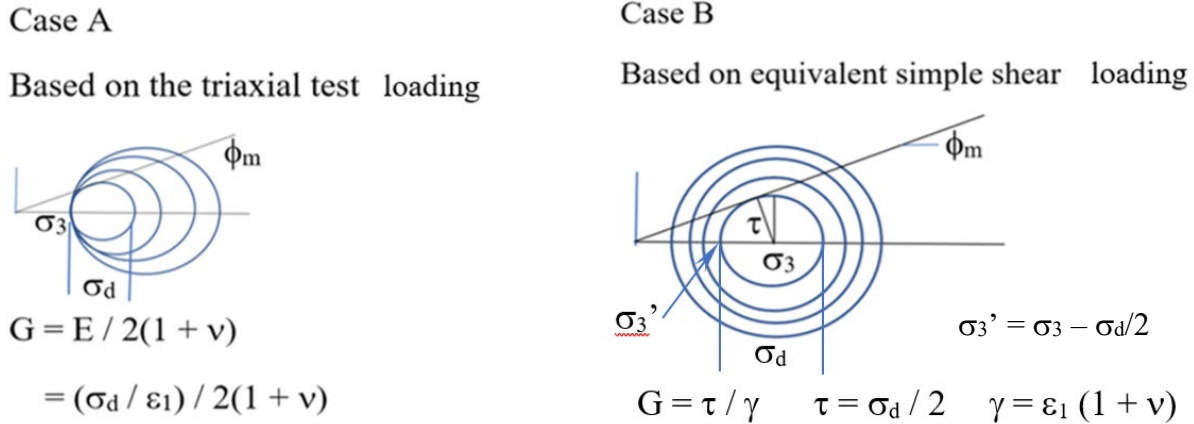
With  $v_{\text{sec}}$  from Eq. 15d for cohesionless ( $\phi$ ) soils, and  $\gamma$  of Eq. 6,  $\gamma$  as a function of  $v_{\text{sec}}$  can then be evaluated. This makes the evaluation of  $G$  (Eq. 5a) and  $G_o$  (Eq. 5b), as well as  $G/G_o$ , possible, for whichever case of loading, A or B in Fig. 8 is envisioned. Note that case B represents simple shear loading as evaluated from triaxial test response.

**Fig. 8 Evaluation of Shear Modulus, G, for Triaxial or Simple Shear Loading**

Case A type loading was used to simulate the Seed and Idriss (1970) and Vucetic Dobry (1991)  $G/G_o$  curves of the Norris (2024) and the Norris and Yang (2025) papers.

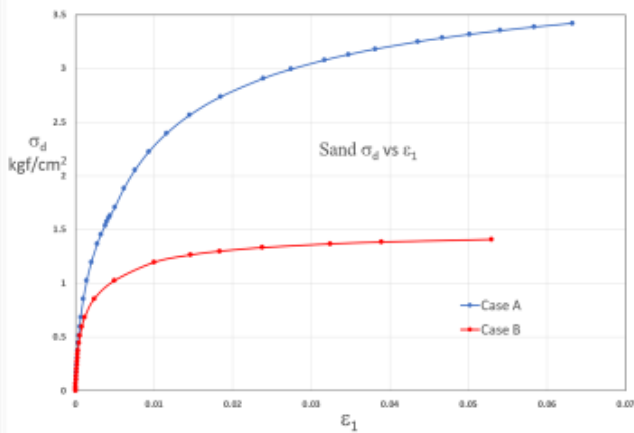
**Fig. 13a Sand Stress-Strain Curve**

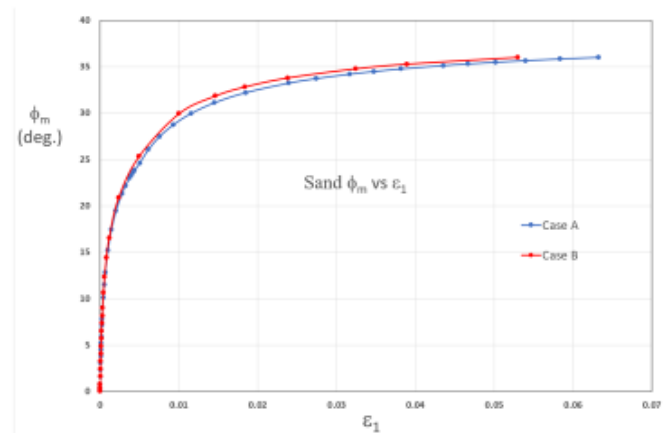
**Fig. 13b Sand  $\phi_m$  vs  $\varepsilon_1$  Curve**

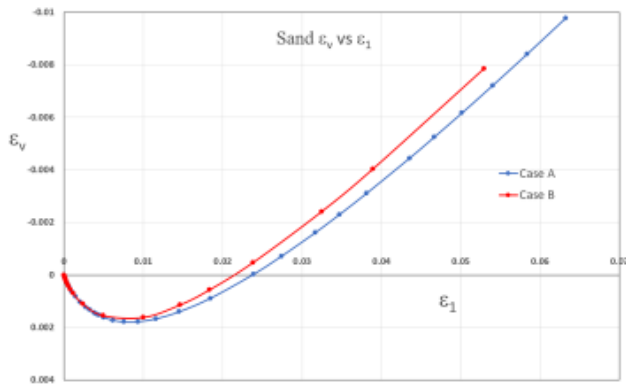
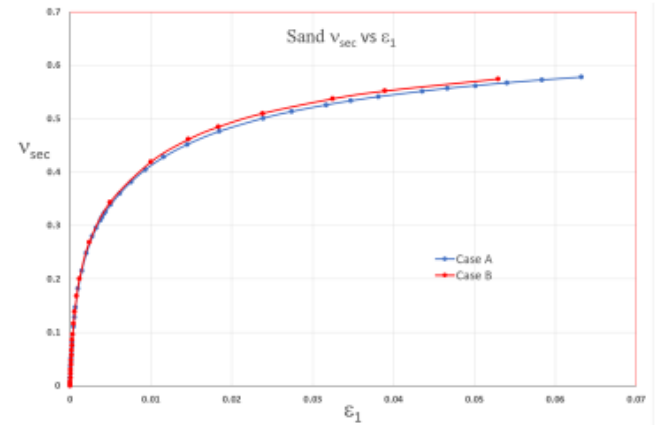
**Fig. 14a Sand Volume Change Curve****Fig. 14b Sand  $v_{sec}$  vs  $\varepsilon_1$  Curve**

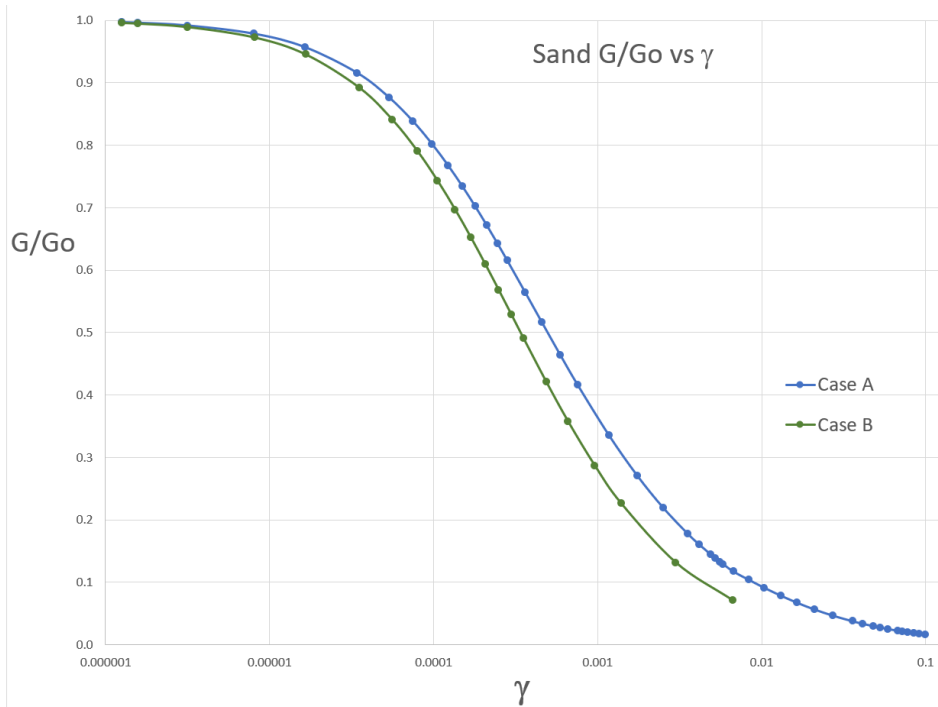
**Fig. 15 Shear Modulus Reduction Curves for a  $\phi$  Soil**

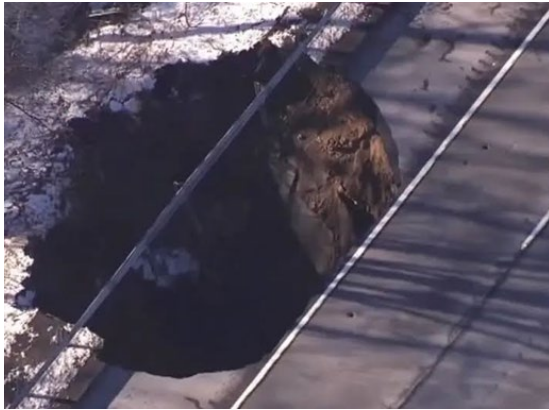
Photo of Mine Subsidence Location 1

- December 26, 2024 – Mine Subsidence Location 1 formed in the eastbound shoulder and lane (~20 ft × 25 ft × 21 ft deep) closing traffic to I-80 EB, with repairs completed and traffic restored in 4 days
- February 10, 2025 – Mine Subsidence Location 2 formed ~70 ft northeast in the center lane (~11 ft x 11 ft x 4 ft deep) closing I-80 EB
- March 19, 2025 – Mine Subsidence Location 3 (~15 ft x 15 ft x 30 ft deep) formed in the median closing I-80 WB, and was filled with concrete
- Traffic was restored in the following phases:
  - May 21, 2025 – I-80 EB right 2 lanes and shoulder
  - May 30, 2025 – I-80 WB right 2 lanes and shoulder
  - June 14, 2025 – I-80 EB all lanes
  - June 21, 2025 – I-80 WB all lanes

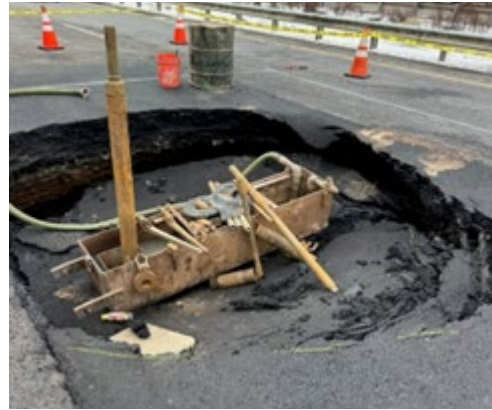
Photo of Mine Subsidence Location 2

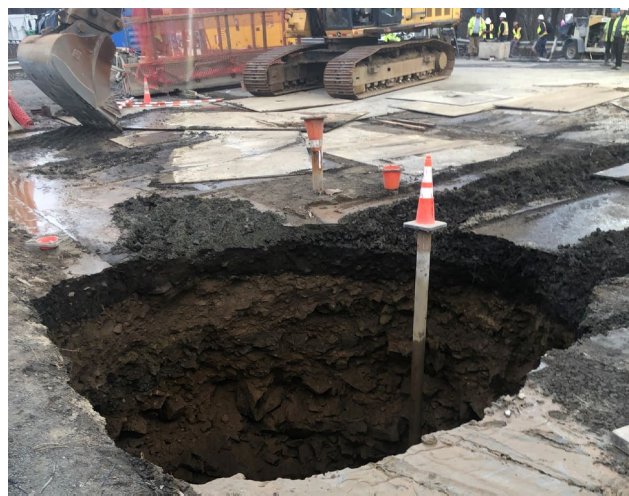
Photo of Mine Subsidence Location 3

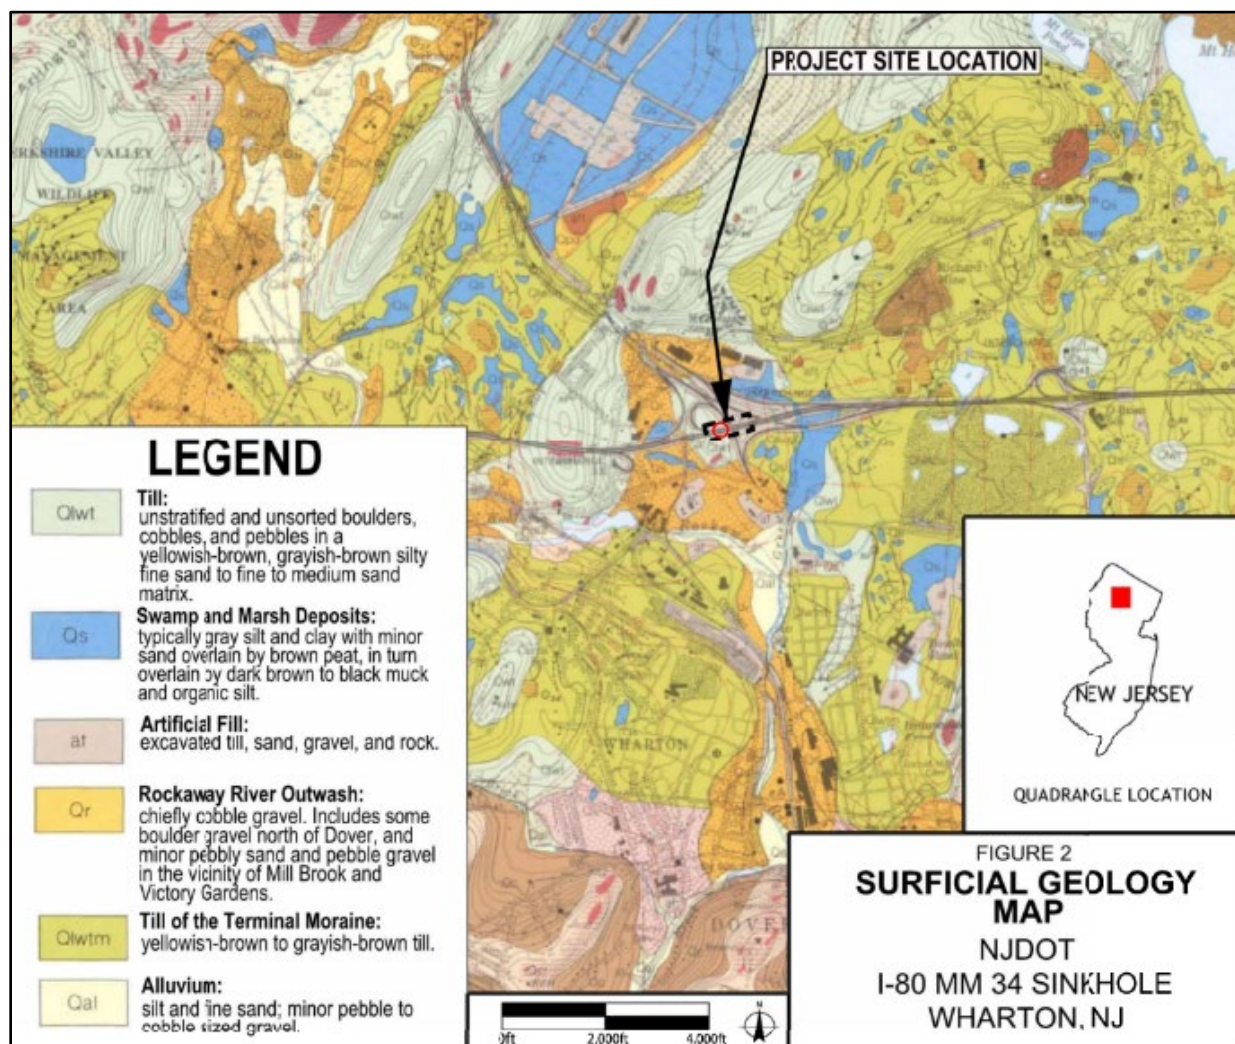
Figure 4 – Surficial Geology

Overlying the bedrock is a dense to very dense layer of glacial till deposited during the advance and retreat of the glacier. The till consists of an unstratified and unsorted mixture of boulders, cobbles, pebbles, and a silty sand matrix. The till material is typically dense to very dense. As the site is located near the glacial terminus, residuum or saprolite (decomposed rock) also occurs at the bedrock/overburden contact at some locations. The saprolite retains a faint rocklike structure, but is friable and noncompact, with the appearance of sand and silt.

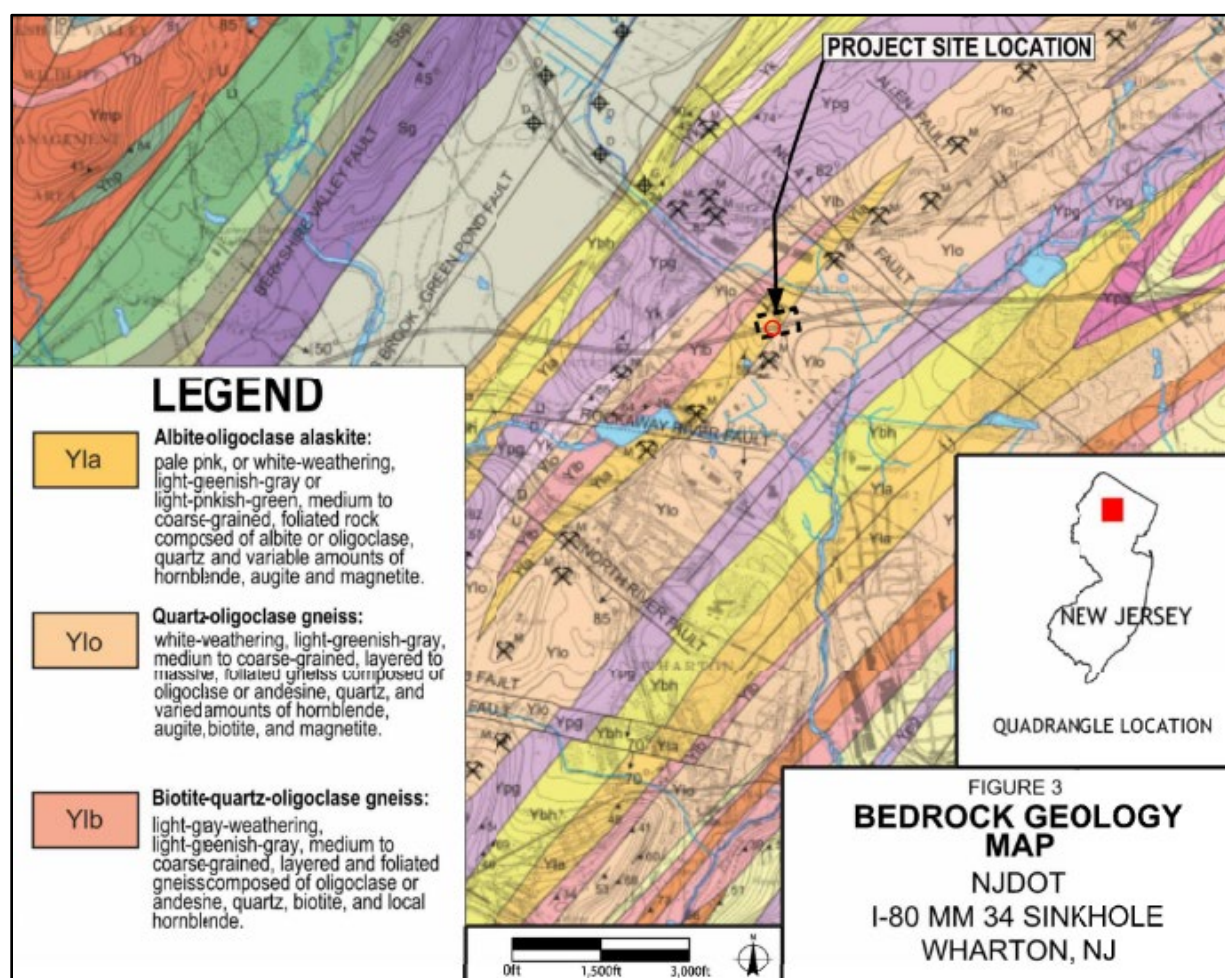
Figure 5 – Bedrock Geology

Regionally, the site is situated within the historic Dover Mining District, one of the earliest iron-producing regions in the United States. Magnetite has been mined in the district since the early 18th century, occurring within Pre-Cambrian meta-sedimentary rocks, magnetite-bearing units, and intrusive igneous rocks. Bedrock underlying the project site consists primarily of quartz–oligoclase gneiss from the Losee Metamorphic Suite, as shown in Figure 5 (Ref. 12). This medium- to coarse-grained, light greenish-gray gneiss contains variable proportions of hornblende, augite, biotite, and magnetite. Magnetite mineralization occurs as individual grains or aggregates 0.04 to 0.20 inches in diameter, and as veinlets, layers, or massive homogeneous bodies (Ref. 17). These ore deposits are interpreted as high-temperature metasomatic replacement bodies formed during the Early Proterozoic. At larger scales, the magnetite bodies are typically lath-shaped, extending up to 2 miles in length with average thicknesses of 10 to 20 feet, dipping at angles greater than 45° and striking 10° to 40° NE.

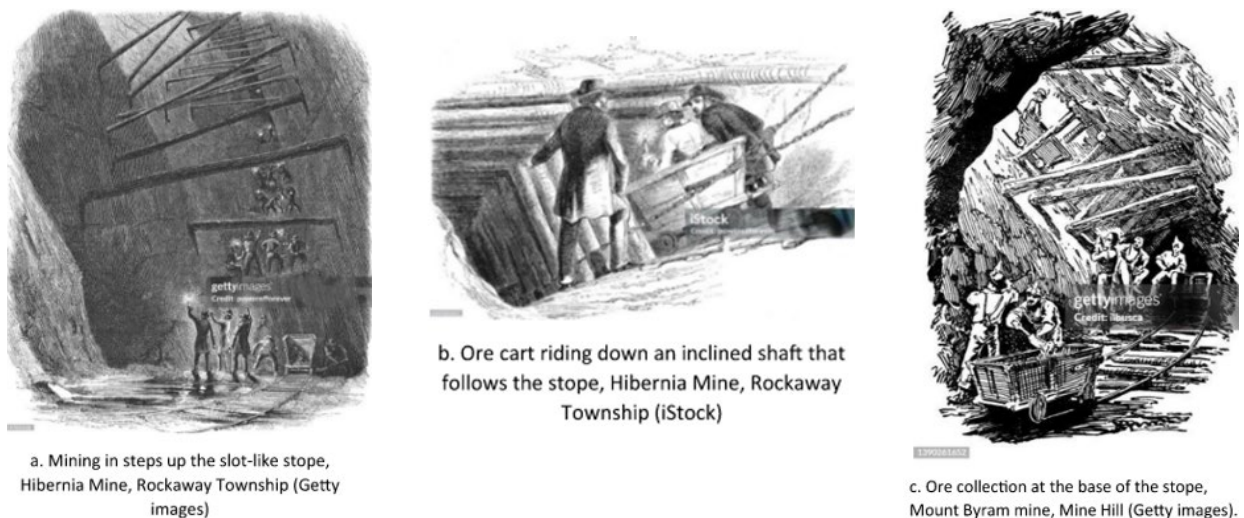
Figure 6: Renderings of Typical Mining Practices in the Dover Mining District

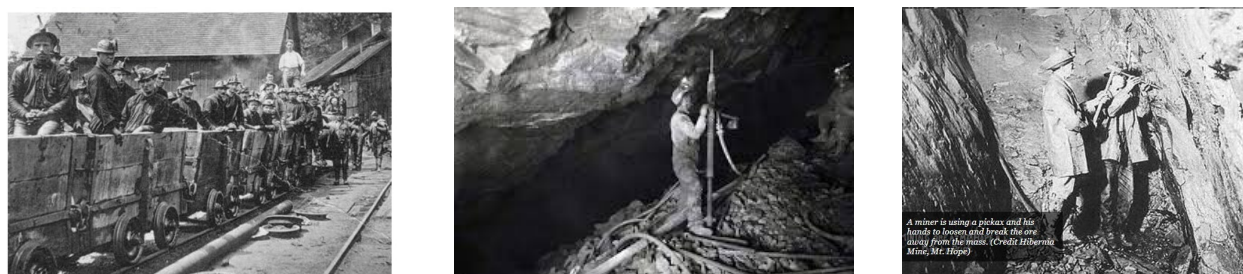
Figure 7: Historic Photos of Typical Mining Practices in the Dover Mining District  
(Credit Hibernia Mine, Mt. Hope)

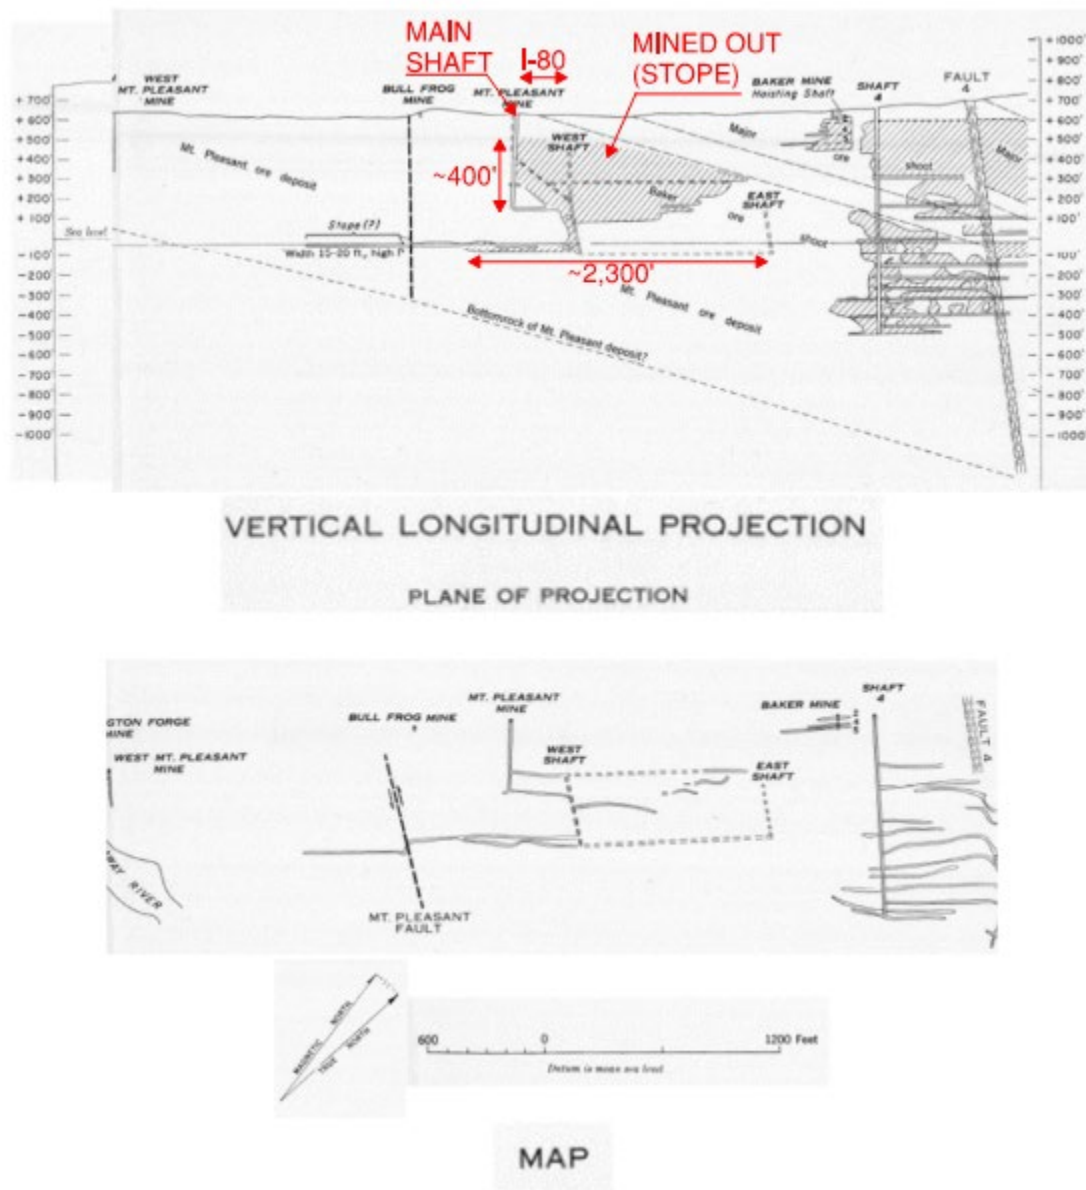
Using these correlated features, the Mt. Pleasant Mine trace from the Sims Map was georeferenced onto modern imagery, aligning surficial pond geometry and mapped faults. A projection with an accuracy of about  $\pm 20$  ft, shows Mine Subsidence Locations 1–3 plotting parallel to the mine trend but slightly northwest of it, consistent with the southeast dip of the stope. The 1958 Sims vertical longitudinal projection and plan view are included as Figure 8 and highlight the estimated elevations and plan layout of the mine.

Figure 8: Annotated Projected Elevation of Mt. Pleasant Mine (Ref. 18)

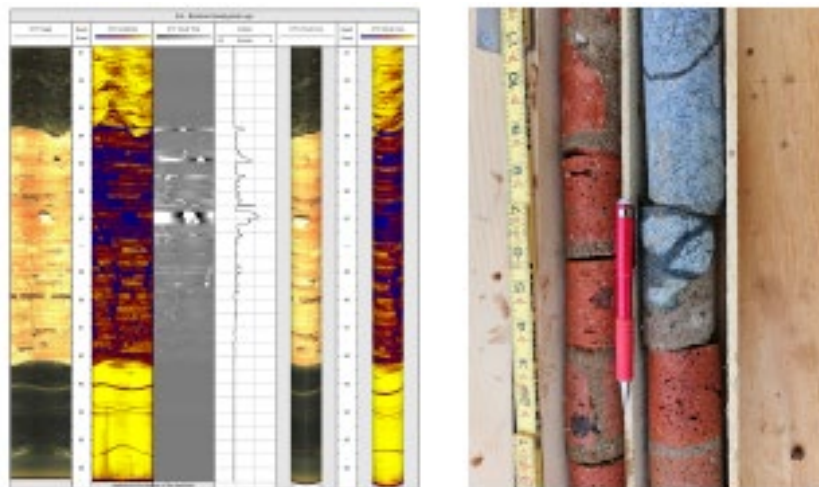
Figure 9 – ATV/OTV Log through Brick Pillar and Core

planar geologic features) are reported as the dip azimuth (dip direction) and dip angle (dip) of each structure. The OTV and ATV dip azimuth data is referenced to true north using a magnetic declination of 13° west and the bedrock structure dip angle data are reported from horizontal. The presence of magnetite rendered the dip direction data unreliable, but the dip angles were able to be interpreted by HRGS. The ATV and OTV were helpful for identifying voids and mine features.

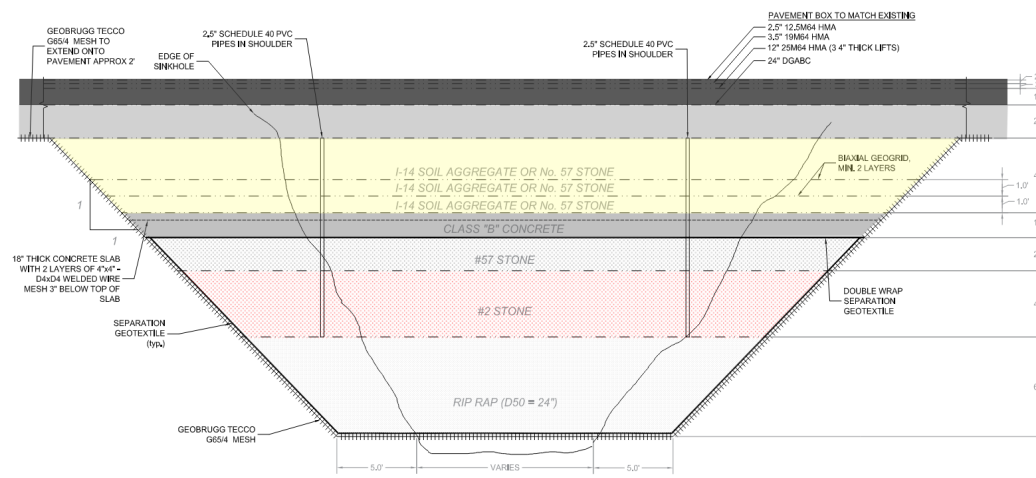
The initial mine subsidence event was repaired using a reverse / inverted filter comprised of granular fill, geosynthetics, steel mesh, and reinforced concrete, as illustrated in Figure 10 below. This approach allowed for rapid restoration of traffic to I-80 Eastbound within 4 days.

Figure 10: Mine Subsidence Location 1 Repair Detail

Most materials were readily available from an adjacent quarry or locally; however, the steel mesh required a rapid overnight delivery from North Carolina. Concrete curing time and time for asphalt to cool before subsequent lifts were placed and traffic restored were some schedule critical items. Throughout all ensuing adjacent mine subsidence events, no evidence of displacement to this temporary repair was identified, however, this area was ultimately within the subsequent micropile supported slab mitigation limits. Micogravity geophysical surveys were performed before pavement was placed, in an effort to locate voids in the area surrounding the repair. Monitoring and additional investigation were recommended, with a plan to develop long-term mitigation as part of an interchange improvements project, which was already in design for this site.

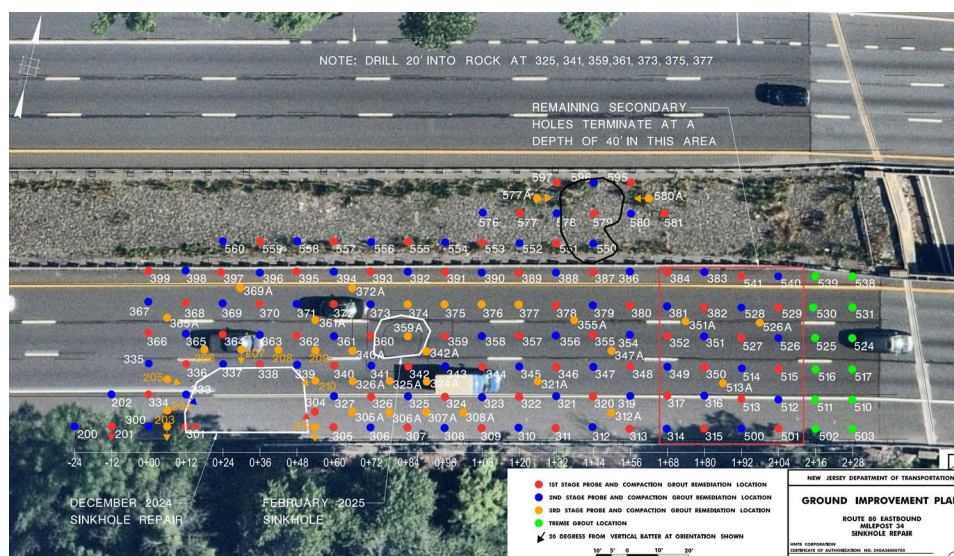
Compaction grouting was used to densify overburden soils and fill voids for improved site safety. In addition, the compaction grouting provided early insight into the top of rock elevation, void locations based on drilling rod drops and grout takes, mine stope and shaft location, alignment, depth, and inclination. The compaction grouting method implemented consisted of drilling a 5.5 inch OD casing to a depth of approximately 3 feet into top of rock, filling the casing with low mobility grout with a 2 – 4 inch slump and 500 psi 28-day compressive strength. Each initial compaction grouting location followed the spacing of the microgravity survey grid in attempt to correlate ground density and grout volumes. In areas with increased grout volumes supplemental grout holes were added until cutoff criteria were met, refer to Figure 11. The casing was retracted in 2-foot stages and pressure was applied, with each stage terminating when a 100 cf volume, 500 psi pressure, or heave cutoff criteria was achieved.

Figure 11 – Compaction grouting plan relative to mine alignment.
