# 75<sup>TH</sup> HIGHWAY GEOLOGY SYMPOSIUM

BETTER HIGHWAYS THROUGH APPLIED GEOLOGY

2026  
HGS  
PROCEEDINGS

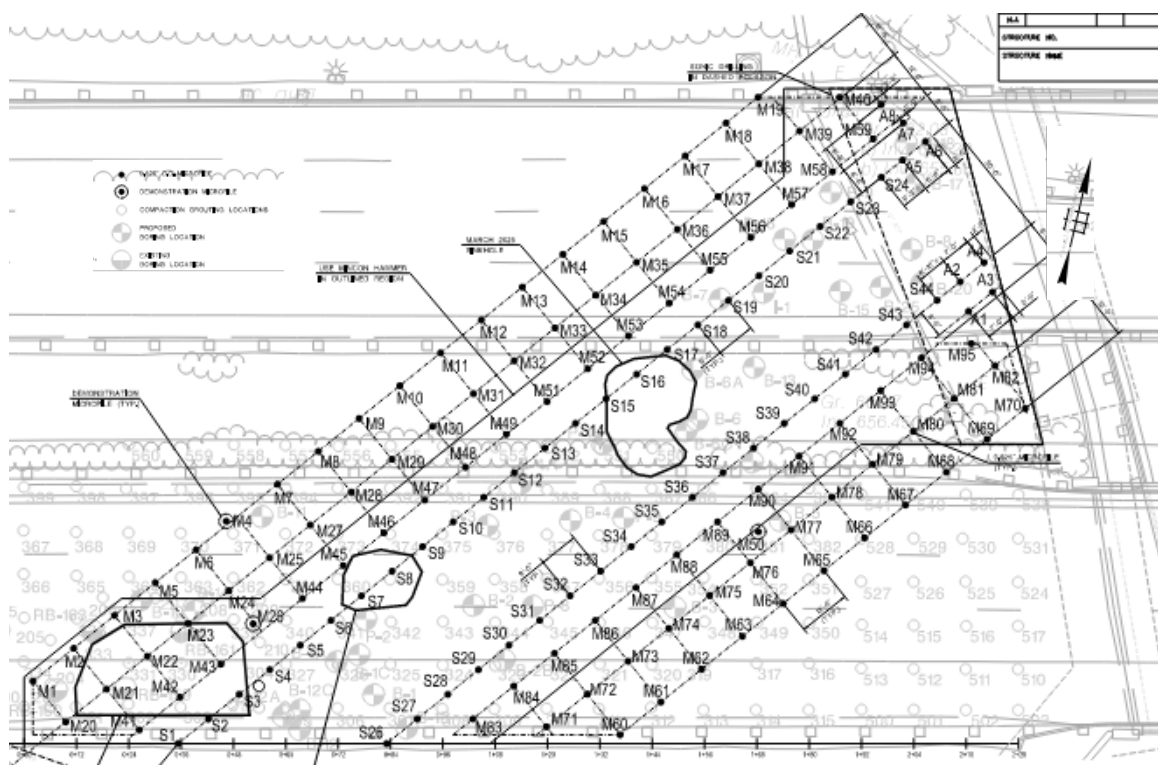
The slab consists of a single row of micropiles on each side of the mine adit (bench at the top of the stope). The micropile supported slab was flanked on each side by a three row micropile supported mat foundation. A total of 146 micropiles were installed. In the north-south direction the micropile supported slab extended from the south edge of I-80 to the north edge of I-80 and was skewed approximately 38.8 degrees across the roadway to align more closely with the trend of the stope. The micropile and slab layout are shown on Figure 12.

Factored axial compressive strength limit state load combinations per micropile ranged from 43 kips to 425 kips. Negligible axial tensile strength limit state load demands were calculated for a single micropile, A1, with a maximum uplift demand of 47 kips, which did not control the design. The micropiles were grouped into three design sections based on the factored axial compressive demands of 250 kips, 300 kips, and 425 kips.

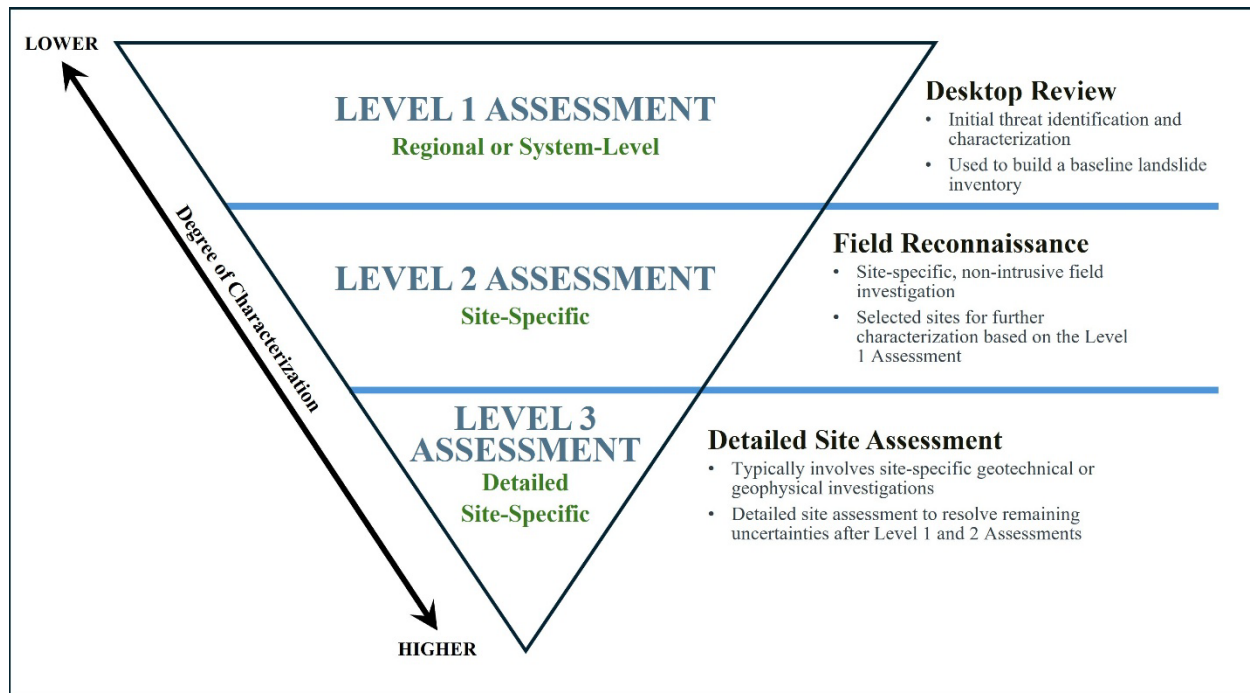
**Figure 1: The Three-Level Framework for Landslide Assessment. The figure is modified from the INGAA Foundation: Recommended Practice for Pipeline Integrity Management of Landslide Hazards (4)**

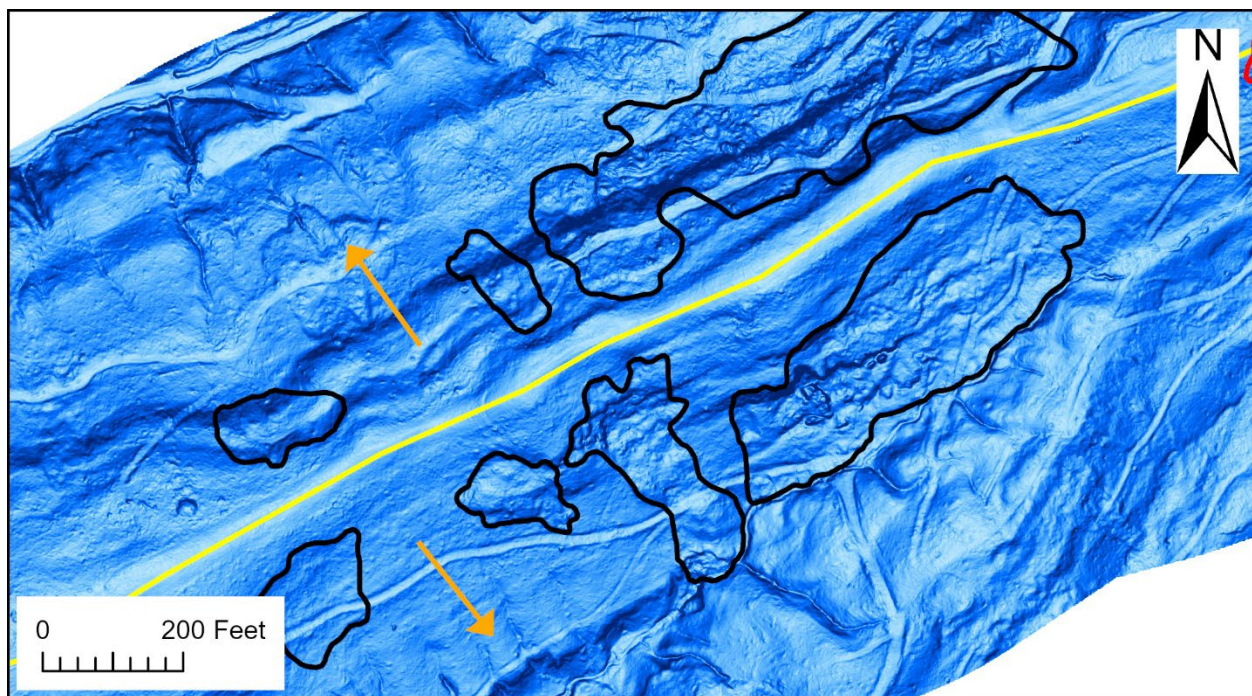
**Figure 2: High-resolution LiDAR imagery (displayed as percent slope in blue-scale) of a pipeline (yellow line), slope direction (orange arrows) and identified landslides (outlined in black). The pipeline is located on a ridge top.**

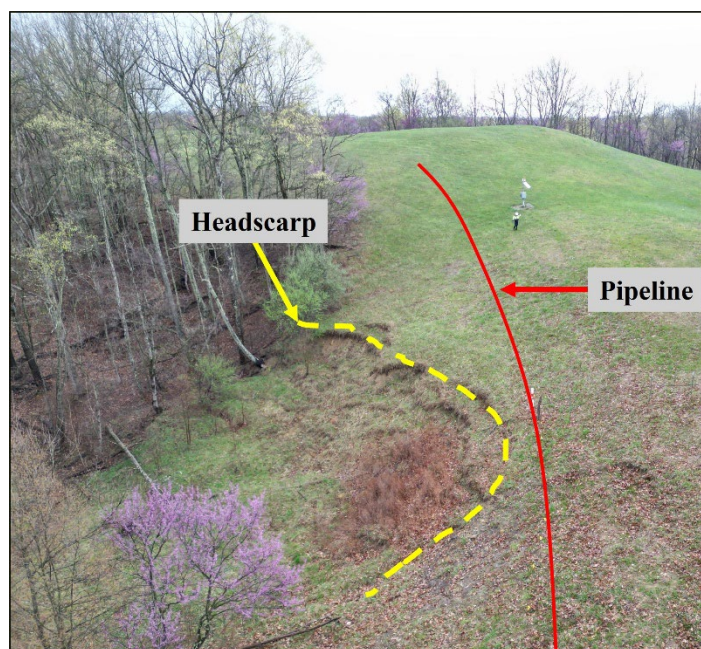
**Figure 3: Aerial photo from a Level 2 Assessment where the relationship between the location of the landslide and the pipeline are confirmed.**

Level 2 Assessments should be performed by an individual or field team experienced in geomorphic landslide identification and characterization. The field assessment should document the geomorphic and geologic conditions observed during the field visit, including conditions both within and outside of the pipeline ROW to develop a more complete understanding of the slope at the time of the site inspection. The presence, location, and condition of key landslide features should be documented and assessed to accurately determine the possible effects of the landslide on the pipeline (Figure 3).

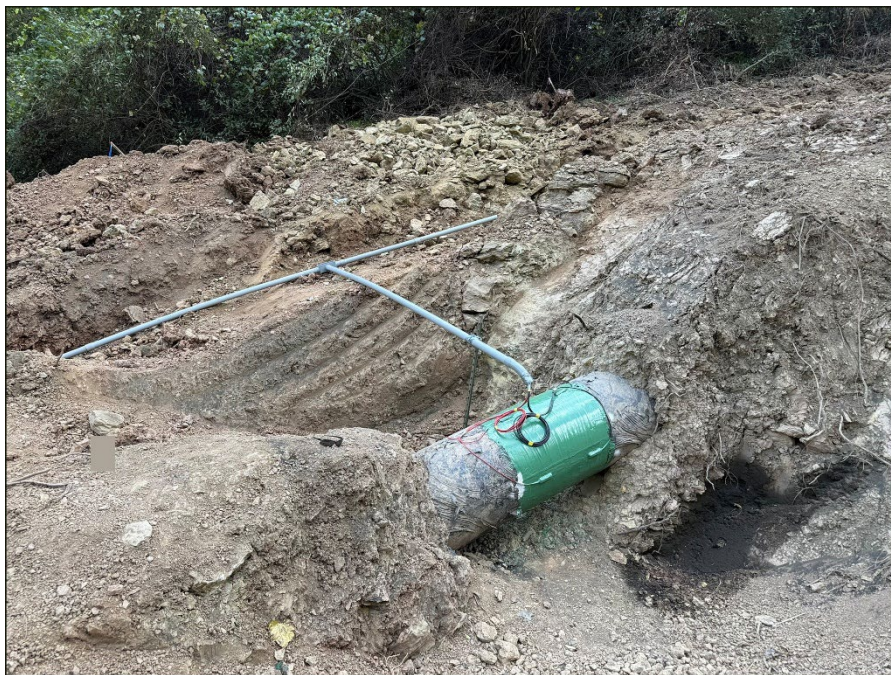
**Figure 4: Excavated section of pipeline for the purpose of installing strain gauges.**

The methods used to conduct a Level 3 Assessment are tailored to the specific landslide and may include detailed surface mapping, geophysical surveys, subsurface investigations such as drilling or test pits, and the possible installation of monitoring instruments such as inclinometers or strain gauges (Figure 4).

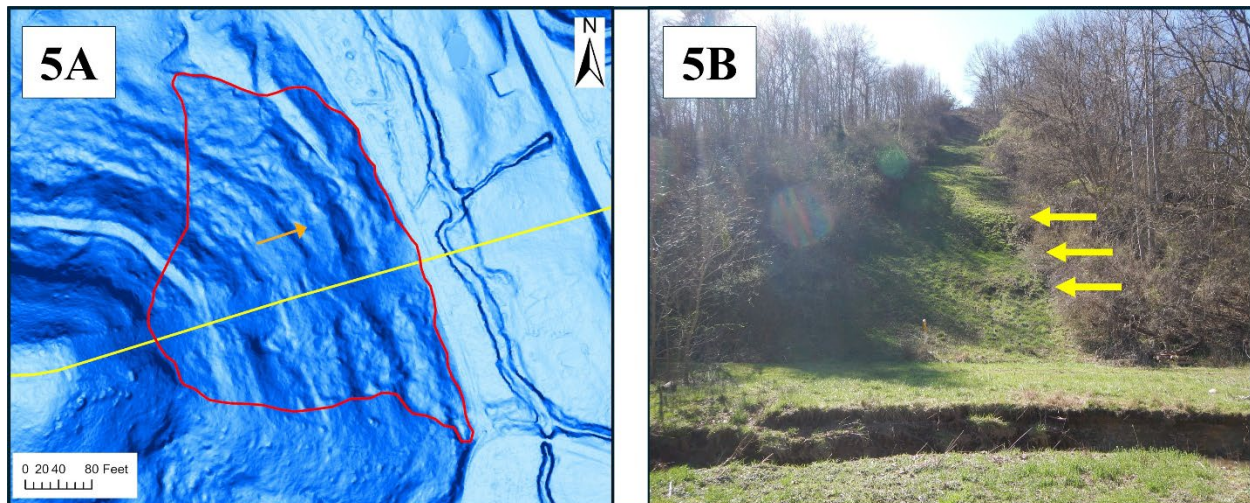
**Figure 5A: High-resolution LiDAR imagery (displayed as percent slope in blue-scale) from 2015 of the relationship of a pipeline (yellow line) to a landslide complex (outlined in red) identified during the Level 1 Assessment. The orange arrow represents the slope direction. Figure 5B: Photo of the landslide complex looking upslope along the pipeline ROW, taken during the 2016 Level 2 Assessment. The yellow arrows point to the area of well-defined hummocks noted during the assessment.**

**Level 1 Assessment – 2015** – The initial regional-scale Level 1 Assessment for the pipelines located in West Virginia was conducted in 2015 using publicly available aerial imagery and high-resolution LiDAR data collected by the pipeline operator. The landslide complex was identified on an east-northeast facing slope of a mountain composed of the interbedded shale, siltstone, and sandstone units that make up the Conemaugh Group (5) (Figure 5A). While reviewing the LiDAR data, the mapper noted a “Possible landslide complex, encompassing the entire western slope, and spanning the ROW traveling axial across the alignment. Possible landslide deformation observed on the ROW across the GIS pipeline centerline; ROW is possibly deformed and ROW margins are difficult to discern. Small trees or shrubs can be seen growing in the ROW in aerial photography (Google Earth: 4/13/2011).”

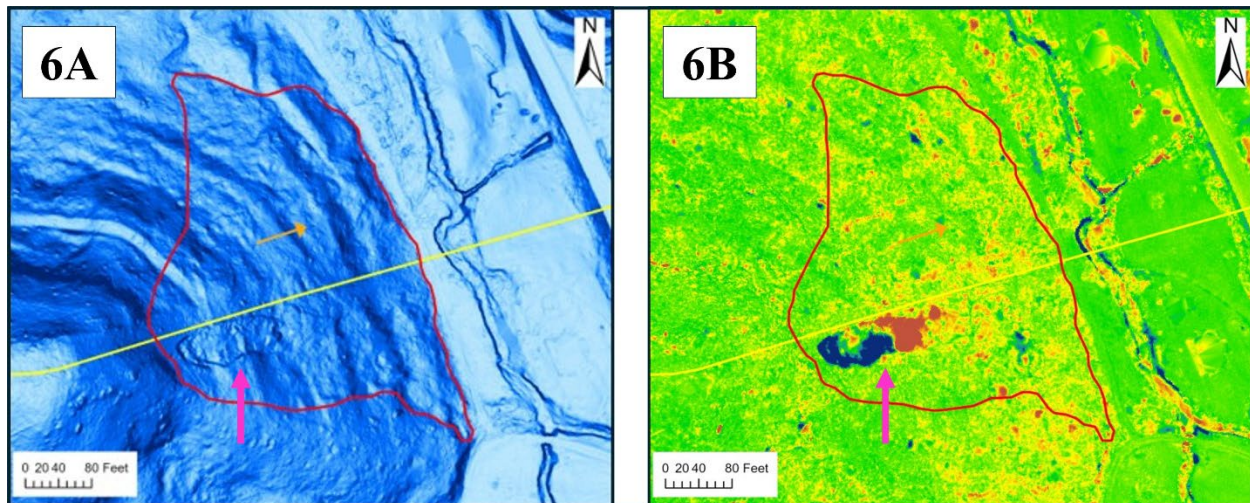
**Figure 6A: High-resolution LiDAR imagery acquired in 2022 of the same landslide complex in West Virginia. Figure 6B: LiDAR Change Detection Heat Map produced by comparing the 2021 and 2022 LiDAR data. The cool colors (i.e. blues) represent areas of net loss and warm colors (i.e. orange to red) represent areas of net gain. Yellow green represents areas with little or no change. The pink arrows highlight the area of active movement.**

LiDAR Change Detection Analysis – 2022 – During the LiDAR Change Detection Analysis, where data from 2022 were compared against data from 2021, possible landslide movement was detected within the landslide complex (Figure 6A & 6B). The mapper noted “Recent movement within [the landslide complex] and across the pipeline centerline. The LiDAR change signature appears to cross the location of the pipeline within the ROW.”

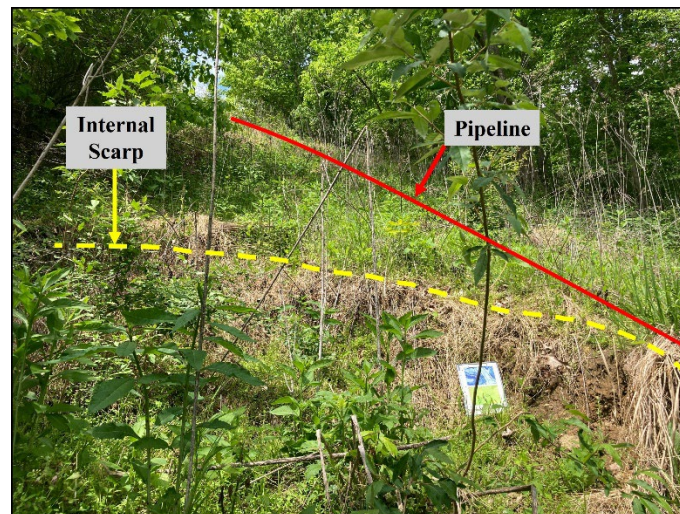
**Figure 7: Photo looking upslope at the internal scarp observed within the ROW during the repeat Level 2 Assessment. The morphology observed during the 2023 site visit corresponded to the area of change identified during the 2022 LiDAR Change Detection Analysis.**

Repeat Level 2 Assessment – 2023 – Due to the disturbance observed within the landslide complex during the LiDAR Change Detection Analysis, a follow-up site assessment was scheduled to determine the magnitude of the failure within the ROW. During the follow-up site assessment, the field team noted that a recent internal failure occurred within the ROW and that the size of the internal landslide morphology measured up to 4 feet high and crossed the location of the pipeline (Figure 7). Based on the size of the recent failure, and the depth to the center of the pipeline, it was determined that the base of the recent failure was located below the depth of the pipeline; therefore, continued landslide movement may have an adverse effect to pipeline integrity.

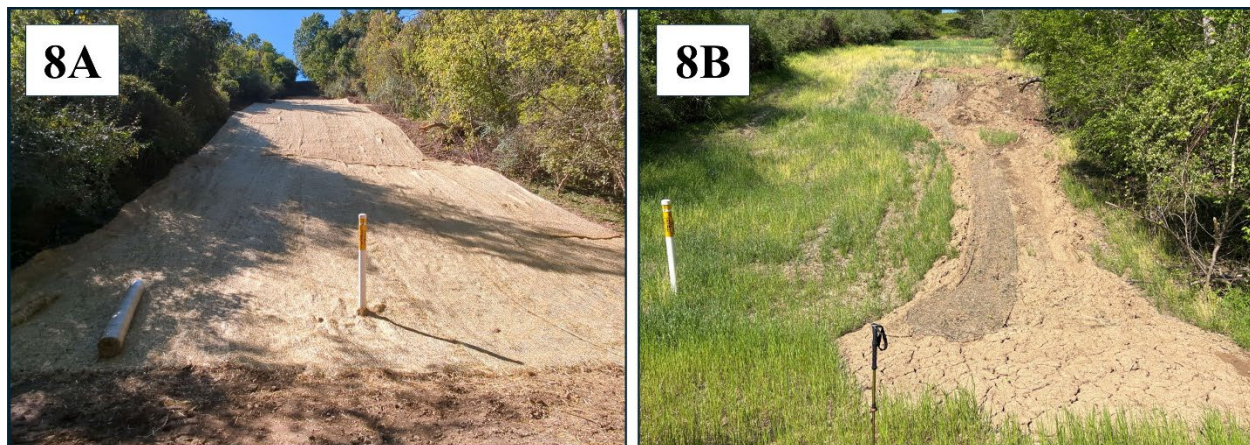
**Figure 8A: Photo looking upslope at the recently regraded ROW located within the landslide complex. The slope was regraded after installation of strain gauges in 2025.**  
**Figure 8B: Looking upslope at the debris flow, which occurred after the slope regrading of Figure 8A.**

Additional Level 3 Assessment – 2025 – Due to the added threat to the integrity of the pipeline imposed by the 2023 internal movement, the decision was made to install four sets of strain gauges on the pipeline along the length of the landslide complex. During installation of the strain gauges, the pipeline is excavated and the entire ROW is typically disturbed, which effectively erases any landslide morphology within the ROW. After installation, the slope within the ROW is regraded and reseeded (Figure 8A).

Assessment. During the 2026 site assessment, the field team noted that a recent failure of the material within the ROW resulted in a debris flow located on the lower portion of the slope (Figure 8B). The failure appeared to be localized in the ROW fill material and did not appear to be indicative of larger, deep-seated landslide movement.

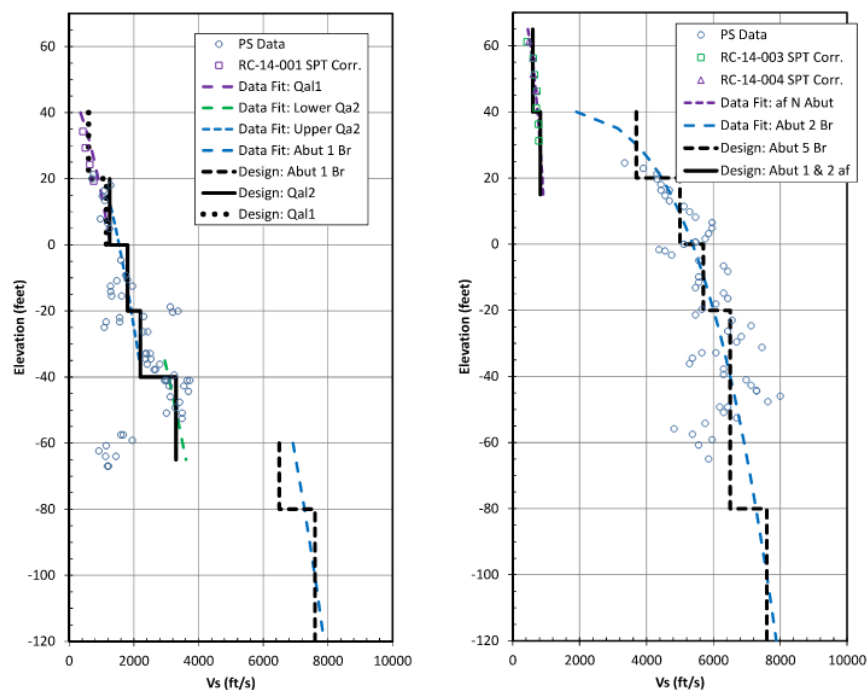
Figure 2: Shear Wave Velocity Profile, Left (RC 14-001), Right (RC 14-003)

Caltrans performed borings and geophysical tests at this site. Borings were performed in 2008, 2009 and 2014. At this time, Logs of Test Borings (LOTB) for this project have not been prepared and we obtained pertinent information from the rough drafted boring logs. In addition, shear wave velocity measurements were performed at two locations (RC 14-001 and RC 14-003) using suspension logging techniques. Based on the data obtained from boring logs, the bridge alignment is underlain by fill materials overlying younger alluvium consisting of sands and gravels with minor cobbles in turn underlain by cobbles and boulders with sand and gravel matrix overlying bedrock consisting of greywacke and shale. Depth to bedrock varies from about 130 to 150 feet at the south abutment to about 40 feet at the north abutment. Shear wave velocities used in our analyses are presented in Figure 2. An idealized profile with boring logs and shear wave velocity measurements are presented on Figure 3. Groundwater is within 15 feet below the ground surface.

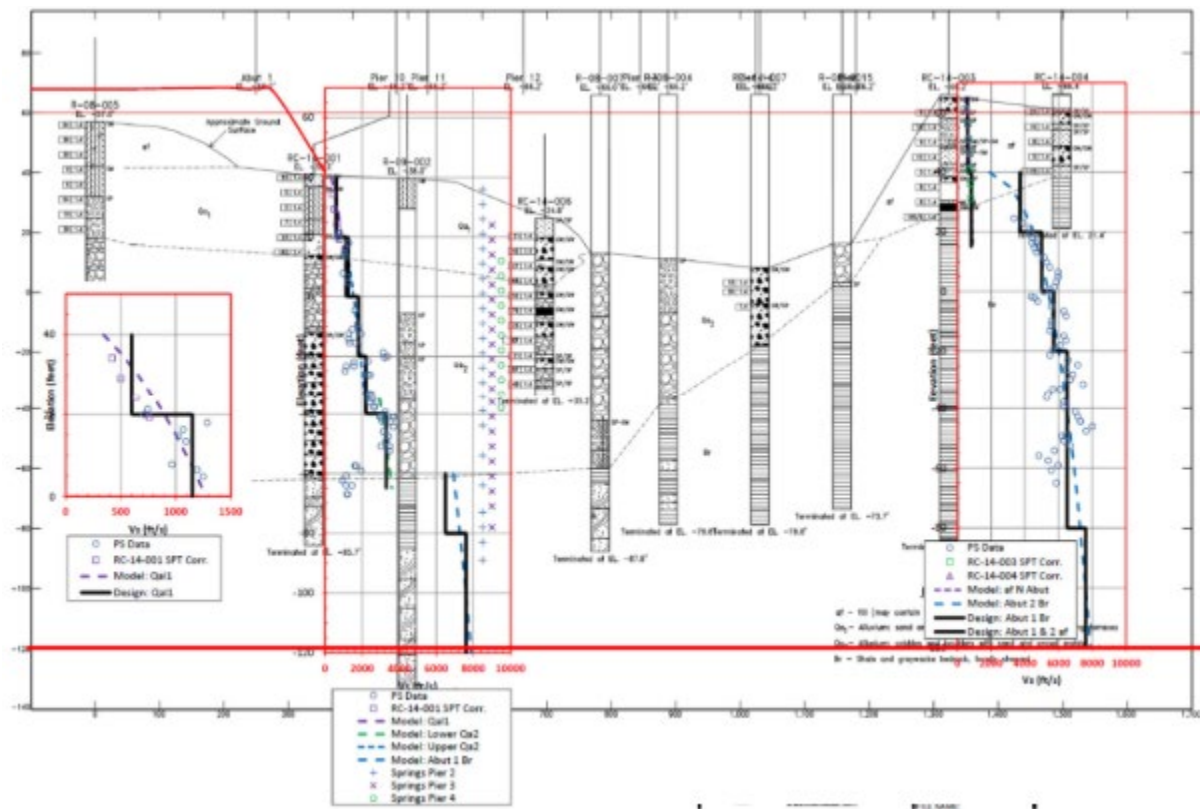
Figure 3: Idealized Soil Profile

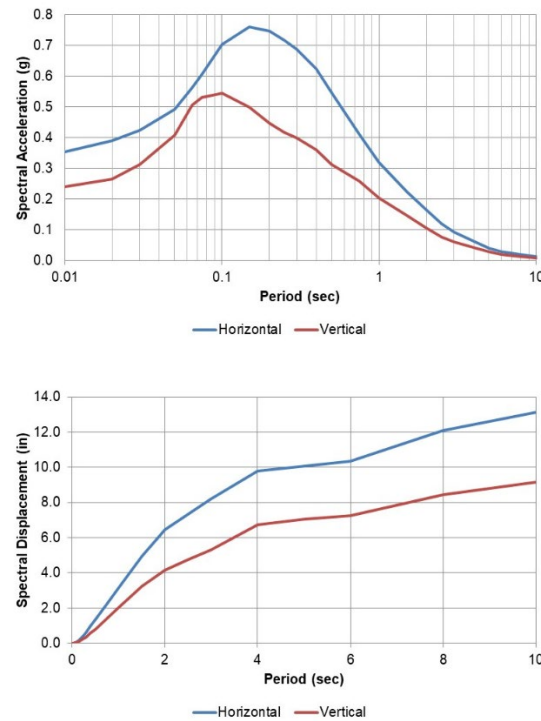
Figure 4: Site-Specific ARS Curves for Outcrop

The resulting outcrop horizontal and vertical spectra for 5 percent damping are presented on Figure 4. These outcrop spectra are the target spectra for our time history matching routine to develop spectral-matched time histories for site response analyses.

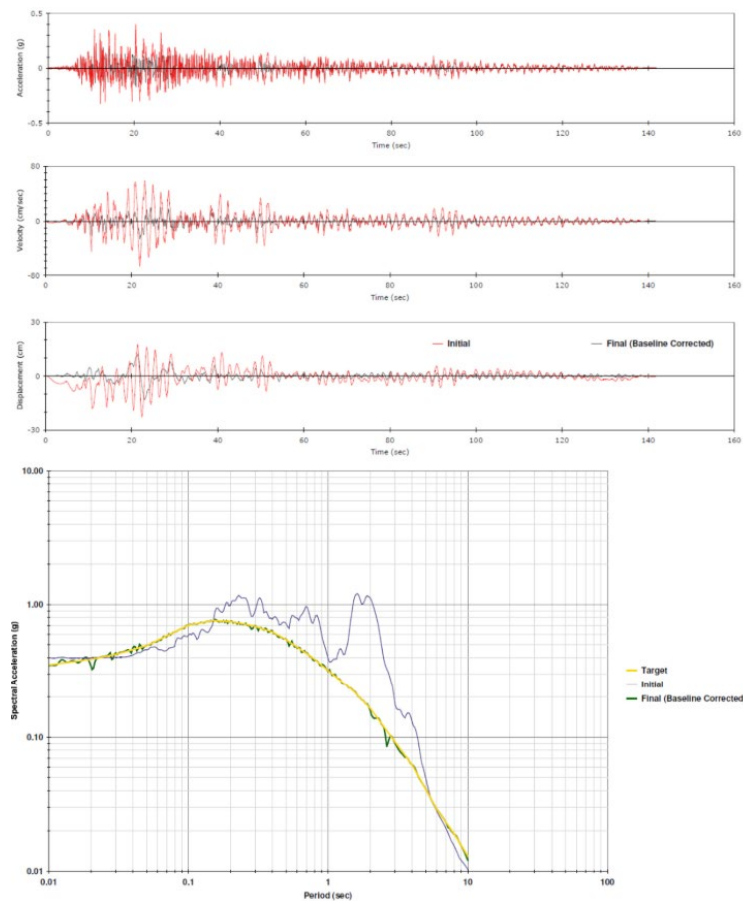
Figure 5: Time History and Spectra of Original and Matched Motions – 2010 Chile EQ – L

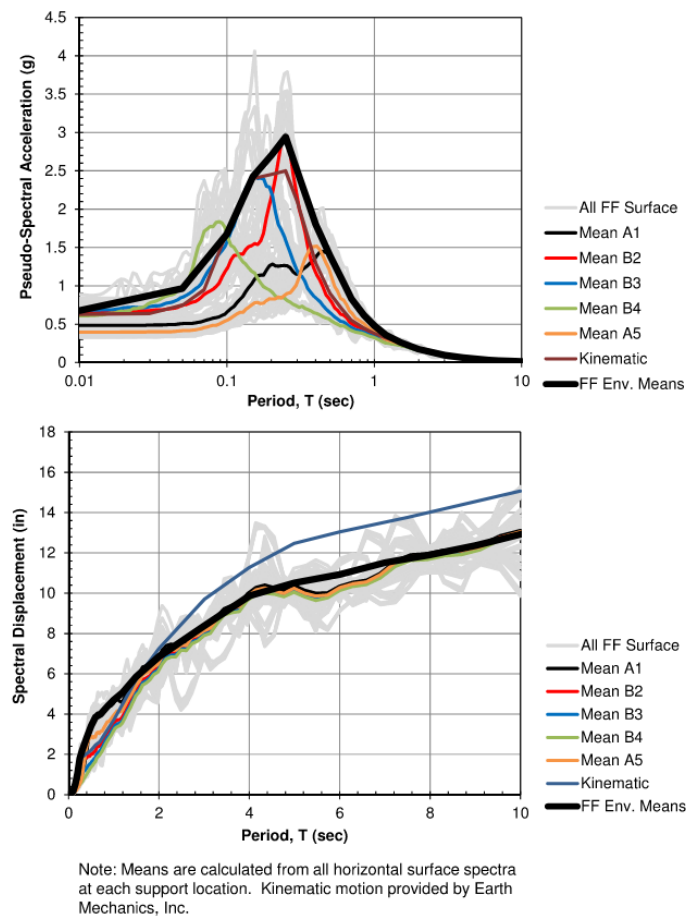
Figure 6: Summary of mean surface spectra with the envelope

Results in terms of longitudinal, transverse, and vertical time histories for acceleration, velocity and displacement and their response spectra at 10-foot vertical intervals along the pile/shaft length at each abutment and bent were obtained and provided to Caltrans. Figure 6 shows mean response spectra resulting from both 1D and 2D site response analyses. The 1D mean response spectra at Abutments 1 and 5 and at Bents 2, 3, and 4 are presented in Figure 6. The kinematic response spectrum is also presented.

Figure 7 shows all the 84<sup>th</sup> percentile spectra including the kinematic and the enveloping spectrum. The enveloping spectrum resulted from taking the envelop of mean spectrum at each abutment and bent locations instead of enveloping all surface response spectra. Figures 6 and 7 shows that different spectra are greater or smaller than each other at different periods. The enveloping 84<sup>th</sup> percentile spectrum was recommended for the design.

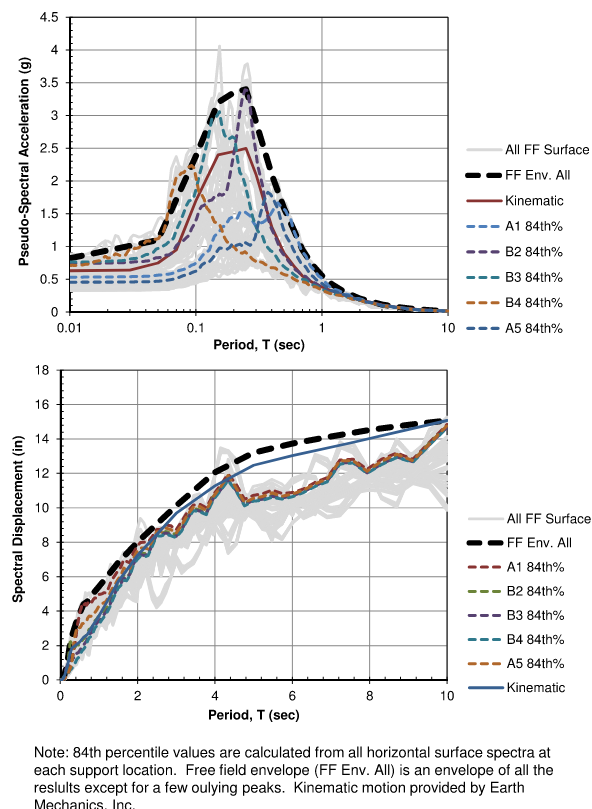
Figure 7: Summary of all surface 84<sup>th</sup> percentile spectra along with the enveloping spectrum.

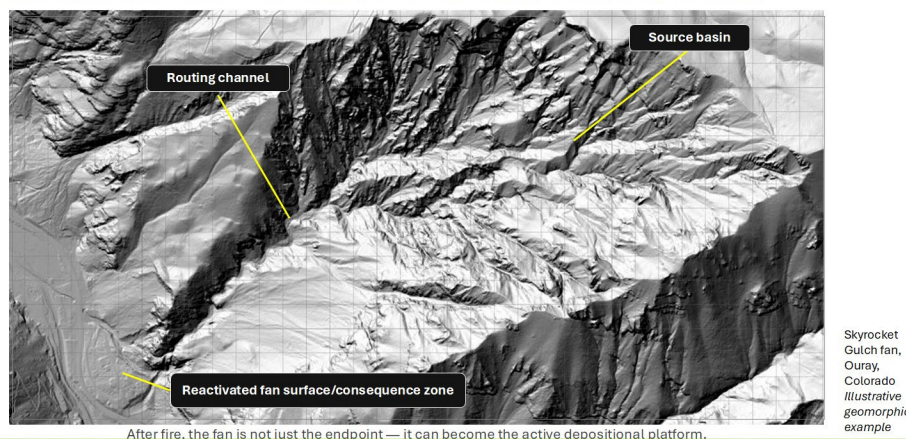
### Figure 1. Conceptual Source Basin–Routing Channel–Receiving Fan Framework.

Conceptual illustration of the connected geomorphic system that forms the basis for the LiDAR-Based Alluvial Fan (LAF) Inventory. Skyrrocket Gulch near Ouray, Colorado, is shown as an illustrative example.

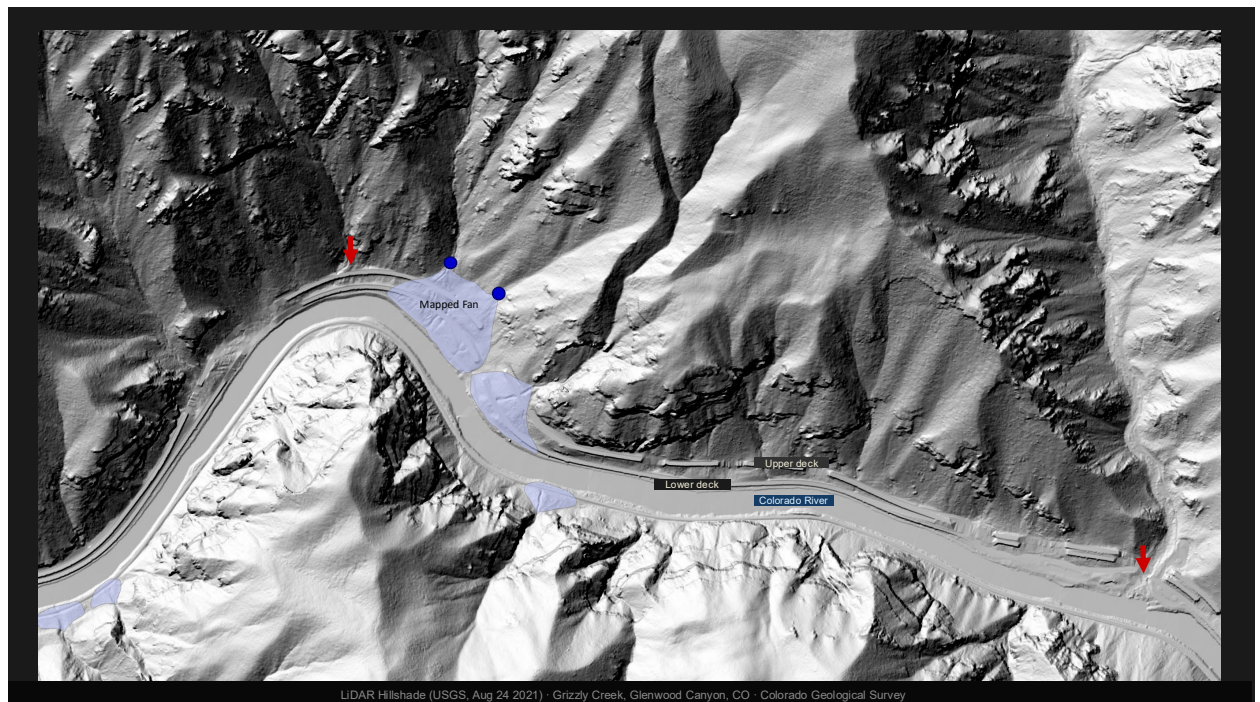
**Figure 2. Mapped Alluvial Fan Landforms Along Interstate 70 in Glenwood Canyon.**

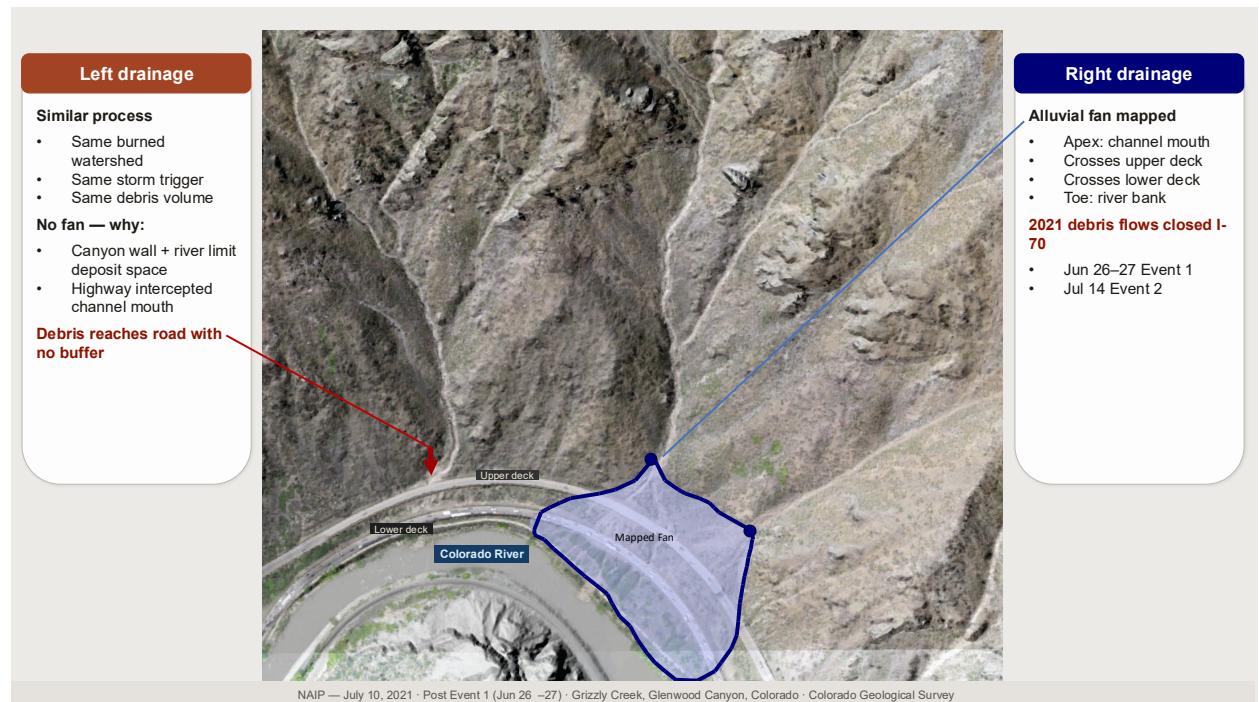
**Figure 3. Contrasting Transportation Consequences in Adjacent Post-Fire Drainages.**

Figure 3 illustrates this concept by comparing two adjacent tributary drainages that experienced similar wildfire and storm conditions but produced different transportation consequences because of their geomorphic setting. The drainage on the left lacks a mapped receiving fan because the canyon wall, the Colorado River, and the transportation corridor offer little opportunity for deposition before sediment reaches the highway. In contrast, the drainage on the right is connected to a mapped alluvial fan that provides a depositional surface where sediment spreads before intersecting Interstate 70. Although hazardous flows originate within the upstream basin, the receiving landform largely governs where corridor-scale consequences develop (1).

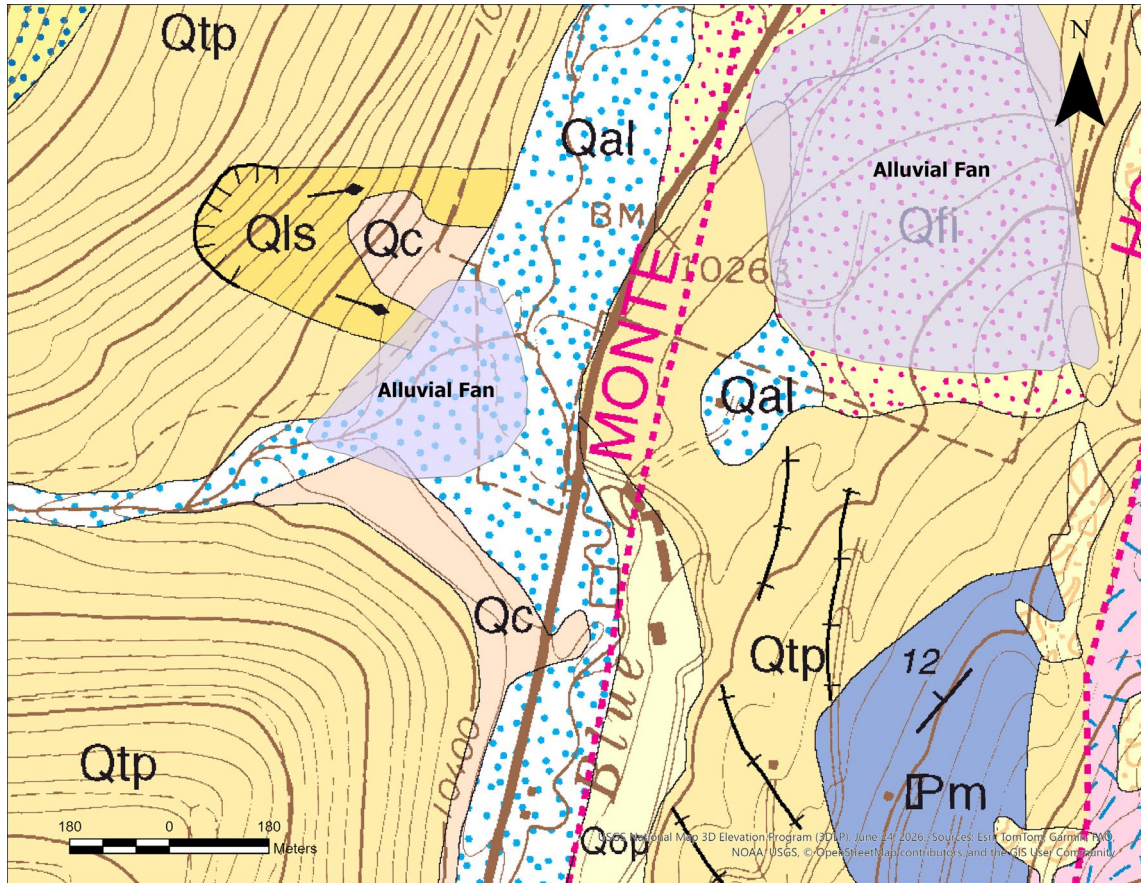
**Figure 4. Conventional Surficial Geologic Mapping with LiDAR-Derived Alluvial Fan Delineation. (9)**

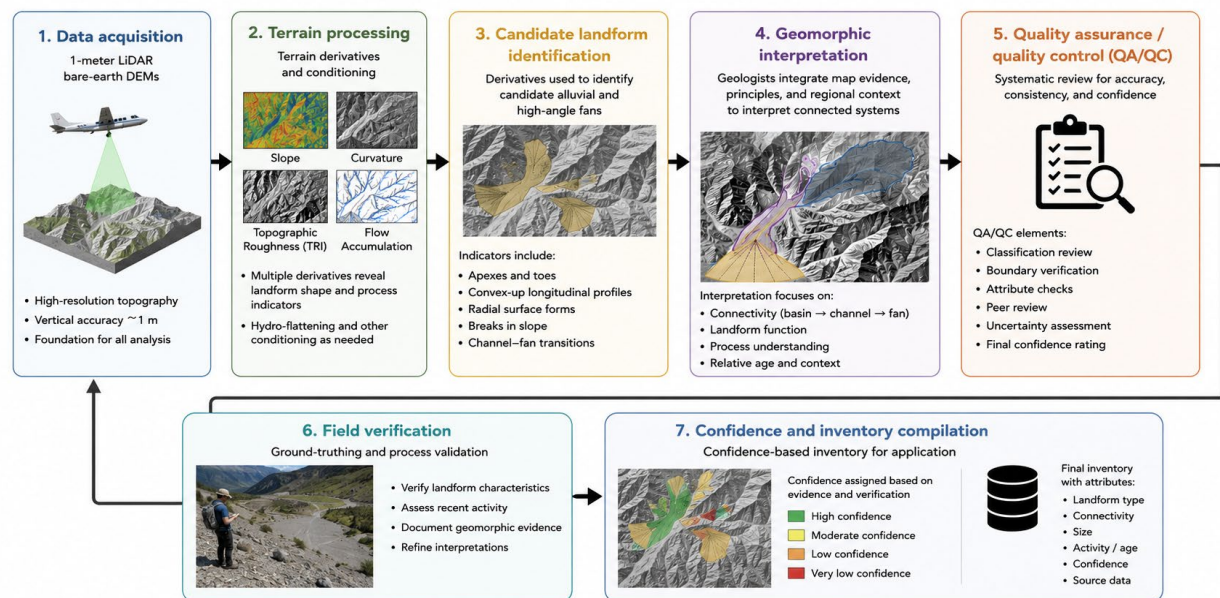
**Figure 5. Repeatable LiDAR-based mapping workflow illustrating data acquisition, terrain processing, geomorphic interpretation, quality assurance, field verification, confidence assessment, and final inventory compilation.**

Mapping begins by identifying candidate alluvial and high-angle fan landforms at basin mouths and locations where confined channels emerge onto lower-gradient terrain. Candidate polygons are then evaluated using multiple geomorphic criteria, including apex position, basin and channel connectivity, fan morphology, terrain derivatives, slope characteristics, and supporting geomorphic evidence. Polygon boundaries are interpreted manually using these complementary datasets rather than generated through automated classification alone.

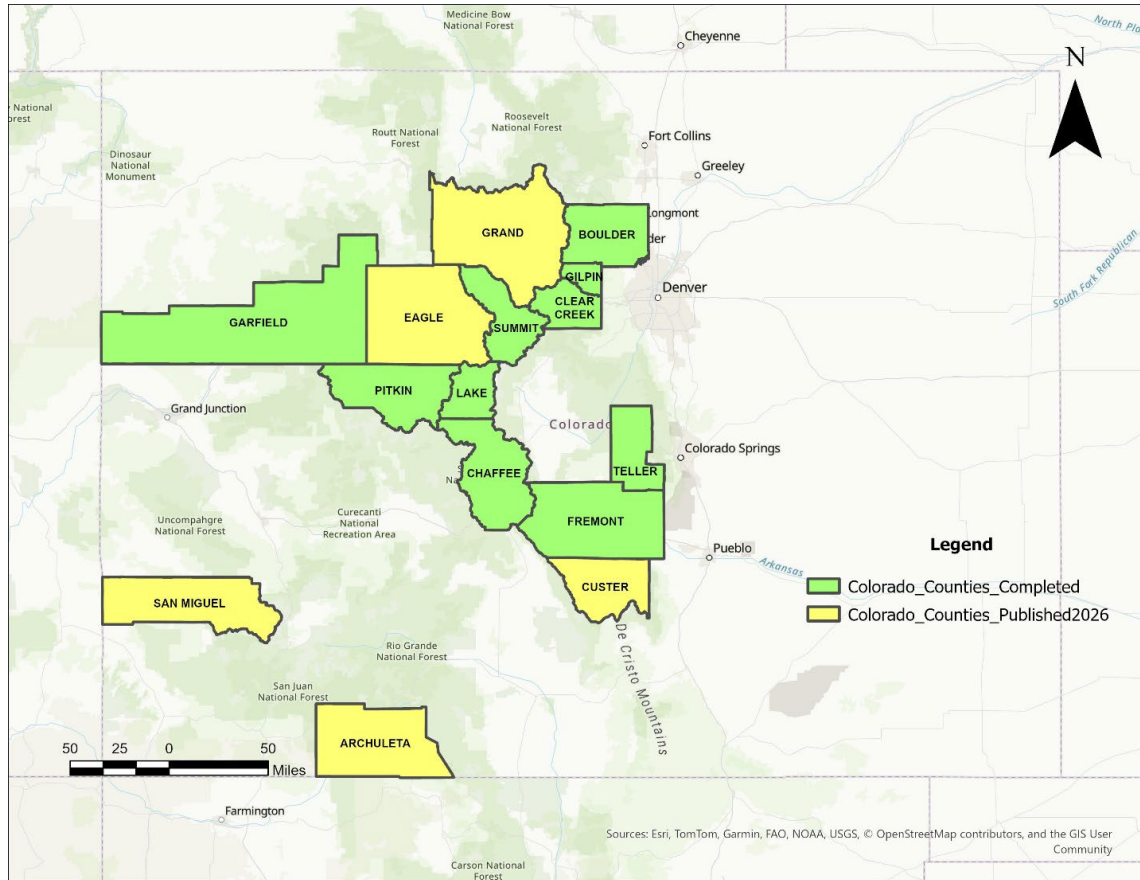
**Figure 6. LiDAR-Based Alluvial Fan Inventory Coverage in Colorado.** Current status of the Colorado Geological Survey's LiDAR-Based Alluvial Fan (LAF) mapping project. Green counties represent the ten completed inventory areas included in this study (Boulder, Chaffee, Clear Creek, Fremont, Garfield, Gilpin, Lake, Pitkin, Summit, and Teller). Yellow counties represent five additional inventory areas (Archuleta, Custer, Eagle, Grand, and San Miguel) that are currently in QA/QC review and planned for publication in 2026. County boundaries are shown for project context. Base map sources: Esri, TomTom, Garmin, FAO, NOAA, USGS, © OpenStreetMap contributors, and the GIS User Community.

The completed LAF Inventory currently includes 8,854 mapped alluvial and high-angle fan landforms distributed across ten Colorado counties, with five additional counties currently undergoing quality assurance and quality control (QA/QC) review for planned publication. Figure 6 illustrates the current geographic extent of the completed inventory and counties presently in progress.

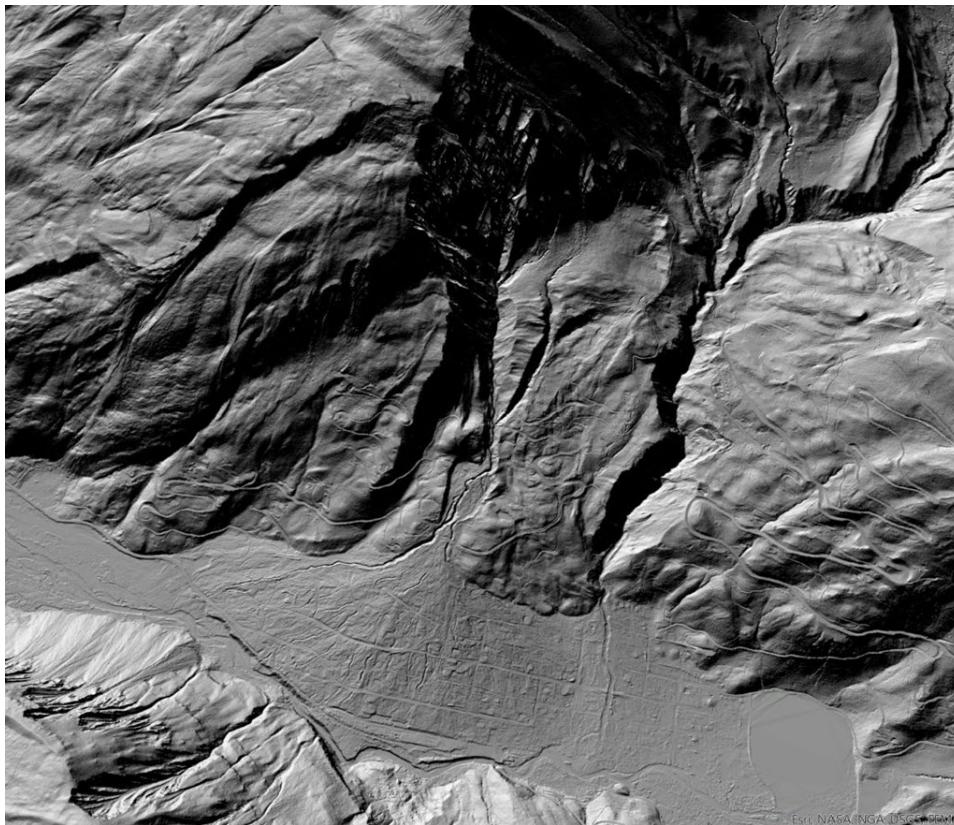
**Figure 7. LiDAR-Based Recognition of Alluvial Fan Morphology in Marble, Colorado.** Bare-earth LiDAR hillshade reveals the morphology and extent of the alluvial fan underlying the developed portion of Marble, Colorado. The example illustrates how LiDAR-based geomorphic interpretation can identify depositional receiving landforms beneath existing development, supporting regional hazard recognition, land-use review, and transportation corridor screening.

The Marble example illustrates how LiDAR-derived terrain models improve recognition of depositional landforms that have been modified by development while preserving sufficient geomorphic evidence to support consistent interpretation. Similar relationships between mapped fan landforms and transportation infrastructure were observed throughout the inventory, although the degree of preservation and anthropogenic modification varied among counties.

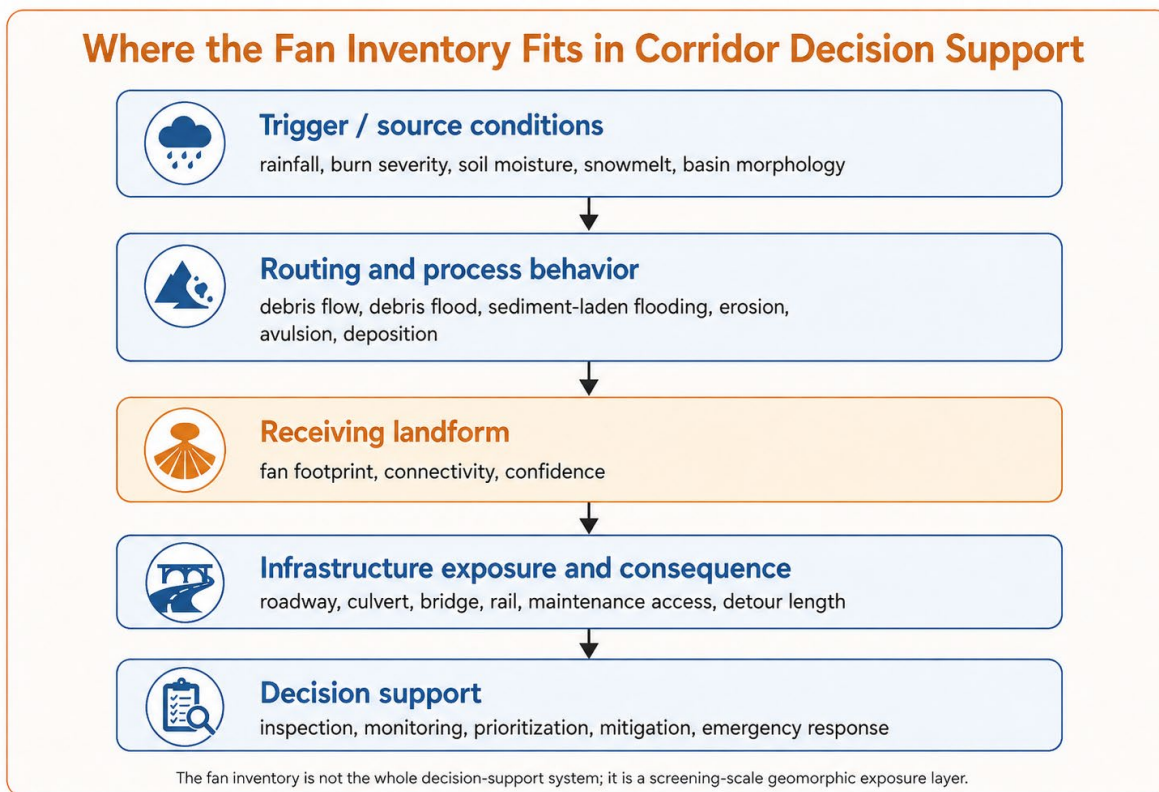
**Figure 8. Conceptual decision-support framework illustrating how interpreted receiving-landform polygons complement source-basin analyses, infrastructure inventories, monitoring, and engineering evaluation.** The LiDAR-based Alluvial Fan Inventory provides a screening-level geomorphic exposure layer rather than a probability model or engineering design tool.

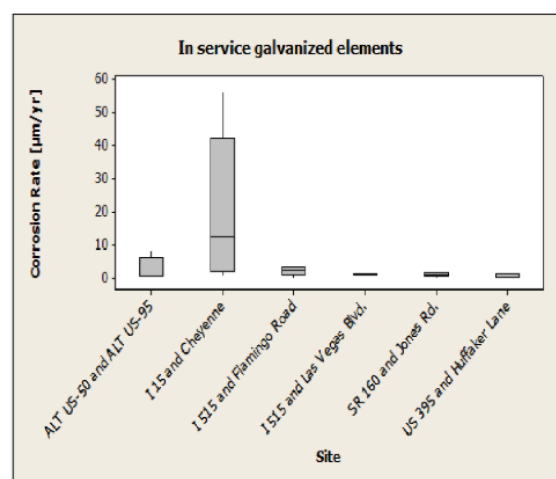
Figure 1 illustrates the distribution of measured corrosion rates for the in-service galvanized reinforcements. Corrosion activity varied considerably among the monitored sites, with the I-15/Cheyenne Boulevard site exhibiting the broadest distribution and highest measured corrosion rates. The remaining sites generally exhibited narrower distributions centered at comparatively lower corrosion rates. The observed variability demonstrates that corrosion performance differs substantially among structures and provides the basis for comparing measured reinforcement performance throughout the statewide monitoring program.

**Figure 1:** Distribution of measured LPR corrosion rates for in-service galvanized reinforcements by monitored site (adapted from the NDOT Phase II Corrosion Investigation)

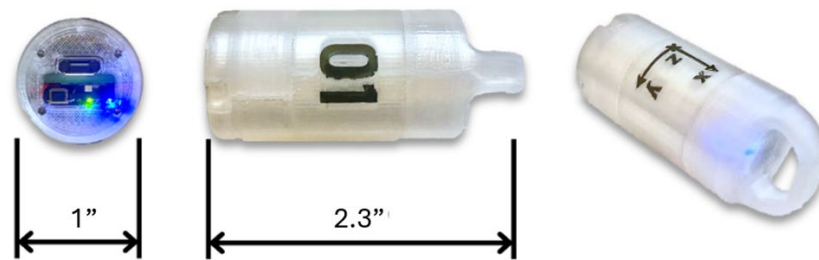
The latest Smart Rock sensor, shown in Figure 1, consists of a 3D-printed capsule containing two triaxial accelerometers, a triaxial gyroscope, and an altimeter. The high-g,  $\pm 400$  g accelerometer measures the high accelerations generated during impacts and rebounds, while the low-g,  $\pm 16$  g accelerometer provides higher resolution at lower acceleration levels. The low-range accelerometer also helps identify whether the block is in free fall (approximately 0 g) or at rest (approximately 1 g). The  $\pm 4,000$  degrees-per-second (dps) gyroscope simultaneously

measures rotation rates about three axes. The altimeter tracks changes in elevation and provides complementary trajectory information, particularly when video recording is unavailable.

**Figure 1 – Latest generation of UNH Smart Rock sensors.**

A SR can be prepared for testing in less than one minute. Data are normally recorded at 100 Hz or at up to 500 Hz when the altimeter is disabled. A translucent cap allows the operator to confirm the sensor status through visible indicator lights. Measurements are automatically saved as a .csv file on a micro-SD card and are available for processing immediately after each test. The sensor is rechargeable through a standard micro-USB connection.

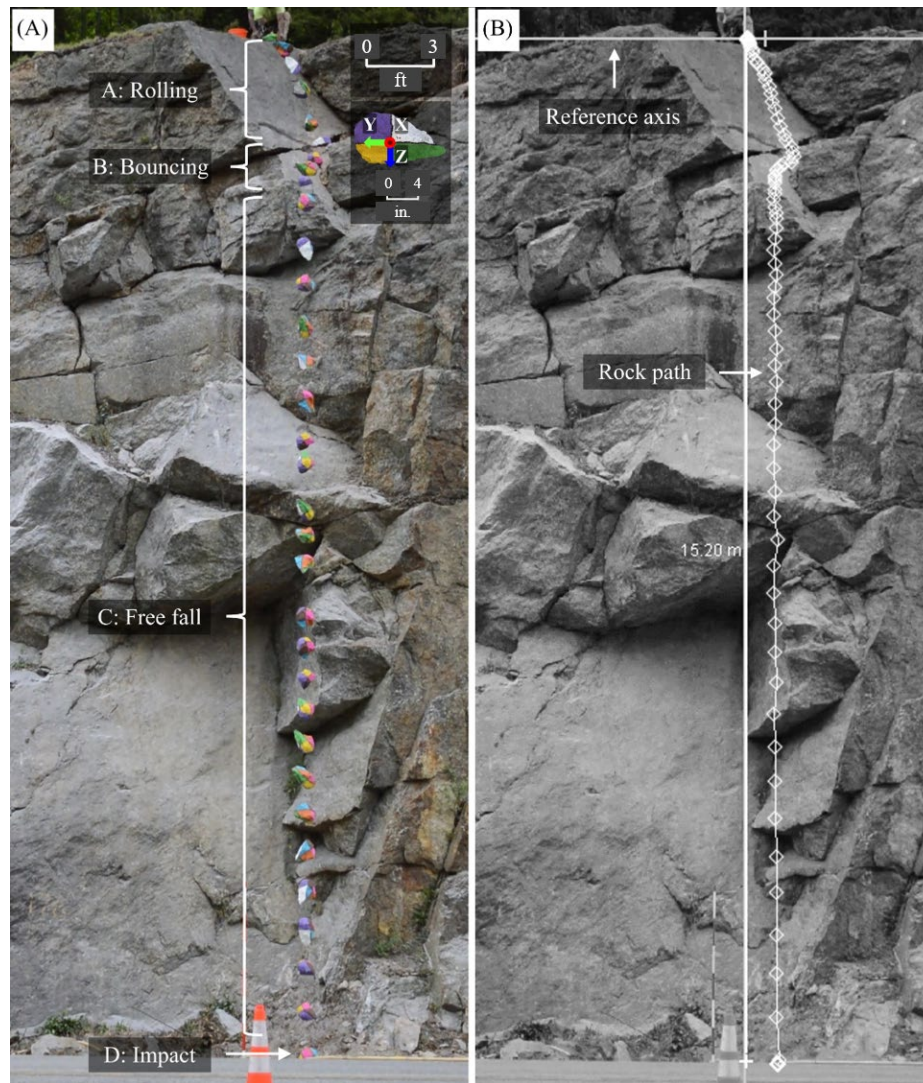
One test site was a 49.5-ft-high granodiorite rock cut in Warner, New Hampshire, with an average inclination of 70° to 85°. A 3.5- to 5-m-wide catchment ditch containing granular soil was located at the base of the slope. Eight rockfall tests were performed at this site. Figure 2 presents one of these tests using a 40.3-lbs natural block.

**Figure 2 – Field rockfall trajectory in Warner, NH: (a) combination of video frames and (b) tracker software.**

Figure 3 shows the Smart Rock outputs for the test shown in Figure 2. The letters A through D in Figures 2 and 3 indicate the different rockfall stages, matched through both SR and video recording times.
