# 75<sup>TH</sup> HIGHWAY GEOLOGY SYMPOSIUM

BETTER HIGHWAYS THROUGH APPLIED GEOLOGY

2026  
HGS  
PROCEEDINGS

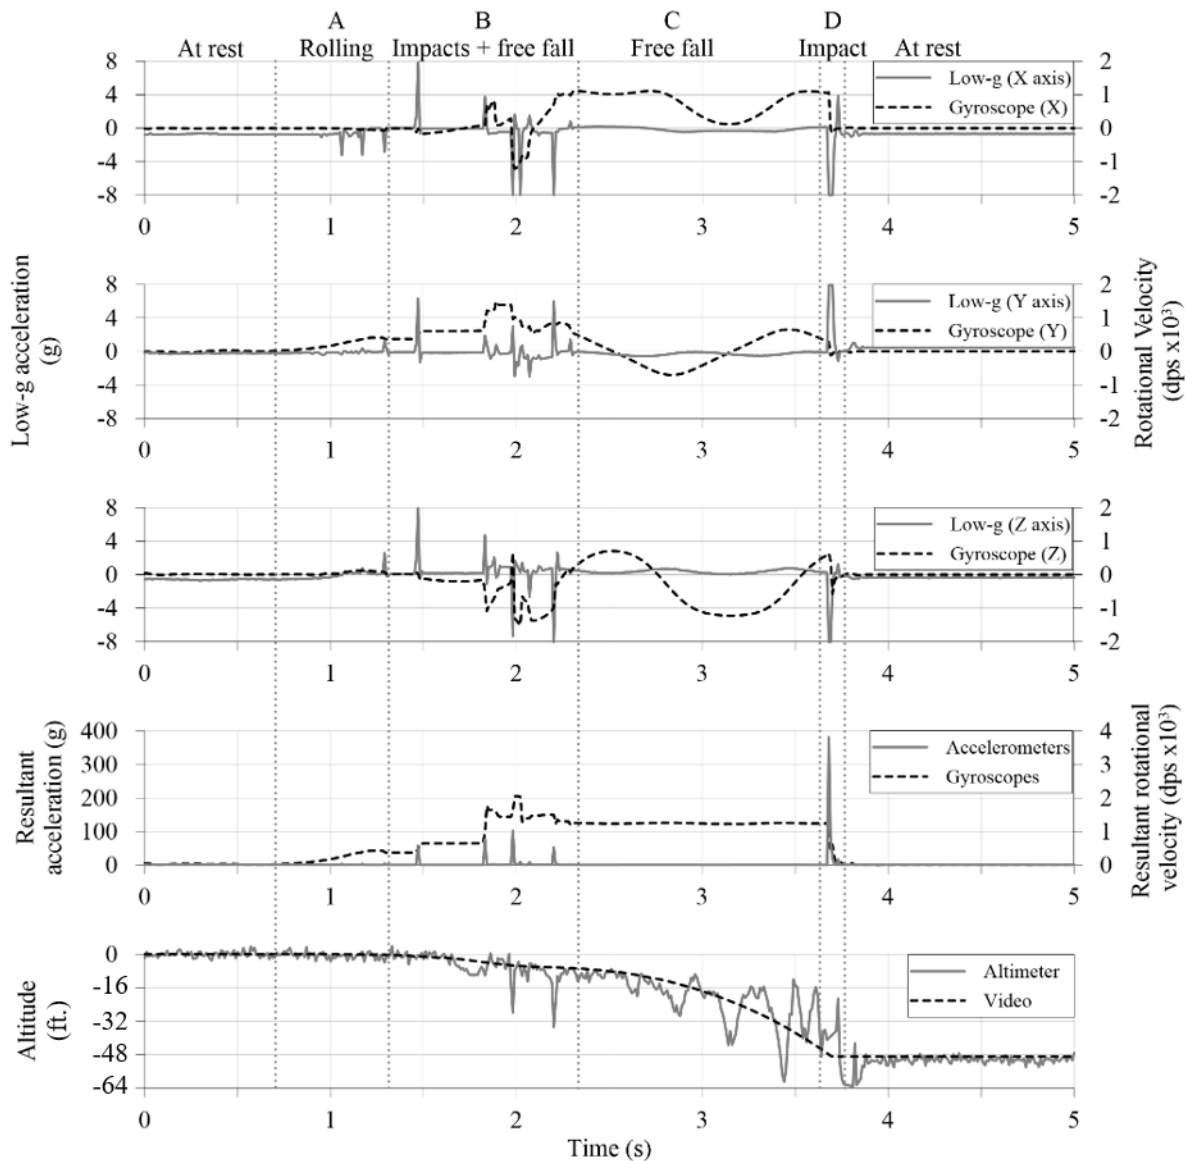
Figure 3 – Smart Rock sensor output for field rockfall test in Warner/NH.

In the example shown, the block initially rolled along the upper portion of the slope (A), producing increasing rotational velocity and acceleration peaks below 4 g. It then rebounded four times against the rock face (B), as indicated by larger acceleration peaks and changes in rotation following each impact. The block then fell freely for approximately 2 s (C), during which it recorded approximately 0 g and rotated about all three axes. The nearly constant resultant rotational velocity during this stage is consistent with the absence of external forces acting on the block in free fall (4). At approximately 3.7 s, the block impacted the catchment ditch and immediately came to rest (D). The measured runout distance from the slope toe was 1.3 m.

Figure 3 shows the Smart Rock outputs for the test shown in Figure 2. The letters A through D in Figures 2 and 3 indicate the different rockfall stages, matched through both SR and video recording times.

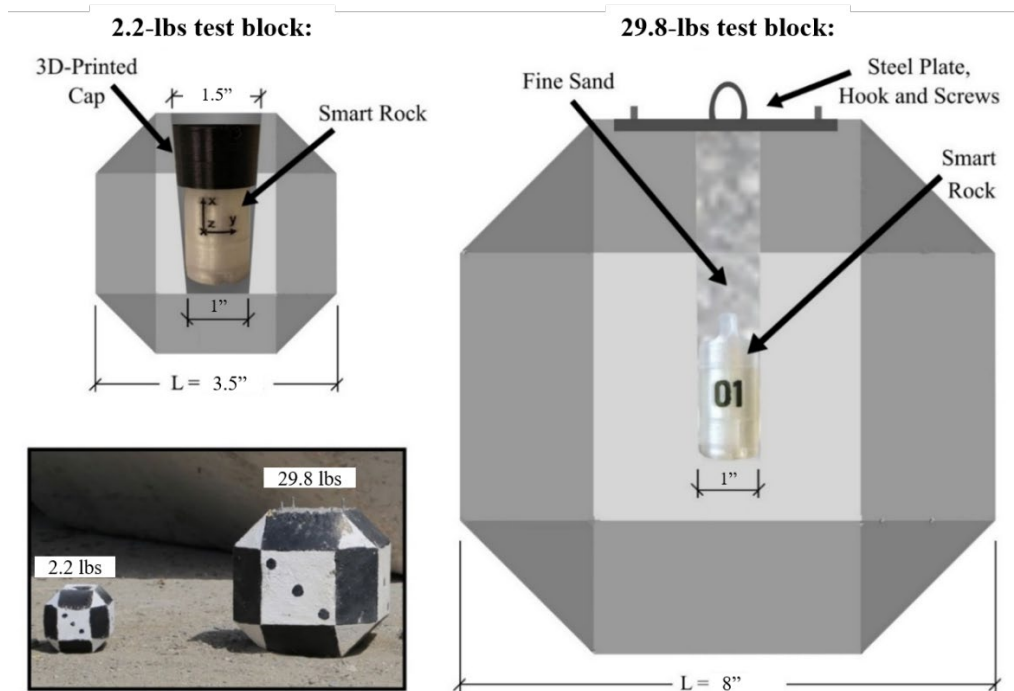
Each block had an orifice at its center of gravity for the Smart Rock sensor. The sensors were secured inside the block using a custom-printed cap or a steel plate, as shown in Figure 4. Blocks were released vertically with minimal initial rotation, and each test condition was repeated three times. Figure 5 shows the experimental setups to vertically release the test blocks at the University of New Hampshire and University Gustave Eiffel's rockfall testing station (France).

Figure 4 – Test block configurations. The 2.2 and 29.8 lbs weights consider the weight of the block, sensor, and additional materials to confine the SR (cap/plate, hook, and screws).

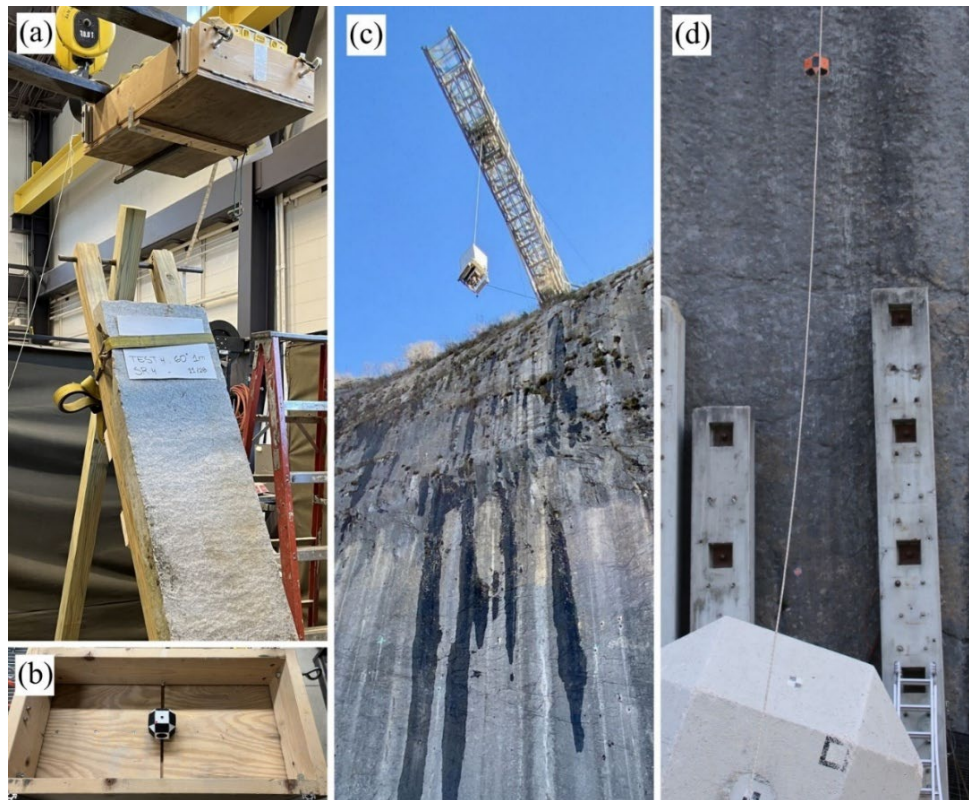
Figure 5 – (a) UNH small-scale setup on rough granite, positioned at 60°, and (b) close-up of rock dropper. (c) Crane at the UGE rockfall test station and (d) test setup on concrete at 20°: 29.8 lbs block, 16 ft. drop.

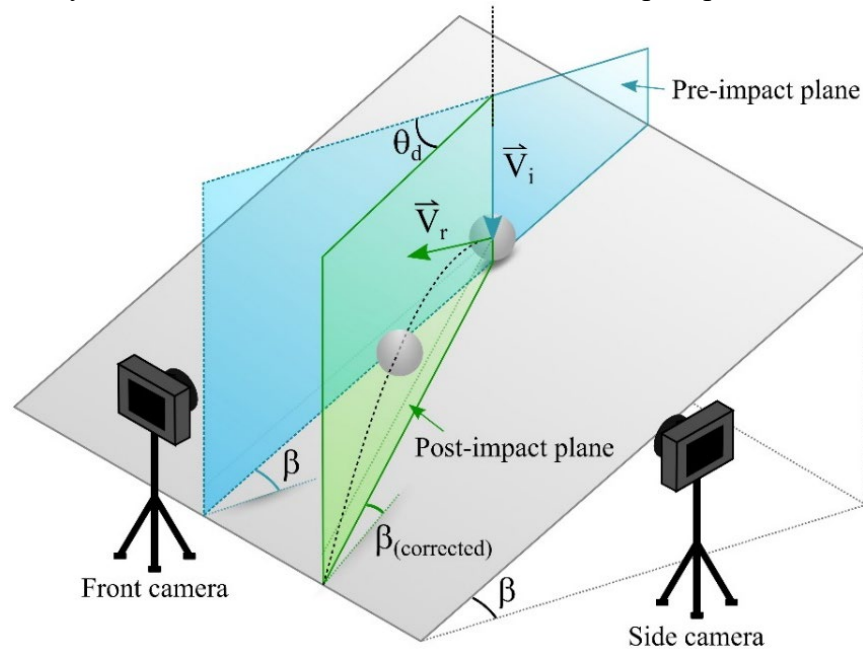
Smart Rock measurements were synchronized with high-speed cameras positioned in front of and beside the test area, as represented in Figure 6. This combined approach provided information not normally available from video observations alone. The combined camera views provided the three-dimensional block trajectory, including displacement, penetration, and translational velocity. Smart Rock measurements allowed the impact phase to be studied directly.

**Figure 6 – Schematic of tests performed under controlled conditions on an inclined plane and frontal and lateral camera views of one drop test on sand.**

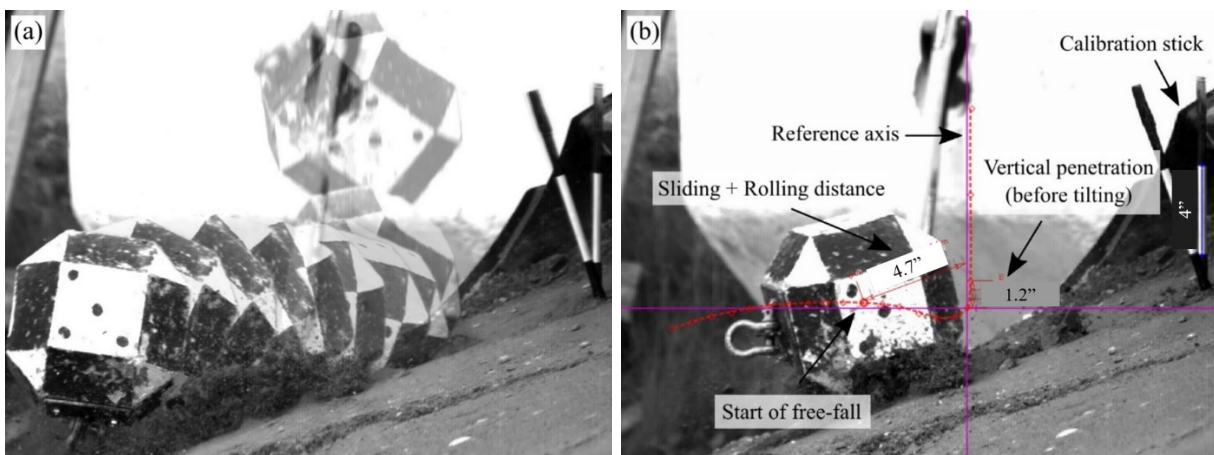
The acceleration measurements identified the exact time of ground contact, the magnitude and duration of impact, and subsequent rebounds. The gyroscope showed how rotation developed during impact and whether the block transitioned into rebound, rolling, or sliding. One example test is shown in Figure 7, where the 29.8-lbs block was released from a drop height of 16 ft. onto sandy gravel soil prepared at a slope of 20°.

**Figure 7 – (a) Block trajectory through combined video frames, and (b) block trajectory using Tracker software.**

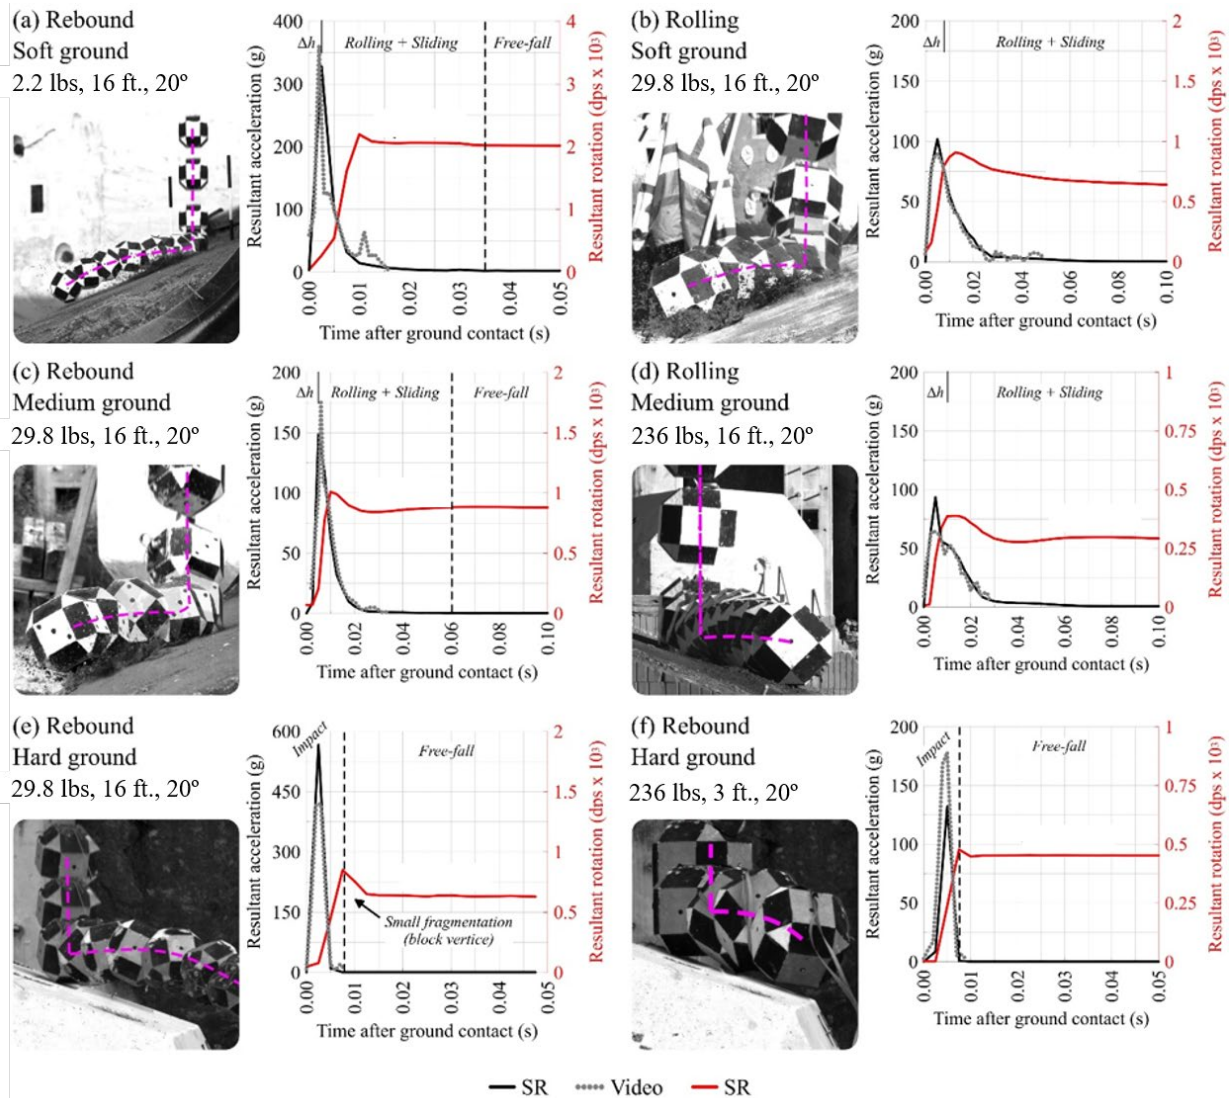
**Figure 8 – Rockfall trajectories under controlled conditions and their respective resultant acceleration and rotational velocity curves obtained through SR and video measurements.**

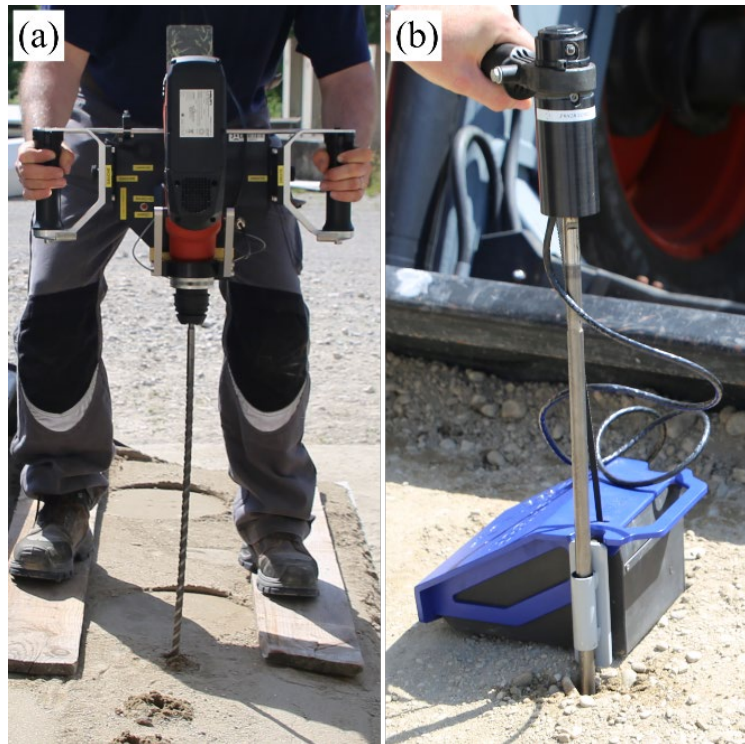
Independent ground characterization was conducted to evaluate and validate this approach. A lightweight deflectorometer measured surface deformability, while a portable Measurement While Drilling device (PMWD, Figure 9a) and a lightweight dynamic cone penetrometer (LDCP, Figure 9b) evaluated resistance to penetration and subsurface variability. Several characterization tests (67 in total) were completed in surfaces prepared under controlled conditions. Agreement between the PMWD, LDCP, and Smart Rock results supported the use of normalized impact duration as an indicator of ground type.

**Figure 9 – Characterization tests under controlled conditions: (a) PMWD on sand and (b) LDCP on sandy gravel.**

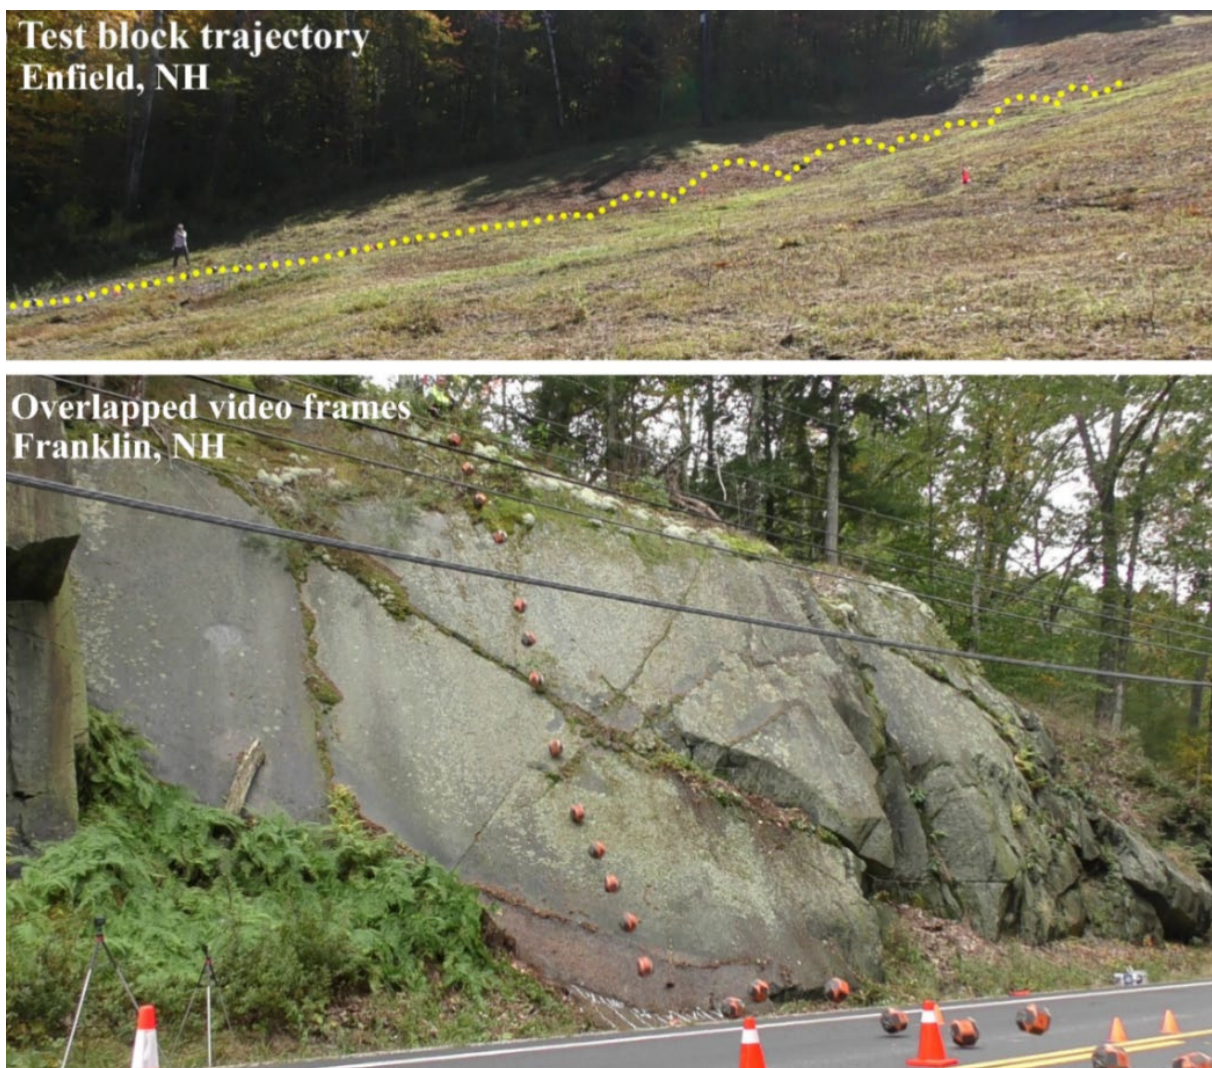
**Figure 10 – Field tests in Enfield and Franklin, NH.**

Twelve additional field experiments were performed at two sites in New Hampshire, shown in Figure 10. Concrete blocks weighing 29.8 lbs and containing two Smart Rock sensors were released from known locations with minimal initial velocity. The sites were selected to represent ground surfaces with different degrees of deformability. PMWD and LDCP tests were completed along the test slopes to independently characterize subsurface resistance and classify the terrain as soft, medium, or hard.

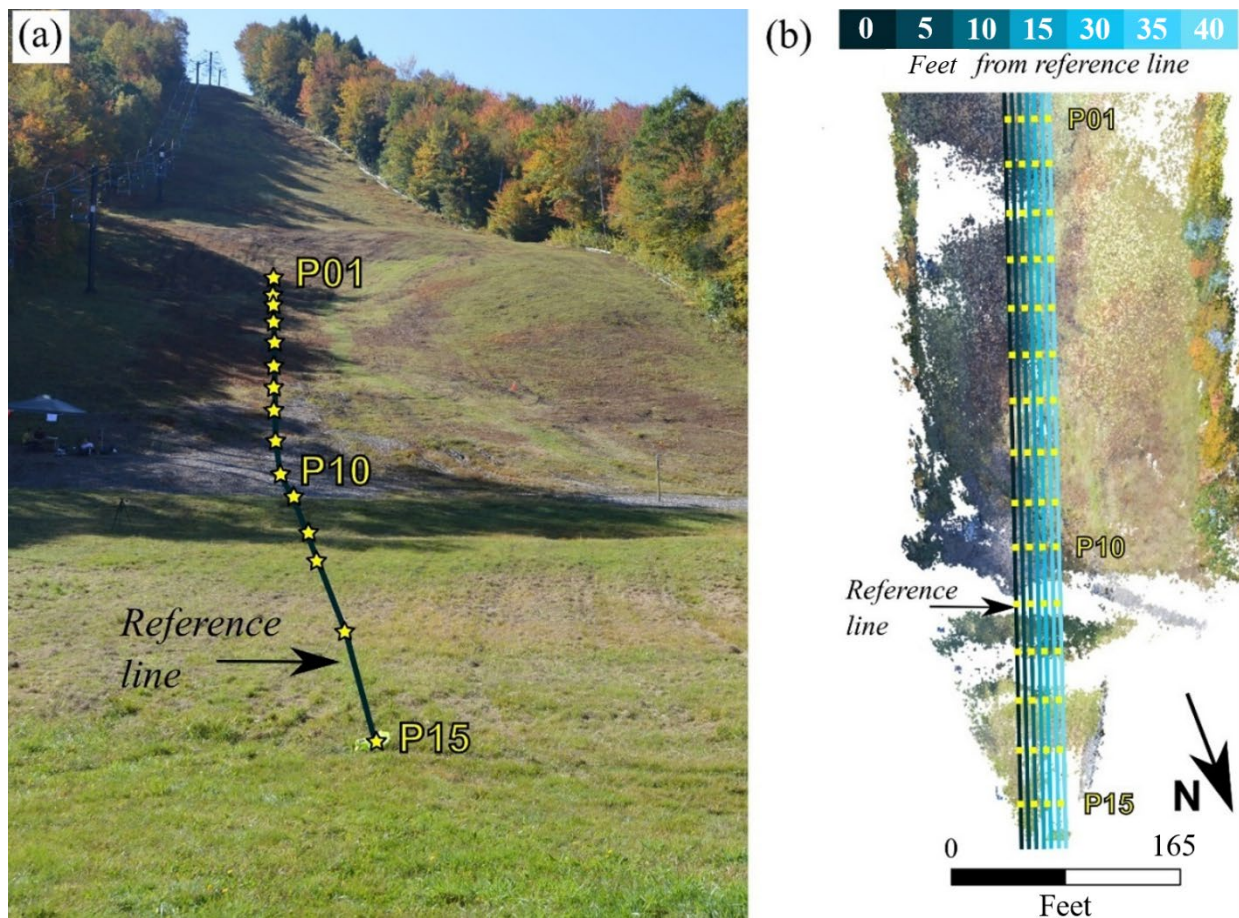
**Figure 11 – (a) Test slope in Enfield/NH, USA. The spaces between each pair of stars measure 33 ft. along the slope surface. (b) Distribution of test locations along the slope profile.**

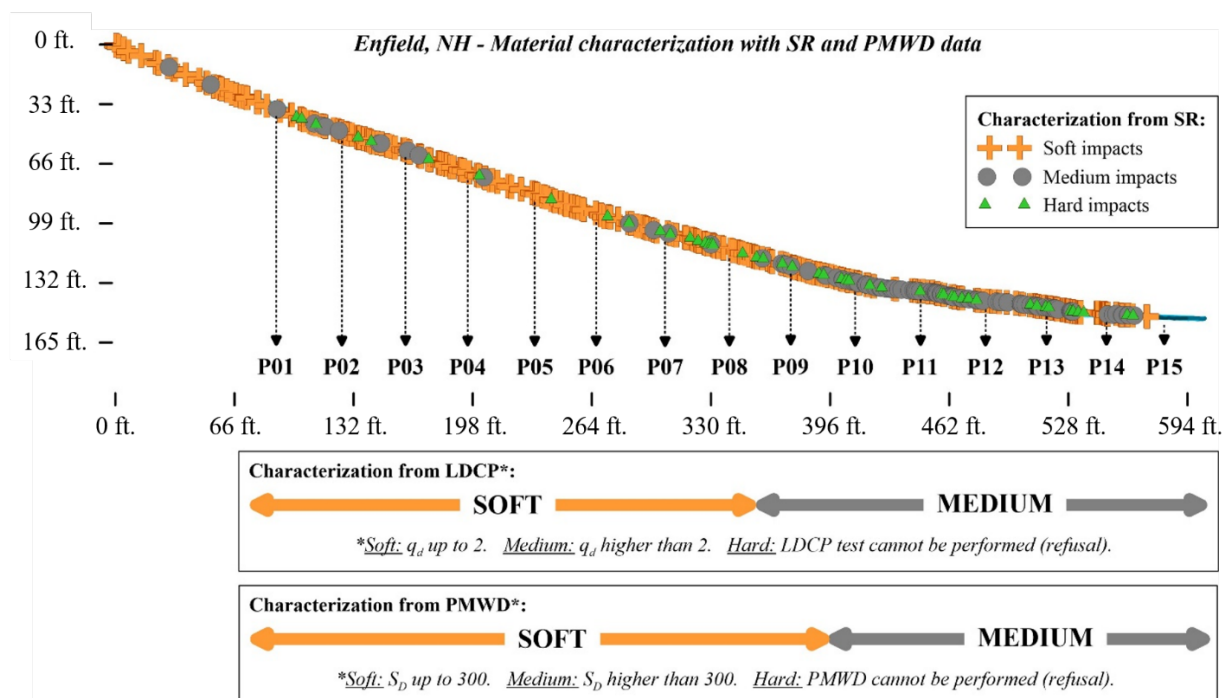
The Smart Rock results showed predominantly soft impacts along the upper slope and a transition toward medium impacts downslope, as shown in Figure 12. This pattern was consistent with the independent PMWD and LDCP profiles. Isolated, hard impacts were generally associated with shallow cobbles or exposed rock rather than a continuous hard-ground layer. This distinction is relevant as a falling block responds to the material at its specific point or area of contact, which may differ from the general description assigned to a larger slope segment.

**Figure 12 – Material characterization in Enfield, NH, based on SR data and in situ characterization testing with LDCP and PMWD.**

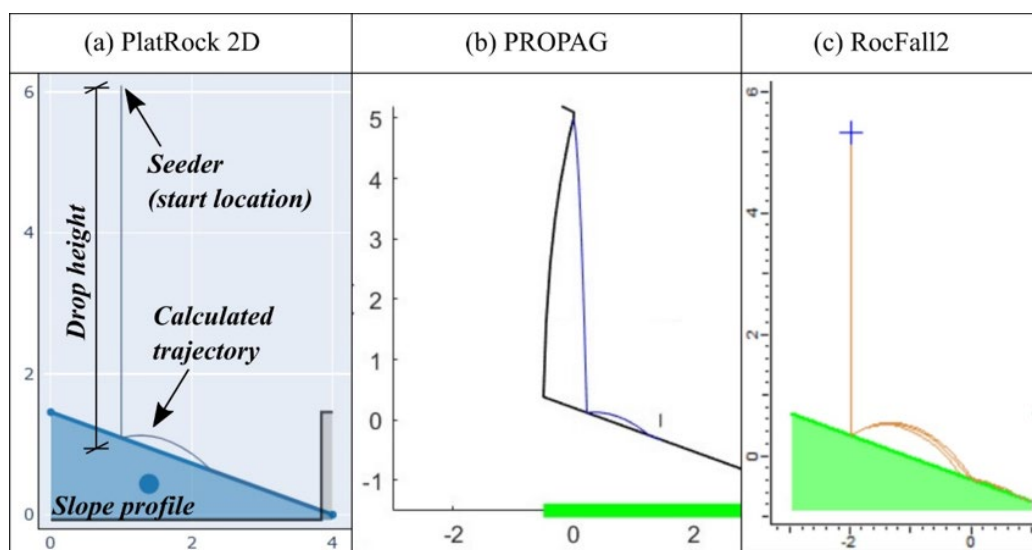
The comparison was completed in two stages. First, the controlled drop tests using the 29.8-lbs block were simulated using default parameters recommended by each program as shown in Figure 13. These tests provided the most complete experimental dataset across soft, medium, and hard ground. Model predictions were compared with measured translational and rotational energies, modes of motion, and apparent coefficients of restitution, which describe the fraction of velocity retained after impact. This comparison showed how each program represented a single impact under known conditions and provided initial ranges of calibrated input parameters.

**Figure 13 - Sample software trajectory outputs – medium ground, 20° slope, 16 ft. drop.**

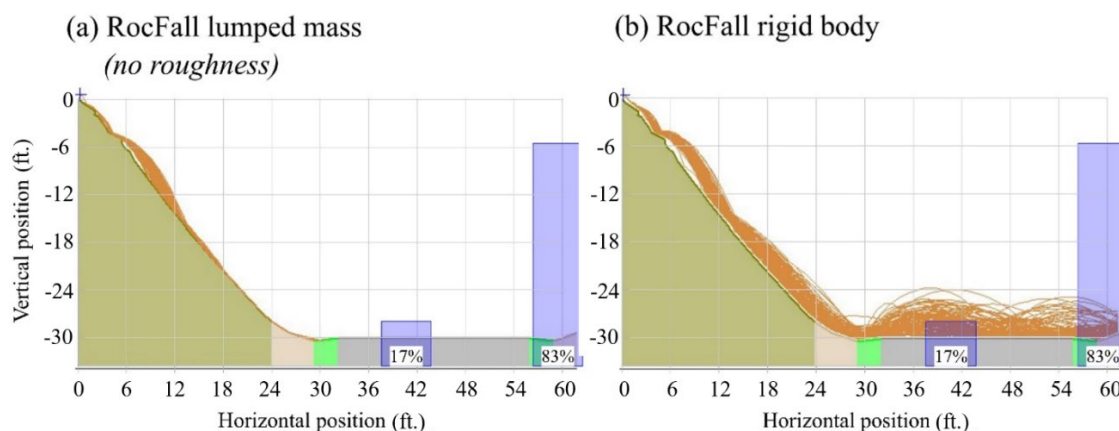
In the second stage, the Enfield and Franklin field experiments were simulated using slope profiles generated from photogrammetry. Ground materials were assigned using the Smart Rock, PMWD, and LDCP classifications. Simulations were first performed with default material parameters and then repeated using parameters calibrated from the controlled tests. Predicted runout distances and rotational behavior were compared with the field measurements. Figure 14 presents the modeled trajectories for both lumped mass (a) and rigid body (b) modeling approaches in RocFall at the Franklin site. The modeled trajectories are compared to the field endpoint locations in blue.

**Figure 14 – RocFall modeled trajectories using default input parameters. (a) Lumped mass without roughness and (b) rigid body model. The bar charts represent the endpoint distribution of the field tests.**

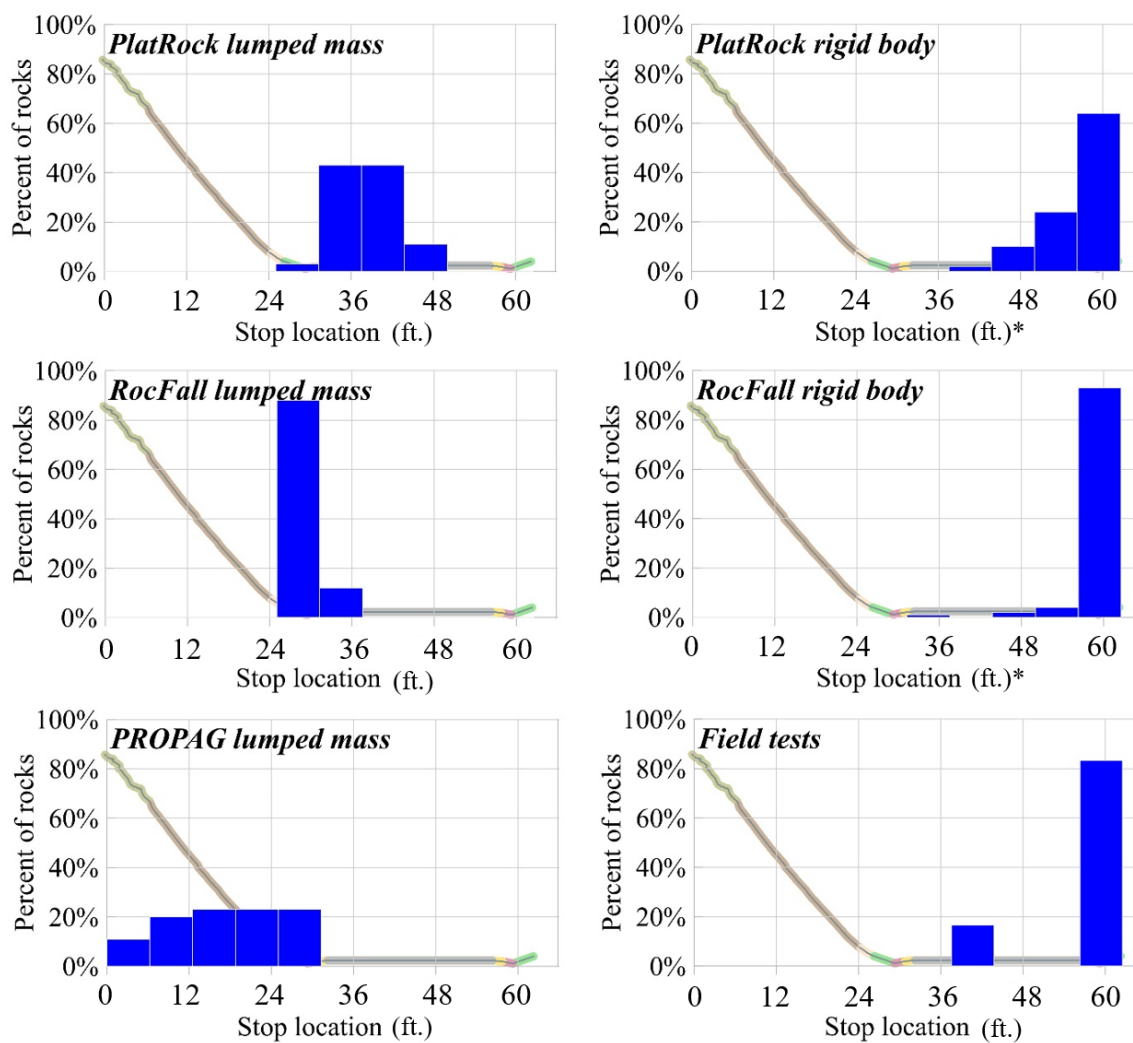
**Figure 15 – Summary of block runout for rockfall models and field tests in Franklin, NH.**

\* Please note that runouts at  $x = 60$  ft. in the models do not always imply that the block fully stopped.

Figure 15 compares the measured runout for each rockfall model and the field measurements at the Franklin site. The PROPAG software only performs predictions using lumped mass models. The runout distances measured in the field were plotted in the last graph for comparison with the numerical results. It can be observed that, while rigid body models reached the runout locations for the field experiments, most lumped mass models stopped in the first catchment ditch the start of the road.
