# 75<sup>th</sup> HIGHWAY GEOLOGY SYMPOSIUM

## FIELD TRIP GUIDE

*Faults, Floods, and Freeways:  
The Geology and Engineering of  
the Reno–Tahoe Corridor*

Reno, Nevada  
October 1, 2026

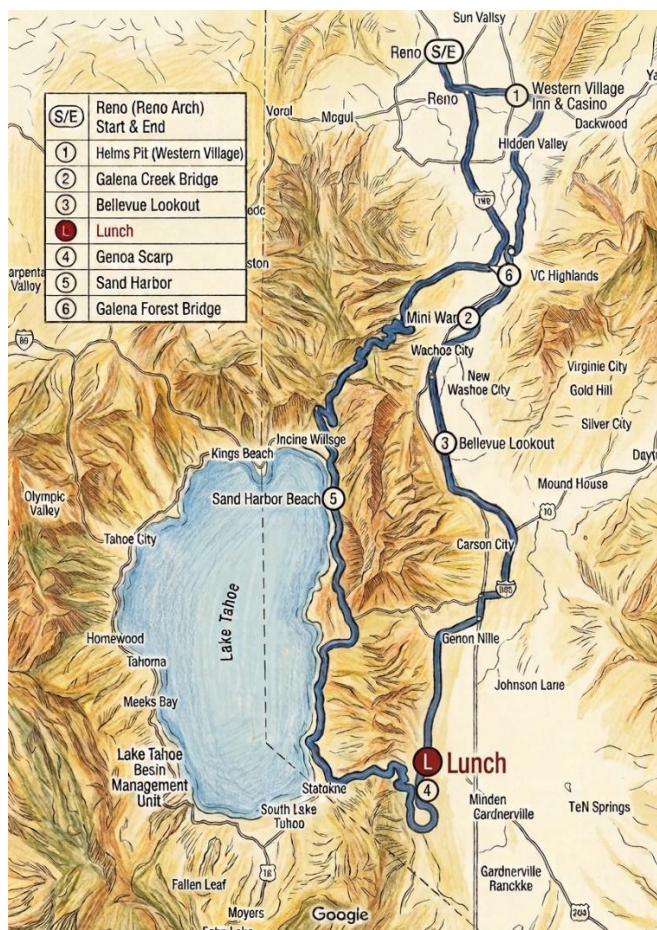
*Map of the field trip route and stop locations*

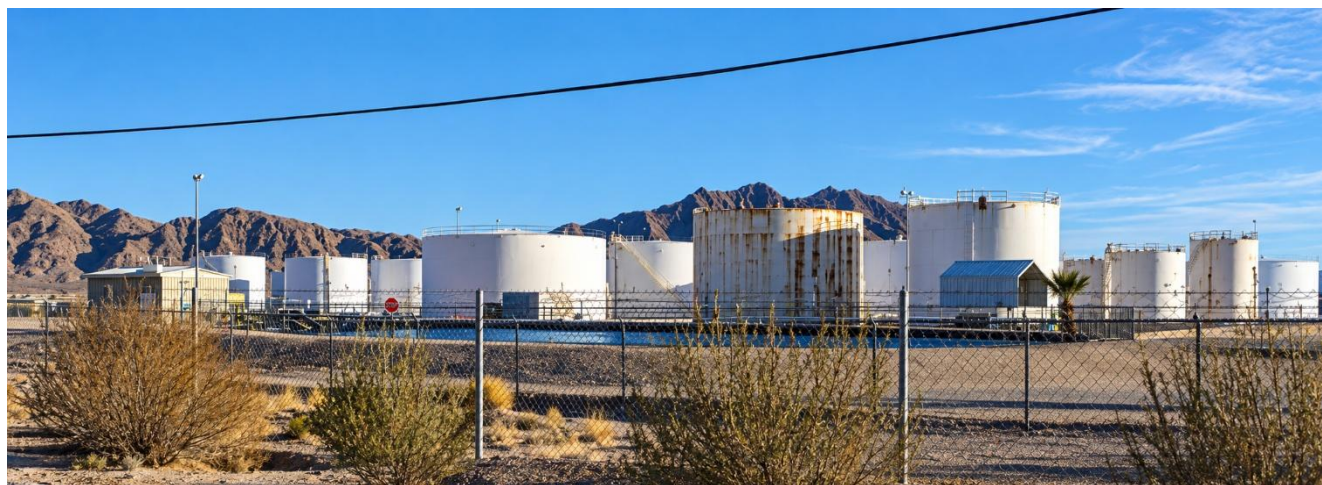
Figure 5. Fuel storage tanks east of the Nugget, visible from I-80 en route to Stop 1.

Just east of the Nugget there are fuel tanks (Figure 5) which in the 1980s, and possibly earlier, leaked fuel that during the operation and drawdown of the water of the Helms aggregate quarry was drawn away from the Truckee River and to the pit, a piece of site history that set up the contamination and cleanup story at Stop 1.

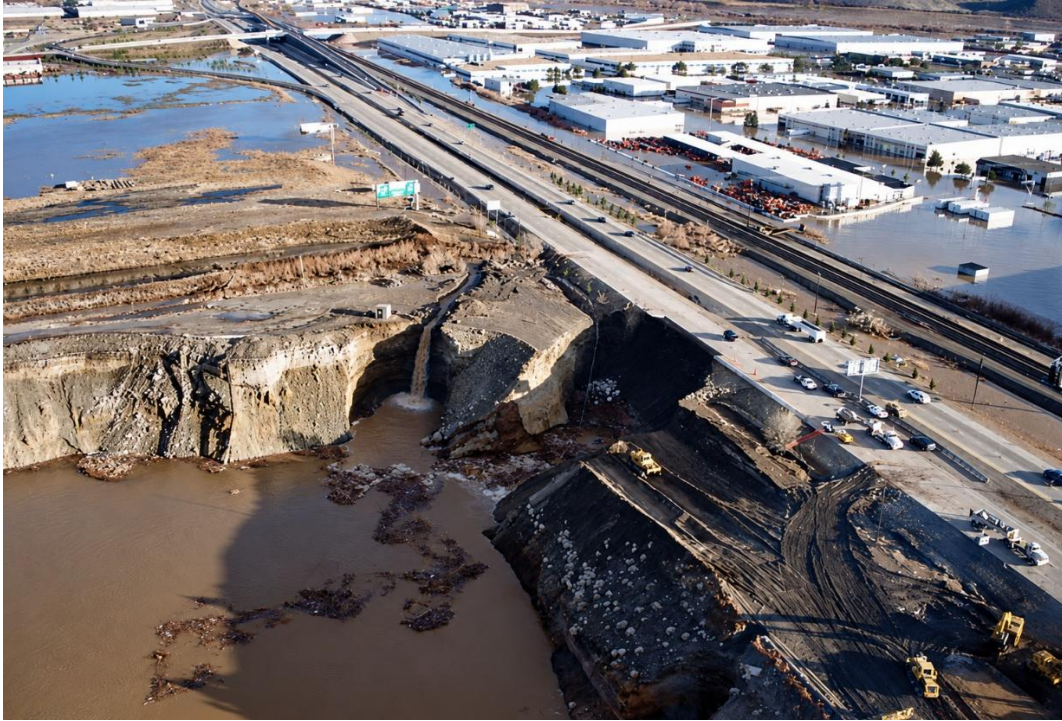
*Figure 6. The January 1997 flood breach: floodwater from the Truckee River undercut and collapsed the wall of Helms Pit, eroding the shoulder of westbound I-80.*

The 1997 event was not a gentle overflow, the pit wall itself gave way, eroding into the adjacent I-80 shoulder as floodwater poured in. The photo below, taken during the event, shows the scale of the collapse relative to the interstate and the flooded industrial park beyond.

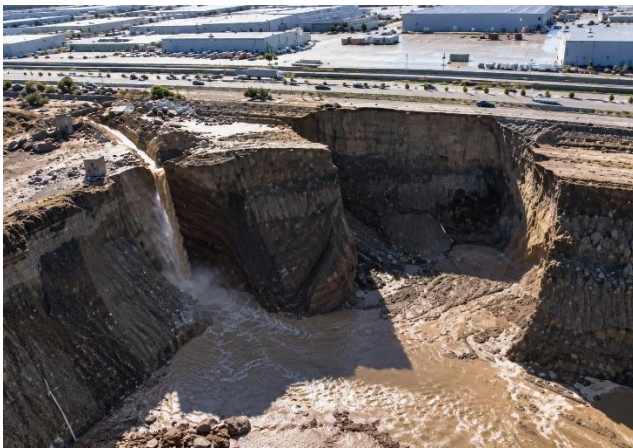
*Figure 7. (left) Closer view of the eroded pit wall at the moment of breach. (right) Sparks Marina in Google Satellite View.*

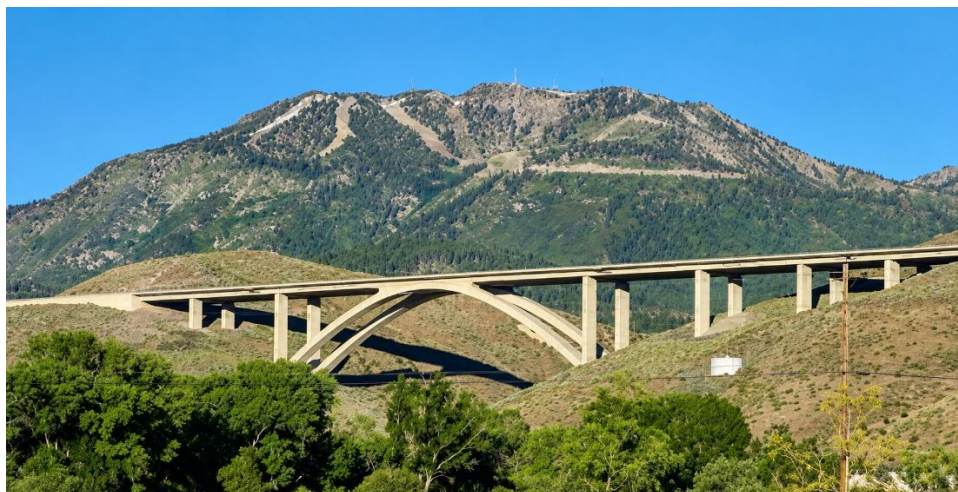
Figure 10. View of the Galena Creek Bridge on I-580 from Pleasant Valley below. Mt. Rose in the background.

Galena Creek Bridge with its dramatic tall piers is reportedly the tallest/longest concrete cathedral arch bridge in the world composed of two parallel cast-in-place concrete arches. The cathedral arch supports the bridge only at the crown; there are no intermediate spandrel columns. The structure serves as the centerpiece on a project that includes eight other cast-in-place concrete box girder bridges. The Nevada Department of Transportation (NDOT) had been planning for several decades to raise I-580 to full interstate highway standards for its entire length within the state. This segment extends the freeway from the Mt. Rose Highway to the Bowers Mansion cutoff in the Northern Washoe Valley.

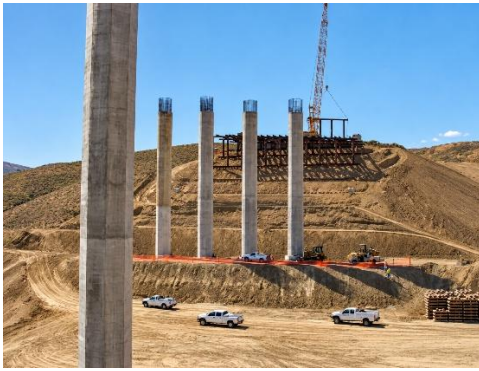
Figure 13. Bridge piers and falsework framing under construction, prior to placement of the arch spans. (NDOT)

The Galena Creek Bridge consists of two parallel cast-in-place concrete arches with a span of 689 ft. Each arch has a width of 19.7 ft and a depth of 11.8 ft. The wall thickness is 1.6 ft. The arches are supported on thrust blocks founded on bedrock. Each arch supports a cast-in-place conventionally reinforced, two cell box girder, 62 ft wide and 8 ft 6 in. deep. Each box girder carries three lanes of traffic. The columns have overall cross-sectional dimensions of 19.7 ft by 9.8 ft with a wall thickness of 3.25 ft. These columns are supported by footings on piles (Figure 13 and Figure 14).

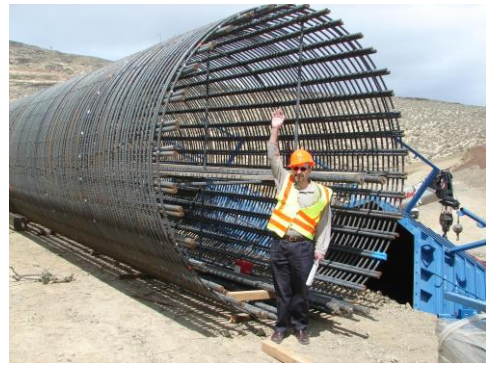
Figure 14. Bridge pier reinforcement cage. (NDOT)

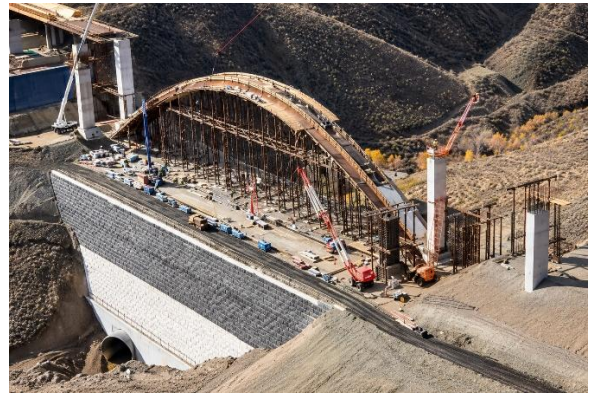
Figure 16. Photo from Durski (ASPIRE The Concrete Bridge Magazine, Winter 2010) of the partly completed arch forms with the MSE/RSS walls in place during construction. (NDOT)

This approach required the use of traditional falsework, which was placed on a foundation created by filling the creek bed. About 523,000 cyd of earth cut from the nearby embankment were used to raise the level 140 ft (highest MSE/RSS wall in the world at the time). The fill measured approximately 385 ft wide at the base and tapered to approximately 210 ft wide at the top. A temporary 400-ft-long tunnel was built to protect the creek, with its walls set 30 ft on either side of the creek to minimize impact on the environment. The new approach required a four-month approval process, and work then began again in early 2007 to finish construction. Figure 15 and Figure 16 show the partly completed arch forms with the MSE/RSS walls in place during construction. The earthen fill was removed and used elsewhere in MSE walls along the route. Vegetation was restored after the bridge was completed.

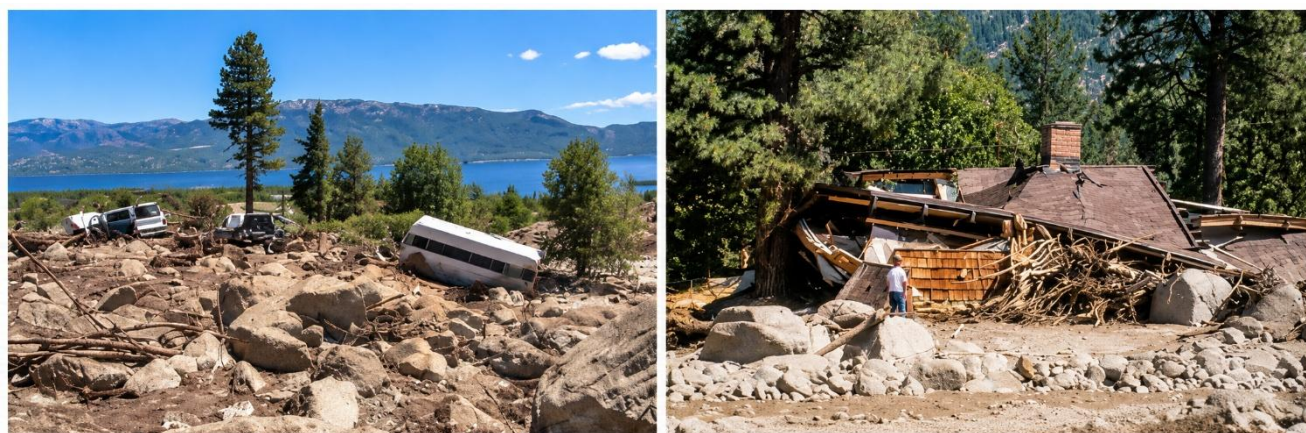
Figure 17. 1983 Ophir Creek debris flow aftermath in Washoe Valley. Historical photographs from the June 10 field trip working guide.

A hang-glider pilot who had launched from the Slide Mountain ski area minutes earlier watched the collapse from above and later described the impact as looking like an explosion that “blew the lake apart” (McLaughlin, 2005). The displaced water and debris, roughly 20 acre-feet, surged down Ophir Creek as a fast-moving flow of mud, rock, and boulders, at times 40 to 50 feet high, snapping mature trees and eventually reaching homes on the valley floor below. One resident, alerted by an unfamiliar rumbling sound from the creek, looked out a back window in time to see what he described as a wall of debris tearing through the landscape “like someone was tearing things up with a bulldozer” (McLaughlin, 2005). The flood destroyed several homes and killed one person (Figure 17, Figure 19, Figure 20, Figure 21, and Figure 22).

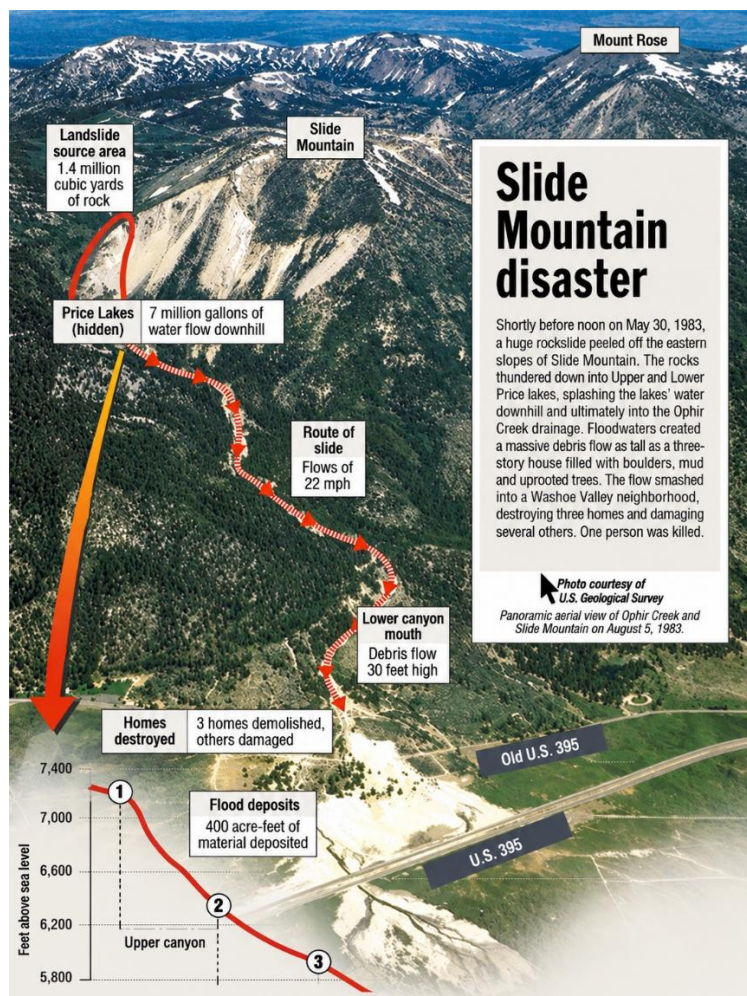
Figure 19. Reno Gazette-Journal graphic illustrating the 1983 Slide Mountain event (RGJ, 2015).

The route into Washoe Valley passes below Slide Mountain, site of one of the most dramatic landslide events in the region's recent history. On the morning of May 30, 1983, Memorial Day, following an exceptionally wet and heavy winter (snowpack around 200 percent of average, driven by a strong El Niño), a mass of roughly 1.4 million cubic yards of rock collapsed from the upper slopes of Slide Mountain into Upper Price Lake (Figure 19).

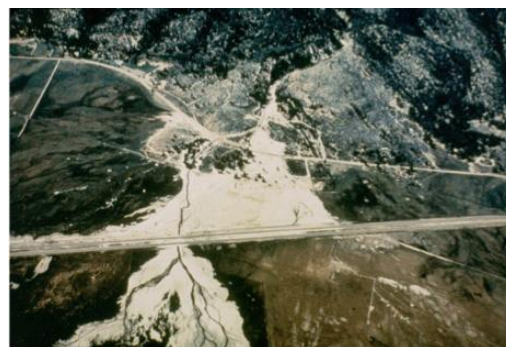
Figure 20. Slide deposits on the floor of Washoe Val. (USGS photo).

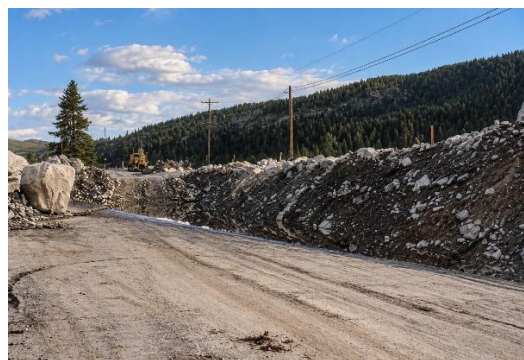
Figure 21. Bouldery slide deposits 6 ft thick being cleared from Bowers Mansion Rd. (RGJ).

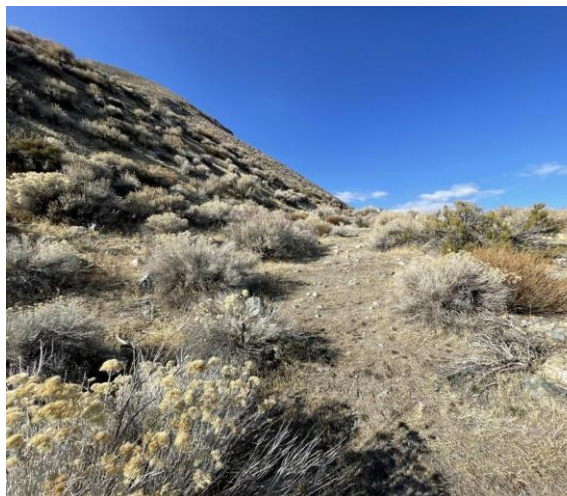
Figure 27. Looking north along the natural part of the Genoa fault scarp at Walley's. Photo by J. Louie.

wall of a gravel quarry formerly used by NDOT (Figure 27 and Figure 28). Participants are invited to walk about 50 meters over rough ground to view the scarp closely.

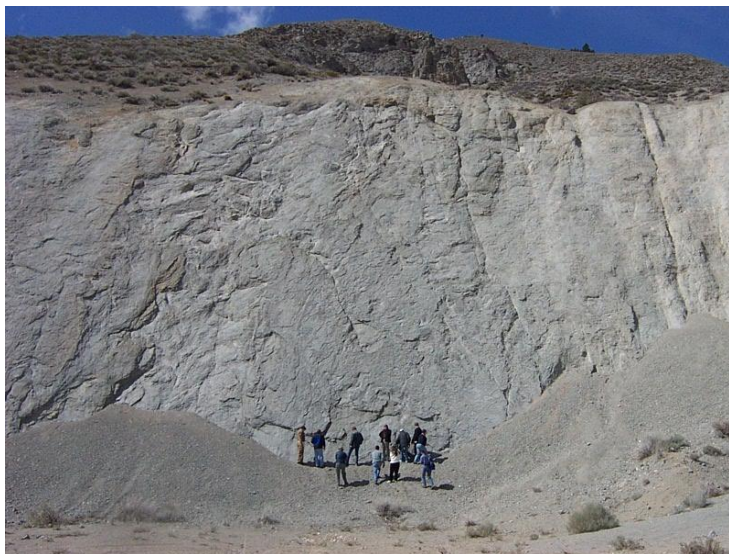
Figure 28. A visible break in the landscape created by an active fault, located near Genoa in Carson Valley.

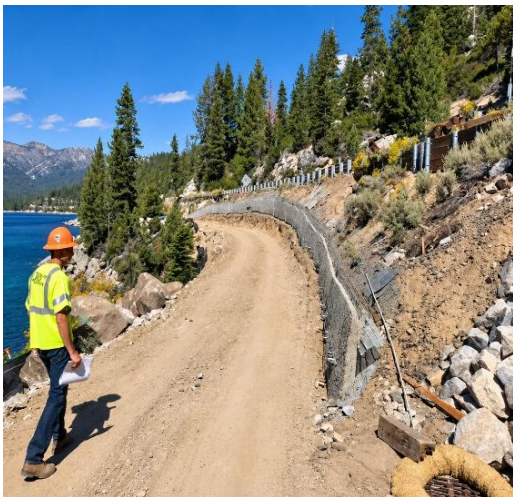
Figure 31. A soil nail wall holds the active highway alignment above the new trail bed.

Constructing the East Shore Trail meant building a durable, ADA-accessible path directly into steep granite slopes above the lake (as in Figure 31), without closing the adjacent highway and under close environmental oversight. The Tahoe Regional Planning Agency (TRPA) monitored construction and aesthetics from a boat throughout the project. Figure 32 shows the north entrance to the lakeside part of the trail.

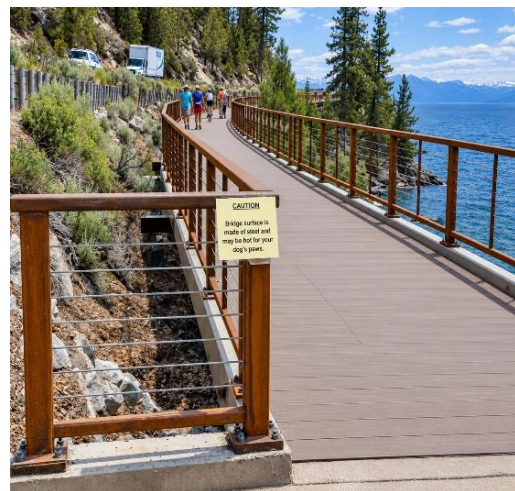
Figure 32. The finished trail: a cantilevered steel-surfaced boardwalk carries walkers and cyclists along the cliff face above Lake Tahoe's east shore.

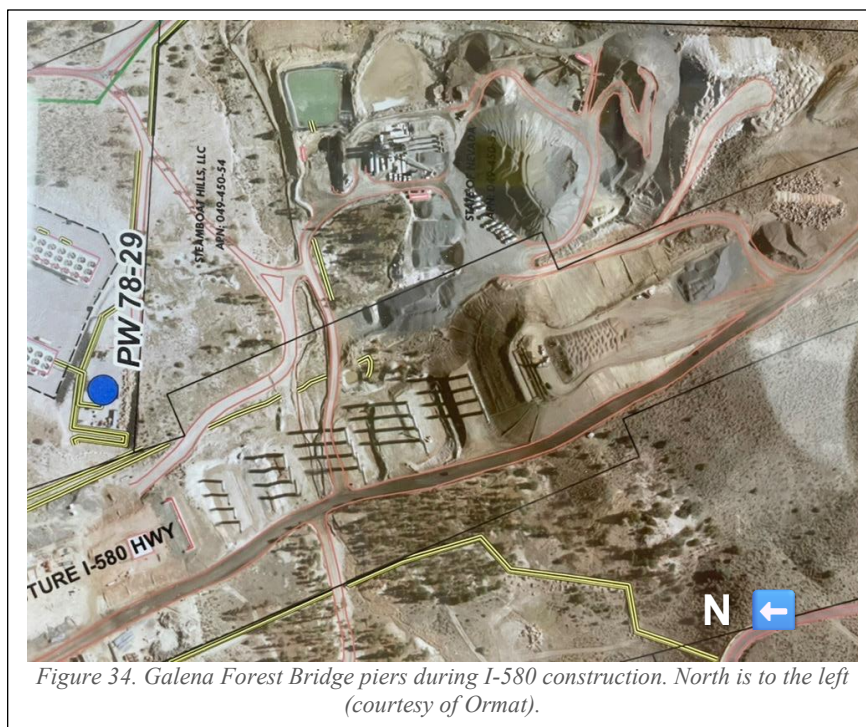
The greater Truckee Meadows area lies within the Walker Lane extensional zone along the eastern margin of the Sierra Nevada. In the Steamboat area, extension is accommodated by northwest striking right lateral oblique faults, east northeast striking left lateral oblique faults, and north south normal faults (Figure 35). The Steamboat Hills form an east-northeast trending intra-basin horst about 9.5 miles south of downtown Reno.

The local geologic section includes Triassic metasedimentary rocks intruded by Cretaceous granodiorite, overlain by Miocene to Quaternary intermediate and felsic volcanic rocks, younger alluvium, and hydrothermal deposits (White et al., 1964). Fracture controlled permeability along northeast, north, and northwest striking faults provide pathways for geothermal fluids (Figure 35). Natural state upflow occurs in Upper Steamboat, with general northeast directed outflow toward Lower Steamboat.
