TWENTIETH ANNUAL HIGHWAY GEOLOGY SYMPOSIUM

Proceedings of a Symposium
held at the
University of Illinois, Urbana-Champaign
April 17-19, 1969

I. SOILS OF ILLINOIS AND THEIR ENGINEERING CHARACTERISTICS

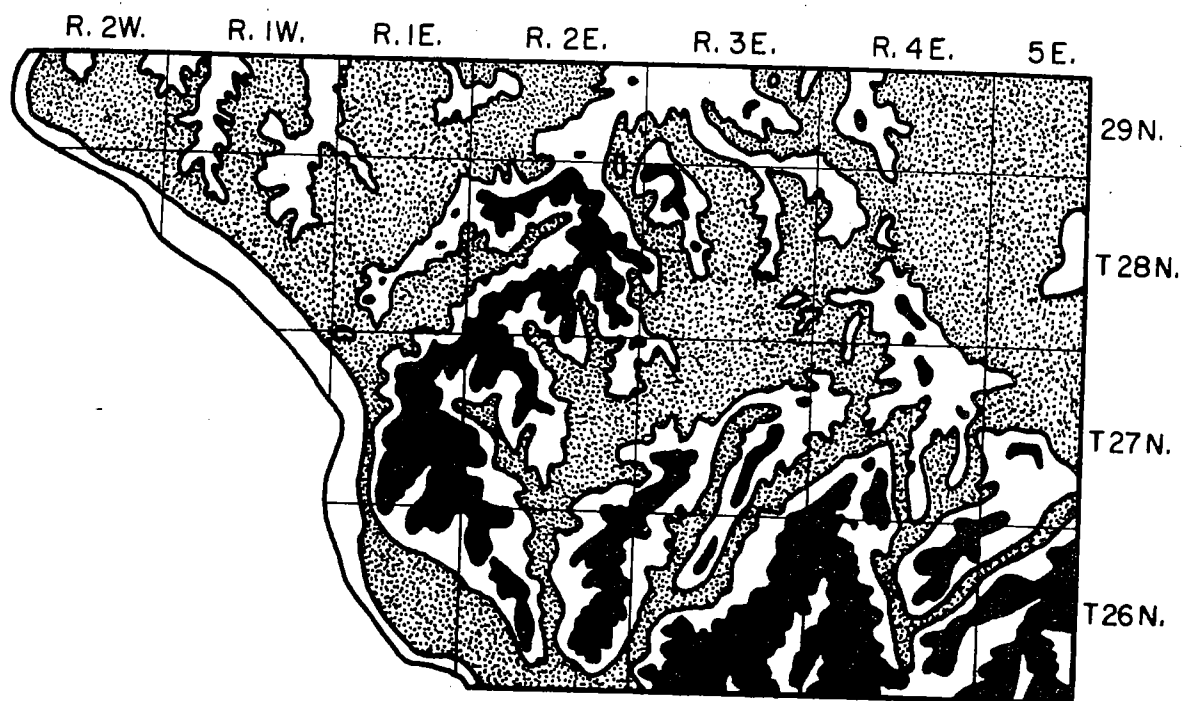
FIGURE 4. GEOLOGIC MAP, JO DAVIESS COUNTY.

The Silurian Dolomite outcropping in the black pattern on the geologic map is creviced, water bearing, and subject to slides. Huge blocks of this dolomite are present at various positions on the slopes underlain by Maquoketa Shale. The principal cause of slides of Silurian Dolomite is the undermining of the subjacent strata by erosion. When support is removed past the center of gravity, the rock block tilts and, depending on the inclination of the slopes, creeps, slides, or falls downward. Alternate freezes and thaws, which shove the outermost blocks further and further slopeward, also contribute to the slides, as do rock glides of the large blocks themselves, powered by their own weight and overriding a wetted and plastic shale surface that tilts up to 7°.

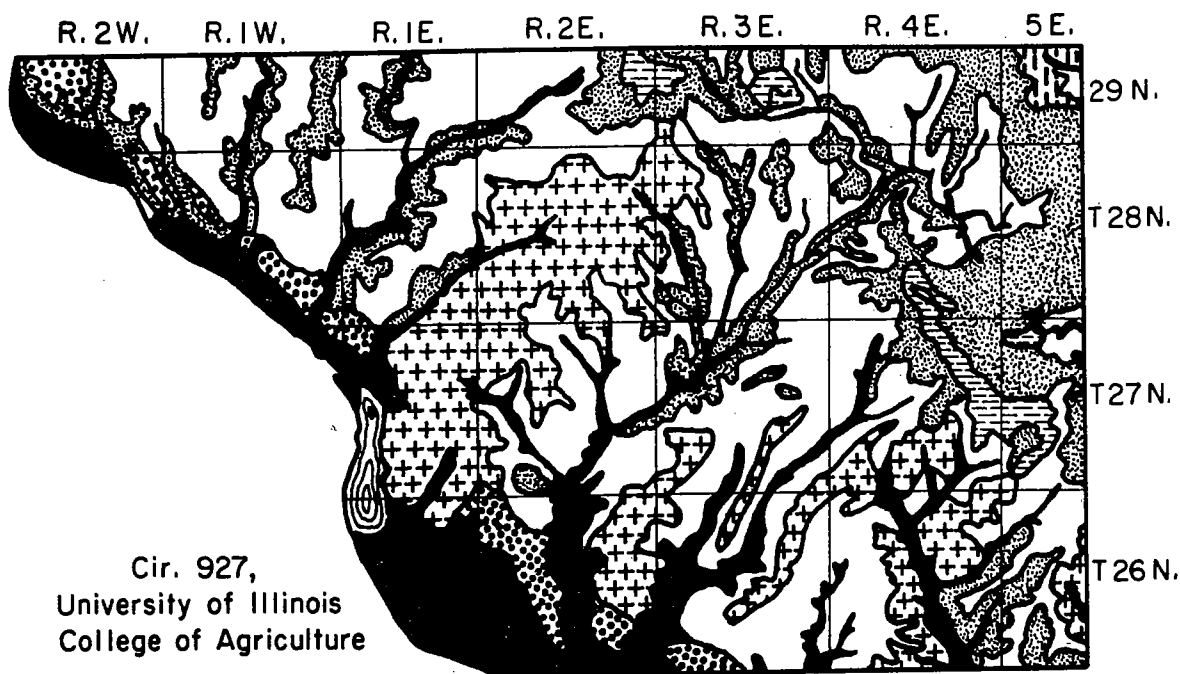
FIGURE 5. SOIL ASSOCIATION MAP - JO DAVIESS COUNTY.

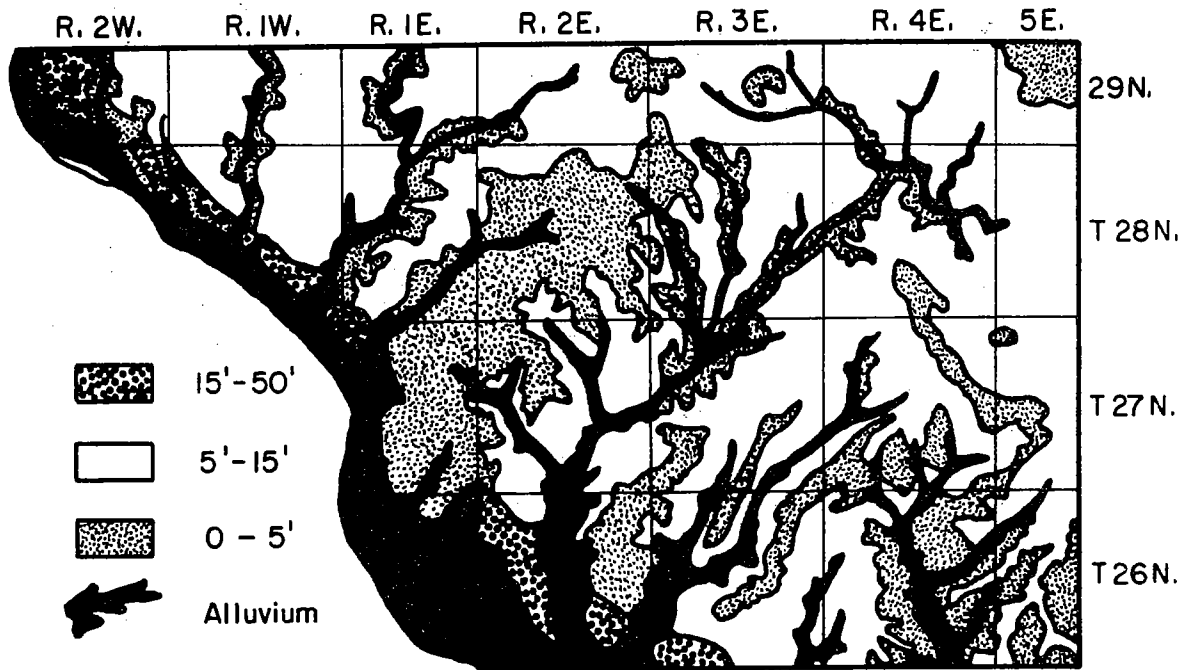
FIGURE 6. MAP ON INFERRED THICKNESS OF LOESS, JO DAVIESS COUNTY

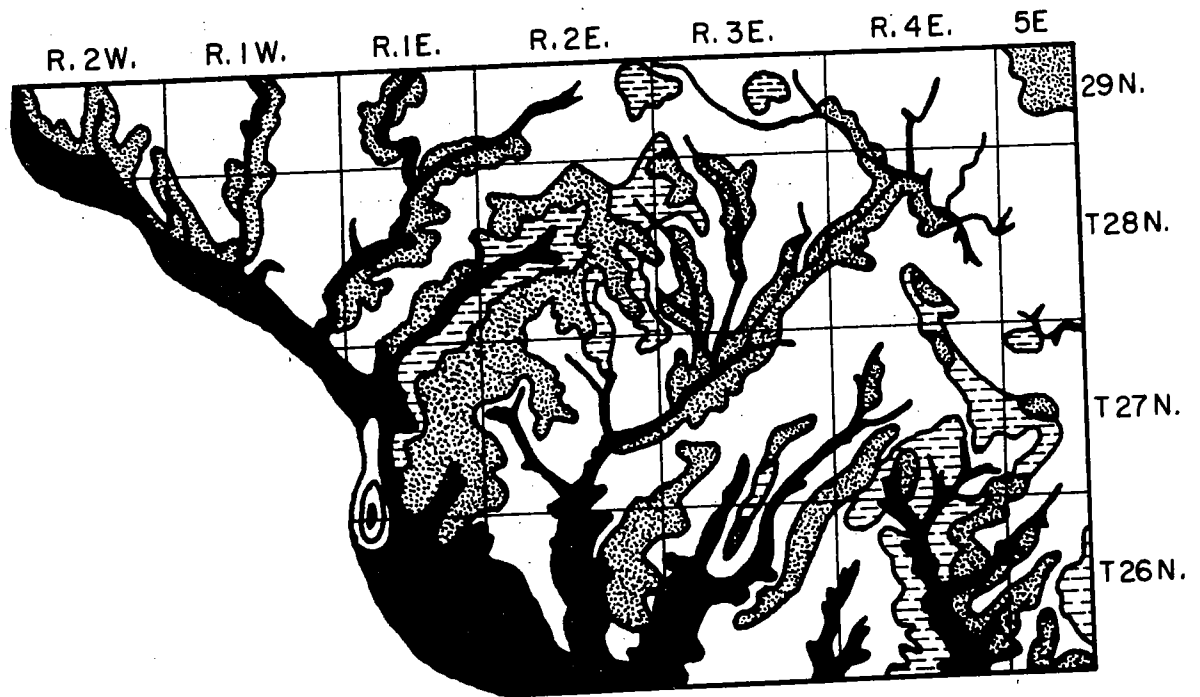
FIGURE 7. ENGINEERING SOIL INTERPRETATION, JO DAVIESS COUNTY.

A fourth soil type, shown on the Engineering Soil Interpretation Map by the black pattern, is the alluvial or water-laid soil. Generally the alluvial soils are thin. Bridge foundation borings at eight stream crossings revealed a maximum depth to bedrock varying from 20 ft to more than 80 ft. On that basis the following thicknesses of alluvium are inferred: main stream near the Mississippi Valley, 100 ft or more; main streams 10 mi upstream from their mouths, 20 to 40 ft; minor streams normally less than 20 ft. These alluvial soils are generally silt loams with dolomite rubbish and chert chips with some clays.

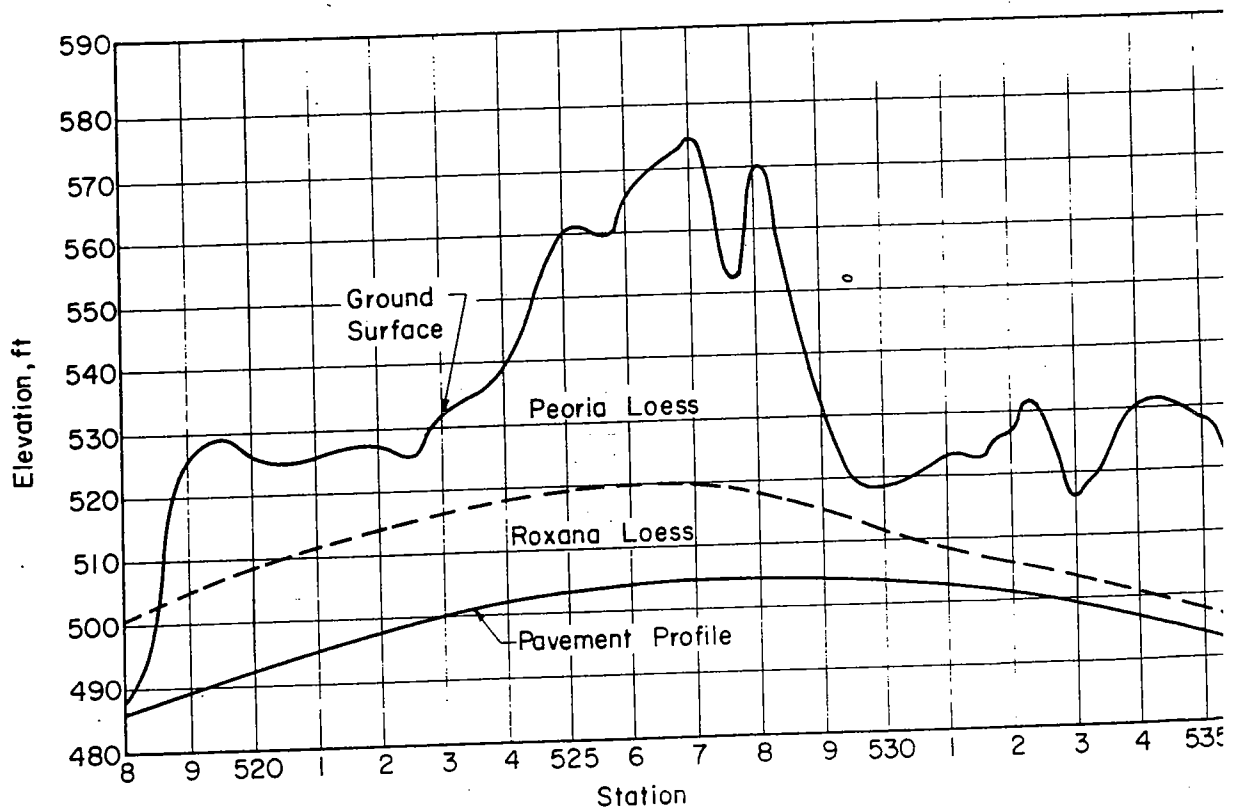
FIGURE 3. PROFILE OF I-270 CUT.

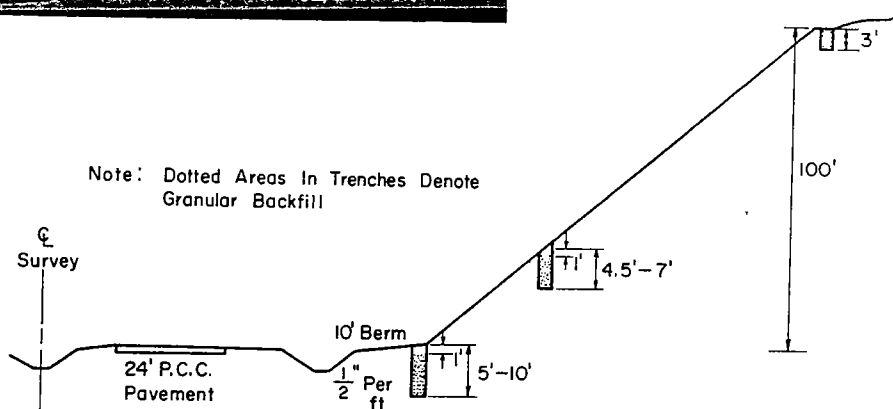
FIGURE 5. REVISED CROSS SECTION FOR I-70 CUT.

The following construction season corrective treatment was begun on the southern slope. Additional perforated pipe was placed in two excessively wet areas part of the way up the slope, resulting in the treatment seen in Figure 5. After the pipe and proper backfilling were placed, all of the slump failure locations were re-shaped, seeded, mulched, and again covered with erosion netting.

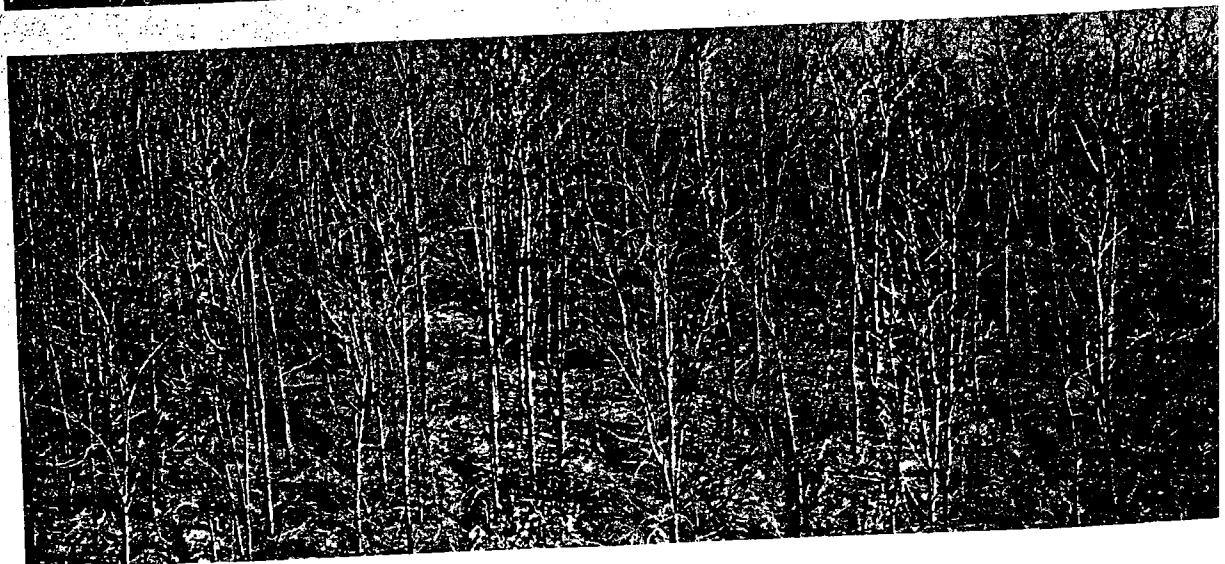
FIGURE 8. EXIST:
SOUTHERN SLOPE
ON I-70 CUT.

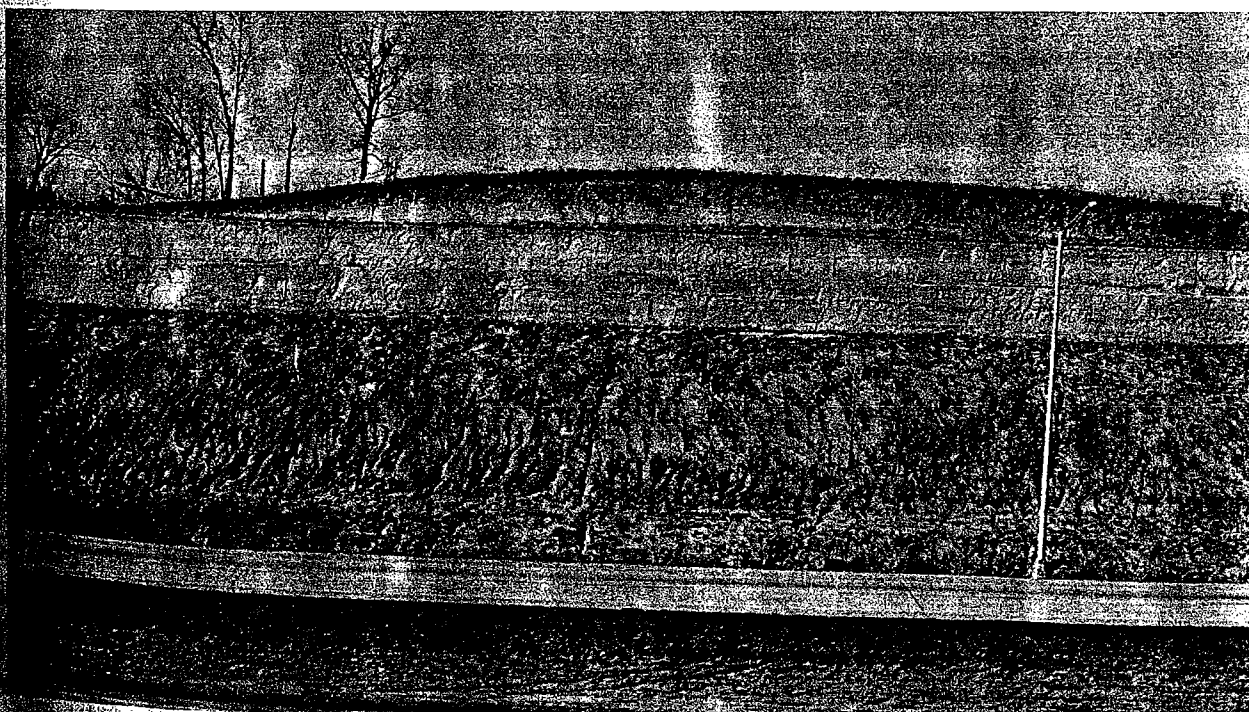
FIGURE 10. EXISTING SOUTH FACING SLOPE ON I-270 CUT.

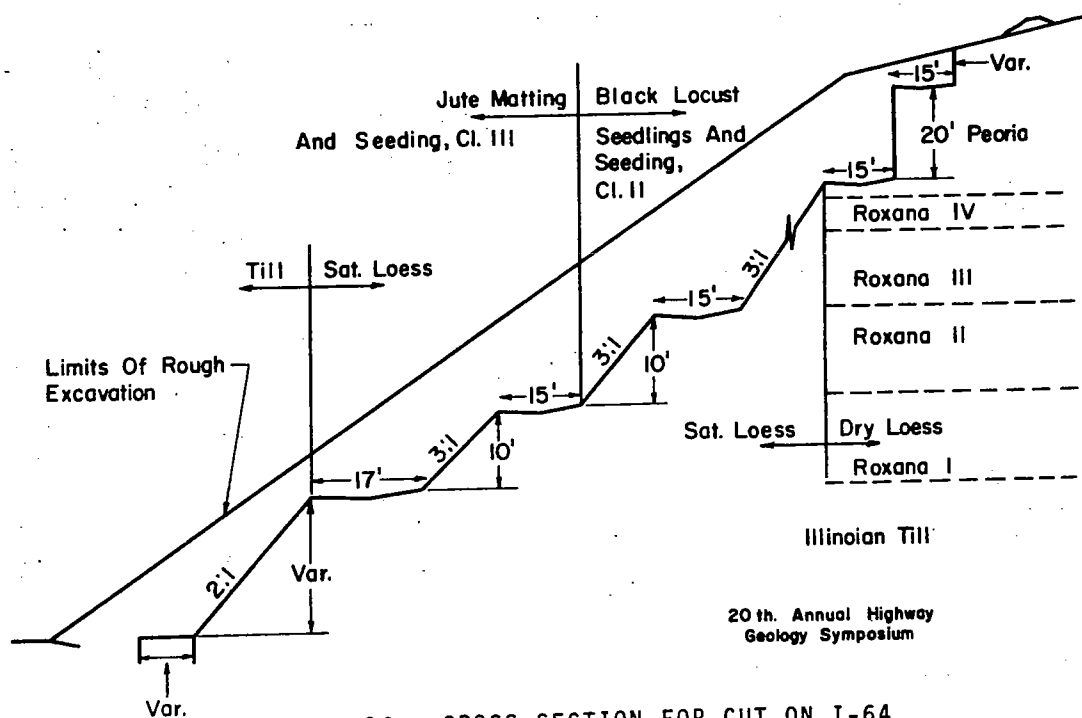
FIGURE 16. CROSS SECTION FOR CUT ON I-64.

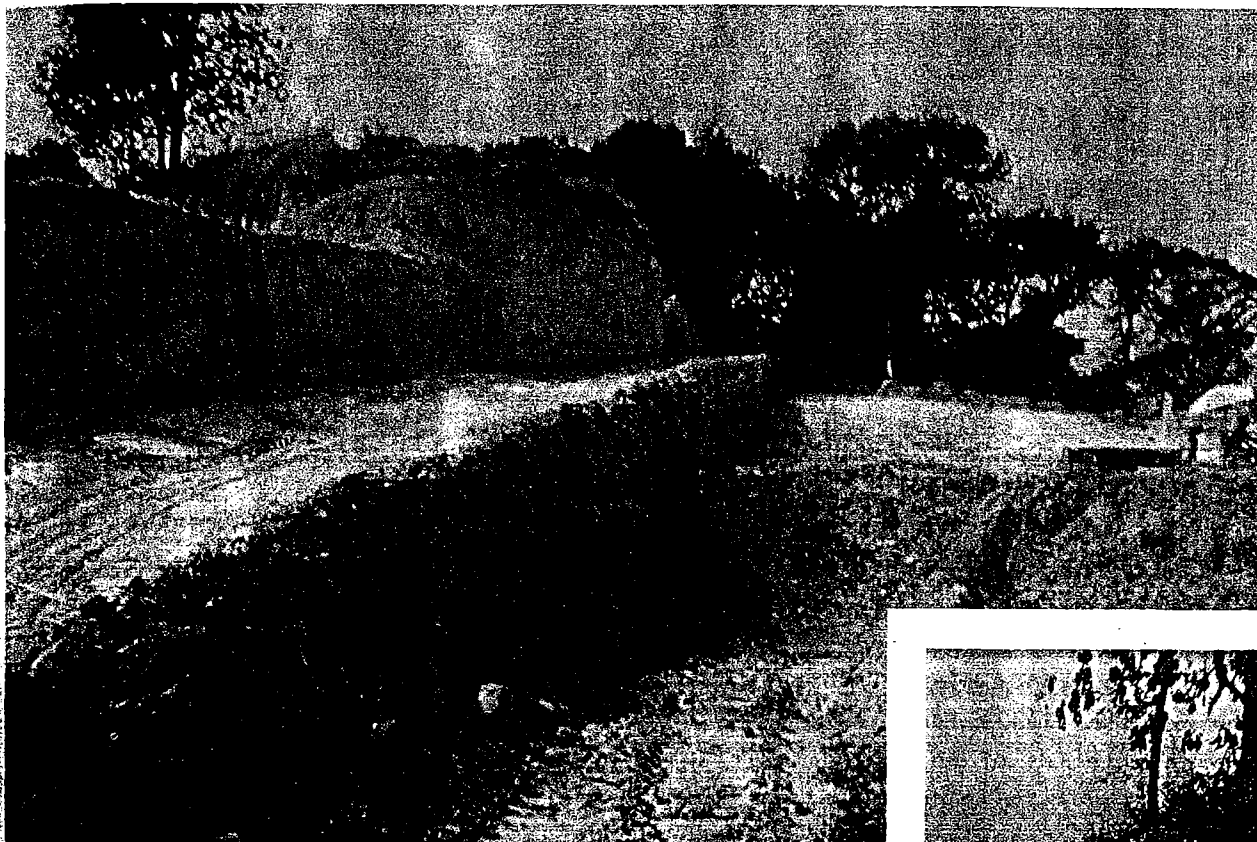
CASE. FIGURE 17. CONSTRUCTION OF
VERTICAL FACES ON THE I-64 CUT.

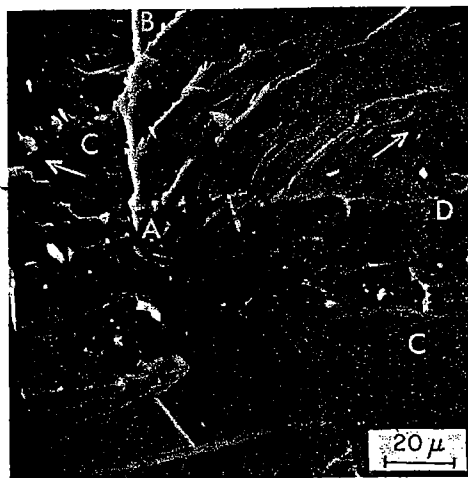
UPPER LEFT

FIGURE 1. TRANSGRANULAR FRACTURE ON RHOMBOHEDRAL CLEAVAGE PLANE IN CALCITE CRYSTAL ICELAND-SPAR TYPE WITH CLEAVAGE STEPS (C). THE ARROWS ARE THE INFERRED DIRECTION OF CRACK PROPAGATION BASED ON THE PATTERN OF CLEAVAGE STEPS.

limestones can best be interpreted by comparing them with extension fractures of single crystals. The three unique and nonparallel cleavage planes possible in calcite contribute to the complexity of fracture markings. Figure 1 shows a portion of an extension fracture surface of a single crystal of Iceland spar calcite, broken along rhombohedral cleavage planes. Cleavage steps indicated by the letter "C" in this figure characterize transgranular fractures, or fractures that pass through individual grains, as distinct from intergranular fractures, or fractures that pass along grain boundaries. Fracture surfaces lacking these markings may or may not be transgranular, but when the markings are present, transgranular fracturing is definitely indicated.

In metals, the direction of propagation of cleavage cracks is parallel to the lineation of the cleavage steps, especially in cases where two cleavage steps coalesce to produce a "river" pattern. (19,20,21) The same pattern has been detected in quartzite stone. (22) Coalescence of cleavage steps also occurs on calcite surfaces, faintly shown in the upper left-hand corner of Figure 1. Interpretation of these cleavage steps, based on behavior of metals, would indicate that the fracture was initiated along the lines AB and AD and was propagated as shown by the arrows.

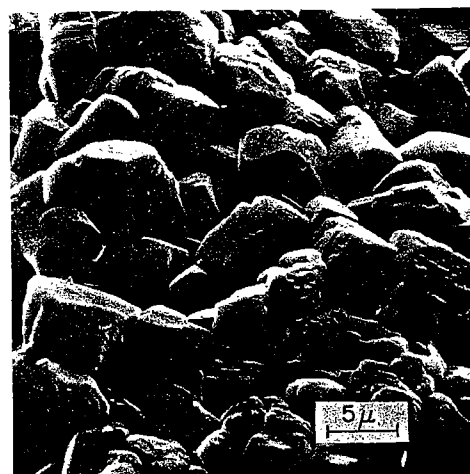
LOWER RIGHT

FIGURE 6. INTERGRANULAR FRACTURE SURFACE IN THE FINE-GRAINED CALCITE IN THE KIMMSWICK LIMESTONE.

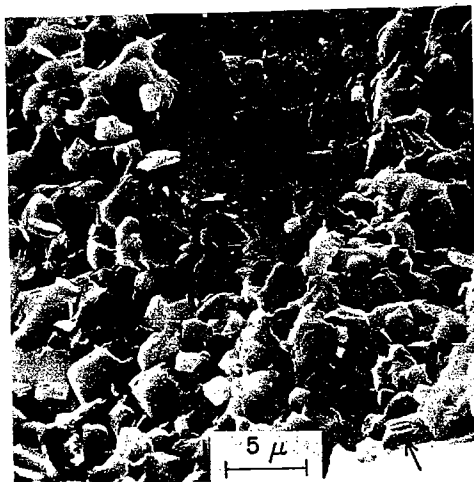
UPPER LEFT

FIGURE 7. TYPICAL EXAMPLE OF TENSILE FRACTURE SURFACES OF MICRITIC COMPONENTS OF VERY FINE-GRAINED CALCITE IN THE ST. LOUIS LIMESTONE. THE FRACTURE IS A MIXTURE OF INTERGRANULAR AND TRANSGRANULAR MODES. ARROWS POINT TO EXAMPLES OF GRAINS THAT WERE DEFINITELY BROKEN.

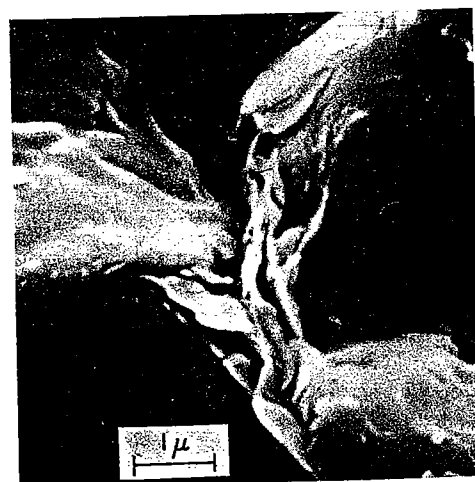
LOWER RIGHT

FIGURE 12. CLAY MATERIAL ALONG GRAIN BOUNDARIES OF CALCITE PARTICLES IN THE KINKAID LIMESTONE.

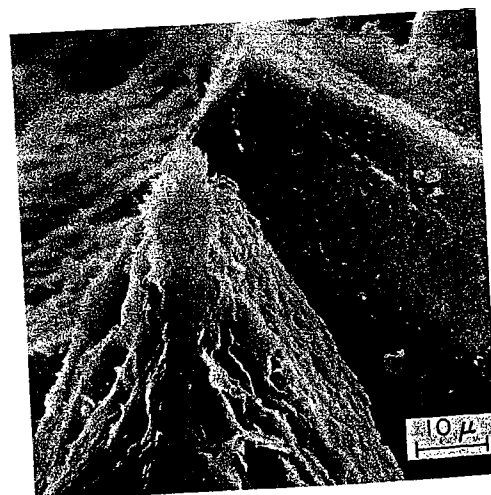
LOWER RIGHT

FIGURE 18. SHEAR CONE PRODUCED DURING FRACTURE OF A SPECIMEN OF THE RACINE DOLOMITE. THE SHEARING LOAD WAS APPLIED TO THE SPECIMEN FROM THE TOP, TOWARD THE BOTTOM OF THE FIGURE.

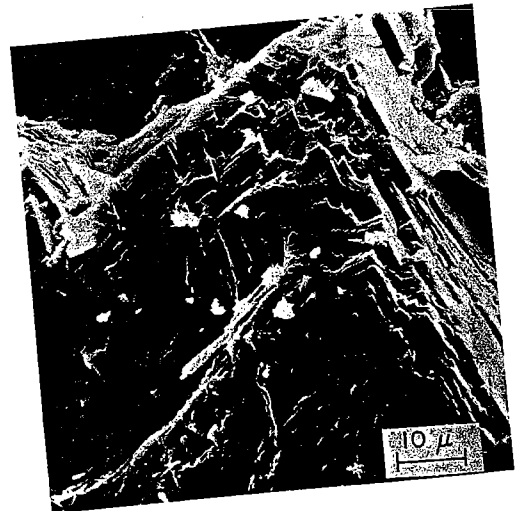
LOWER RIGHT

FIGURE 24. TRANSGRANULAR FRACTURE OF DOLOMITE GRAIN IN SAMPLE #67-303 OF THE JOLIET DOLOMITE, SHOWING NUMEROUS INTRAGRANULAR VOIDS.

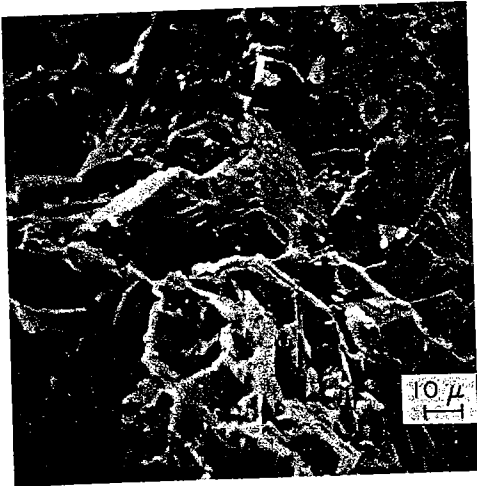
LEFT

FIGURE 25. MAINLY TRANSGRANULAR FRACTURE OF A SPECIMEN OF DOLOMITE FROM THE SALEM FORMATION.

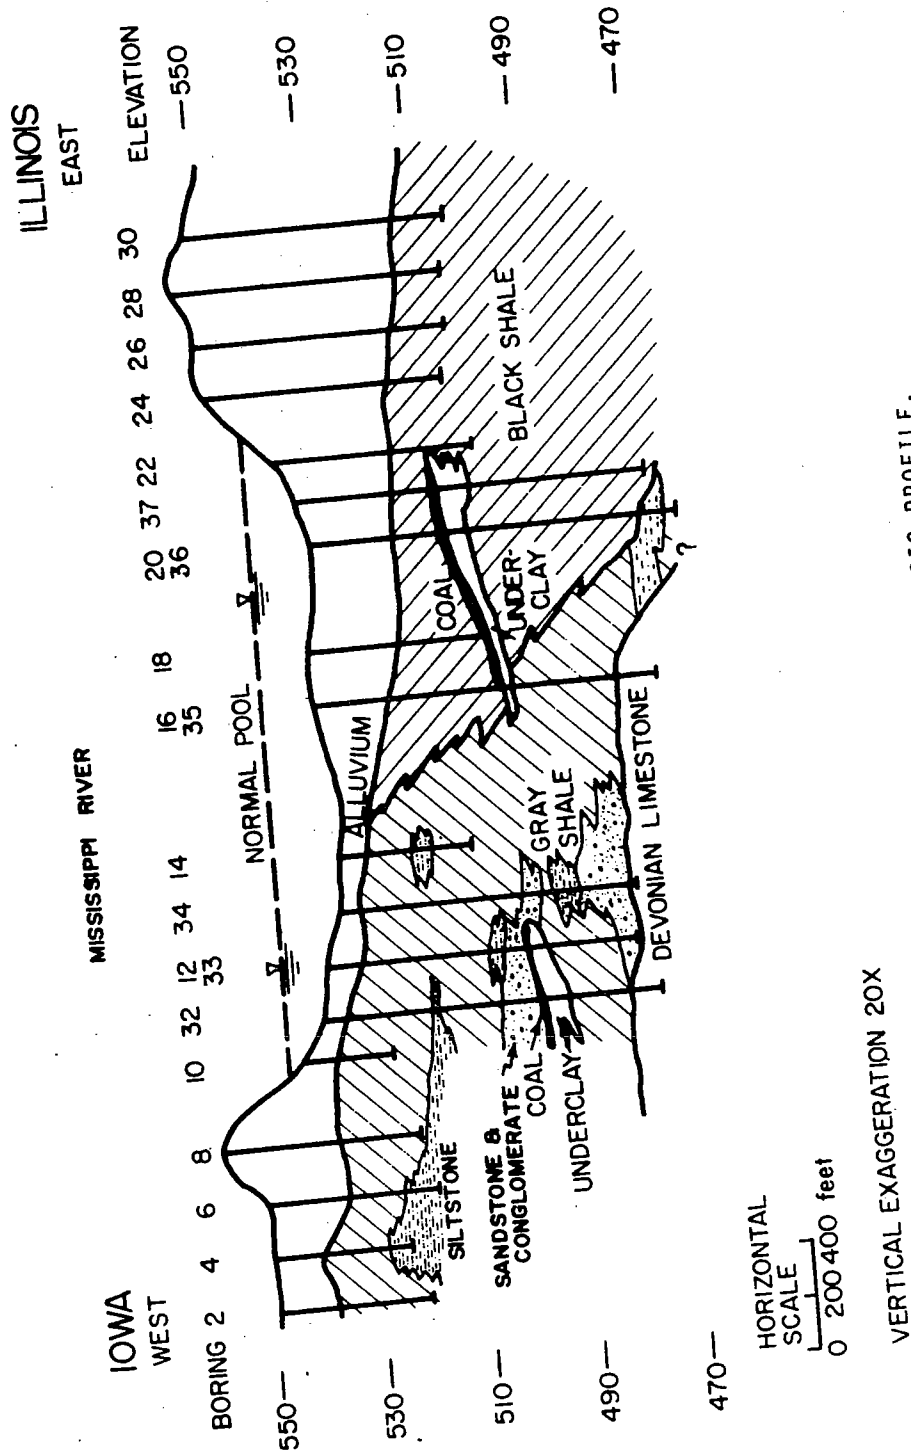
FIGURE 3. GENERALIZED GEOLOGIC PROFILE.

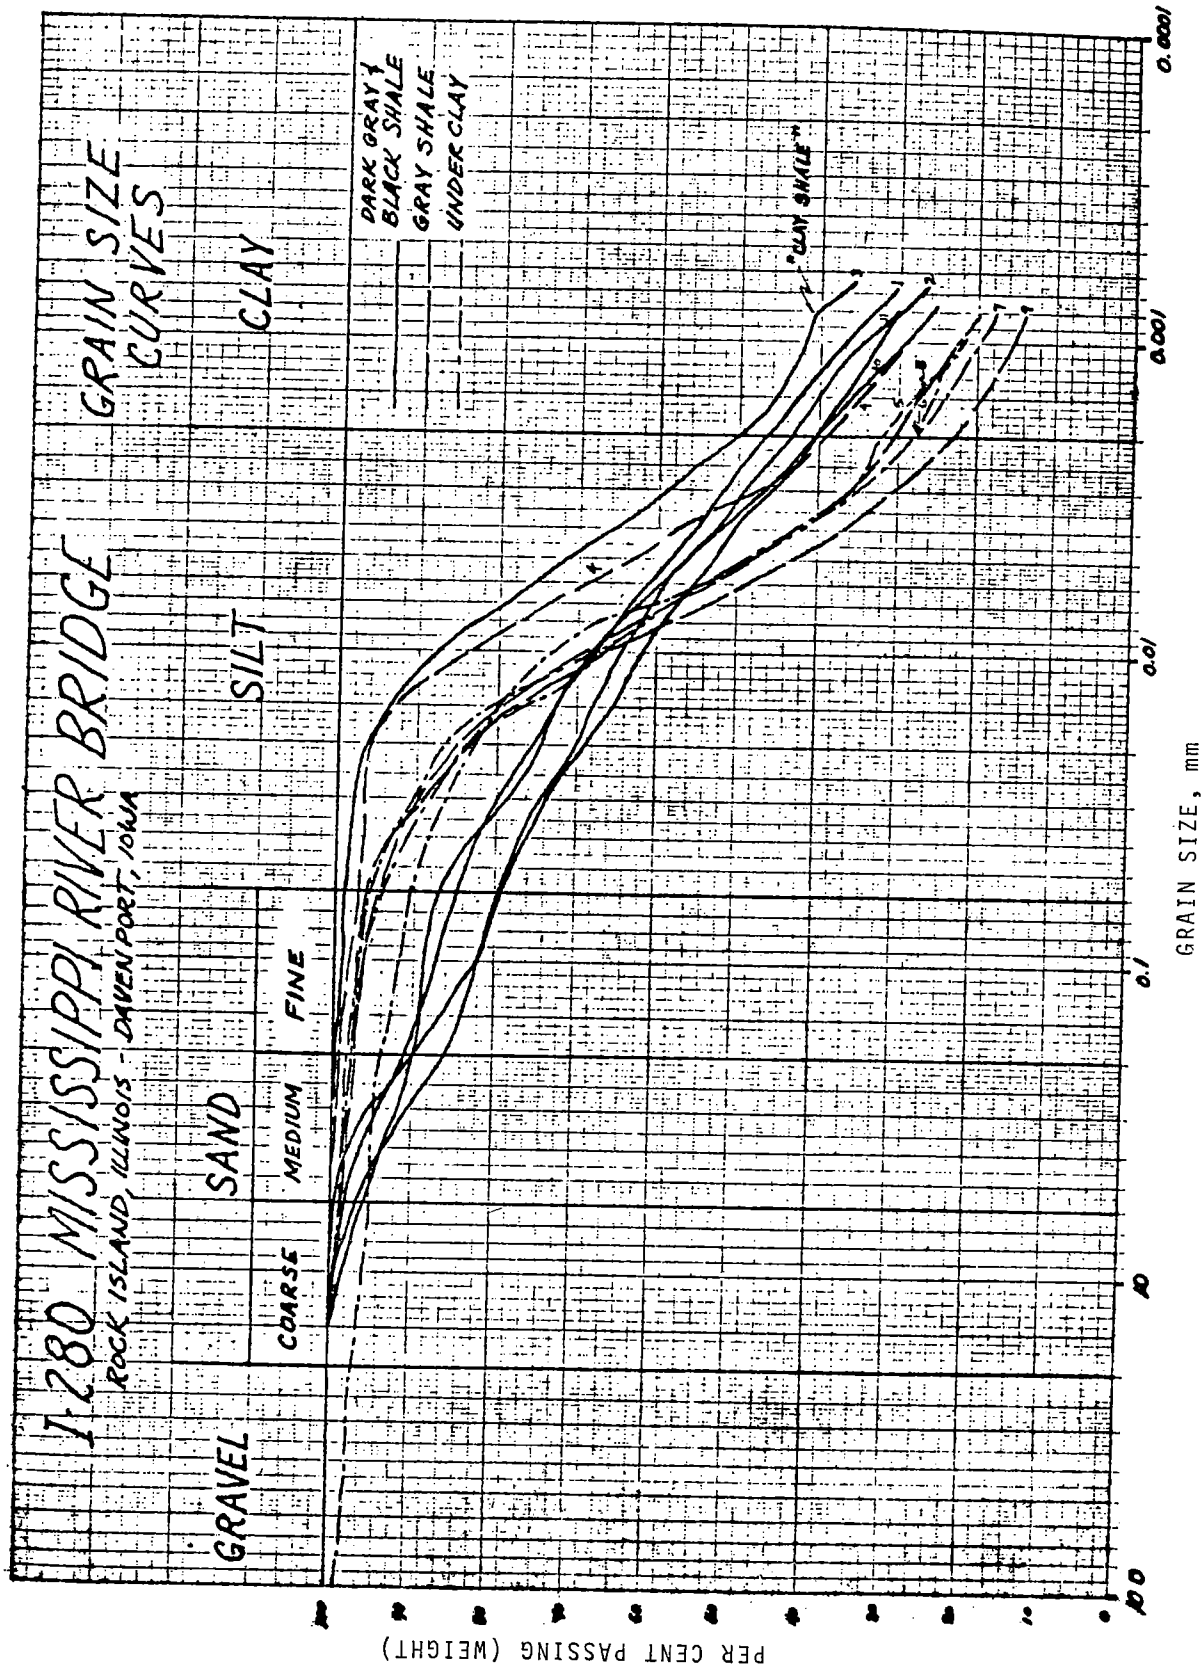
FIGURE 4. GRAIN SIZE CURVES.

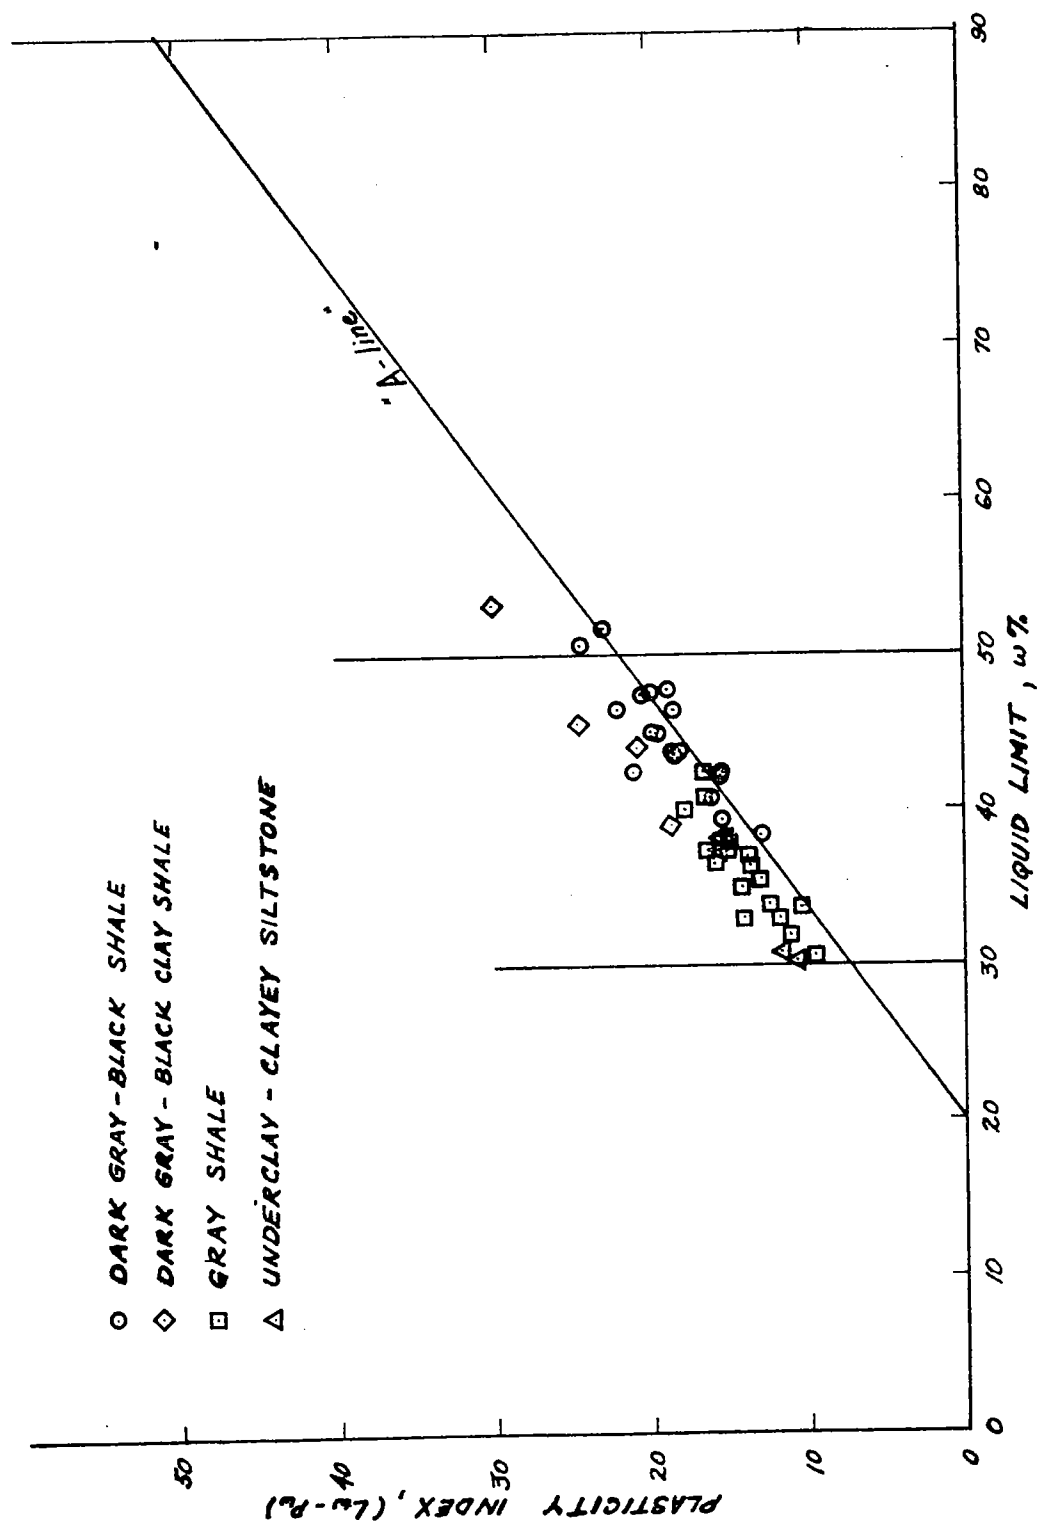
FIGURE 5. PLASTICITY CHART.

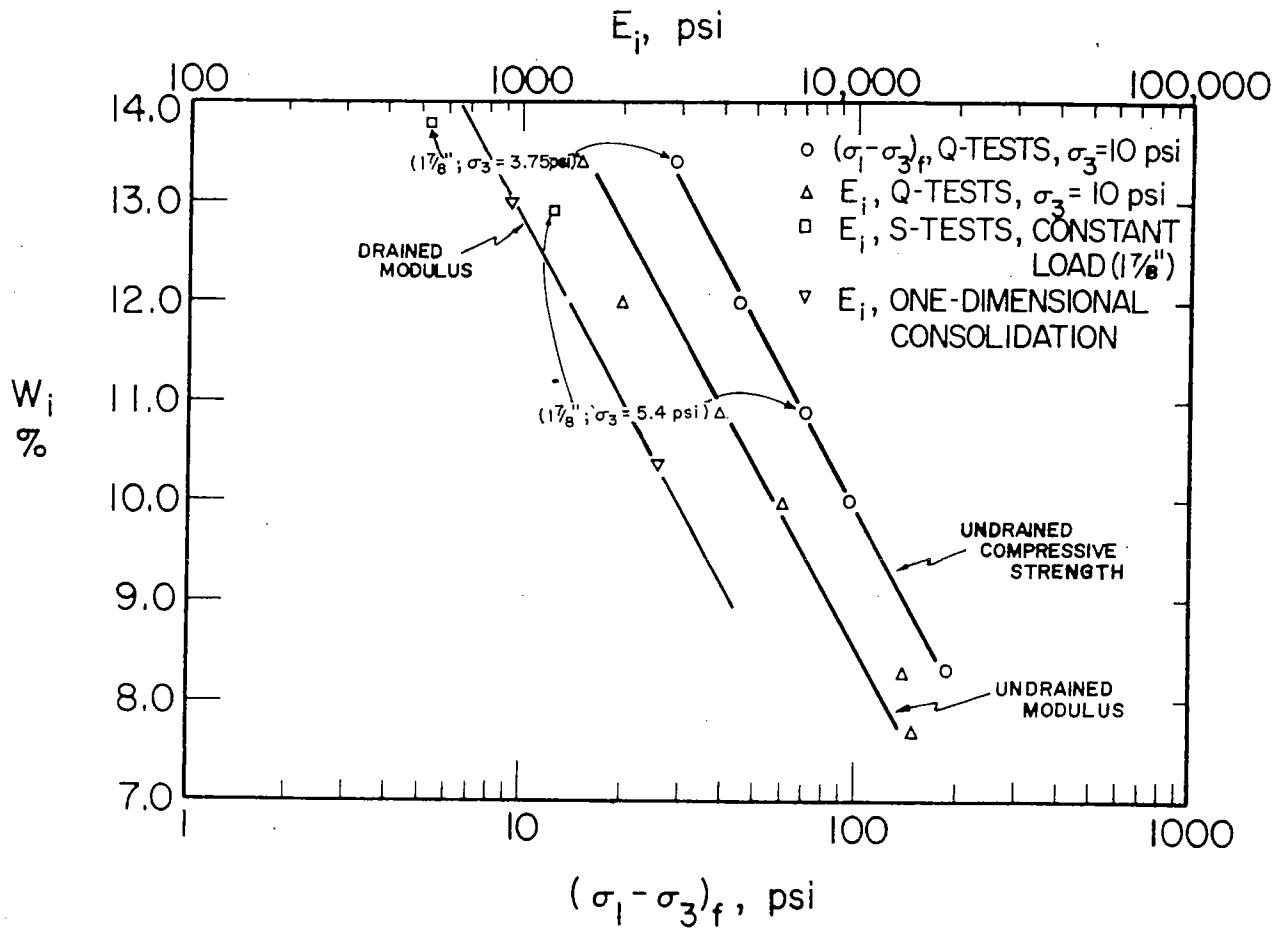
FIGURE 15. MODULUS AND COMPRESSIVE STRENGTH FOR GRAY SHALE.

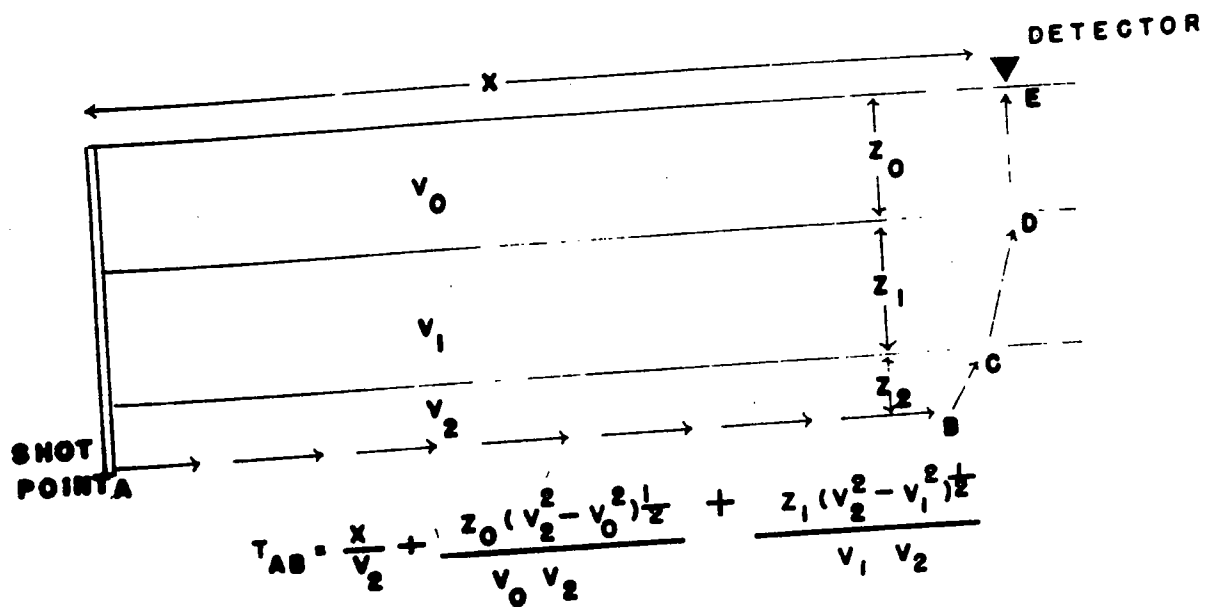
FIGURE 1. LEAST-TIME RAY PATH, THREE-LAYER SYSTEM.

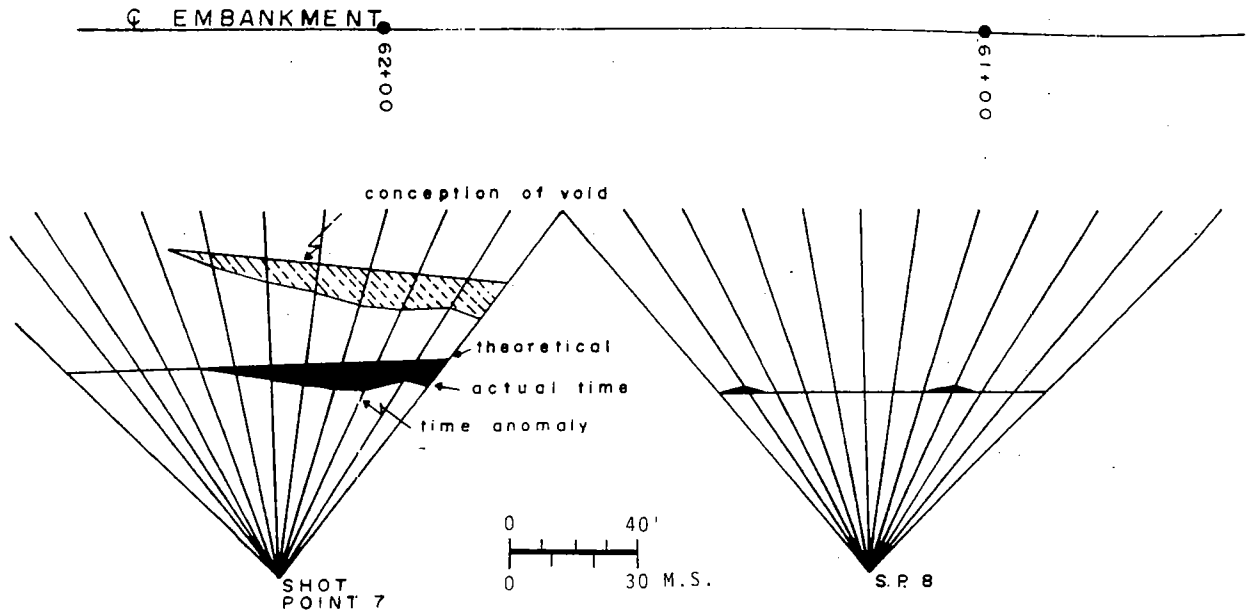
FIGURE 3. SEISMIC SPREADS

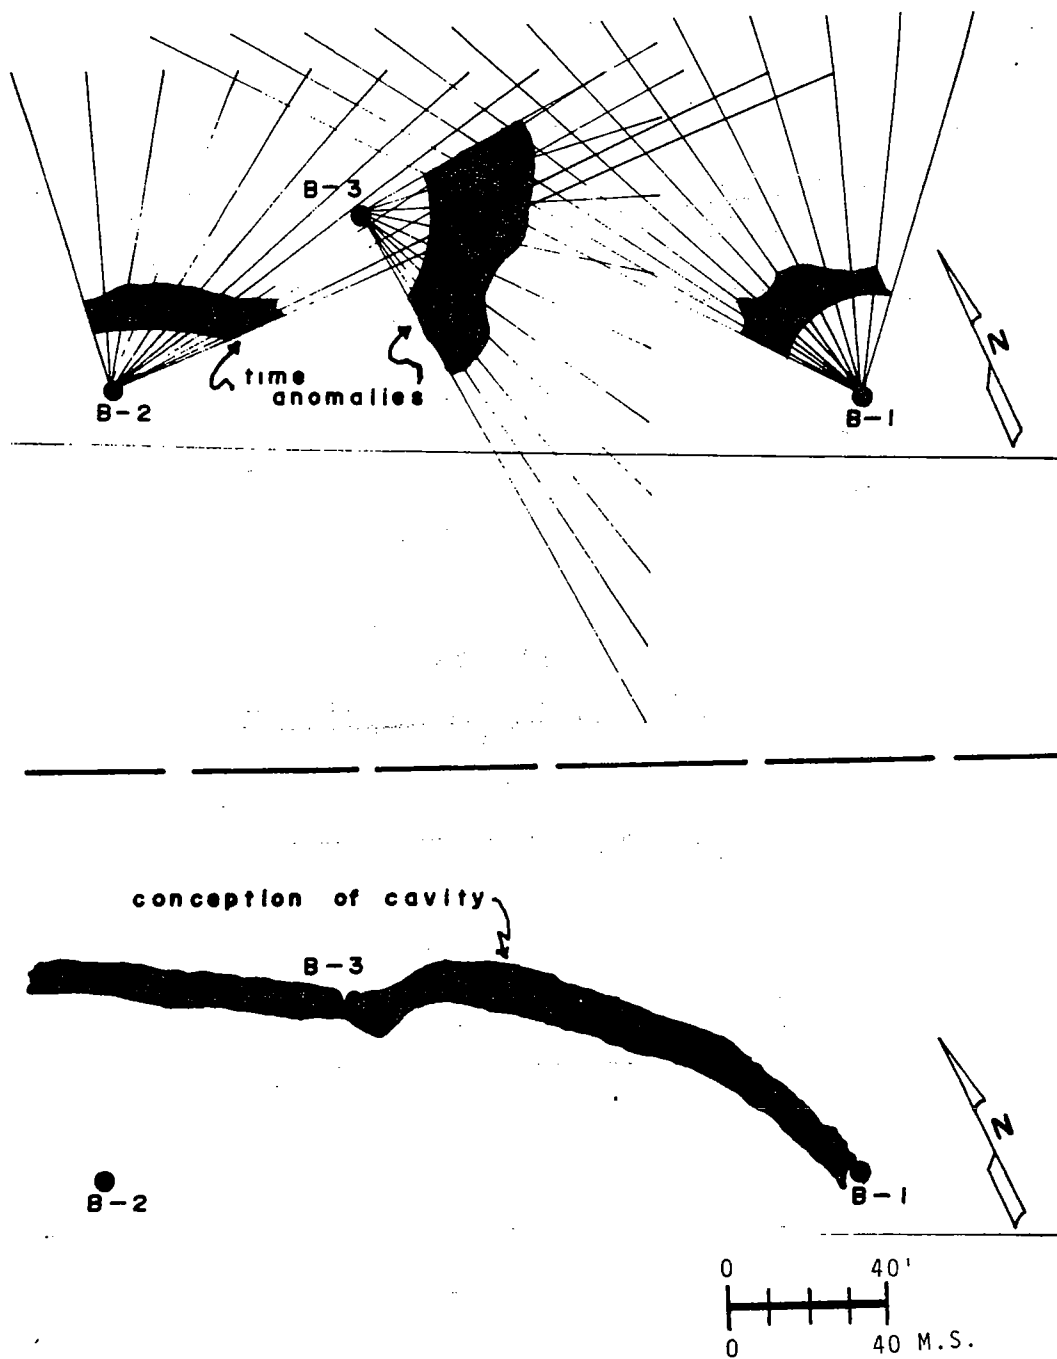
FIGURE 5. SEISMIC SPREAD AND CAVITY PLAN, KNOX DOLOMITE

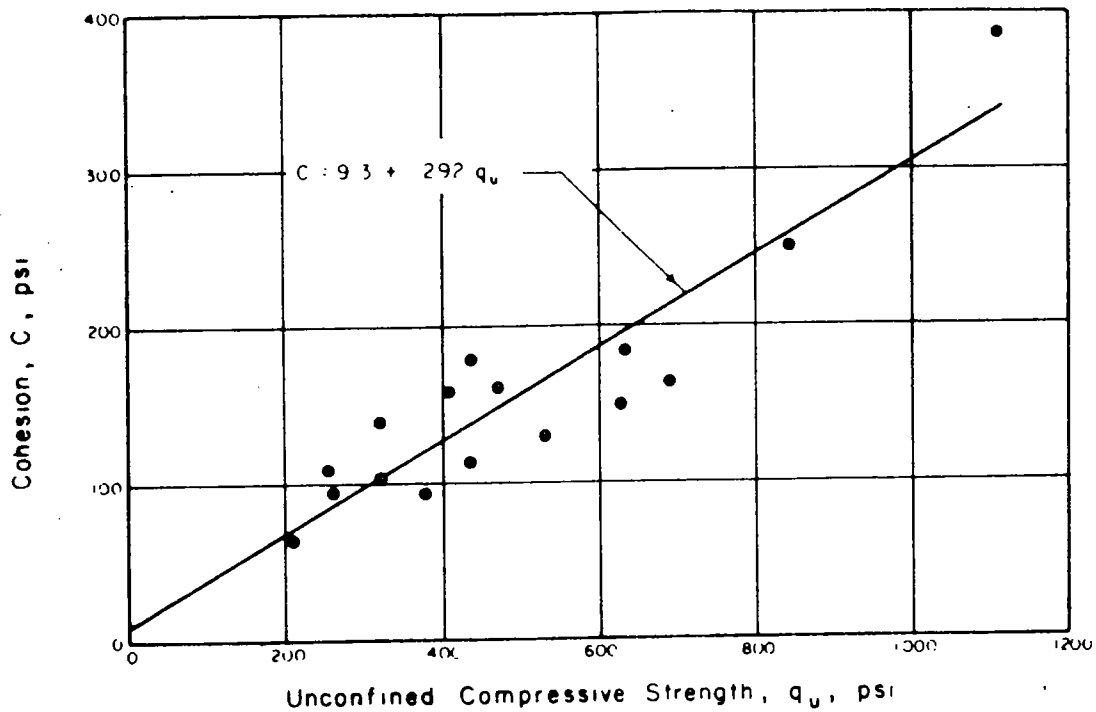
FIGURE 1. COHESION VS UNCONFINED COMPRESSIVE STRENGTH OF LIME-SOIL MIXTURES.

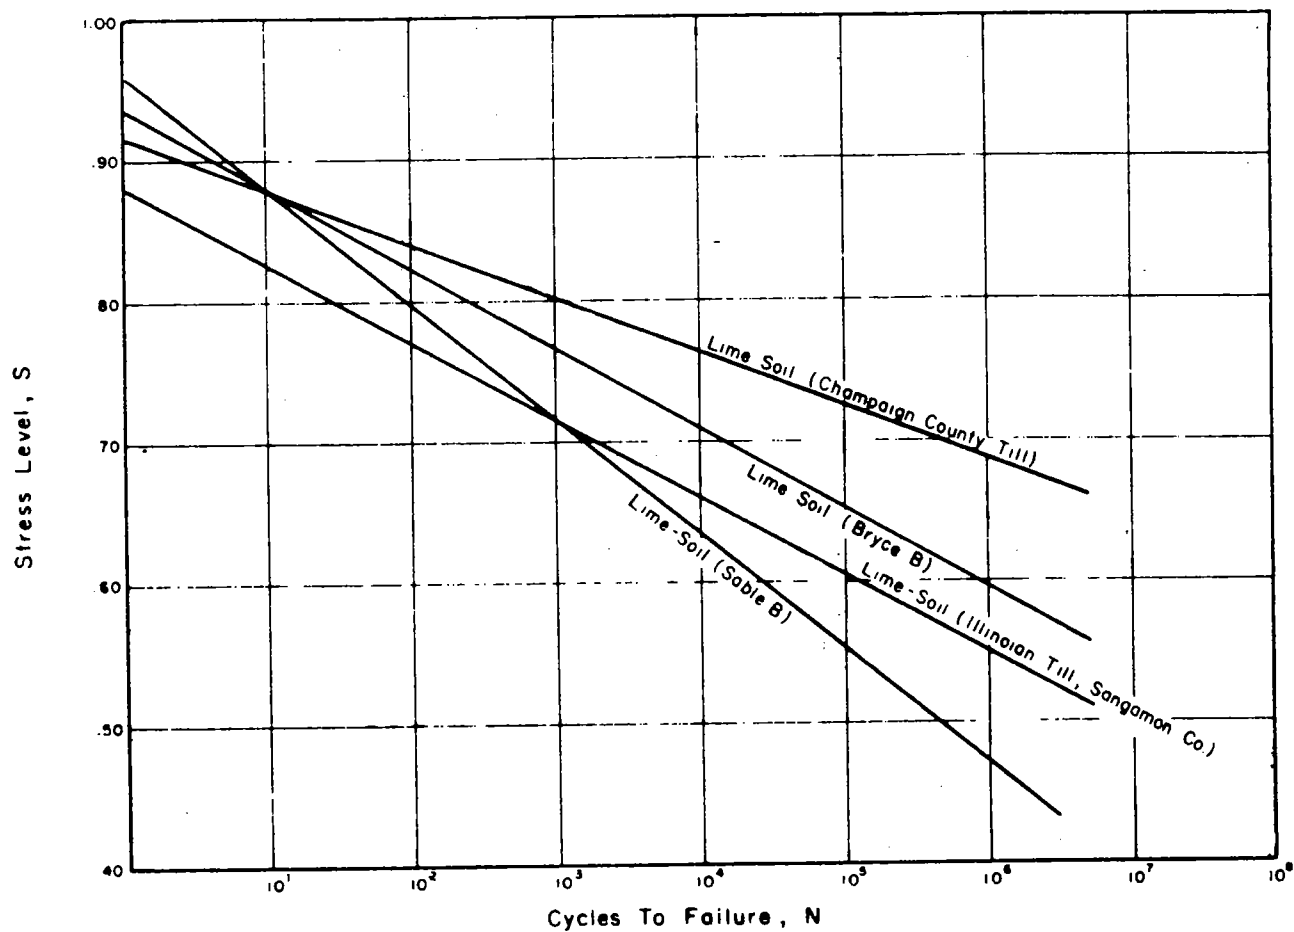
FIGURE 3. FLEXURAL FATIGUE RESPONSE CURVES.

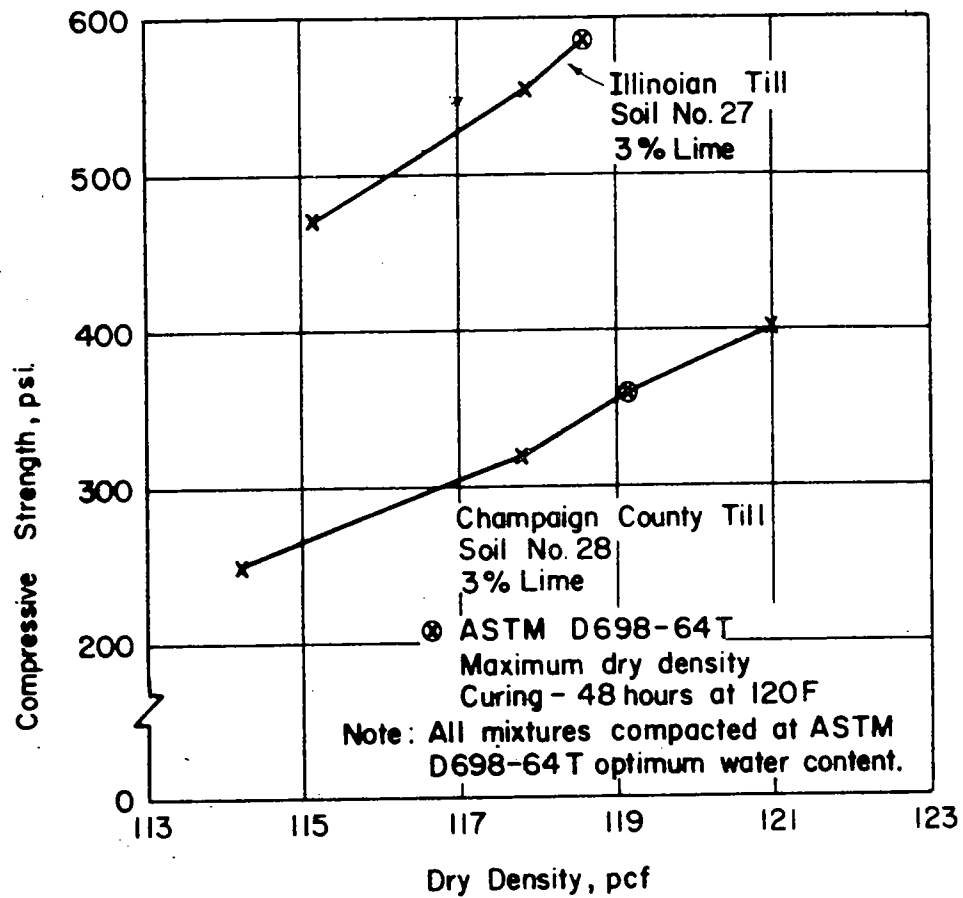
FIGURE 4. INFLUENCE OF DENSITY ON THE STRENGTH OF CURED LIME-SOIL MIXTURES.
