TWENTIETH ANNUAL HIGHWAY GEOLOGY SYMPOSIUM

Proceedings of a Symposium
held at the
University of Illinois, Urbana-Champaign
April 17-19, 1969

I. SOILS OF ILLINOIS AND THEIR ENGINEERING CHARACTERISTICS

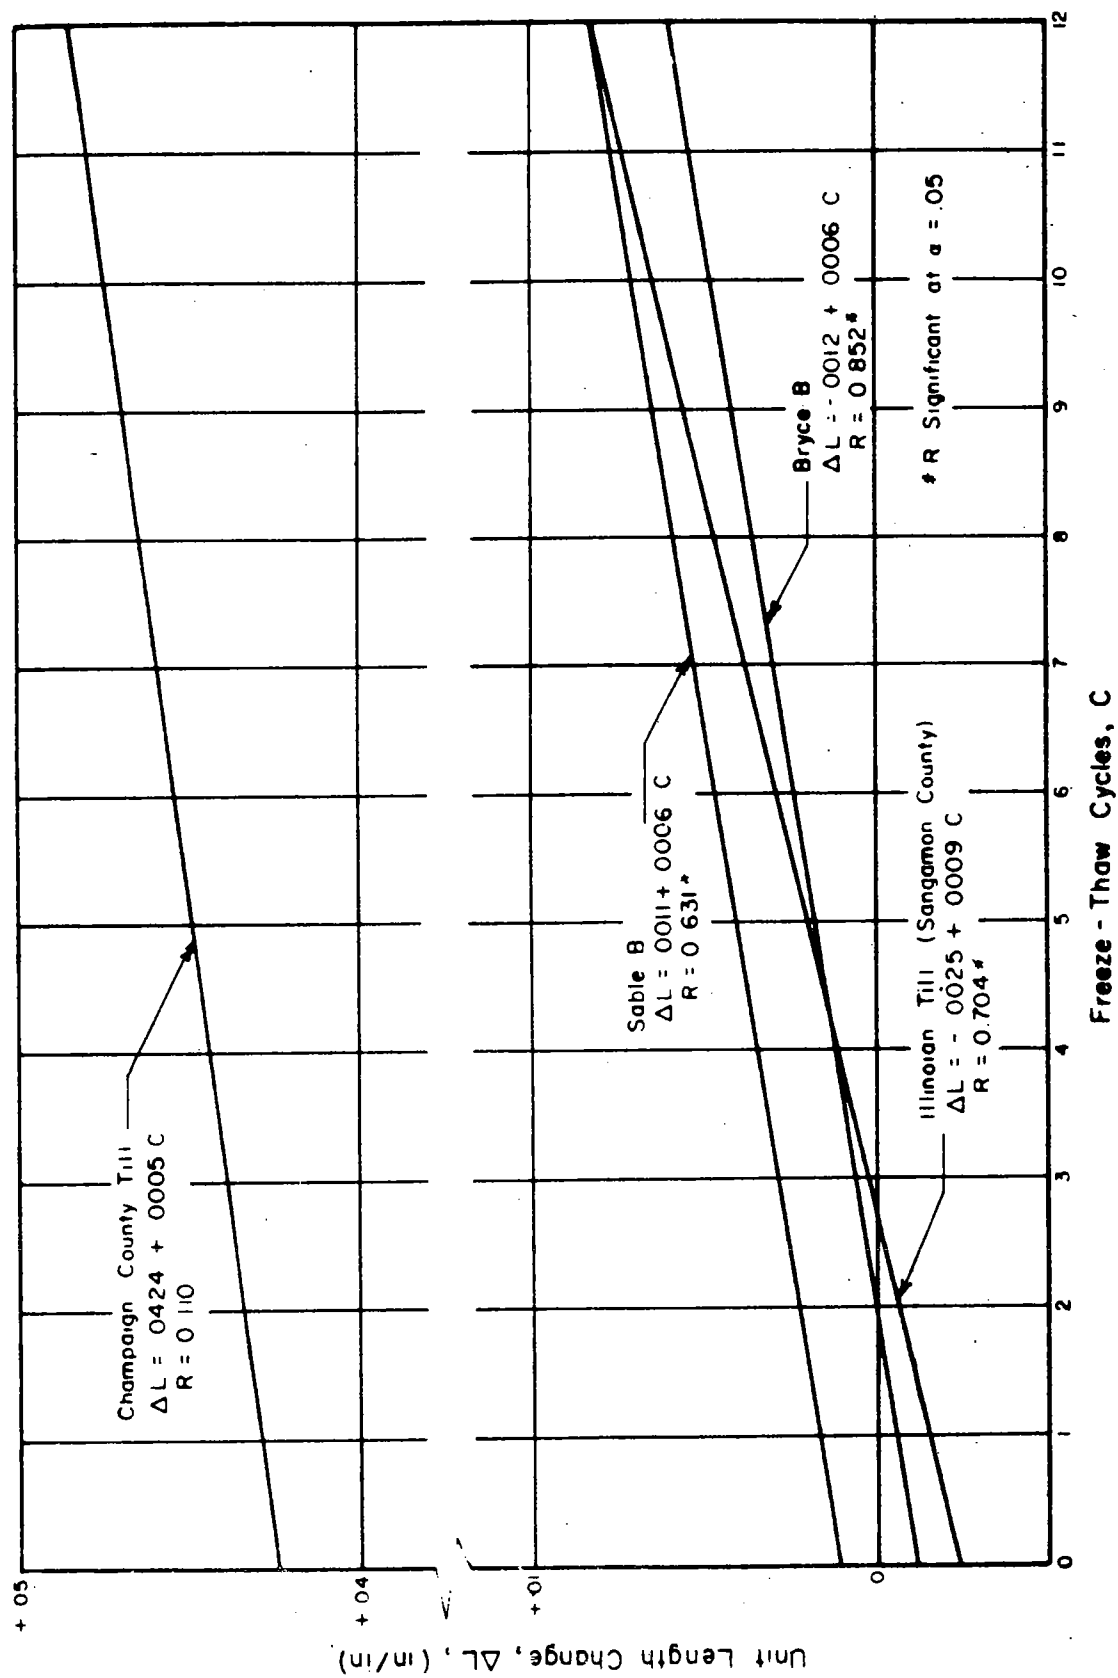
FIGURE 10. INFLUENCE OF FREEZE-THAW CYCLES ON UNIT LENGTH CHANGE (48-HR CURING)

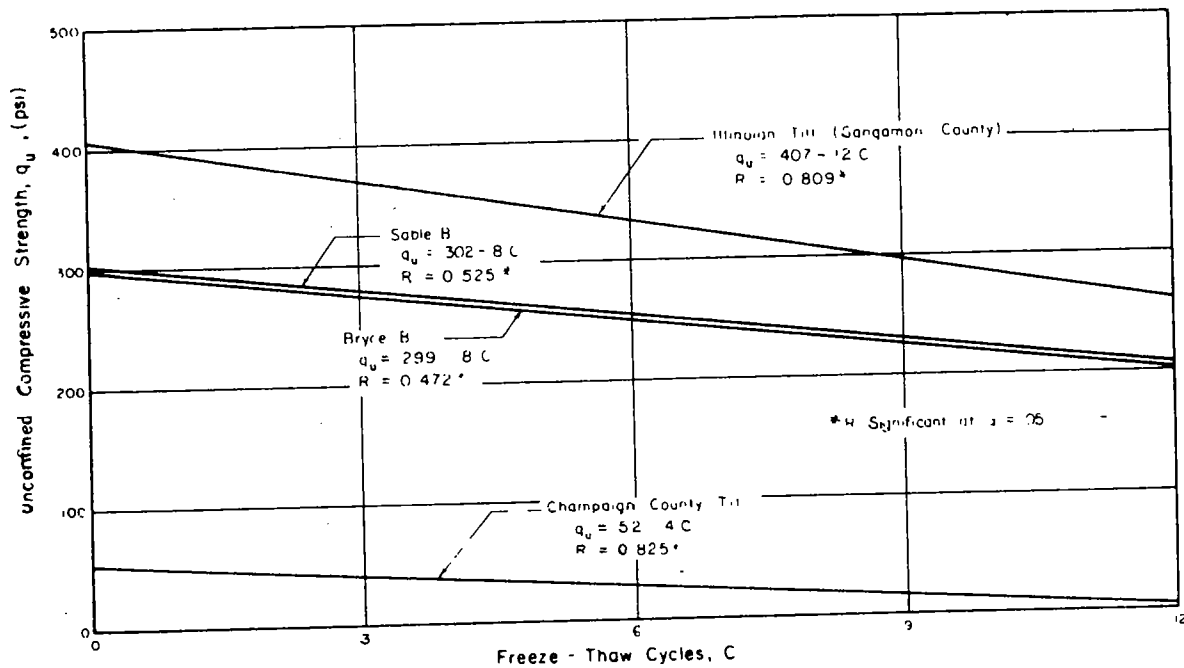
FIGURE 11. INFLUENCE OF FREEZE-THAW CYCLES ON UNCONFINED COMPRESSIVE STRENGTH (48-HR CURING).

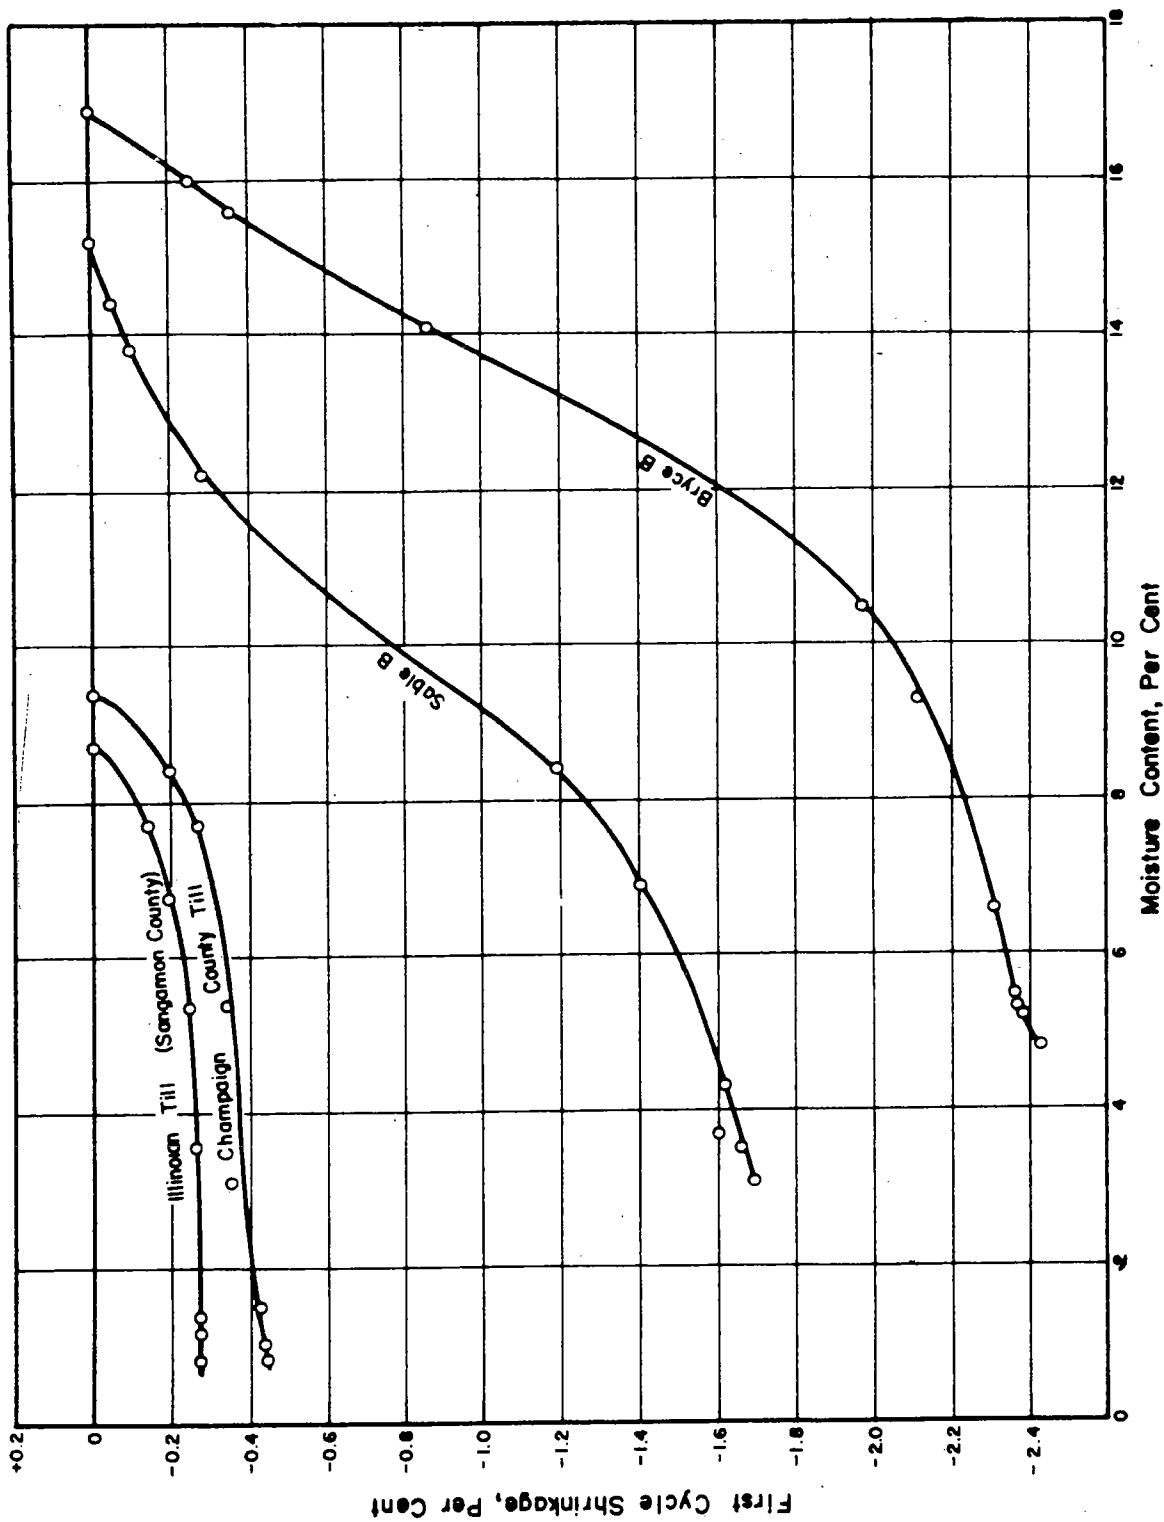
FIGURE 15. FIRST-CYCLE SHRINKAGE OF NATURAL SOILS.

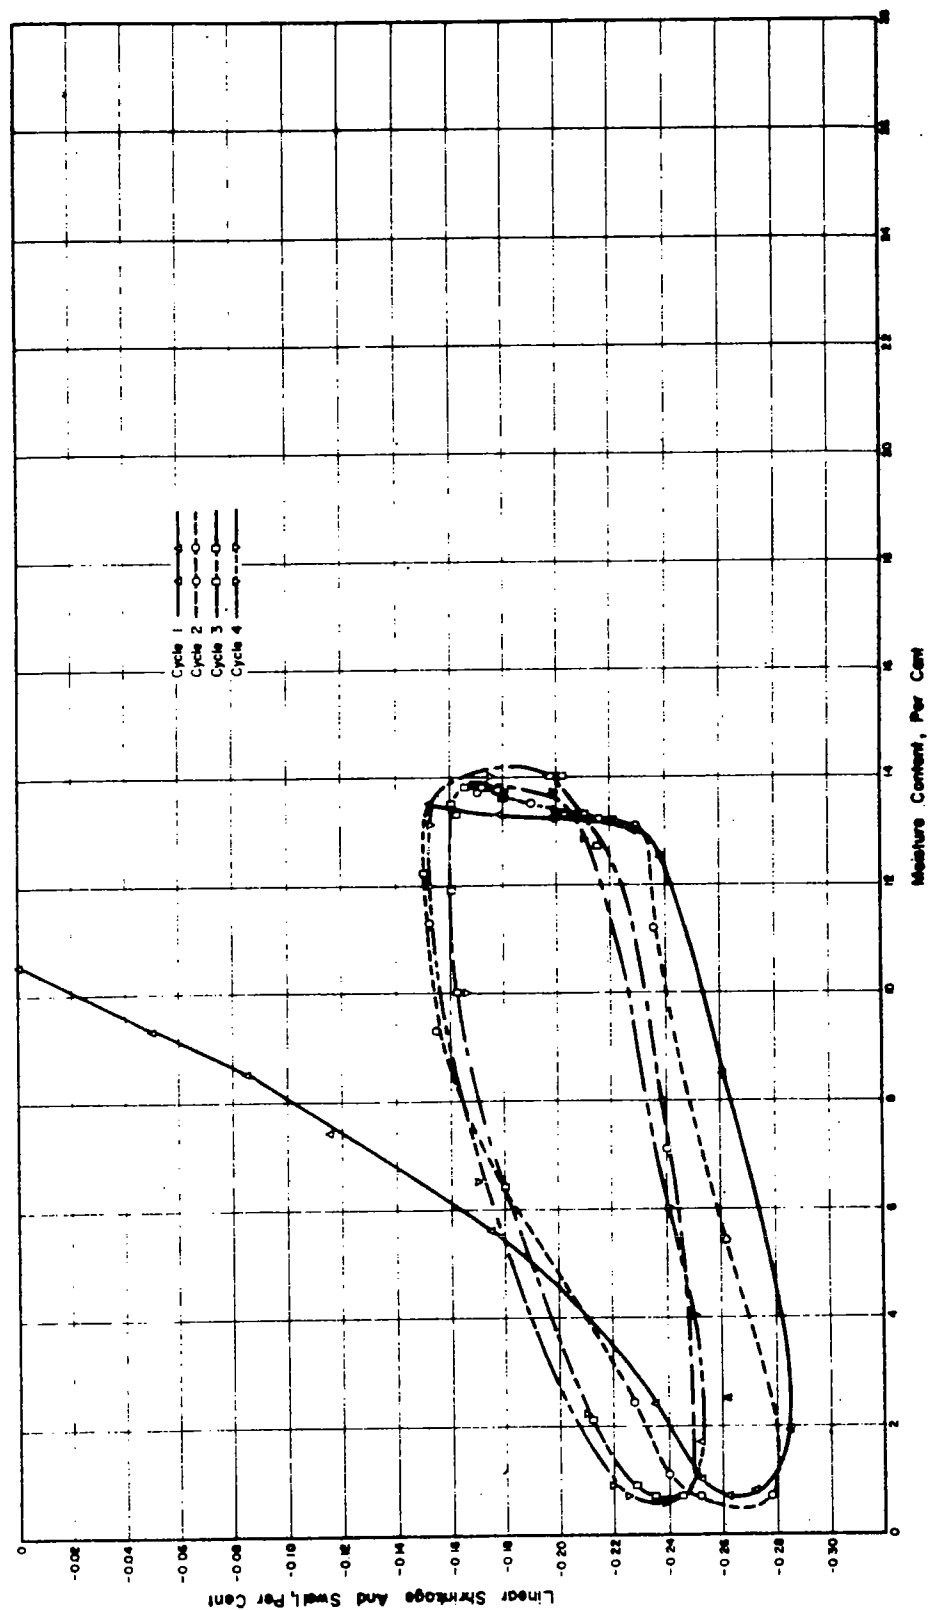
FIGURE 16. CONTINUOUS SHRINKAGE AND SWELL CURVES FOR ILLINOIAN TILL
(SANGAMON COUNTY) MIXTURE (48-HR CURING).

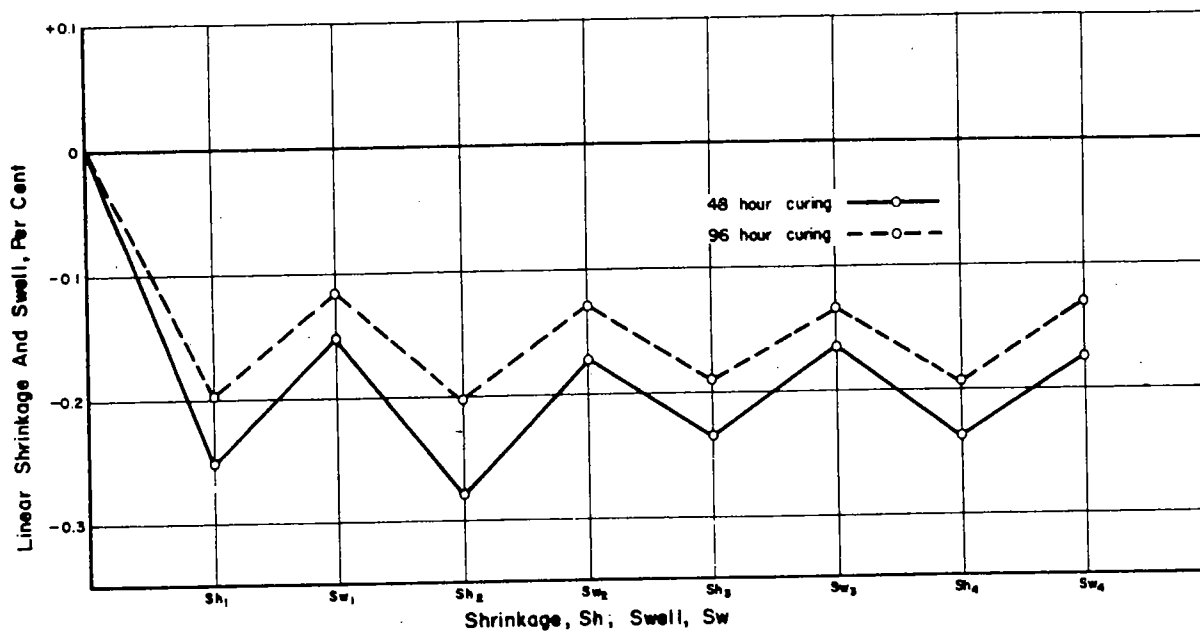
FIGURE 17. MAXIMUM LINEAR SHRINKAGE AND SWELL OF ILLINOIAN TILL (SANGAMON COUNTY) MIXTURE.
