Proceedings of the Symposium  
held at The University of Kansas, Lawrence, Kansas  
April 23-24, 1970

# TWENTY-FIRST ANNUAL HIGHWAY GEOLOGY SYMPOSIUM

PROCEEDINGS OF THE 21ST ANNUAL  
HIGHWAY GEOLOGY SYMPOSIUM

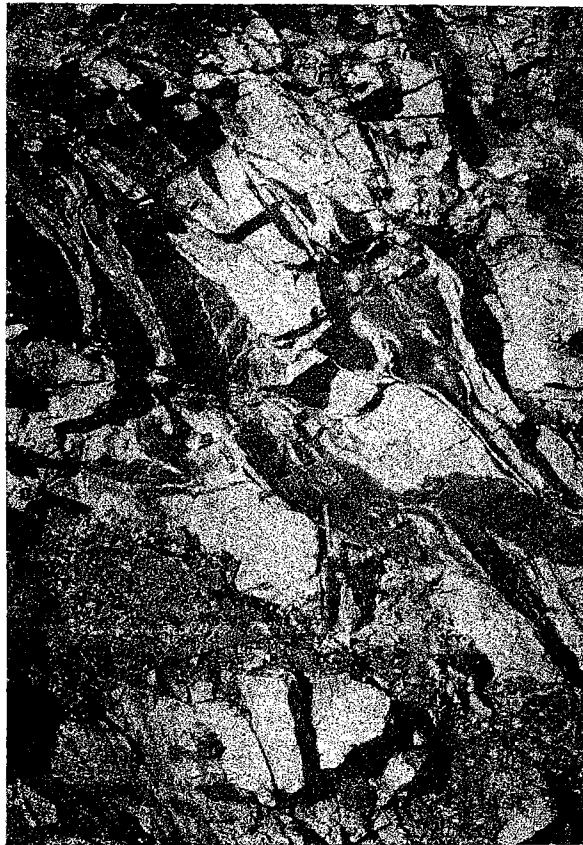
Plate 8. Metamorphic-rock exposure northeast of Bailey, Colorado. Exposure clearly shows the joint patterns and foliations occurring in a gneiss, with backslope construction and maintenance problems apparent. Note rock hammer in center of picture.

When considering rock structure in cut-slope design, the word structure is used in two different ways. One is the structure within the rock, such as bedding, foliation, and jointing (Plate 10). The other is the over-all structural geology of the area, such as folding, faulting, and tectonic movement (Plate 11).

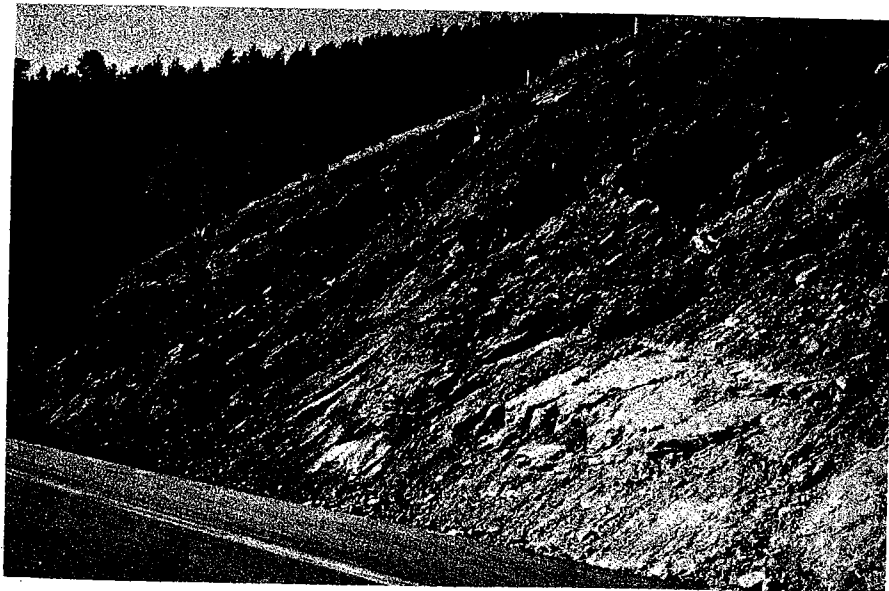
Plate 12. Upturned sedimentary rocks west of Dayton, Wyoming. Example of a bedding plane rock slide.

In design and construction, both of these characteristics are important, and in some cases work together to cause unstable rock-slope conditions. An example is a rock cut in upturned sedimentary rocks where fractures along a bedding plane allow broken rock to slip along the bedding plane, and then to fall into the cut (Plates 12, 13, 14, 15 and 16).

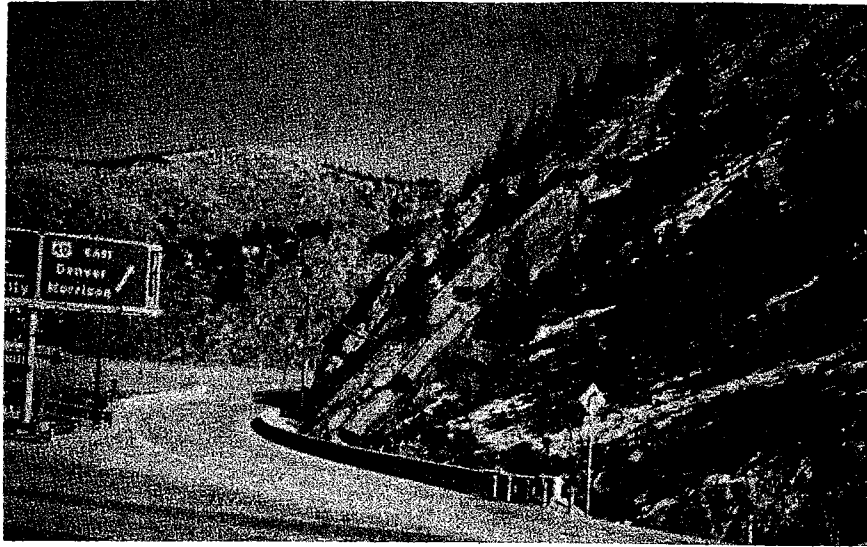
Plate 15. Rock cut east of Idaho Springs, Colorado. Showing rock-slide area as described in Plate 11. Road is on down-dip side of the foliation planes in the rock.

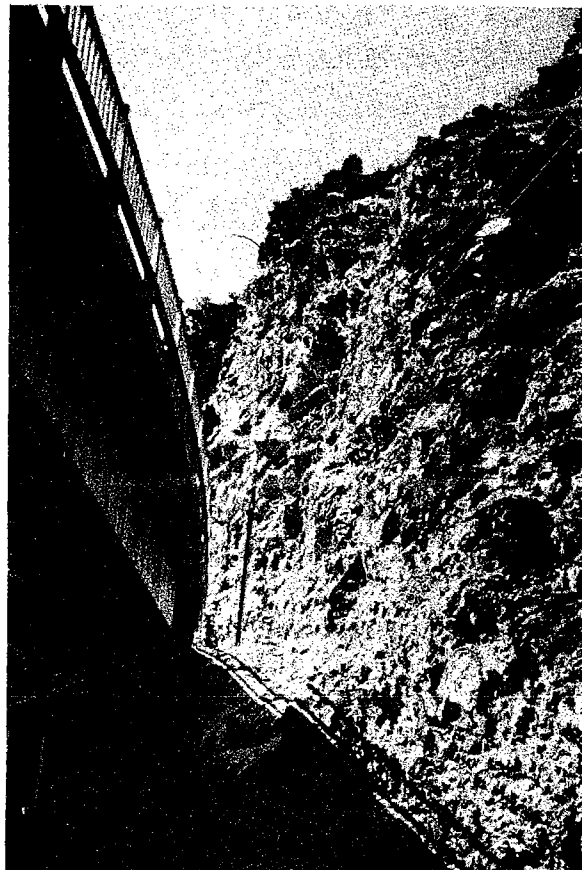
Plate 16. Rock cut east of Idaho Springs, Colorado, on opposite side of canyon from Plate 15, showing up-dip side of the same rock formation. This slope is nearly vertical whereas slope in Plate 15 is following the foliation plane.

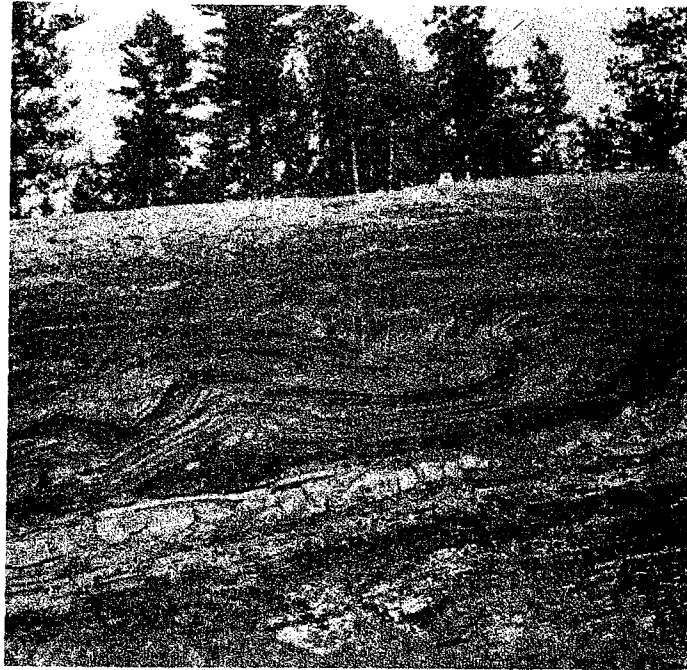
Plate 19. Folded sedimentary rocks southeast of Taos, New Mexico. Fracturing of rock due to folding can create slope-stability problems.

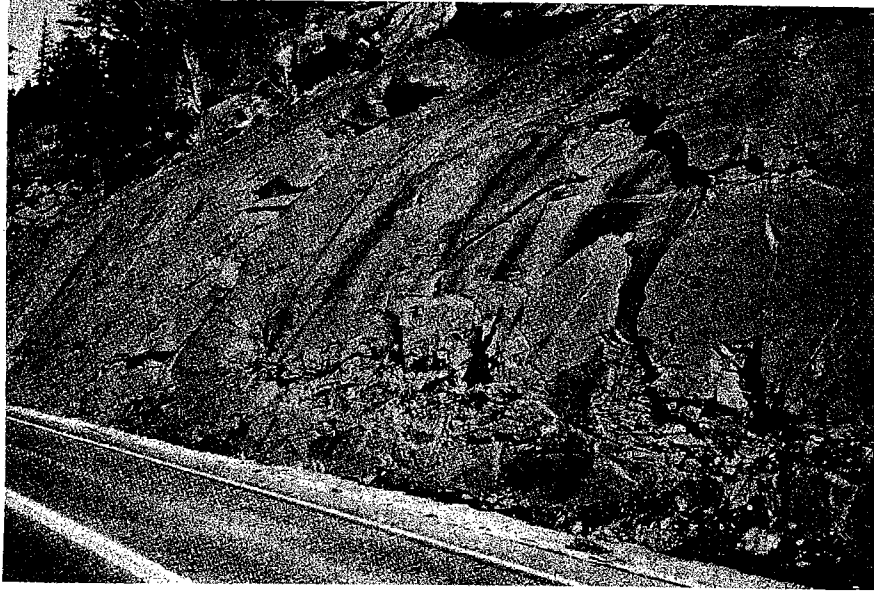
Plate 22. Example of a sandstone being over-shot during cut excavation. Over-shooting may create residual stress zones in the rock which could cause spalling as these stresses are relieved.

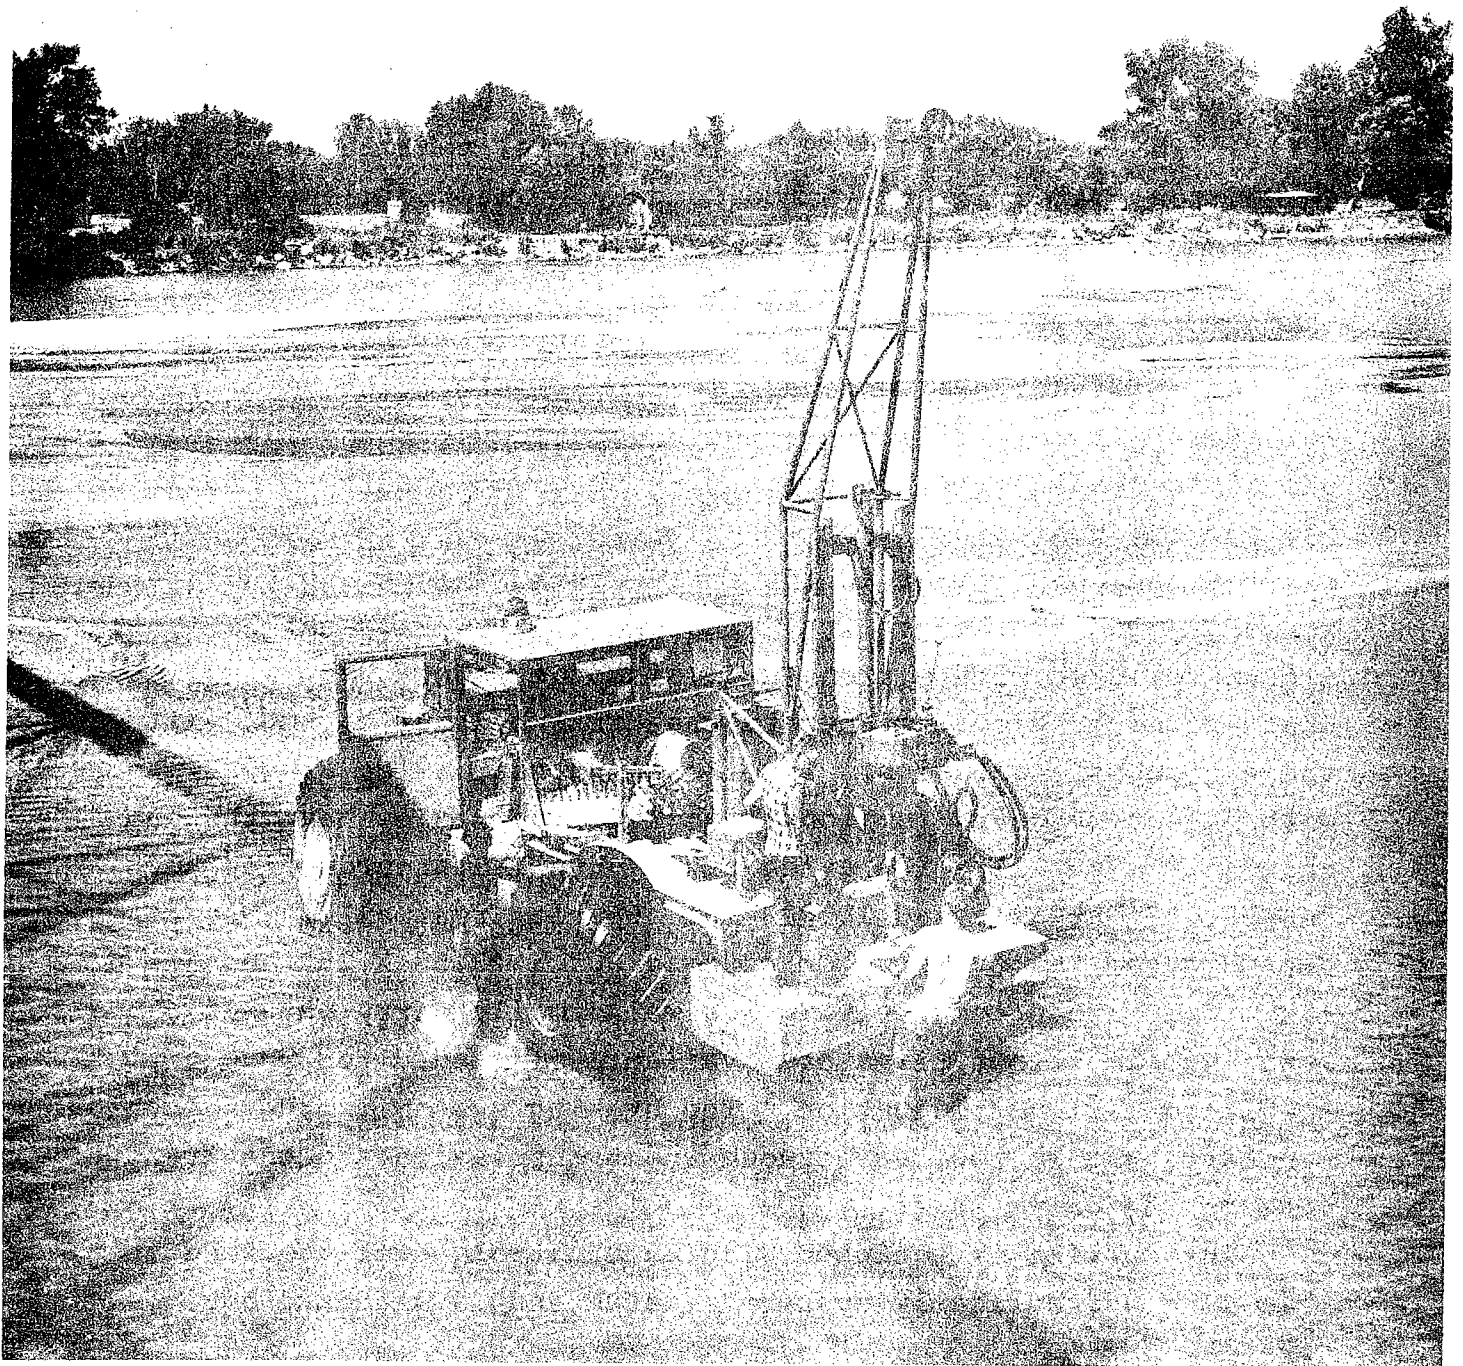
Figure 1. SWAMP BUGGY ON PLATTE RIVER

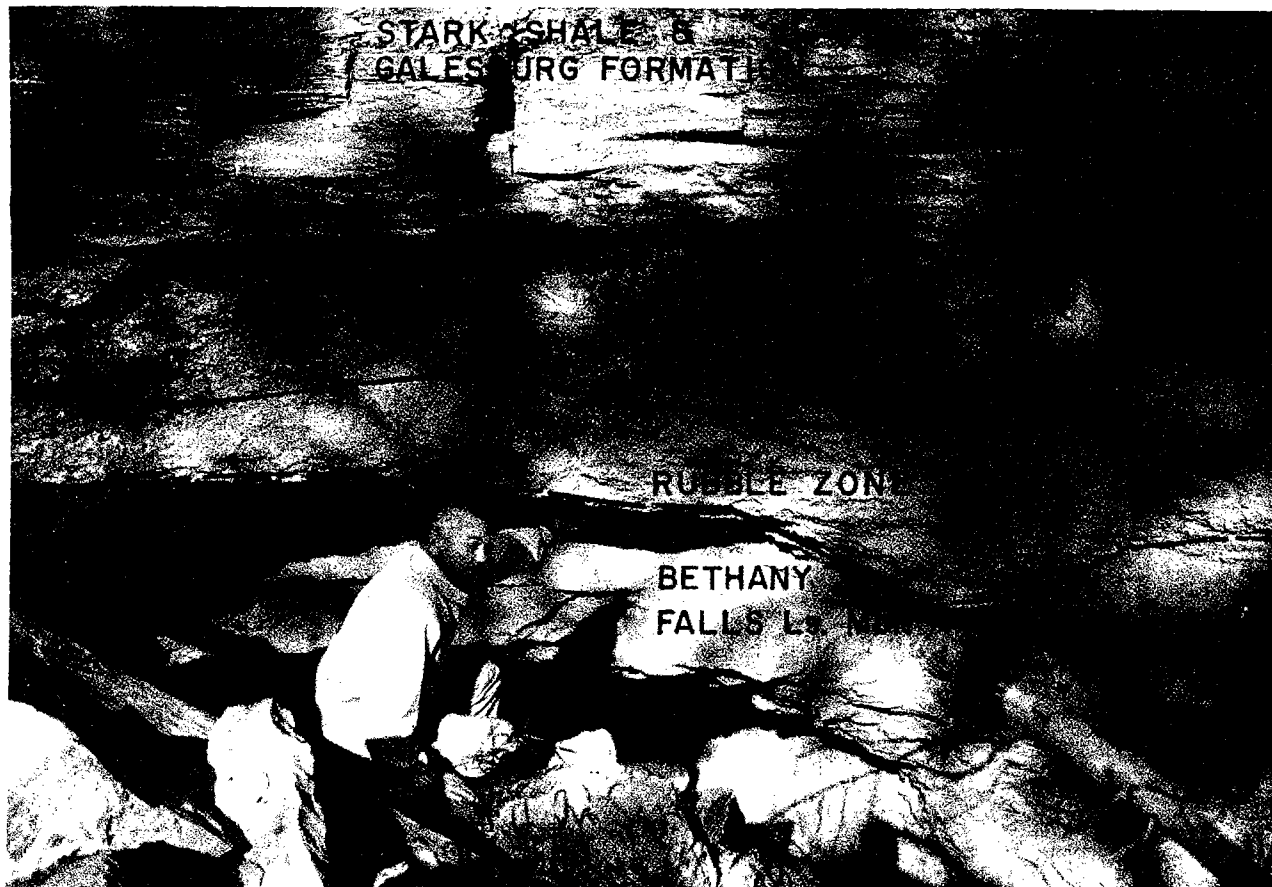
Figure 8. The rubble zone, upper Bethany Falls, can vary from 1 to almost 3 feet in thickness. A thick rubble zone reduces mine roof strength. (Photograph by Jerry D. Vineyard)

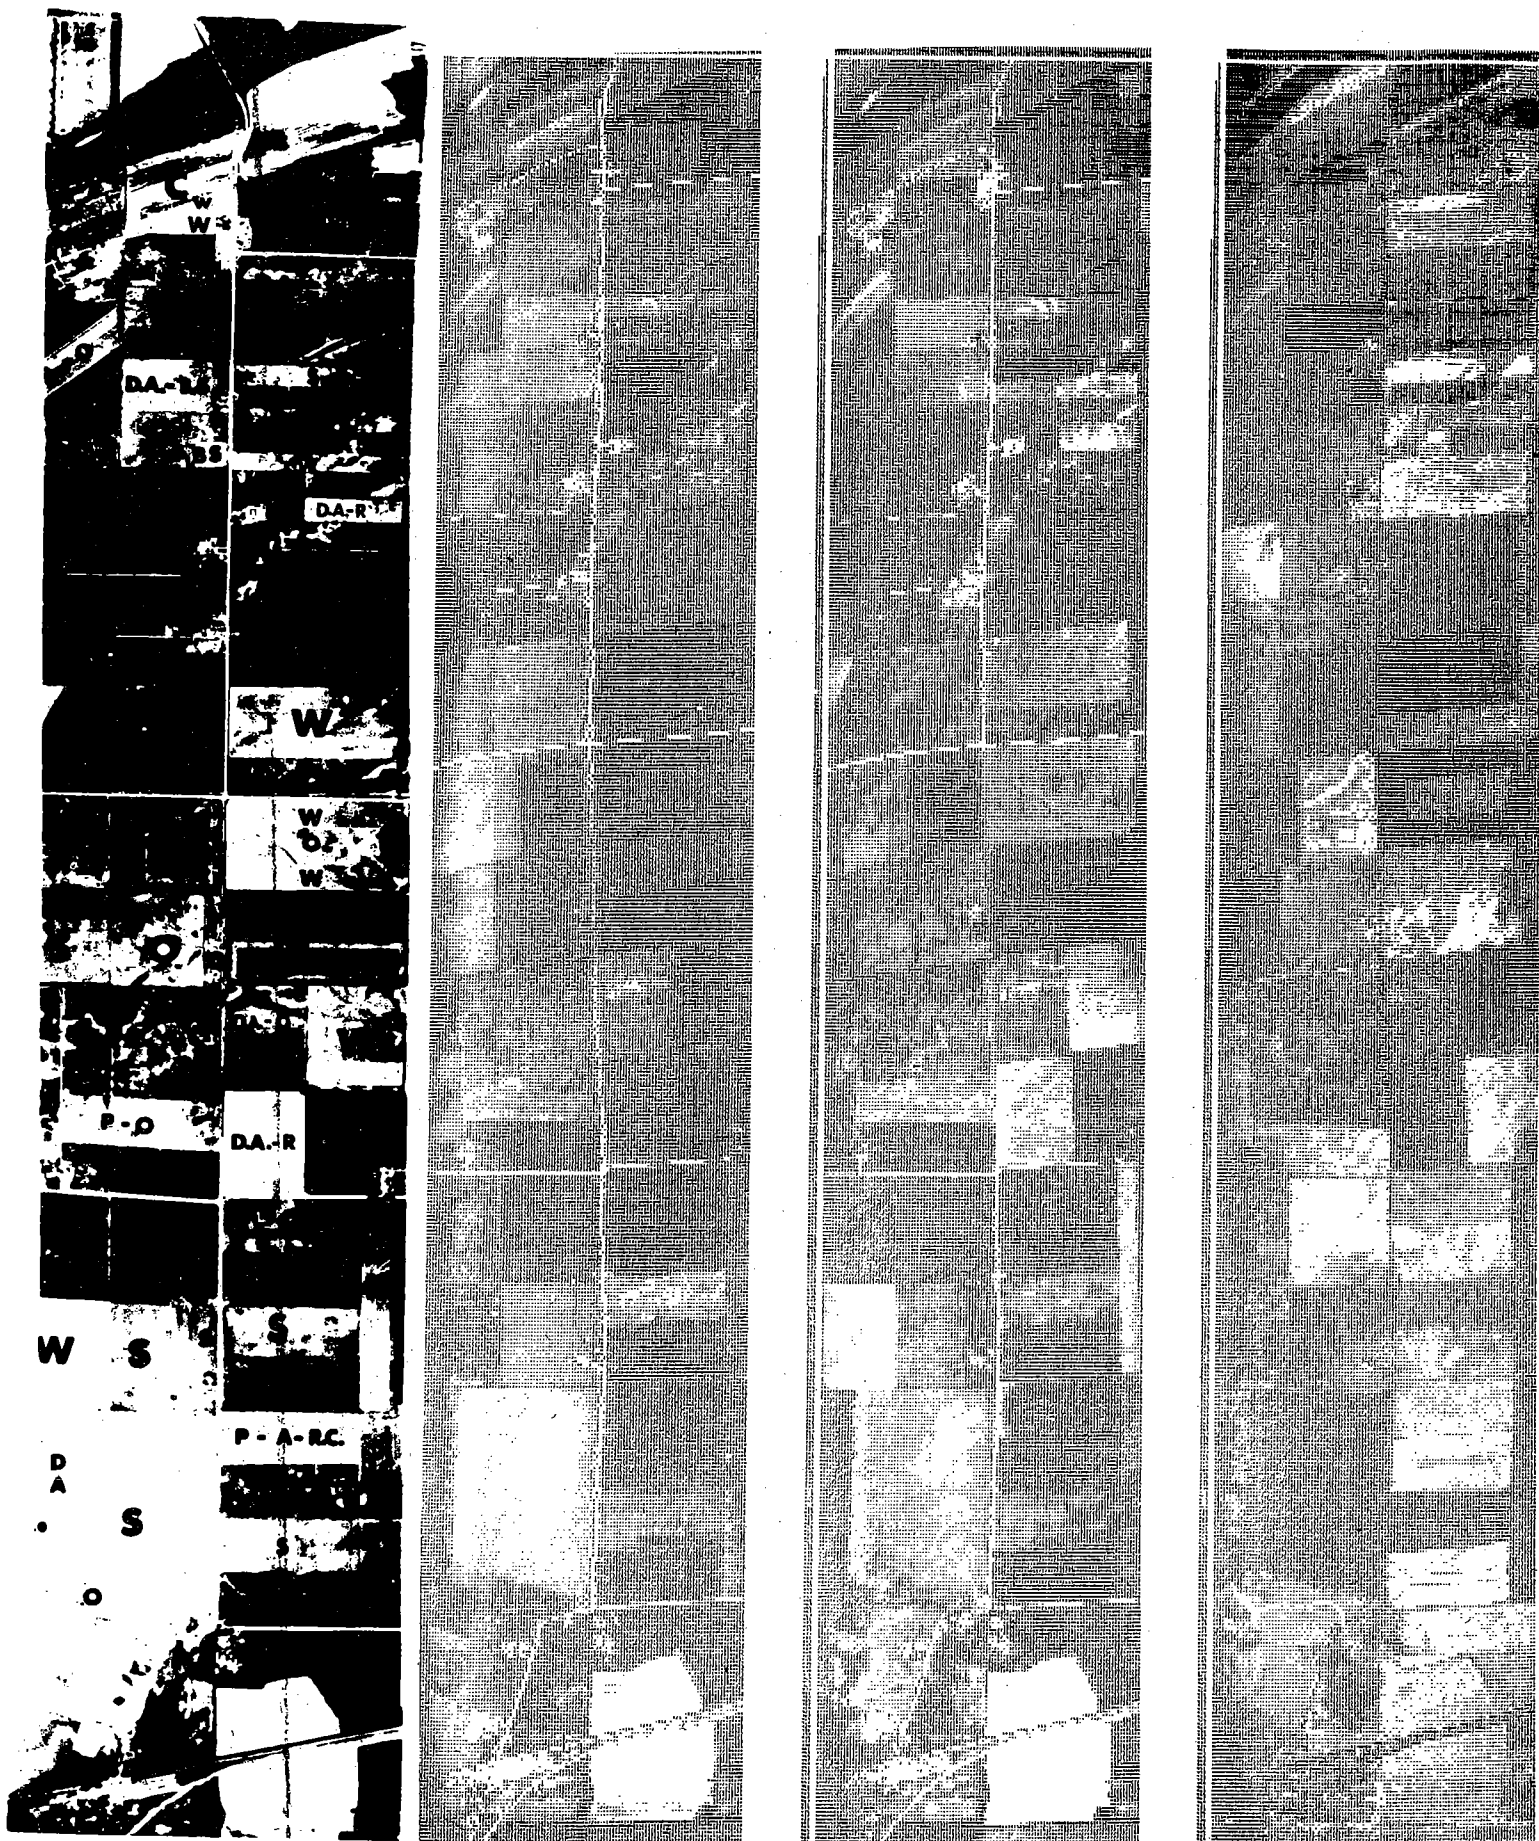
FIGURE 7 - Computer printouts of three wavelength bands of multispectral data ( $.40-.44\mu$ ,  $.62-.66\mu$ ,  $.80-1.0\mu$ ).

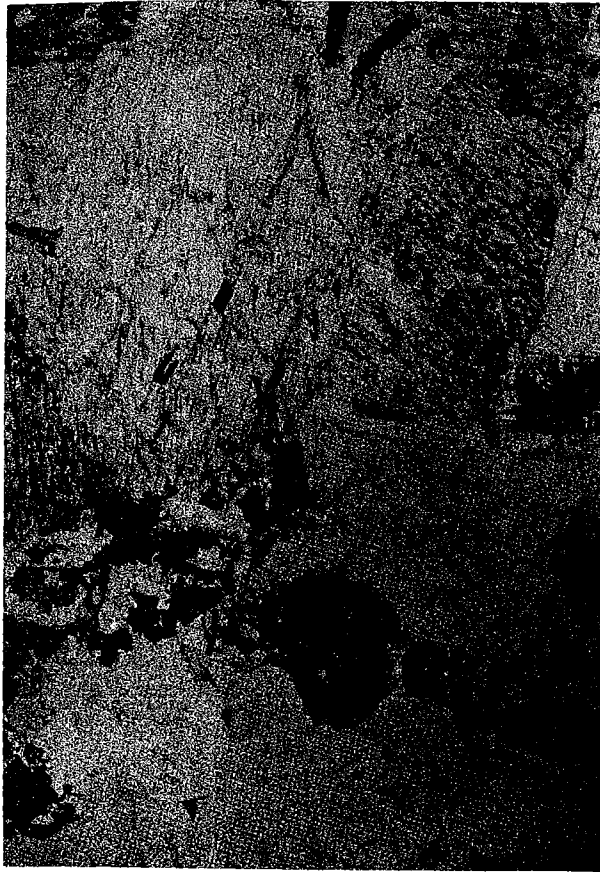
Plate 2. Granite (Lands End). Coarse interlocked grains of highly altered plagioclase, partially altered orthoclase, unaltered quartz and dark mica. (PPL x 8.5)

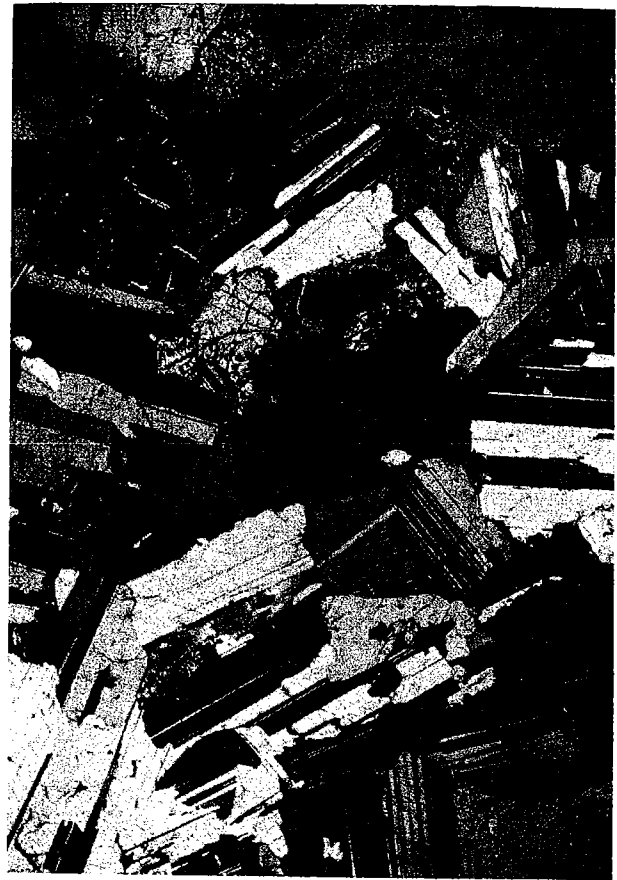
Plate 3. Gabbro. Coarse interlocking grains of calcic feldspar, olivine and poikilitic pyroxene. (x 8.5)

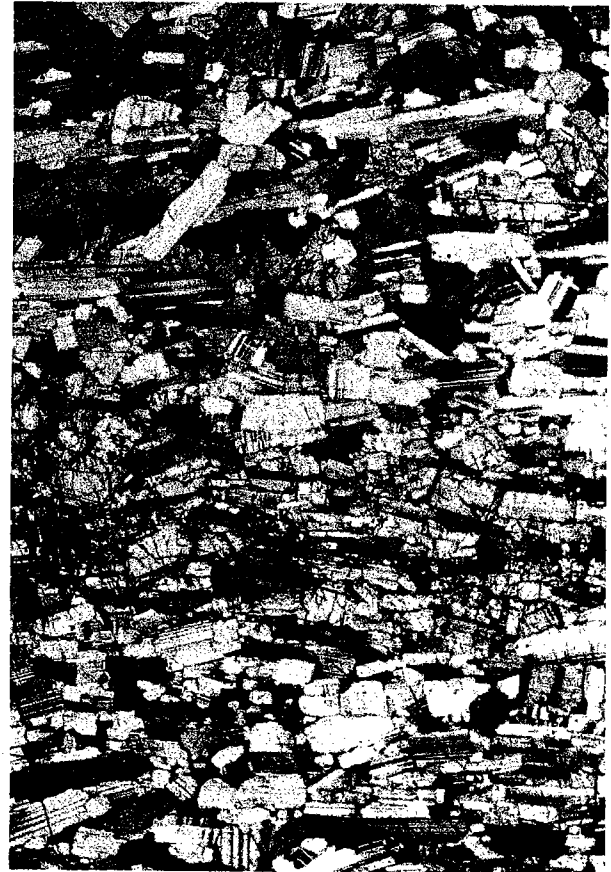
Plate 4. Dolerite/Gabbro. Medium grained interlocking grains of feldspar and pyroxene showing distinct orientation (foliation) with possible banding. (x 8.5)

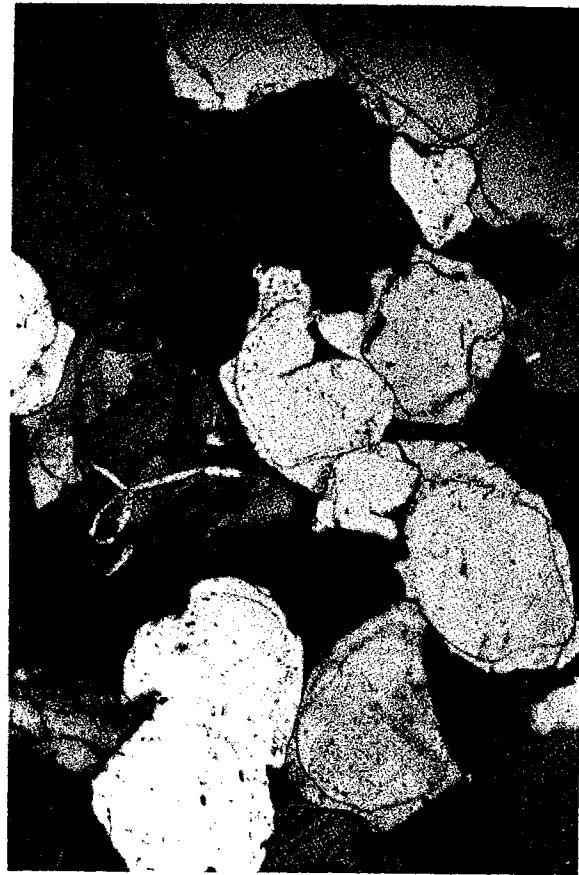
Plate 8. Recrystallized Sandstone (Penrith). Small wind rounded quartz grains cemented together by additional growth of silica from percolating solutions. The quartz jacket is clearly visible. (# x 50)

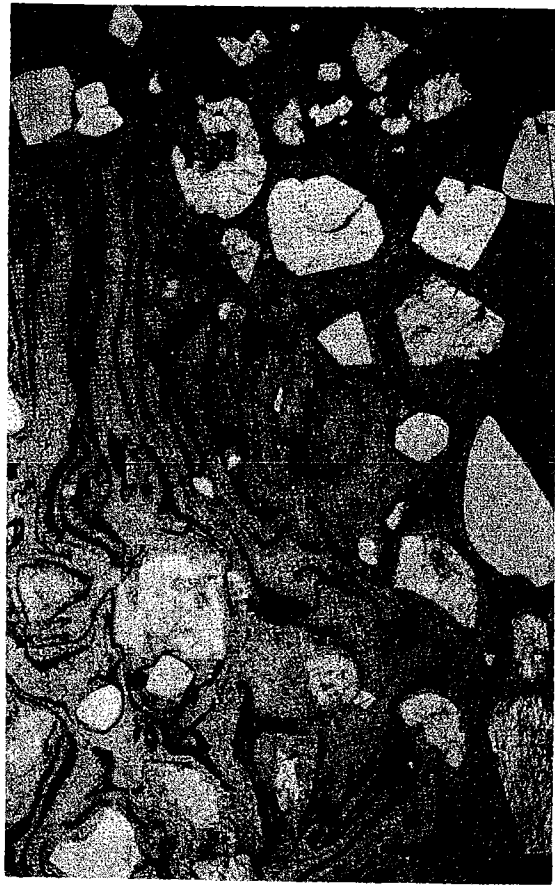
Plate 5. Quartz Porphyry (Dun Dubh, Arran). Phenocrysts of quartz and feldspar set in a cryptocrystalline ground mass which clearly shows flow structure. (PPL x 8.5)

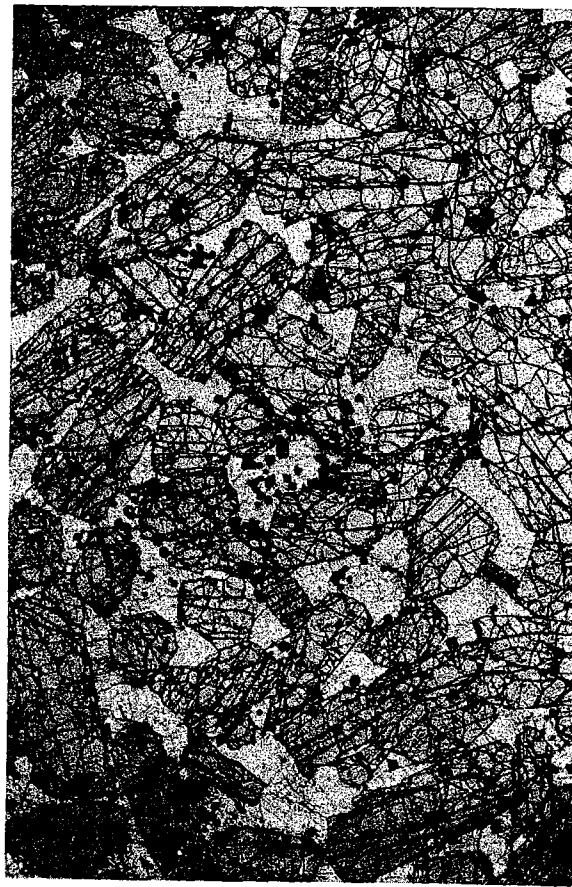
Plate 7. Black specks of finely disseminated metallic ore (Chrome Spinel) occurring in coarse-grained, olivine-rich ultrabasic rock. (PPL x 8.5)

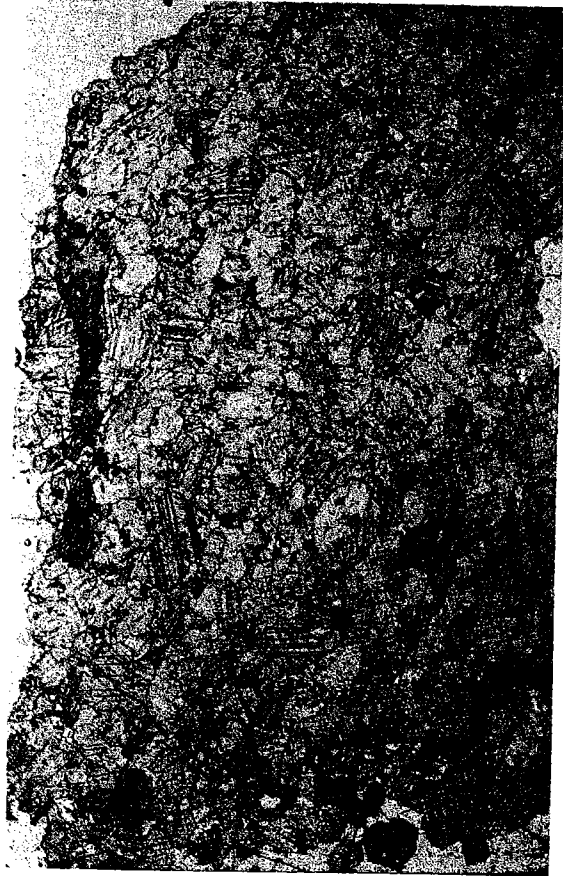
Plate 10. Saccharoidal Limestone (Tomintoul). Recrystallization of calcite due to metamorphism, resulting in granular texture (marble). The cleavage is clearly apparent. (PPL x 8.5)

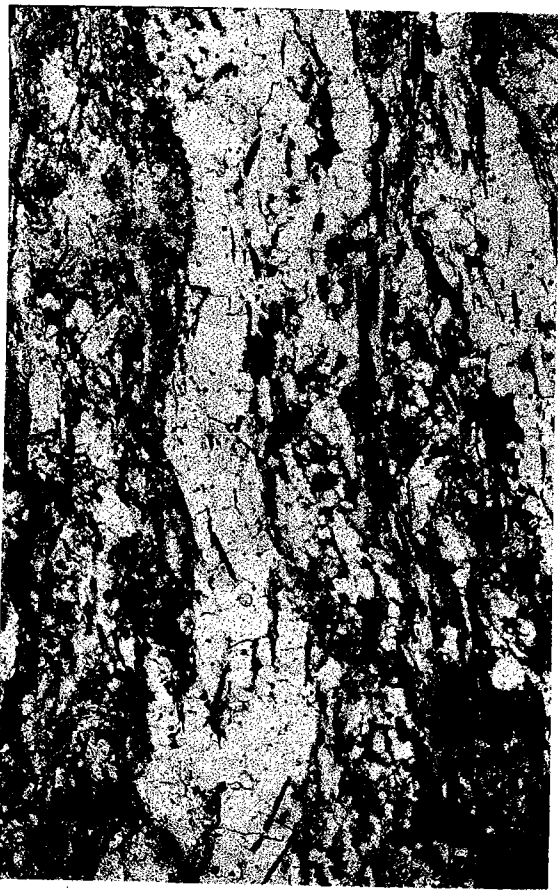
Plate 11. Quartz-mica Schist (Perthshire). Metamorphism has resulted in the banding of large quartz, felspar and mica crystals to produce a distinctly foliated rock. (PPL x 8.5)

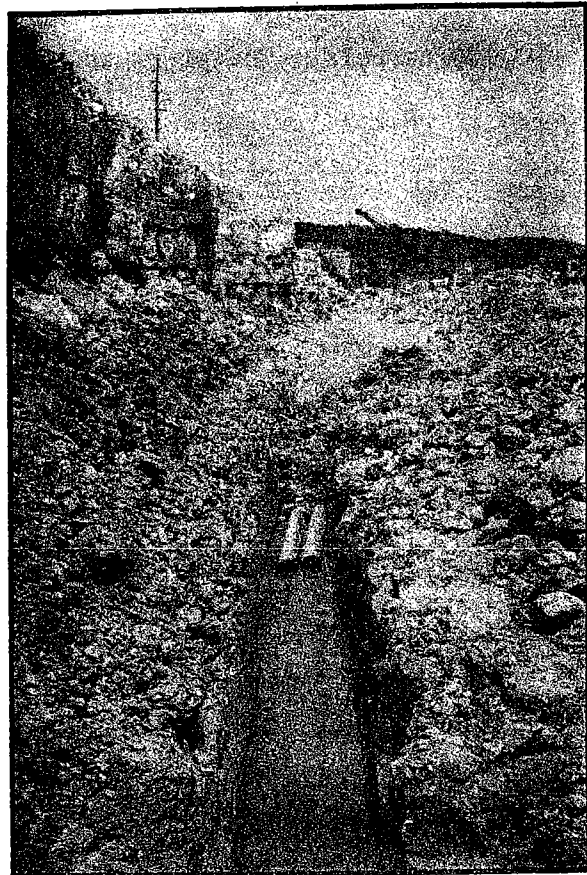
LANE	FRISBIE-ARGENTINE	33.8
SH.	LIMESTONE	25.1
SPG. HILLS	BONNER SPGS.	22.3
MERRIAM	SHALE	17.2
VILAS	SH.

PORTLAND CEMENT MANUFACTURING PROCESS  
AT  
BONNER SPRINGS, KANSAS  
(Courtesy Portland Cement Corporation)

C3 - The Lone Star Cement Plant observed at this site produces about 6,500 barrels of Portland Cement per 24 hour day having a yearly productive capacity of 2,400,000 barrels. The plant uses 2,000 tons of cement rock per day. The source of rock is quarried from the Argentine-Frisbie, Farley, and Spring Hill-Merriam Limestone units, with a composite thickness of approximately 75 feet (Figure 13). The Bonner Springs Shale is wasted in the quarrying operation. Portions of this geologic section are shown in Figure 9 and Figure 10. Gypsum is required in the manufacturing process and this is mined from strata of Permian Age in South Central Kansas.

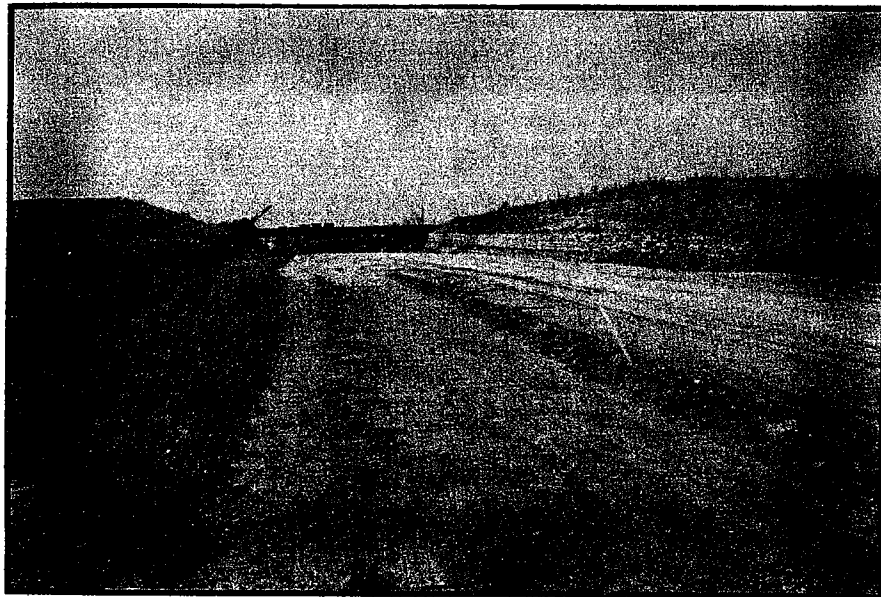
Figure 24  
Location Where Shale Was Subgraded

H-2 - Subgrading - Figure 24 shows an area of subgrading on Highway K-10. This location is a short distance east of the underdrain location. When laboratory tests indicate that a shale will be unstable under the roadbed, the shale is removed from the subgrade to a depth of 8" as indicated in Figure 25, and backfilled with more stable material. In this case crushed limestone was used for the backfill.

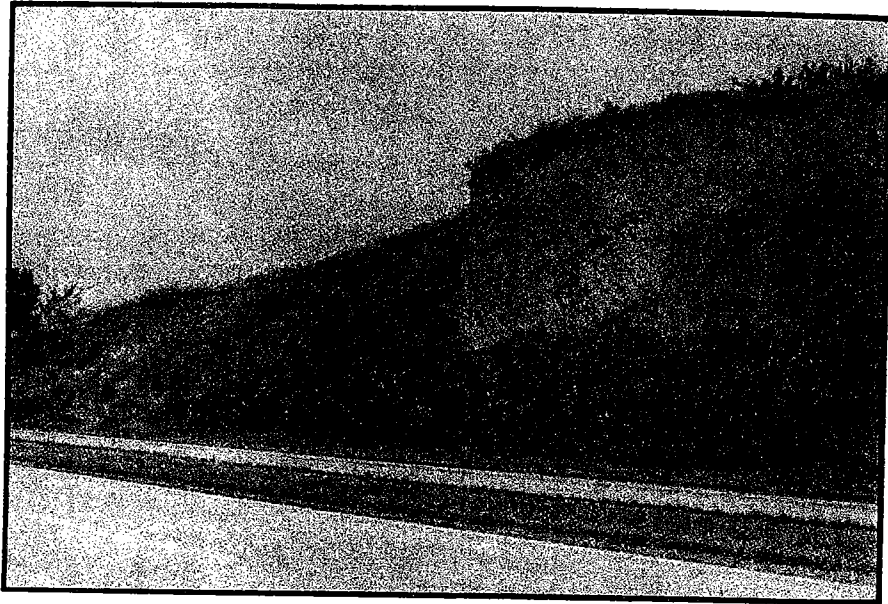
Figure 47  
Backslope In Loess-Like Material And  
Sand On I-70 West Of Kansas City
