THIRTIETH ANNUAL HIGHWAY GEOLOGY SYMPOSIUM

AUGUST 8-10, 1979

PORTLAND, OREGON

PROCEEDINGS

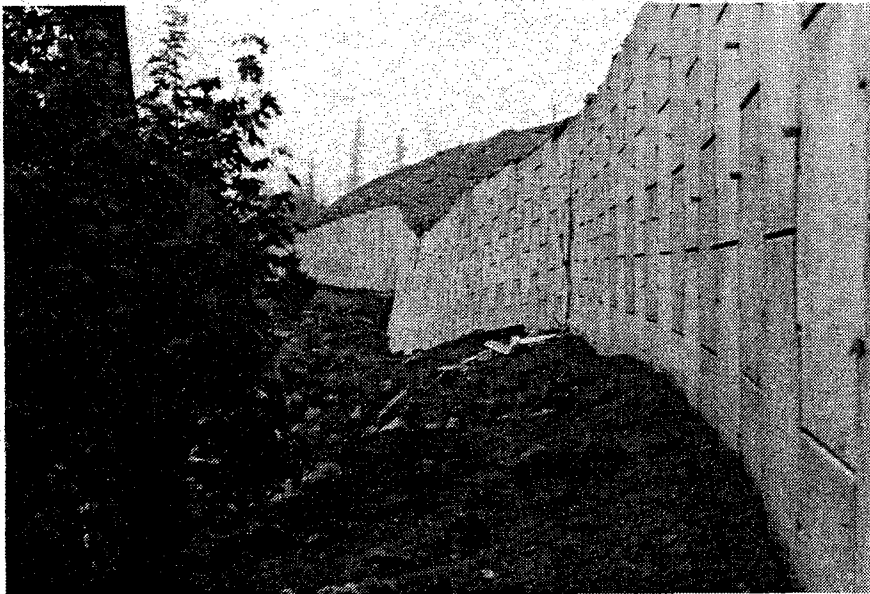
The RE wall underwent a significant displacement as a result of the slide movement. The top of the wall in the center of the slide was displaced 18 feet horizontally, the bottom of the wall was displaced 23 feet horizontally, and the wall dropped 12 feet vertically (photo 2).

Photo 2 RE Wall Movement Caused by Landslide

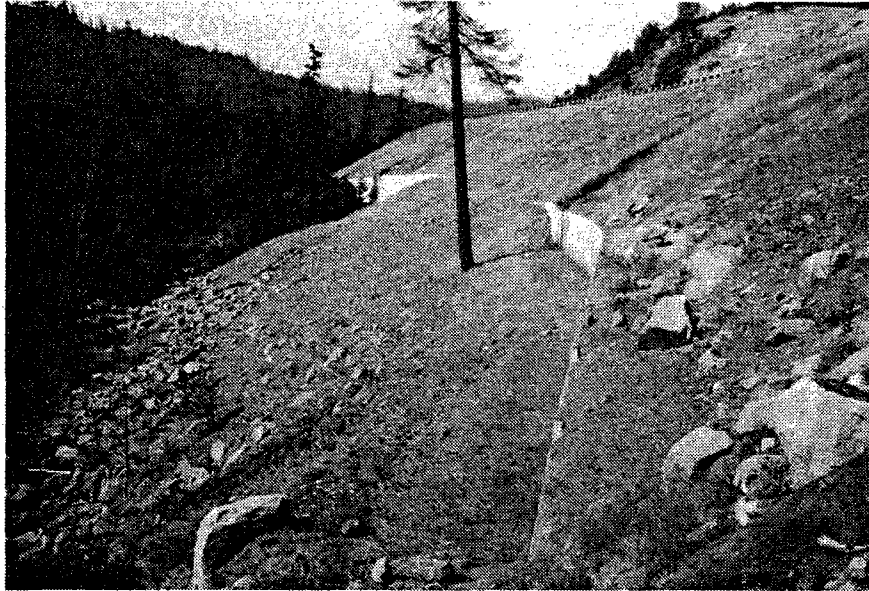
Photo 9 End View of Buttress Correction

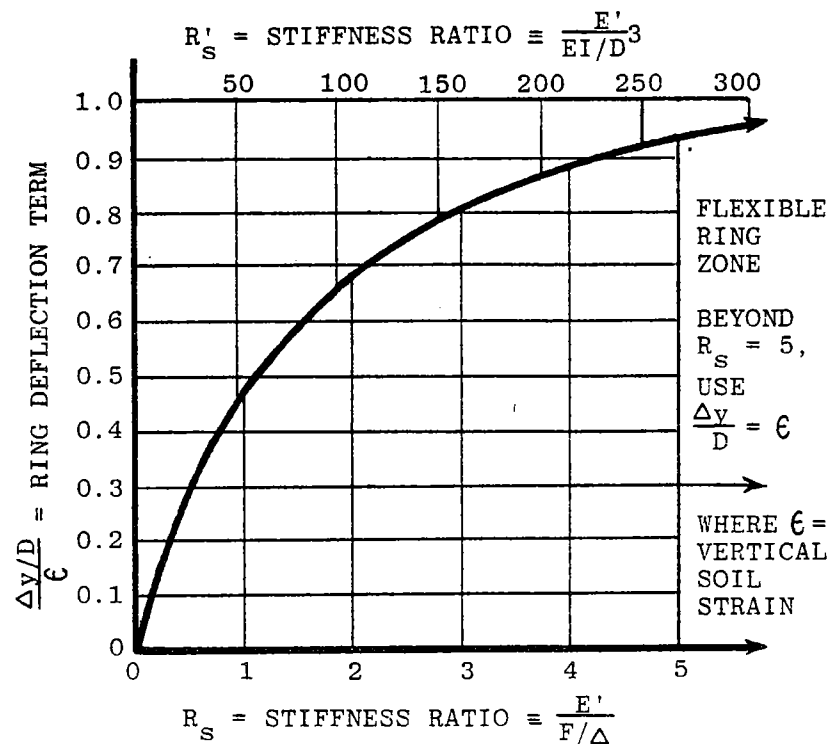
Figure 7. Summary of much data on the dimensionless ring deflection term for buried tubing as a function of the dimensionless stiffness ratio. It is noteworthy that corrugated polyethylene tubing generally falls to the right of the graph in the flexible ring zone, where $\Delta y/D = \epsilon$.

Figure 7 is used as follows. The pipe stiffness $F/\Delta y$ for corrugated polyethylene tubing is usually about 40 psi, but may be up near 70 psi. Soil stiffness E' for loose sand envelope ranges up from roughly 700 psi. Thus, the least stiffness ratio for buried corrugated polyethylene tubing is about $700/70 = 10$ which is off the chart to the right of figure 7. Therefore, for all practical purposes, $(\Delta y/D)/E = 1$. In other words, the ring deflection $\Delta y/D$ is roughly equal to the vertical soil strain ϵ .

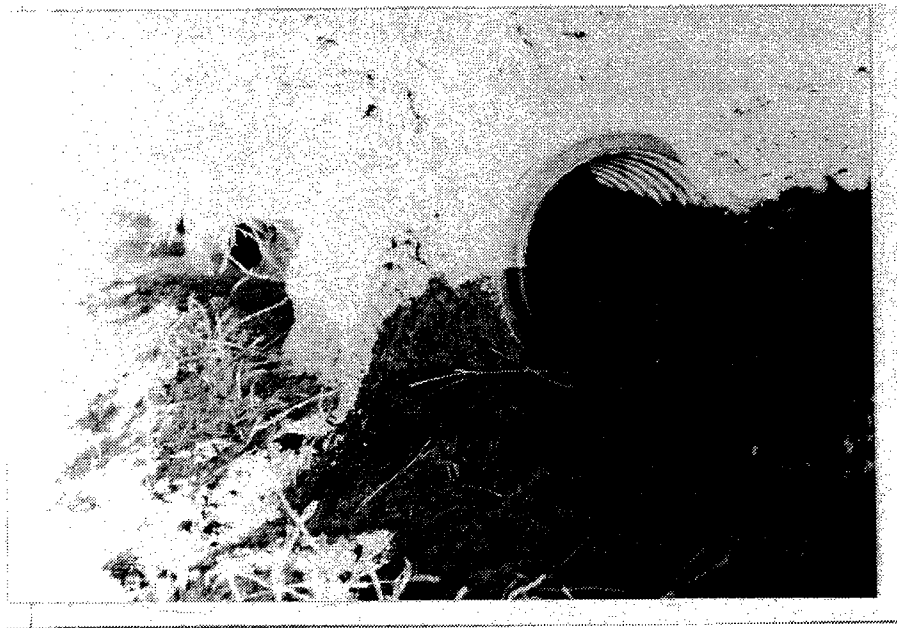
Figure 12. Corrugated polyethylene tubing is installed with a pit-run gravel envelope in a trench. This is a Case 2 installation.

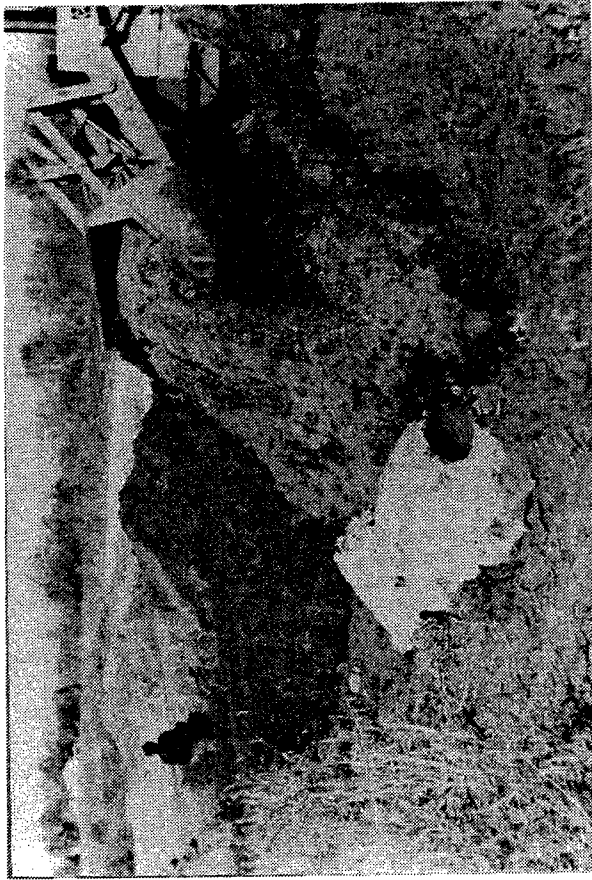
Figure 13. After the gravel envelope is placed, in a ditch in this case, native soil is used to complete the backfill. This is a Case 3 installation. The gravel envelope comprises four to six inches of bedding and four to six inches of "select" soil envelope (pit-run gravel, which is conservatively poor for a "select" soil envelope). The "select" soil is specified with a friction angle of no less than 30° , a compressibility of no less than 5% at the vertical soil pressure anticipated, and adequate qualities as a filter if the tubing is to serve as a slotted drain.

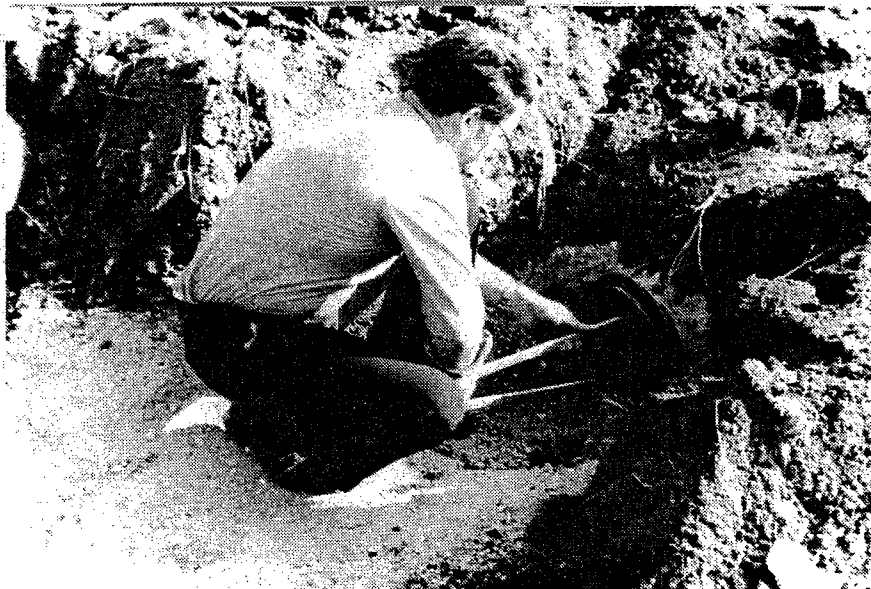
Figure 17. Inside diameters before and after loading were measured by means of a special inside caliper.

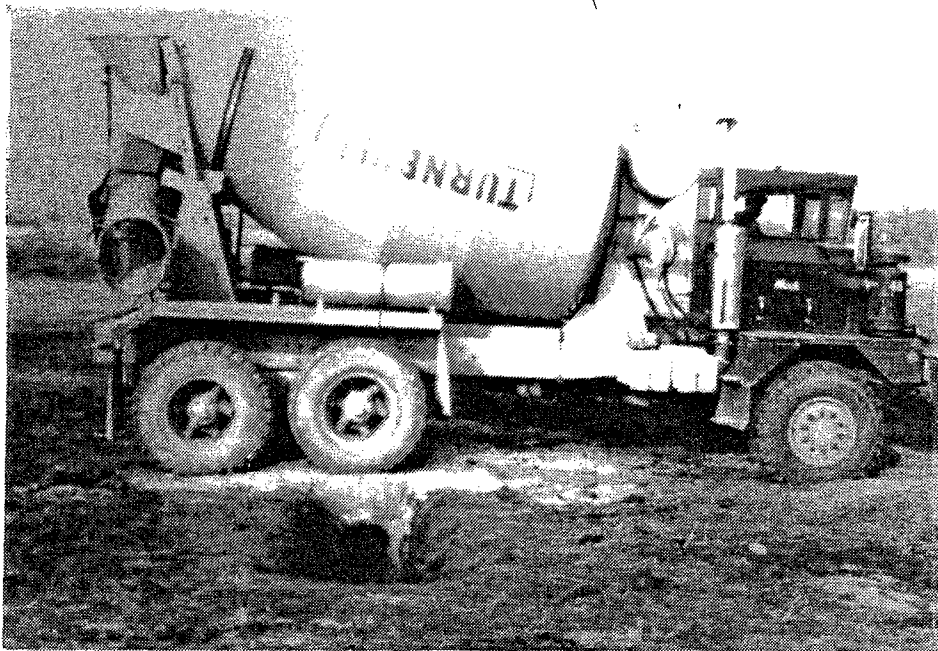
Figure 20. A driveway application for 12-inch corrugated polyethylene tubing. Eleven cubic yard concrete truck--total load 48,000 pounds, with 9,000 pounds per set of duals.

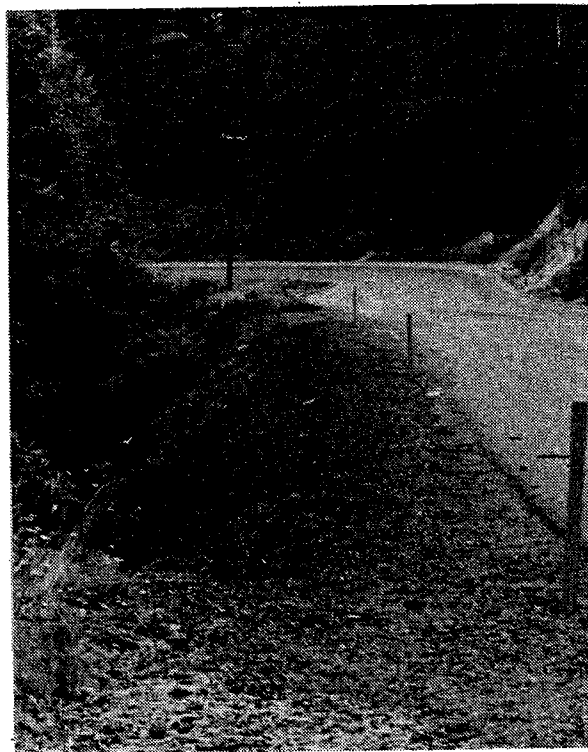
Figure 3 - Sawdust Fill - crack typical
on fills with steep side slope

We have also experienced some slope distress on the outside edge of the sawdust embankment where the sides were constructed to 1:1 slopes. As the distress is minimal and not yet endangering the roadway, we have not taken any action. We do, however, recommend maximum side slopes of $1\frac{1}{2}$:1 in sawdust.

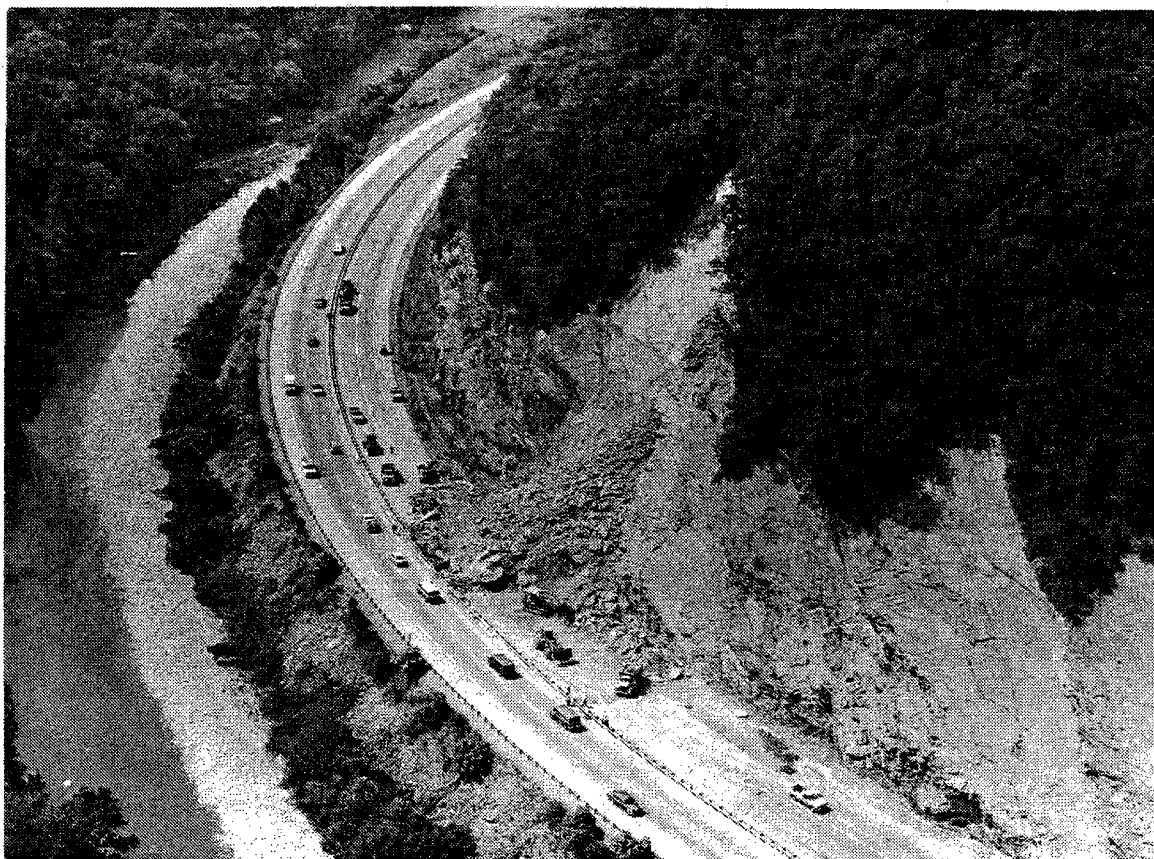
Figure 4. Aerial view of the slide shown in Figure 3 as it appeared two days after it occurred in July 1976.

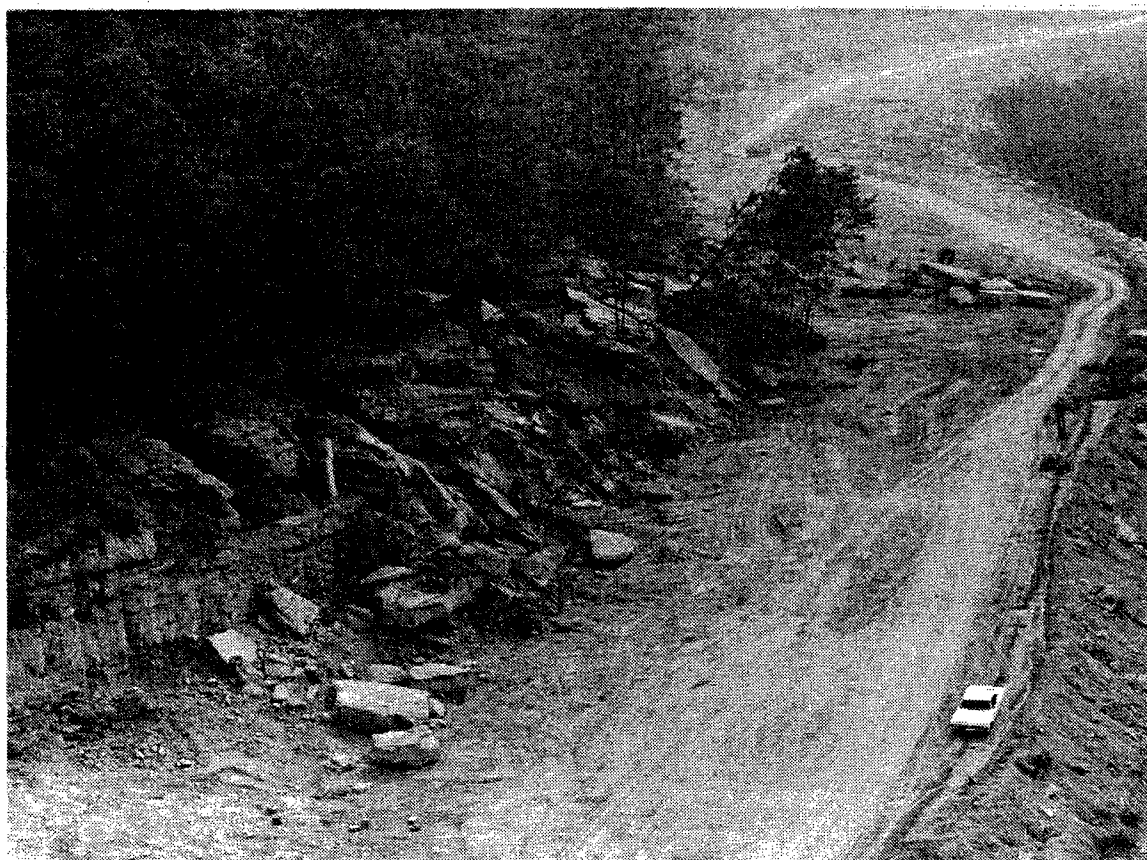
Figure 6. The strata in this cut which failed during construction are inclined approximately 22 degrees toward the roadway.

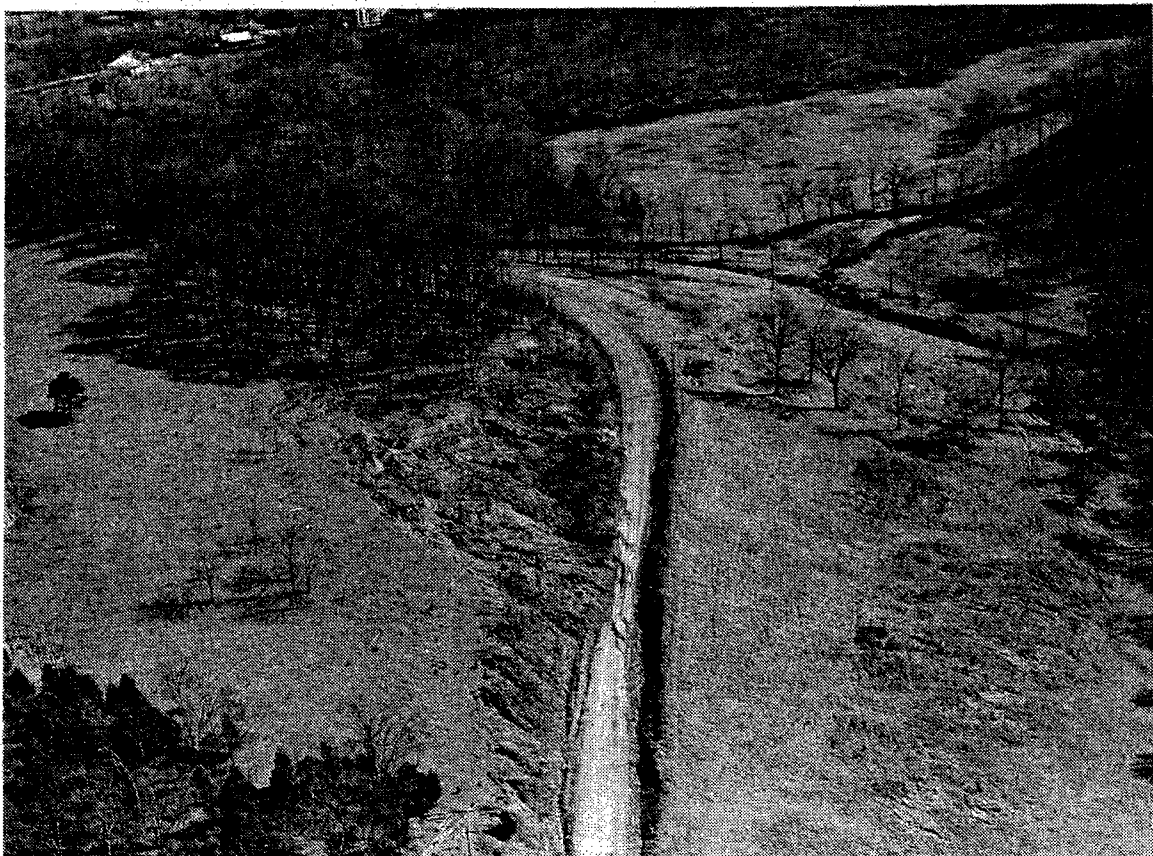
Figure 8. This failure began as a rotational slide but had deteriorated to a slump-flow by the time this photograph was taken.

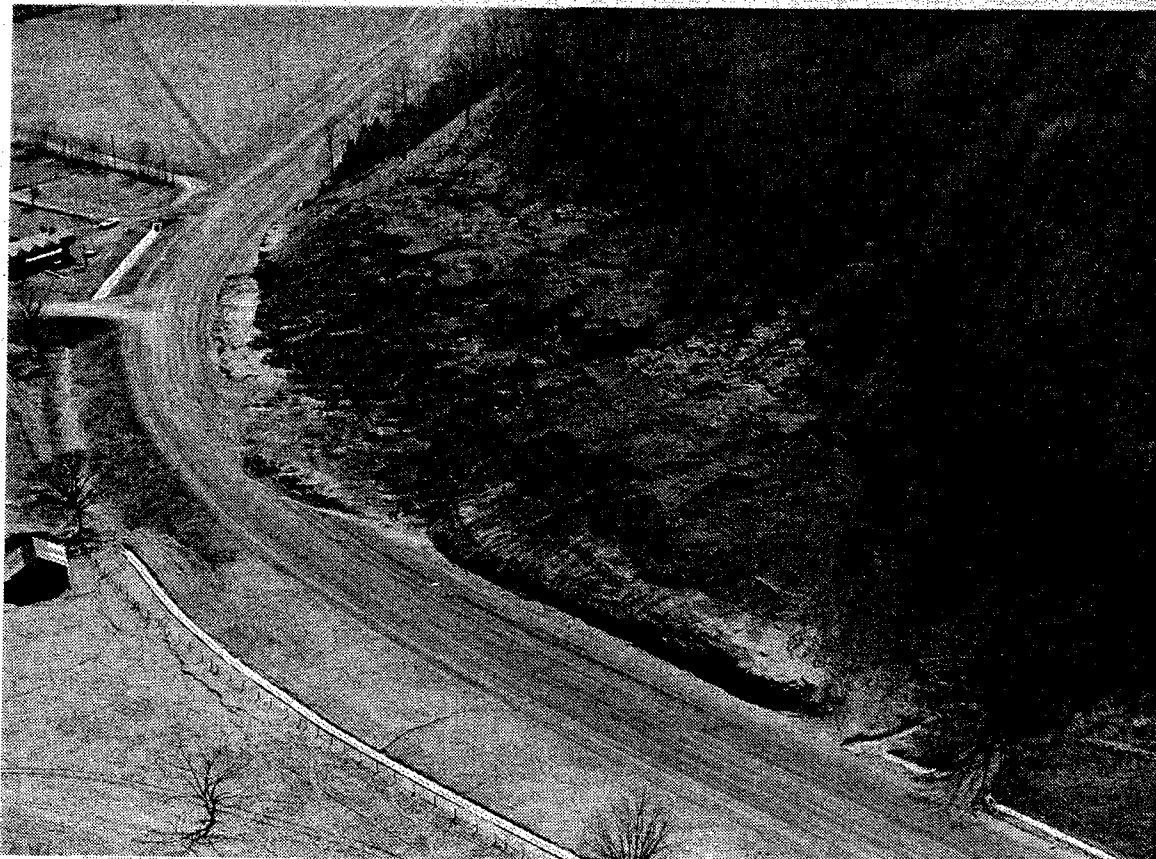
Figure 10. This failure occurred when 9 inches of rain fell during a 24-hour period in March 1975.

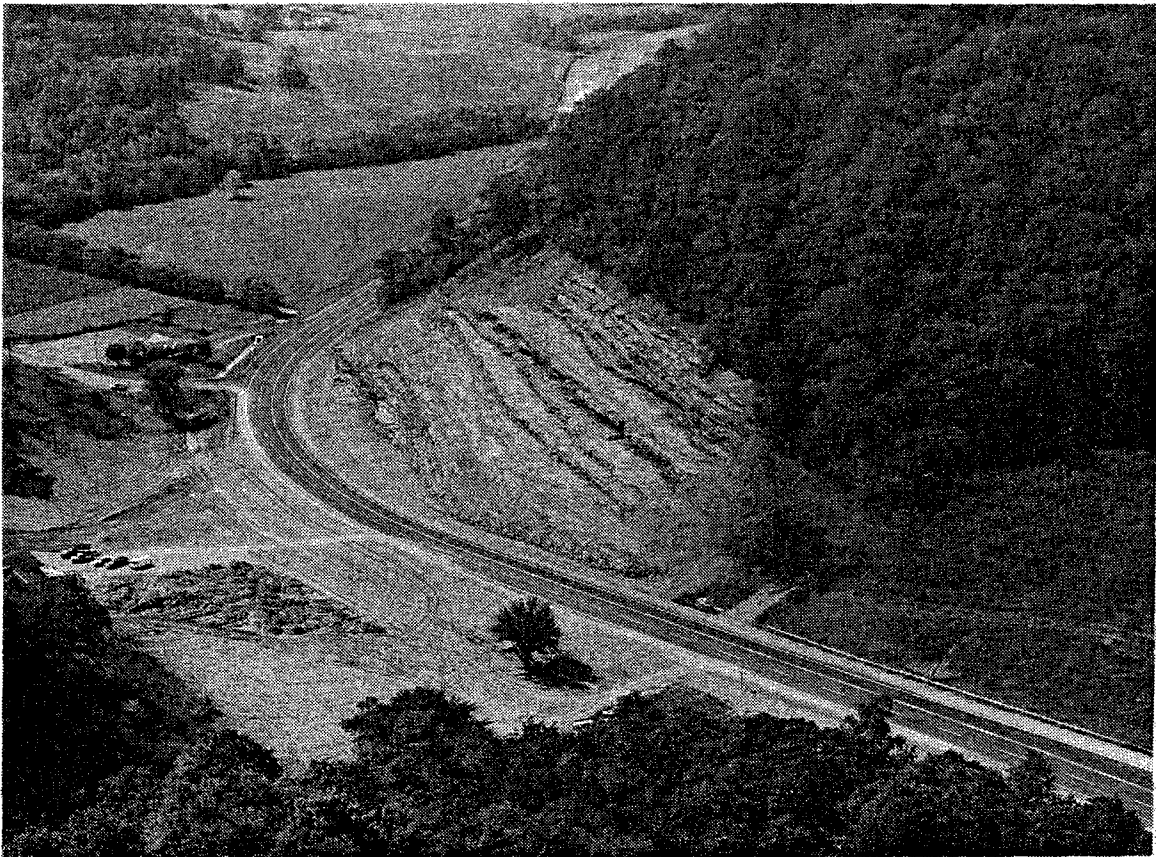
Figure 17. Total removal was the measure used to correct the mud flow shown in Figures 9 and 10.

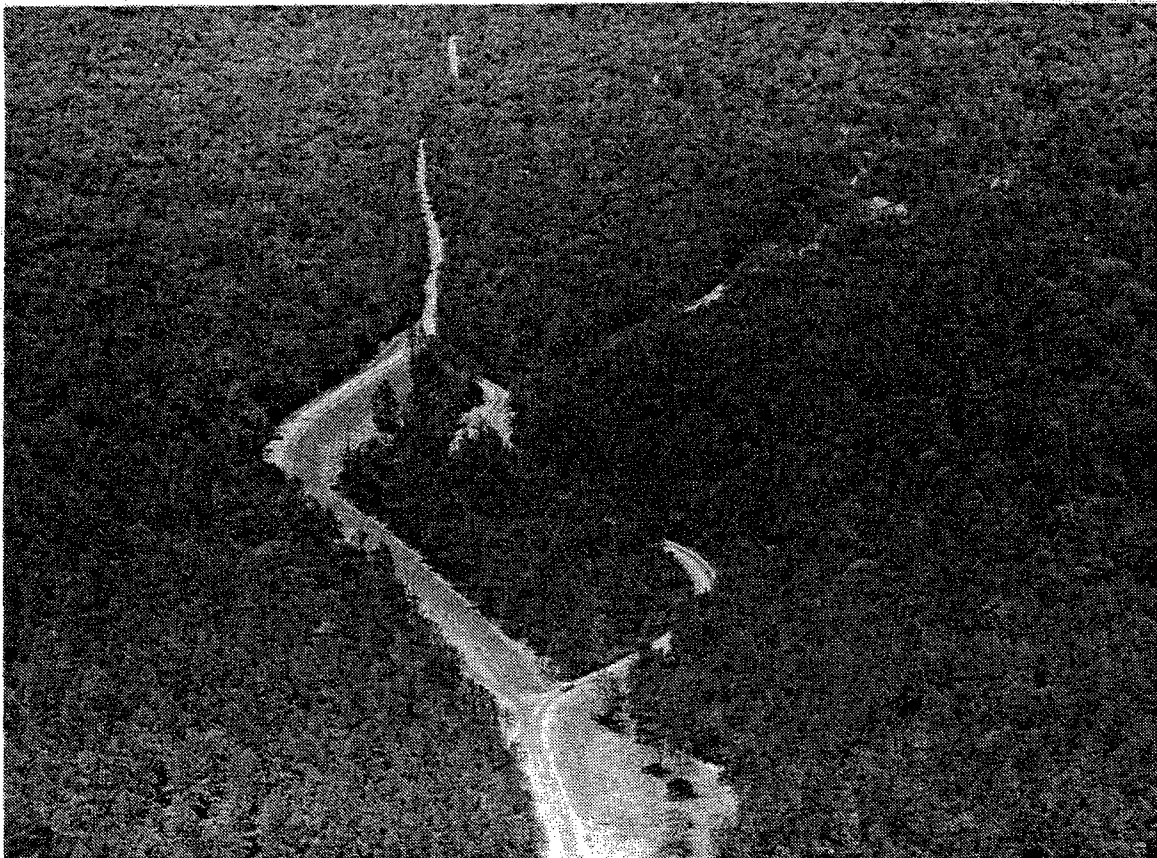
Figure 18. Relocation was the means used to correct the problem shown in Figure 13. The new alignment is at the left.

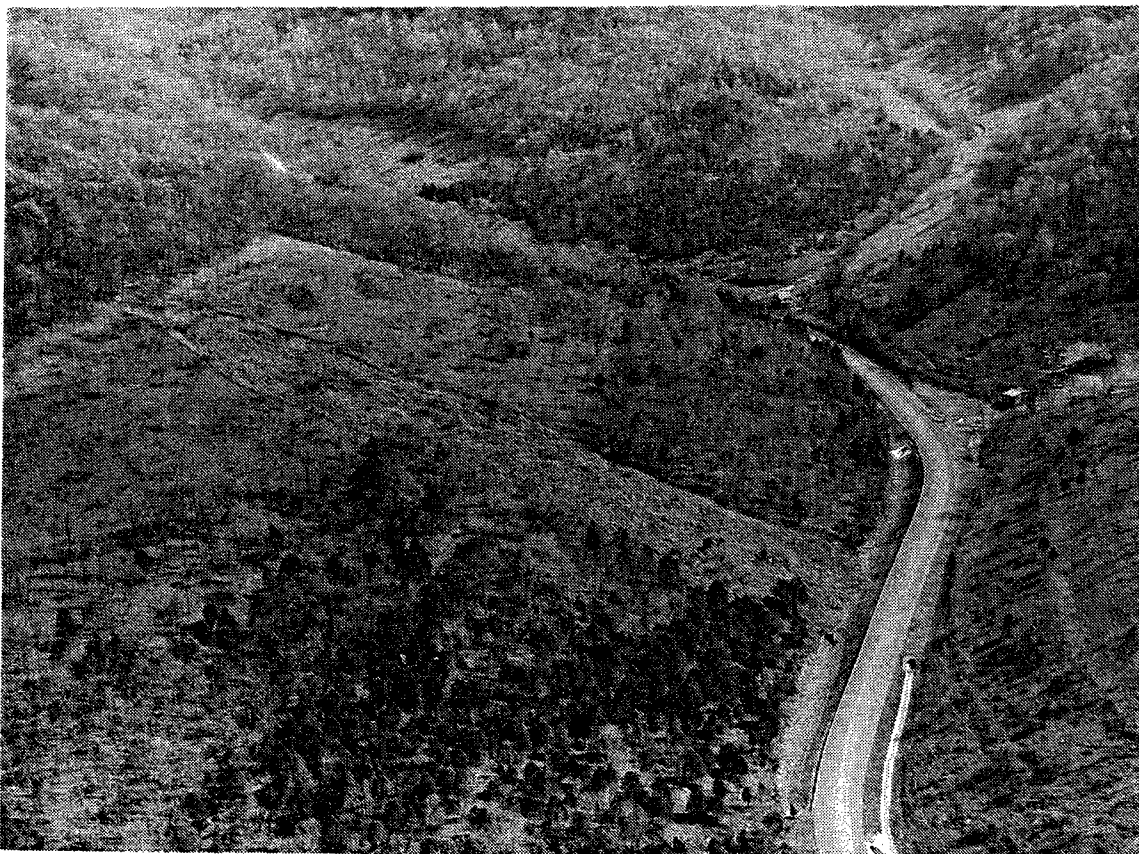
Figure 19. Relocation and re-routing of surface drainage were the methods used in the correction of this slide in Putnam County (see Figures 14 and 15).

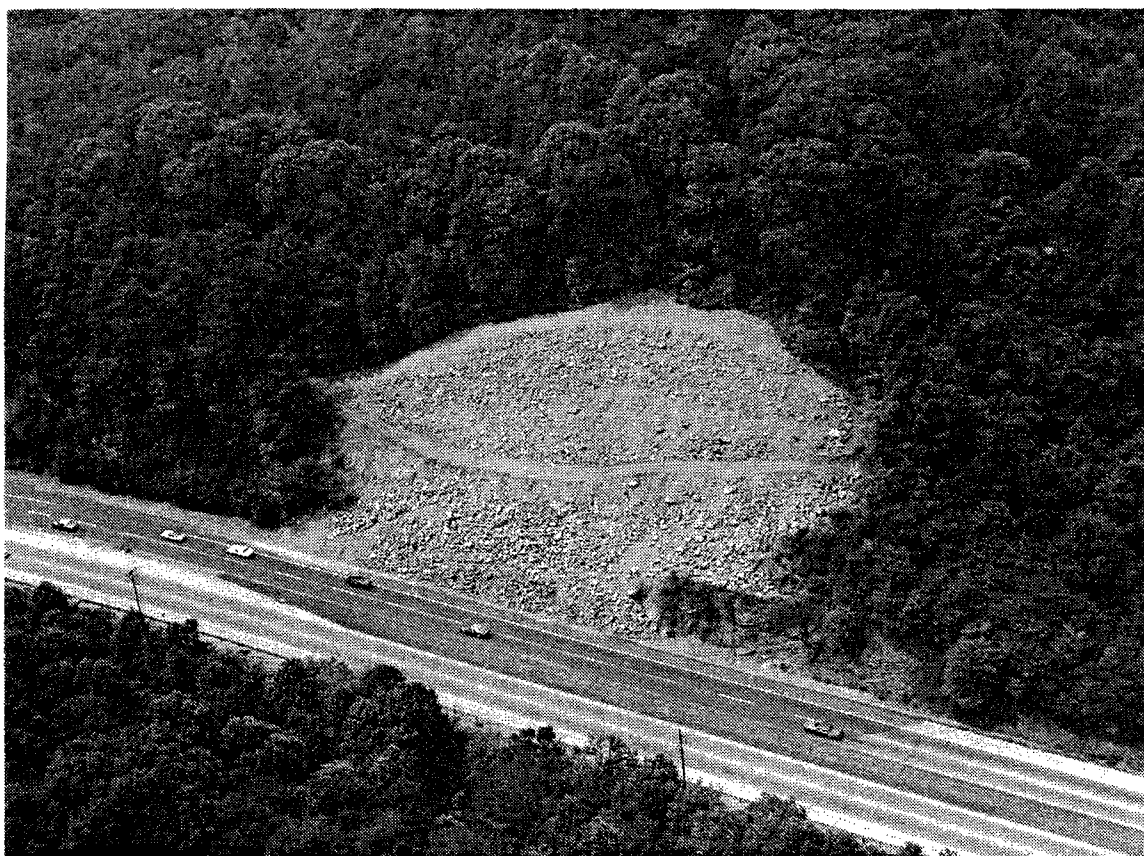
Figure 20. Partial removal and a revetment-like buttress were utilized in the repair of the mud flow shown in Figures 11 and 12.

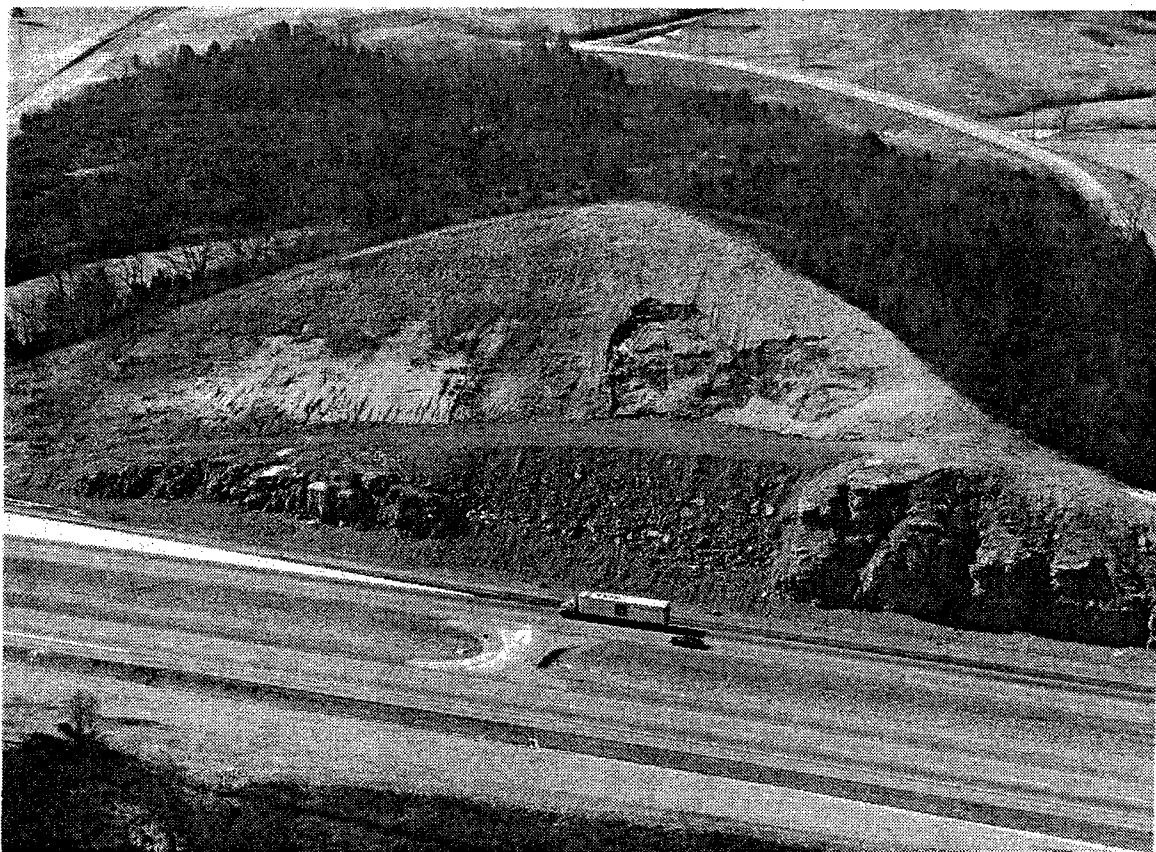
Figure 23. Removal and restraint with a rock buttress were the corrective measures utilized (see Figure 22).

buttress and some deterioration of adjacent "mud cutters," no additional problems have developed (Figure 23).

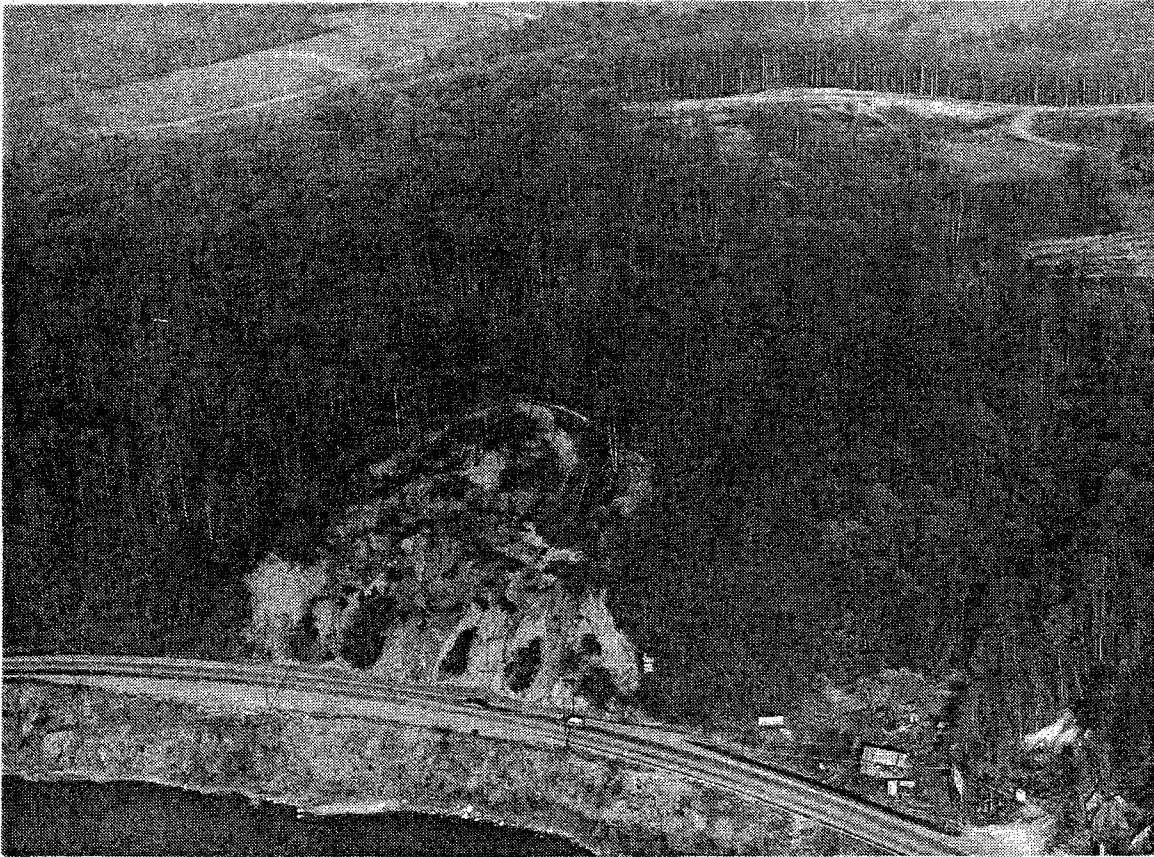
Figure 25. This failure, a translational-slump-flow, developed along relict bedding that dipped directly toward the roadway.

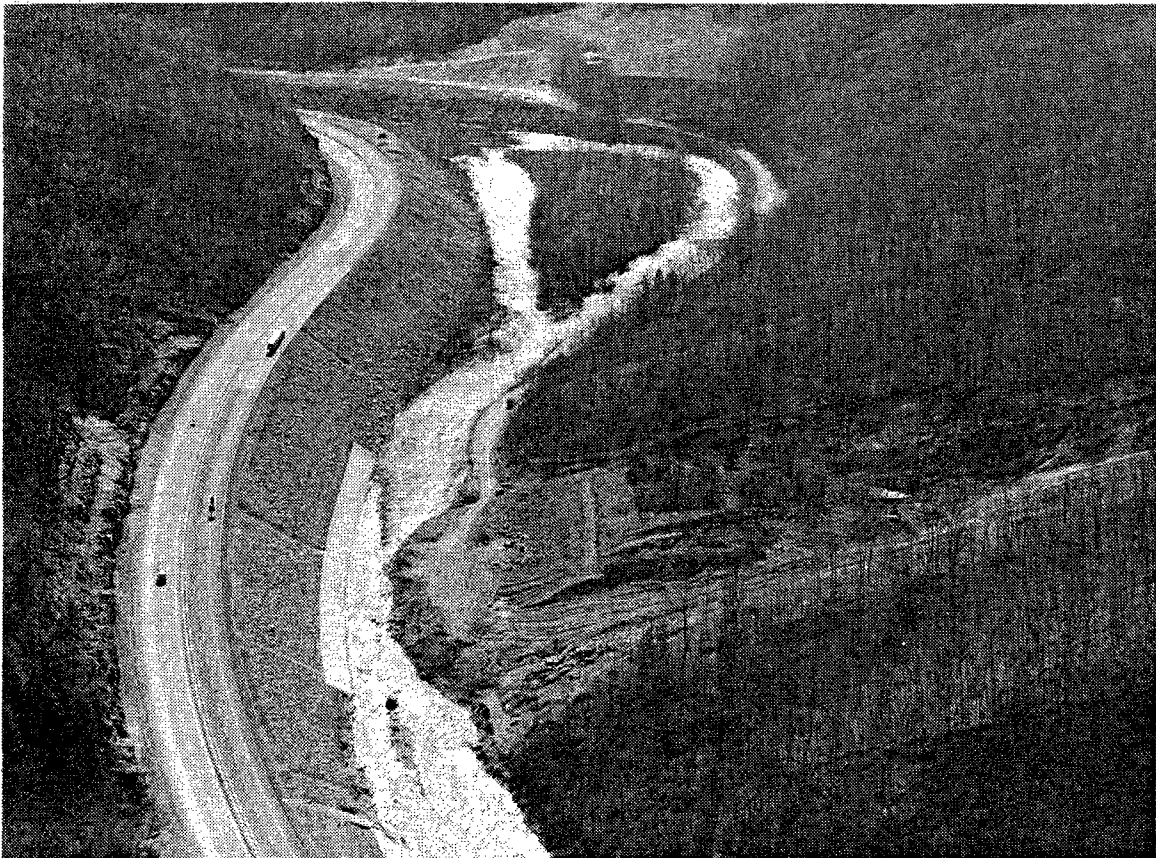
Figure 27. Eastward view of the Waterville slide along Interstate-40 in Cocke County as it appeared in February 1973.

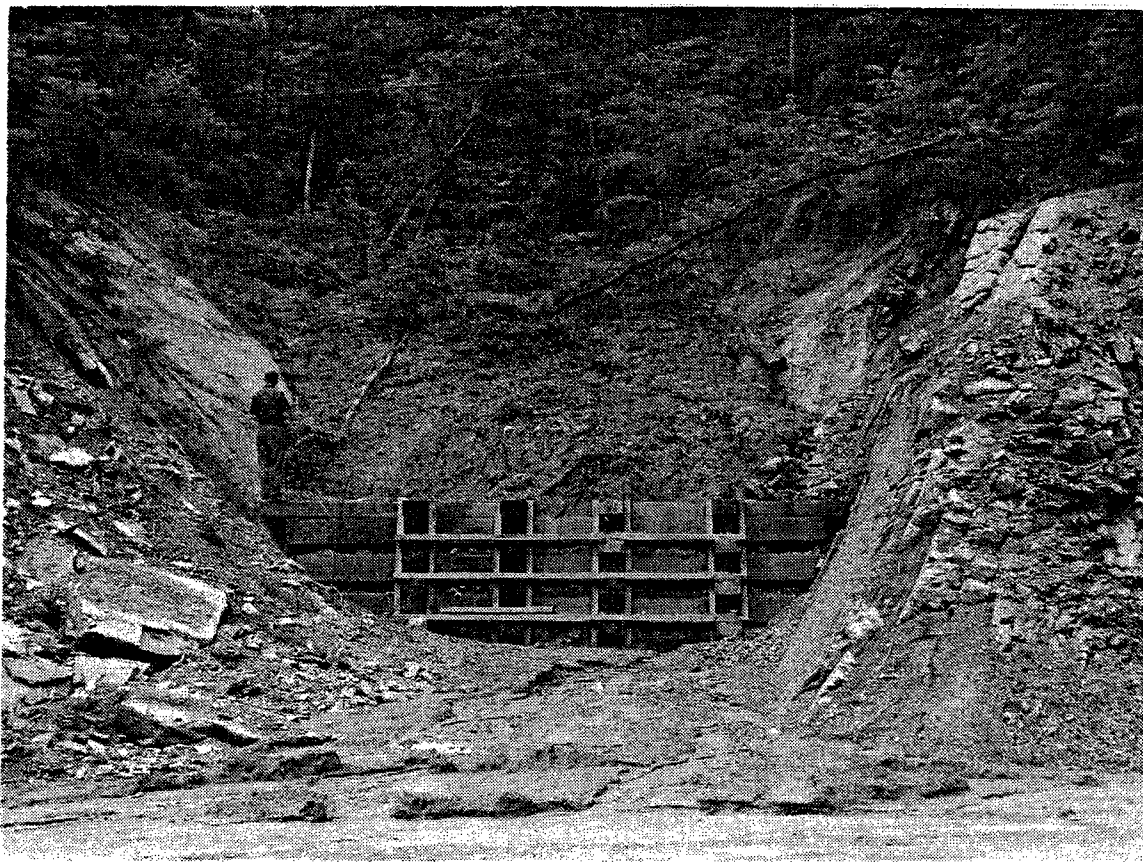
Figure 44. A small timber structure used to control a translational slide that developed in a plunging syncline along a rural road in Hamilton County.
