# Proceedings of the 39<sup>th</sup> Highway Geology Symposium

**Construction to Minimize Environmental Impact**  
**Co-sponsored by**

**Park City, Utah**  
**August 17-19, 1988**

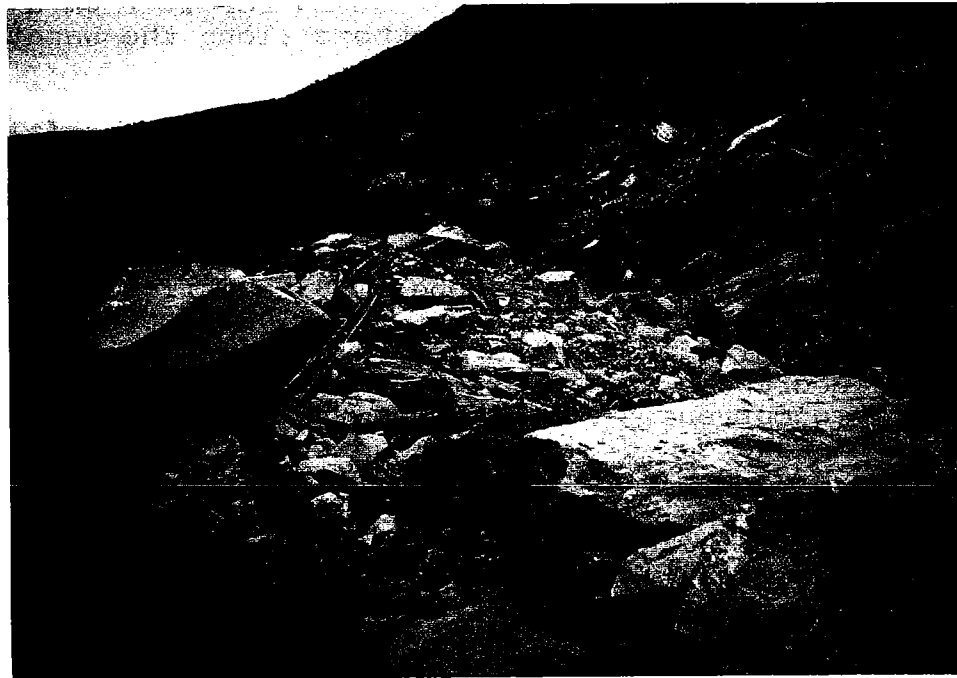
Figure 1. July 1, 1988 rock fall in Bloody Mary Wash north of Arches National Park. Boulders of Wingate sandstone damaged tracks of the Rio Grande Railroad. Photo courtesy of Genevieve Atwood.

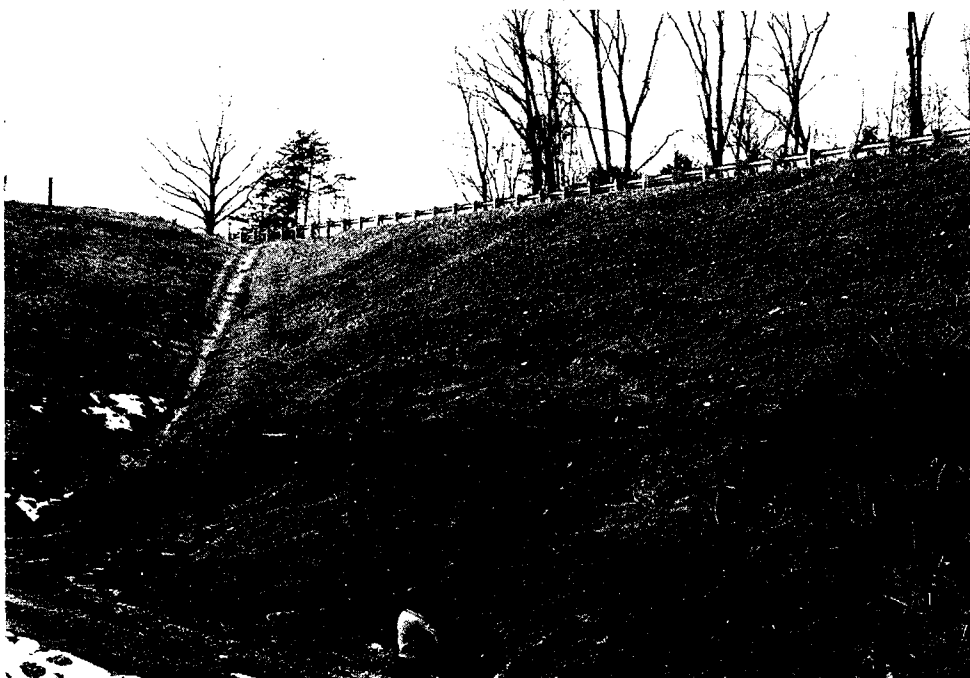
**Photo 3. Area 1: slump failure - live cribwall construction; January 1987**

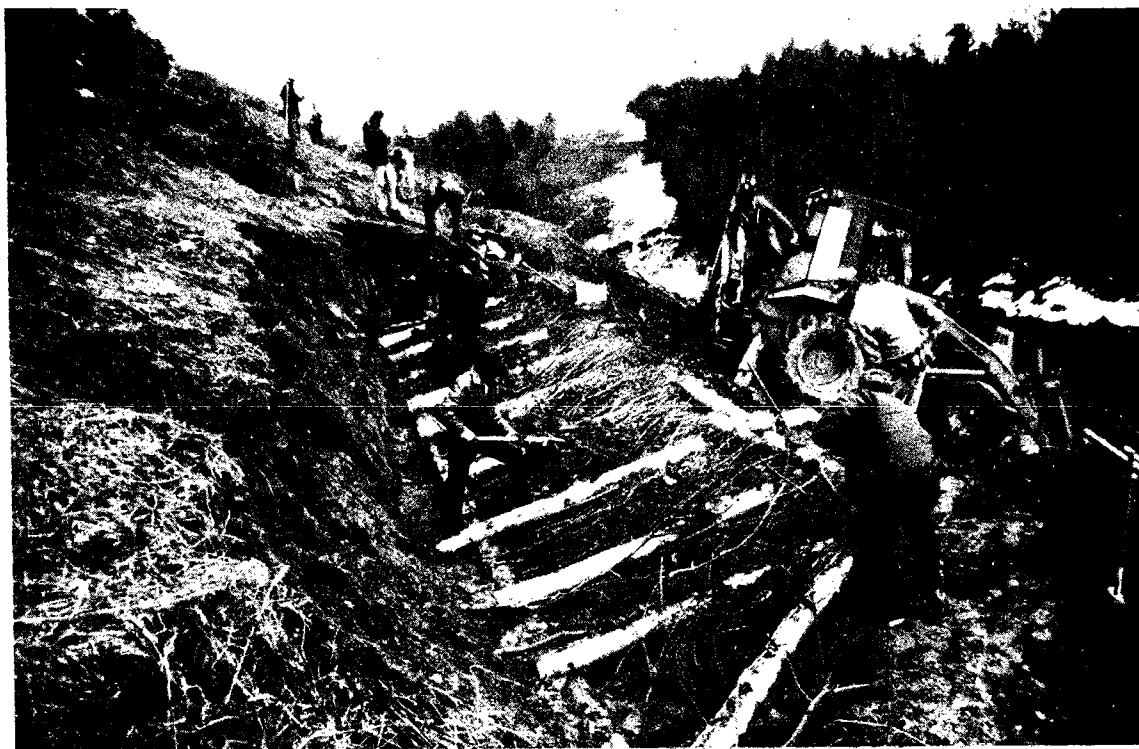
**Photo 4. Close-up of live cribwall construction**

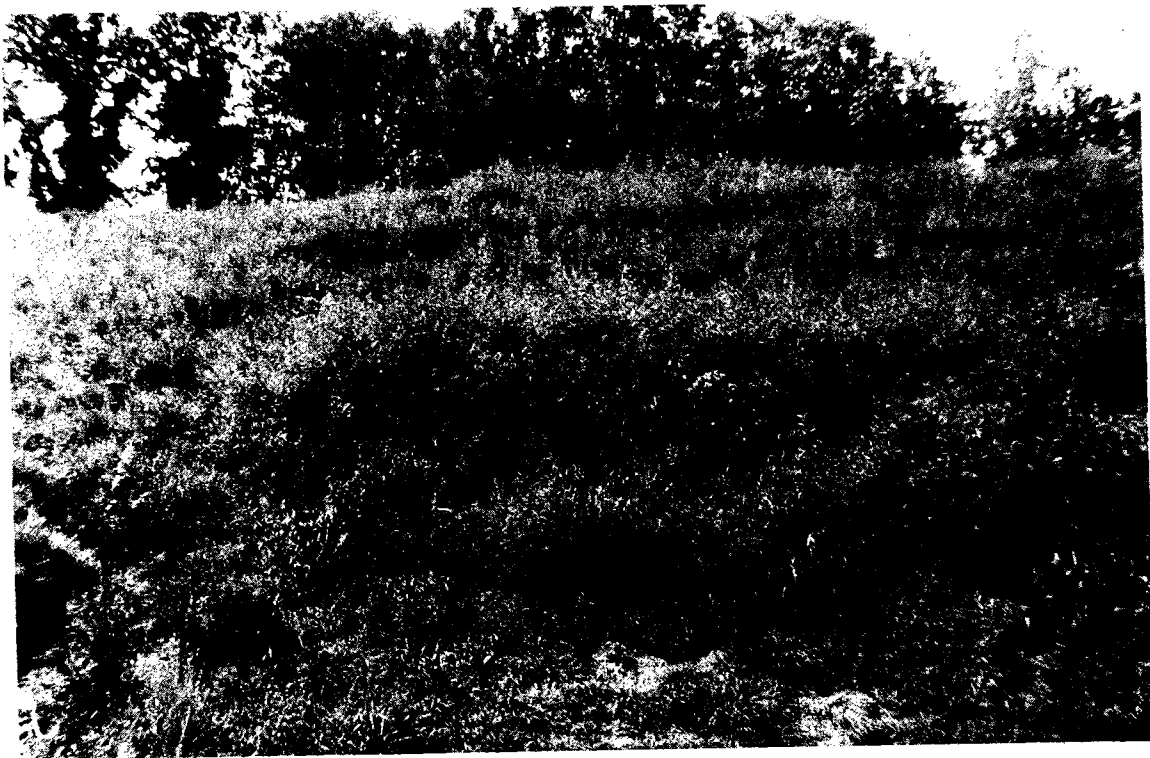
**Photo 5. . Repaired live cribwall construction; July 1987**

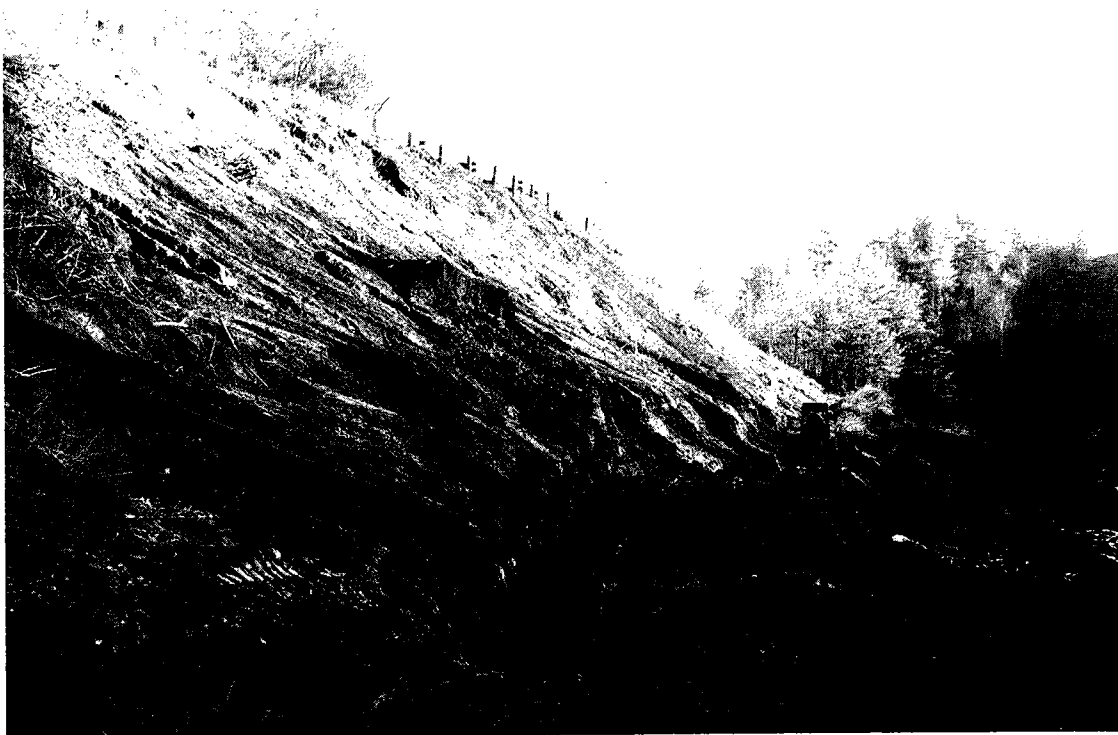
**Photo 6. Area 1: Prior to cut brushlayer installation; January 1987**

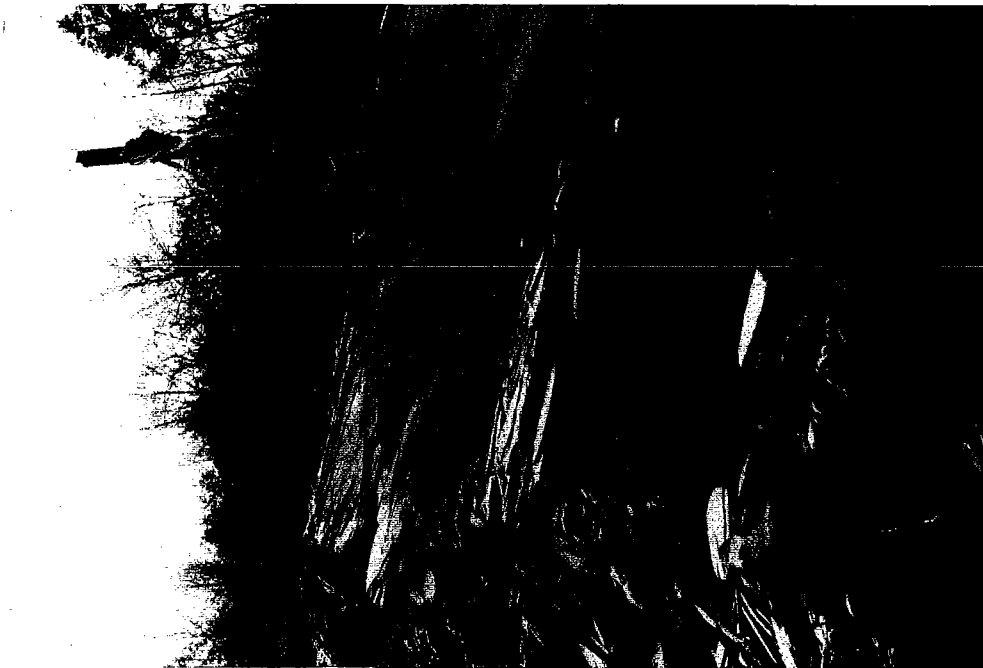
Air track drills were winched down the subject rock slope in order to drill the oriented pre-split face.

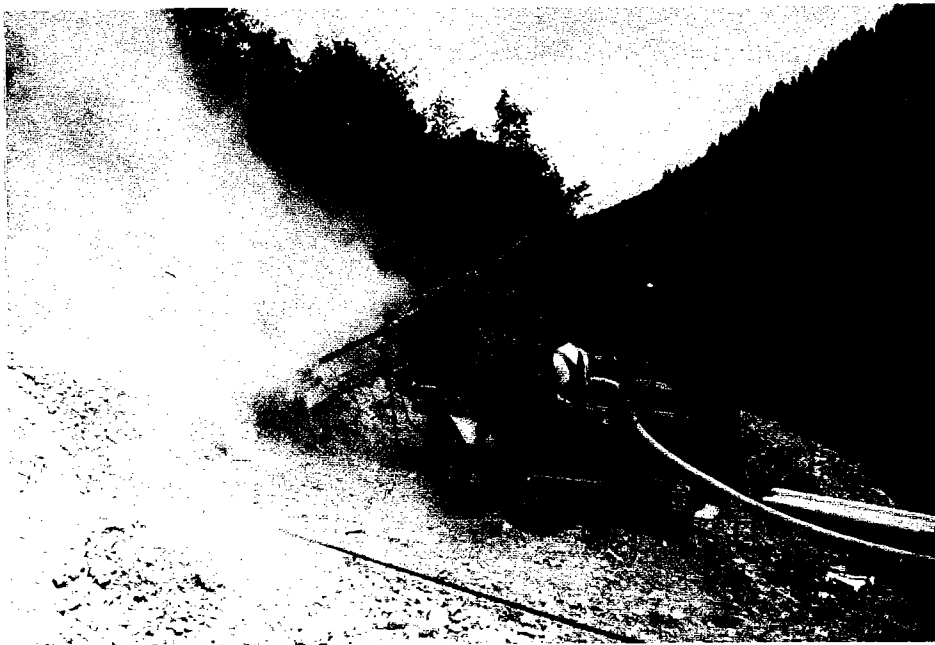
**DRILLING**  
**FIGURE 7**

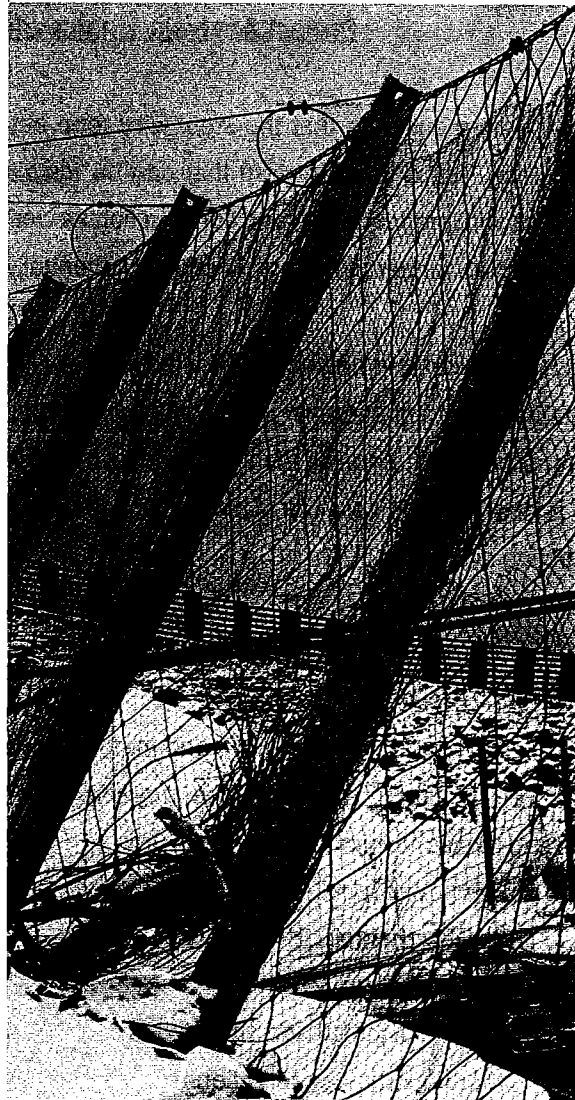
Picture 4 - Rockfall fence system with breaking devices

Installation of these fences is rather simple due to the standardized design of the system. As many nets as necessary can be added in order to accommodate any particular length that the system is designed for. Foundation design data and detailed drawings are supplied by the manufacturer. Once the foundations have been poured, the setting of the net system support columns then occurs. The net support wire ropes are installed and the suspension wire ropes are securely anchored to the ground. Finally, the wire rope nets are placed and seamed with wire ropes to the net support ropes and cyclone fencing is spread and fastened to the wire rope netting.
