# **PROCEEDINGS OF THE 43RD ANNUAL HIGHWAY GEOLOGY SYMPOSIUM**

**AUGUST 19-21, 1992  
Fayetteville, Arkansas**

**Department of Civil Engineering, University of Arkansas  
Arkansas State Highway and Transportation Department  
and  
Arkansas Geological Commission**

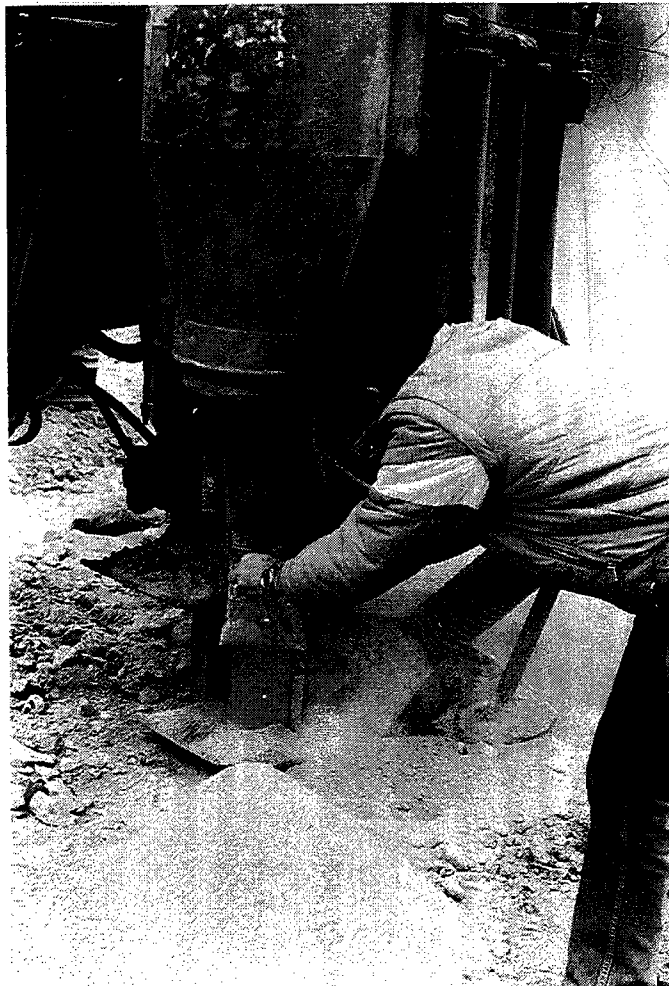
Fig.2 Sampling production drill cuttings for acid/base testing during construction.

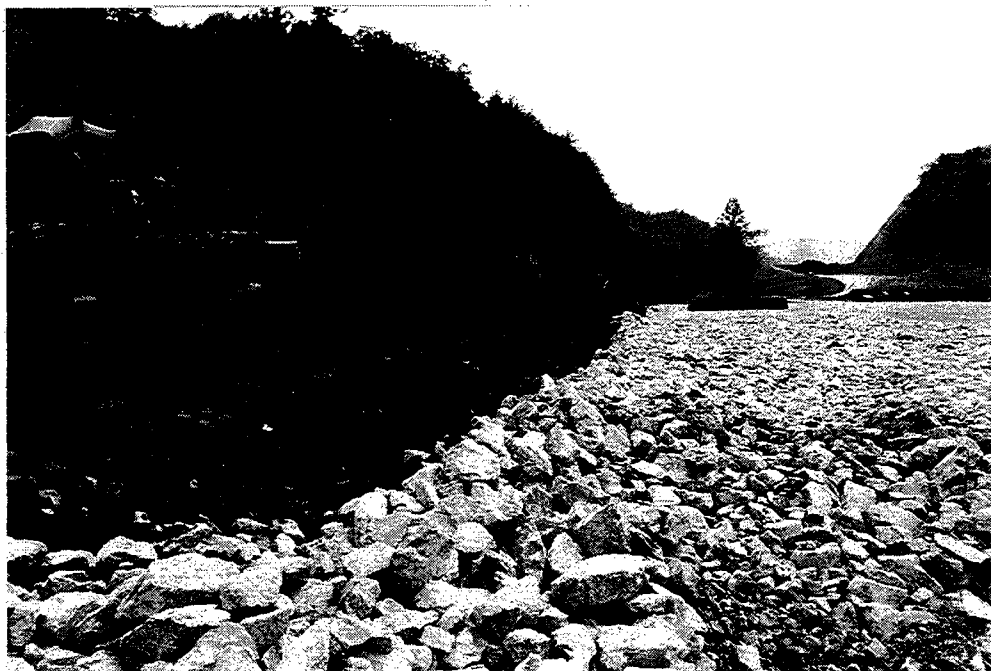
Fig.3 Construction of the clay liner encapsulation method showing limestone drainage pad and early stages of clay liner construction.

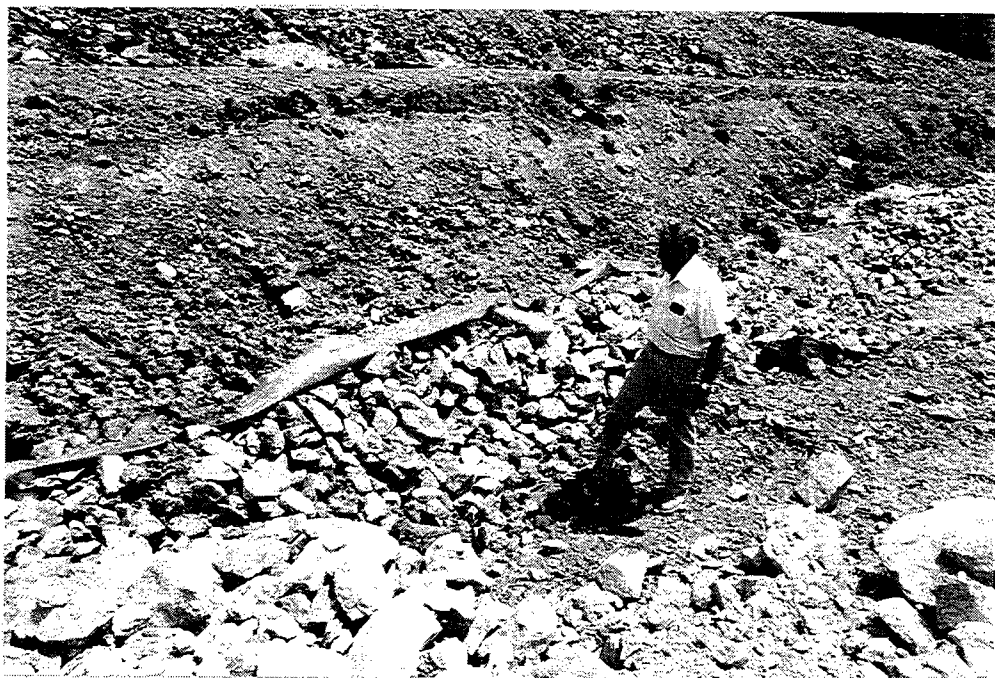
Fig.4 Side view of clay liner encapsulation during construction showing rock drainage pad, filter cloth and compacted clay liner.

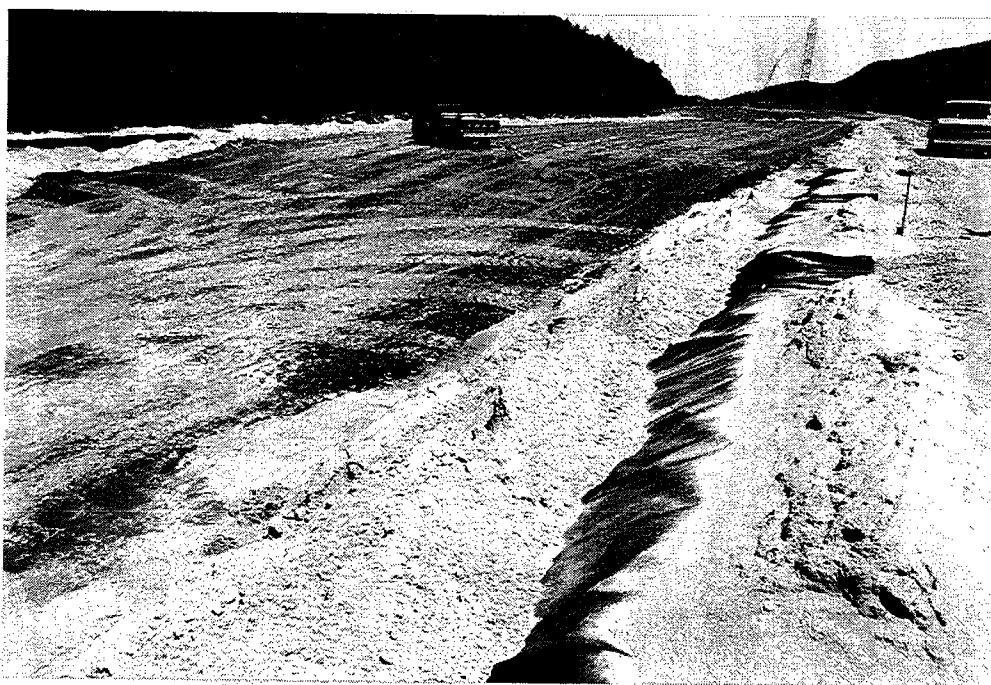
Fig.7

This photo illustrates the compacted nature of the acid rock material placed in the geomembrane encapsulation area.

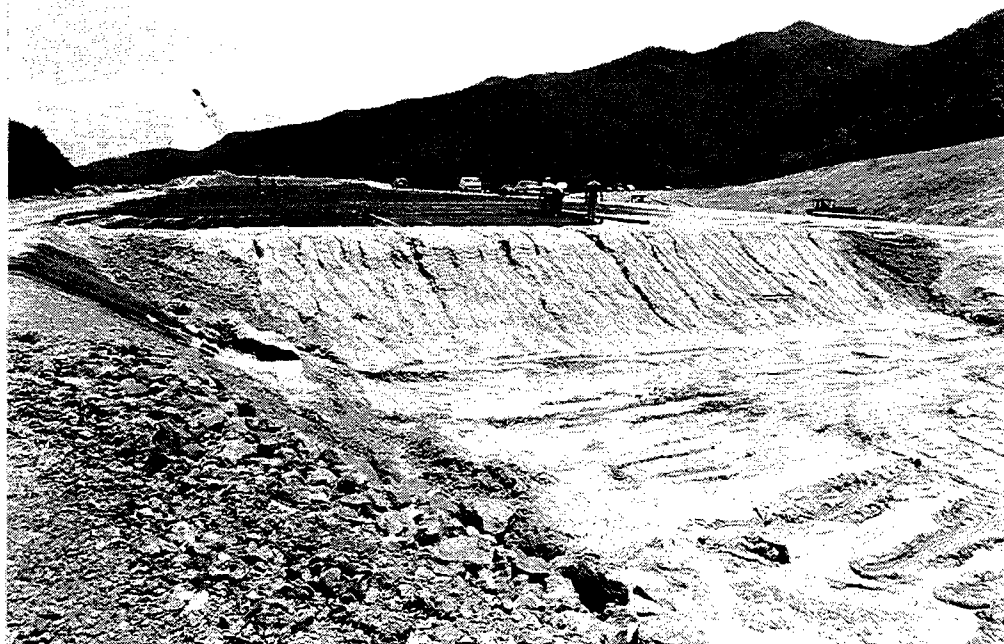
Fig.9

Geomembrane encapsulation site nearing completion; foreground slope is open-end of trench with agriculture lime exposed - soon to be enclosed in geomembrane.

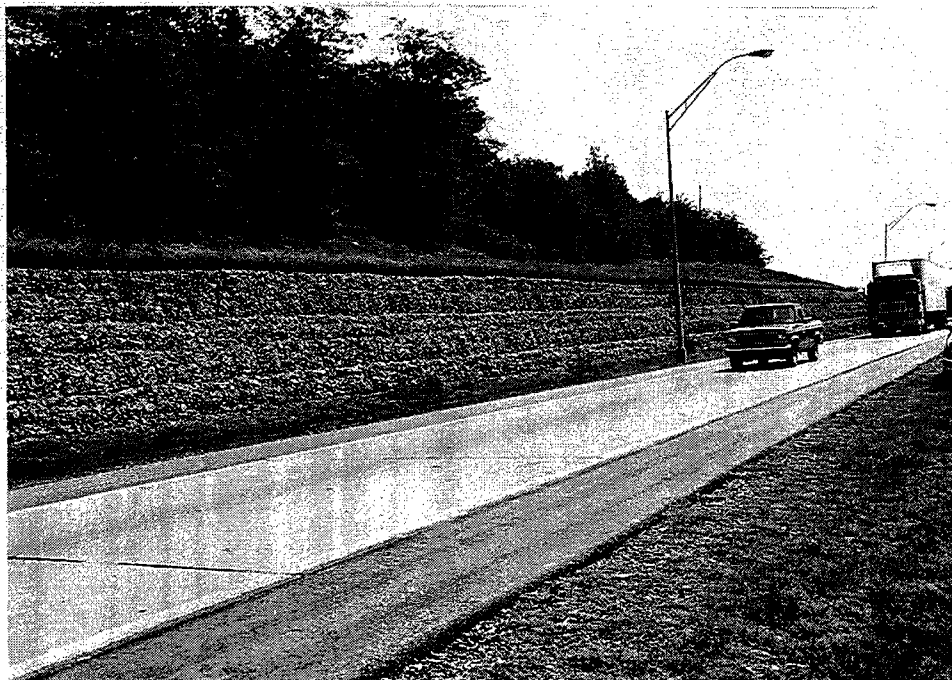
**Figure 6 A.** -- Gabion wall at exit 10 on I-540 in Fort Smith.

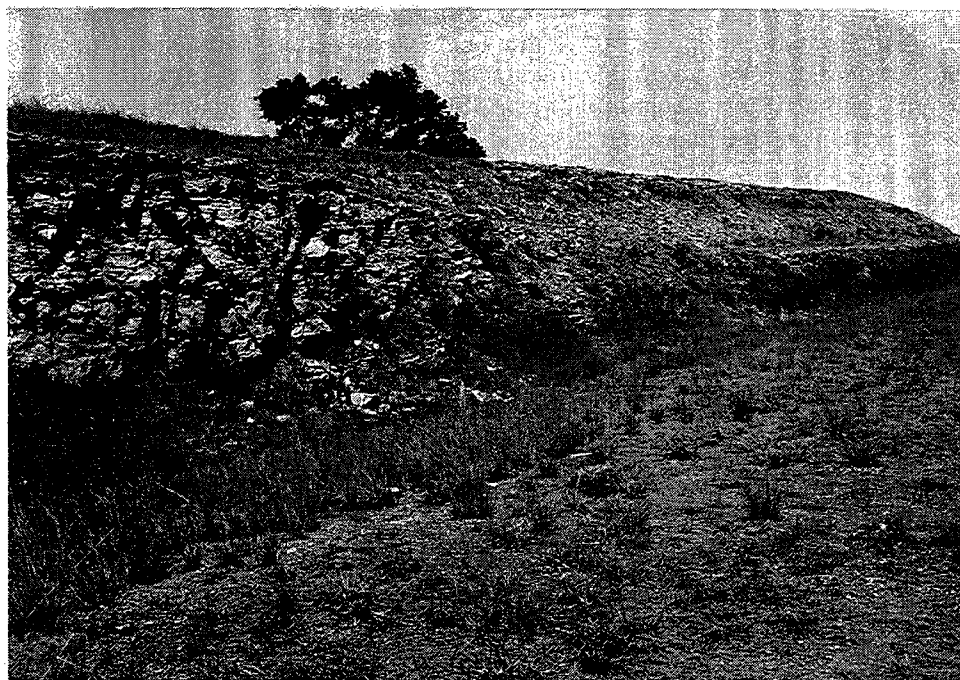
**Figure 9 A.** -- Small fault separating massive channel sandstone with abundant joint sets on left from thin siltstones and shales on right in the lower Atoka Formation. The downthrown block is on the left (south).

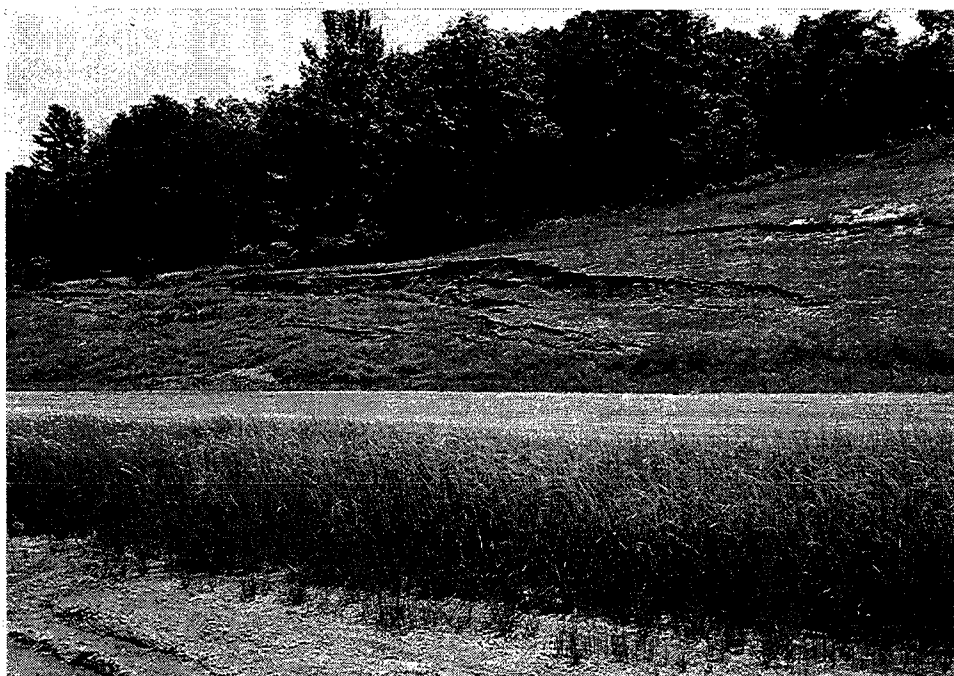
**Figure 9 B.** -- Minor landslides with a series of crown scarps and small pressure ridges in soils and weathered shales at the northeast part of STOP 2 roadcut.

At this road cut, 89,000 cubic yards of material were removed. Some relatively small landslides have formed along the northeast side of the excavation, mostly in the soils and partially weathered shales (Figure 9B). They are presently being evaluated for removal and/or remedial procedures. Most of the landslides occur in the same stratigraphic interval that has caused significant landslide accumulations at STOP 3 – some 0.7 miles to the northeast. The problem is mostly related to the high degree of the slopes and the high surficial water content of the weathered shales. Thin bentonite-rich shales are reported in the lower Atoka and upper Bloyd and they probably occur in these strata. Especially upon weathering, these intervals could further aid and abet the local instability of the bedrock and soils.

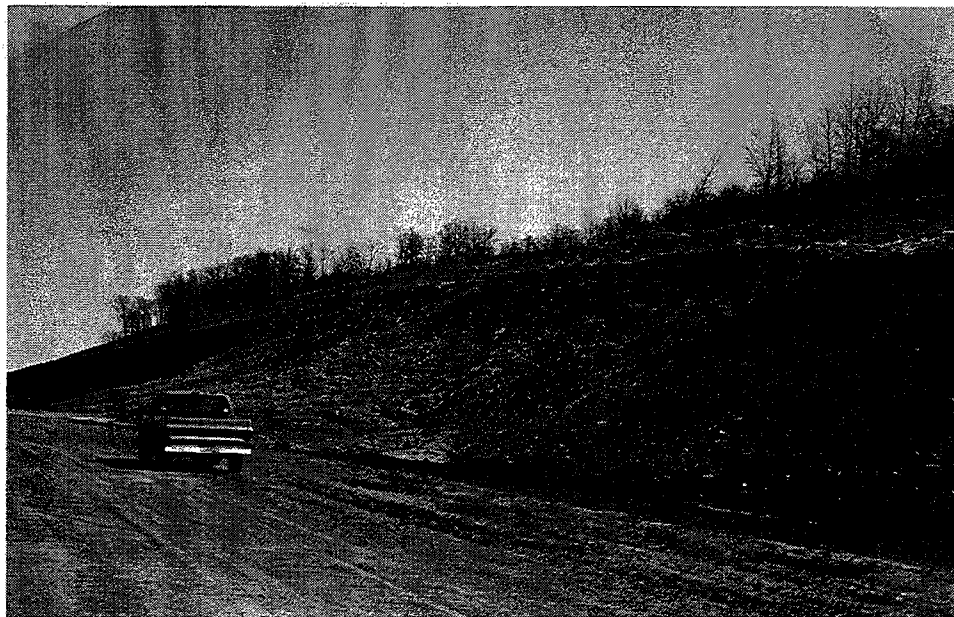
**Figure 10 A.** -- *A small recent continuation of a formerly larger landslide at the south part of STOP 3.*

Initially, the roadway was excavated with nearly vertical slopes, removing over 91,000 cubic yards of material. During the excavation period, cracks were discovered in the colluvium near the top of the slope. At this time, the contractor began excavating the colluvium on a gentler 3:1 slope to prevent possible failure. However, after a heavy local rainfall, large amounts of surface water runoff and increased subsurface seepage caused two slope failures to occur in the immediate area (Figure 10 A).

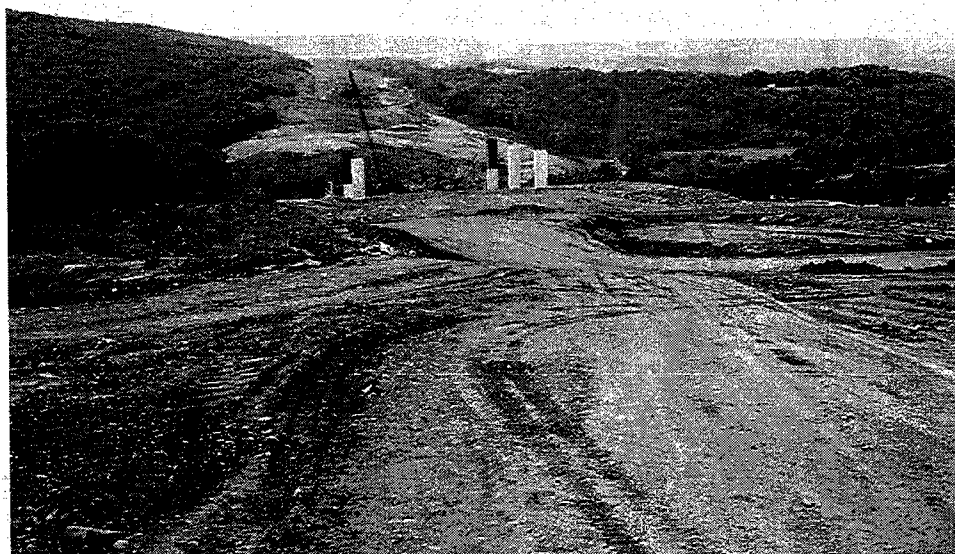
**Figure 12 B.** -- Excavation, bridge, and buttress walls south of West Fork, Arkansas in lower Atoka and Bloyd strata at STOP 4.

At this stop there will be an opportunity to discuss and evaluate the numerous geotechnical problems of extensive side hill excavations, bridge construction across a narrow valley, and buttress walls over 70 feet high that are undercut as much as 20 feet to achieve foundation stability (Figures 12B,

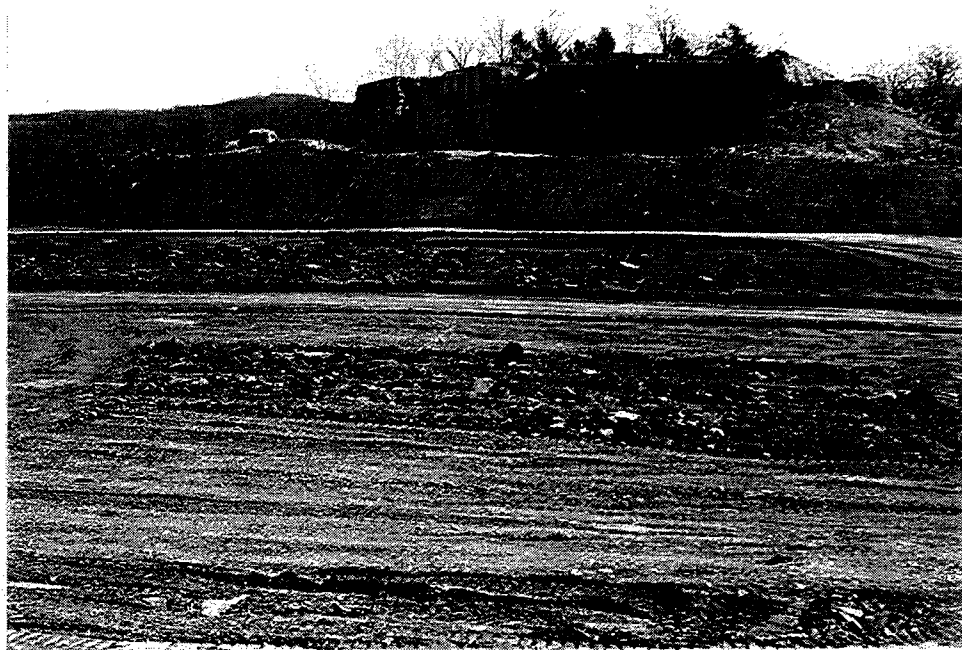
**Figure 15 A.** -- A monadnock of Pitkin Limestone underlain by Fayetteville Shale on the east side of relocated U.S. Hwy. 71 and formerly a part of the McClinton-Anchor quarry at mileage 58.9.

- 58.9      McClinton-Anchor quarry in Pitkin Limestone to (west) and view of relocated U.S. Hwy. 71 which cuts across the former quarry. Crushed rock and riprap is used on local construction projects, as well as on portions of the relocated U.S. Hwy. 71. A monadnock of Pitkin Limestone in the east end of the former quarry now lies east of relocated U.S. Hwy. 71 (Figure 15A). It is underlain by the Fayetteville Shale.

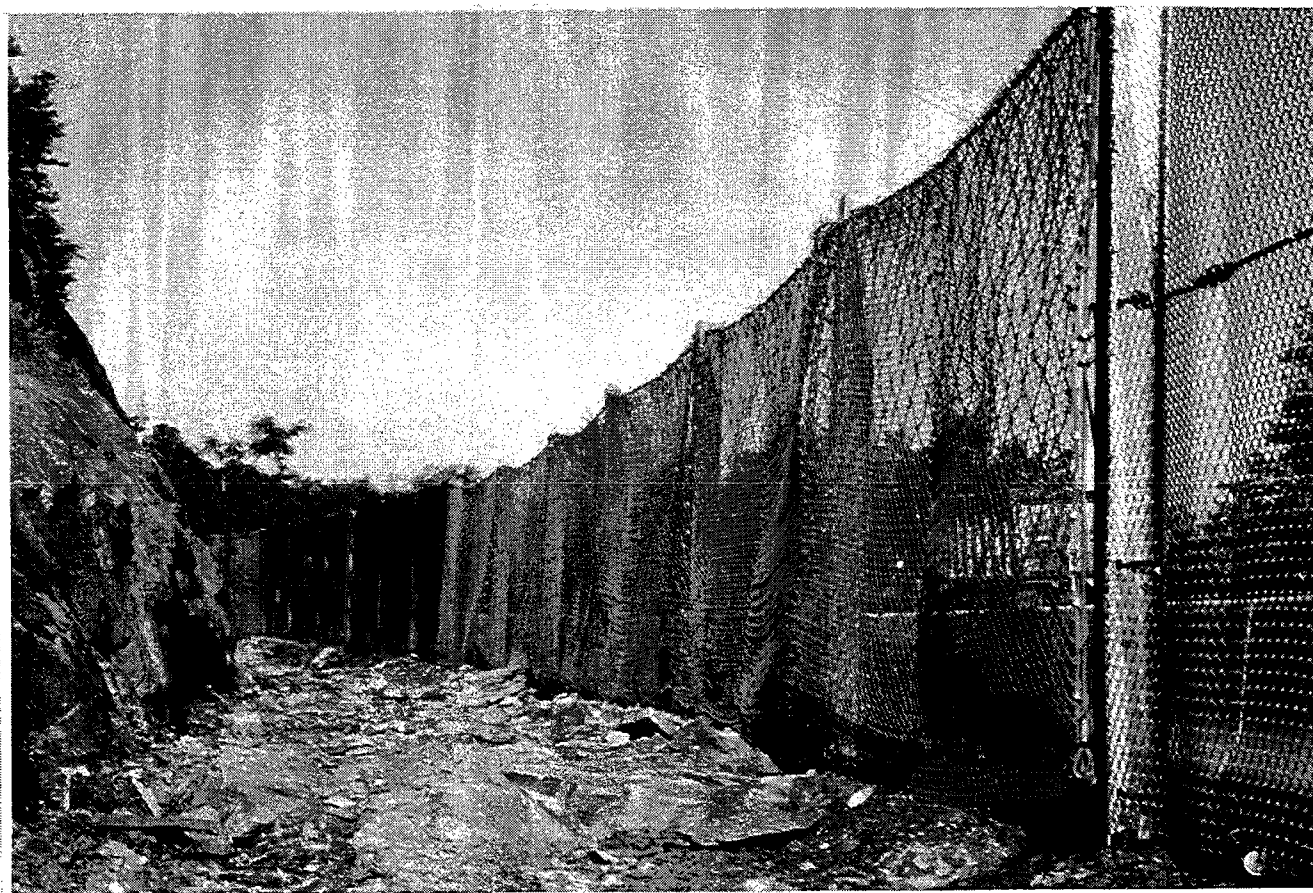
**Pennsylvania DOT - S. R. 924  
Retro-fitted Nets**

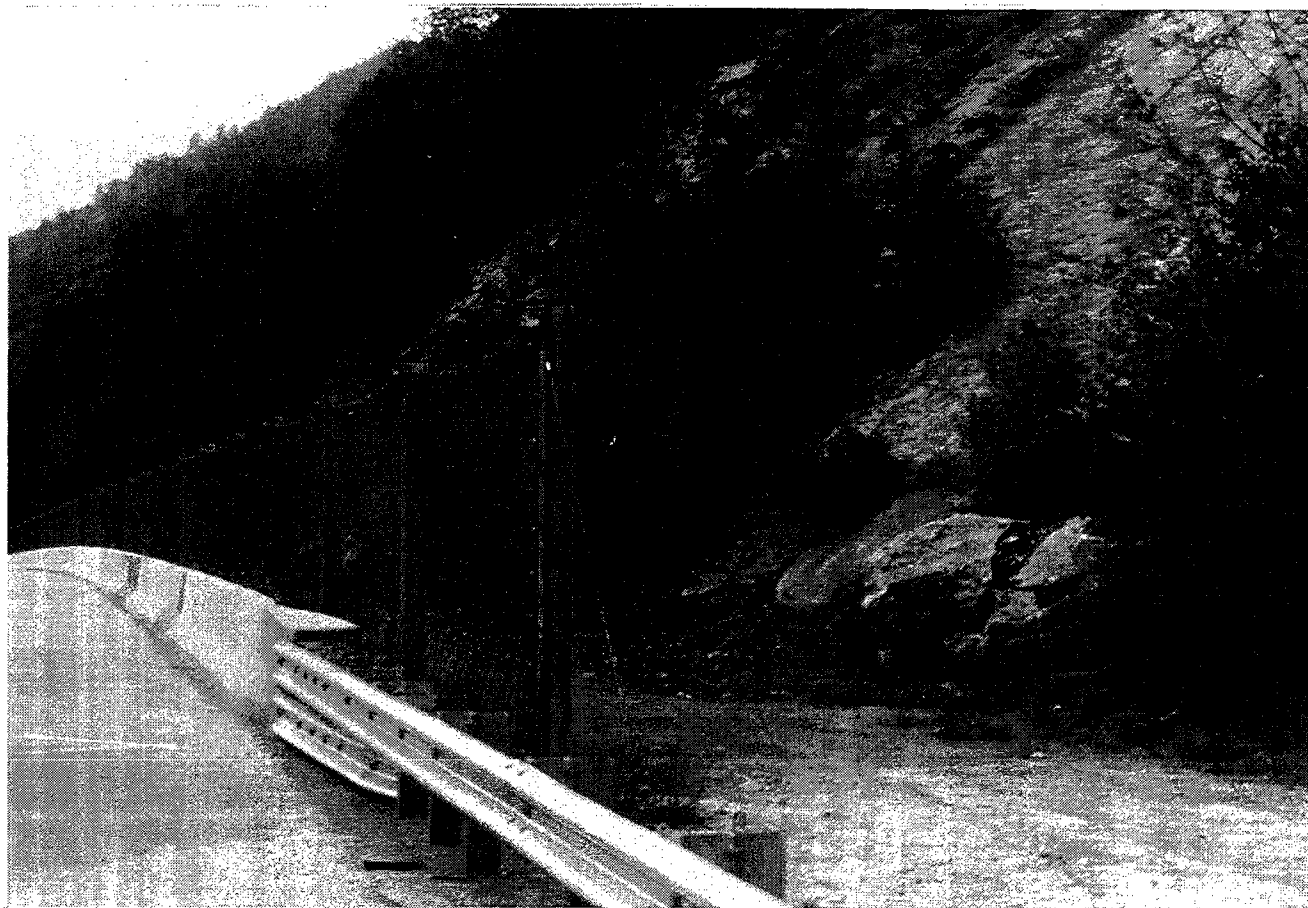
**Tennessee DOT - I-40  
Rockfall Catchment Barrier**

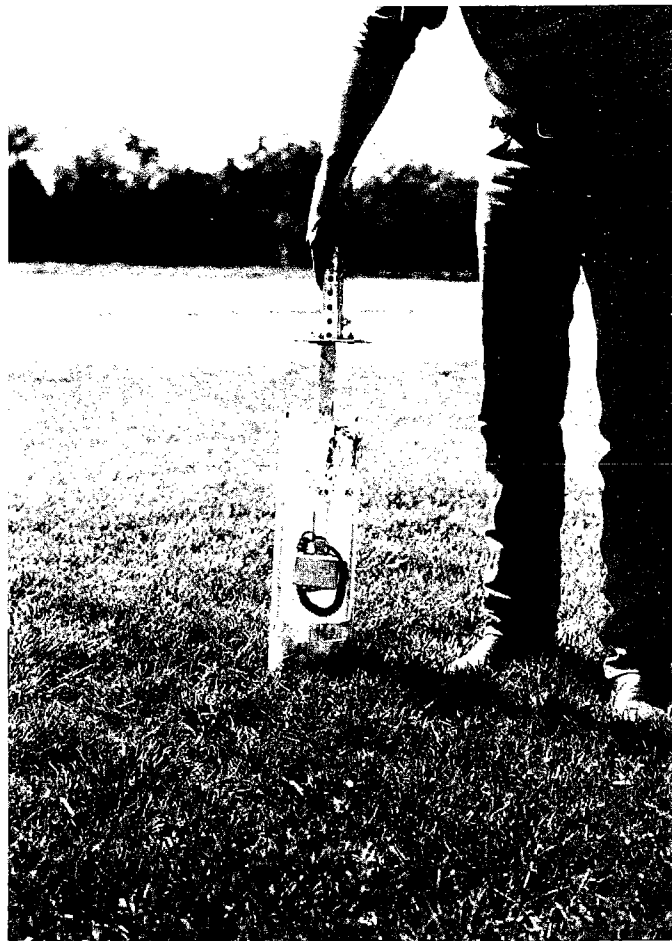
Fig.8 Plastic tube with 35mm
