PROCEEDINGS OF THE 44TH ANNUAL HIGHWAY GEOLOGY SYMPOSIUM

**MAY 19-21, 1993
Tampa, Florida**

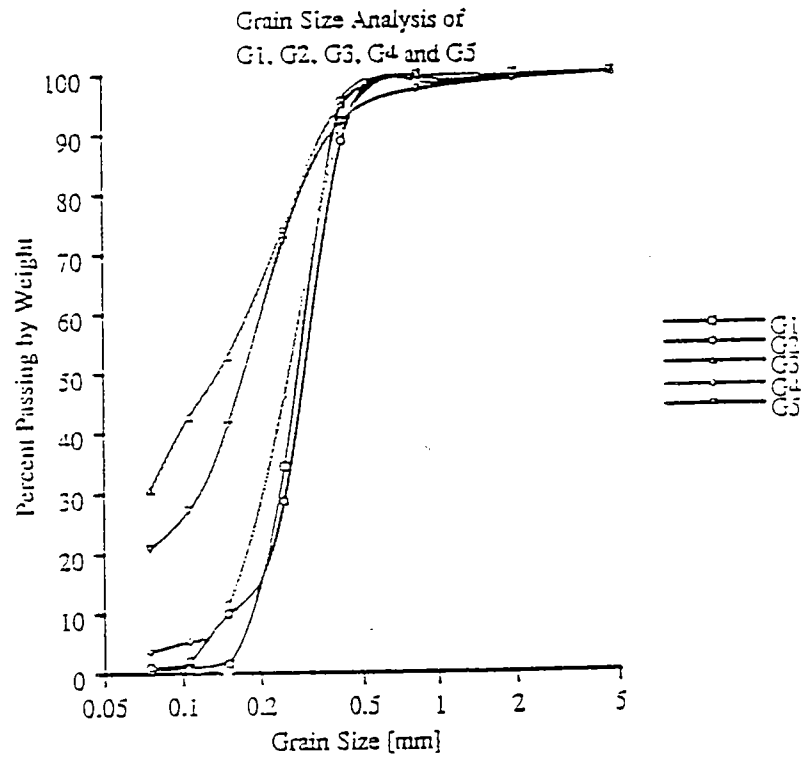
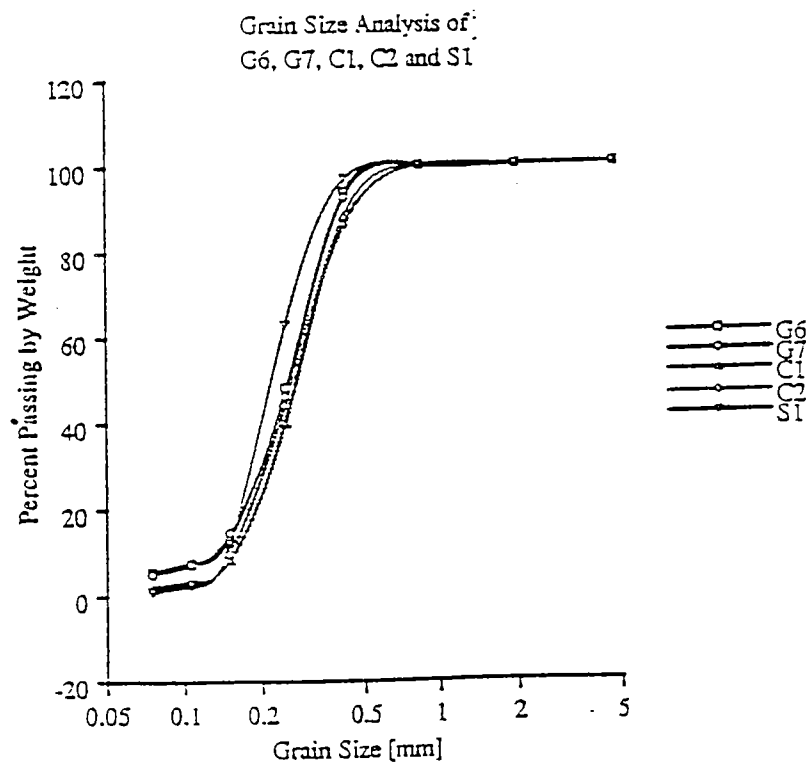
GRAIN SIZE ANALYSIS OF THE TEN SAMPLES TESTED

The particle size distributions of the ten test samples are shown in Figure 2. Table 2 shows typical distribution of a waste foundry sand sample and the gradation requirements of fine aggregate in Portland cement concrete and a particular surface mixture of asphalt concrete (asphalt sand) as per Indiana highway specifications of 1988.

In Portland cement concrete, clays and other fines can increase the water demand which increases the amount of cement to maintain the strength. ASTM C33 allows for 5% by weight of -200 mesh materials (smaller than 0.075mm). In asphalt concrete an increase of fines result in decrease of percentage voids. Two out of ten samples (G3 and G5) failed this requirement, as can be seen from particle size distribution curves (Figure 2).

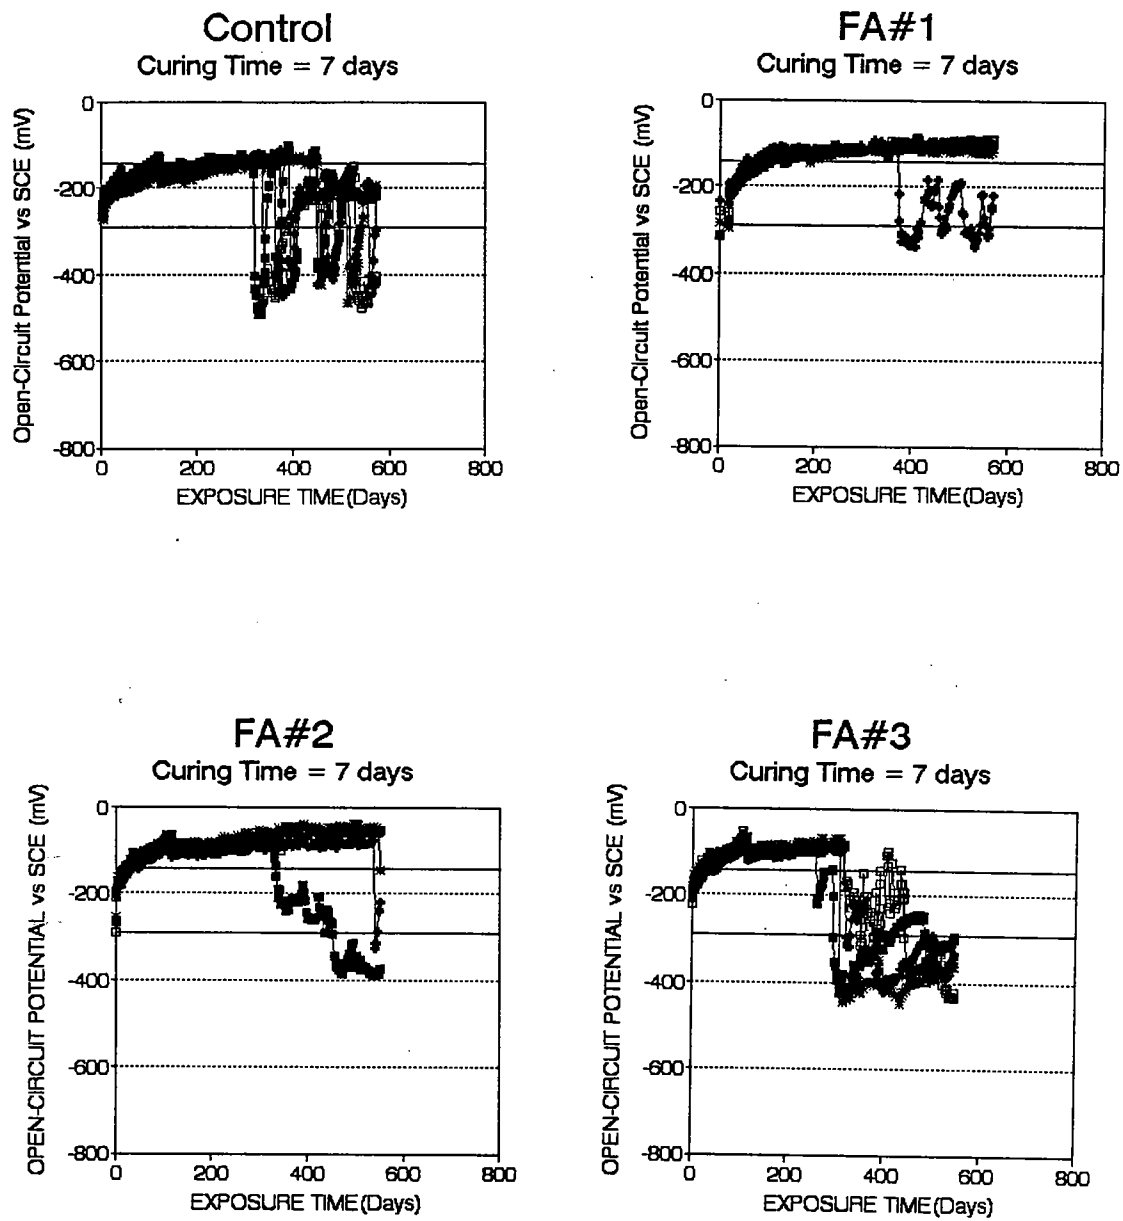
Figure 3- Open-circuit potential measurements of reinforcing steel in plain and fly ash concrete as a function of exposure time to a sodium chloride solution.

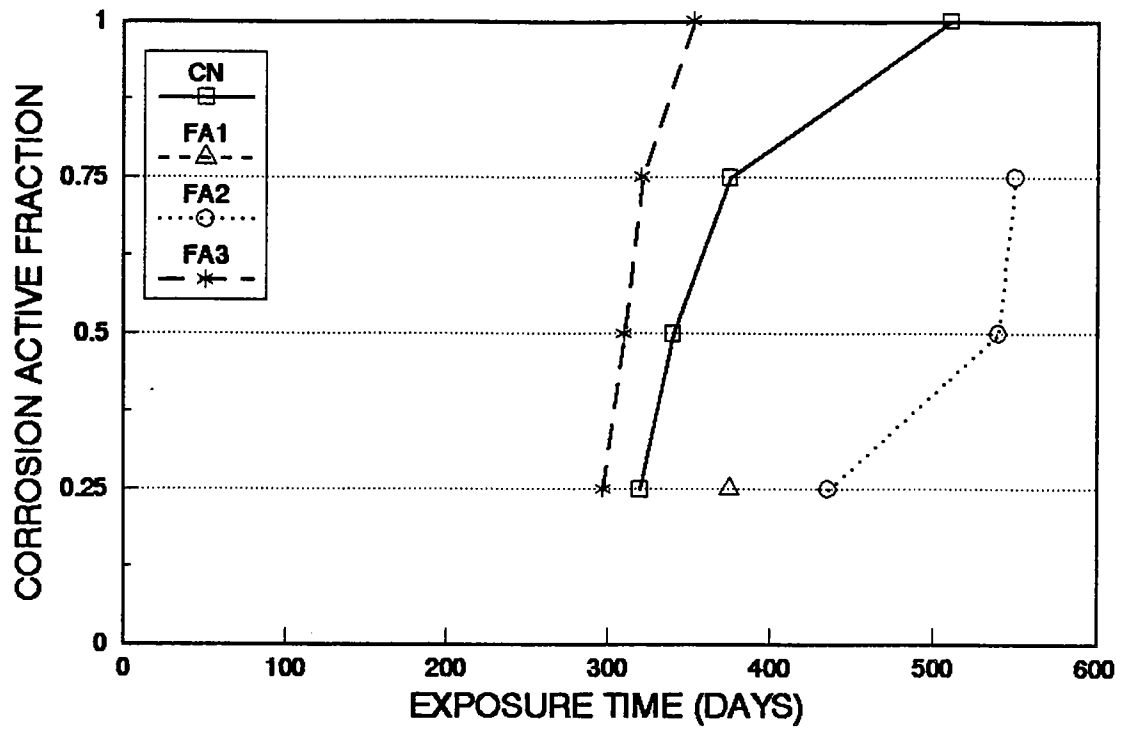
Figure 4- Corrosion active fraction of reinforcement in plain and fly ash concrete as a function of exposure time to sodium chloride solution.

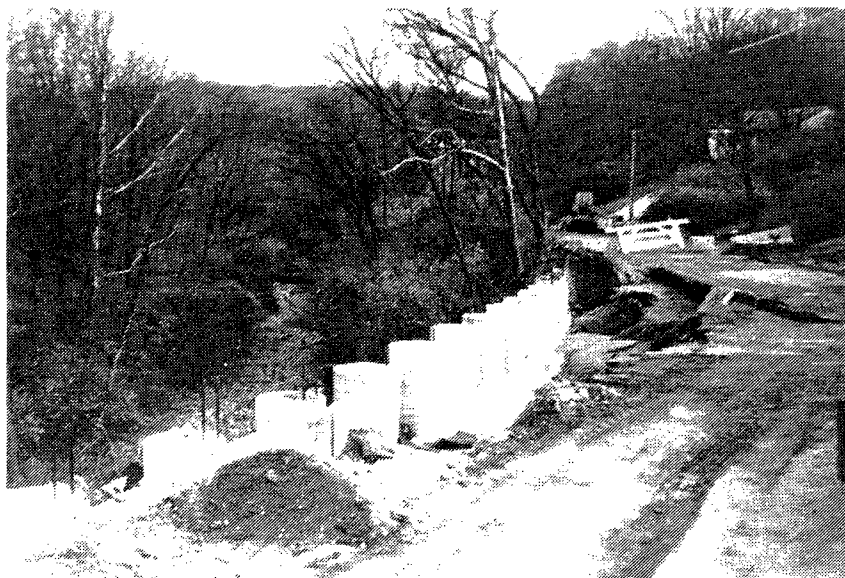
Figure 9: Remediation work in progress at the West Fork Road site.
