46 TH HIGHWAY GEOLOGY SYMPOSIUM

CHARLESTON, WEST VIRGINIA
MAY 14-17, 1995

PROCEEDINGS

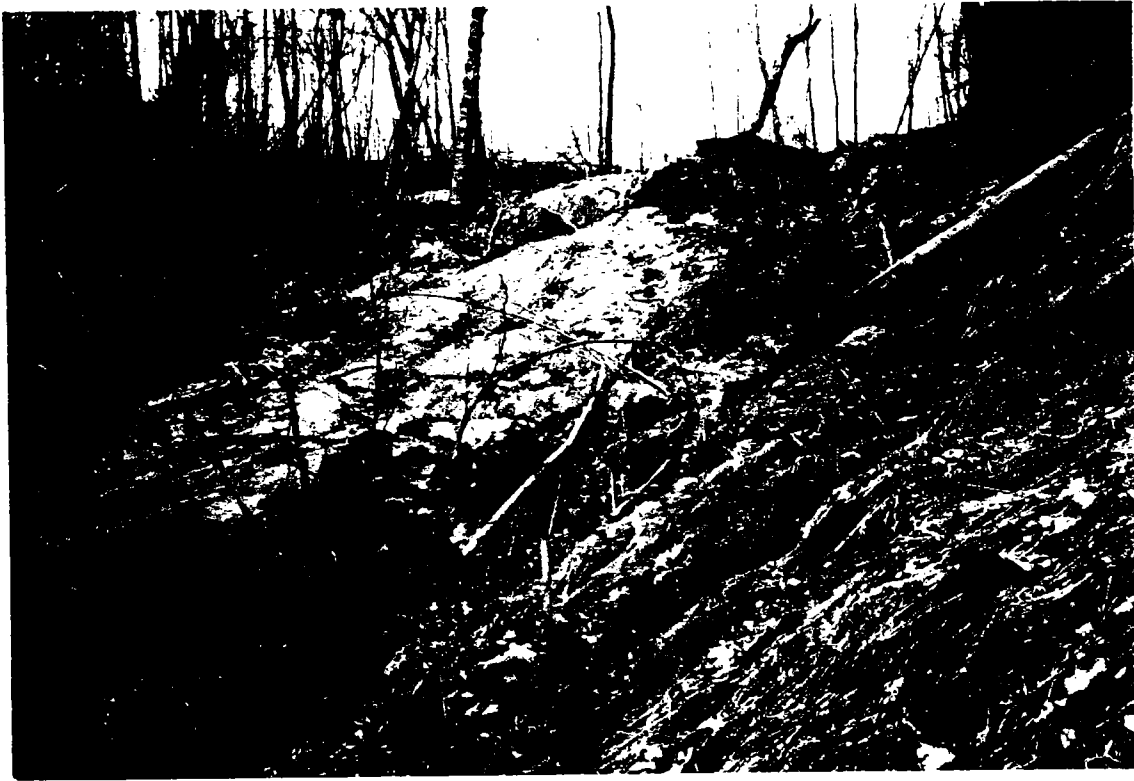
Figure 2: Photograph showing the middle transect of stakes with the middle and upper regions of the slide mass as the backdrop.

Monitoring of the slide from July 1993 to June 1994 has shown that the site is still unstable. Movements of up to 3 feet (0.9 m) were recorded along the eastern transect, while movements of 2 to 2.5 feet (0.6-0.75 m) were observed along the west and middle transects respectively. Plots of movement versus time for the eastern transect are shown in Figure 7.

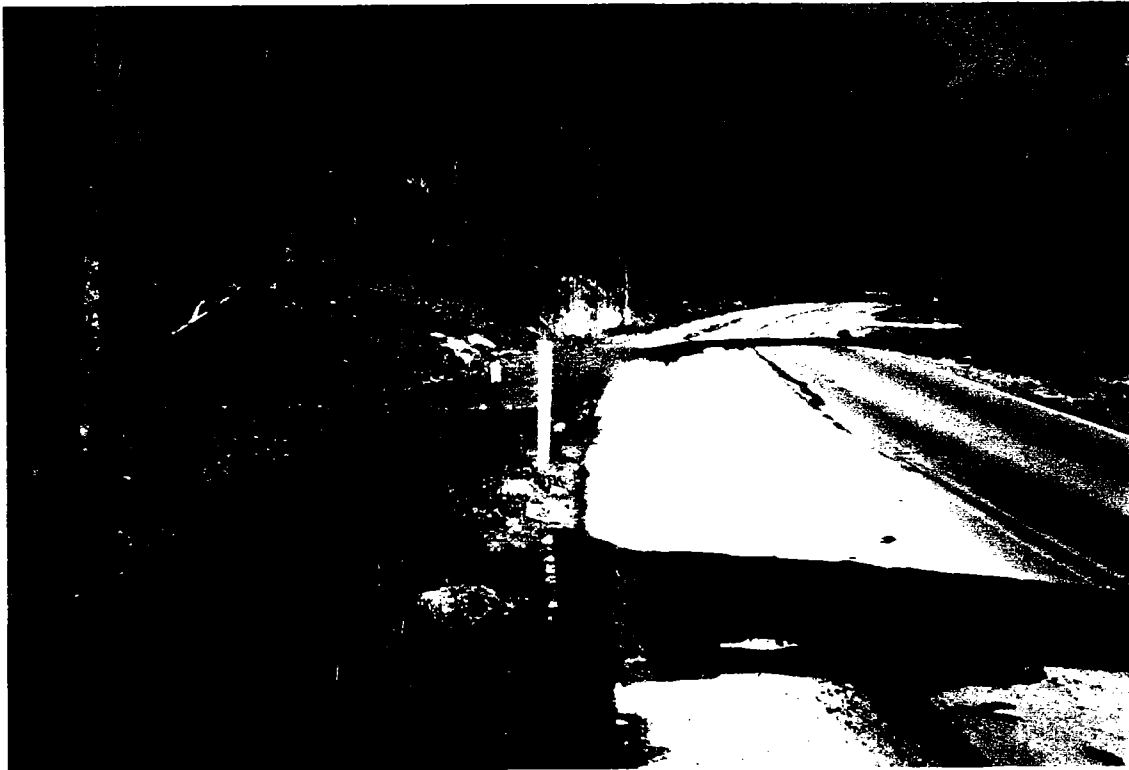
Figure 6: Sediment choked drainage ditch, which has forced water to drain over Chagrin River Road.

The site stratigraphy consists of 60 feet (18.3 m) of silty clay (CL) overlying sand (SP) and gravel (GW) (Figure 5). The slope failure is a combination of slump and flow movements (Varnes, 1978), primarily occurring within the silty clay. A small spring emerges from the base of the sand layer and forms a small stream that flows down over the toe of the slide and into a sediment choked drainage culvert (Figure 6). Poor maintenance of this drainage culvert prevents proper drainage of the toe of the landslide and contributes to slope instability.

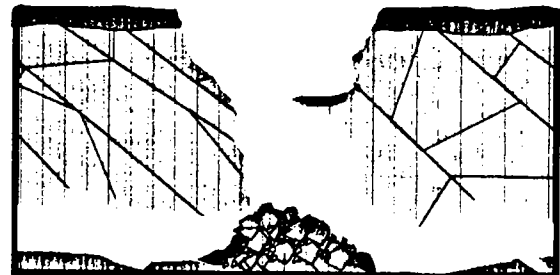
FIGURE 2A

CAVE COLLAPSE SINKHOLE

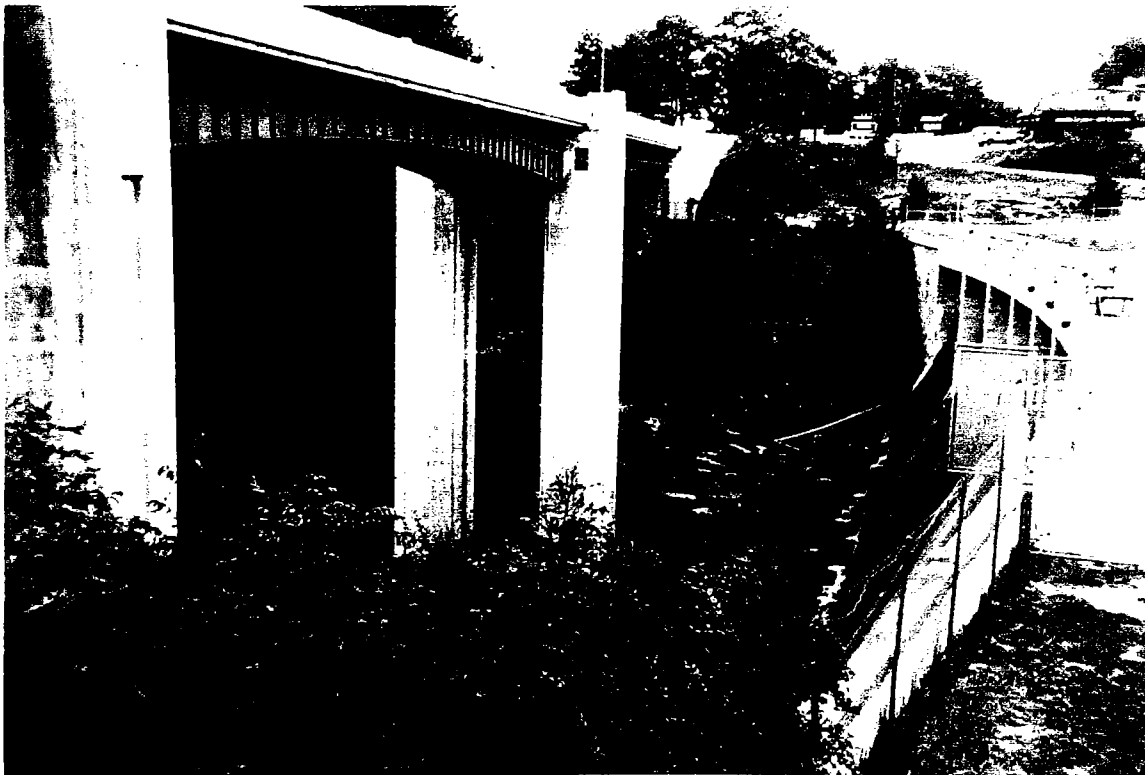
PHOTO 1 - TALLULAH GORGE BRIDGE AND TALLULAH FALLS DAM

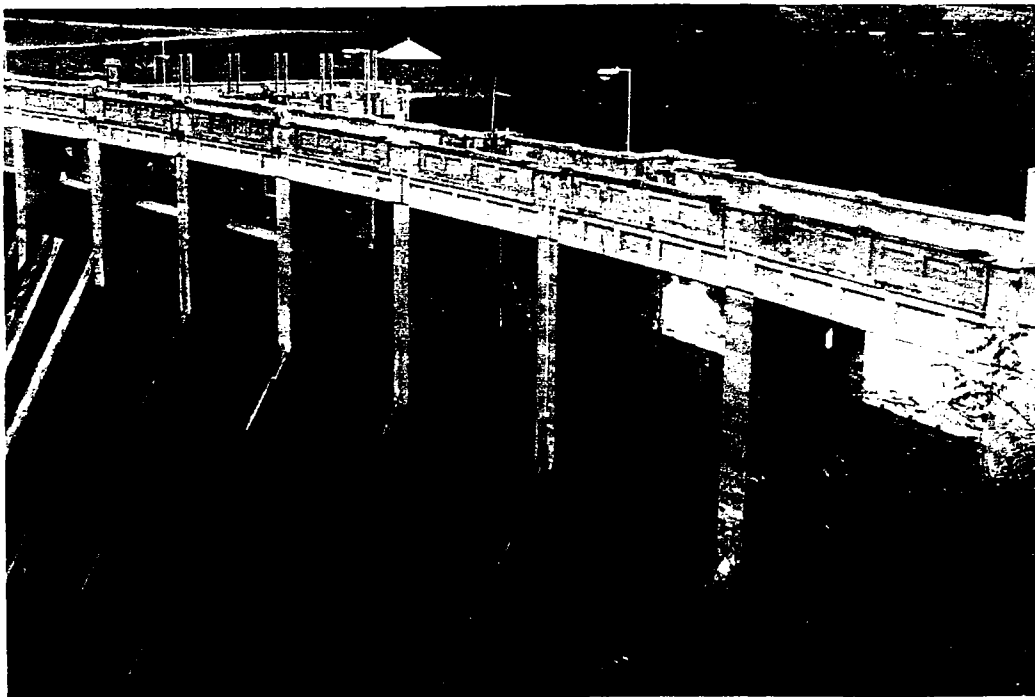
PHOTO 4 - DAM CREST WITH FLASHBOARDS

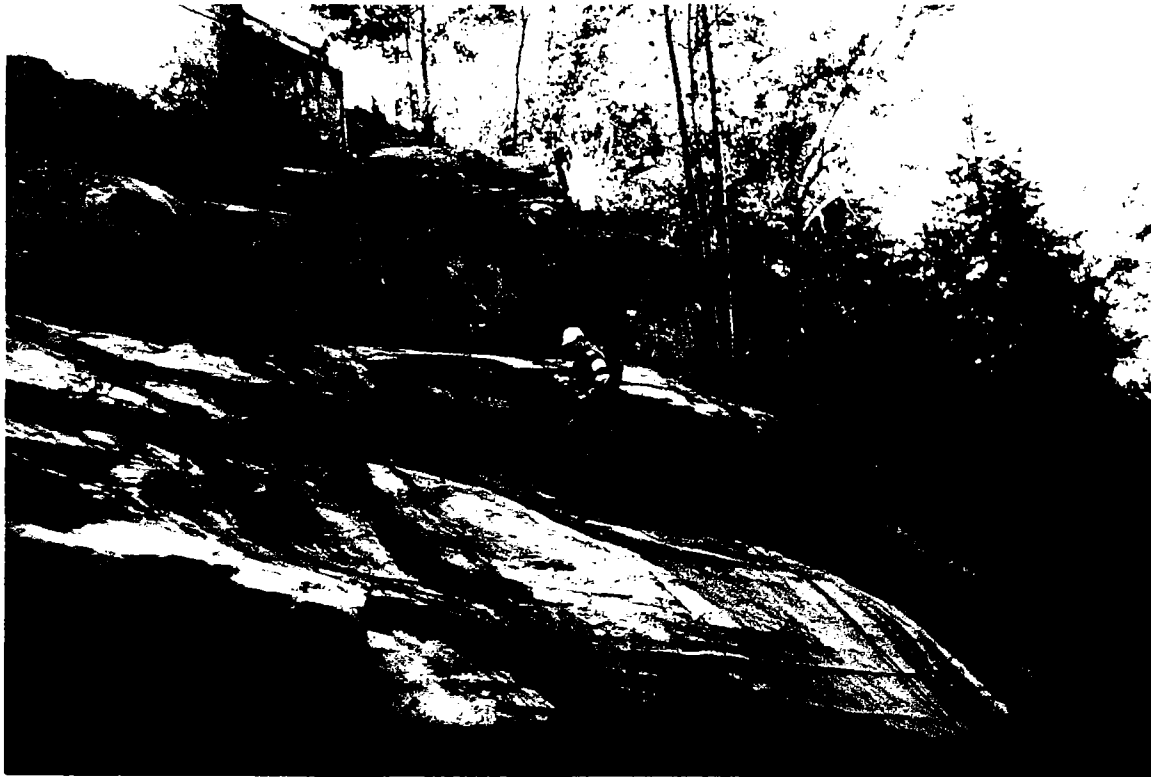
PHOTO 6 - SURVEY AND GEOLOGICAL MAPPING, PIER 2 SIDE

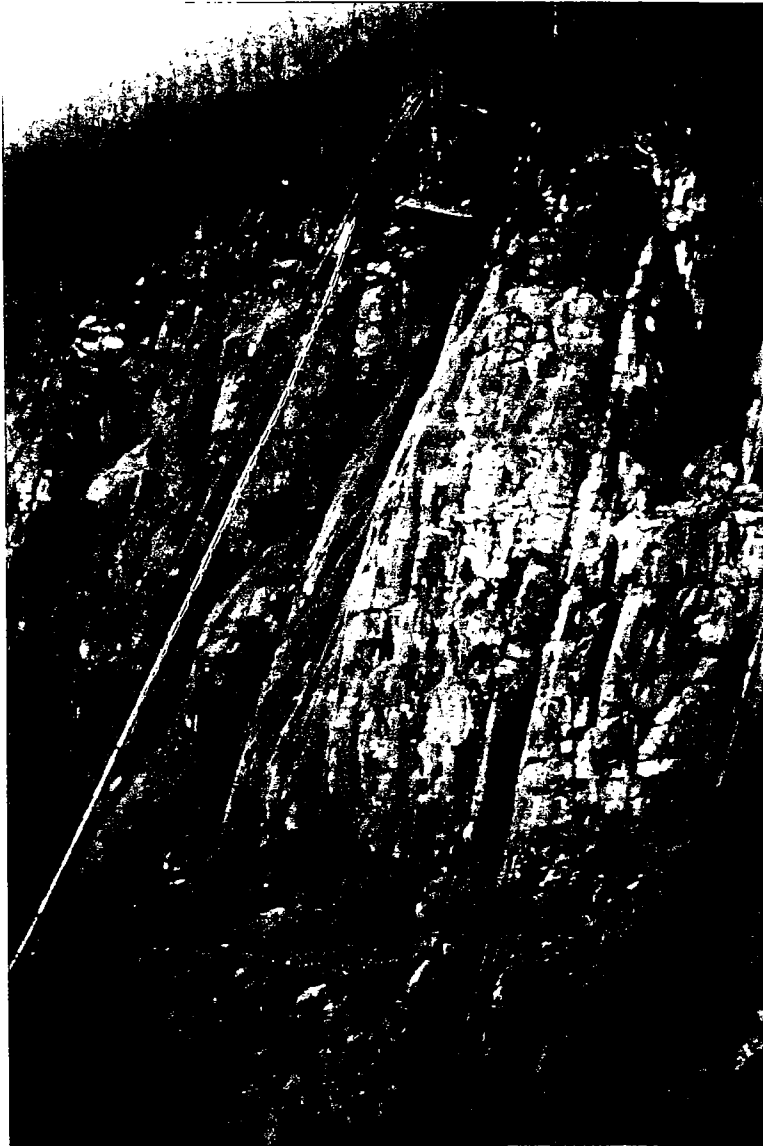
Figure 6

All the drilling and installation work was performed from a work platform suspended from the crane. The contractor used two different size air traks with the smaller one being used to access the highest anchor bolt locations. The air compressor for the drill remained on the ground and the air hose ran from it up to the platform. Two (2) guide ropes were secured to the platform and their purpose was to position the platform while the crane swung it into place. The air tracks on the platform performed the drilling and it was necessary to secure the platform to the cut before drilling (Figure 7).

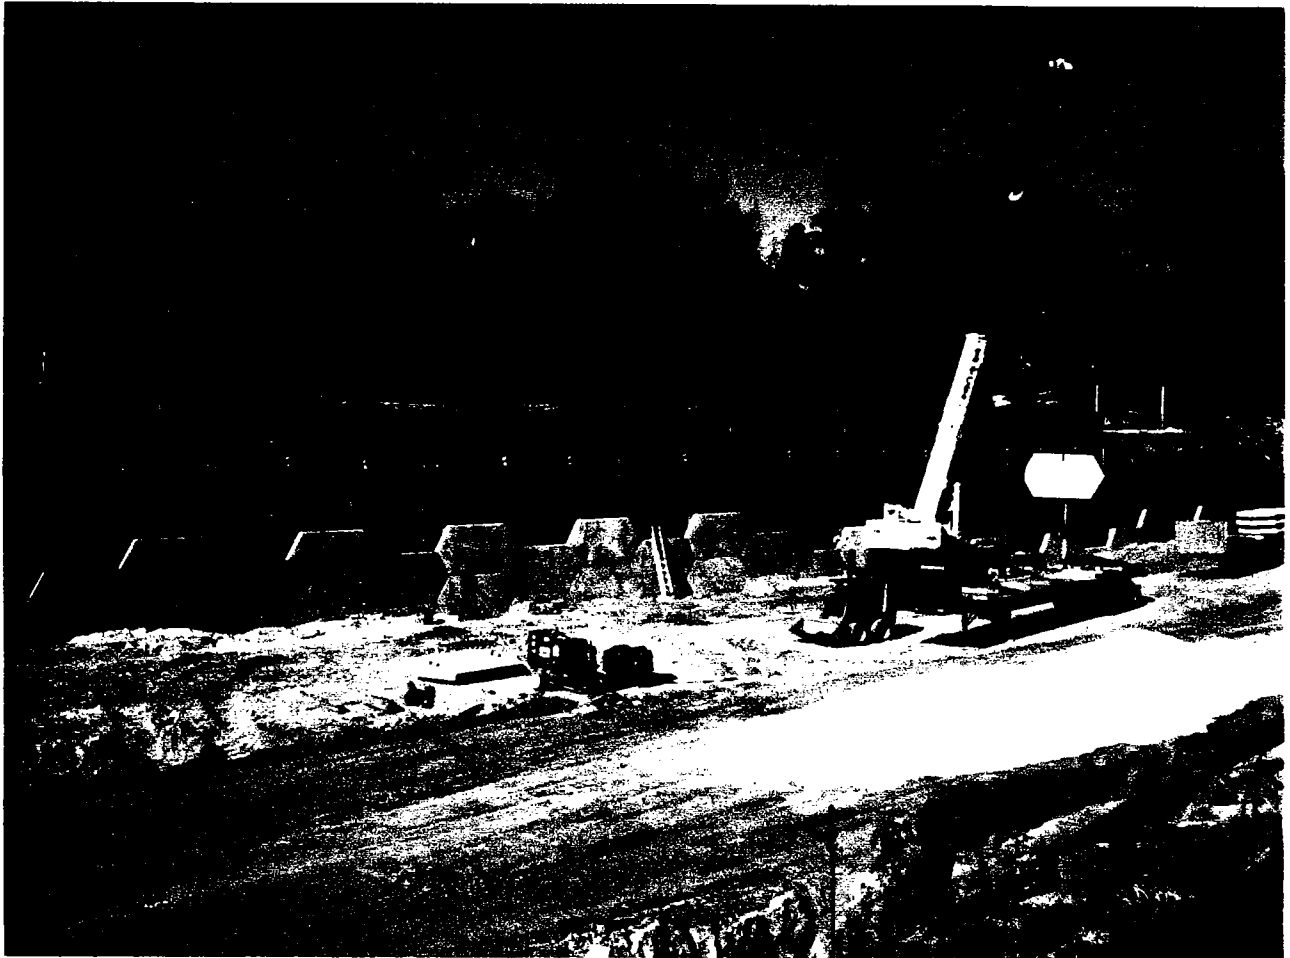
Photo 2.

sing has occurred. Photo 1 shows a tiedback wall built with a cast-in-place, reinforced concrete facing, while Photo 2 shows a tiedback wall built with precast panels without exposed wales and anchorheads.

Tiedback Wall Built With Precast Panels Without Exposed Wales and Anchorheads

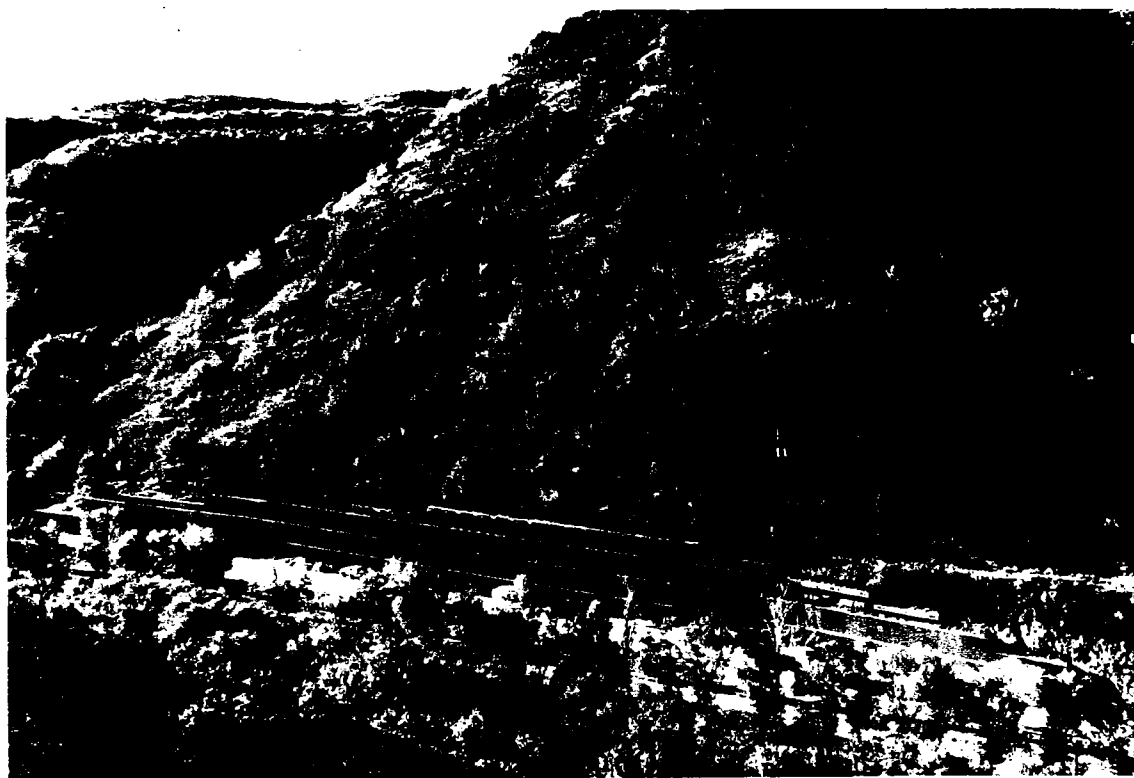
After the footing was cast and reached design strength, erection of the precast facing panels was begun. Up to this point the temporary shotcrete and soil nails carried the earth pressure between successive wale levels. The final step in completing the load transfer from the earth to the wales was the erection of precast panels to span vertically between wales. Gravel backfill was placed between the precast facing panels and temporary shotcrete. Photo 3 shows the 90% completed wall.

Photo 3. Semi-completed Wall

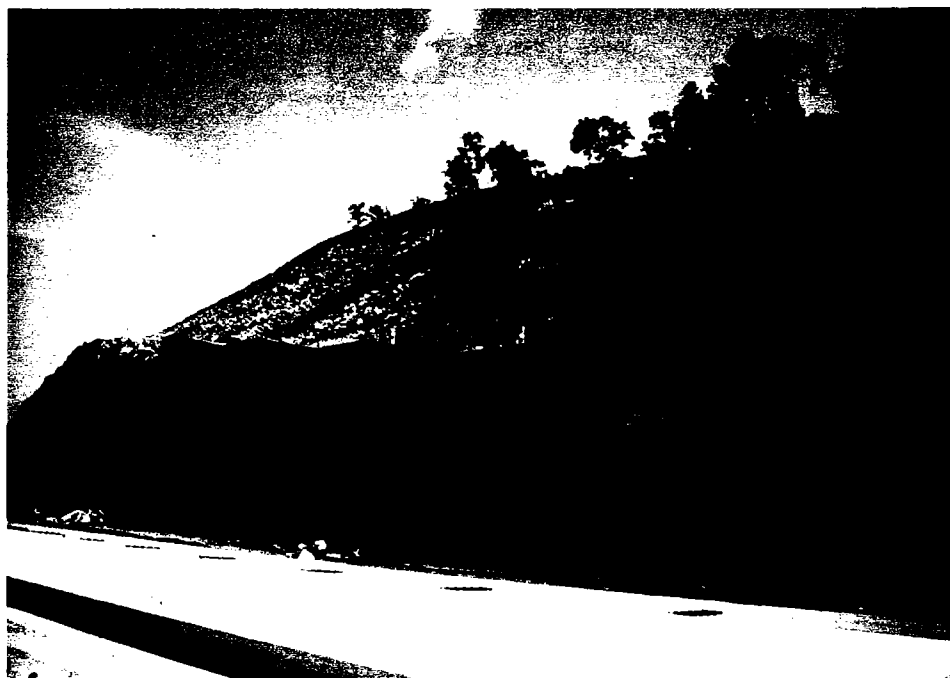
Construction began with the excavation of a shallow cut. In many sections the excavator could only remove two to three buckets full at a time before the cut had to be stabilized. The cut was stabilized by placing reinforcing mesh, installing drains, and shotcreting. Once the shotcrete had set up, an air track was used to drill small diameter holes for the soil nails. These holes were then filled with grout and the nails were installed. The next day a plate was attached to each nail. To construct the second and successive lifts, an additional five feet of material was removed immediately underneath the soil mass that had just been stabilized by the soil nails and shotcrete. This procedure was repeated until the excavation was completed. The excavation and soil nailing process was made quite difficult because of large boulders, cavities and other features that made a clean excavation impossible. As soon as subgrade was reached, a leveling pad was poured on which the precast panels would be set. Precast panels were then attached to the plates and held in place by the soil nails. As the panels were set on top of each other and connected to the nails, backfill was placed to fill the irregular void behind the panels and to provide drainage. Photo 4 shows the completed wall.

Photo 4. Completed Wall

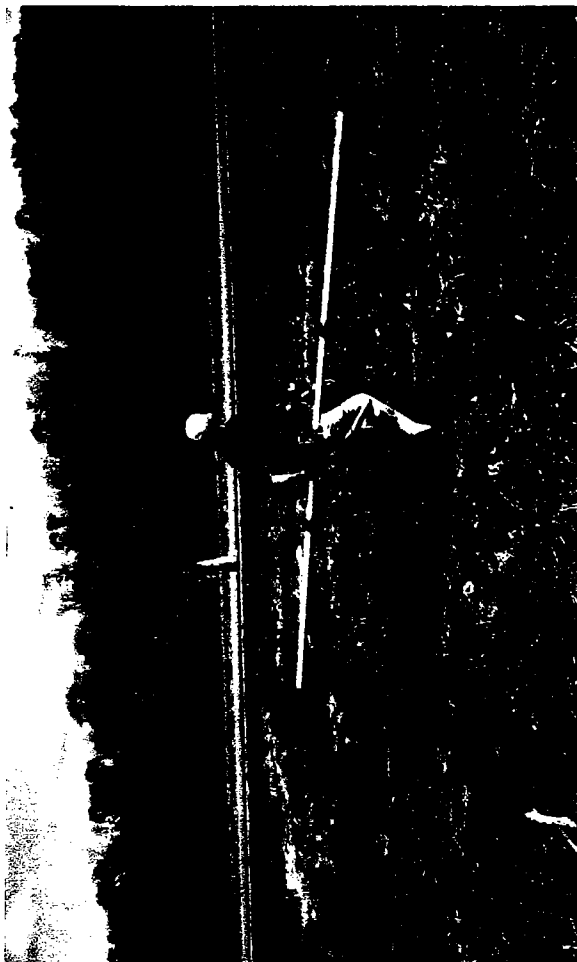
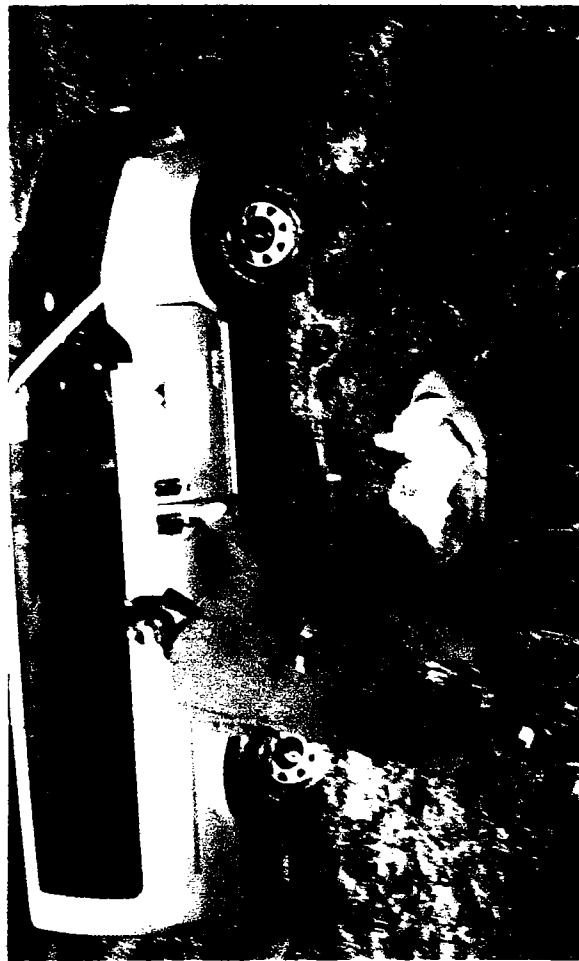
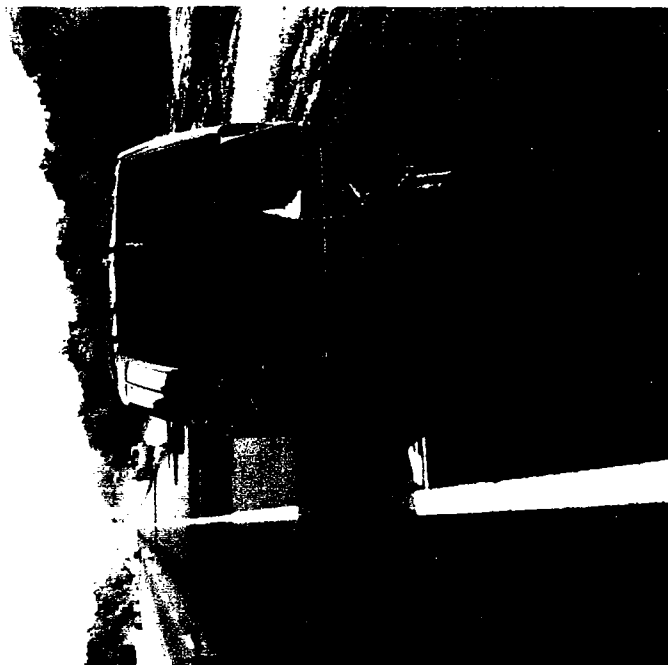
FIGURE 7: GEOPHYSICAL TECHNIQUES

ELECTROMAGNETIC CONDUCTIVITY
(EM)

SEISMIC REFRACTION
(SR)

GROUND PENETRATING
RADAR (GPR)

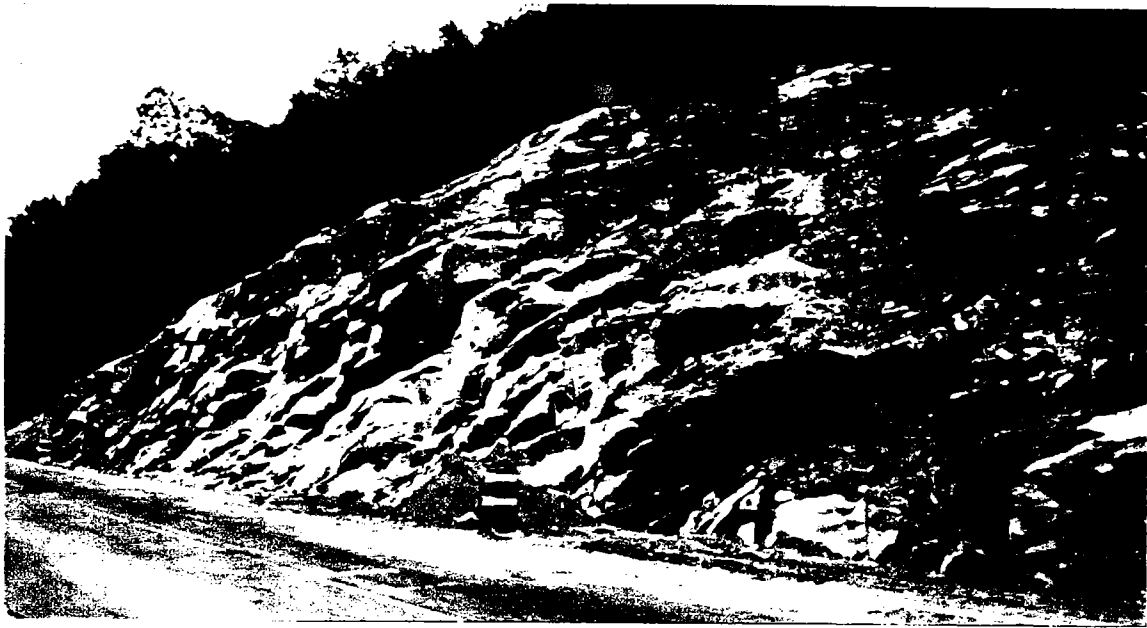
FIGURE 2

At Caroga lake, three slopes were cut using the modified presplit method, with a sum total of 1720 feet of presplit. 0.34 lb./ft. of presplit powder was used for the entire project. The entire first slope was used as a test section, subject to approval by a NYSDOT Engineering Geologist, and the APA. Upon inspecting the results of the initial blasts, it became apparent that the presplit line was shearing along the back row of holes. Instead of experimenting with changes, it was decided to complete this first slope according to the specification. Regardless of the problems encountered with the presplit blasting, a rough look was obtained, and this test section was accepted by both the APA and NYSDOT. Figure 2 is an overall view of this rock slope.

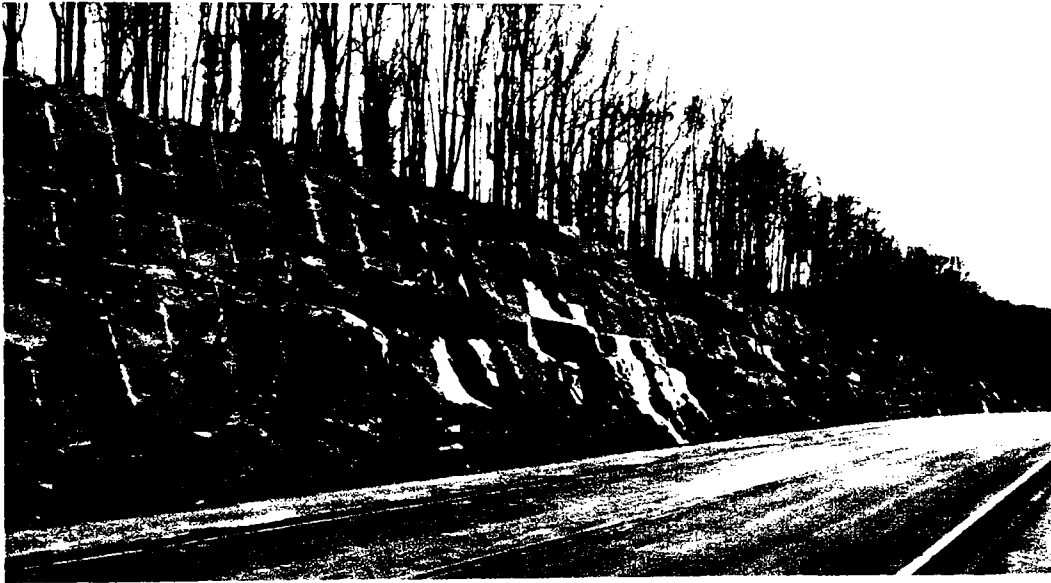
FIGURE 4

At Long Lake, 24 rock slopes have been recut using the modified presplit technique, with a sum total of approximately 5750 feet of presplit. 0.25 lb./ft. of presplit powder was used for the entire project. Two slopes were cut using the specified 5 foot spacing x 2.5 foot burden, but again, shearing along the back row of holes was a problem (See Figure 4).

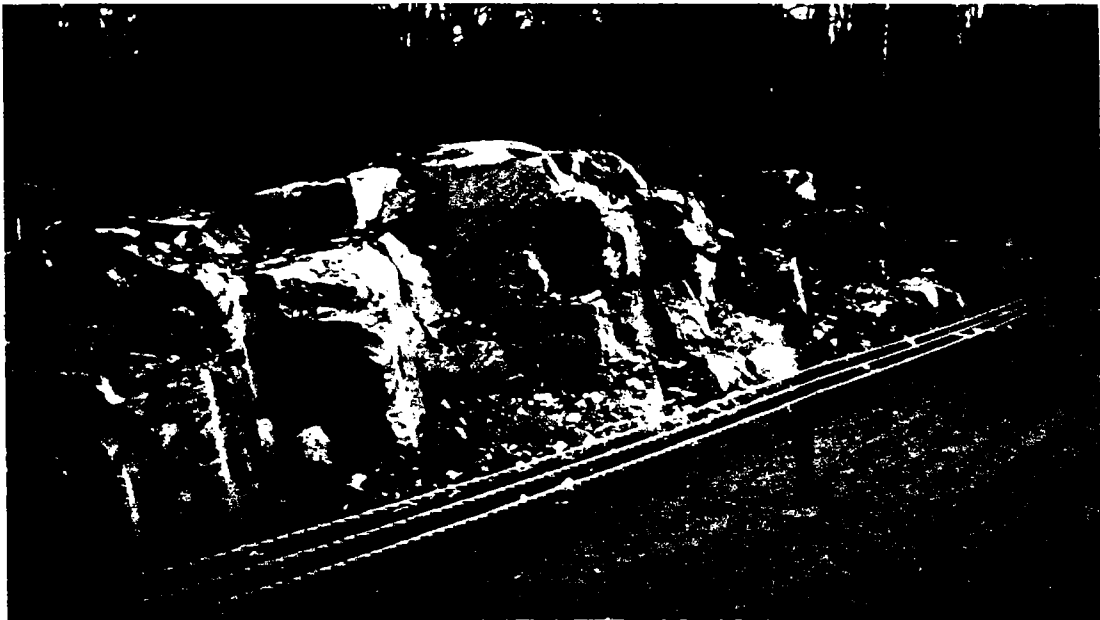
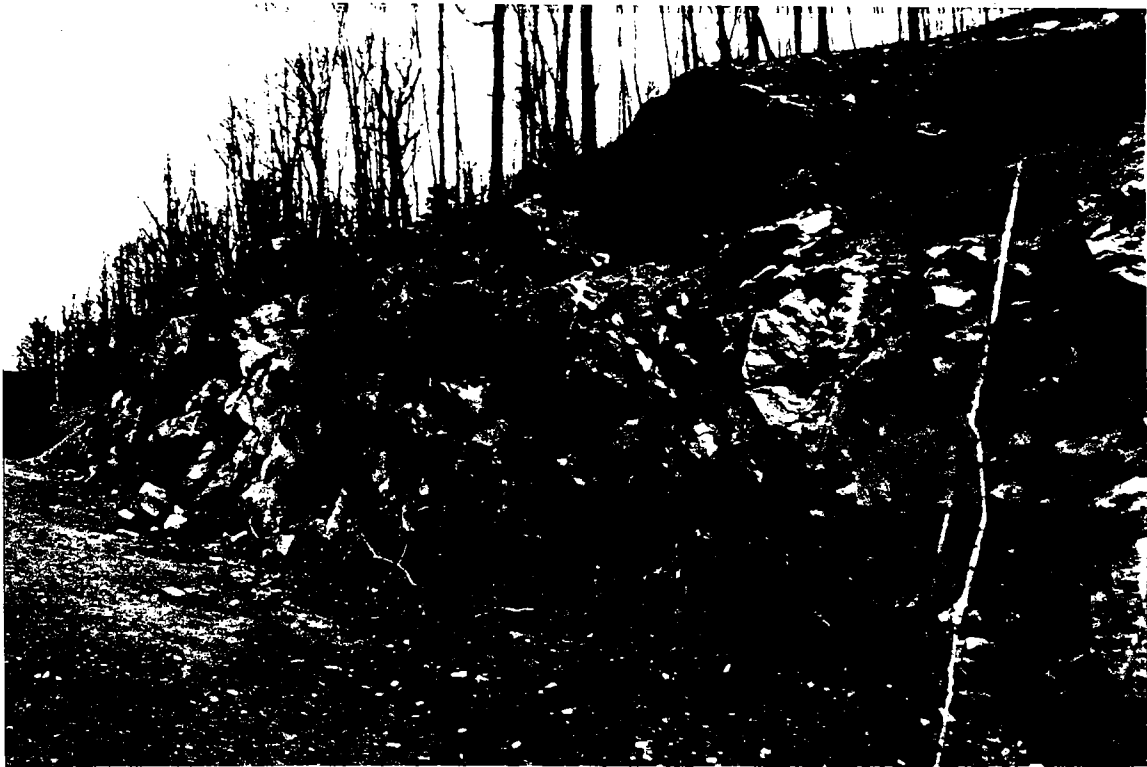
Based on the results obtained on these two slopes, the decision was made to widen the pattern to 6 foot spacing x 3 foot burden, and this pattern was maintained for the remainder of the project. In regard to the APA's wish to construct rough, "natural" looking rock slopes, we feel that many of the cuts on this project were a success. Figures 5 and 6 illustrate two such slopes.

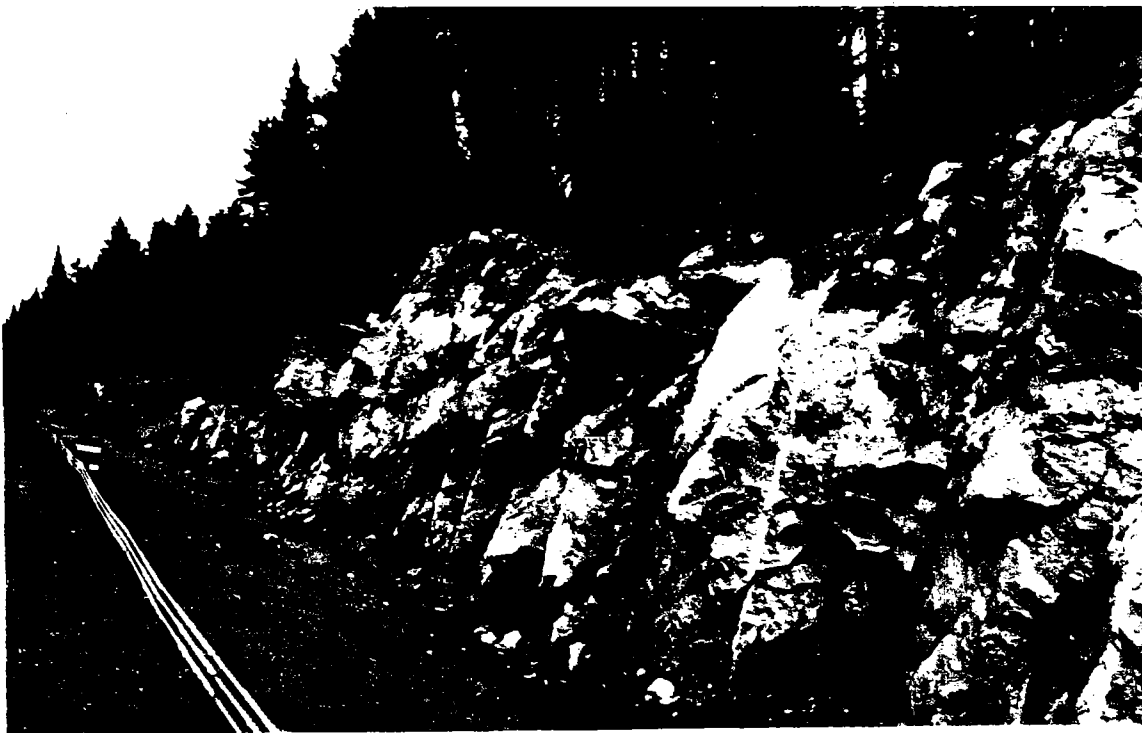
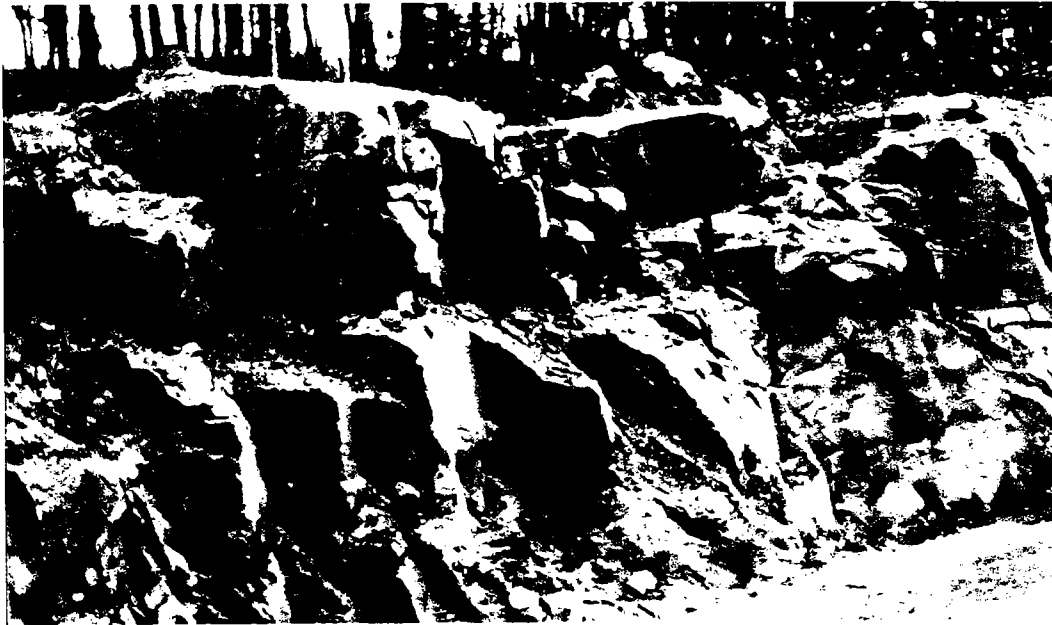
Figures 7 and 8 show two slopes on this project which illustrate the effect of staggered presplitting and jointing combining to produce a rough, stable rockslope.

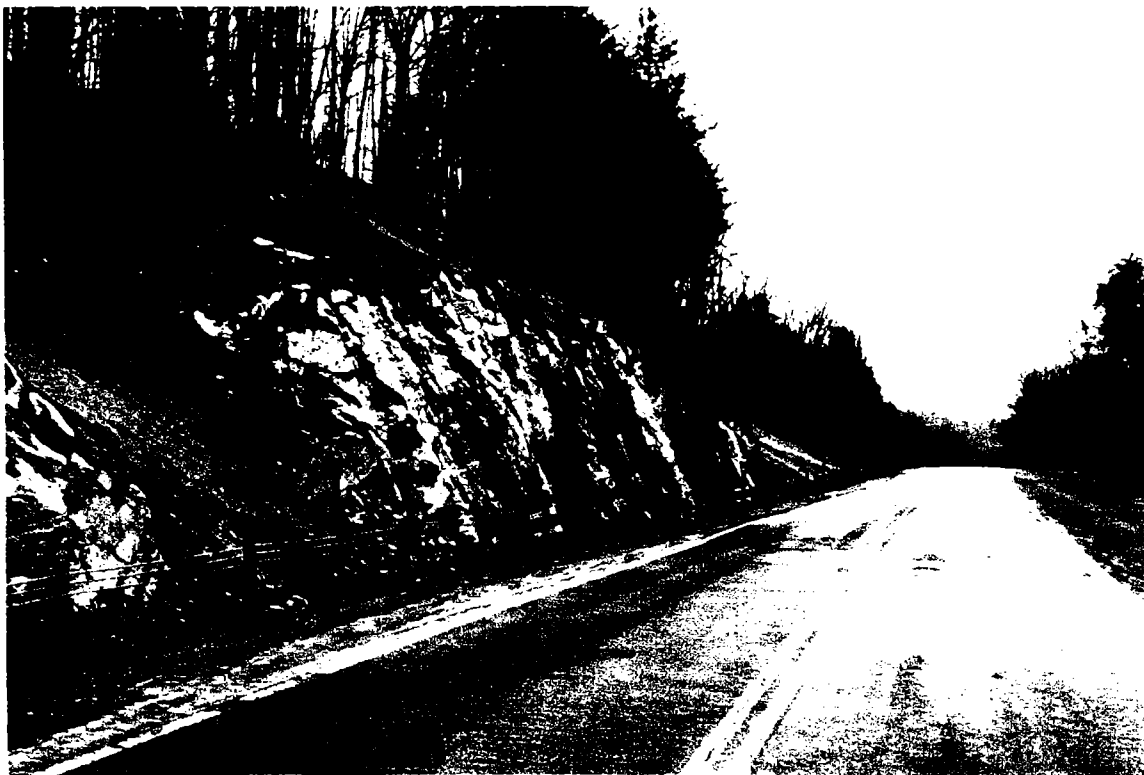
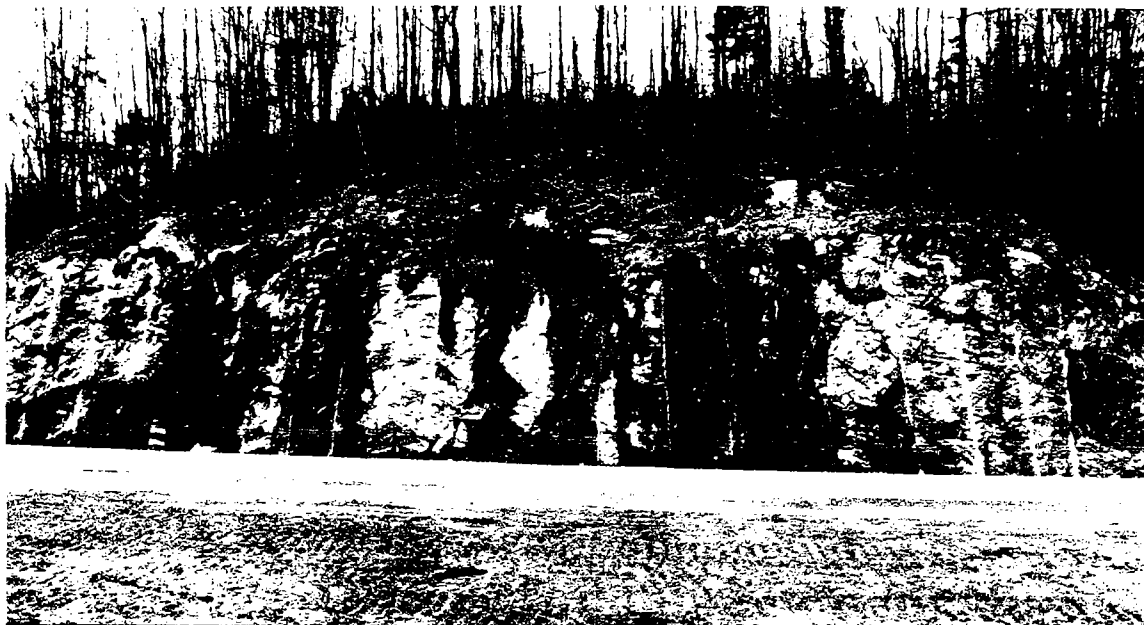
As previously noted, one hope of the APA was that this method of blasting would minimize the visual impact of the drill-butt traces. We feel that we were at least partially successful in this respect, as the following figures illustrate. Figures 9 and 10 show a typical cut at Long Lake. As seen by an approaching motorist, the drill-butt traces are barely visible (Figure 9) until directly upon the slope (Figure 10).

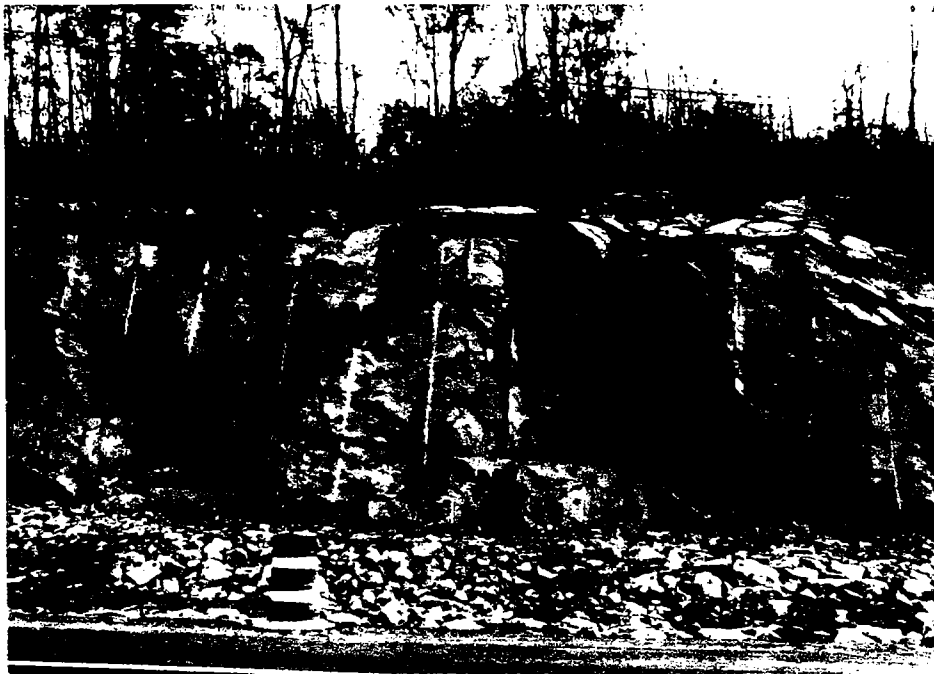
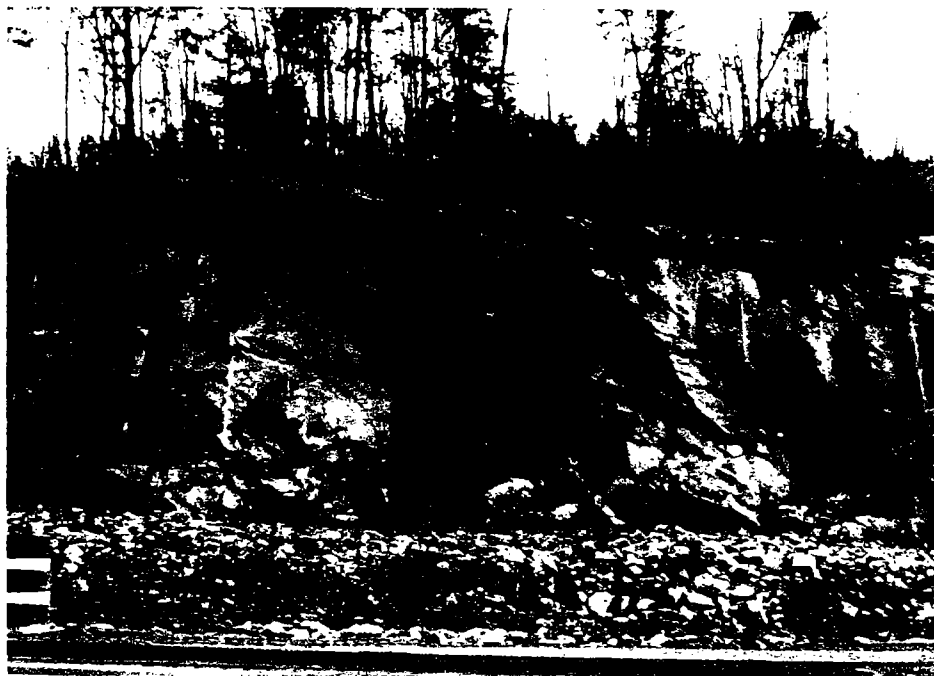
The project at Ticonderoga involved only one cut, 350 feet in length. Three test sections were shot on this slope, the first using the specified 5 foot spacing x 2.5 foot burden, and .33 lb./ft. of presplit powder. This test shot resulted in shearing along the back row of presplit holes. The pattern was widened to 6 foot spacing x 3 foot burden for the second test section, with no visible improvement in the results. In fact, this shot resulted in breakage behind the back row of presplit holes. Because of this, the presplit powder was changed from .33 lb/ft. to .25 lb/ft for the third test section, maintaining the 6 foot x 3 foot pattern. This change appears to have prevented any further breakage behind the presplit line, but shearing along the back row of holes continued. However, the test section was approved by a NYSDOT Engineering Geologist, and this blasting pattern and powder strength was used for the remainder of the project. Figure 11 shows the area of the second test section, illustrating the breakage behind the presplit line. Obviously, the nature of the jointing played a role in this breakage. Figure 12 shows how staggered presplitting and jointing can combine to produce the opposite of what is desired when the orientation of a major joint set closely matches the orientation of the finished presplit face.
