PROCEEDINGS OF THE 24th ANNUAL
HIGHWAY GEOLOGY SYMPOSIUM

SHERIDAN CENTER
SHERIDAN, WYOMING
AUGUST 9-10, 1973

Sponsored By
WYOMING STATE HIGHWAY DEPARTMENT

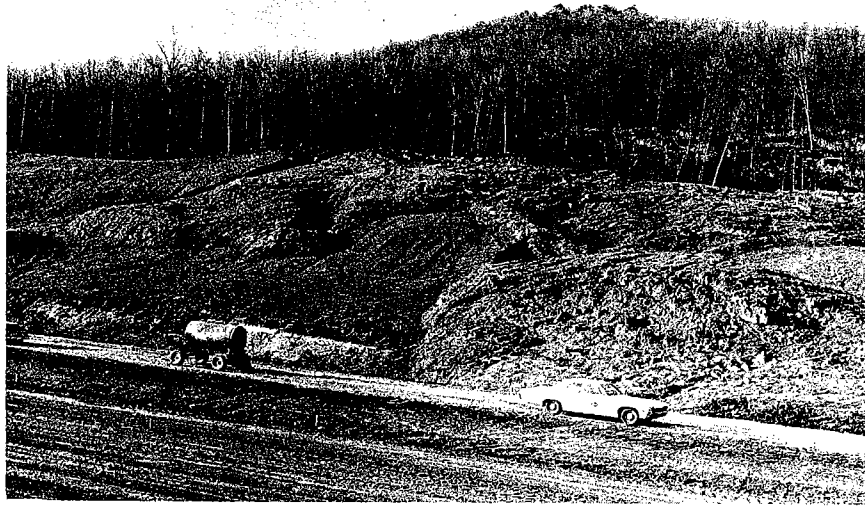
The failures vary all the way from creep and flow movements occurring over a relatively long span of time (Figures 4 and 5) to instantaneous collapses (Figures 6 and 7). Depending on conditions, these collapses may occur almost immediately and with the emplacement of only a few feet of embankment, or they may not occur for several years after initial construction. The latter failures are due primarily to pore pressure buildups resulting from a damming effect caused by deterioration and further consolidation of the shale materials from which the embankments are constructed, or simply damming by consolidation along the colluvium-clay/shale interface beneath the fills. These collapses often occur during or

FIGURE 4. COLLUVIAL SLIDE ALONG I-40 NEAR CRAB ORCHARD IN CUMBERLAND COUNTY.

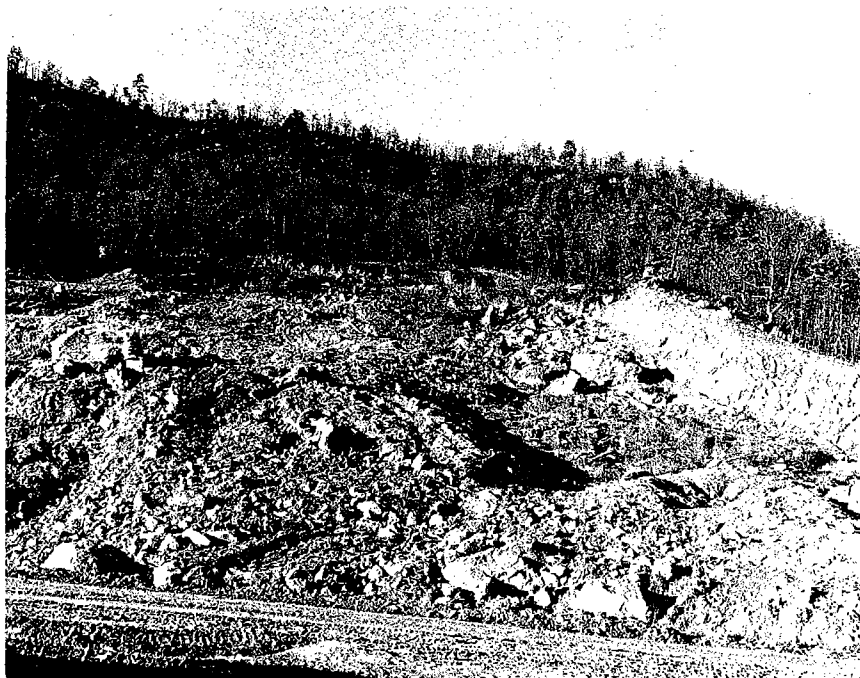
FIGURE 5. MASSIVE COLLUVIAL CUT SLIDE ALONG INTERSTATE -40 NEAR ROCKWOOD IN ROANE COUNTY.

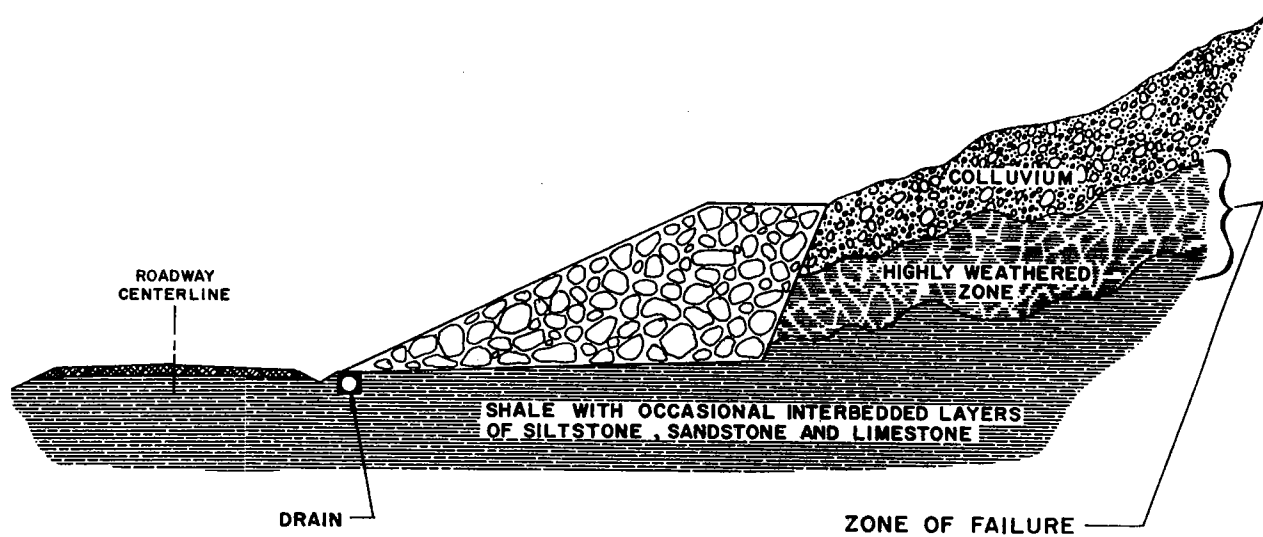
FIGURE 8.

Rock buttresses (Figures 8 and 9) are free-draining gravity structures consisting of large blocks of non-degradable sandstone or limestone. The gradation being used calls for 50% of the material to be greater than one cubic foot, with no more than 10% passing the #2 sieve. Because of its free-draining characteristics, the rock buttress works well in restraining colluvial slides. Movement is prevented by restraint while at the same time allowing

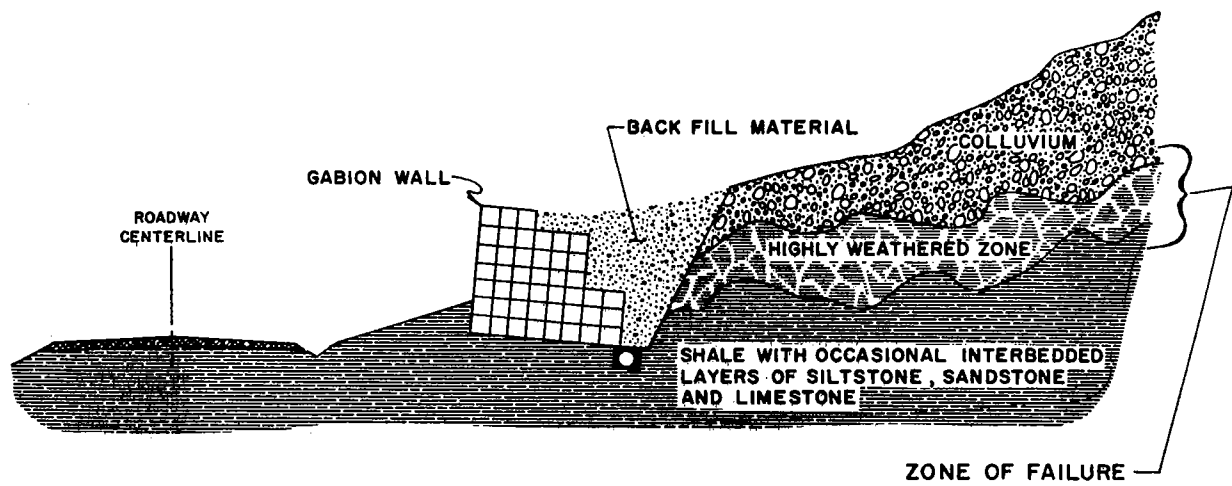
FIGURE 10

A second type of restraint structure being utilized at Rockwood is the Gabion wall (Figures 10 and 11). It is a free-draining, heavy, monolithic gravity structure consisting of wire mesh baskets (Gabions) filled with coarse, non-degradable rock. The Gabions are made of zinc-coated Number 11 steel wire and range in size from 3' X 3' X 3' to 3' X 3' X 9'. In the construction of the wall, each basket is secured to an adjacent basket with a tie-wire and then loaded in place. Gabion walls provide the flexibility needed to cope with the differential settlement so typical of the site conditions at Rockwood. Since they require considerably less lateral space than rock buttresses, they were used where space was somewhat limited. Another major advantage is that once the materials are on the construction site, the wall construction may continue even under very adverse weather conditions.

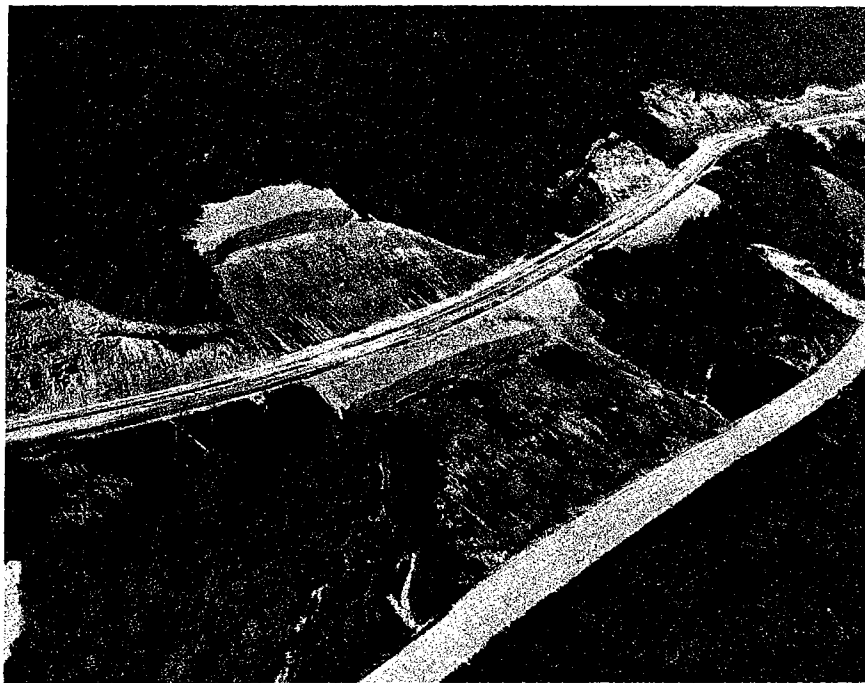
FIGURE 11. AERIAL VIEW OF TWO GABION WALLS BEING USED TO RESTRAIN SLIDES ALONG THE EAST-BOUND AND WEST-BOUND LANES OF I-40 AT ROCKWOOD.

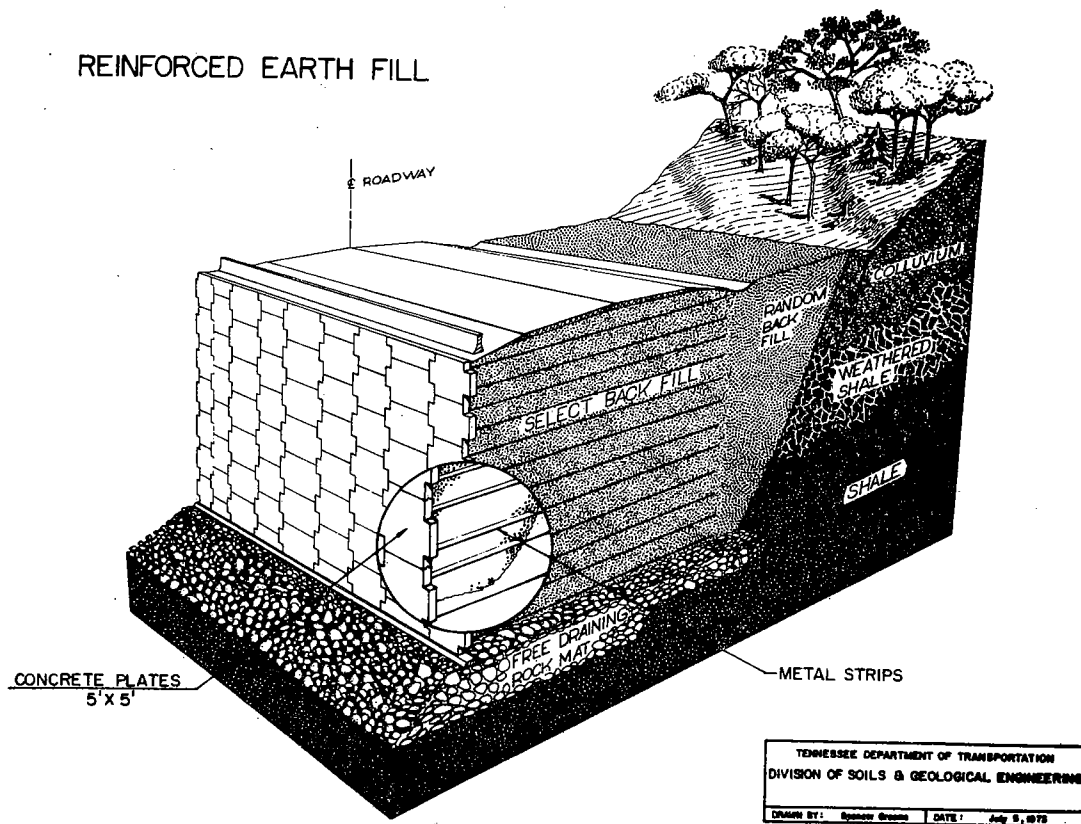
FIGURE 12. SCHEMATIC OF REINFORCED EARTH WALL BEING USED TO SPAN A SLIDE AREA ALONG I-40 AT ROCKWOOD (REFER TO FIGURE 7)

In August of this year, a third type of restraint structure will be constructed; that of reinforced earth (Figure 12). While most of the buttresses and Gabions have been used to control cut slides, the reinforced earth structure will serve as a platform to carry the east-bound lane across a fill area (see Figure 7). It was chosen in lieu of the rock pad--soil platform design used in a similar slide (Figures 13 and 14) because of economics.

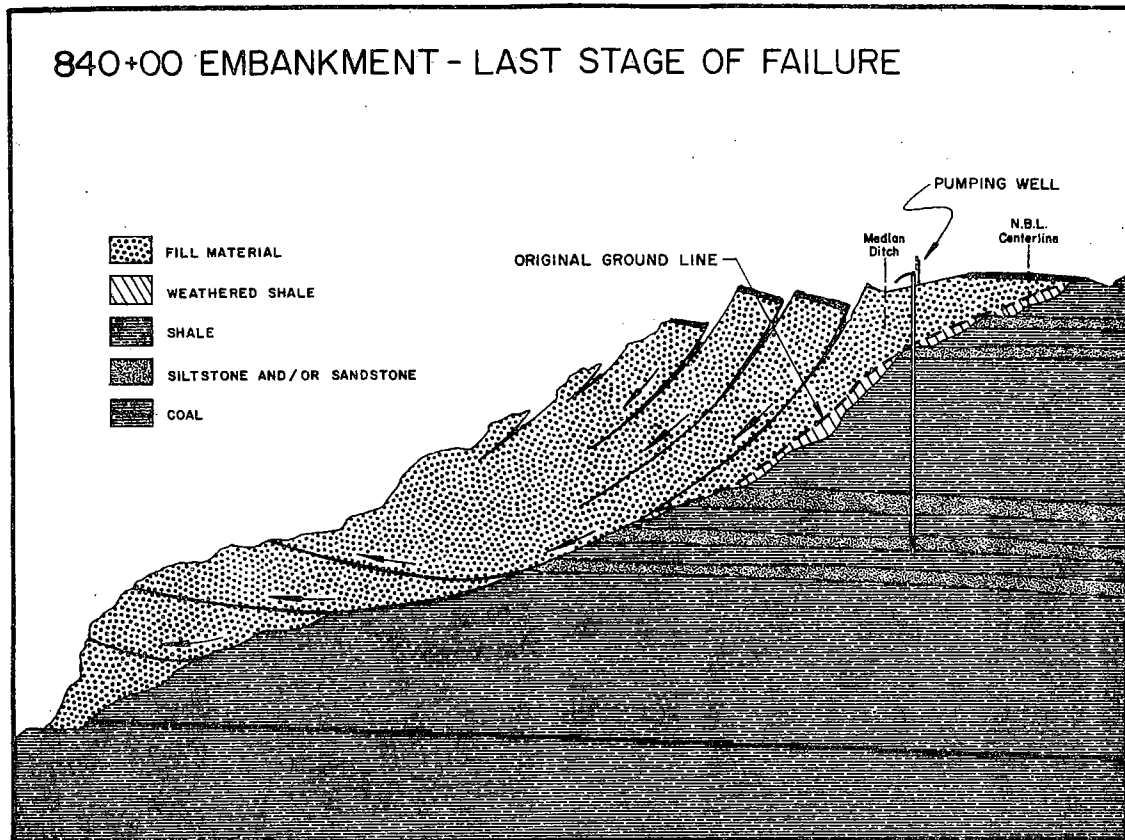
FIGURE 19.

To lower the water table at the 840+00 (south-bound lane) slide (Figures 16 and 19), the Department employed a different method. There, twelve 100 foot vertical wells were drilled on 25-foot centers along the median above the slide, and equipped with $\frac{1}{2}$ hp. submersible automatically actuating pumps. Horizontal drains could not be used because of the height, steepness and deteriorated condition of the outside slope. Since the 840+00 slide was to be repaired using the removal and replacement method, and since the removal of this material was expected to jeopardize the stability of the north-bound lane, it was determined that the median area had to be dewatered. This would, hopefully, result in a shear strength increase of the material that was to be exposed in the median. As it was, the 1:1 slope (Figure 20) remained well intact to the full removal depth. Those who were involved in the

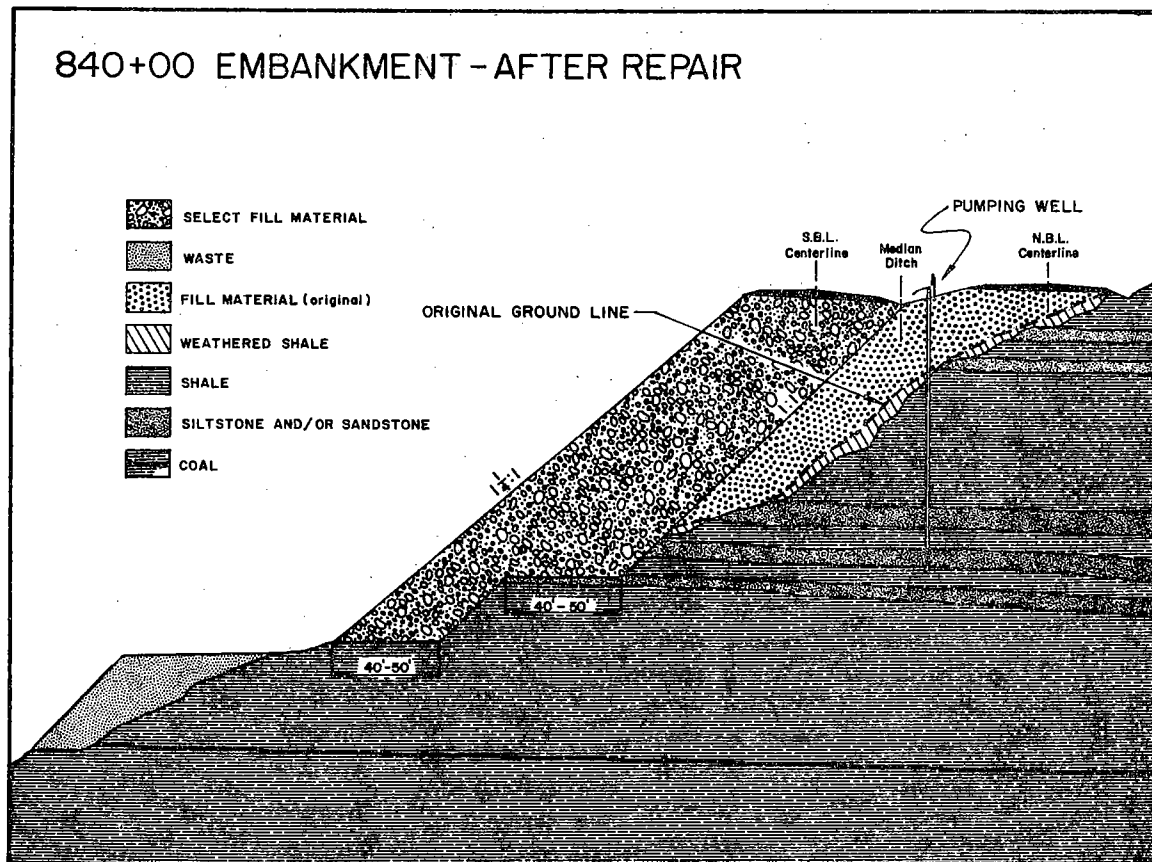
FIGURE 20.

construction of the 840+00 repair on a day-to-day basis .
unanimously agreed that the stability of the median slope
had to be attributed to the dewatering operation.

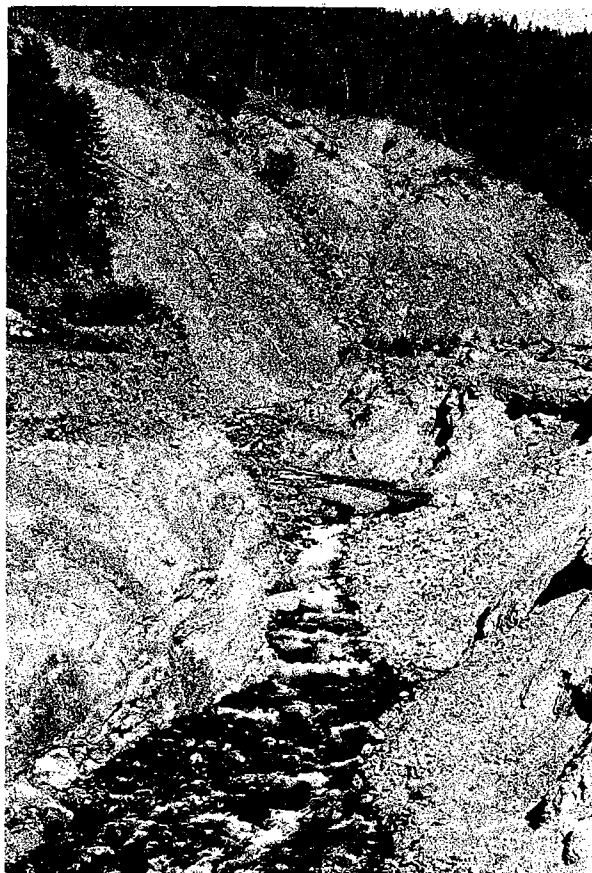
Photo 3

The most immediate damage resulting from the capture of Bluff Creek was the destruction of the segment of State Highway 96 which crossed the breached divide. This damage was costly in terms of the interruption it caused in access to the town of Orleans. Several hundred people were isolated for several weeks while the road was closed. It was also costly in terms of

Gorge formed by rapid downcutting by
Bluff Creek after December 1964 capture.
The gorge is approximately 100 m wide
at the top and 40 m deep.

repair to the road. A 122 m (401 ft) span steel arch bridge costing close to \$1,000,000 was constructed to cross the chasm created by the stream capture.

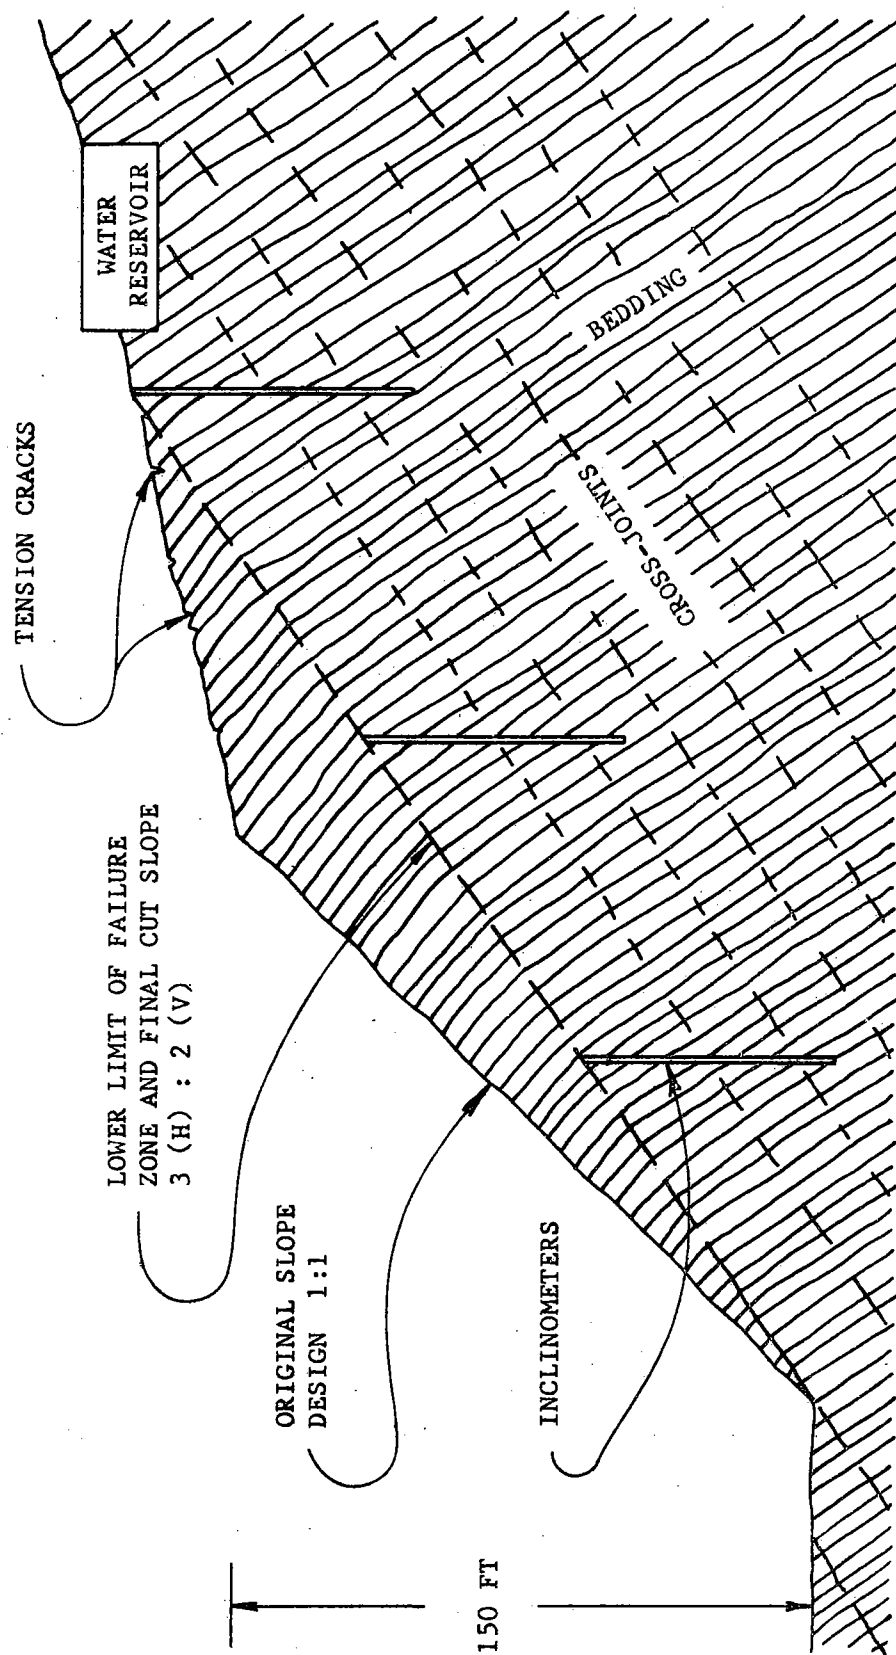
FIG. 8

The first example (Figure 8) is a toppling-type failure of a 150-foot-deep cut, excavated in weathered flysch-type rock. The strike of the bedding is parallel with the slope, and the dip is into the slope. Except for bedding, joints normal to bedding could be observed in the rock mass. They are, however, never continuous, being limited only to one or two layers. The cut was designed at a slope of 45 degrees (1:1), and it failed immediately after the excavation. A series of test pits along the failure axis revealed that the failure had a character of toppling and the cut slope was flattened to an angle normal to bedding.

It should be mentioned that there are no reliable methods available to analyze this type of failure, and that the flattening of the slope was recommended basically according to an engineering judgement. With regard to the uncertainty of the solution and with regard to the water reservoir located close above the cut crest, three inclinometers were installed along the slope to monitor the slope performance. After one year of monitoring, no deformations were observed on the slope.

Toppling-type failures of the same type occurred at several other locations along the highway. Most of them happened in weathered rock and without presence of groundwater. To avoid failures of this type, cut slopes were flattened to angles normal to bedding, wherever possible.

TOPPLING TYPE FAILURE

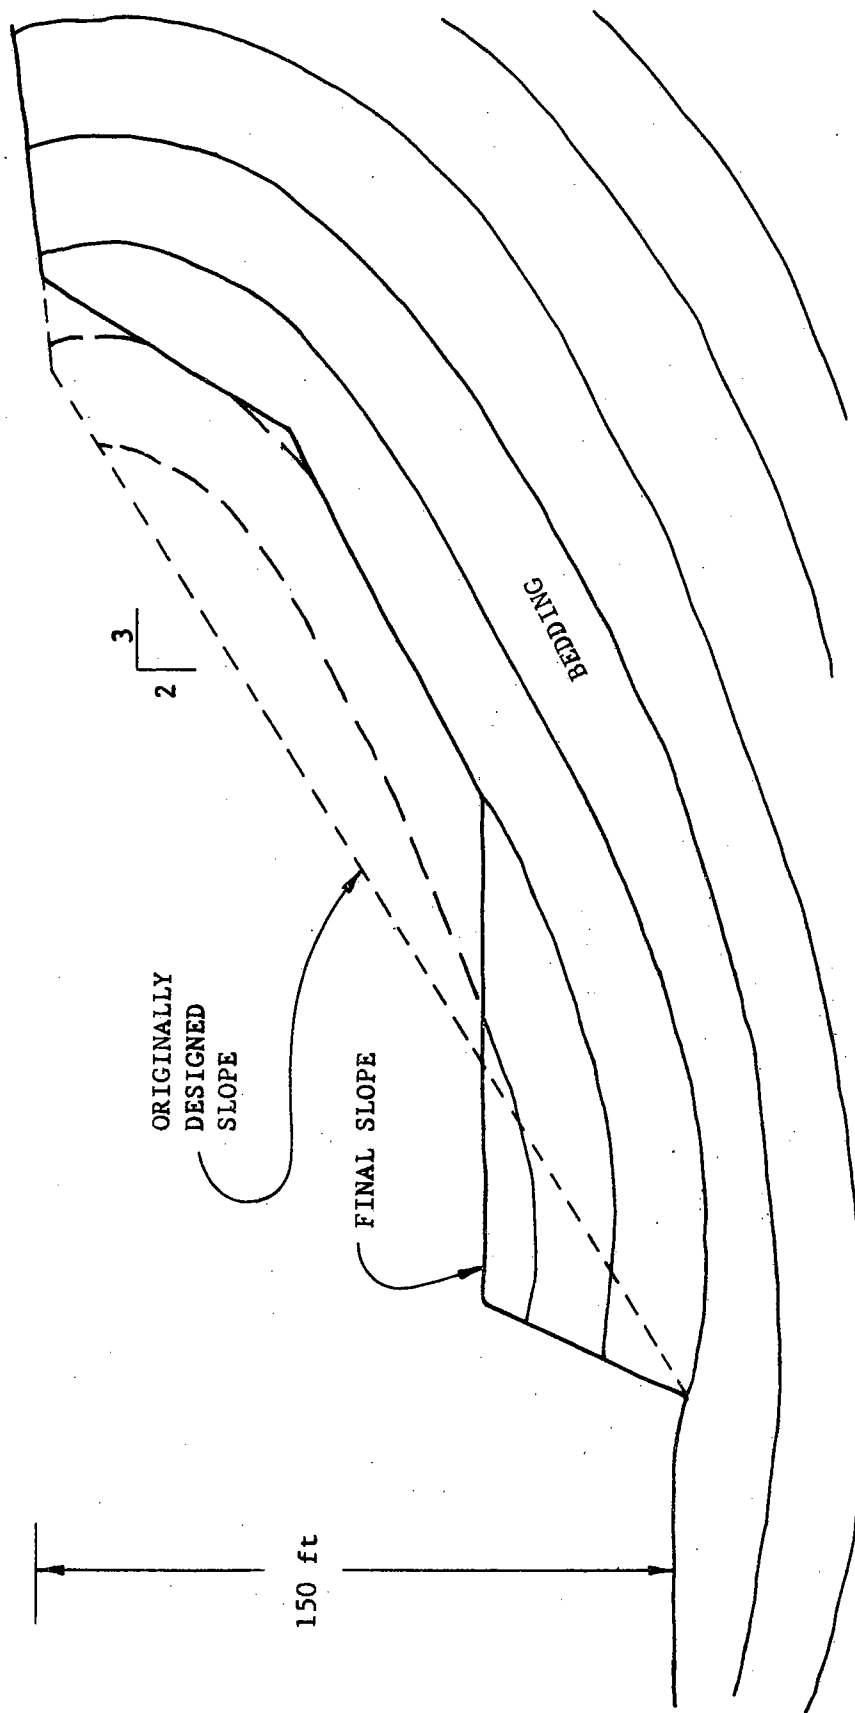
FIG. 9

The second example (Figure 9) is the design of a cut slope in the right flank of a large syncline structure. The bedrock is formed by sound shales where only bedding planes comprise potential failure planes. A cut slope of 2 (V) : 3 (H) was carefully designed using non-circular Spencer's stability analysis. The shearing resistance along bedding was estimated on the direct shear testing apparatus of the Imperial College in London.

During the cut construction, small failures started to develop along bedding planes. Their volume increased with proceeding excavation; and finally, the construction had to be interrupted and the cut slope re-designed.

The safety factor of the originally-designed slope was lower than one, and the cut was re-designed as indicated on Figure 9. A sufficiently thick loading berm was left at the lower third of the cut slope. The middle portion of the cut was excavated along bedding.

DESIGN OF A CUT
IN A SYNCLINE

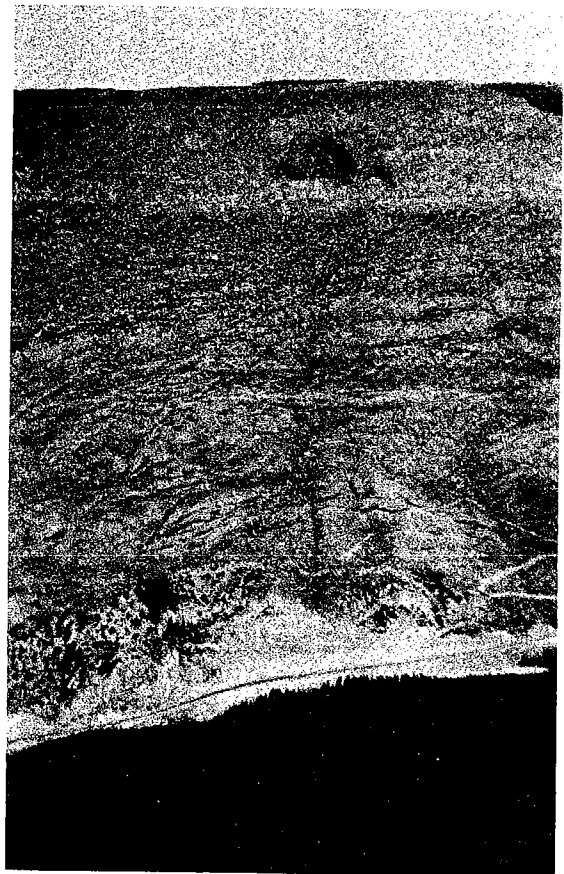
Fig. 2. Oblique view of slide area Sta. 661-683. Note relict slide features nearly duplicating present slide and straight line of supposed joint or fault extending from the slide area to the skyline. Faint scar in middle area is location of a drain line intercepting springs above slide.

Study of air and ground photography revealed that the present slide scarp almost exactly occupied the crescent scars of earlier movements. The photos also show a straight line, displayed as a green line of lush vegetation, extending all the way to the canyon rim (Fig. 2). This may be a fault or major joint. Along this line springs appear and disappear several times with continual surface flow only at the wettest seasons. The line intersects the crescent scars near their center. It is theorized that the water split and went both ways along the relict scarps to emerge as springs and seeps, with the most of the volume at Sta. 661. One of the first steps in controlling this slide was to trap as much of this water as possible where it was on the surface, some 1500 feet upslope from the head of the slide, and divert it through a pipeline into another drainage outside the slide area.

The remainder of the solution to this slide can best be called relocation or avoidance. The former road location is now covered by slide material and buttress earthfill. Shell Creek originally ran in a deep granite gorge about where the present road now lies between approximately Sta. 662 and Sta. 672. The stream bed was shifted about 100 feet south in a channel cut into the granite rock. At the same time the gradient was flattened to 2% so that a waterfall was created at the outlet (Fig. 3). The channel upstream was then filled to conform to the new gradient. This provided a buttress fill which controlled the large mud wave which had developed in the creek bed. It also provided space for a large volume of waste soil material and has made fishermen access and parking possible where none existed before.

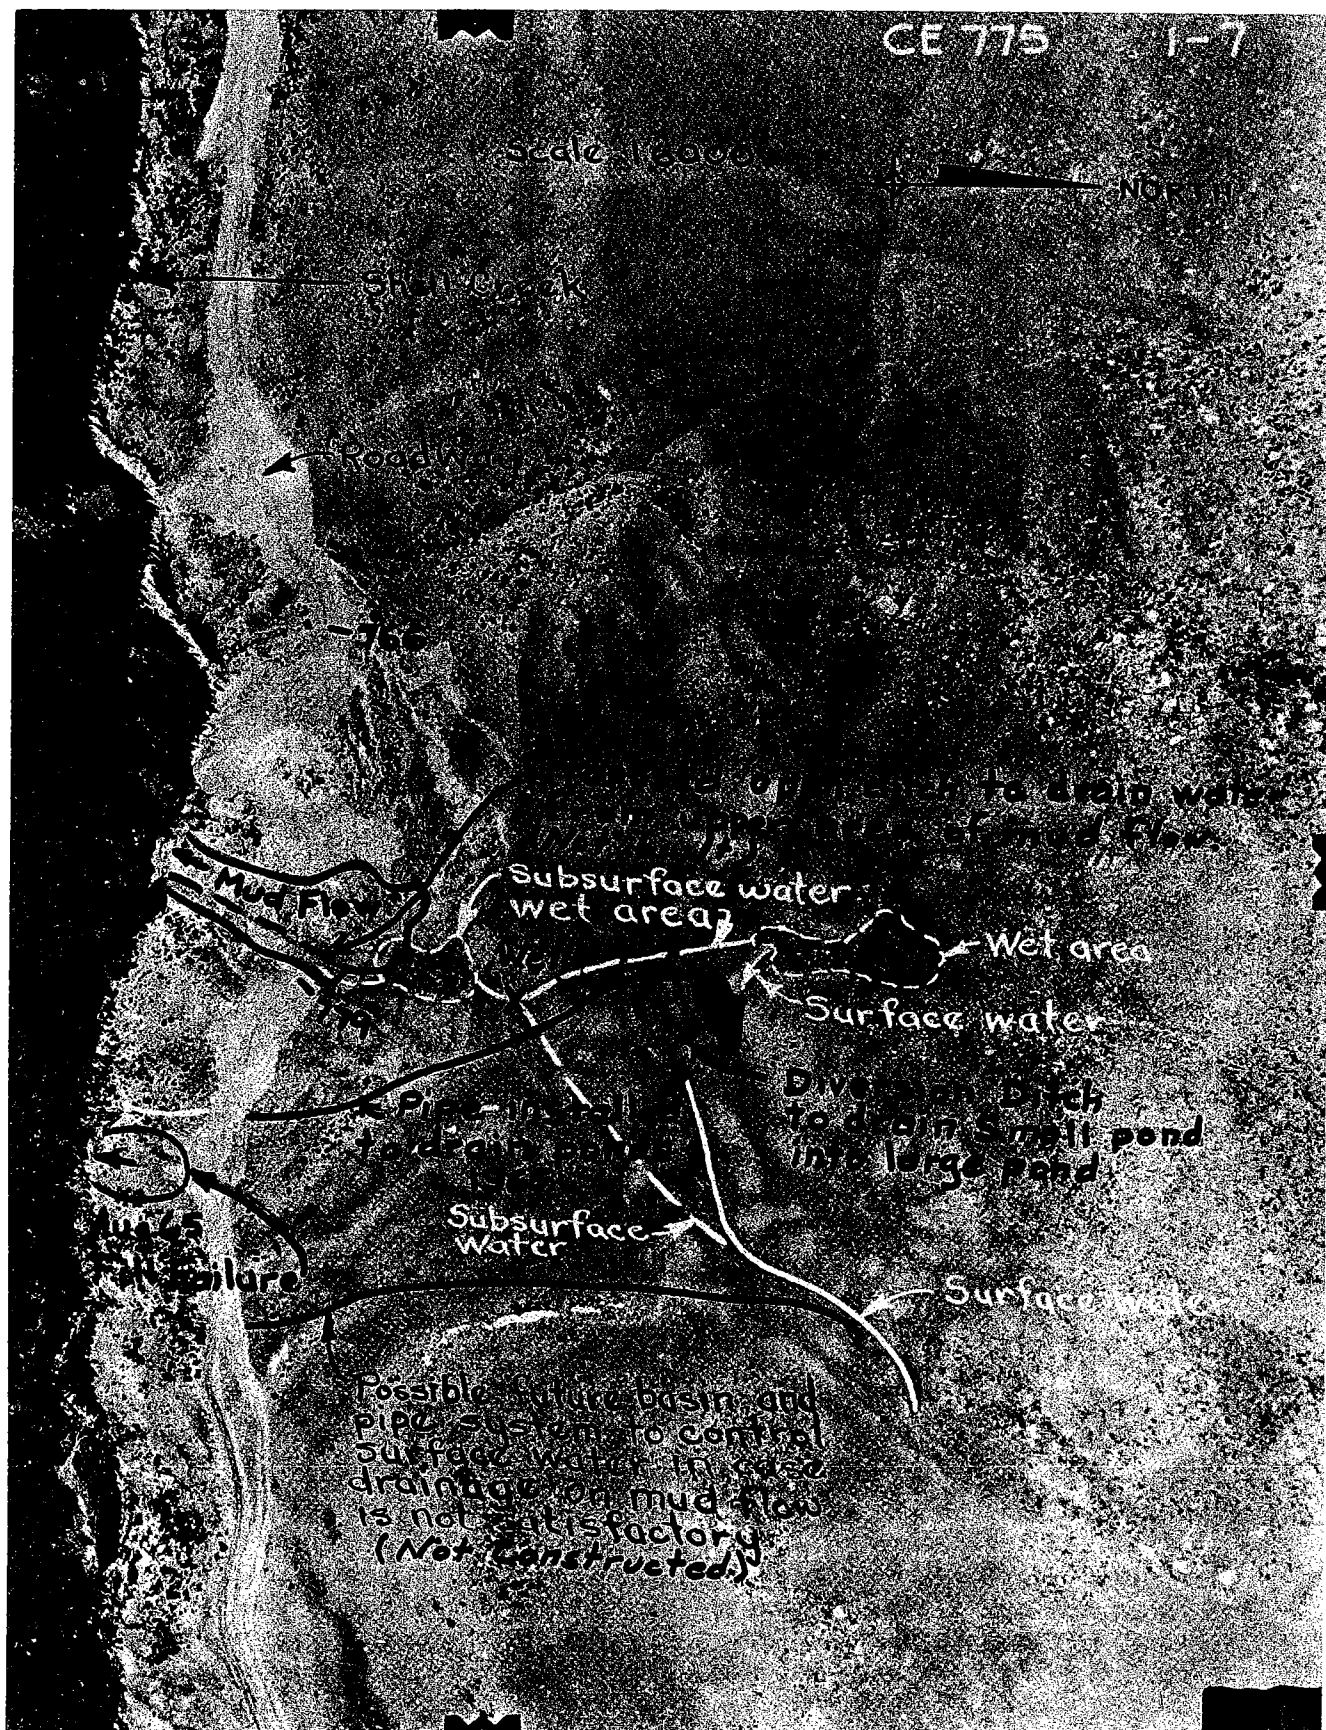
Fig. 5. After Sennett. Vertical air photo of major slide area showing several remedial measures proposed early in the studies. Eventual location of relief well was near the intersection of dashed lines above the head of the mudflow.

While there was initial opposition to draining ponds which served livestock and game and which were seemingly a long distance from the slide, this was done since it was abundantly evident that they contributed to the mudflow problem. The smaller was trenched into the larger pond. Spring boxes were placed in the larger pond and a buried pipeline took the water around the slide area into a roadside culvert where it was released. The ponds have never been allowed to refill though springs in the area were still active and the water diversion was not total, up to the start of pumping in the drainage well in 1971.

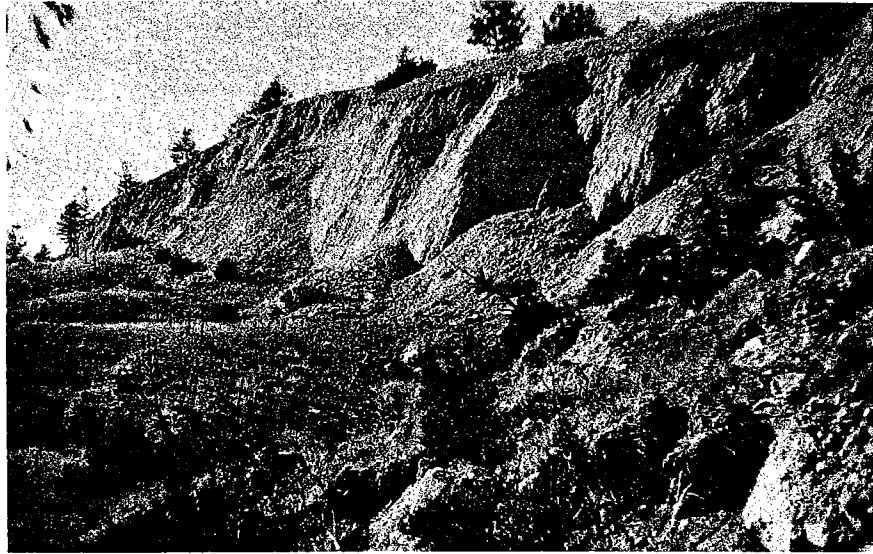
The toe of the slump also reached Shell Creek. The upper units of the slump area were dropped almost vertically about 60 feet and the head-scarp remains almost unchanged (Fig. 6). The upper units were nearly intact and contemporary photos show a long section of fence and several undisturbed trees on these units. The lower units were badly jumbled and subsequent adjustments have further reduced them.

Fig. 6. Contemporary view of upper unit and headscarp near Sta. 770. Scarp is more than 60 feet high. Note undisturbed fence on slump block.

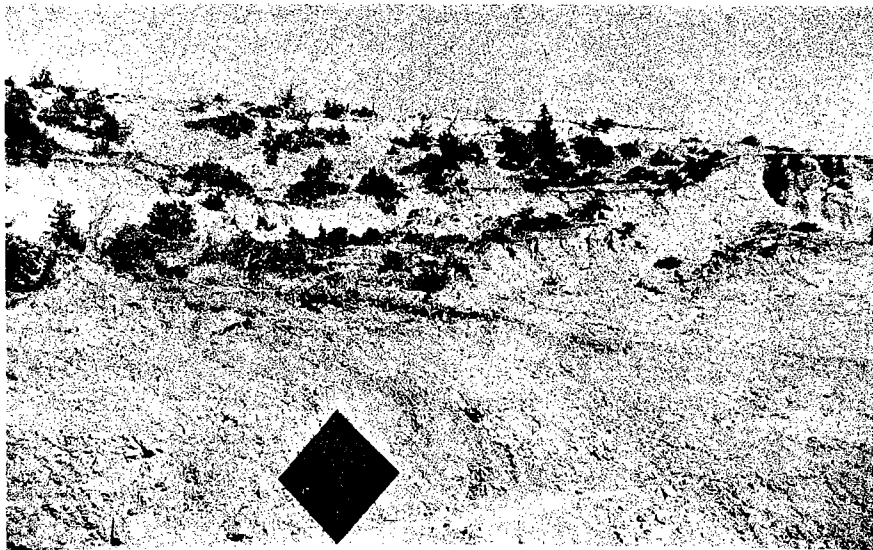
Fig. 7. View up from restored road near Sta. 776 showing face of major slump area.

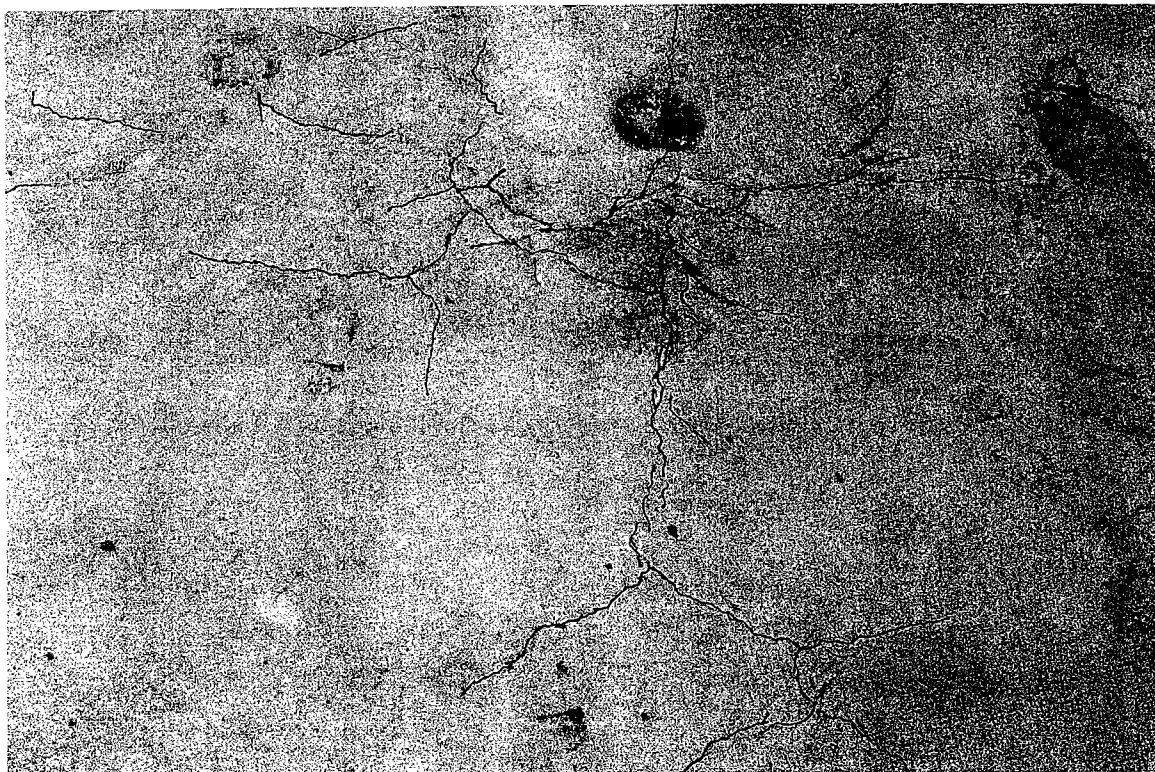
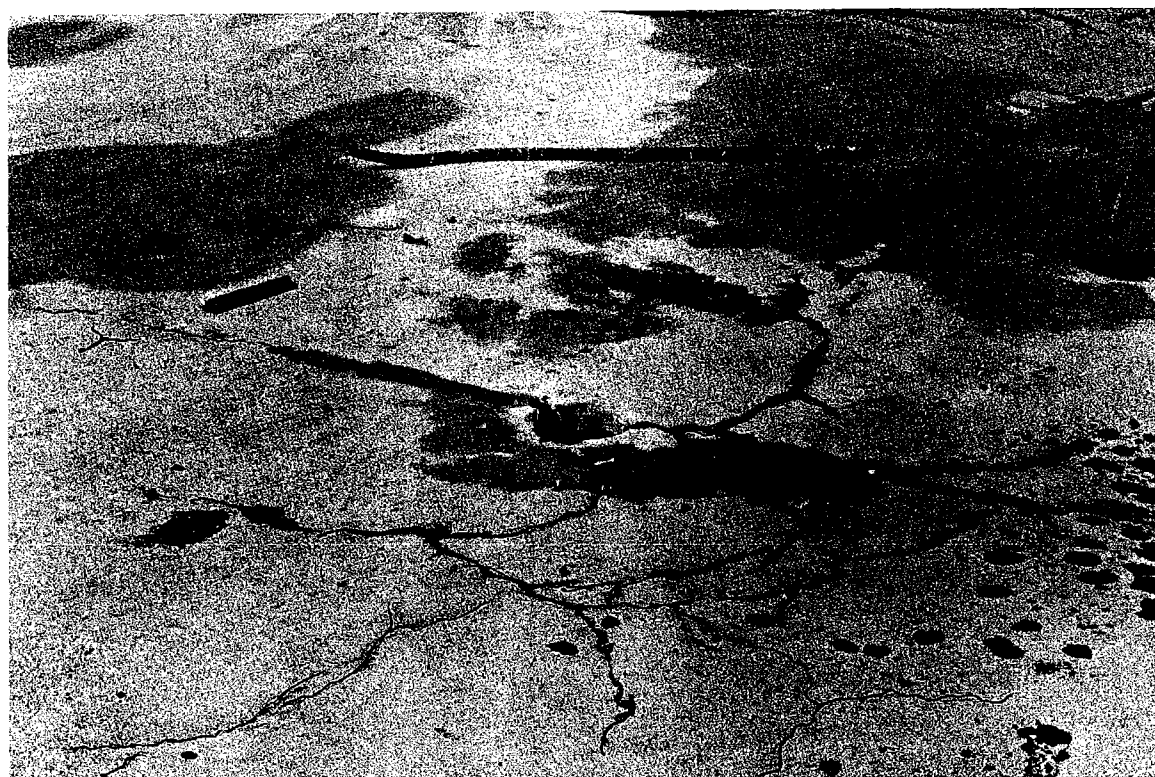
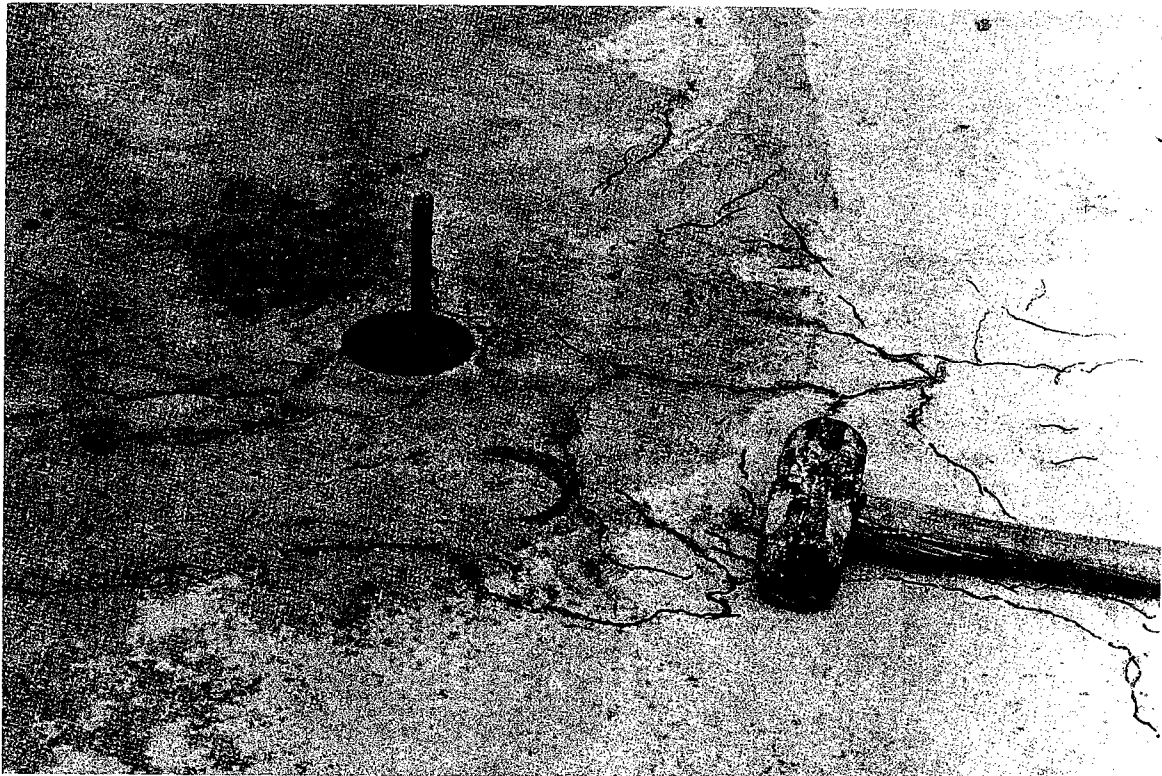
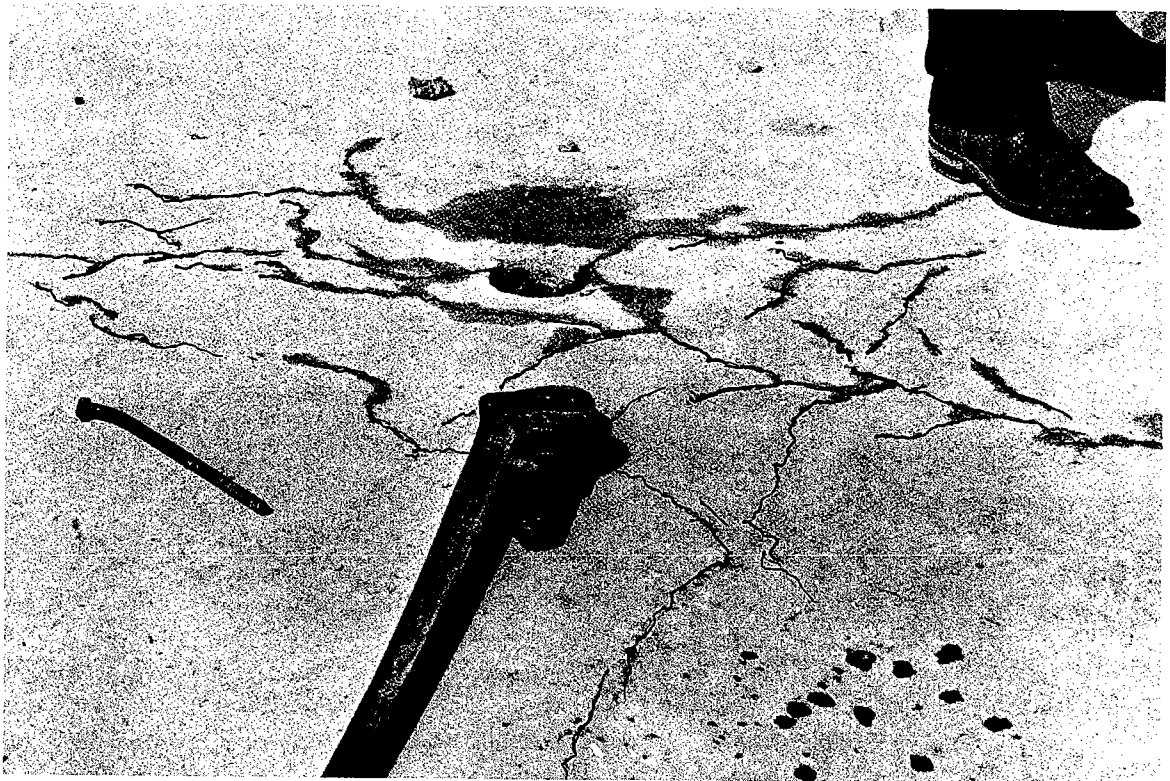
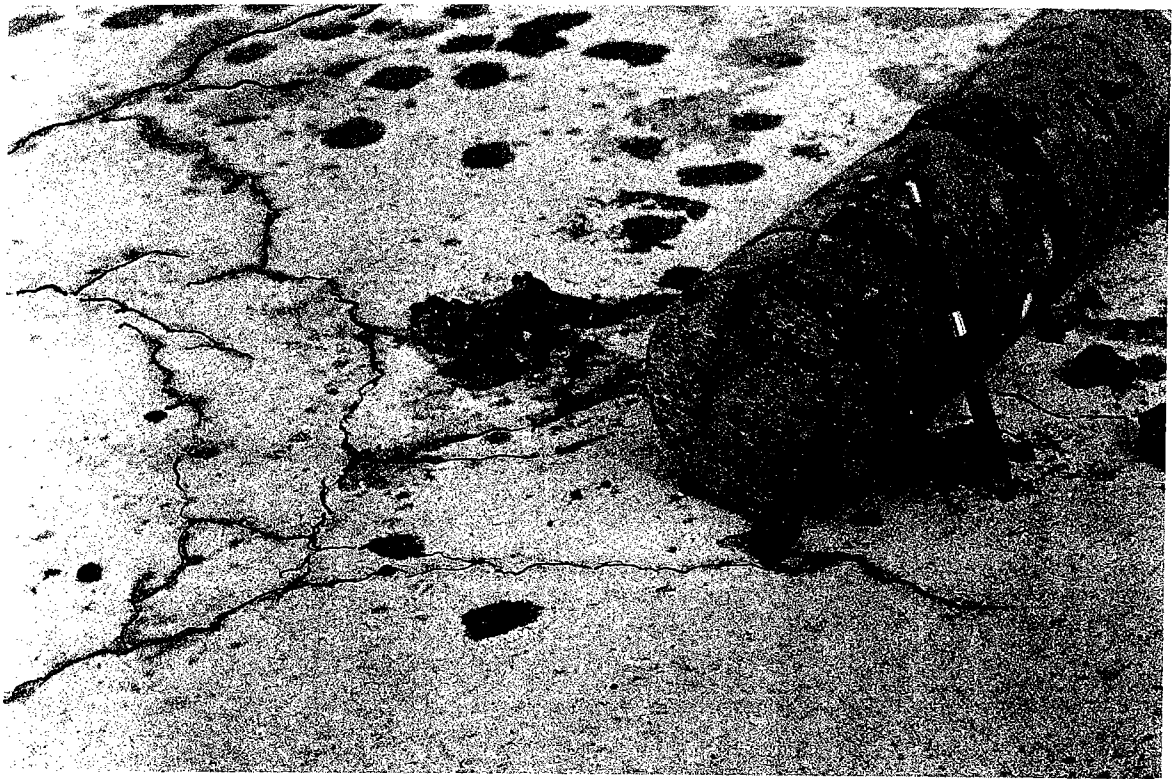
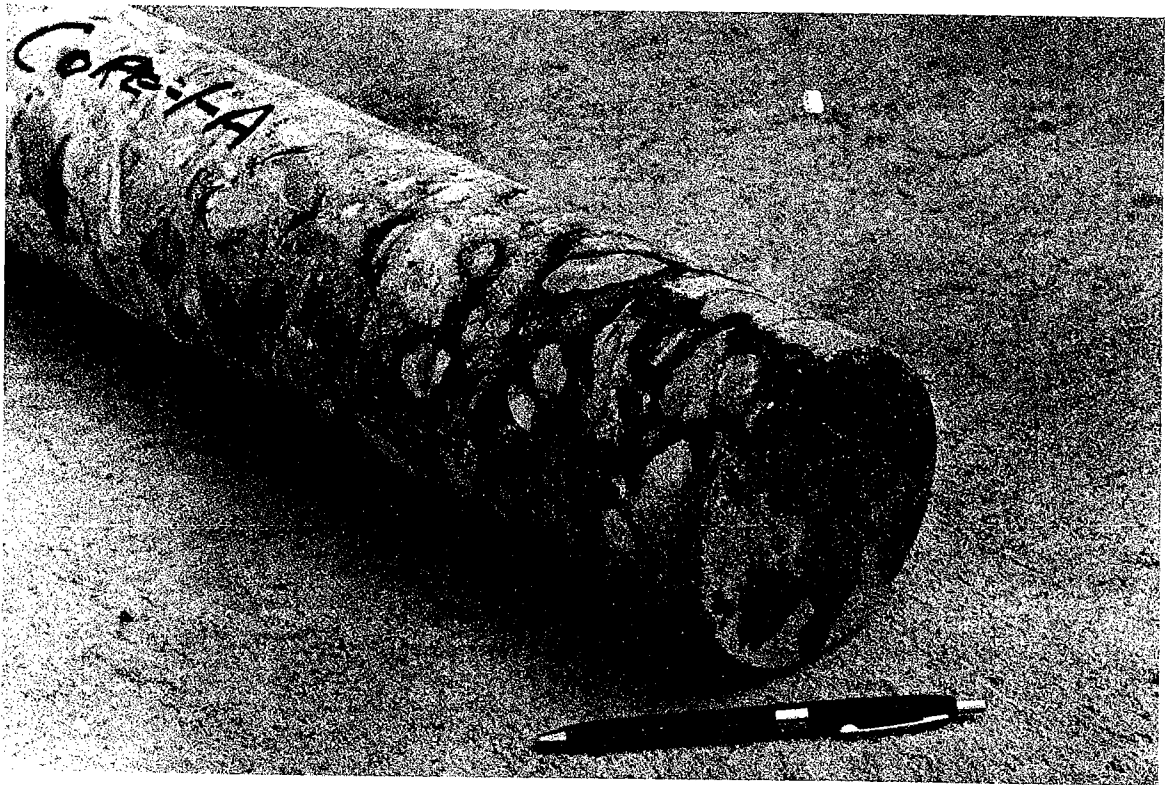
The condition of the deck surface and cores examined for this investigation, documented by personnel from the Houston Urban Office, can best be seen in the photographs taken during their on-site inspections during May 1972. The photos, shown as Figures 2-7, illustrate the distress cracks, which occurred in the unstable concrete as a result of the incorporated unsound cement, as well as show the condition of the cores removed from the deck. As can be seen, the crack patterns occur in localized areas a few feet across and sometimes show lineation when influenced by the underlying reinforcement.

The crack patterns range in size from those shown in Figures 2-5 of the bridge deck, to hair-line cracks as those covering the entire surface of the column (Figures 26 and 27), down to the microcracks noted in the paste from all the examined structures. Especially, unusual are the "septa-like" cracks found in several air voids of the column. These unusual microcracks shown as Figures 28, 29 and 30 appear to have been formed before final-set of the paste and "healed" as calcium hydroxide solutions were forced into the void space and solidified. Microcracks were also noted throughout the retaining-wall samples. Large cracks visible on the top of Core VI-A removed from the bridge deck were easily traced to depths of about 10 inches. Several pronounced horizontal separation cracks were found some 6 inches from the bottom of the core, but were not associated with the rebar (Figures 31 and 32).

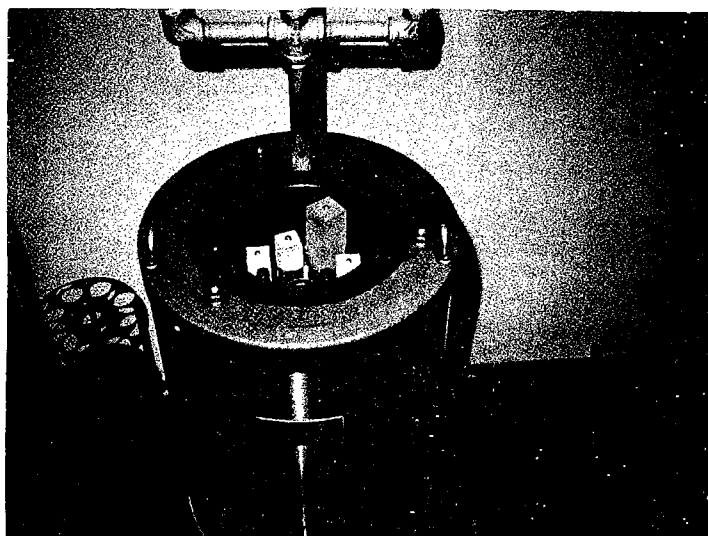
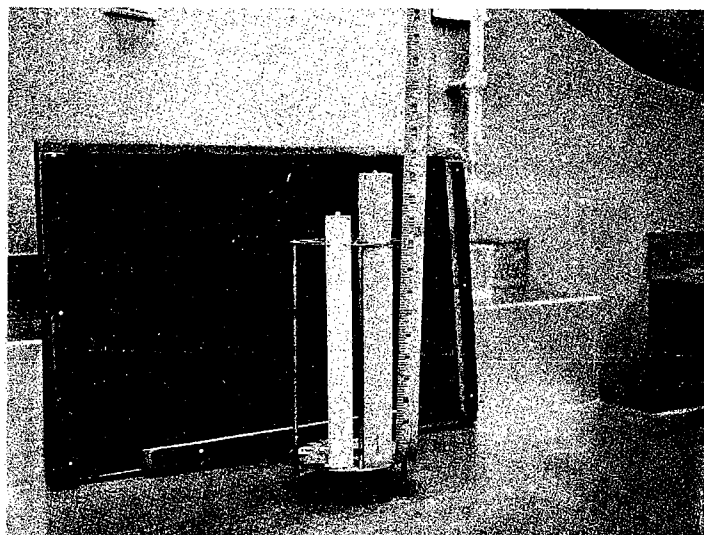
Of the seven cement samples listed in Table II, two exhibited approximately 20% expansion when subjected to the autoclave test. Figures 14 and 15 show prisms cast with normal and the unsound cement (#72-2321-D) as observed in the autoclave and after removal. Figures 16 and 17 illustrate results of the autoclave test on a number of unsound prisms. The relative amounts of expansion can be easily compared with a "normal" prism. Figure 17 shows a prism made with cement from sample #72-2349-D which still exhibited 20% expansion even after the cement was aerated for three days.
