PROCEEDINGS OF THE 24th ANNUAL
HIGHWAY GEOLOGY SYMPOSIUM

SHERIDAN CENTER
SHERIDAN, WYOMING
AUGUST 9-10, 1973

Sponsored By
WYOMING STATE HIGHWAY DEPARTMENT

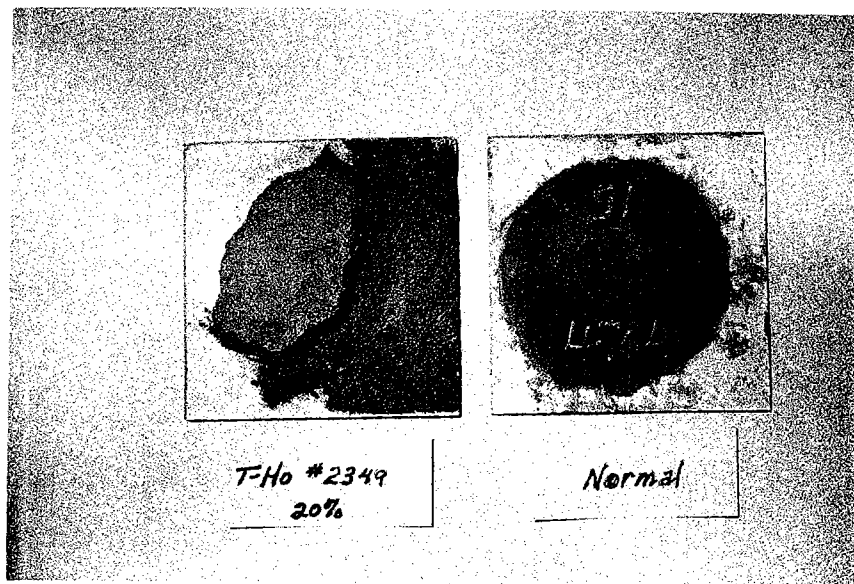
Fig. 18

Results from samples being subjected to the pat-boiler test are best illustrated by Figures 18, 19, 21 and 22. A neat-cement sample made with the unsound cement (#2349) completely disintegrated when it was subjected to the pat-boiler (steam bath) for 5 hours as shown in Figure 18. The sample was cured in a moist chamber for 24 hours. A normal control sample which exhibited no expansion is also shown for comparison. Figure 19 shows exudations that were observed on the bottom of one of the neat-cement samples (#3137) after being subjected to the steam bath. Figure 20 shows a similar type of exudation observed on the surface of a piece of concrete (from the bridge deck) which had been subjected to the autoclave test.

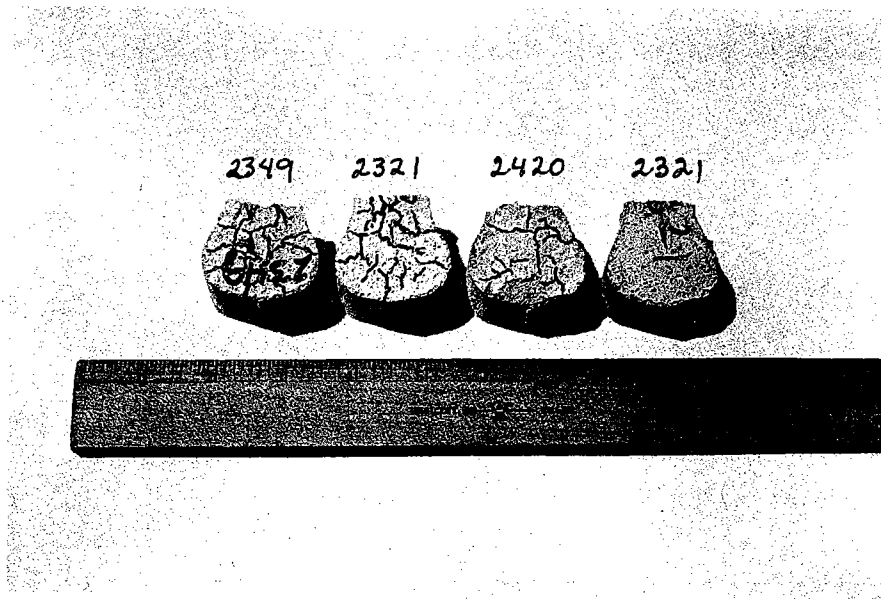
Fig. 21

Figures 21 and 22 illustrate the effect of 5 hours of steam on briquettes made with the unsound cement. An untreated briquette is shown on the far right for comparison in Figure 21. Photomicrographs taken at 4X show details of the crack pattern as observed on the curved sides of specimen #2321 in Figure 22; a close-up of the untreated sample showing a crack-free condition is illustrated as Figure 23. Briquettes containing the bad cement (#2321 and #2349) cured 7 days in water and left exposed in the laboratory for 5 months still showed to be unsound by the autoclave and steam-bath tests.

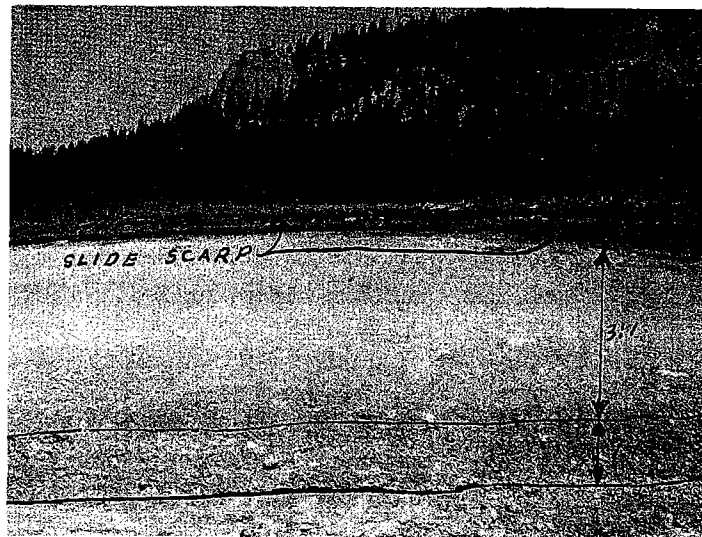
Figure A

During installation of the underdrain, a backslope failure occurred which was caused by severing the slide plane with the underdrain ditch. The movement involved approximately one million cubic yards, with the scarp located 600-700 feet left of centerline.

Slide area showing scarp and cut slopes

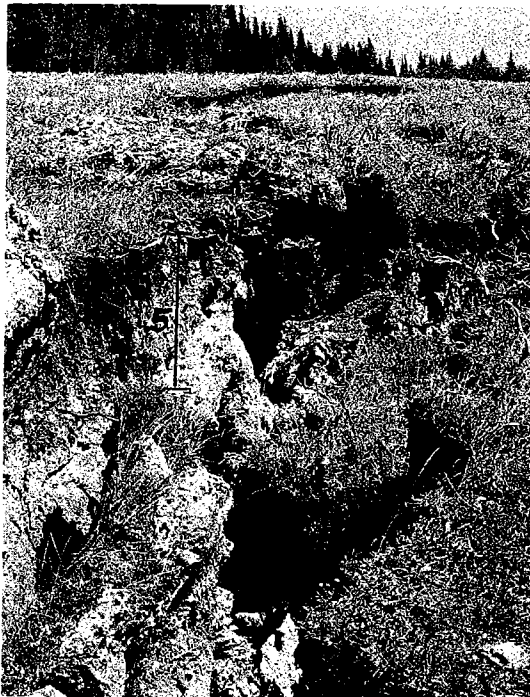
Figure B

Note flat terrain of scarp
area shown above

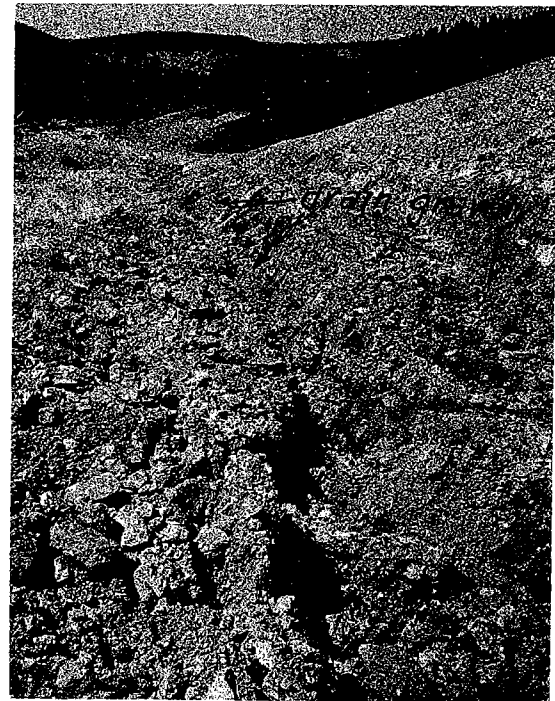
Figure C

Photograph above shows former location
of underdrain trench closed by the
slide. Drain gravel was forced up by
compression in completed section.

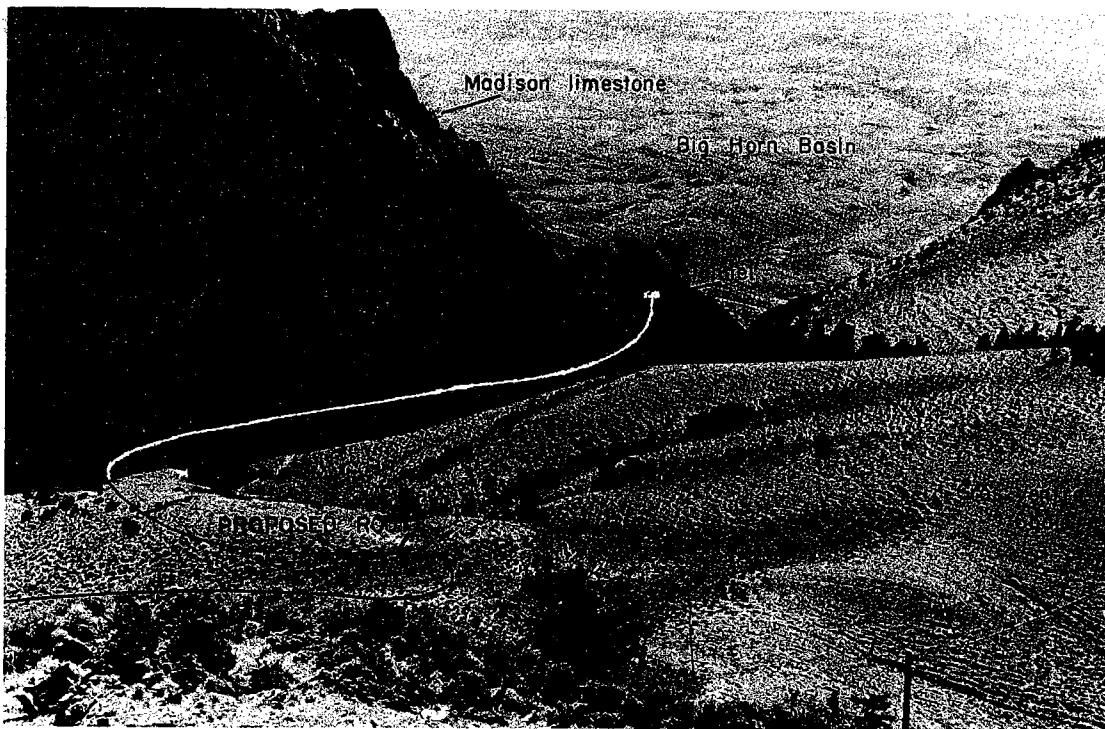
Figure G

The proposed highway construction project viewed in part at this stop, is located on the west slope of the Big Horn Mountains. The new alignment avoids unstable slide areas to the north along the existing highway; although, problems concerning fill stability and backslip design in jointed, hard rock (granite and limestone) arise in certain areas of the proposed alignment where line shifts to avoid these problems are essentially impossible (see figure G).

View of proposed highway, looking west toward Big Horn Basin

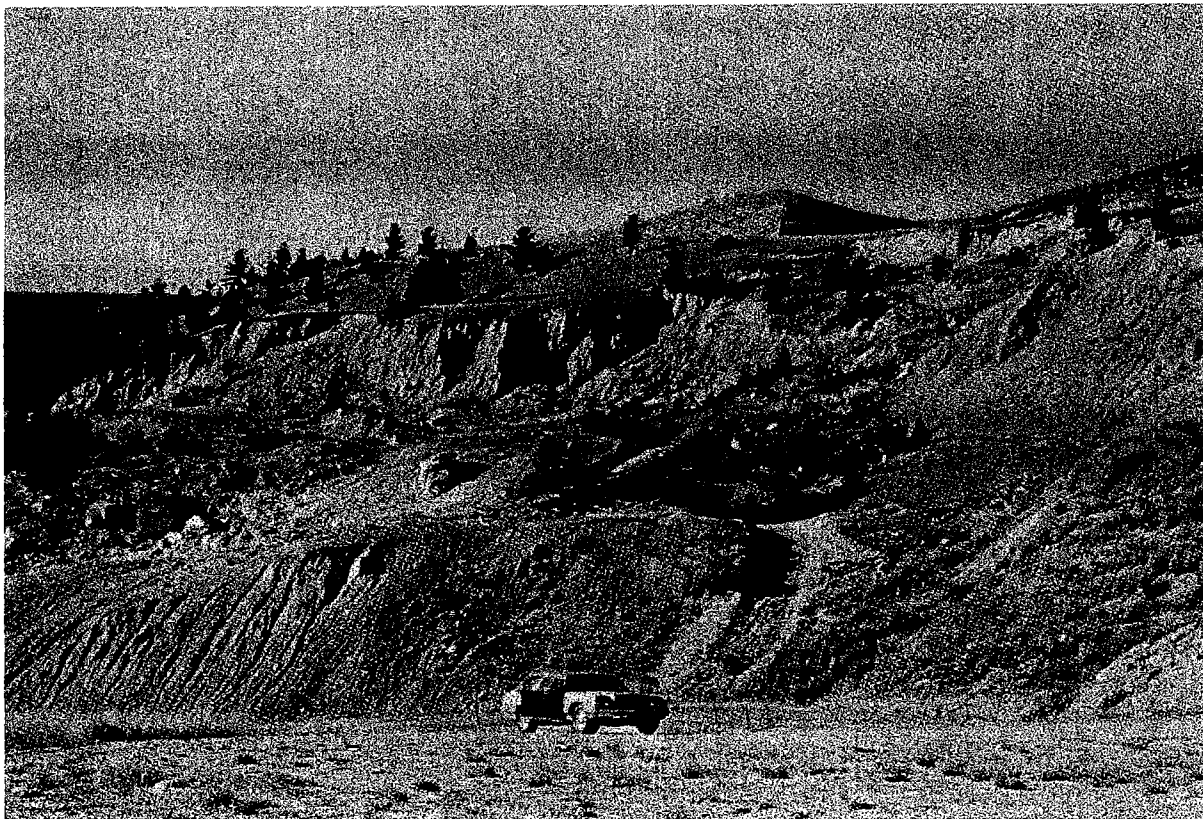
Figure J

Shell Canyon Slide Area

This stop affords a good view of the Shell Canyon slide area which is located on the southwestern flank of the Big Horns. The slide, which failed during road construction, lies within an older, very large slide zone. The formations involved are of Cambrian age as in other areas visited. The discussion at this stop will include the history and the remedial action taken during and subsequent to construction.
