PROCEEDINGS

HOMESTAKE'S GRIZZLY GULCH TAILINGS DISPOSAL PROJECT

Mark C. Carrigan - Dames & Moore
David R. Shaddrick - Homestake Mining Company

ABSTRACT

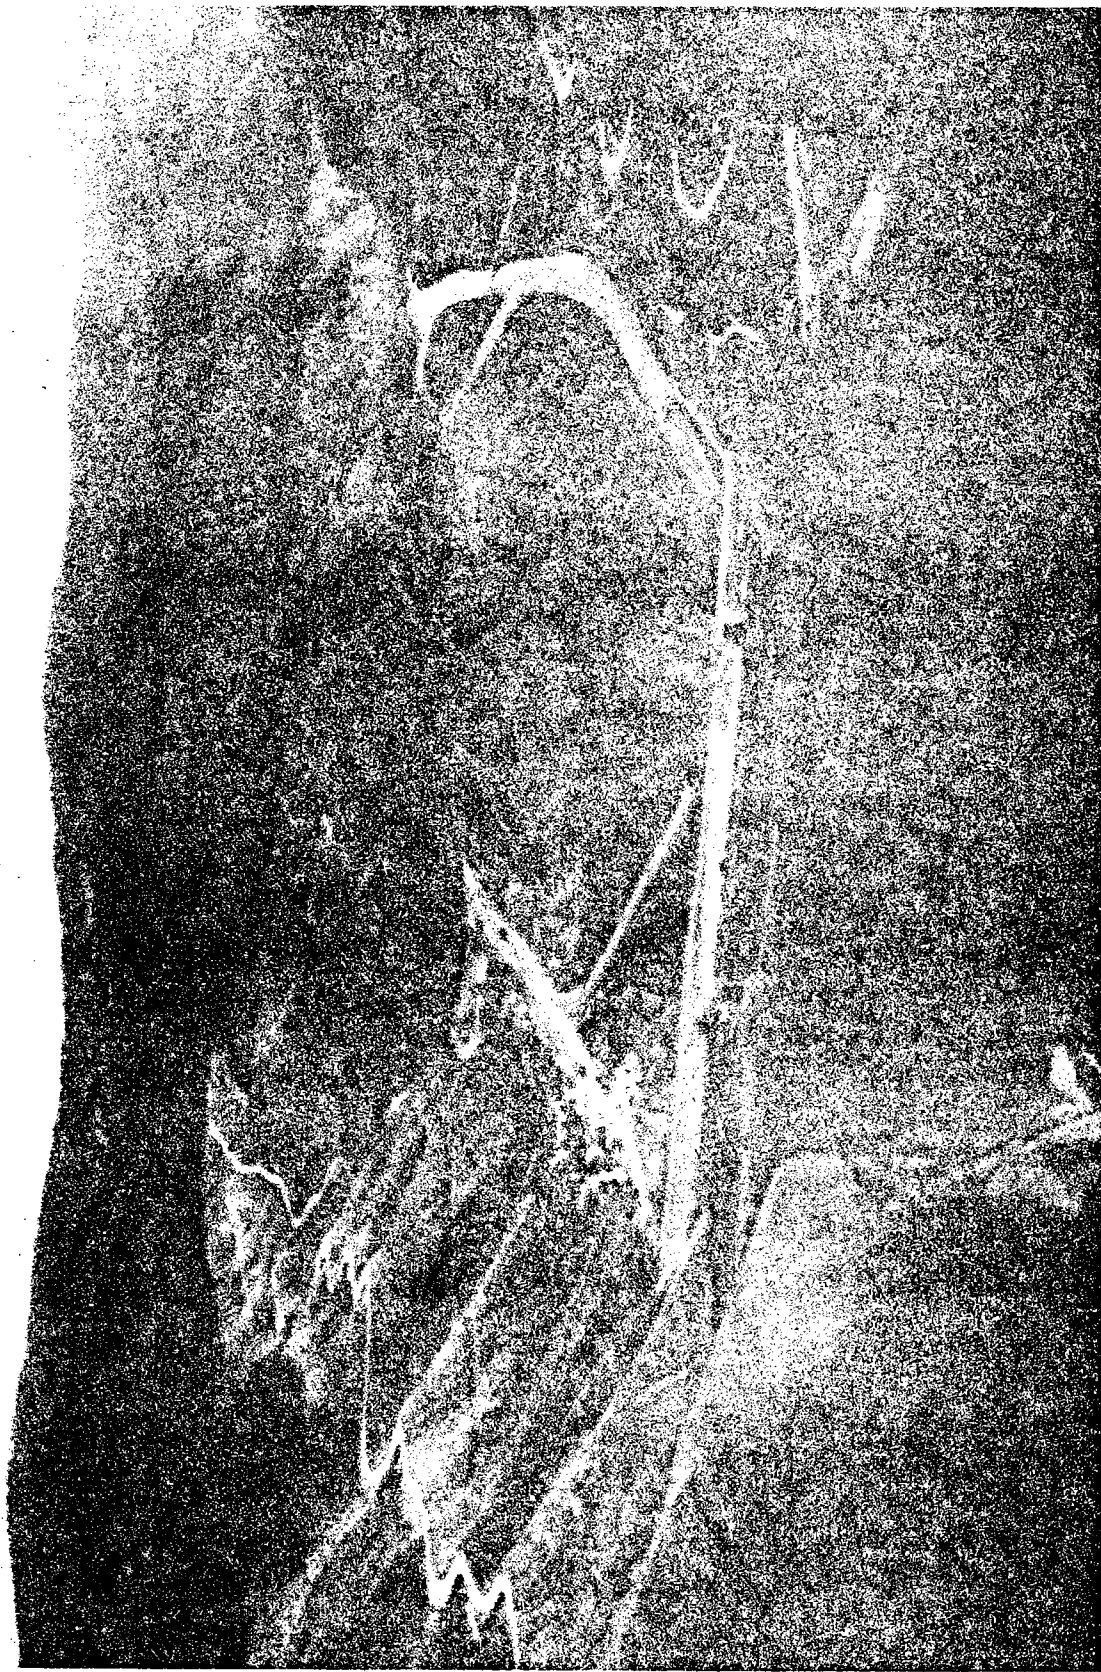
Figure 10. Aerial of Dam. (under construction)

Work on the project actually got underway in March, 1976, and is scheduled to be completed in the fall of 1977. Upon completion the Grizzly Gulch Tailings Disposal Project will provide an environmentally safe repository for Homestake's tailings for decades to come, and it may well provide a model for other firms with similar waste disposal problems (Figure 10).

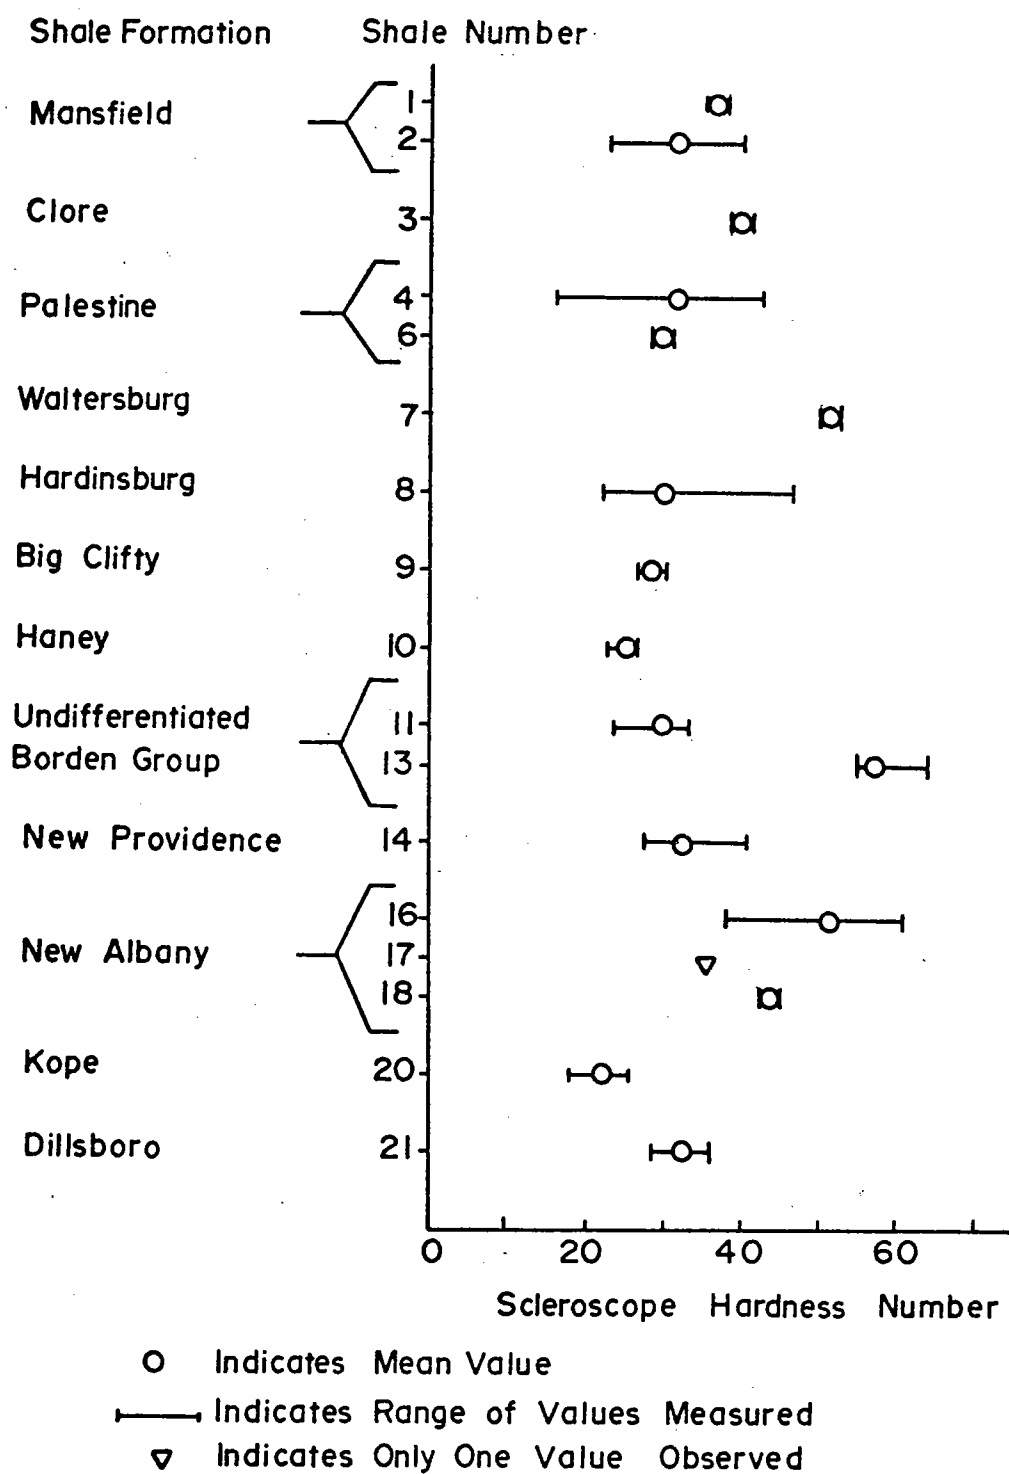
FIGURE 5 AVERAGE VALUES AND RANGE OF SCLEROSCOPE HARDNESS FOR VARIOUS SHALES AT ZERO MOISTURE CONTENT.

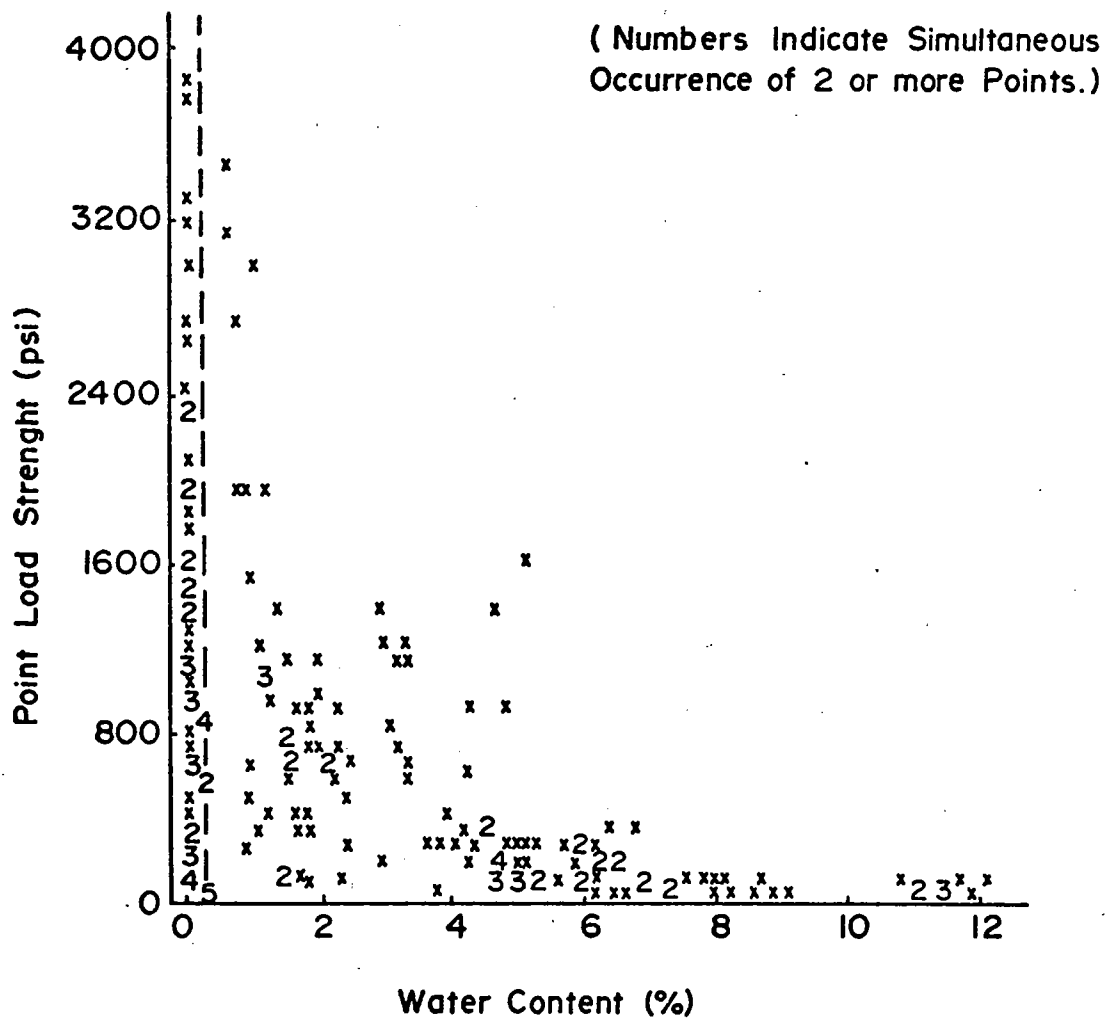
FIGURE 7 VARIATION IN POINT LOAD STRENGTH WITH WATER CONTENT FOR ALL SHALES TESTED.

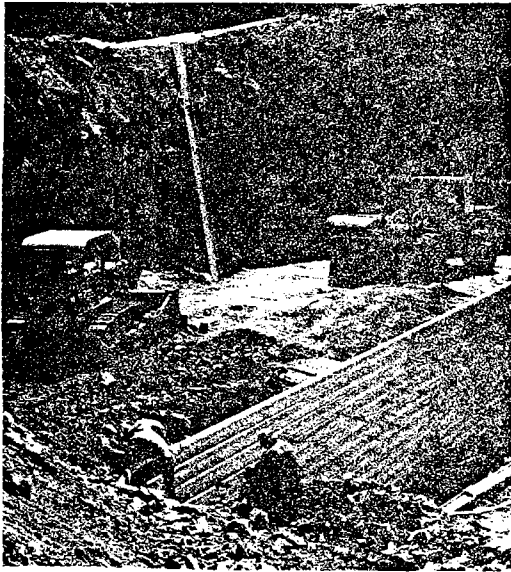
Photo 4. Erection of facing elements and backfill operations.

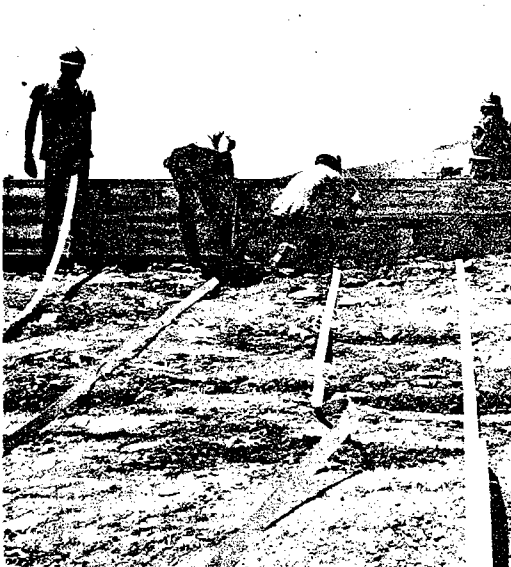
Photo 6. Attaching reinforcing elements to 13 inch face "skins".

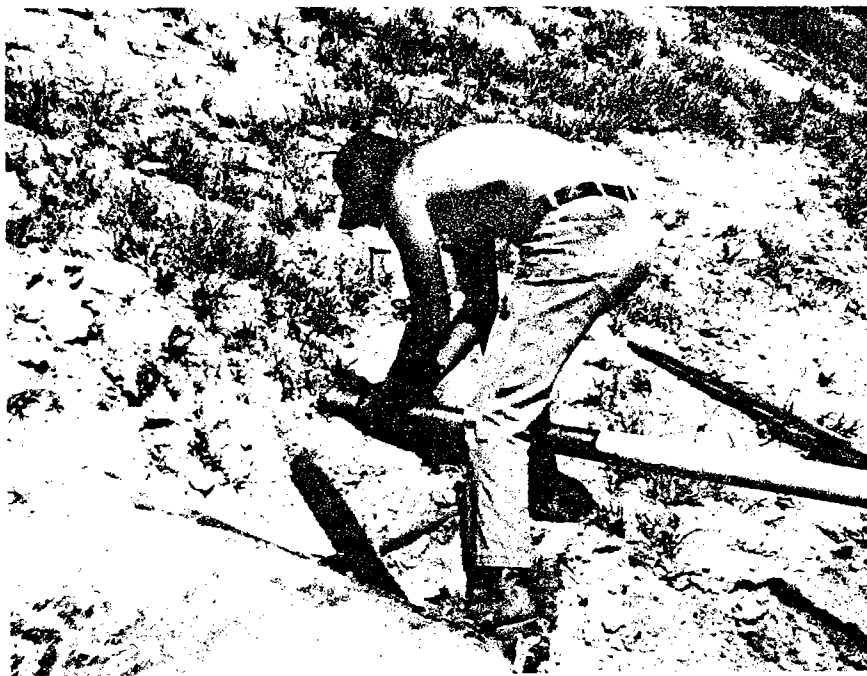
Figure 4. Air hammer on the end of the drill rod is being positioned to start a hole.

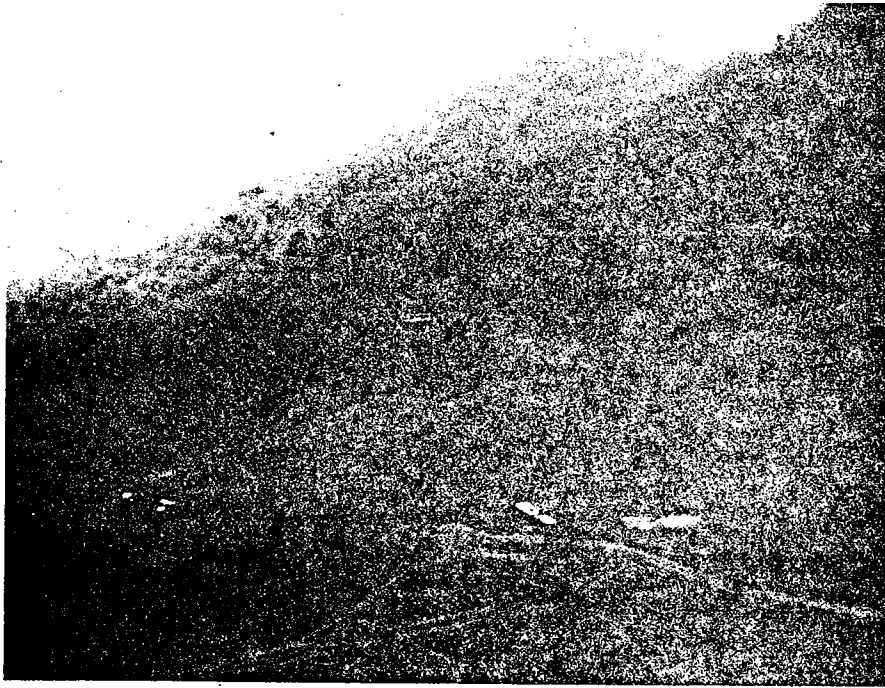
Figure 12. Construction of the counterweight at the toe of Slide Area 7. Tower is about 50 feet behind the slide.

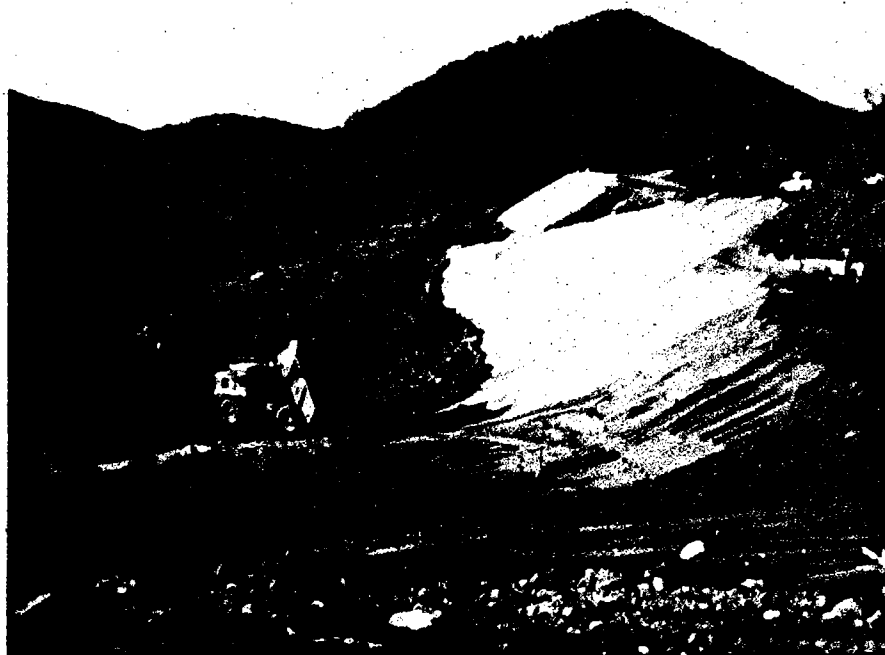
Figure 15. Embankment material being placed over sand and stone blanket. Lighter material is stone; the darker, sand.

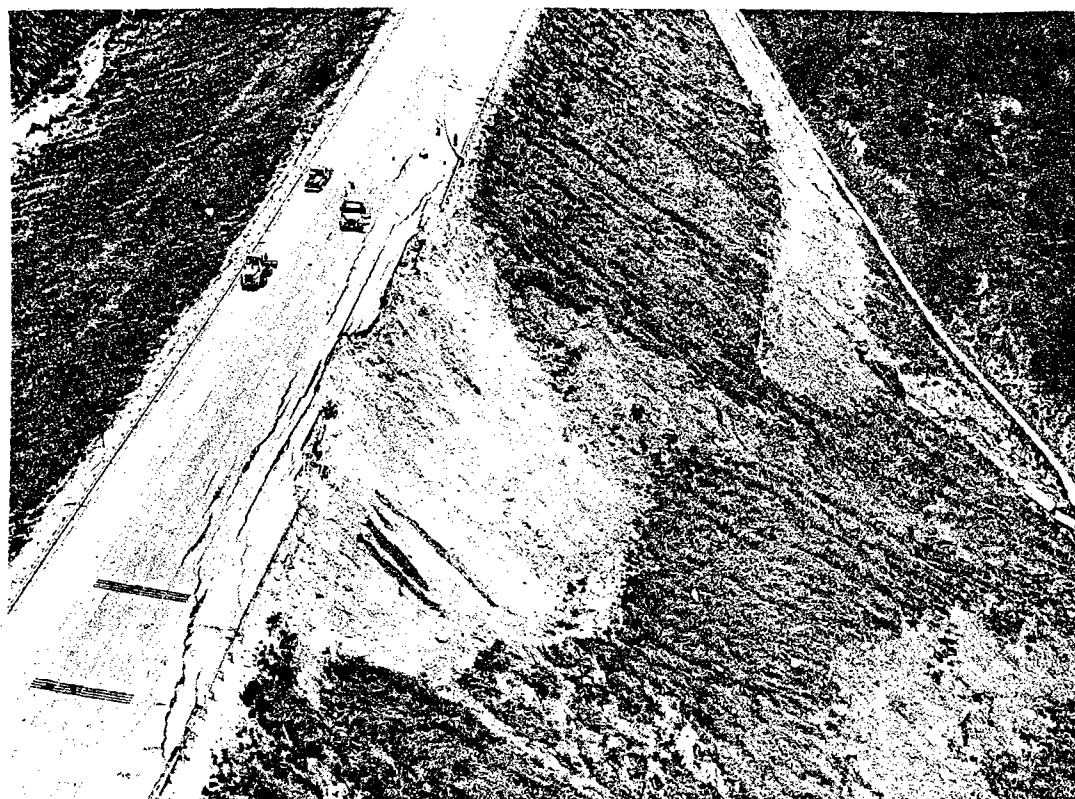
Figure 12. Aerial View of a massive Fill Failure along I-75 in Campbell County.

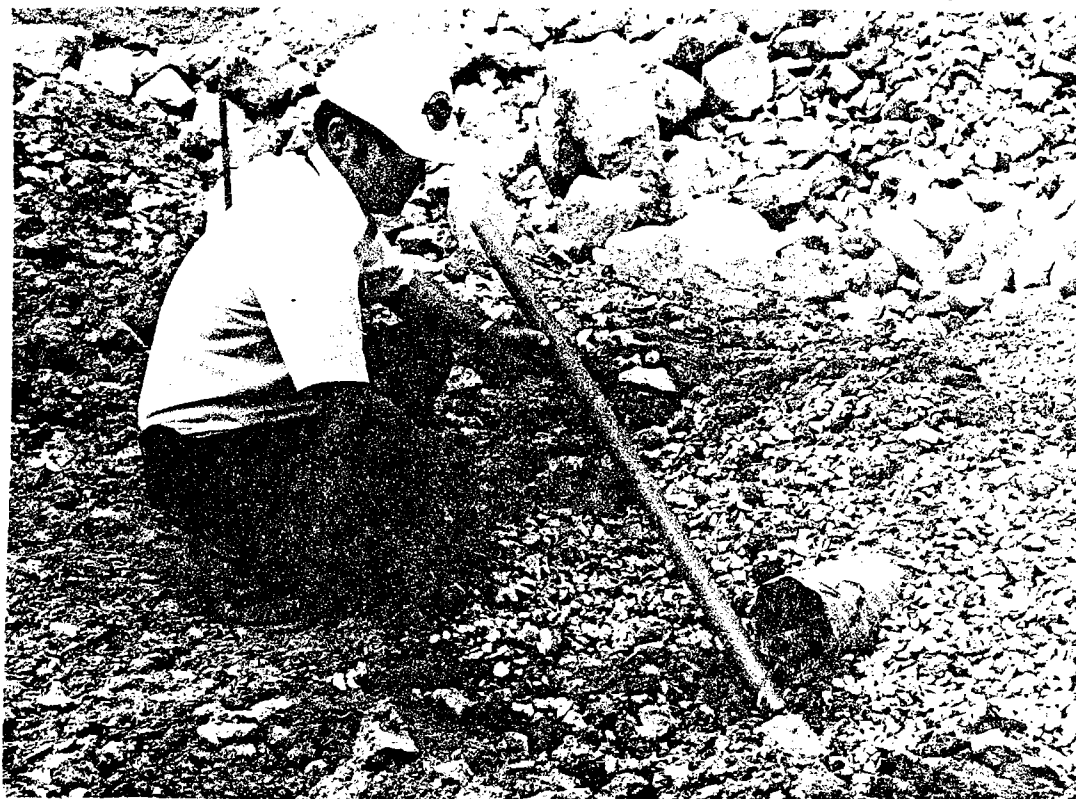
Figure 14. Water issuing from a Horizontal Drain installed in the 1464+00 slide.

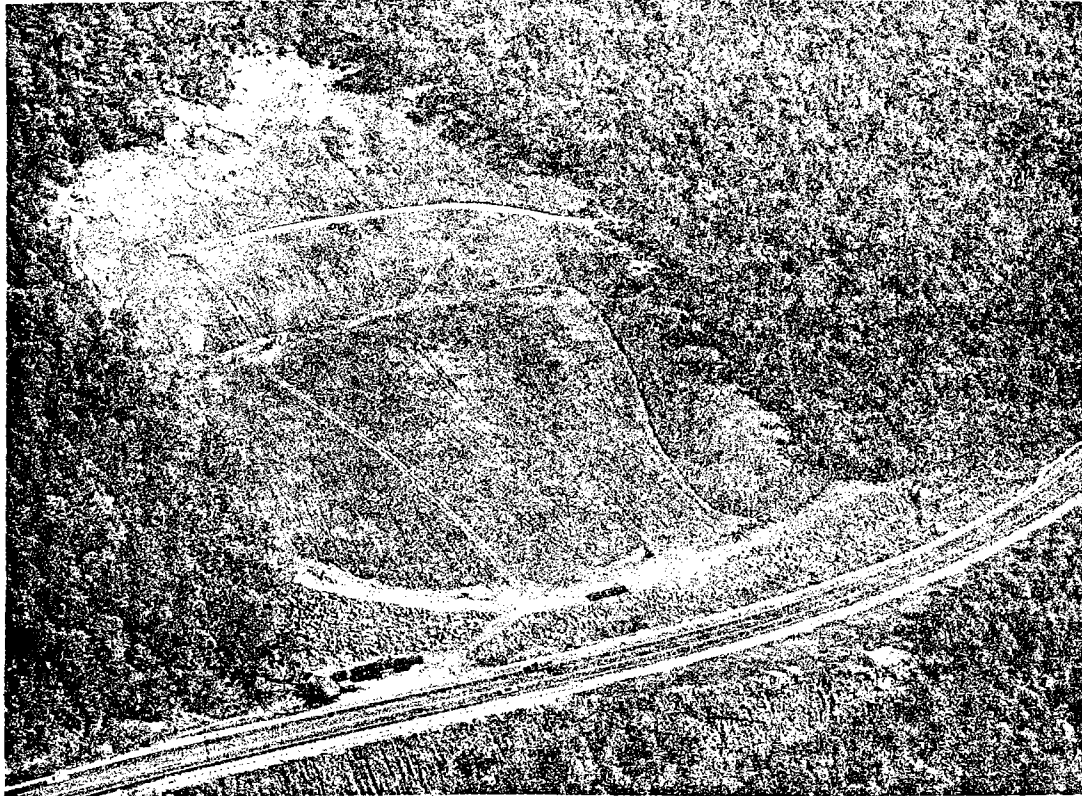
Figure 23. Aerial View of Repaired Slide #8 Along I-40 at Rockwood (see Figure 22).

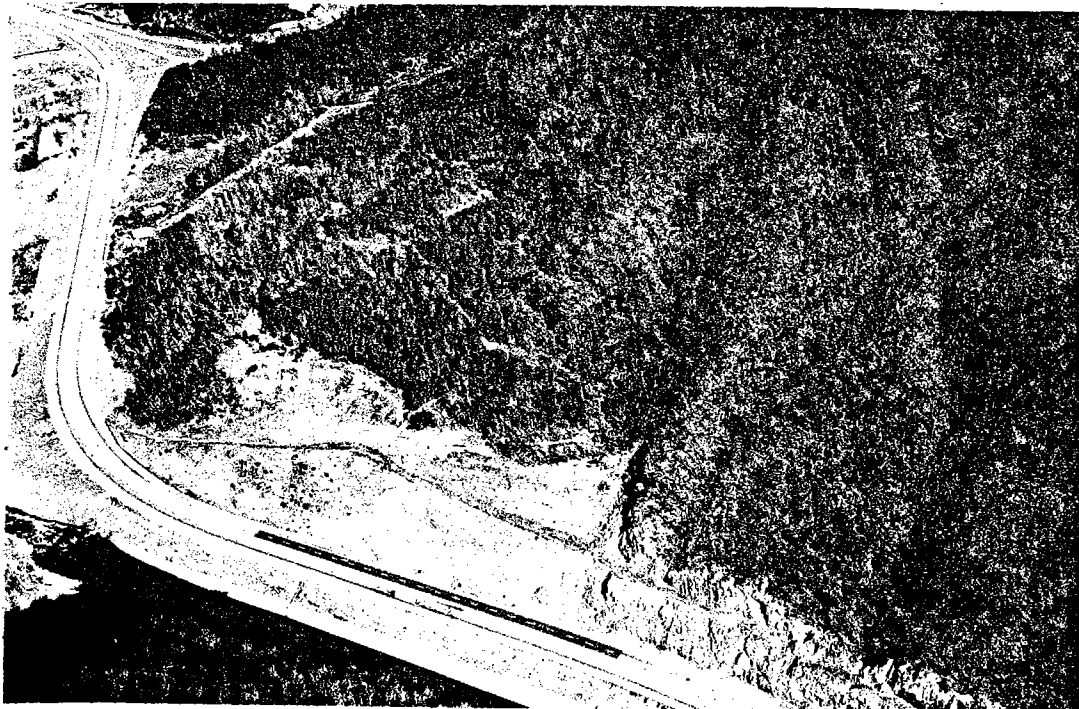
Figure 26. Horizontal Drain Installation at Rockwood (see Pad "B", Figure 25).

on March 30, 1976 following a 2.2 inch rainstorm, the total output of the 23 drains at Pad "B" was 1.78 liters/sec (28.2 gallons/min). This can be compared to more average total flows of 0.74 liters/sec (11.8 gallons/min) on March 10, 1976 and 1.06 liters/sec (16.7 gallons/min) on May 21, 1976 (Figure 26). It is interesting to note that while most of the drains at least doubled their flows during or following rainstorms, some flows actually diminished. For example, following the March 30th rainstorm, the flow of drain no. 10 at Pad "B" was only .0019 liters/sec (.03 gallons/min), while during more average times such as March 10th and May 21st it was flowing at a rate of .03 liters/sec (.5 gallons/min) and .026 liters/sec (.42 gallons/min) respectively. In addition to no. 10, six other drains at this location also had flow reductions immediately following the March 30th rainstorm. And, as was the case with no. 10, they also returned to higher average flows soon thereafter. There is probably no important significance that can be attached to this, other than that it reconfirms the fact that ground water flows in such environments are not easy to analyze and interpret and most assuredly are not always predictable.
