PROCEEDINGS of the 33rd ANNUAL HIGHWAY GEOLOGY SYMPOSIUM

ENGINEERING GEOLOGY and ENVIRONMENTAL CONSTRAINTS

Engineering Geology
and
Environmental Constraints
in
Vail, Colorado
1982

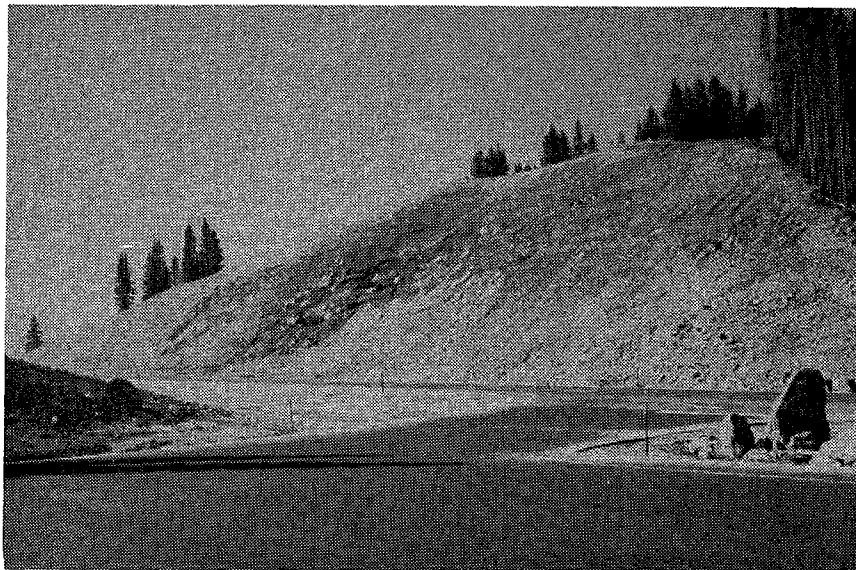
Figure 3. Exposure of Minturn-Maroon Formations in west side of road cut on south side of Clinton Dam.

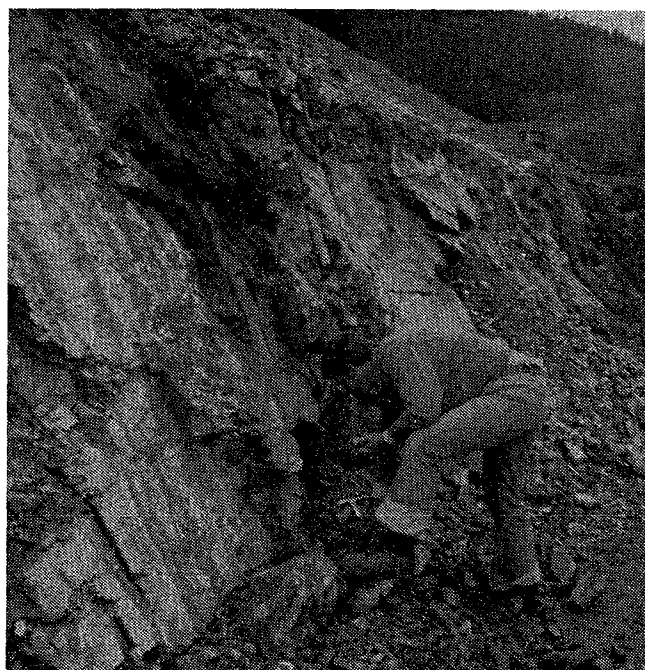
Figure 4. Exposure of Tertiary intrusive rock in trench dug on south side of Mayflower gulch.

The igneous intrusives of Tertiary age in the study area are quartz monzonite porphyries which should be relatively sound and stable in their unaltered state (see Fig. 4). If these rocks are encountered in a weathered and/or fractured condition at grade along the alignment they could cause stability problems.

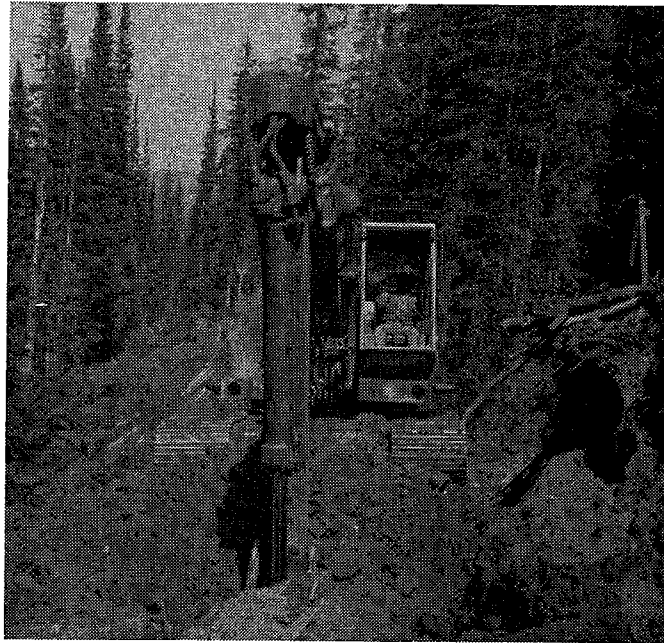
Figure 5. Backhoe in operation on pioneer road in "tenderloin" area.

Exposures of intrusive rocks in outcrops or test pits along the alignment were dug easily with a backhoe because they were weathered and well jointed (see Figs. 5 and 6). These rocks should prove to be rippable close to the surface where frost action and weathering have weakened them.

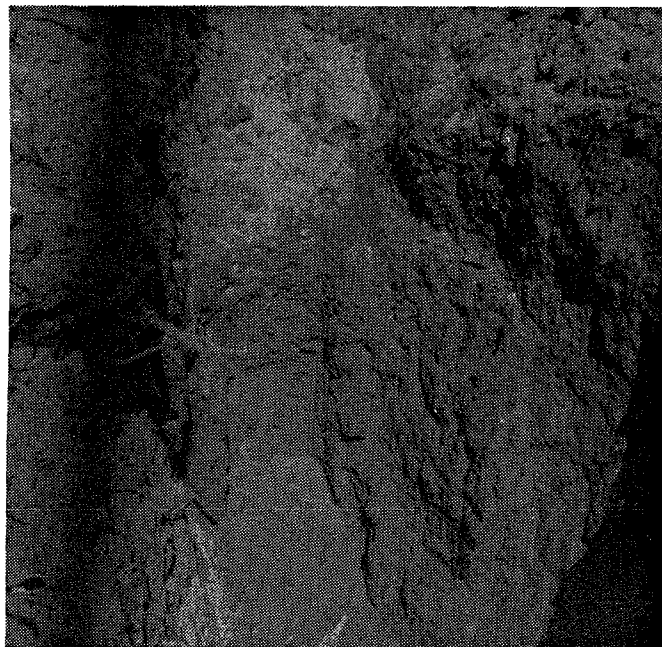
Figure 6. Backhoe pit in jointed and weathered Tertiary intrusive rock, "tenderloin" area.

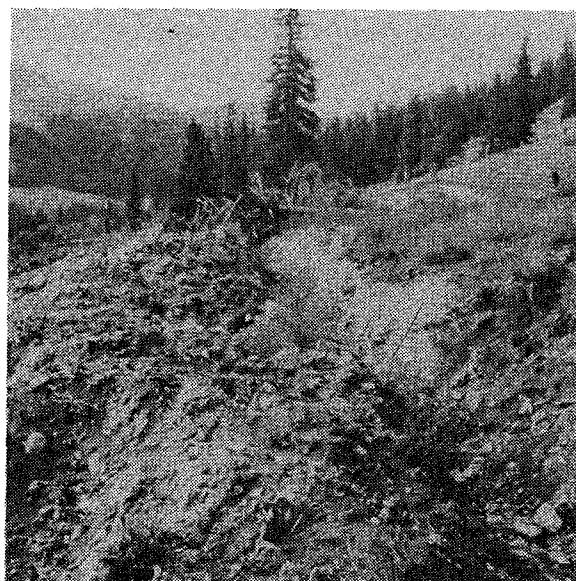
Figure 7. Glacial till exposed above Borrow Area B. Material on left (west) has slumped; note light-colored scar marking uphill limit of slump.

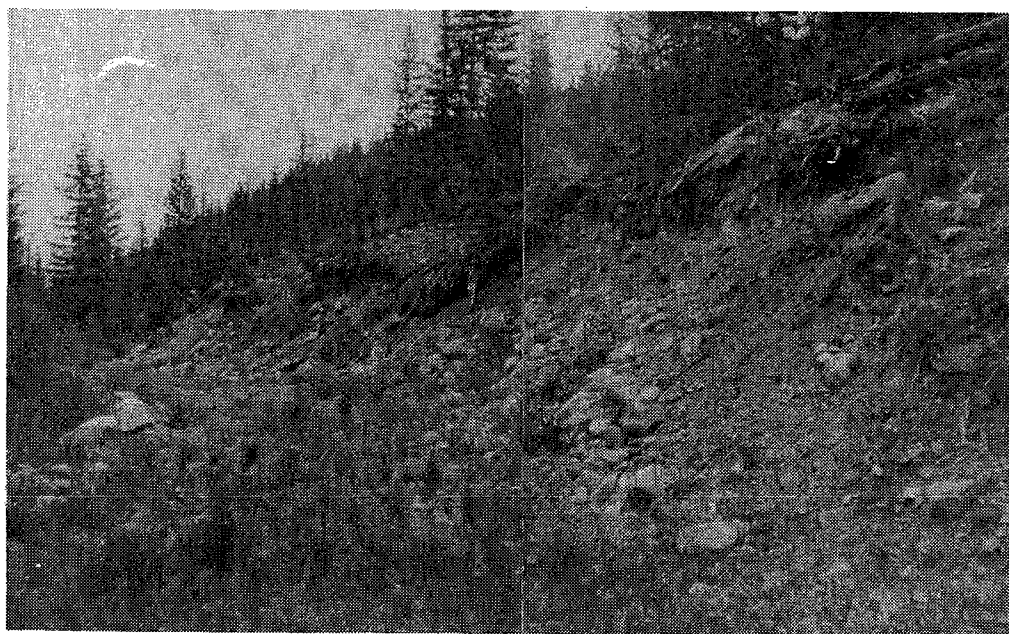
Figure 8. Glacial till exposed in old drill site road at about Sta. 164+50.

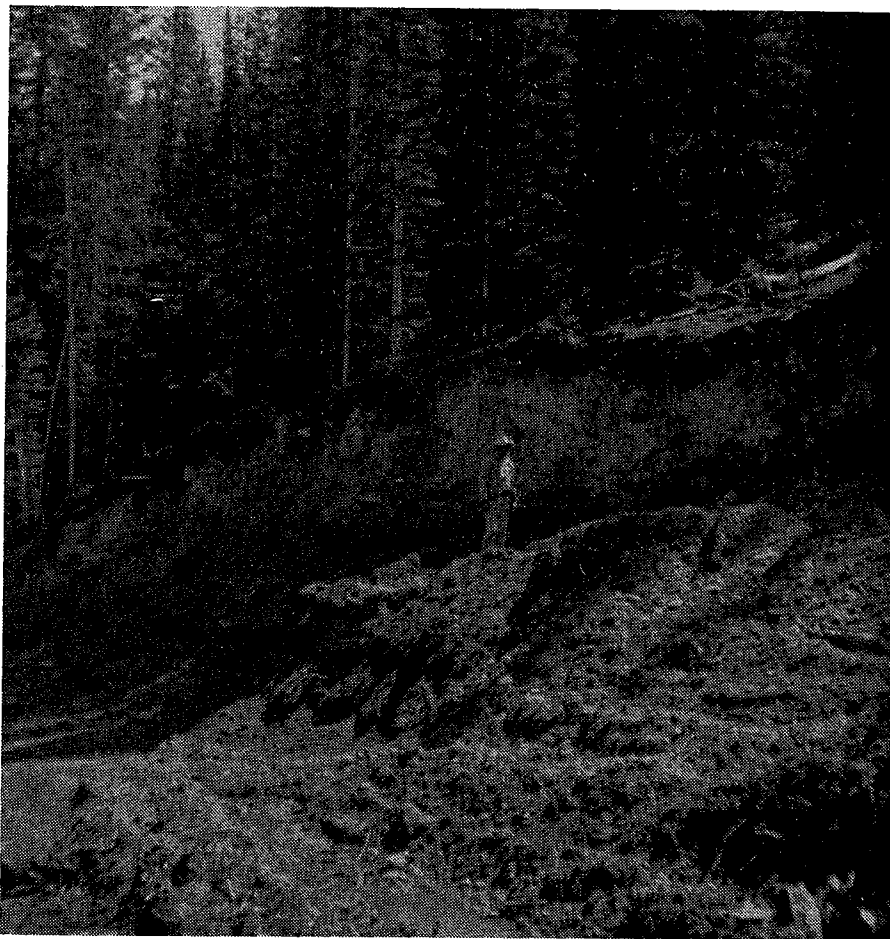
Figure 9. Slump in cut for drill road at about Sta. 124+50. After cut was made slumping apparently occurred in several episodes.

In moist, poorly drained areas, such as the "tenderloin" (Stas. 115+00 to 157+00), which exist along the alignment, disruption of the surface material in any way is likely to cause failure (see Fig. 9). Engineered drainage and slopes appear to be the most readily applied corrective measures in this situation. Additional engineering design (i.e. retaining walls and armored slopes) may be needed in specific locations. Removal and replacement of some of this material is suggested as a remedial measure if zones of high clay content or organic matter are encountered during construction.

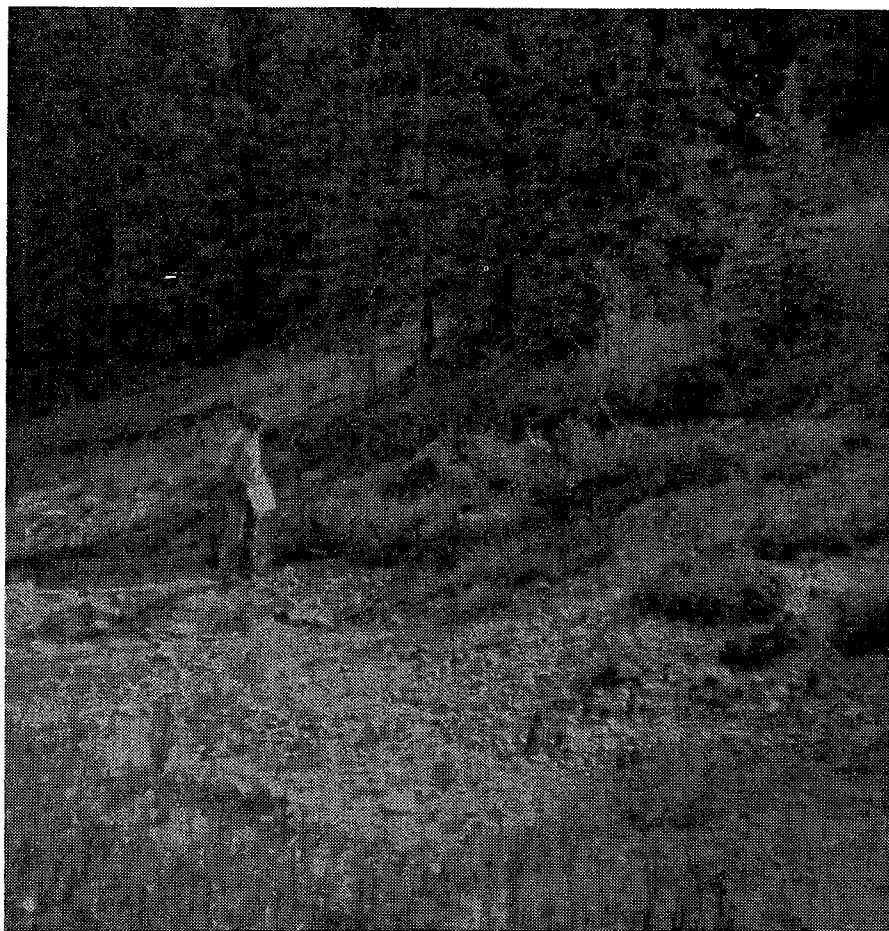
Figure 10. Small landslide or slump that occurred between August 6 and 10, 1976 in morainal material at about Sta. 110 on the north side of Mayflower Creek.

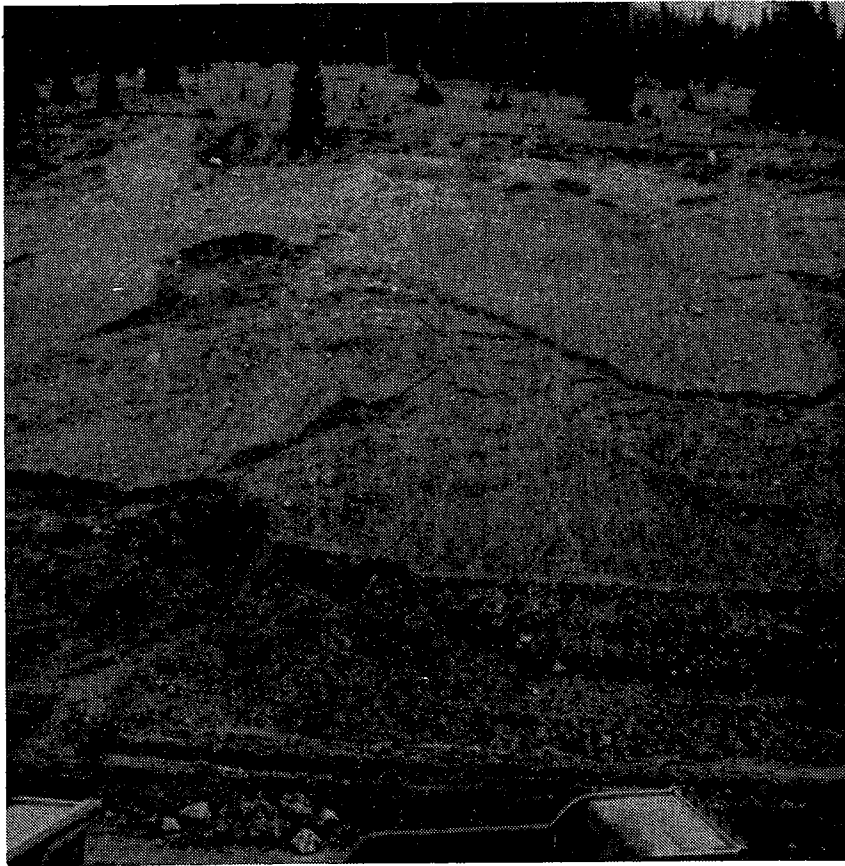
Figure 12. Right cut slope at about Sta. 39+00 in Borrow Area B, September 1976. Note failures indicated by multiple scarps. This picture is typical of conditions in the cut slope between Stas. 36+50 and 41+00.

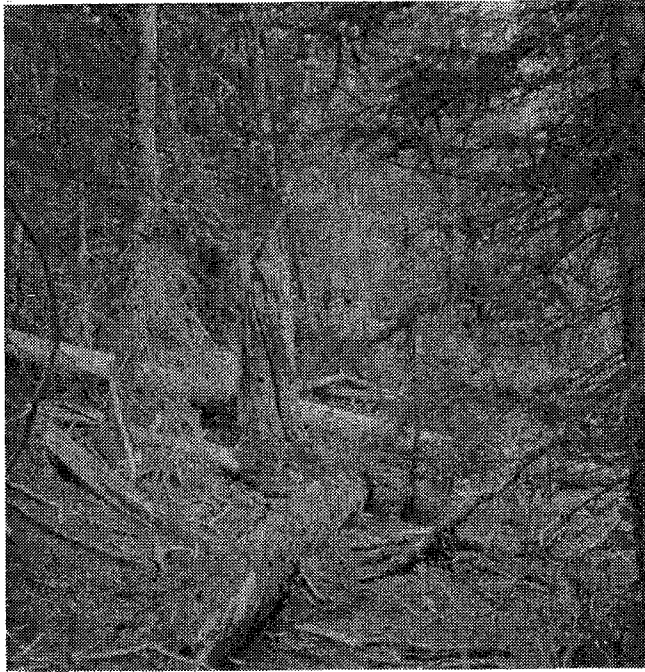
Figure 14. Dense vegetation in "tenderloin" area.

An area of extremely unstable surface conditions had been known and studied along the alignment from approximately Sta. 115+00 to Sta. 157+00 (see Fig. 11). Figures 14, 15 and 16 illustrate density of vegetation cover, and unstable morainal materials in this area, which has been nicknamed the "tenderloin." Numerous scarps and related evidences of failure, as well as dozens of seeps, springs and small boggy areas filled with lush, water-loving vegetation indicate the general instability of this reach of the alignment. The surficial deposits in this area appear to be a relatively thin, highly irregular mantle of till and colluvium.

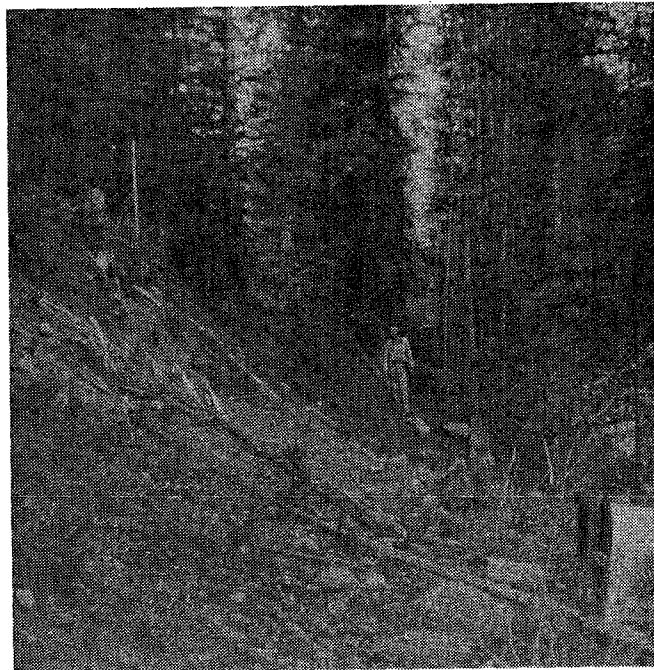
Figure 15. Unstable slope in morainal deposits, "tenderloin" area.

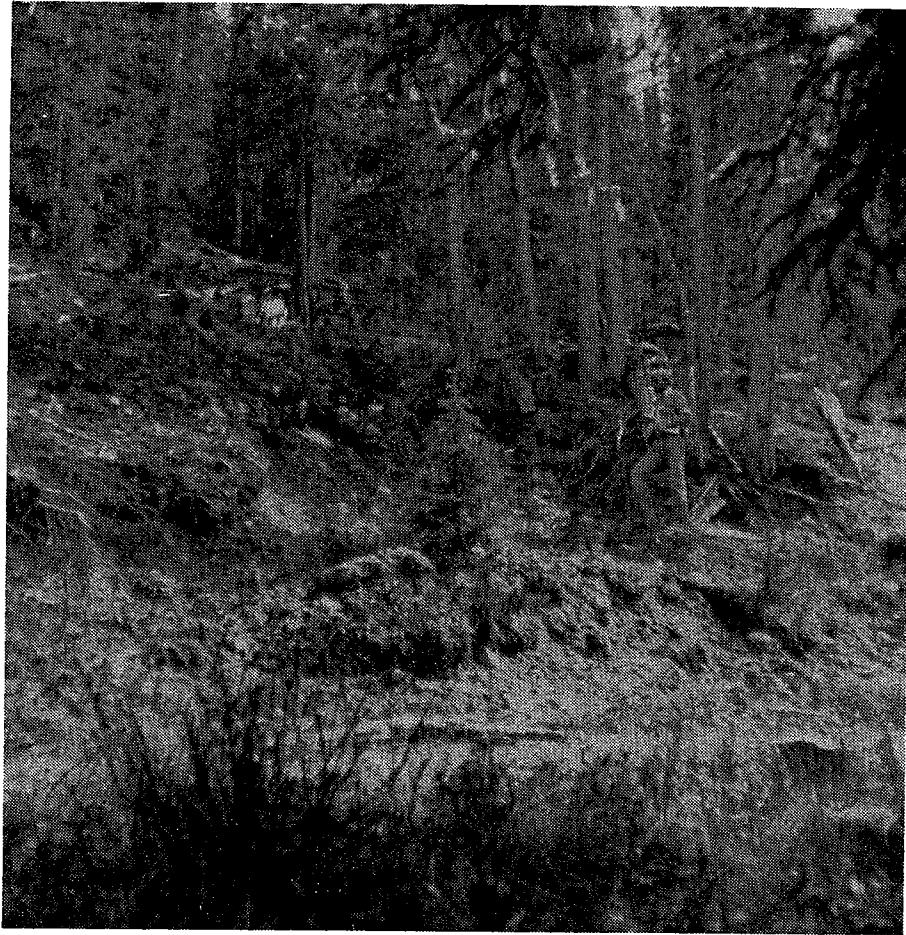
Figure 16. Multiple scarps above an old drill location access road at about Sta. 145+00 in the "tenderloin" area.

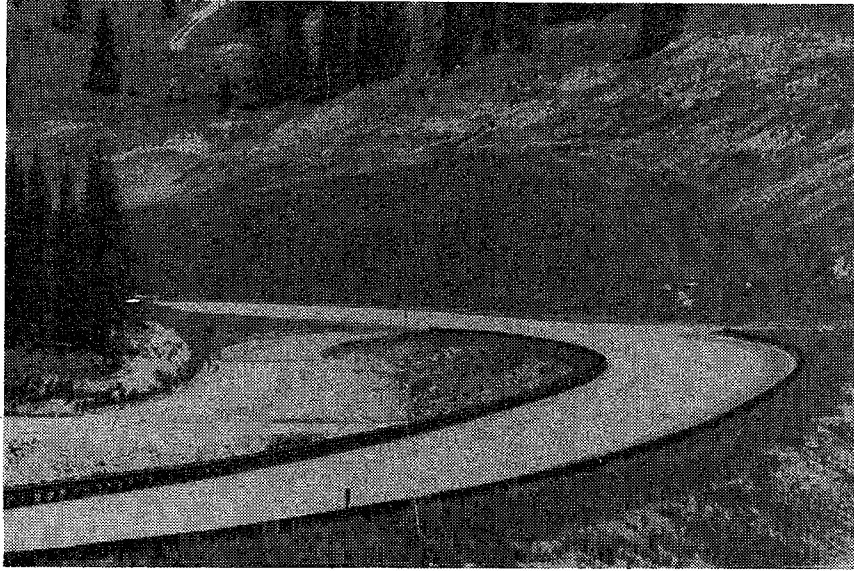
Figure 18. Borrow Area B. Berm (dark arcuate area) in lower part of cut has been an effective barrier to major failure.

Figure 18 shows Borrow Area B and the stabilizing berm which was emplaced to load the base of the cut. The crest drain (see Fig. 19) along the top of the cut was performing as intended although some material had sloughed down into the permeable drain. Some slumping (see Fig. 20) had occurred in the vicinity of Sta. 45+00 and this appeared to be due to excess water in a clayey environment.

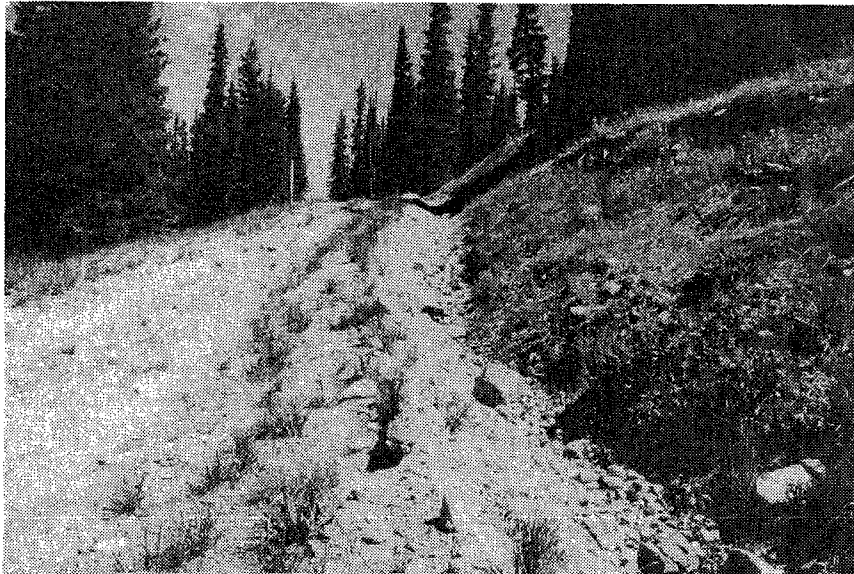
Figure 19. Crest drain on right above Borrow Area B. cut. Drain is effectively transmitting water through porous blanket although some sloughing has occurred.

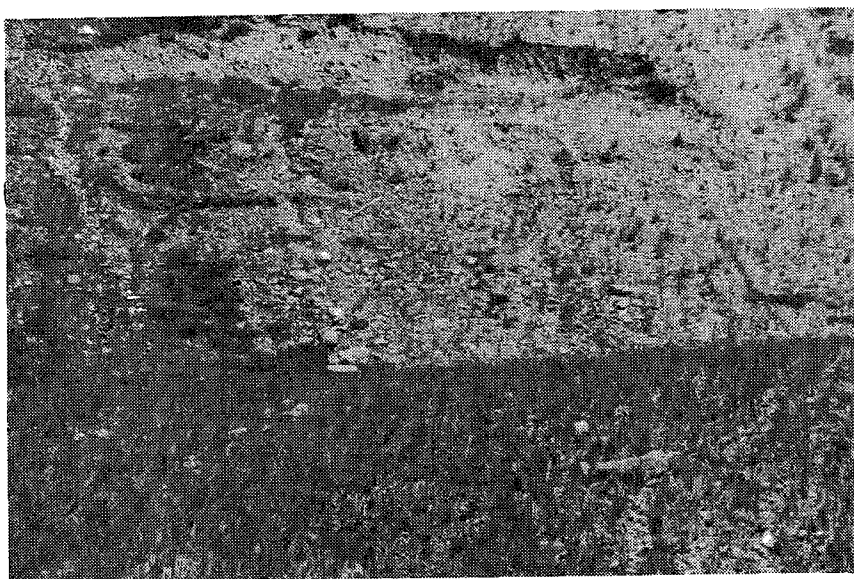
Figure 20. Minor sloughing of morainal material in Borrow Area B above berm surface (lower third of picture).

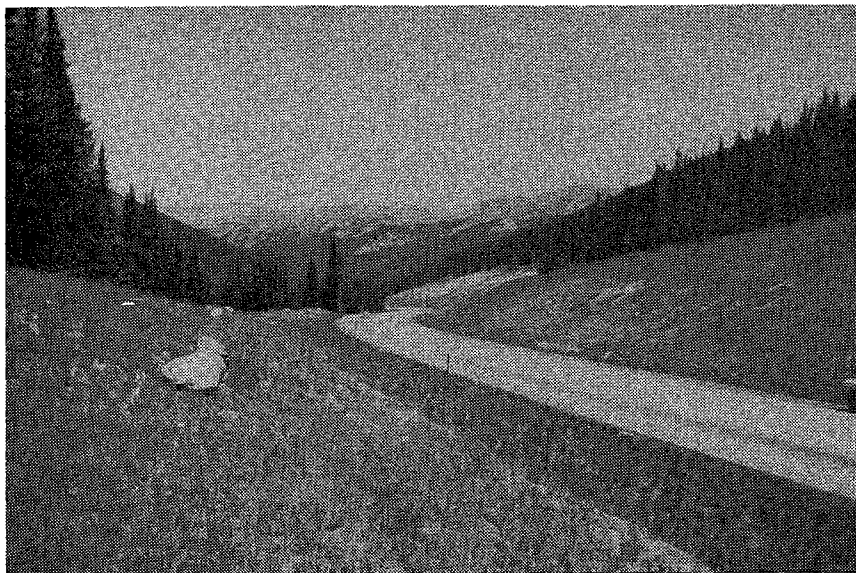
Figure 22. Panoramic view of "tenderloin" area. Note the well established stand of grass in the foreground. Rocks such as the large boulder to the left were placed at random along some of the slopes as a matter of aesthetics.

The system of subdrains placed in the "tenderloin" area was of particular interest. Figure 22 is a panoramic view of the "tenderloin" in which it can be seen that no major failures have occurred. Minor slump features such as the one shown in Fig. 23 are uncommon through this reach of the alignment.

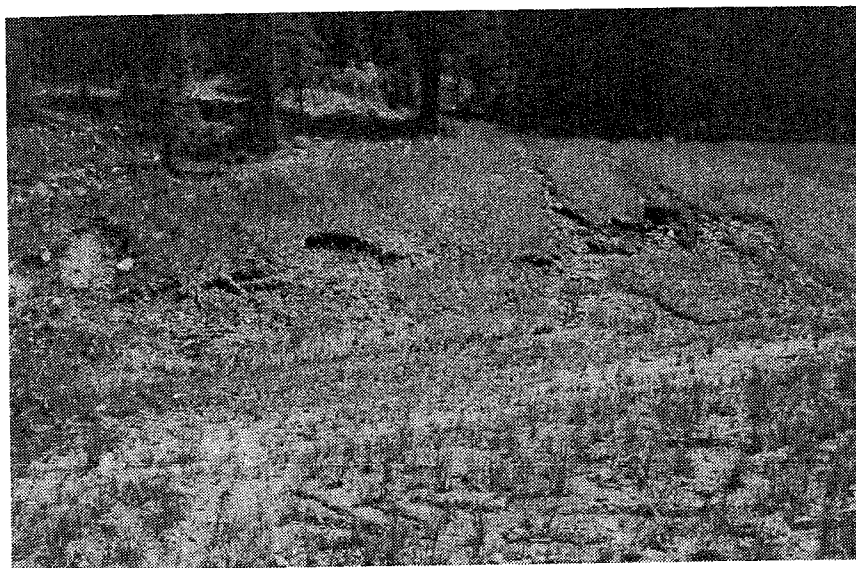
Figure 23. Minor slump features in the "tenderloin" area just south of Humbug Creek.

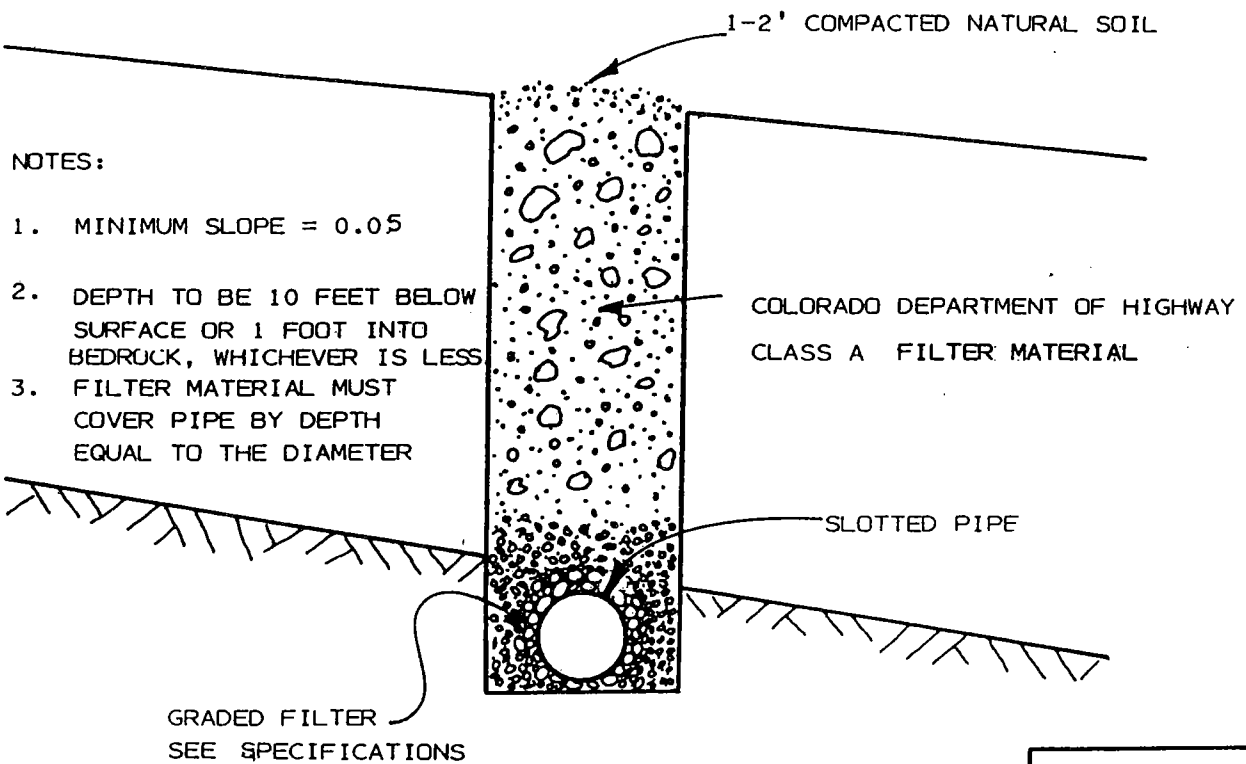
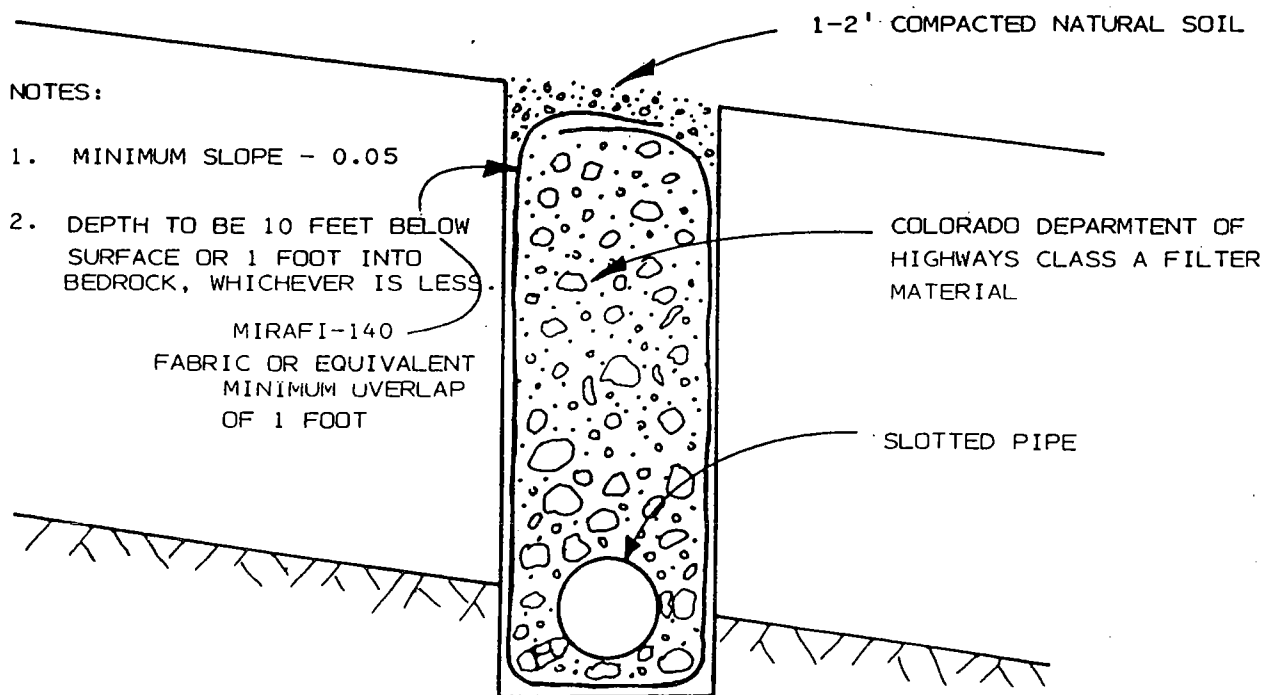
TYPICAL DRAIN DETAILS

TYPE I

TYPE II

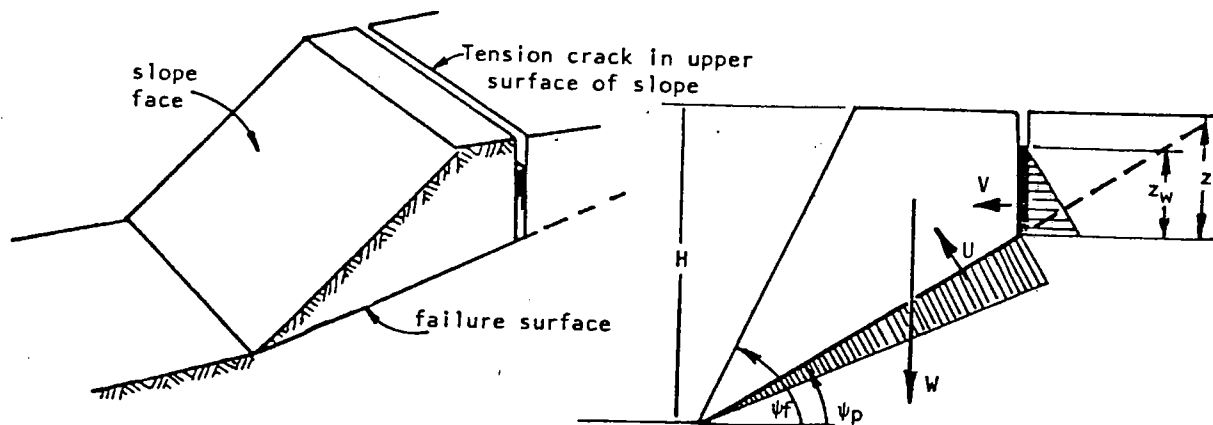
FIGURE 1 INFLUENCE OF WATER PRESSURE ON SLOPE STABILITY

$$F = \frac{CA + (W \cos \psi_p - U - V \sin \psi_p) \tan \phi}{W \sin \psi_p + V \cos \psi_p}$$

V = lateral force exerted by water within tension crack

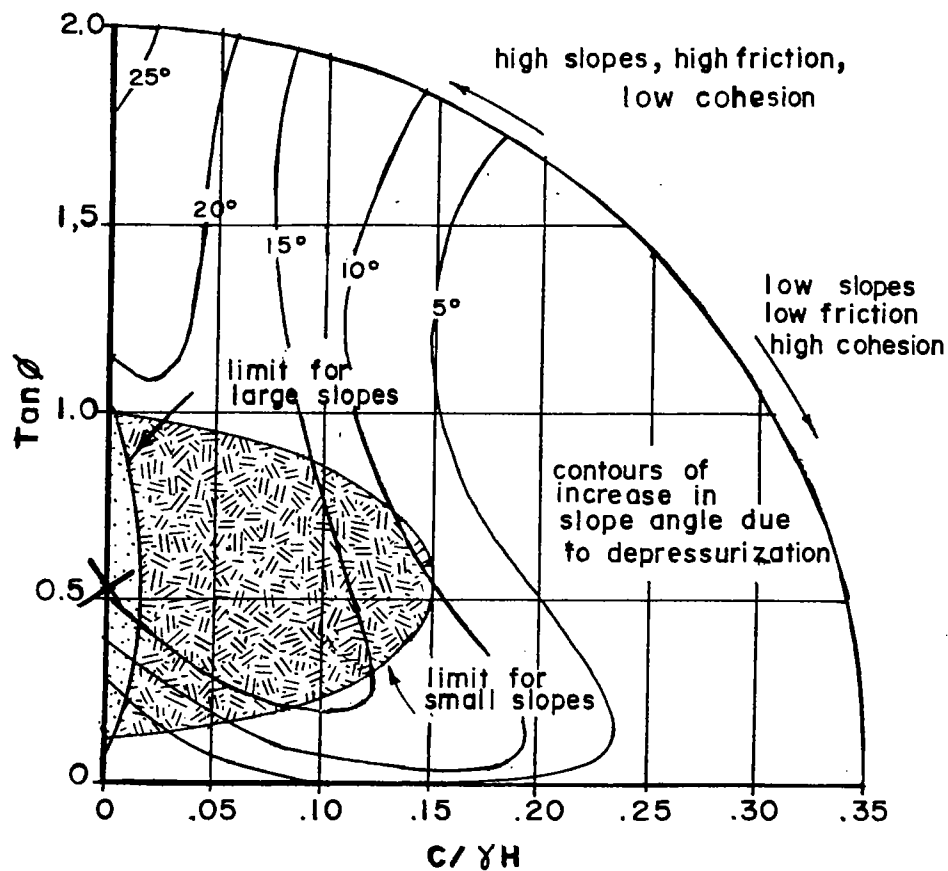
**FIGURE 2 RESULTANT INCREASE IN SLOPE ANGLE DUE TO
TOTAL DEPRESSURIZATION**

C = effective cohesion
 ϕ = effective friction angle
 H = slope height
 γ = unit weight of rock

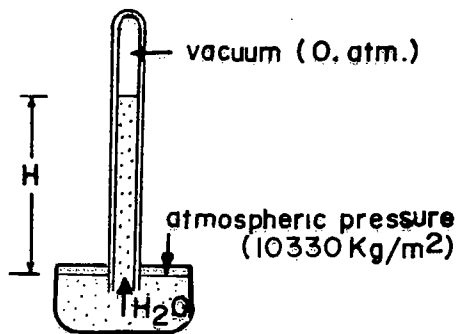
FIGURE 5A VACUUM PRINCIPLE

WHEREBY:

H = height of water column

$$H = \frac{\text{atmospheric pressure (10330 Kg/m}^2\text{)}}{\text{density of water (1000 Kg/m}^2\text{)}} \\ = 10.3 \text{ m (at mean sea level)}$$

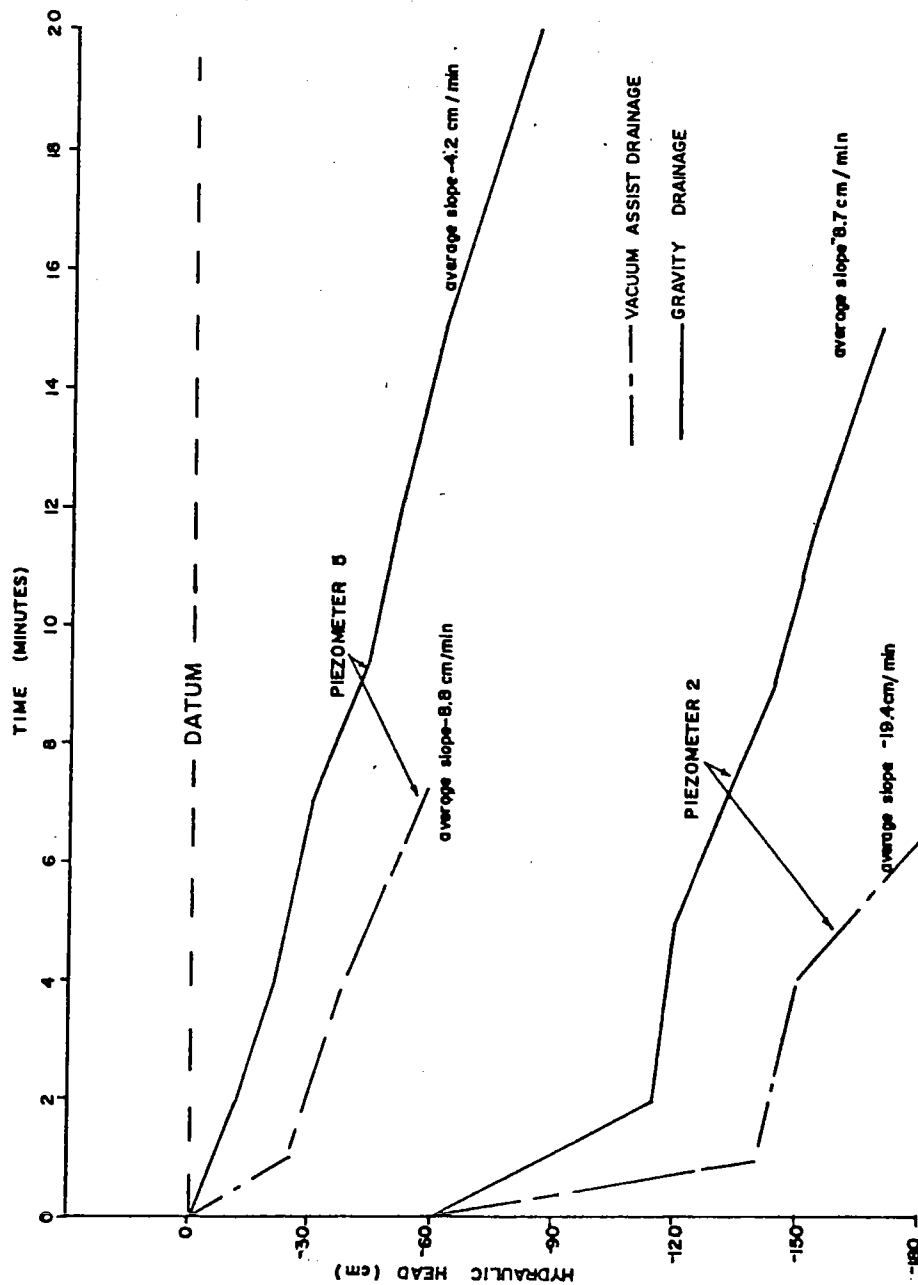
FIGURE 16 PLOT OF DRAWDOWN VS. TIME UNDER: a) gravity drainage
b) vacuum drainage

A comparative study between vacuum assist and gravity drainage was conducted by monitoring the drawdown rates within the individual piezometers. The model was recharged to a base situation and subsequently analyzed under the respective drainage conditions. Relative drawdown is shown by Figure 16.

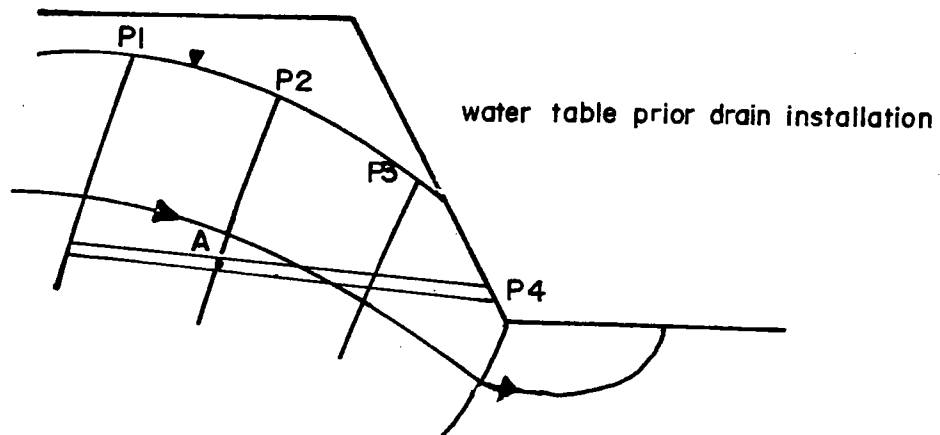
FIGURE 17 INCREASED HYDRAULIC GRADIENT UNDER VACUUM

CASE 1
ASSUME NO VACUUM ($P_4 = 1 \text{ atm.}$)
 $H \text{ AT POINT A} = P_2 - 1 \text{ atm.}$

CASE 2
ASSUME VACUUM ASSIST
 $H \text{ AT POINT A} = P_2 - 0 \text{ atm.}$

CONSEQUENCE : GRADIENT IS GREATER: CASE 2

- Vacuum assist drainage enables an individual drain to exhibit a wider zone of influence. This is partly due to an increased permeability; the capillary effects within the joints are partially negated by the increased hydraulic gradient, (Figure 17). In addition, the water table can be drawn a further 5 m below the level of the drain. Consequently fewer drains have to be installed in order to produce benefits similar to those of gravity drains.

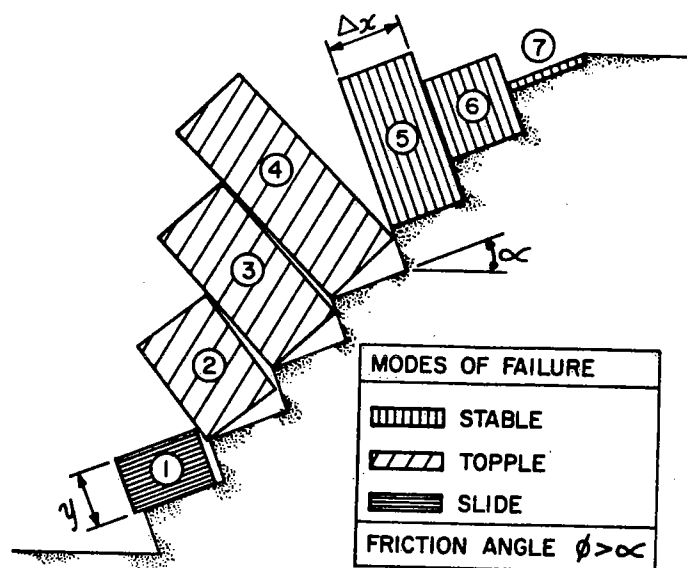
Short slabs at the crest which do not meet the criterion shown in Equation (1) and do not slide on the base, are stable (Figure 1, slabs 5,6,7). A longer slab which topples (slabs 2,3,4) exerts a thrust on the slab immediately below it on the slope. This thrust produces a turning moment on the lower block which increases its tendency to topple creating a "domino effect".

Figure 1 Mechanism of Toppling Slope Failure

However, each slab is constrained from toppling by the force transmitted upwards from the block below it, and from the shear forces acting on its sides. As this motion progresses down the slope, the magnitude of the thrust from the upper slabs may be sufficient, near the toe, to cause short slabs that do not meet the criterion shown in Equation (1) to topple. However, where the moment from the slabs above is such that the ratio of the shear to normal forces on the base of the slab exceeds the friction coefficient of the base, then the slab will slide rather than topple (Figure 1, slab 1). Since the magnitude of the thrust is dependent upon the friction of properties of the surfaces of the slabs, as well as their dimensions, stability is governed both by the geometry of the slope and the rock properties.

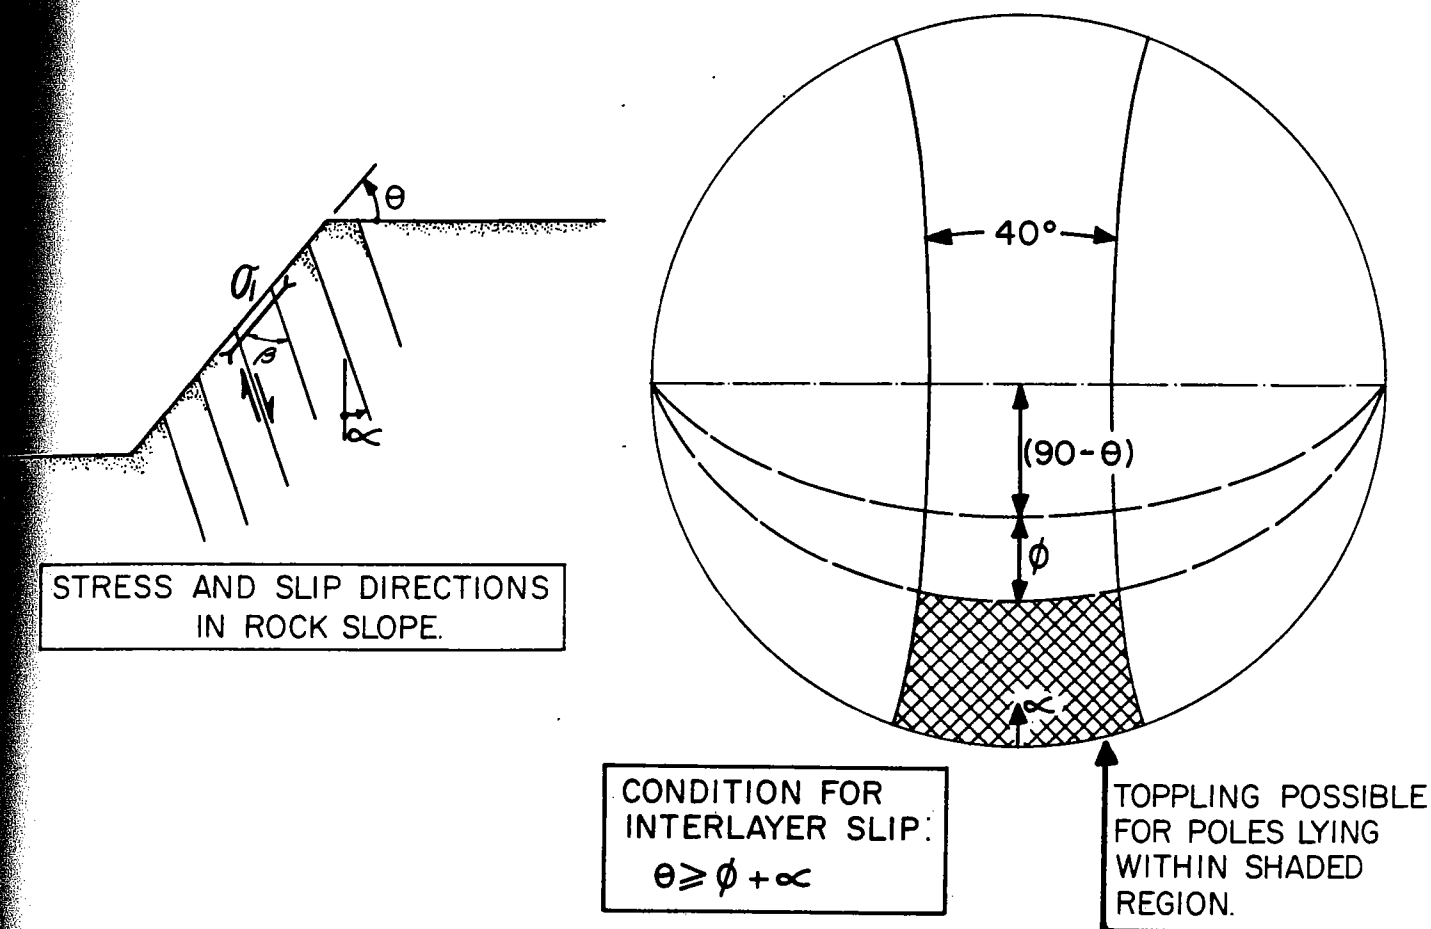
Figure 2 illustrates a slope cut at an angle of θ° , containing fractures which dip into the slope at an angle of $(90-\infty)$. Assume that the friction angle of these fractures is θ . In the region of the slope close to the face, there will be a uniaxial stress condition with stress σ_1 , parallel to the slope face, the normal and shear stresses acting on the fractures are:

Figure 2 Kinematic Condition For Flexural Slip Which Precedes Toppling

This condition for slip is shown on the stereonet Figure 2 where planes with poles lying within the shaded region, i.e. dips range from $\alpha = 0$ (vertical) to $\alpha = (\theta - \phi)$, have potential for causing toppling. The lateral limits of the shaded zone are governed by the range of strike of the planes in relation to the strike of the cut. Where the strike of these planes differs from the strike of the slope by an amount greater than about 20° , the planes form a series of stepped faces with each slab supporting the one behind it and toppling failure is inhibited. There-

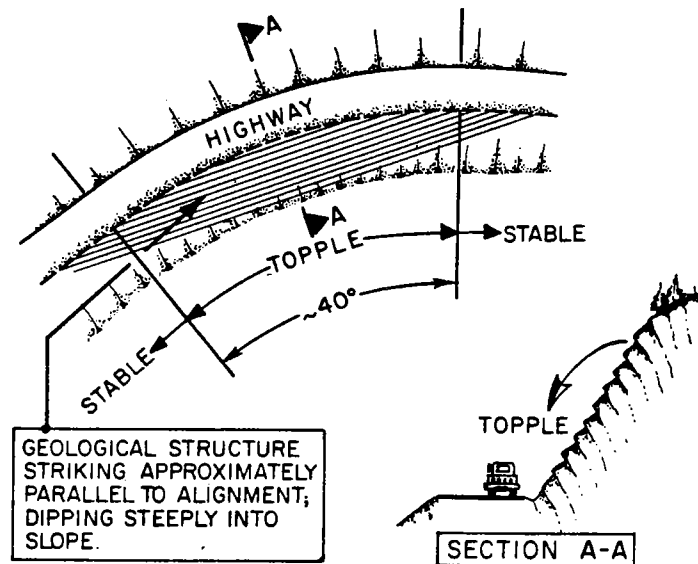
fore, the difference between the strike of the fractures causing toppling and the strike of the highway cut will show the approximate lateral extent of the toppling failure (Figure 3). This figure also shows that the smaller the radius of the curve, the shorter the length of the toppling failure.

Figure 3 Relationship between highway curvature and toppling failure

- c) Realign the highway so that the strike of the cut slope is not parallel to the strike of the toppling fractures. The difference in angle should be about 20° to ensure that continuous faces of toppling slabs are not exposed. Figure 4(c) shows re-alignment of a tangent, while Figure 3 shows how the radius of curvature influences the length of a toppling slope.

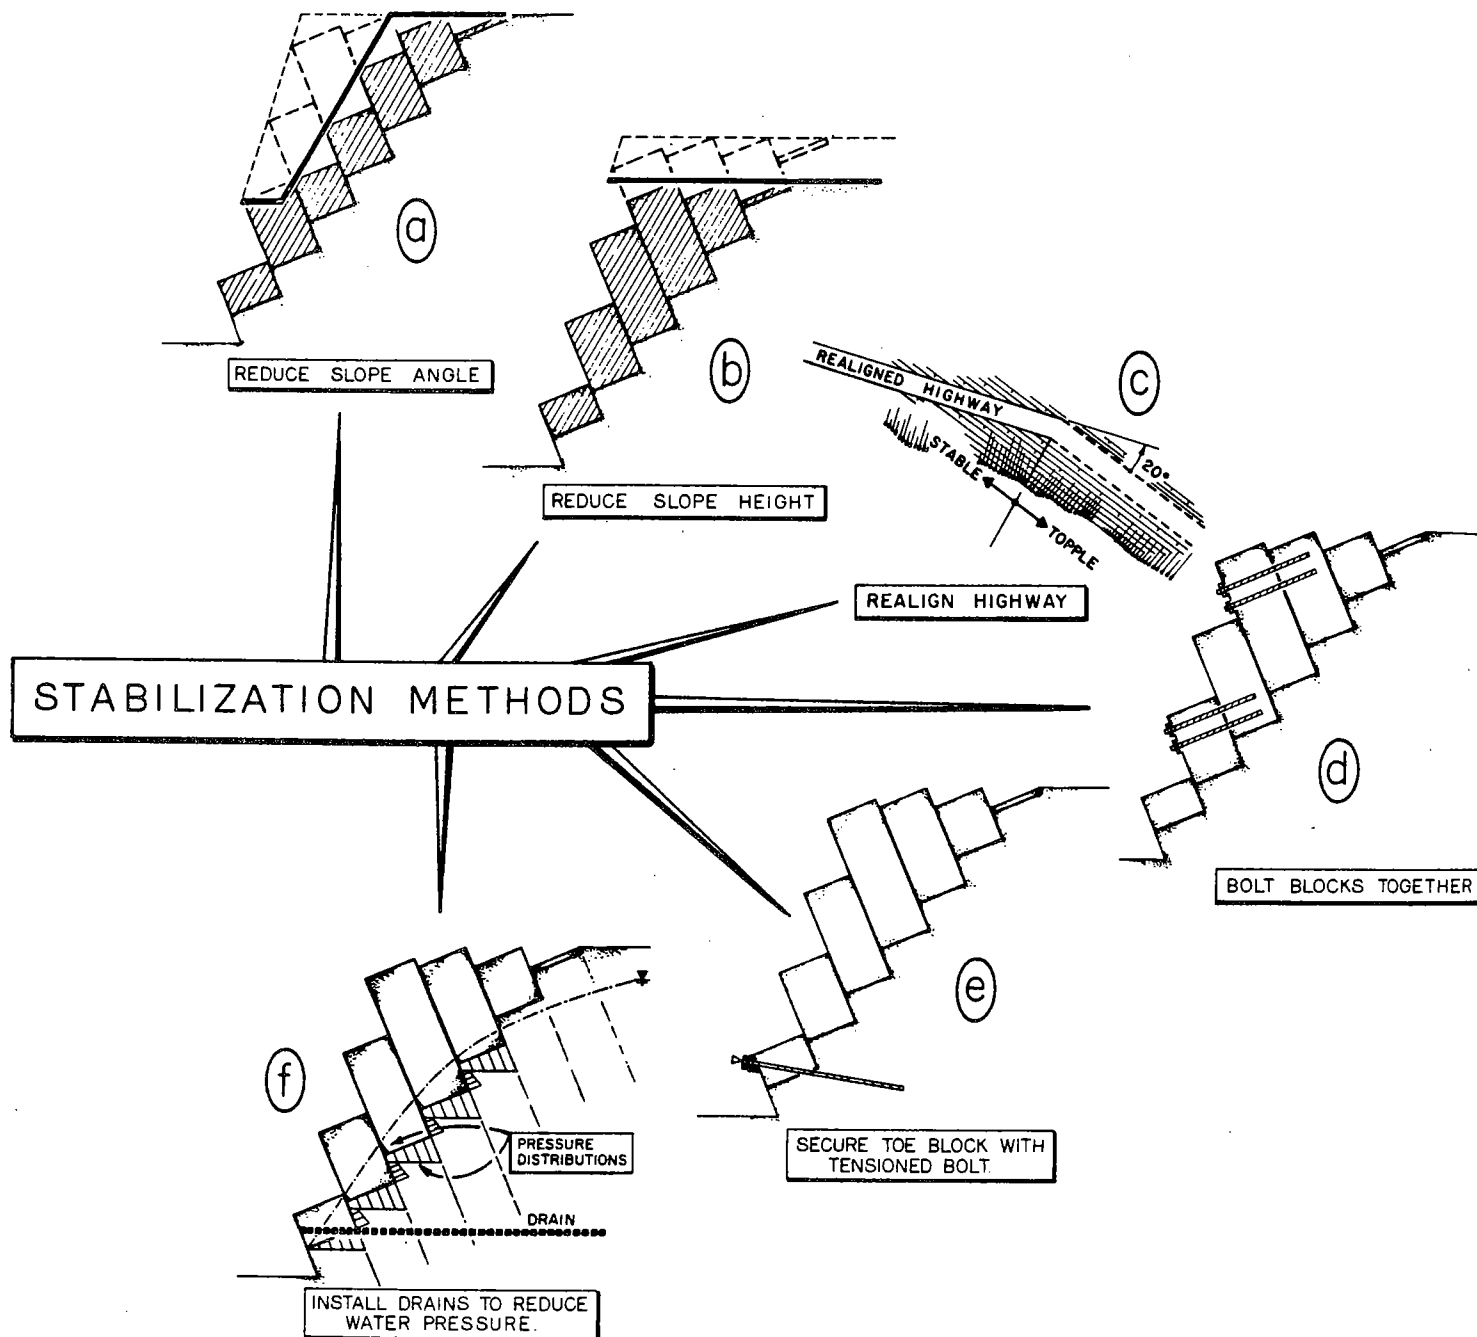
The following paragraphs discuss six different stabilization methods for toppling failures, and discuss the relative merits and practicability of each. The techniques are shown diagrammatically in Figure 4.

Figure 4 Stabilization Methods for Toppling Failures

Drainage can often be achieved by drilling horizontal drains from the toe of the slope as illustrated in Figure 4(e). If there is little hydraulic connection between the steep fractures forming the toppling slabs, then the drain must be long enough to intersect those fractures which outcrop near the slope crest to ensure good drainage. Piezometers should also be installed to monitor water pressures.

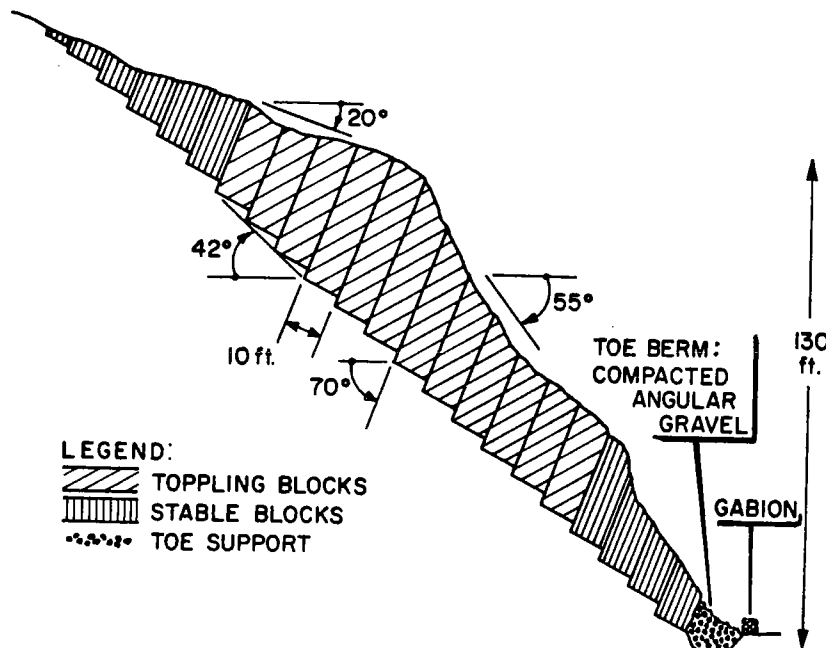
Figure 5 Toe Berm to Stabilize Toppling Slope Failure

The concluding part of this paper describes the measures that were taken to stabilize a 130 ft. high toppling failure above a major railroad. The only rock excavation that had taken place during construction of the railroad was near the toe. In this area, the slope angle was about 70° compared to the overall angle of 55° . Also, a 20 ft. wide ditch had formed an overhanging face about 16 ft. high.

have been expensive because the site was isolated, and access was difficult. Therefore, it was decided to place a compacted gravel berm in the ditch to provide the necessary support. A 3 ft. high gabion wall was constructed at the outside edge of the berm to form a catchment area for rock falls. No scaling of the slope was carried out because it was considered that the rock was so broken that scaling would only temporarily reduce the rock fall hazard.
