PROCEEDINGS of the 33rd ANNUAL HIGHWAY GEOLOGY SYMPOSIUM

ENGINEERING GEOLOGY and ENVIRONMENTAL CONSTRAINTS

Engineering Geology
and
Environmental Constraints
in
Vail, Colorado
1982

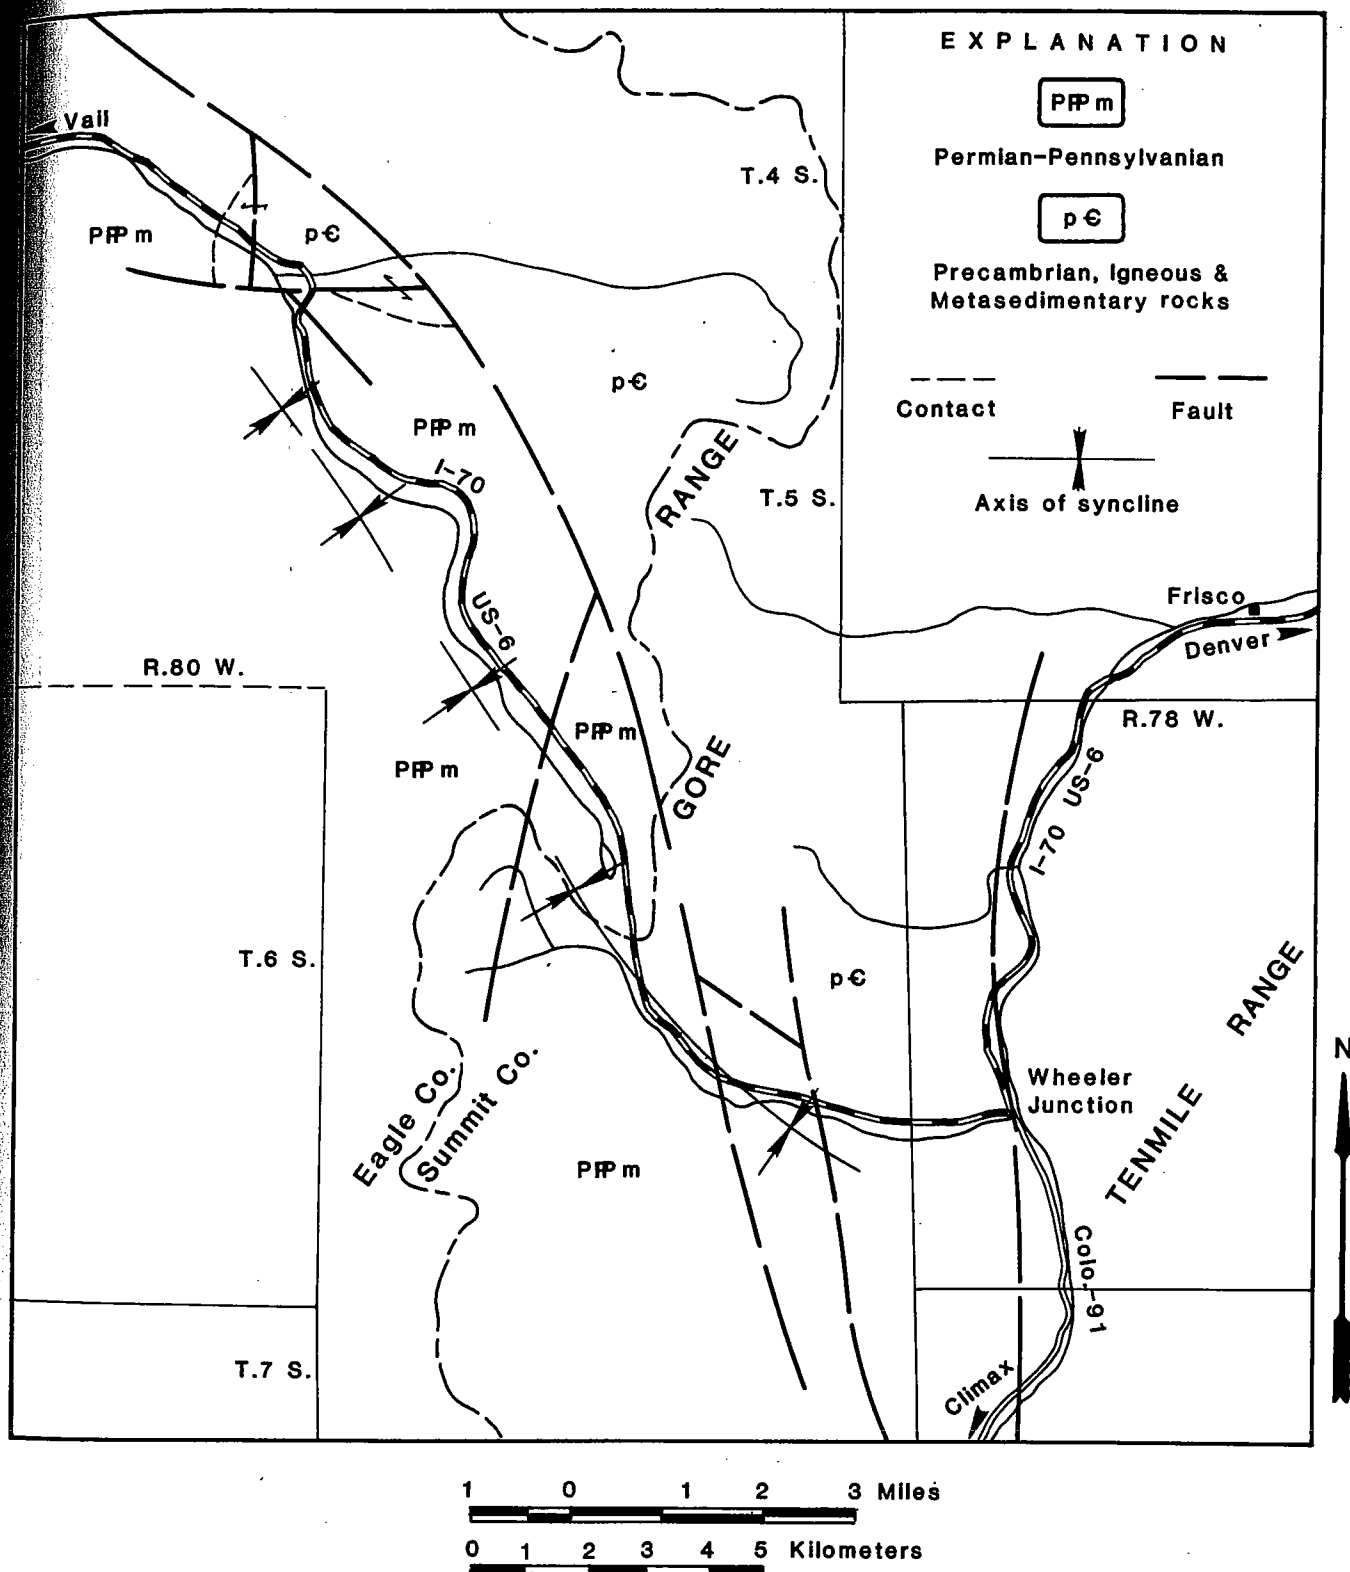
**Figure 2.--GENERALIZED BEDROCK GEOLOGIC MAP,
VAIL PASS AREA, COLORADO**

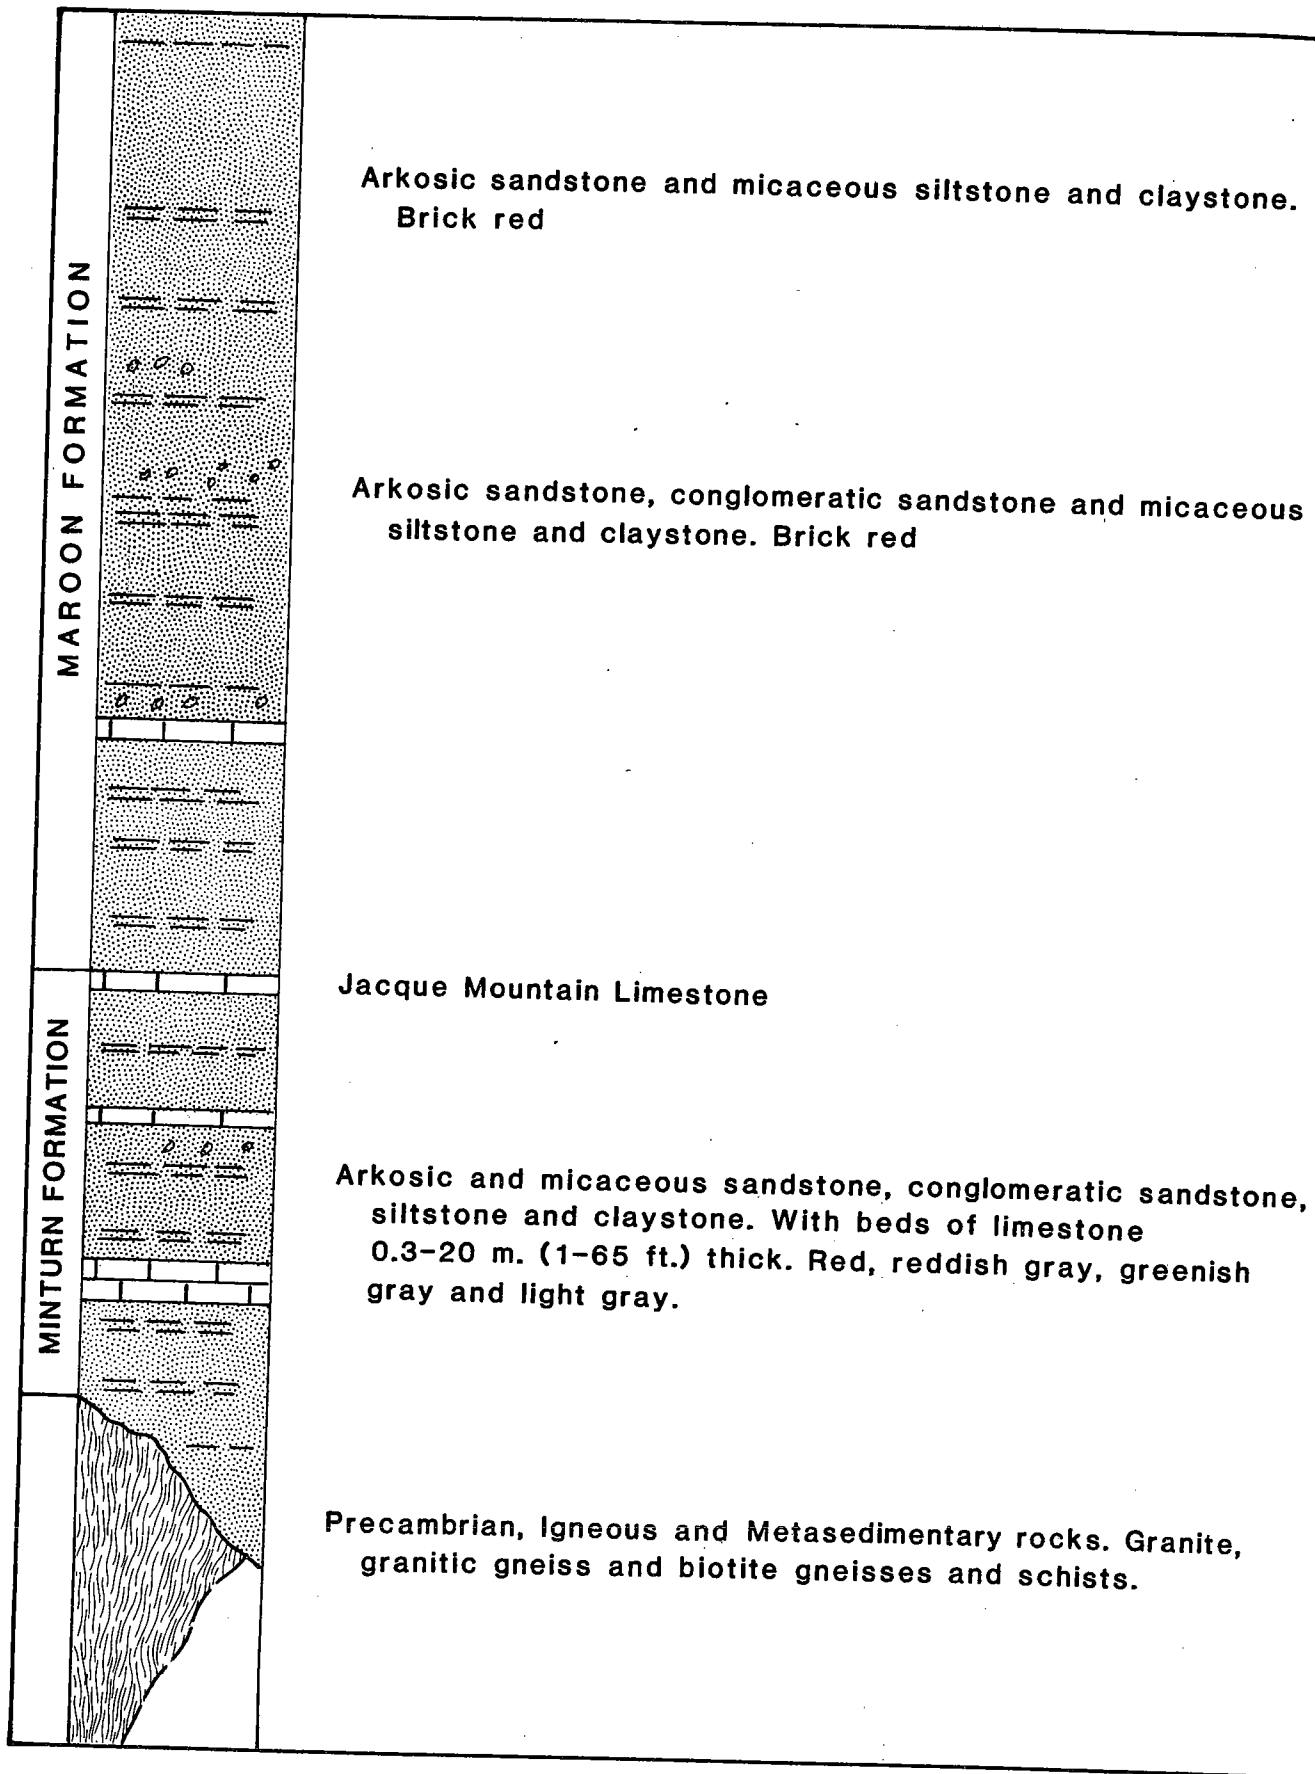
**Figure 3.--GENERALIZED STRATIGRAPHIC COLUMN,
VAIL PASS AREA, COLORADO**

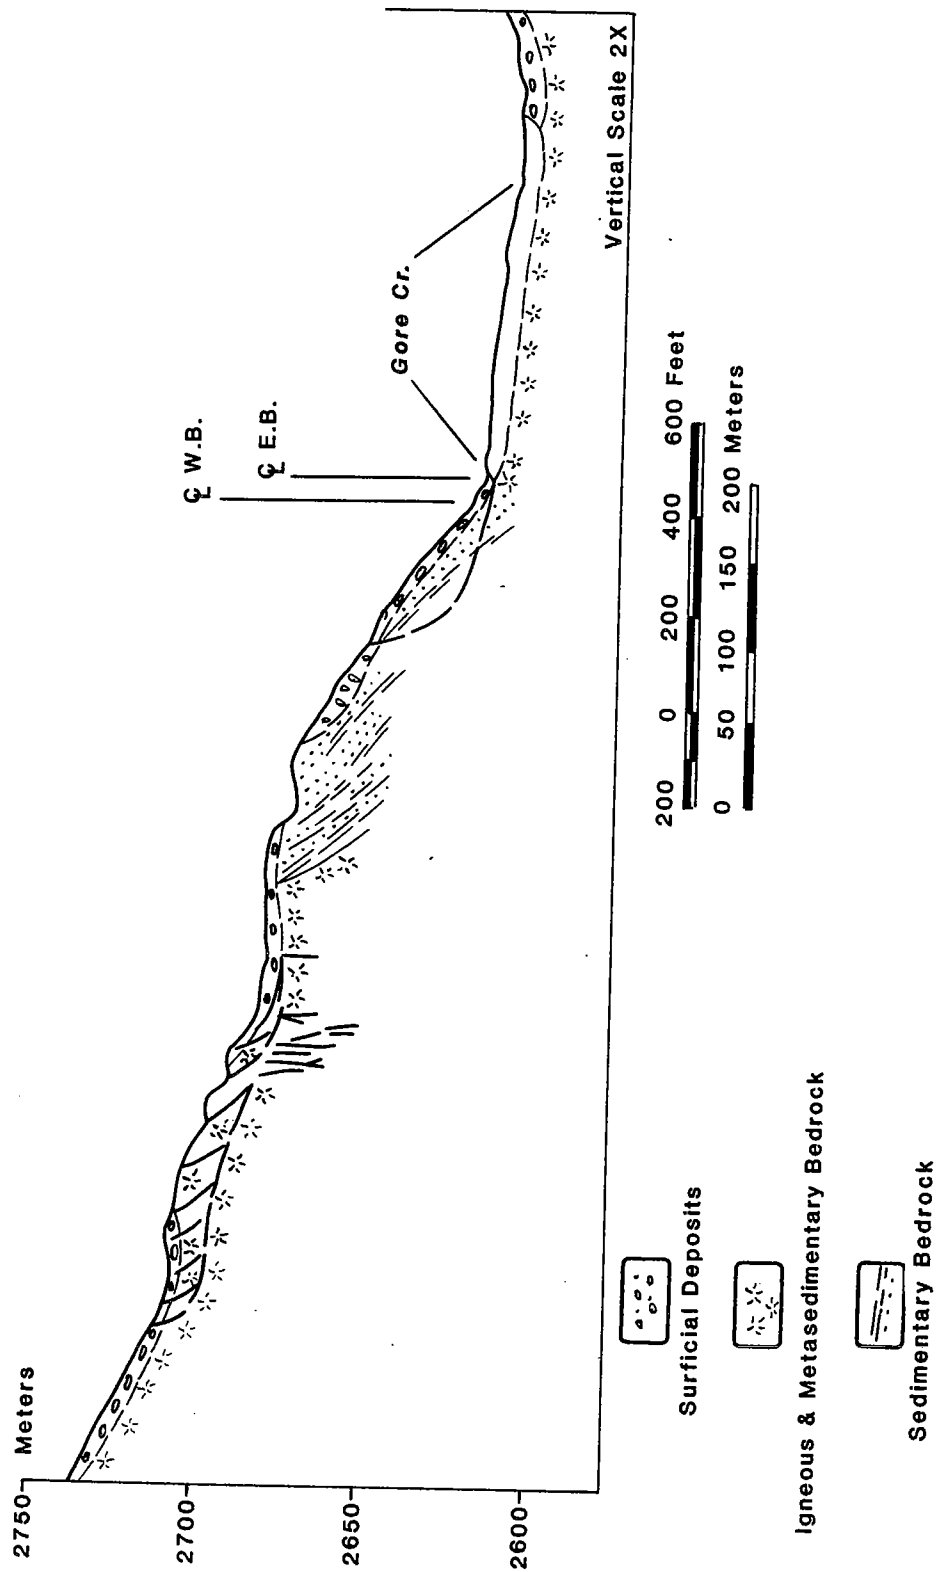
**Figure 5.--CROSS SECTION OF BEDROCK LANDSLIDE
IN IGNEOUS AND METASEDIMENTARY ROCK (Station 3)**

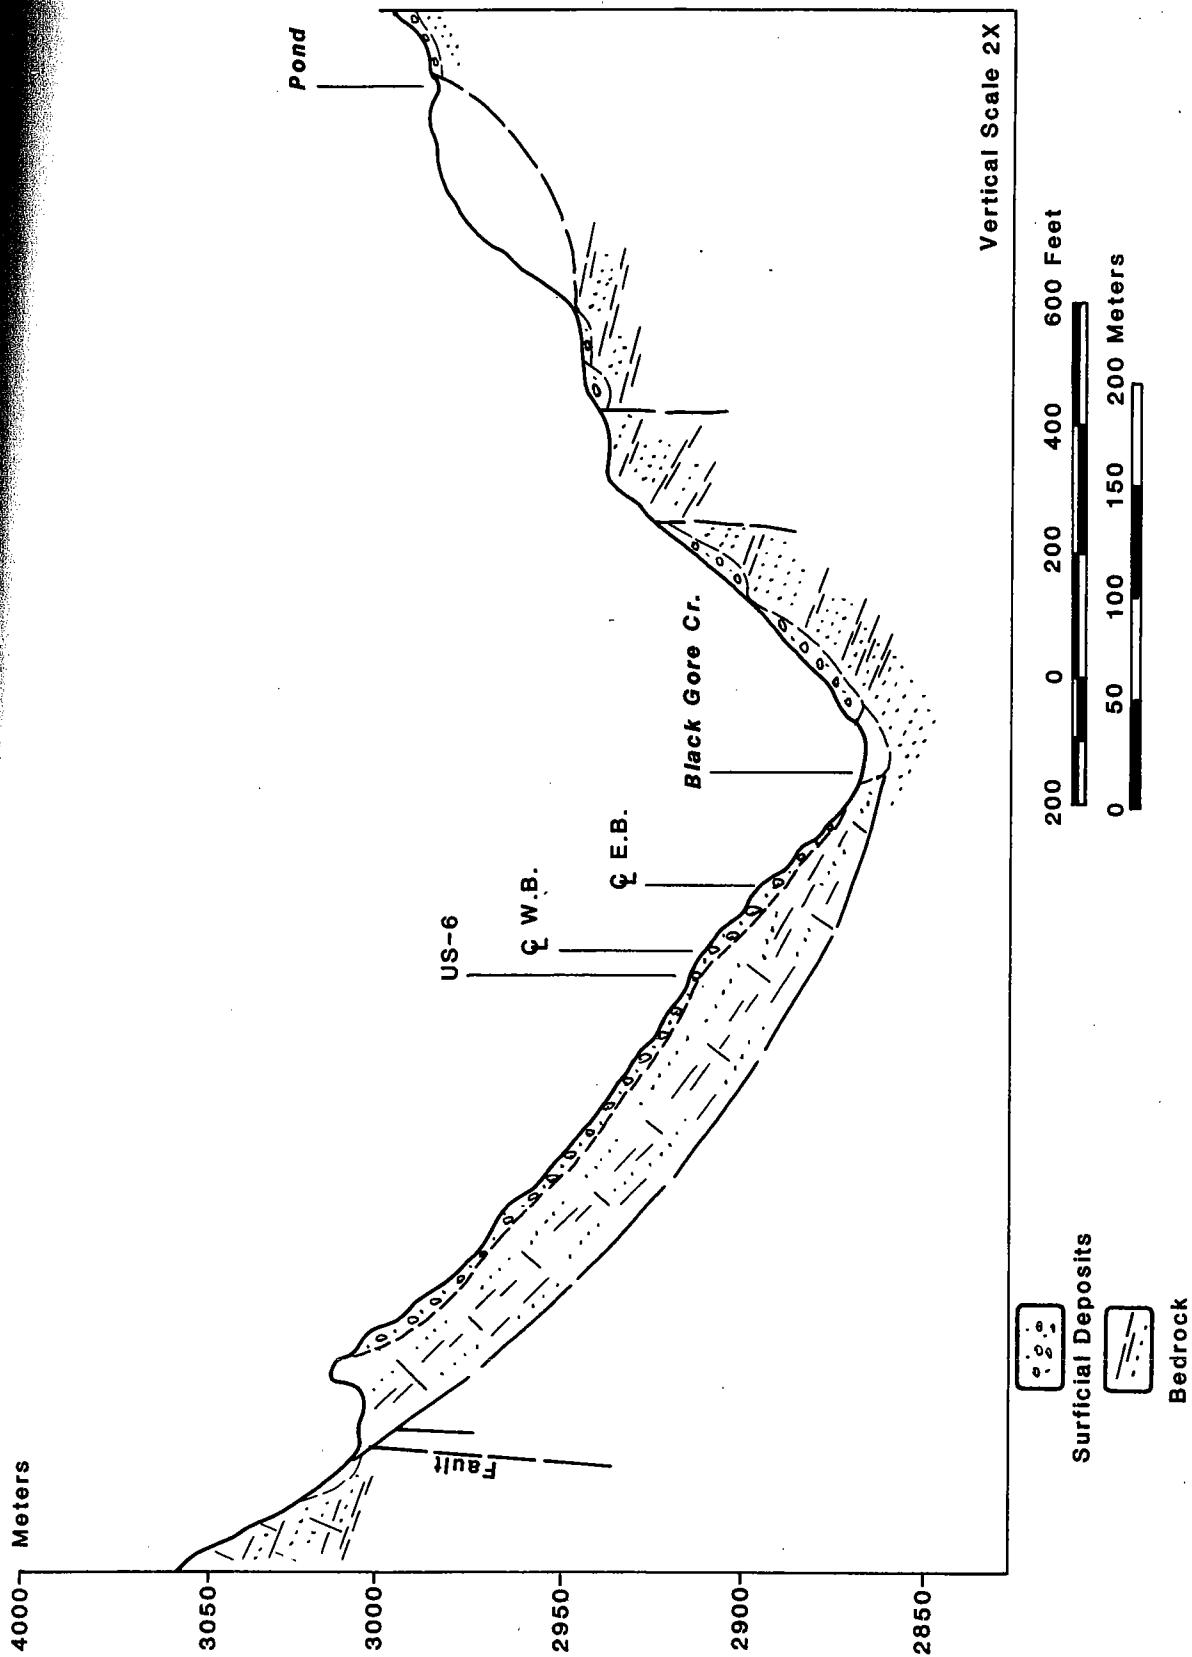
**Figure 6.--CROSS SECTION OF BEDROCK LANDSLIDE IN SEDIMENTARY ROCK
VAIL PASS AREA, COLORADO**

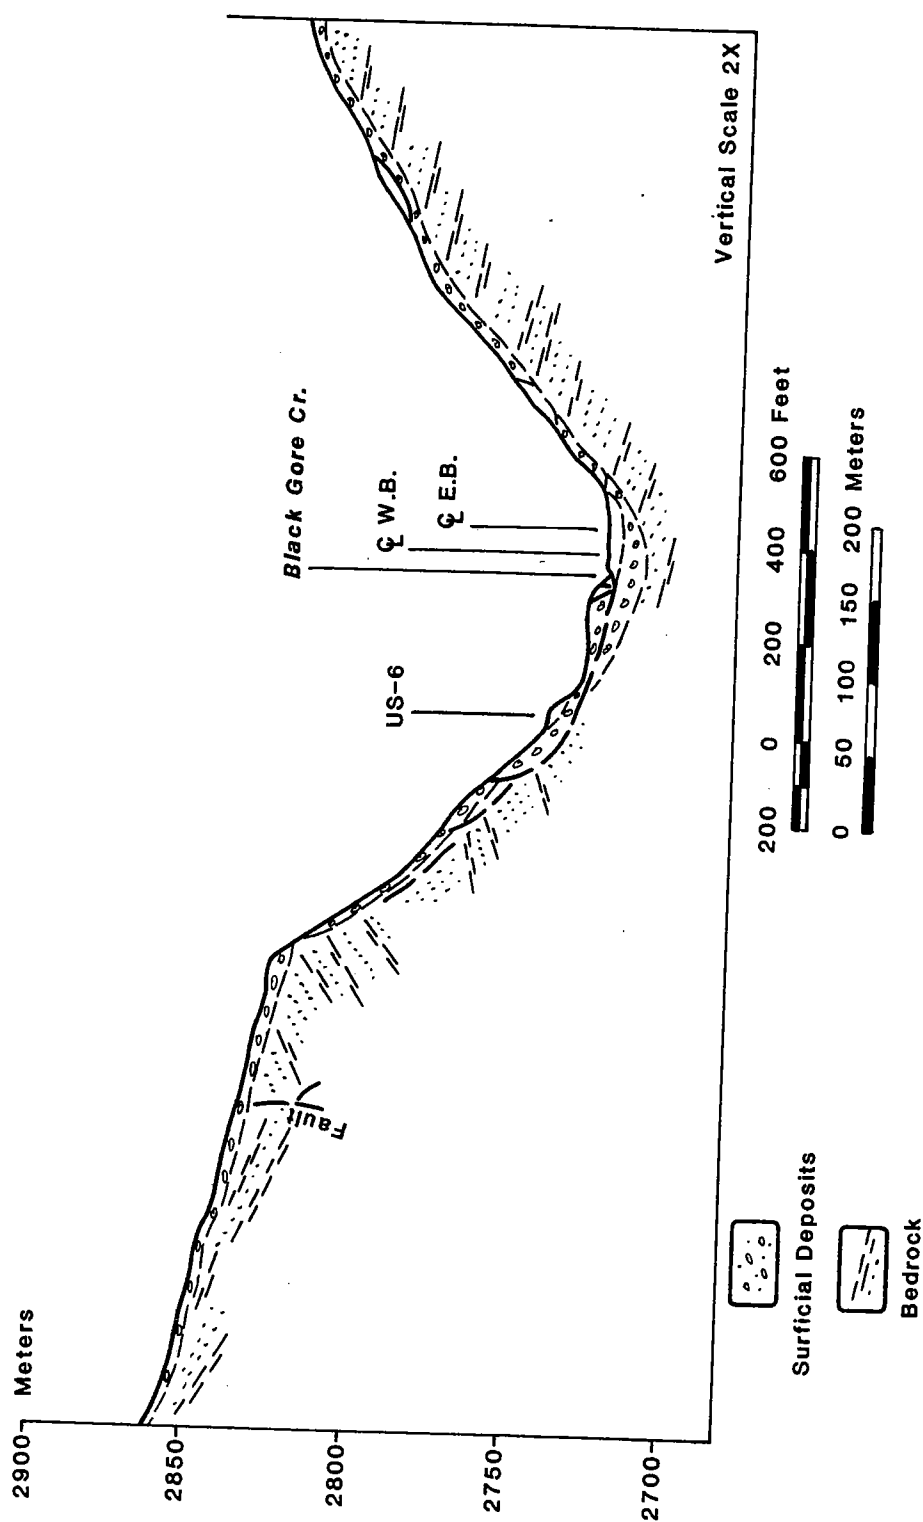
**Figure 7.--CROSS SECTION OF LANDSLIDE IN SURFICIAL DEPOSITS
VAIL PASS AREA, COLORADO**

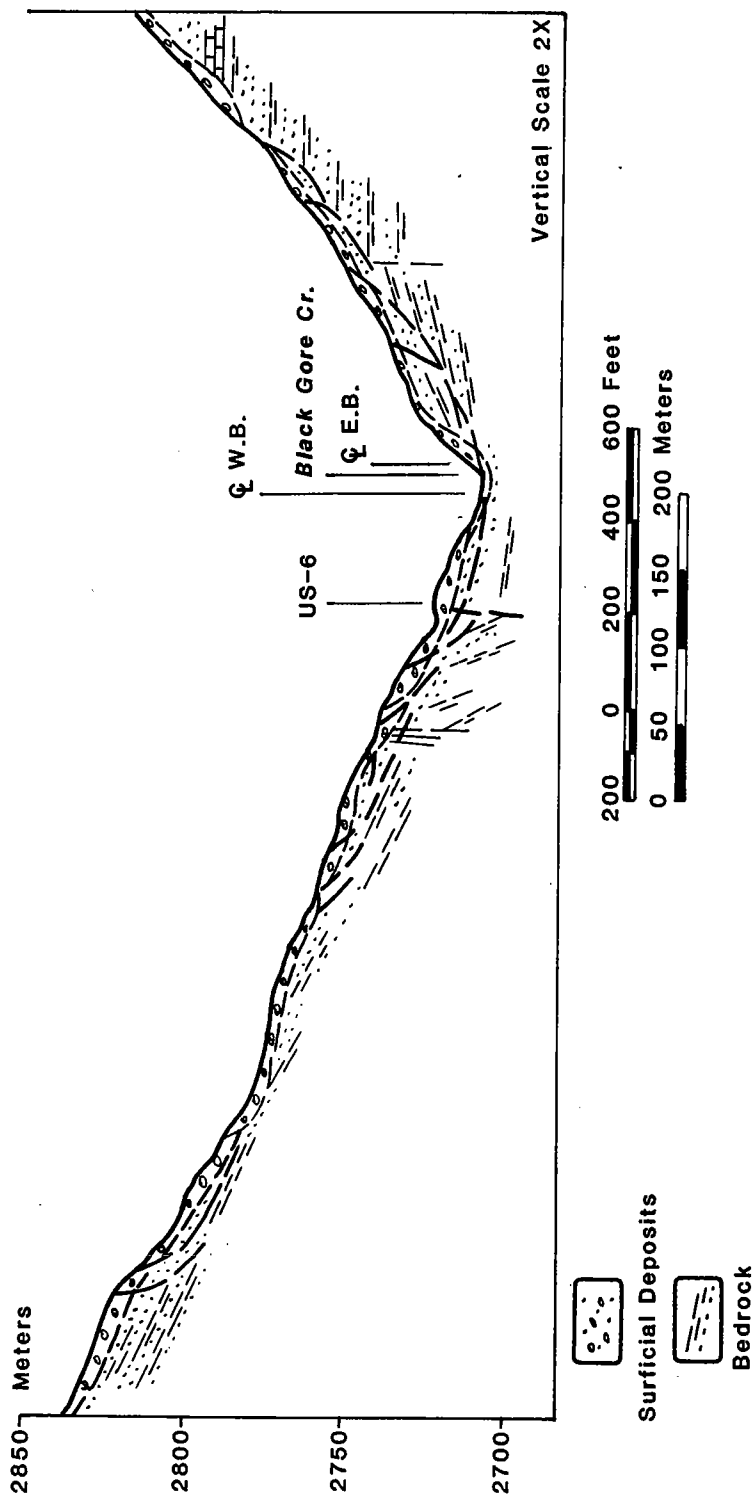
**Figure 8.--CROSS SECTION THROUGH ABUTING LANDSLIDES
VAIL PASS AREA, COLORADO**

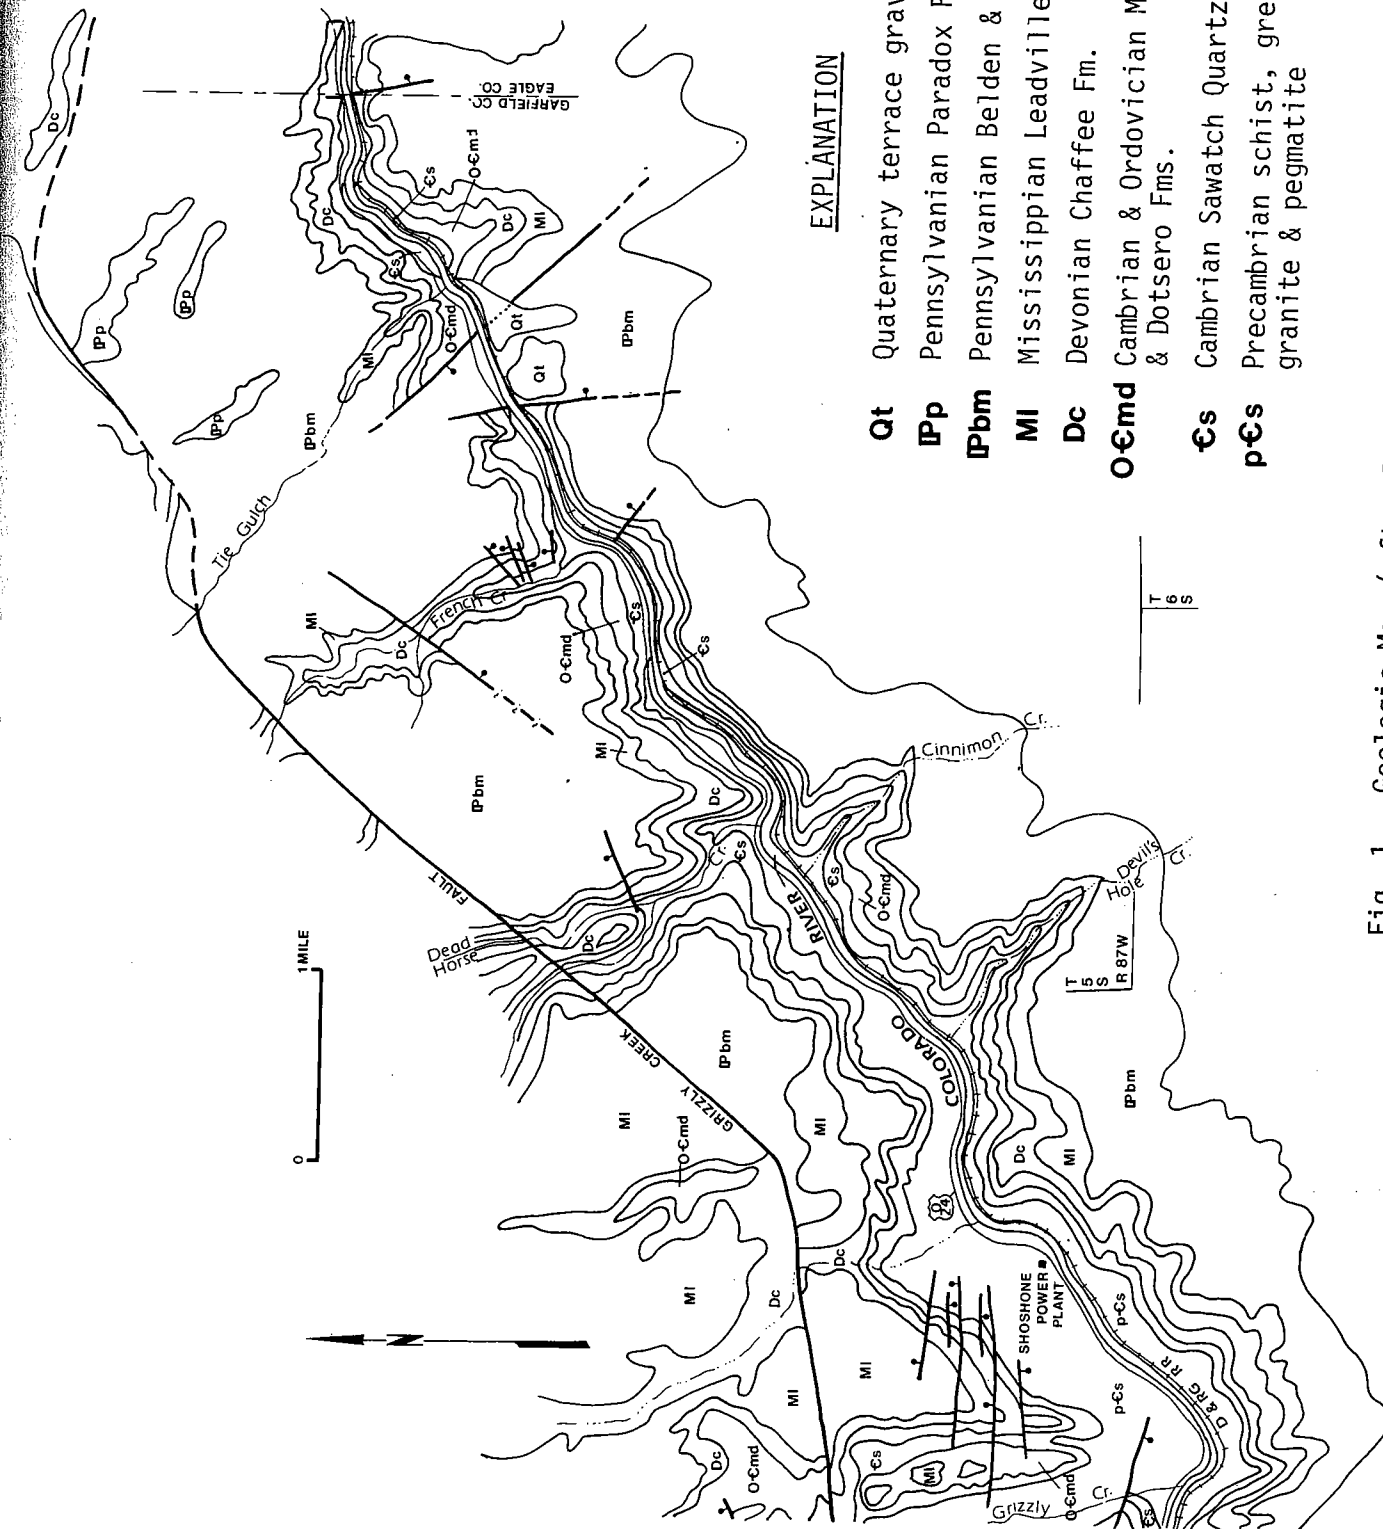
Fig. 1 - Geologic Map (after Bass & Northrup, 1963).

The Glenwood Canyon is deeply incised through several thousand feet of early Paleozoic sedimentary and pre-Cambrian igneous and metamorphic rocks of the White River Uplift (Fig. 1). The bottom of the canyon, also known as the Narrows, contains Quaternary deposits including talus, debris fans, terrace deposits and thick clay beds (Fig. 9).

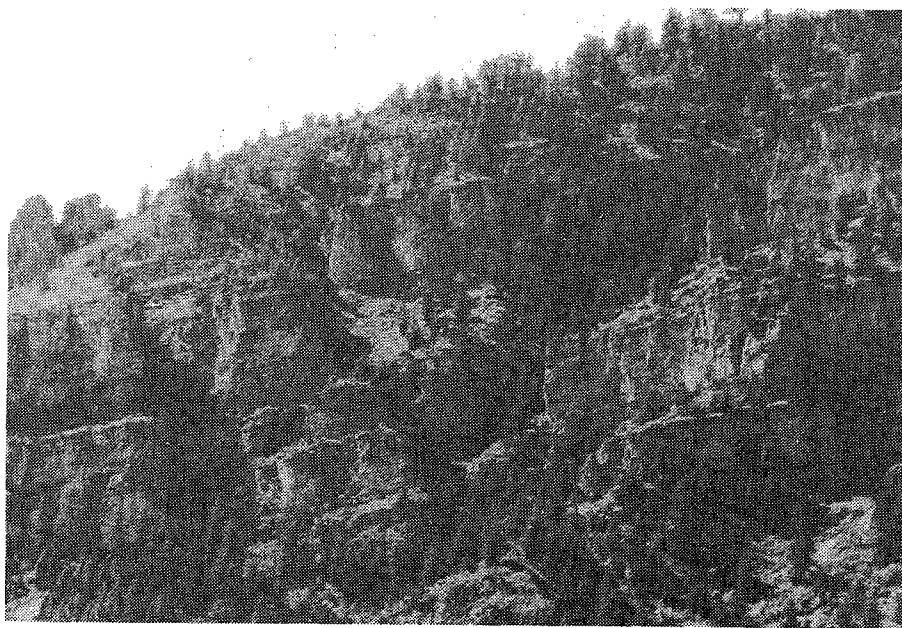
Fig. 4 - Marker bed (Clinetop Member) accentuating horst-and-graben structures just east of Grizzly Creek.

The Dotsero Formation, late Cambrian age, which conformably overlies the watch consists of about 100 feet of thin bedded dolomites and limestone pebble conglomerates interbedded with thin dolomitic shales. The upper beds of the Dotsero present one of the best marker units in the canyon. They consist of a ledge forming algal limestone which weathers to a very light grey or white and can be readily recognized throughout the area. (Fig. 4).

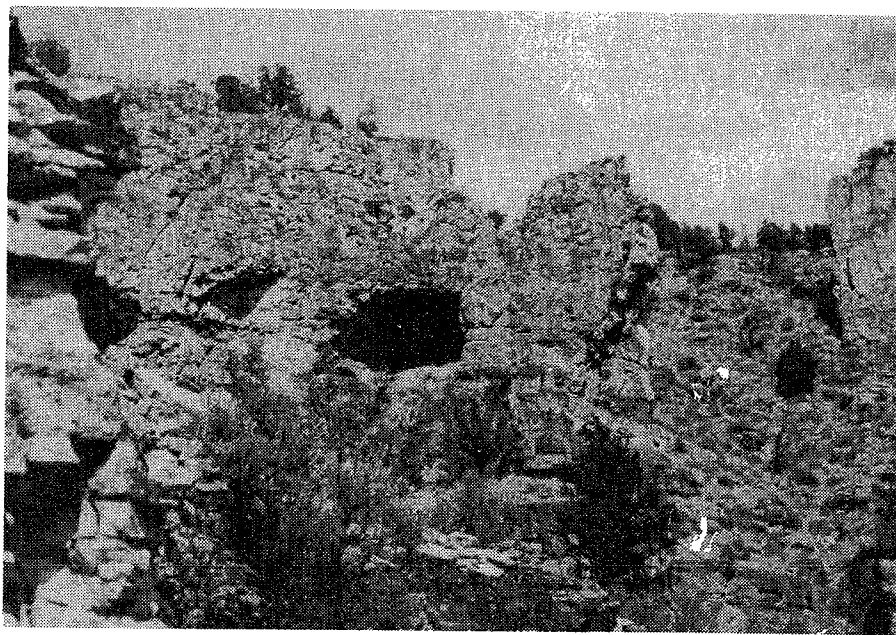
Fig. 5 - Relic karst terrane and solution features at the top of the Leadville Limestone just north of Golden Bear Ranch.

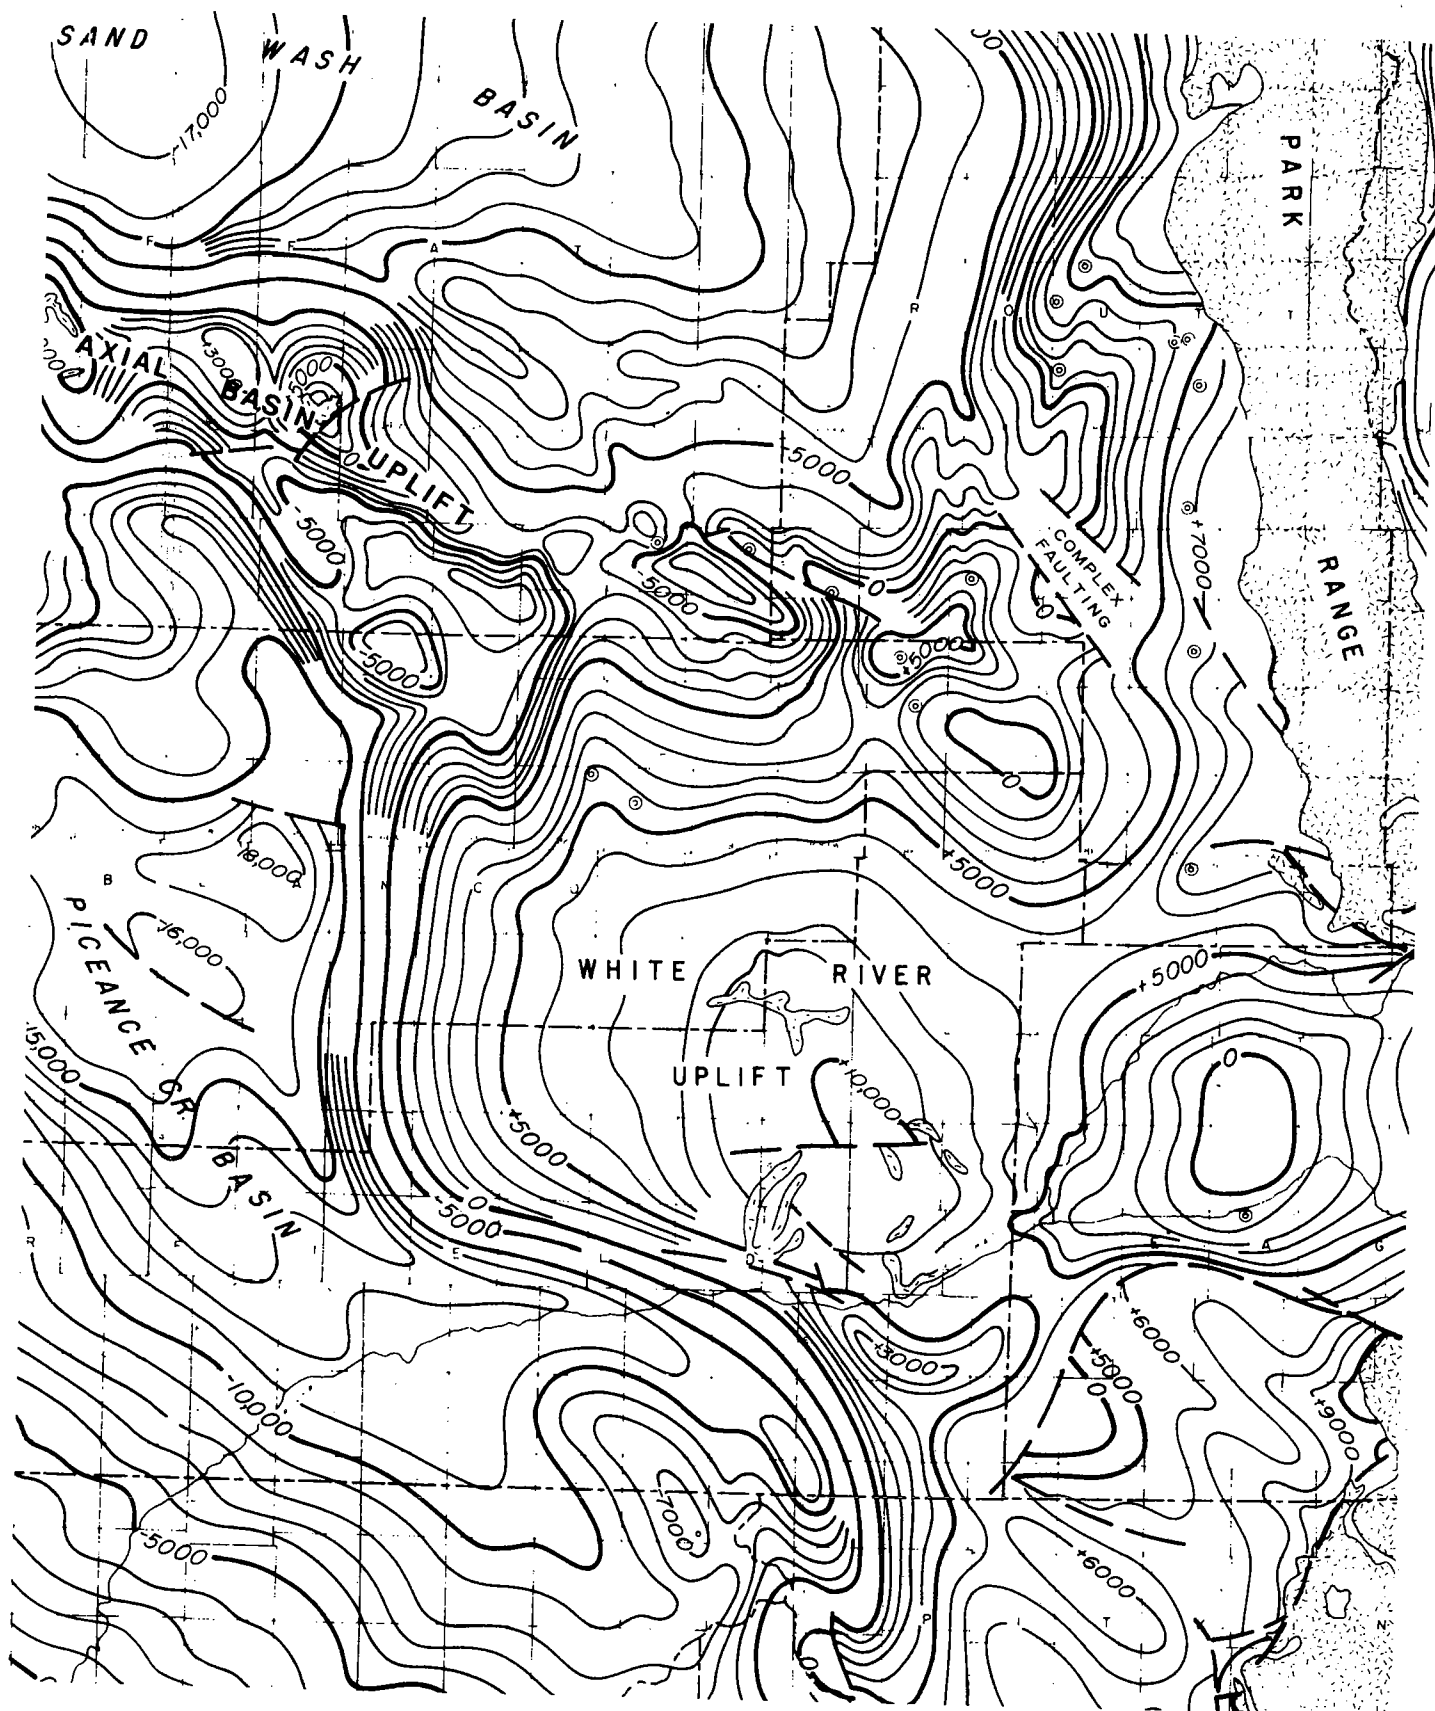
Fig. 6 - Structure contours on the top of the crystalline complex
(from MacLachlan, 1969).

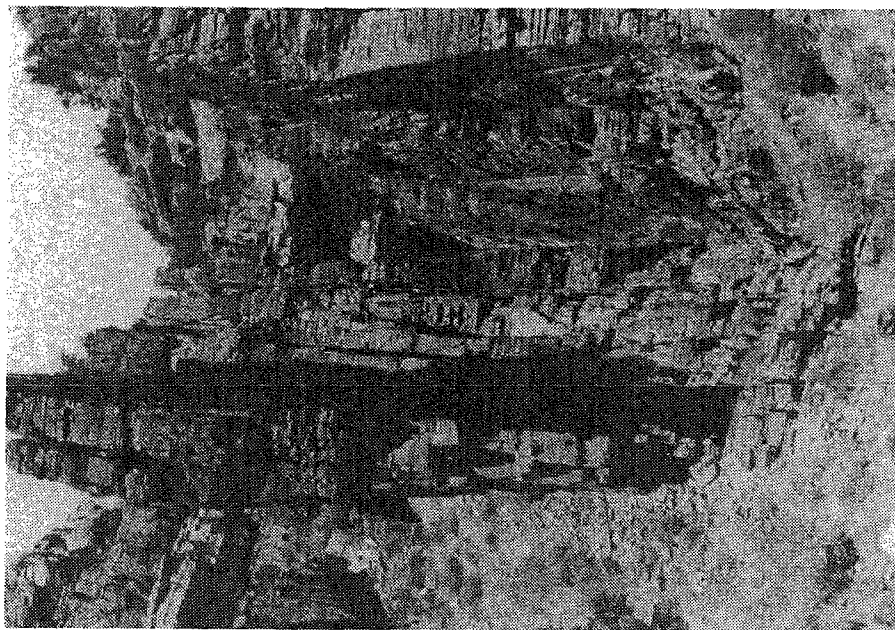
Fig. 7 - Massively jointed Sawatch Quartzite
forms Book Cliffs near eastern end of the
Narrows

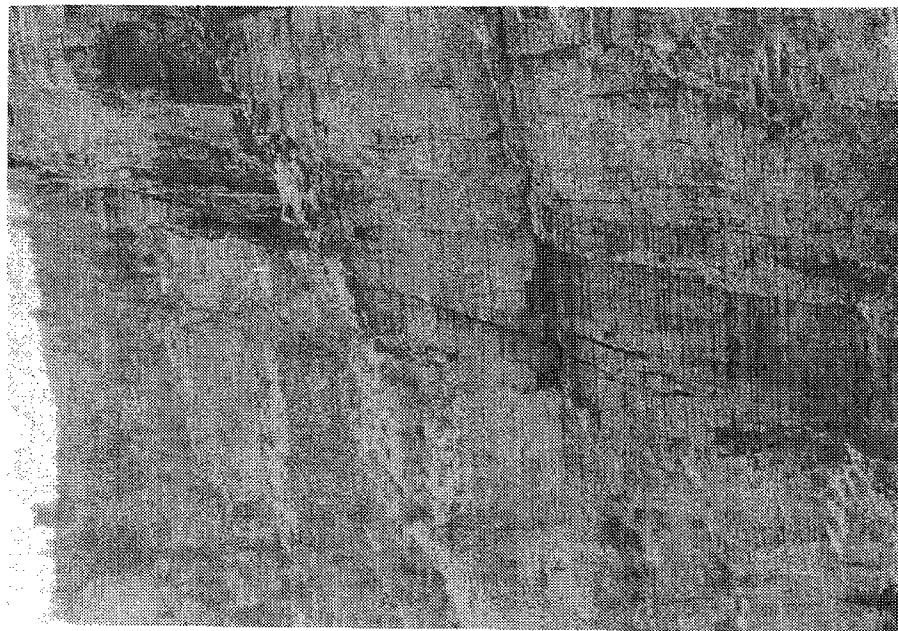
Fig. 8 - Rockfall hazard near Deadhorse Creek,
note the continuity of jointing and "wedging"
of lower block.

The in-place bedrock, where exposed along the right-of-way, possesses excellent bearing and stability characteristics. If there is a problem associated with the bedrock it is most certainly the significant risk of rockfall associated with almost the entire length of the Narrows. (Fig. 8).

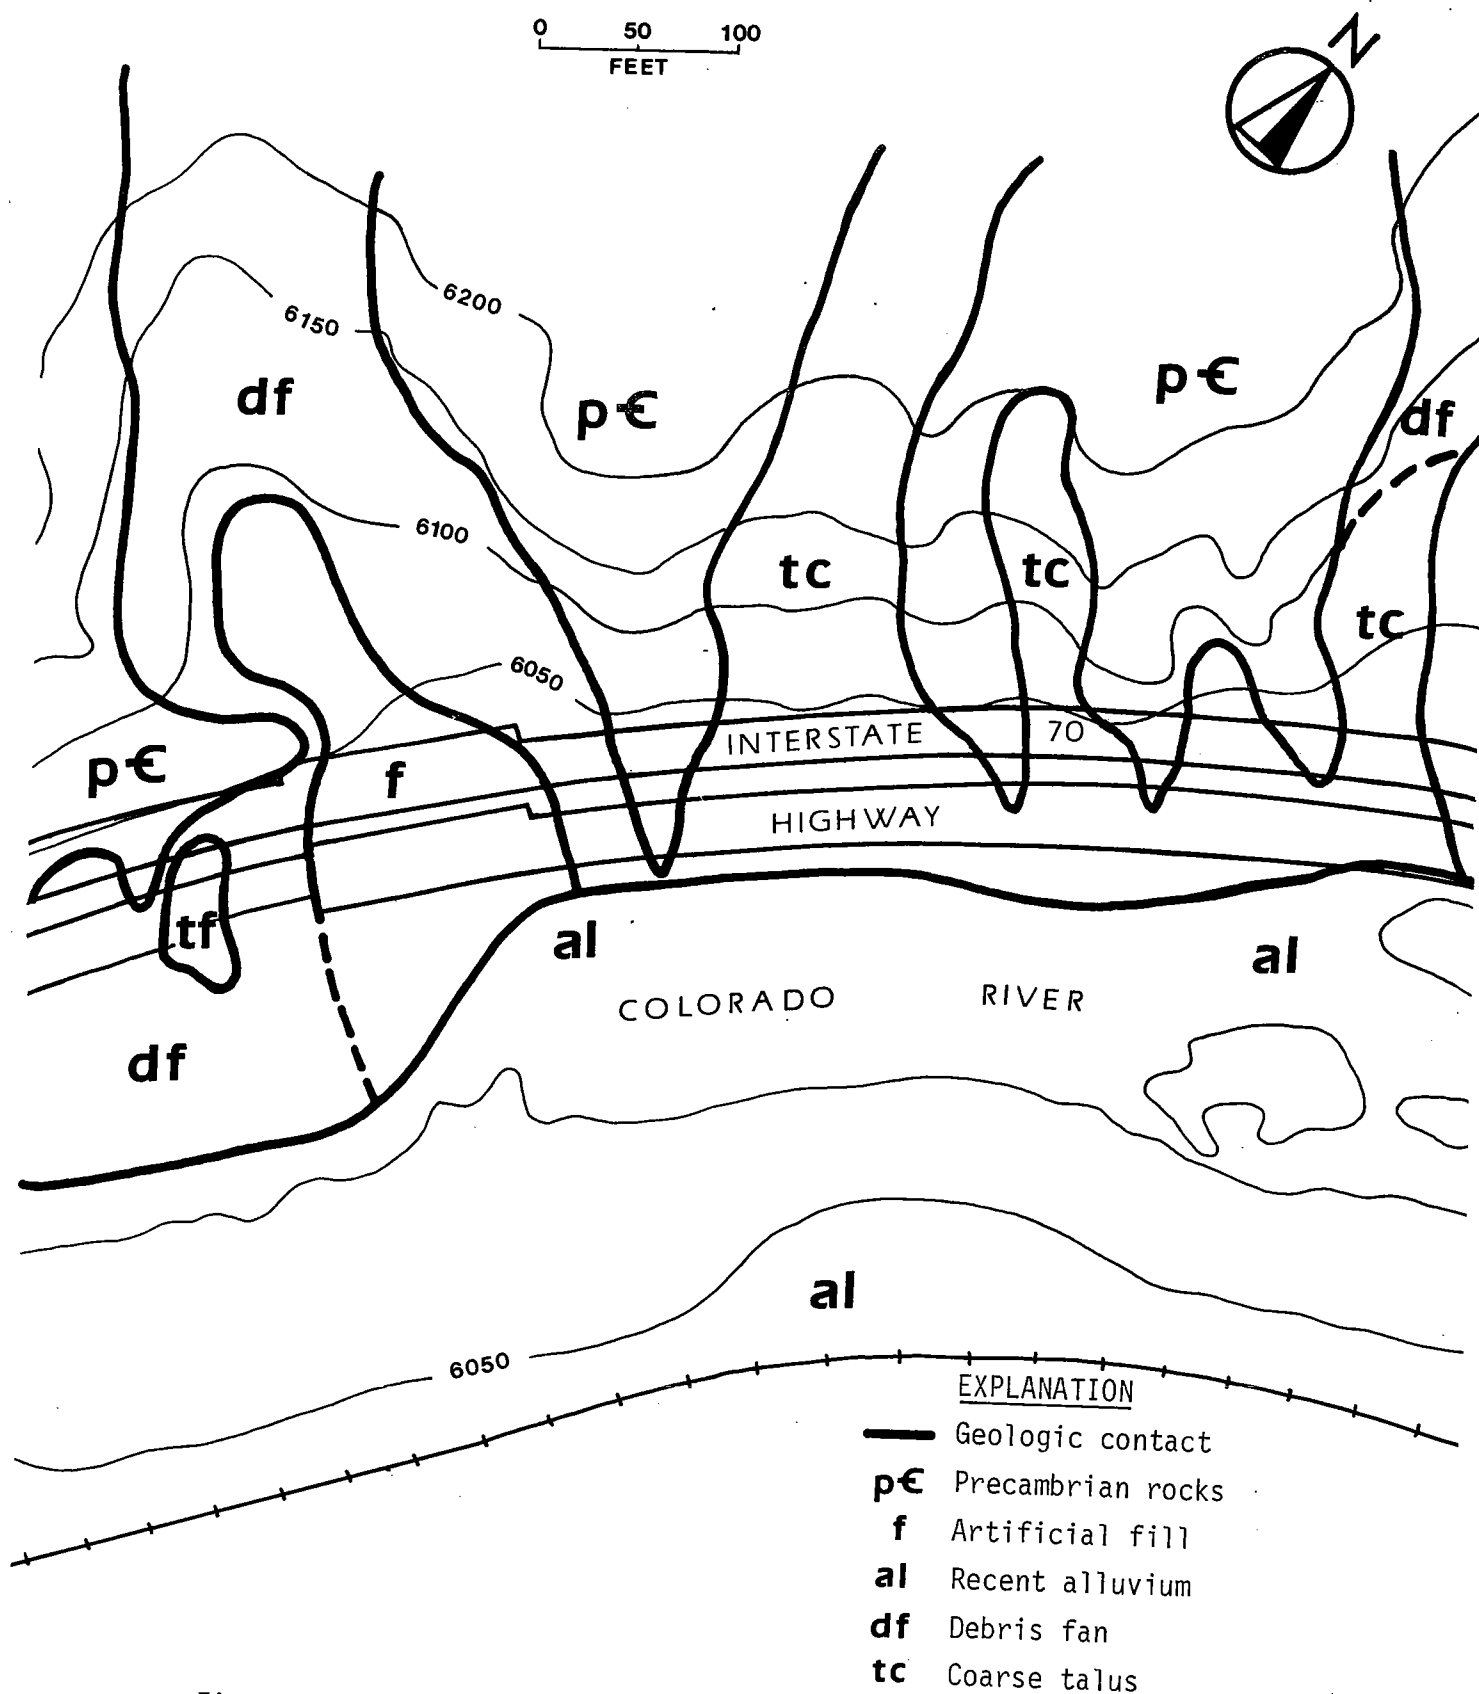
Fig. 9 - Engineering geology and surficial deposits along a reach of I-70 just west of Hanging Lake Reststop (from Colorado Dept. of Highways).

Quaternary deposits of talus, debris fans, alluvium and clay lenses can be observed in a narrow, discontinuous zone bounded by the river channel and the confining bedrock cliffs (Fig. 9). These deposits generally underly the actual roadway alignment and their presence and abrupt boundaries represent the major engineering geological implications associated with the construction of the highway.

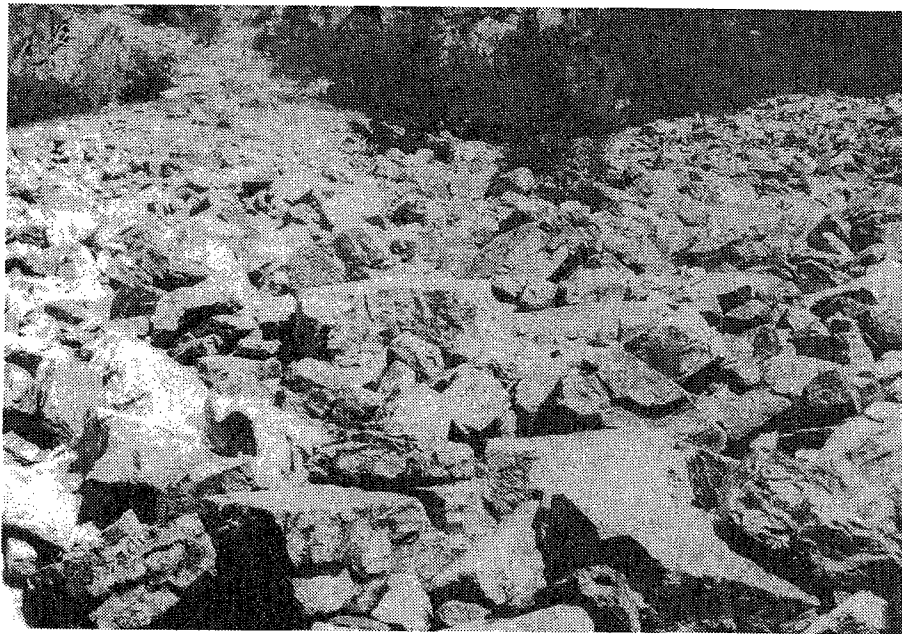
Fig. 10 - Blocky, coarse talus near French Creek.

drainage associated with the side streams and their debris fans. The engineering solutions to some of these problems will be the focus of parts of tomorrow's field trip. (Figs. 10 and 11).

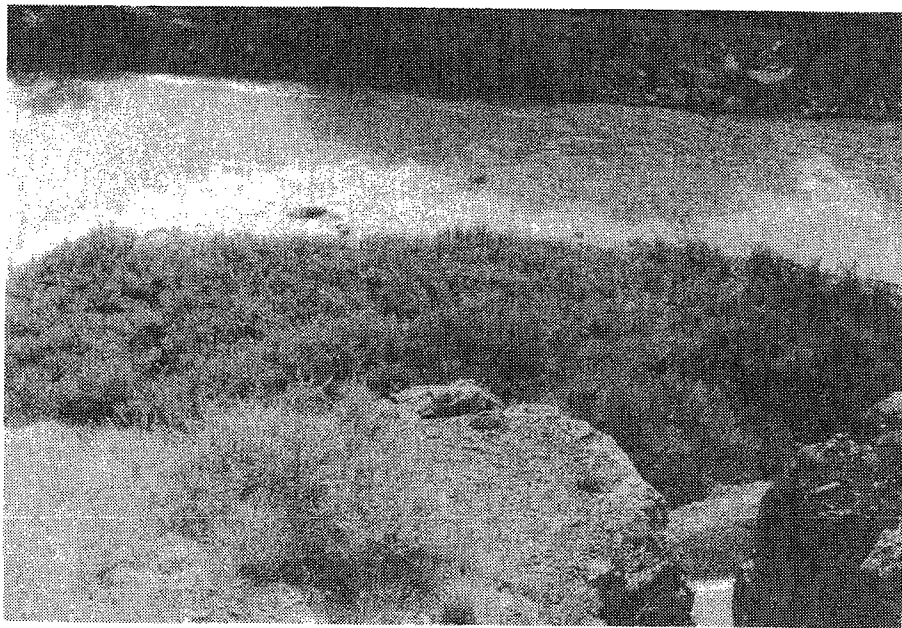
Fig. 11 - Debris fan at Tie Gulch restricts the channel to approximately half its normal width.

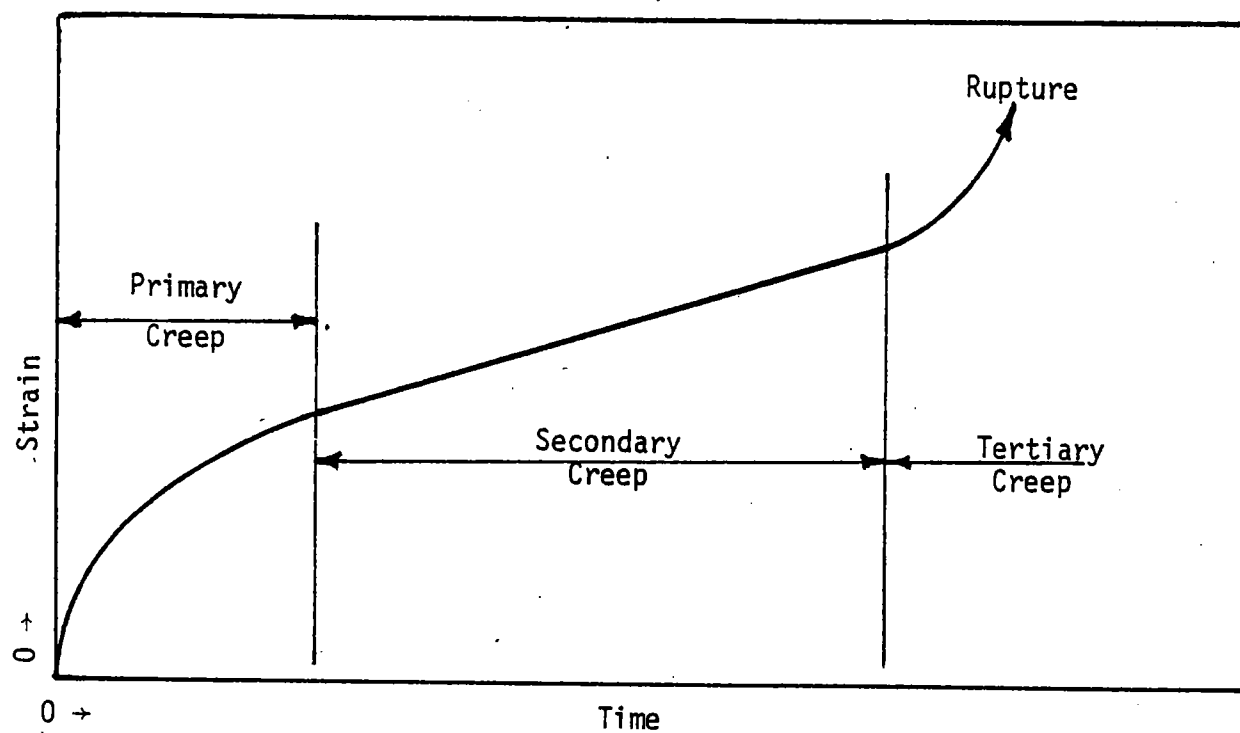
FIGURE 3 Phases of Creep for a Typical Geotextile Tested in Isolation at Constant Load and Temperature.
