PROCEEDINGS of the 33rd ANNUAL HIGHWAY GEOLOGY SYMPOSIUM

ENGINEERING GEOLOGY and ENVIRONMENTAL CONSTRAINTS

Engineering Geology
and
Environmental Constraints
in
Vail, Colorado
1982

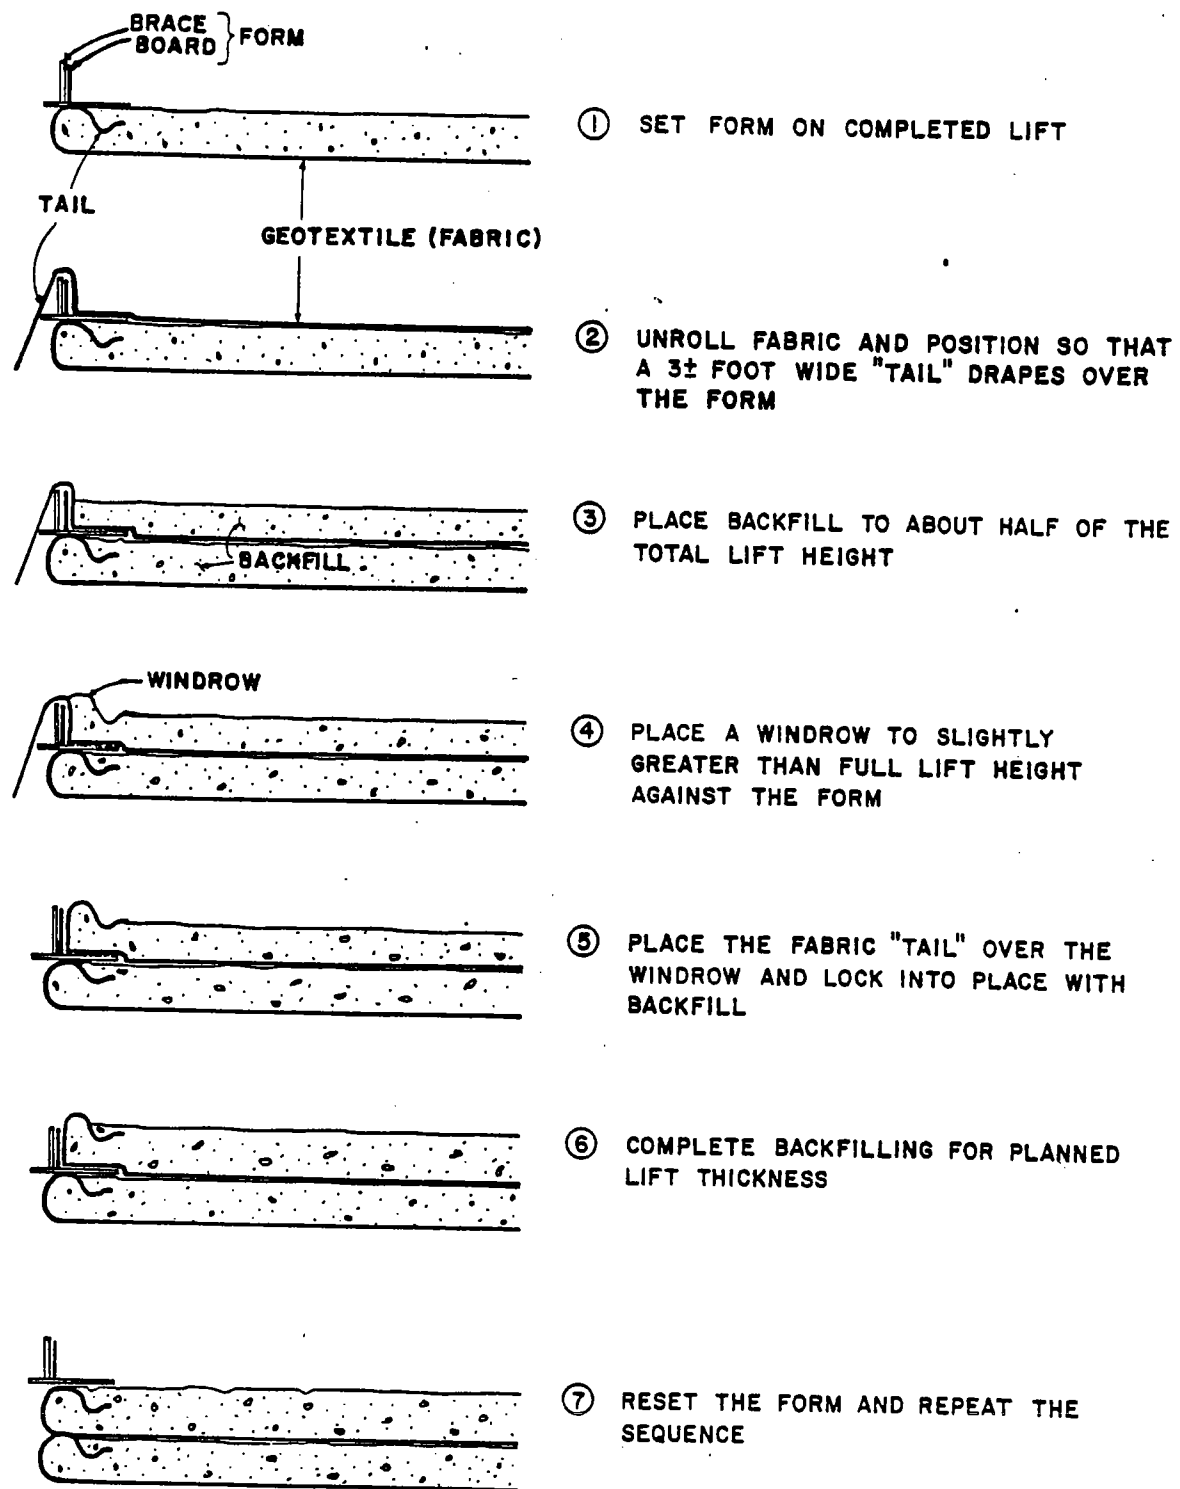
FIGURE 6 General Geotextile Wall Construction Procedure.

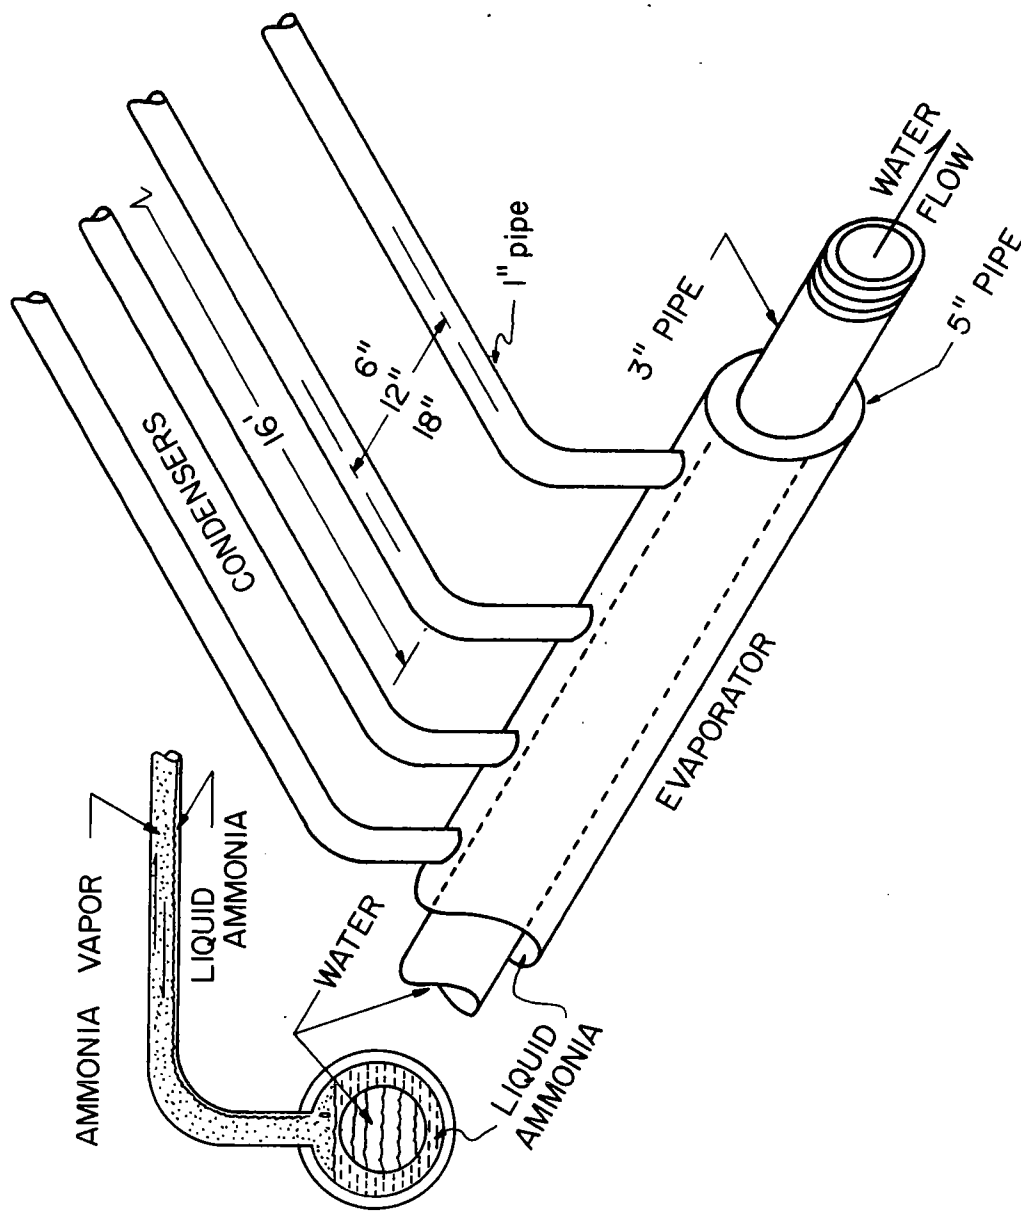
Figure 1. SETA's Heat Pipe Design for the Glenwood Springs Geothermally Heated Bridge.

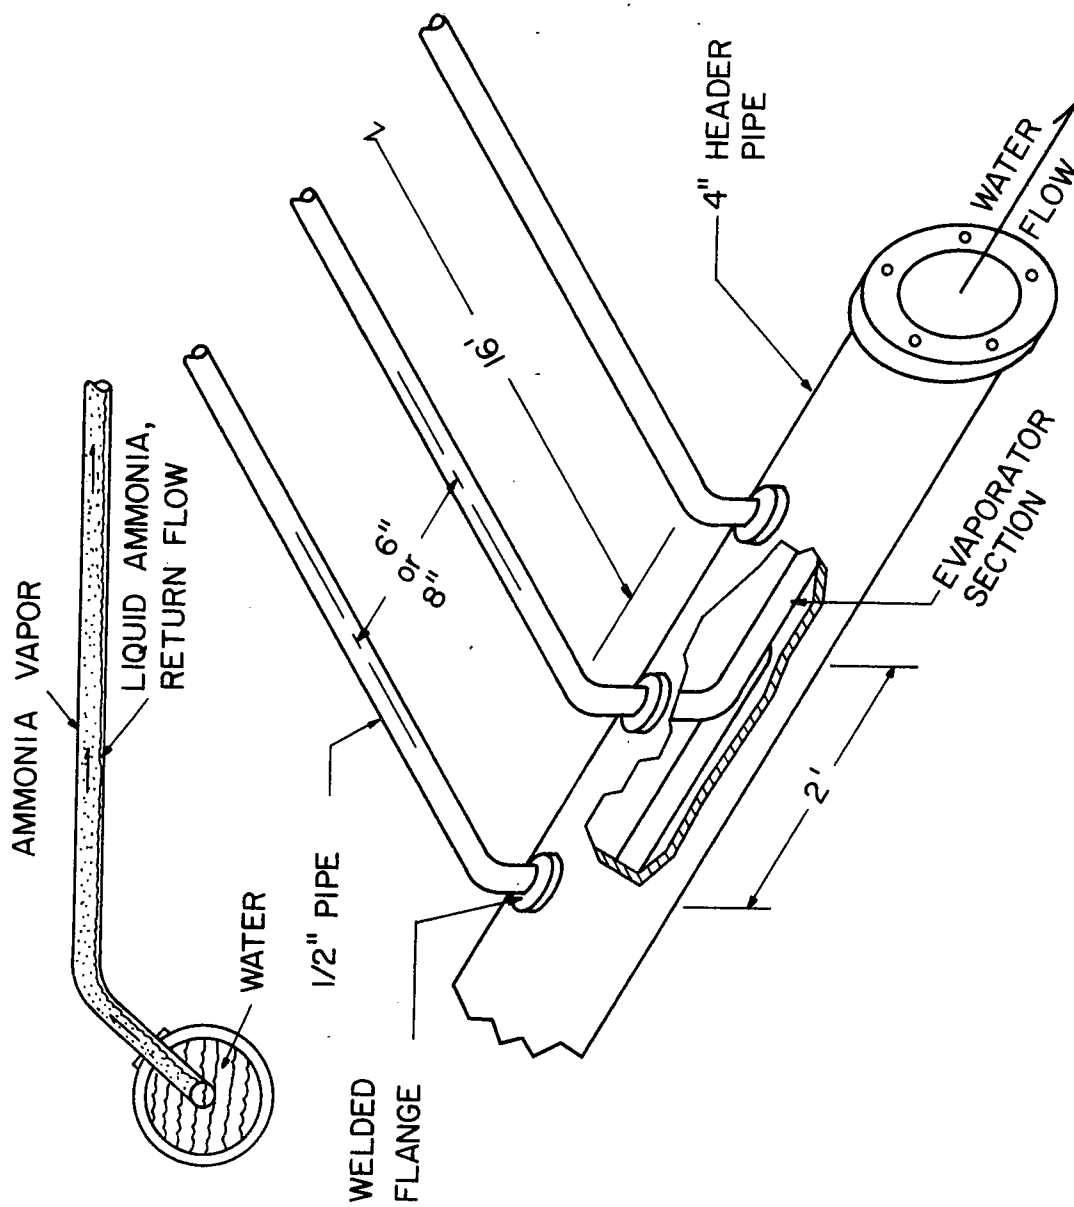
Figure 2. EEI's Heat Pipe Design for the Glenwood Springs Geothermally Heated Bridge.

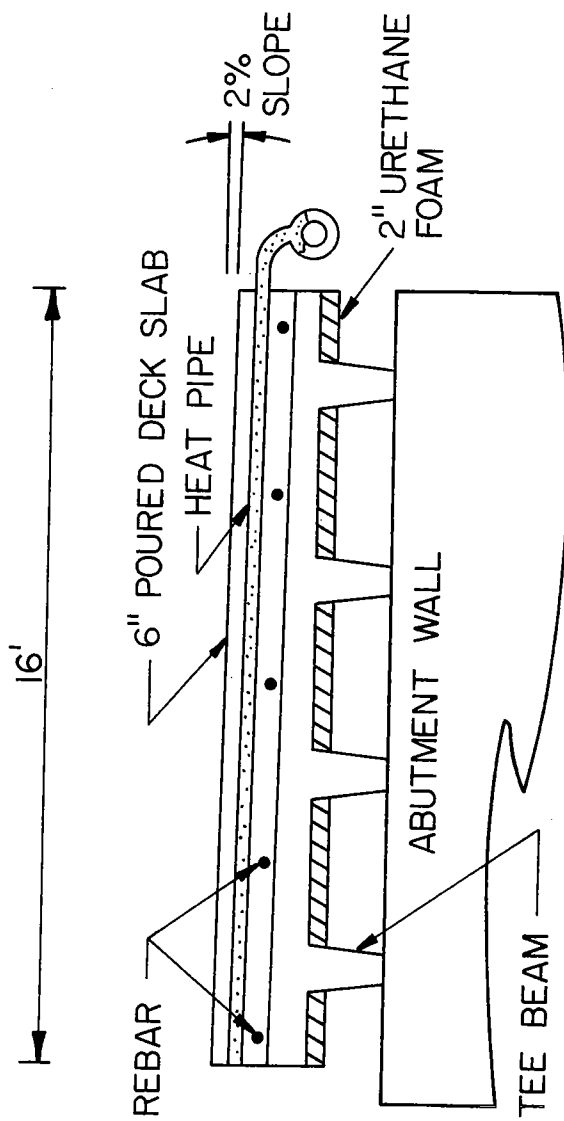
Figure 3. End View of Prototype Bridge.

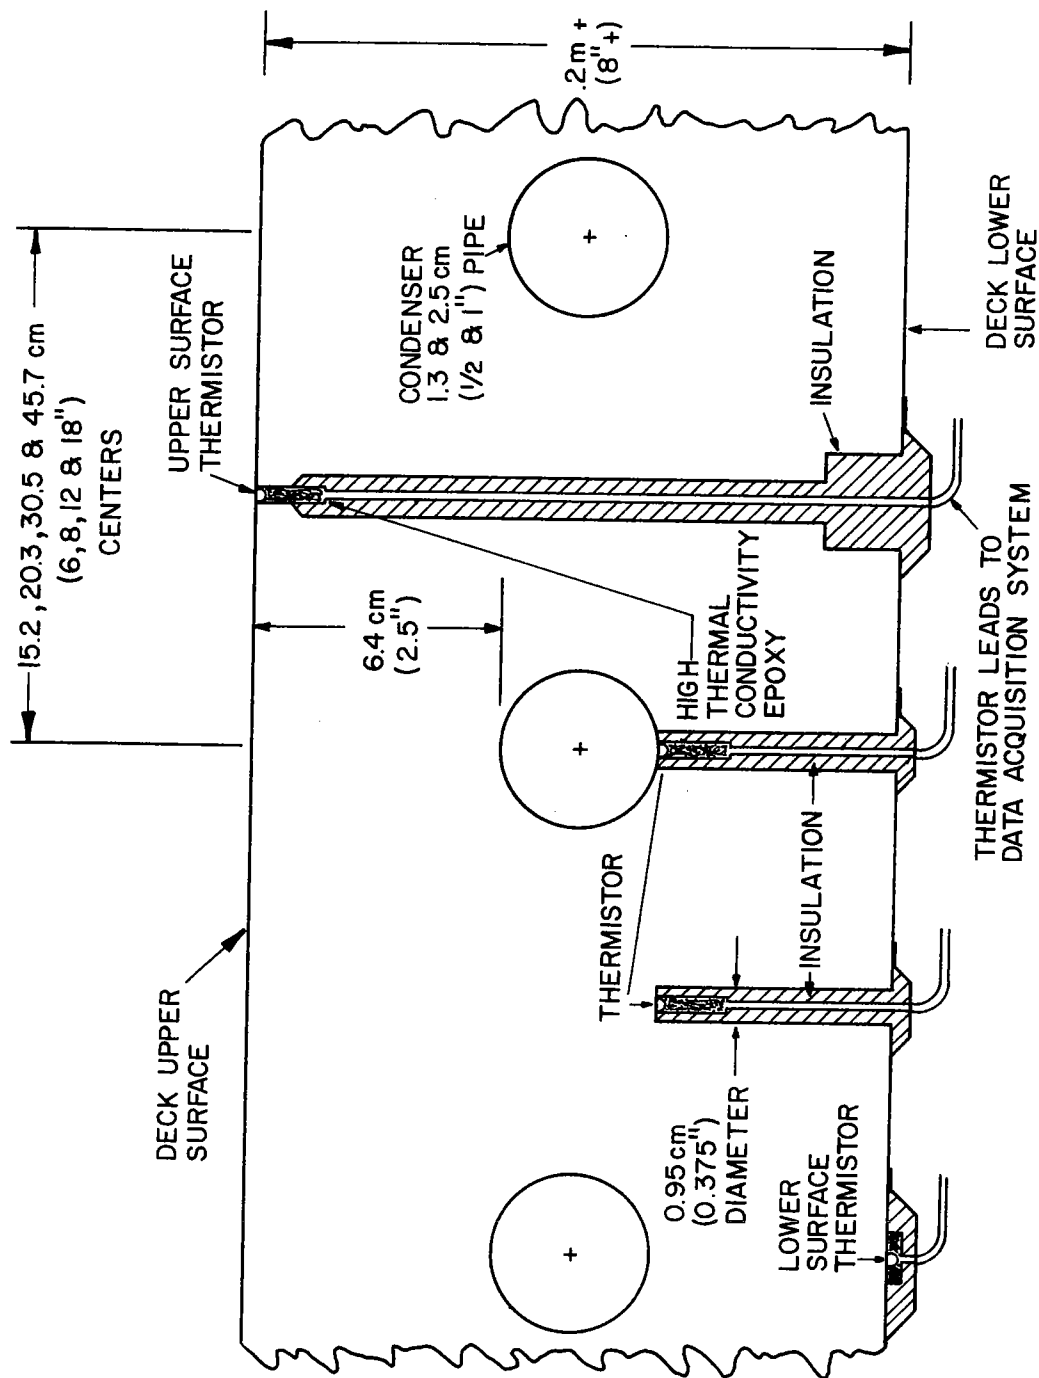
Figure 4. Typical Temperature Instrumentation in the Deck.

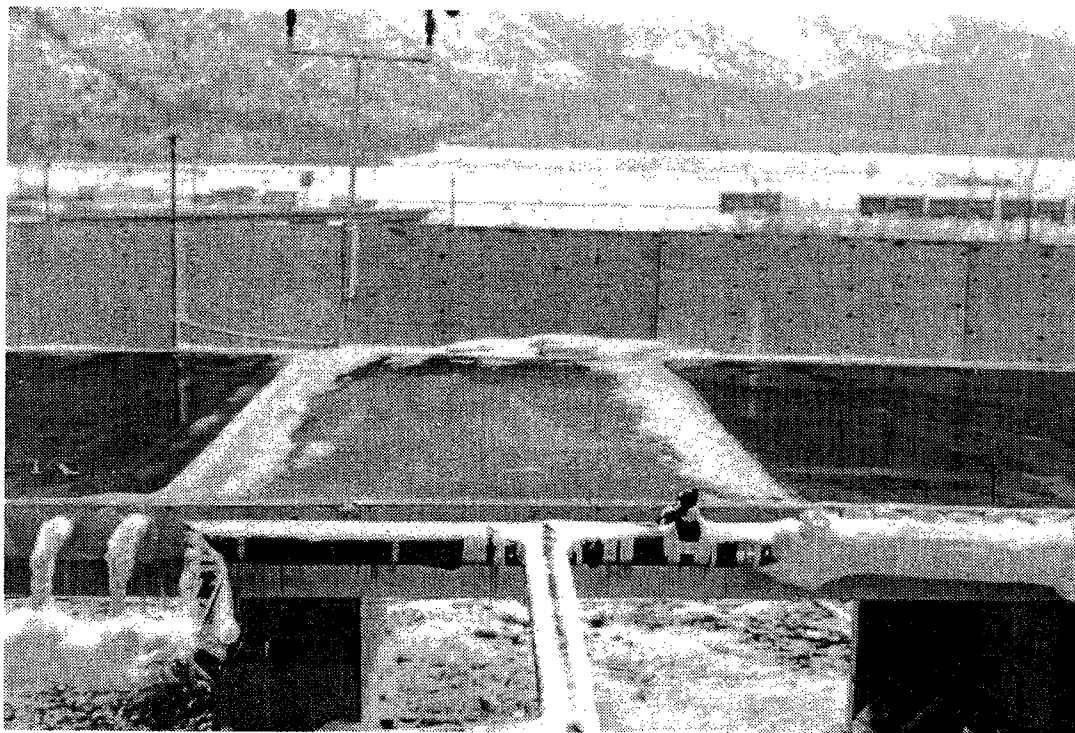
Figure 5. Typical Melting Event with an Ice Covered Unheated Control and Wet Heated Surfaces.

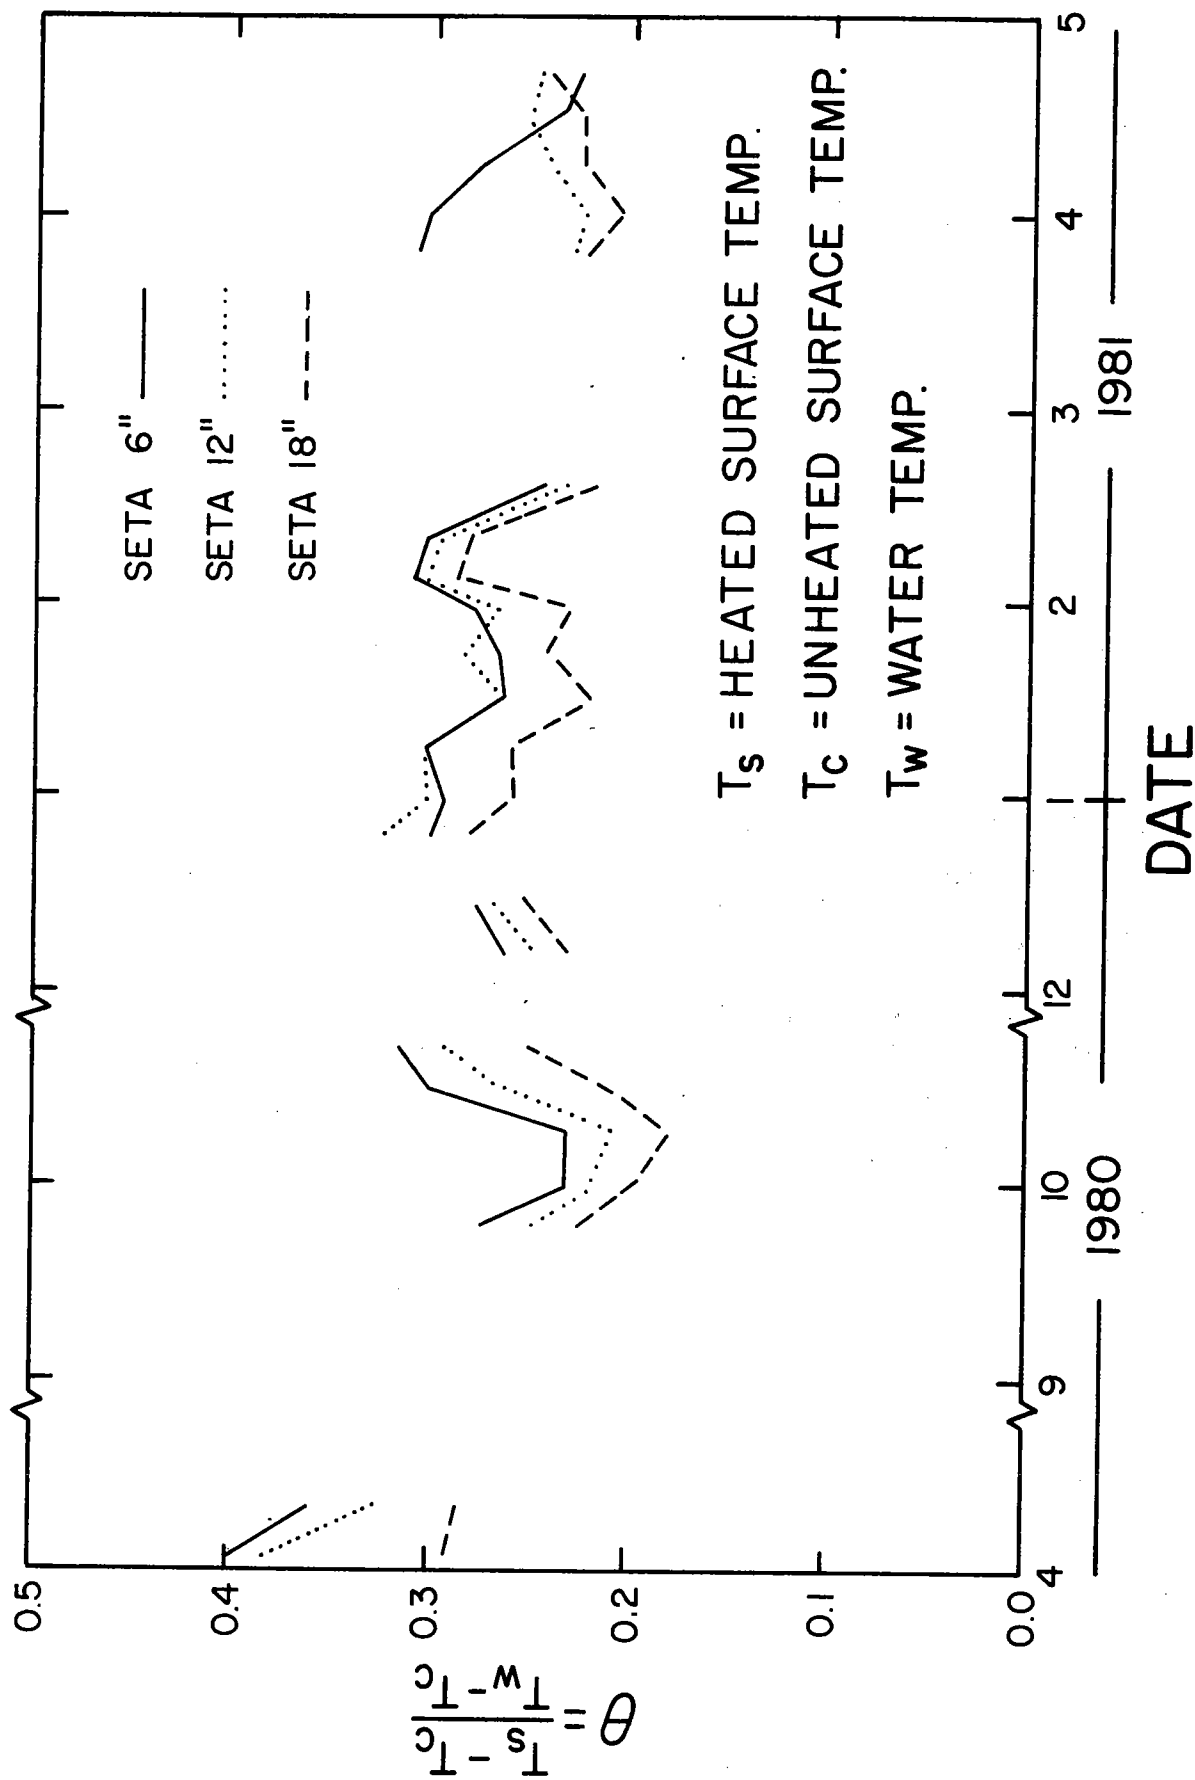
Figure 6. Coefficient of Performance θ versus Time for the SETA Heat Pipe Modulus.

θ for the SETA 12" manifold varied between 0.21 and 0.43 and it had an average θ of 0.23 over the mid-winter months. The variation for the SETA 18" module was 0.13 to 0.29 with a 0.25 mid-winter mean. A detailed heat transfer analysis of these data and the corresponding environmental data indicated that the fouling had reduced the experimentally observed conductance of the SETA modules by at least 55%. The major effect of fouling on these units appears to have occurred fairly early in the experiment in that they maintained a reasonably constant conductance over the latter part of the experiment. Figure 6 indicates that the relative effects of the fouling on the SETA modules were such that there was very little difference in their performances after February 1981.

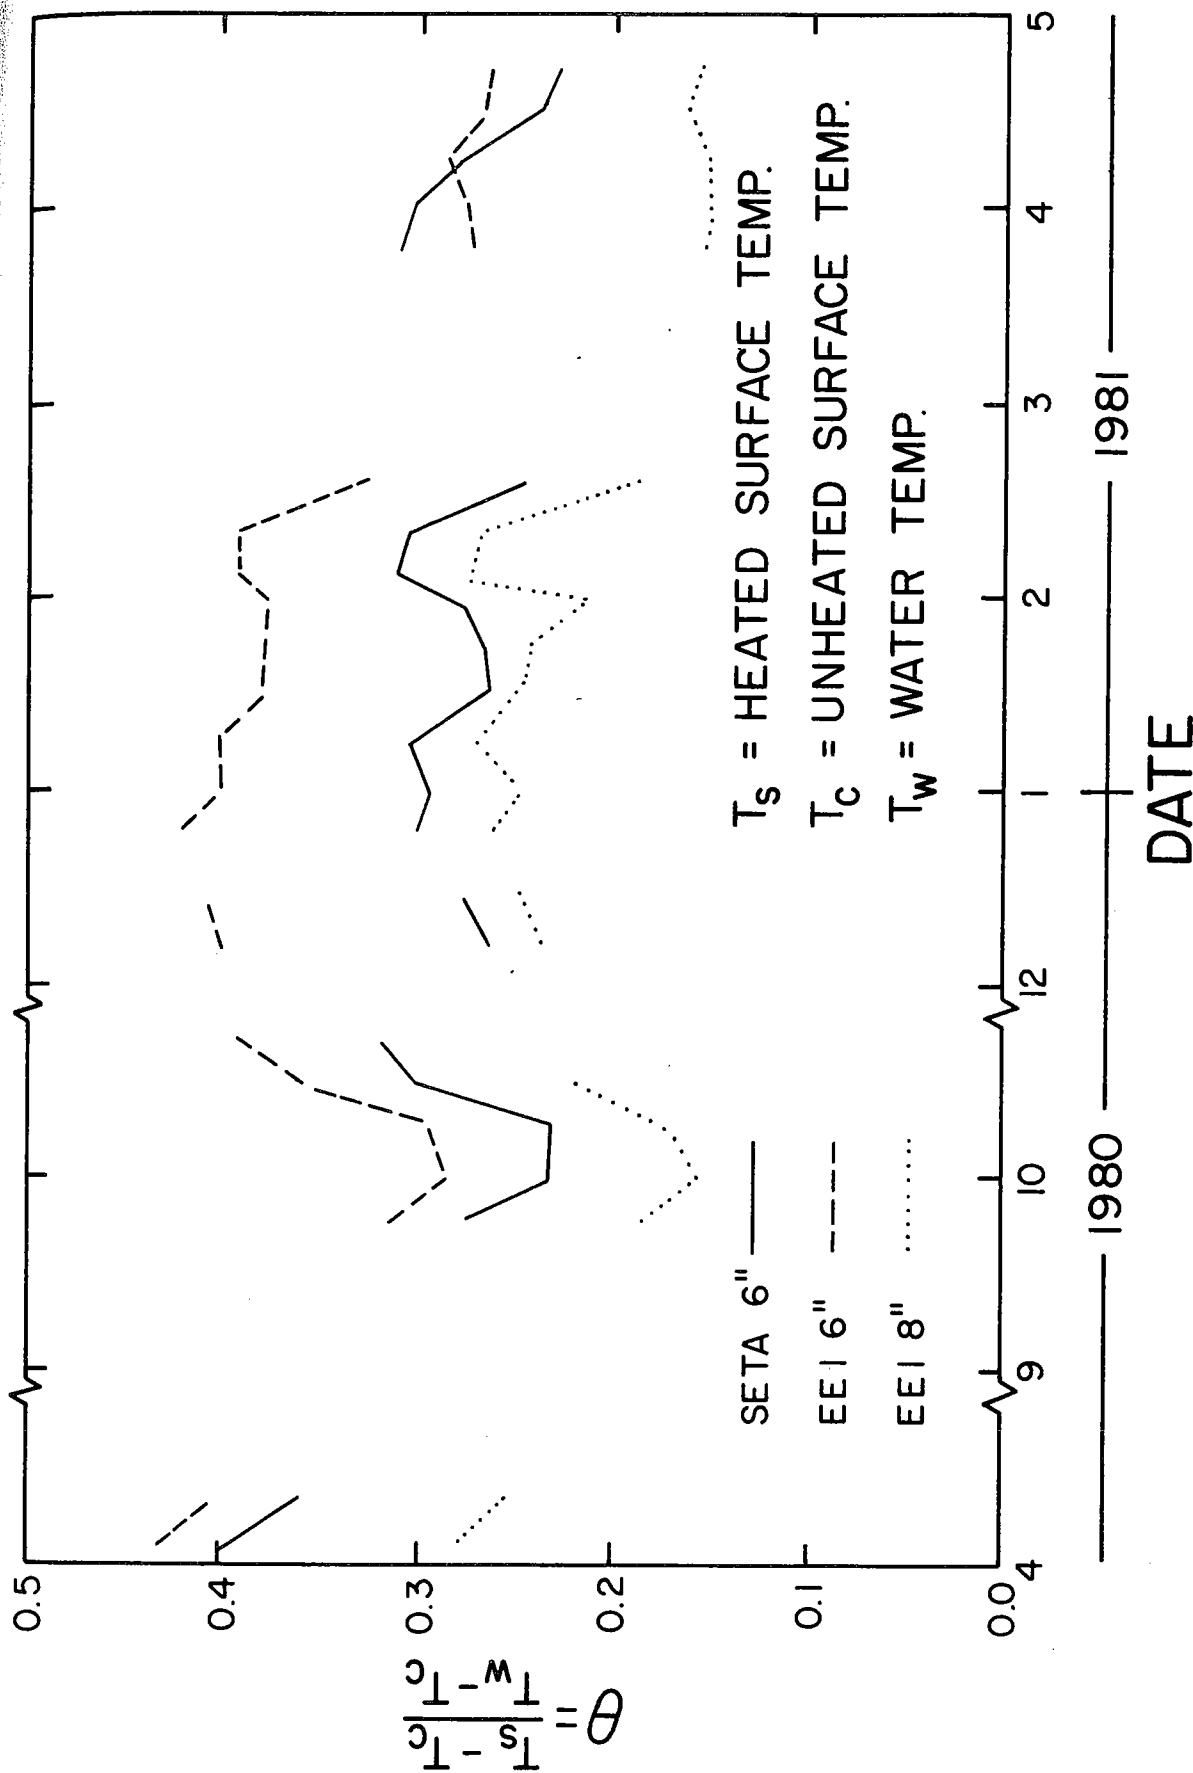
Figure 7. Coefficient of Performance θ versus Time for the EEI Heat Pipe Modulus and the SETA 6" Modulus.

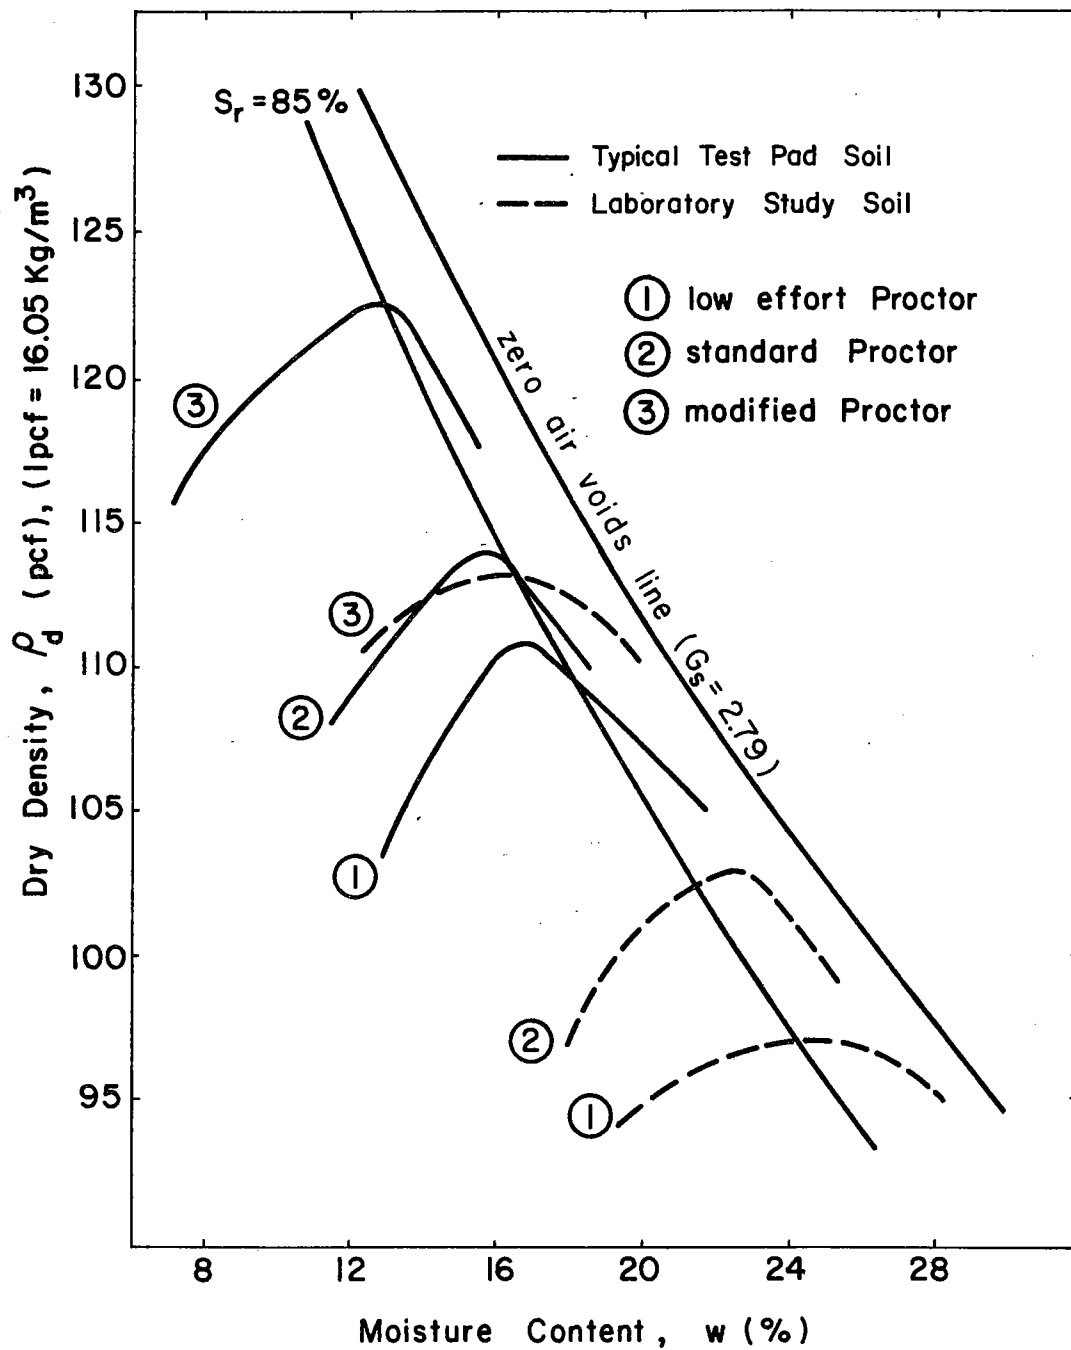
Figure 1: Impact Compaction Curves for Test Pad and Laboratory Study Soils.

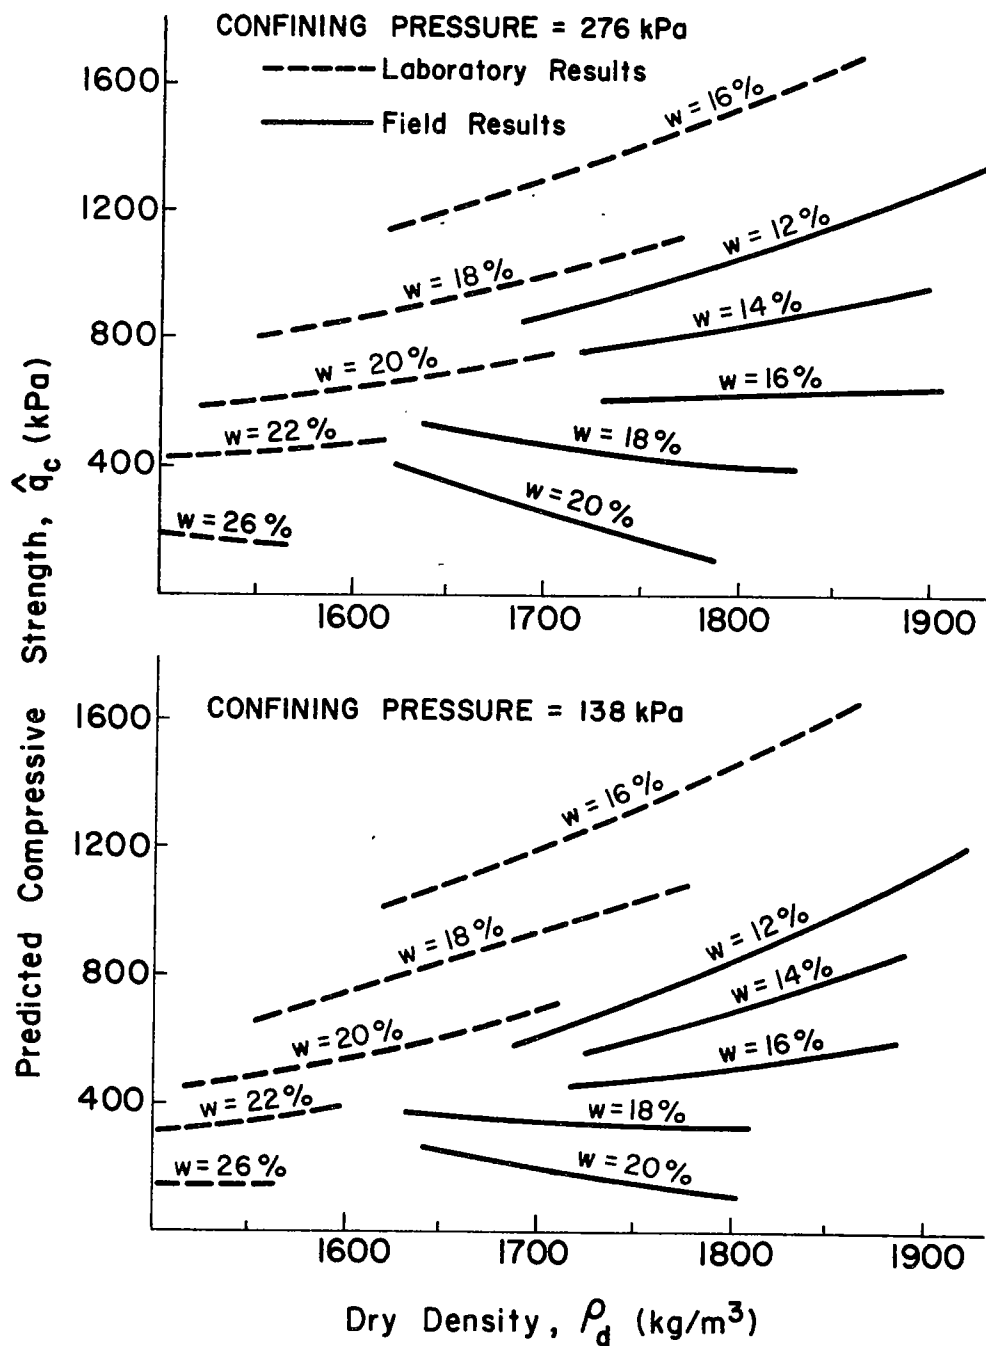
Figure 2: Predicted Compressive Strength–Dry Density Relationship at Constant Water Content.

where \hat{q}_c is the estimated compressive strength in kPa. Typical values are shown in Figure 2.

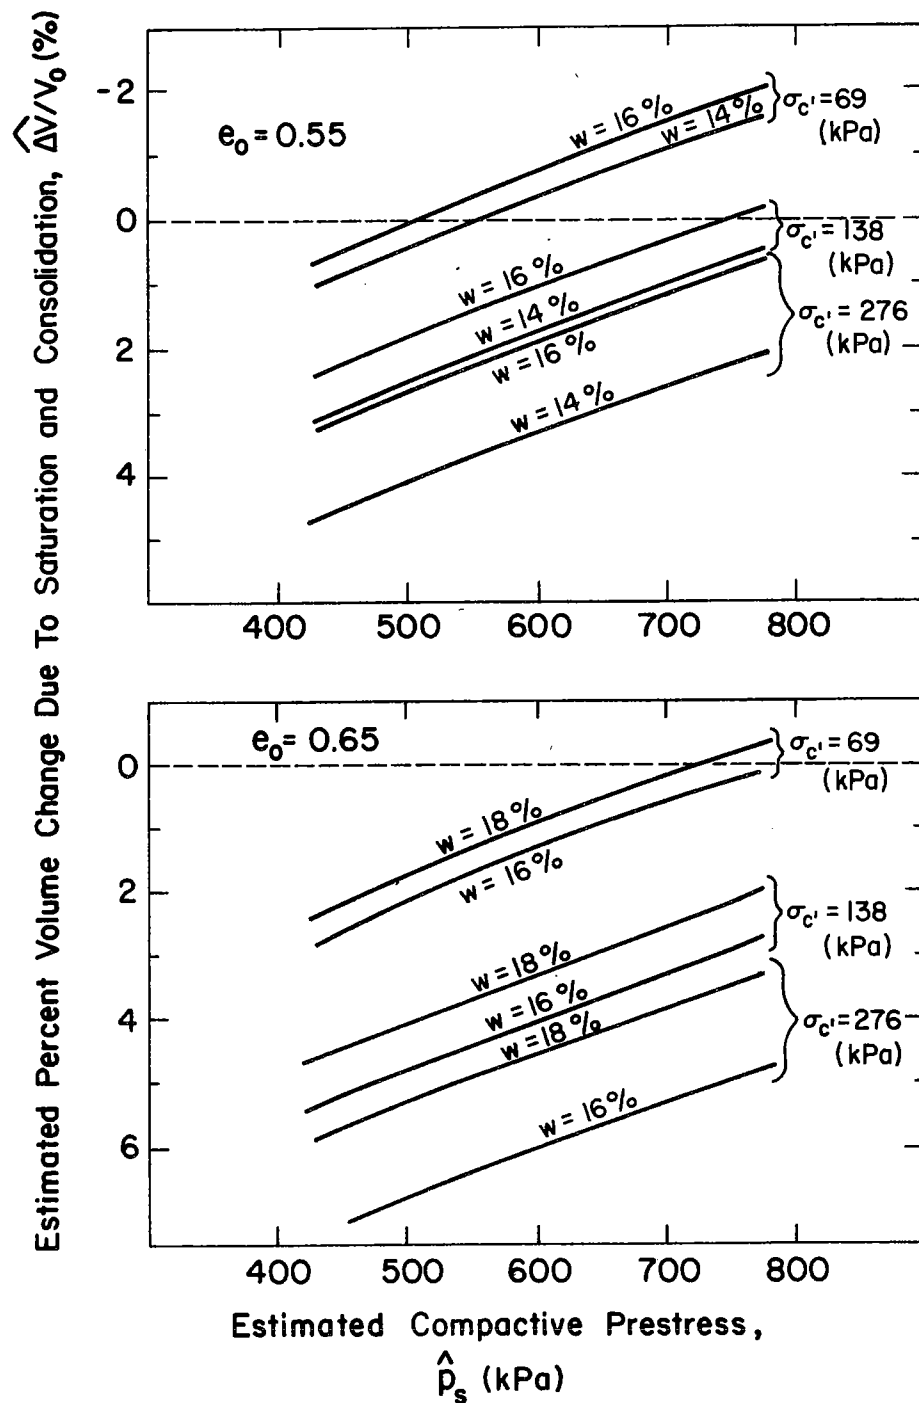
Figure 3: Prediction of Field Percent Volume Change Due to Saturation Under Confinement at a Constant Initial Void Ratio. (Swell is Negative)

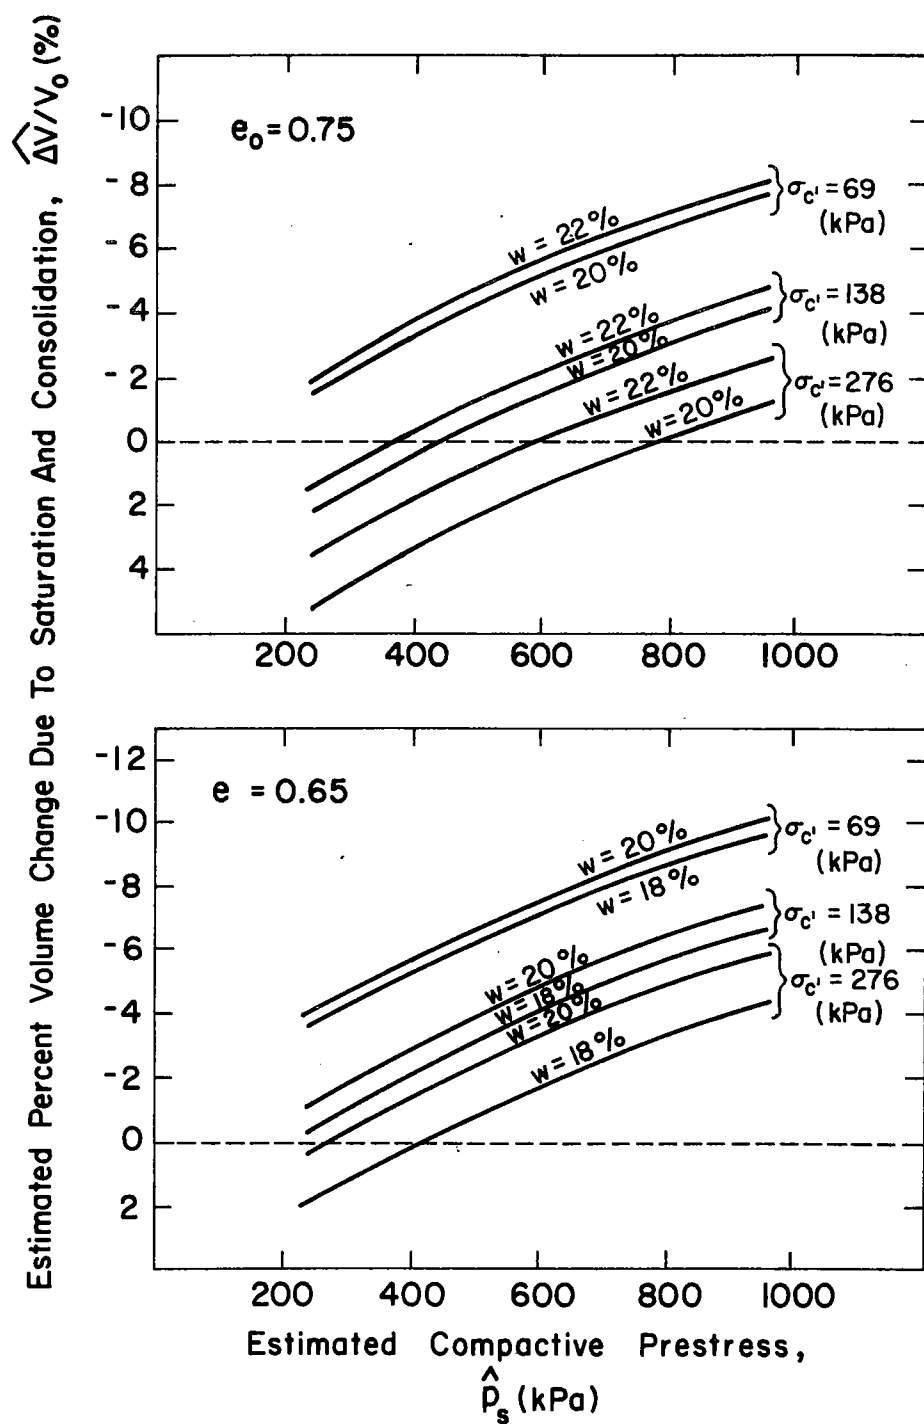
Figure 4: Prediction of Laboratory Percent Volume Change Due to Saturation Under Confinement at a Constant Initial Void Ratio. (Swell is Negative)

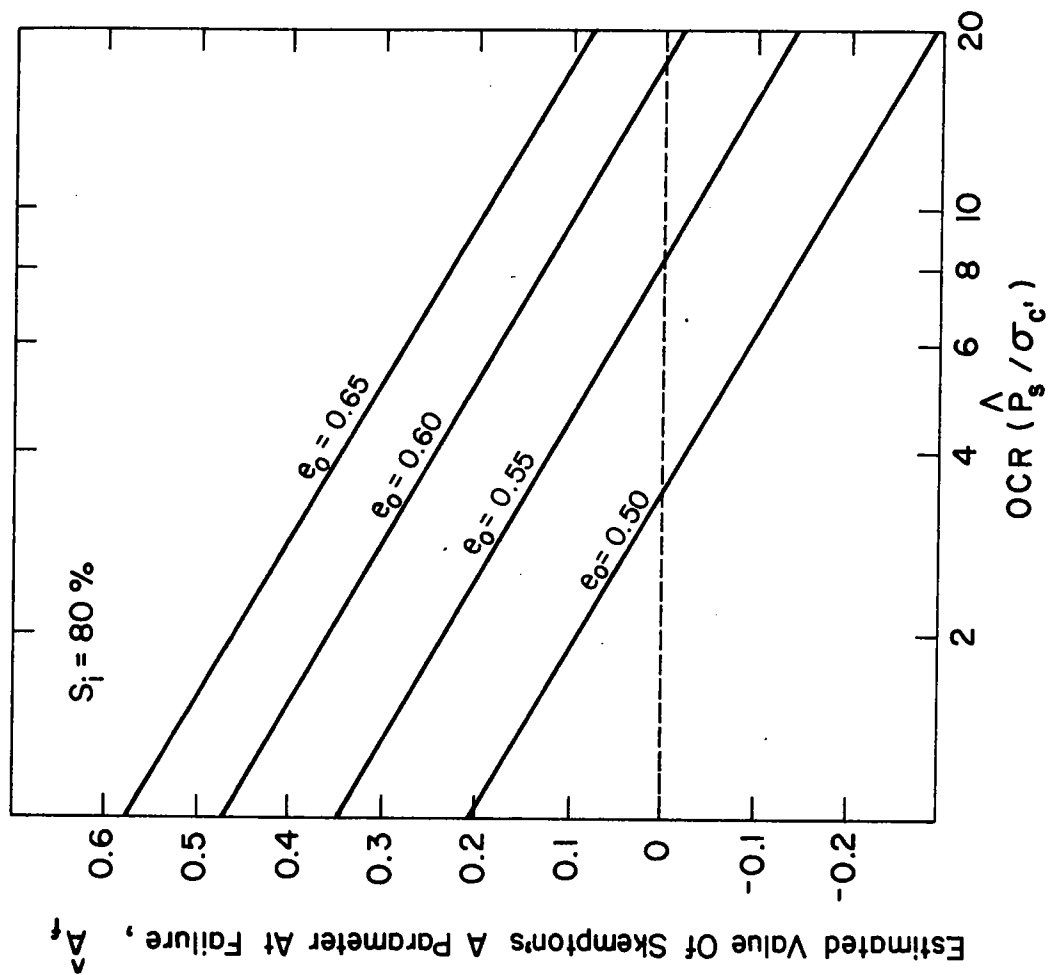
Figure 5: Field Skempton's A Parameter at Failure Verses OCR at a Constant Initial Saturation.

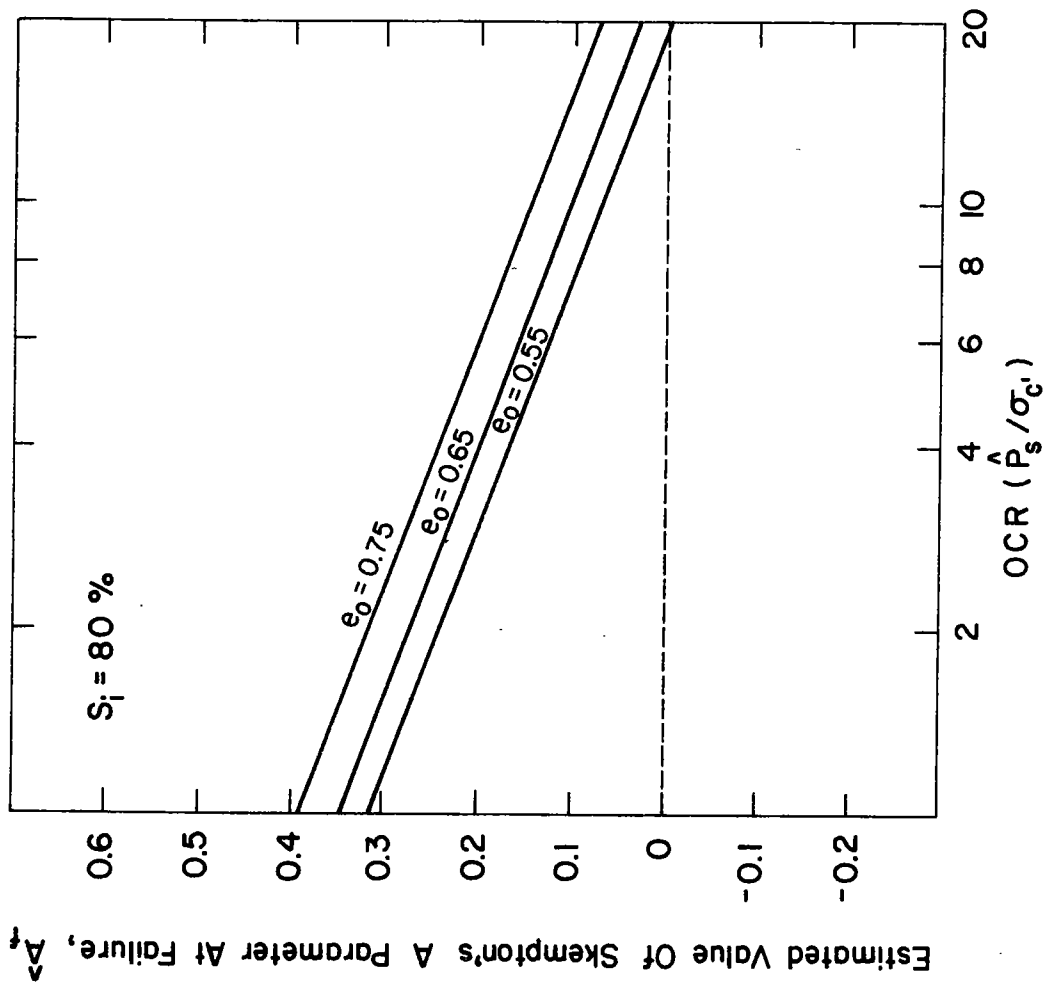
Figure 6: Laboratory Skempton's A Parameter at Failure Verses OCR at a Constant Initial Saturation.

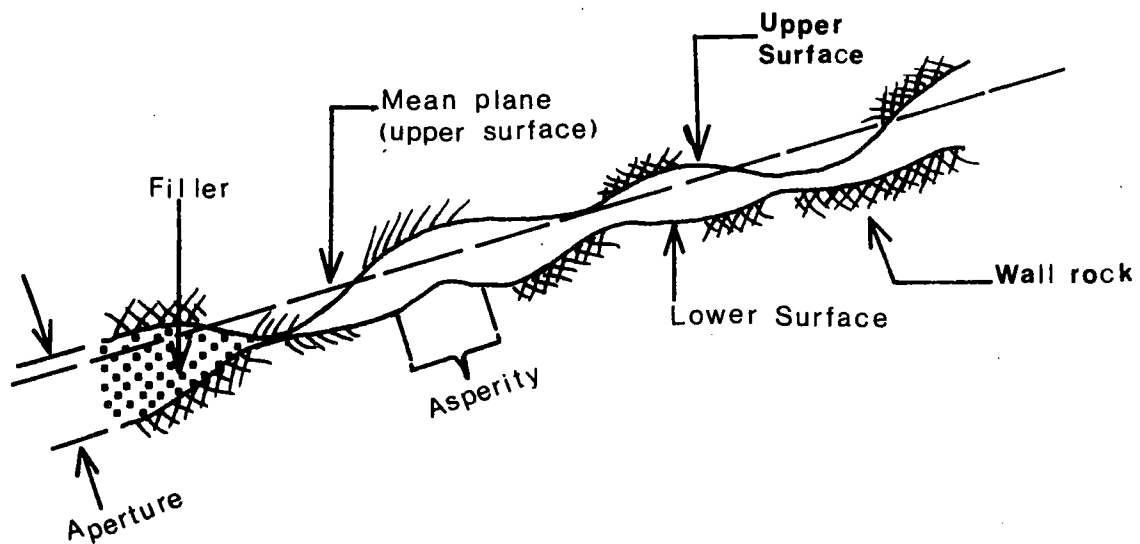
Figure 1. Characteristic features of an Individual Discontinuity (modified from 3)

- (i) An aperture is the distance between discontinuity surfaces, measured perpendicularly to the mean plane. This term, however, becomes rather ambiguous if the surfaces touch only at a few points such as shown in Figure 1.
- (ii) The filler is the transported material which takes up the space between the discontinuity surfaces, either in a complete or partial fashion.
- (iii) The asperities are the deviations of the surface of the discontinuity from a mean plane as viewed at various scales. The largest deviations are referred to as "undulations" whereas the smallest deviations are regarded as "roughness". Detailed descriptions of discontinuities in rock can be found in (1) and (2).

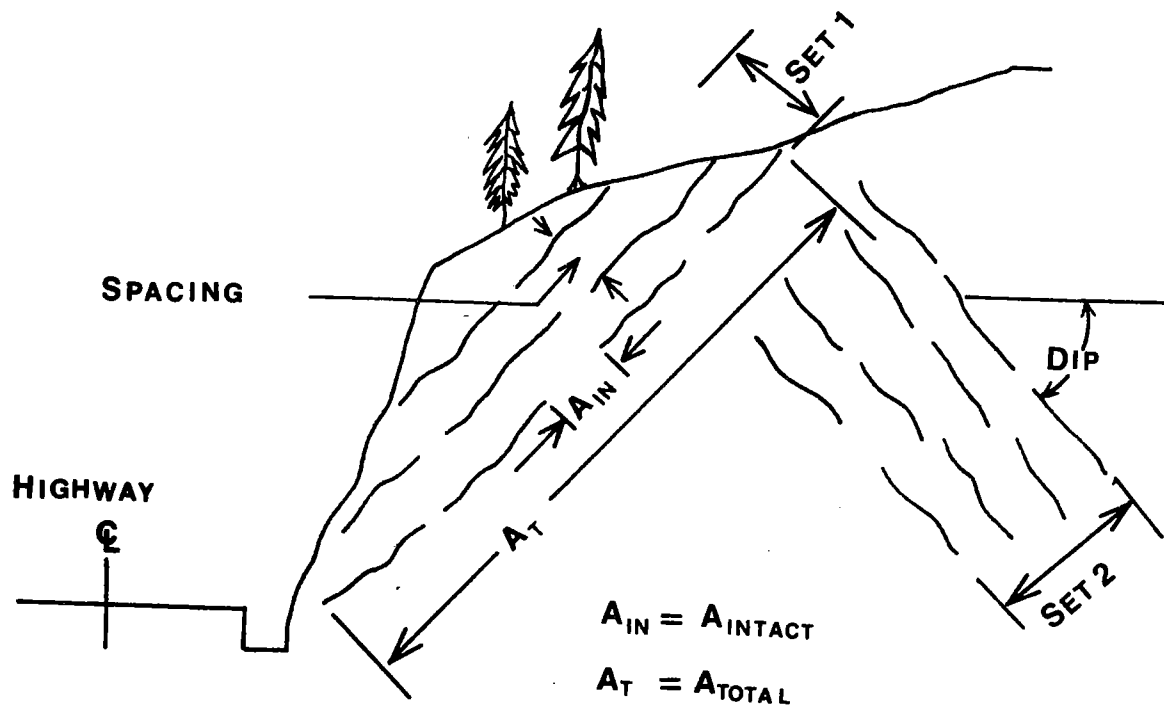
Figure 2. Geometry of typical discontinuity planes on a highway slope (modified from 3)

Rock mass discontinuities are groups of planar surfaces that occur in a given rock mass. Characteristic features of rock mass discontinuities include (i) attitude, (ii) set, (iii) spacing, (iv) system, and (v) persistence. These features are shown schematically in Figure 2 and are defined below. These definitions are based on reference (7).

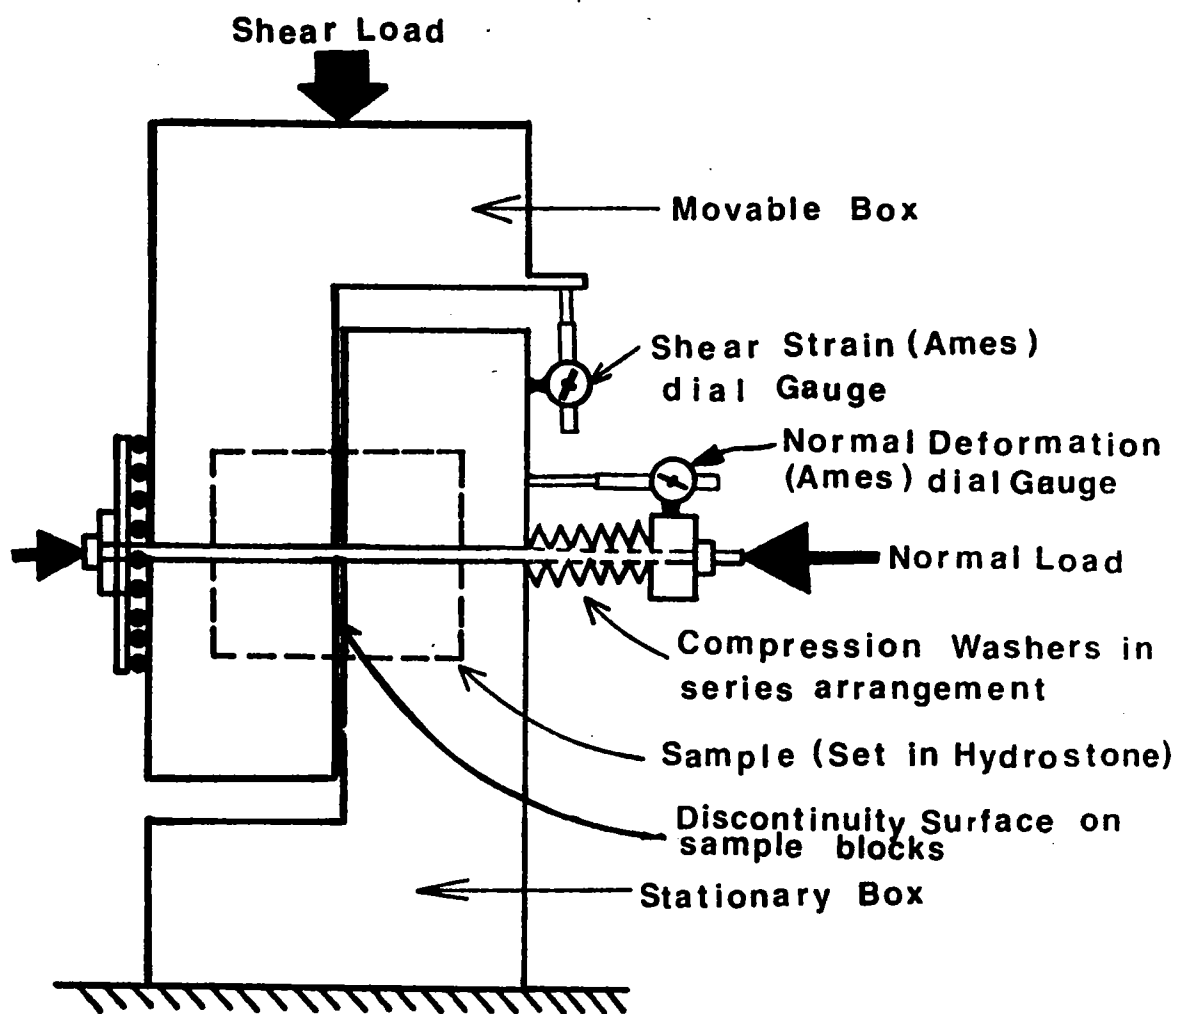
Figure 4 Diagrammatic representation of the arrangement for the direct shear test.

Using the apparatus shown in Figures 4 and 5, it was possible to follow a loading path in which the normal stiffness was held constant. That is, the normal force was set at an initial value using a spring and the shear force was gradually increased until constant readings or a drop in readings were obtained in the shear dial gauges. The change in the normal force either during a test or during an increment at the end of a test, was equal to the displacement in the normal direction multiplied by a spring constant.

This shear apparatus is generally similar to the Ohio River District (U.S. Army Corps of Engineers) shear apparatus described in (3) except that the normal load in this case is applied through 20 Belleville Spring washers arranged in series instead of using a hydraulic jack. The deflections produced in the normal displacement dial gauges, as a result of compression of the washers, is multiplied by the spring constant to
