PROCEEDINGS of the 33rd ANNUAL HIGHWAY GEOLOGY SYMPOSIUM

ENGINEERING GEOLOGY and ENVIRONMENTAL CONSTRAINTS

Engineering Geology
and
Environmental Constraints
in
Vail, Colorado
1982

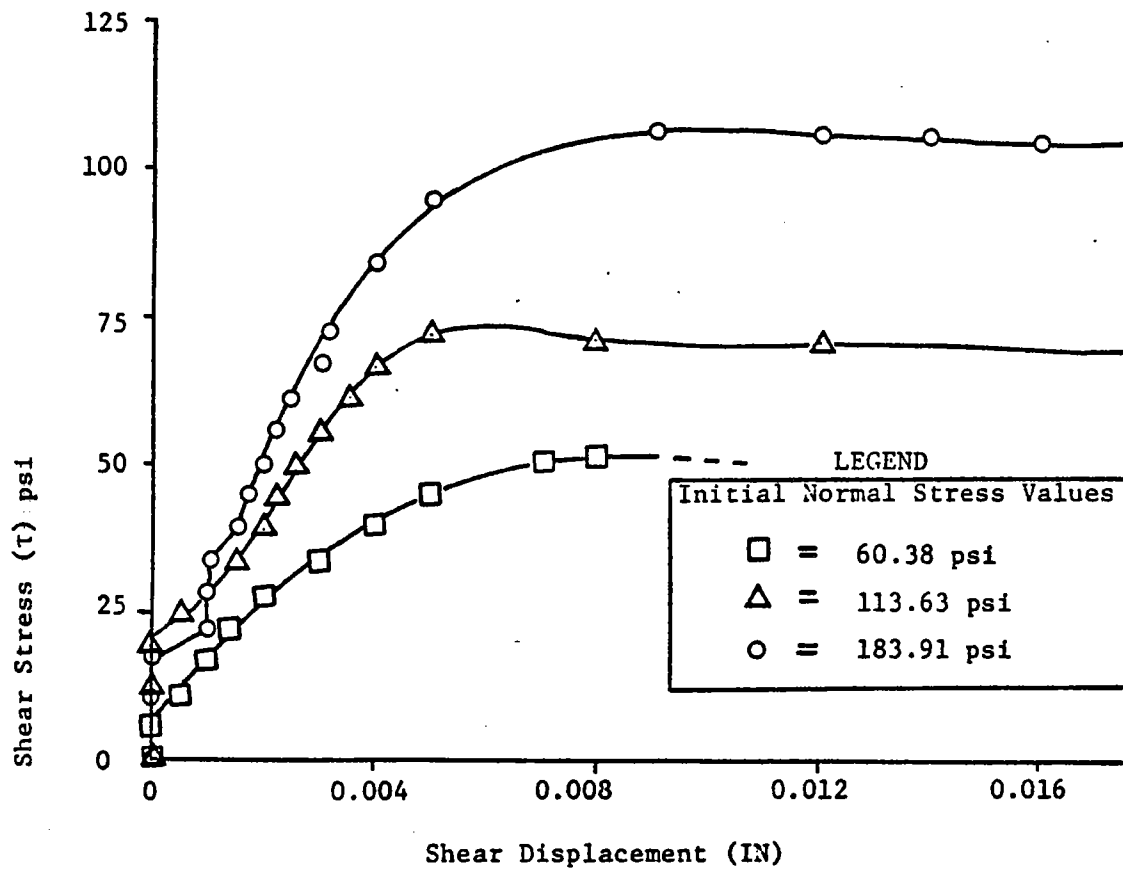
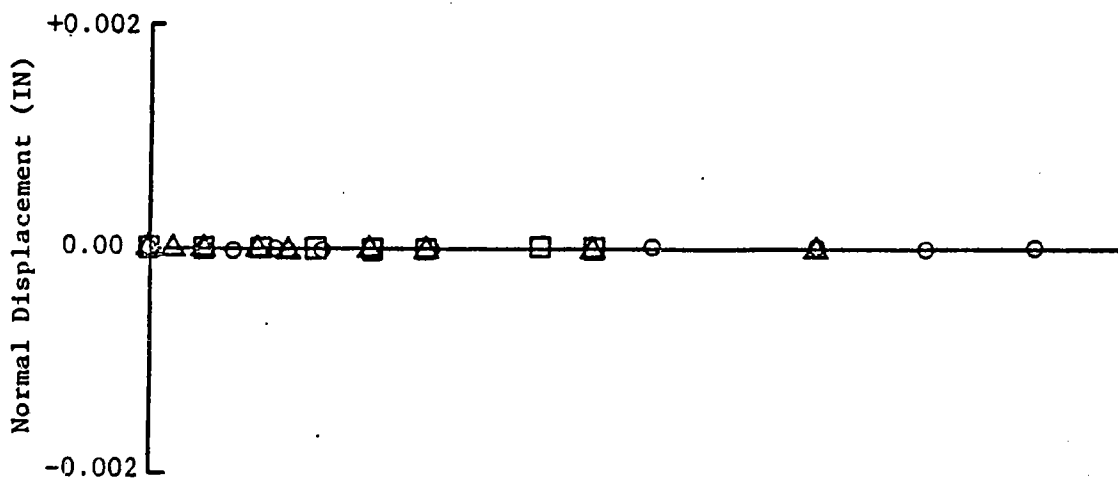
Figure 6. Direct shear test on fine-grained sandstone.
Shear stress () and normal displacement versus shear displacement. Test #1.

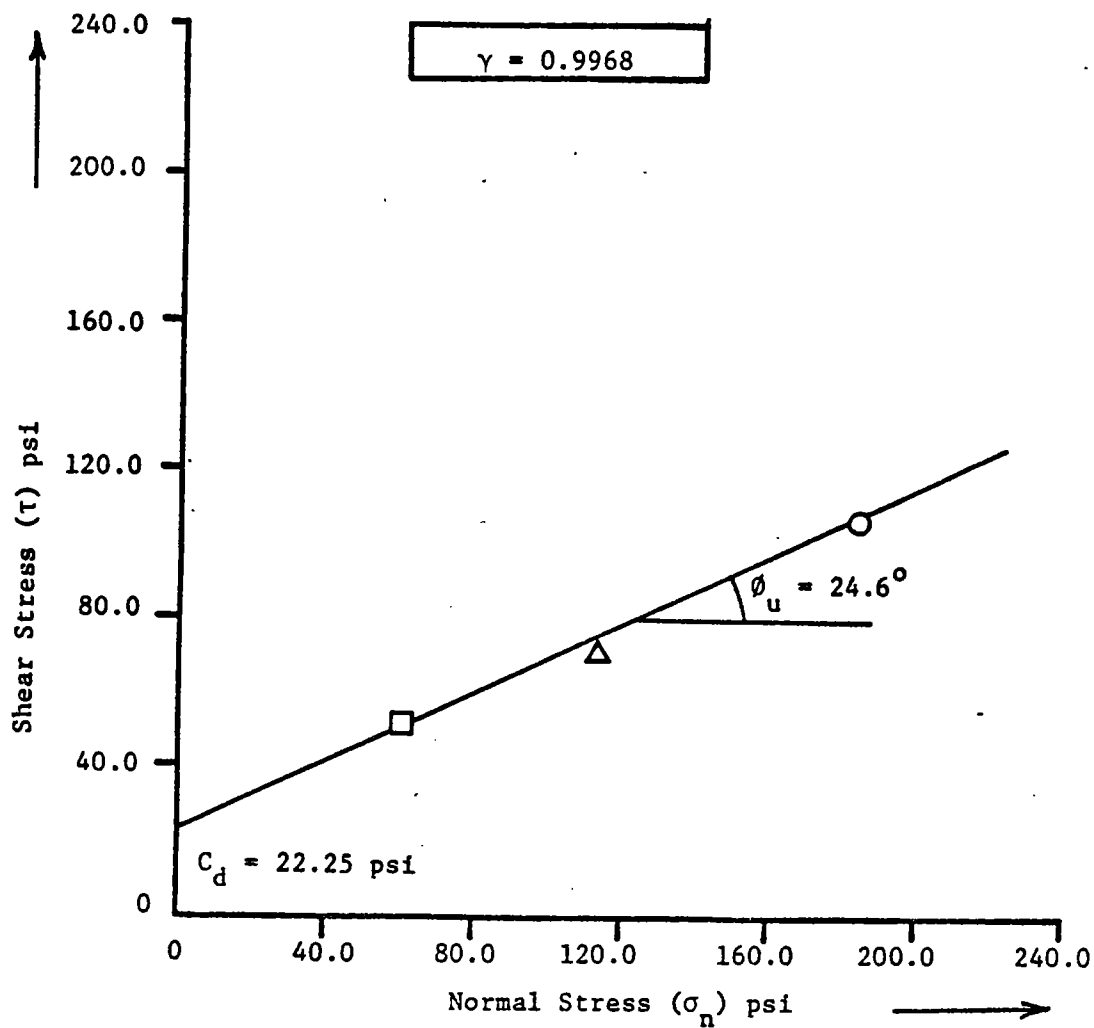
Figure 7. Direct shear test on a fine-grained sandstone from Narrow-Lake, Greene-Sullivan County, Indiana. Test #1

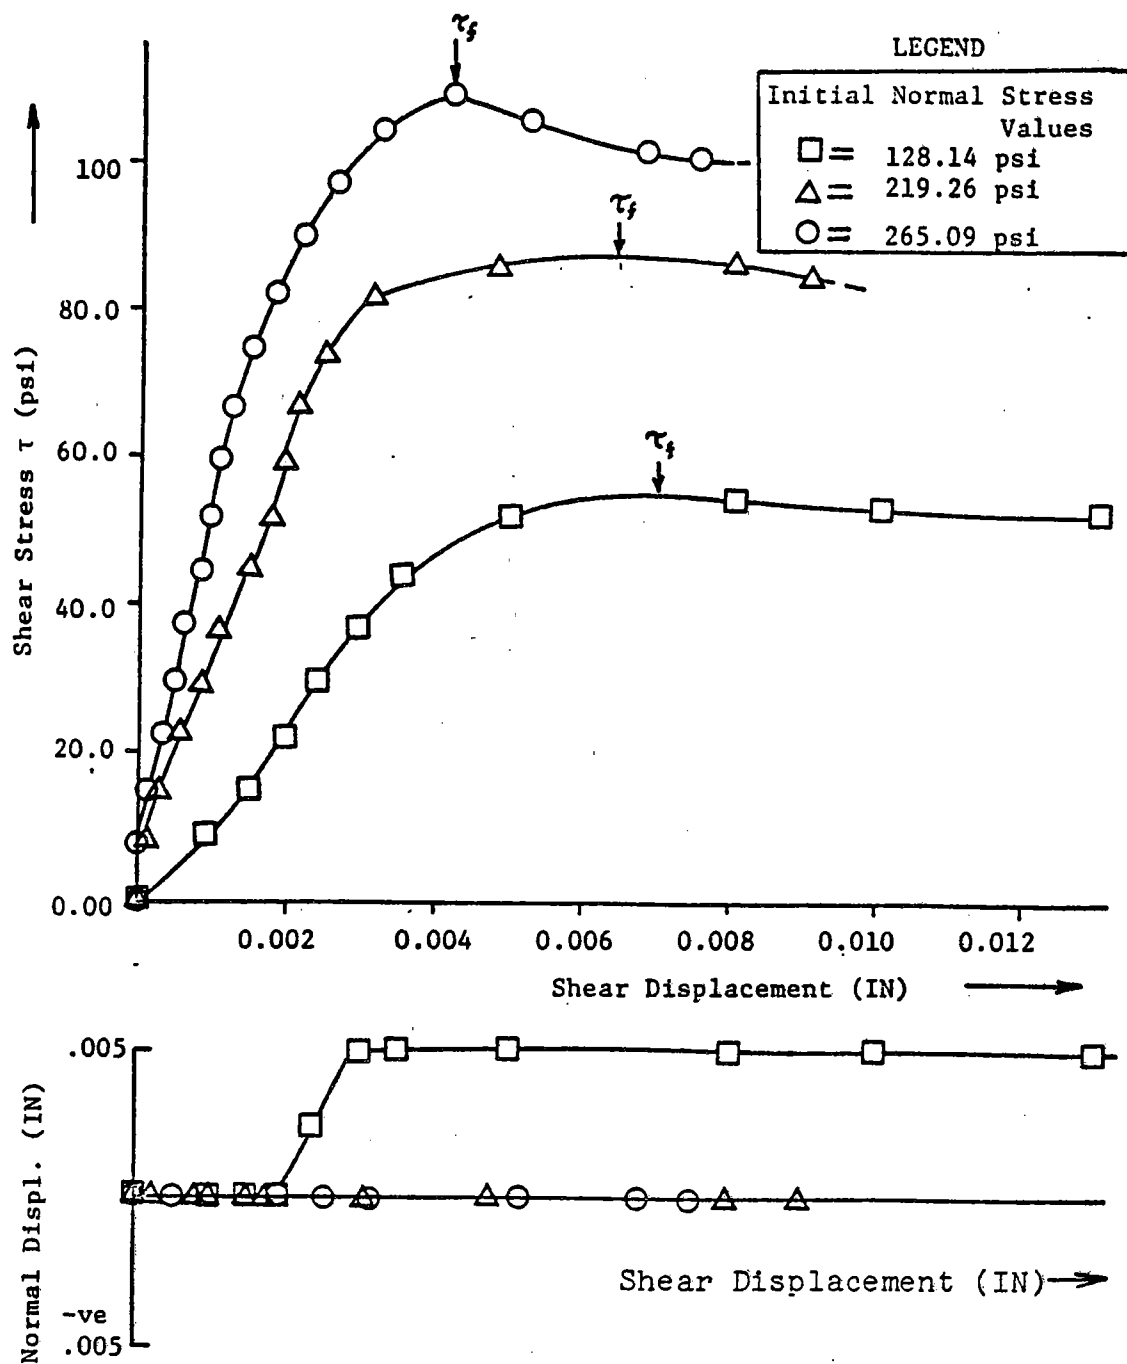
Figure 8. Direct shear test on fine-grained sandstone. Shear stress (τ) and normal displacement versus shear displacement. Test #5.

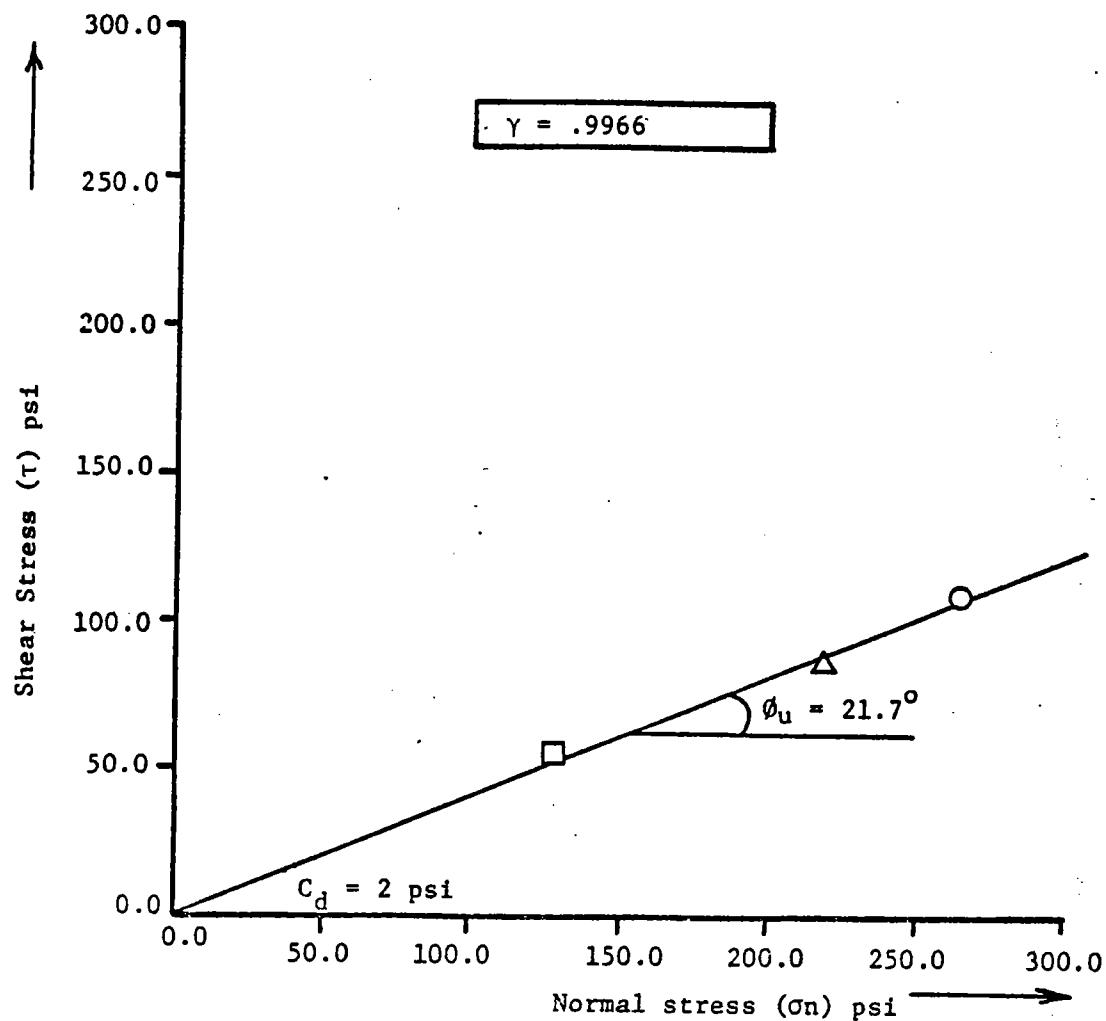
Figure 9. Direct shear test on a fine-grained sandstone from Lonnie-Lake, Greene-Sullivan County, Indiana. Test #5

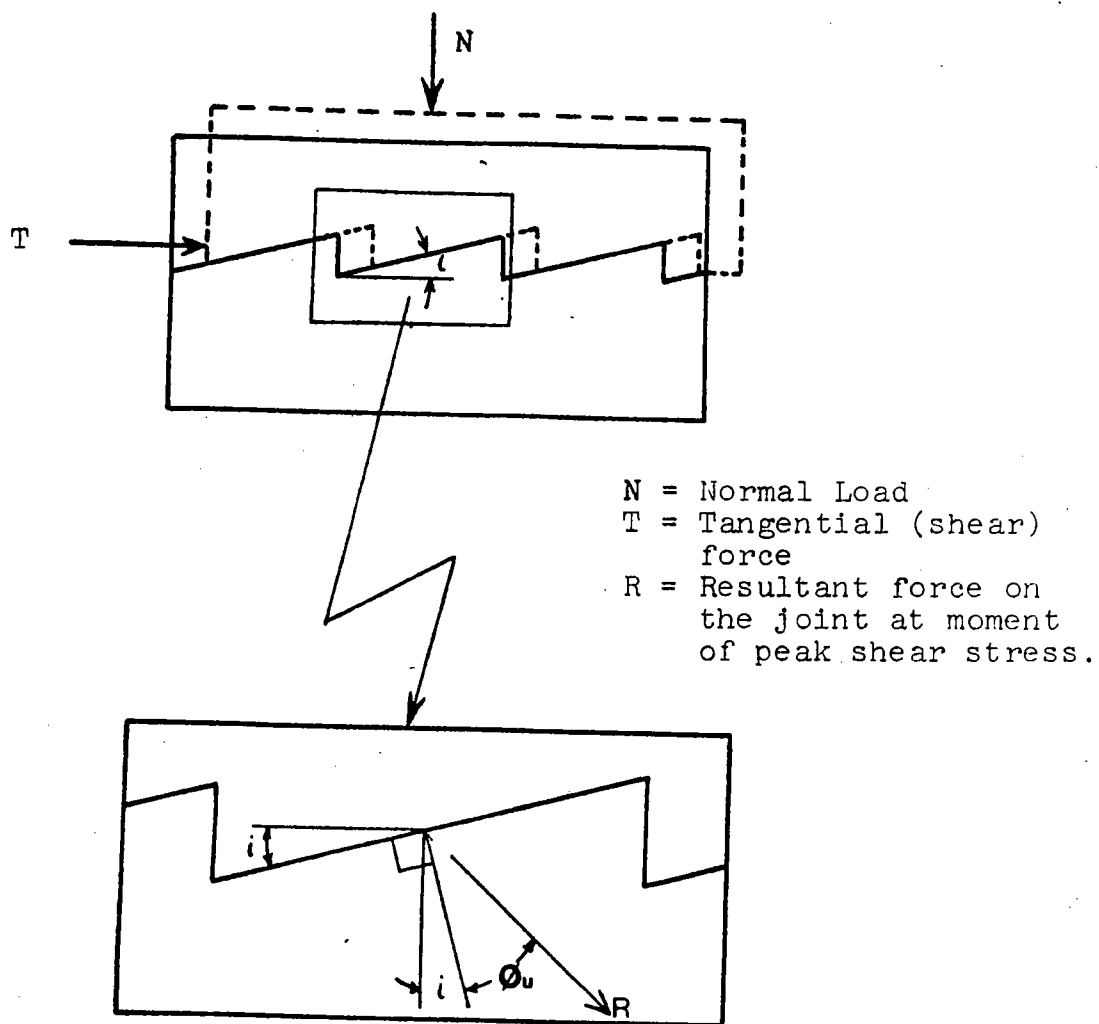
Figure 10. The basis for Patton's Law for joint shear strength (modified from Goodman, 1980).

The rather wide range of values of friction angles (ϕ) and shear strength intercepts (C_d) is probably due to the fact that the joint surfaces had asperities with various degrees of roughness. Thus, the values of the tabulated friction angles in Table 2 which are higher than the mean value could be represented by the relationship $\phi_{eff} = (\phi_u + i)$ according to Patton's law (5,9) for joint shear strength, where ϕ_{eff} = effective friction angle for the joint; ϕ_u = friction angle of a smooth joint ($\approx \phi_r$ which is the residual friction angle for intact rock specimens); and i = angle of inclination of the asperity relative to the mean joint plane (see Fig. 10).

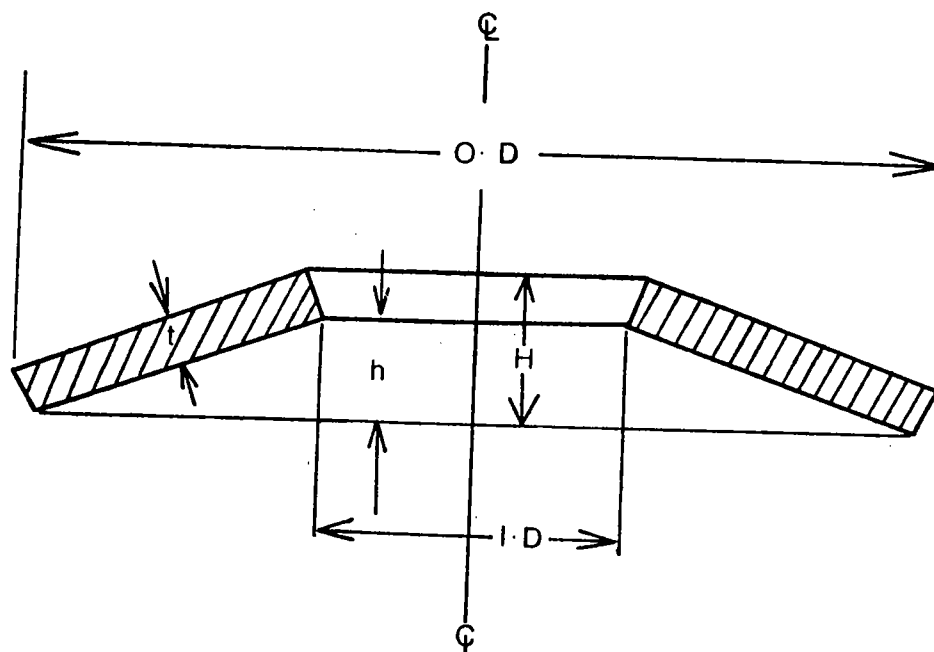
Outside Diameter (O.D) = 2.50 in (63.50 mm); $h = (H-t) =$
0.06 in (1.524 mm)
Inside Diameter (I.D) = 1.250 in (31.75 mm)
Thickness (t) = 0.120 in (3.048 mm)
Load at flat position = 3200 lb (1451.5 Kg)

Figure A1.1 Configuration of the Belleville Spring Washer

The configuration of each Belleville spring washer, manufactured by the Associated Spring Corporation, is as shown in Figure A1.1. The type used is Catalog Number B2500-120, made of spring steel material and has dimensions shown in Figure A1.1.

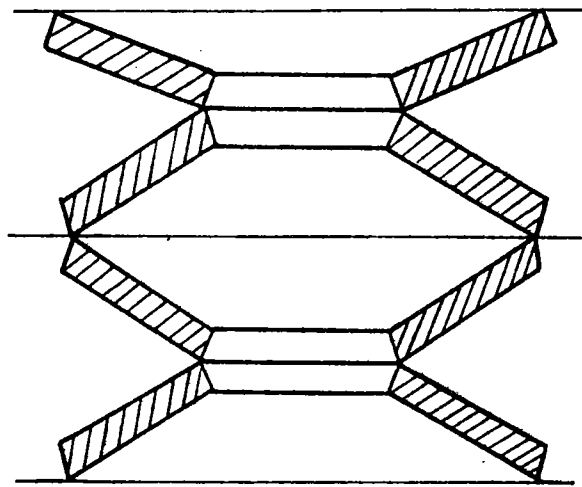
Figure A1.2 Arrangement of Belleville spring washers in series.

The two halves of the direct shear box with no samples inside, were assembled such that the stationary box (Figure 3.13) lay on top. A stack of 20 spring washers, arranged in series (see Figure A1.2) was installed on a rod attached to the top of the stationary box. A hardened guide was therefore placed on top of the springs. The shear box and spring assembly then was placed between the upper and lower loading platforms of a Baldwin-Tate-Emery Universal Testing machine which provided the load for the spring calibration process.

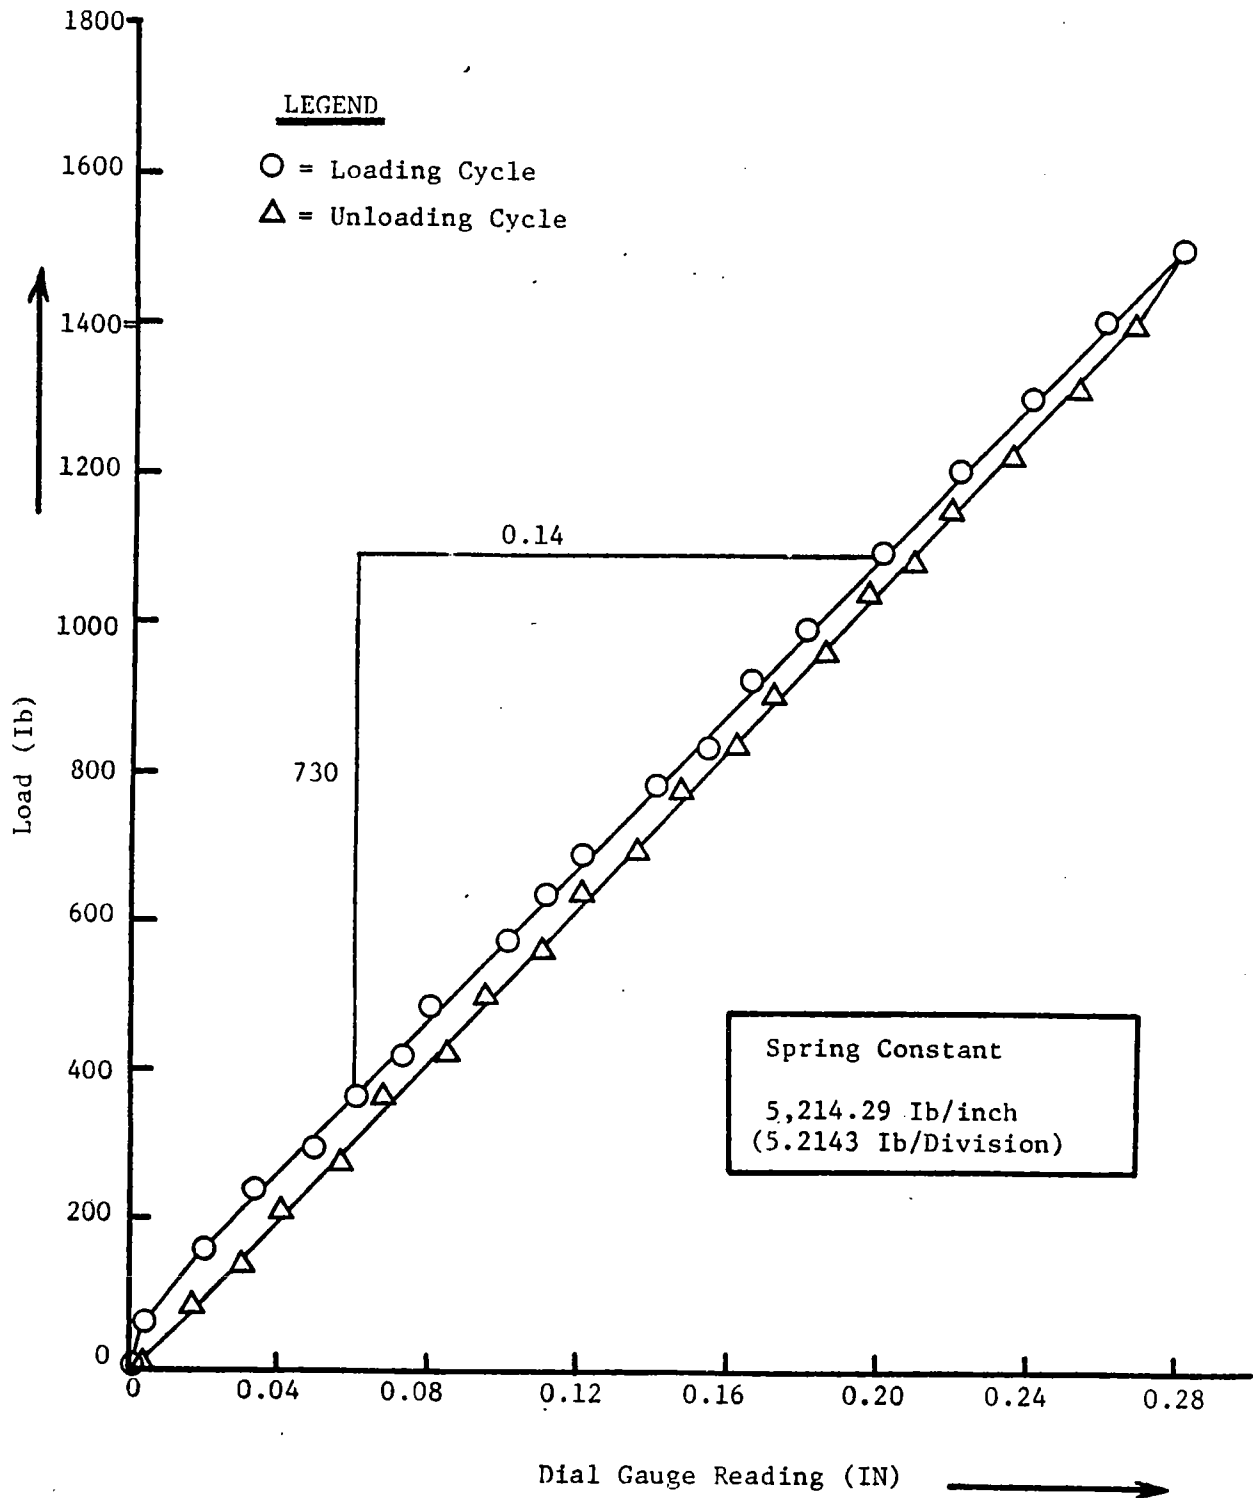
Figure A1.3 Shear-box spring calibration curve (20-washers in series arrangement).

Load Load was applied at an average rate of about 40 Ib per minute until a dial gauge deflection of about $\frac{1}{4}$ inch was attained before unloading at an approximate rate of 40 Ib per minute also. A plot of load versus dial gauge reading was made (Figure A1.3) and the spring constant determined as 5,214.29 Ib per inch. The shear box spring system calibration data are presented in Table A1.1.

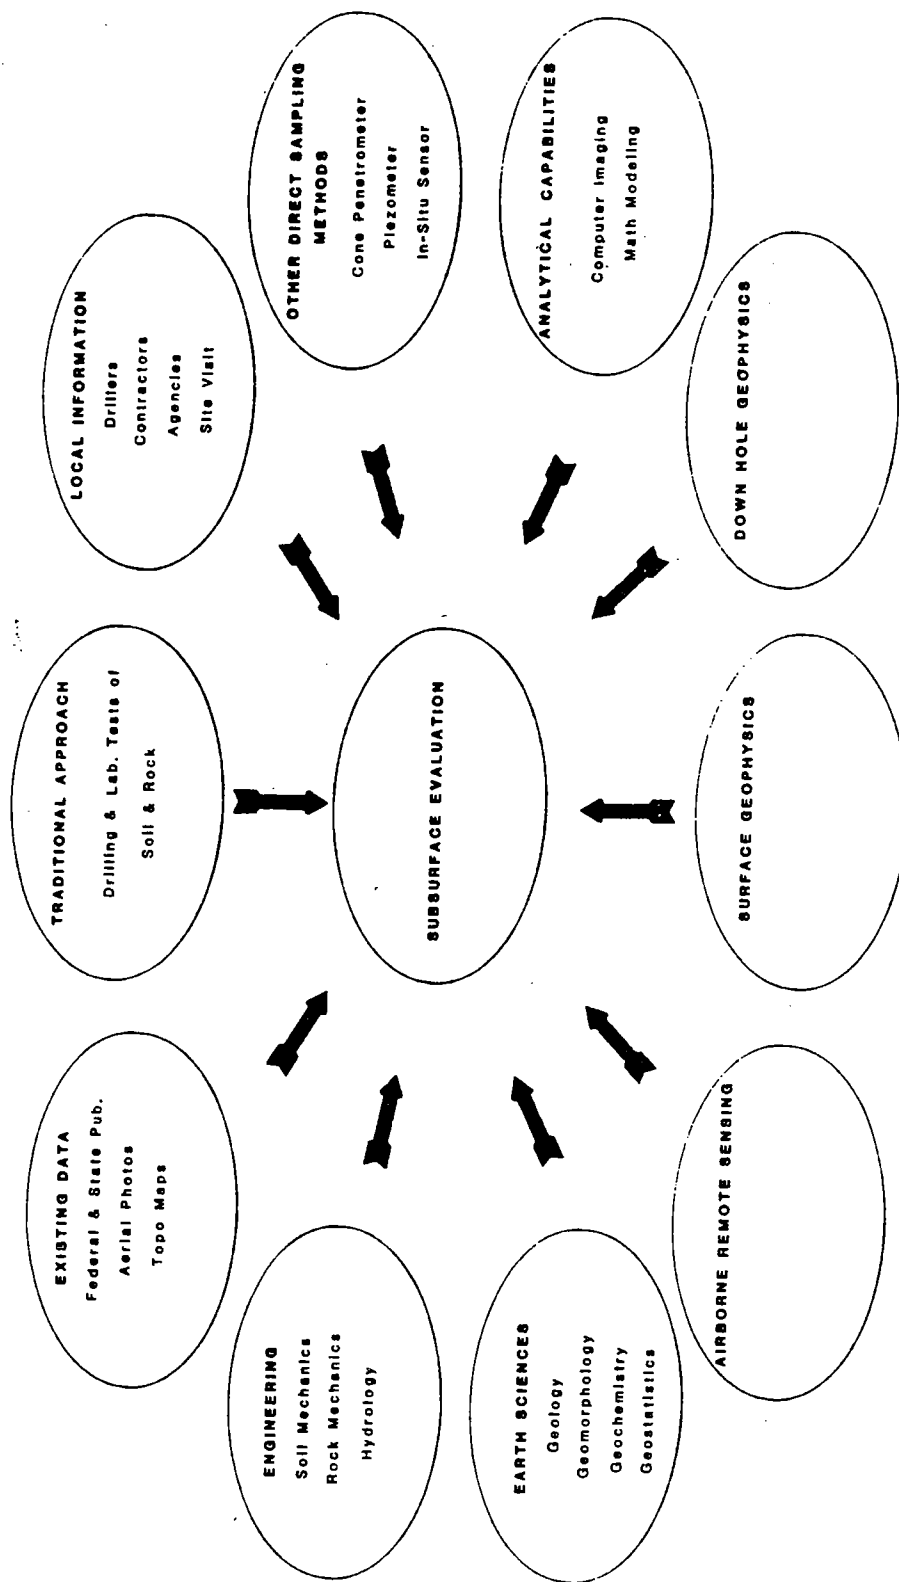
FIG.1 Technical resources and tools which can be utilized in a subsurface investigation.

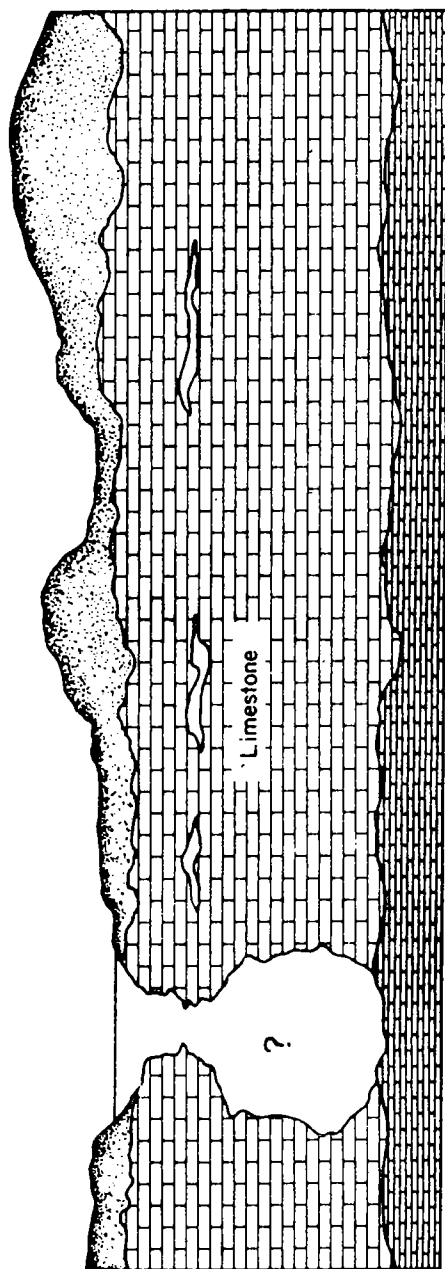
**FIG.3 Generalized geologic section based upon regional information
and initial on site drilling.**

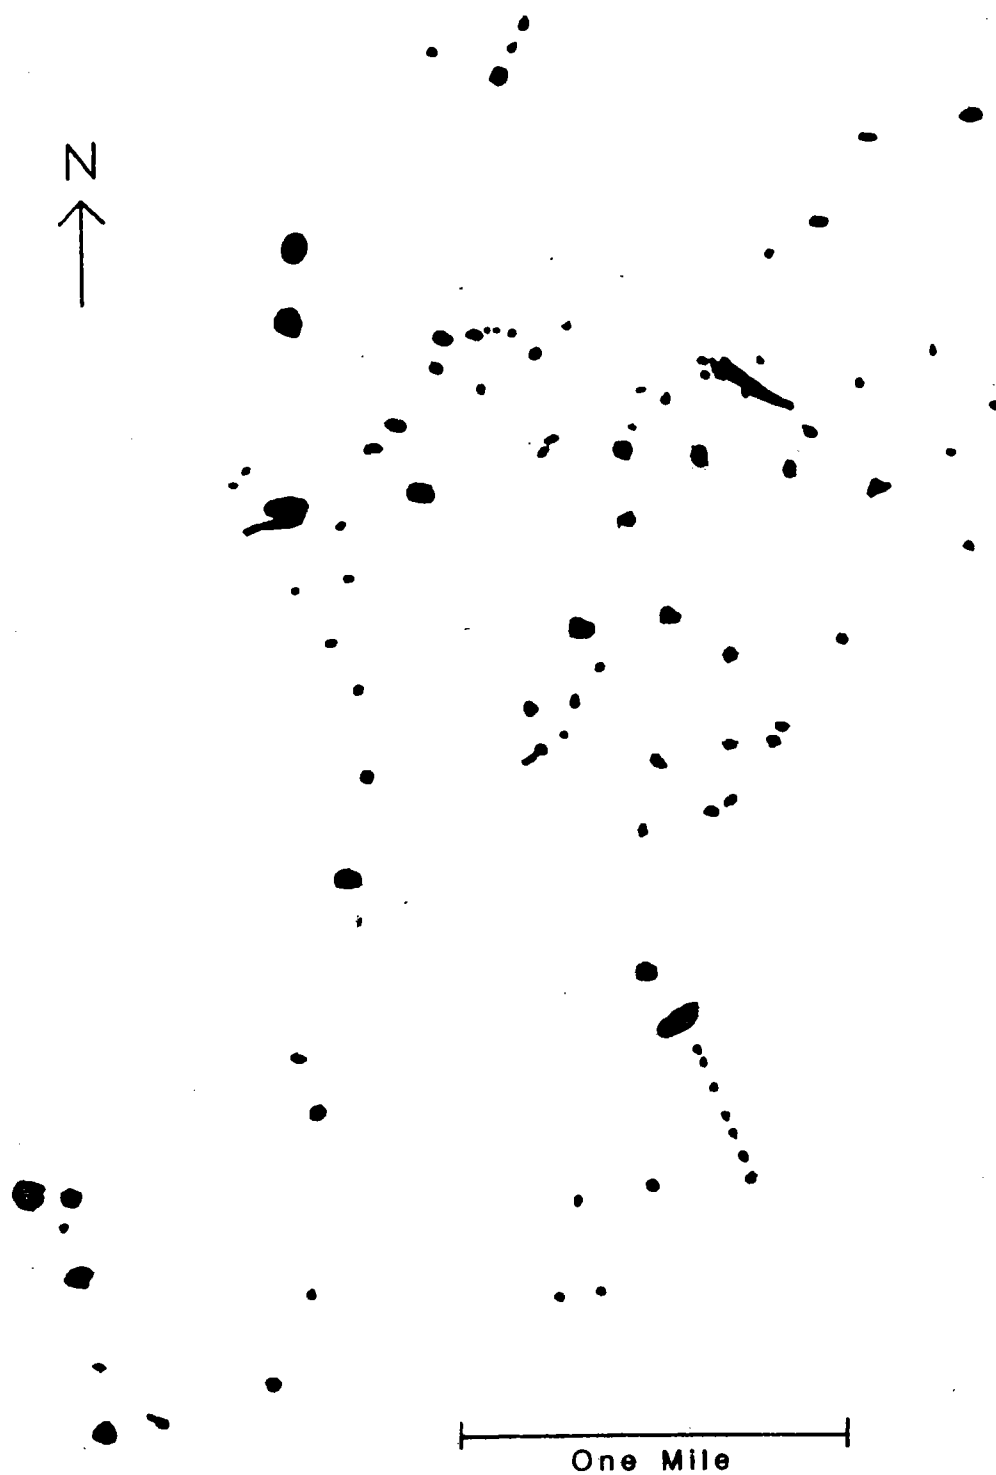
**FIG.4 Distribution of sinkholes based upon
existing aerial photography.**

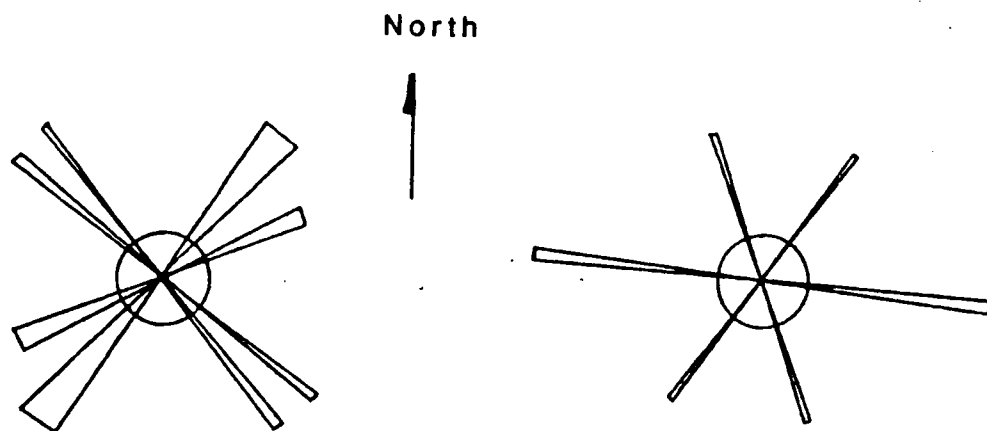
FIG.5 Lineament angle relationships.

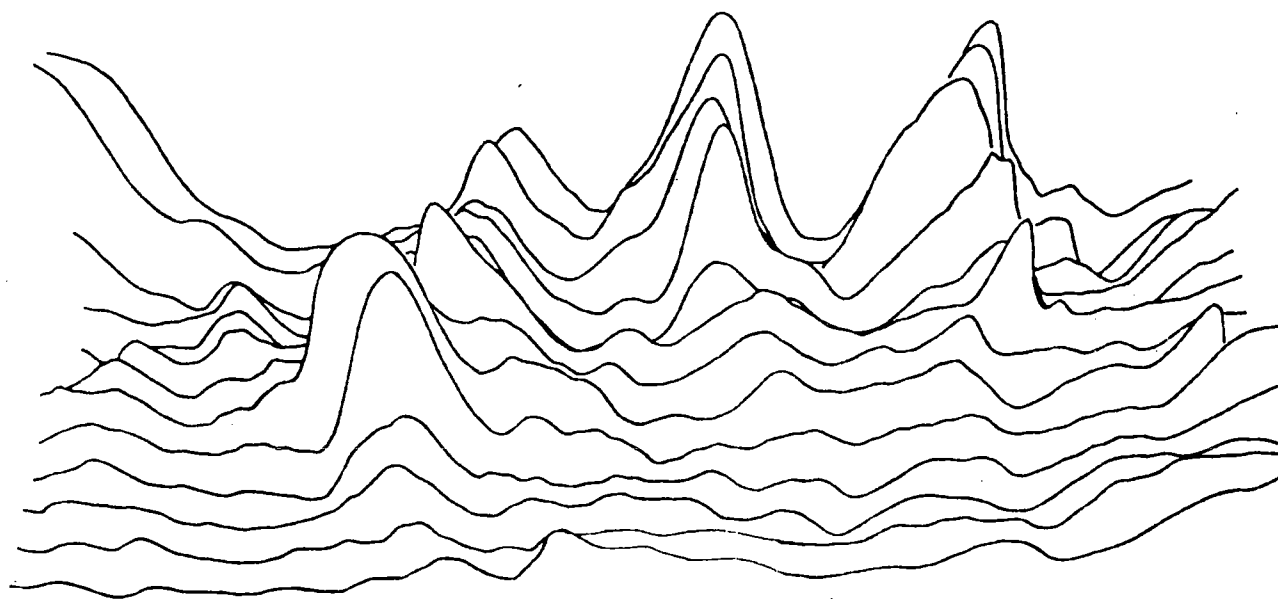
FIG.6 EM conductivity data shows fracture trends in rock.

the instruments. Figure 6 shows the location and orientation of shallow fractures in the rock, based upon EM measurements. Figure 7 shows a radar profile of soil conditions; the anomaly is related to a fracture in underlying rock. By carrying out a number of parallel passes, a linear trend could be established in the soil anomaly which correlated with regional lineament trends. Figure 8 shows a large paleokarst feature (sinkhole) which has been filled in with natural sand deposits. Localized piping, related to rock fractures, are also shown. These features remain totally undetected by experienced geologists from surface observations, but are clearly detected by radar.

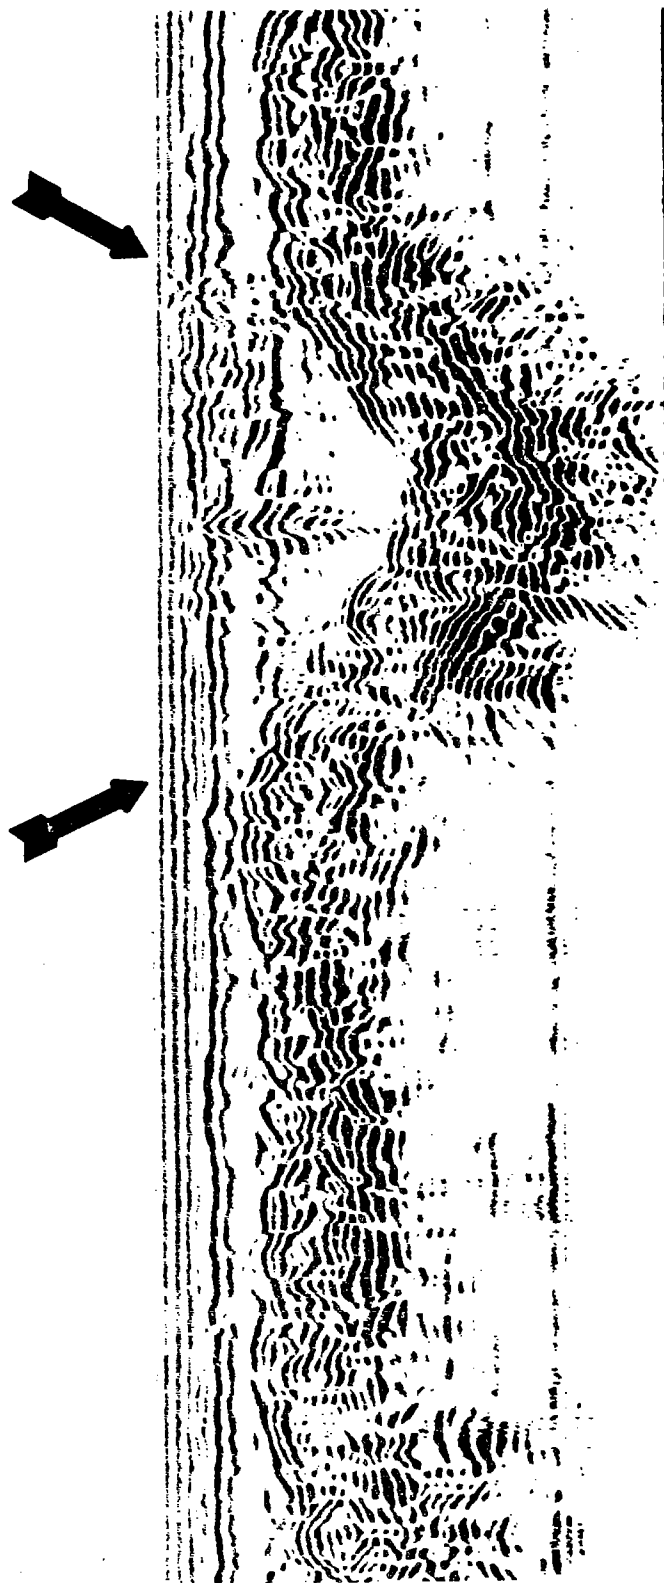
FIG.7 Radar data showe anomalous soil conditions related to underlying fractures in rock.

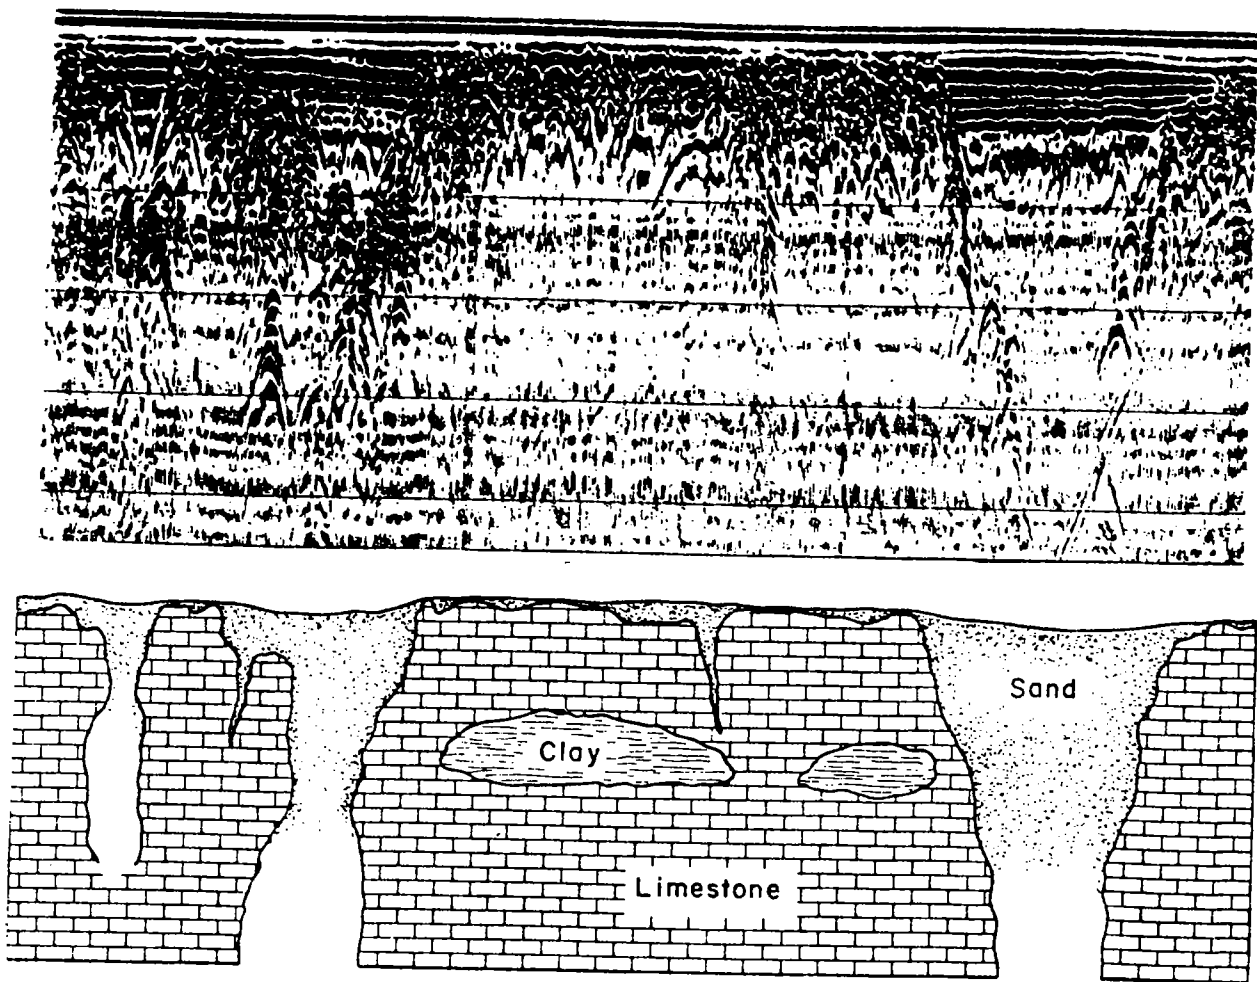
**FIG.8 Radar data and generalized cross section
showing large sinkholes and piping.**

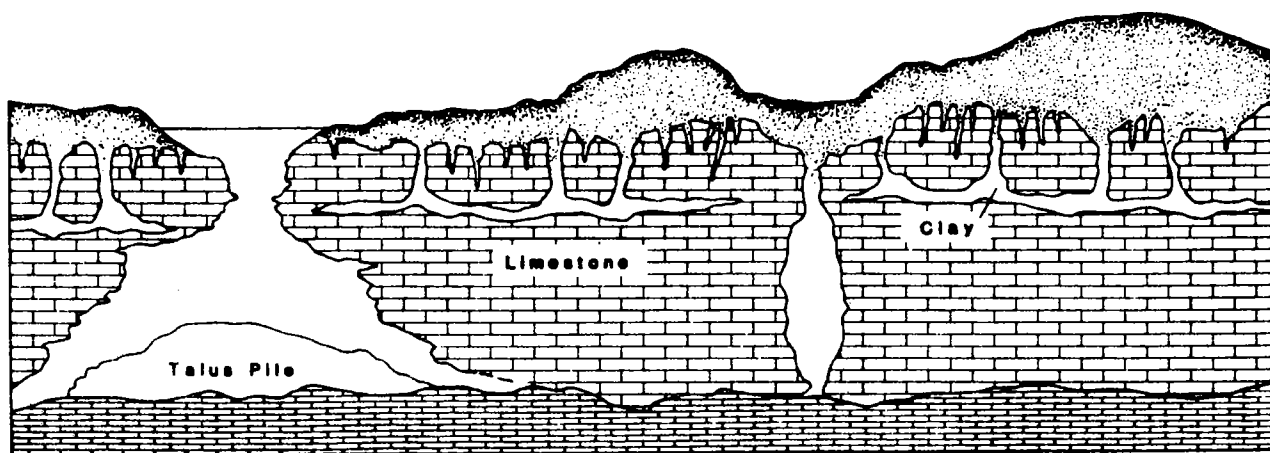
FIG.10 Generalized geologic section based upon integration of all information derived from example project.

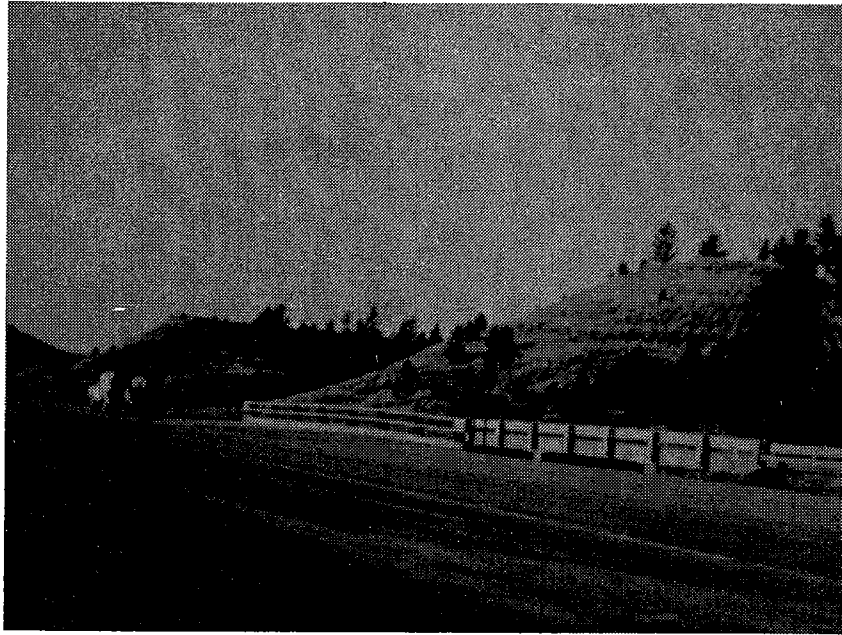
Fig. 1: Note the sag in the bridge rail in behind the pickup truck. I-90 Northeastern Wyoming.

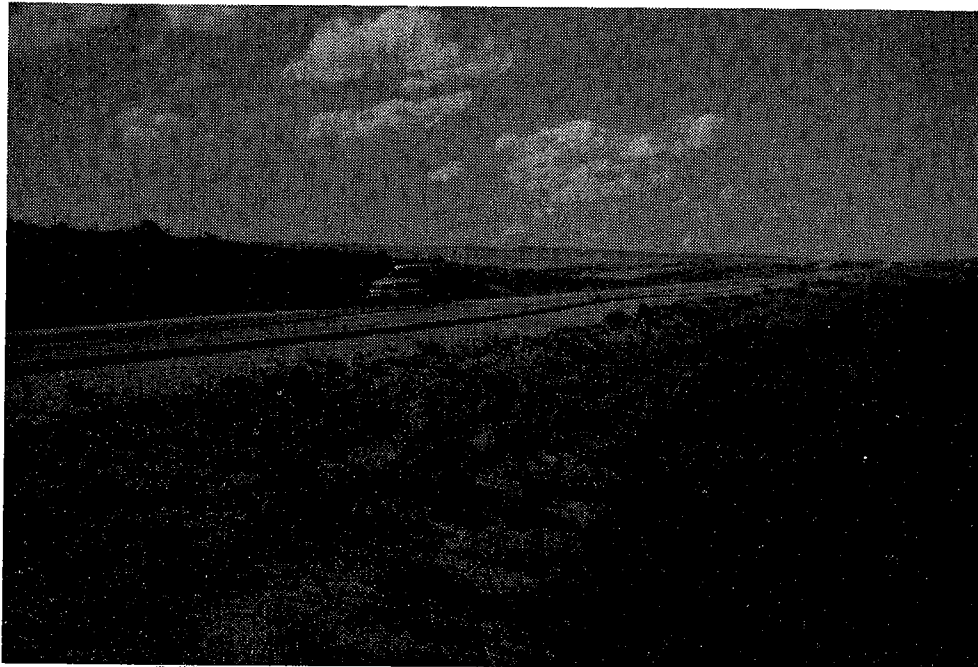
Fig. 2: Heaves due to a swelling shale. On I-25 (a) North Central Wyoming.

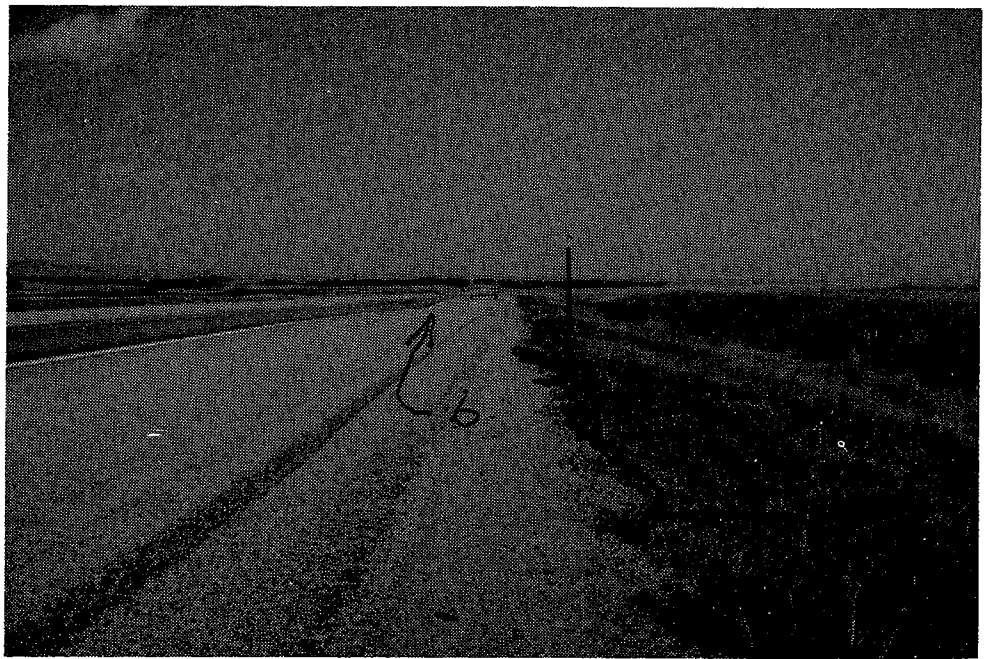
Fig. 3: Settlement failure due to collapsing soils derived from the tertiary shales. I-25 North Central Wyoming.

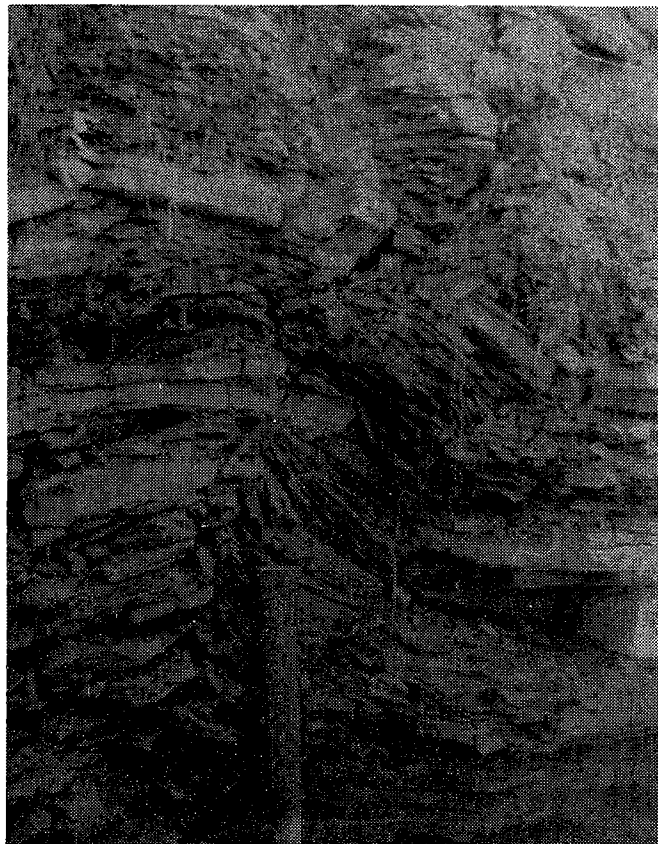
Fig. 4: Heave in the shale bedrock which is the foundation for the roadway. Heaving occurred due to concentration at the surface water by the roadway section.

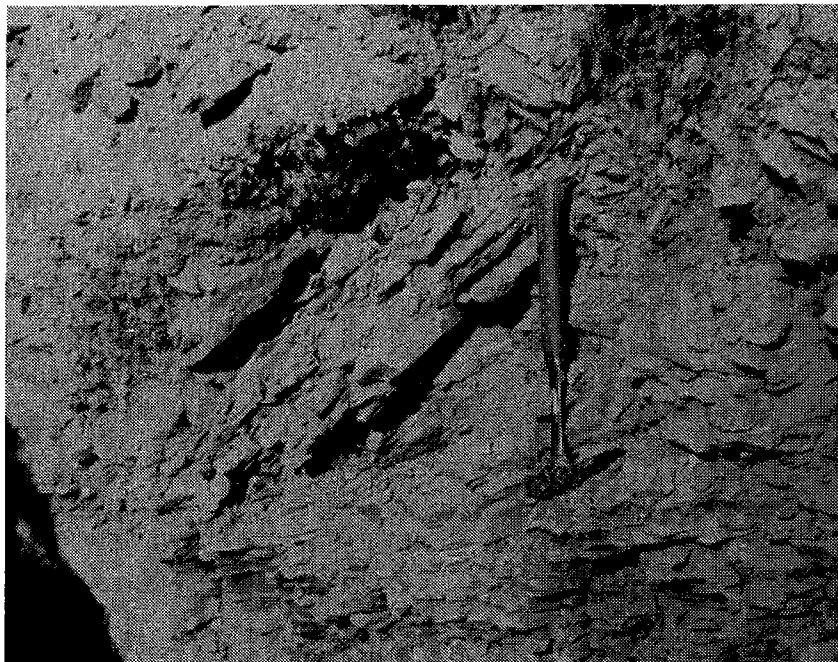
Fig. 5: Heaving in shale below the existing roadway. Note the horizontal beds approximately four feet below the heaved section.

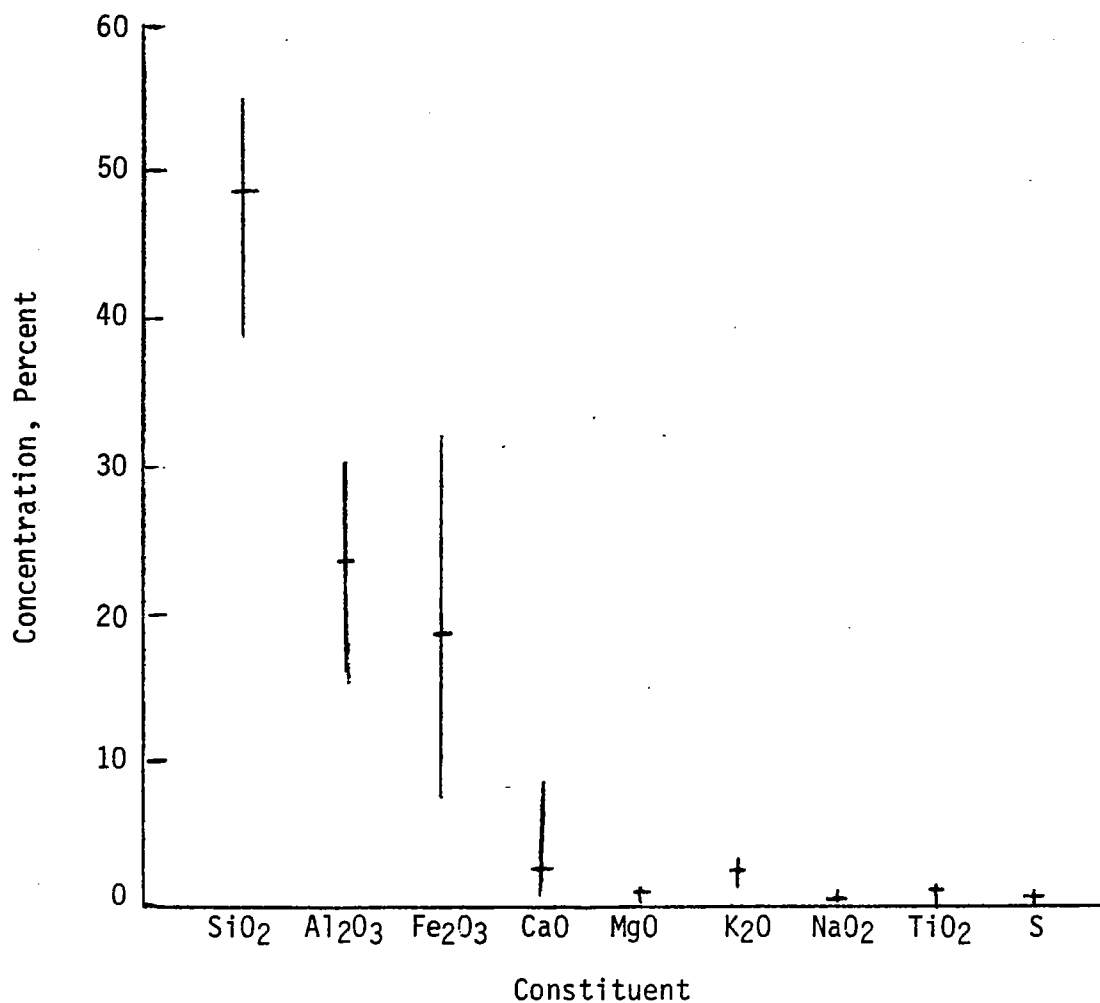
Figure 1. Chemical Constituents of Kentucky Fly Ashes
(From Rose, Lowe, and Floyd, 1979)

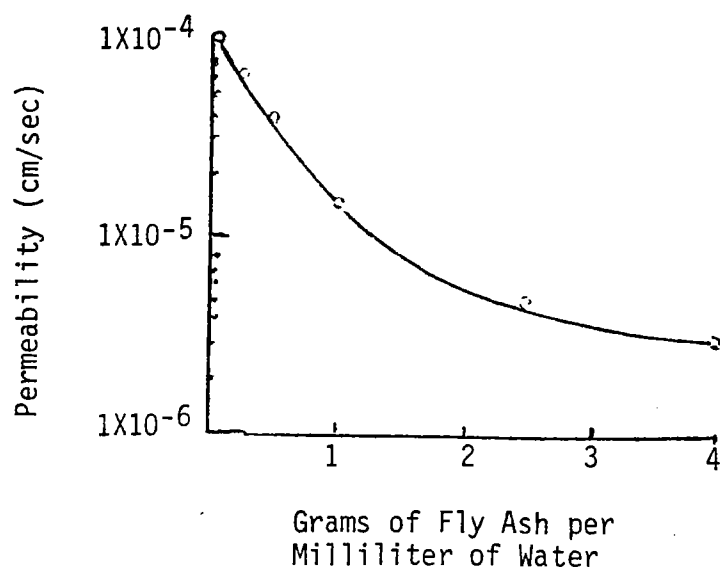
Figure 2. Permeability of Fly Ash -
Water Slurry Mixtures

slurry, a type C (sub-bituminous) Wyoming fly ash had an ASTM D-2434 permeability between 5.8×10^{-5} cm/sec and 3.2×10^{-6} cm/sec (Figure 2). When mixed with sand or clay on a 50% by weight basis, the mixtures had permeabilities in the 10^{-6} cm/sec range. When placed dry, however, the type C Wyoming fly ash developed cracks due to the chemical reaction with water, creating a secondary permeability of 10^{-3} cm/sec. Observed permeabilities of the Michigan fly ashes were in the 10^{-3} cm/sec range (Gray and Lin, April 1972).
