PREFACE

The Papers and Information contained in this Proceedings Volume were presented at the 35th Annual Highway Geology Symposium and Field Trip held on the campus of San Jose State University in San Jose, California, August 15-17, 1984. The theme of the conference was "Geotechnical Problems Associated with Transportation Routes on a Major Plate Boundary". This theme was selected to emphasize the difficulties that engineers and geologists have in dealing with the problems planning. of designing and constructing in characterized active by faults, evolving (often unstable) topography, and active shorelines. The conference brought together more than 100 scientists and engineers from various parts of the United States to share new information and ideas.

HIGHWAY GEOLOGY SYMPOSIUM

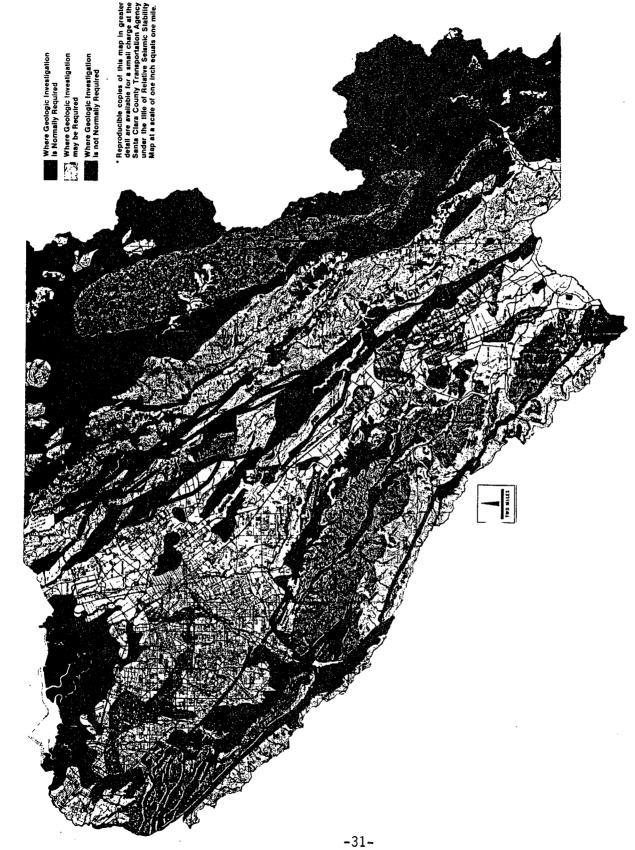
Figure 22. "Investigative Needs" map, available from the Santa Clara County government, indicates those areas for which geologic reports would be appropriate. The requirement for a geologic report is based on generalized knowledge about the presence or absence of particular geological hazards within a selected area (Santa Clara County, 1976)

What efforts are under way that would allow the increasing population to live with the geologic hazards that are in the San Francisco Bay area? One approach is to use effective planning, to focus the investigative efforts. Because of the geotechnical expertise and limited resources (time and money), there is little chance that the entire route of a proposed transportation corridor can be evaluated in infinite detail. The use of maps such as those provided by the government of Santa Clara County, on which areas have been designated in which geologic may exist permits the better utilization of hazards investigative resources (Figure 22). On this map, areas which are shown as red zones (the darkest grey tones) are those in which geologic hazards are believed to exist and additional geological investigations are warrented. Green zones are areas in which no

hazards are known to exist and additional geologic work probably is unnecessary. The yellow zone, a cautionary zone, is one in which specific information is lacking; caution should be exercised and additional geologic investigation may be prudent. Much about the activity and the mechanics of fault rupture has been learned during the Alguist-Priolo special studies which were required by the state legislature following the 1971 San Fernando earthquake. result of this legislation, the State Geologist was required to establish zones approximately 0.25 miles in width, along faults which are believed to be potentially active. Within these zones, studies are required to insure that special geological structures for human occupancy will be built on ground capable of undergoing fault rupture.

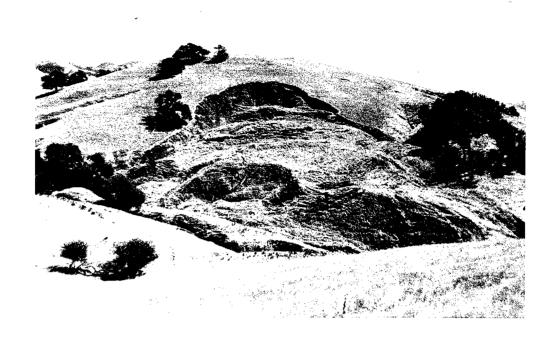
Figure 3. Rotational slump east of Morgan Hill.

Slides were mapped using red ink, on the topographic road maps. Arrows, indicating the direction of movement, and identification numbers for each slide were included on the maps. Numbers cross-indexed the observed slope failures with data sheets that were compiled for each slide (Figure 2). Data sheets, devised by the Santa Clara County Geologist, were utilized to catalogue each slope failure with respect to location, nature of failure (mudflow, rotational slump, debris avalanche, etc.), dimensions, slope gradient, lithology, drainage structures involved, age of slide, and potential risk to life and property. All roads actually traversed in each area were indicated on the maps in green ink. Potential slope failures, where suggested by topography, drainage and vegetation, were mapped in blue ink. Figures 3 and 4 illustrate a well defined rotational slump east of Morgan Hill and the corresponding map segment.

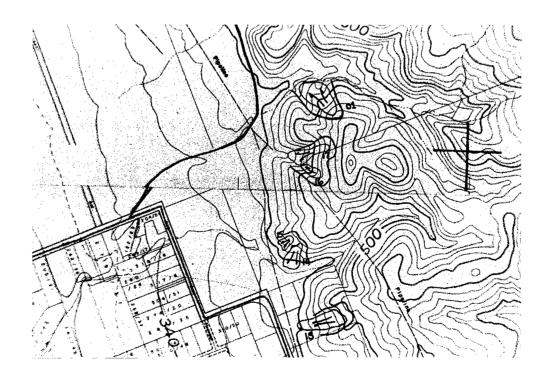
Figure 4. Rotational slump (01) illustrated on contour map.

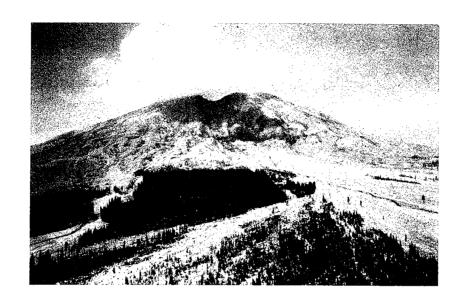
Figure 2. Mudflow deposits on the east side of Mount St. Helens.

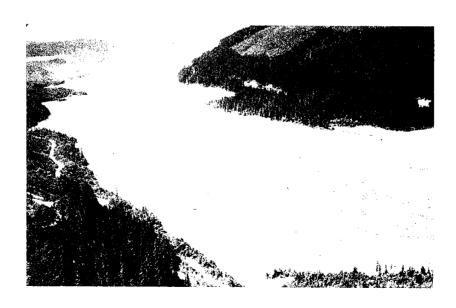
Figure 3. Mudflow deposit in the Muddy River arm of Swift Reservoir (photo courtesy of John J. Cassidy).

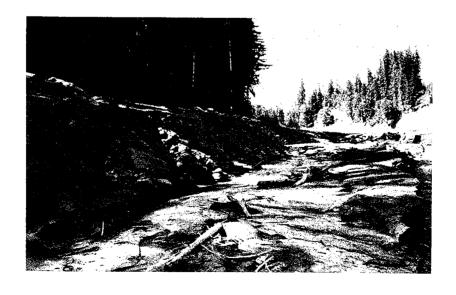
Figure 5. Eroded mudflow deposit in Muddy River drainage.

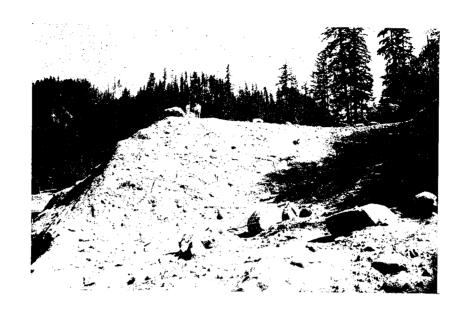
Figure 8. Large boulders deposited on a bridge abutment by mudflows southeast of Mount St. Helens.

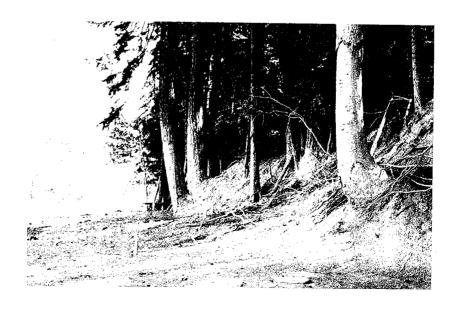
Figure 9. Bark removed from trees by the coarse material supported in a mudflow.

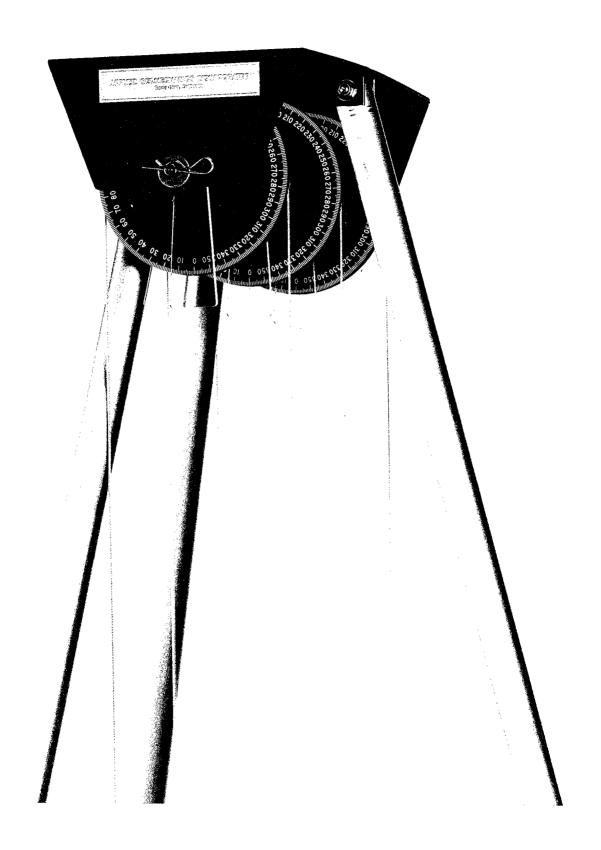
Figure 4. APPLIED GEOMECHANICS AGI-200 Borehole Creepmeter.
This is a purely mechanical transducer that measures the lengthening or shortening of wires anchored at different depths in a borehole.

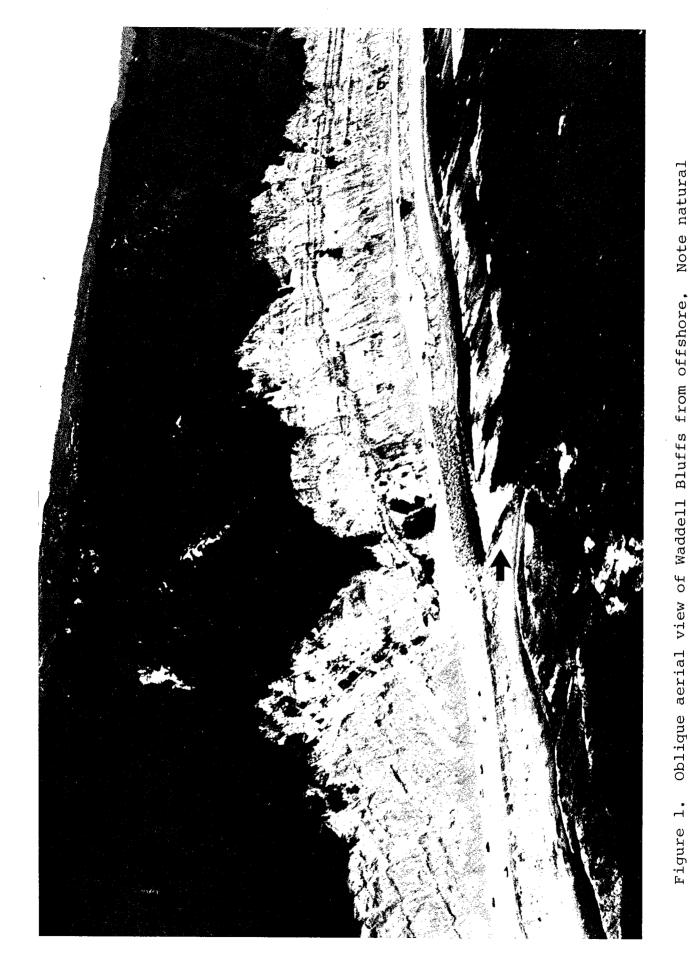
Oblique aerial view of Waddell Bluffs from offshore, Note natural groin in center (arrow) of photo, and protective riprap immediately downcoast,

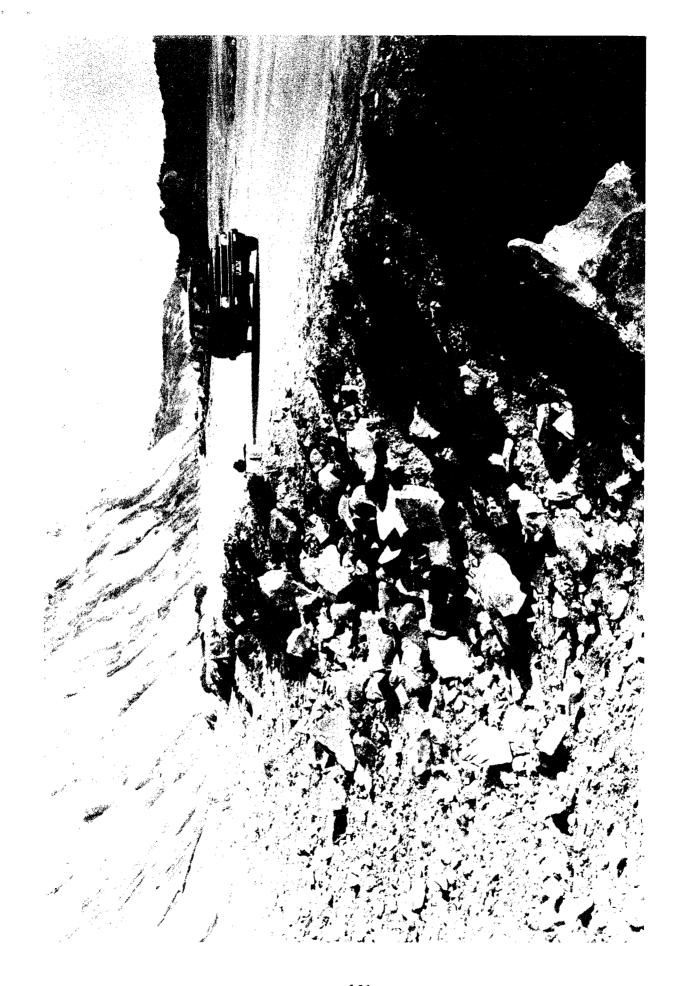
Debris trench along Northern bluffs in nearly full, un-maintained condition (December 1982.) Figure 8.

The design dimensions, however, must be maintained if the bouncing and rolling rocks are to be kept off the roadway. Trench inspection on a number of site visits in late 1982 and early 1983 showed the northern half of the trench to be over half full and that bounding rocks were regularly reaching the roadway (Figures 10 and 11). According to Ritchie's observations, rock slopes of 0.75:1 (53 degrees) and over 60 feet in height (at Waddell Bluffs maximum heights are over 350 feet) would require a trench 15 feet wide and 6 feet deep. Depths along much of the northern half of the trench in early 1983 were only two to four feet (Figures 8 and 10).

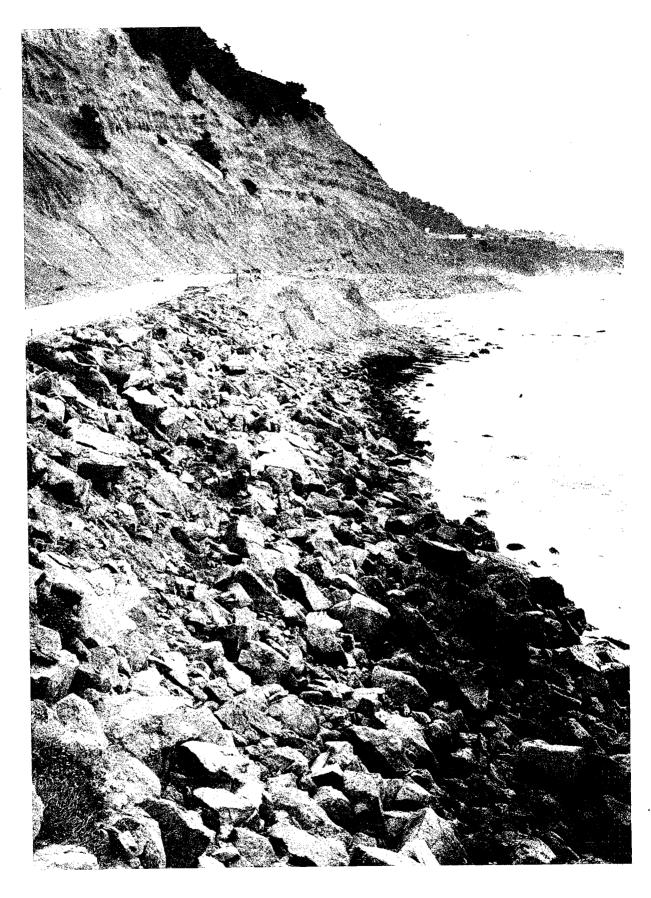
Figure 12. Initial riprap emplaced in 1947 to protect eroded area downcoast from natural groin. Some settlement has occurred. View downcoast.

ures 1 and 12). The mudstone bedrock platform in the intertidal zone provided a good foundation for the riprap. The base of the rock was placed at - 6 feet MLLW and extended to a height of +40 ft., which is considerably higher and lower than most riprap emplacement. Typically in the Monterey Bay area. riprap may extend from elevations of -2 to +1 ft. MLLW to +16 to 24 ft. MLLW. The slope of the original rock was 1.75:1. No maintenance is on record for this riprap since its emplacement in 1947-48. The structure is still in good condition although the rock has settled and shifted somewhat such that the slope is now concave up with the lower portion less steep than the upper portion (Figure 12). There has been no more than 10 to 15 feet of seaward movement of any of the rock. Over the years following installation of the rock, there has been a gradual downcoast movement of the smaller granitic rocks from For example, 2 to 3 ft. diameter rocks have moved approximately 50 feet downcoast, 1 to 2 ft. diameter rocks have moved 100 feet and 8 inch rocks have been transported 300 feet.

removed and the roadway itself was undermined and began to collapse. Ultimately, approximately 24,000 tons of riprap was brought in a cost of \$605,000 to protect two sections totaling about 1800 feet of Highway One (Figures 12 and 13). The 1983 winter was severe by any measure, over \$100 million in damage to the California coast was recorded (Griggs and Johnson, 1983). If severe winters of this sort reoccur, additional riprap may well be required in order to protect the remaining exposed portions of Highway One at Waddell Bluffs.

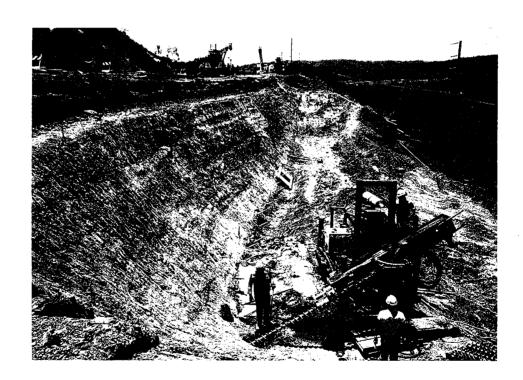
FIGURE 4

Figure 4 shows the slide after the loose material was removed and during the installation of the bottom level of tiebacks.

The drill rig is operating on a twenty-foot wide bench which continued to settle and move downslope while installing this level of tiebacks. The drilling for the tiebacks indicated that the anchors were being placed in very compact claystone with seams and lenses of sandstone and cemented sand. Resistance to drilling in the claystone and cemented sand was about the same, while resistance in the sandstone was much greater. After each tieback shaft was drilled, the corrosion-protected tieback tendon and a grout tube was placed to the bottom of the hole. Neat cement grout was then tremied through the bottom of the pipe until clean grout came out to the surface of the drill shaft. The grout was allowed to achieve an initial set of 15 to 30 minutes, then grout was again pumped from the bottom of the hole as a second-stage of pressure grouting. Grout pressures up to 300 psi were achieved until grout began to come up to the surface around the grout plug, at which time the second-stage grouting operation was stopped.

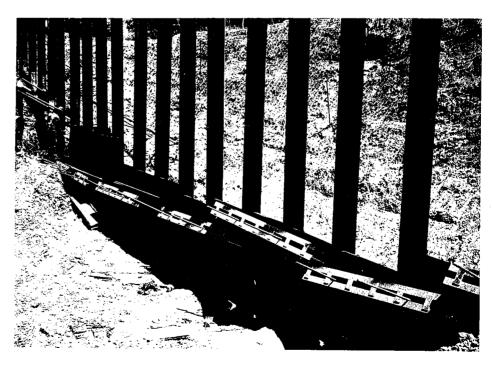
FIGURE 8

Figure 8 shows the front of the wall with the lower tiebacks extended through the wale prior to being locked off at 15 kips.

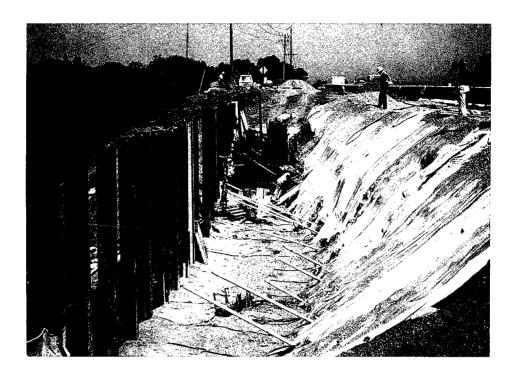
FIGURE 9

Most of the middle and upper levels of tiebacks were installed from behind the wall as shown in Figures 9 and 10.

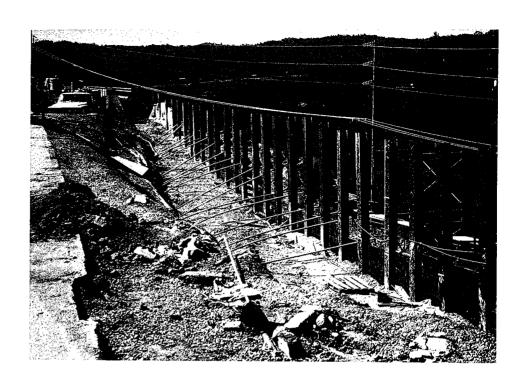
FIGURE 11

Some of the tieback extensions to the front of the wall are very long, up to 20 feet, see Figure 11. Backfilling of the lower portion of the wall was accomplished by end dumping crushed rock from the top of the slope to the bottom of the wall. Backfilling around the upper level of tendons was accomplished by end dumping roadway embankment soil from the top of the slope, then compacting the soil with hand-held compactors around the tendons. Because the tendons were at an angle, good compaction under the tendon was hard to achieve and some bending in the bars was observed. Figure 12 shows one of the completed walls with a maximum depth of approximately 28 feet.

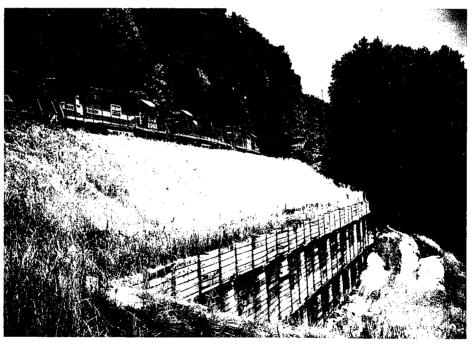
FIGURE 14

Three specialist firms submitted proposals for design and construction of the wall, and Schnabel Foundation Company was selected to perform the work. As a part of our design, we utilized our patented corrosion protection for the tiebacks. Figure 14 shows a view of the completed wall. This landslide stabilization wall was built from the top down, right through the fill. Drainage material was placed behind the wood lagging as the lagging was installed.

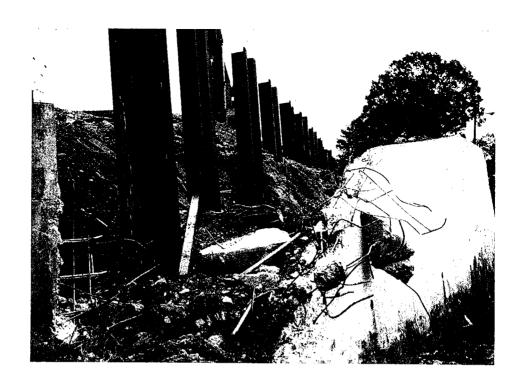
FIGURE 18

Figures 18 and 19 show the patented double-zee soldier beam, wood lagging, and tiedback wall being installed behind the failed cantilever retaining wall. Figure 20 shows the tiedback wall complete with a thin concrete face. The concrete face was the desired end product required in the performance specifications prepared by the owner.

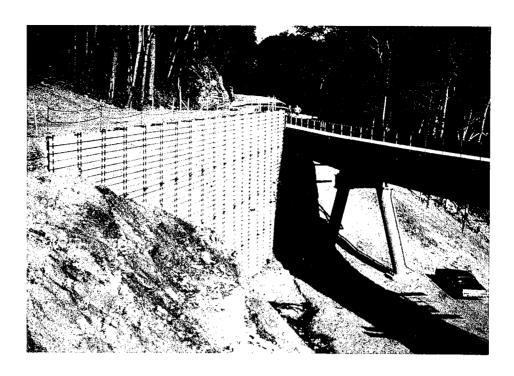
FIGURE 21

I would like to digress here a moment and mention that various wall facings can be placed on a tiedback wall. We have discussed two already, wood lagging and concrete. We do not recommend wood because of the potential for continued maintenance problems. Other types of wall facings an owner may want to specify include precast concrete, Figure 21 or cinder block, Figure 22.

The precast boards in Figure 21 were attached to the face of the soldier beams, in front of the wood lagging. The wood lagging had been installed between the soldier beams as the site was excavated to subgrade. The cinder block wall in Figure 22 is a patented system called Ivany Block and is installed from the bottom up in front of the wood lagging.
