**PROCEEDINGS OF THE 38TH ANNUAL  
HIGHWAY GEOLOGY SYMPOSIUM**

**"HIGHWAY CONSTRUCTION IN  
UNSTABLE TOPOGRAPHY"**

**Pittsburgh, Pennsylvania  
May 11, 12 & 13, 1987**

**CO-SPONSORED BY  
Pennsylvania Department of Transportation  
and  
Engineers' Society of Western Pennsylvania**

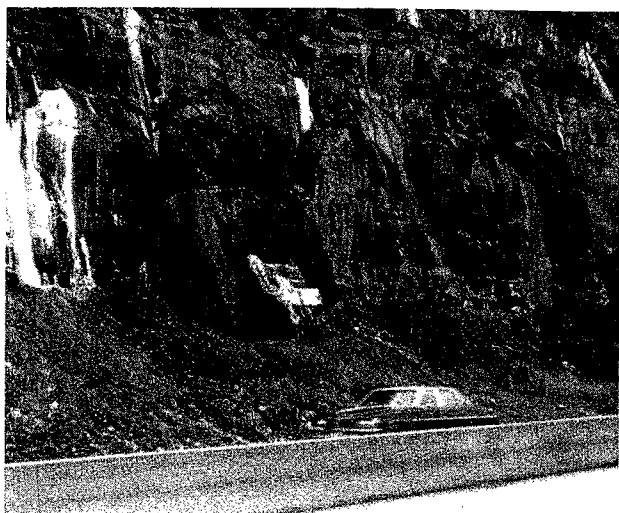
Figure 4: Large plane failures at Mingo Junction cut.

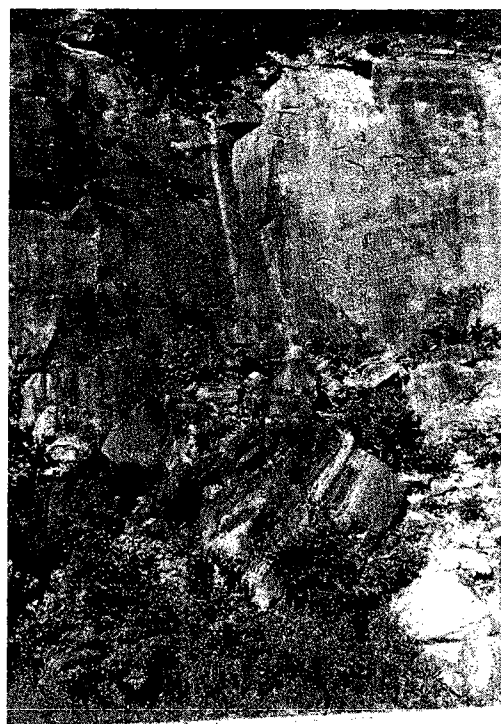
Figure 5: Shallow wedge failure at Mingo Junction cut. Notice the large rock blocks in the foreground.

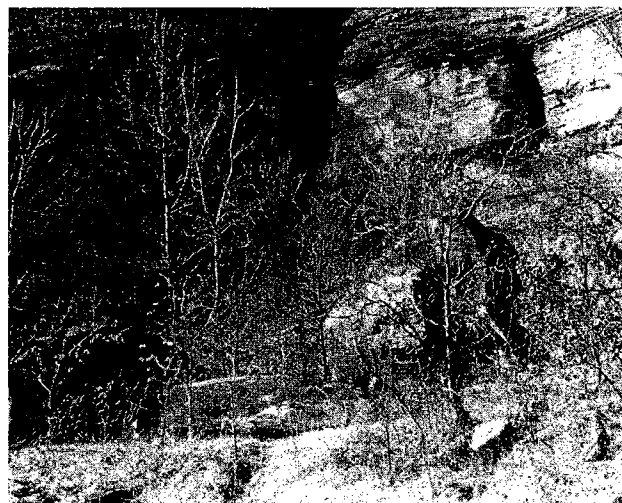
Joint sets A and E represent the valley stress relief joints at this site. According to Table 4, these joint sets result in failures P1, W1, W3, and W4. The zero values of factors of safety for W3 and W4 suggest that these are wedge-shaped rock falls. Joint set E dips into the slope and could possibly result in toppling failure but evidence for such a failure was not found in the field. Several examples of well developed plane failures can be seen at this site. The one shown in Figure 8 happened in the massive sandstone. The largest rock block, on the right side of the figure has a volume of nearly 9000 cubic feet. Another plane failure occurred within two months after completing field work at this site. In this failure, a large rock block measuring 144 cubic ft, landed within 20 ft of where the joint survey

Figure 8: Large plane failure at Brilliant cut. Notice the near right-angle joints in the upper right and the large rock blocks in the foreground.

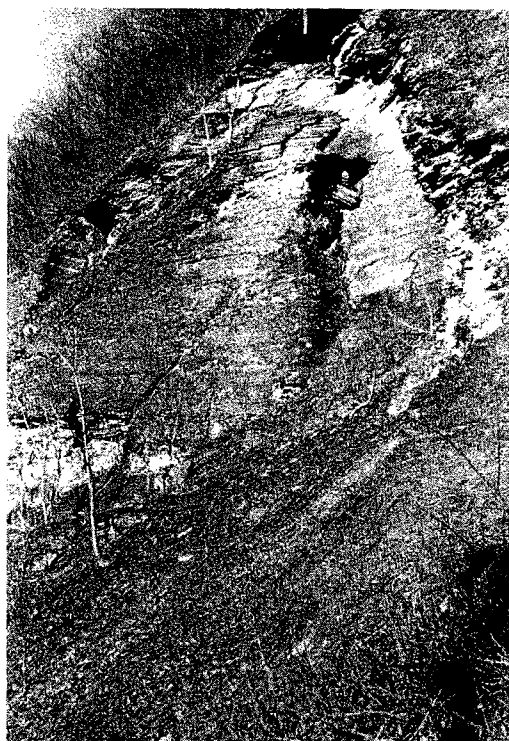
No valley stress relief joints within the requisite 20 degrees of the river orientation (generally north-south) were determined from the stereonet contour diagram. However, as seen in Figure 11, some large plane failures were observed at this site. These plane

Figure 11: Plane failure at East Steubenville cut.

failures occur where the road trends nearly parallel to joint set C (N24° E/86° NW). The dominant wedge failures W2 and W3, are formed by combinations of joint set A with joint sets B and C. These are large wedges as illustrated in Figure 12. The shale, due to its siliceous nature, has an extremely high (99%) shale durability rating, whereas the claystone completely disintegrates in water giving a zero rating. However, undercutting

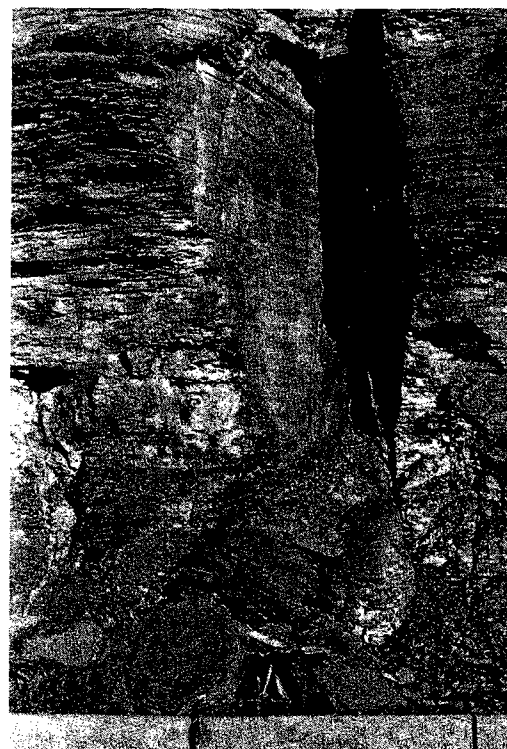
Figure 12: Wedge failure at East Steubenville cut.

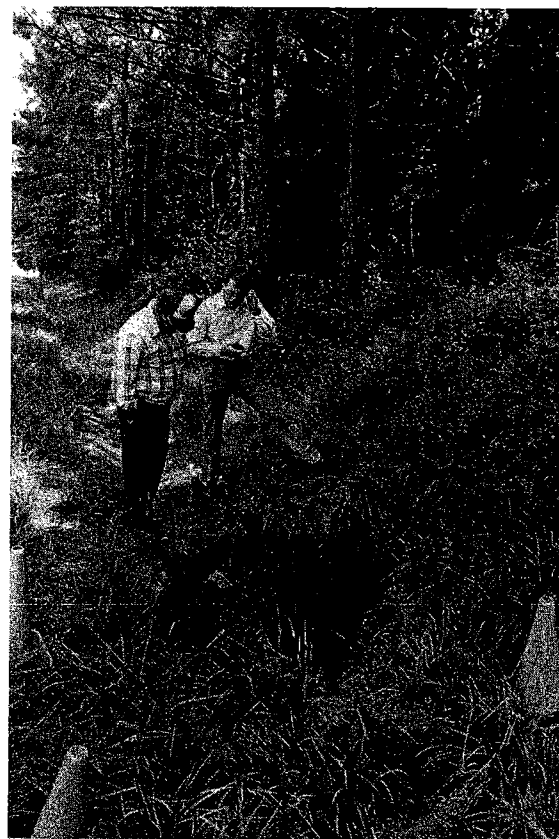
Figure 4. Induced sink-hole along untreated ditch-line; note bedrock in throat of collapse.

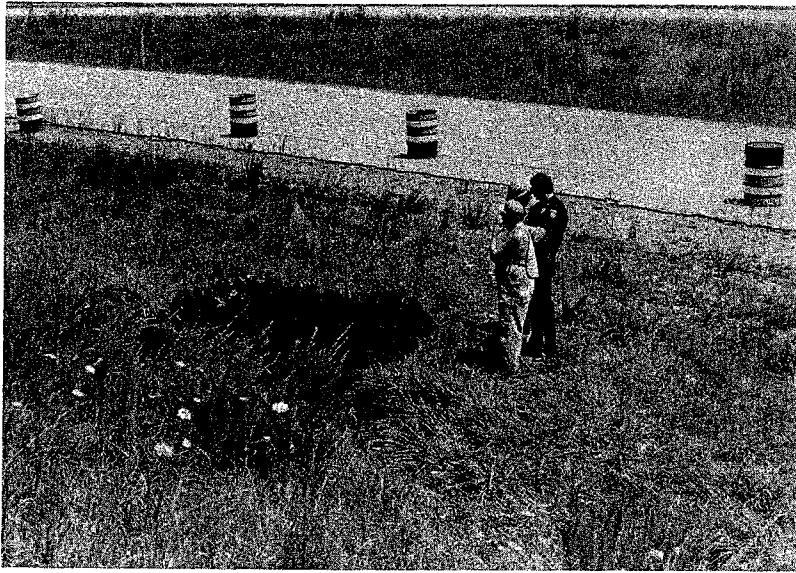
Figure 5. An unpaved ditchline resulted in this collapse along S. R. 73 in Maryville, Tennessee.

Paved or treated ditchlines were found to be associated with only 6.9% of the induced collapses. Results of the study indicate that the majority of the ditchline induced sinkholes (93.1%) developed along untreated ditches (Figure 5). The

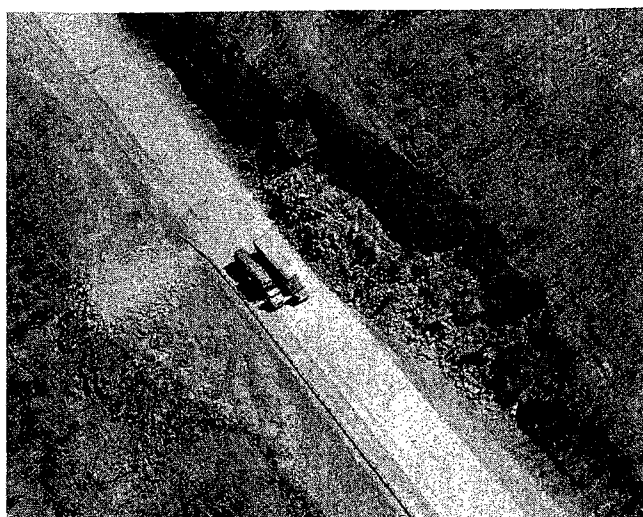
Figure 3. Aerial view of I-81 rock slide as it appeared on March 21, 1986, one day after cut-slope failure. Note the long headwall scarp and the blocky nature of the slide mass. (Photo courtesy of Pennsylvania Department of Transportation).

At failure, the slide mass was approximately 185 ft wide, 40 ft long, and 20 to 40 ft high and had a total volume of approximately 7000 yd<sup>3</sup> (Figure 3). The limiting discontinuities of the failure consisted of a curved, subvertical strike joint (head scarp), subvertical dip joints (side scarps), and several undulatory bedding planes (slide surface) (Figure 4). Shear failure took place mainly within weathered mudstone lenses that partially fill several adjacent northwest-plunging crossbed troughs. At the extreme northeast end, however, slippage occurred on a 1- to 2-inch band of friable sandstone that had been intensely leached and oxidized by the intermittent movement of perched groundwater. The average size of blocks in the slide - 1 to 2 ft on a side - reflected the typical spacing of bedding planes and strike and dip joints; one huge block - more than 10 feet square - remained intact at the extreme northeast end (Figure 5).
