# Proceedings

Highway Geology Symposium

PROCEEDINGS OF THE 22ND ANNUAL  
HIGHWAY GEOLOGY SYMPOSIUM

The University of Oklahoma  
Norman, Oklahoma  
April 22-23, 1971

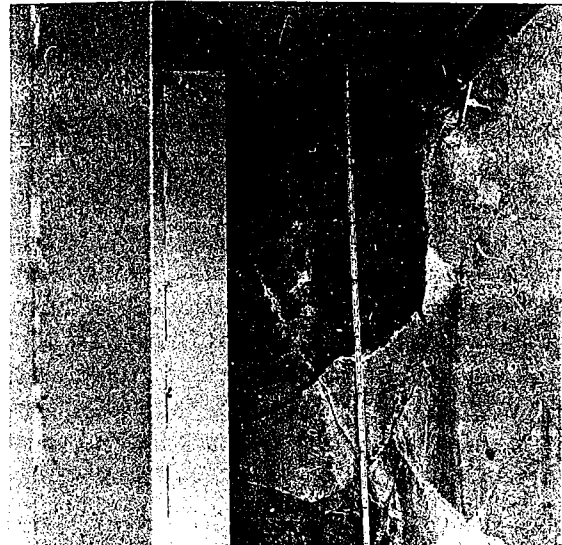
Figure 5. Damage to abutment backwalls. A is a photograph of abutment no. 1; B is abutment no. 2.

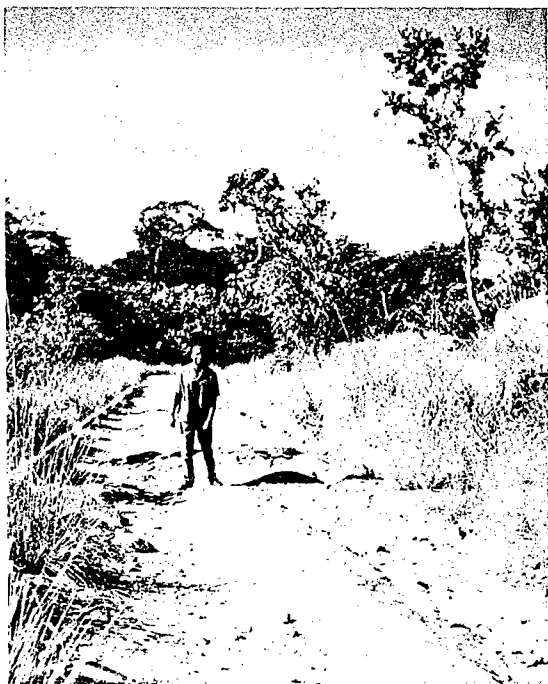
*Figure 5. A section of road developed in weathered clayey and bouldery soil of the Crystalline rocks.*

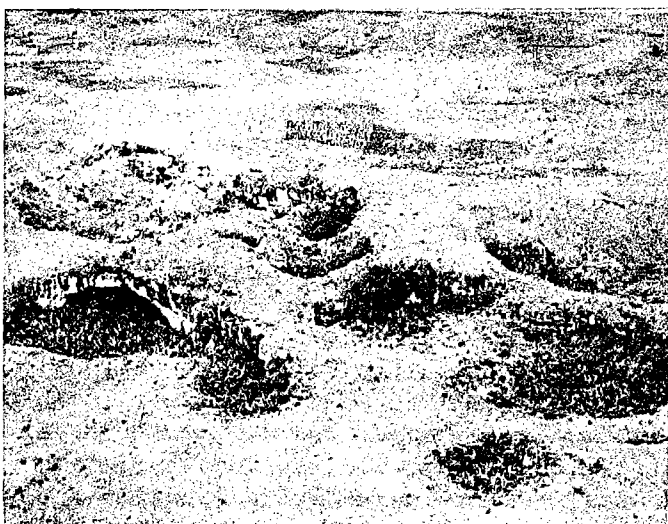
*Figure 7. Sinkholes in Carbonate rocks on left bank of Lubi River north of Kabeya-Komaunga.*

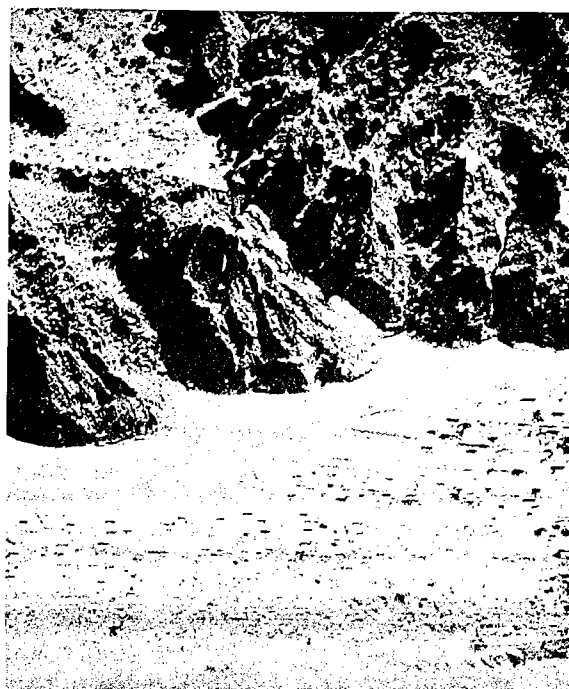
*Figure 8. Erosional cirques in the northern part of the area along the south side of the Mwanzangoma River.*

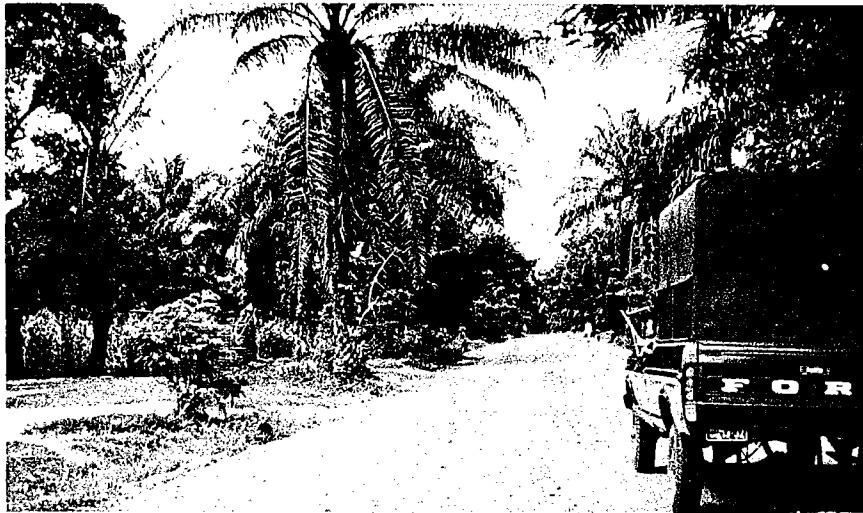
*Figure 9. Section of well-maintained road at Bena Mbala on southern alignment. Waste gravels from diamond mining operations are used to surface road.*

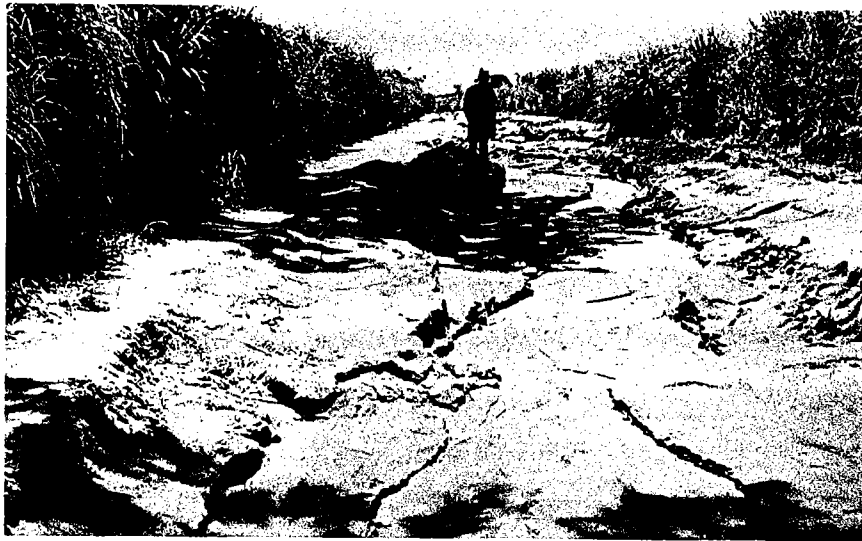
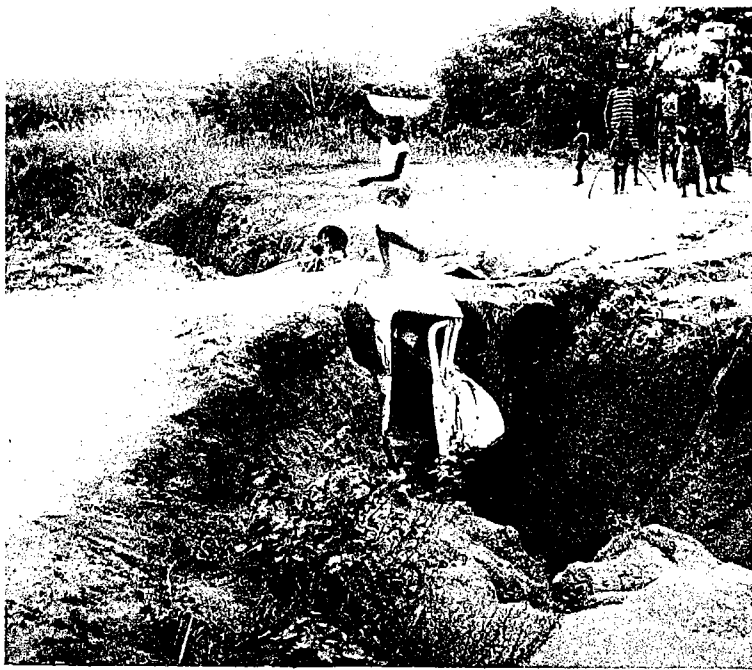
*Figure 10. Examples of side-drain erosion: A, near Bakwa-Mpuka on northern alignment; B, on the Sandstone and Siltstone unit of another section on the northern alignment; and C, truck-body culvert in badly eroded side drain on southern alignment.*
